United States Patent [19][11] **Patent Number:** **6,002,790****Horvath et al.**[45] **Date of Patent:** **Dec. 14, 1999**[54] **METHOD FOR DETECTING AND MEASURING VOIDS IN CONDUCTOR INSULATION SYSTEMS**[75] Inventors: **David A. Horvath**, Ann Arbor; **Steven M. Avila**, Novi, both of Mich.[73] Assignee: **Advent Engineering Services, Inc.**, Ann Arbor, Mich.[21] Appl. No.: **08/762,536**[22] Filed: **Dec. 9, 1996**[51] **Int. Cl.**⁶ **G06K 9/00**[52] **U.S. Cl.** **382/141; 348/92**[58] **Field of Search** 382/141, 144, 382/145, 149; 348/86, 92, 125, 128; 250/339[56] **References Cited**

METHOD FOR DETECTING AND MEASURING VOIDS IN CONDUCTOR INSULATION SYSTEMS

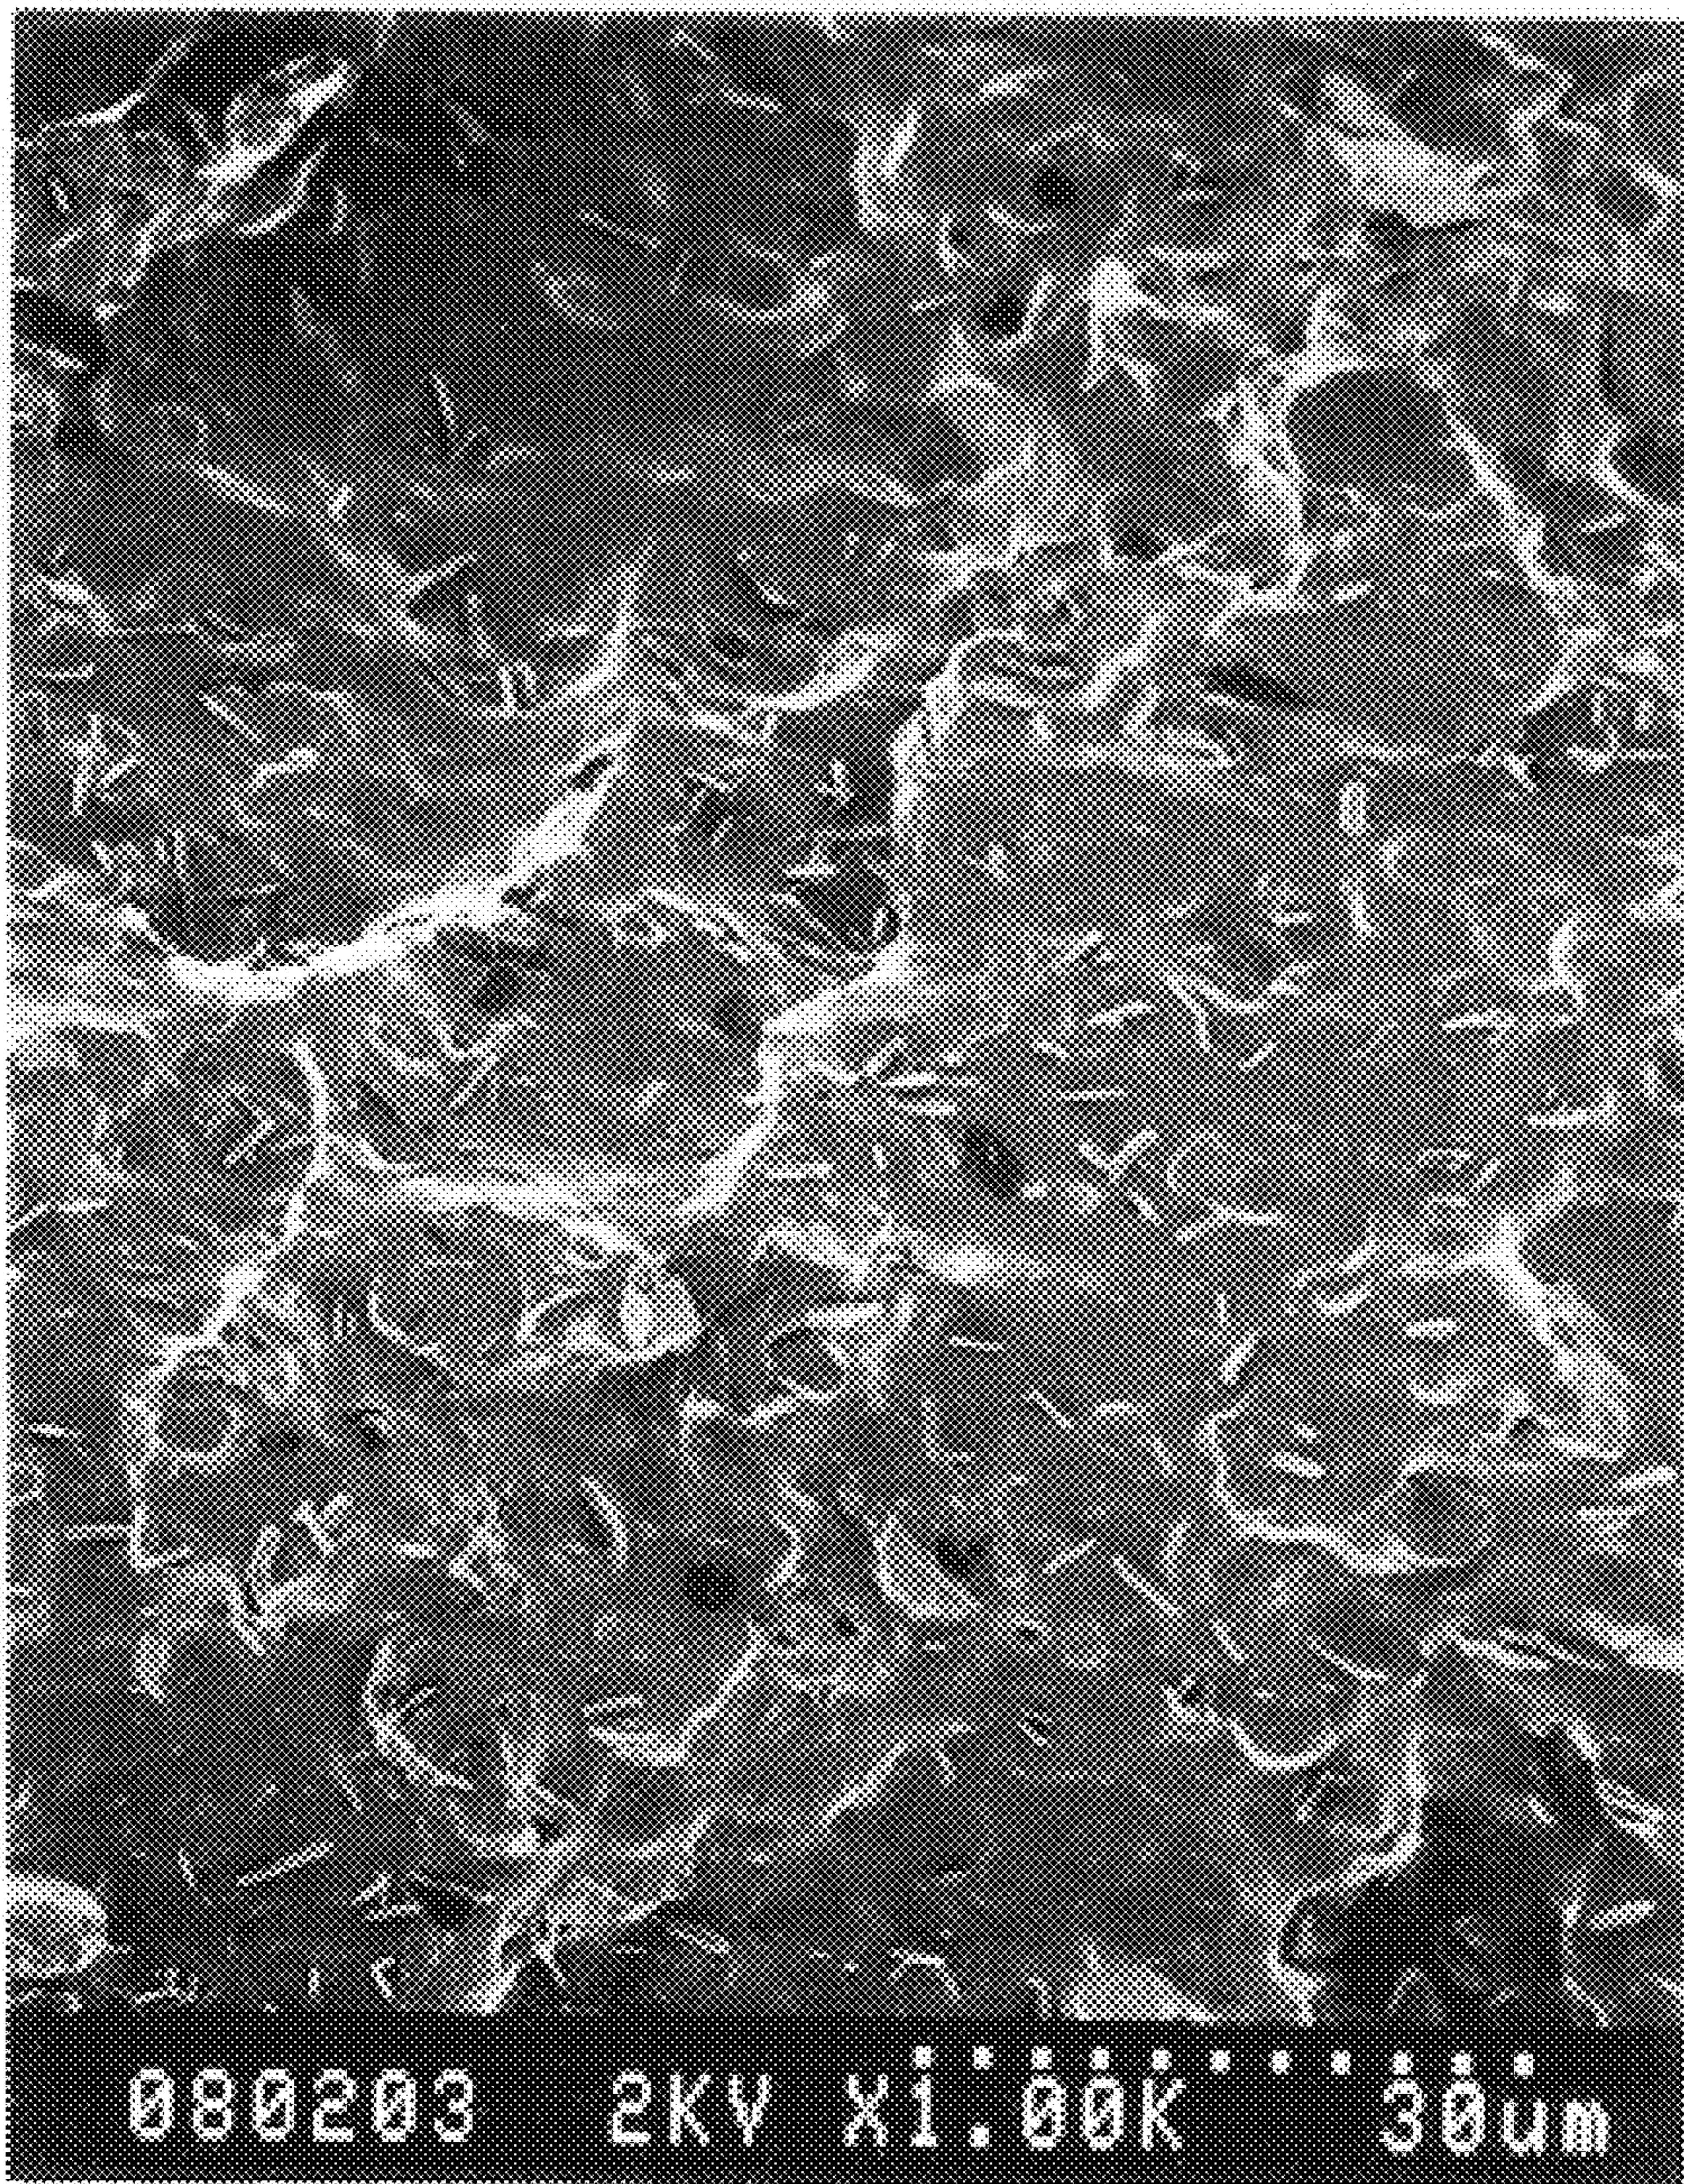
FIG. 19 is a scanning electron microscopic image of Sample 8 at 1000 \times .

An estimated 35 spherical voids are identified over a $0.05\ \text{cm}^3$ volume, which relates to a density of about 700 voids/ cm^3 . FIG. 19 depicts a freeze-fracture surface of a longitudinal cross-sectional cut. The pellet-shaped items in FIGS. 19 and 20 are filler materials. Discussions with Rockbestos, the manufacturer of the cable Samples tested, revealed that Rockbestos uses a Translink-37 surface-treated clay in its cable to improve the bonding of the polymer chains, thereby increasing cable strength. At a micrograph scale of $30\ \mu\text{m}$, the smallest void identified is about 2.5 microns. The largest void is estimated to be 6.5 microns.

areas of Sample 1. FIG. 18 shows entire spherical-shaped cavities grouped in a pattern in Sample 6. FIGS. 19 and 20 show much smaller cavities in a grouped pattern in Sample 8. The fact that void size is smaller in the new cable insulator supports the theory that void size increases with age. However, other possible causes of smaller void sizes include improved manufacturing processes and addition of fillers in the insulation material.

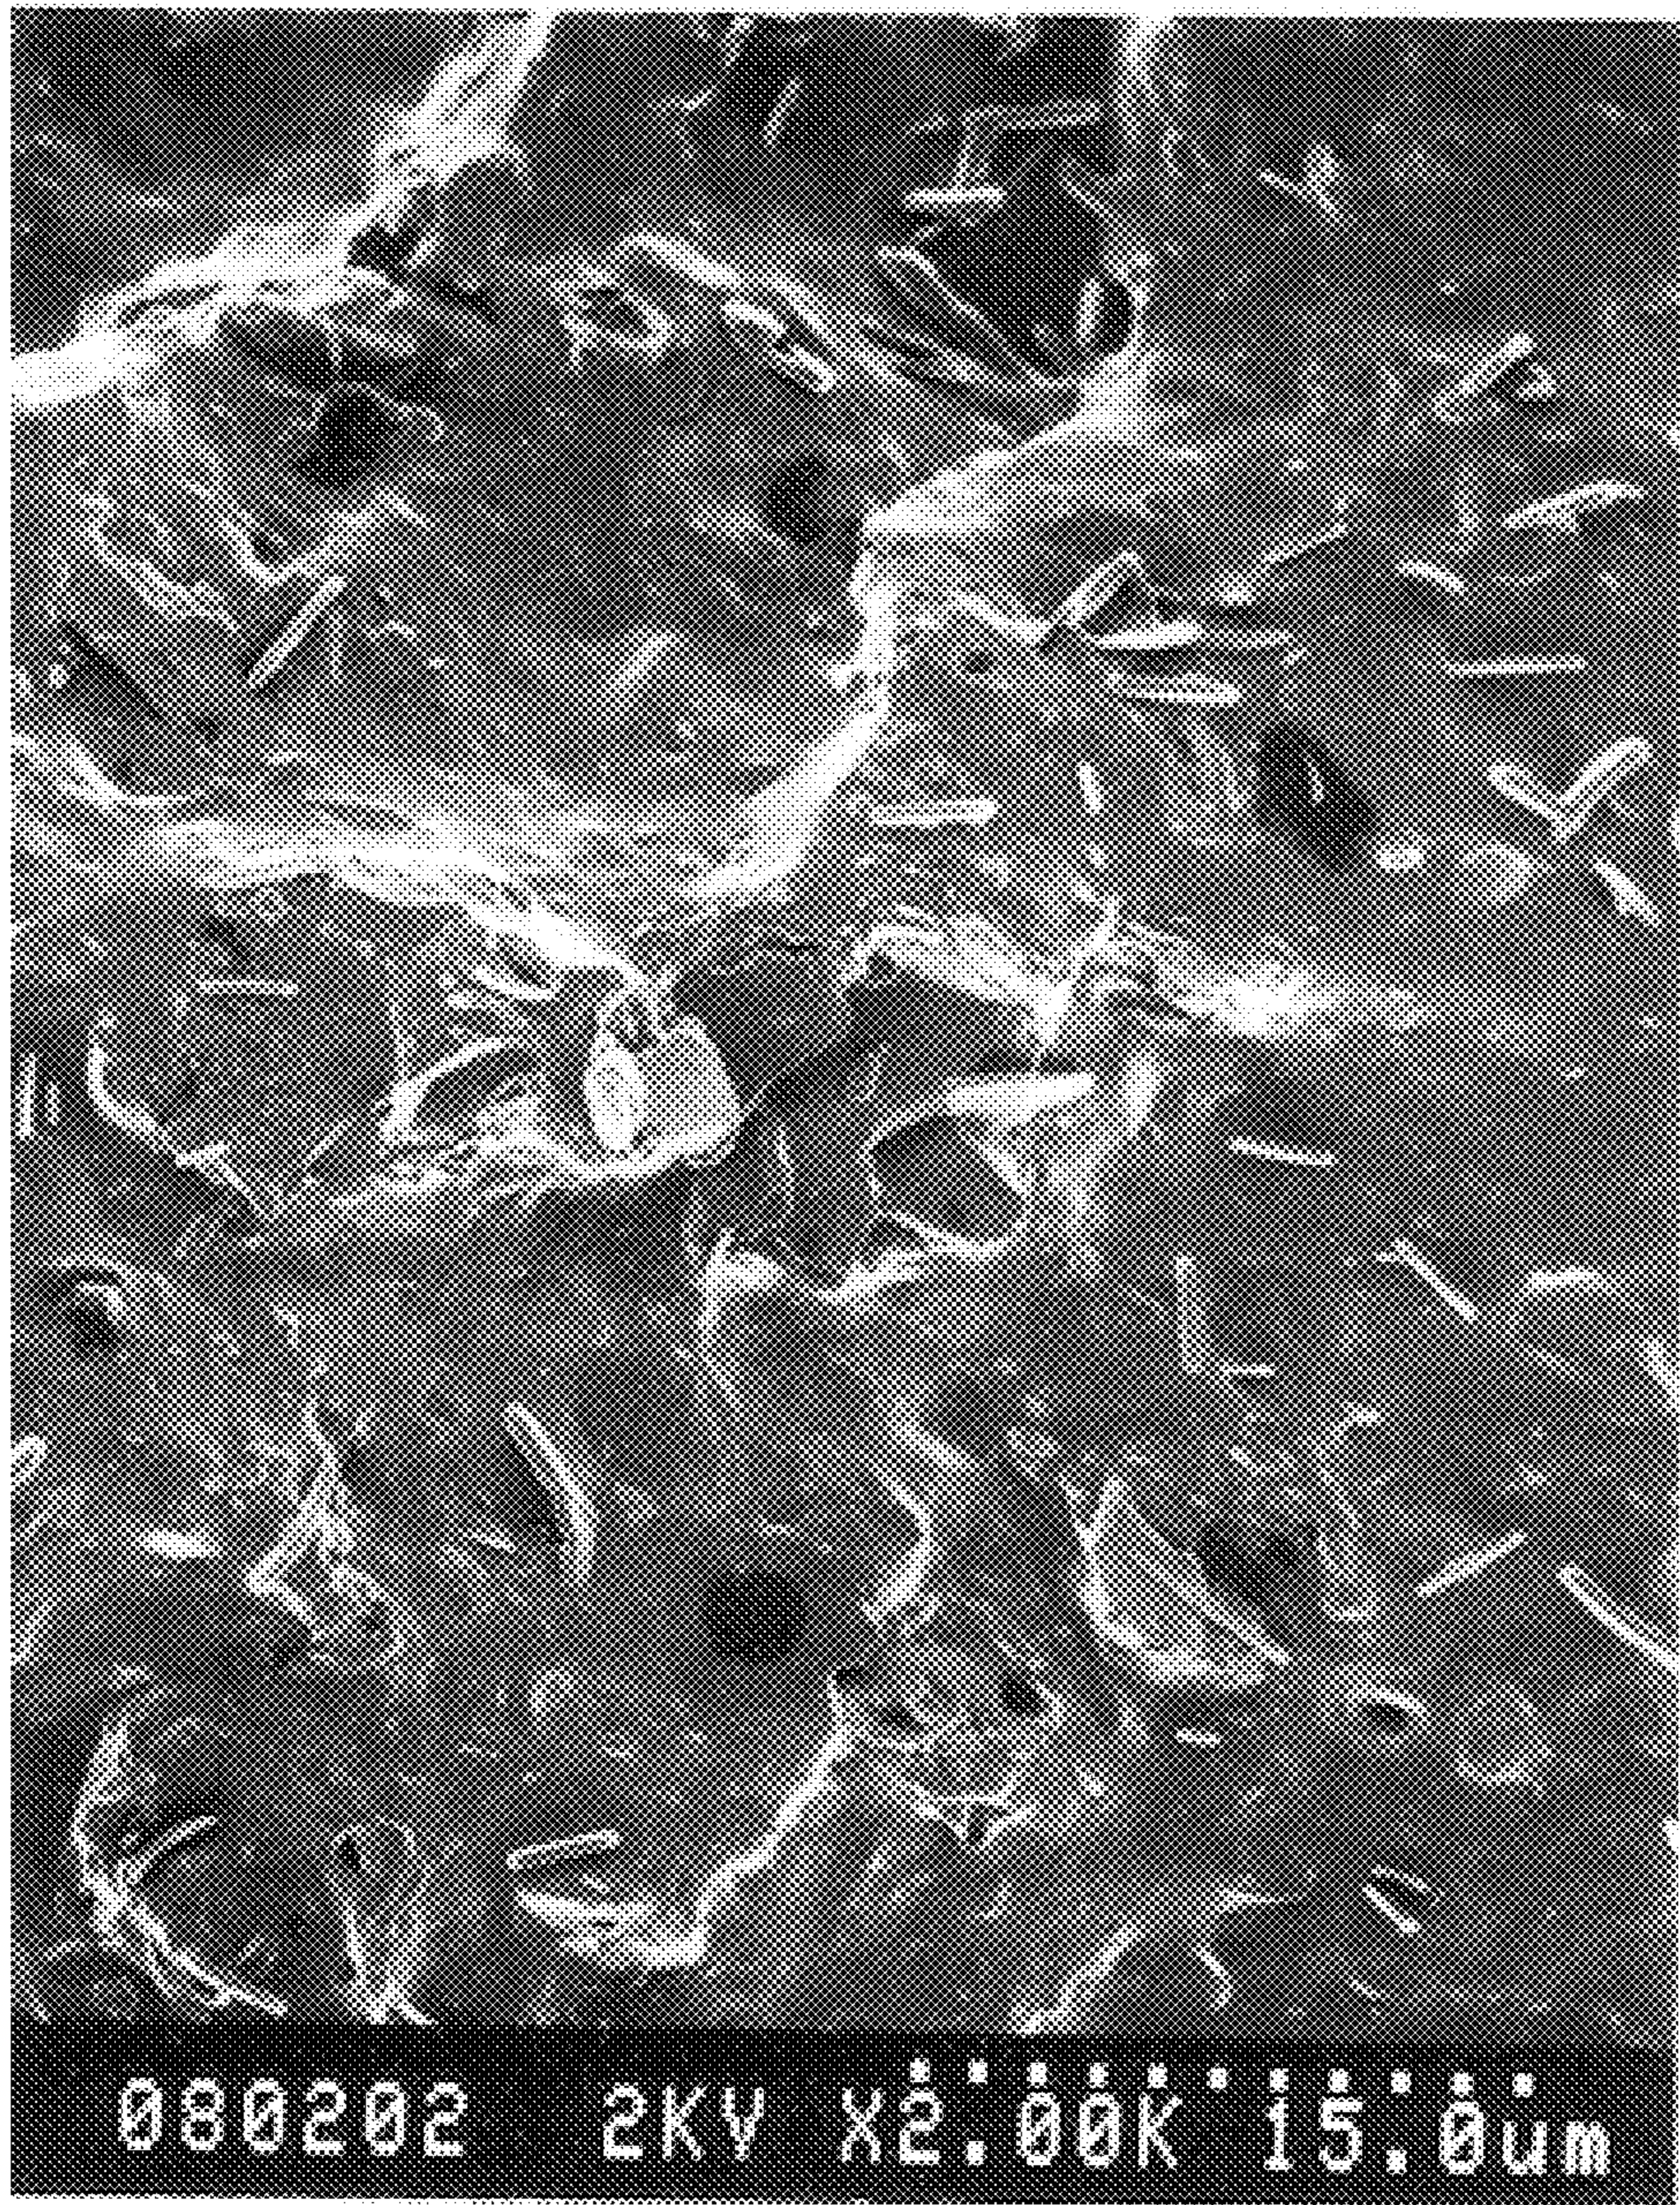
FIG. 20 is a scanning electron microscopic image of Sample 8 at 2000 \times .
