# United States Patent [19]

[11] Patent Number: **6,049,978**

[54] **METHODS FOR REPAIRING AND RECLASSIFYING GAS TURBINE ENGINE AIRFOIL PARTS**

[73] Assignee: **Recast Airfoil Group**, North Haven, Conn.

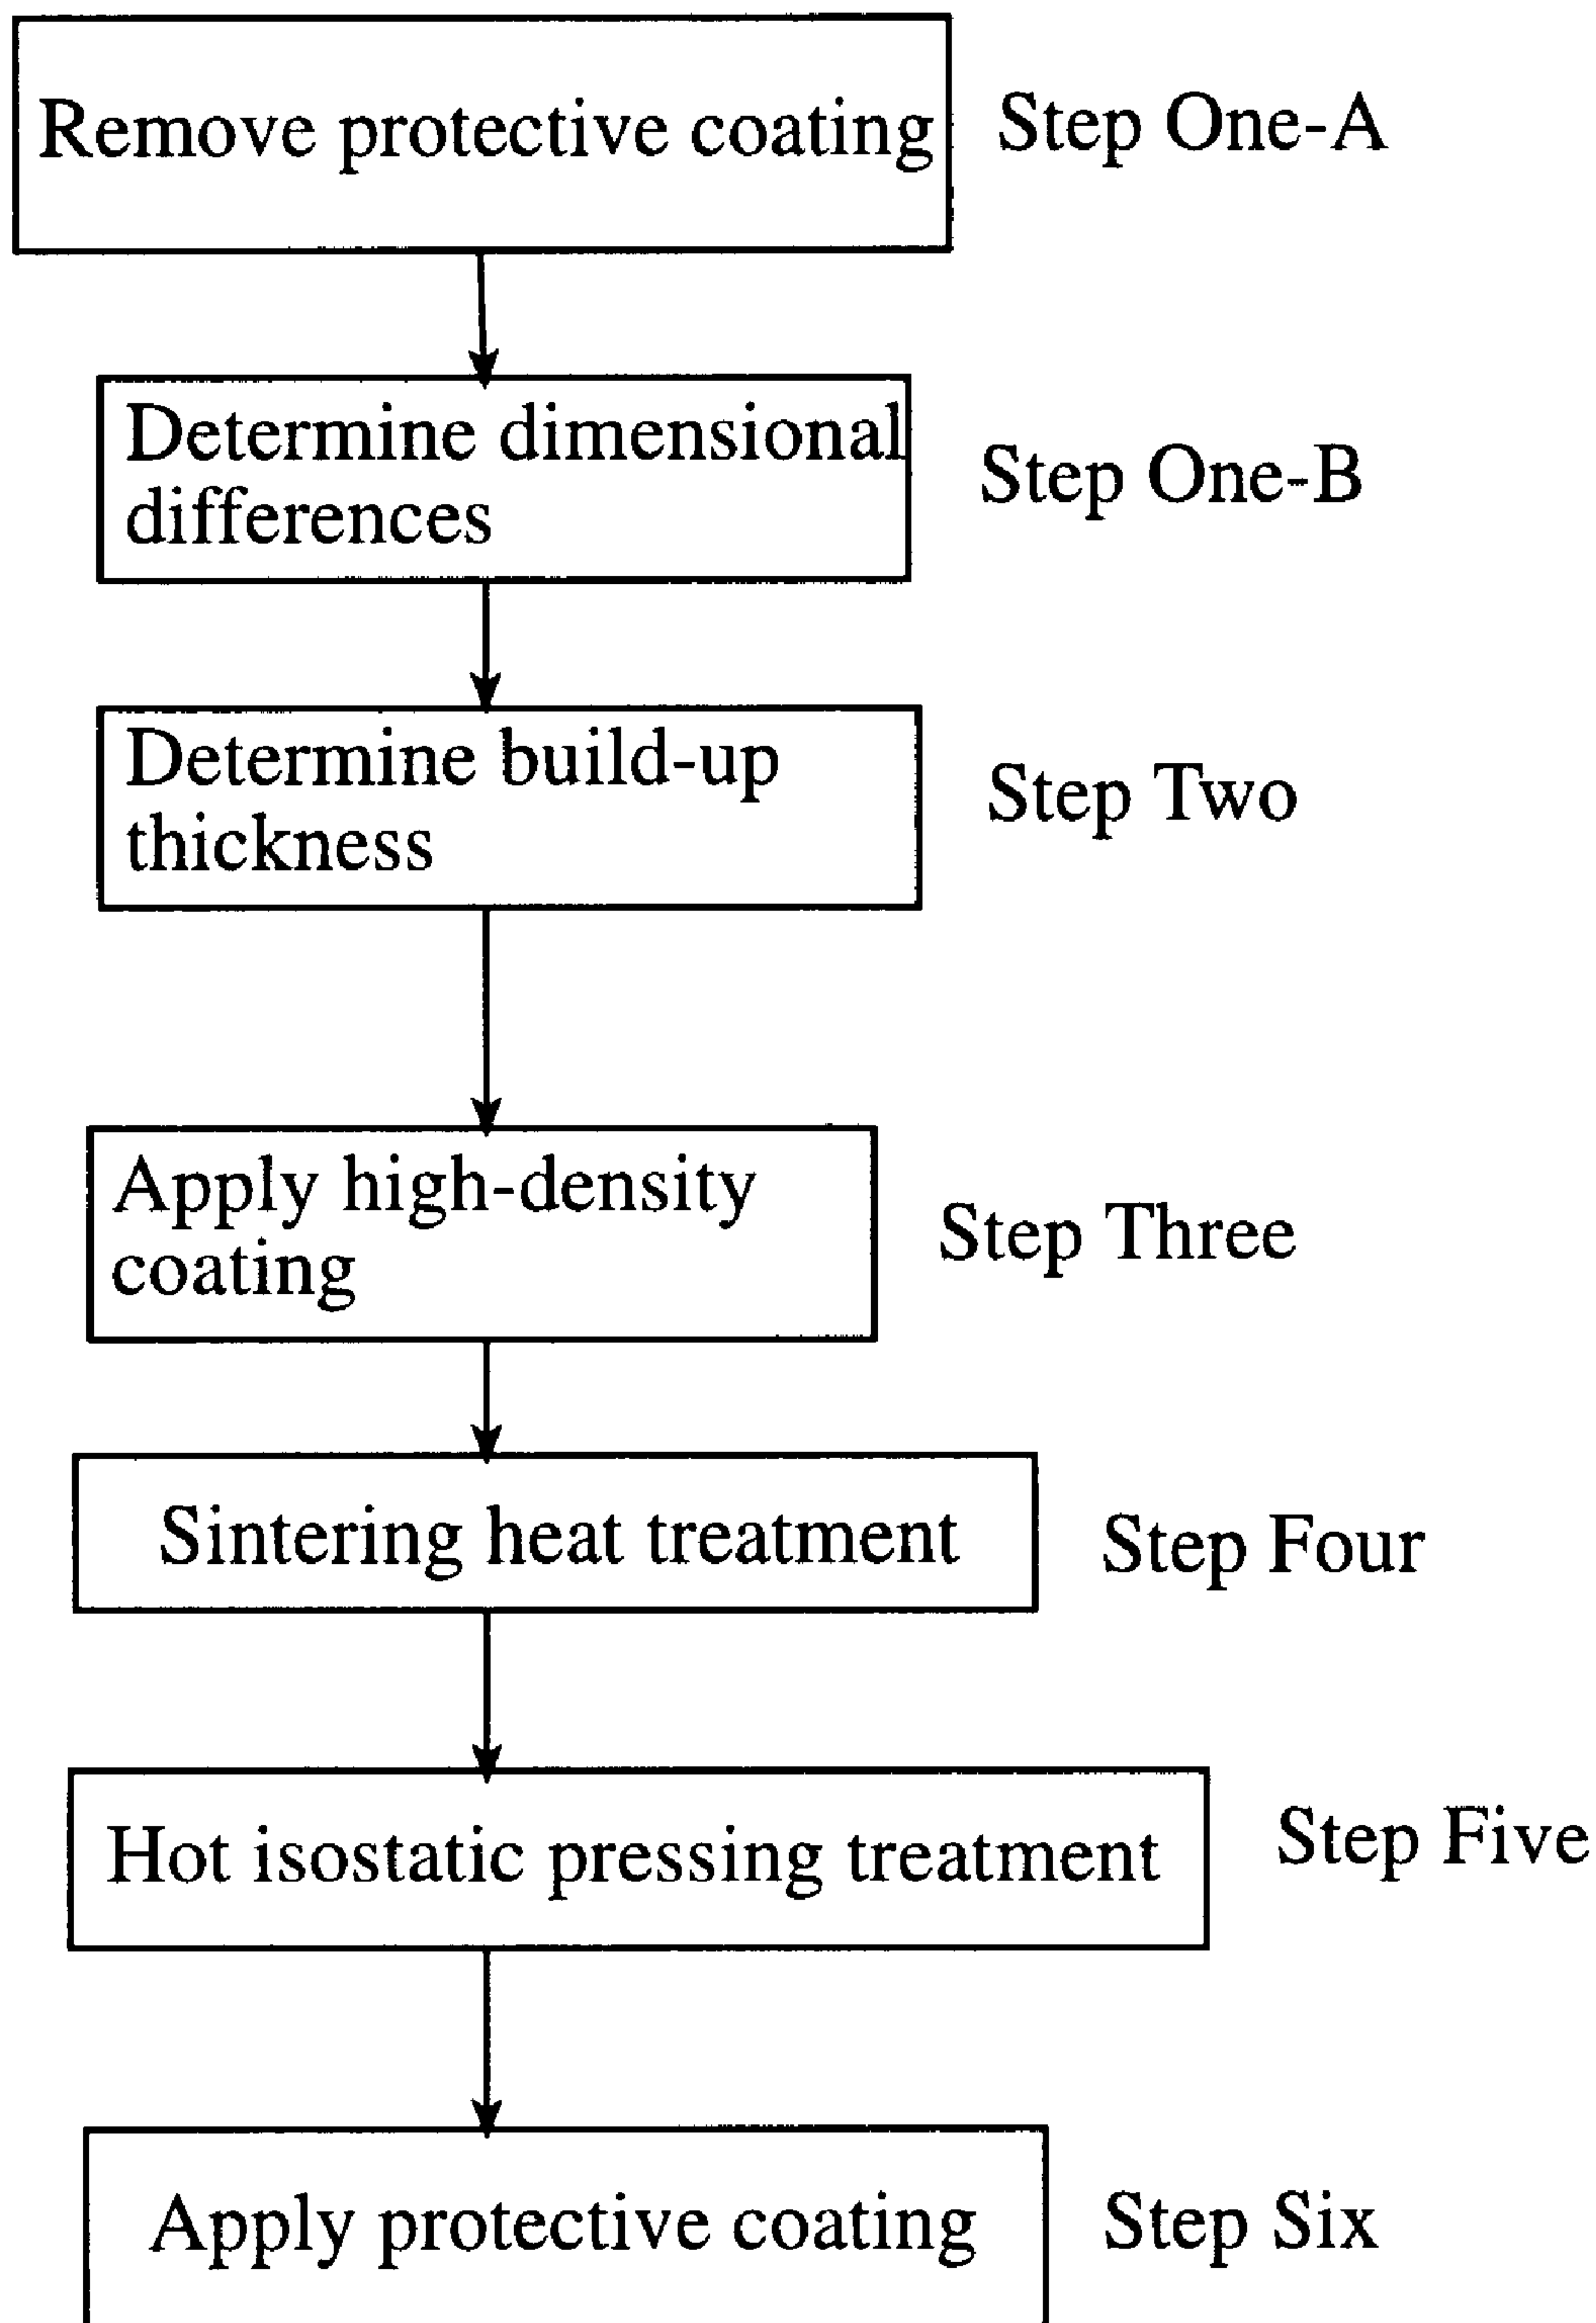
Figure 1(a)

FIG. 1(a) is a flow chart showing the steps of the inventive method for repairing a gas turbine engine airfoil part;

Referring to FIG. 1(a), in accordance with the present invention, the dimensional differences between pre-repaired dimensions of a turbine engine airfoil part and desired post-repair dimensions of the turbine engine airfoil part are determined (Step One-B). The turbine engine airfoil part has a substrate comprised of a superalloy. A build-up thickness of coating material required to obtain the desired post-repair dimensions of the turbine engine airfoil part is determined (Step Two). A high-density coating process, such as HVOF, is used to coat the turbine engine airfoil part with a coating material to the determined build-up thickness of coating material effective to obtain the desired post-repair dimensions after performing a sintering heat treatment and a hot isostatic pressing treatment (Step Three). The coating material comprises a metal alloy capable of forming a diffusion bond with the substrate of the turbine engine airfoil part. After the coating material is applied, a sintering heat treatment process is performed to prevent gas entrapment of the coating material and/or the diffusion bonding area during the hot isostatic pressing process (Step Four). Then, the hot isostatic pressing process is performed to obtain a post-repair turbine engine airfoil part having the desired post-repair dimensions and having diffusion bonding between the coating material and the turbine engine airfoil substrate (Step Five).

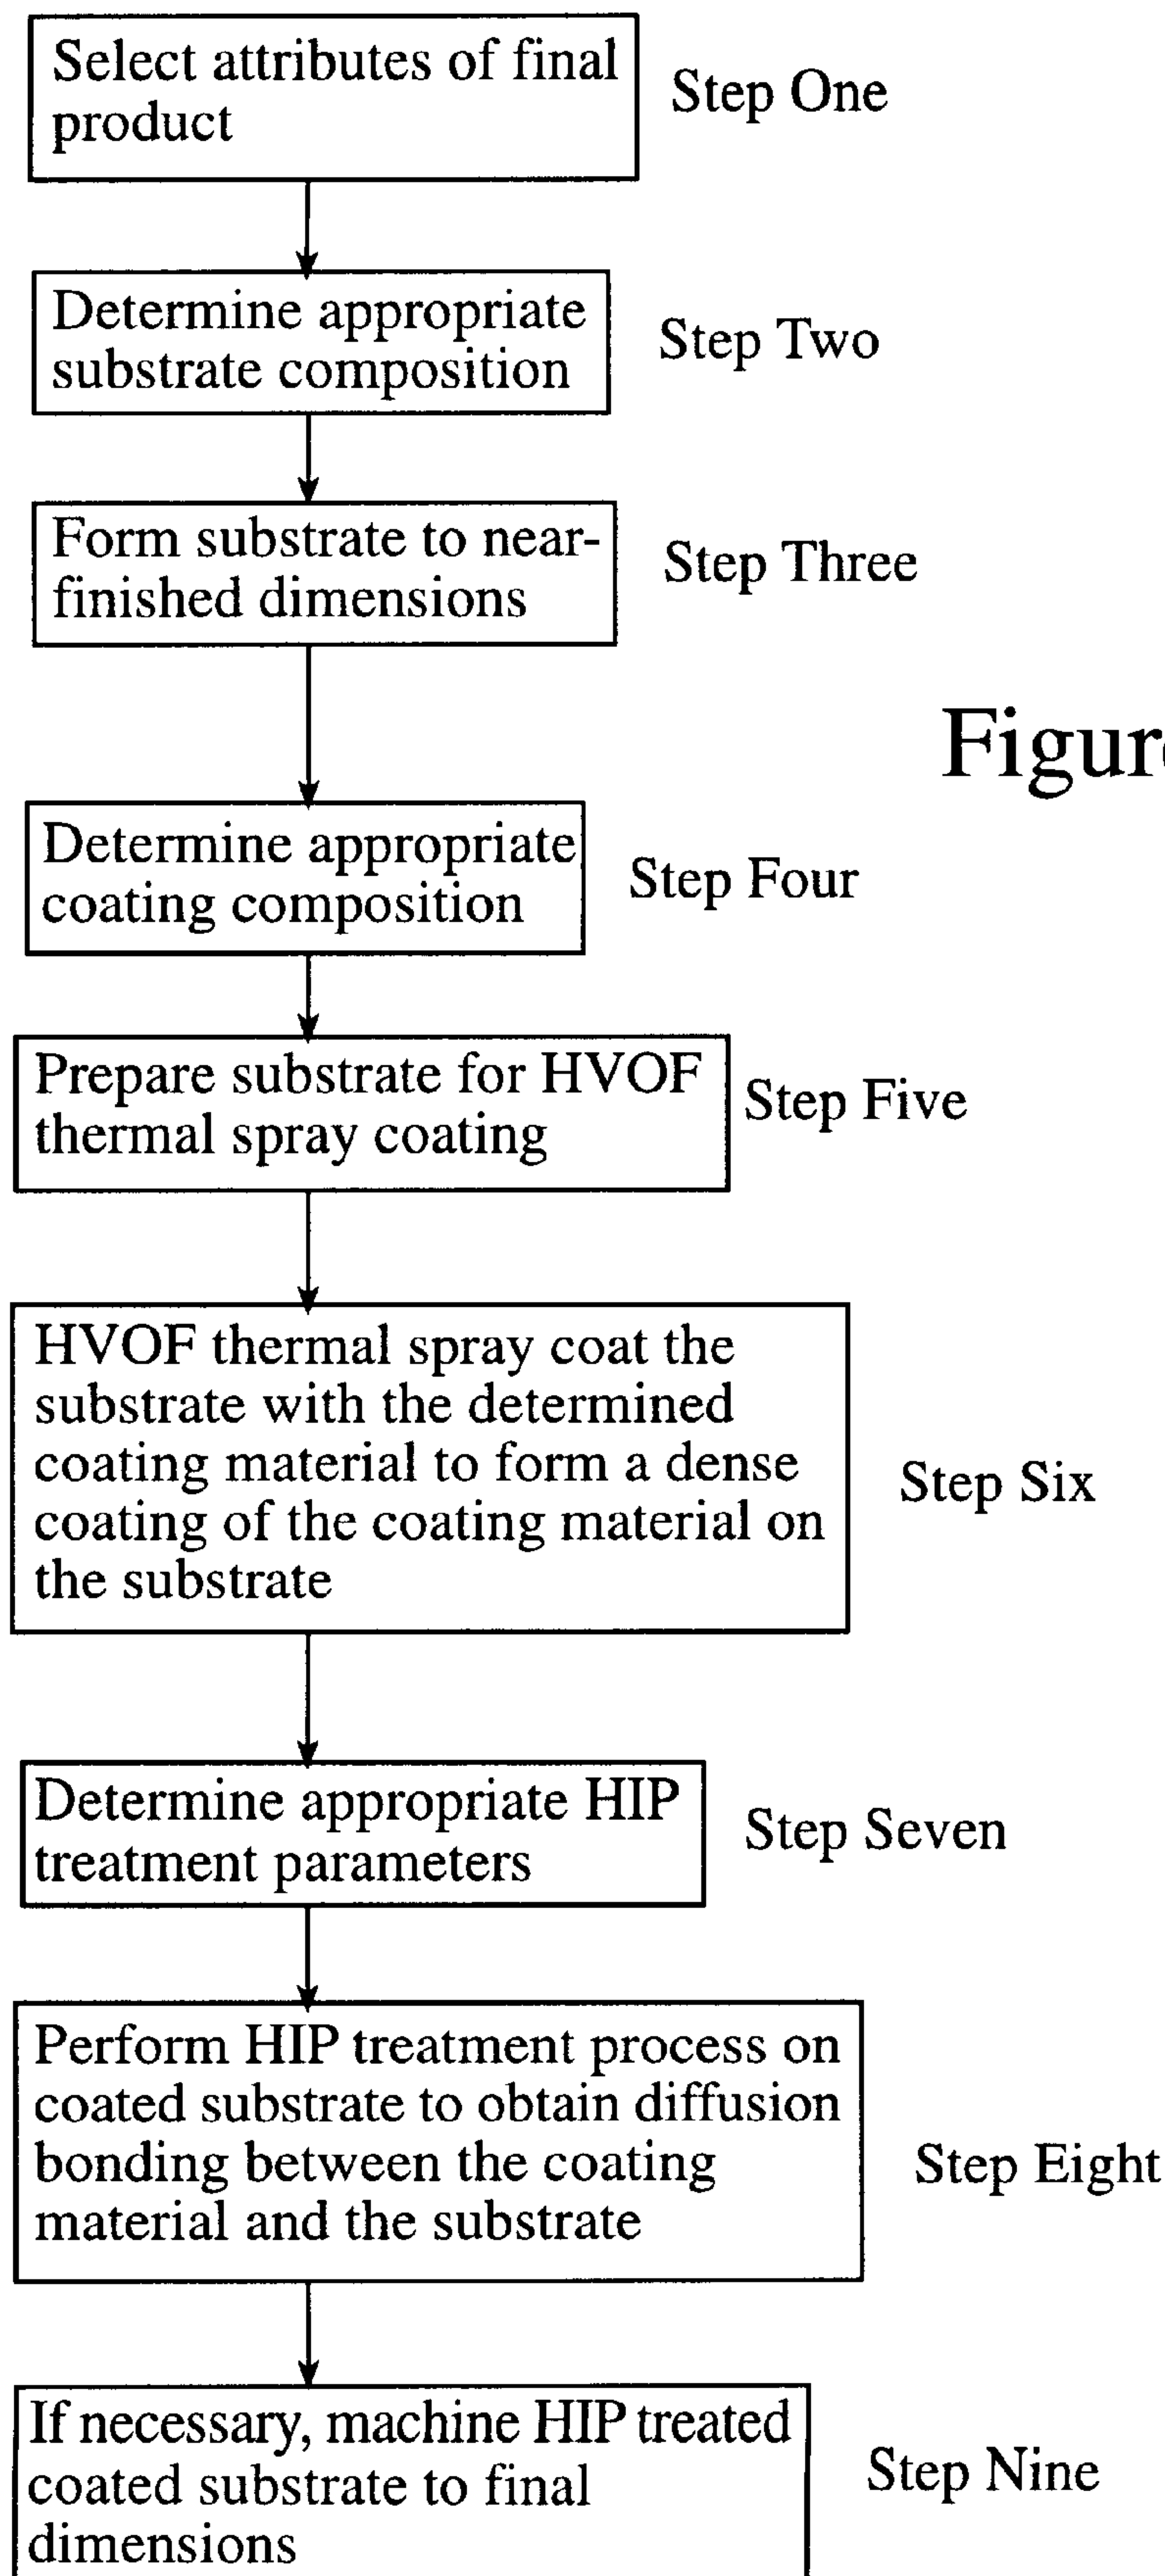
Figure 1(b)

FIG. 1(b) is a flow chart showing the steps of the inventive method of forming metal products and metal components having a wear resistant coating;

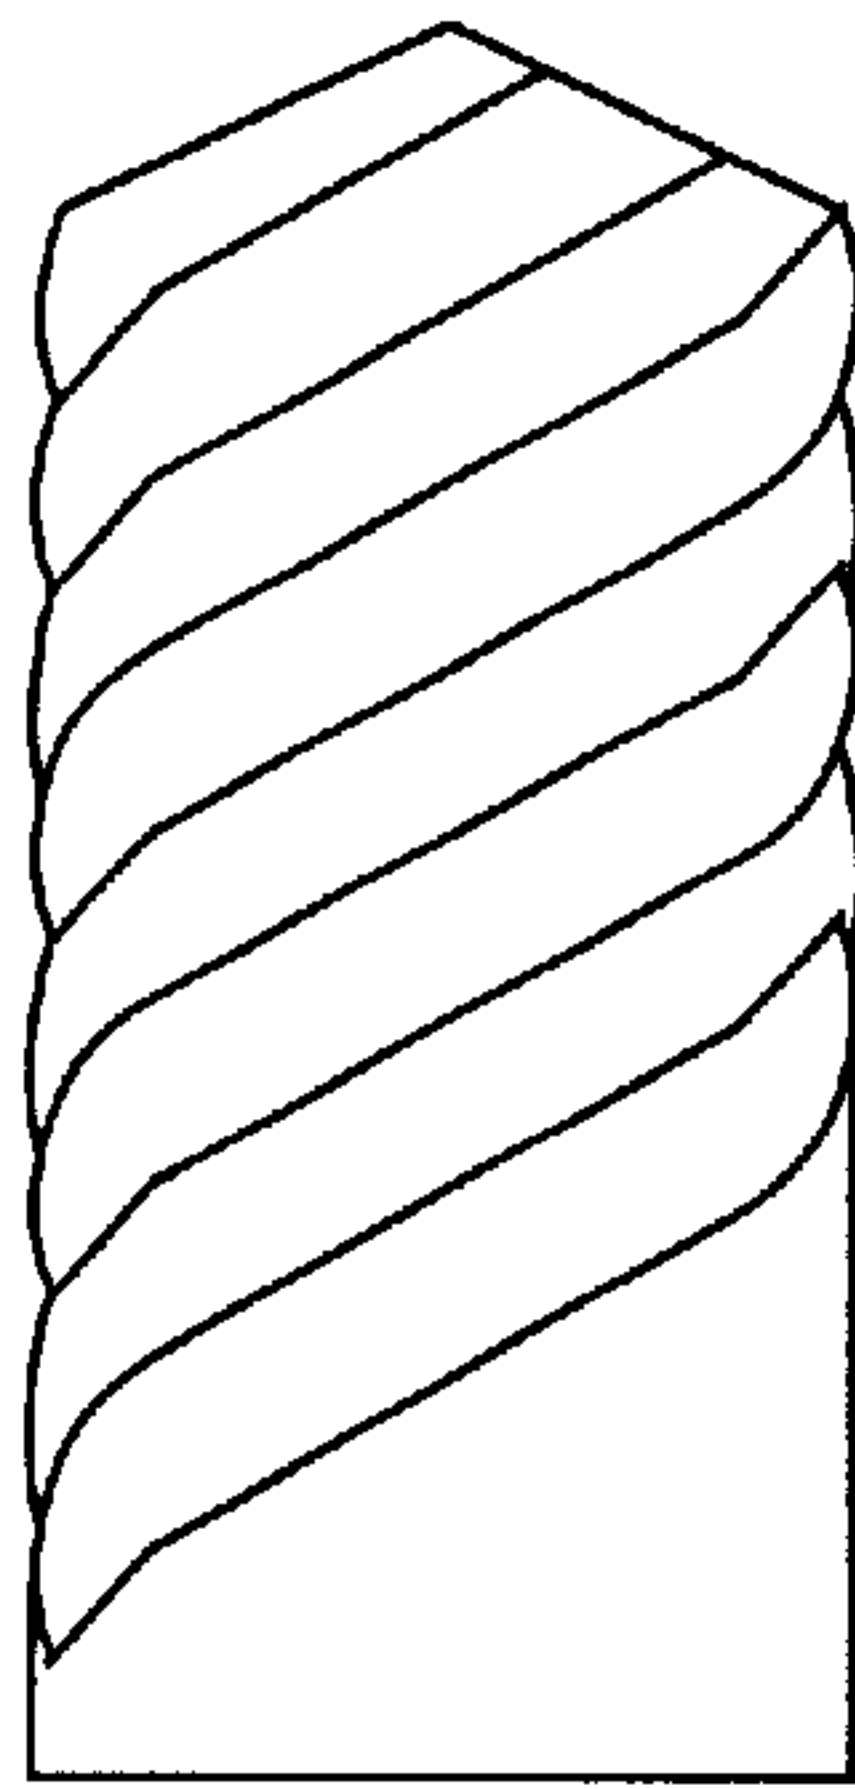
Figure 2(a)

FIG. 2(a) is a schematic view of a tool substrate provided in accordance with the inventive method of forming metal components having a wear resistant coating;

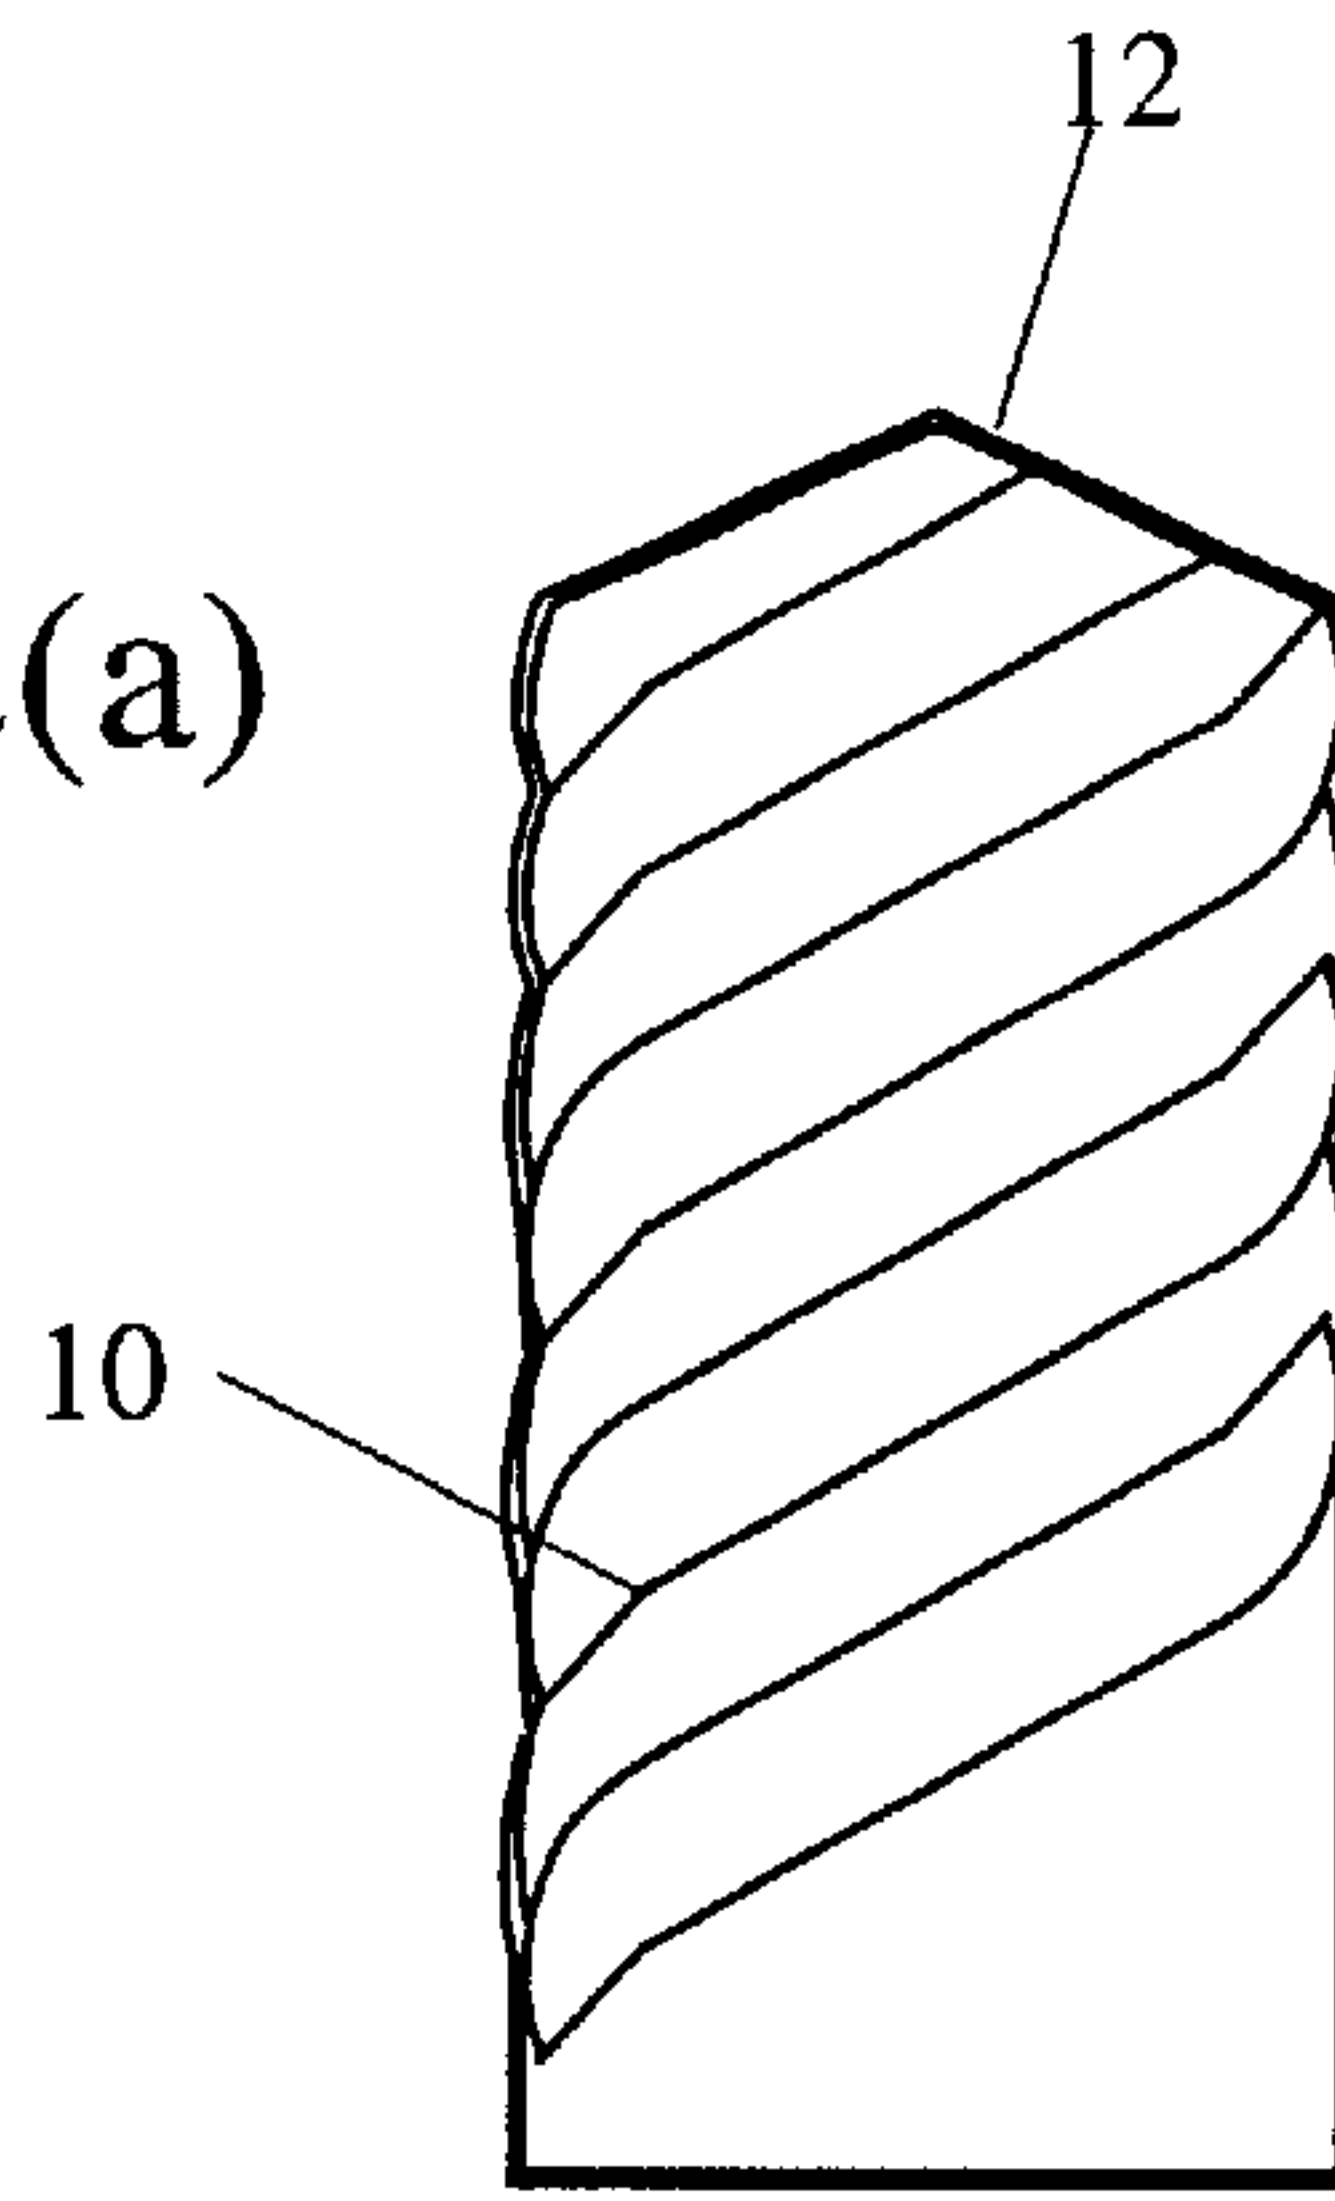
Figure 2(b)

FIG. 2(b) is a schematic view of the tool substrate having a wear resistant coating applied using an HVOF thermal spray process in accordance with the inventive method of treating metal components having a wear resistant coating;

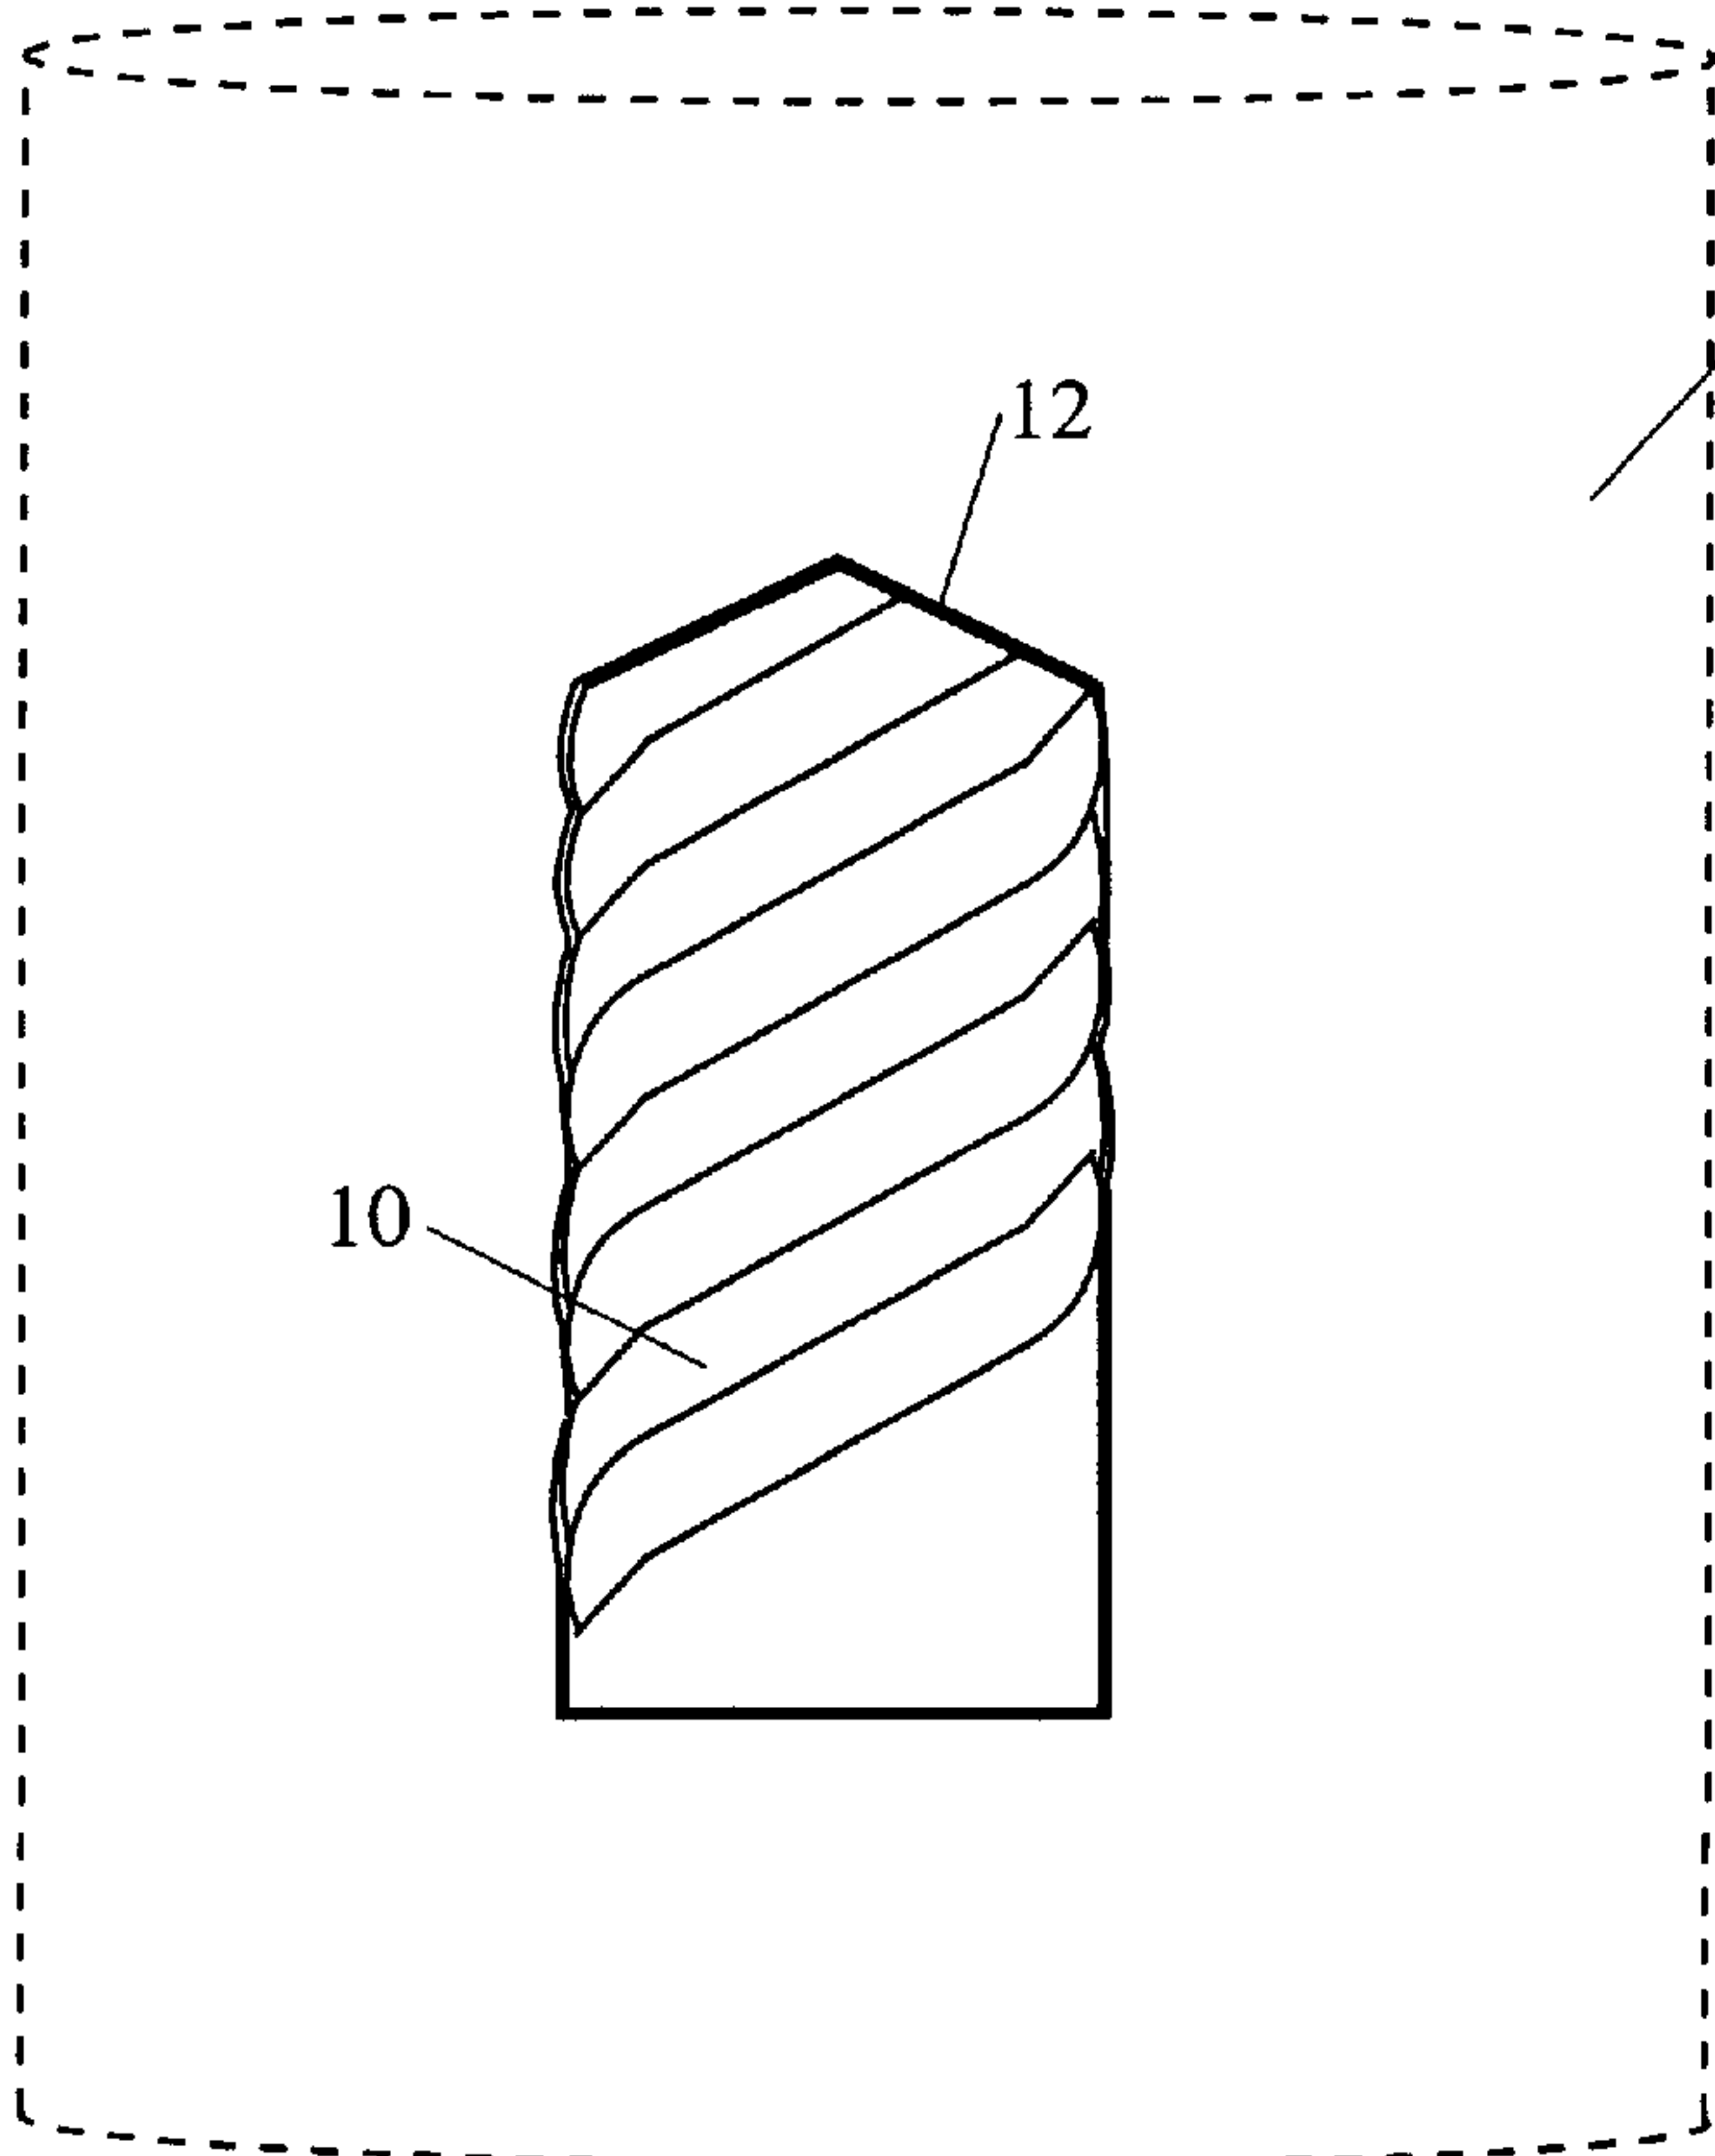
Figure 2(c)

FIG. 2(c) is a schematic view of the HVOF spray coated tool substrate undergoing a HIP treatment process in a HIP vessel in accordance with the inventive method of forming metal components having a wear resistant coating;

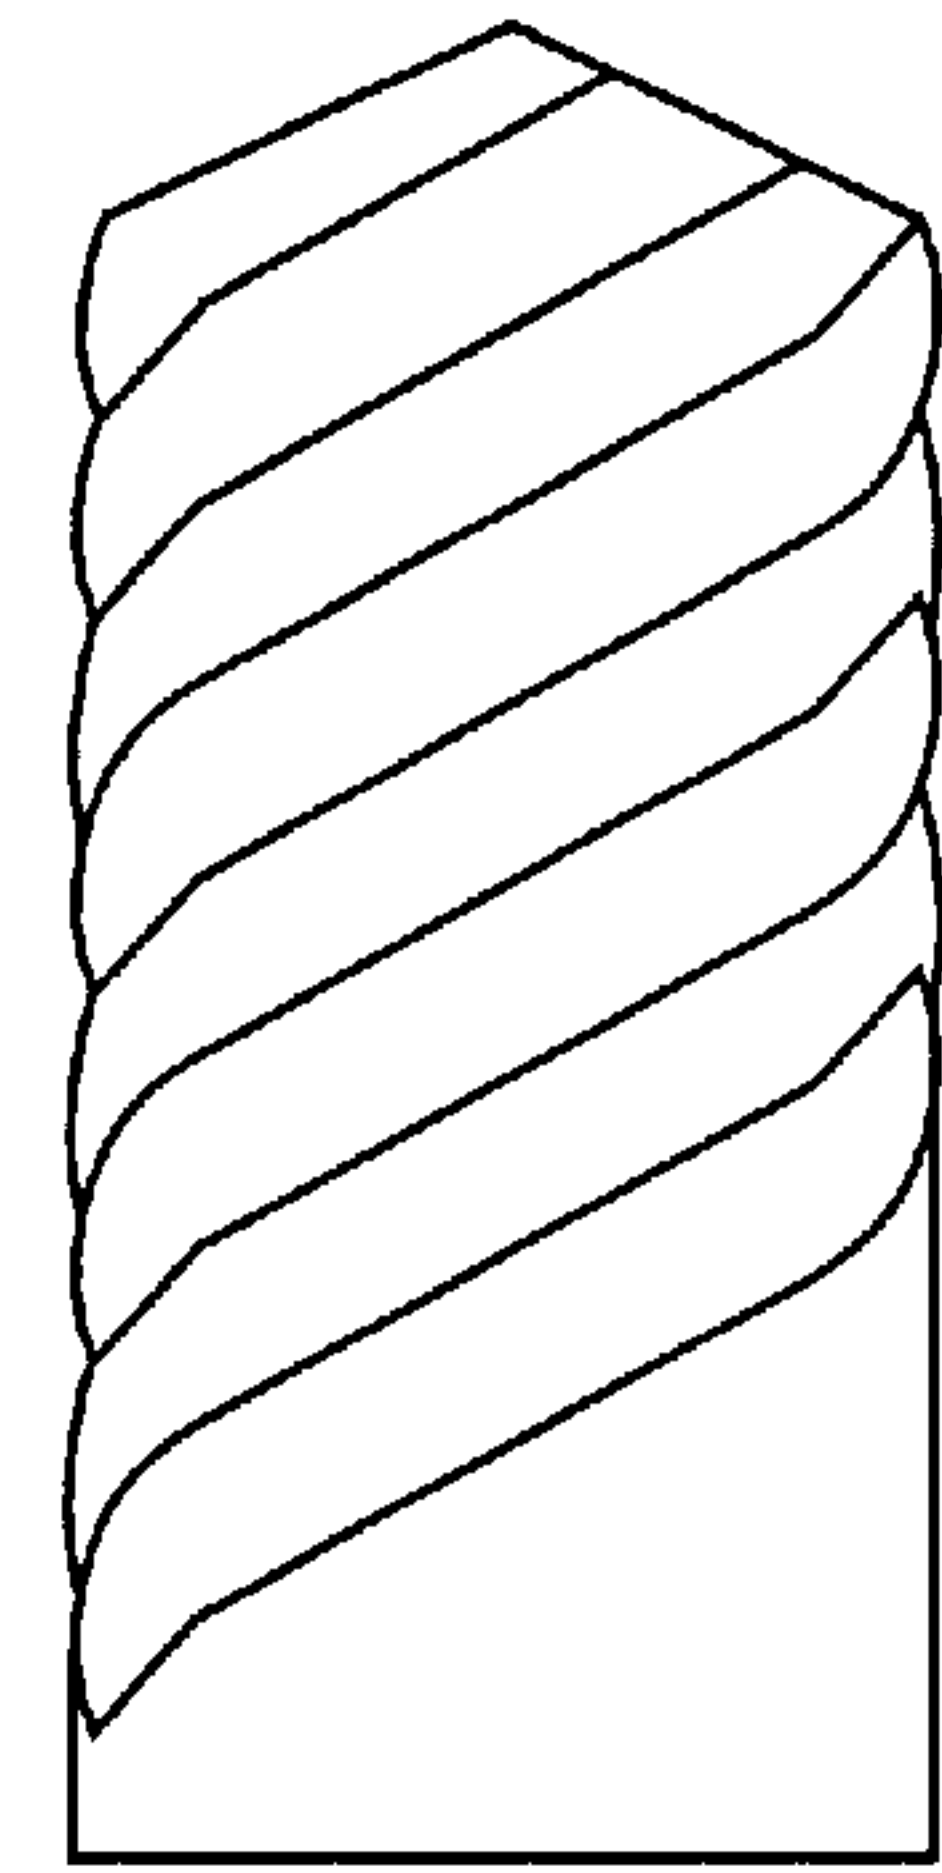
Figure 2(d)

FIG. 2(d) is a schematic view of the final HVOF spray coated and HIP treated tool having a wear resistant coating layer diffusion bonded to the tool substrate in accordance with the inventive method of forming metal components having a wear resistant coating;

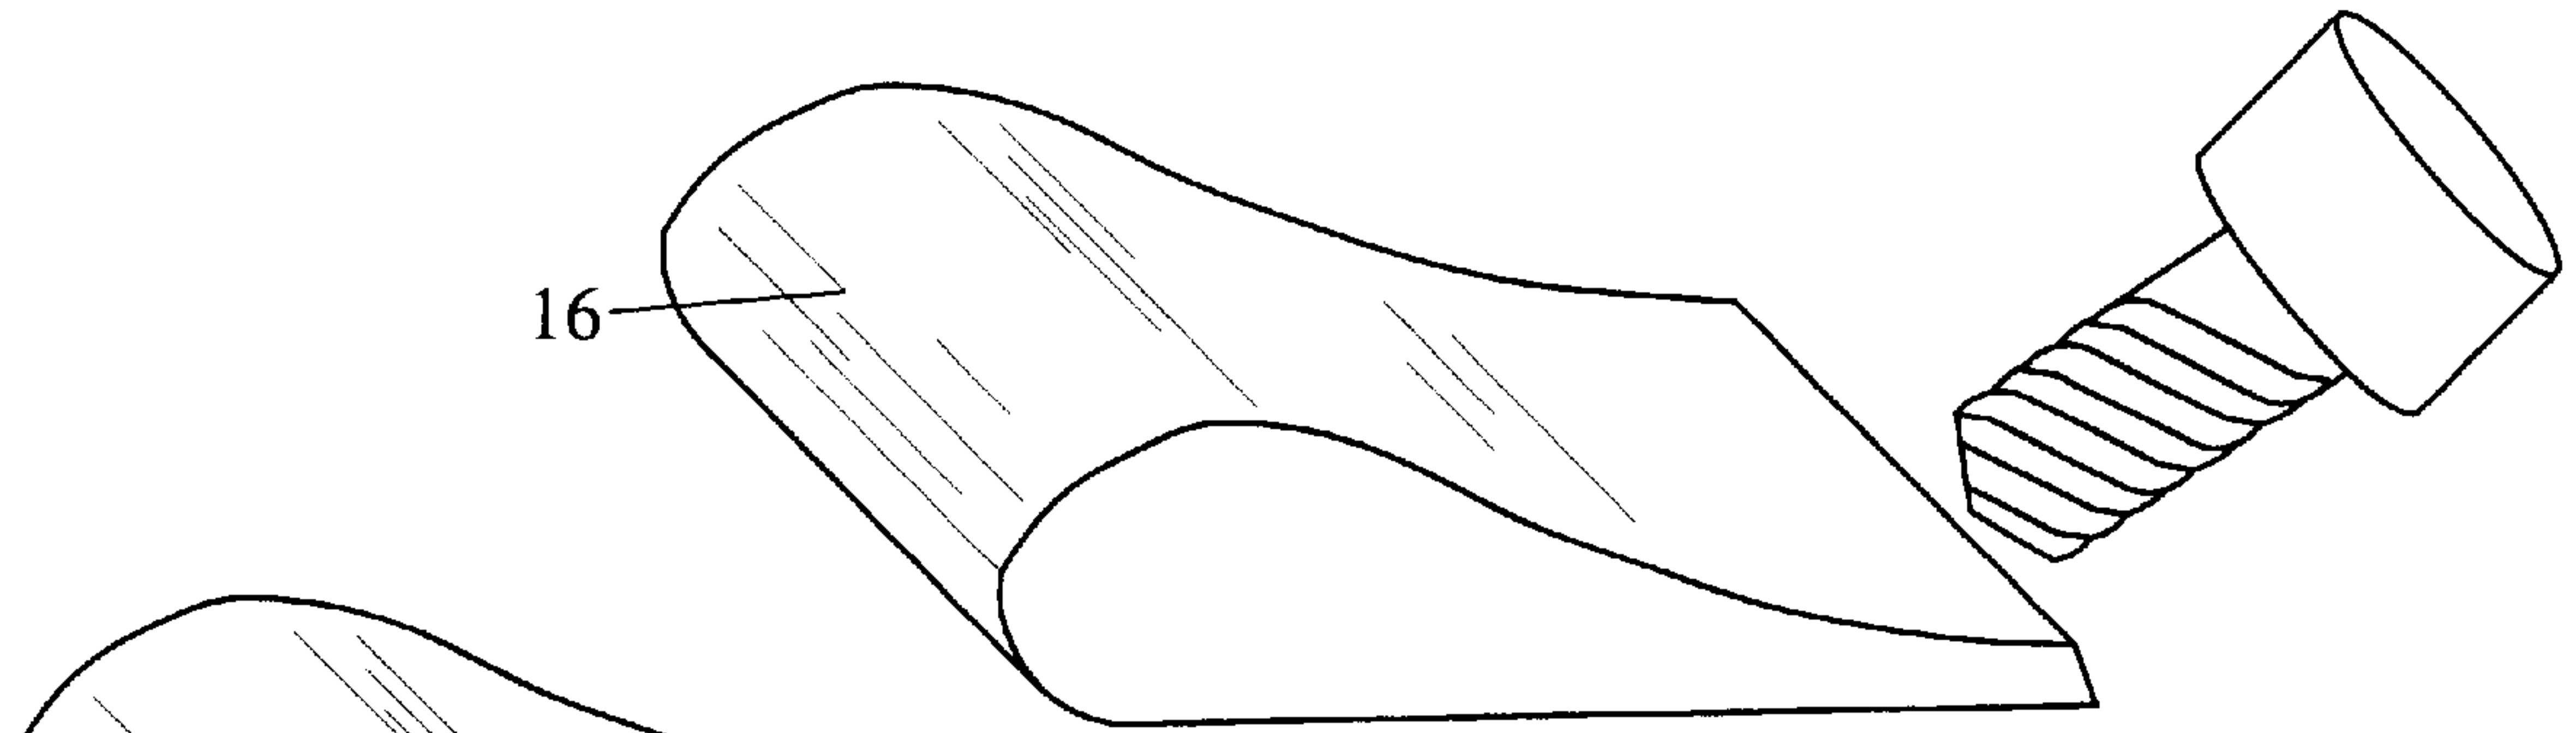
Figure 3(a)

FIG. 3(a) is a schematic perspective view of a cast metal component undergoing a machining operation in accordance with the inventive method of forming a metal product;

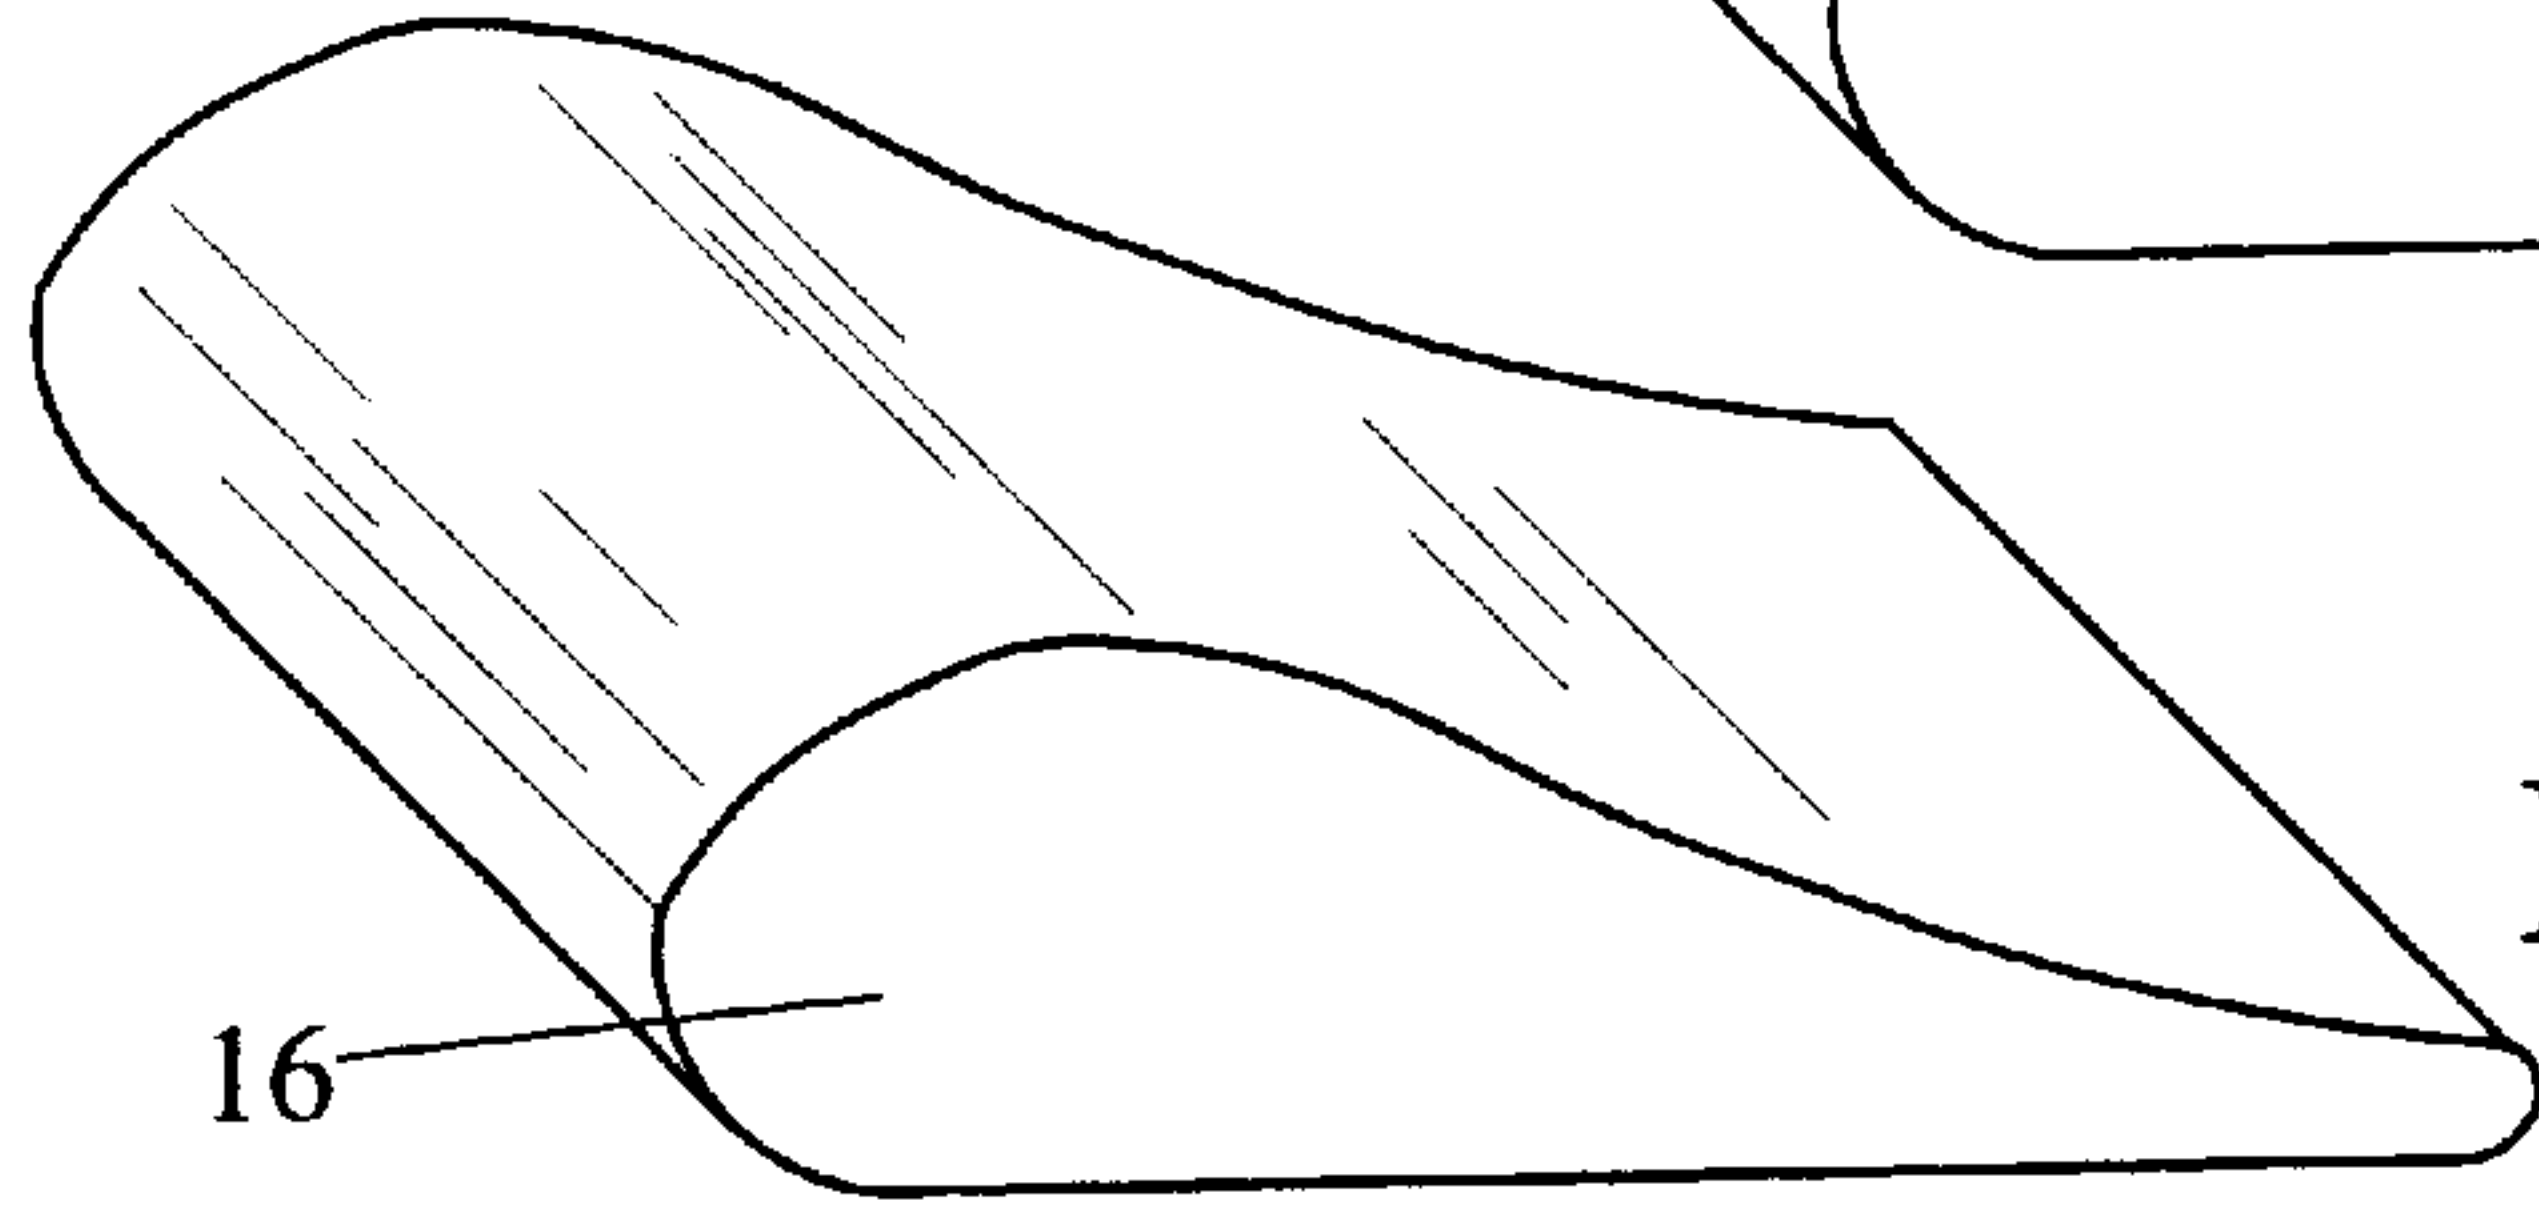
Figure 3(b)

FIG. 3(b) is a schematic perspective view of the machined cast metal component in accordance with the inventive method of forming a metal product;
