# United States Patent [19]

[11] Patent Number: **6,049,978**

[54] **METHODS FOR REPAIRING AND RECLASSIFYING GAS TURBINE ENGINE AIRFOIL PARTS**

[73] Assignee: **Recast Airfoil Group**, North Haven, Conn.

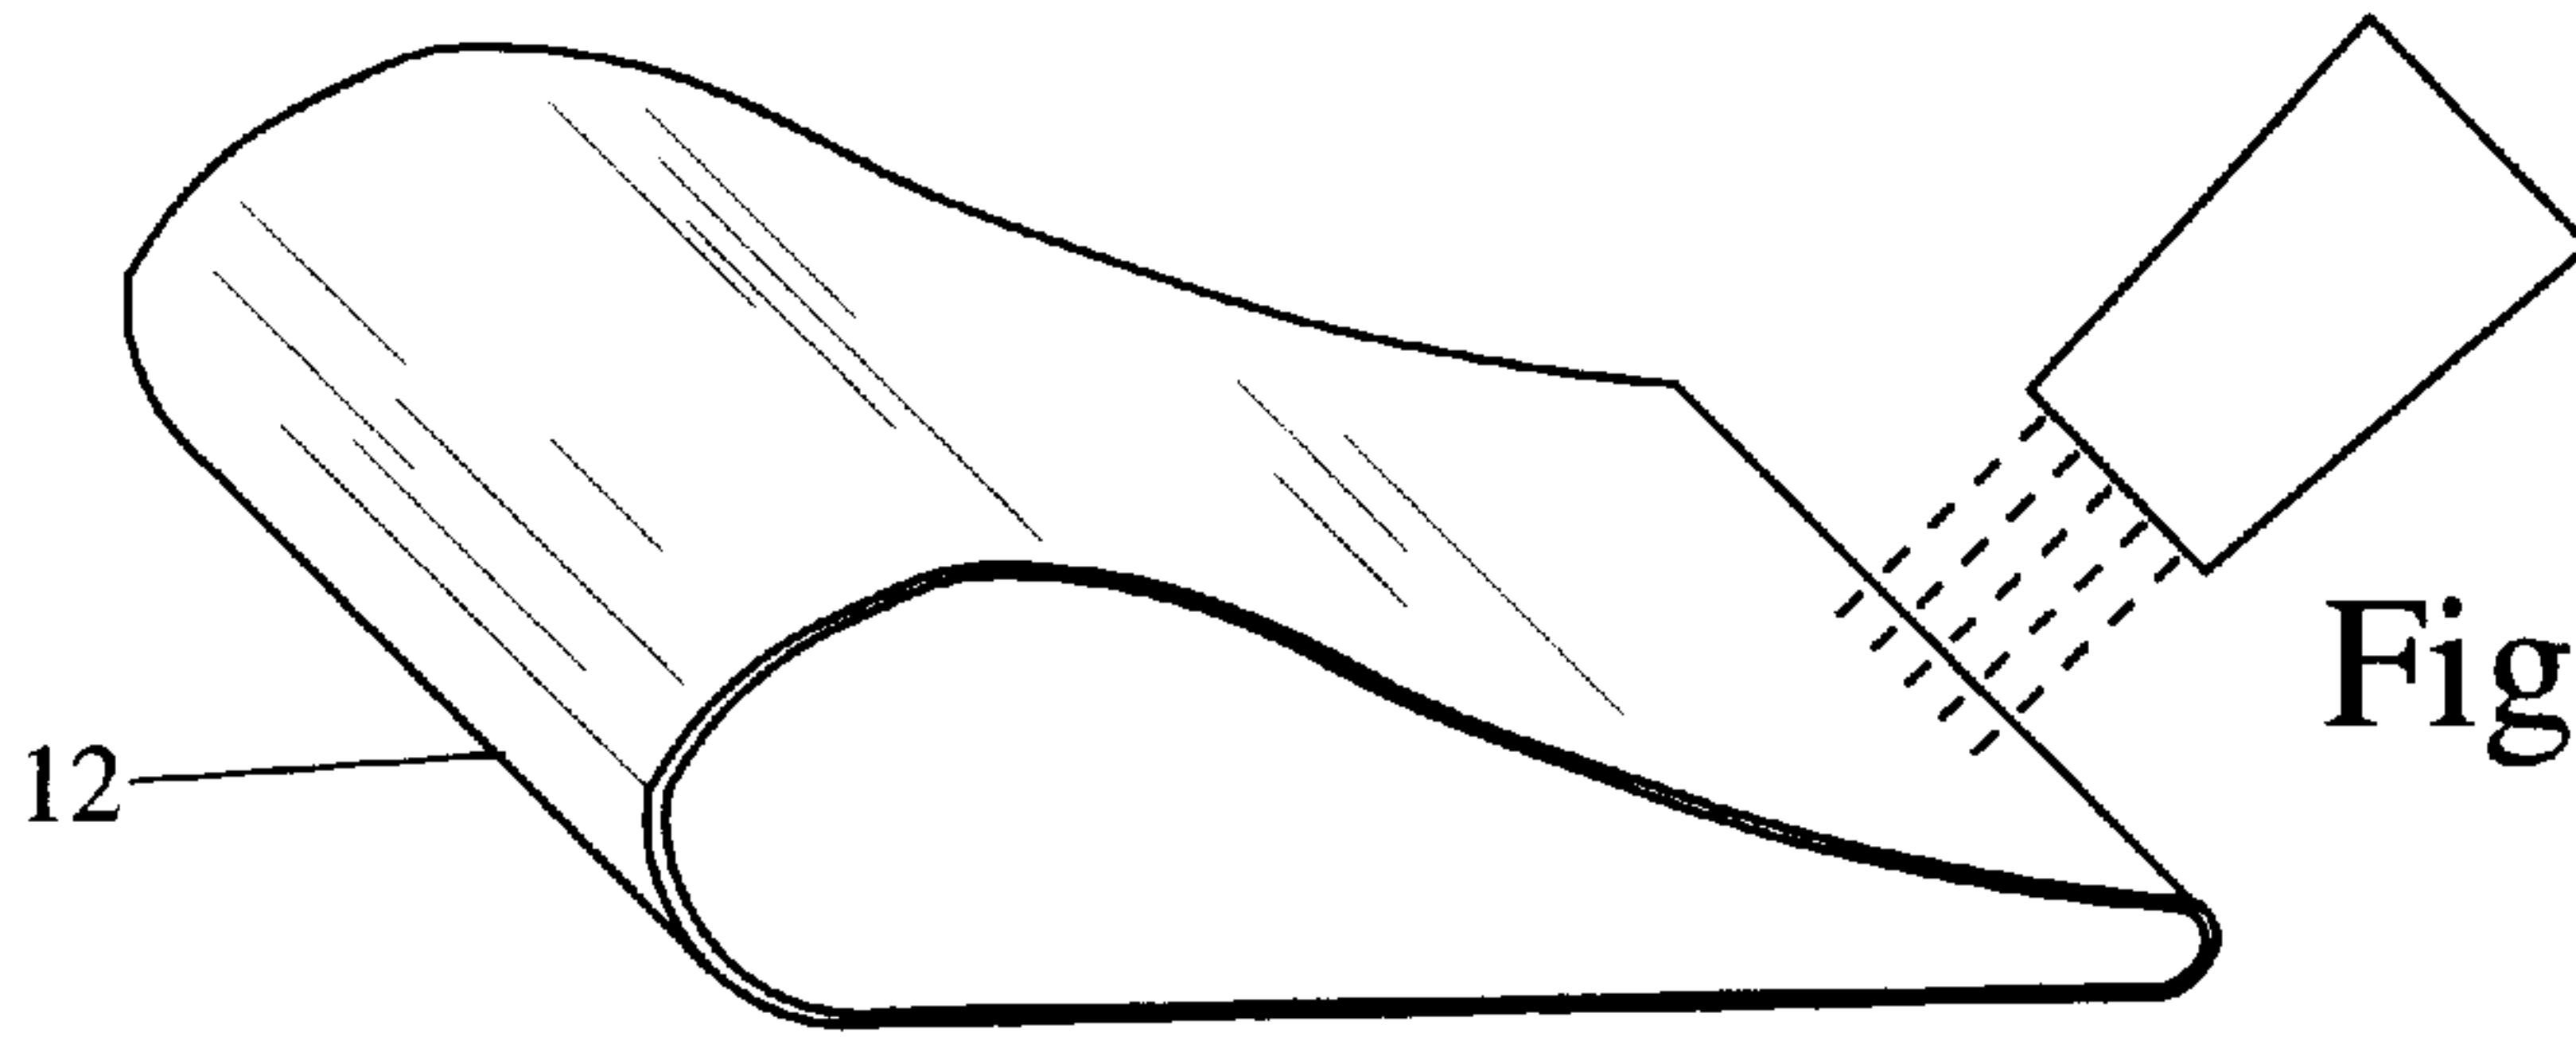
Figure 3(c)

FIG. 3(c) is a schematic perspective view of the machined cast metal component having a coating applied using an HVOF thermal spray process in accordance with the inventive method of forming a metal product;

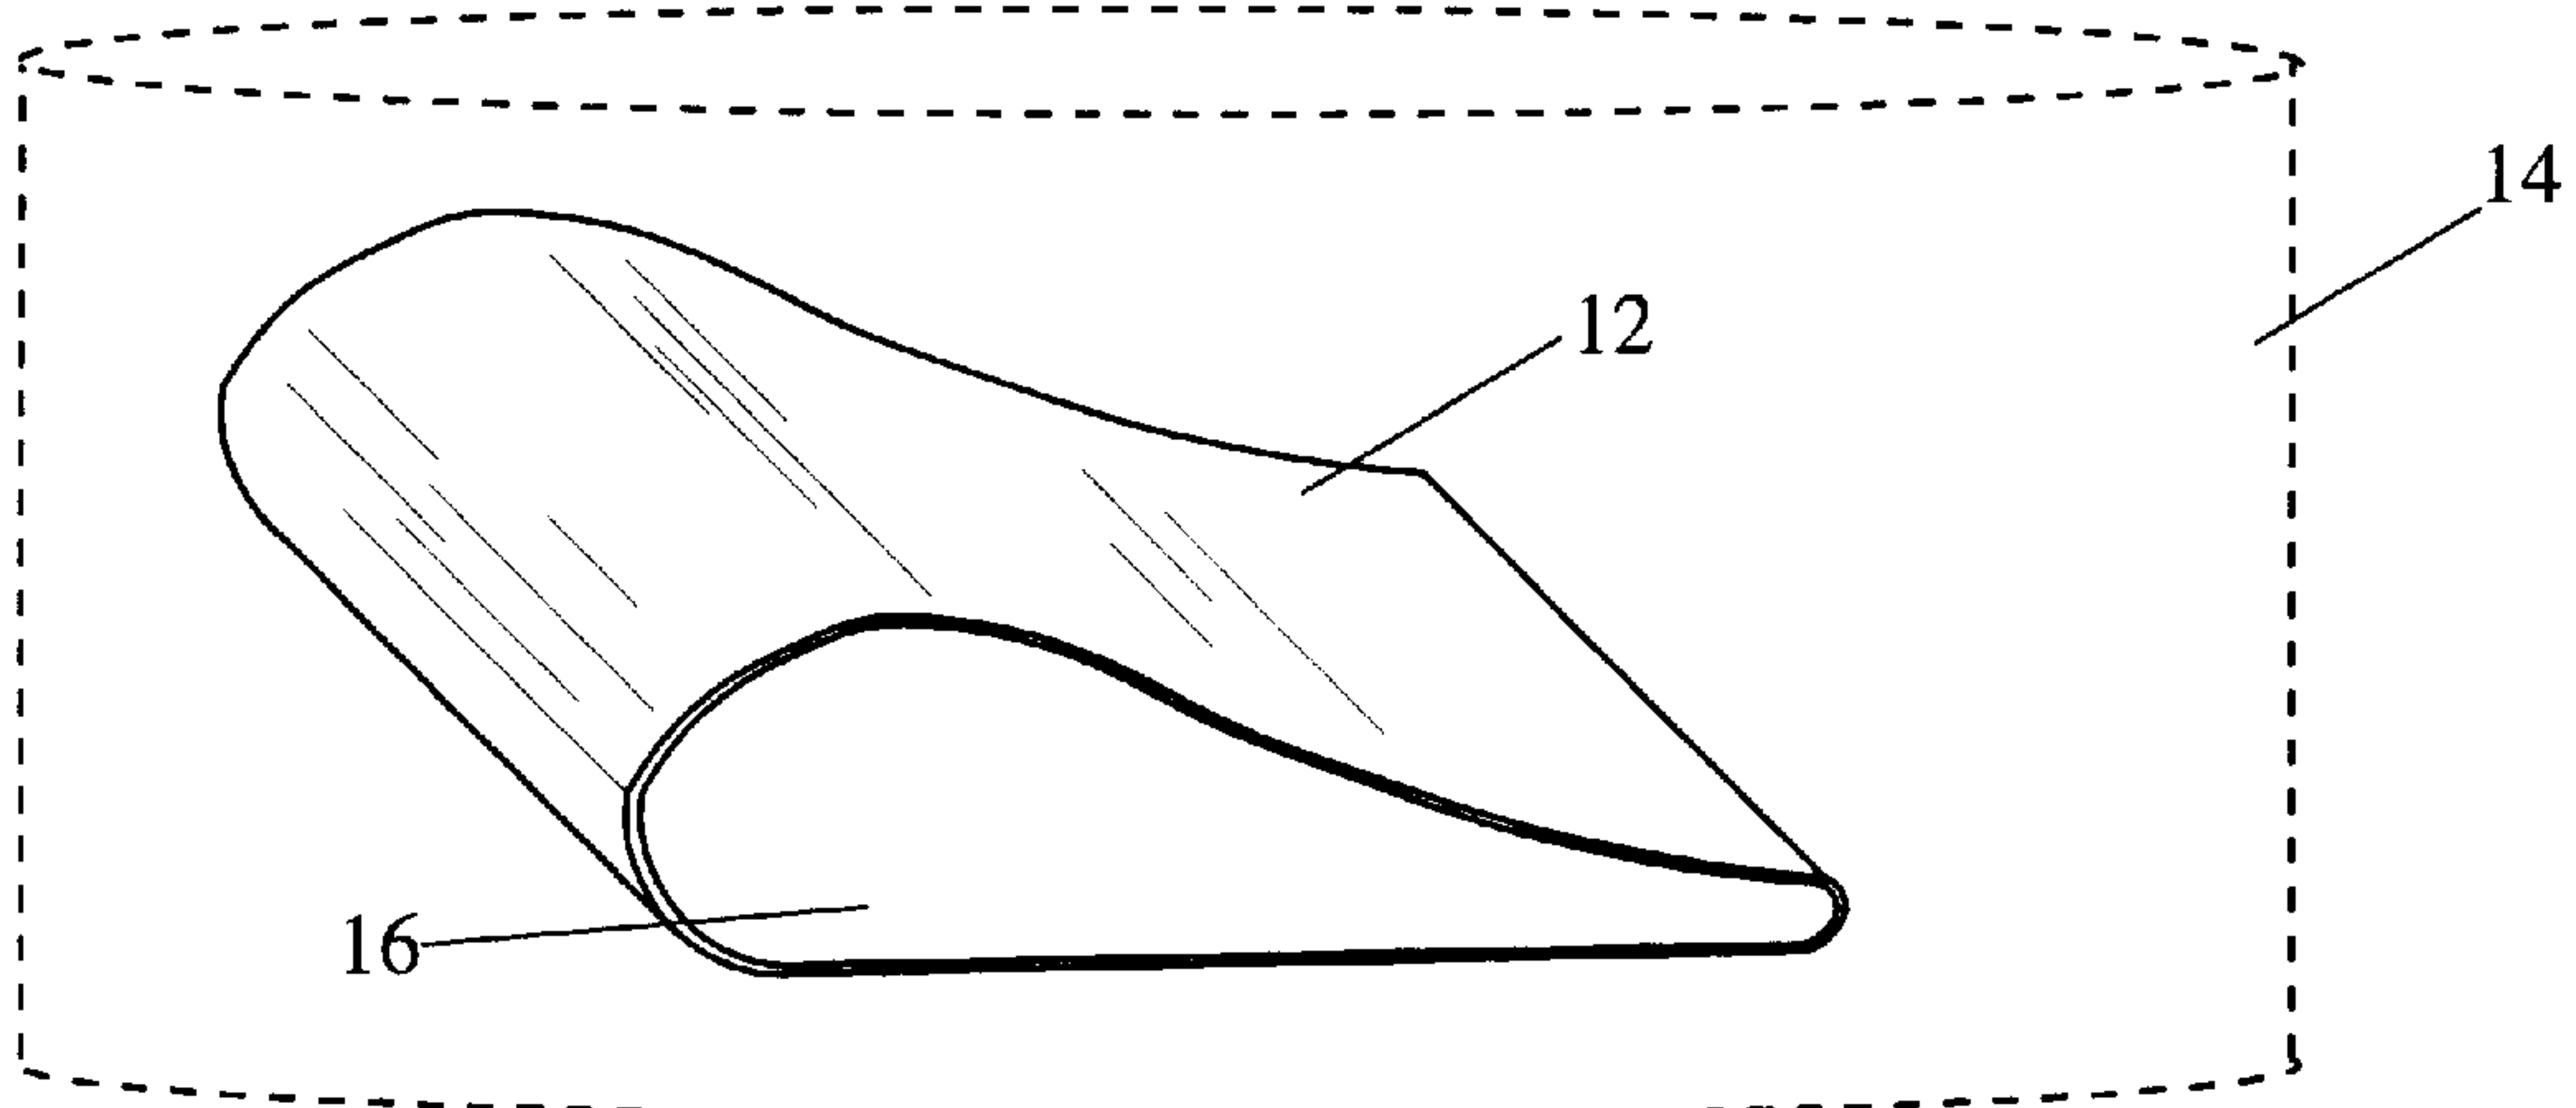
Figure 3(d)

FIG. 3(d) is a schematic perspective view of the HVOF spray coated machined cast metal component undergoing a HIP treatment process in a HIP vessel in accordance with the inventive method of forming a metal product;

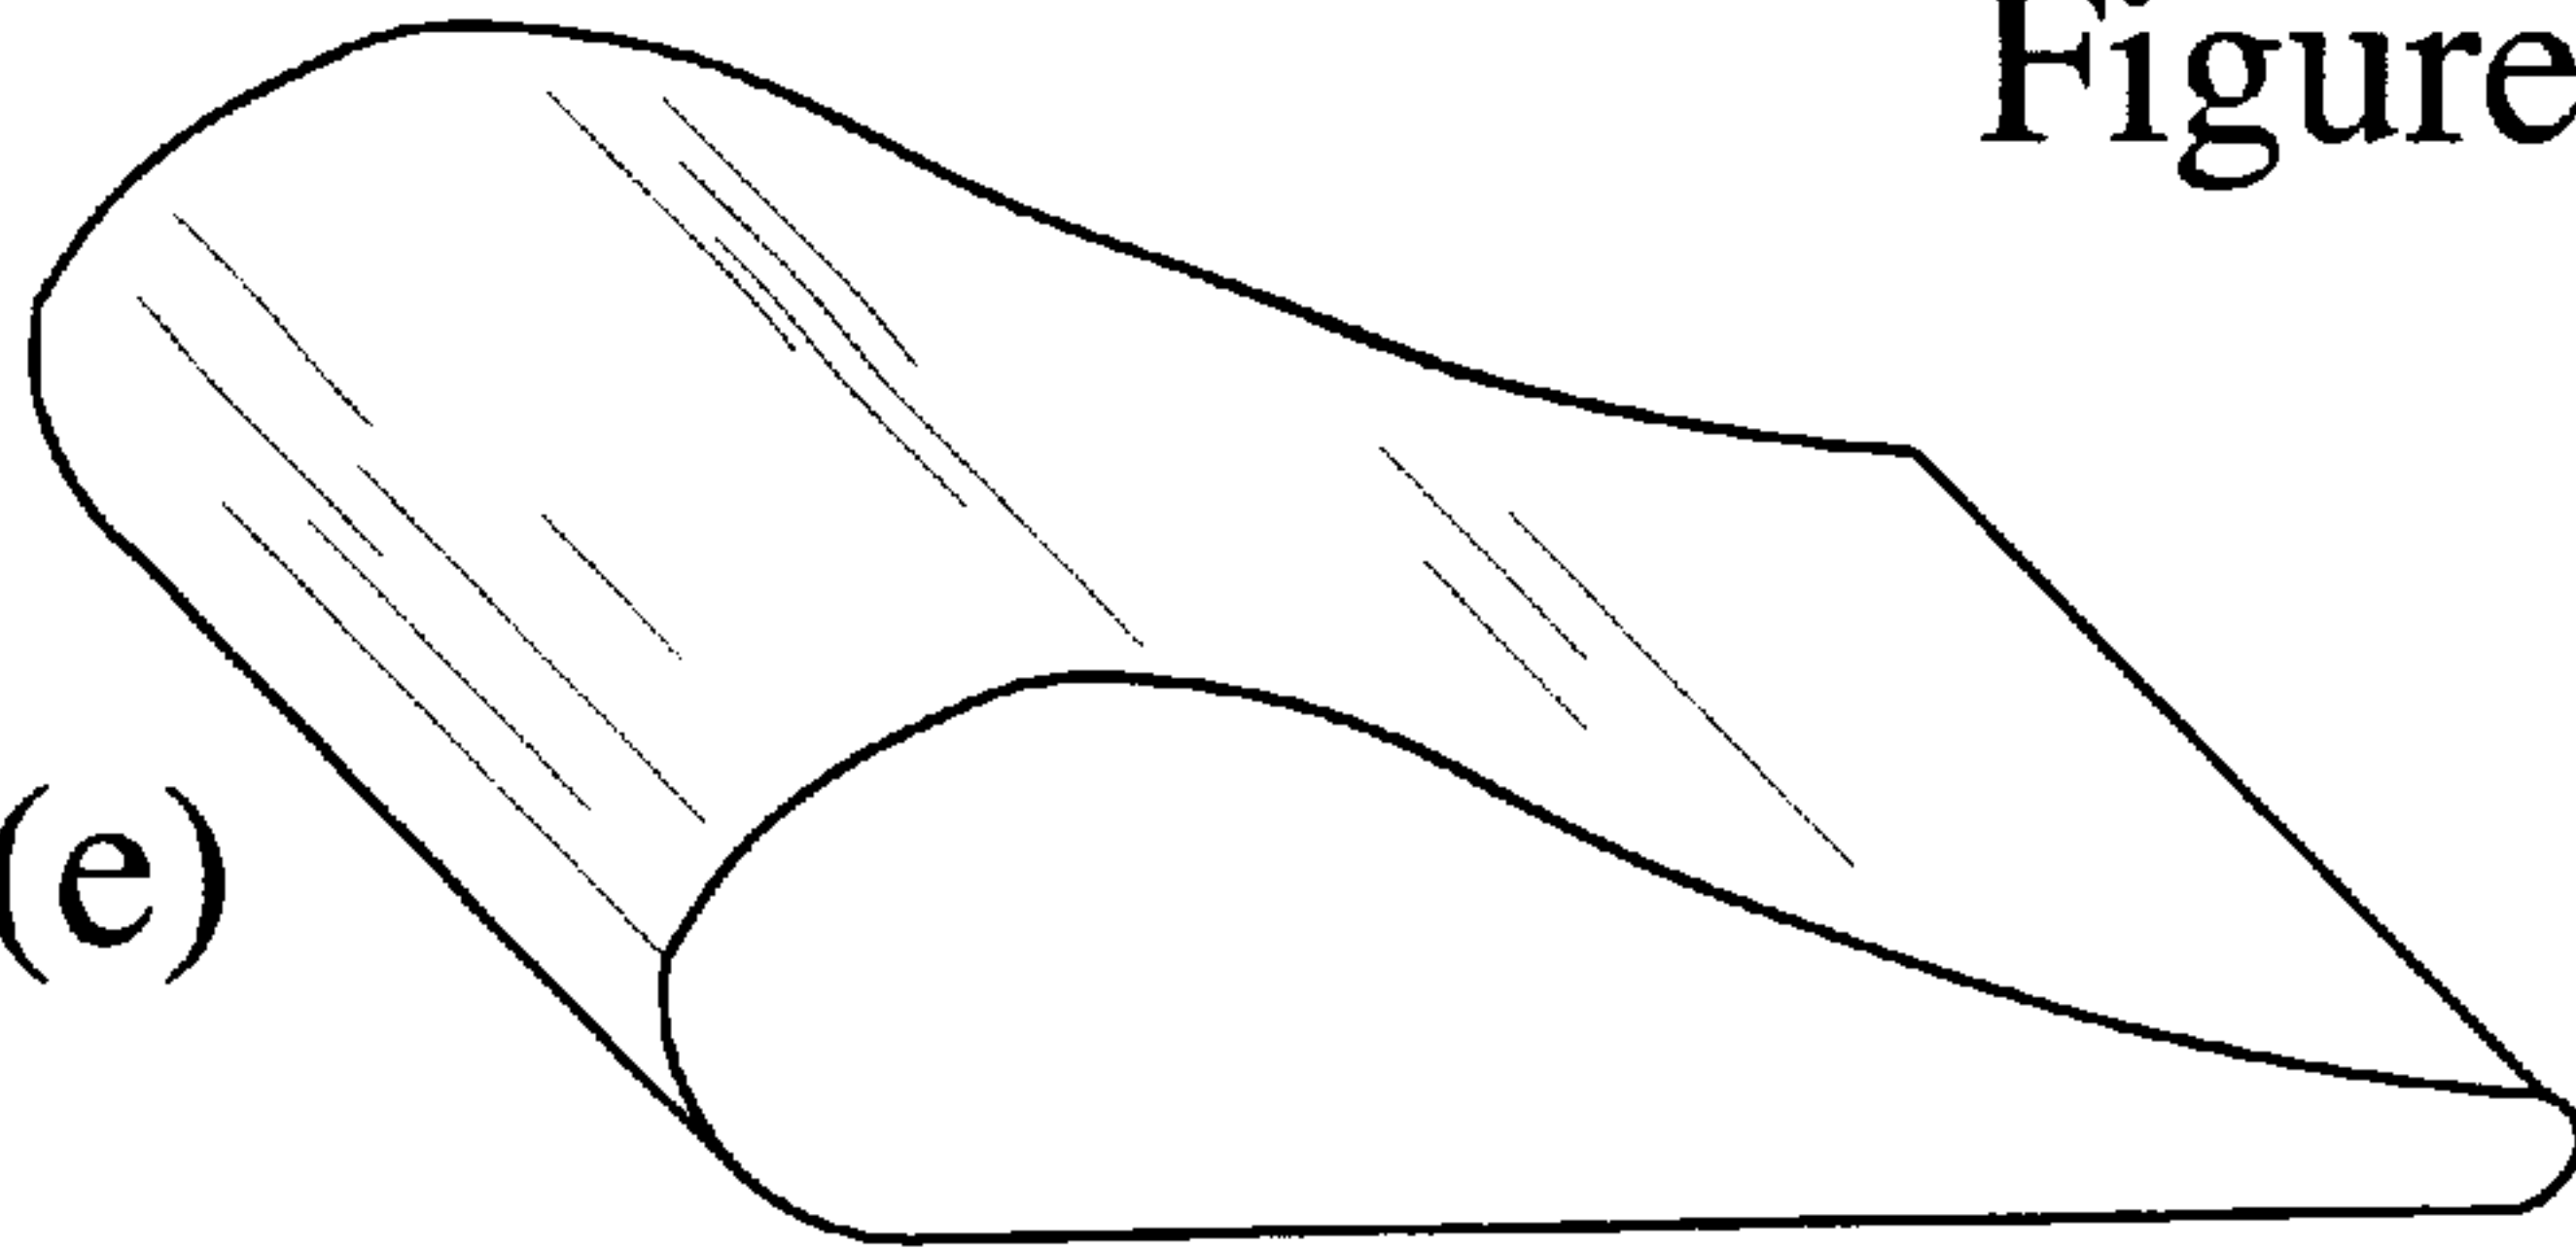
Figure 3(e)

FIG. 3(e) is a schematic perspective view of the final HVOF spray coated and HIP treated machined cast metal product having a coating layer diffusion bonded to the machined cast metal component in accordance with the inventive method of forming a metal product;

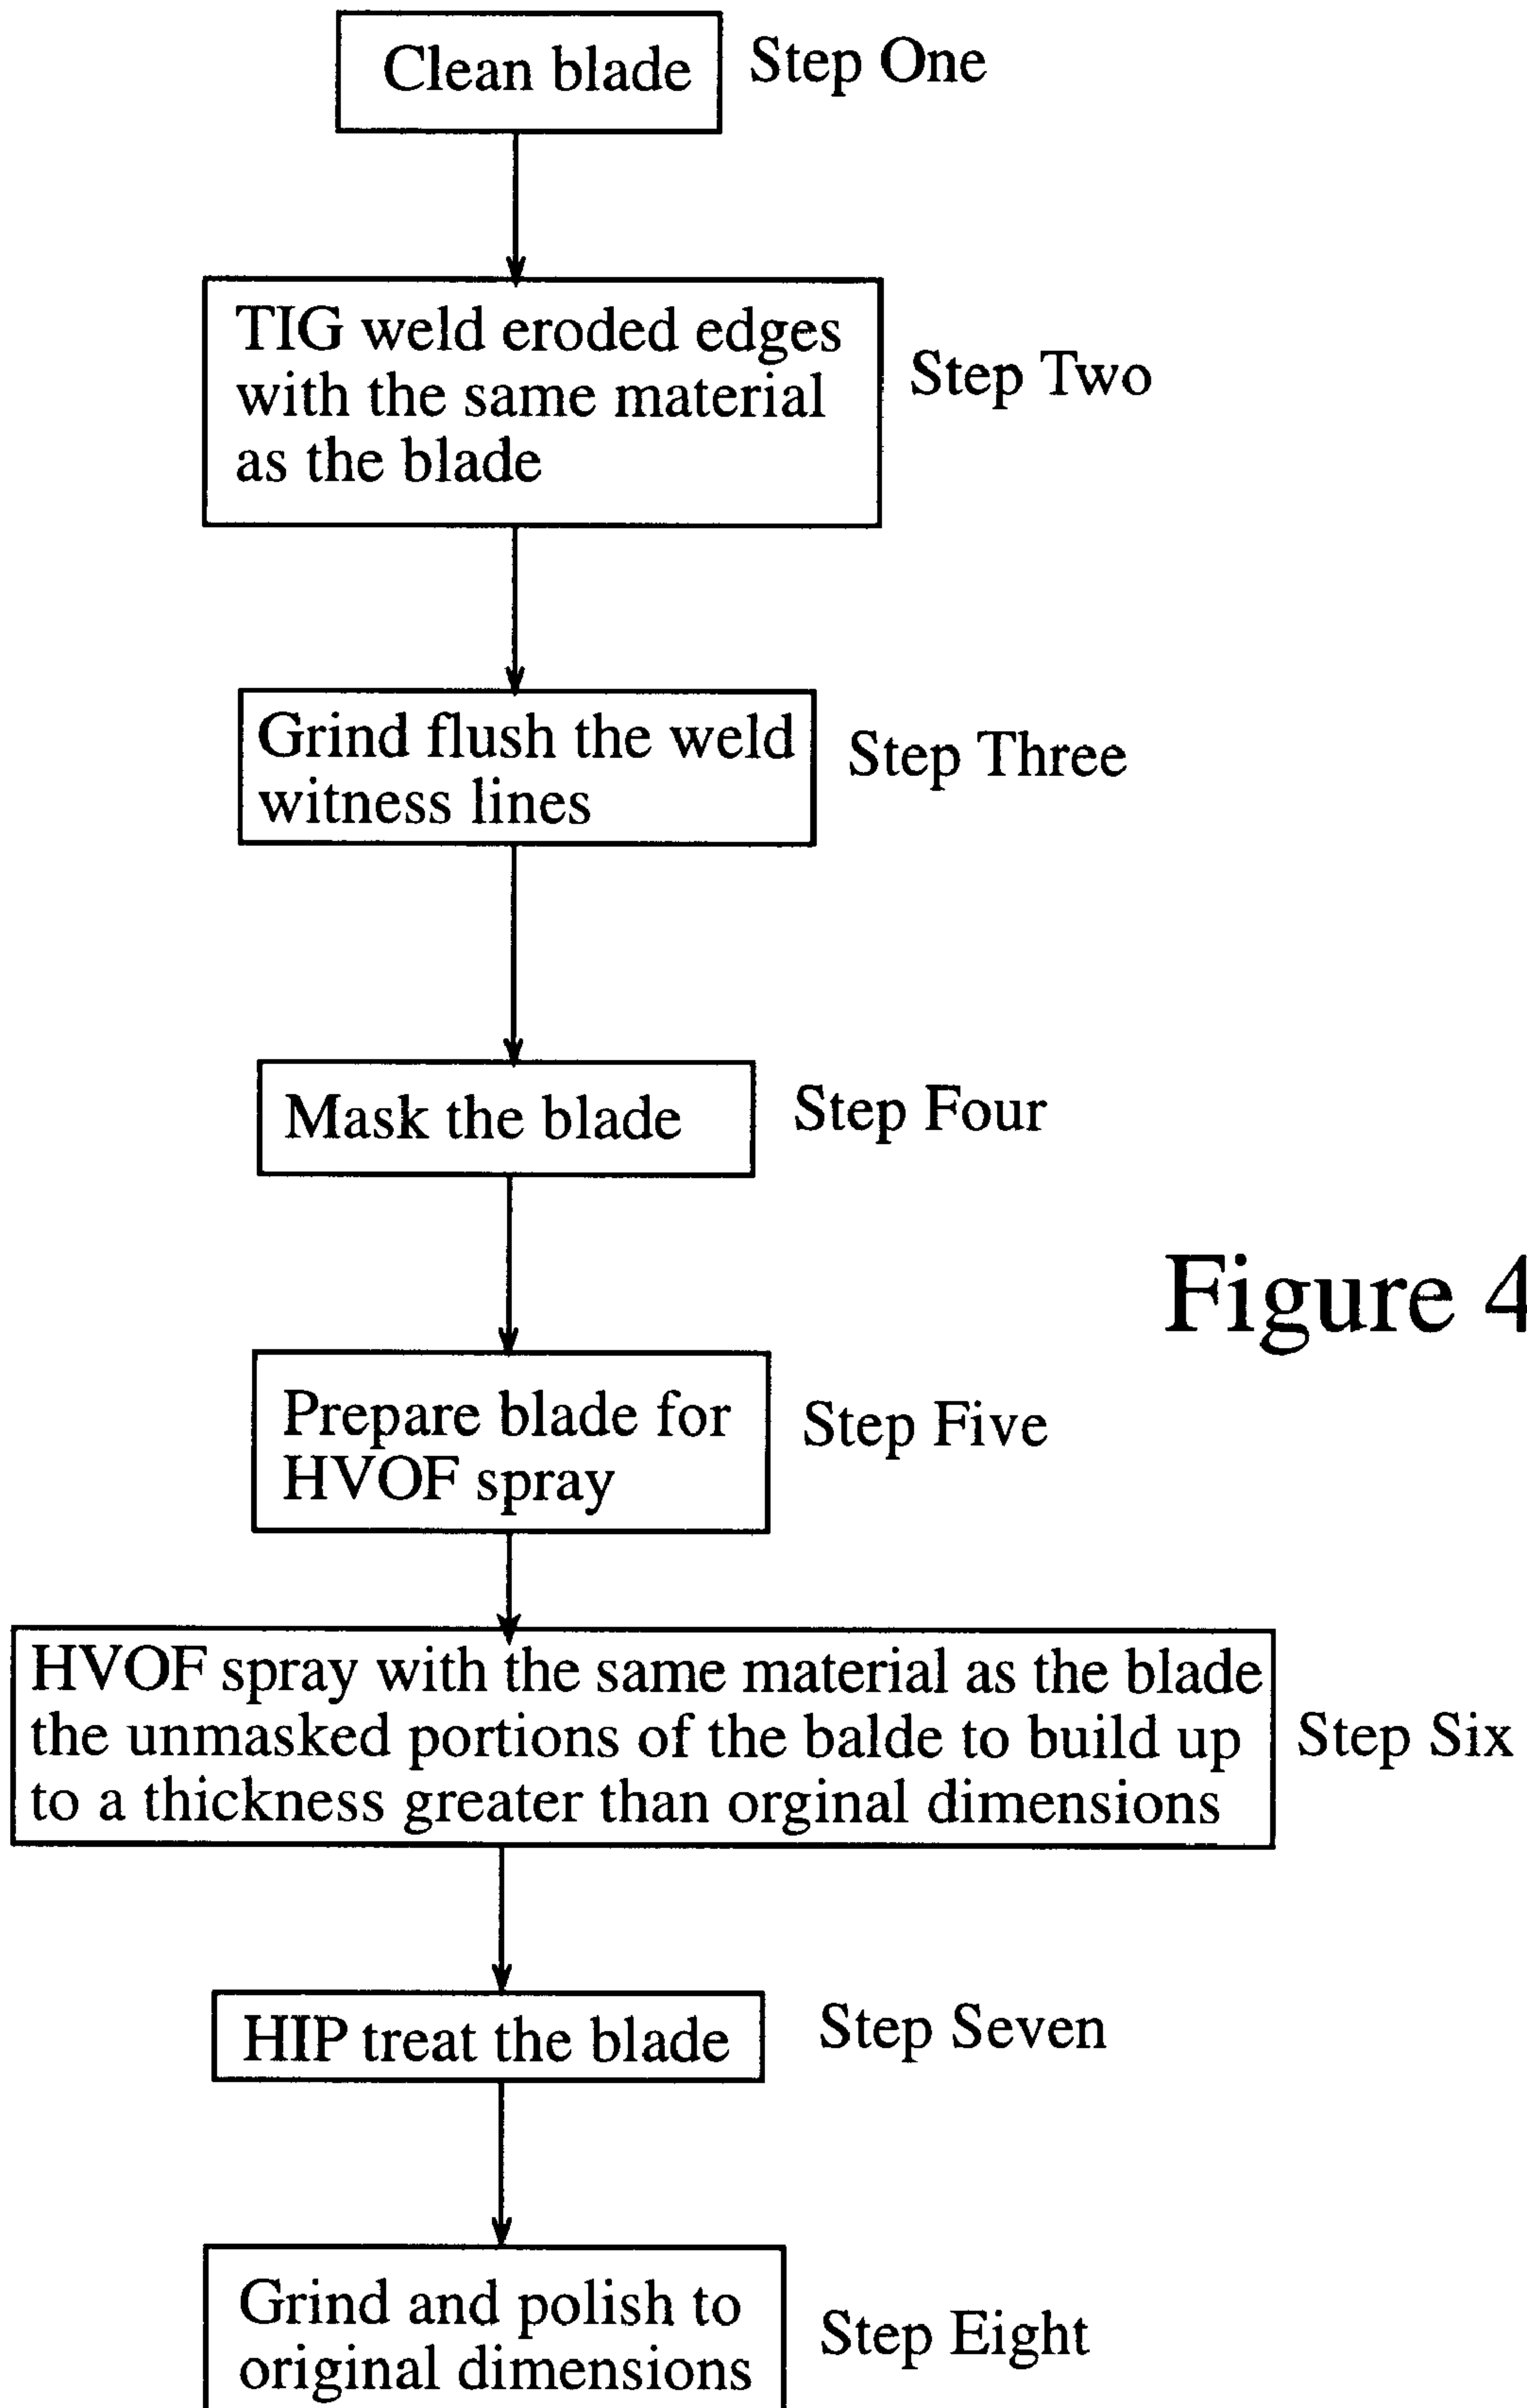
Figure 4

FIG. 4 is a flow chart showing the steps of the inventive method of repairing a turbine engine part;

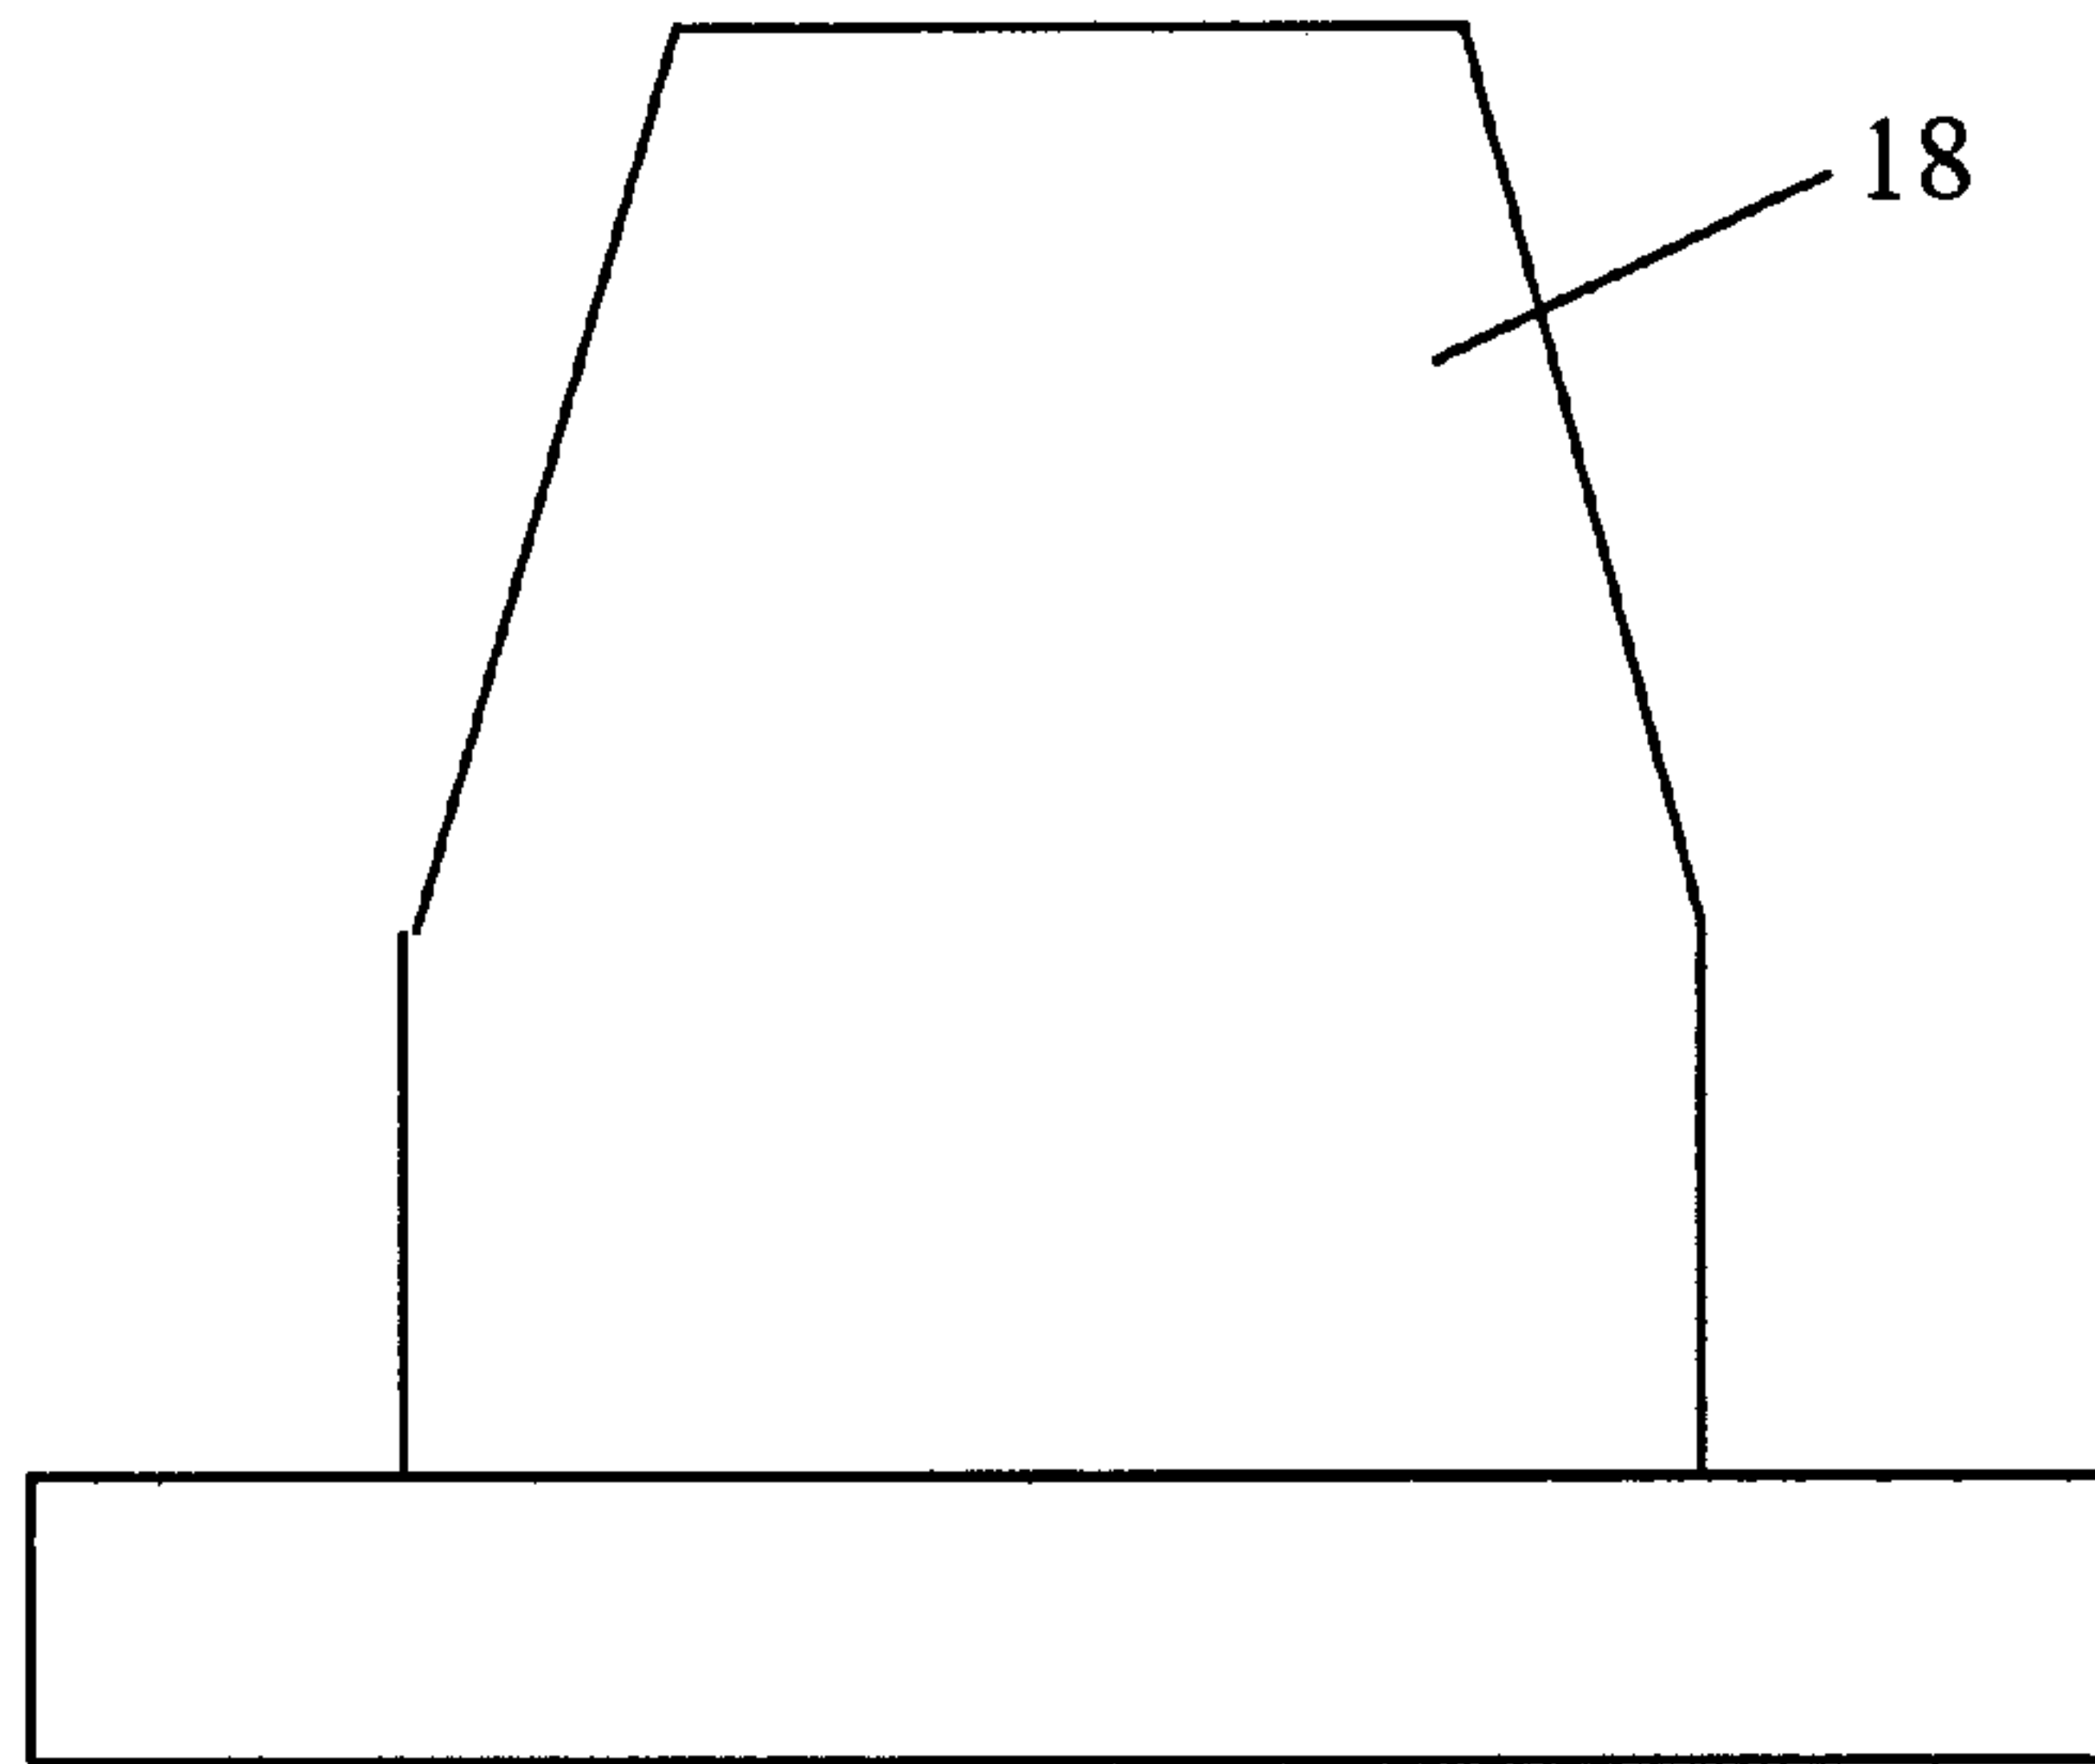
Figure 5(a)

FIG. 5(a) is a schematic side view of a worn turbine engine part before undergoing the inventive method of repairing a turbine engine part;

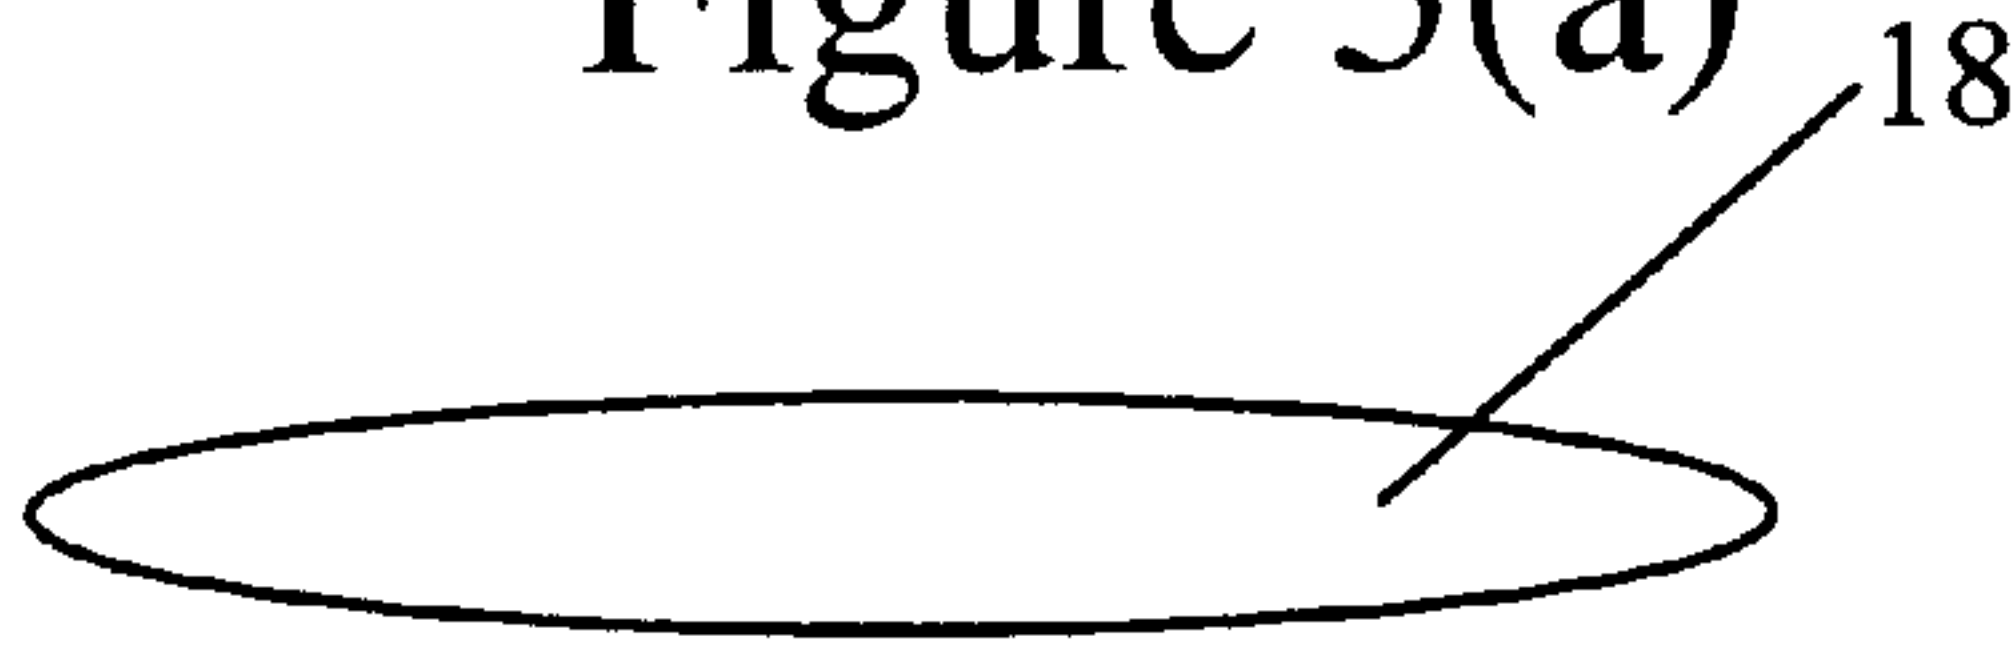
Figure 5(b)

FIG. 5(b) is a schematic cross-sectional view of the worn turbine engine part before undergoing the inventive method of repairing a turbine engine part;

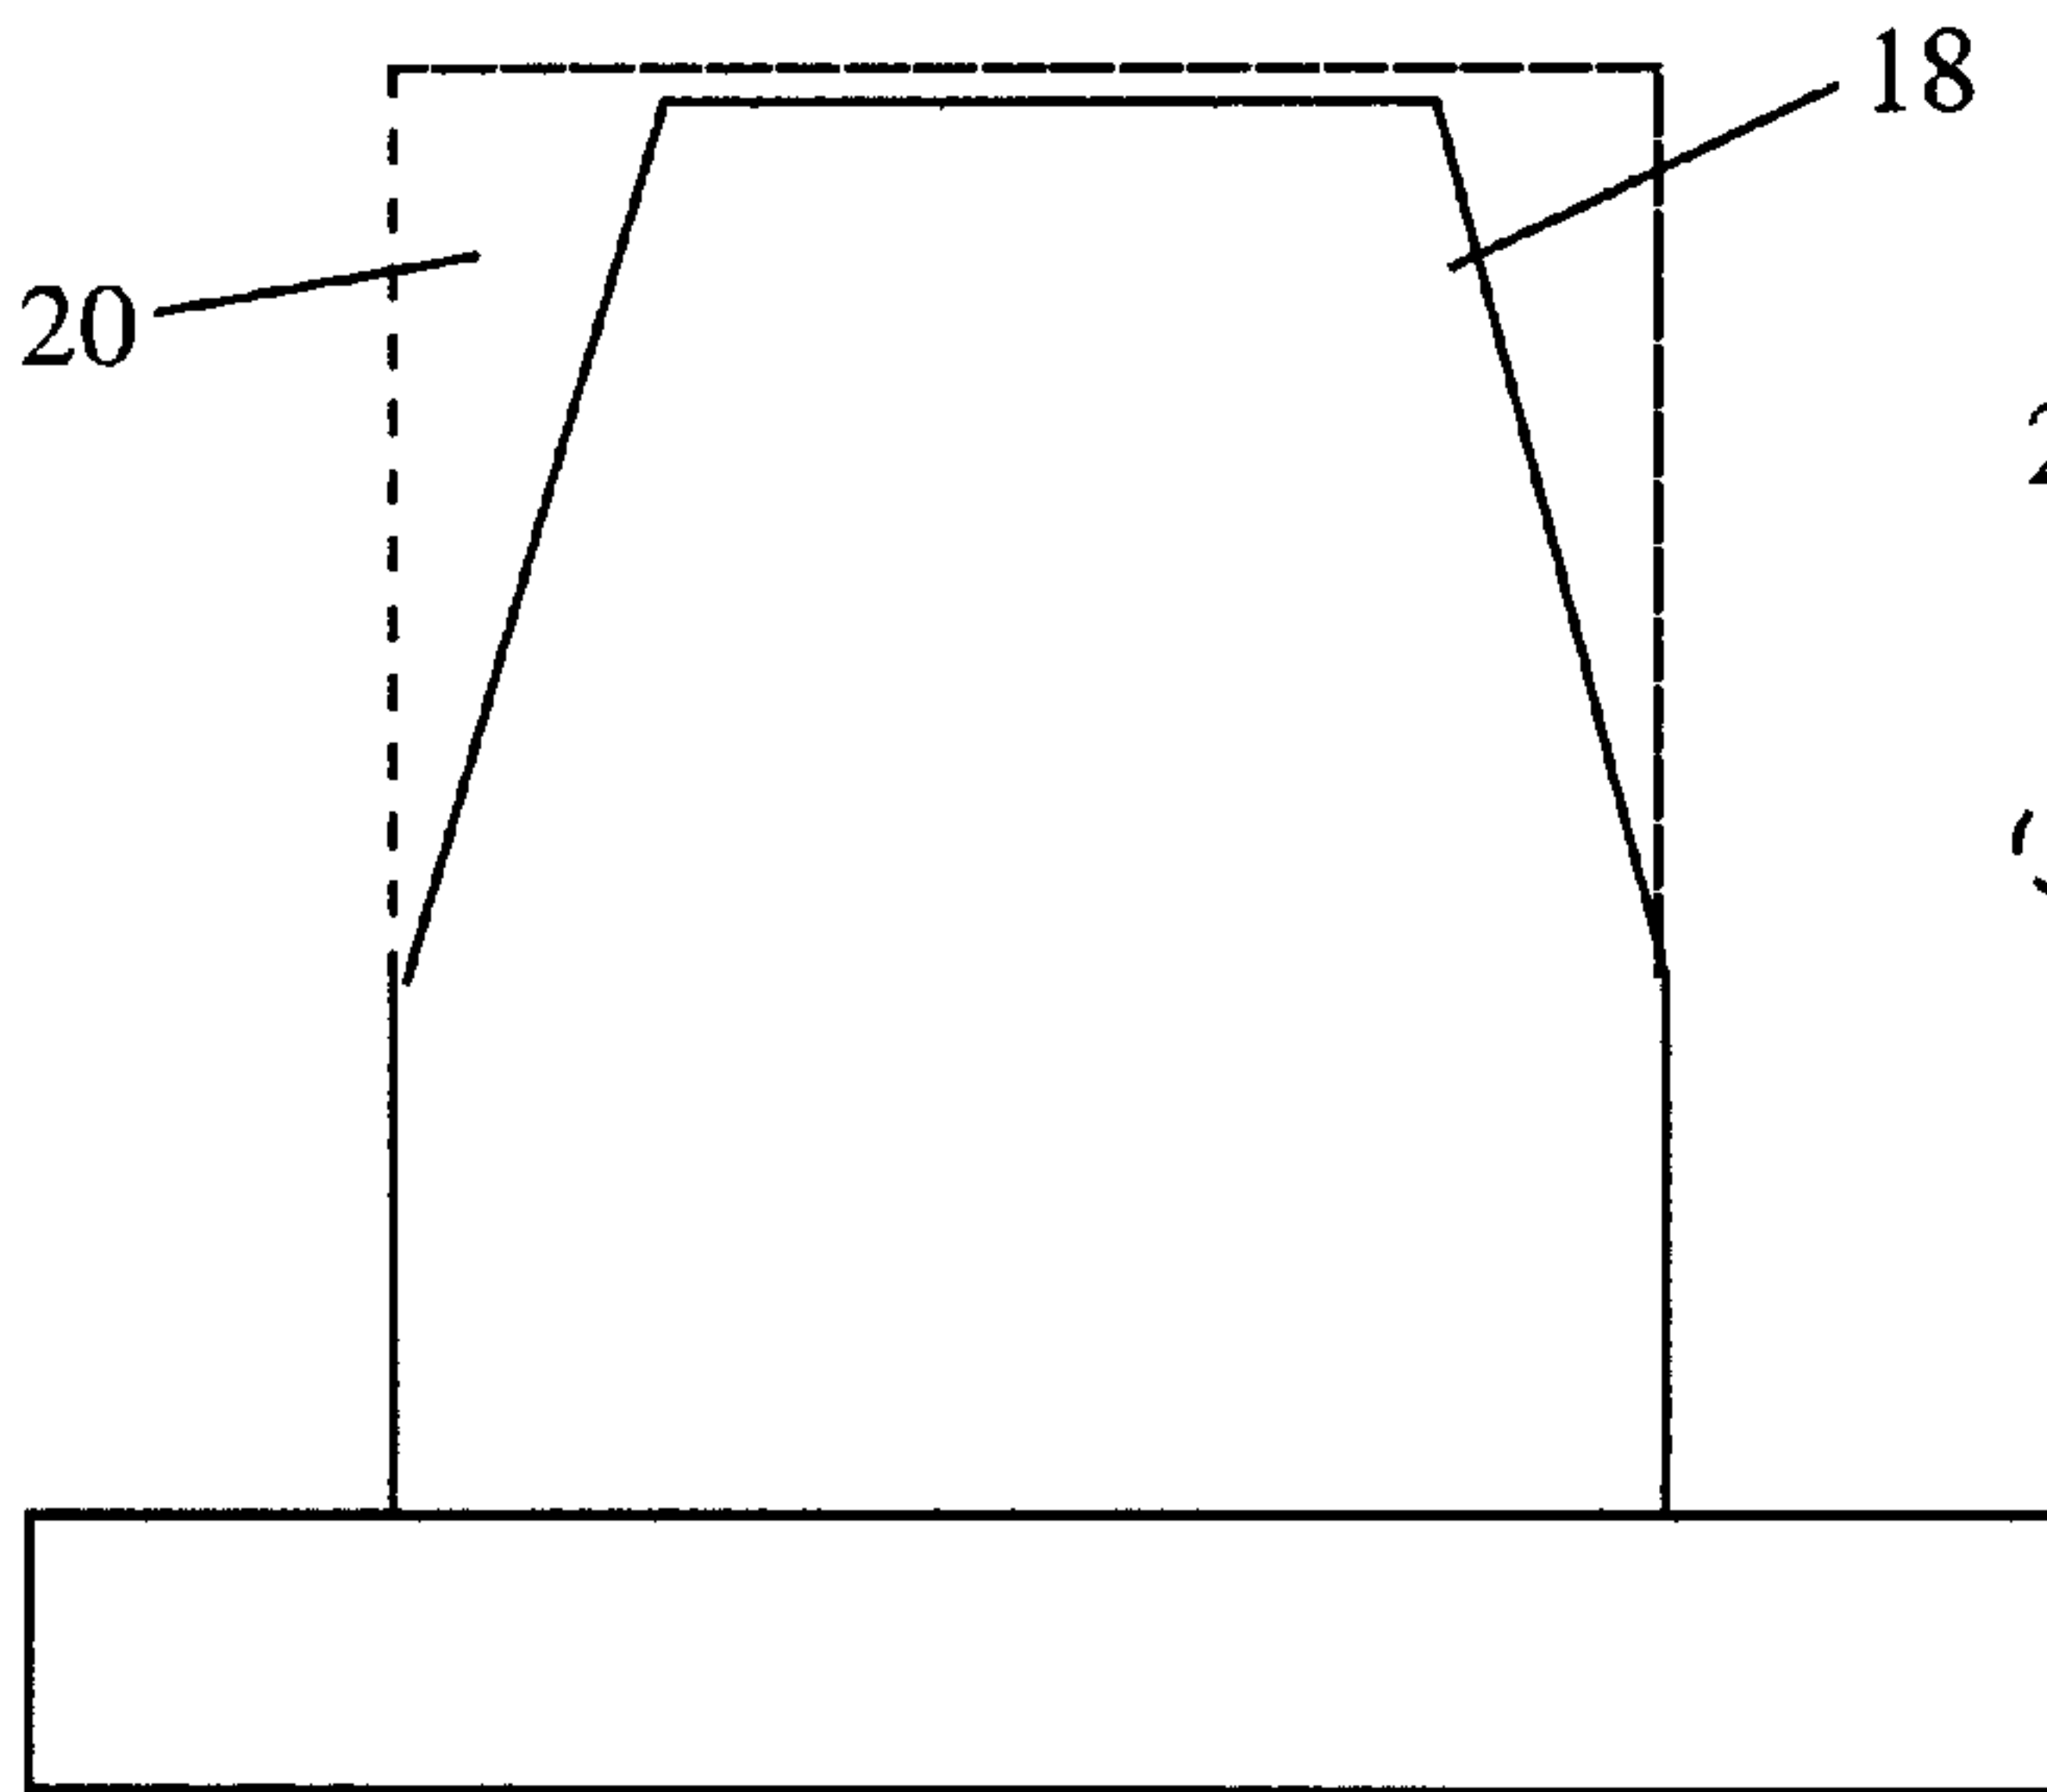
Figure 6(a)

FIG. 6(a) is a schematic side view of the worn turbine engine part showing the worn areas to be repaired using the inventive method of repairing a turbine engine part;
