# United States Patent [19]

[11] Patent Number: **6,049,978**

[54] **METHODS FOR REPAIRING AND RECLASSIFYING GAS TURBINE ENGINE AIRFOIL PARTS**

[73] Assignee: **Recast Airfoil Group**, North Haven, Conn.

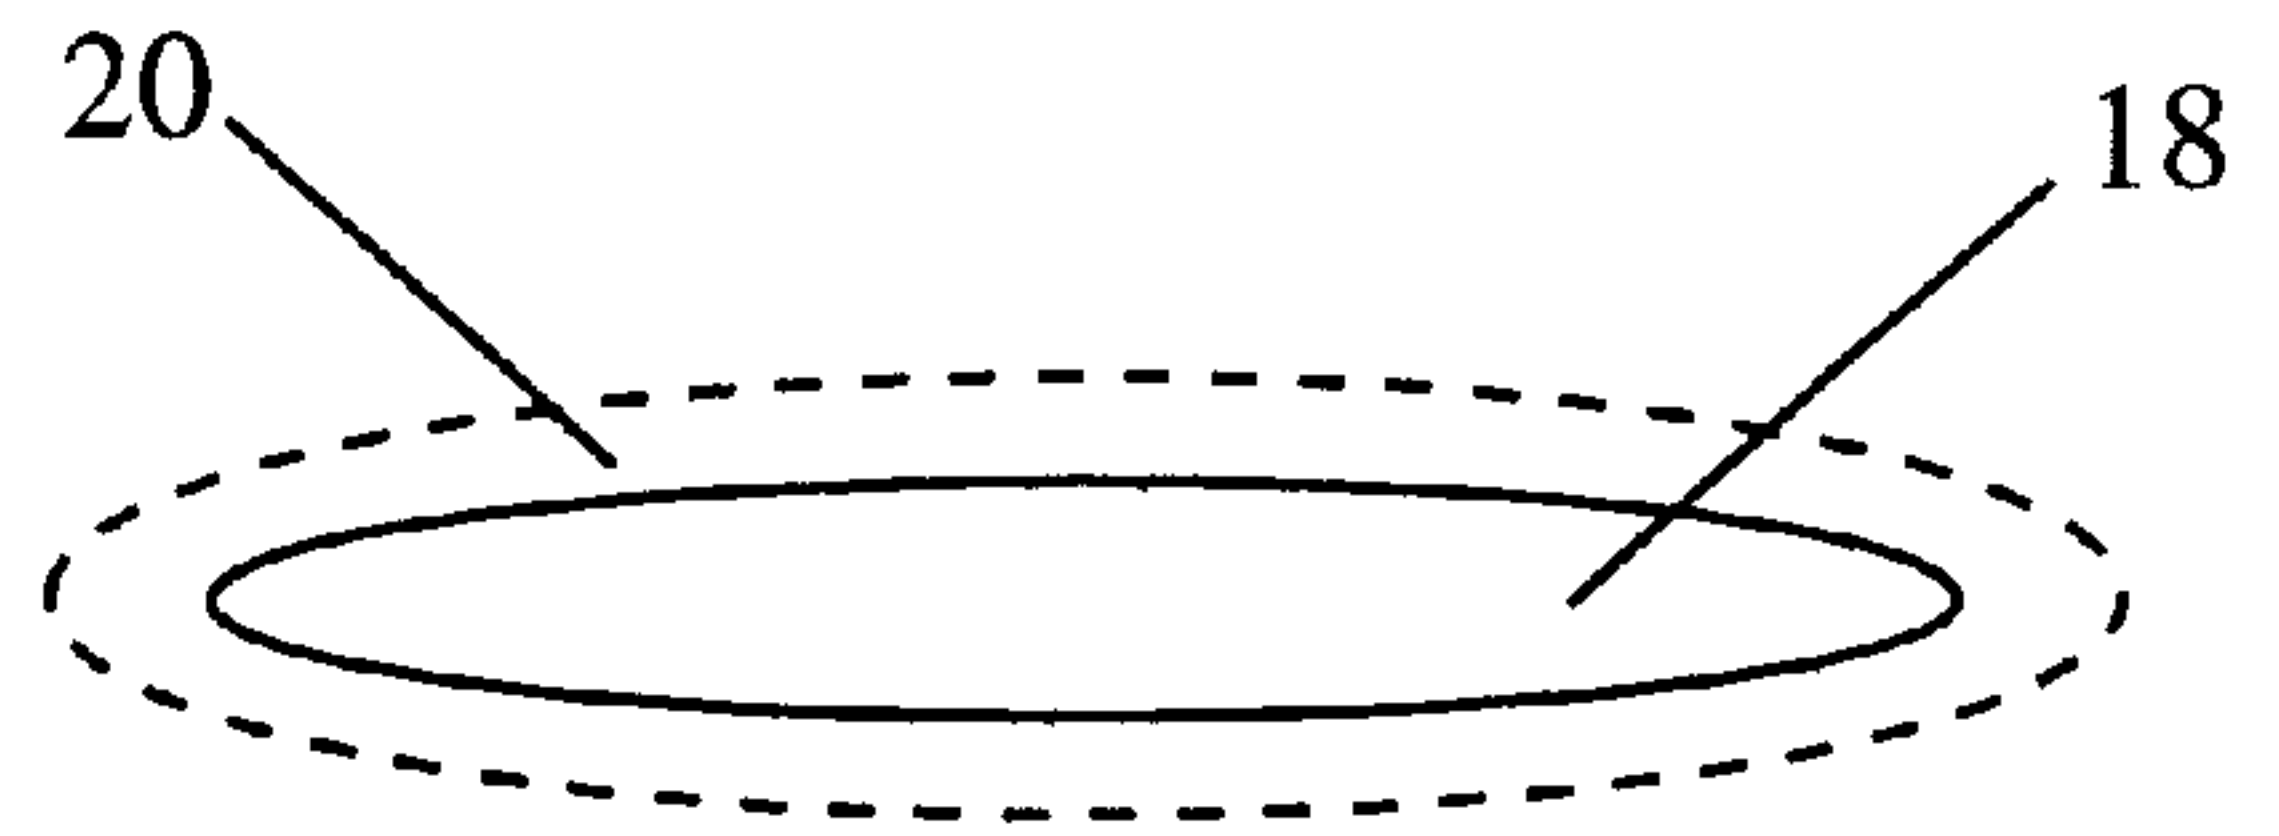
Figure 6(b)

FIG. 6(b) is a schematic cross-sectional view of the worn turbine engine part showing the worn areas to be repaired using the inventive method of repairing a turbine engine part;

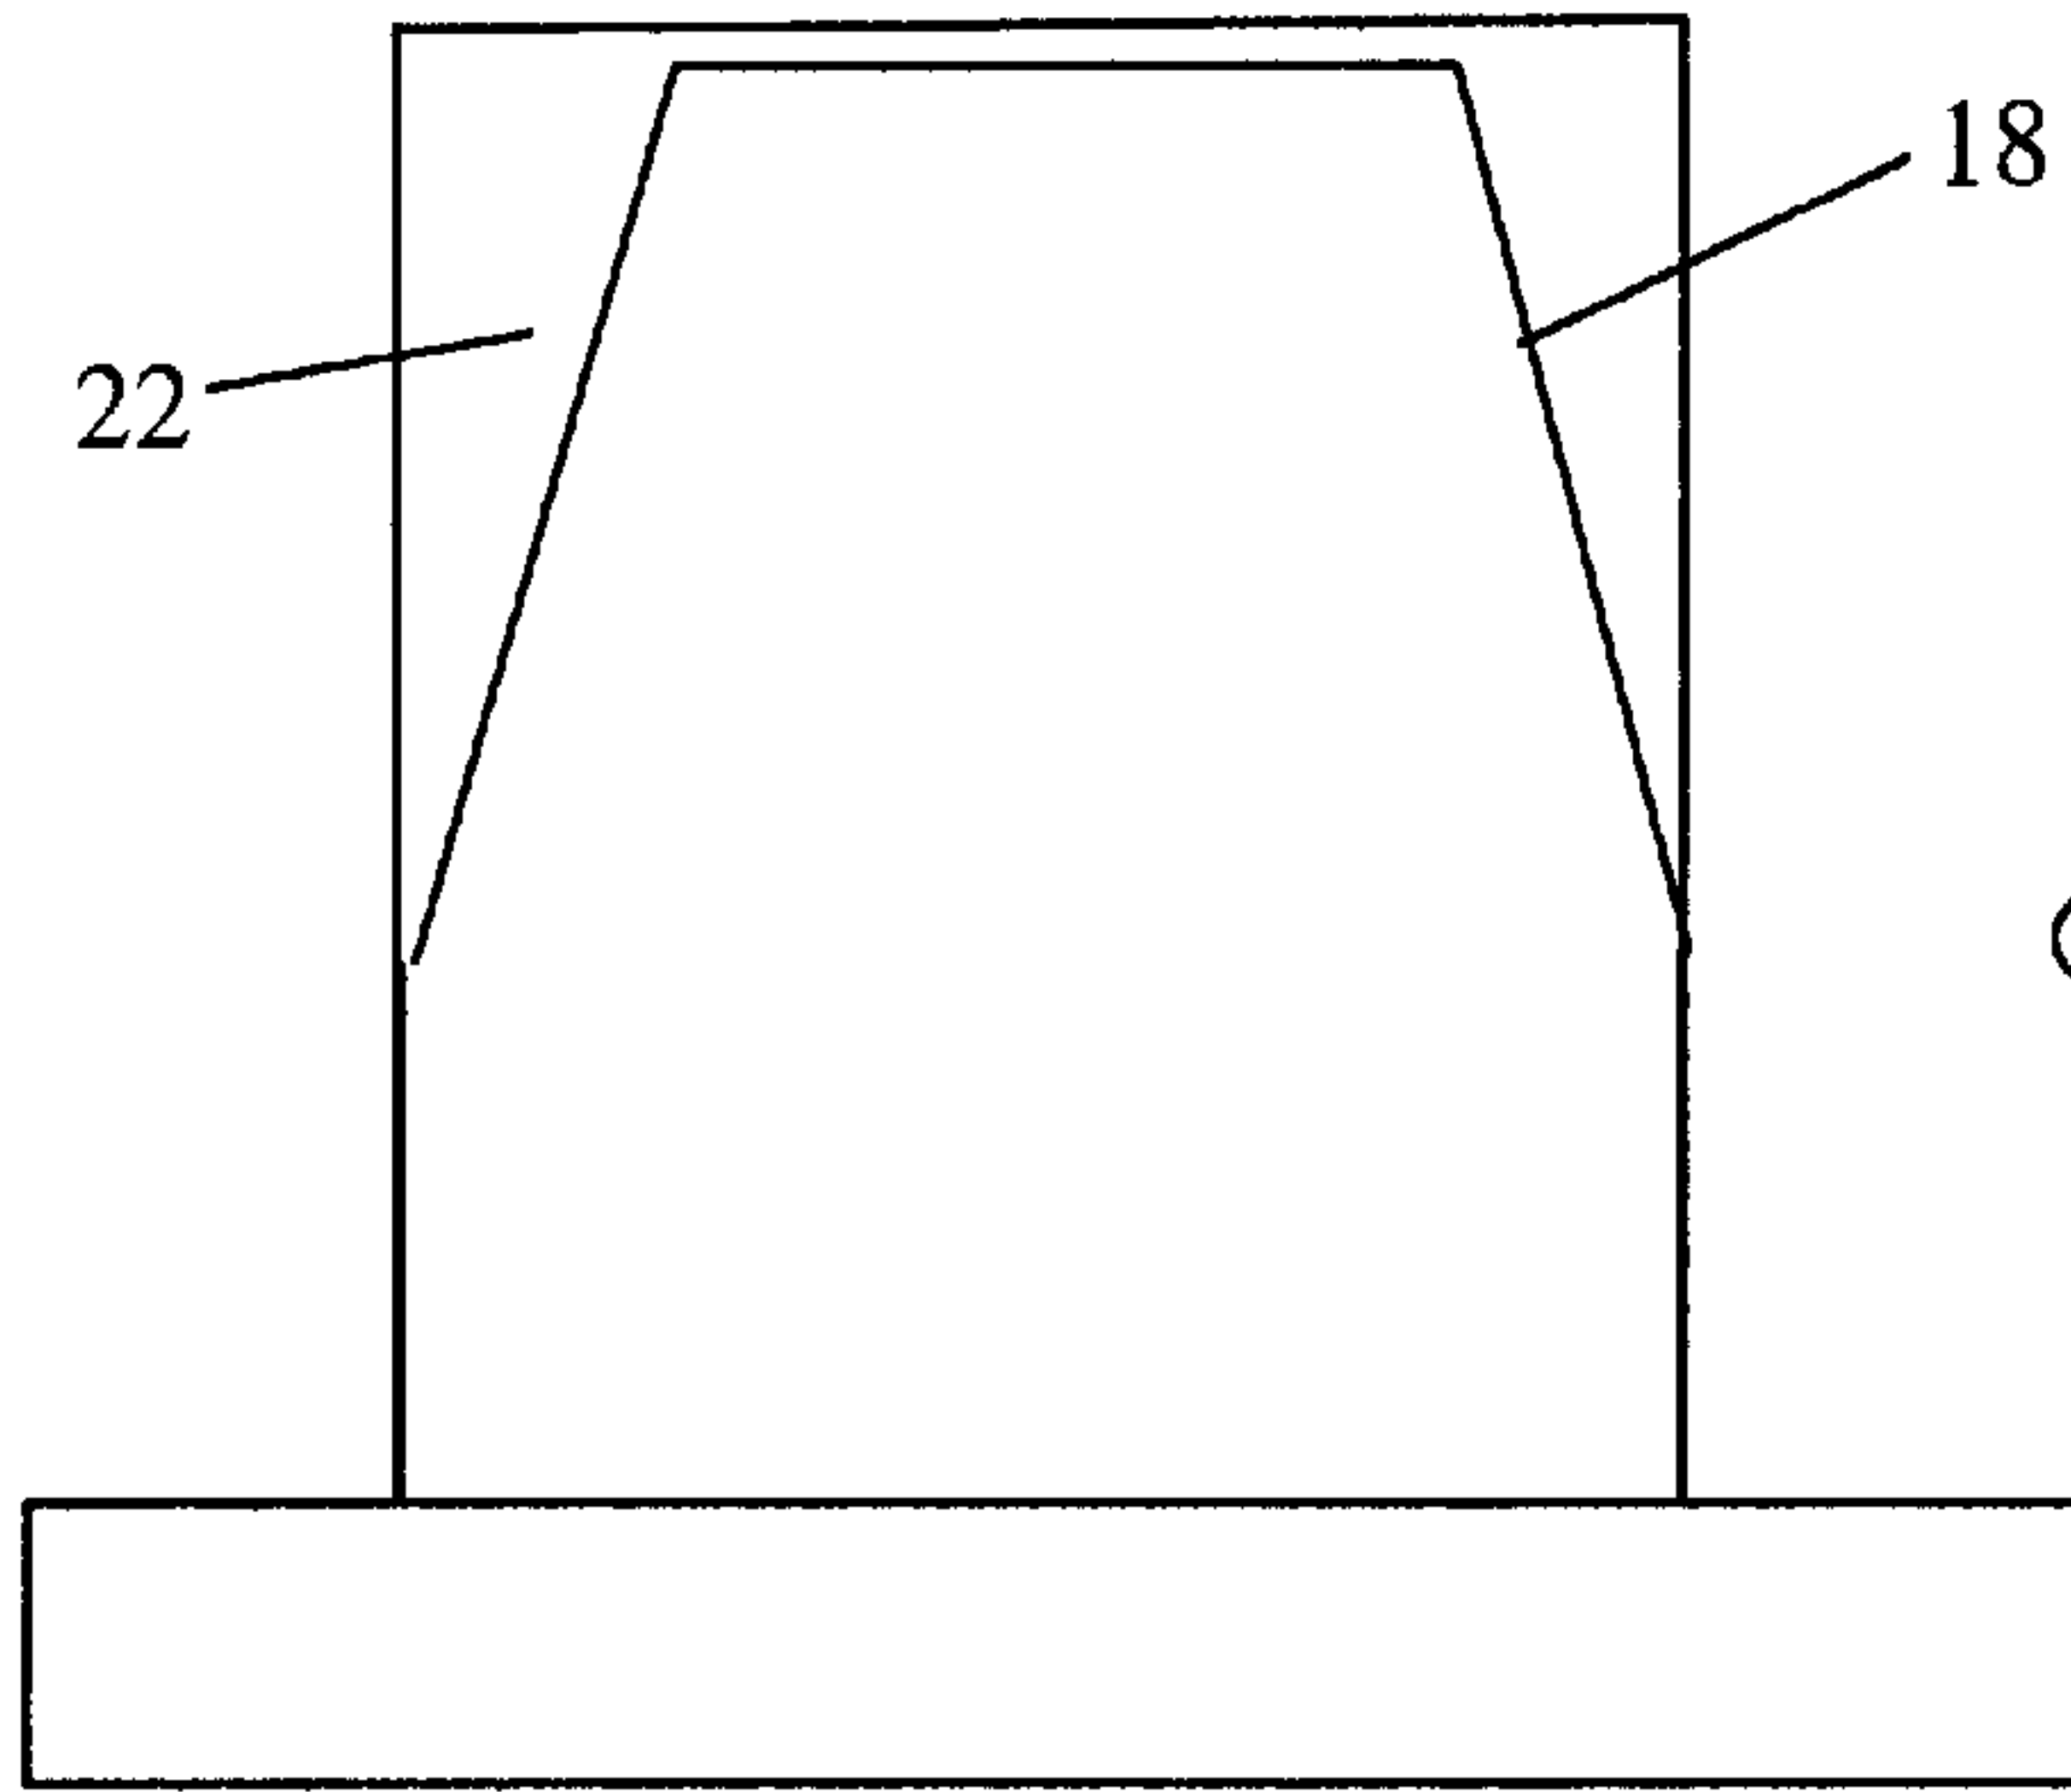
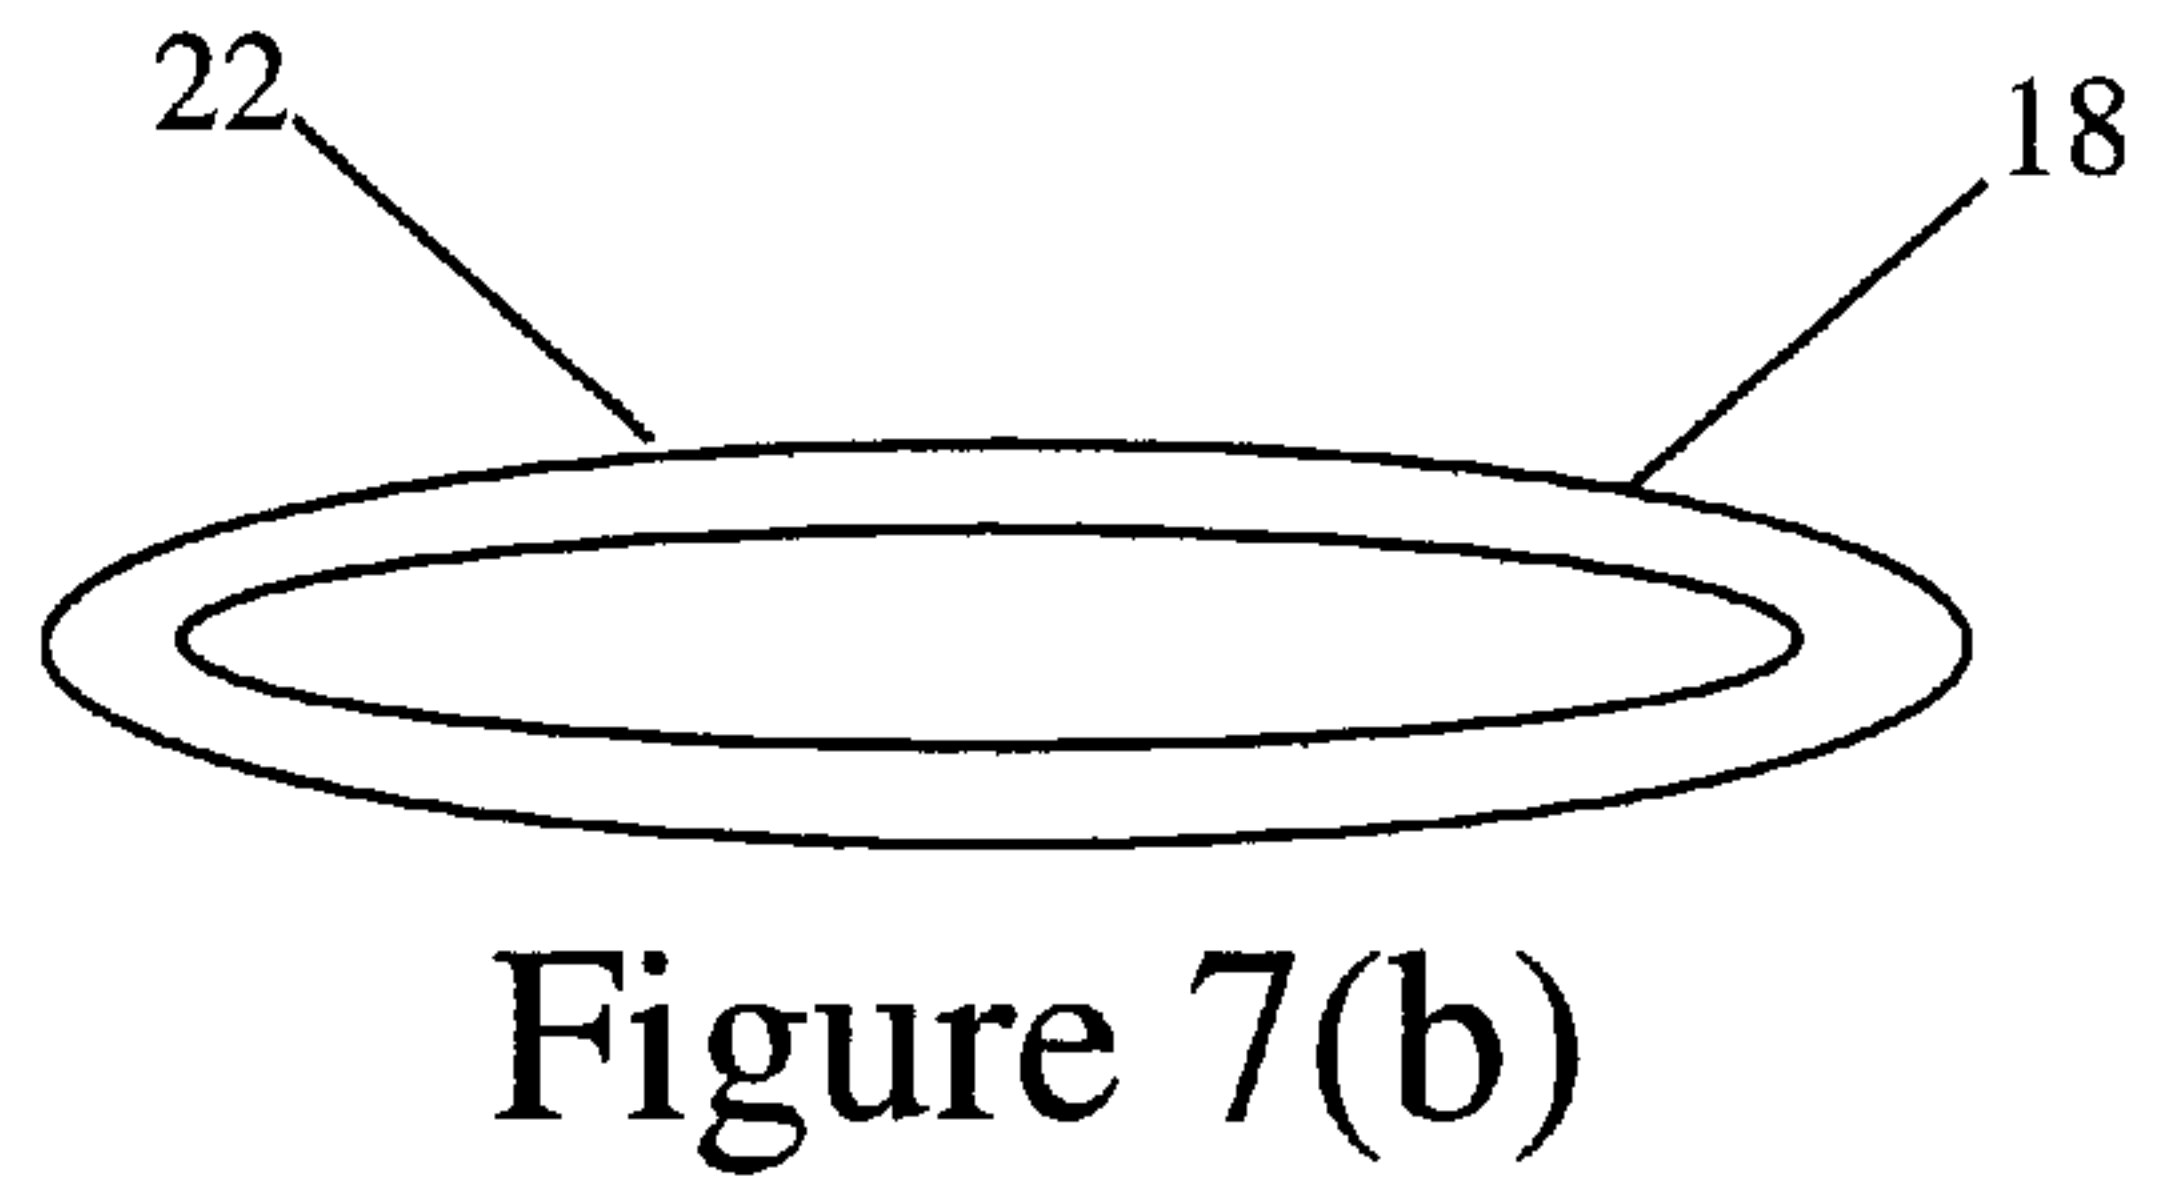
Figure 7(a)

FIG. 7(a) is a schematic side view of the worn turbine engine part showing the worn areas filled in with similar weld material in accordance with the inventive method of repairing a turbine engine part;

FIG. 7(b) is a schematic cross-sectional view of the worn turbine engine part showing the worn areas filled in with similar weld material in accordance with the inventive method of repairing a turbine engine part;

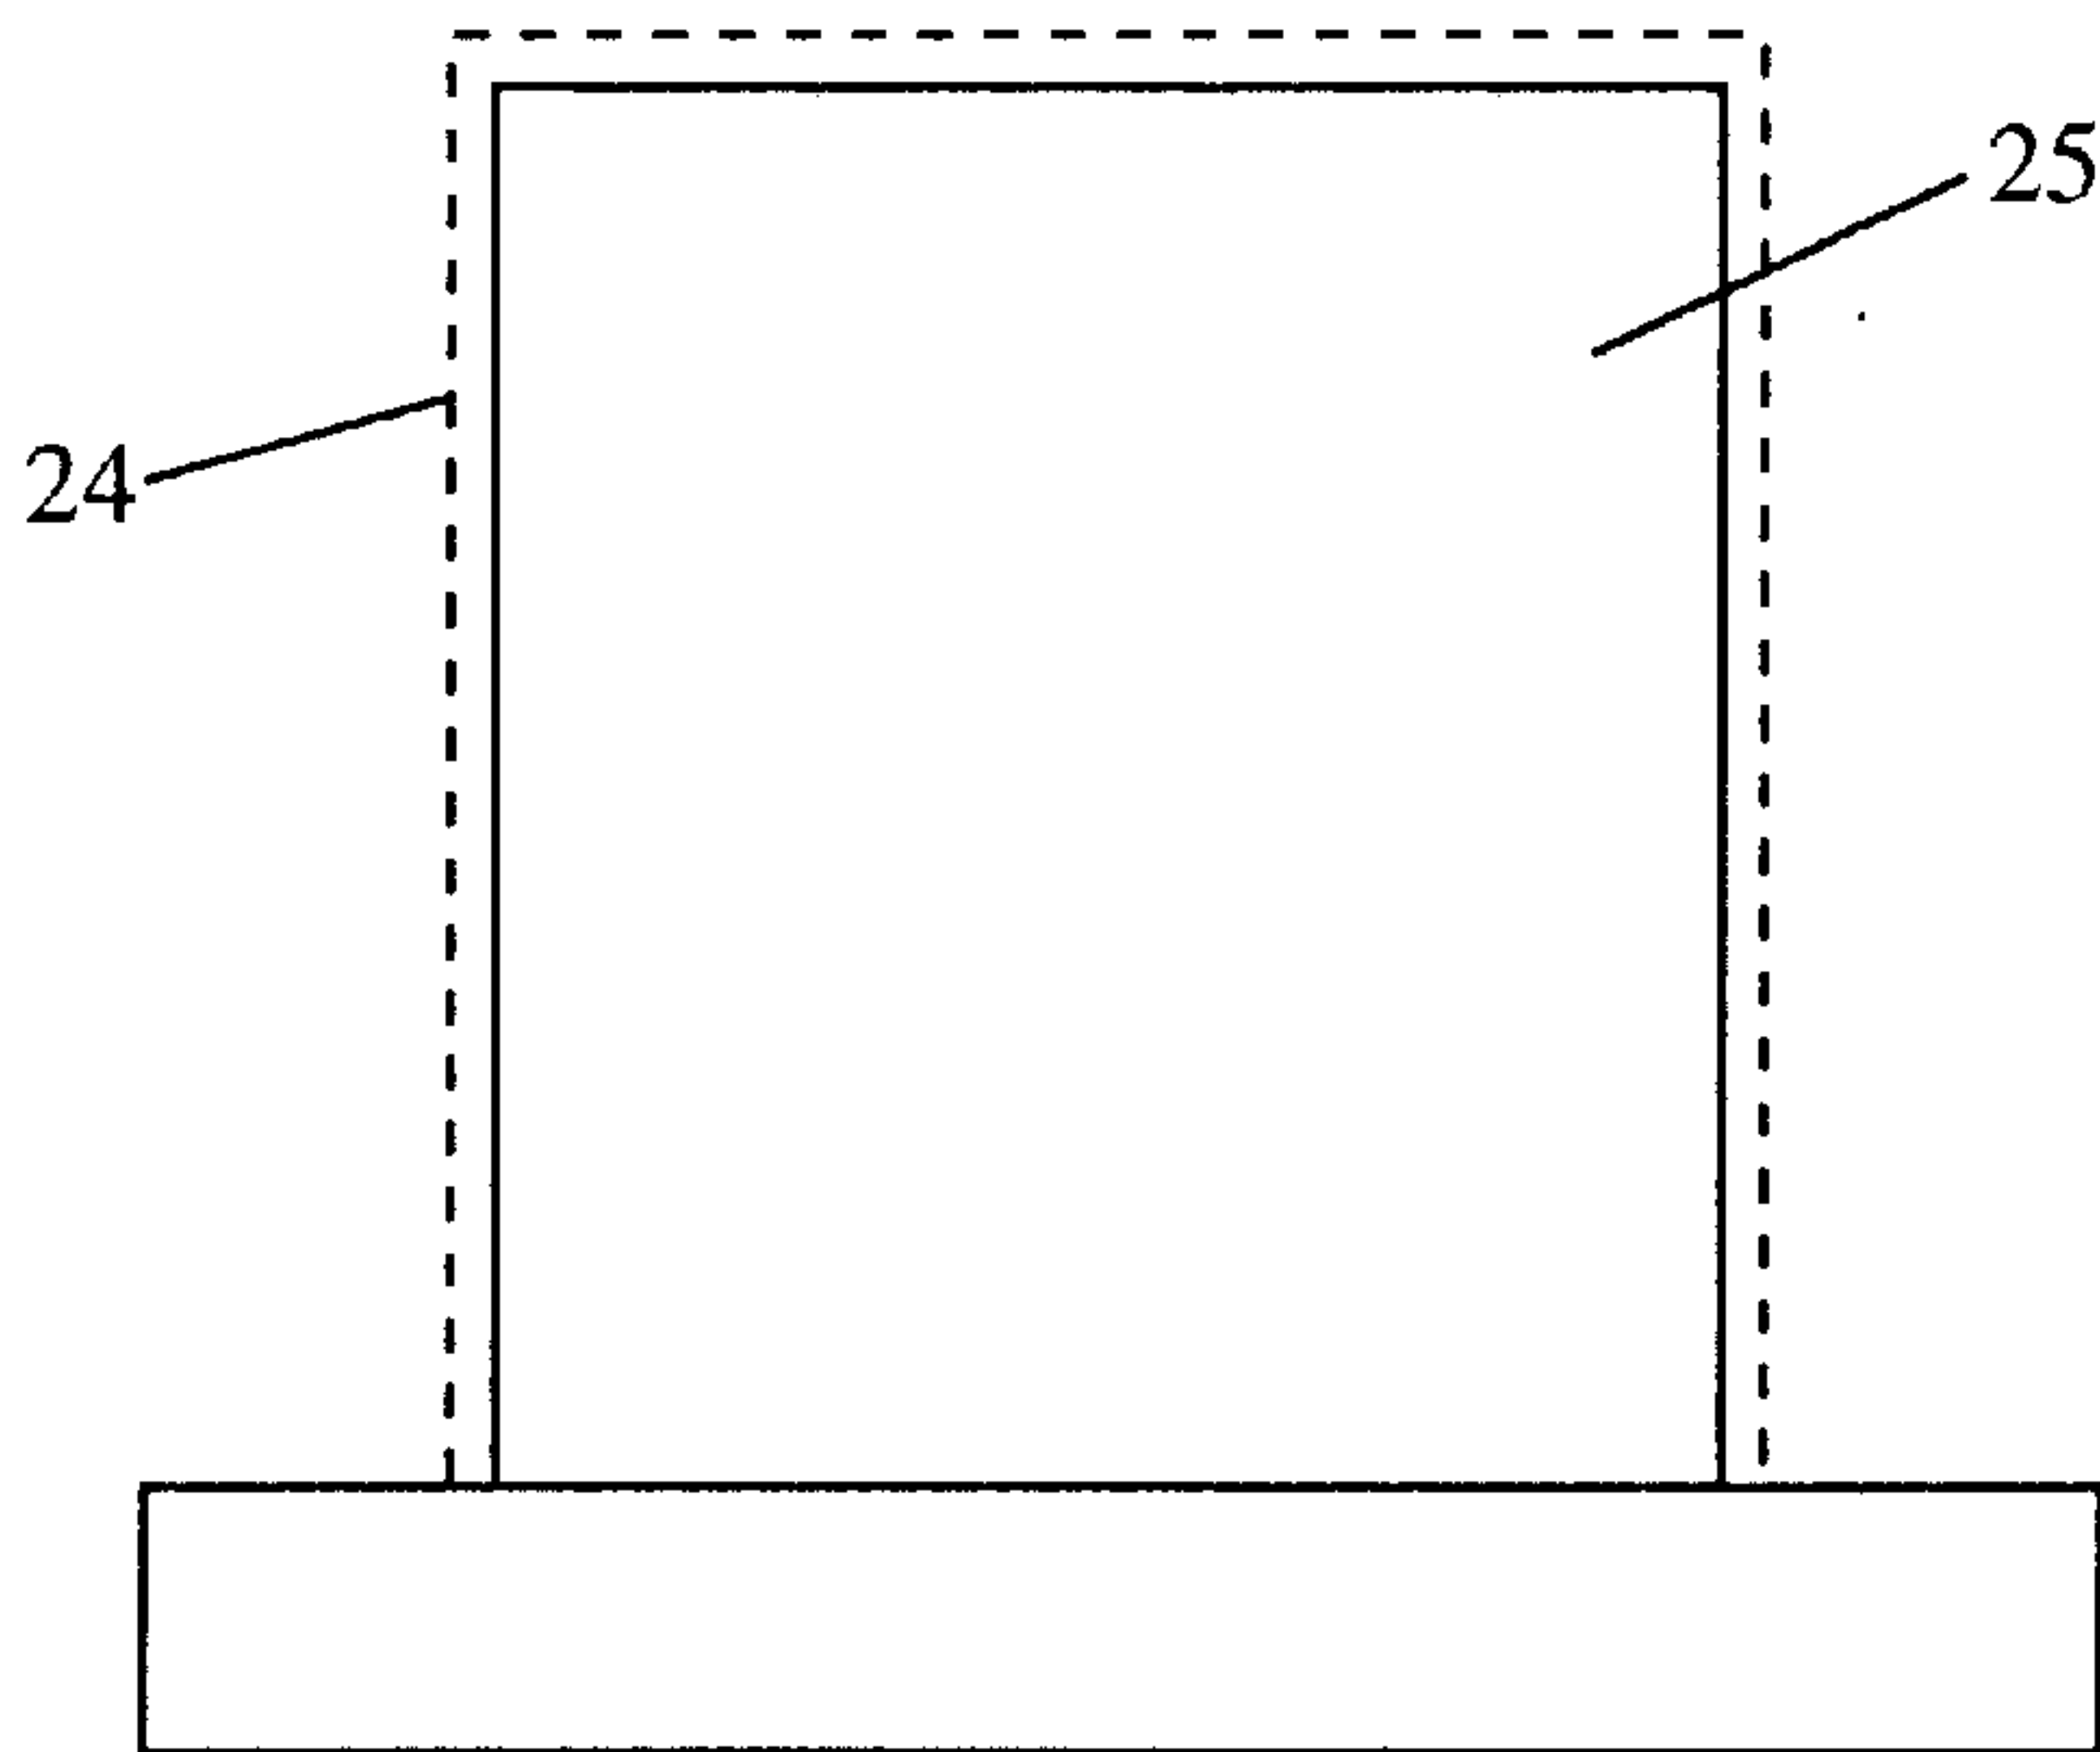
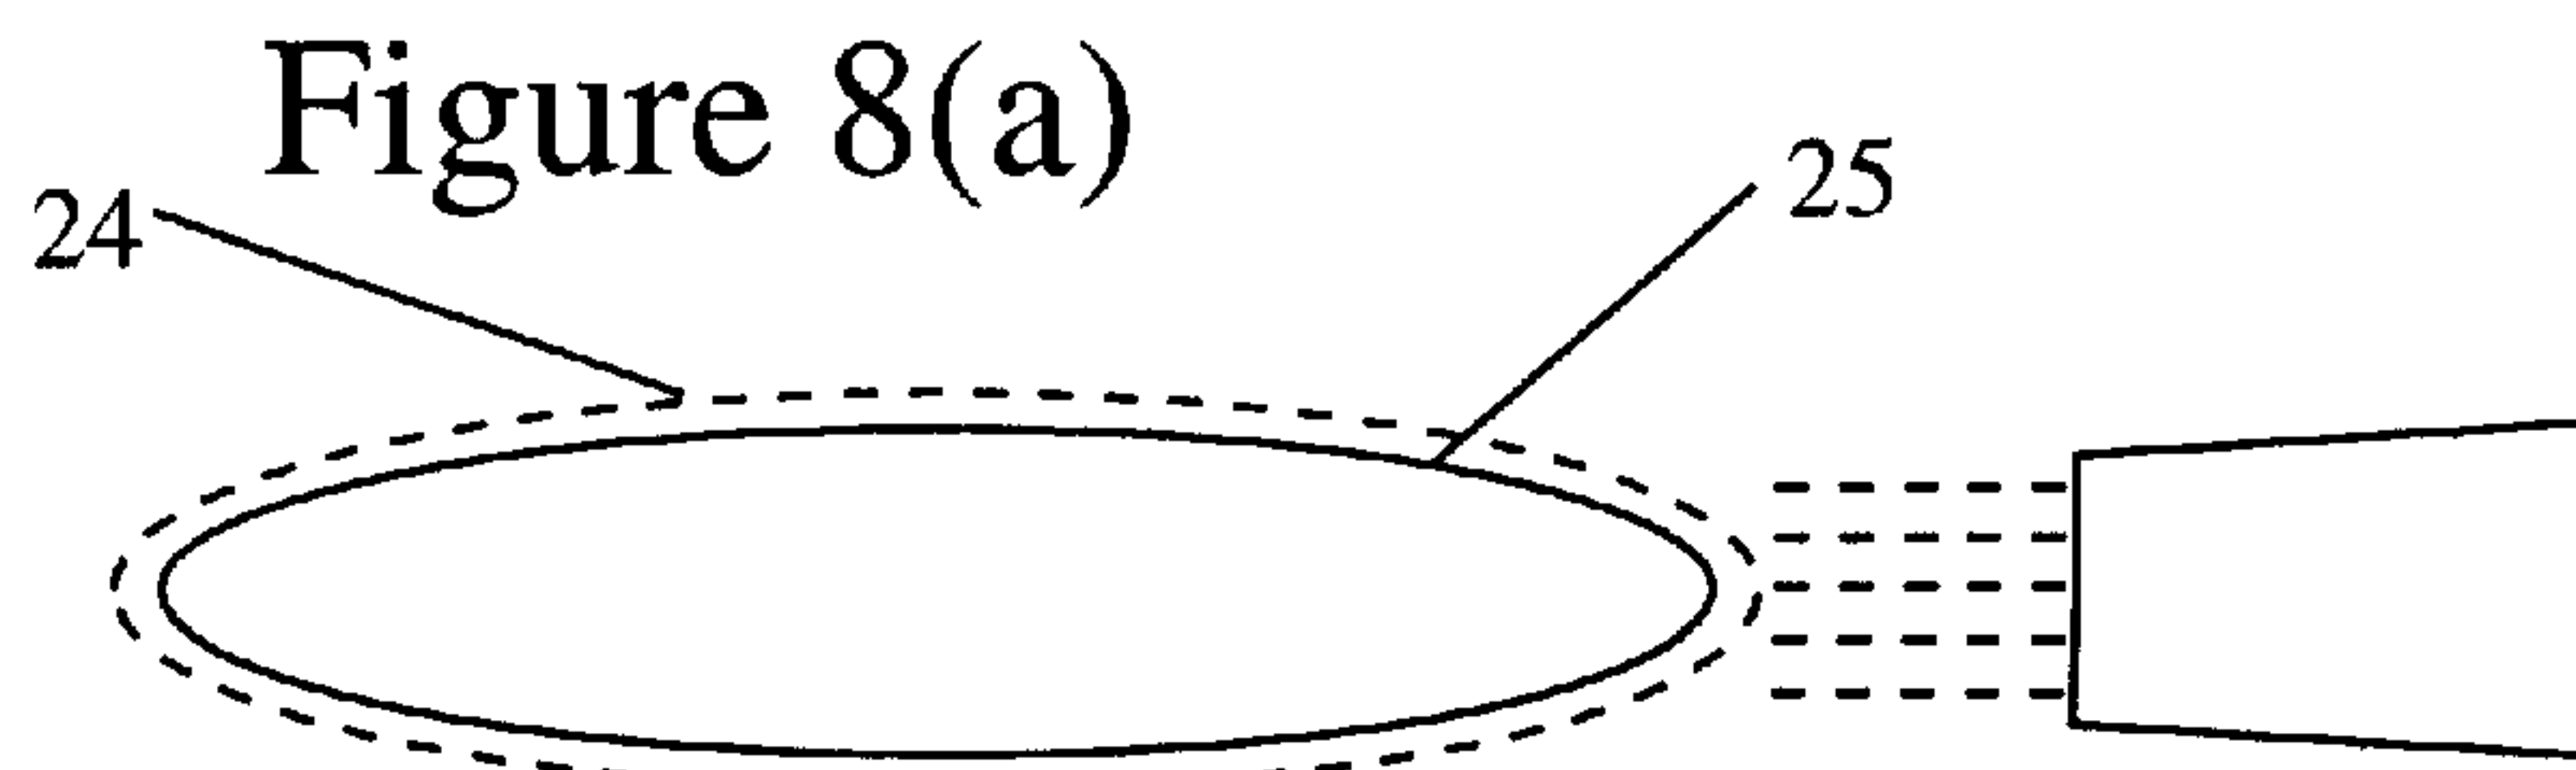
Figure 8(b)

FIG. 8(a) is a schematic side view of the welded turbine engine part showing areas to be built up with similar coating material using an HVOF spray coating process in accordance with the inventive method of repairing a turbine engine part;

FIG. 8(b) is a schematic cross-sectional view of the welded turbine engine part showing areas to be built up with similar coating material using an HVOF spray coating process in accordance with the inventive method of repairing a turbine engine part;

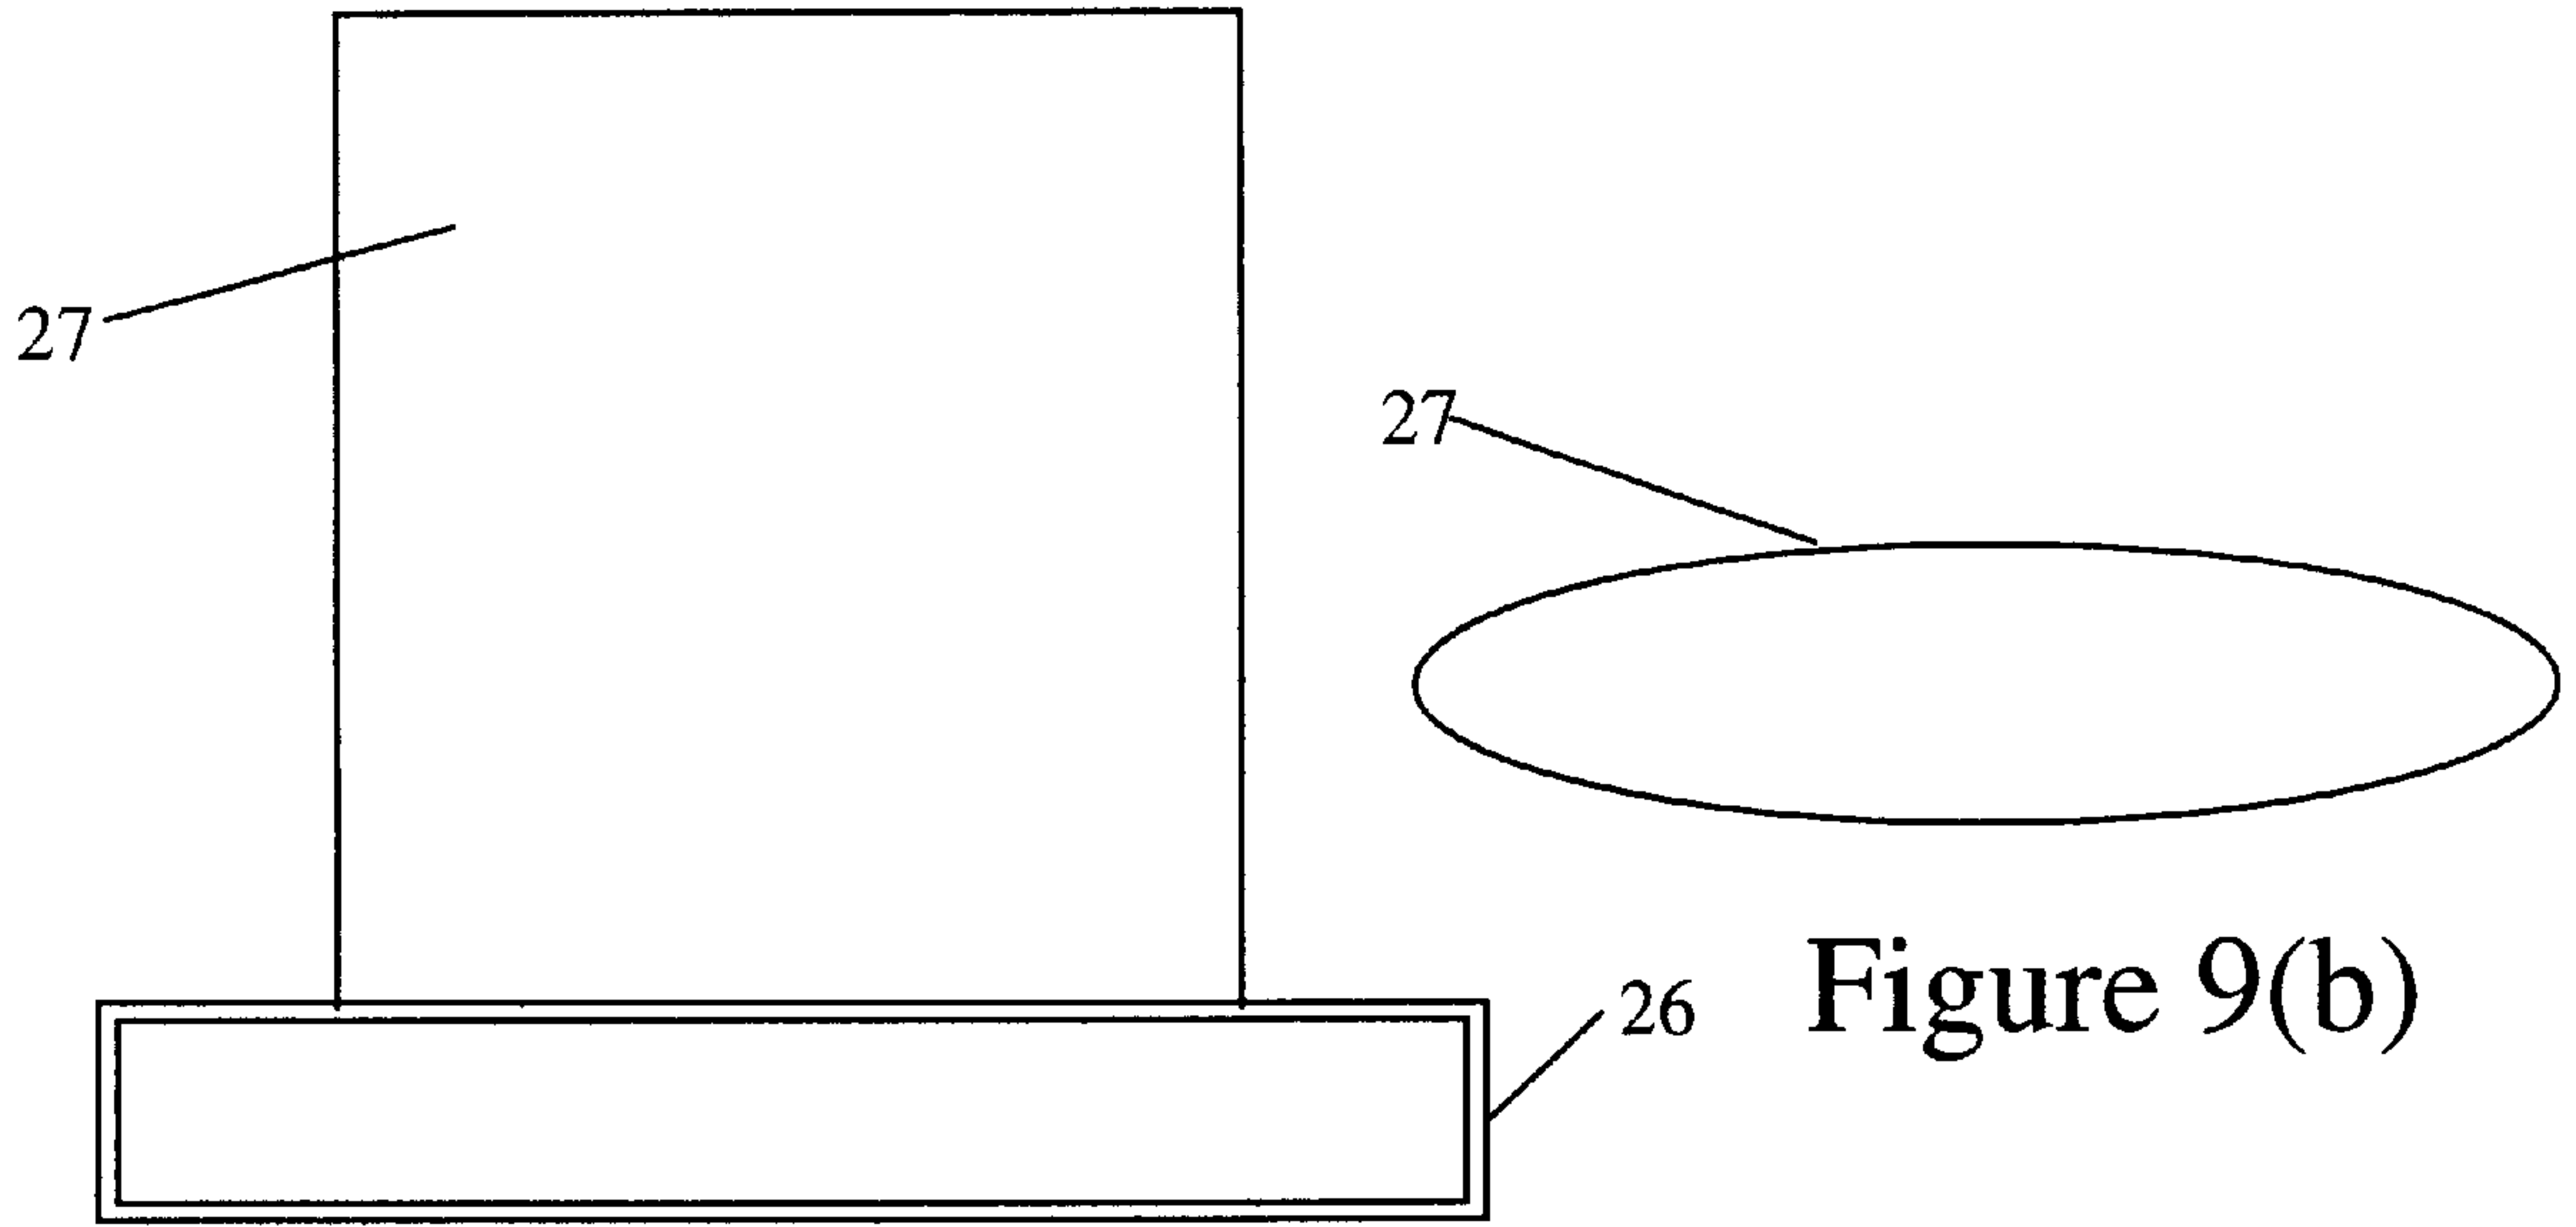
Figure 9(a)

FIG. 9(a) is a schematic side view of the HVOF built up, welded turbine engine part showing an area masked before performing the HVOF spray coating process in accordance with the inventive method of repairing a turbine engine part;

FIG. 9(b) is a schematic cross-sectional view of the HVOF built up, welded turbine engine part in accordance with the inventive method of repairing a turbine engine part;

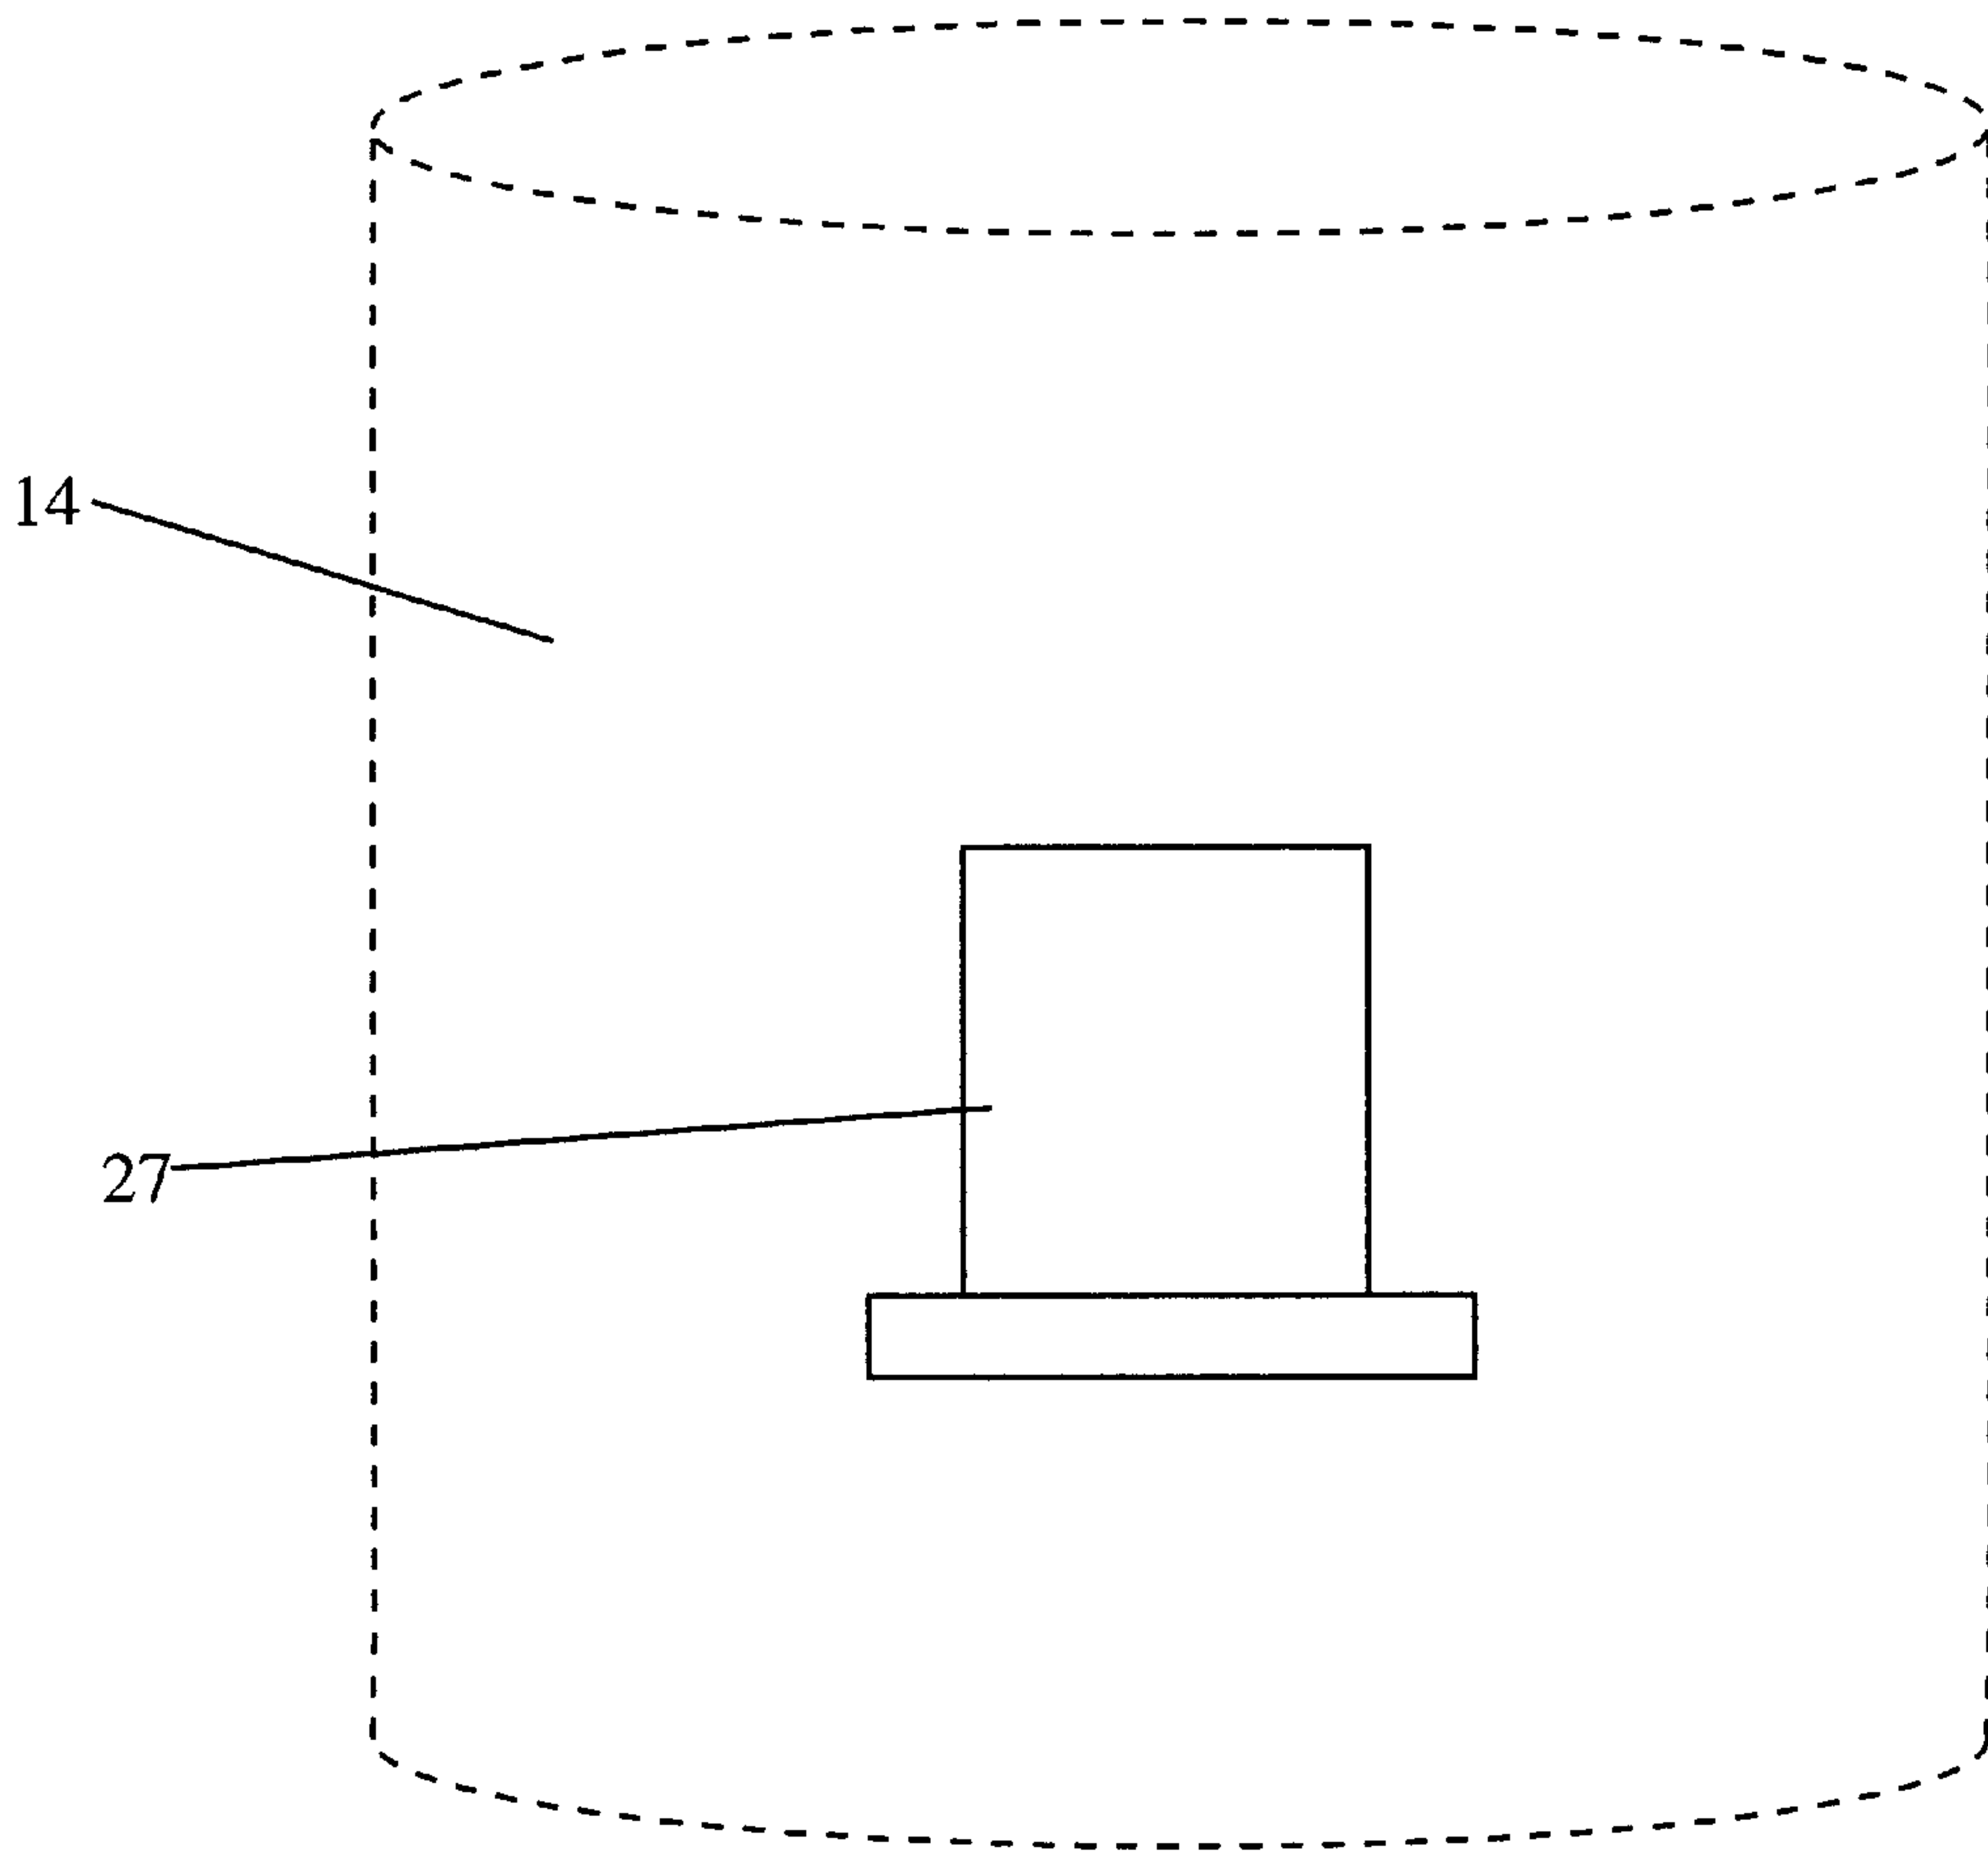
Figure 10

FIG. 10 is a schematic view of the HVOF built up, welded turbine engine part undergoing a HIP treatment process in a HIP vessel in accordance with the inventive method of repairing a turbine engine part;
