# United States Patent [19]

[11] Patent Number: **6,049,978**

[54] **METHODS FOR REPAIRING AND RECLASSIFYING GAS TURBINE ENGINE AIRFOIL PARTS**

[73] Assignee: **Recast Airfoil Group**, North Haven, Conn.

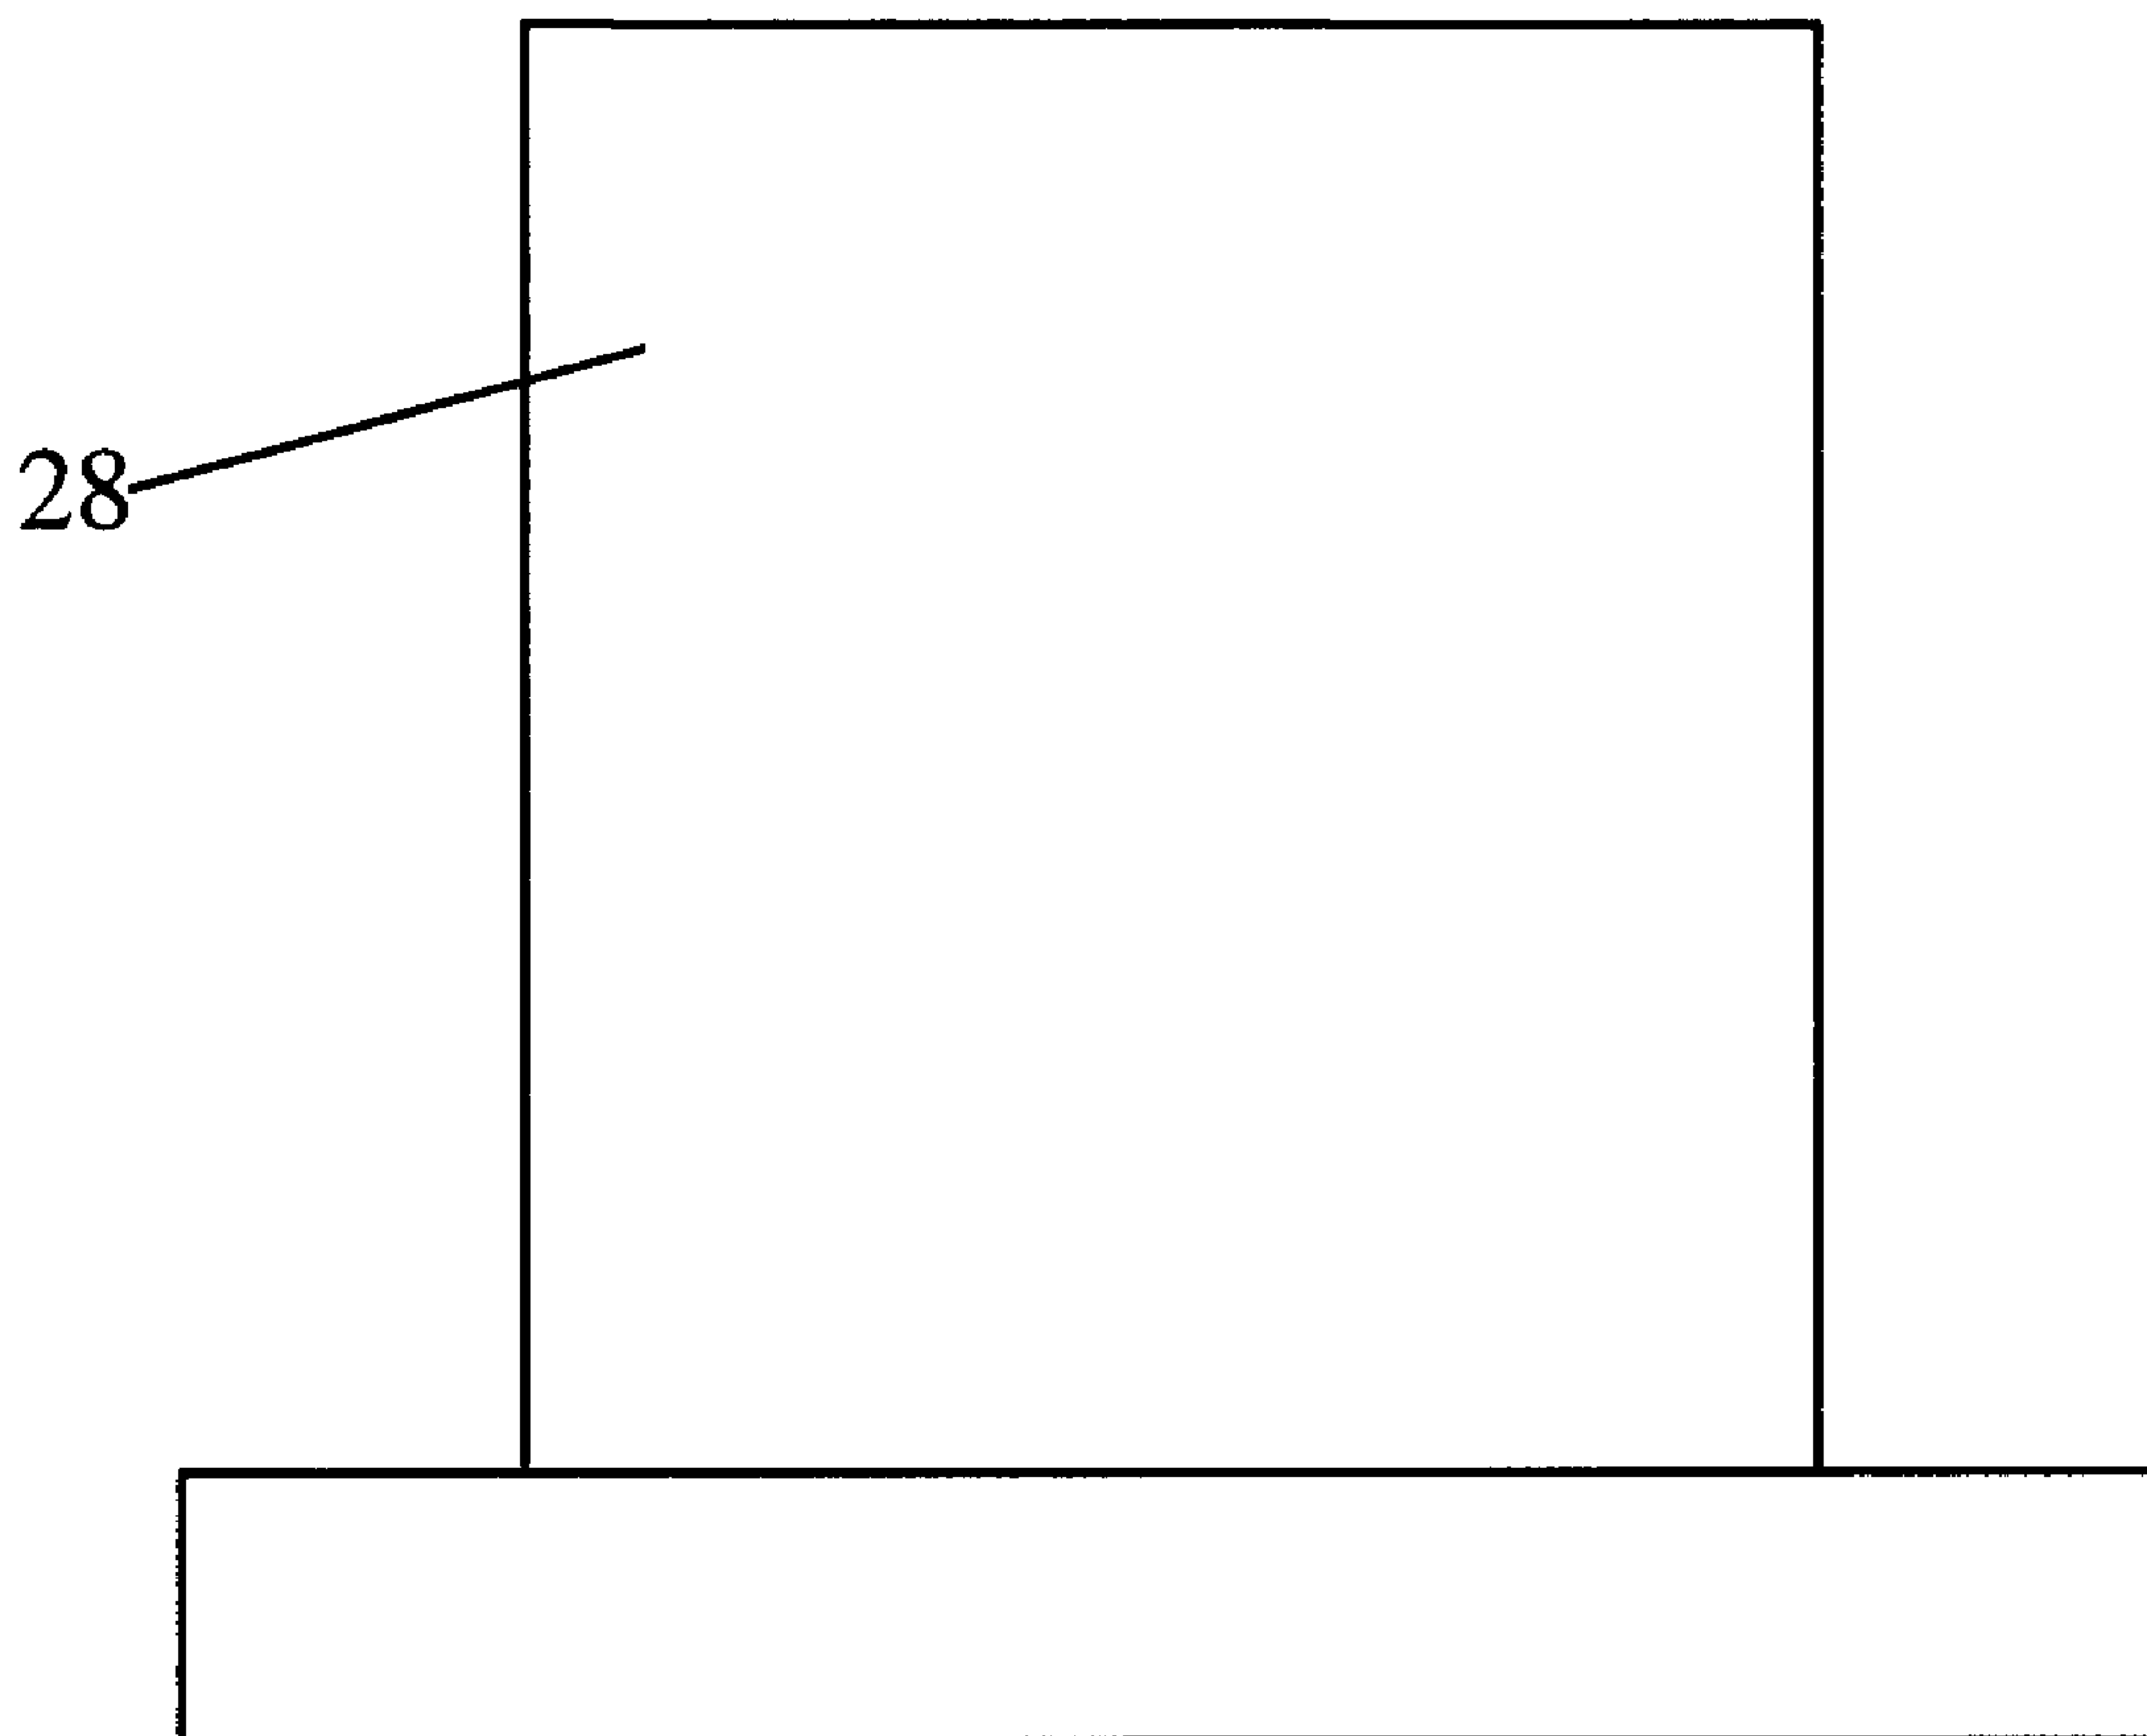
Figure 11(a)

FIG. 11(a) is a schematic side view of the final HVOF spray coated and HIP repaired turbine engine part having a similar metal coating layer diffusion bonded to the original parent substrate and welded portions in accordance with the inventive method of repairing a turbine engine part;

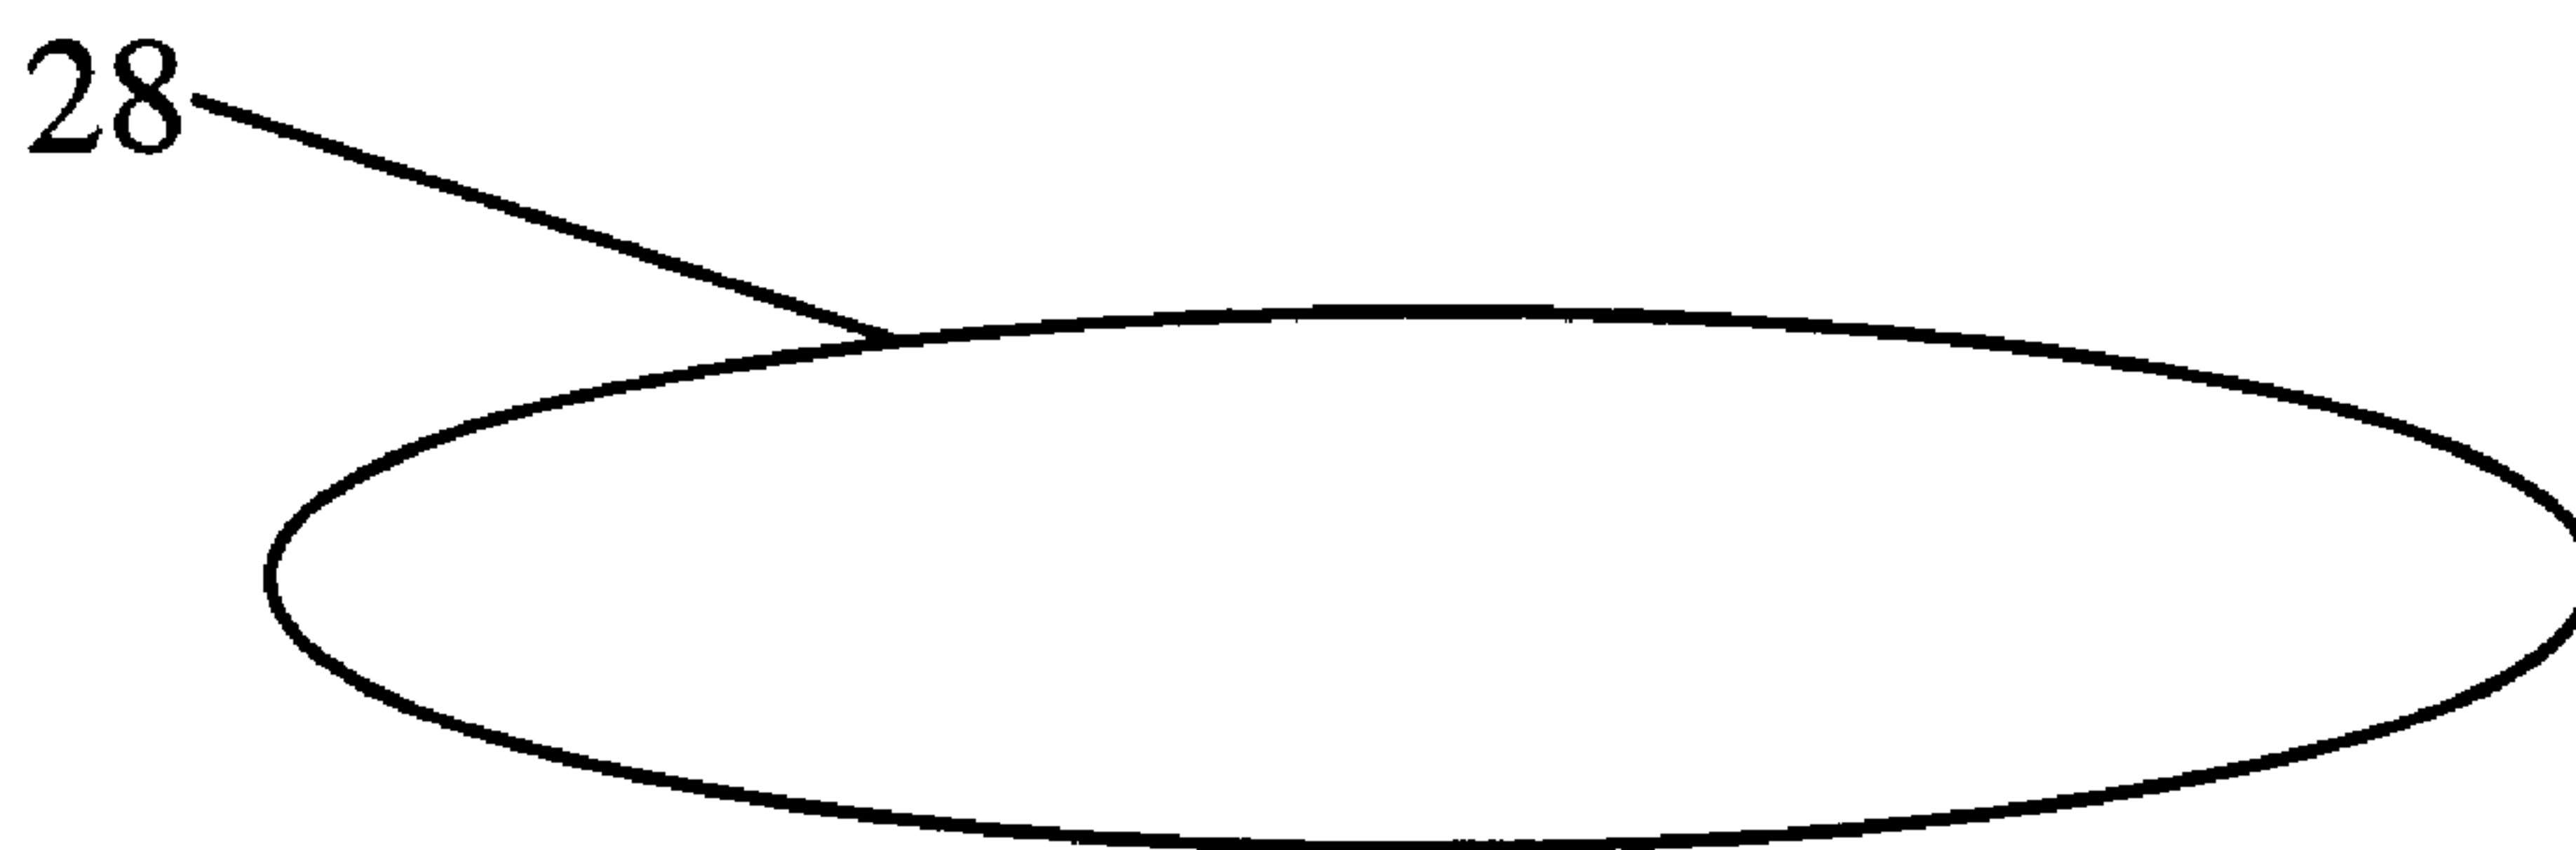
Figure 11(b)

FIG. 11(b) is a schematic cross-sectional view of the final HVOF spray coated and HIP repaired turbine engine part having a similar metal coating layer diffusion bonded to the original parent substrate and welded portions in accordance with the inventive method of repairing a turbine engine part;

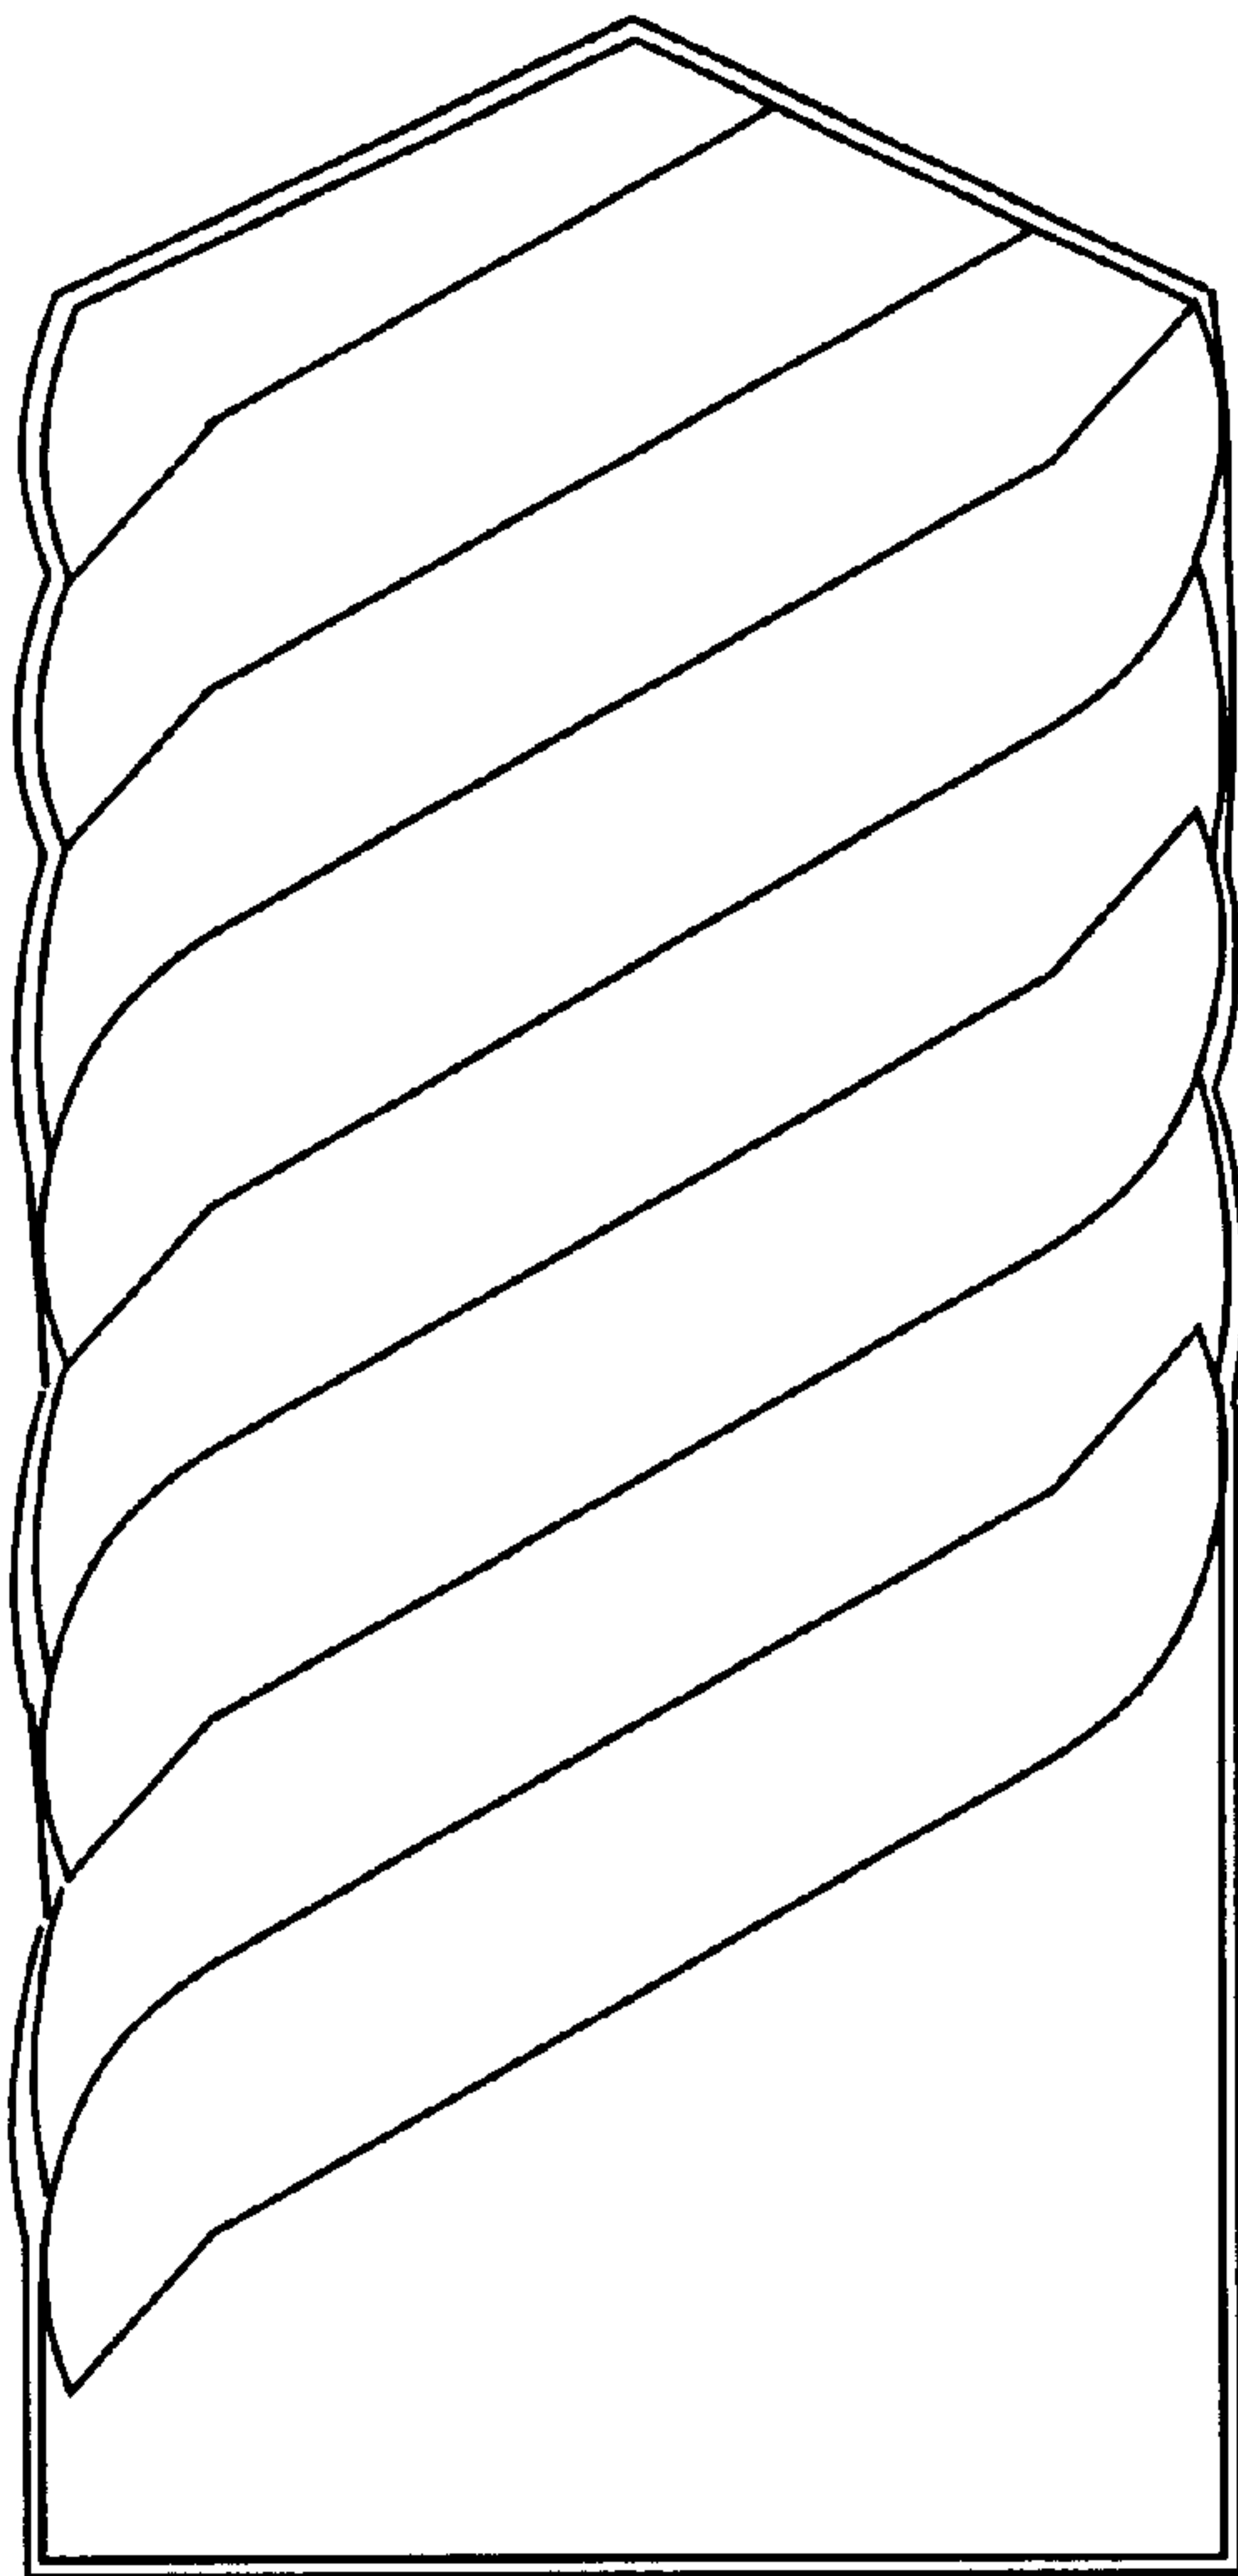
Figure 12(a)  
Prior Art

FIG. 12(a) is a side view of a prior art tool bit coated with a wear resistant coating;

FIG. 12(a) is a side view of a prior art tool bit coated with a wear resistant coating. In this case, the wear resistant coating may be applied by the Chemical Vapor Deposition method so that the entire tool bit substrate receives an even thin film of a relatively hard material, such as Carbide, Cobalt or TiN. Since the coating adheres to the tool bit substrate mostly via a mechanical bond located at a boundary interface, flaking and chipping off the coating off of the substrate is likely to occur during use, limiting the service life of the tool bit. FIG. 12(b) is a side view of a prior art tool bit having a fixed wear resistant cutting tip. In this case, a relatively hard metal cutting tip is fixed to the relatively soft tool bit substrate. The metal cutting tip, which is typically comprised of a Carbide or Cobalt alloy, is fixed to the tool bit substrate by brazing. During extended use the tool bit is likely to fail at the relatively brittle brazed interface between the metal cutting tip and the tool substrate, and again, the useful service life of the tool bit is limited.

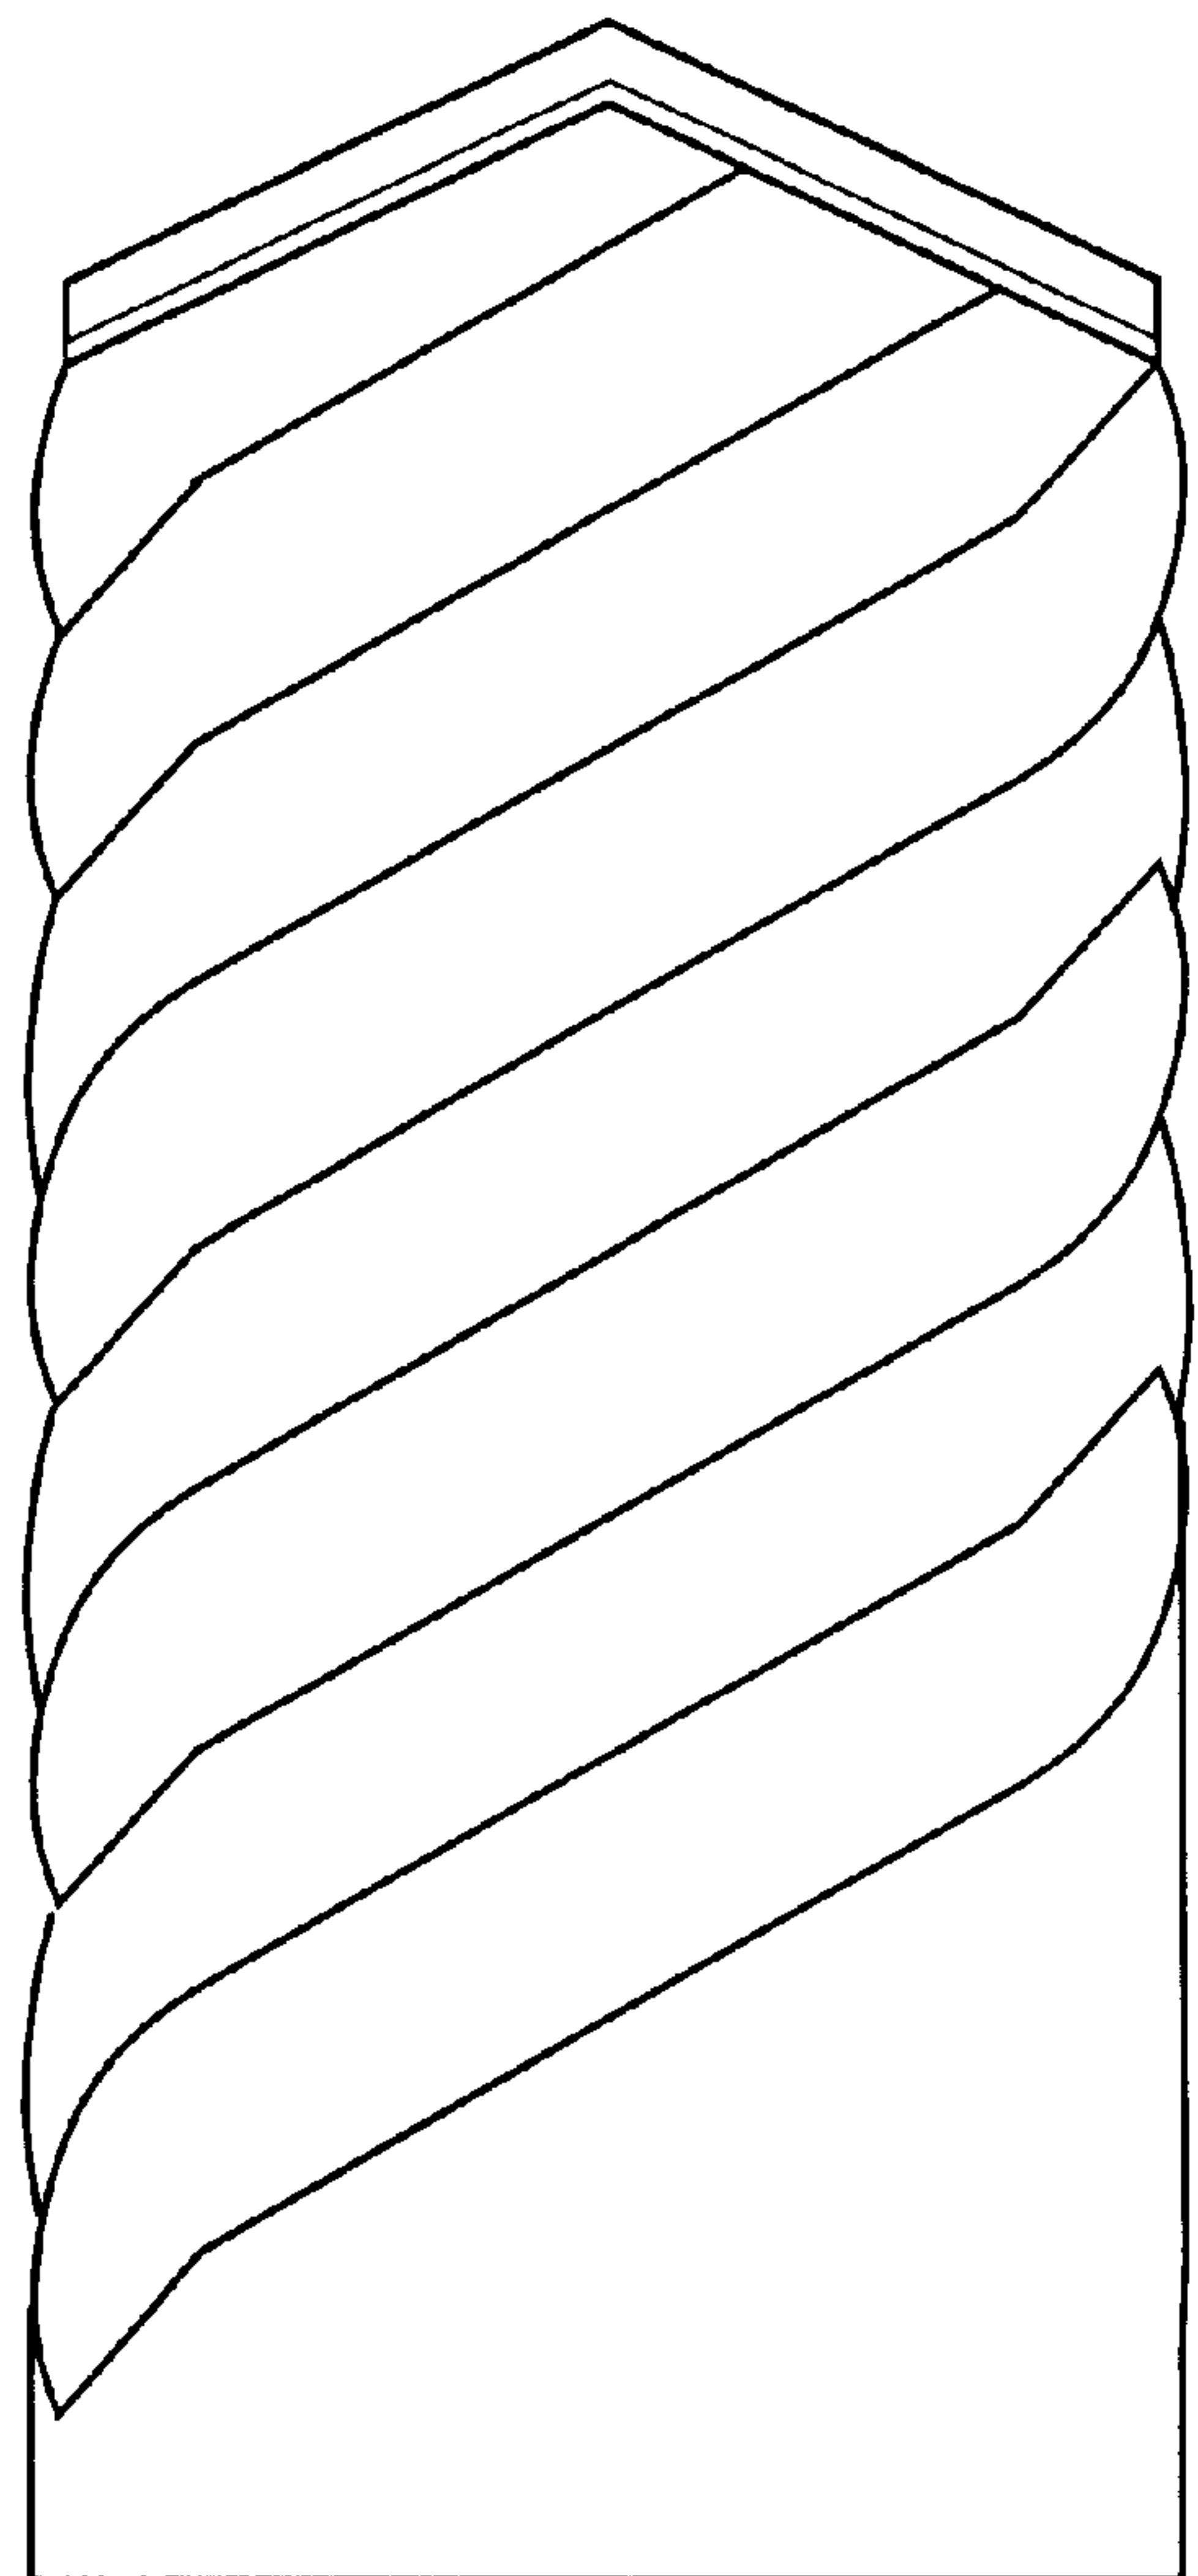
Figure 12(b)  
Prior Art

FIG. 12(b) is a side view of a prior art tool bit having a fixed wear resistant cutting tip;

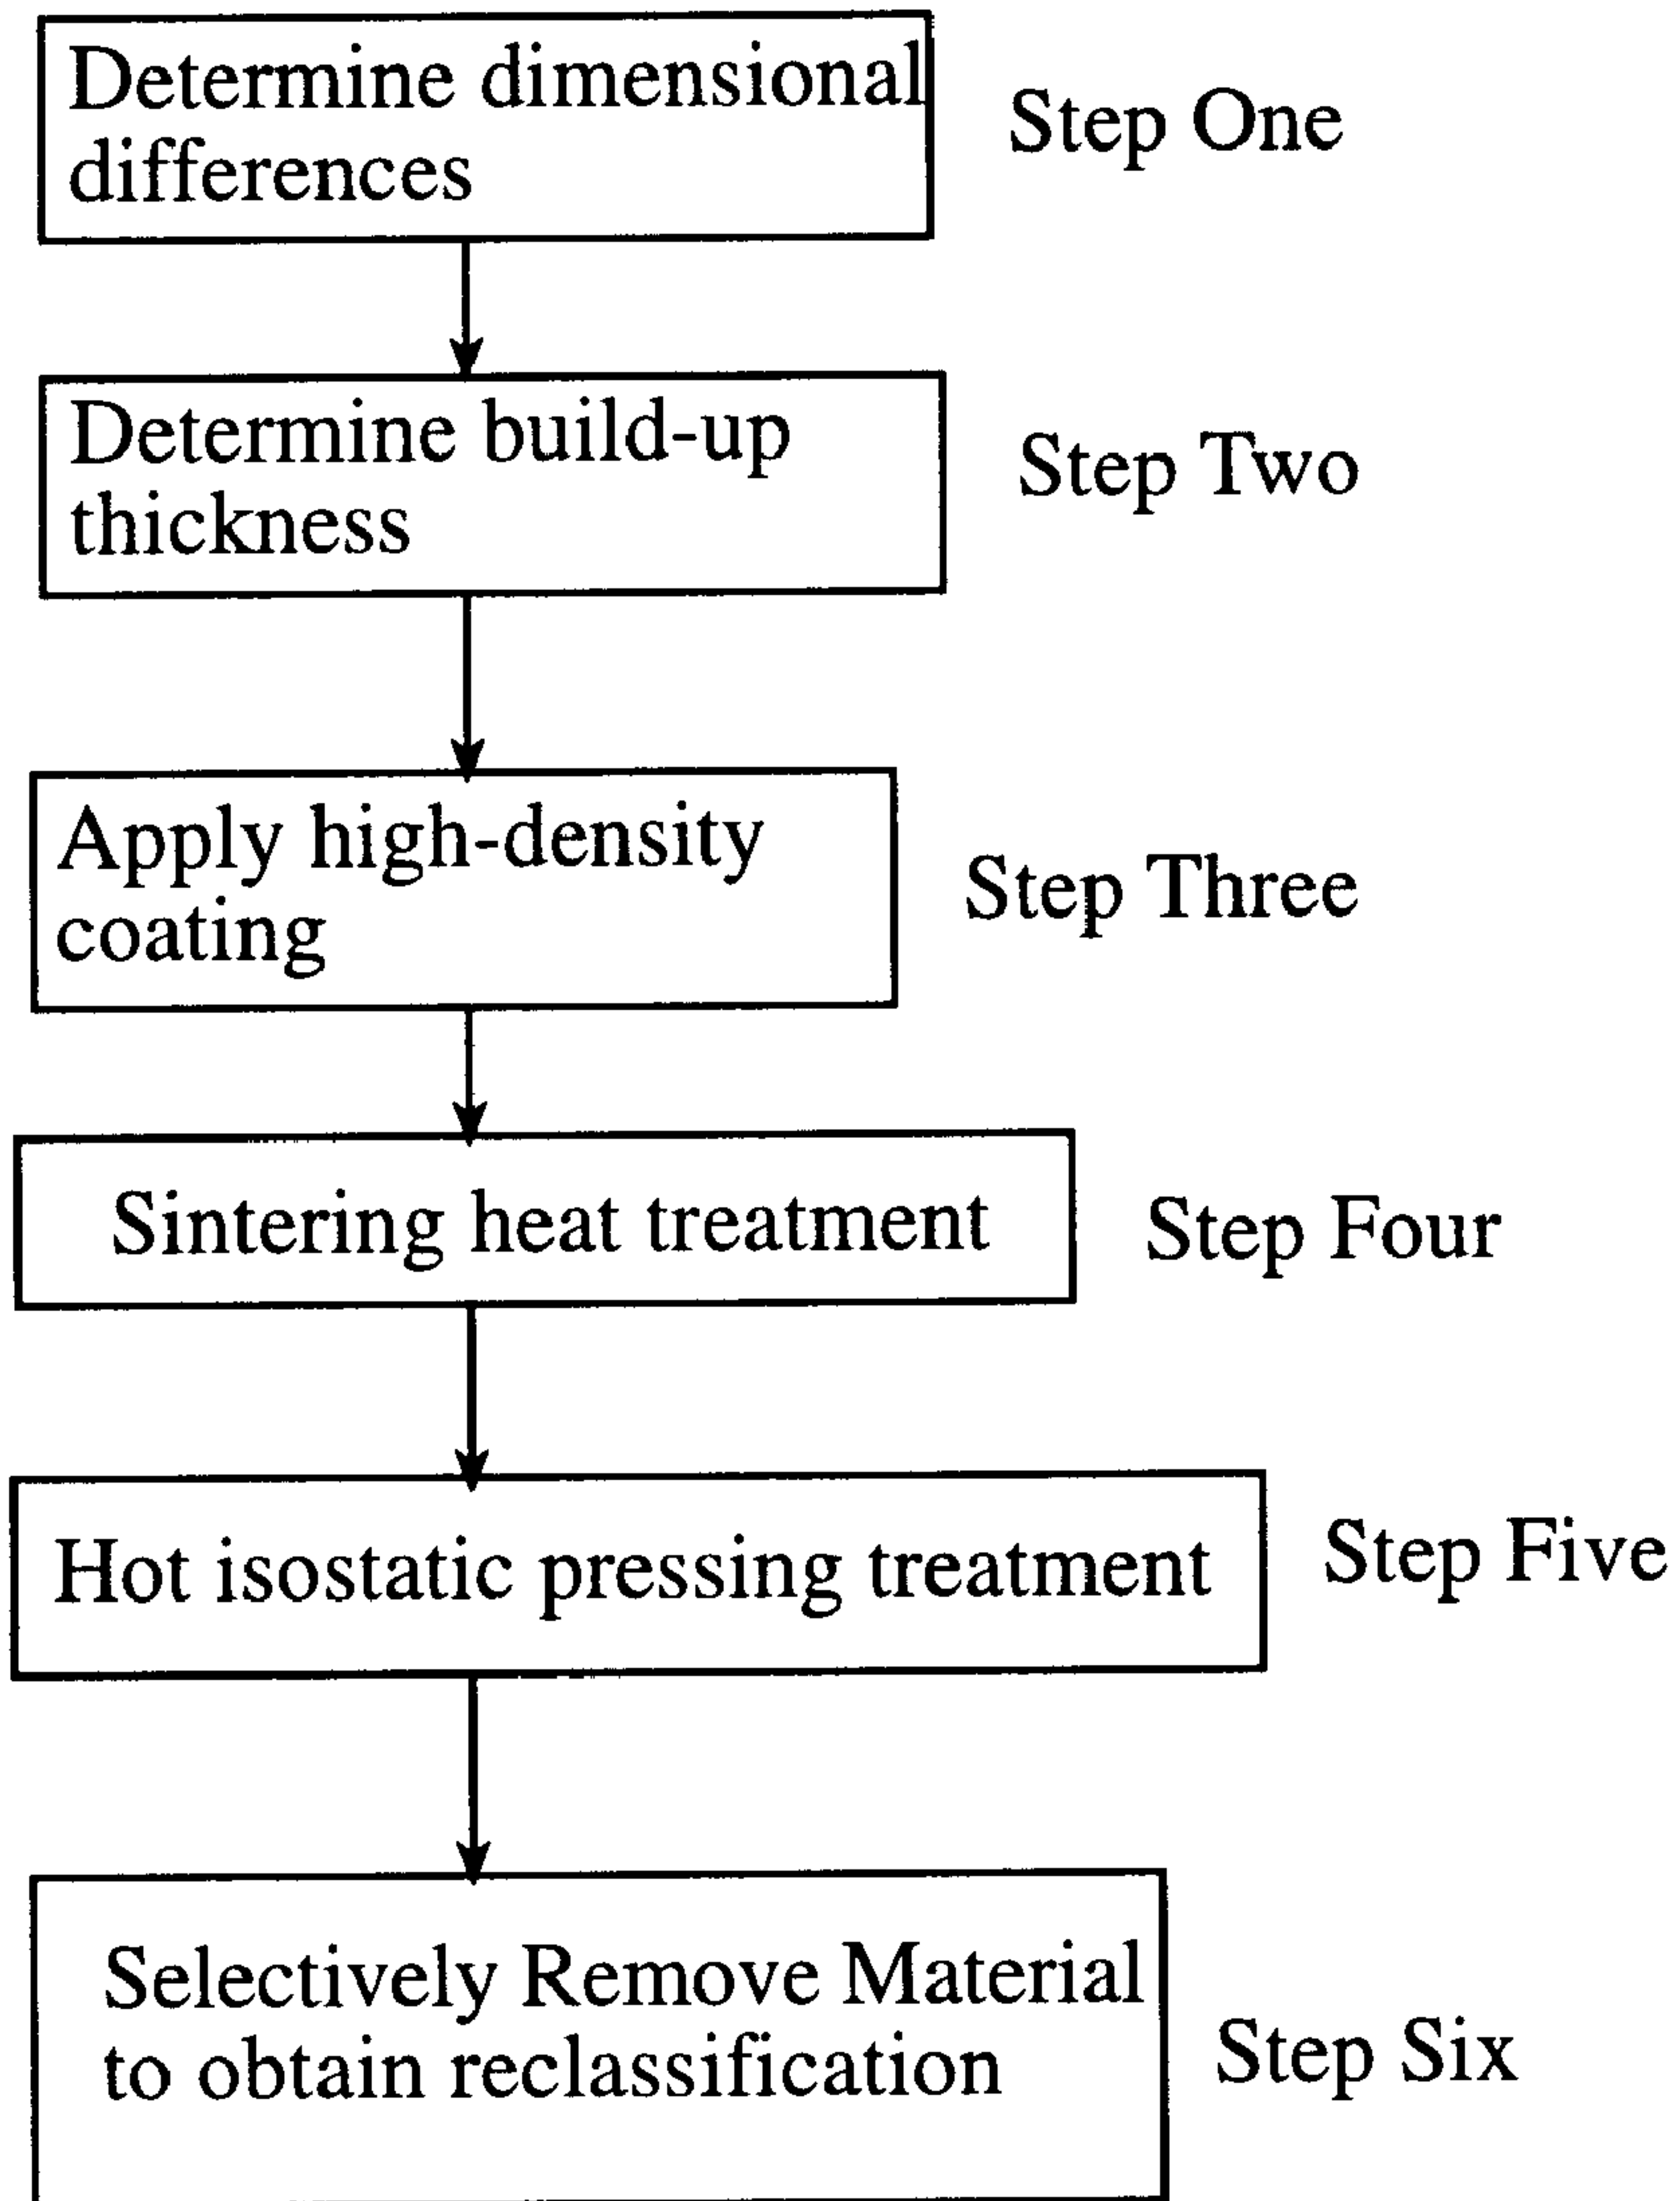
Figure 13

FIG. 13 is a flow chart showing the steps of the inventive method for reclassifying a gas turbine engine airfoil part;
