**United States Patent** [19]  
**Arnold**

[11] **Patent Number:** **6,049,978**  
[45] **Date of Patent:** **Apr. 18, 2000**

[54] **METHODS FOR REPAIRING AND RECLASSIFYING GAS TURBINE ENGINE AIRFOIL PARTS**

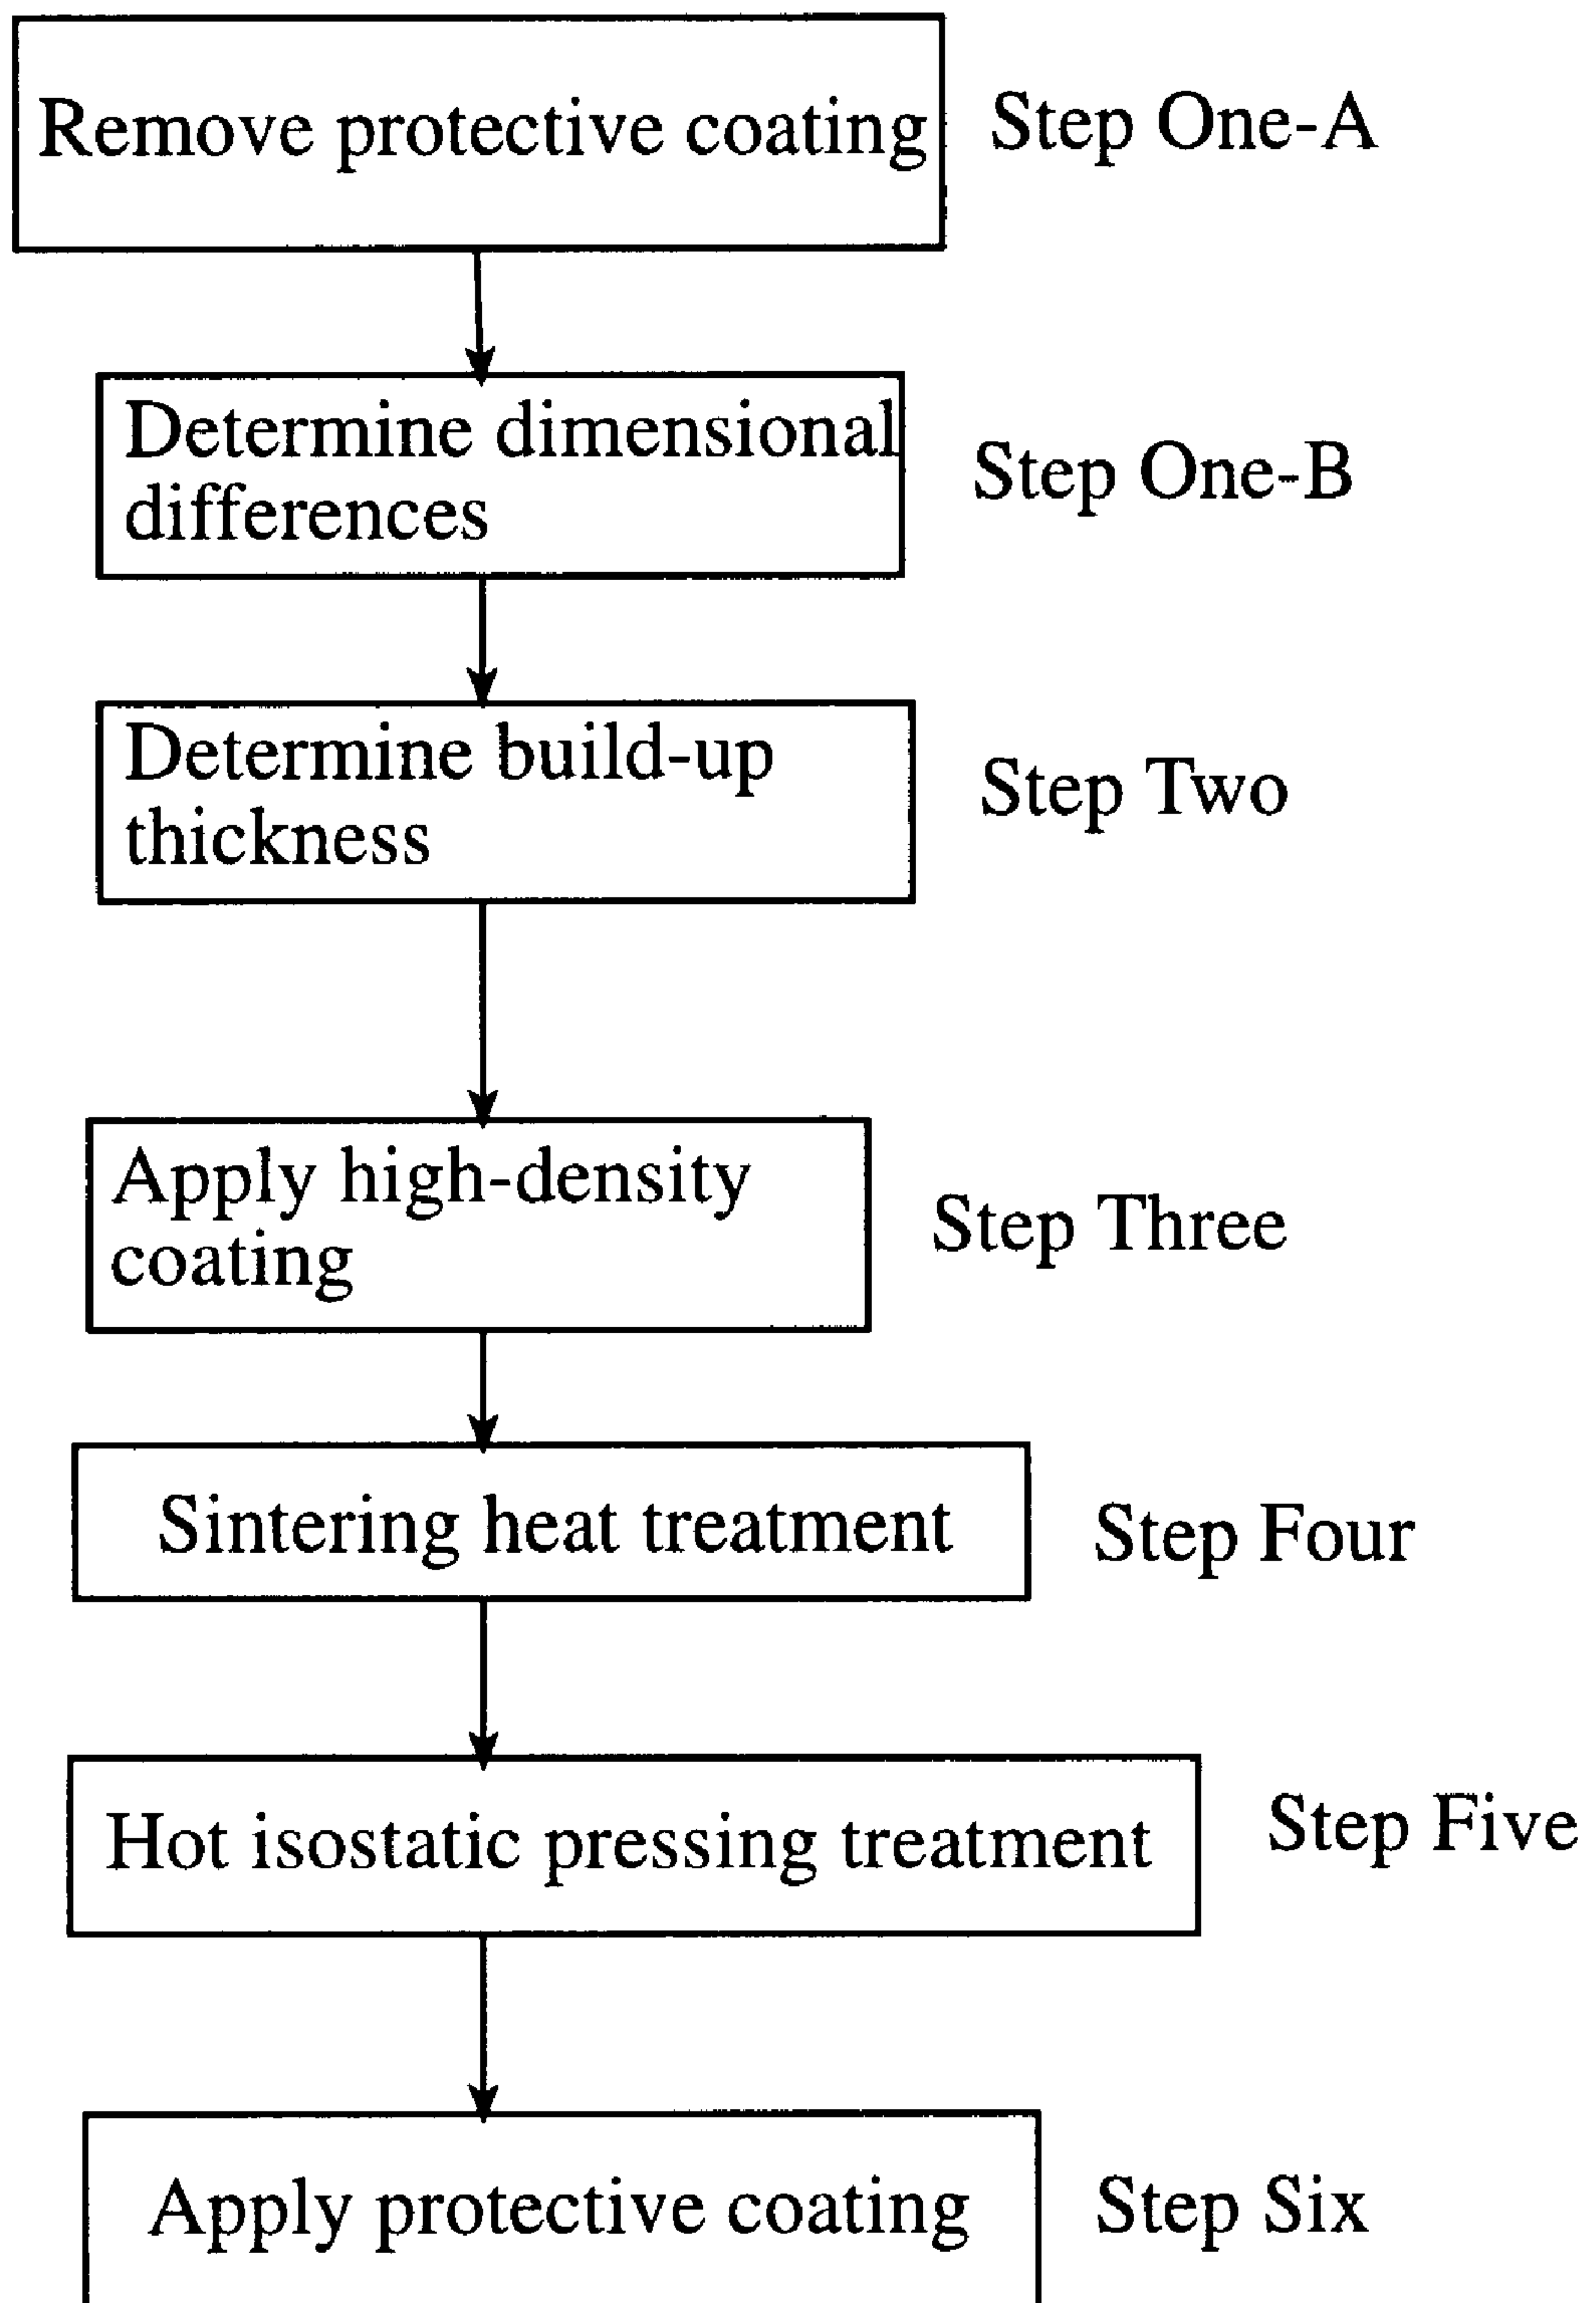
Figure 1(a)

FIG. 1(a) is a flow chart showing the steps of the inventive method for repairing a gas turbine engine airfoil part;

Referring to FIG. 1(a), in accordance with the present invention, the dimensional differences between pre-repaired dimensions of a turbine engine airfoil part and desired post-repair dimensions of the turbine engine airfoil part are determined (Step One-B). The turbine engine airfoil part has a substrate comprised of a superalloy. A build-up thickness of coating material required to obtain the desired post-repair dimensions of the turbine engine airfoil part is determined (Step Two). A high-density coating process, such as HVOF, is used to coat the turbine engine airfoil part with a coating material to the determined build-up thickness of coating material effective to obtain the desired post-repair dimensions after performing a sintering heat treatment and a hot isostatic pressing treatment (Step Three). The coating material comprises a metal alloy capable of forming a diffusion bond with the substrate of the turbine engine airfoil part. After the coating material is applied, a sintering heat treatment process is performed to prevent gas entrapment of the coating material and/or the diffusion bonding area during the hot isostatic pressing process (Step Four). Then, the hot isostatic pressing process is performed to obtain a post-repair turbine engine airfoil part having the desired post-repair dimensions and having diffusion bonding between the coating material and the turbine engine airfoil substrate (Step Five).

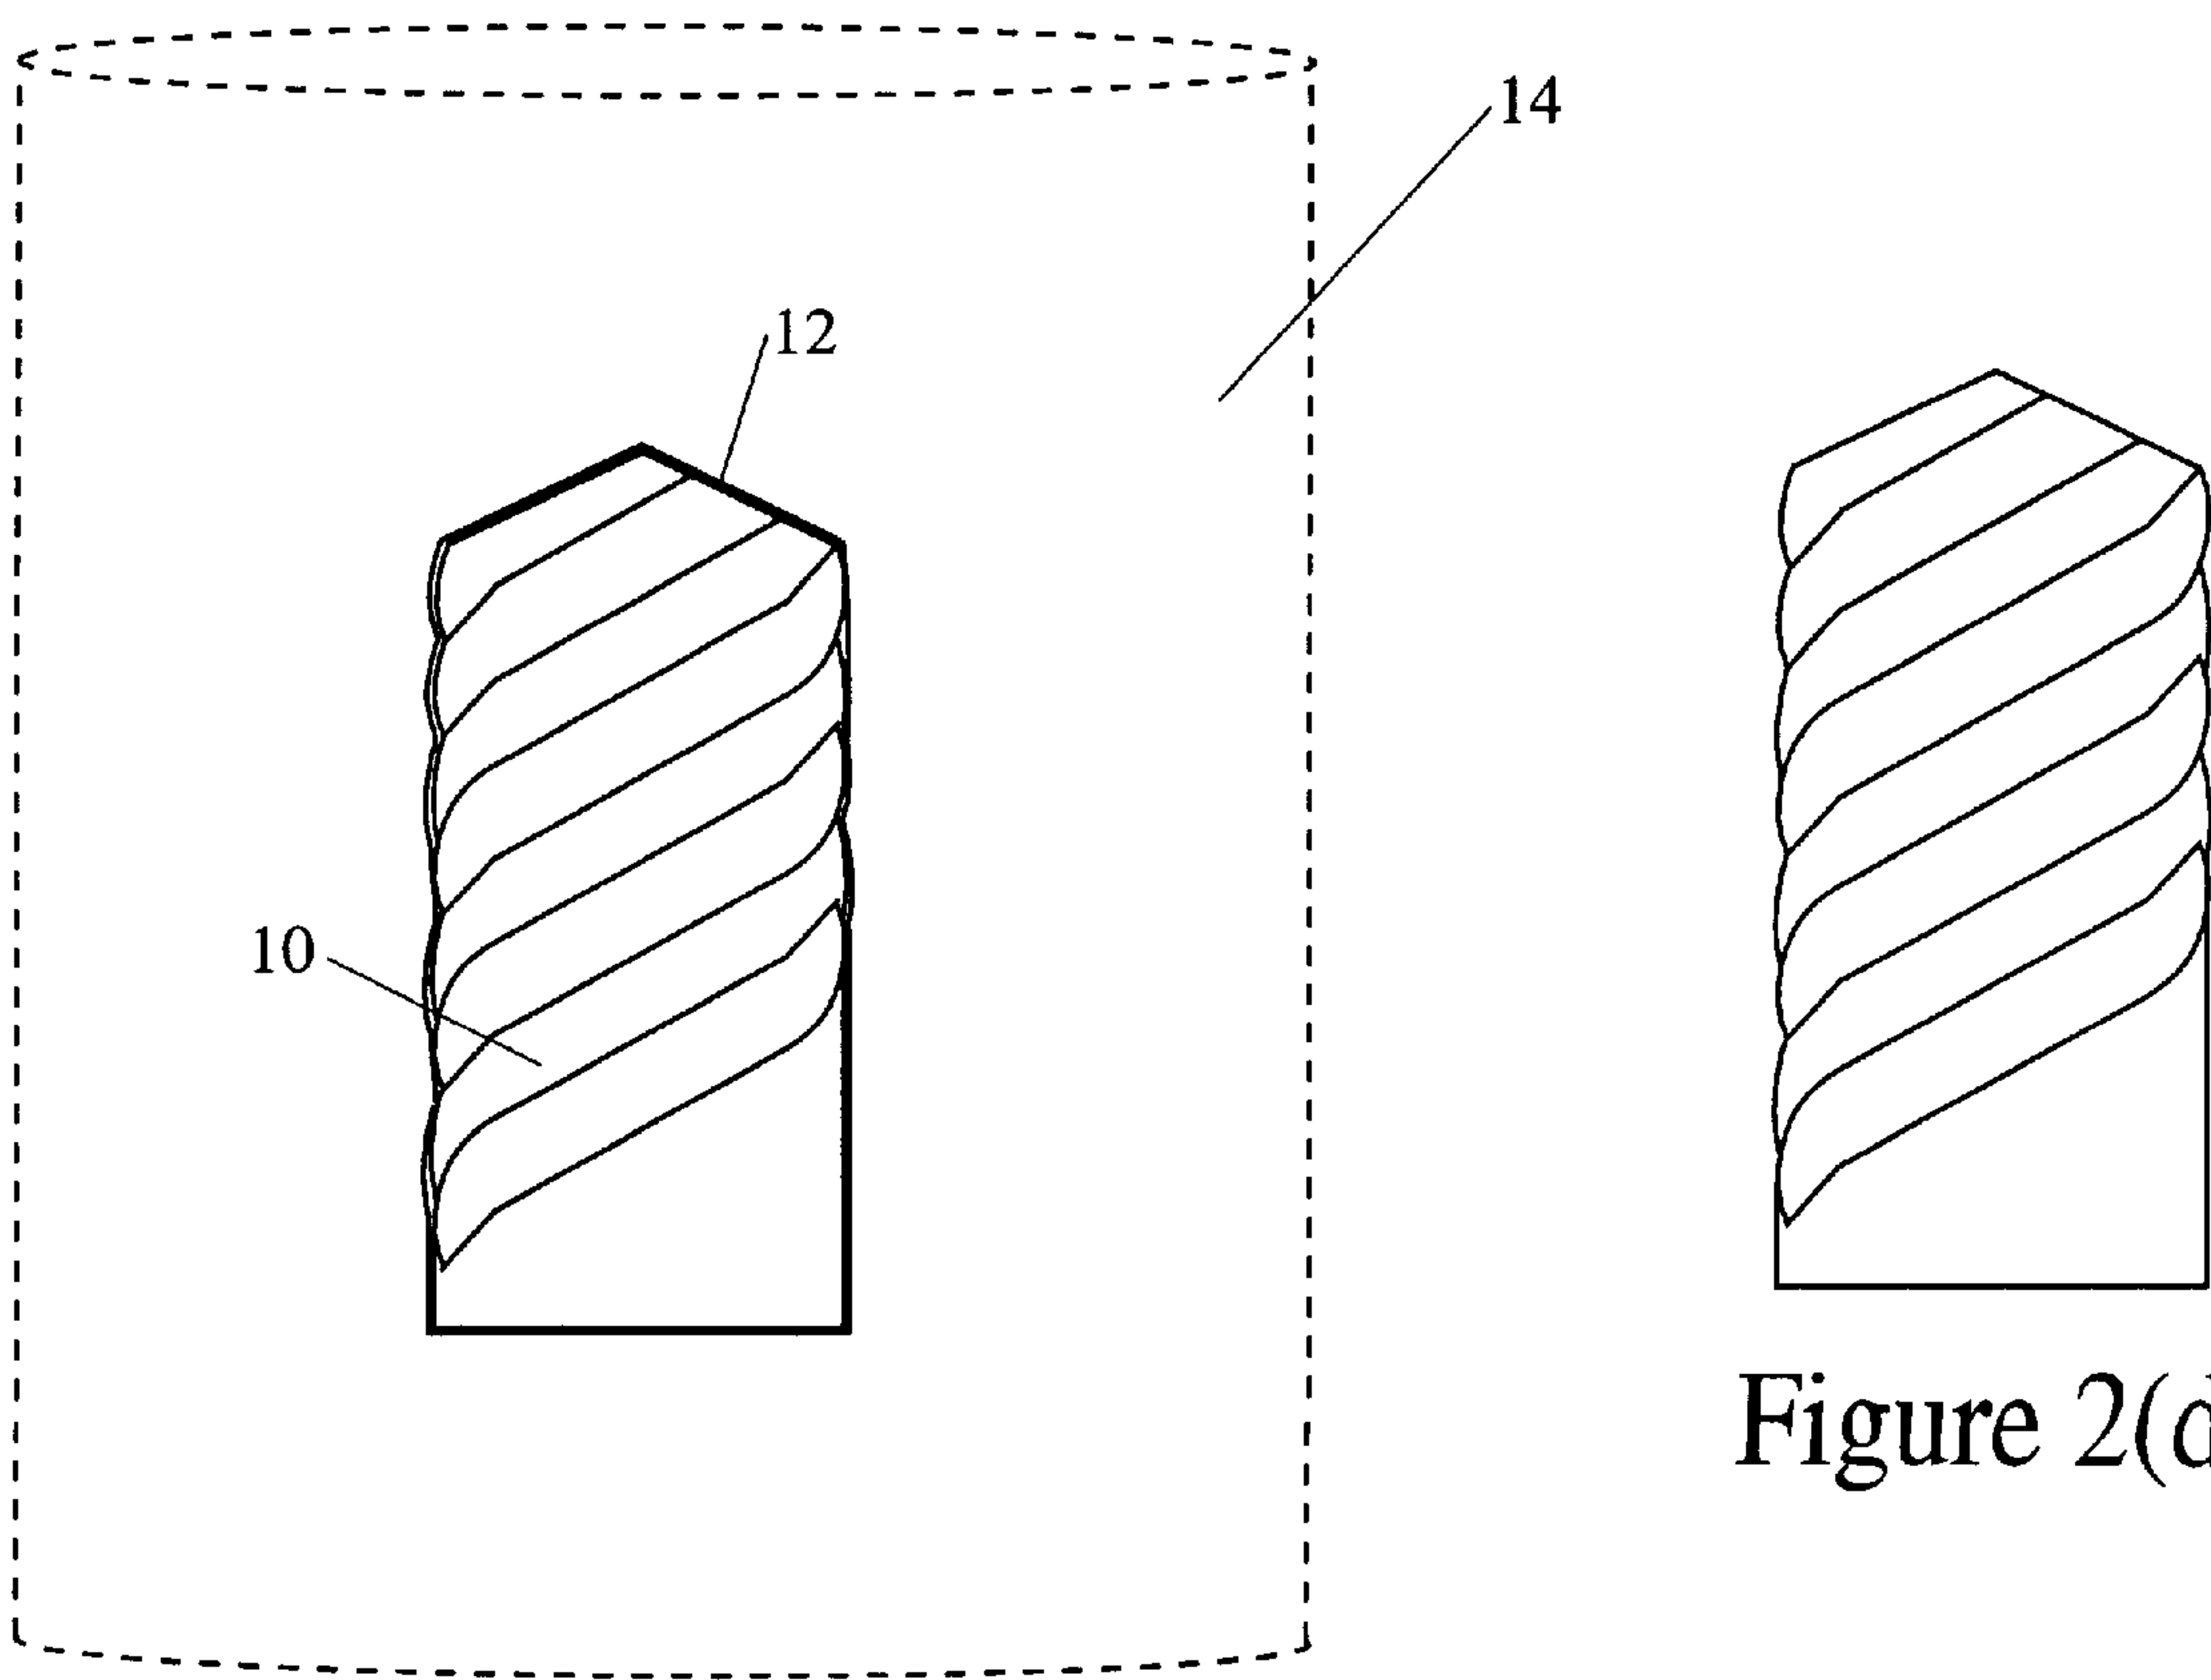
Figure 2(c)

FIG. 2(c) is a schematic view of the HVOF spray coated tool substrate undergoing a HIP treatment process in a HIP vessel in accordance with the inventive method of forming metal components having a wear resistant coating;

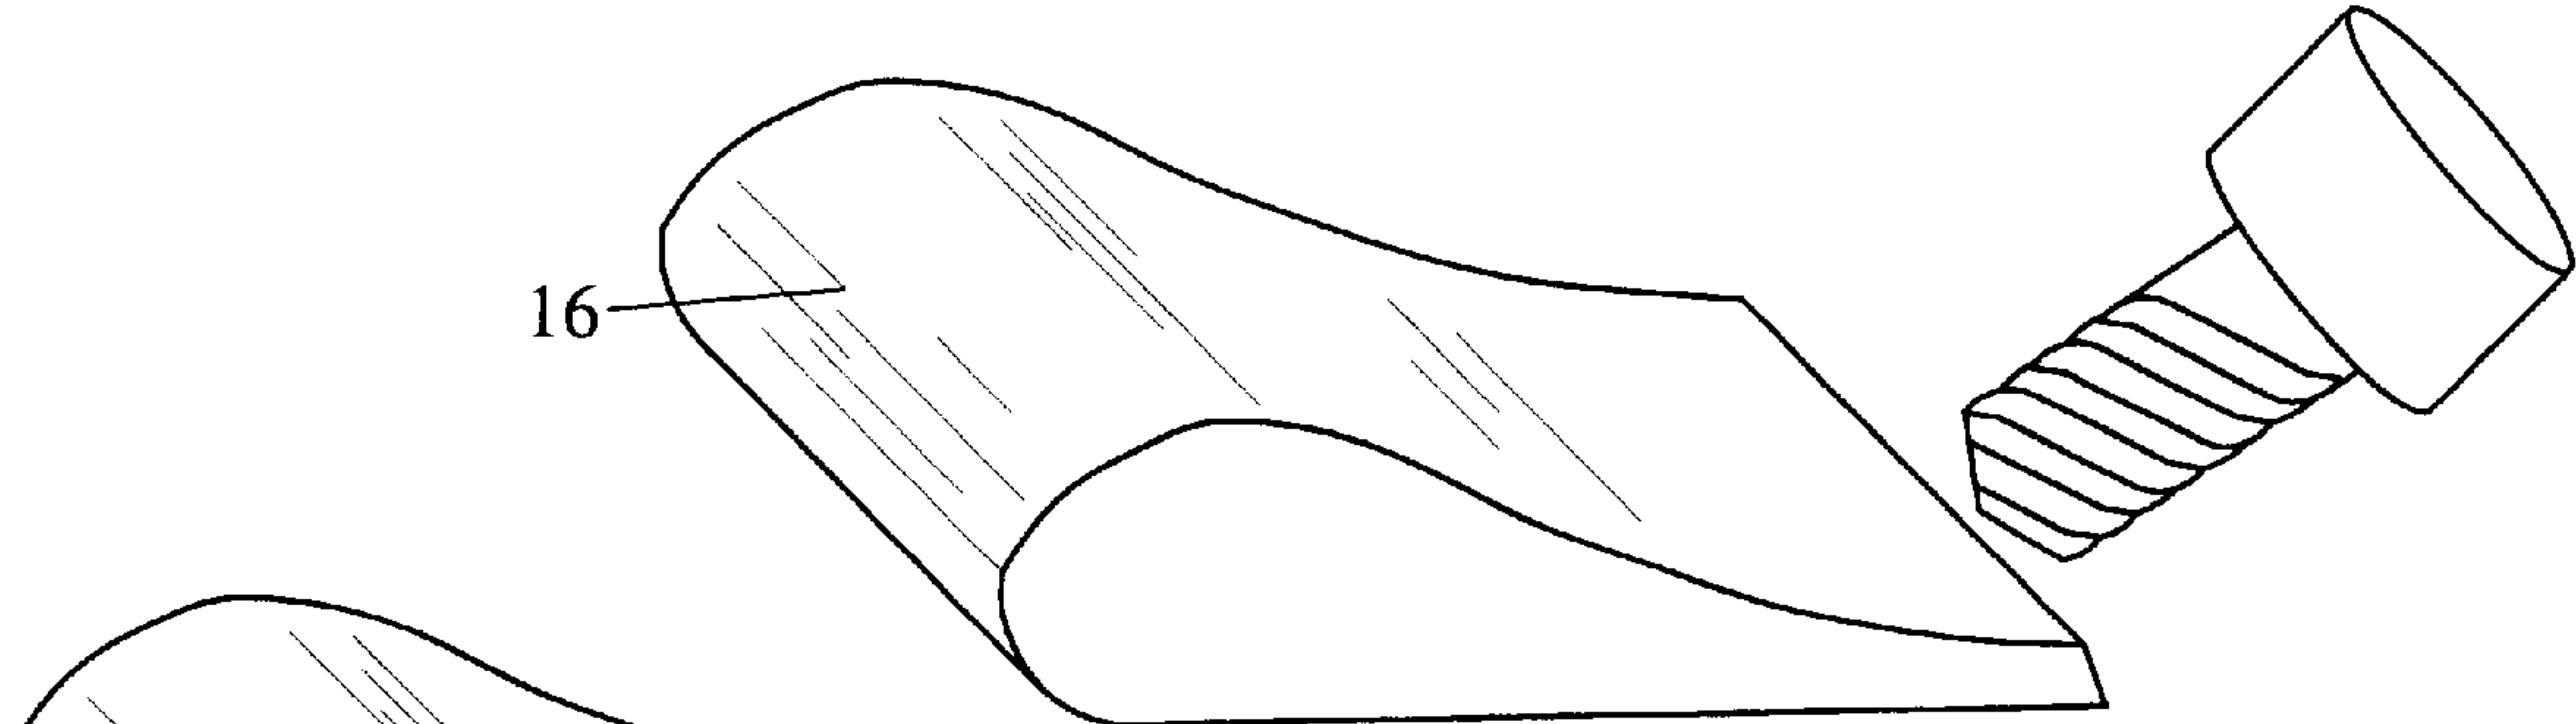
Figure 2(d)

FIG. 2(d) is a schematic view of the final HVOF spray coated and HIP treated tool having a wear resistant coating layer diffusion bonded to the tool substrate in accordance with the inventive method of forming metal components having a wear resistant coating;

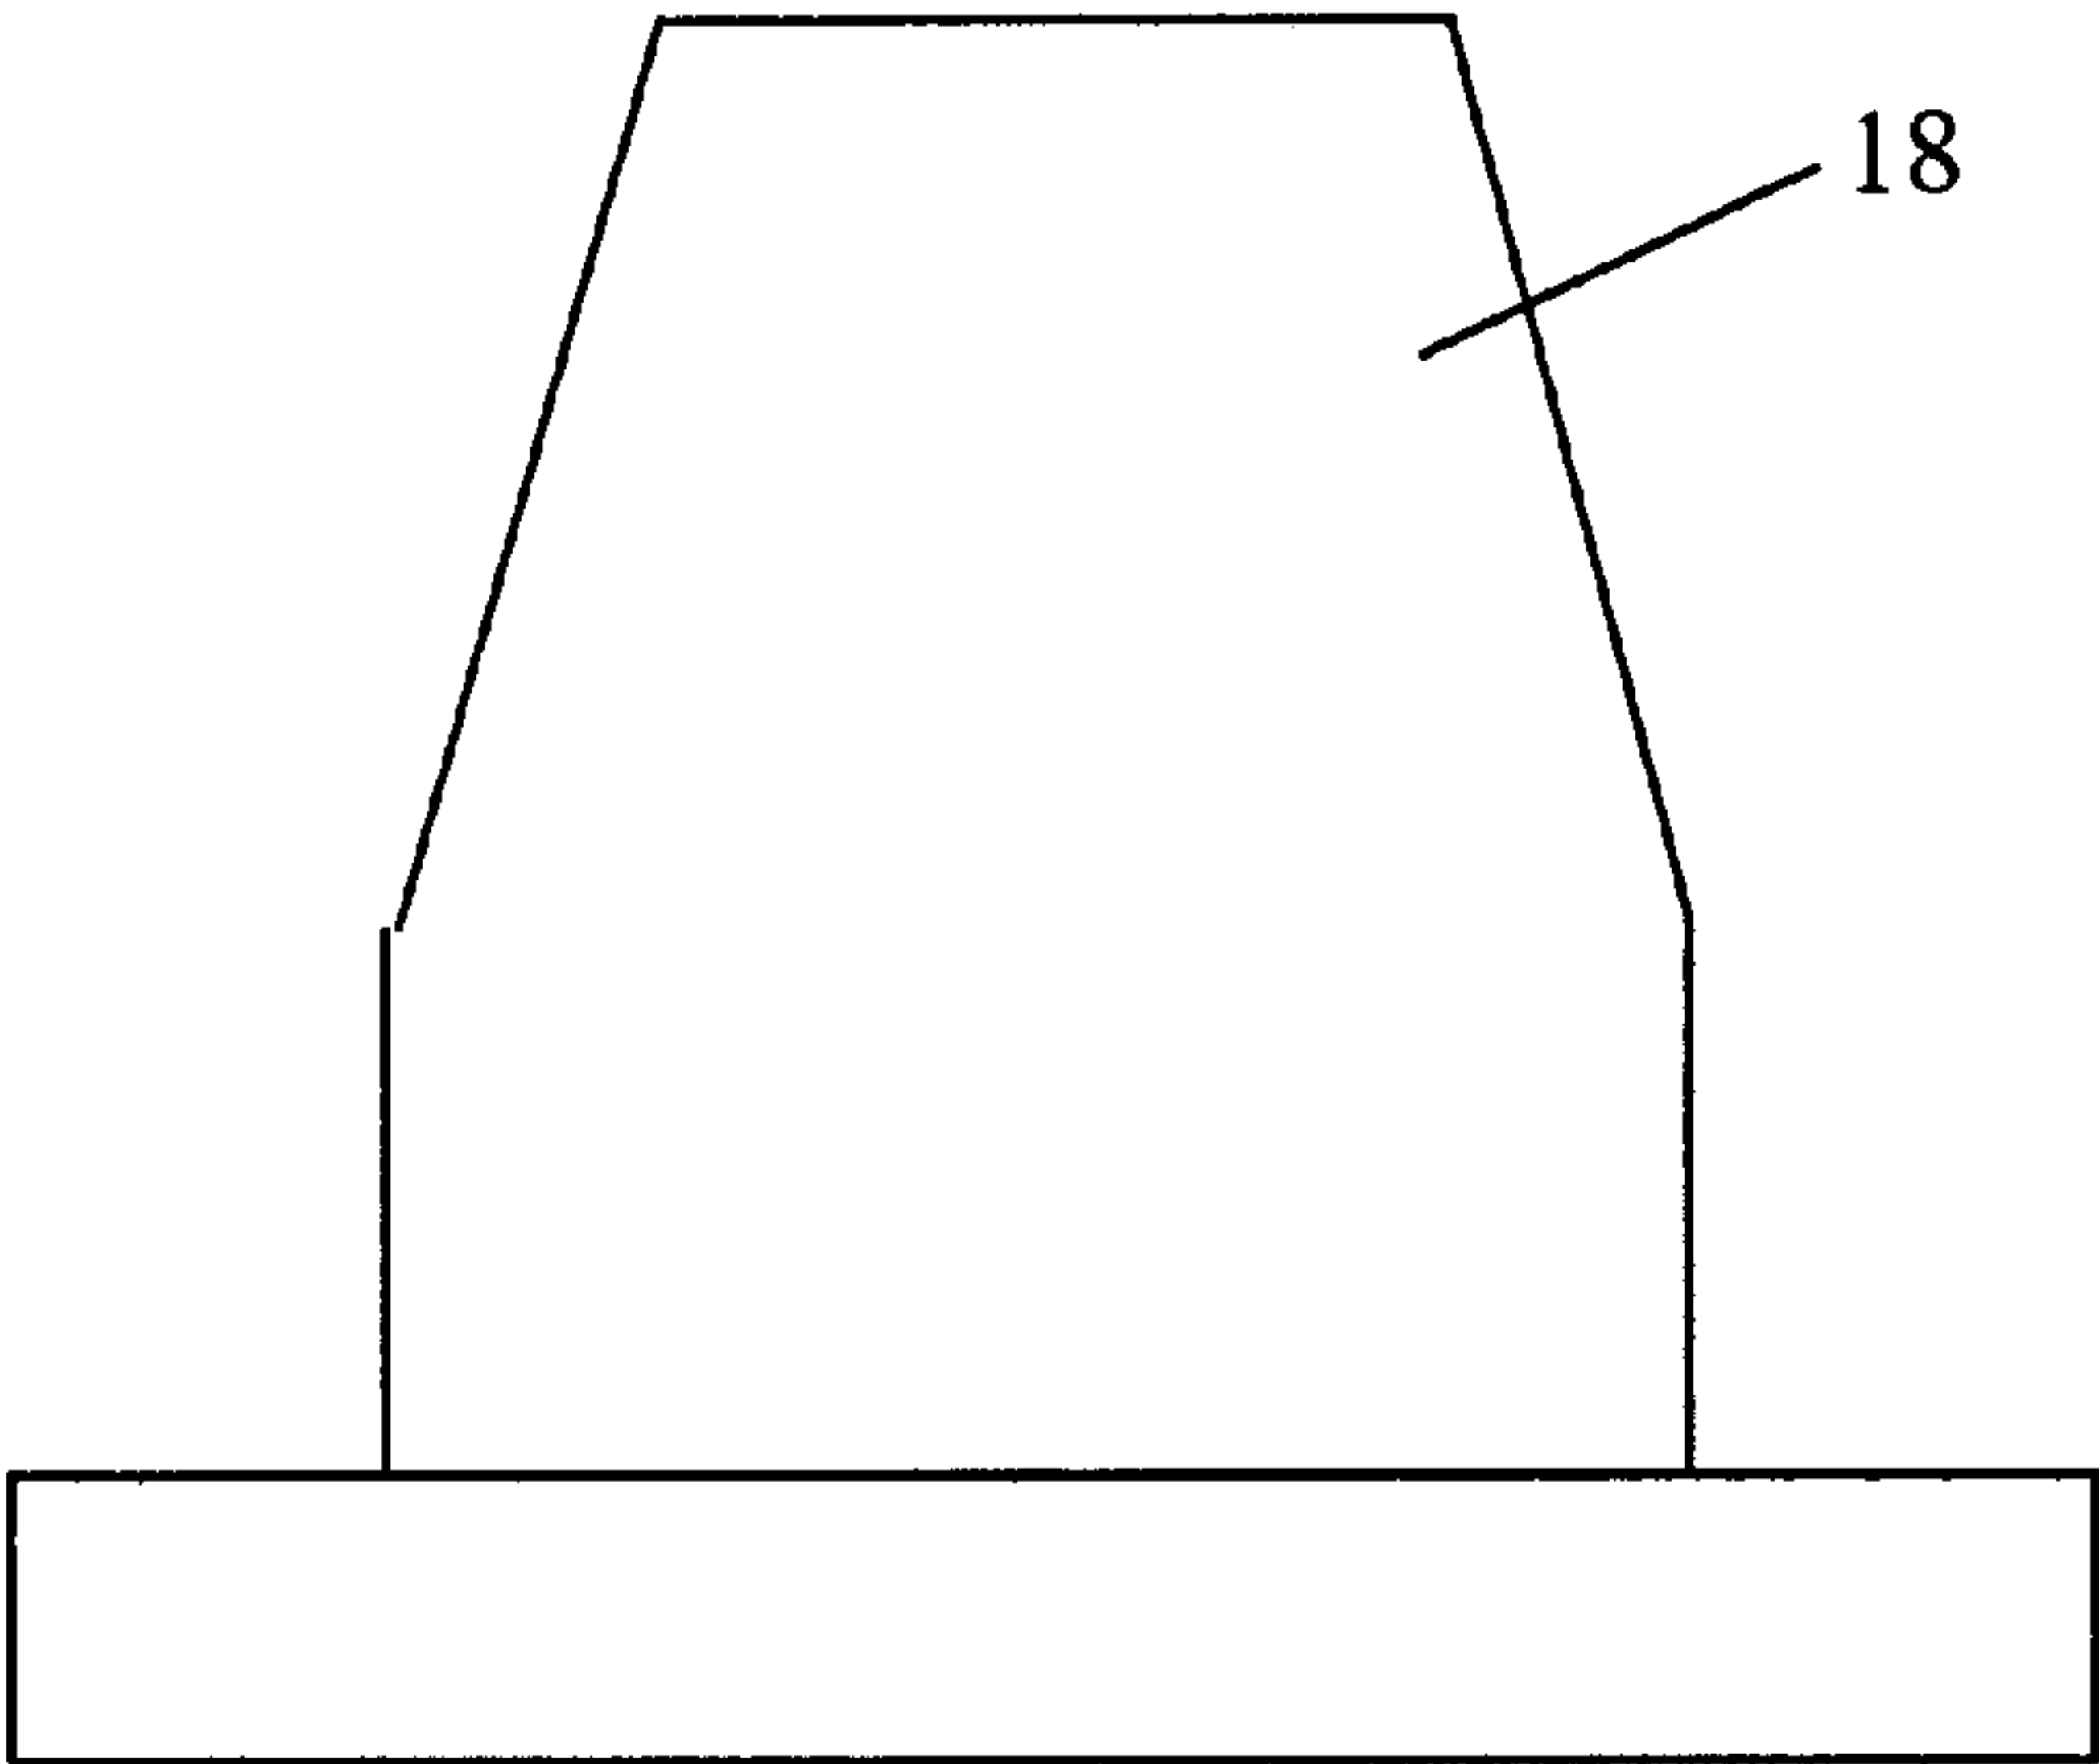
Figure 5(a)

FIG. 5(a) is a schematic side view of a worn turbine engine part before undergoing the inventive method of repairing a turbine engine part;

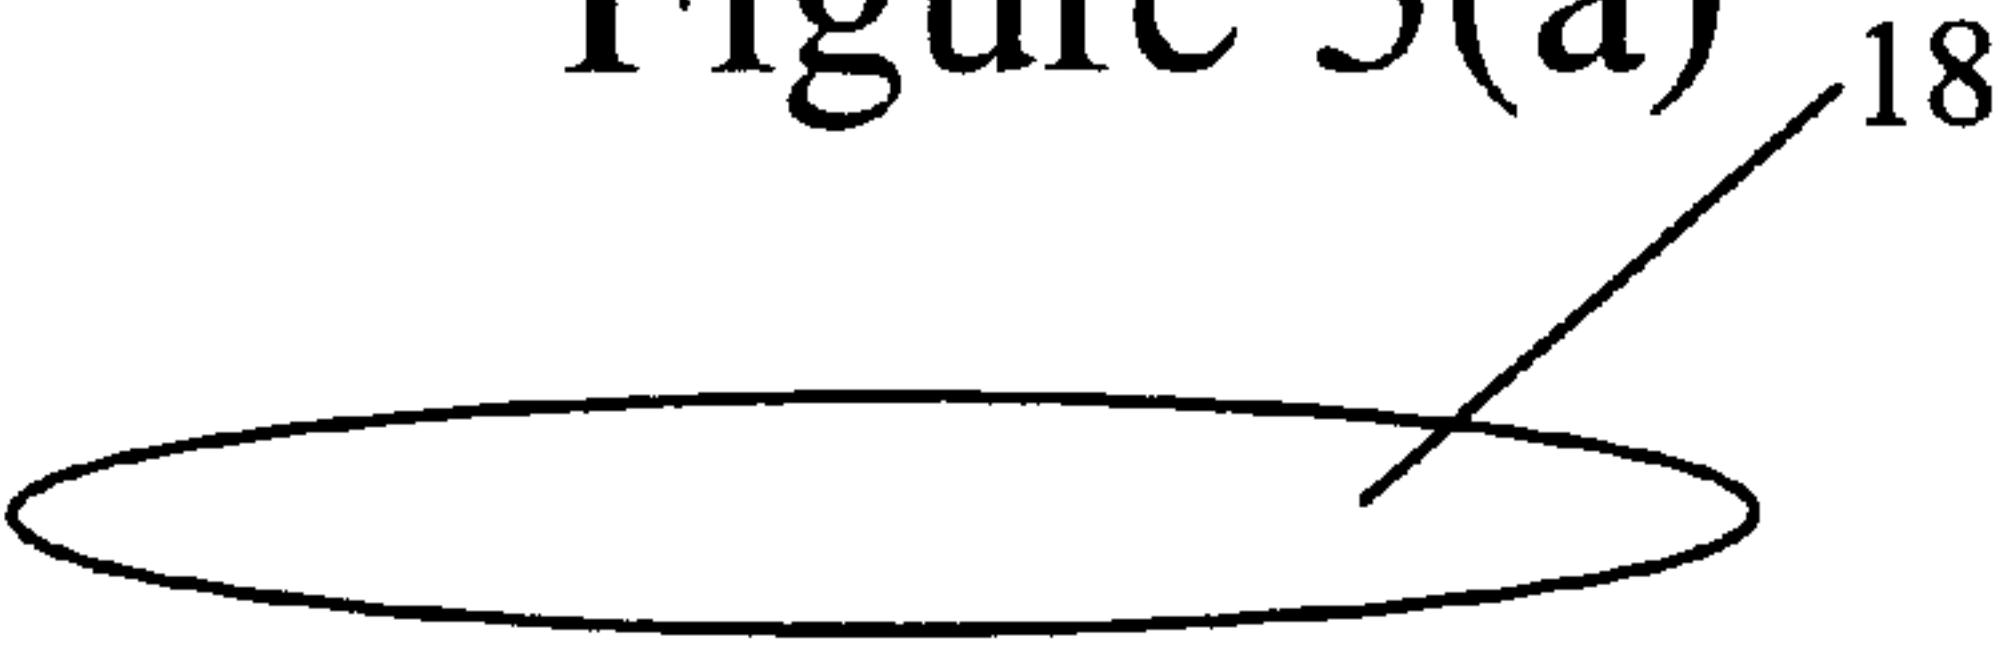
Figure 5(b)

FIG. 5(b) is a schematic cross-sectional view of the worn turbine engine part before undergoing the inventive method of repairing a turbine engine part;

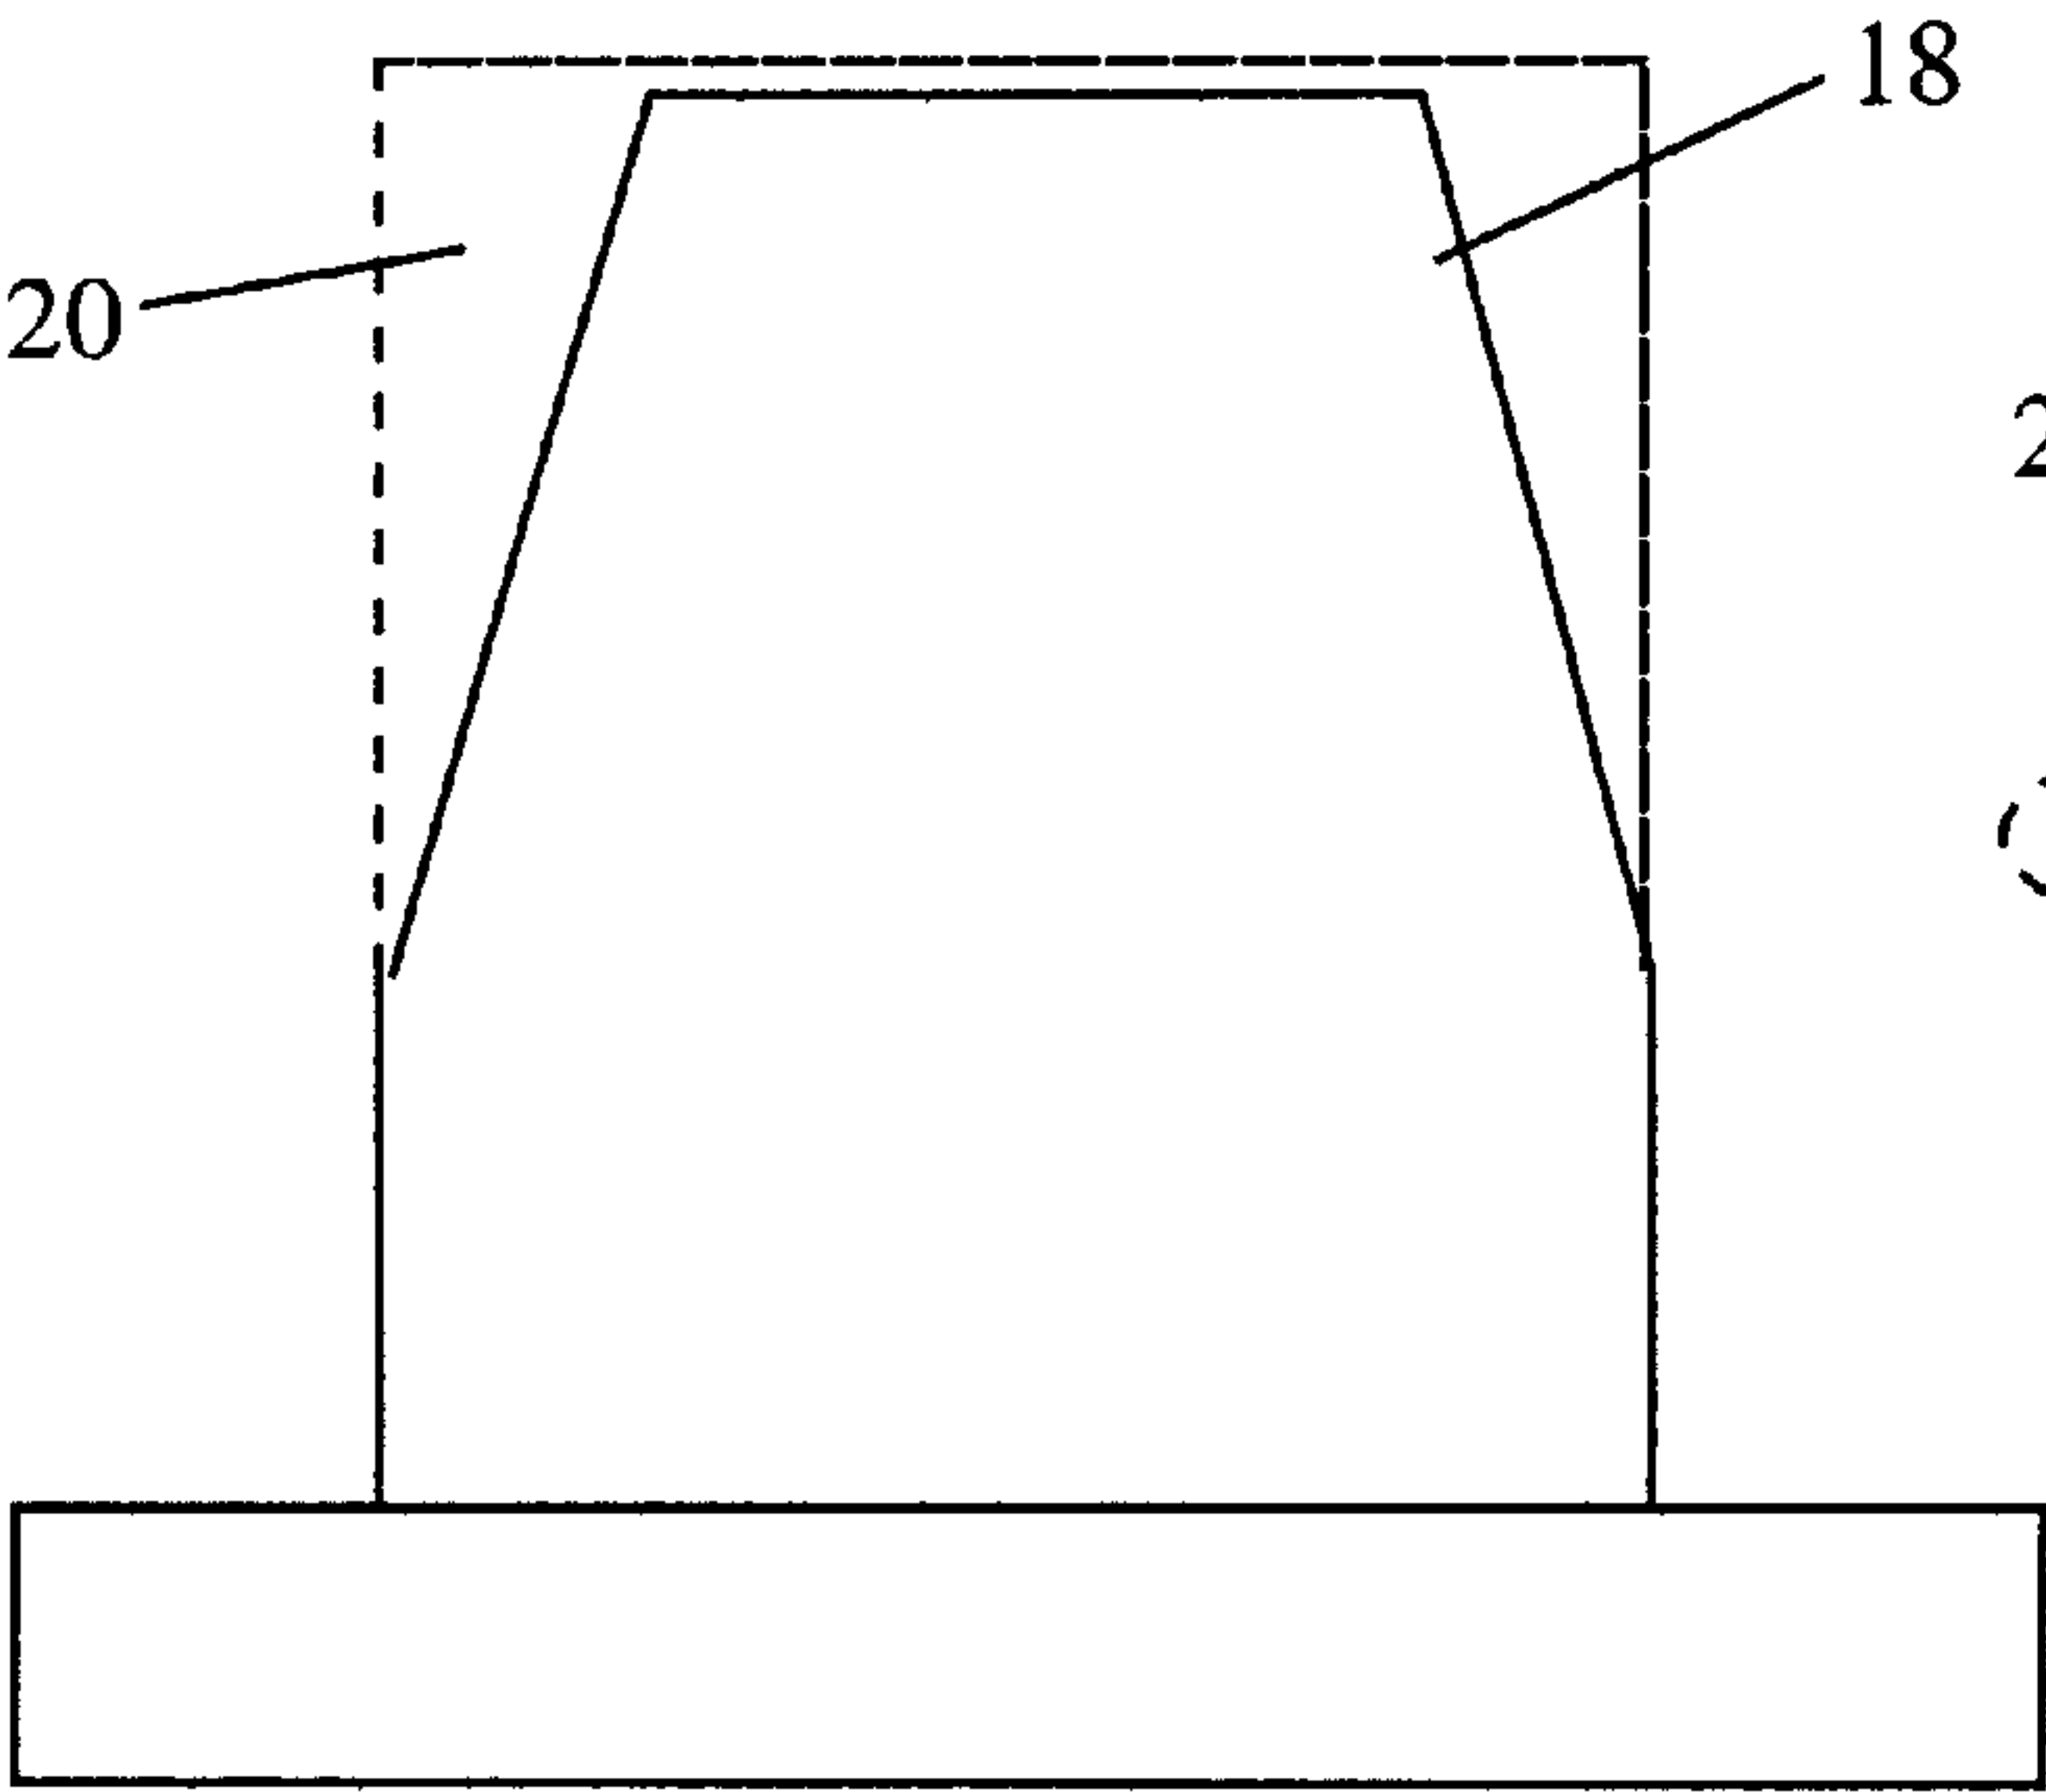
Figure 6(a)

FIG. 6(a) is a schematic side view of the worn turbine engine part showing the worn areas to be repaired using the inventive method of repairing a turbine engine part;

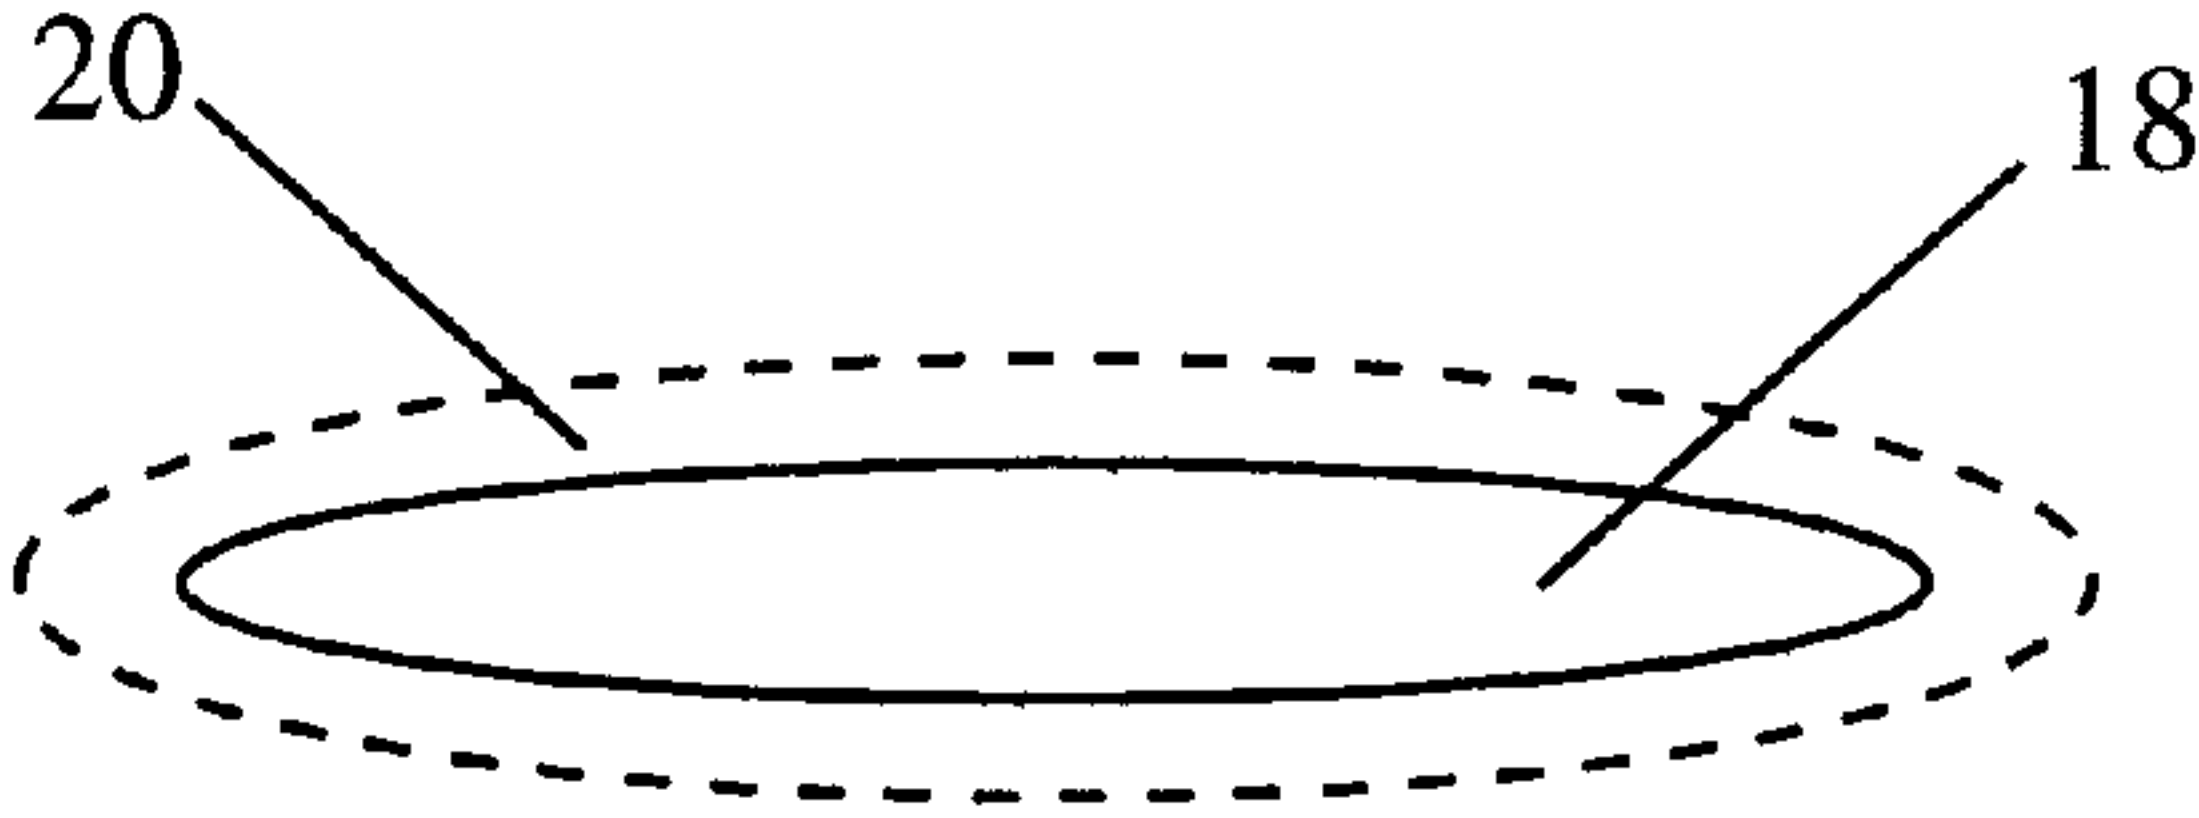
Figure 6(b)

FIG. 6(b) is a schematic cross-sectional view of the worn turbine engine part showing the worn areas to be repaired using the inventive method of repairing a turbine engine part;
