**United States Patent** [19]  
**Arnold**

[11] **Patent Number:** **6,049,978**  
[45] **Date of Patent:** **Apr. 18, 2000**

[54] **METHODS FOR REPAIRING AND RECLASSIFYING GAS TURBINE ENGINE AIRFOIL PARTS**

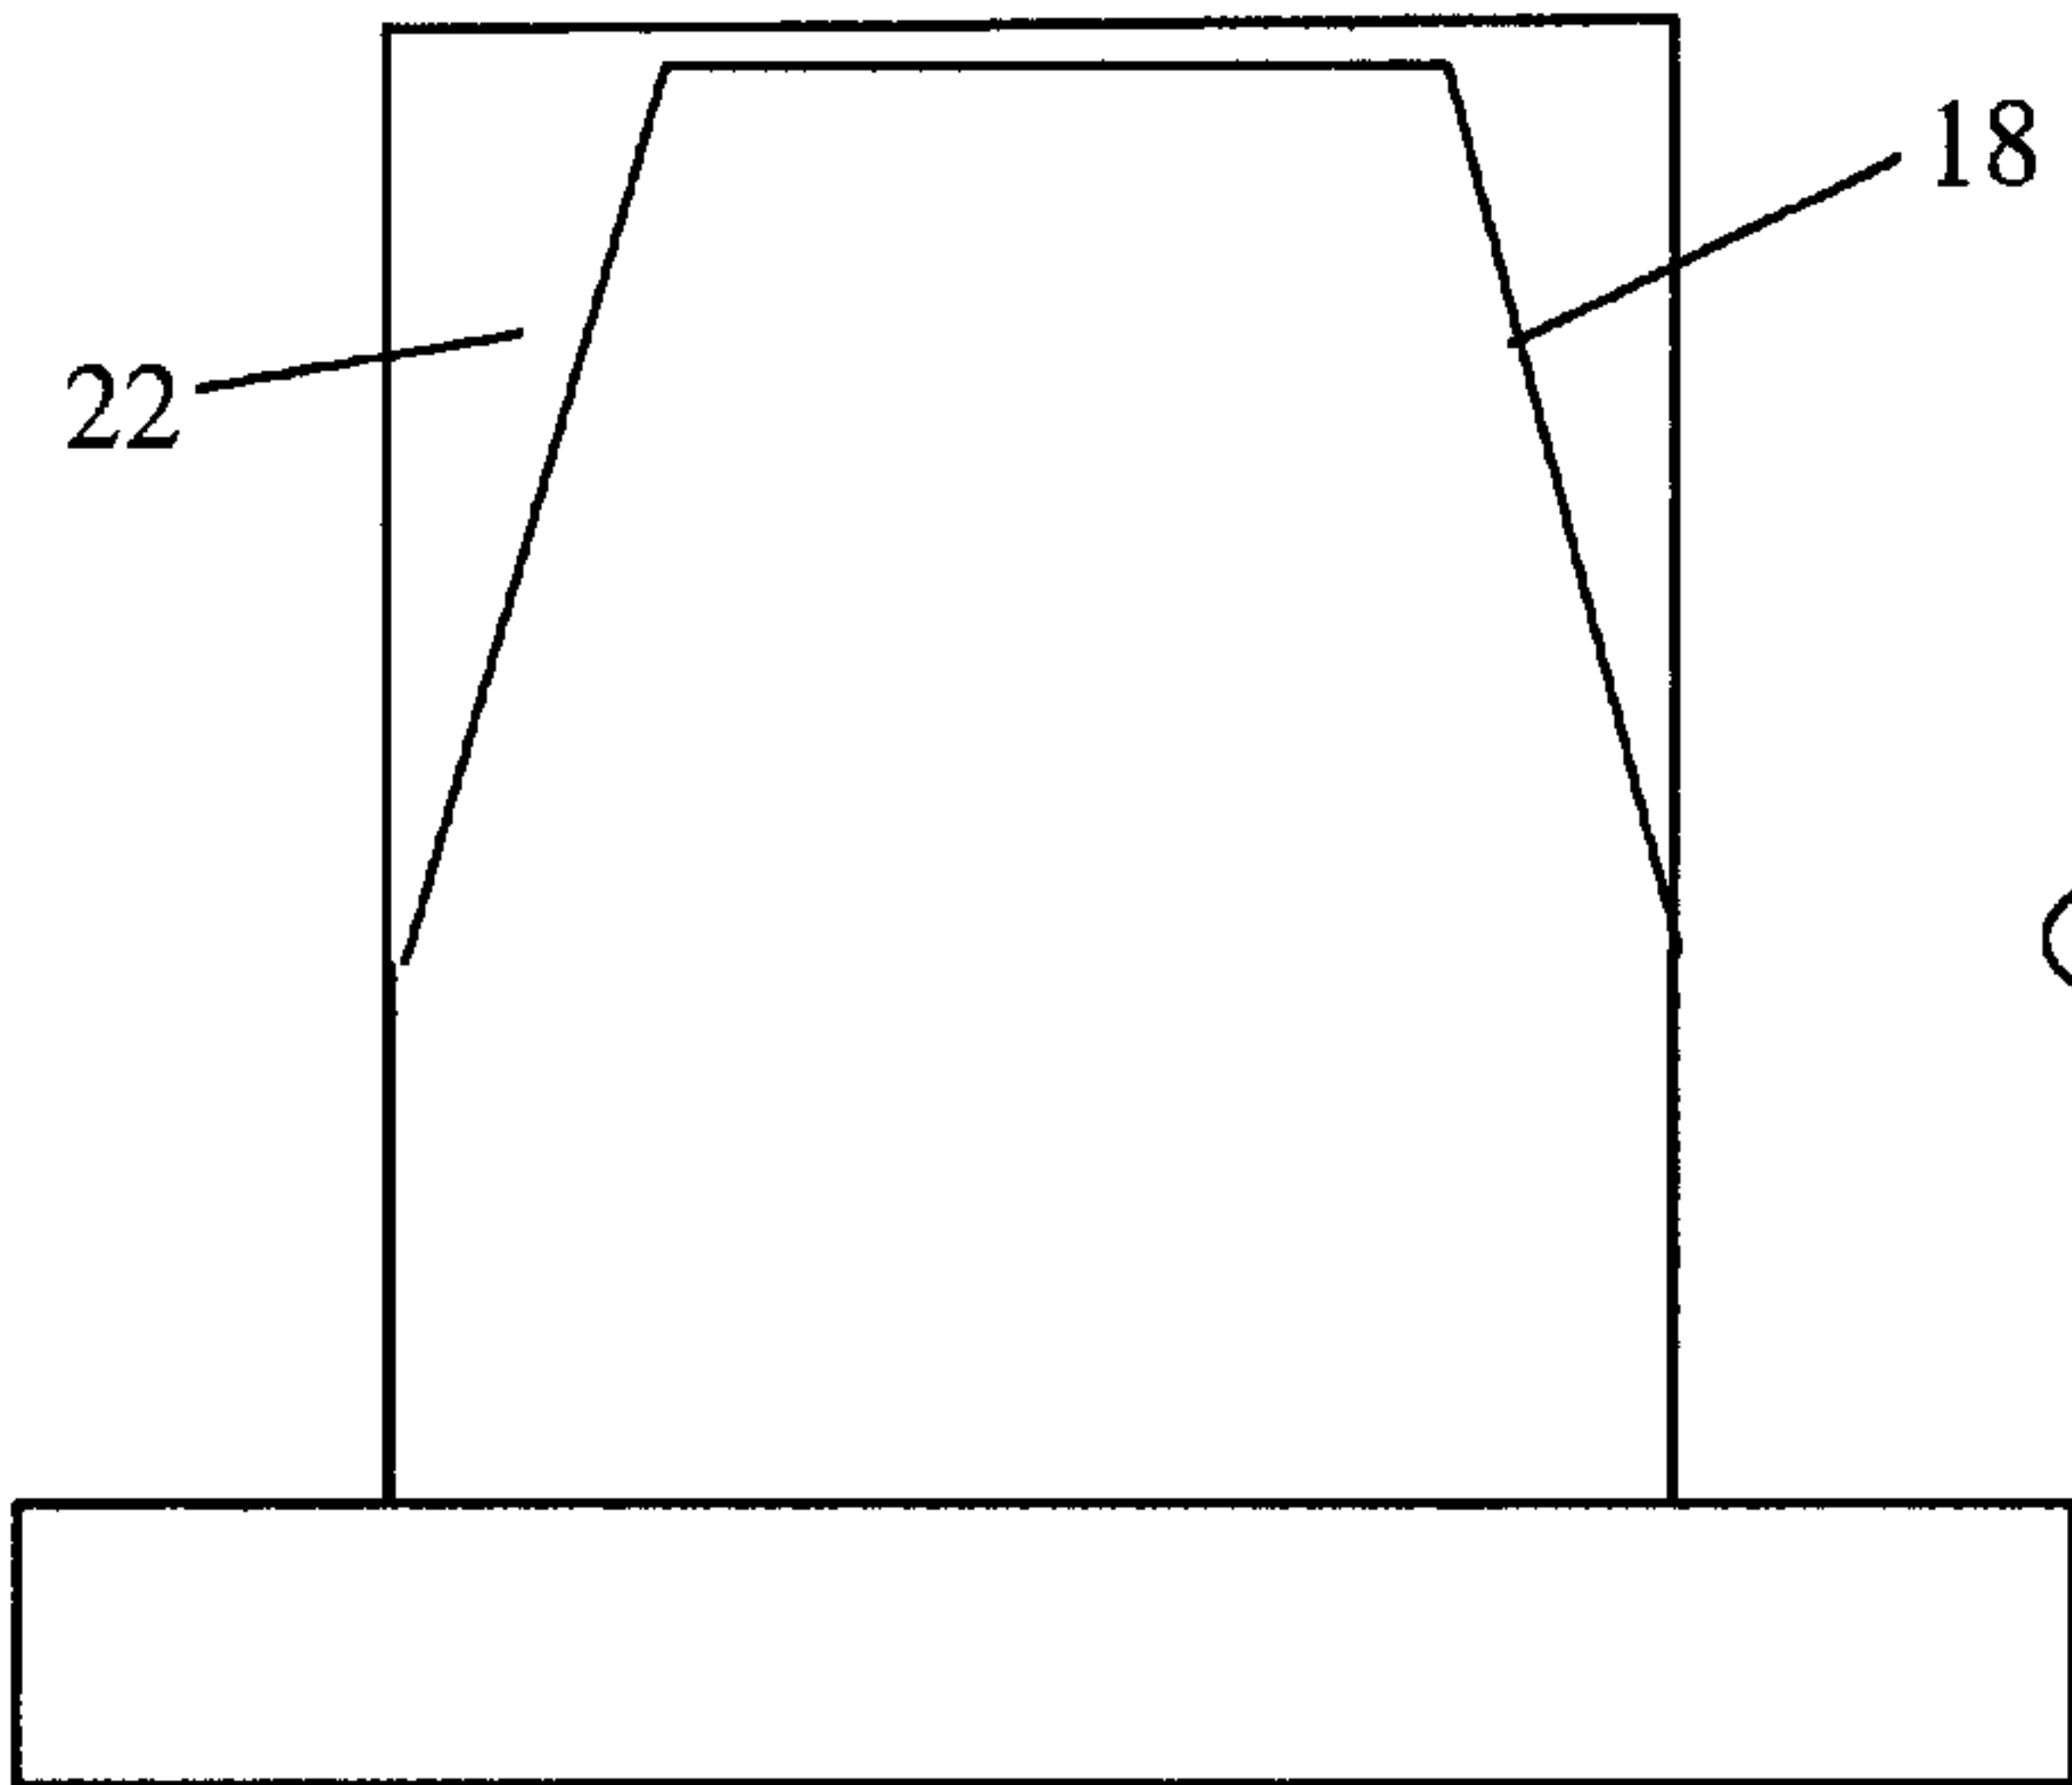
Figure 7(a)

FIG. 7(a) is a schematic side view of the worn turbine engine part showing the worn areas filled in with similar weld material in accordance with the inventive method of repairing a turbine engine part;

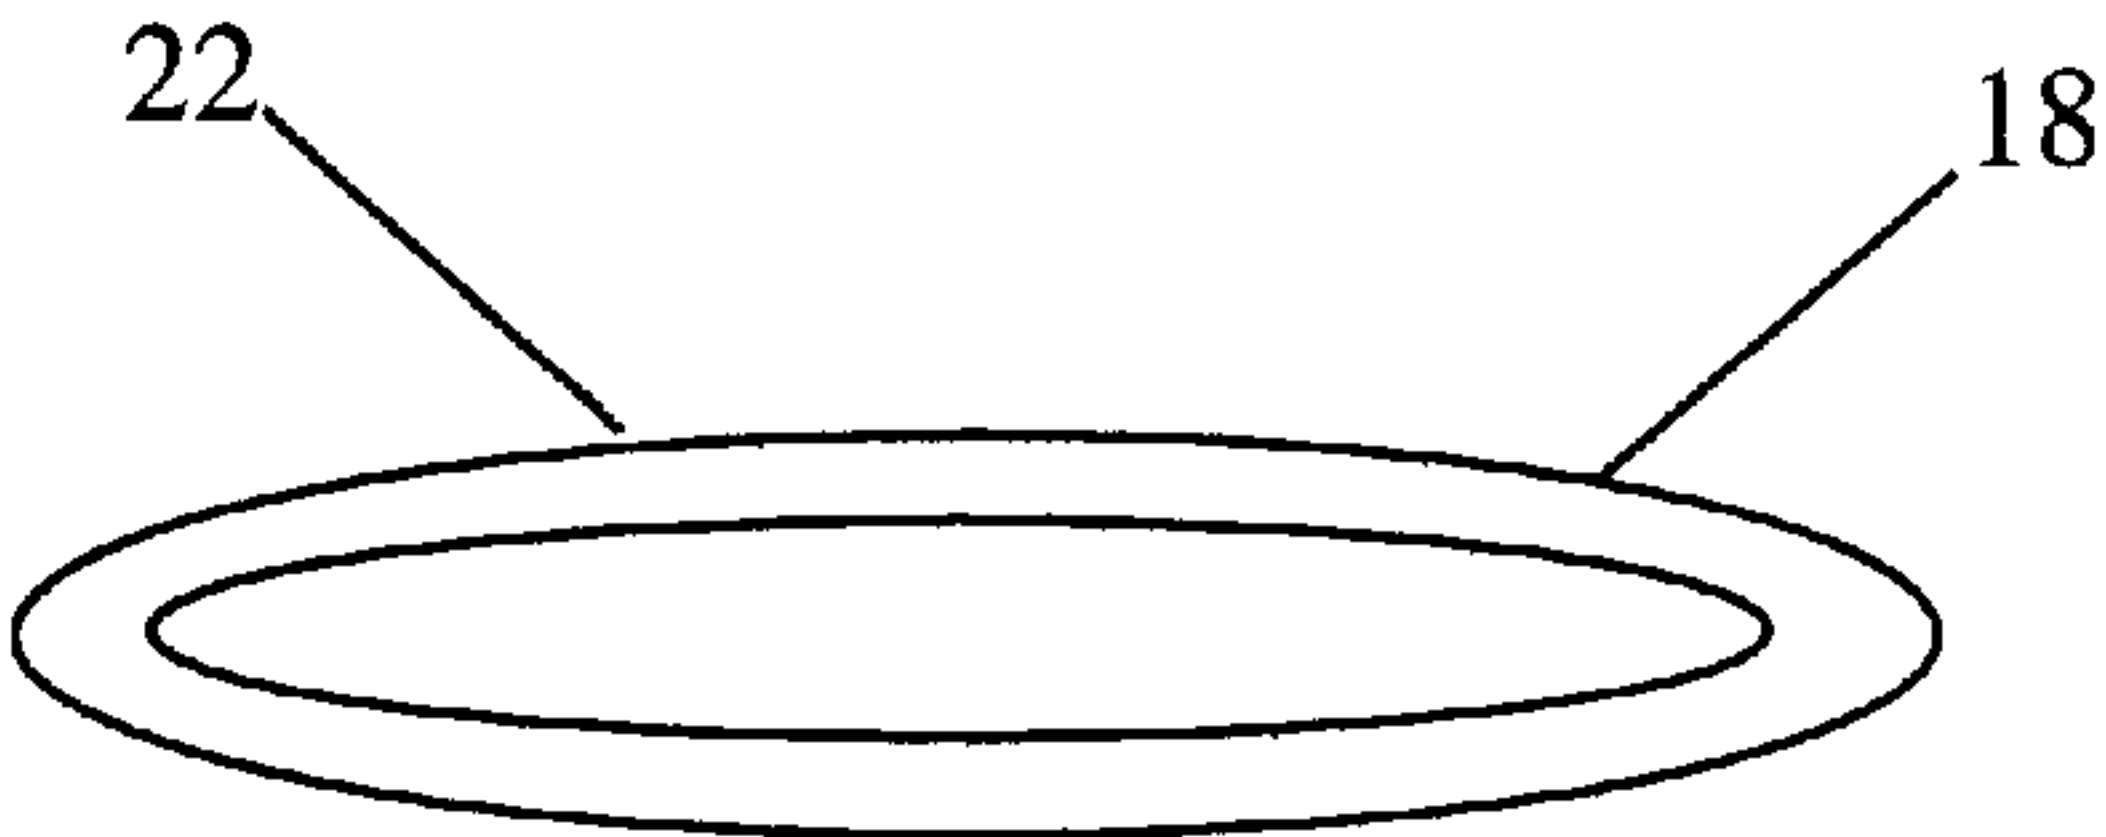
Figure 7(b)

FIG. 7(b) is a schematic cross-sectional view of the worn turbine engine part showing the worn areas filled in with similar weld material in accordance with the inventive method of repairing a turbine engine part;

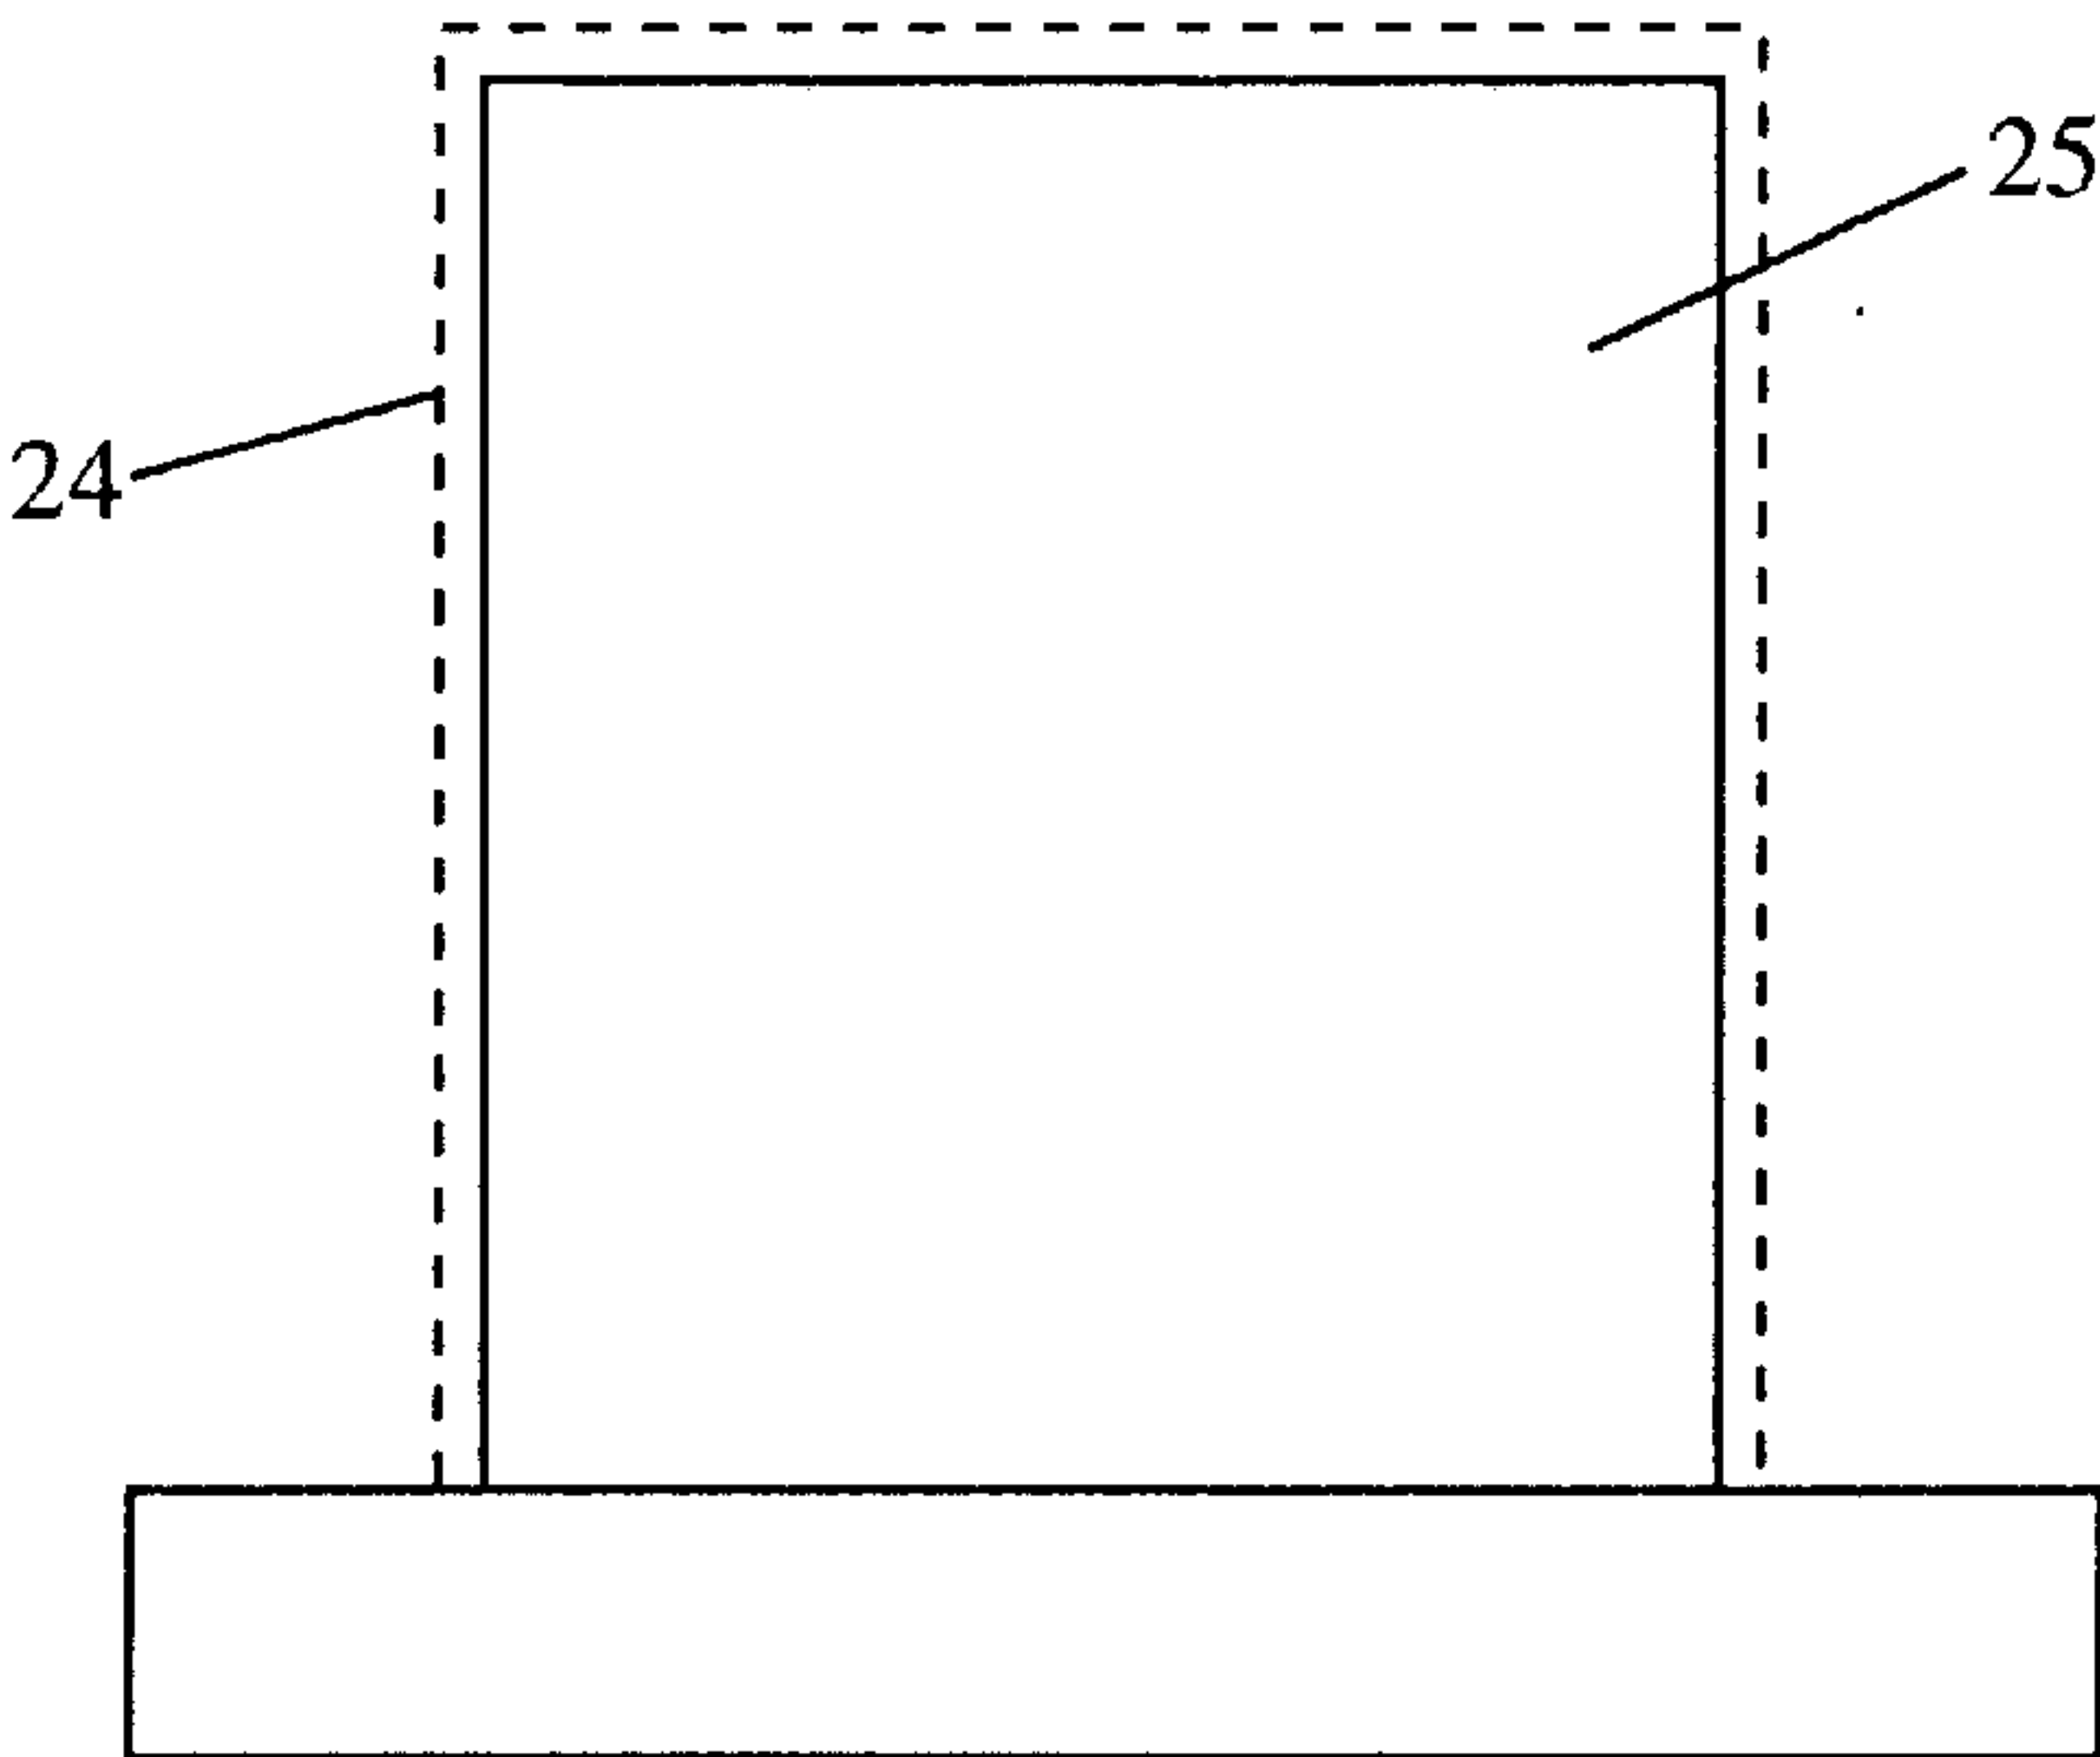
Figure 8(a)

FIG. 8(a) is a schematic side view of the welded turbine engine part showing areas to be built up with similar coating material using an HVOF spray coating process in accordance with the inventive method of repairing a turbine engine part;

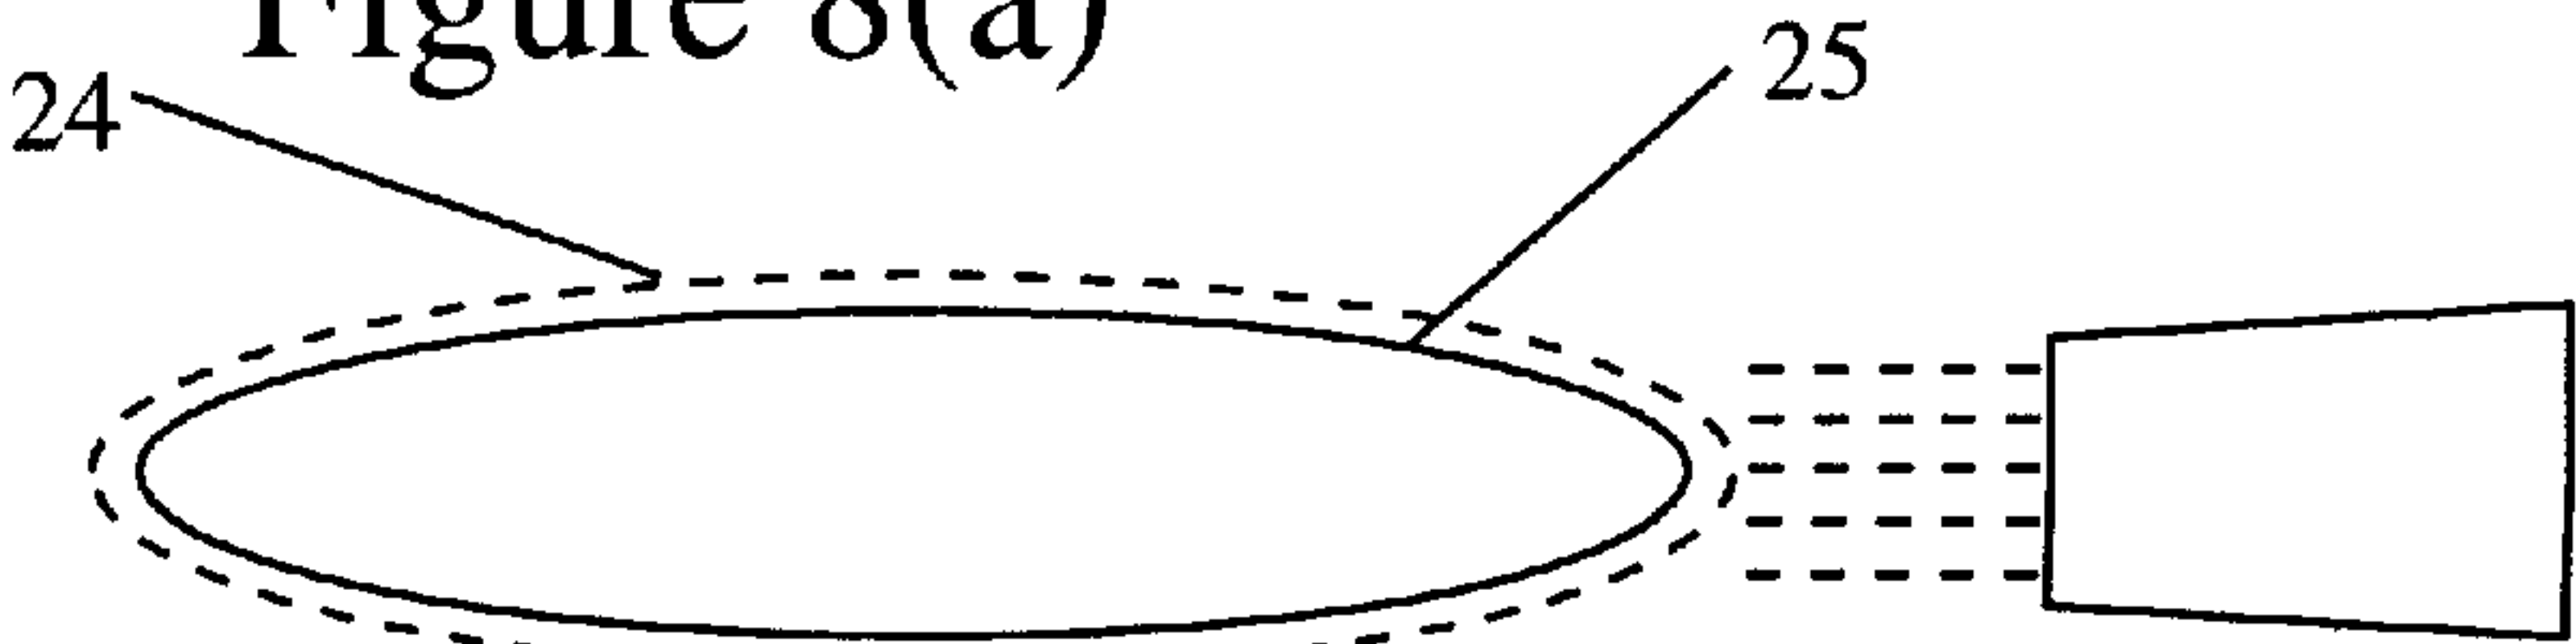
Figure 8(b)

FIG. 8(b) is a schematic cross-sectional view of the welded turbine engine part showing areas to be built up with similar coating material using an HVOF spray coating process in accordance with the inventive method of repairing a turbine engine part;

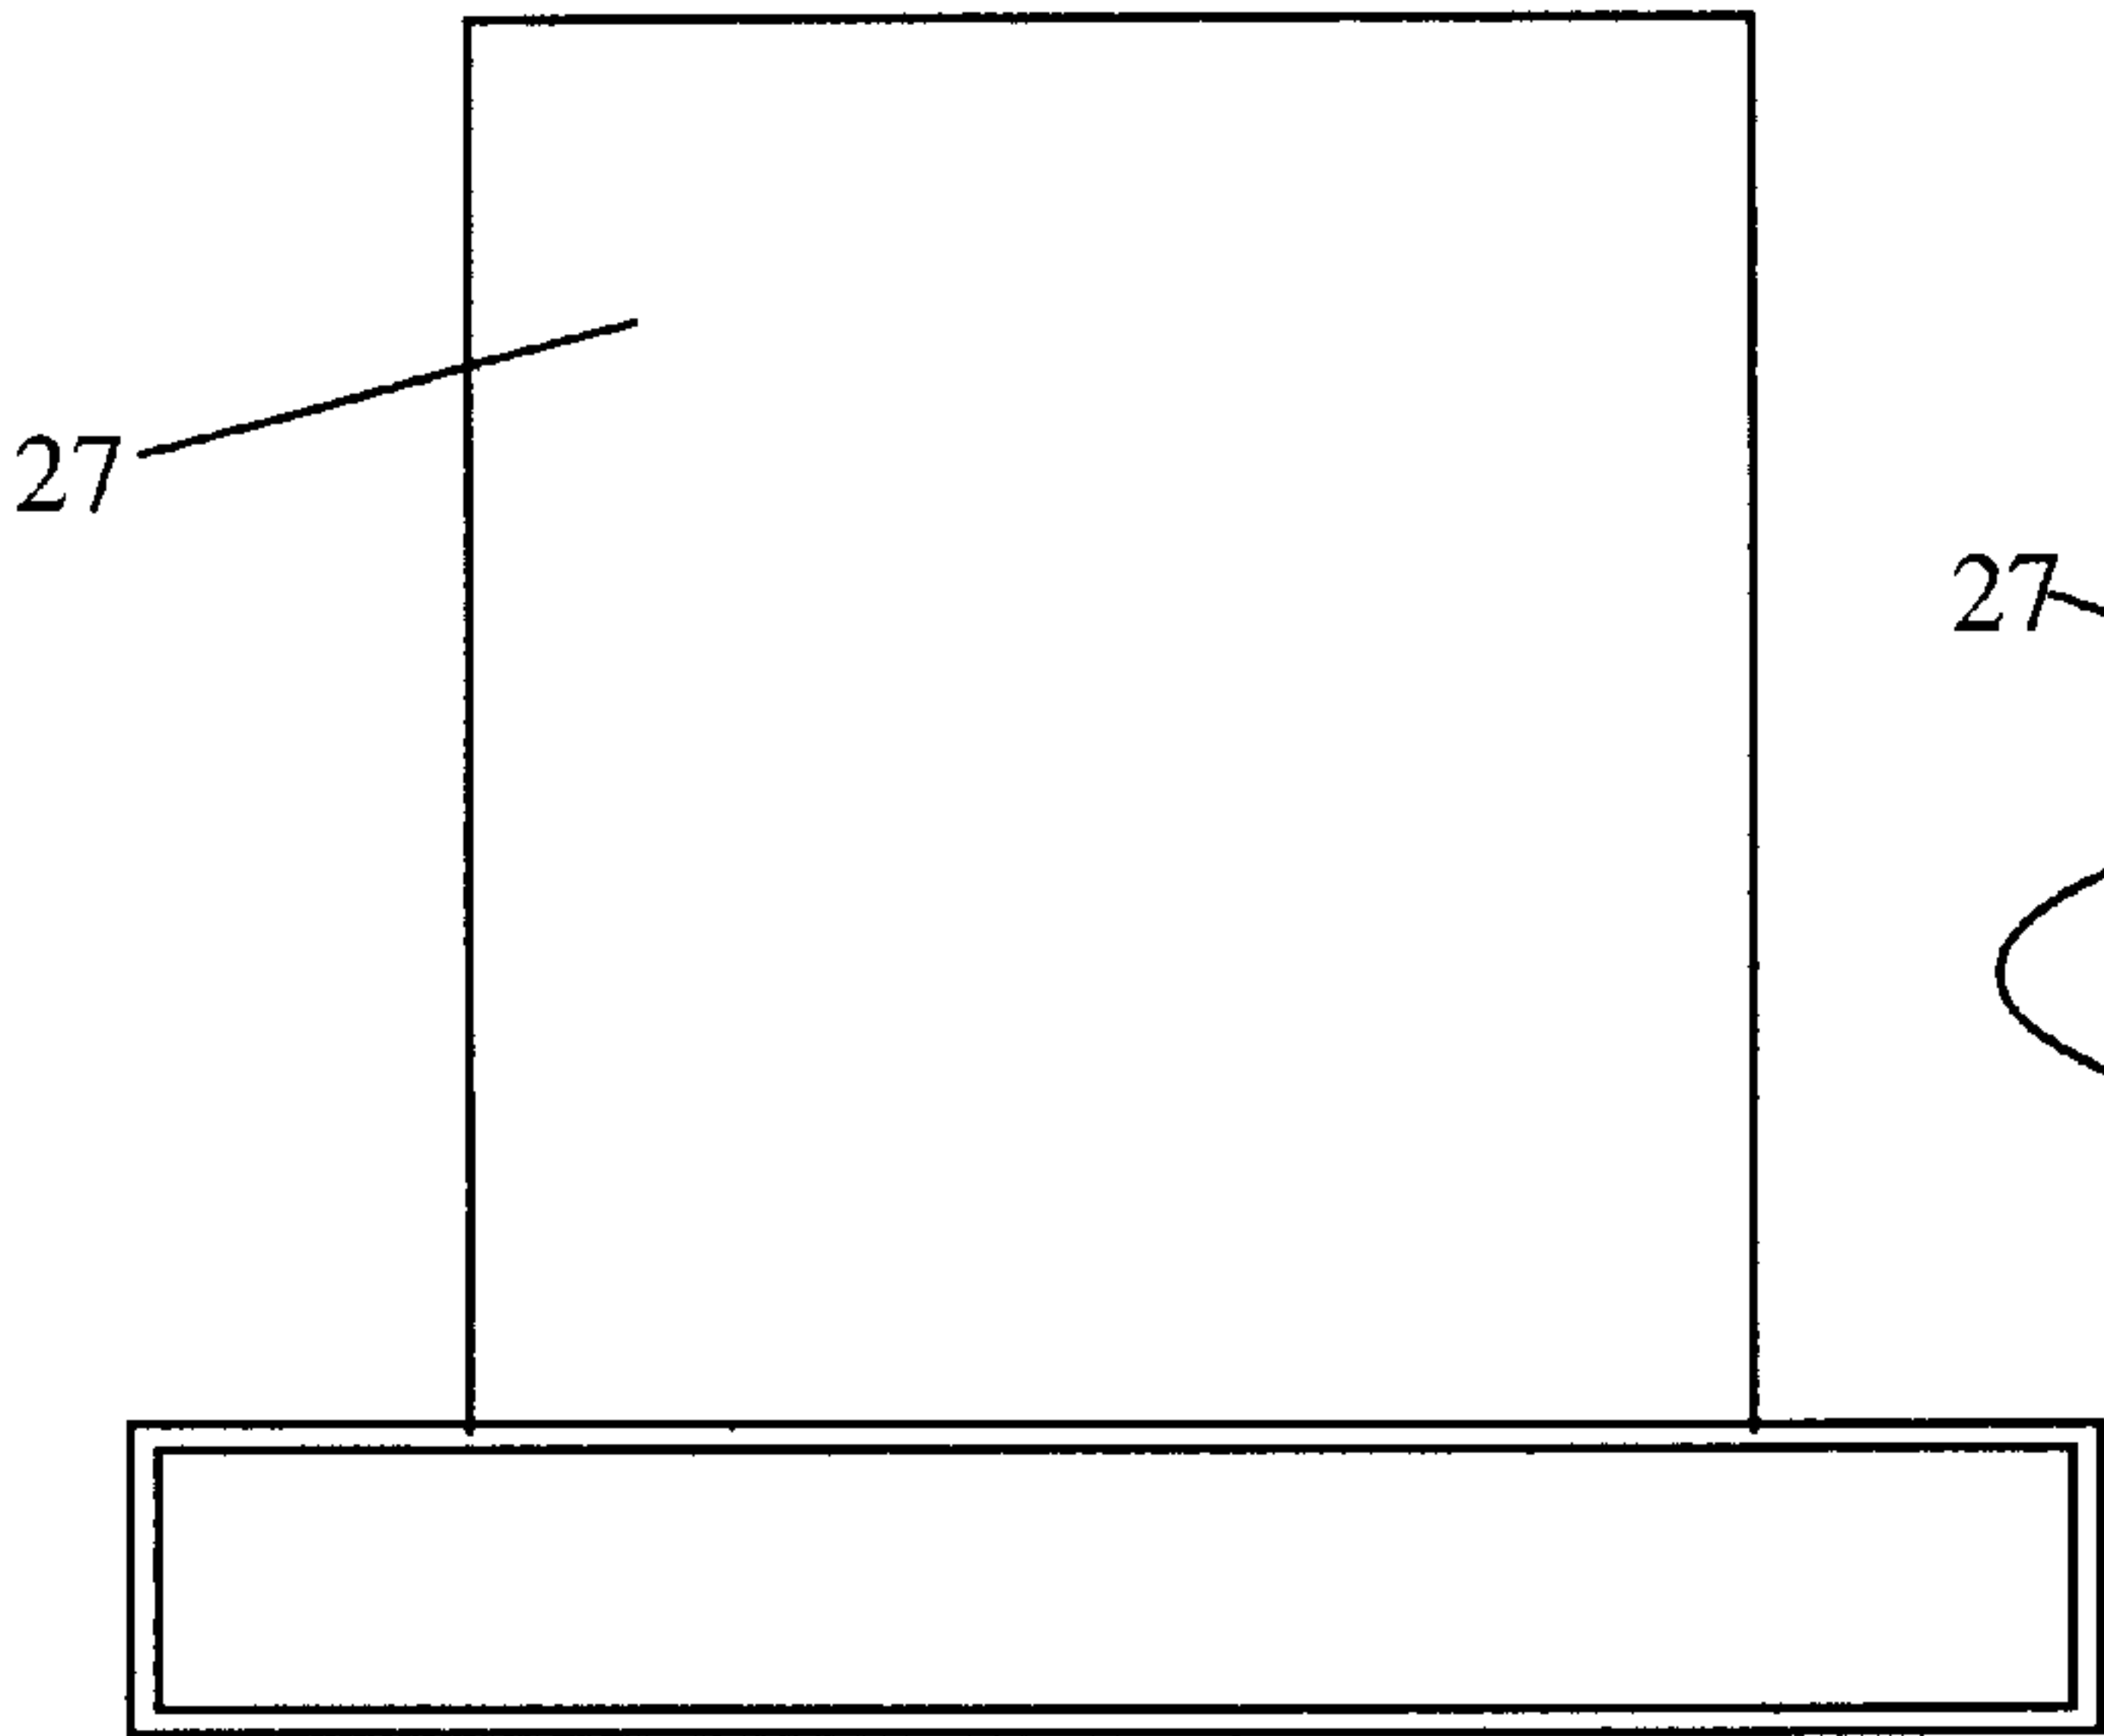
Figure 9(a)

FIG. 9(a) is a schematic side view of the HVOF built up, welded turbine engine part showing an area masked before performing the HVOF spray coating process in accordance with the inventive method of repairing a turbine engine part;

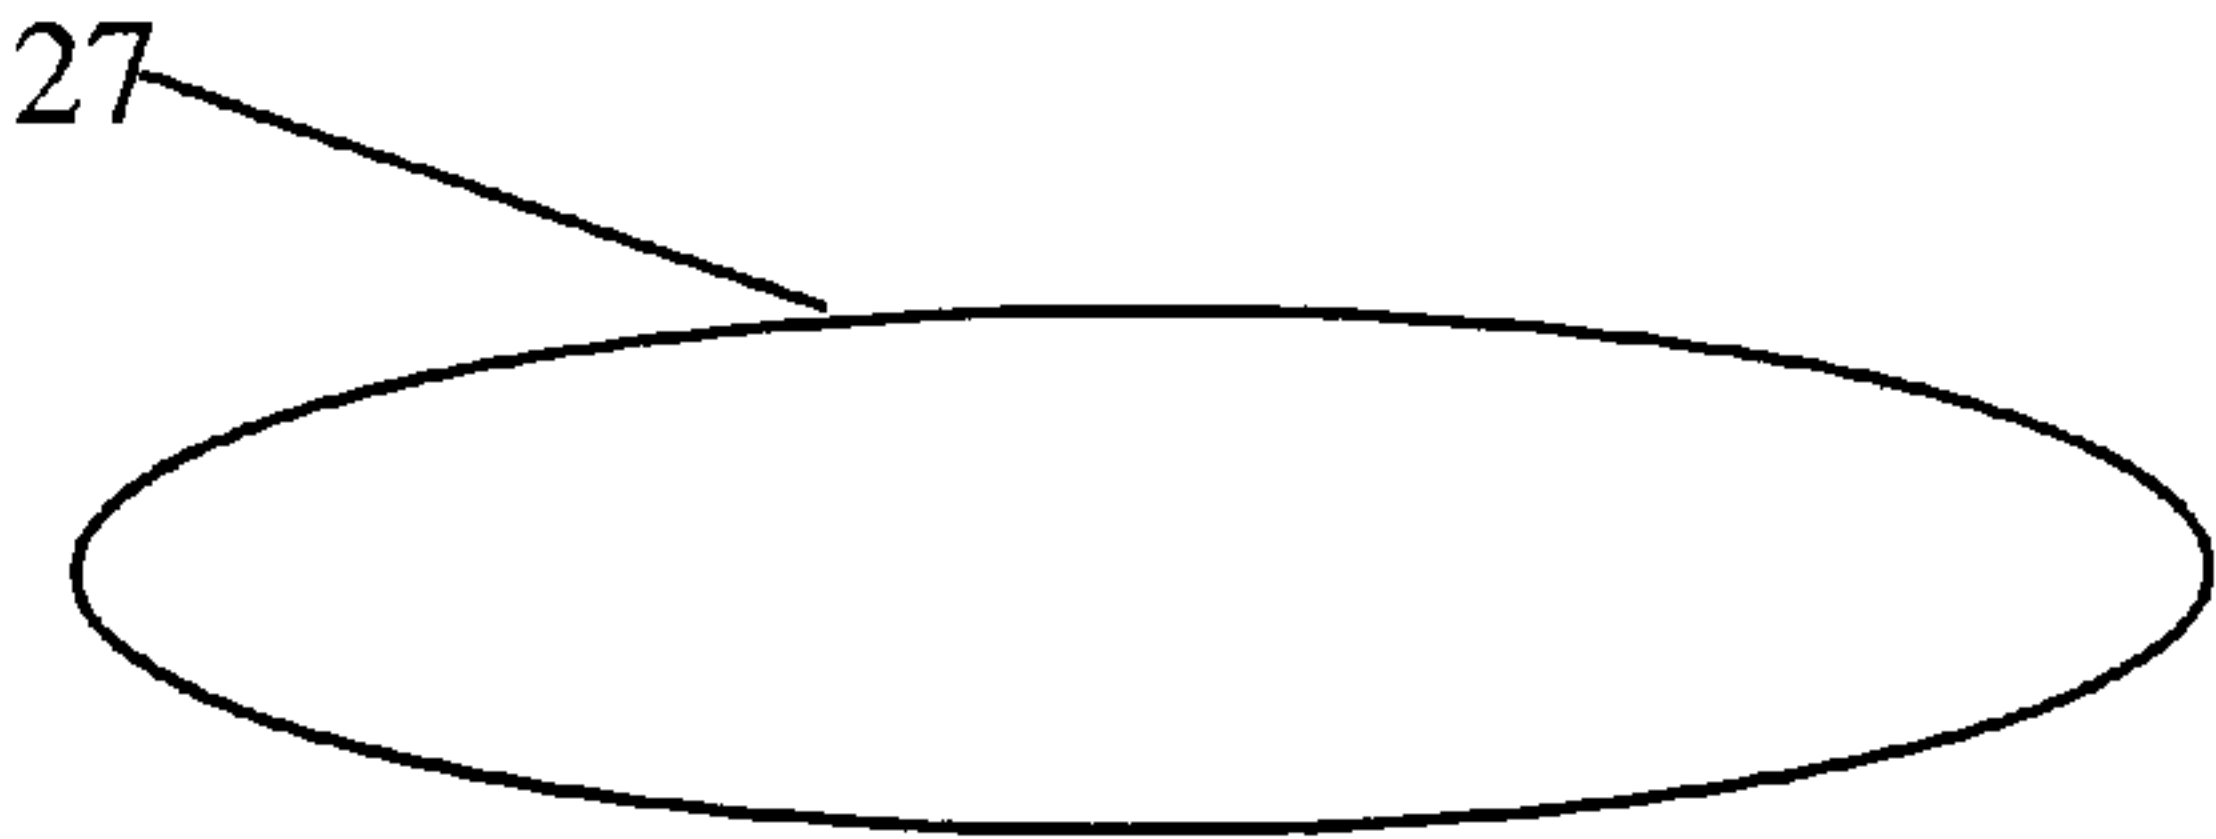
Figure 9(b)

FIG. 9(b) is a schematic cross-sectional view of the HVOF built up, welded turbine engine part in accordance with the inventive method of repairing a turbine engine part;

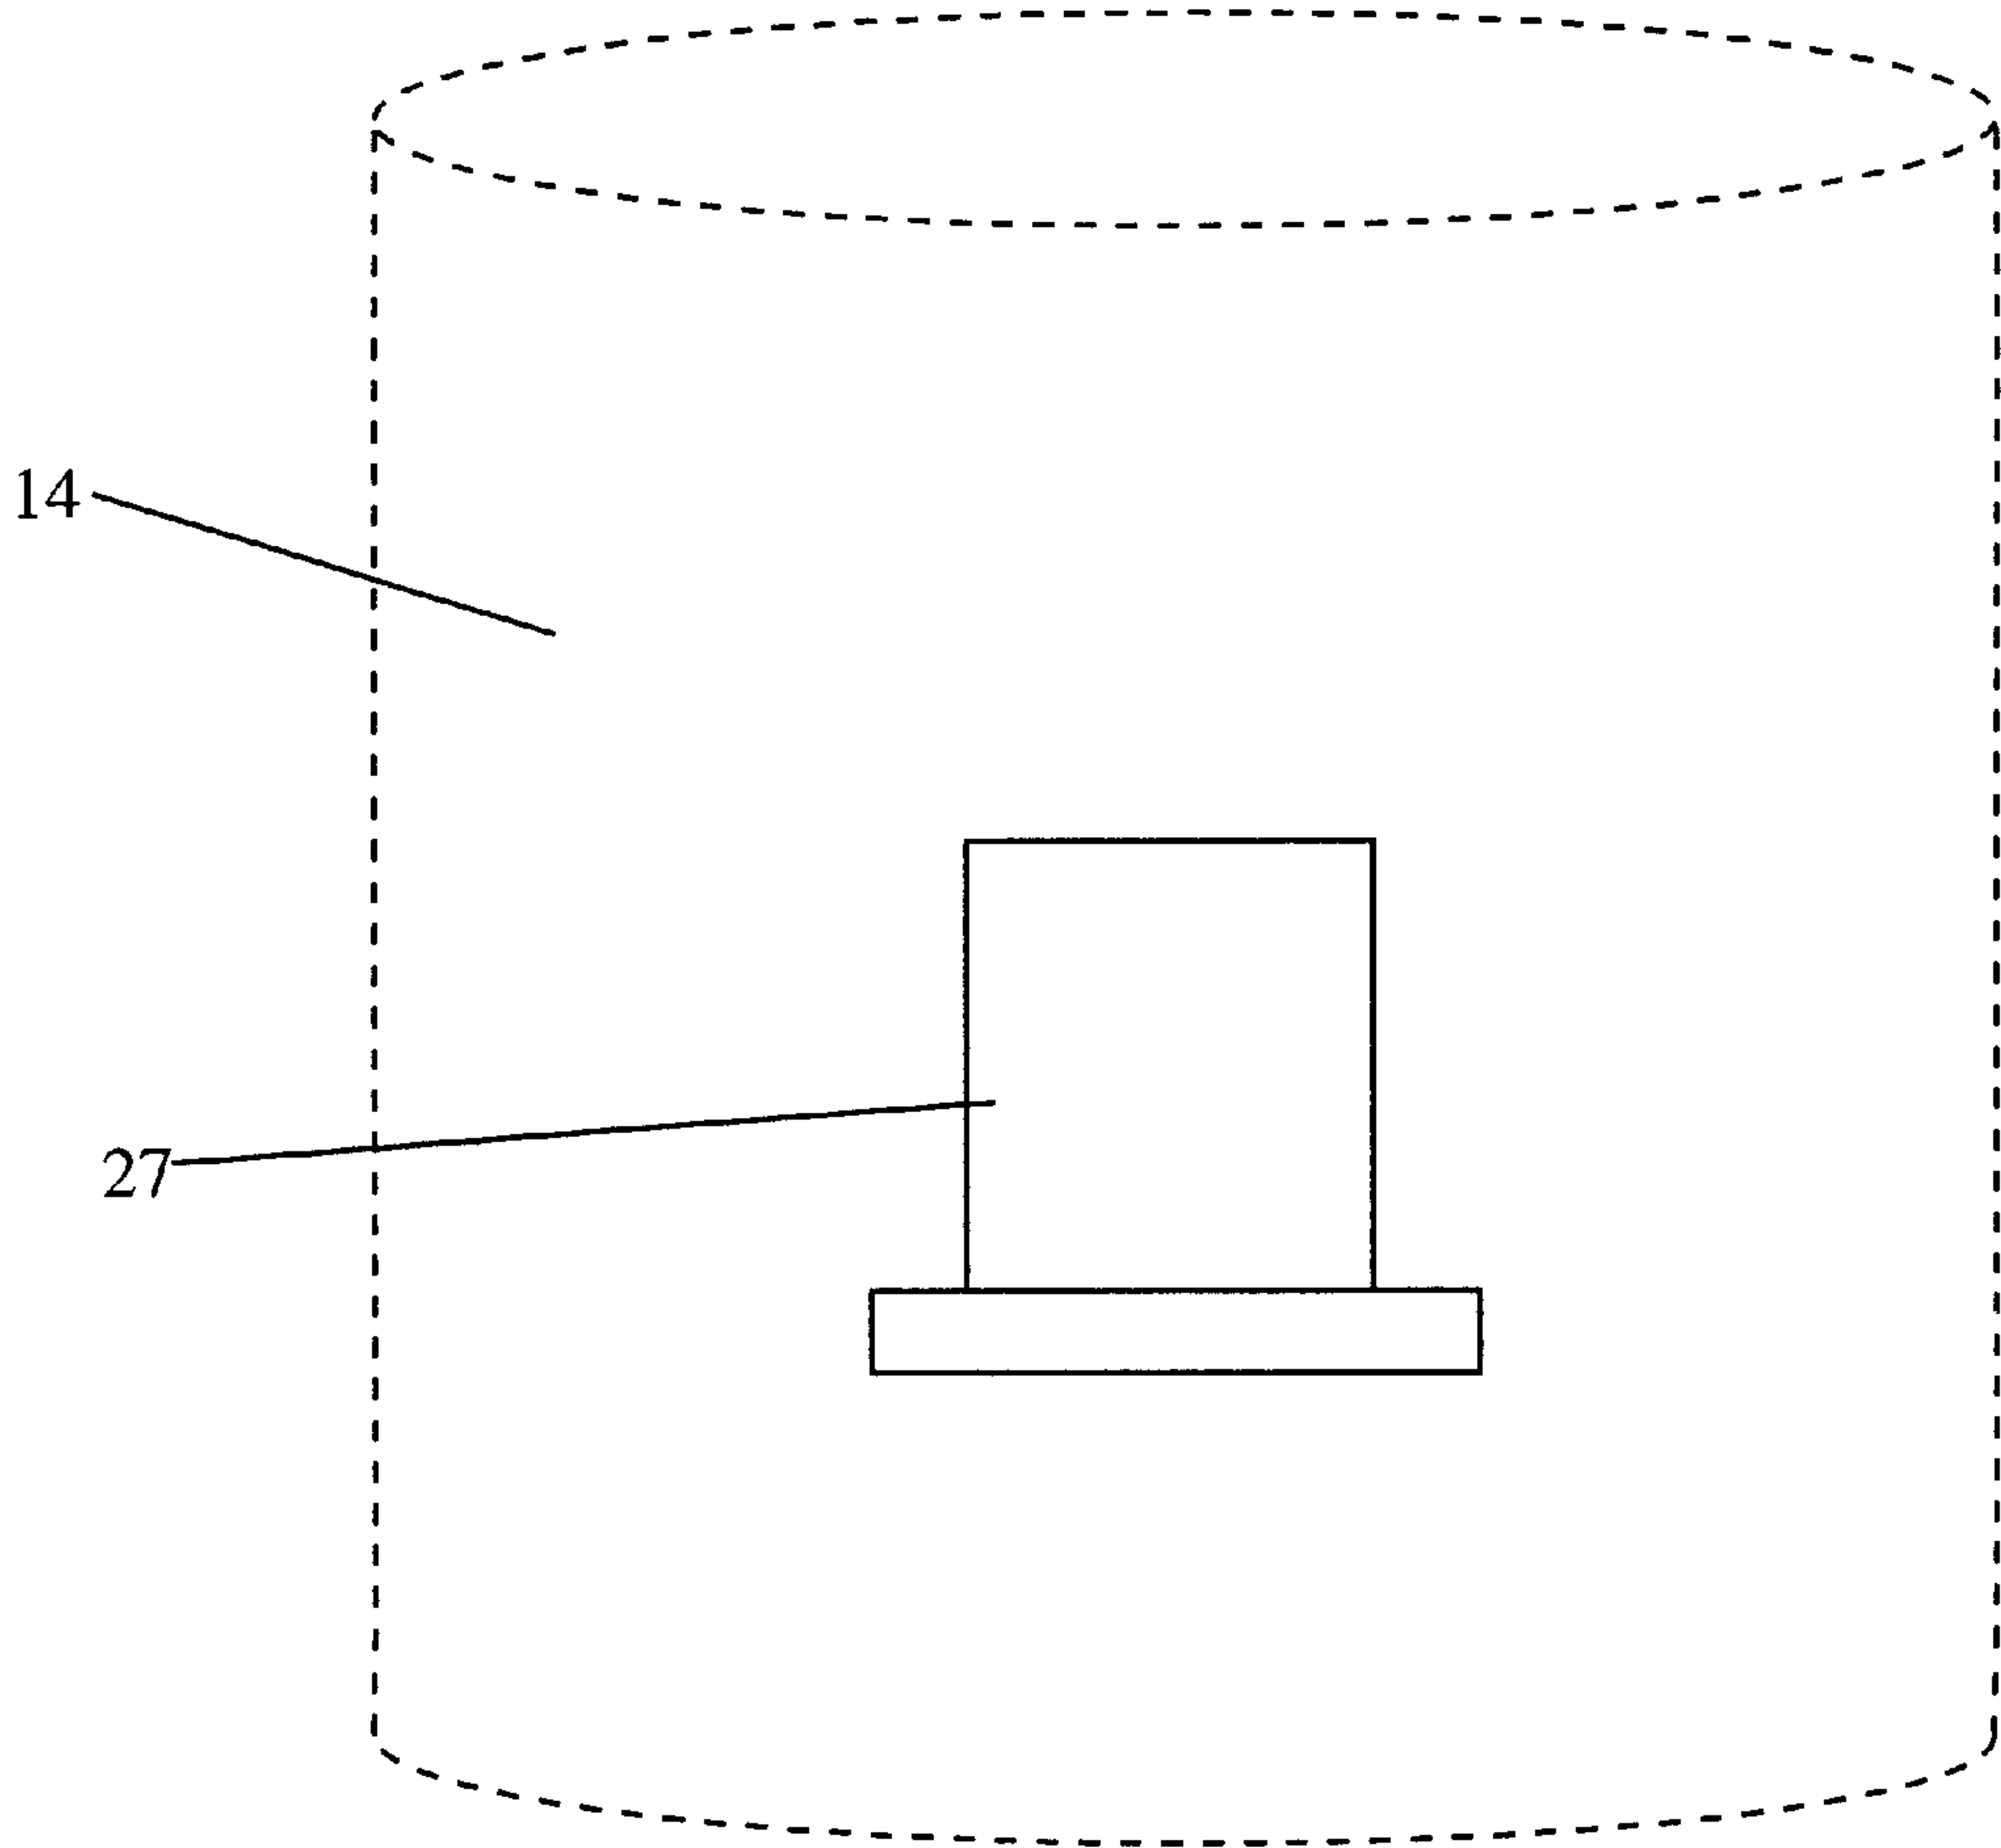
Figure 10

FIG. 10 is a schematic view of the HVOF built up, welded turbine engine part undergoing a HIP treatment process in a HIP vessel in accordance with the inventive method of repairing a turbine engine part;
