**United States Patent** [19]  
**Arnold**

[11] **Patent Number:** **6,049,978**  
[45] **Date of Patent:** **Apr. 18, 2000**

[54] **METHODS FOR REPAIRING AND RECLASSIFYING GAS TURBINE ENGINE AIRFOIL PARTS**

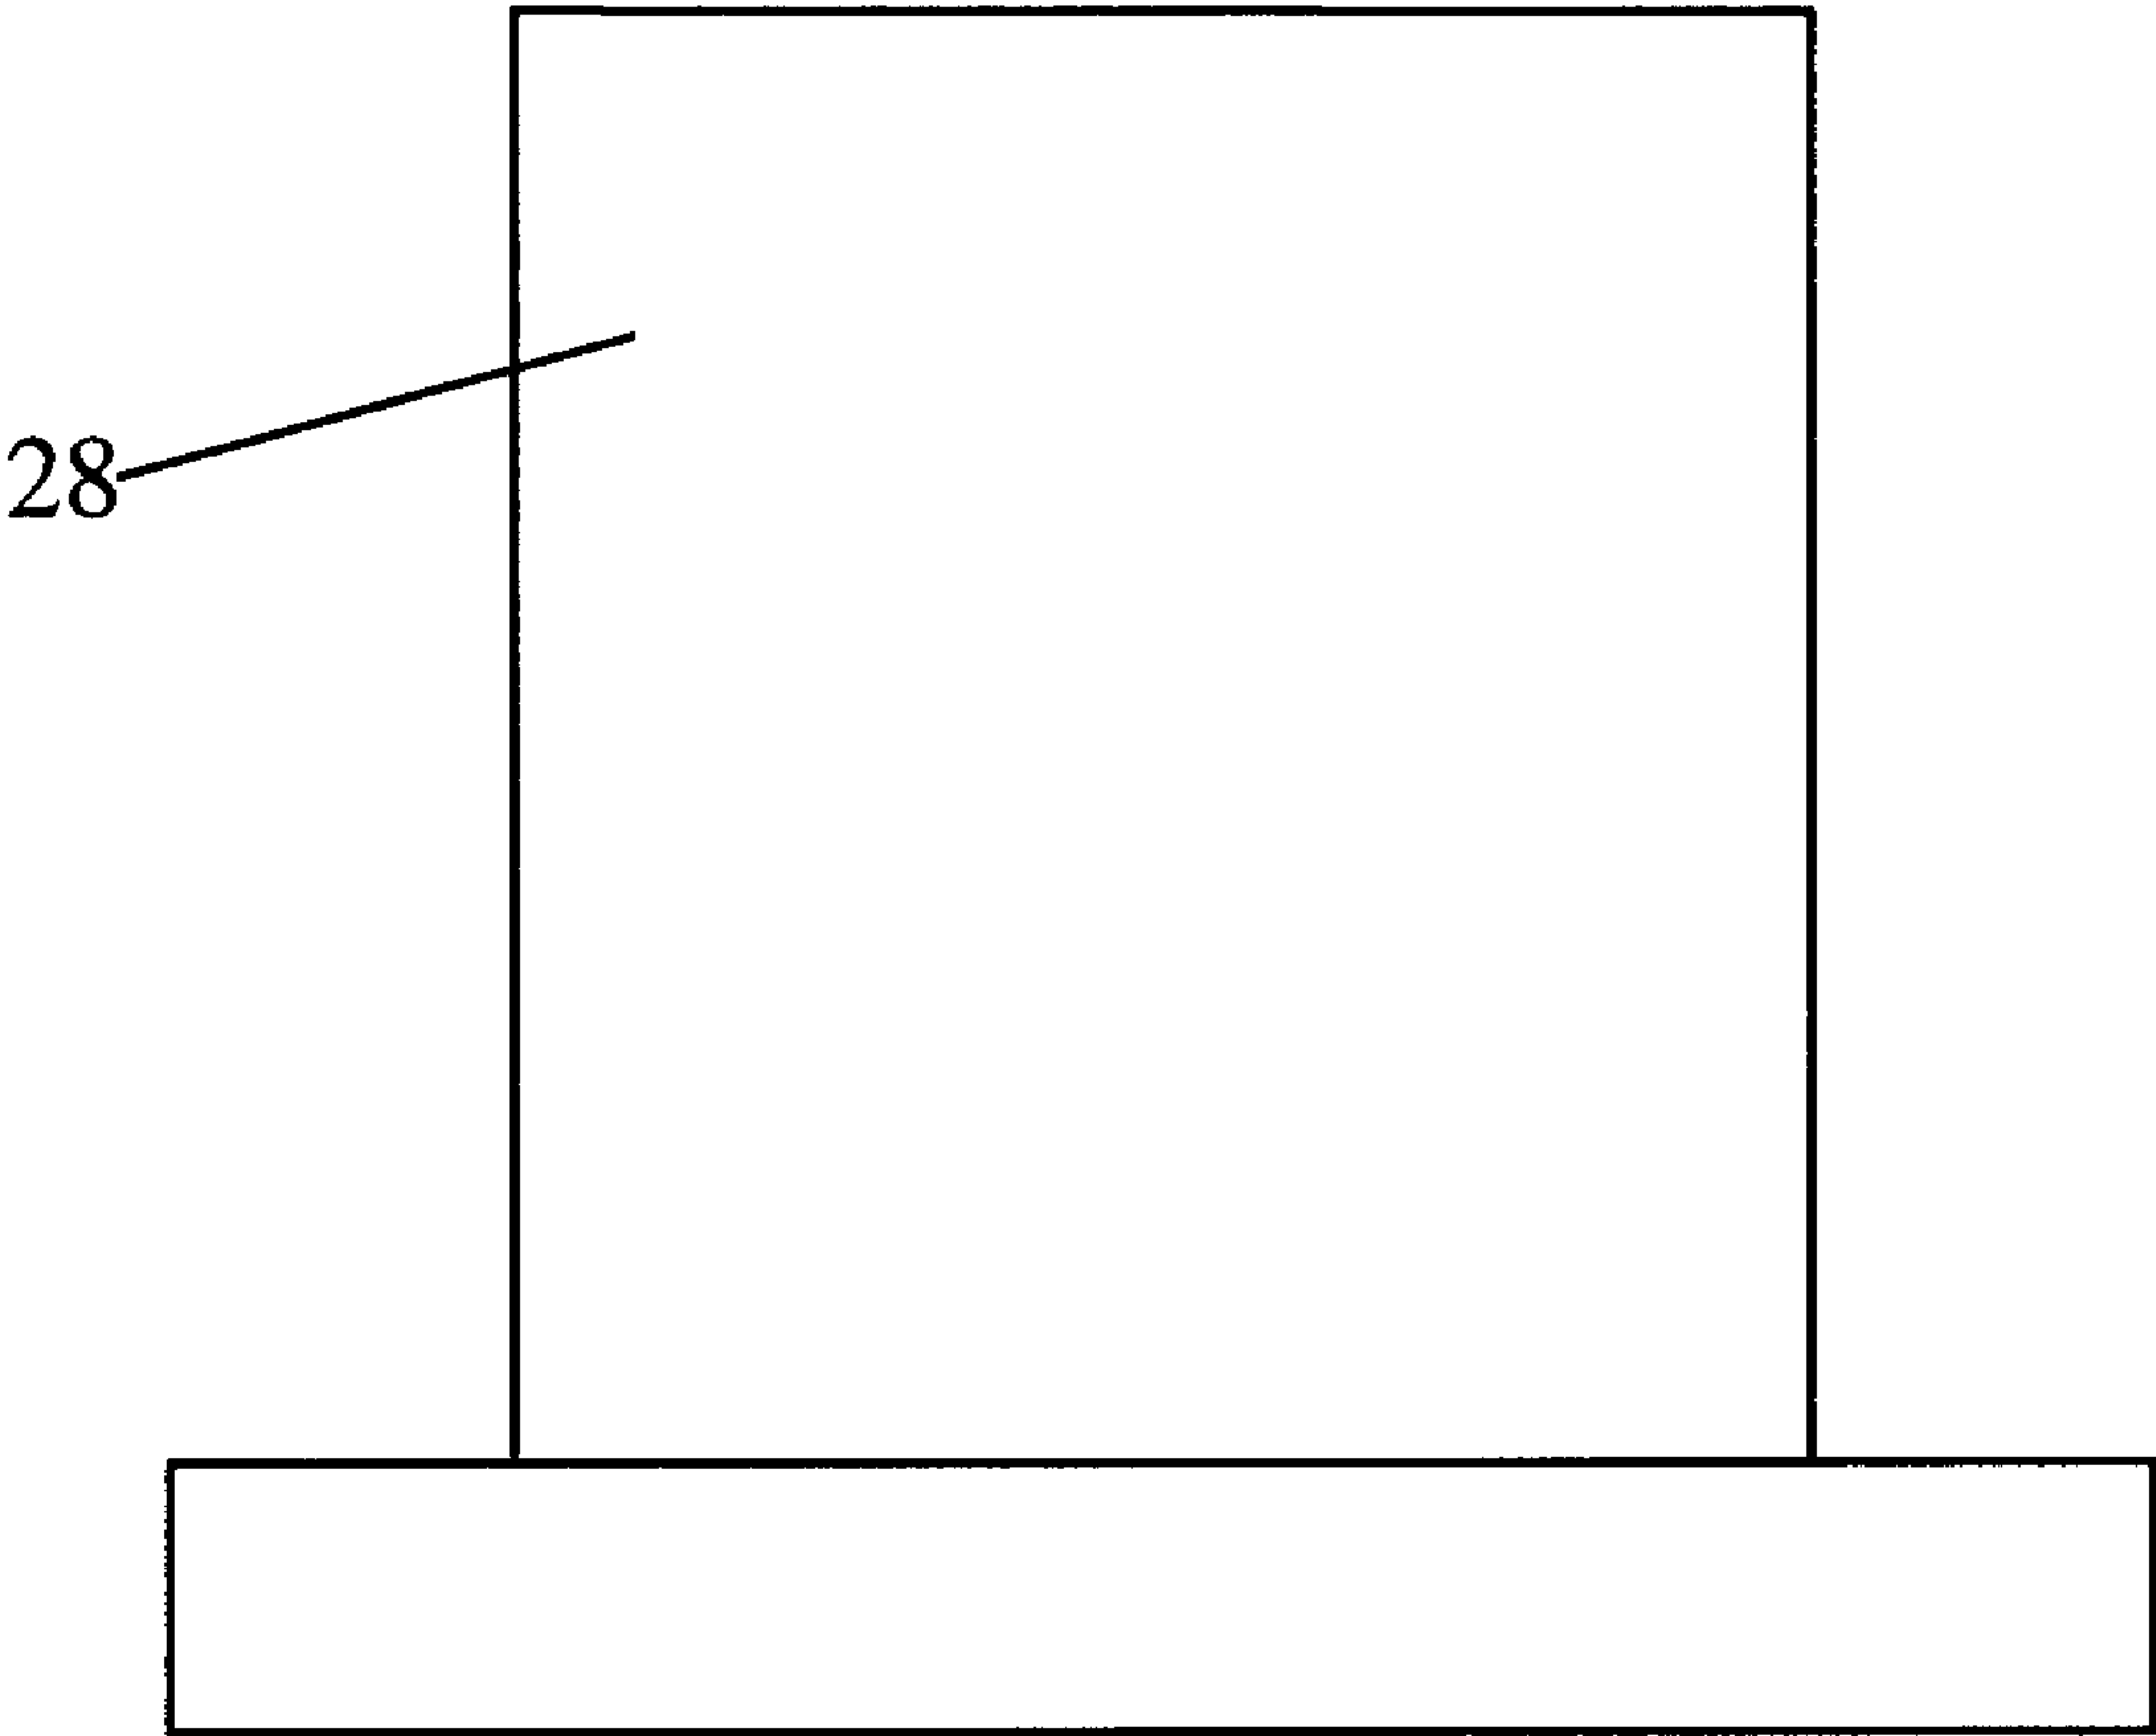
Figure 11(a)

FIG. 11(a) is a schematic side view of the final HVOF spray coated and HIP repaired turbine engine part having a similar metal coating layer diffusion bonded to the original parent substrate and welded portions in accordance with the inventive method of repairing a turbine engine part;

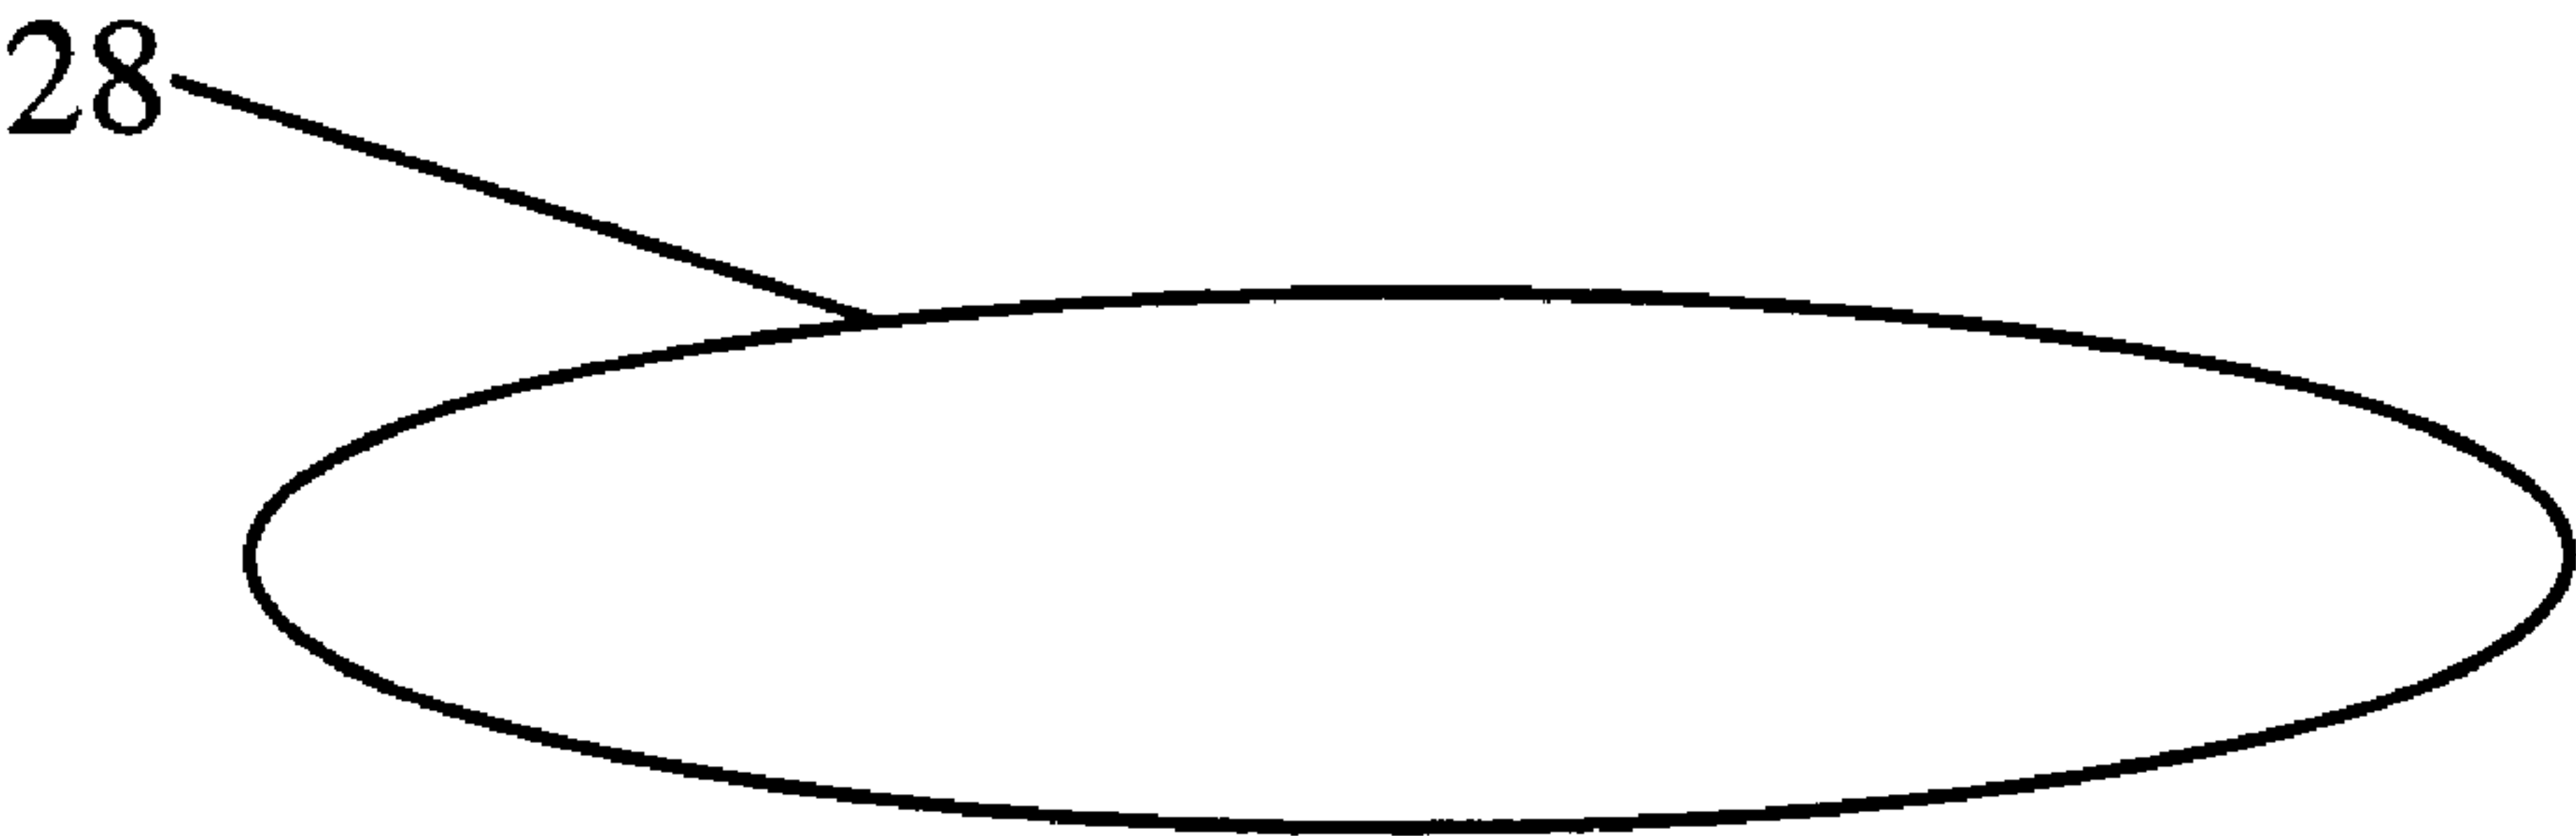
Figure 11(b)

FIG. 11(b) is a schematic cross-sectional view of the final HVOF spray coated and HIP repaired turbine engine part having a similar metal coating layer diffusion bonded to the original parent substrate and welded portions in accordance with the inventive method of repairing a turbine engine part;

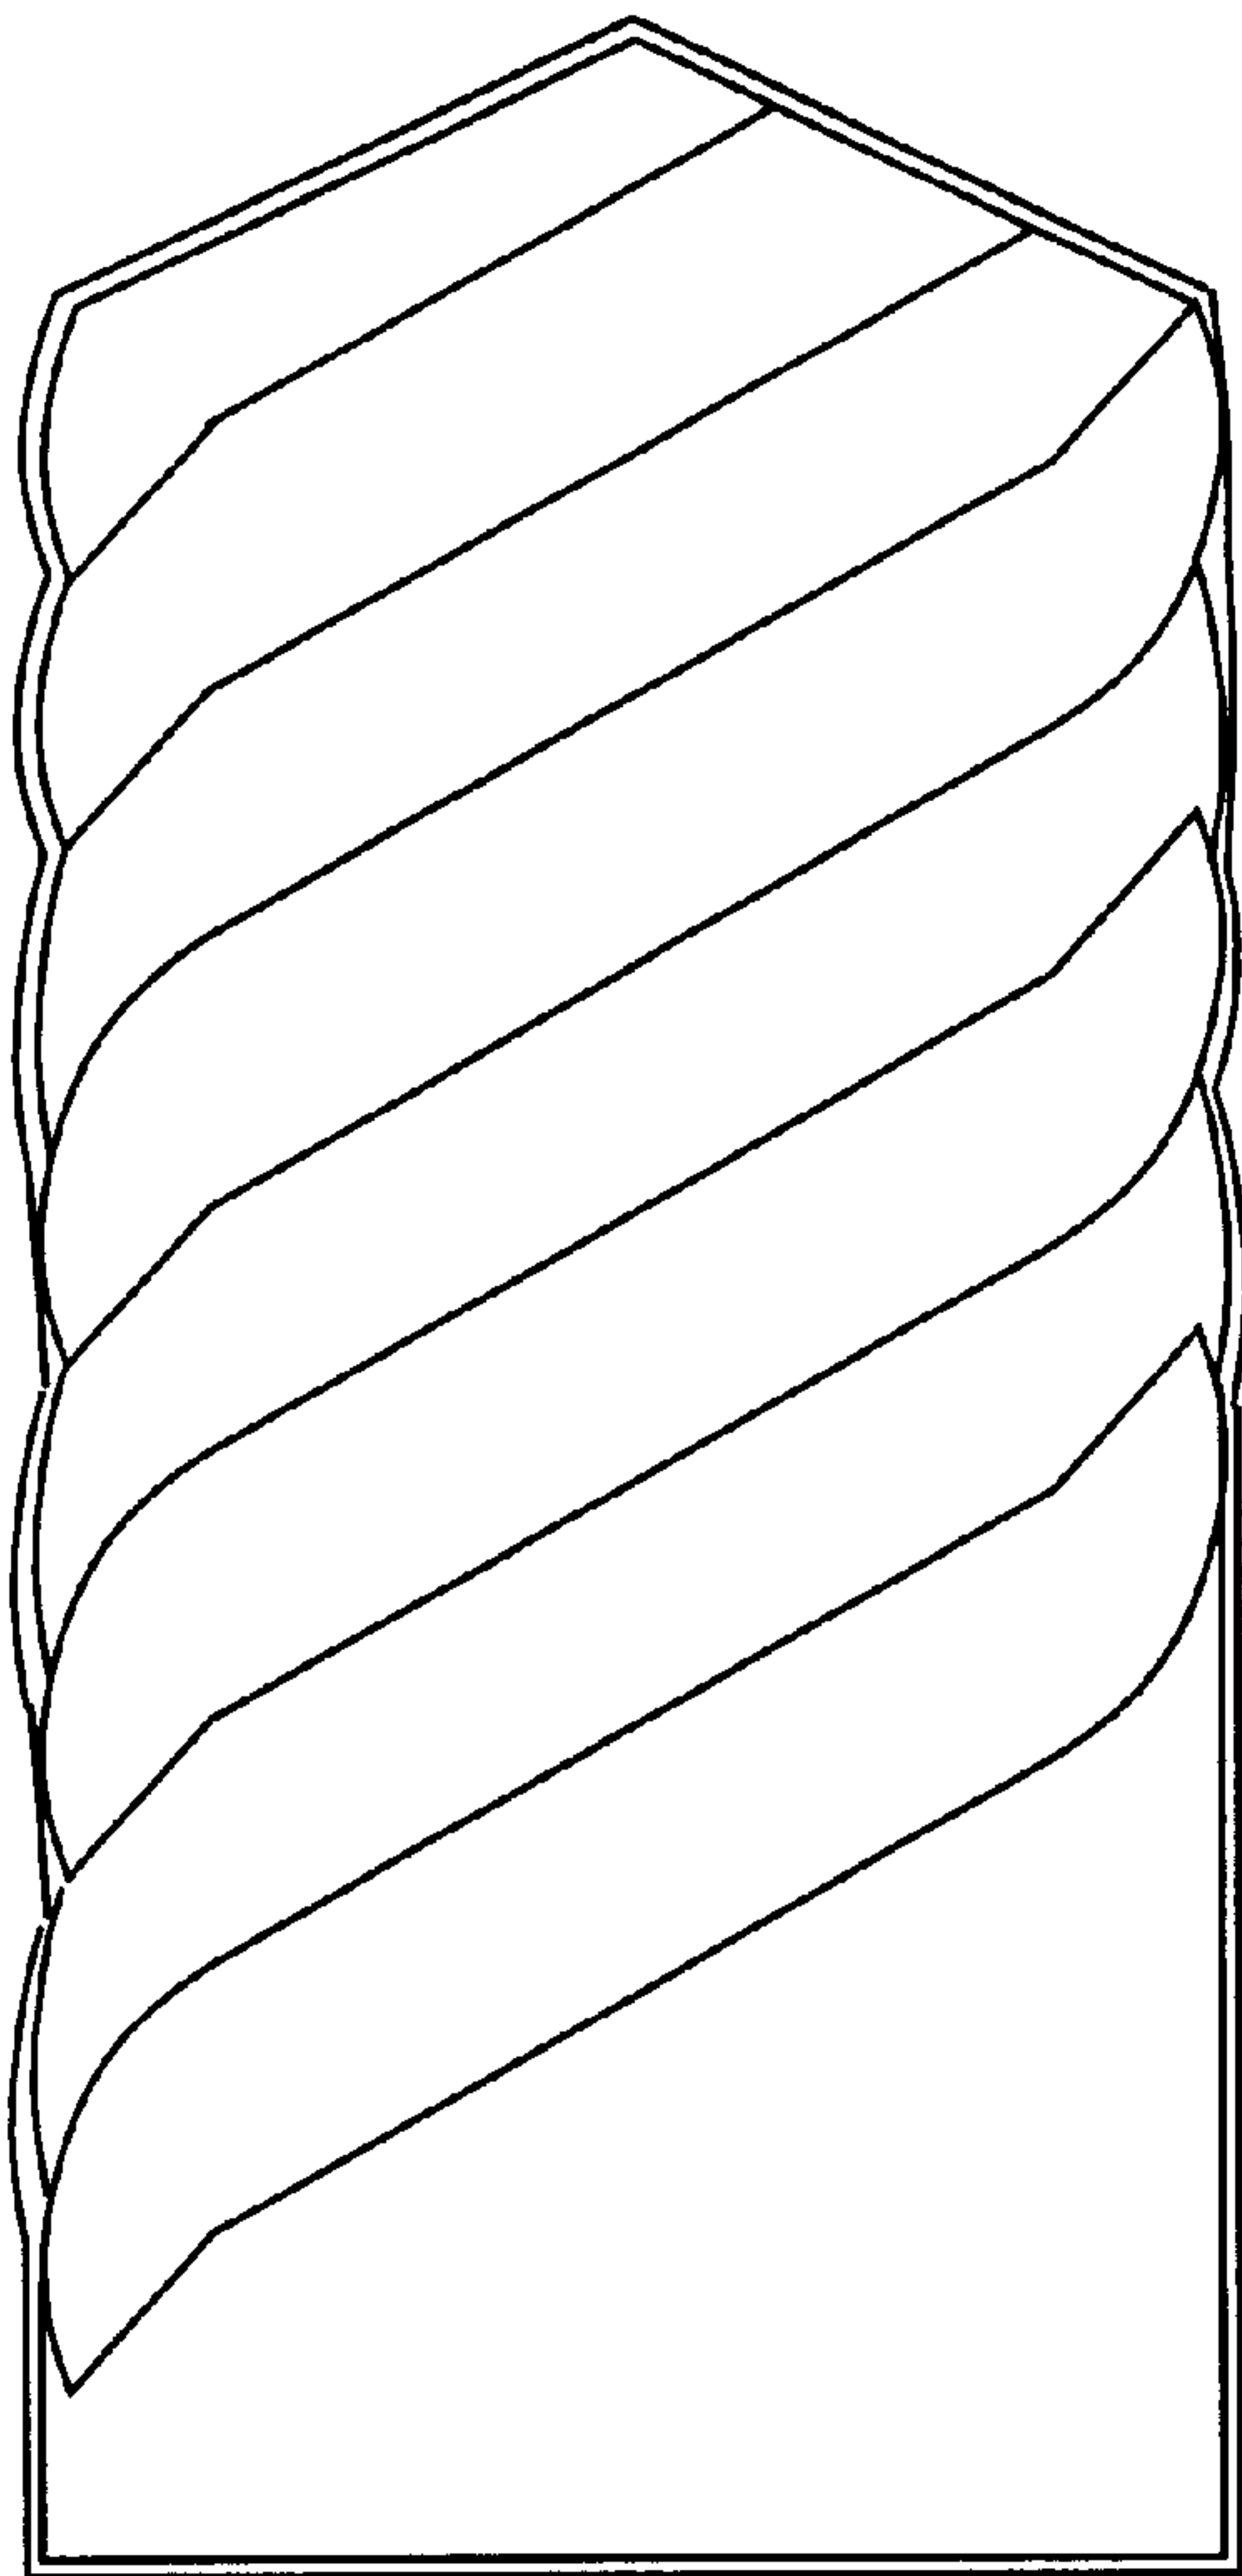
Figure 12(a)  
Prior Art

FIG. 12(a) is a side view of a prior art tool bit coated with a wear resistant coating;

FIG. 12(a) is a side view of a prior art tool bit coated with a wear resistant coating. In this case, the wear resistant coating may be applied by the Chemical Vapor Deposition method so that the entire tool bit substrate receives an even thin film of a relatively hard material, such as Carbide, Cobalt or TiN. Since the coating adheres to the tool bit substrate mostly via a mechanical bond located at a boundary interface, flaking and chipping off the coating off of the substrate is likely to occur during use, limiting the service life of the tool bit. FIG. 12(b) is a side view of a prior art tool bit having a fixed wear resistant cutting tip. In this case, a relatively hard metal cutting tip is fixed to the relatively soft tool bit substrate. The metal cutting tip, which is typically comprised of a Carbide or Cobalt alloy, is fixed to the tool bit substrate by brazing. During extended use the tool bit is likely to fail at the relatively brittle brazed interface between the metal cutting tip and the tool substrate, and again, the useful service life of the tool bit is limited.

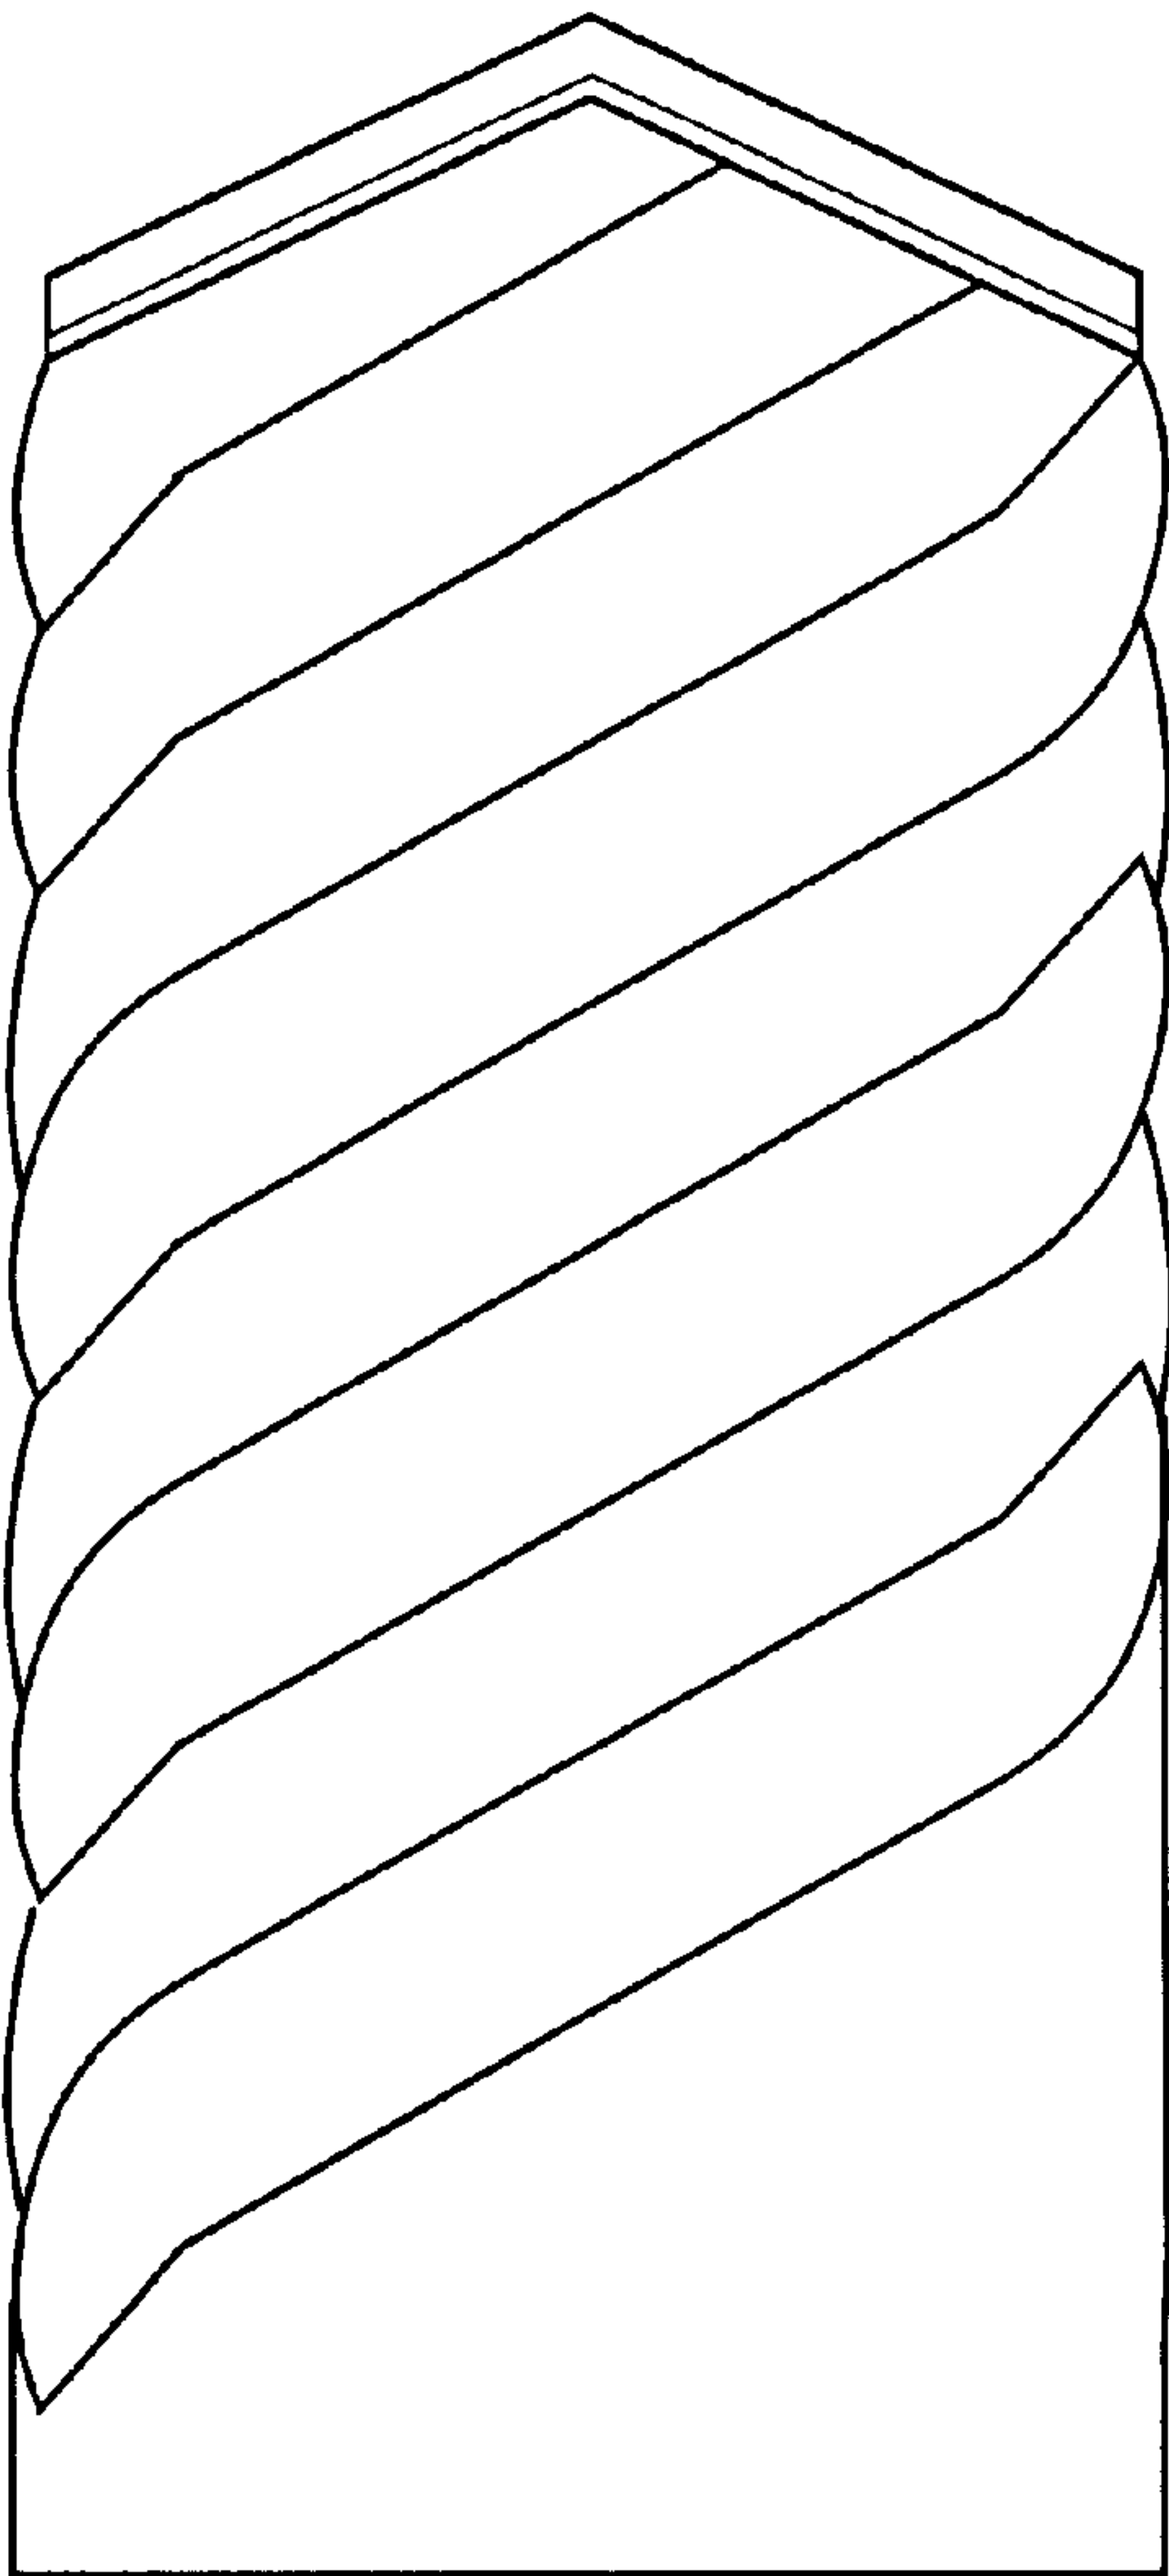
Figure 12(b)  
Prior Art

FIG. 12(b) is a side view of a prior art tool bit having a fixed wear resistant cutting tip;
