US006090437A

[11] Patent Number: 6,090,437
[45] Date of Patent: Jul. 18, 2000

[54] FLOOR REPAIR METHOD

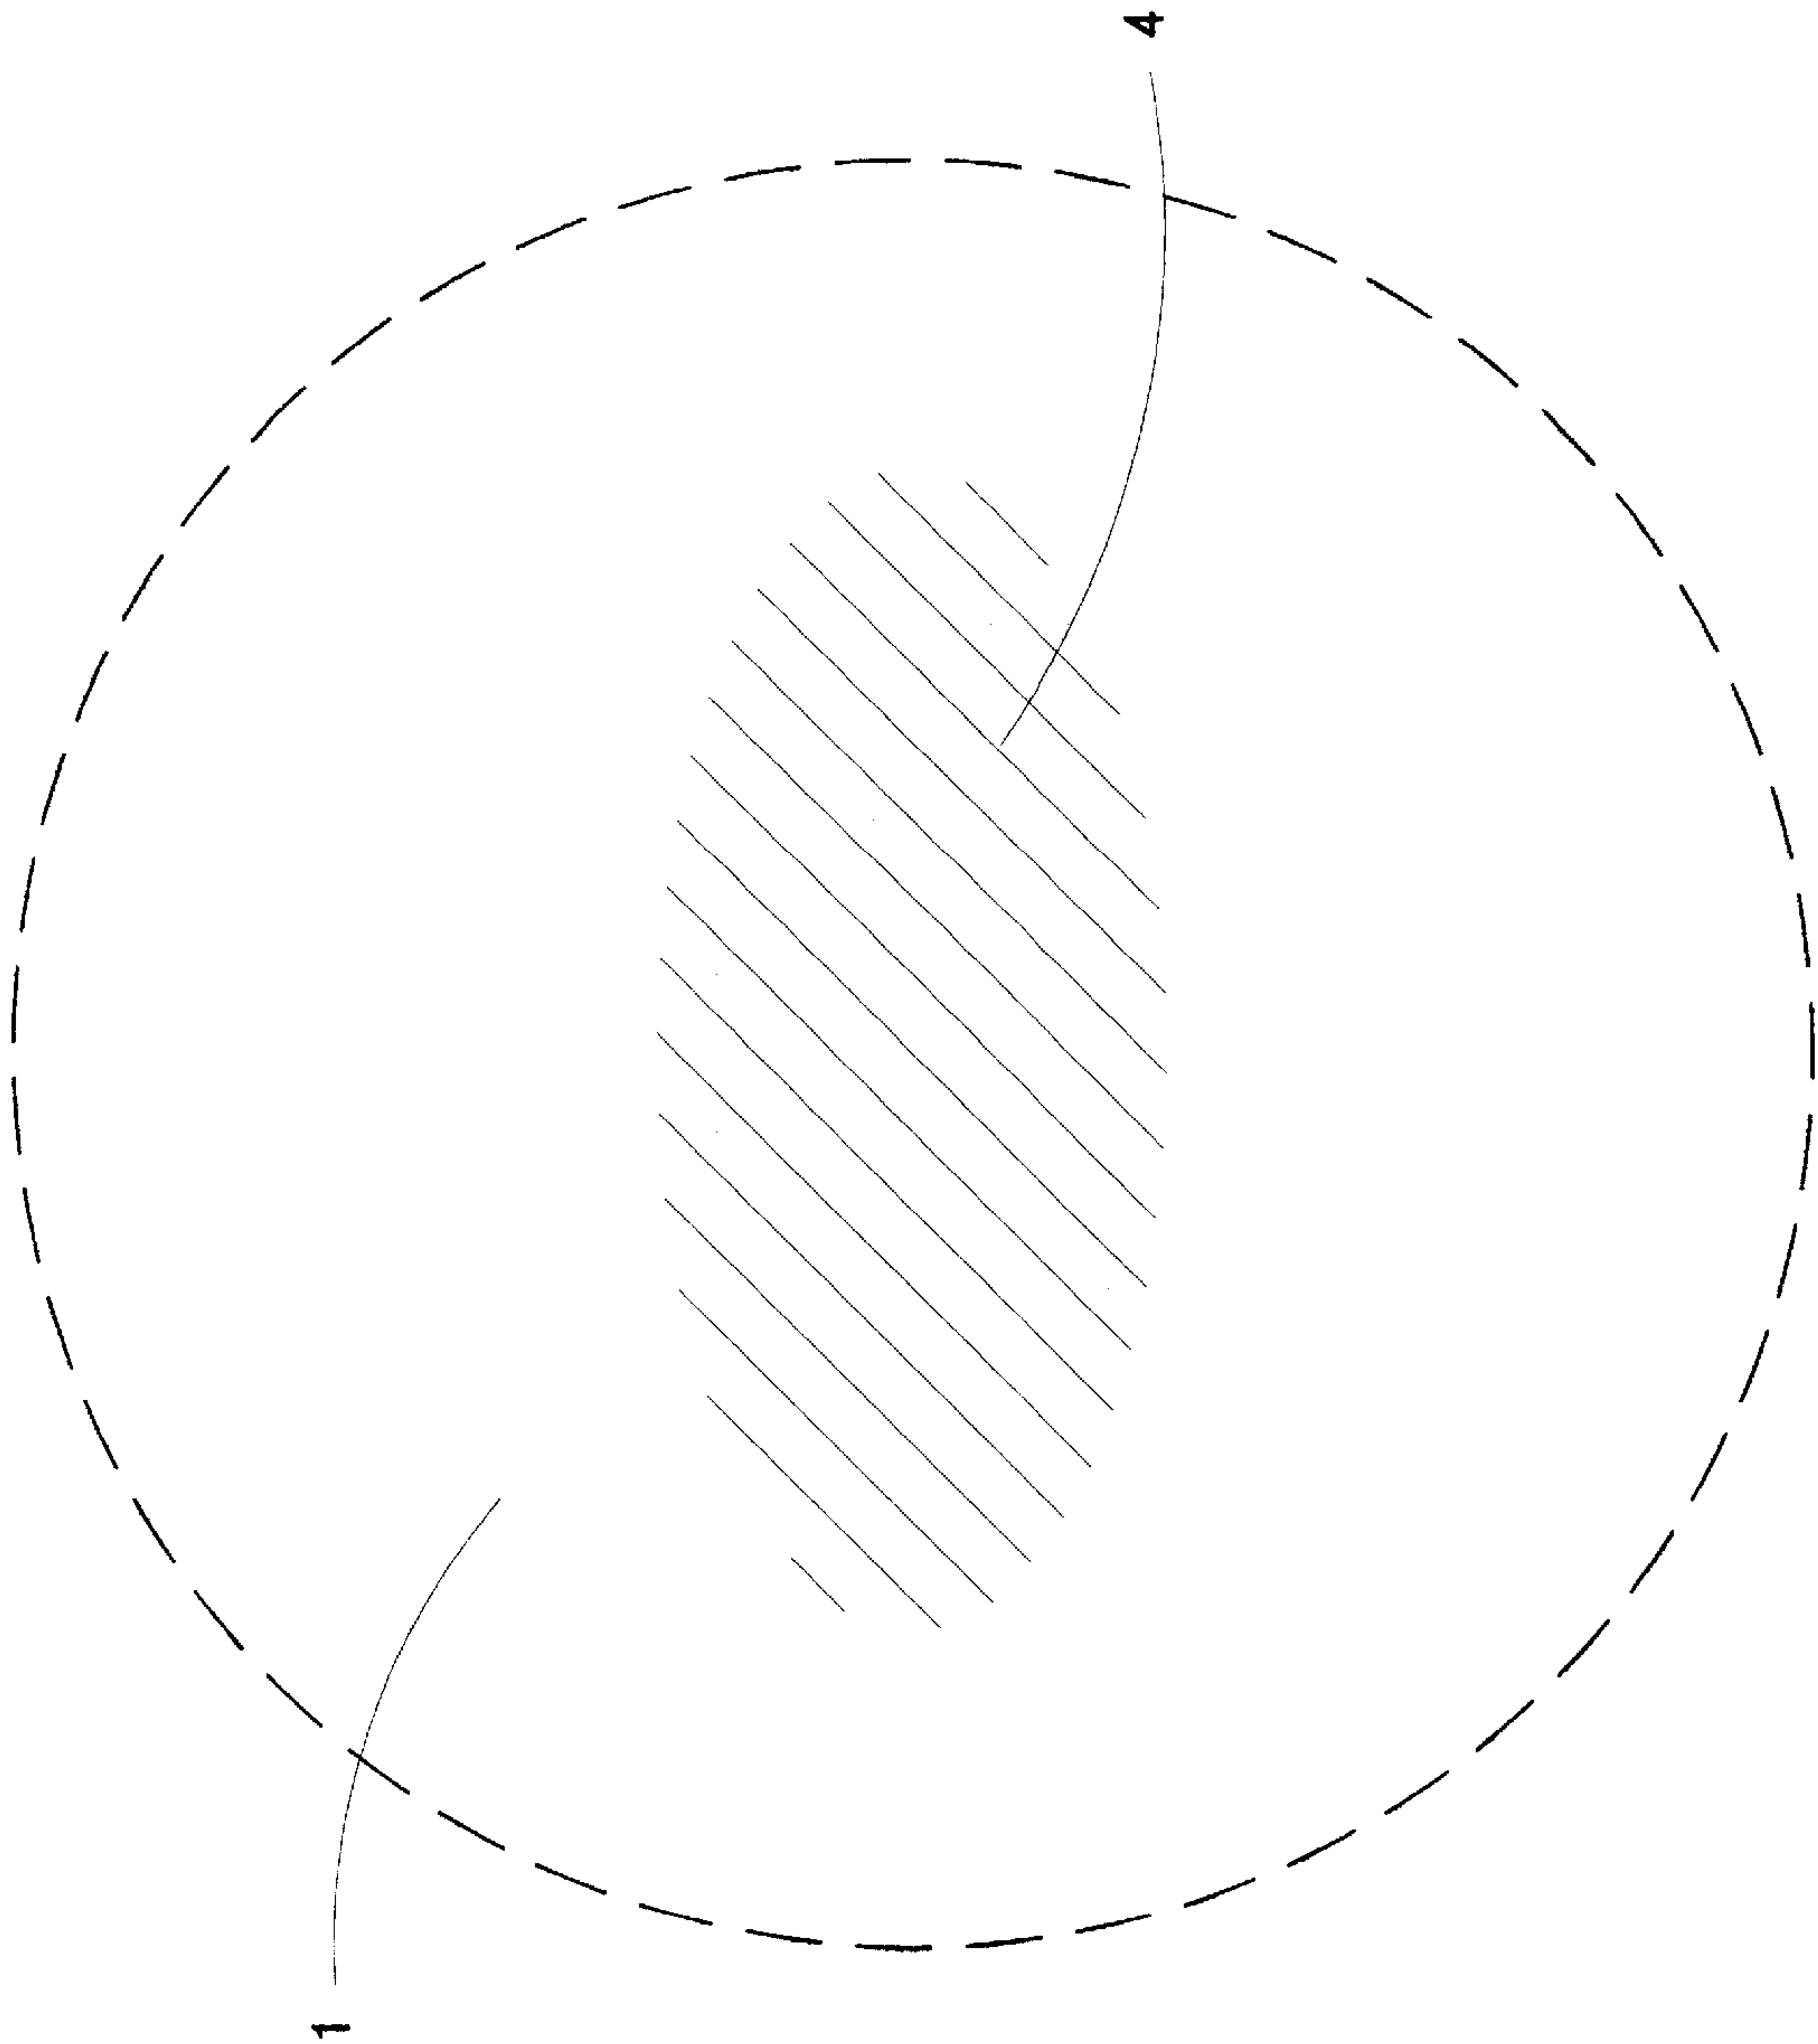
FIG. 1 depicts a vinyl or linoleum floor area having a cigarette burn.

Referring simultaneously to FIGS. 1 and 3, Reference Numeral 1 designates an upper surface of a section of floor covering stratum 2, typically comprising vinyl or linoleum. Typically, such a vinyl or linoleum floor stratum 2 is adhesively applied to an underlayment 8 which serves as a base stratum. Referring to FIG. 1, a cigarette burn 4 represents one of several potential types of damage to the surface 1 of the, referring to FIG. 3, vinyl or linoleum cover stratum 2.

Referring simultaneously to FIGS. 1, 2, and 3, a linoleum knife or other utility knife is preferably utilized to cut away the damaged cigarette burn area 4. Preferably, the utility knife is tilted at a 45 degree angle, leaving an inwardly beveled wall 6. Such inwardly beveled wall 6 provides additional surface contact area for enhanced adhesion of adhesive saturated filler material.

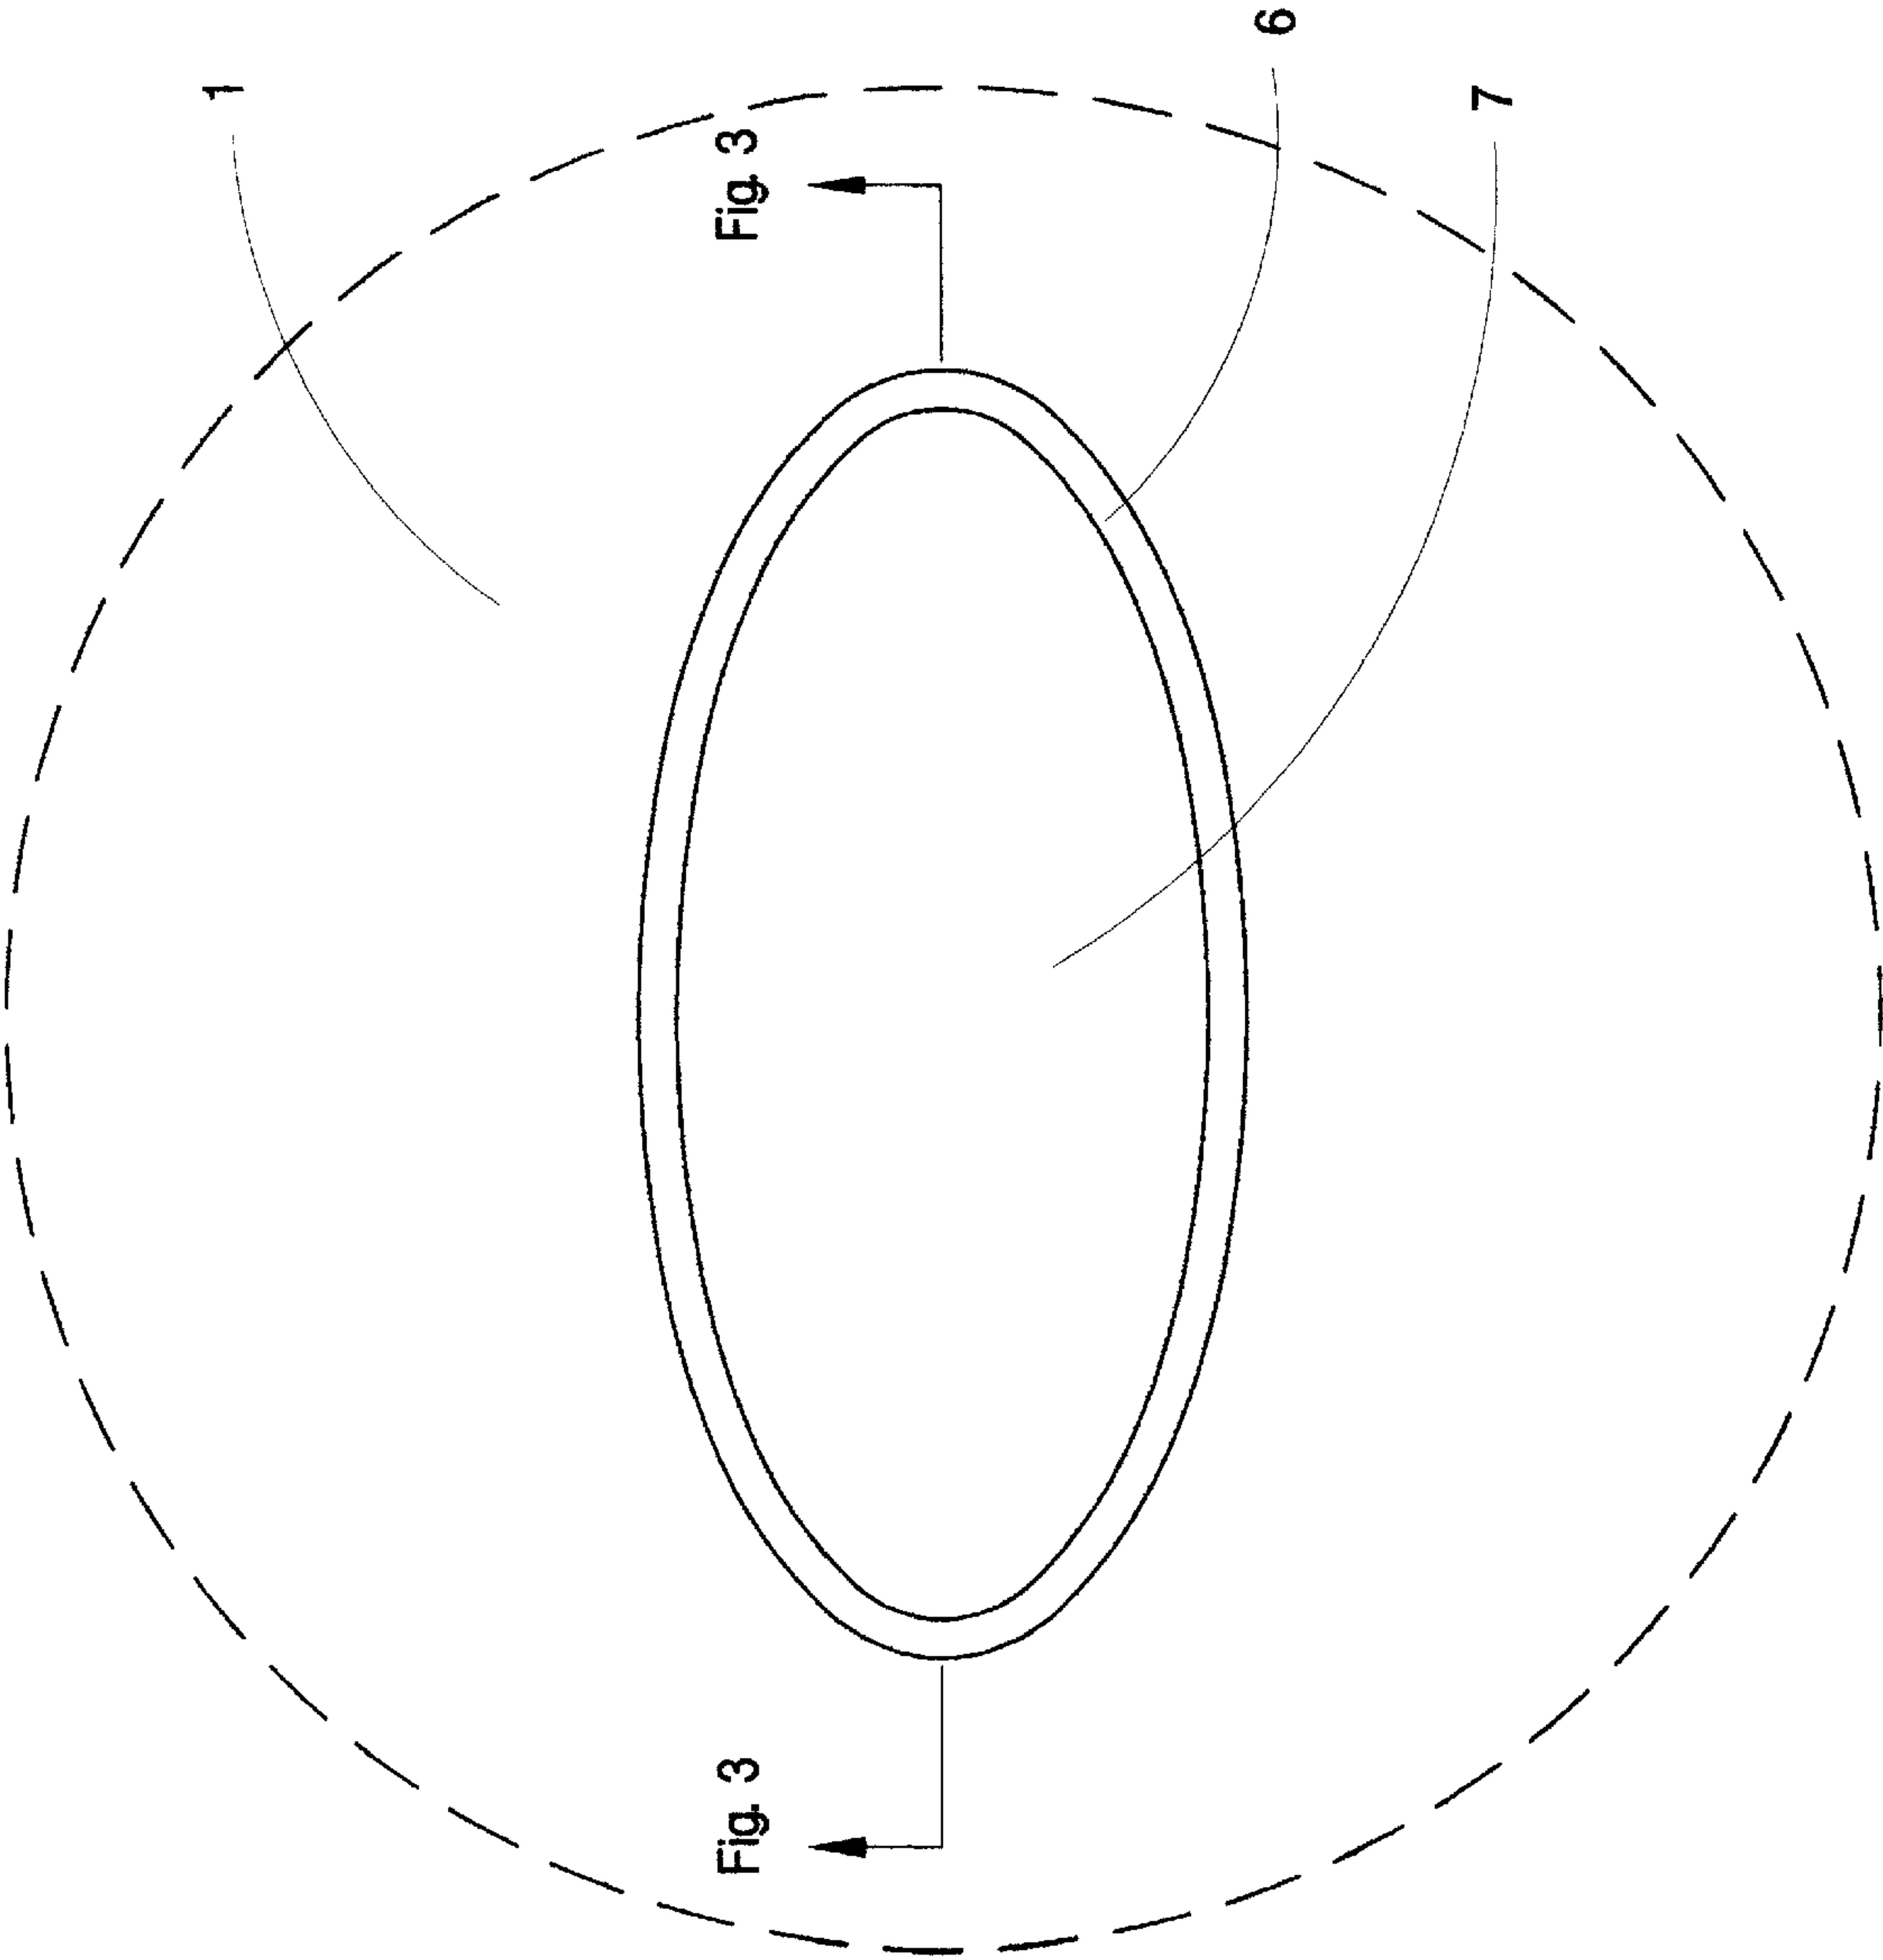
FIG. 2 depicts the vinyl or linoleum floor area depicted in FIG. 1 after removal of the burned area.

Referring simultaneously to FIGS. 2 and 3, upon completion of the trimming or cutting step, as the case may be, the upper surface 7 of the underlayment stratum 8 is exposed, such upper surface 7 serving as a floor spanning across the lower end of the void or depression formed in said trimming or cutting step. Typically, the upper surface 7 of the underlayment stratum 8 is dark in color; while typically, the upper surface 1 of the vinyl or linoleum stratum 2 has a contrasting

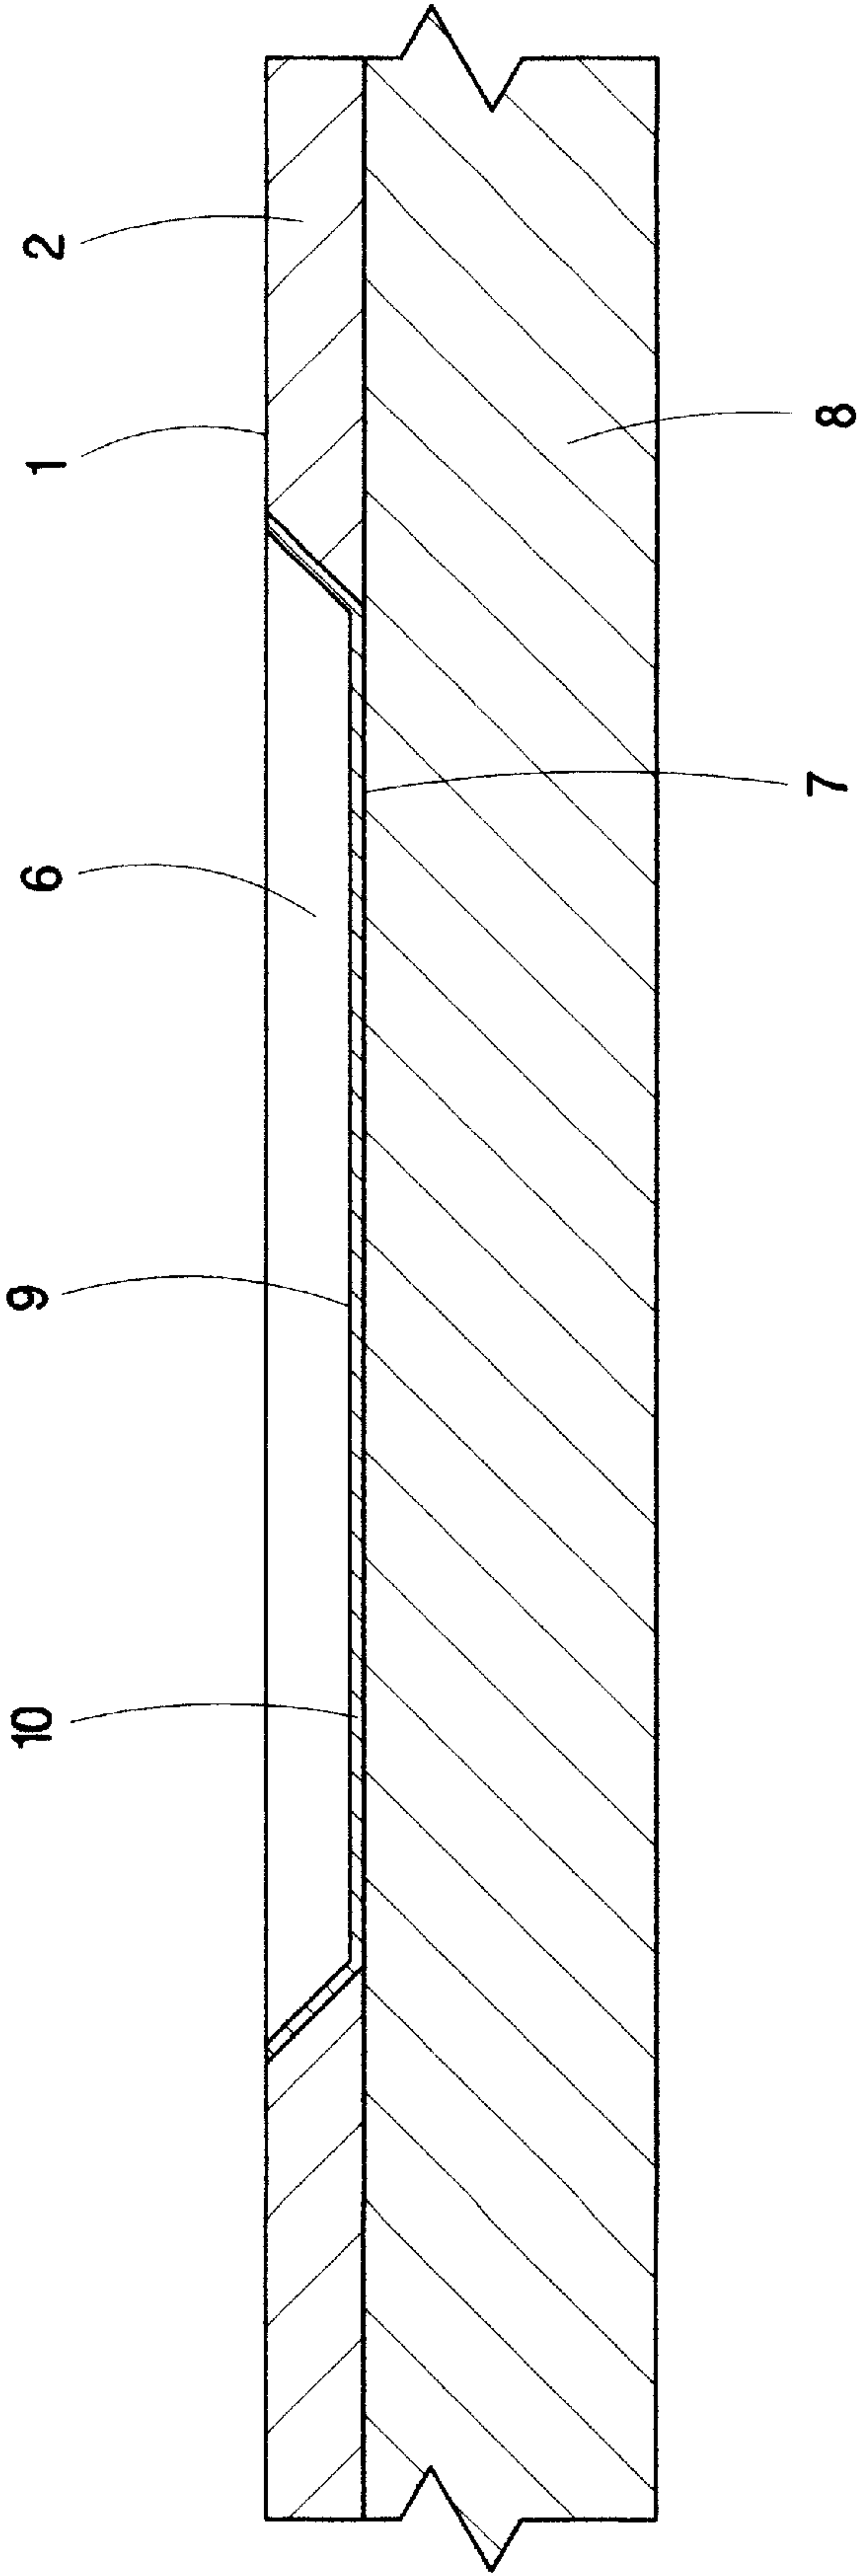
FIG. 3 is a sectional view of FIG. 2.

Referring to FIG. 3, after performance of said dust and debris removal step, the beveled side walls 6 and the upper surface 7 of the underlayment stratum 8 are painted with a layer of paint 10. Preferably, the paint 10 is light in color and is a water based paint. Suitable paints are water based white tempera paint and water based white latex paint. Where sufficient atmospheric moisture exist, light colored enamel paint may suitably be utilized. The light or white coloration of the paint is desirable so that the upper surface 9 of the paint 10 masks the typically dark coloration of the upper surface 7 of the underlayment stratum 8. Utilization of a water based paint is preferable in most circumstances because residual moisture within the paint serves as a catalyst for hardening of cyanoacrylate ester adhesives.

Referring simultaneously to FIGS. 3 and 4, prior to complete drying of the paint 10, a powdered filler material 12 is poured into the void. Preferably, the filler material 12 is non-reactive with cyanoacrylate ester adhesives and does not dissolve in such adhesives. A preferable filler material is powdered sodium bicarbonate. Suitable filler materials are powdered calcium carbonate, powdered silica, and powdered corn starch.

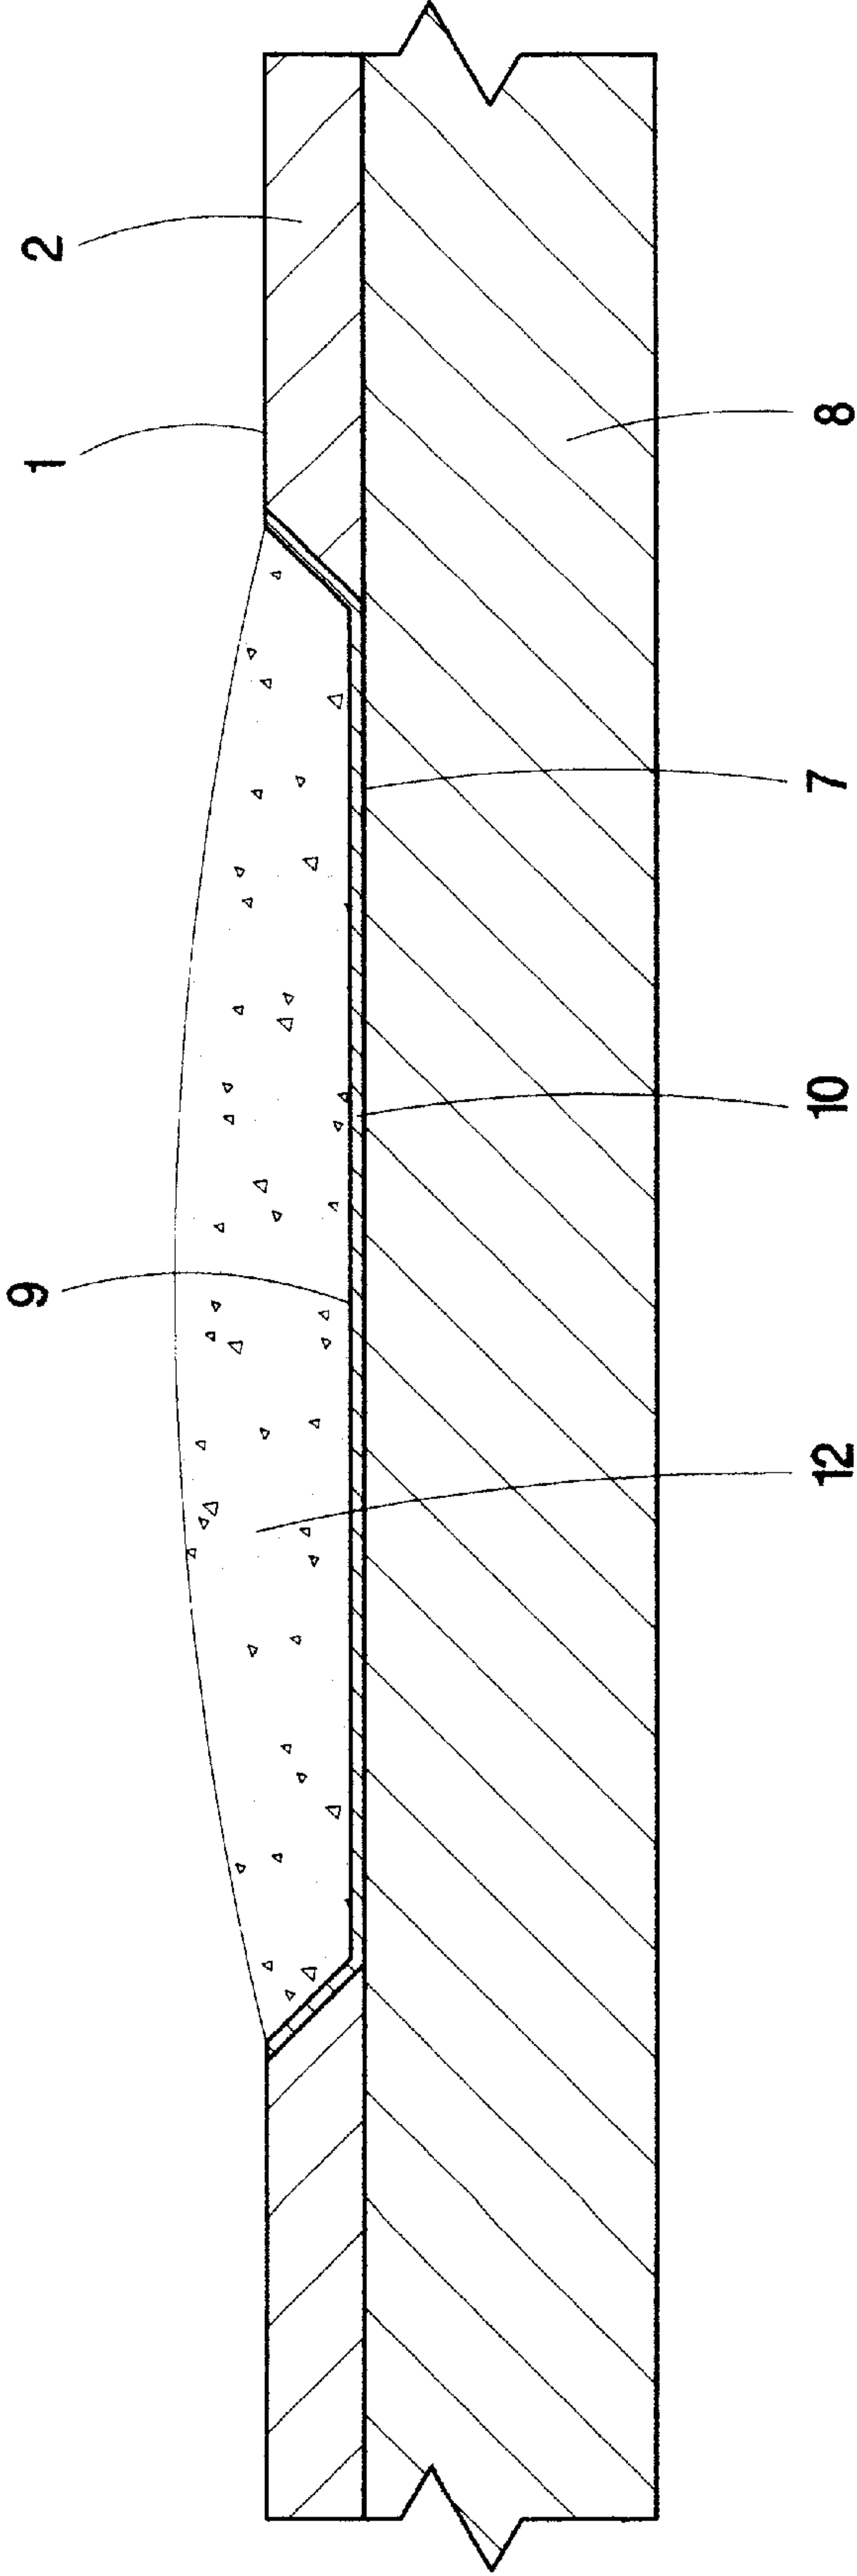
FIG. 4 redepicts FIG. 3 after the step of pouring filler material.

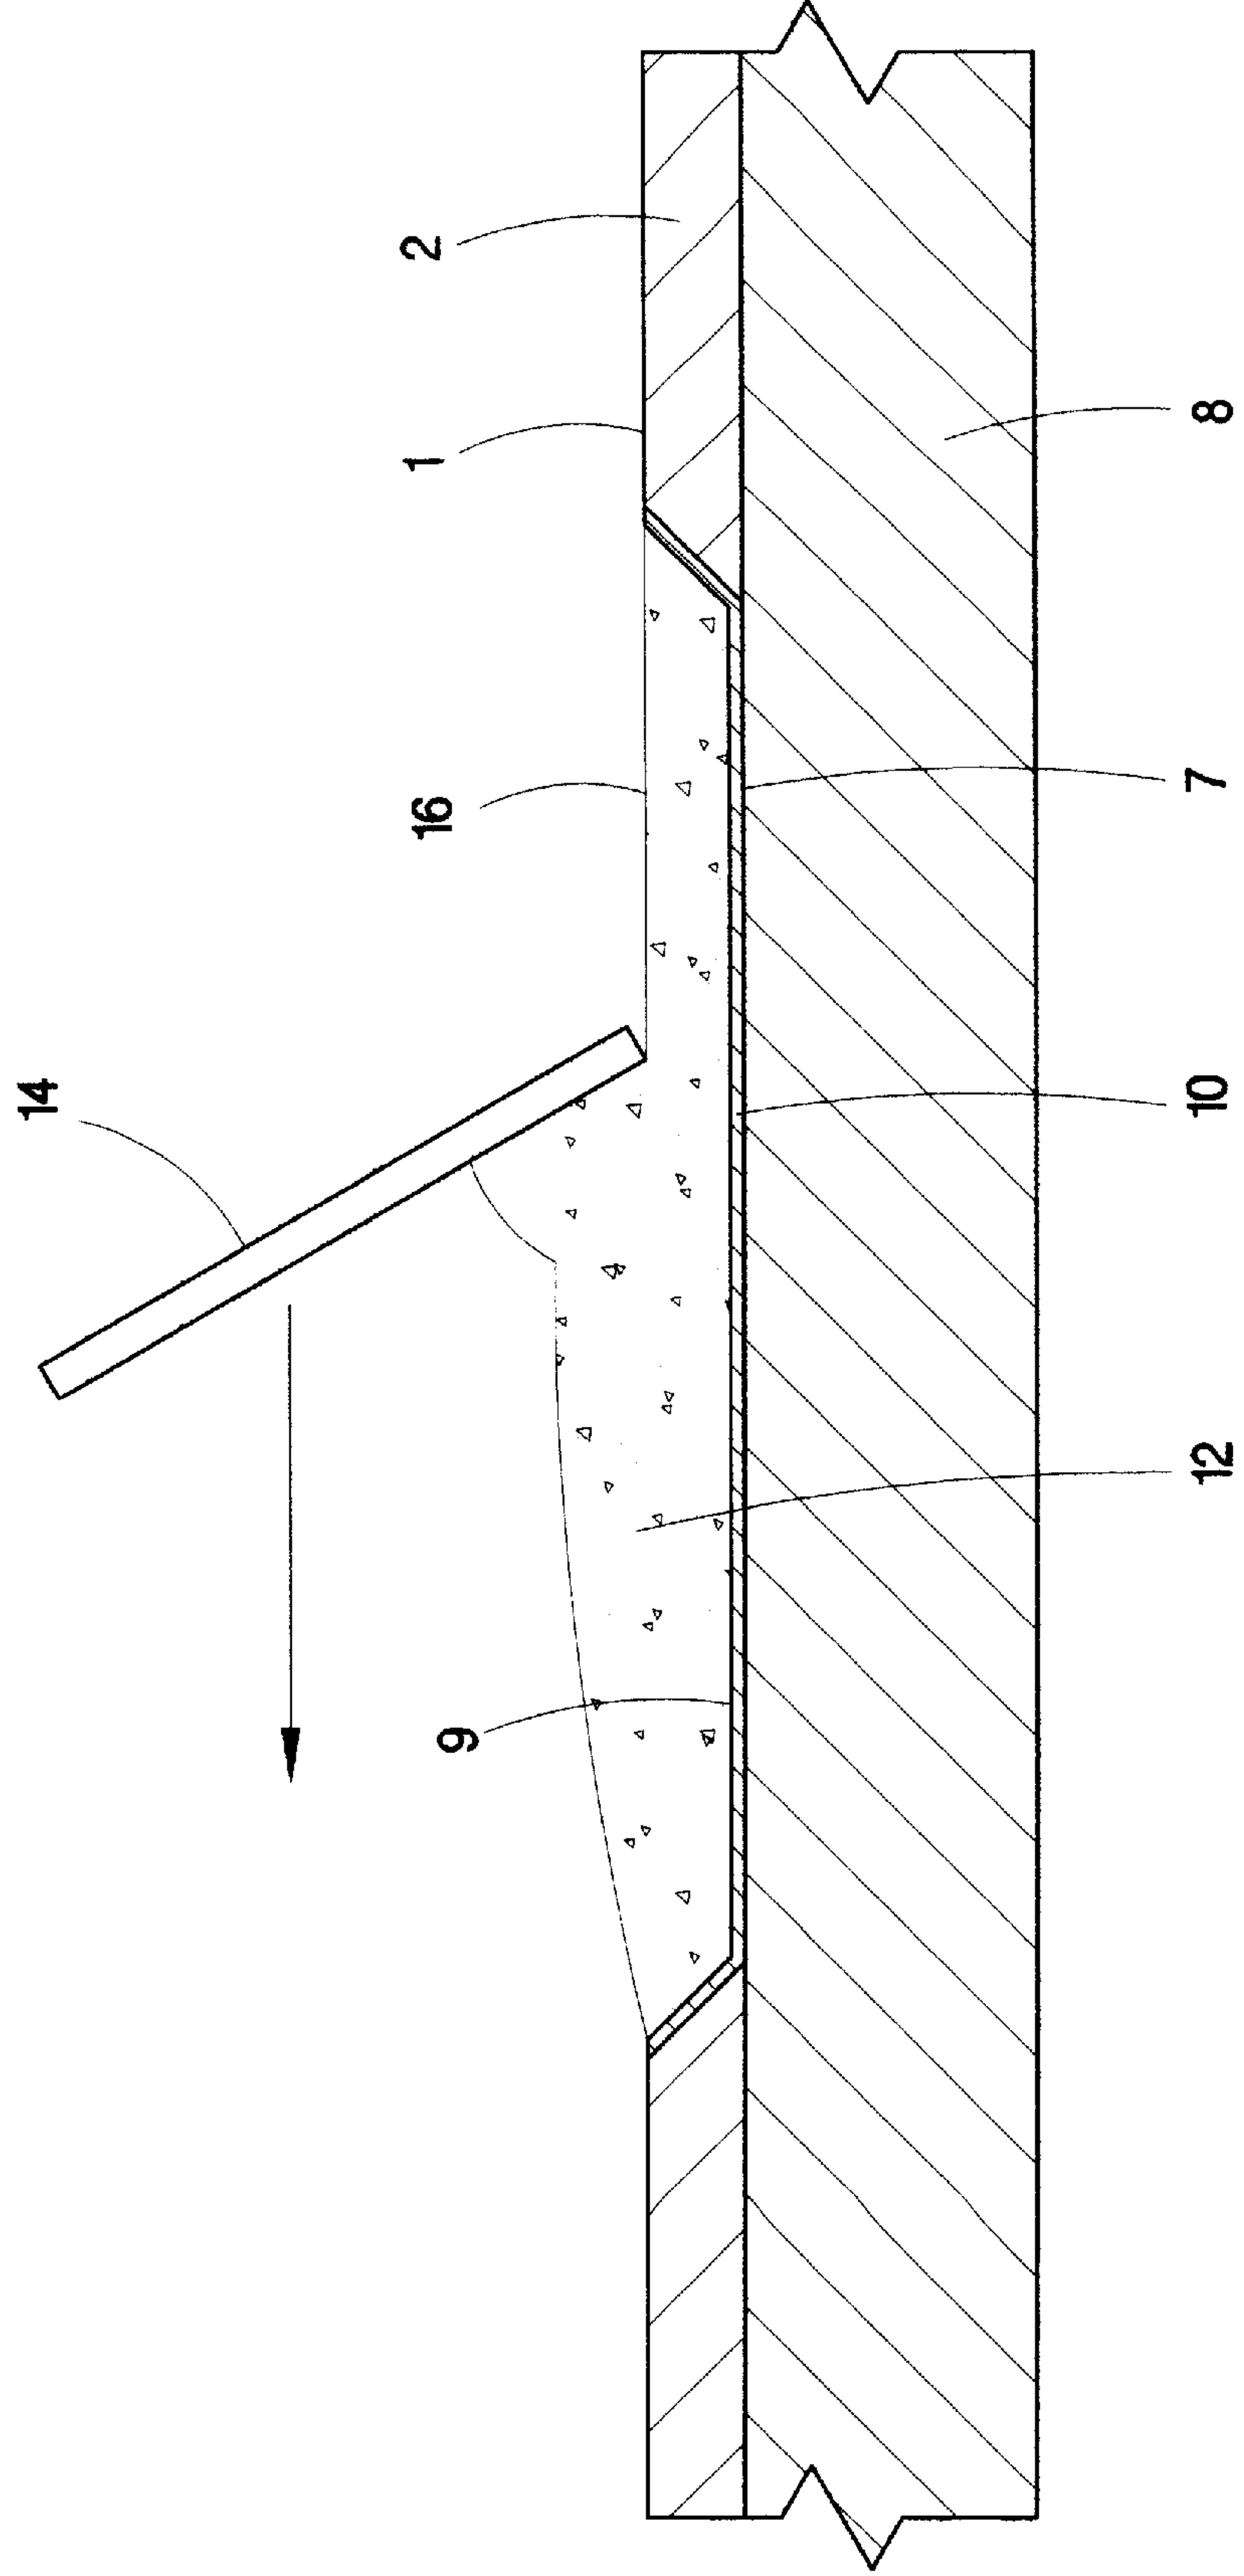
FIG. 5 redepicts FIG. 4 depicting a troweling step.

Referring to FIG. 5, after filler pouring step, a trowel 14 having a straight lower edge is utilized to trowel the filler material 12, forming an upper filler material surface 16 which is co-extensive with the upper surface 1 of the vinyl or linoleum stratum 2. Said troweling step is preferably performed prior to complete drying of the paint 10.

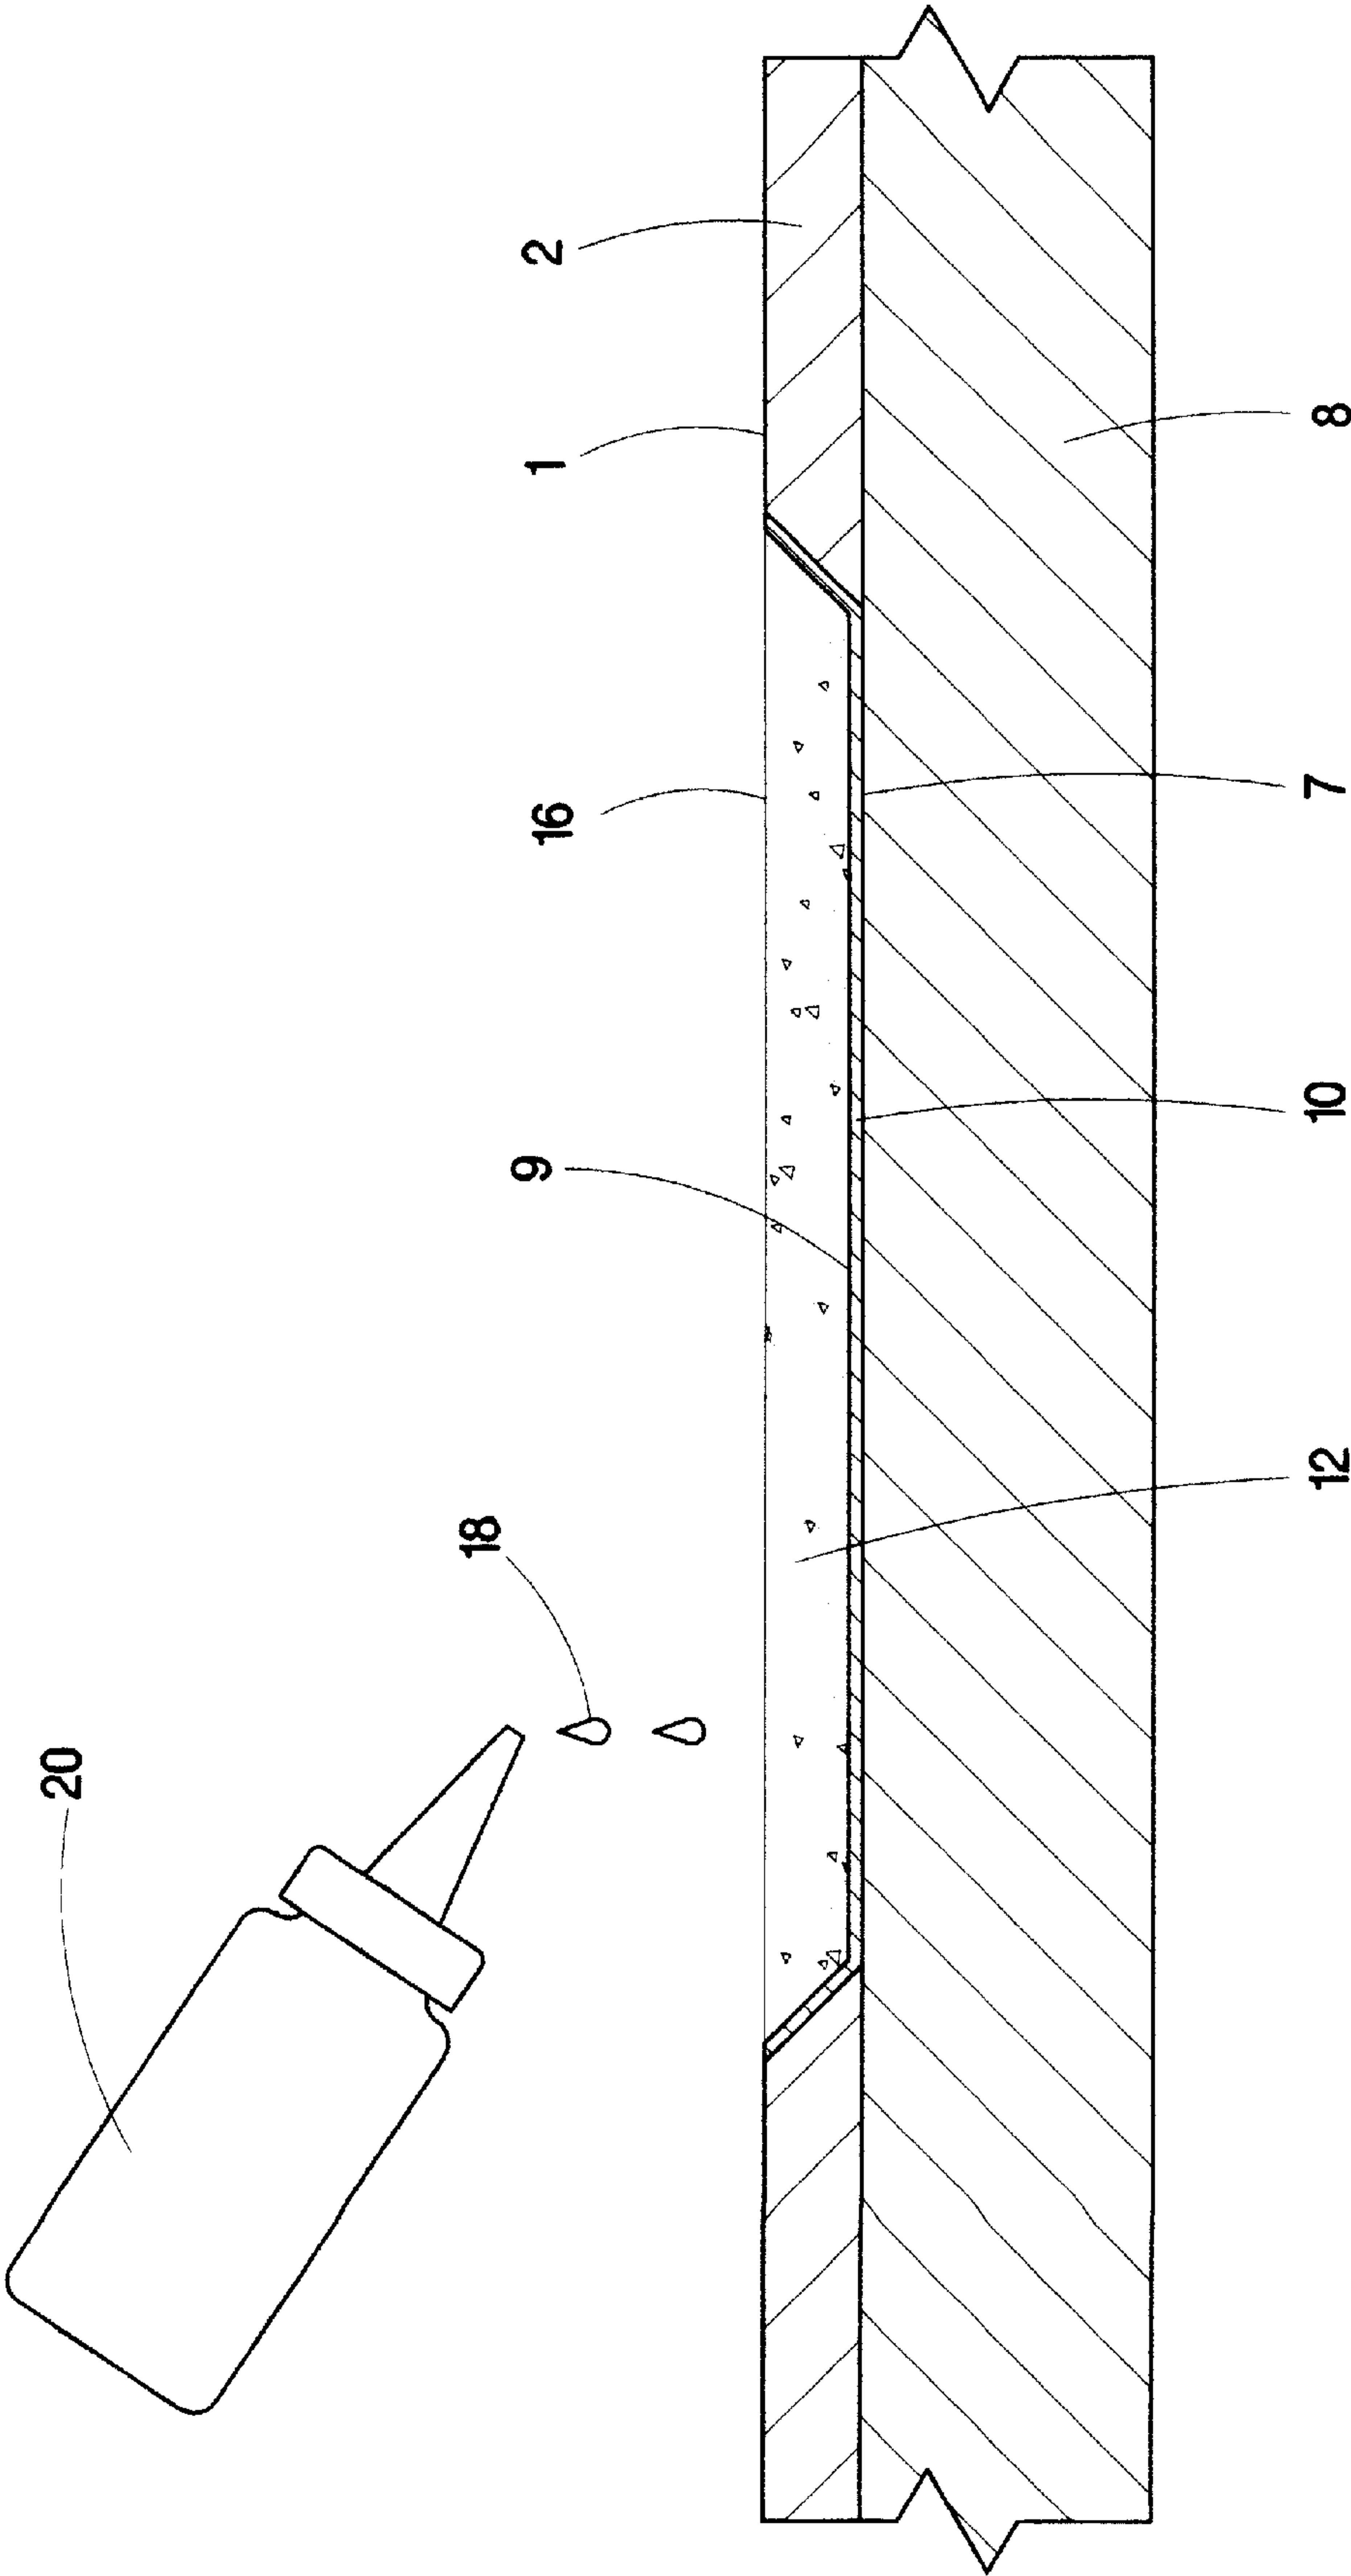
FIG. 6 redepicts FIG. 5 after completion of the troweling step and upon commencement of the adhesive introduction step.

Referring to FIG. 6, a cyanoacrylate ester adhesive 18, preferably methyl or ethyl based, is preferably dispensed from a squeeze bottle or tube 20 into the filler material 12, the dispensing of such adhesive continuing until the filler material 12 is saturated with such adhesive. Preferably, the adhesive dispensing step is performed prior to complete drying of the paint 10. Also preferably, the cyanoacrylate ester adhesive has a kinematic viscosity between 0.5 centistokes and 250 centistokes. Where viscosity of the adhesive exceeds 250 centistokes, percolation of the adhesive through the powder filler material ceases to occur, preventing saturation of the filler material.

Upon dispensing of the cyanoacrylate ester adhesive, water moisture from the paint 10 begins to react with the adhesive, hardening the adhesive. Typically, complete hardening occurs within ten to fifteen minutes. After such hardening occurs, it is preferable that the upper surface 16 of the filler material 12 be sanded with a fine grade of sandpaper to a smooth finish.
