US006090437A

[11] **Patent Number:** **6,090,437**
[45] **Date of Patent:** **Jul. 18, 2000**

[54] **FLOOR REPAIR METHOD**

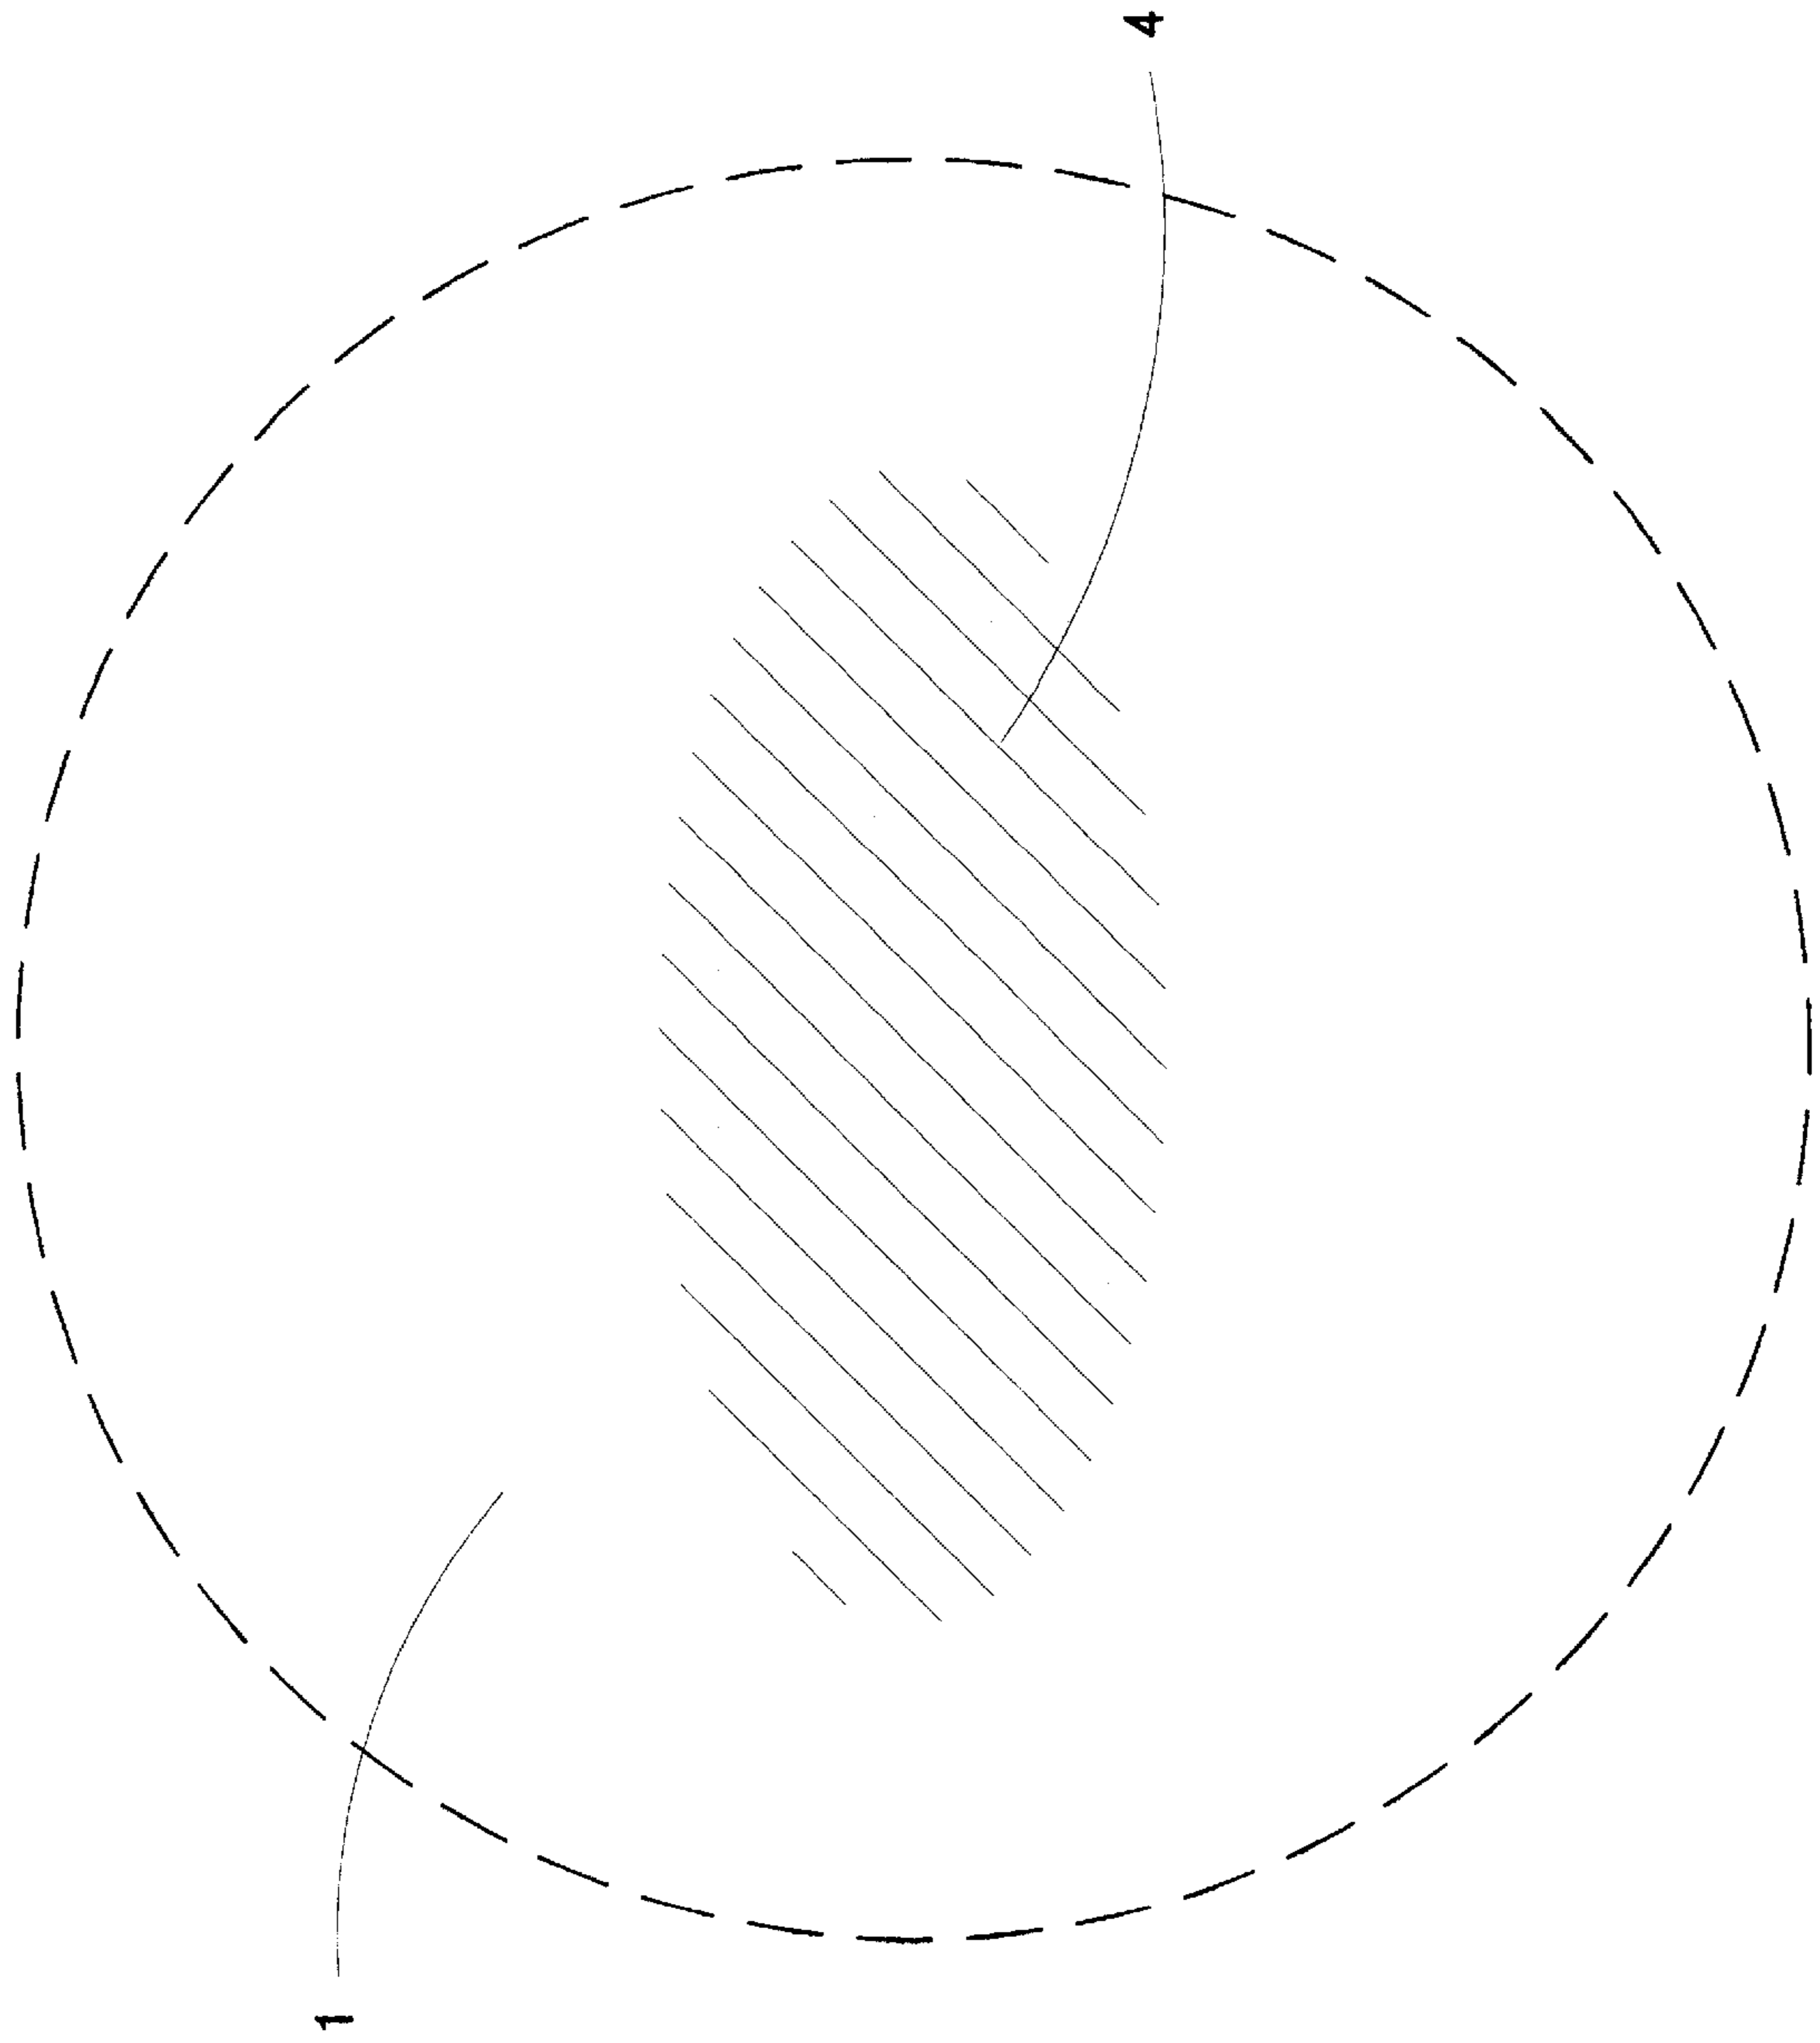
FIG. 1 depicts a vinyl or linoleum floor area having a cigarette burn.

Referring simultaneously to FIGS. 1 and 3, Reference Numeral 1 designates an upper surface of a section of floor covering stratum 2, typically comprising vinyl or linoleum. Typically, such a vinyl or linoleum floor stratum 2 is adhesively applied to an underlayment 8 which serves as a base stratum. Referring to FIG. 1, a cigarette burn 4 represents one of several potential types of damage to the surface 1 of the, referring to FIG. 3, vinyl or linoleum cover stratum 2.

Referring simultaneously to FIGS. 1, 2, and 3, a linoleum knife or other utility knife is preferably utilized to cut away the damaged cigarette burn area 4. Preferably, the utility knife is tilted at a 45 degree angle, leaving an inwardly beveled wall 6. Such inwardly beveled wall 6 provides additional surface contact area for enhanced adhesion of adhesive saturated filler material.

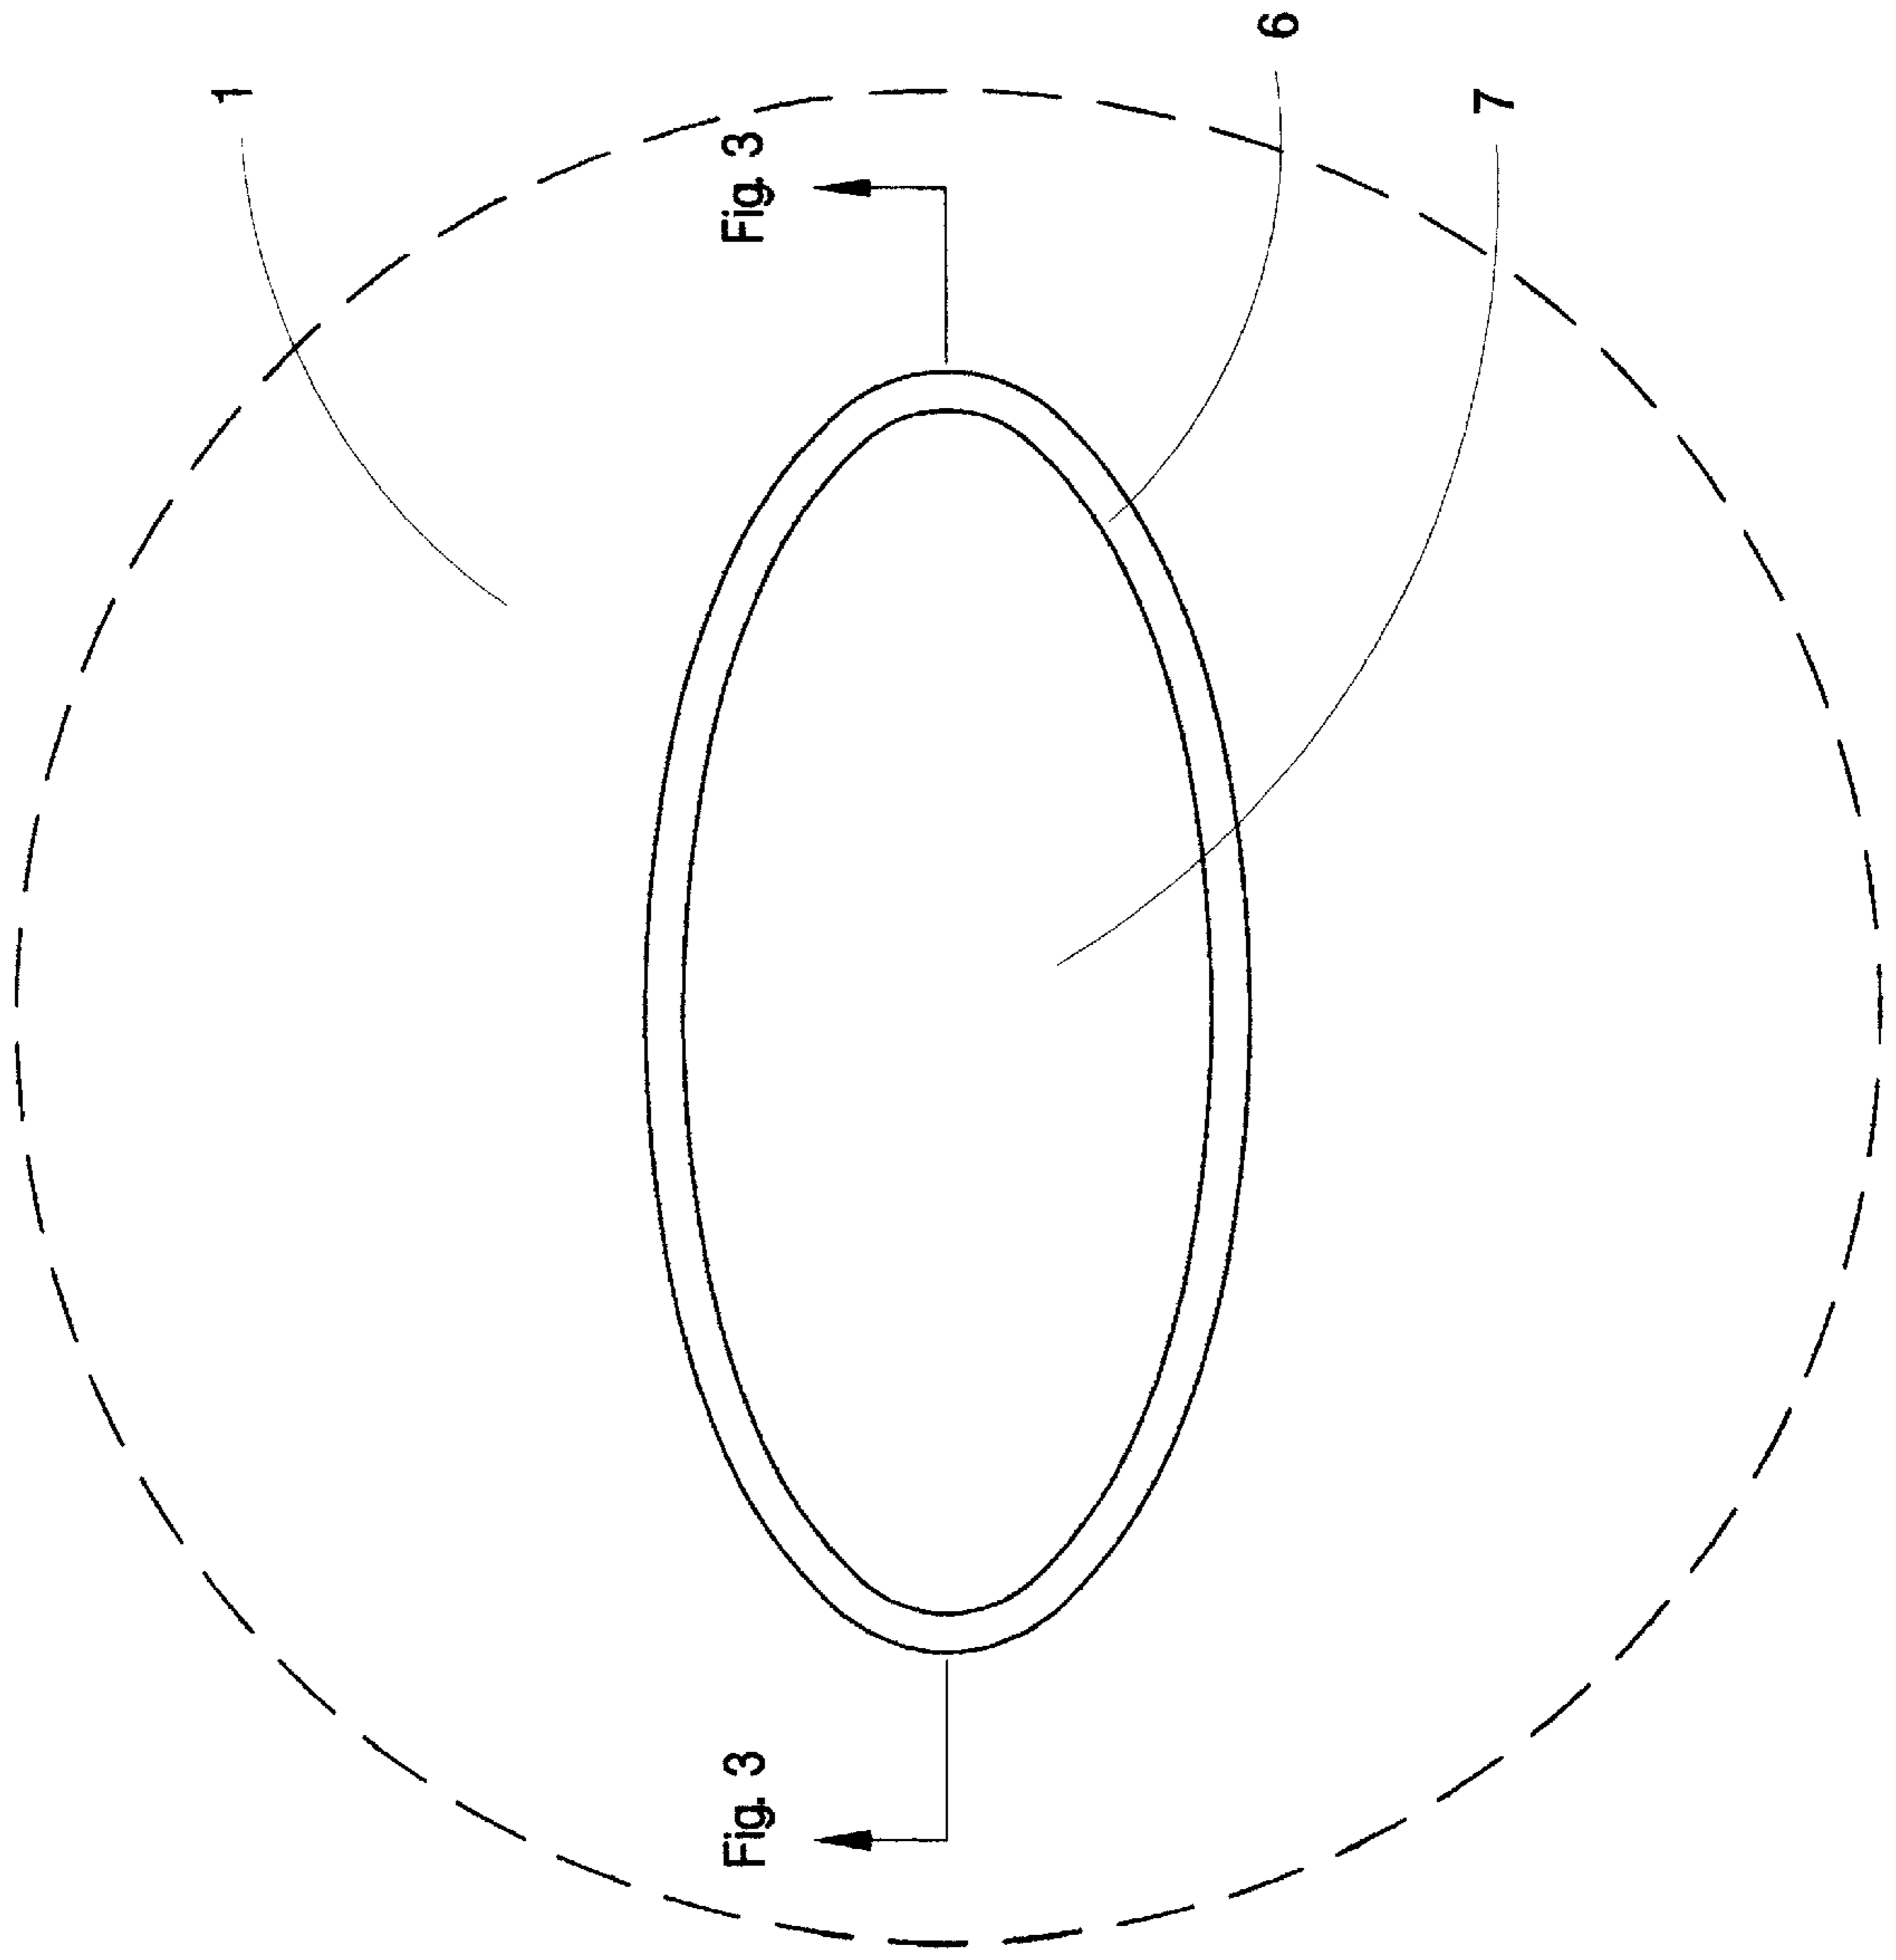
FIG. 2 depicts the vinyl or linoleum floor area depicted in FIG. 1 after removal of the burned area.

Referring simultaneously to FIGS. 2 and 3, upon completion of the trimming or cutting step, as the case may be, the upper surface 7 of the underlayment stratum 8 is exposed, such upper surface 7 serving as a floor spanning across the lower end of the void or depression formed in said trimming or cutting step. Typically, the upper surface 7 of the underlayment stratum 8 is dark in color; while typically, the upper surface 1 of the vinyl or linoleum stratum 2 has a contrasting

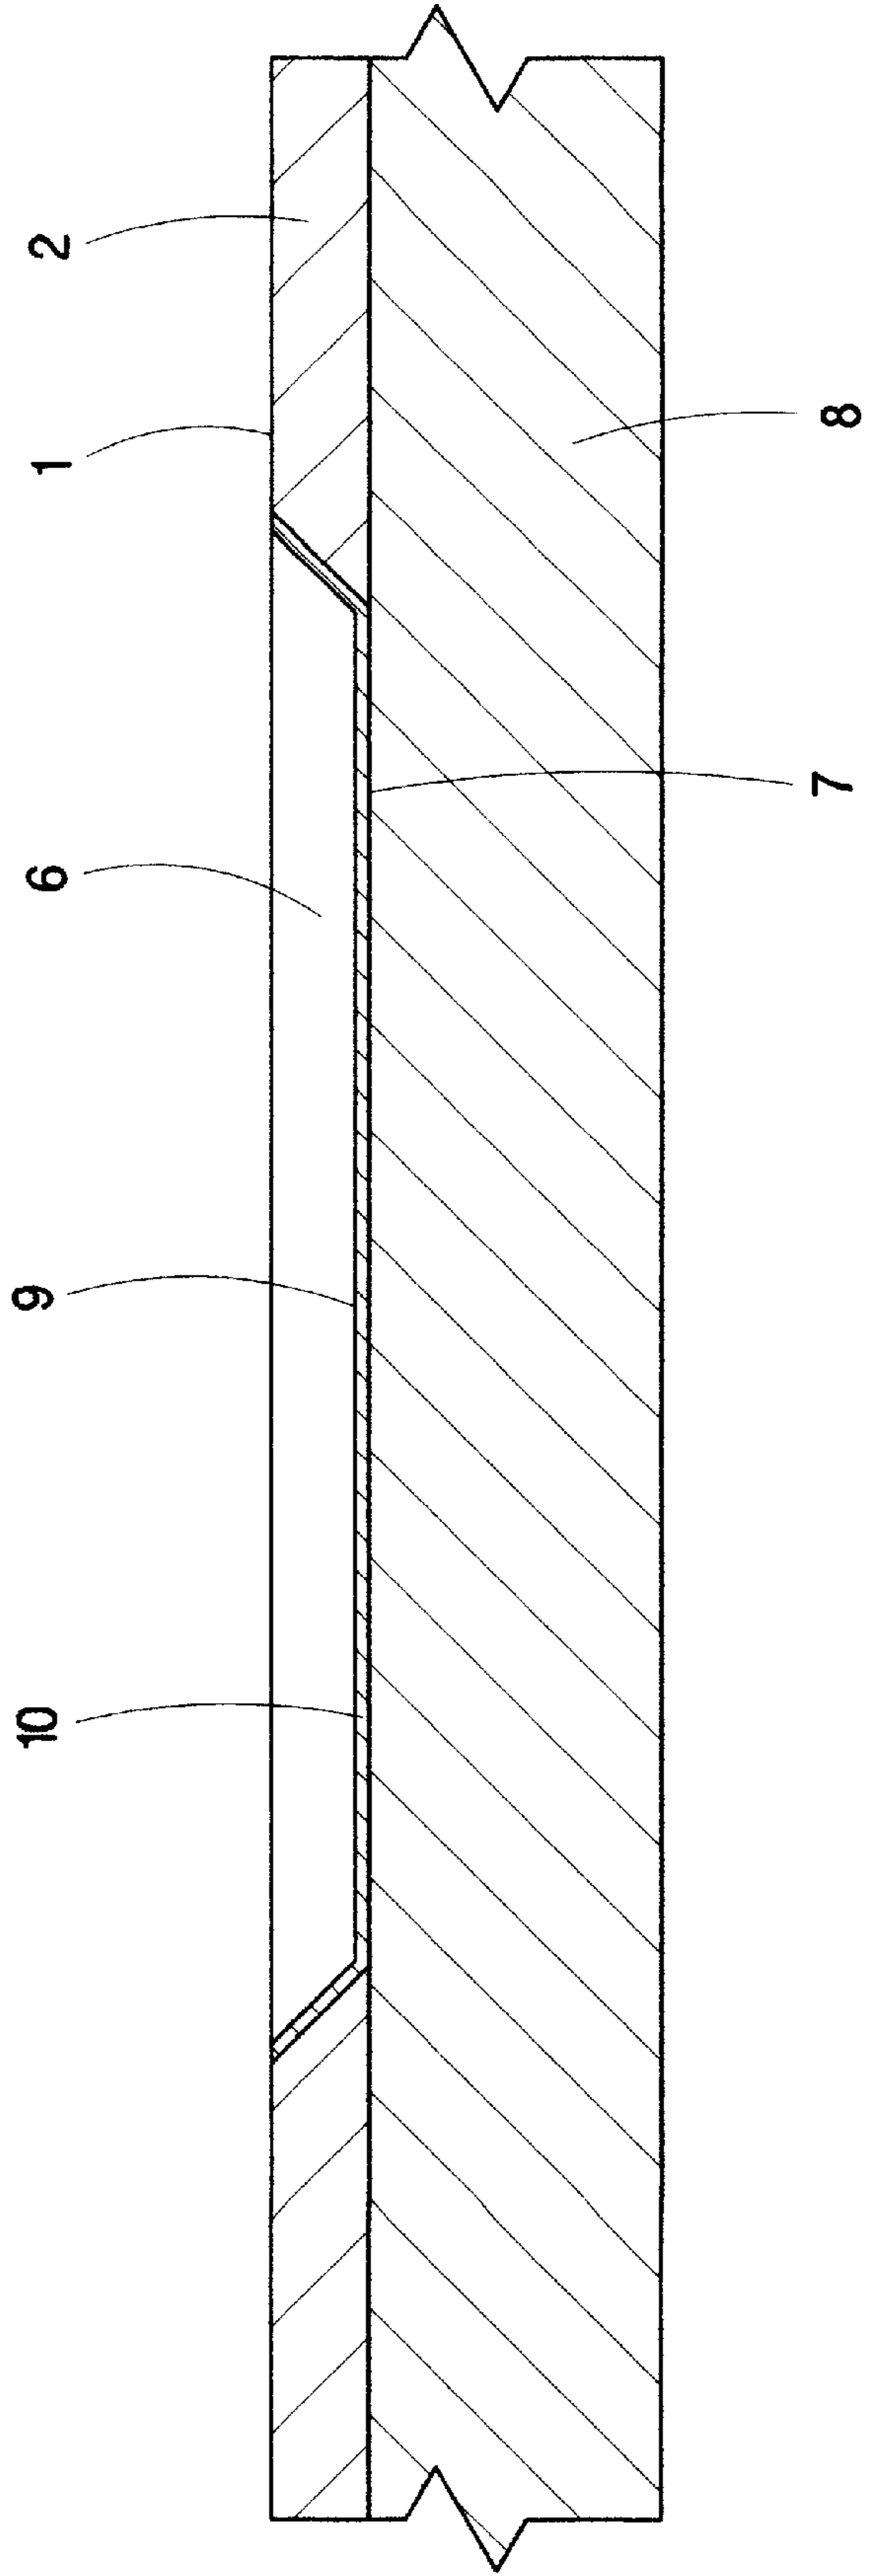
FIG. 3 is a sectional view of FIG. 2.

Referring to FIG. 3, after performance of said dust and debris removal step, the beveled side walls 6 and the upper surface 7 of the underlayment stratum 8 are painted with a layer of paint 10. Preferably, the paint 10 is light in color and is a water based paint. Suitable paints are water based white tempera paint and water based white latex paint. Where sufficient atmospheric moisture exist, light colored enamel paint may suitably be utilized. The light or white coloration of the paint is desirable so that the upper surface 9 of the paint 10 masks the typically dark coloration of the upper surface 7 of the underlayment stratum 8. Utilization of a water based paint is preferable in most circumstances because residual moisture within the paint serves as a catalyst for hardening of cyanoacrylate ester adhesives.

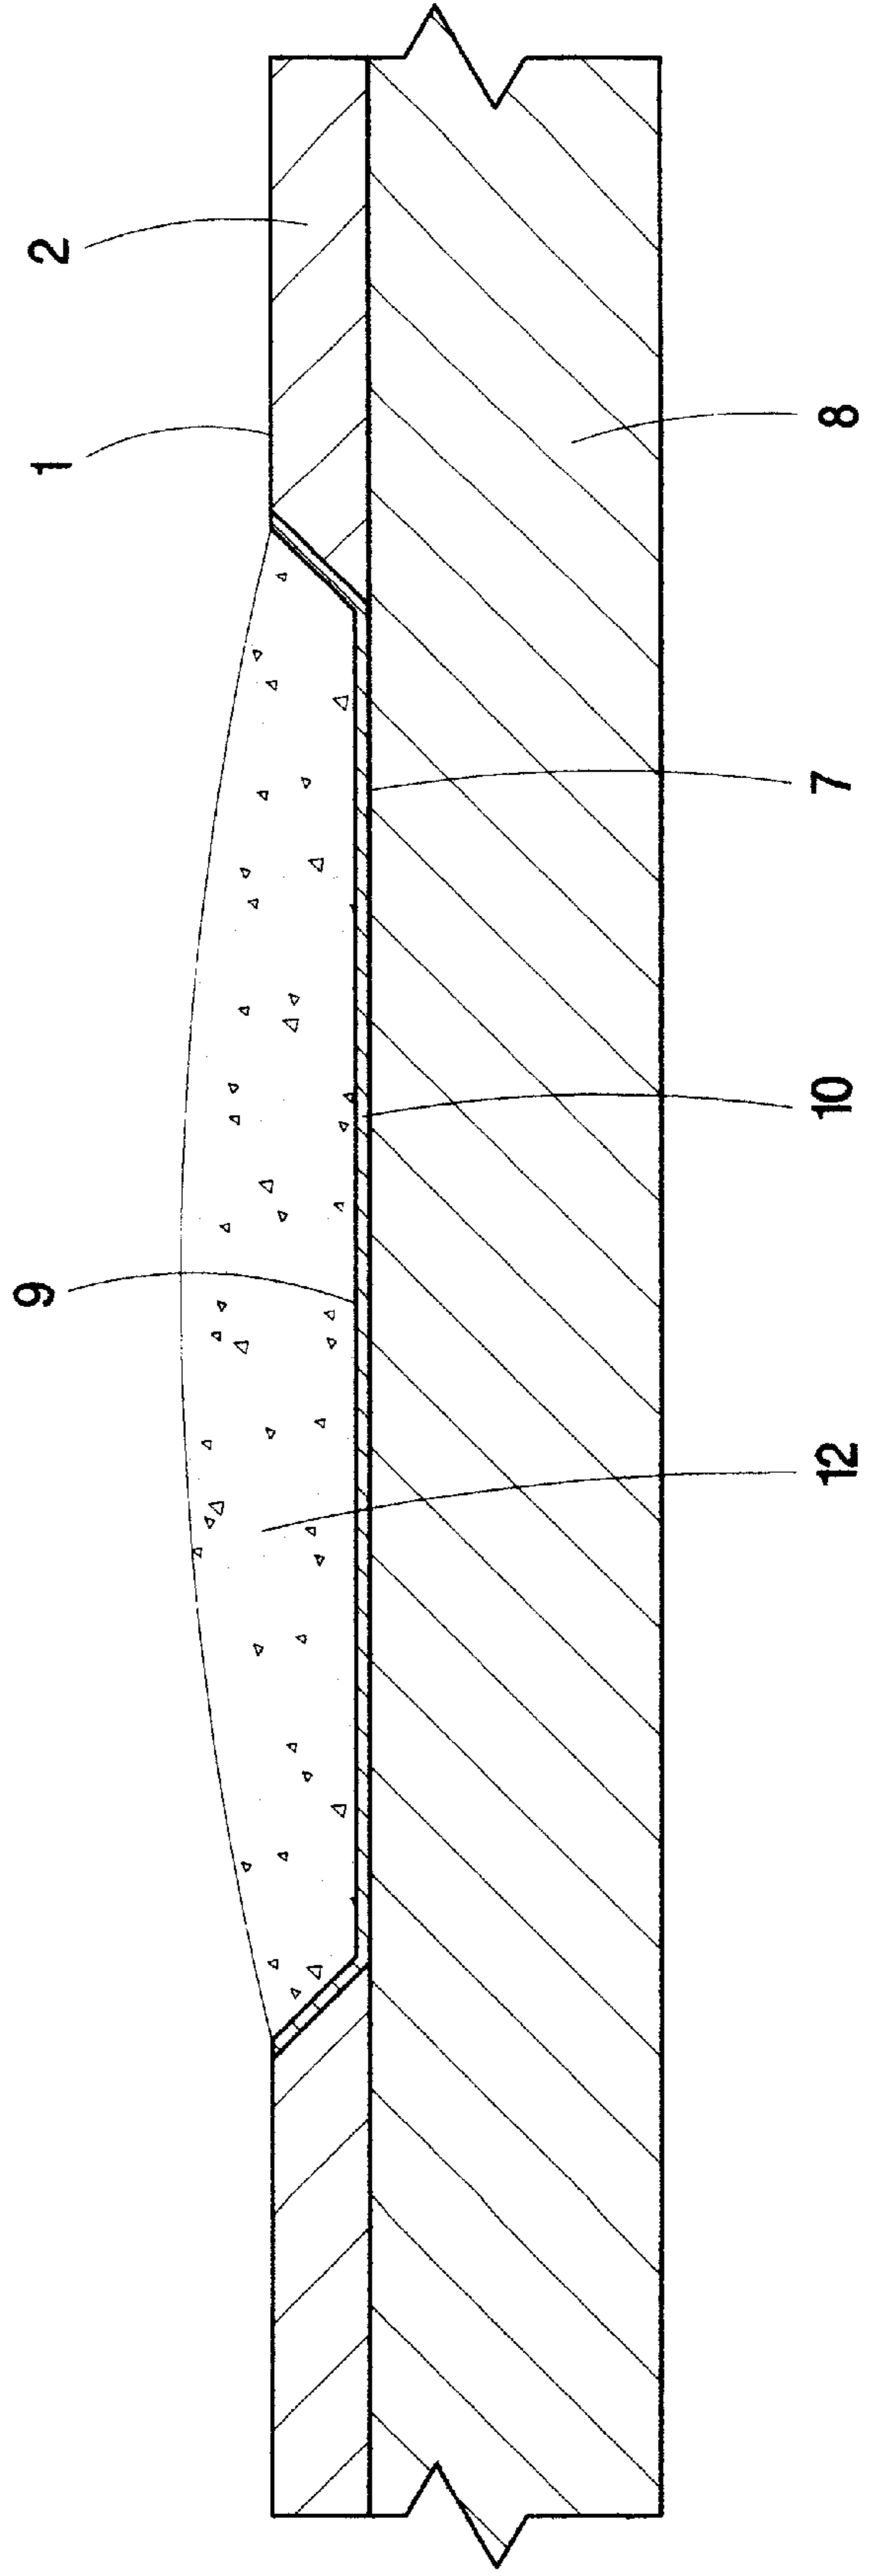
FIG. 4 redepicts FIG. 3 after the step of pouring filler material.

Referring simultaneously to FIGS. 3 and 4, prior to complete drying of the paint 10, a powdered filler material 12 is poured into the void. Preferably, the filler material 12 is non-reactive with cyanoacrylate ester adhesives and does not dissolve in such adhesives. A preferable filler material is powdered sodium bicarbonate. Suitable filler materials are powdered calcium carbonate, powdered silica, and powdered corn starch.

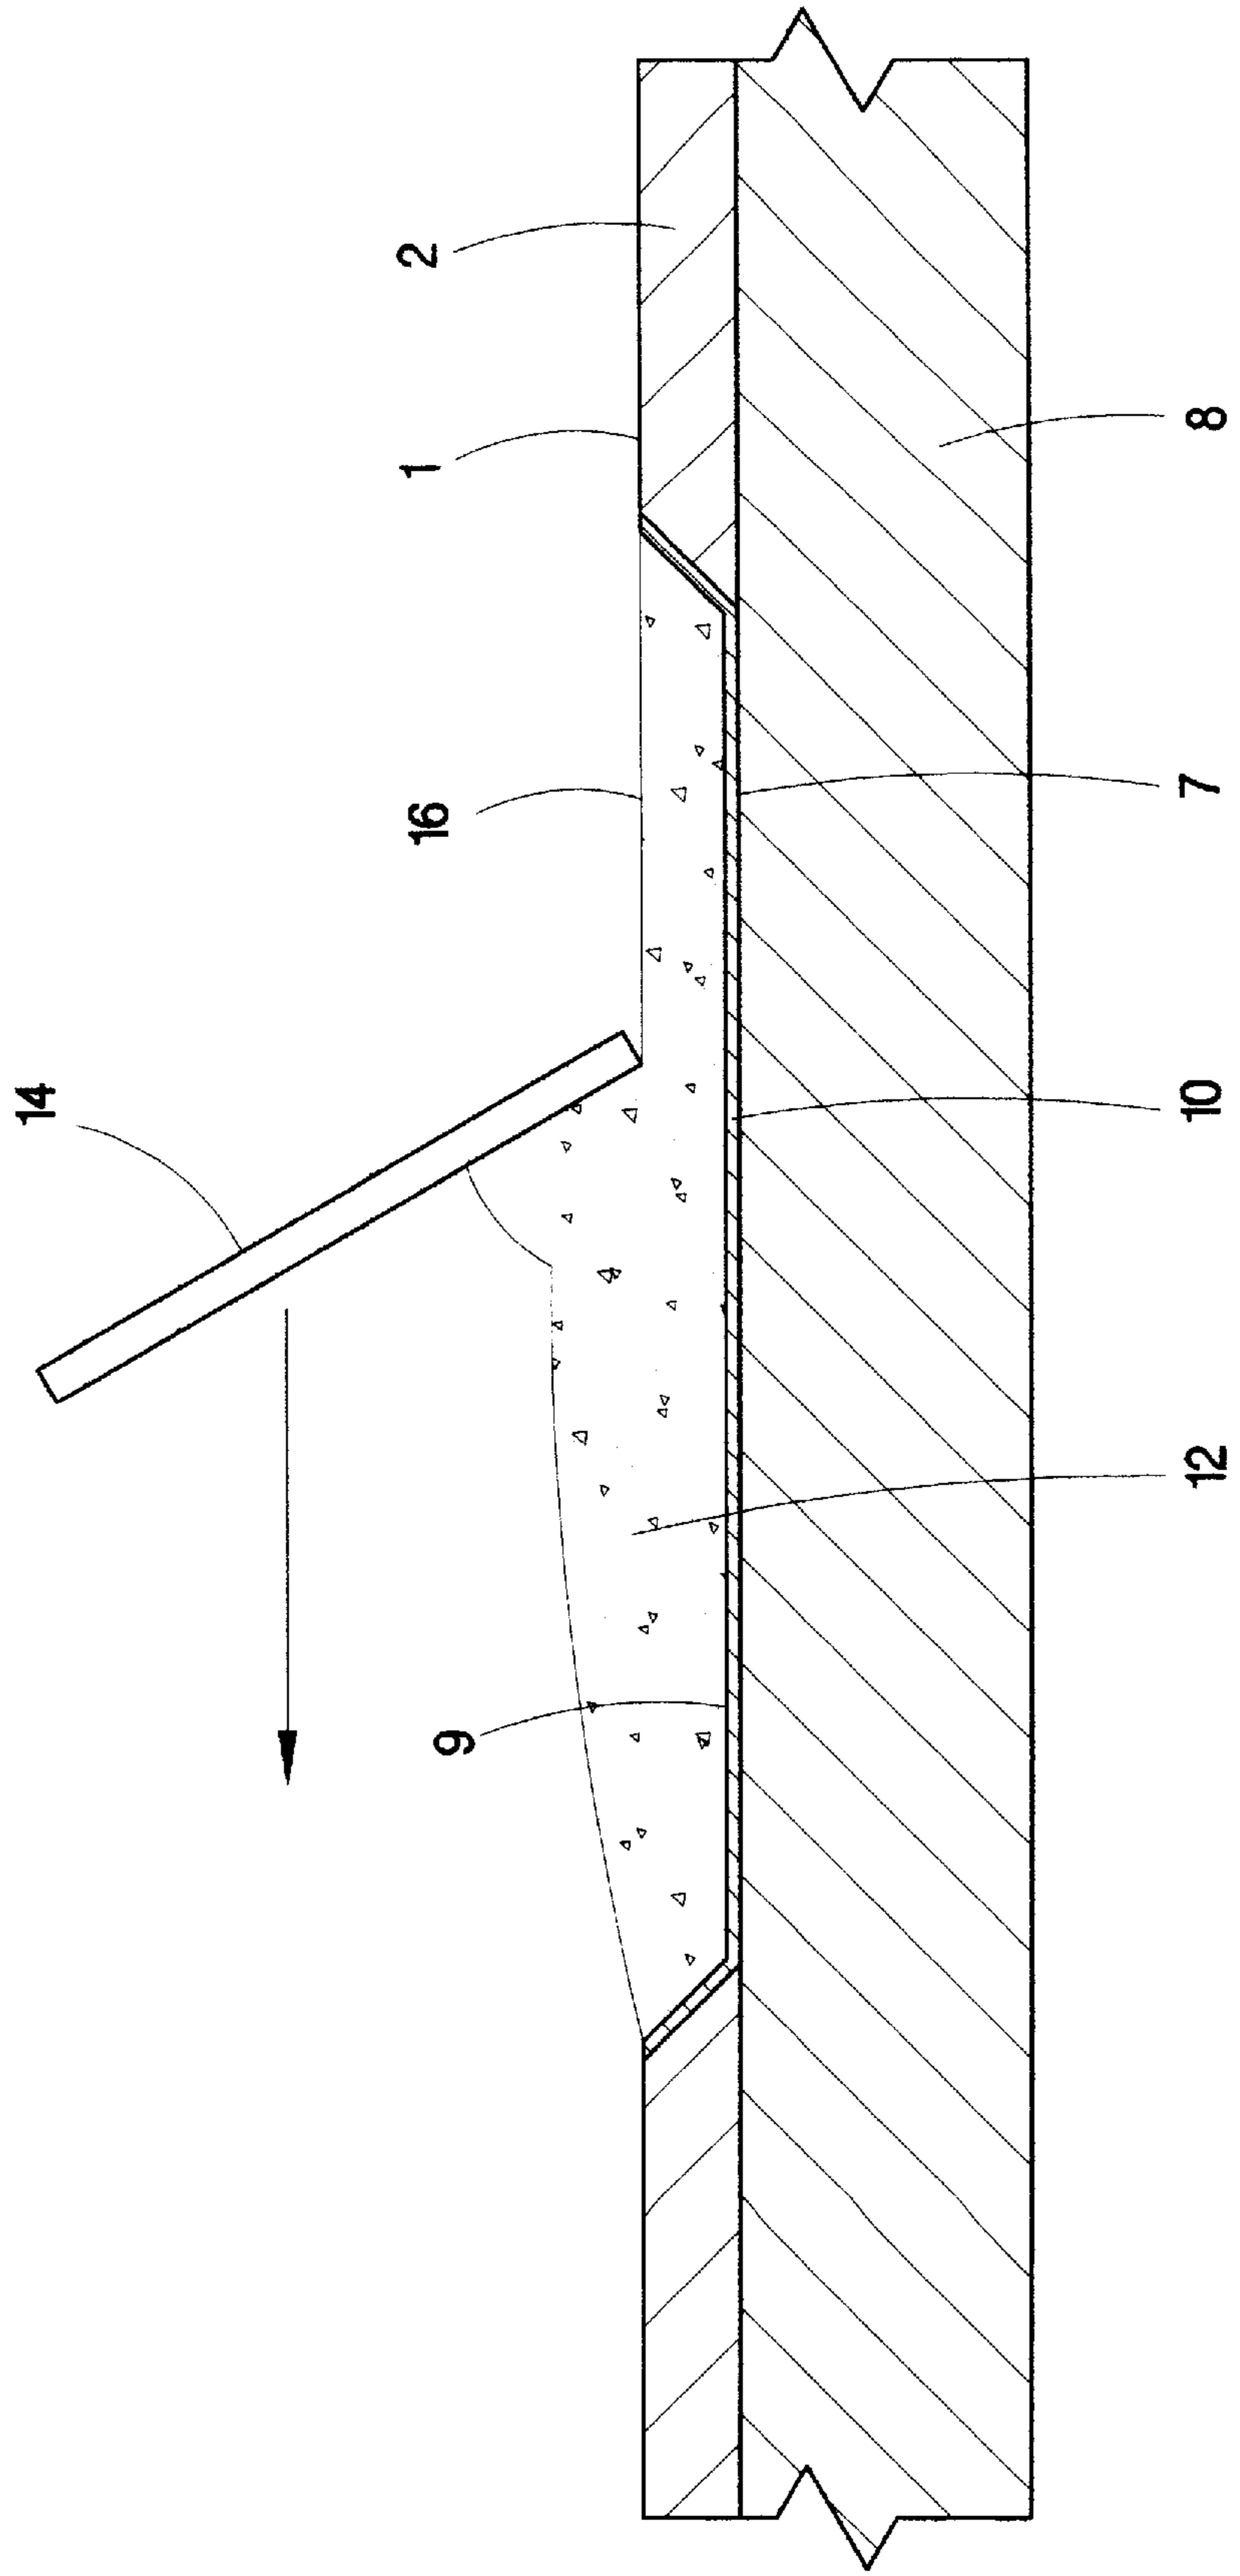
FIG. 5 redepicts FIG. 4 depicting a troweling step.

Referring to FIG. 5, after filler pouring step, a trowel 14 having a straight lower edge is utilized to trowel the filler material 12, forming an upper filler material surface 16 which is co-extensive with the upper surface 1 of the vinyl or linoleum stratum 2. Said troweling step is preferably performed prior to complete drying of the paint 10.

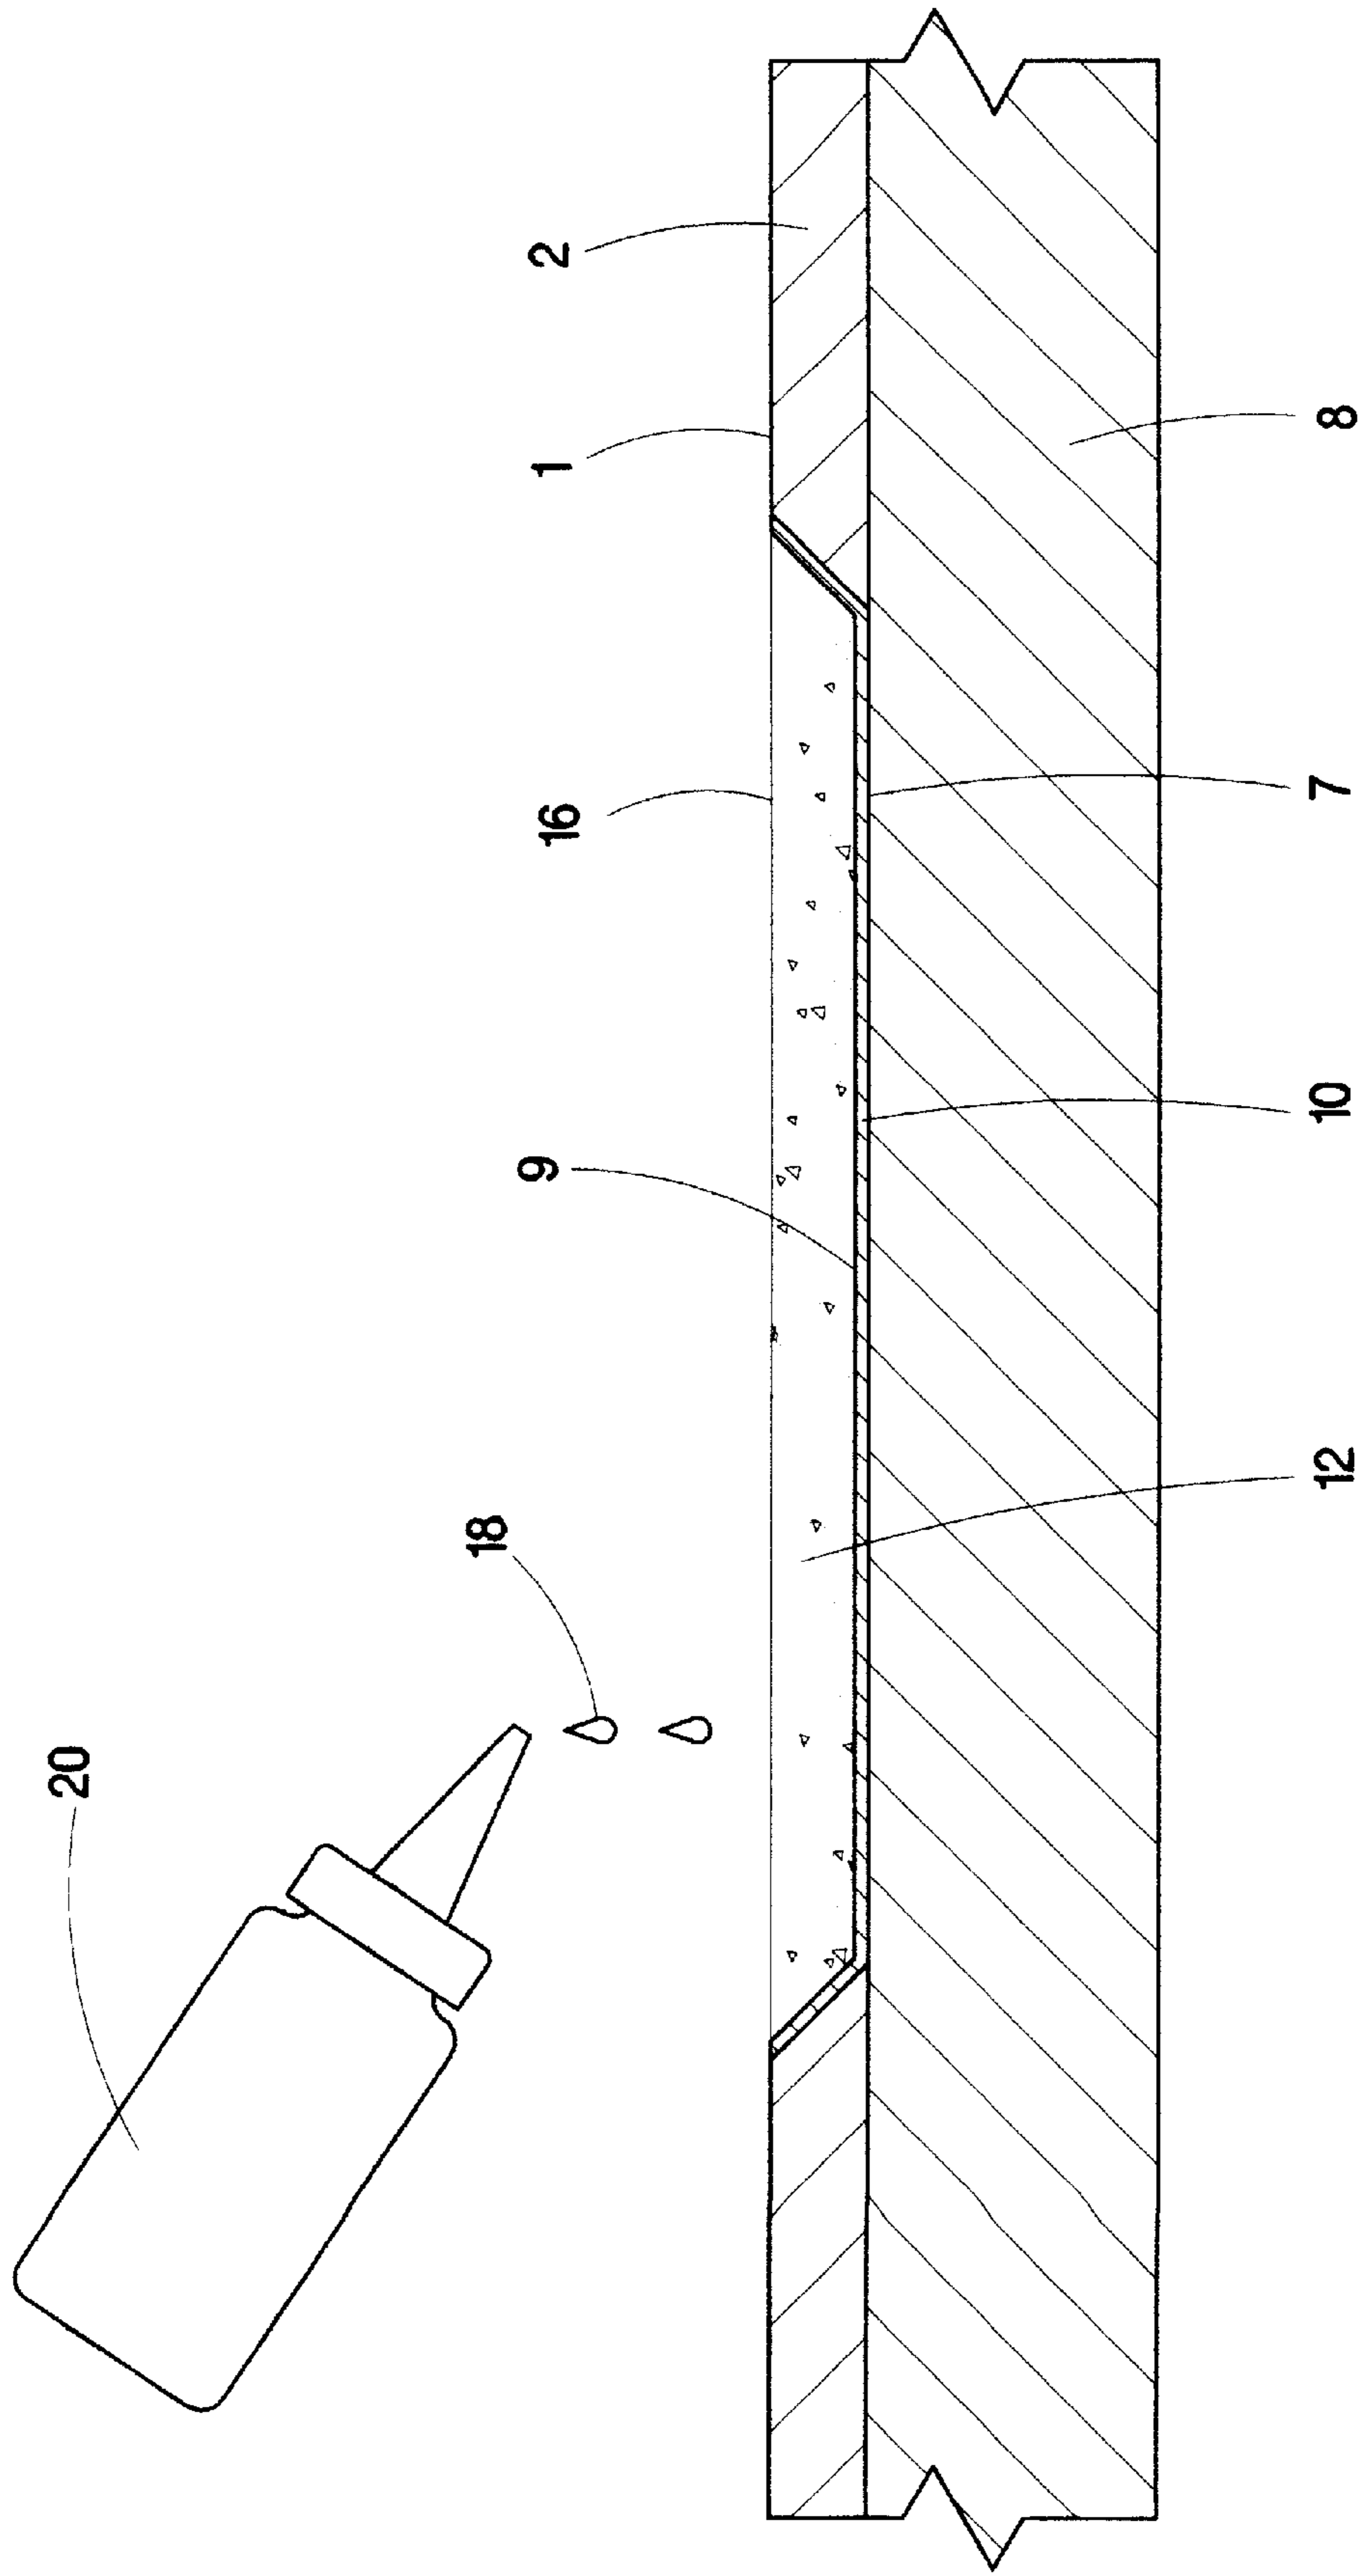
FIG. 6 redepicts FIG. 5 after completion of the troweling step and upon commencement of the adhesive introduction step.

Referring to FIG. 6, a cyanoacrylate ester adhesive 18, preferably methyl or ethyl based, is preferably dispensed from a squeeze bottle or tube 20 into the filler material 12, the dispensing of such adhesive continuing until the filler material 12 is saturated with such adhesive. Preferably, the adhesive dispensing step is performed prior to complete drying of the paint 10. Also preferably, the cyanoacrylate ester adhesive has a kinematic viscosity between 0.5 centistokes and 250 centistokes. Where viscosity of the adhesive exceeds 250 centistokes, percolation of the adhesive through the powder filler material ceases to occur, preventing saturation of the filler material.
