[11] Patent Number: **6,116,776**  
[45] Date of Patent: **Sep. 12, 2000**

[54] **METHOD AND APPARATUS FOR  
DETECTING IRREGULARITIES ON OR IN  
THE WALL OF A VESSEL**

[75] Inventor: **Michael Keith Bowling**, Blackborough  
Cullompton, United Kingdom

[73] Assignee: **Somerset Technical Laboratories Ltd.**,  
Somerset, United Kingdom

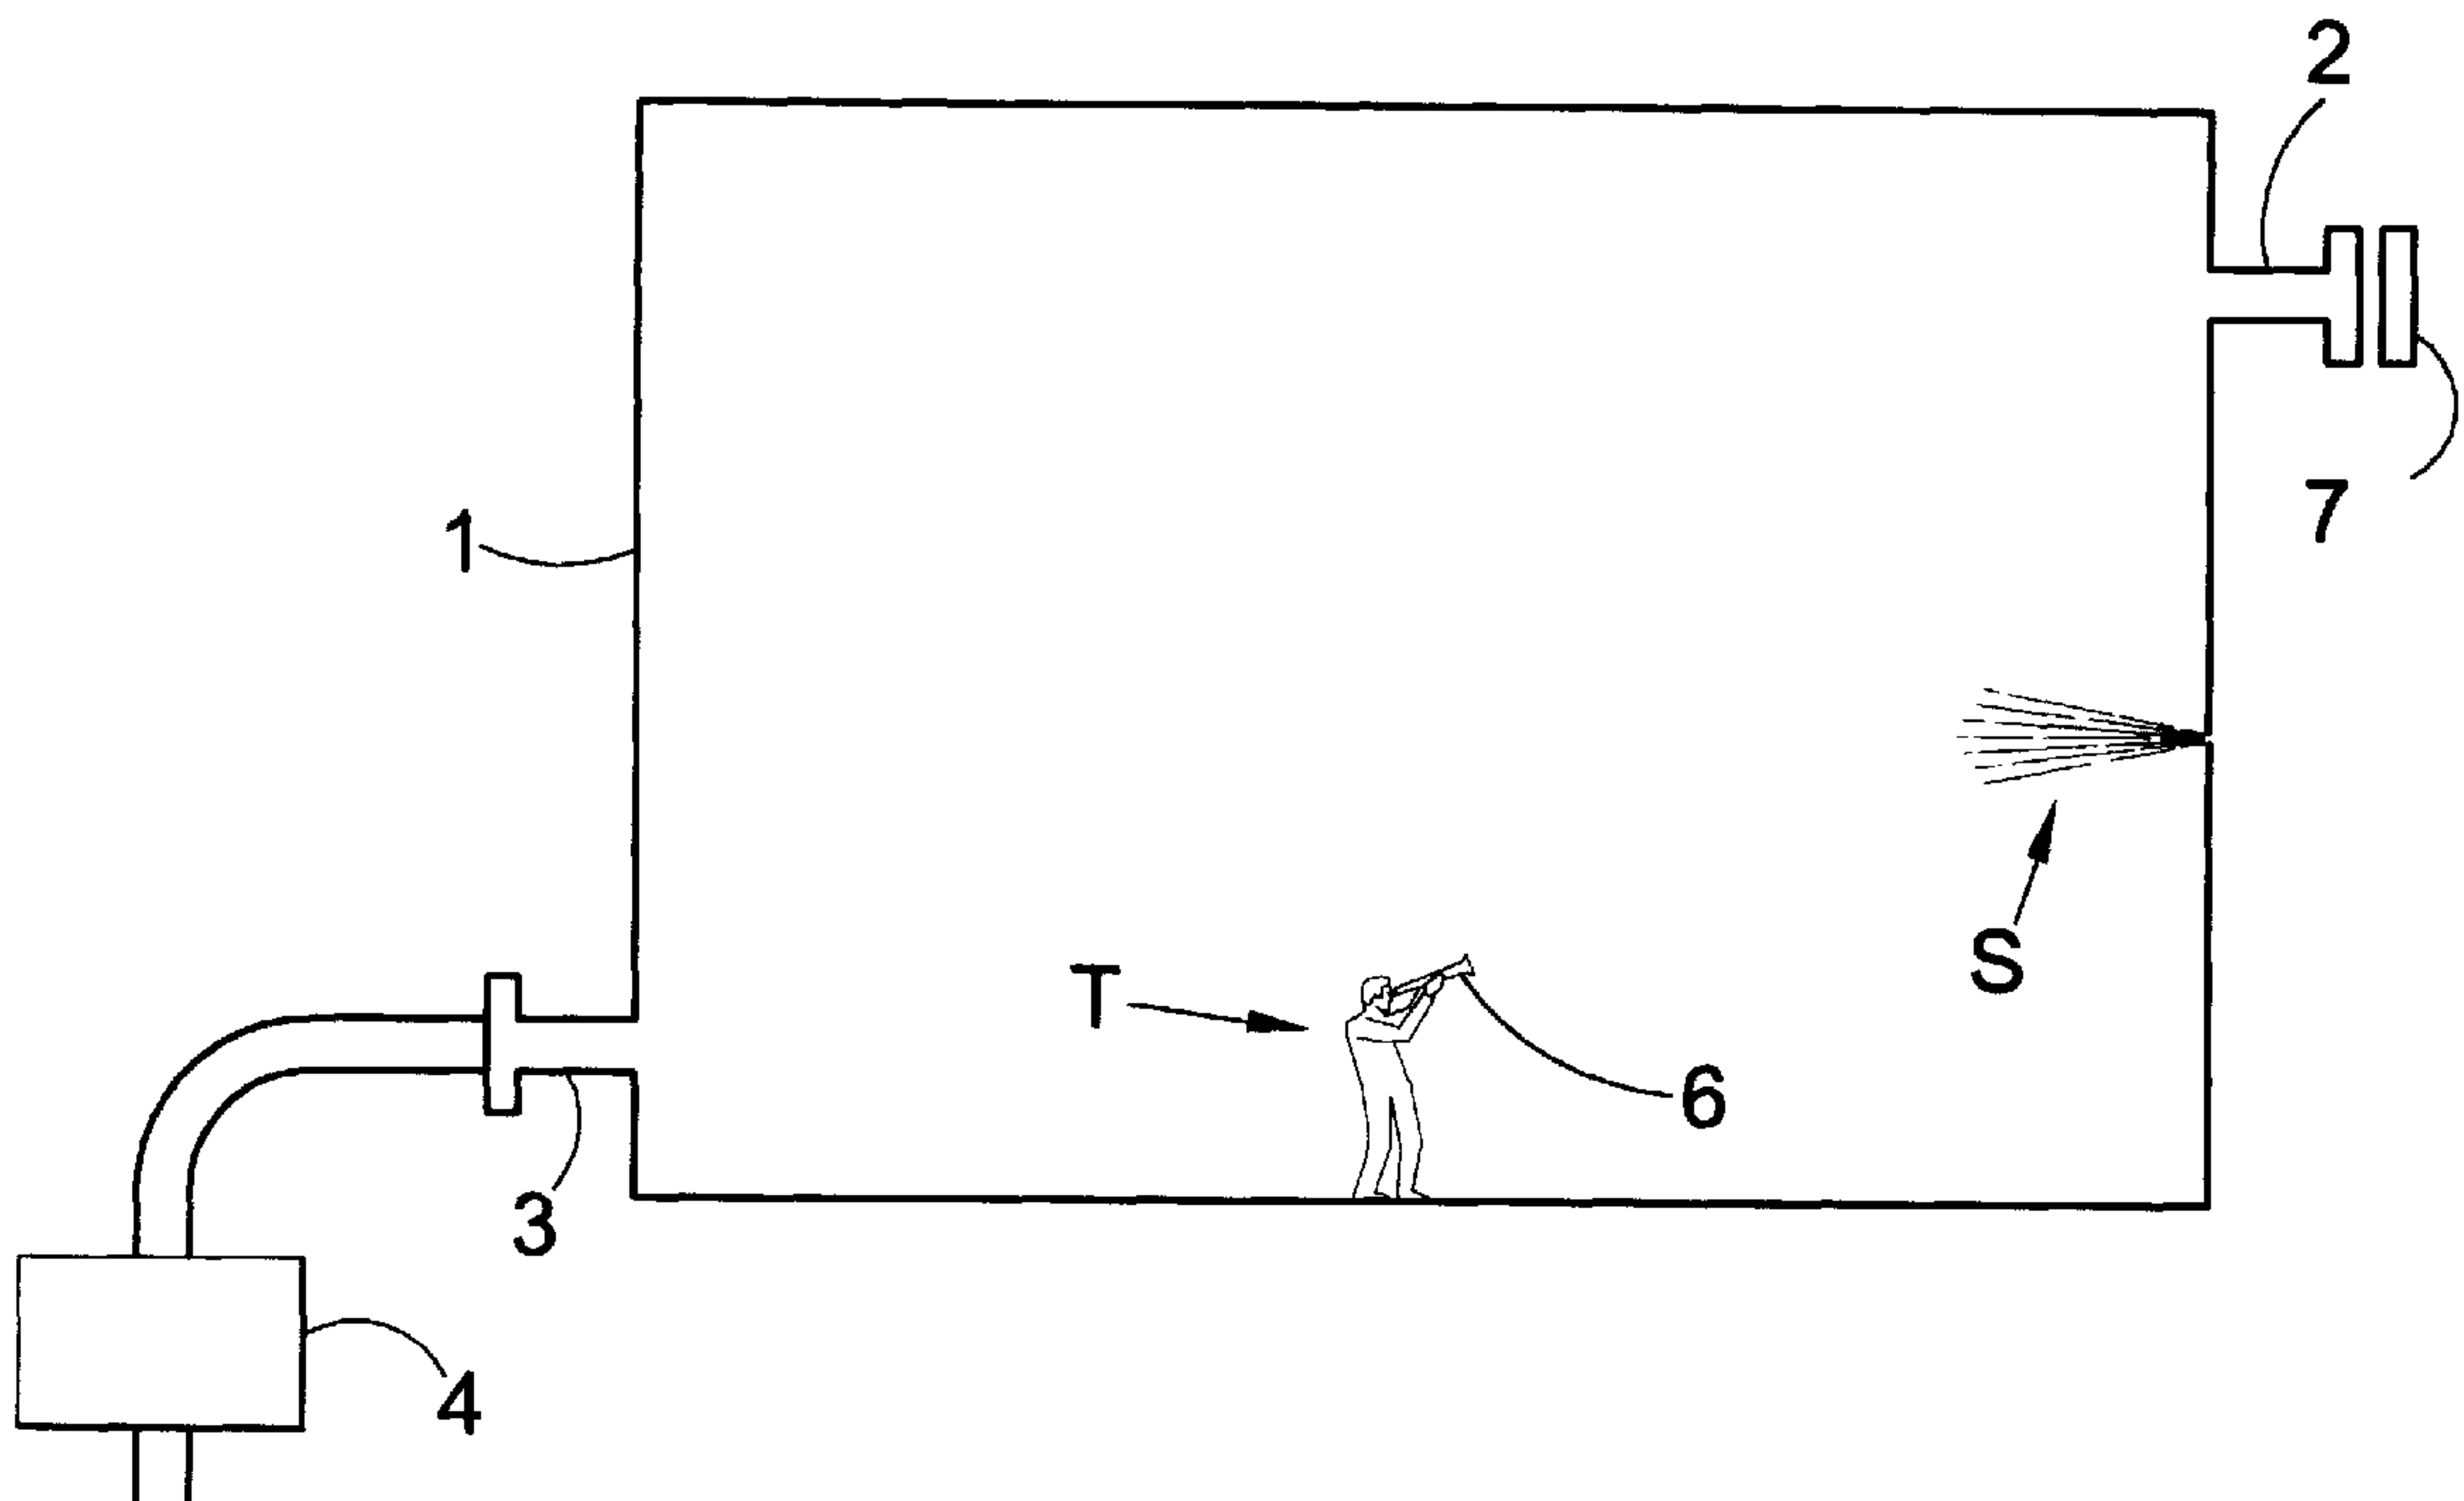
Fig. 1

FIG. 1 is a diagrammatic sectional view of a non-jacketed food processing vessel undergoing testing in accordance with a preferred form of the invention;

Referring firstly to FIG. 1, a single-skinned food processing vessel 1 has a product inlet 2 and a product outlet 3. Any product contained in the vessel will be contaminated from the atmosphere, e.g. by air-borne bacteria, if any leaks are not found and remedied. To test the vessel for leaks the inlet 2 is sealed by a suitable closure 7 and a technician T enters the vessel 1, using breathing apparatus if necessary. A fan-type extractor 4 is coupled to the outlet 3 and another technician (not shown) working outside the vessel turns on the fan to draw air out of the product chamber and thereby create a pressure differential between the inside of the vessel and the external atmosphere.

When the pressure inside the vessel falls to less than  $1.4 \times 10^4 \text{ Nm}^{-2}$  (2 psi) the first technician T uses thermal imaging equipment 6 to scan the inner surface of the vessel wall. Any flaws in the wall will admit a stream of air S into the vessel, resulting in a localised temperature drop which will be rendered visible through the imaging equipment 6. The positions of any leaks are noted and the appropriate repair work can then be carried out before recommissioning the vessel.

FIG. 4 illustrates a similar method to that described in relation to FIG. 1, being used to check for leaks in a container such as a refrigerated room or refrigerated vehicle 30, of the kind which generally contains products requiring that a low temperature be maintained to ensure longer life, From time to time leaks may occur through the insulated wall of the room, causing an internal temperature rise and increased risk of product failure. When such vehicles are manufactured or repaired it is very difficult to test them for leaks using known testing methods.
