[11] Patent Number: **6,154,959**

[54] **LASER CLADDING A TURBINE ENGINE VANE PLATFORM**

[73] Assignee: **Chromalloy Gas Turbine Corporation**, San Antonio, Tex.

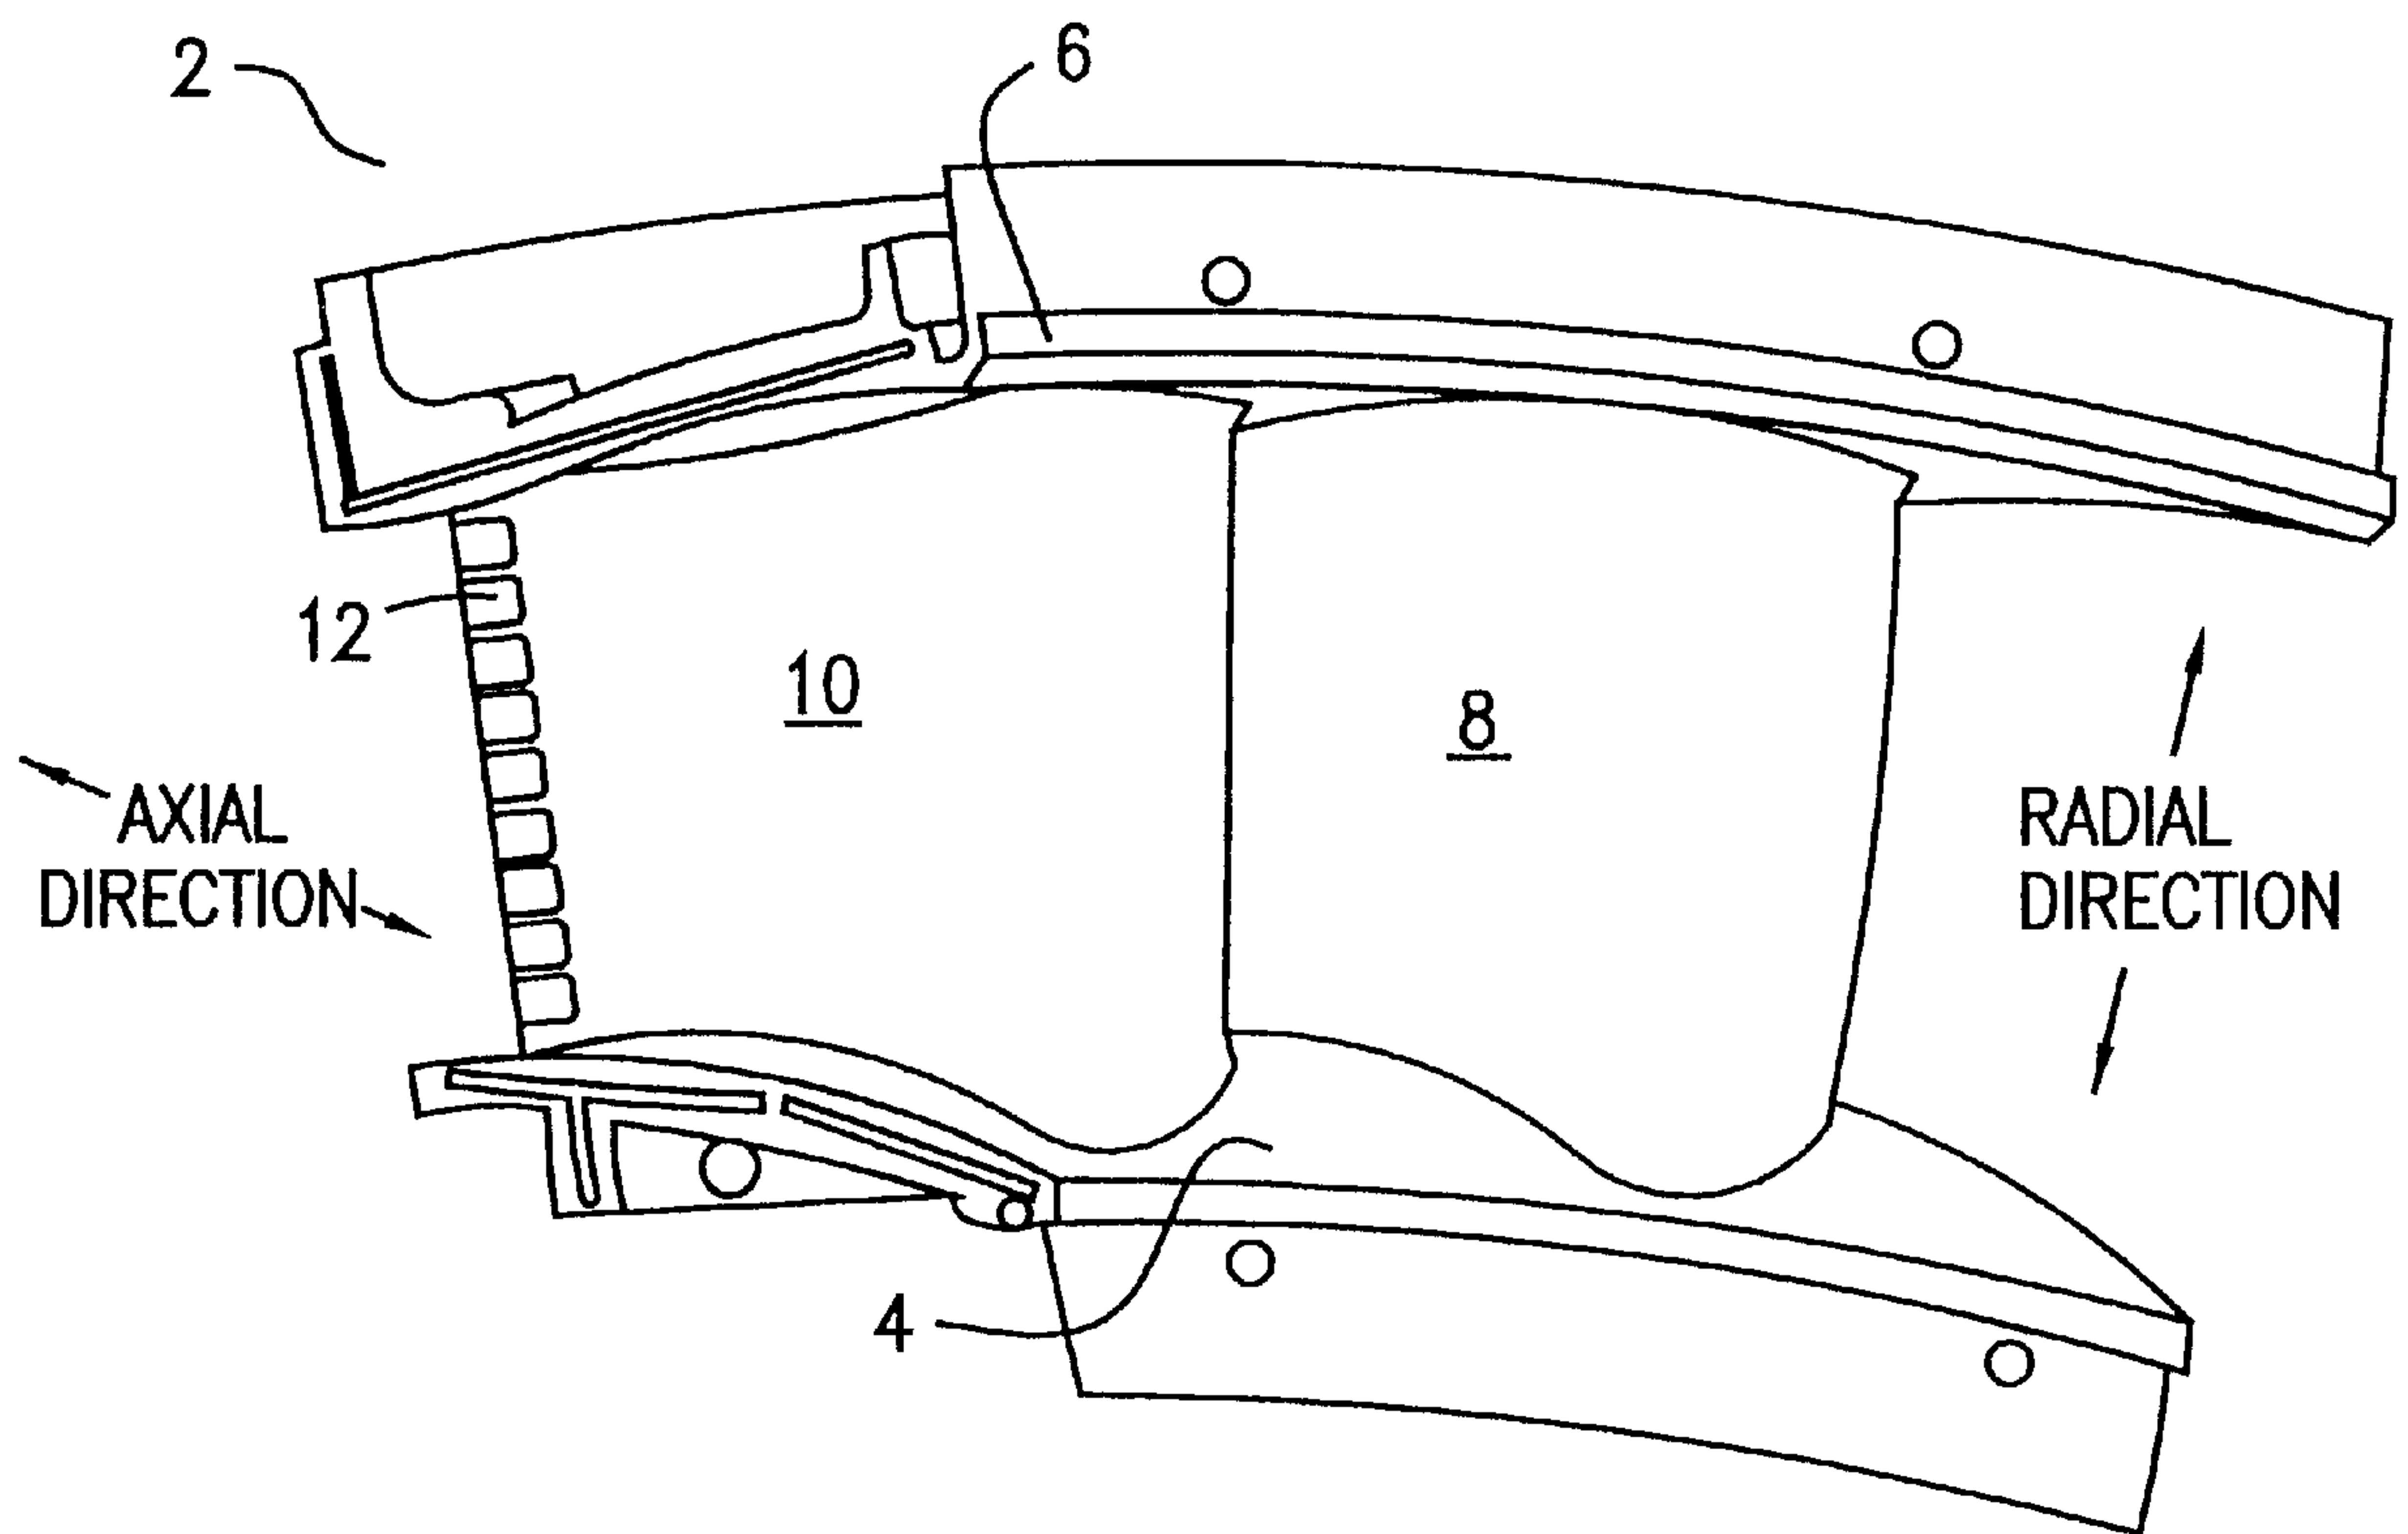
FIG. 1 is a perspective view of a turbine vane upon which the method of the present invention is performed;

Referring to the drawing figures which like reference numerals refer to like elements, FIG. 1 is a perspective view of a turbine vane upon which the method of the present invention is performed. Turbine vane 2 which will be repaired according to the method of the present invention is comprised of inner platform 4, outer platform 6, lead airfoil 8 and trailing airfoil 10. Prior to repair, lead airfoil 8 and trailing airfoil 10 are either cast as an integrated unit with one or both of inner platform 4 and outer platform 6, or are welded and/or brazed to one or both of inner platform 4 and outer platform 6. It should be noted that although FIG. 1 shows two airfoils, 8 and 10, a turbine vane can be comprised of any number of airfoils. Cooling slots 12 are positioned at the trailing edge of lead airfoil 8 and trailing airfoil 10.

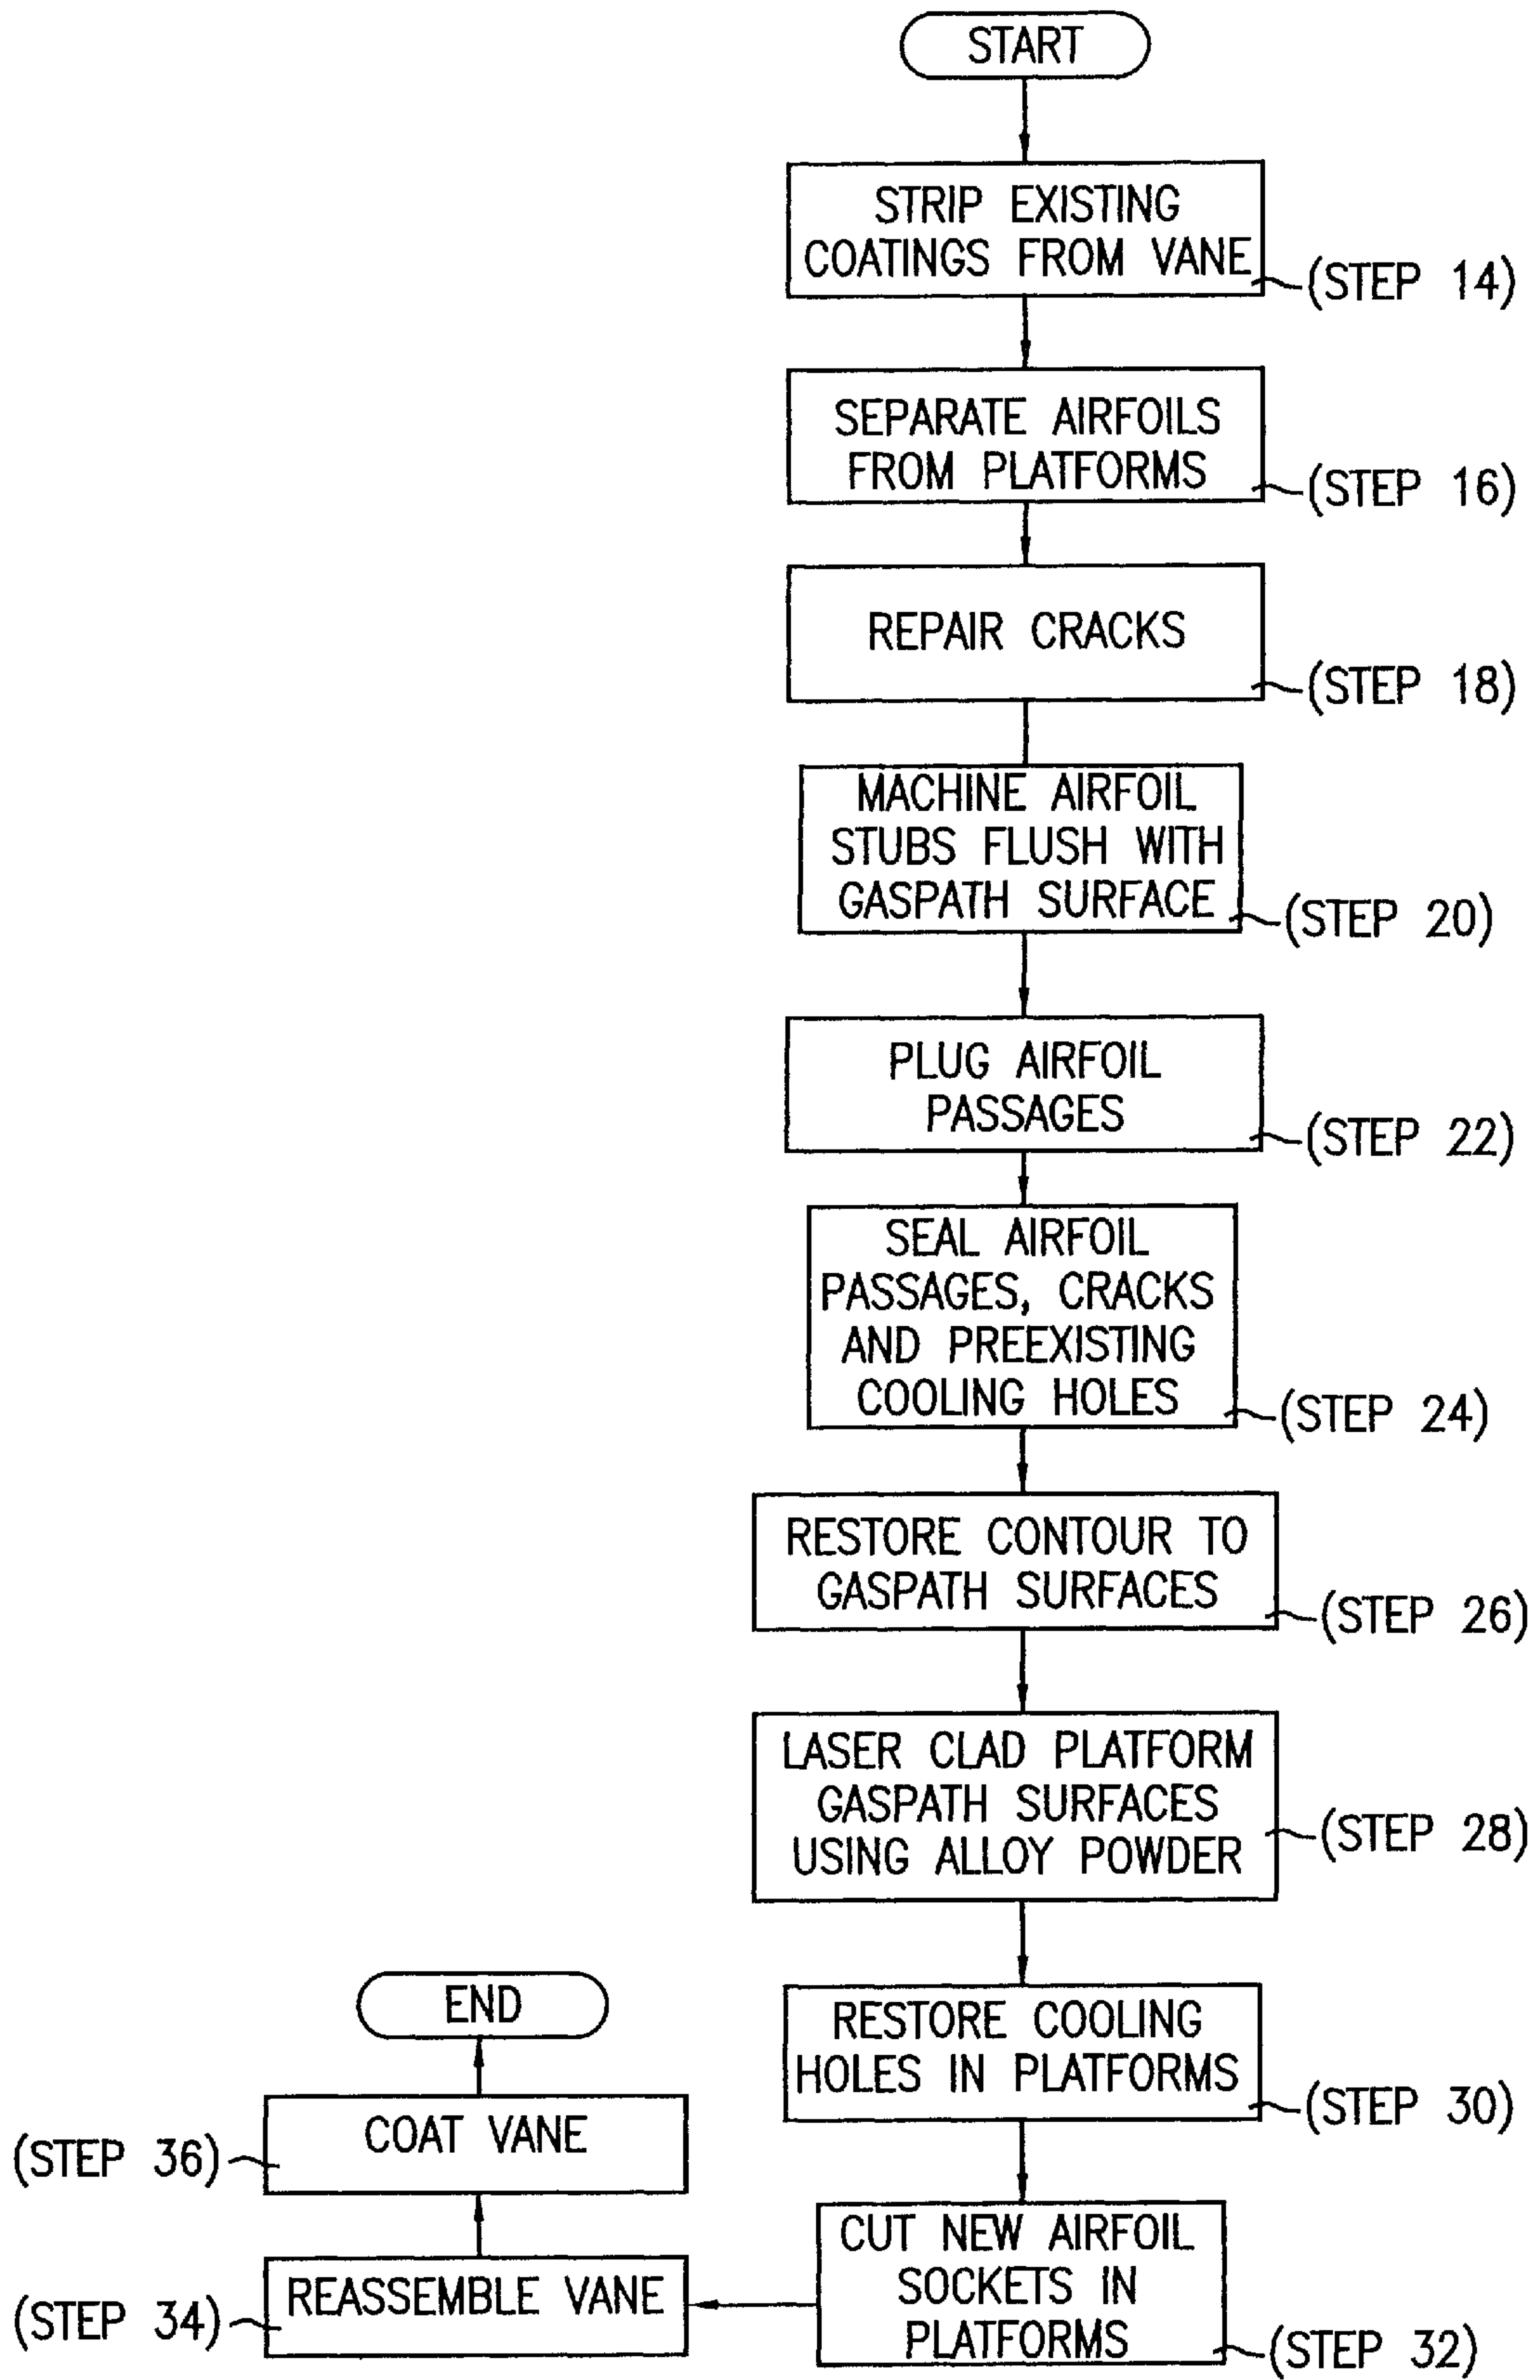
FIG. 2 is a flow chart of an airfoil replacement method of the present invention;

The vane refurbishment method of the present invention is now described with respect to the flow chart shown in FIG. 2.

A vane being refurbished is first subjected to chemical treatment to strip existing coatings from the vane (step 14). Methods for stripping these coatings are known and include for instance, a initial gritblast operation followed by immersion in a heated solution of 50% nitric/50% phosphoric acid. A subsequent gritblast after rinsing and drying the vanes may complete the process. Depending on the specific coating being removed, additional cycles in other acids may be required.

Once the vane is stripped of coatings, airfoils 8 and 10 are separated from inner platform 4 and outer platform 6 (step 16). Where the vane to be repaired is a component assembly vane, the platforms and airfoils can be separated by heating the entire assembly to a temperature sufficient to melt the braze joints. Alternatively the airfoils can be cut from the vanes leaving airfoil stubs 38 as shown in FIG. 3.

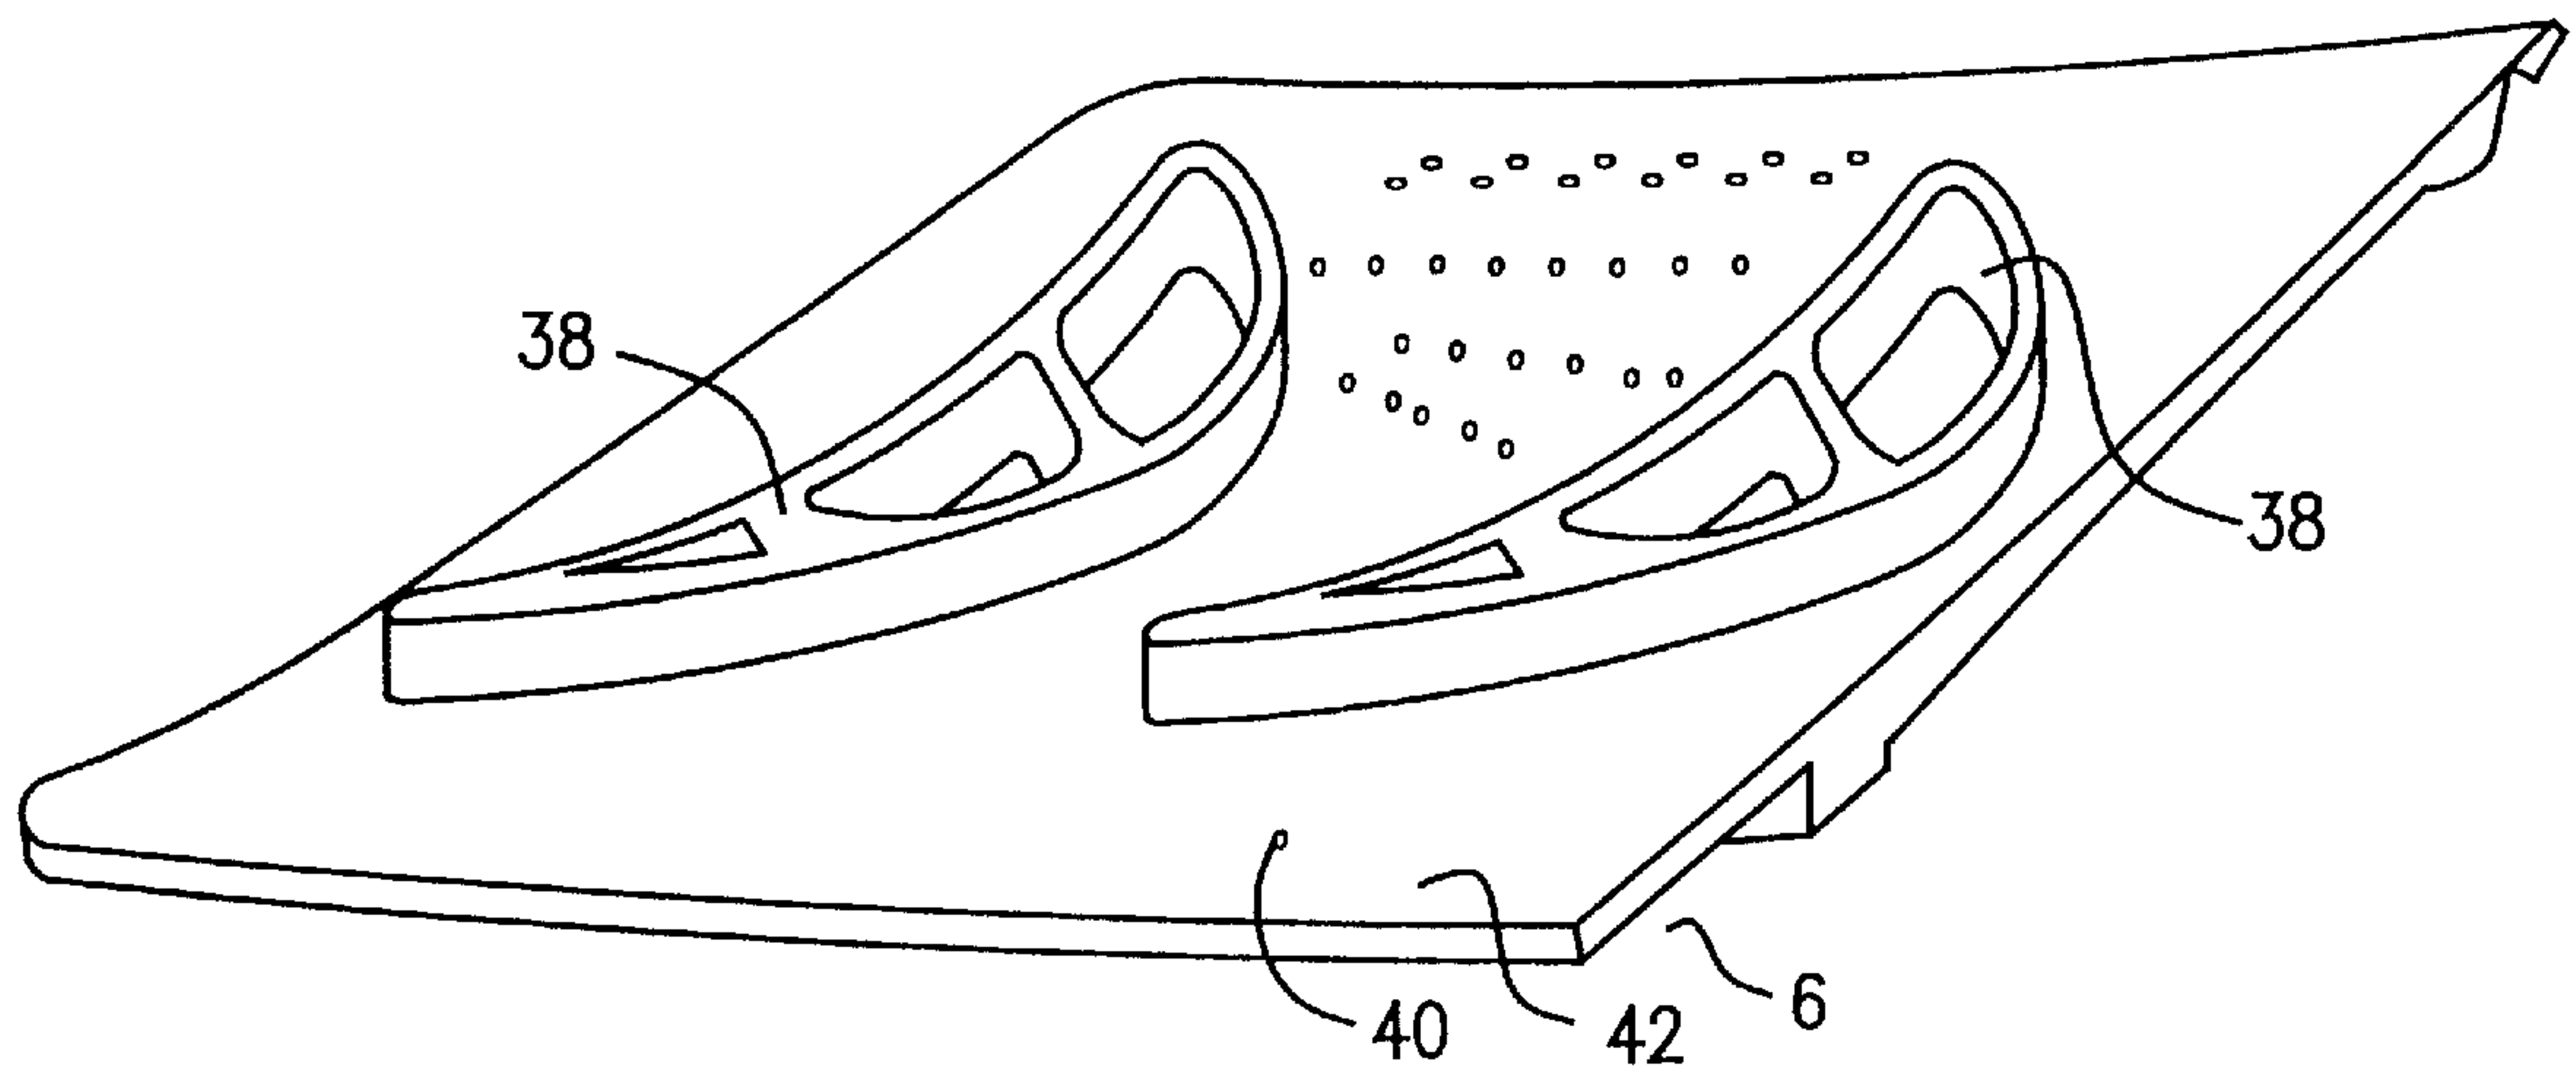
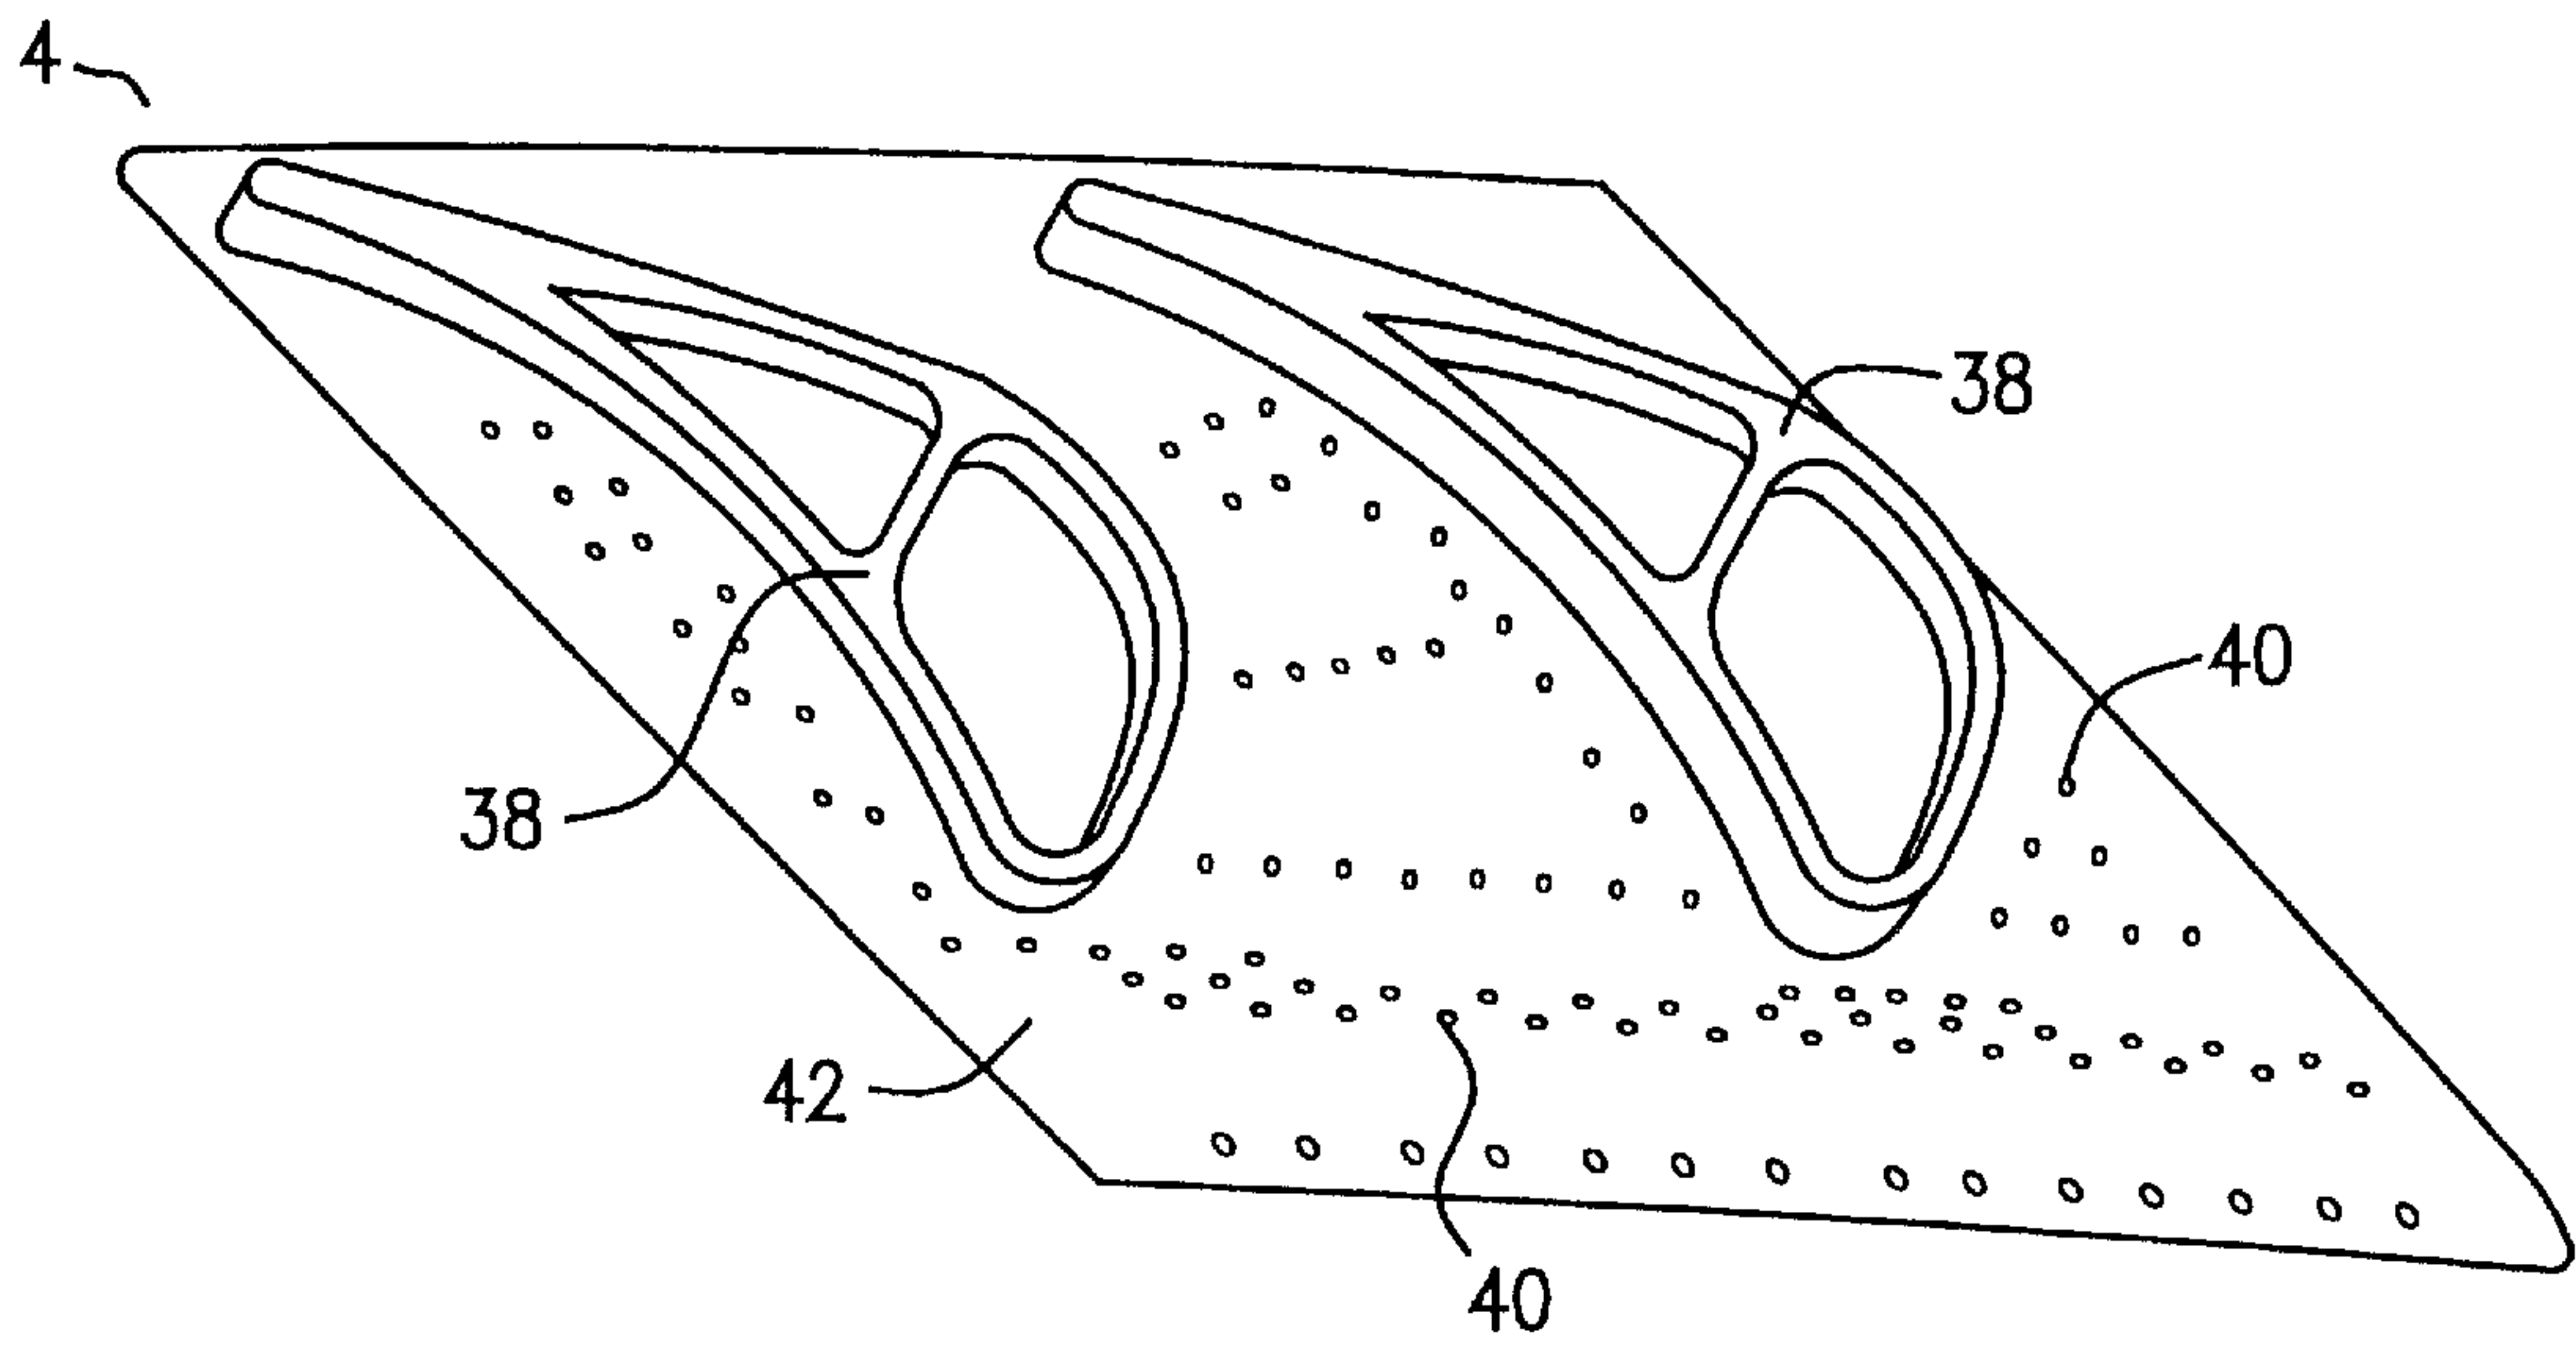
FIG. 3 is a perspective view of vane platforms with the airfoils removed to form airfoil stubs;

In the case where the airfoils are integrally cast with the platforms, separation is achieved by cutting airfoils 8 and 10 from vane 2 such that stubs from airfoils 8 and 10 protrude from inner platform 4 and outer platform 6. FIG. 3 shows inner platform 4 and outer platform 6 with airfoils 8 and 10 removed to form airfoil stubs 38.

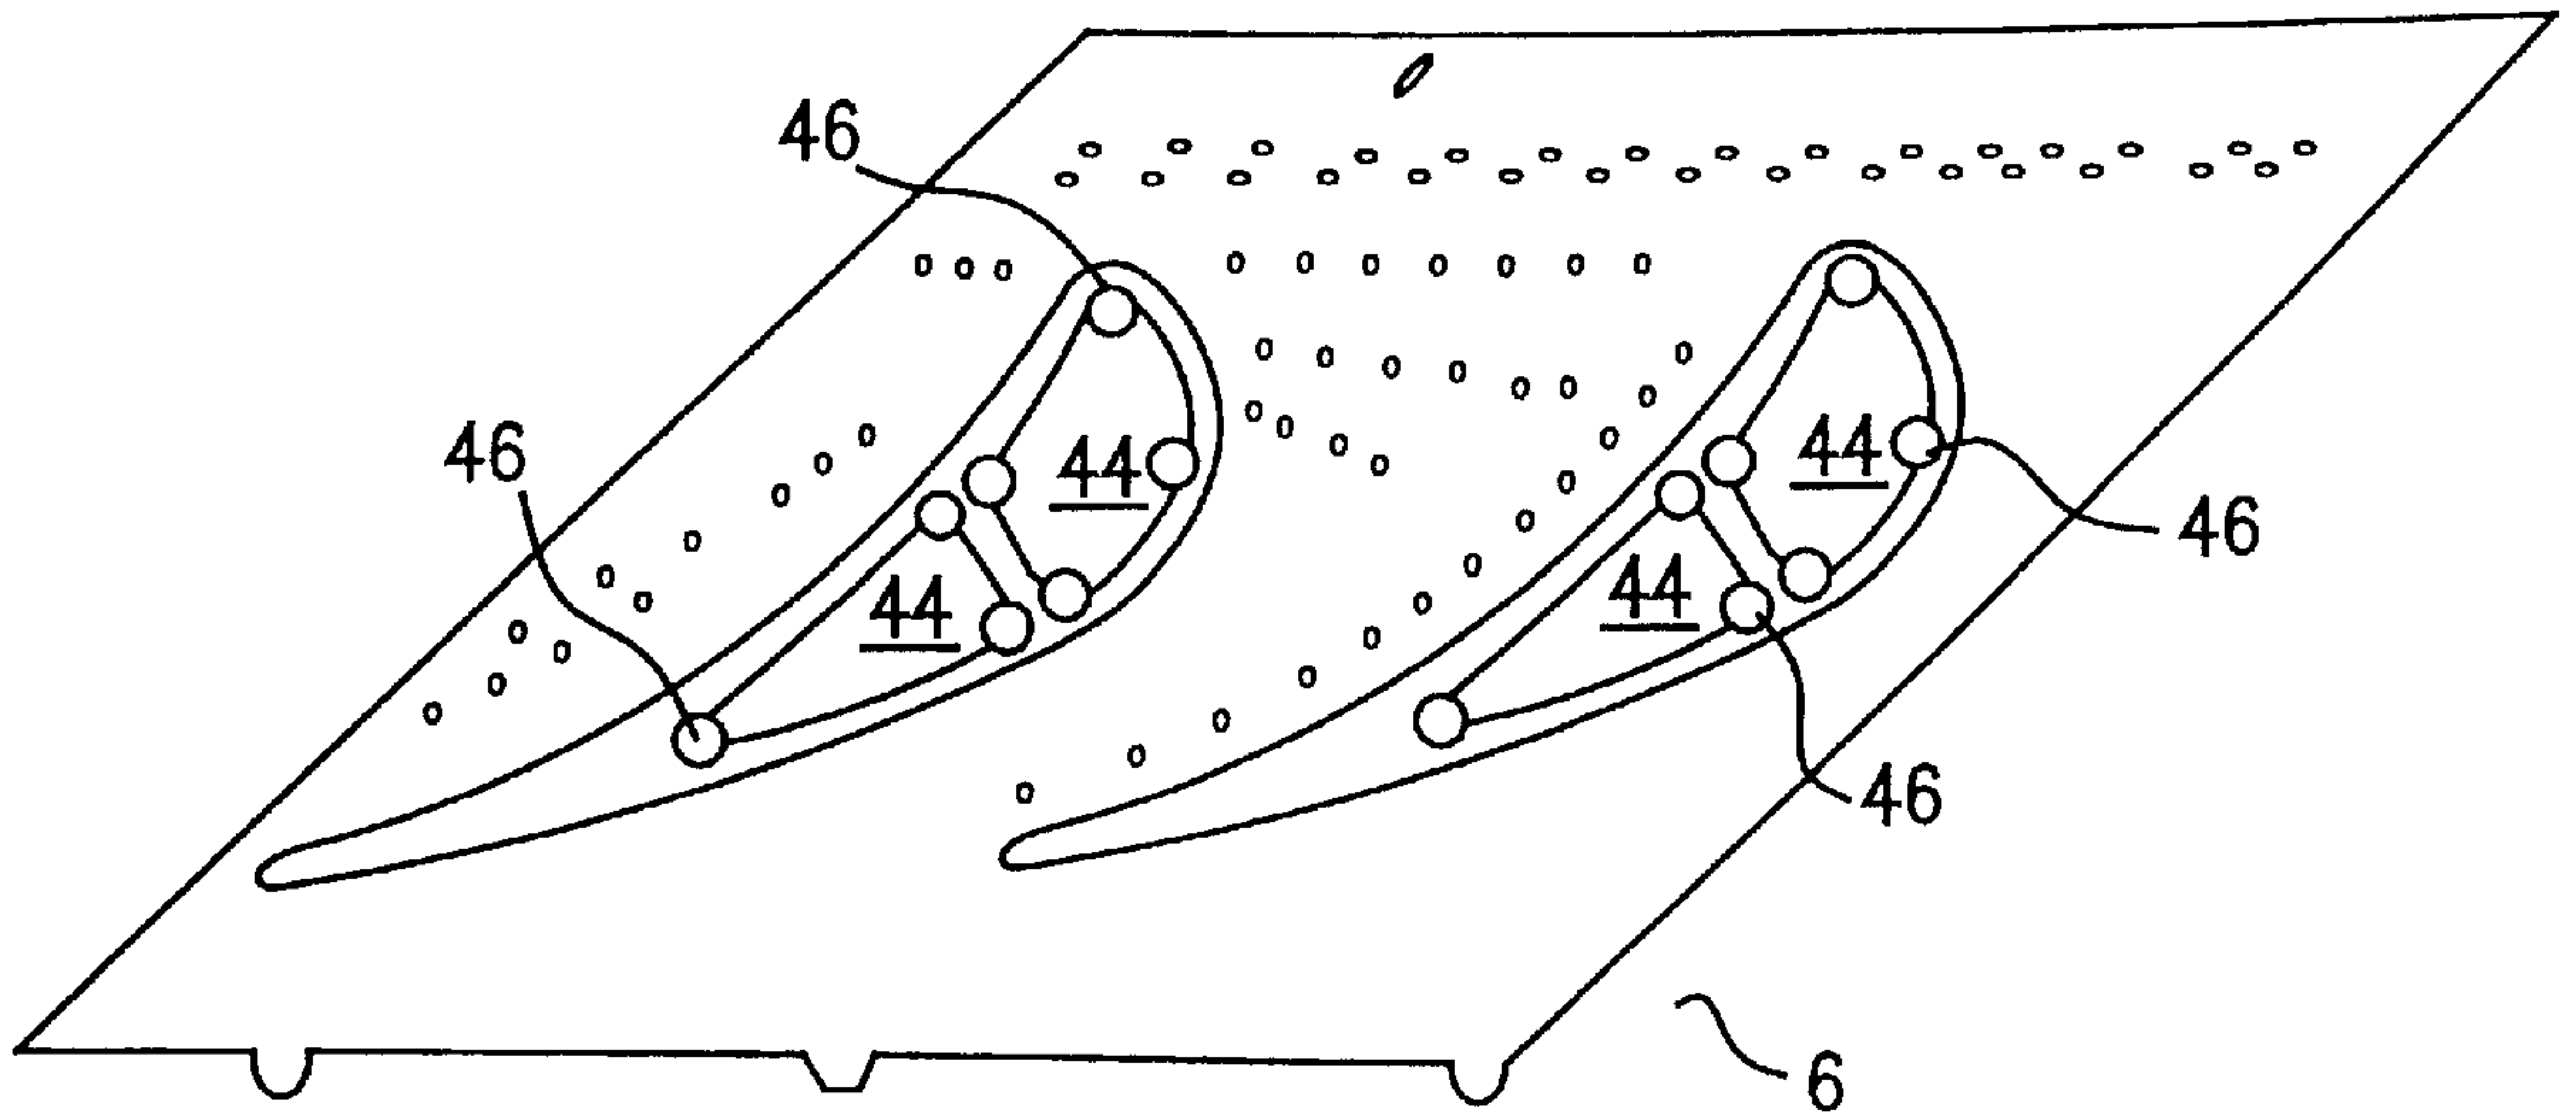
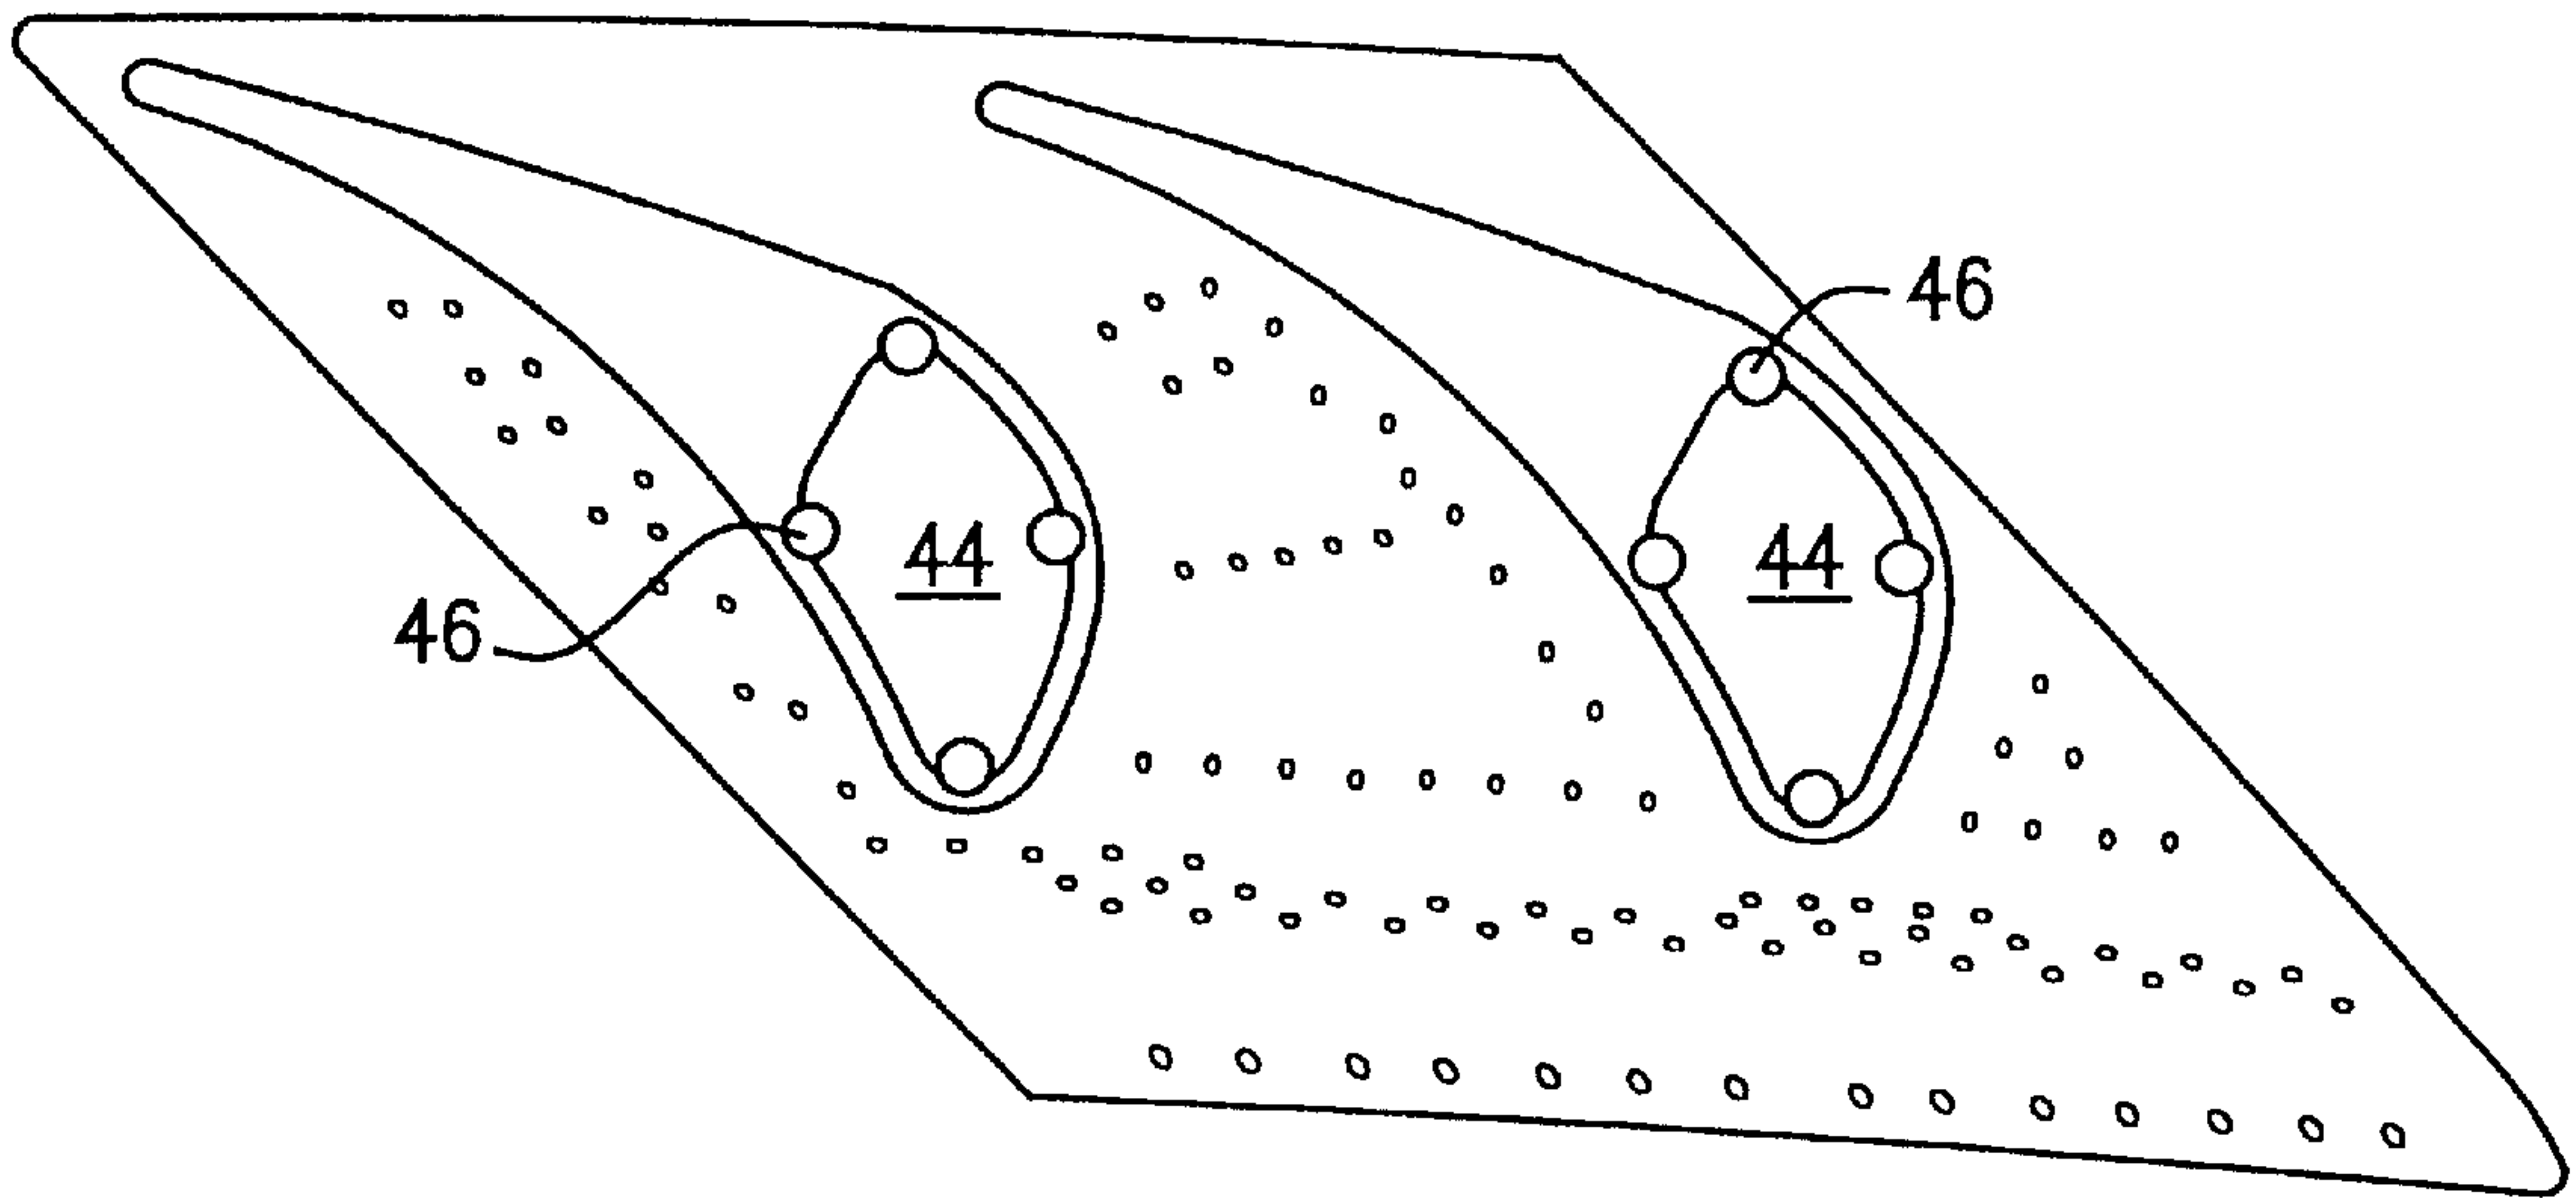
FIG. 4 is a perspective view of vane platforms having plugged platform openings;

The airfoil passages in platforms 4 and 6 are then plugged (step 22). FIG. 4 shows a perspective view of inner platform 4 and outer platform 6 with plugged platform openings. Plugs 44 are machined to fit into the corresponding airfoil openings in the platform, and tack welds 46 are used to hold plugs 44 in place. Plugs used are cut from alloy materials which are compatible to the platform base alloy, i.e. the plug alloy will weld or braze uniformly with the platform base alloy. Typically the base element of the alloy for the plug is

the same as that of the alloy for the platform, i.e. a cobalt based superalloy. For X-40 cobalt alloy platforms L-605 cobalt alloy plugs are useful.
