[11] Patent Number: **6,154,959**

[54] **LASER CLADDING A TURBINE ENGINE VANE PLATFORM**

[73] Assignee: **Chromalloy Gas Turbine Corporation**, San Antonio, Tex.

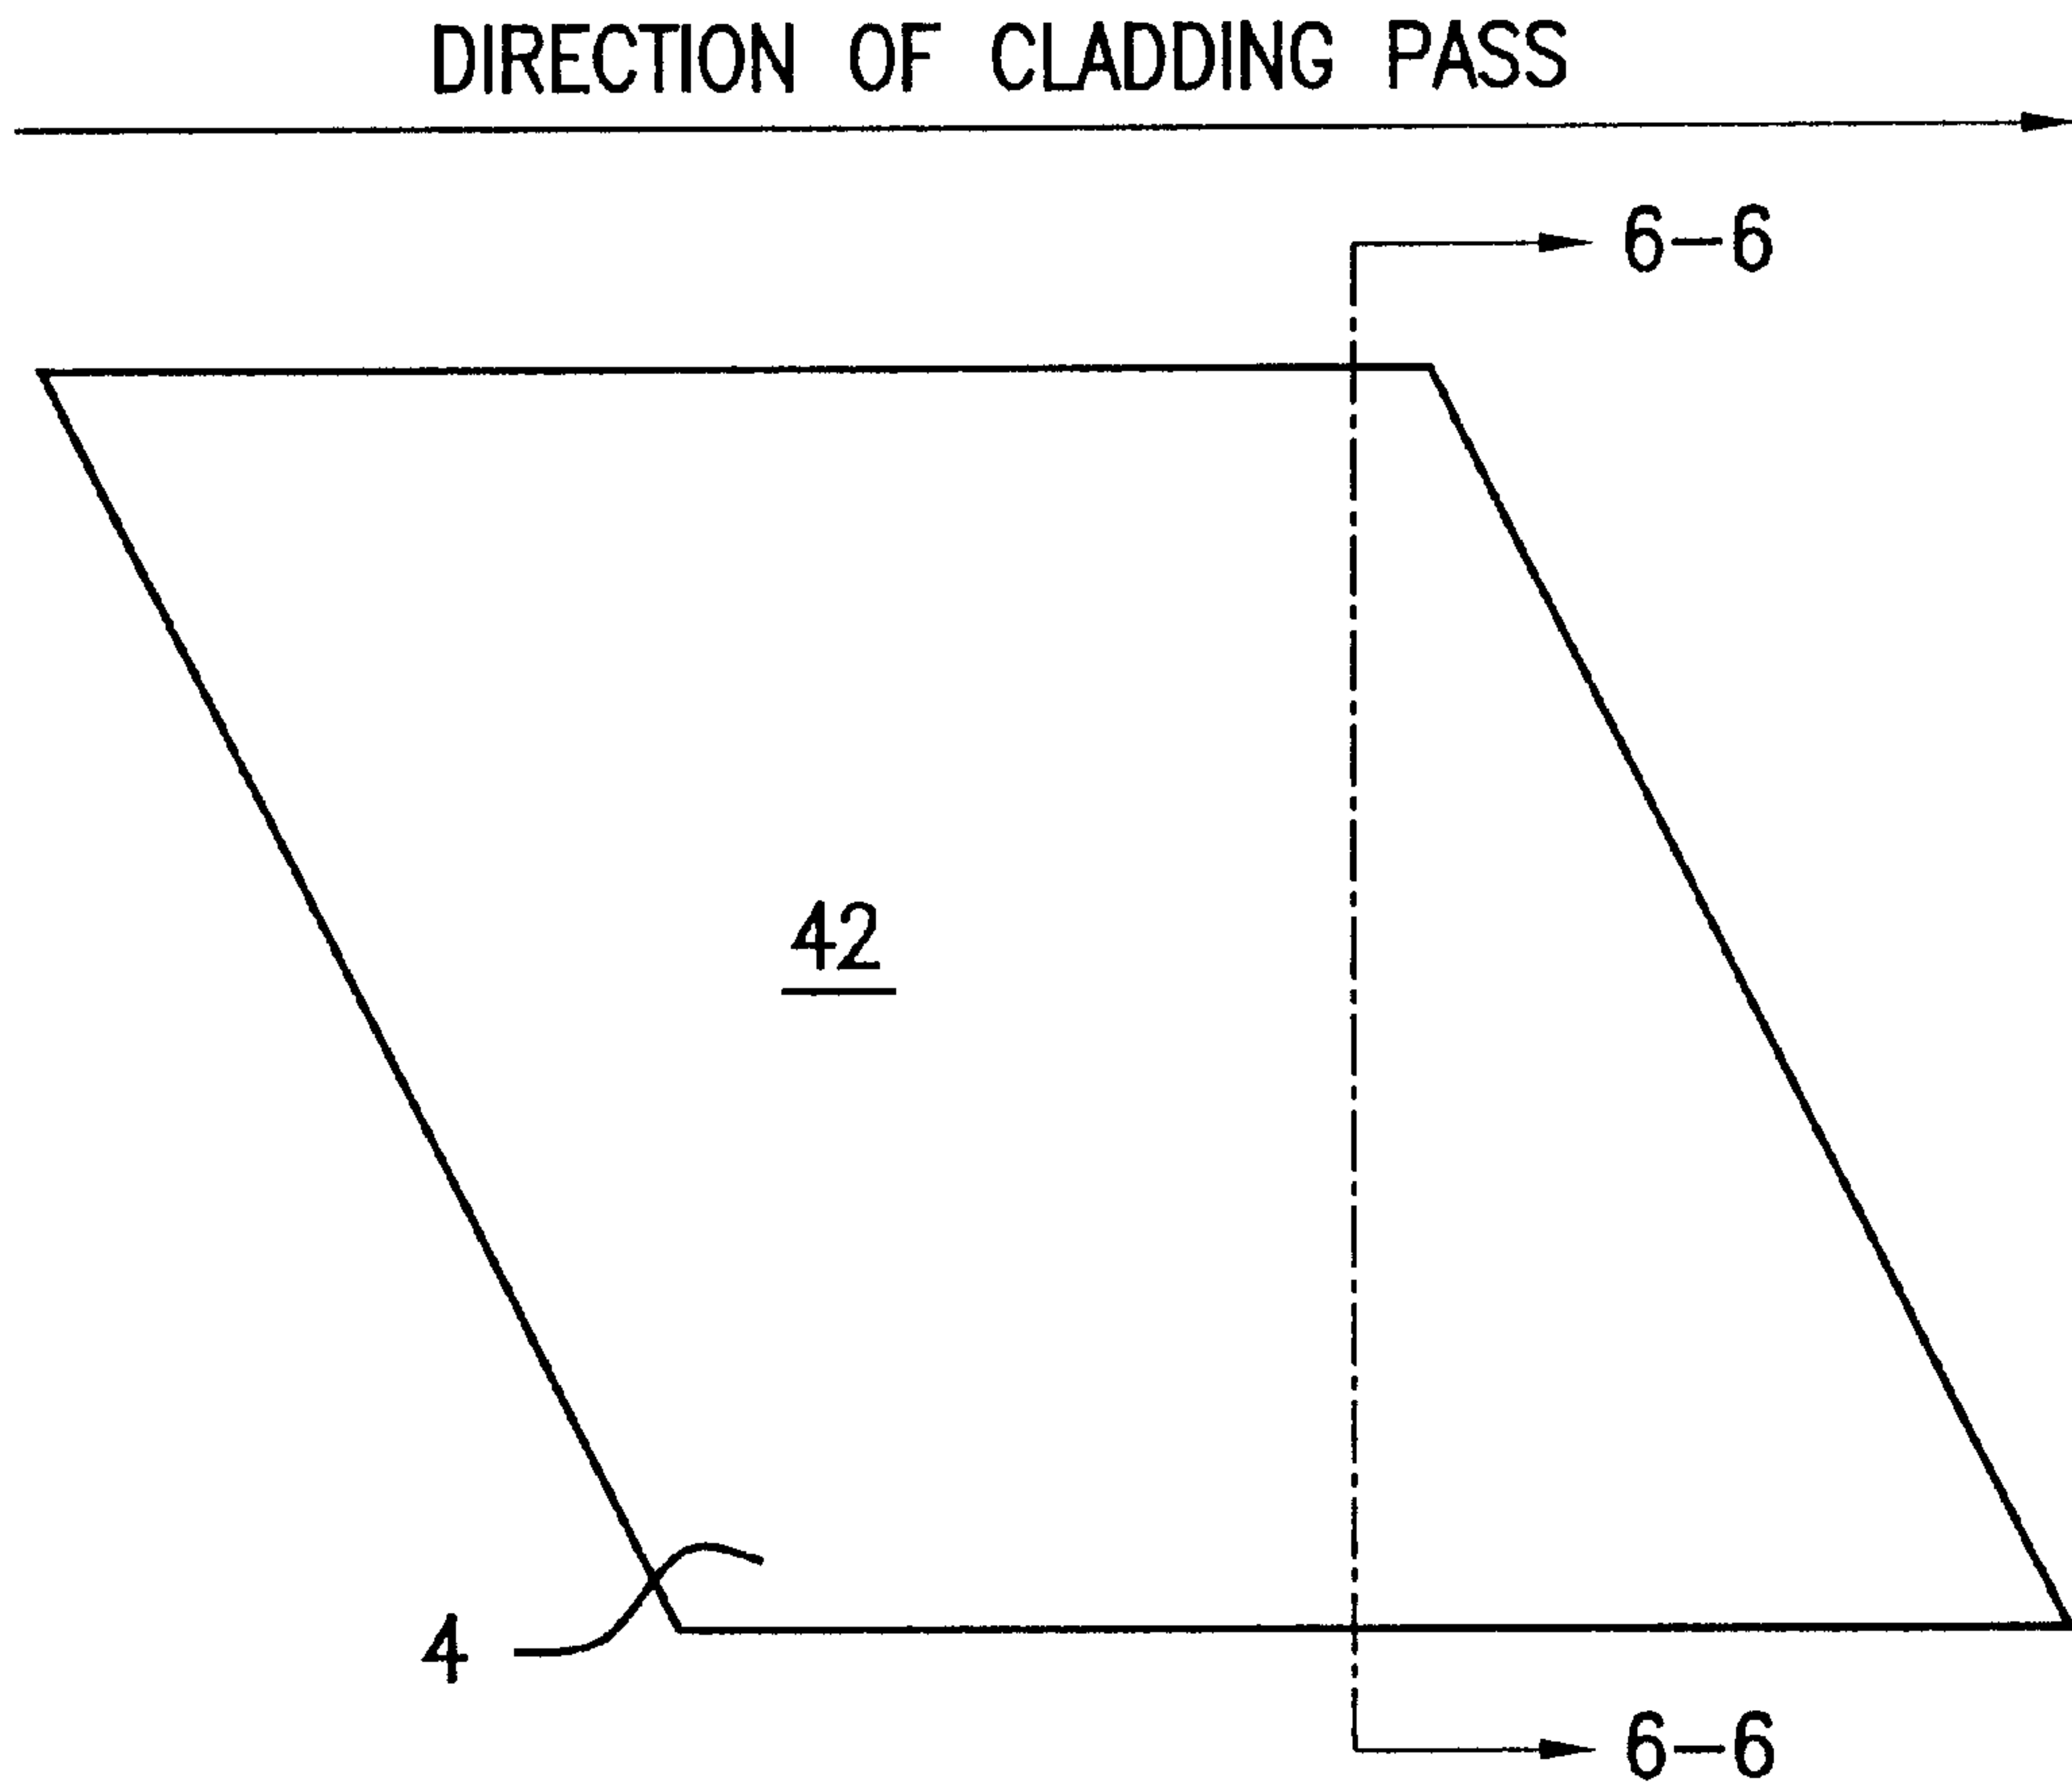
FIG. 5 is a top view of a vane platform;

FIGS. **5** and **6** depict the laser cladding process as performed on platform **4**, in which FIG. **5** is a top view of platform **4** and FIG. **6** is a section view thereof taken through section **6—6**. As shown in FIG. **5**, gaspath surface **42** is laser clad by a series of cladding passes performed sequentially as a series of rows across platform **4**. At the end of each laser cladding pass, the cladding apparatus moves to an adjacent row and cladding material is applied to gaspath surface **42** on platform **4**. As shown in FIG. **6**, laser cladding **48** applied to gaspath surface **42** provides a series of raised areas in the form of bumps **50**. Bumps **50** traverse platform **4** and are elongated in the direction of the cladding pass, i.e., row.

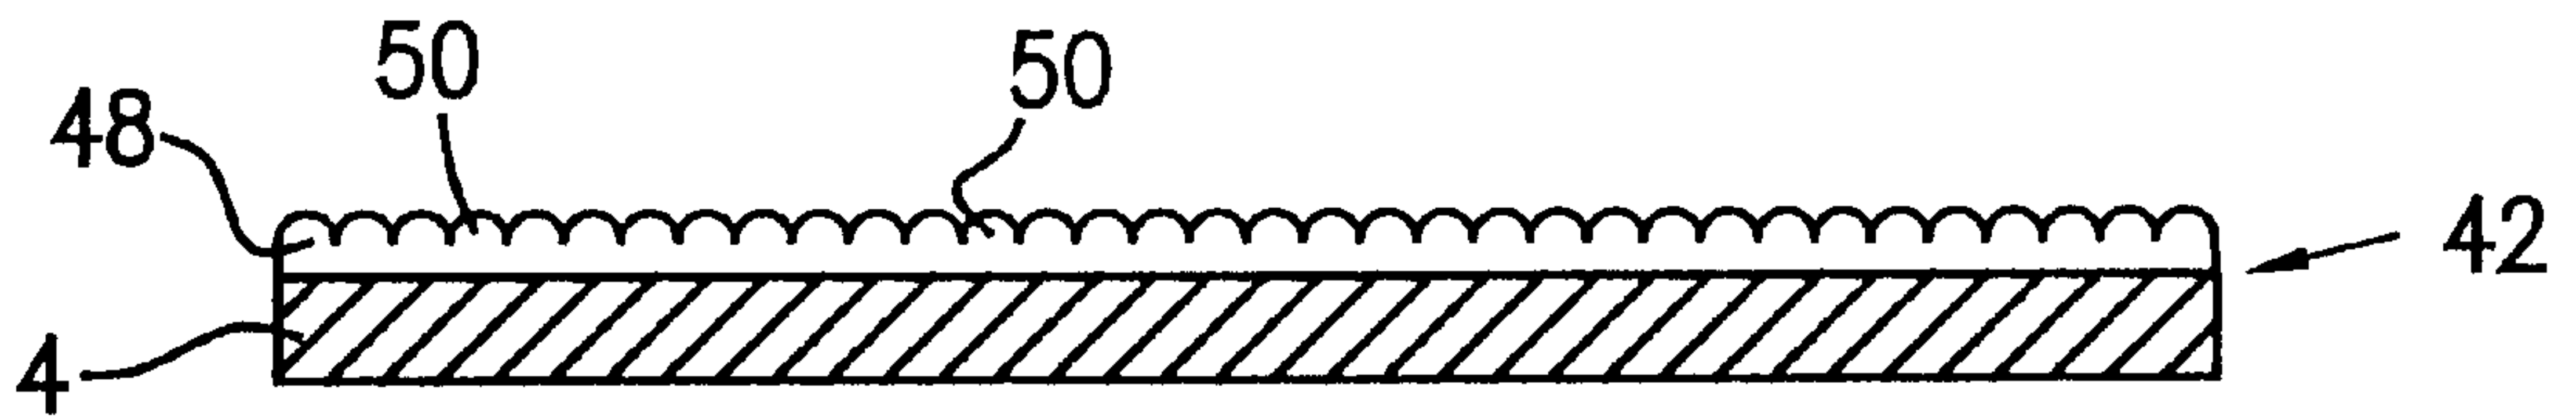
FIG. 6 is a section view of the vane platform in FIG. 5 taken through section 6—6, showing a laser clad surface;

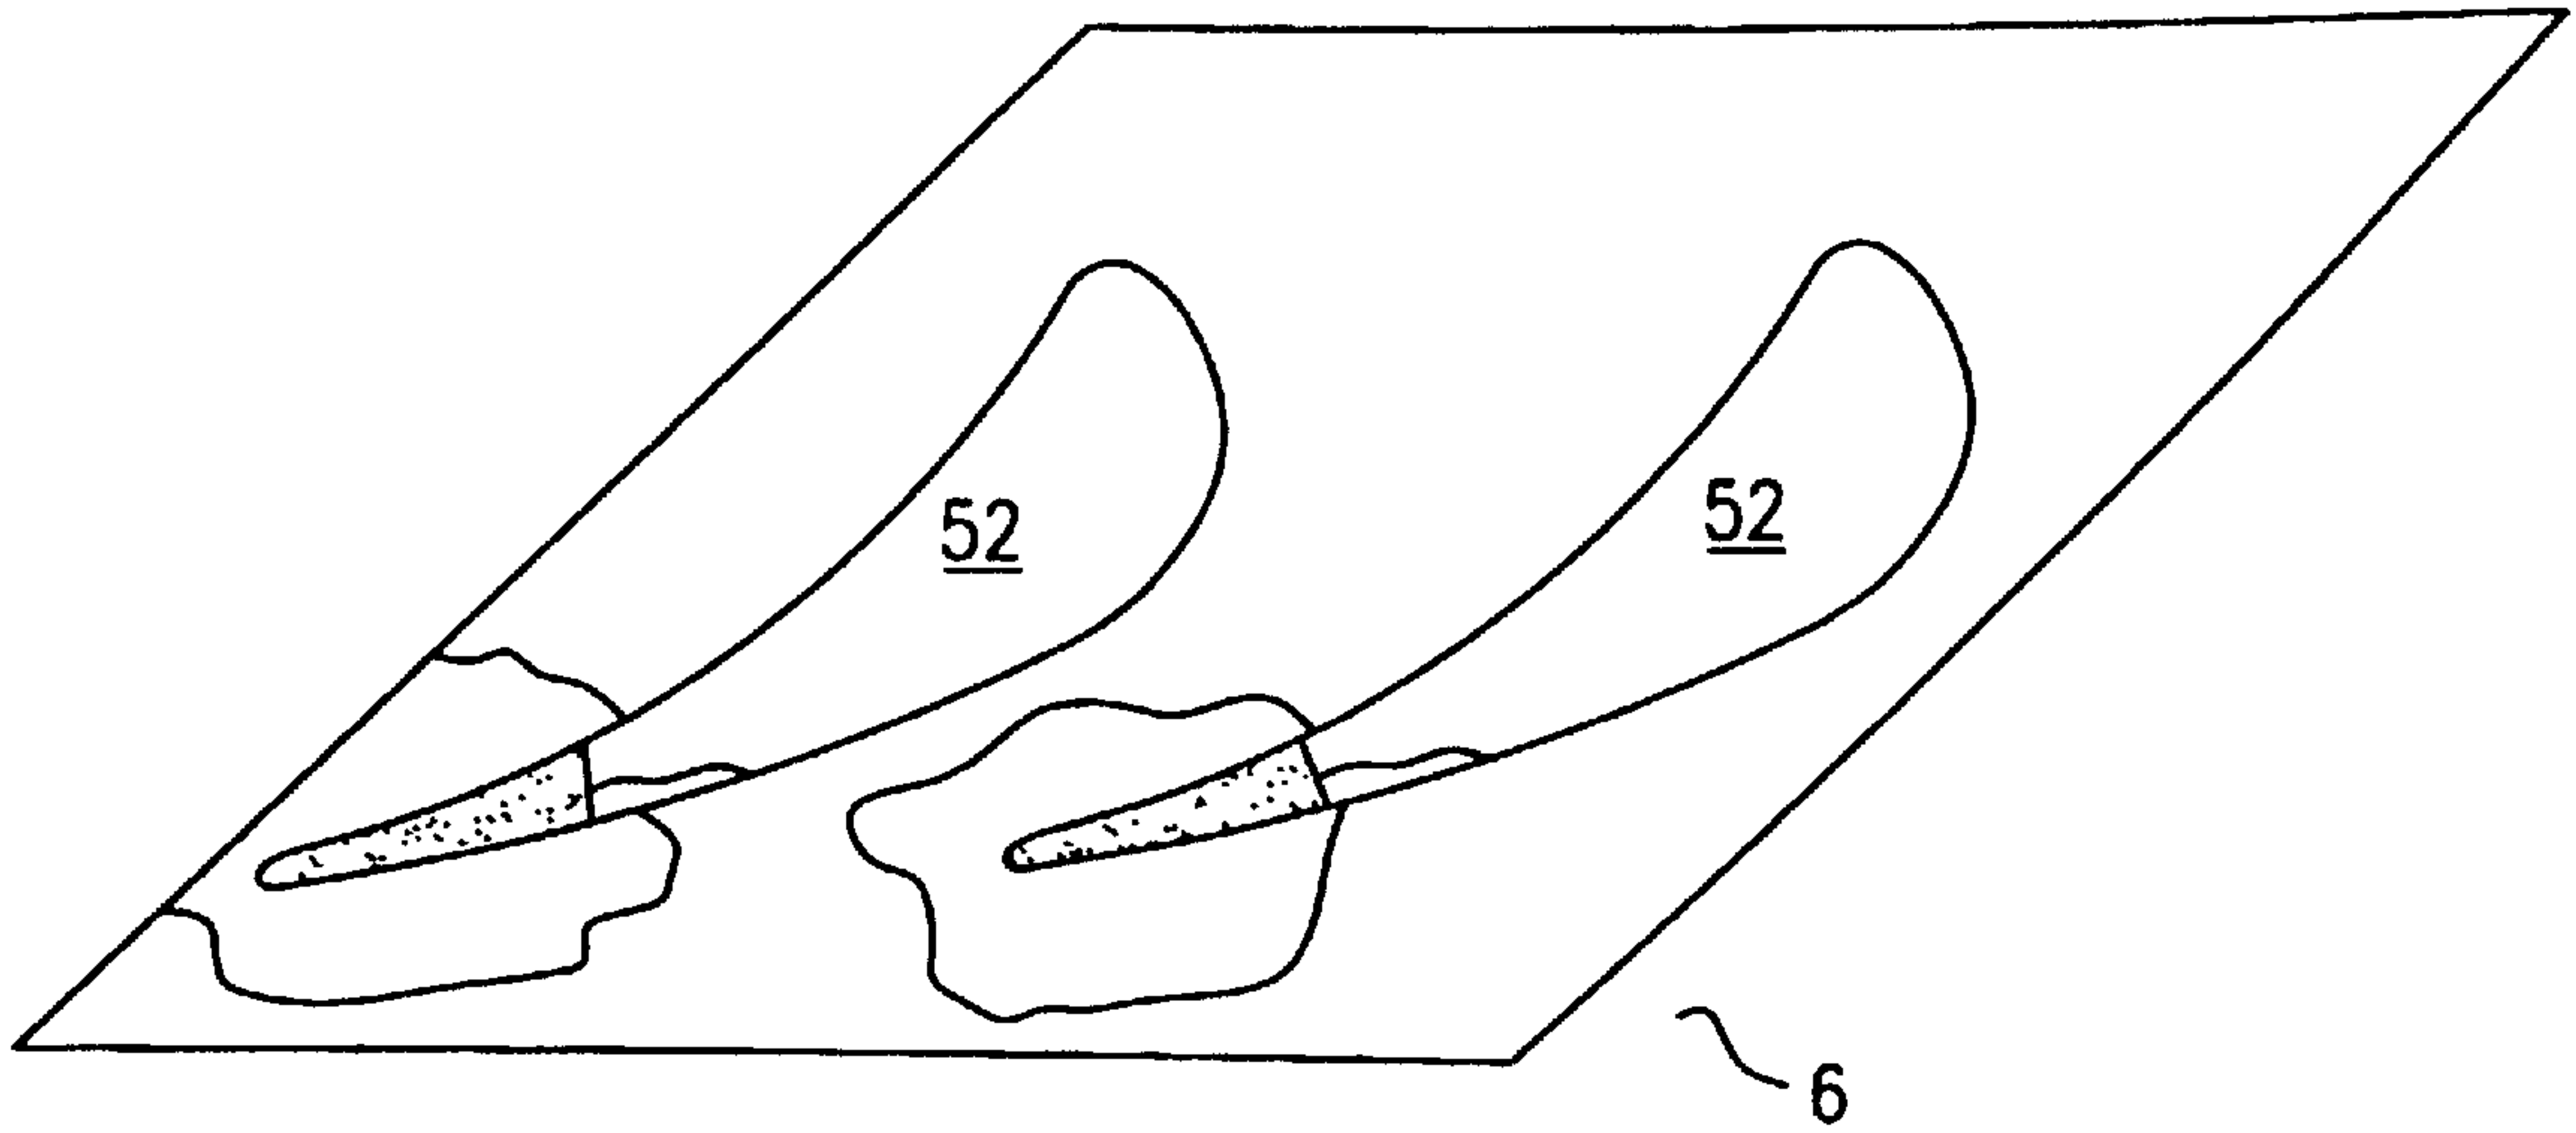
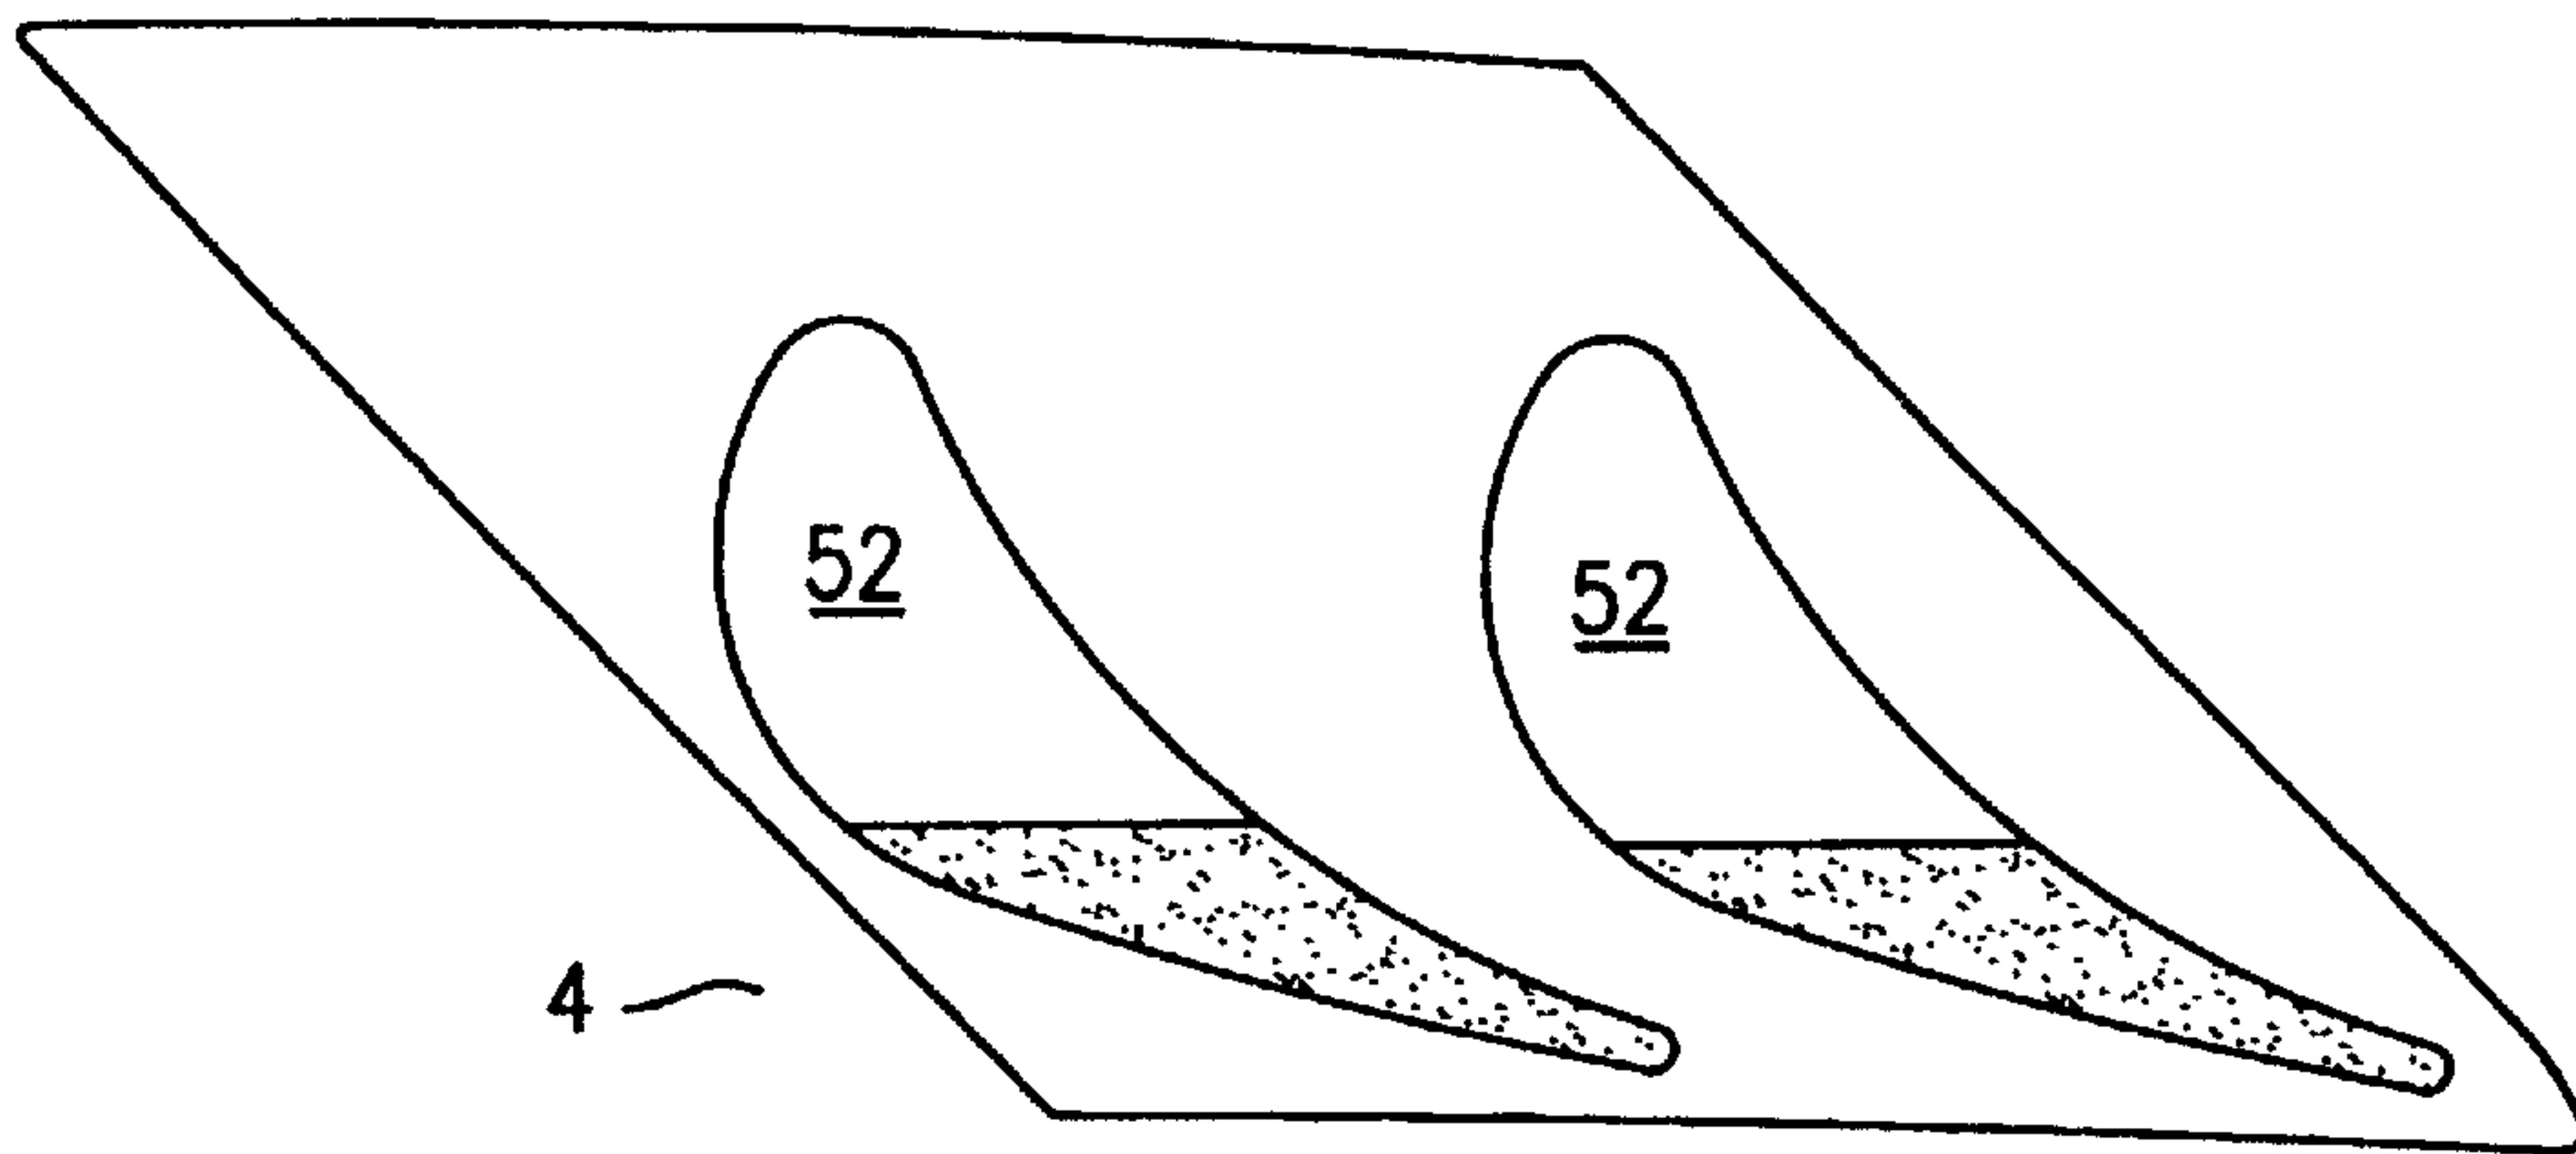
FIG. 7 is a perspective view of vane platforms with new sockets cut through; and

carbon dioxide gas to generate a continuous beam at a set frequency. A YAG laser emits a pulsed beam, generated by a yttrium, aluminum, garnet crystal, which is excited by flash lamps. CO₂ lasers are generally used for cutting or welding applications, and YAG lasers are generally used for hole drilling or cutting. FIG. **7** shows an example of platforms **4** and **6** with sockets **52** cut through.

Because airfoil sockets **52** are cut into completely sealed platforms **4** and **6**, airfoil sockets **52** can be repositioned on platforms **4** and **6** in a different location than during the original manufacture of vane **2**. This allows extreme flexibility such that different sized airfoils, as compared with the original airfoils, can be used, and the class area can also be adjusted to optimize the performance of vane **2** within the turbine engine.

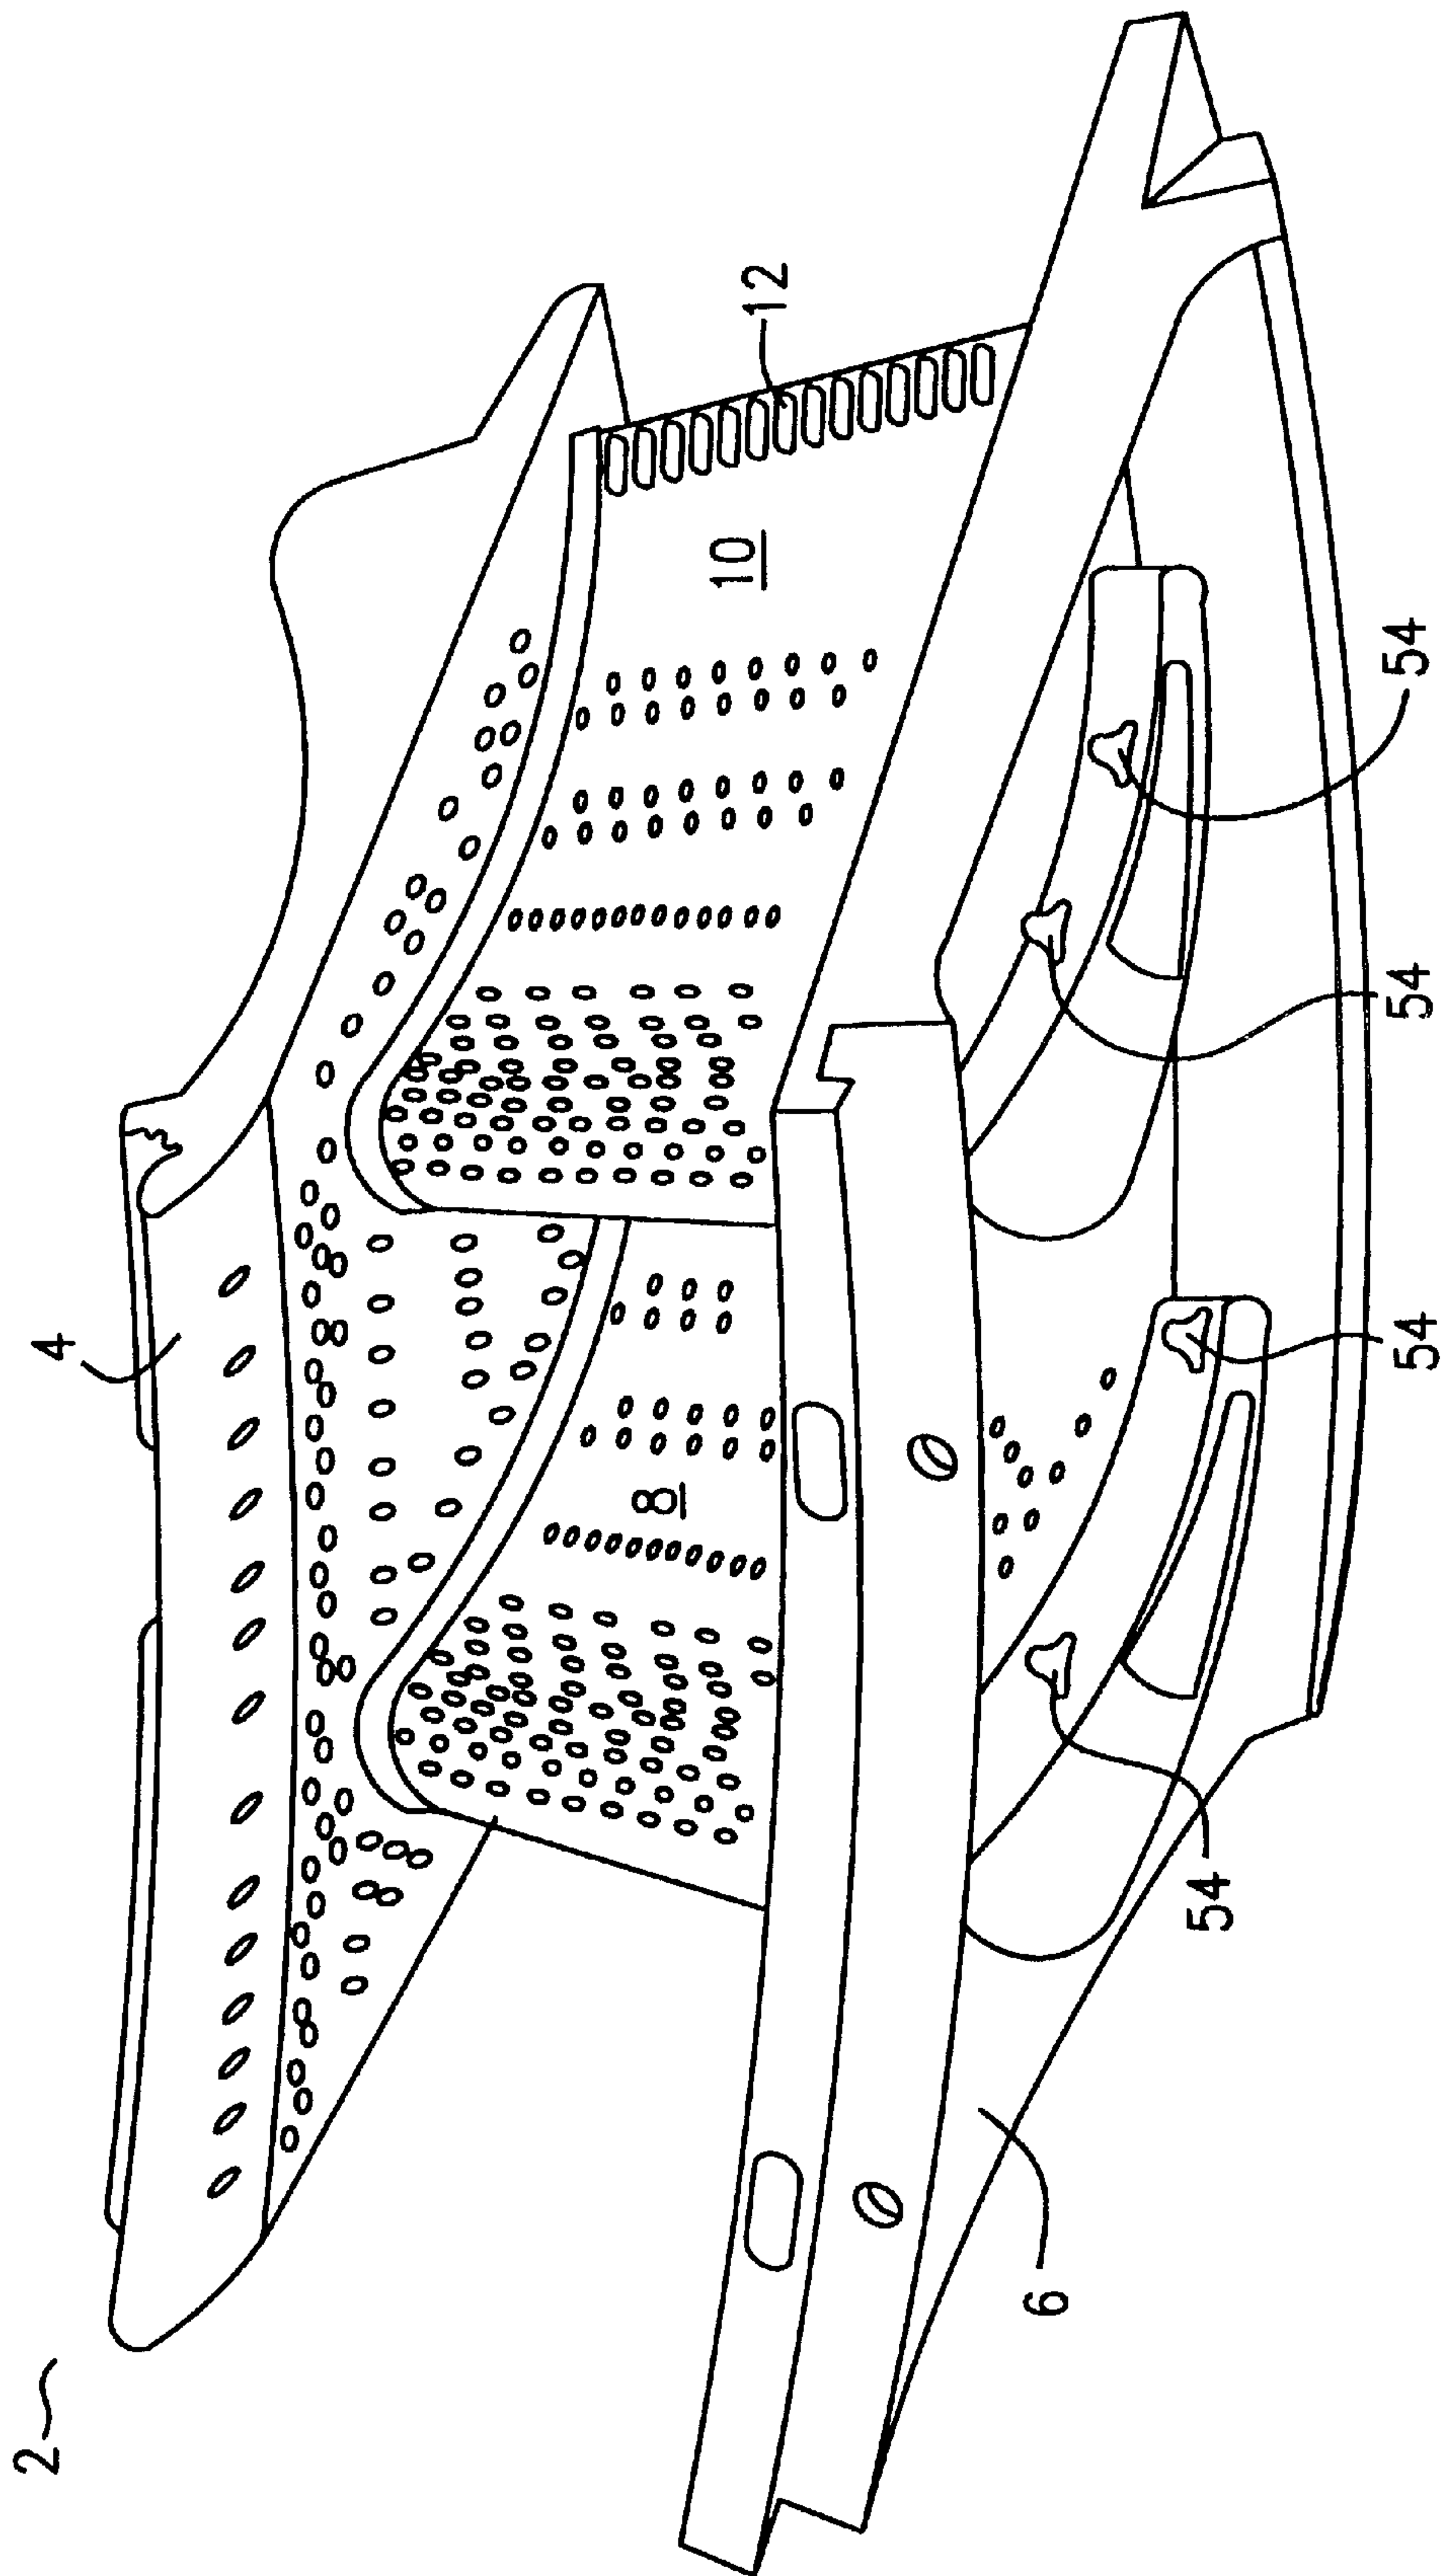
FIG. 8 is a perspective view of an assembled vane with airfoil segments welded to the platform.

FIG. **8** shows a perspective view of an assembled vane **2** after airfoil segments have been tack welded to the platforms. In particular, lead airfoil **8** and trailing airfoil **10** are shown tack welded to inner platform **4** and outer platform **6** by airfoil tack welds **48**.

Final machining of vane **2** is performed to finish proper gaspath surfacing and other critical surfaces including the mate faces on each platform end, bolt flanges, top and bottom edges of the platforms, seals, etc. Gaspath surfaces **42** on reassembled vane **2** are then coated using a conventional protective coating, for example, an aluminide coating, and coating process (step **36**). Cladding using the blended powder in step **28** allows the aluminide coating to be easily and uniformly applied to the replacement airfoils and the platform, thereby protecting gaspath surfaces **42**.
