(12) **United States Patent**  
**Azuma**

(10) **Patent No.:** **US 6,311,652 B2**  
(45) **Date of Patent:** **Nov. 6, 2001**

(54) **METHOD OF REPAIRING A CYLINDER HEAD HAVING COOLING WATER PASSAGES**

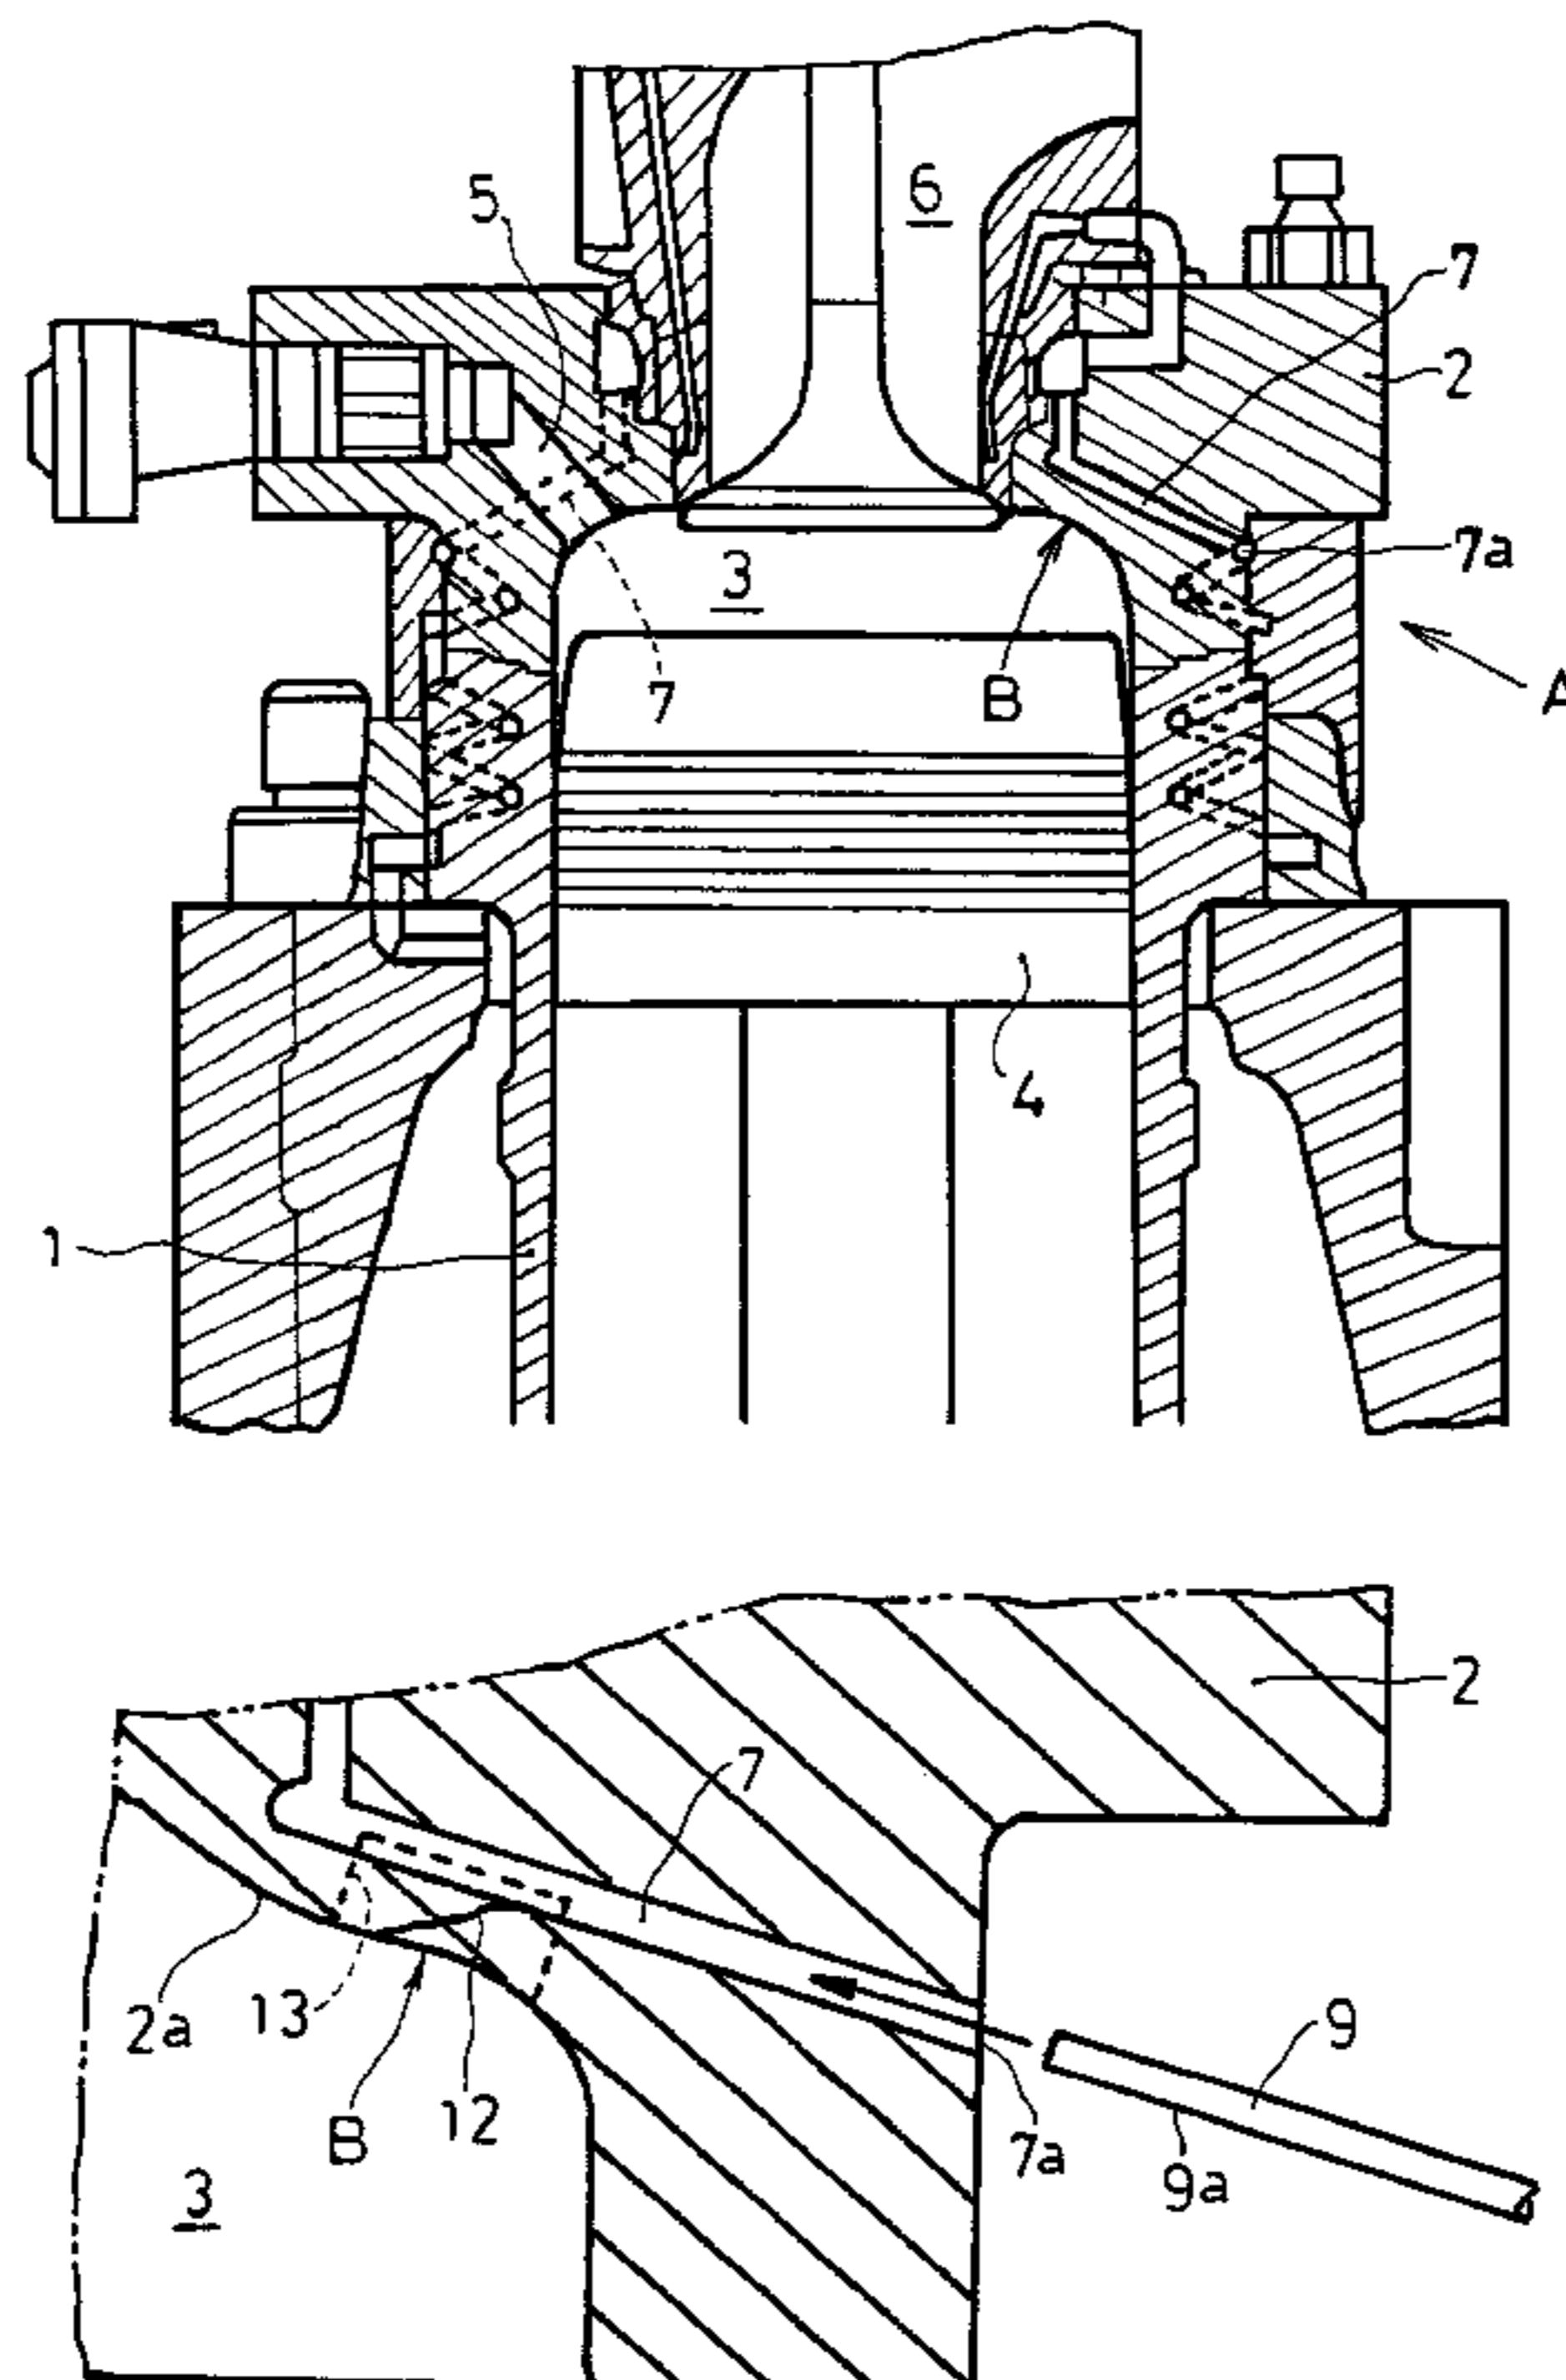
FIG. 1 is a cross sectional view of a part of a water cooling  
type internal combustion engine containing a cylinder head  
suitable to be repaired by the method according to one  
embodiment of the present invention.

Referring to FIG. 1, a water cooling type internal com-  
bustion engine includes a cylinder 1, a cylinder head 2  
secured on the cylinder 1, a piston 4 capable of reciprocating  
within the cylinder 1, a combustion chamber 3 defined by  
the cylinder 1 and the cylinder head 2 and the piston 4, an  
intake port 5 for intaking a mixed gas into the combustion  
chamber 3, and an exhaust port 6 for exhausting burned gas  
from the combustion chamber 3. The exhaust port 6 extends  
through the central portion of the cylinder head 2.

The cylinder head 2 contains a plurality of cooling fluid  
passages (cooling water passages) 7 each having a circular  
cross section and having an opening 7a on the outer surface  
of the cylinder head 2. FIG. 3 is a top plane view indicating  
the cylinder head of FIG. 1, when viewed from the com-  
bustion chamber 3. As can be clearly seen from FIG. 3, the  
plurality of cooling water passages 7 are arranged to extend  
radially within the cylinder head 2. In this manner, the  
cooling fluid (the cooling water) flowing through these  
cooling water passages 7 cools the cylinder head 2. In one  
embodiment, the cooling water passages 7 are formed by  
boring in the direction shown by an arrow A in FIG. 1 from  
the outer surface of the cylinder head 2 prior to the assem-  
bling of the entire engine.

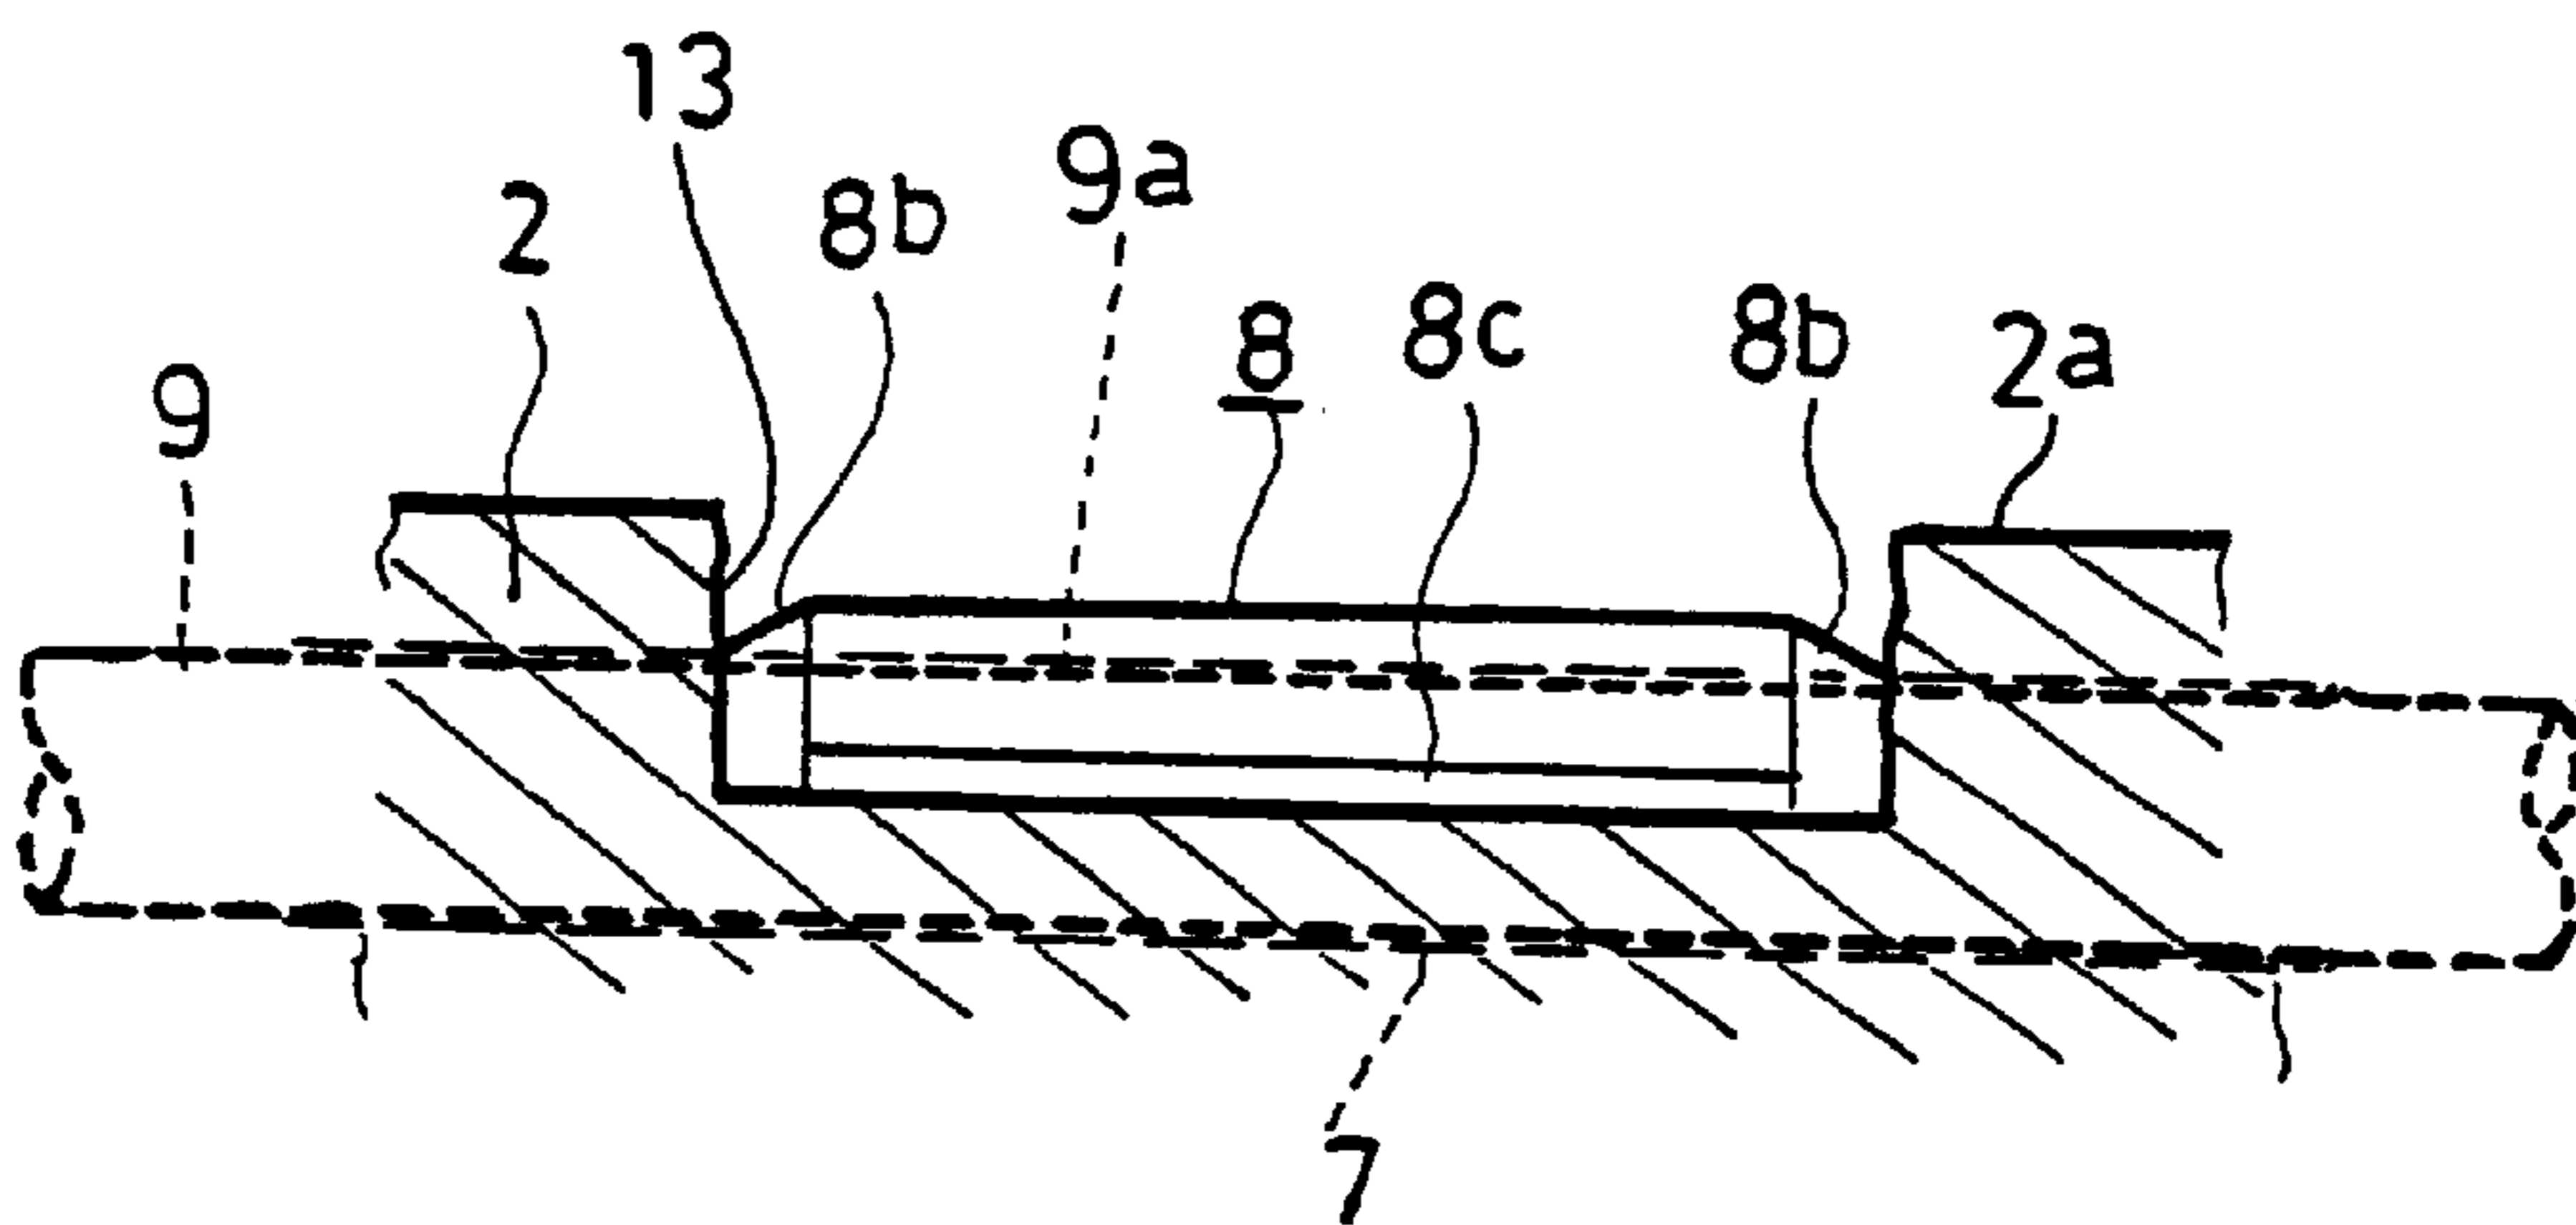
FIG. 8 is an explanatory view indicating one step of the  
method according to one embodiment of the present inven-  
tion.

Afterwards, each of the cooling water passages 7 is treated in the following manner. Namely, as shown in FIG. 8, a half-pipe 8 shown in FIGS. 4 and 5 is fixed within the groove 13 of the cylinder head 2 by means of welding such as TIG (Tungsten Inert Gas) arc welding, MIG (Metallic Inert Gas) arc welding or submerged arc welding, with the use of a filler metal 10. Under this condition, it is preferable that the welding operation be performed after welding portions have been preheated to a temperature of 100-150° C. with the use of a gas burner.

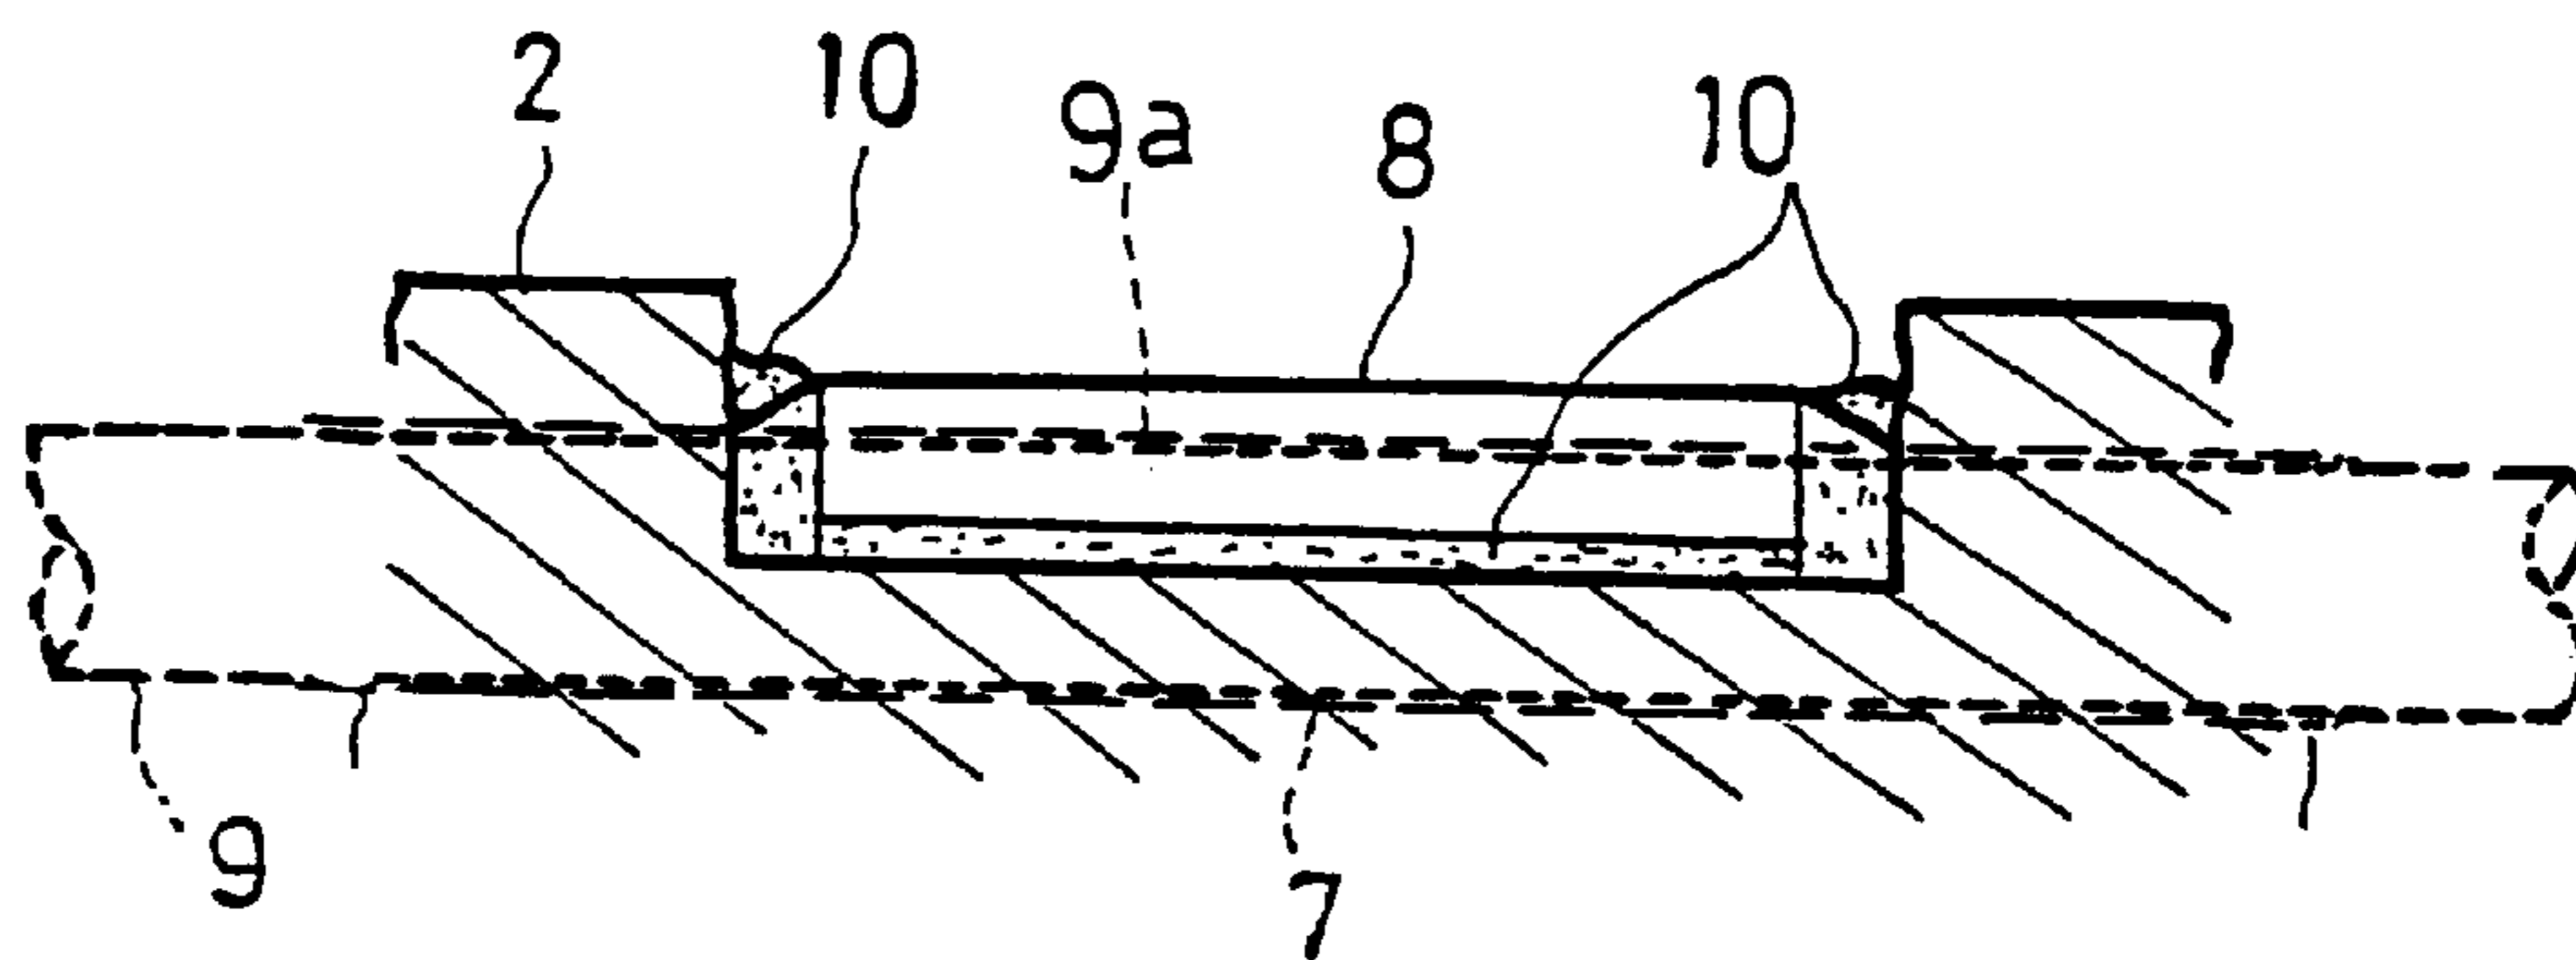
FIG. 9 is a cross sectional view indicating a part of a  
cylinder head repaired by the method according to one  
embodiment of the present invention.

Each half-pipe 8, upon being fixed in position as shown in FIG. 9, has a semicircular cross section which is as large as the half of the cross section of a cooling water passage 7. Therefore, as shown in FIG. 5, the inner surface 8a of each half-pipe 8 is the same as the half of a cooling water passage 7. Further, each half-pipe 8, as shown in FIG. 6, has a length which is equal to the width W (see FIG. 3) of a groove 13. In this way, as shown in FIG. 6, a half-pipe 8 is mounted on the guide member 9 so as to cover up the outer surface 9a of the guide member 9, which was previously exposed in the groove 13. At this time, as shown in FIG. 9, the inner surface 8a of the half-pipe 8, together with the inner surface 7b of the cooling water passage 7 having a semicircular cross section, serve to define a cooling water passage 7 upon completion of the repairing of the engine.

After each half-pipe 8 has been attached to the cylinder head 2, the guide member 9 is pulled so as to be removed from the cooling water passage 7, and, as shown in FIG. 9, the groove 13 is filled with filler metal 11. In order to remove a welding stress, it is preferred to perform a shot peening, for example, on the surface of a first and a second layer of the filler metal.
