(12) United States Patent Shim

US 6,327,007 B1 (10) Patent No.:

(54)	LIQUID CRYSTAL DISPLAY ACTIVE
	MATRIX WITH MULTIPLE REPAIR LINES
	HAVING RECTANGULAR CLOSED LOOPS

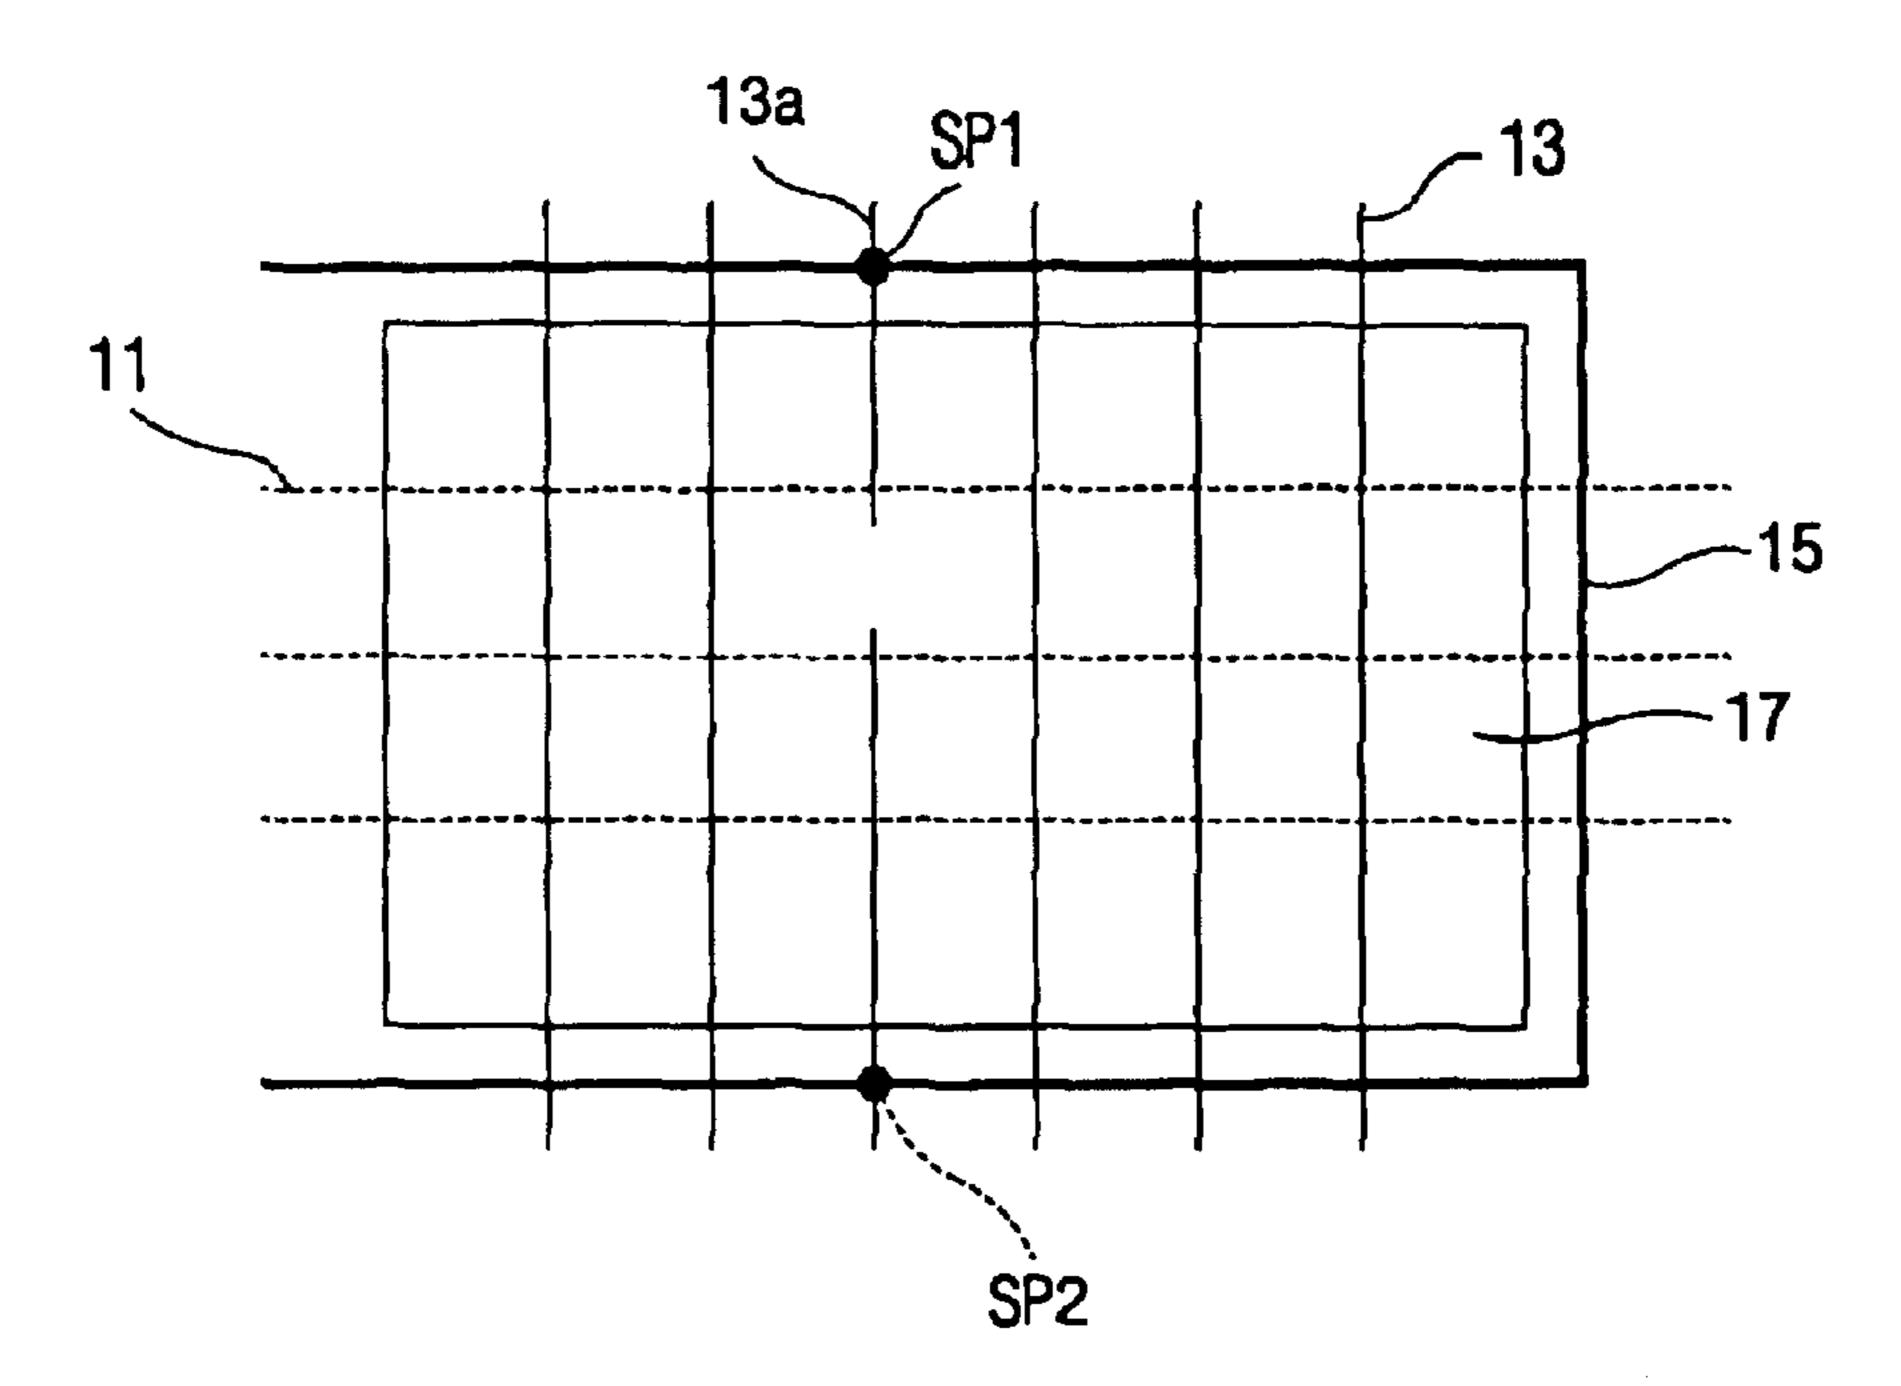
(PRIOR ART) FIG. 1

FIG. 1 shows a conventional repair structure for a line defect of a TFT-LCD device. An active display region 17 with a plurality of pixels is located on a substrate of a liquid crystal display (LCD) device. A plurality of gate lines 11 are arranged in a transverse direction and a plurality of data lines 13 are arranged in a longitudinal direction. A repair line 15 is located outside the active display region 17 in order to repair an open data line. When one of the data lines 13 is opened, the repair line 15 is connected to the open line at two cross points SP1 and SP2. Then, the data signal flows toward a source electrode along a path in the repair line 15.

However, the conventional repair structures have the following disadvantages. Since the repair line 15 is formed outside the active display region 17 in FIGS. 1, 2 and 3, the length of the path of the repair line 15 along which the gate 65 or data signals must flow is long. Thus, a resistance of the repair line 15 increases causing signal loss and signal delay.

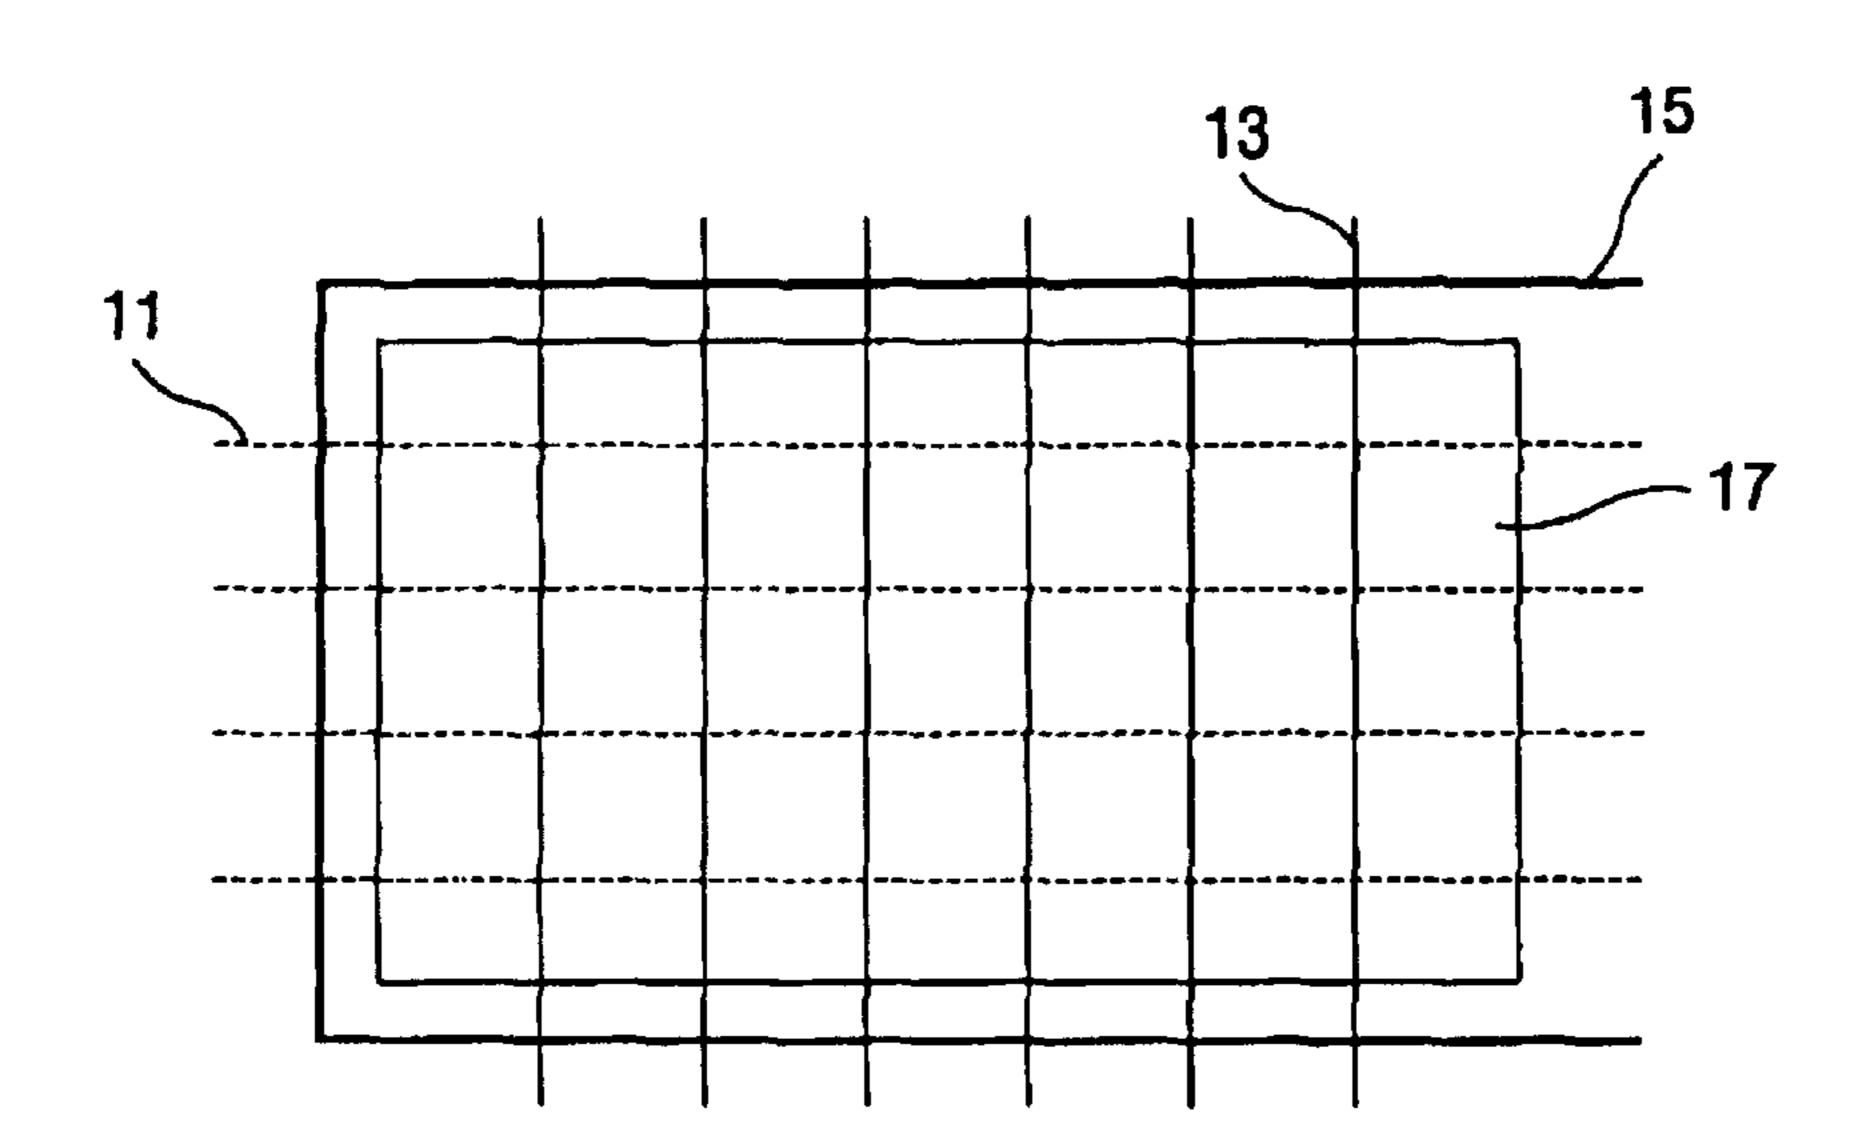
(PRIOR ART) FIG. 2

FIG. 2 shows a modified conventional repair structure of FIG. 1, and FIG. 3 shows another conventional repair structure. In FIGS. 2 and 3, the same method as in FIG. 1 is 60 used to repair the line defect.

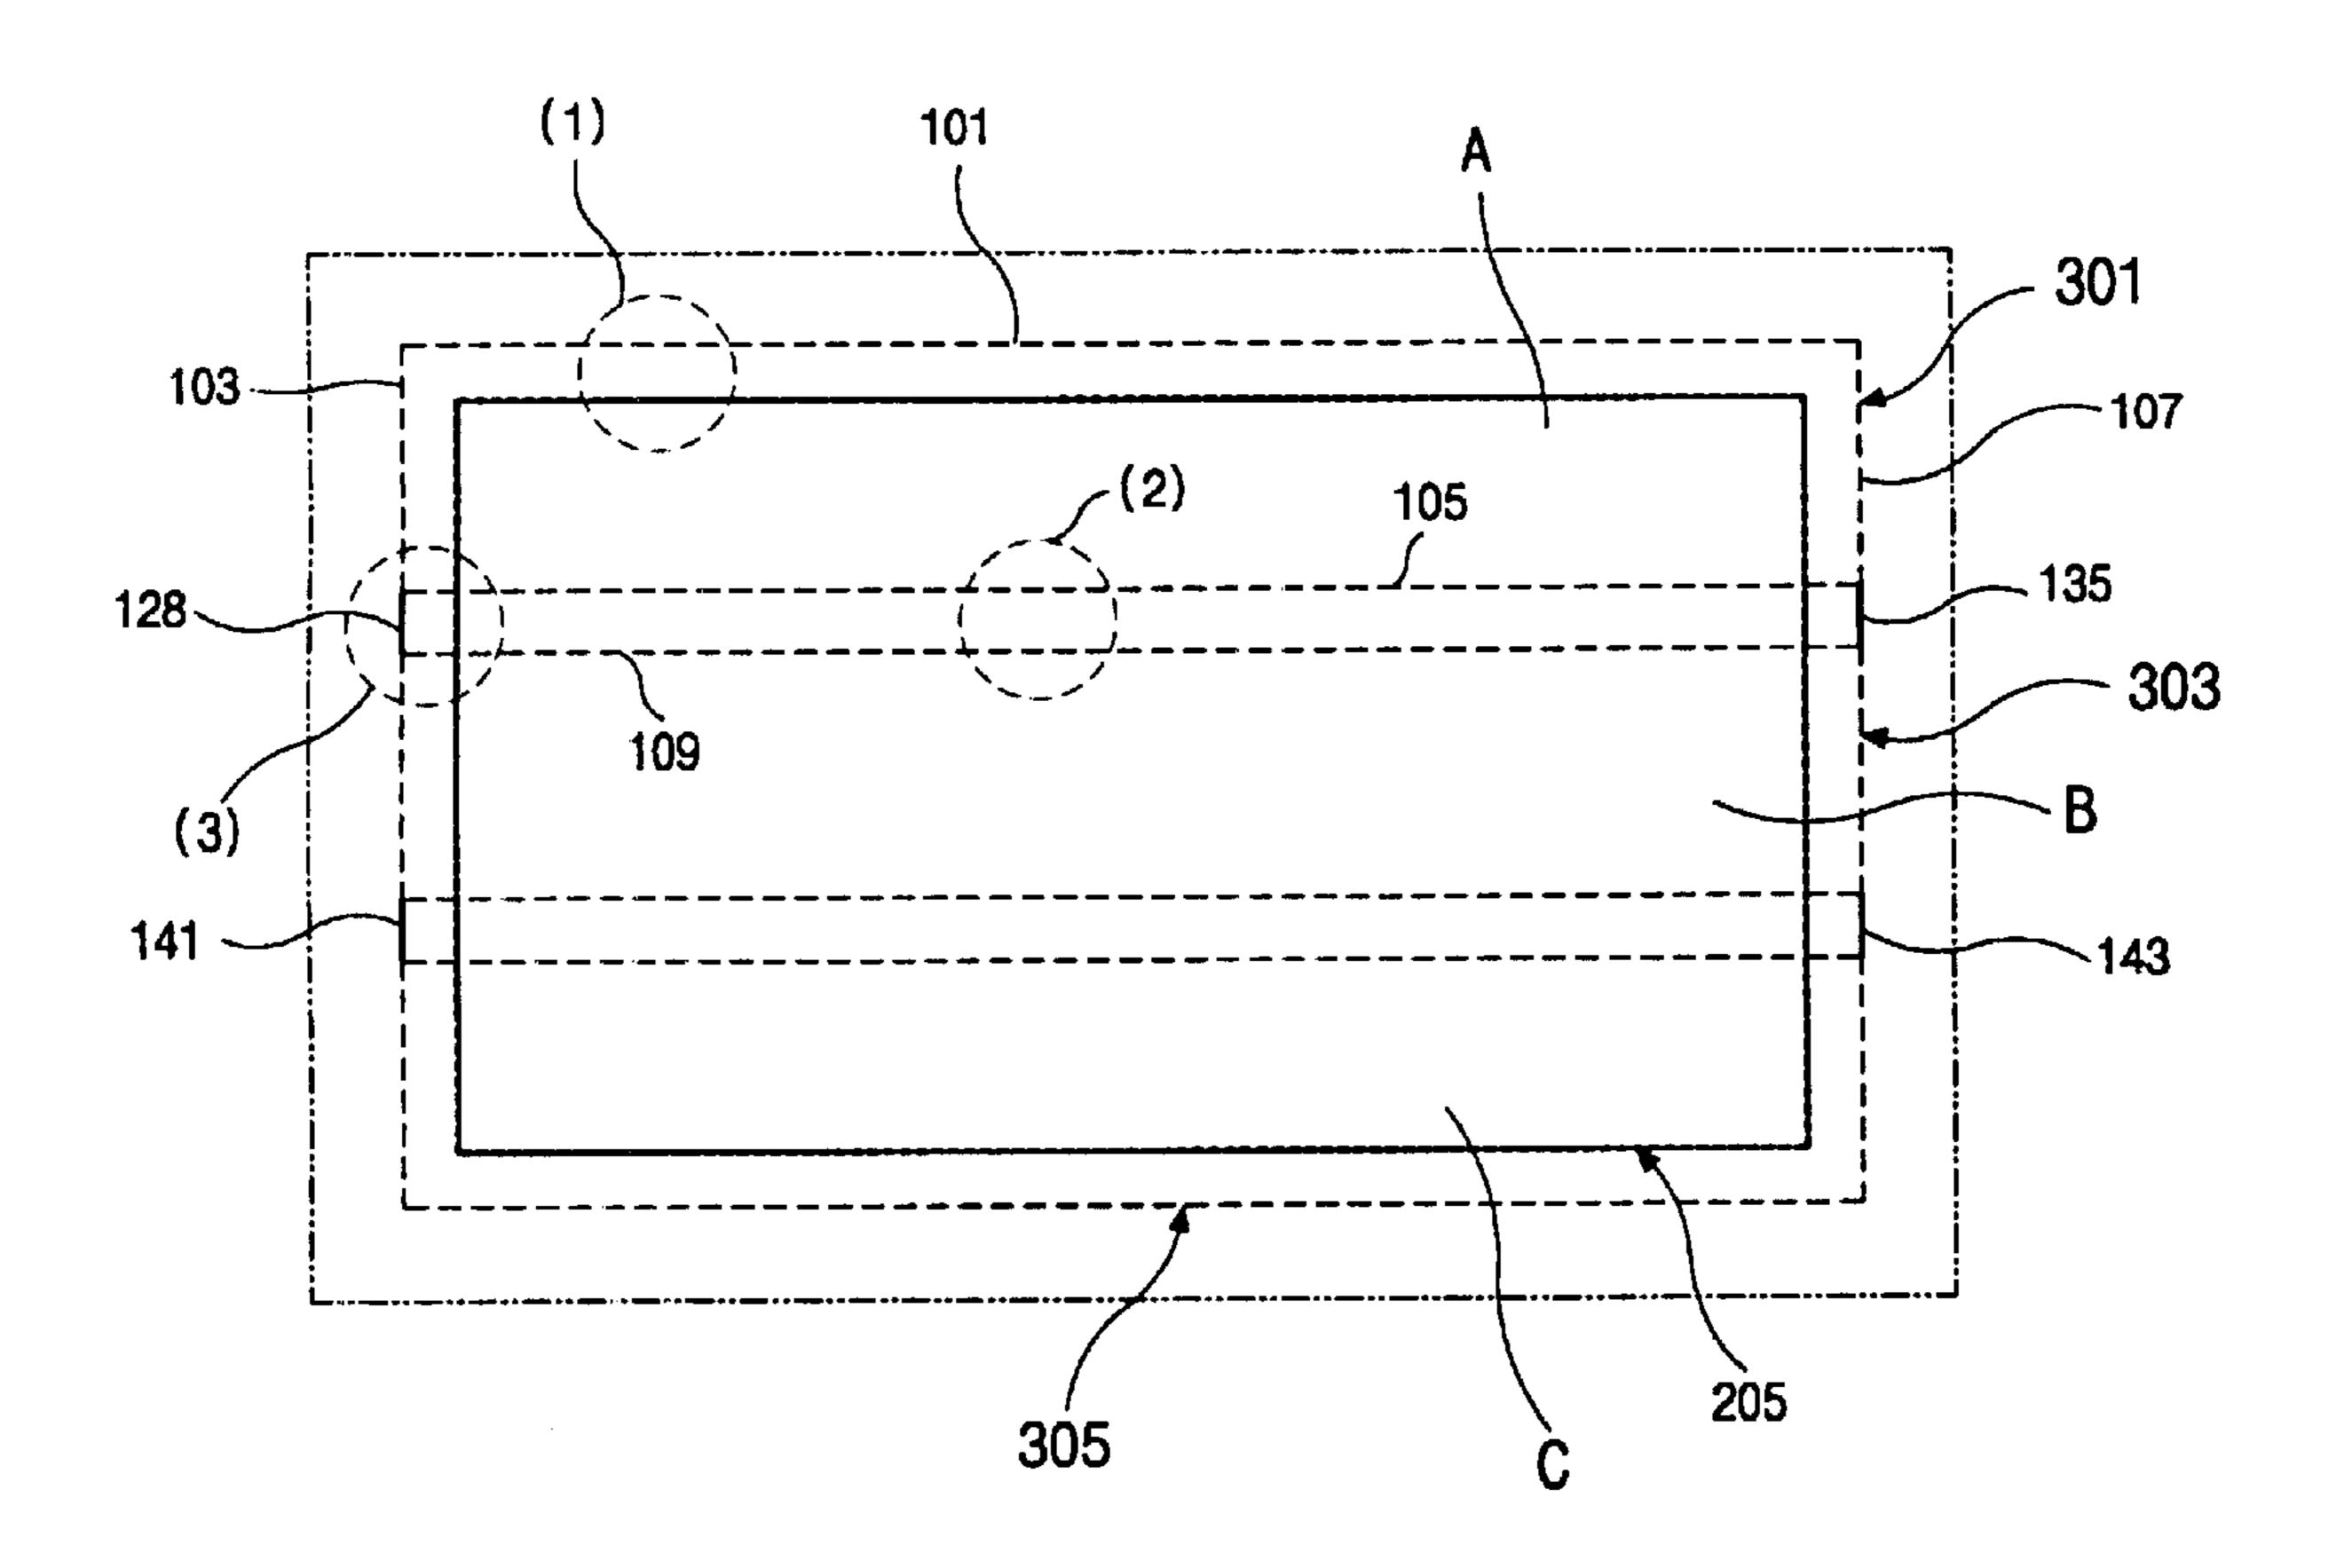
FIG. 4

As shown in FIG. 4, an active display region 205 with a plurality of pixels is divided into three sections "A", "B" and "C". Three repair lines 301, 303 and 305 are located in sections "A", "B" and "C" in the form of a rectangular 15 closed loop, respectively. They are also electrically disconnected from each other.

The rectangular closed loop repair line 301 in section "A" has a first transverse repair line 101, a second transverse repair line 105 spaced from and parallel to the first trans-20 verse repair line 101, and first and second longitudinal repair lines 103 and 107 connecting the first and second transverse repair lines 101 and 105. The first and second longitudinal repair lines 103 and 107 are located in the non-display region or outside the active display region 205 without 25 overlapping the data lines (not shown).

The rectangular closed loop repair lines 303 and 305 of sections "B" and "C" are substantially the same as that of section "A".

First and second connection bars 128 and 135 are preferably arranged to couple the rectangular closed loop repair lines 301 and 303. The third and fourth connection bars 141 and 143 are also arranged to connect the rectangular closed loop repair lines 303 and 305. The connection bars 128, 135, 141 and 143 are arranged on an insulating layer on the rectangular closed loop repair lines 301, 303 and 305.

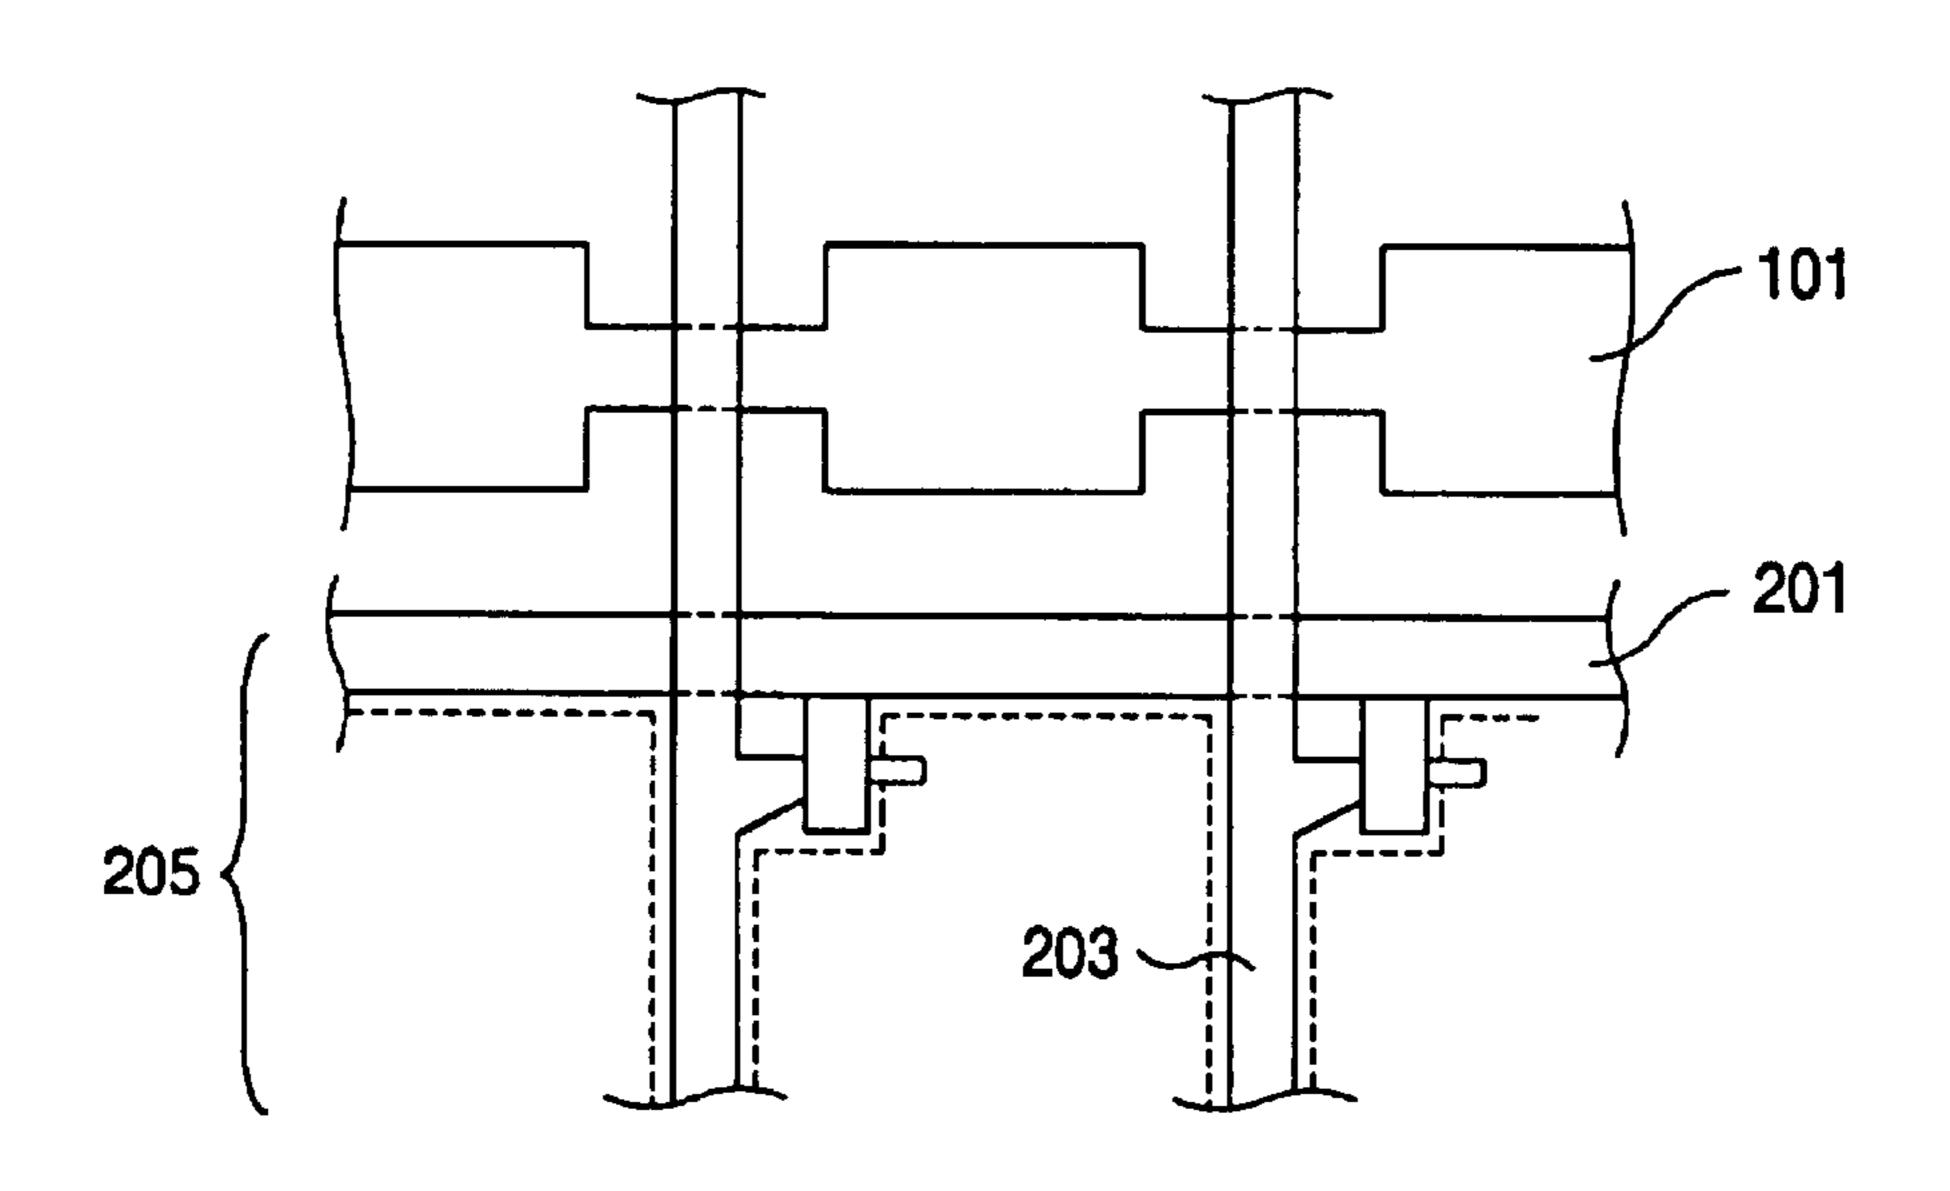
FIG. 5

As shown in FIG. 5, which is an enlarged view of portion (1) in FIG. 4, the first transverse repair line 101 is located at a portion outside the active display region 205 and crosses over the data line 203 with an insulating layer (not shown) between them.

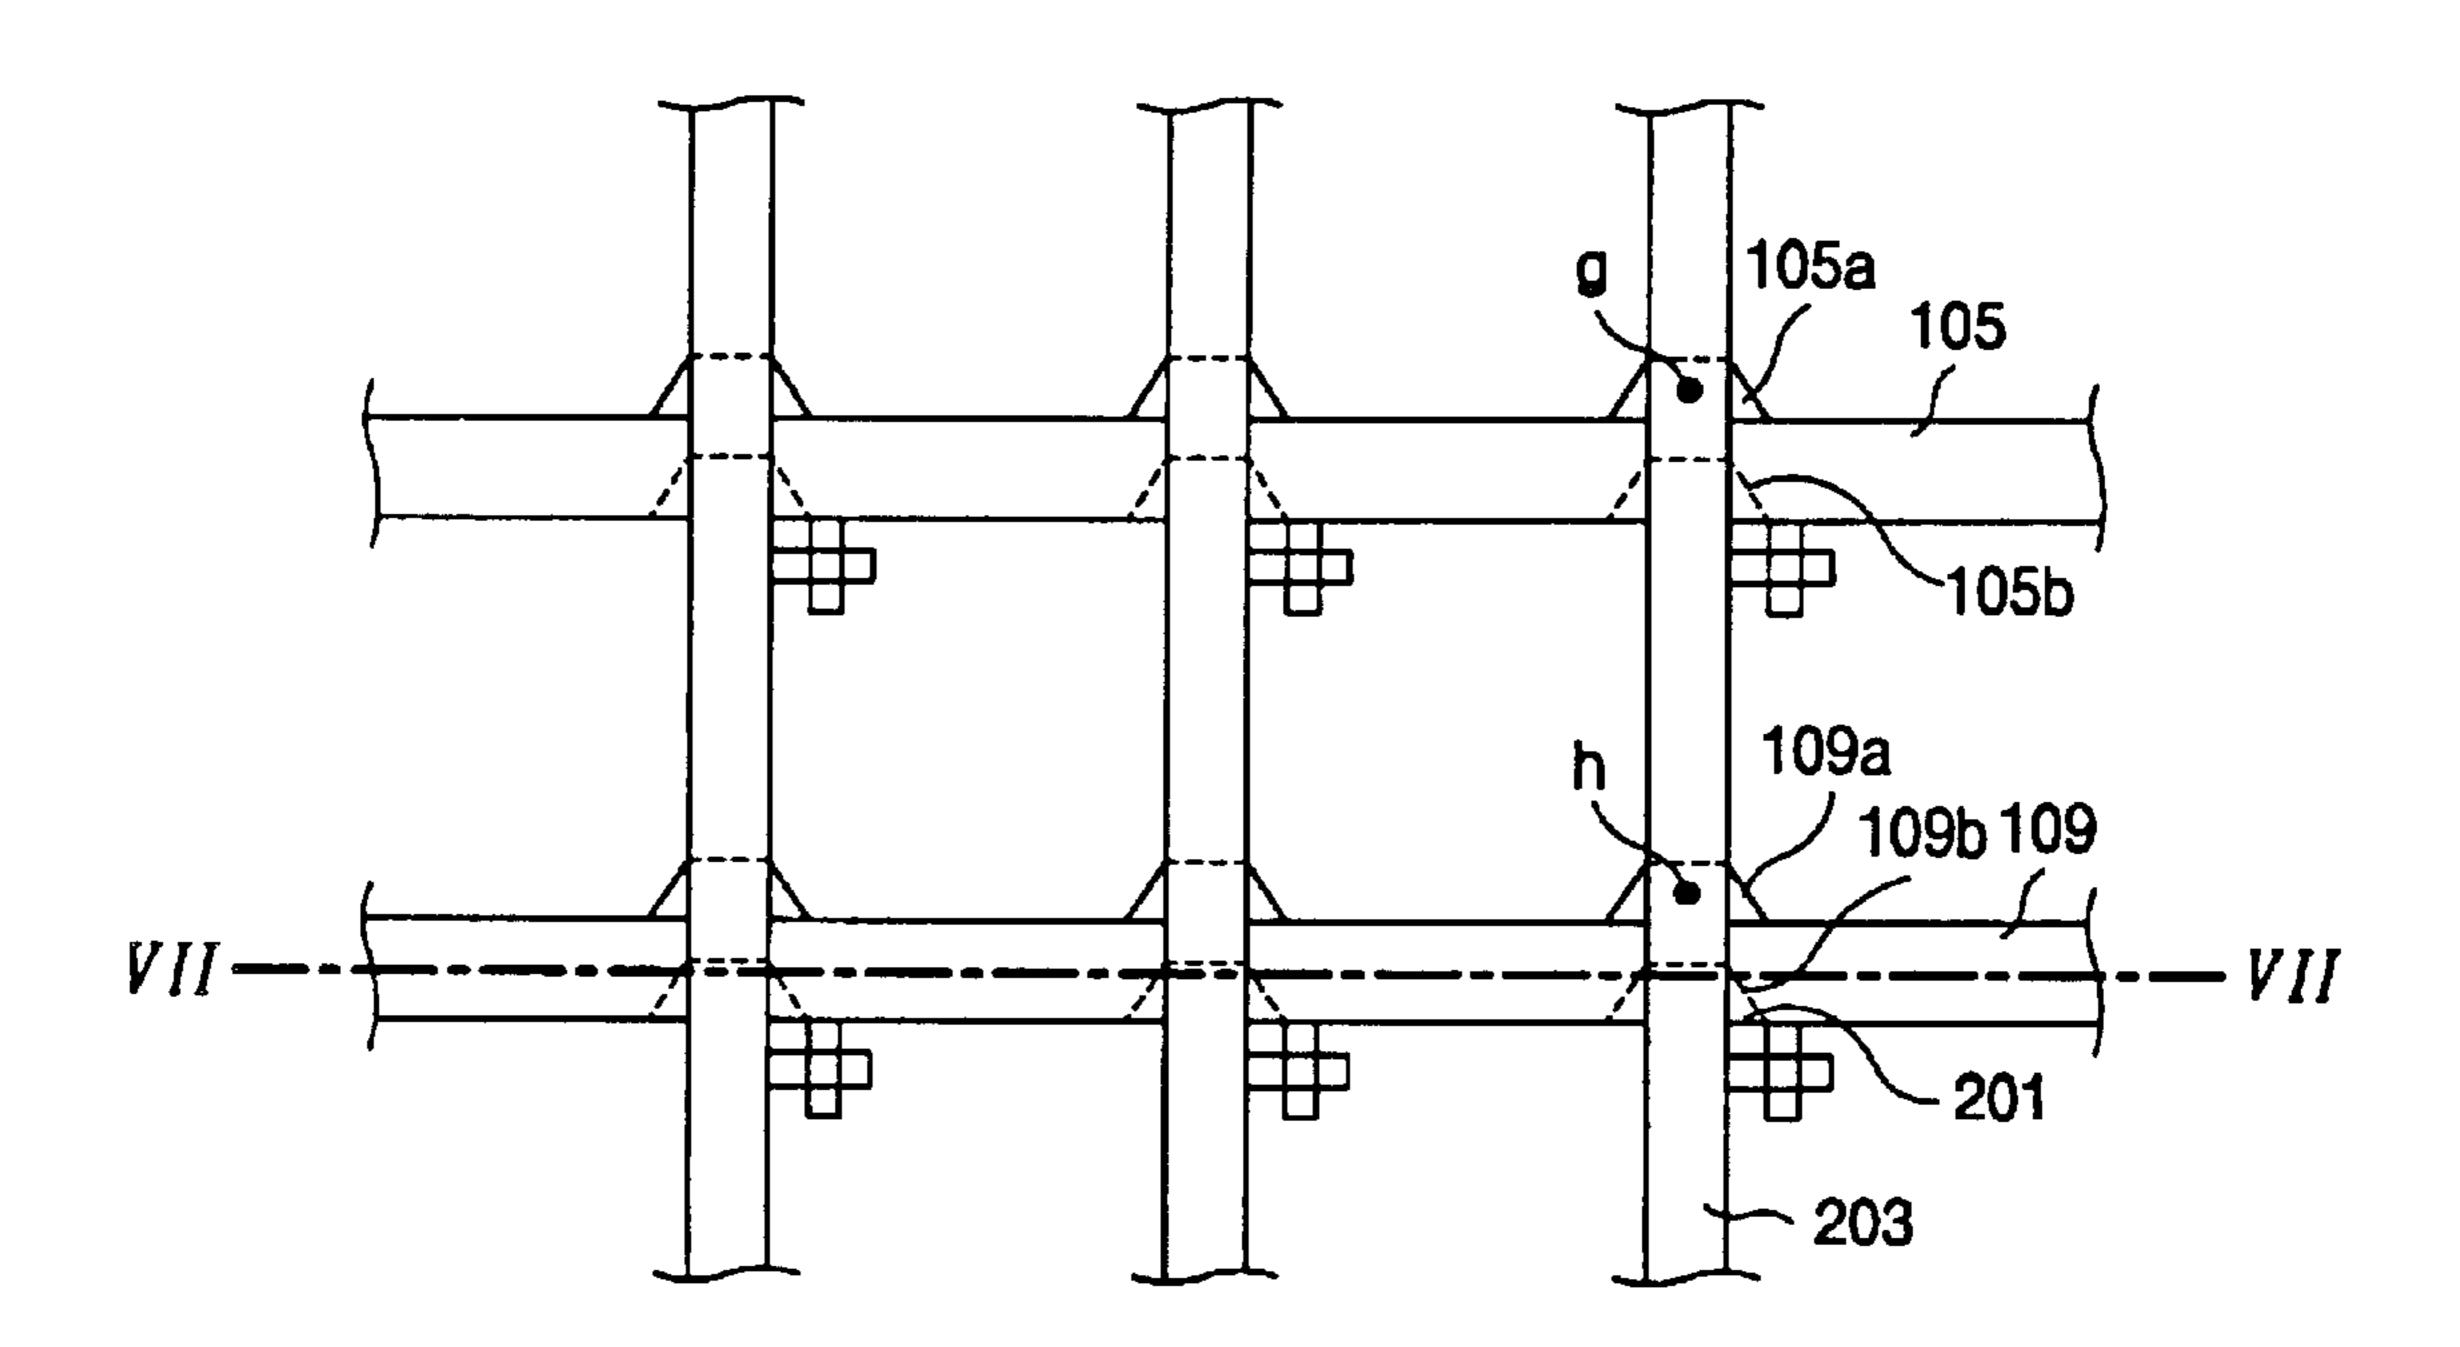
FIG. 6 is an enlarged view of portion (2) in FIGS. 4. As shown in FIG. 6, the transverse repair lines 105 and 109 have protrusion portions 105a and 109a and recess portions 105b and 109b, respectively, at all cross points with the data lines 203 such as the cross points "g" and "h". The gate line is linearly shaped without any protrusions. Thus, there is no gate line over the protrusion portions 105a and 109a of the repair lines 105 and 109.

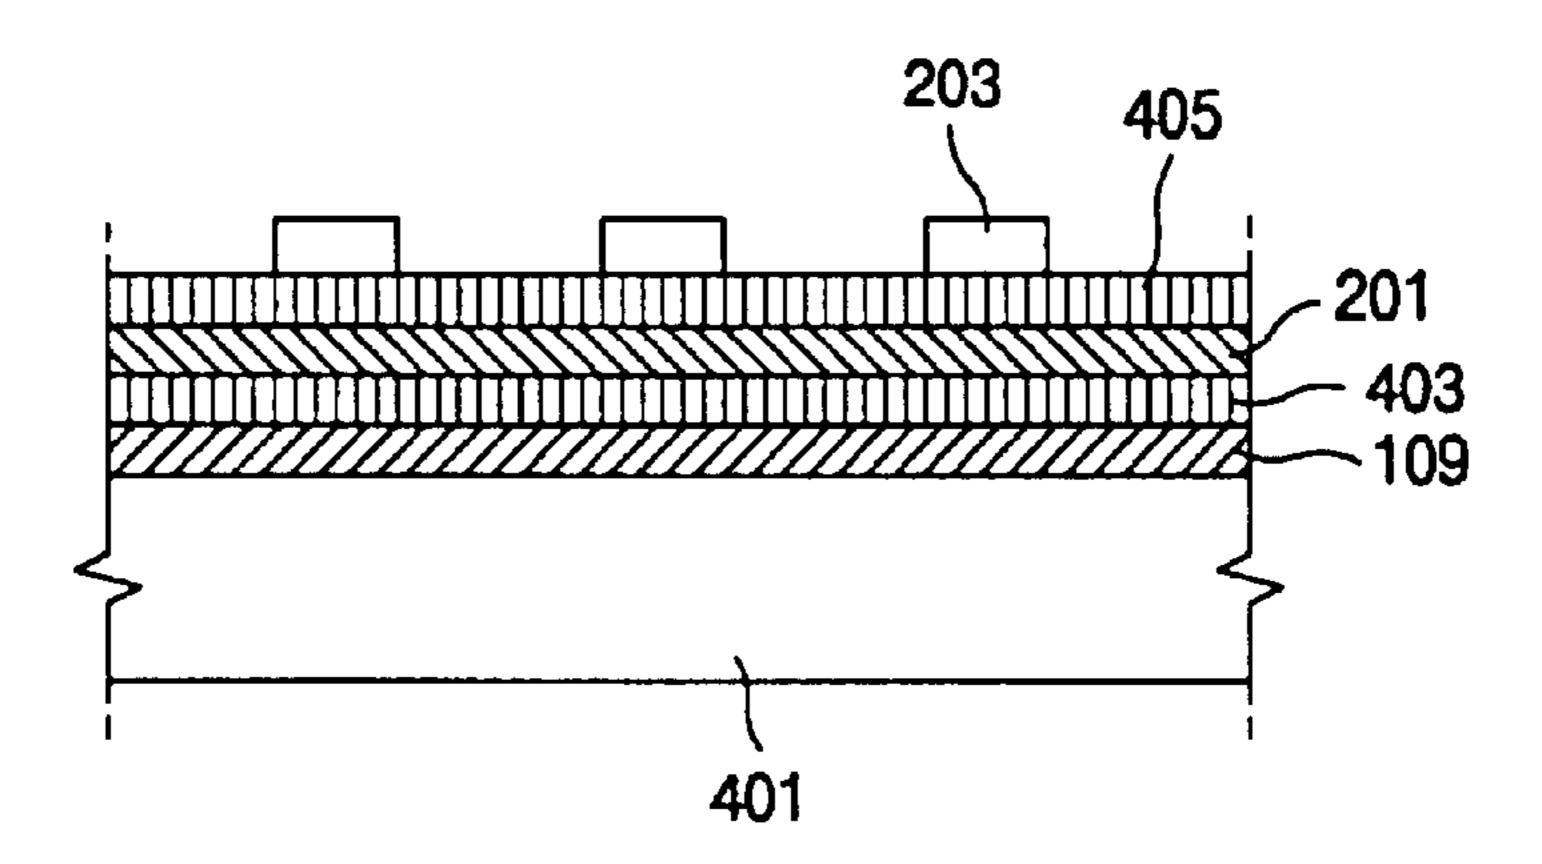
FIG. 7 shows a sectional view taken along line VII—VII of FIG. 6. On a glass substrate 401 is deposited and patterned a suitable conductive metal preferably selected from the group consisting of Mo, Al, W and W-Ta or the like in order to form the repair line 109. Then, a first insulating layer 403 is formed on the repair line 109. On the first insulating layer 403 is formed the gate line 201. On the gate line 201, a second insulating layer 405 is formed. On the second insulating layer 405, the data lines 203 are formed which cross over the gate line 201. The repair line 109, the gate line 201 and the data line 203 are electrically disconnected or insulated from each other by the first and second insulating layers 403 and 405.

When the gate line 201 become open, it is electrically connected to the repair line 109 through the first insulating 65 layer 403 at a point where the repair line 109 is positioned below the opened gate line 201. When the data line 203 is

opened, it is shorted with the repair line 109 at the protrusion portion 109a through the second insulating layer 405.

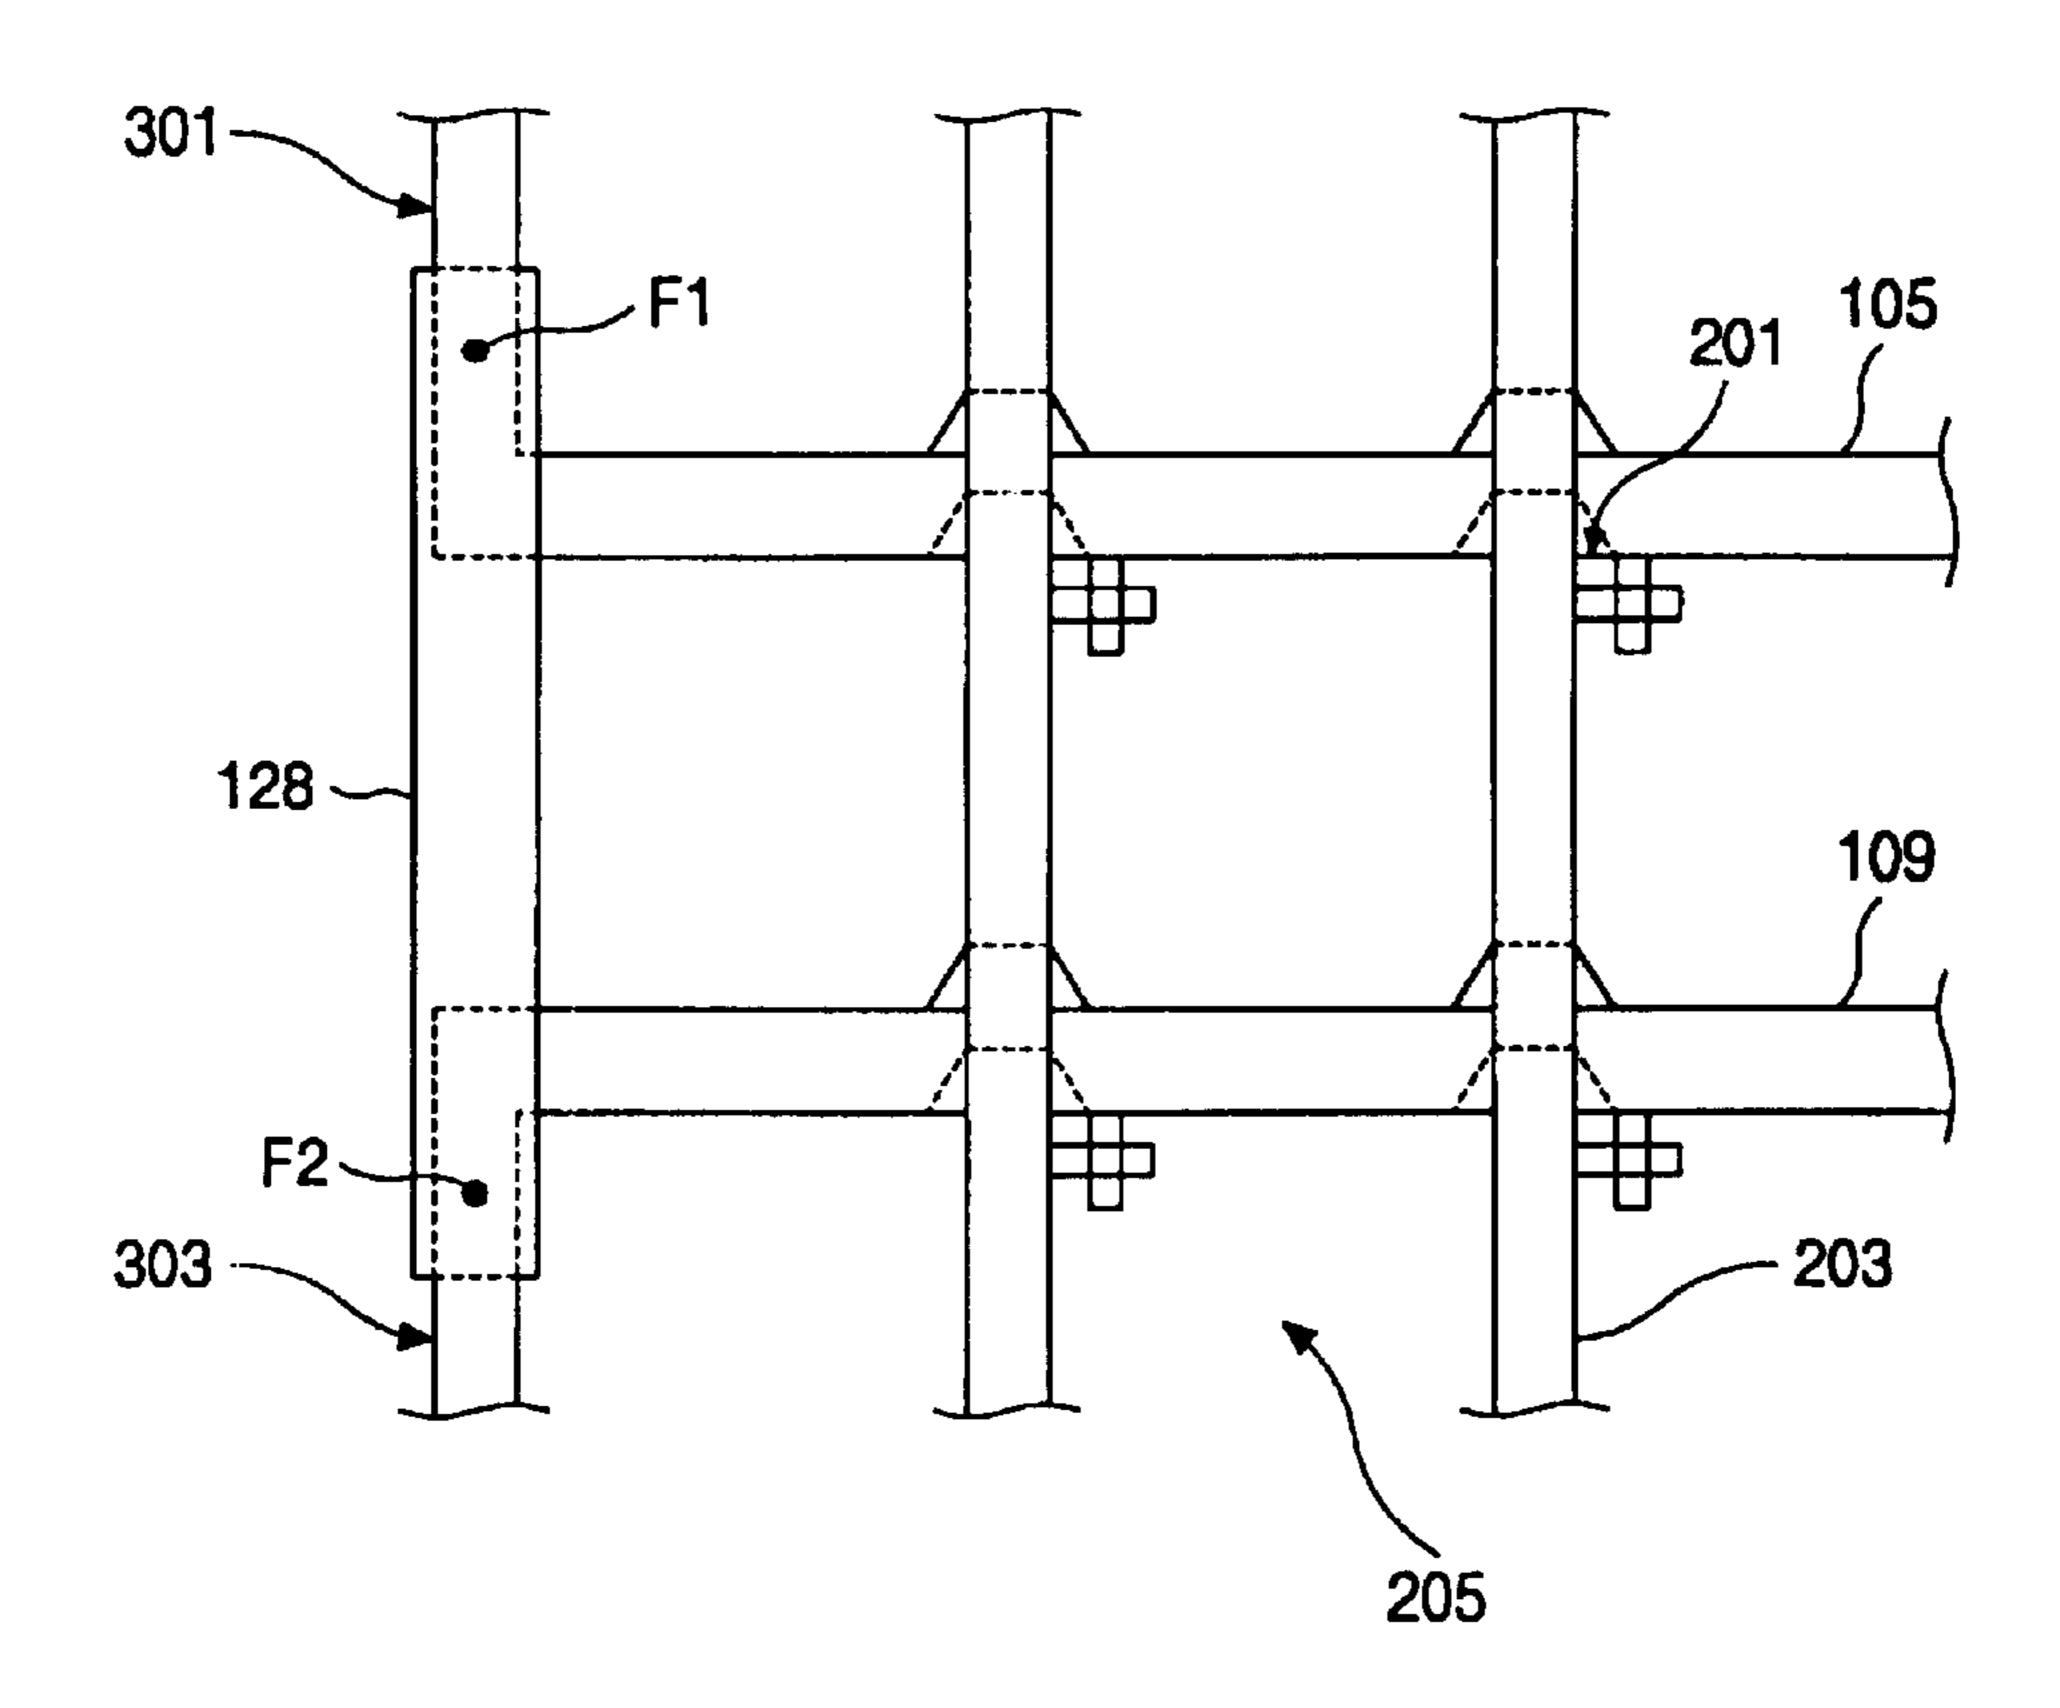
FIG. 8 shows one of the connection bars for coupling the adjacent rectangular closed loop repair lines 301, 303 and 305. The connection bar 128 couples the adjacent repair lines 301 and 303 mainly when one of the repair lines 301 and 303 is opened. The connection bar 128 is arranged on an insulating layer (not shown) over each end portion of the first longitudinal repair lines of the rectangular closed loop repair lines 301 and 303. The rectangular closed loop repair lines 301 and 303 are connected to each other at the overlapping portions "F1" and "F2" by the connection bar 128.
