(12) United States Patent Shim

US 6,327,007 B1 (10) Patent No.:

(54)	LIQUID CRYSTAL DISPLAY ACTIVE
	MATRIX WITH MULTIPLE REPAIR LINES
	HAVING RECTANGULAR CLOSED LOOPS

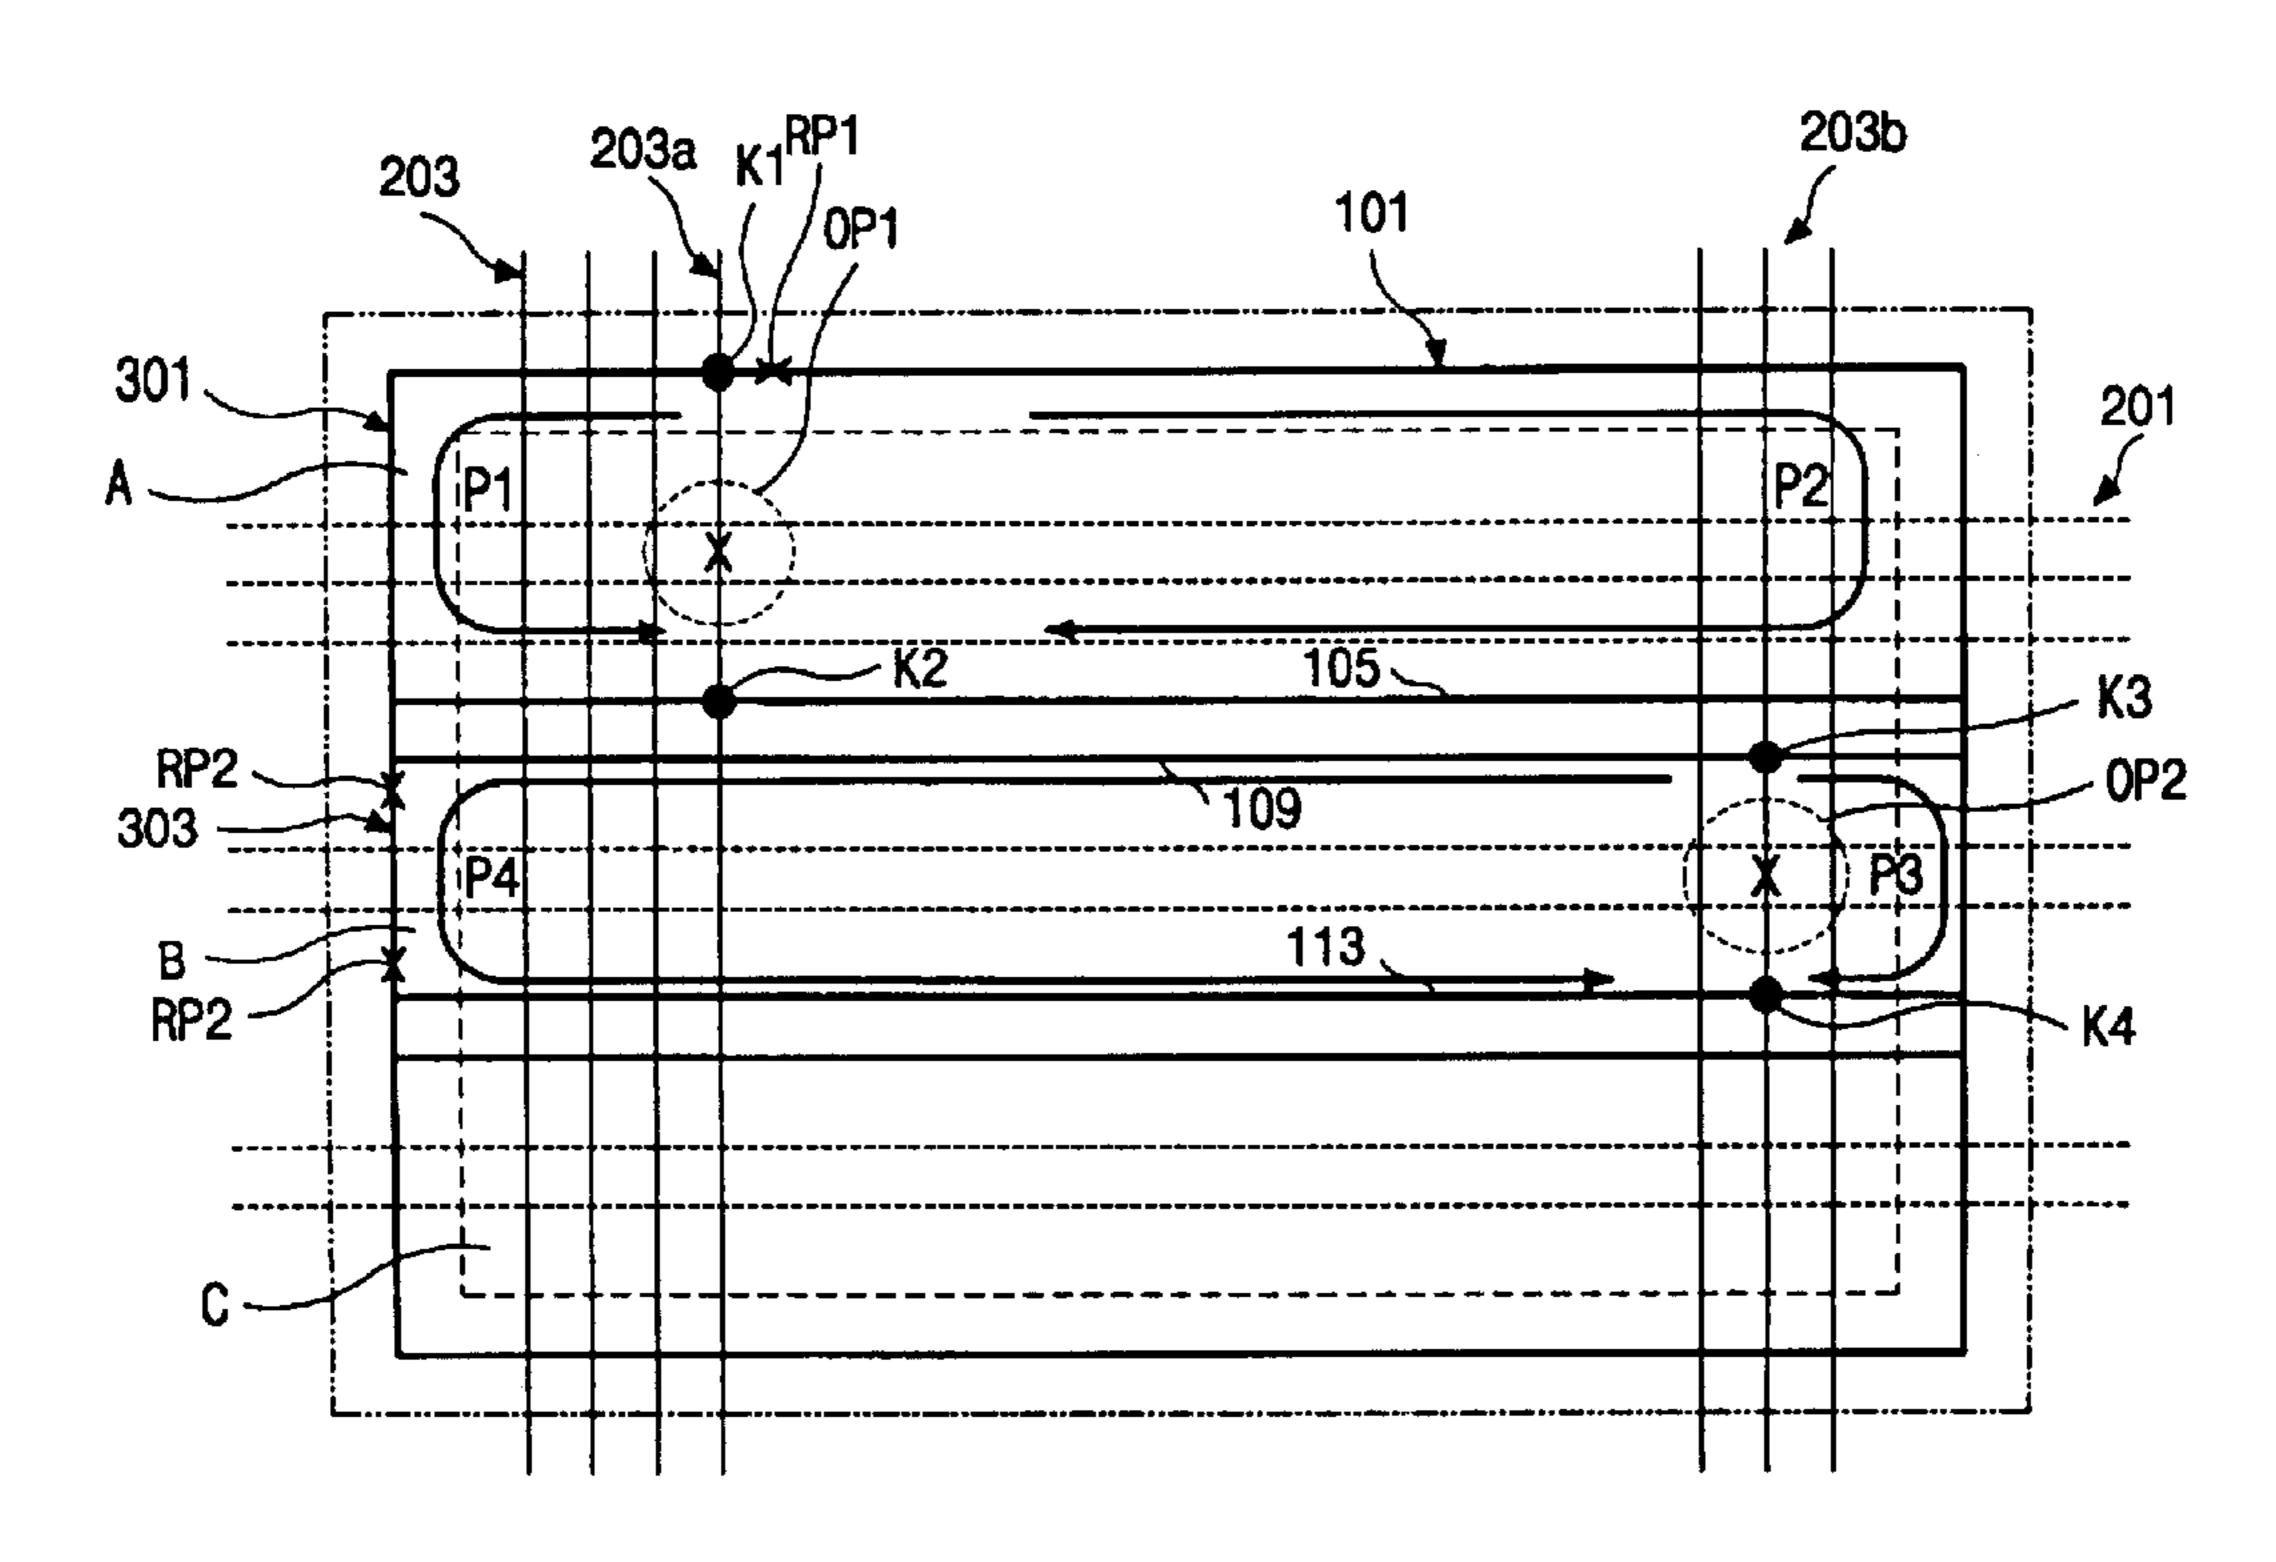
FIG. 9 shows a method for repairing a data line with a line defect.

Let us assume that certain data lines 203a and 203b are opened at portions OP1 and OP2 in sections "A" and "B", respectively. In order to repair the open portion OP1 in section "A", the data line 203a is connected to the first transverse repair line 101 of the closed loop repair line 301 at a cross point "K1" and to the second transverse repair line 105 of the repair line 301 at a cross point "K2". Then the data signal can transmit through two paths P1 and P2. Then, a portion RP1 in the longer path P2 is preferably cut.

In order to repair the open portion OP2, the data line 203b is connected to the first transverse repair line 109 of the closed loop repair line 303 at a cross point "K3" and to the second transverse repair line 113 of the repair line 303 at a cross point "K4". The data signal can transmit through two paths P3 and P4. Then, a small portion in the longer path P4 is preferably cut.

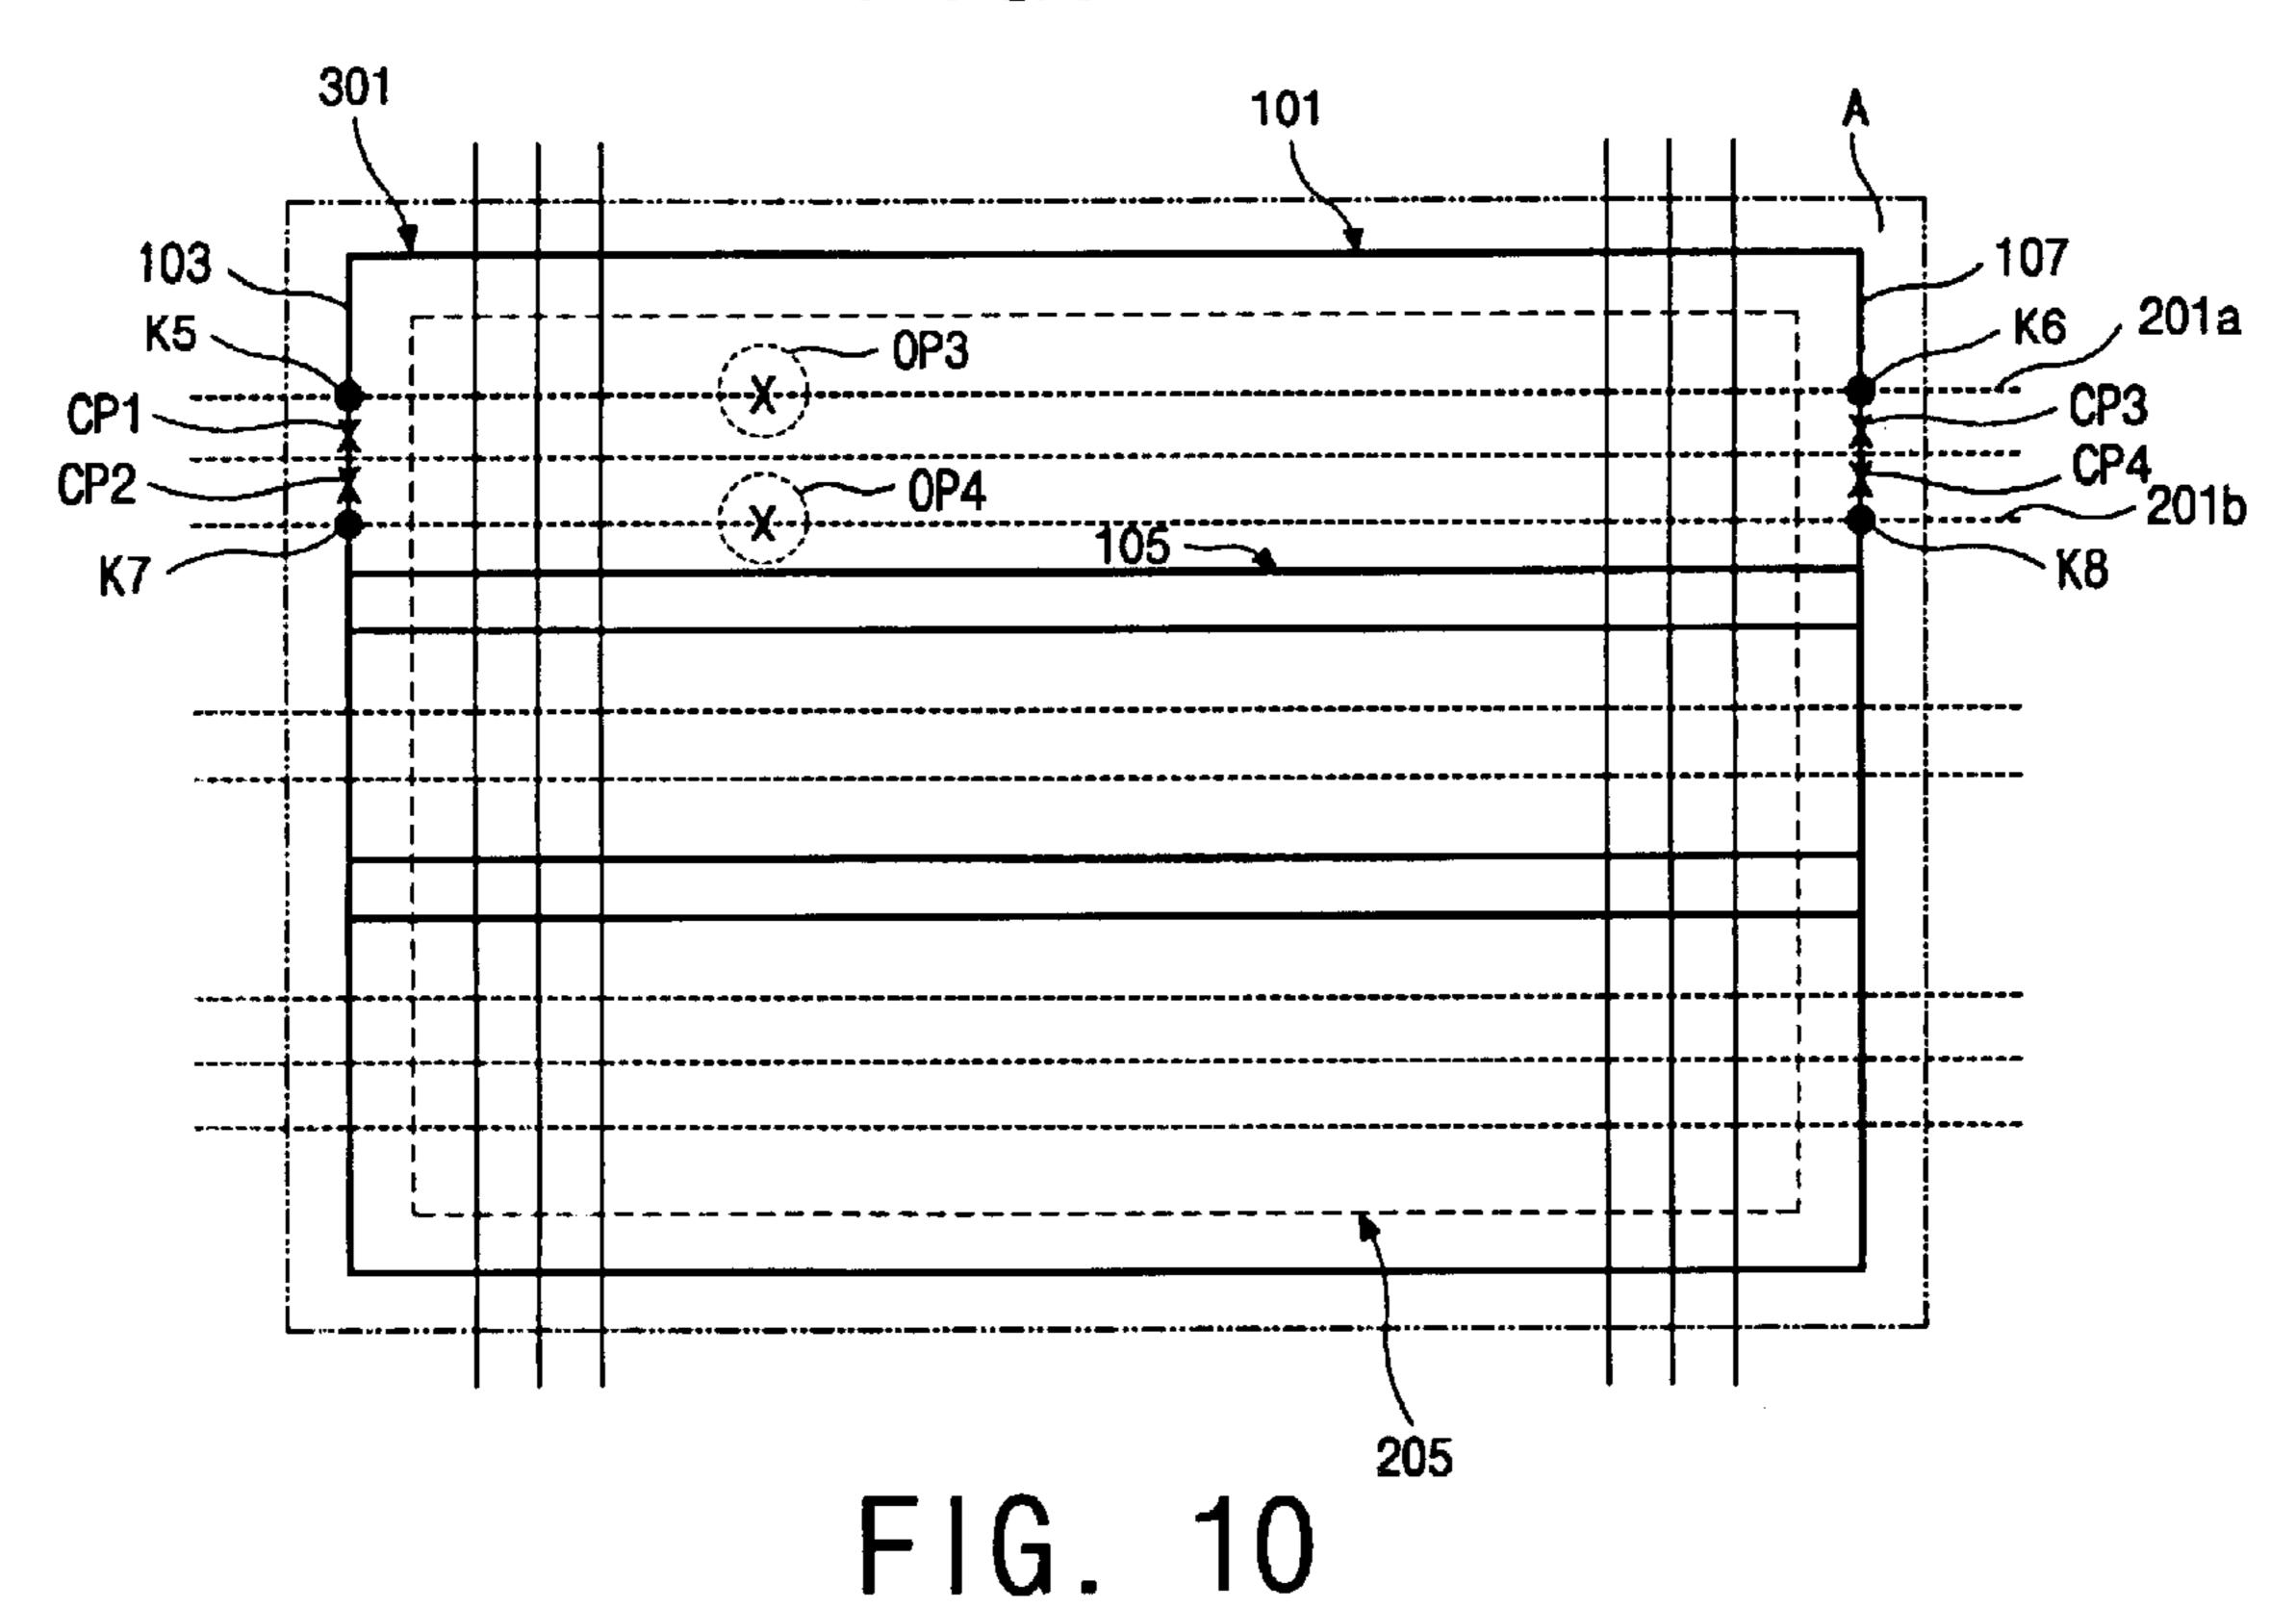
FIG. 10 shows a method for repairing a line defect in a gate line.

Let us assume that certain gate lines 201a and 201b become open at portions OP3 and OP4 in section "A", respectively. In order to repair the open portion OP3 in the section "A", the gate line 201a is connected to the first longitudinal repair line 103 of the closed loop repair line 301 at a cross point "K5" and to the second longitudinal repair line 107 of the repair line 301 at a cross point "K6". In order to repair the open portion OP4, the gate line 201b is connected to the first longitudinal repair line 103 of the closed loop repair line 301 at a cross point "K7" and to the second longitudinal repair line 107 of the repair line 301 at a cross point "K8".

However, paths that will interfere with the repair line should be removed. For example, one path in the rectangular closed loop repair line 301 which is connected to a good gate line and the other path in the rectangular closed loop repair line 301 which is connected to the good gate line should be electrically disconnected from each other. Thus, portions CP1 and CP2 on the first longitudinal repair line 103 and cutting portions CP3 and CP4 on the second longitudinal repair line 107 are removed or cut to allow each gate signal to flow separately along each corresponding path in the rectangular closed loop repair line 301.
