(10) **Patent No.:** **US 6,352,406 B1**
(45) **Date of Patent:** **Mar. 5, 2002**

(54) **METHOD FOR ASSESSING QUALITY OF A COATING PROCESS AND ASSEMBLY THEREFOR**

(73) Assignee: **General Electric Company**, Schenectady, NY (US)

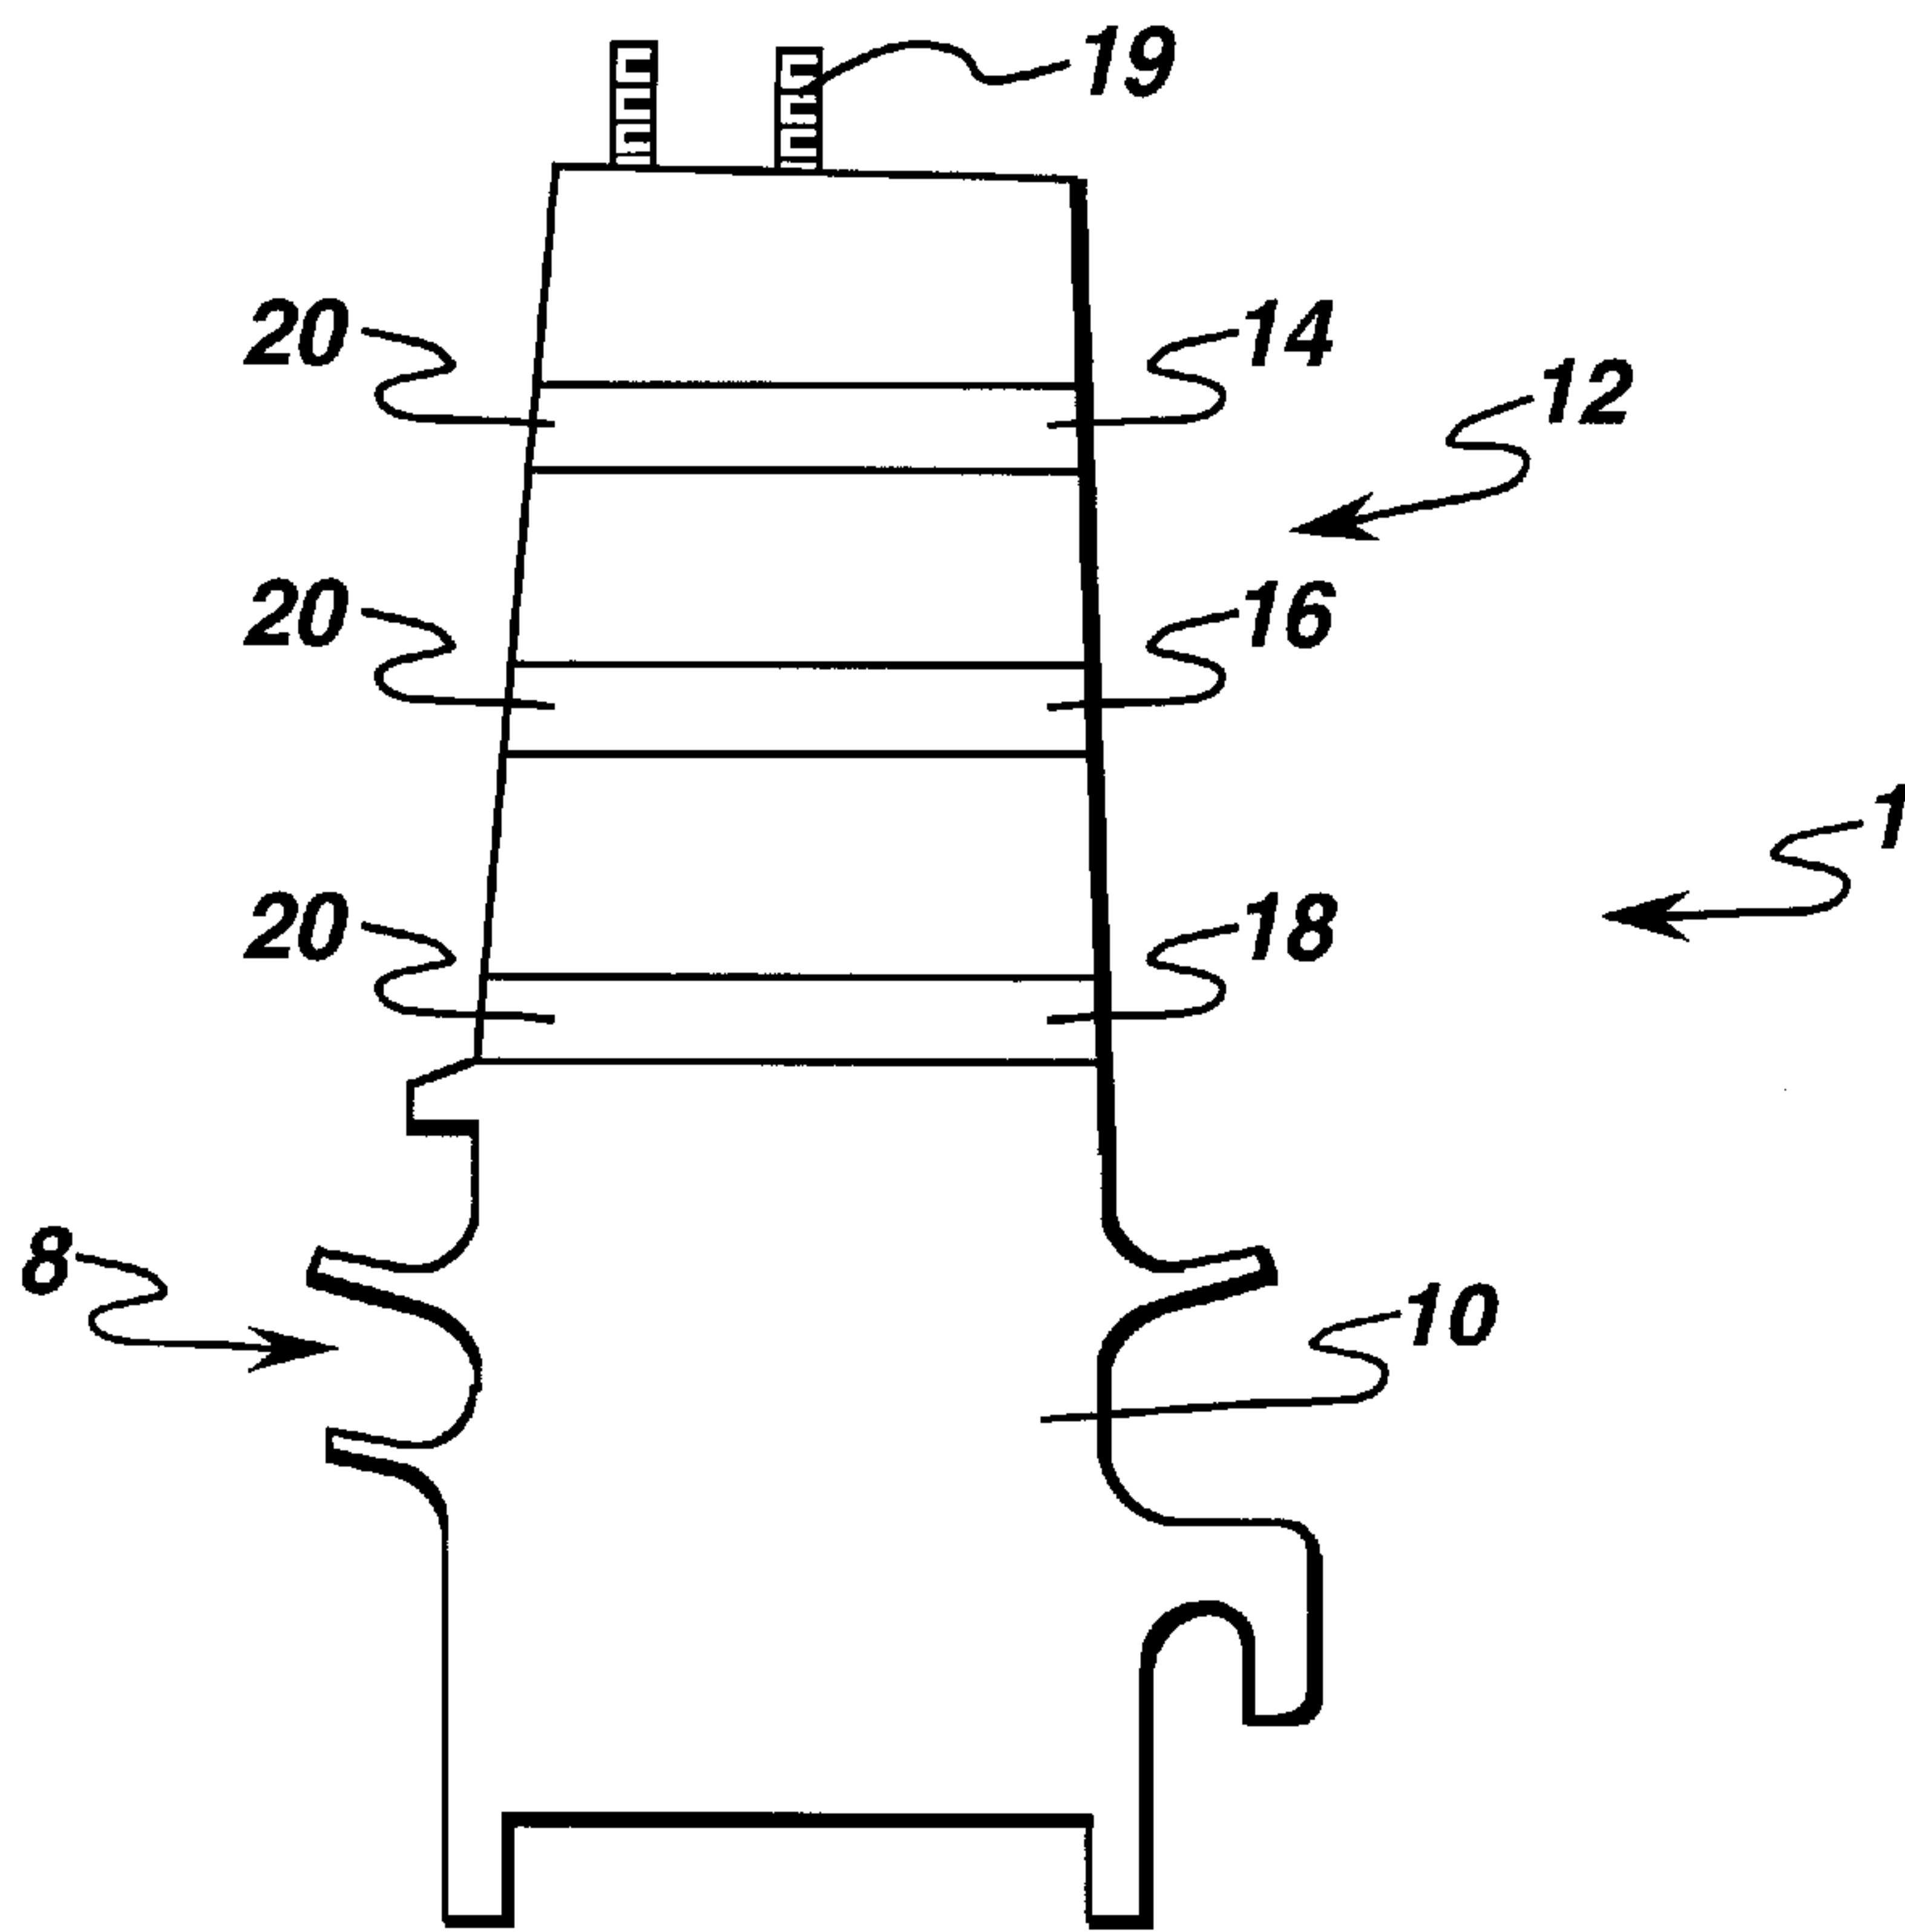
fig. 1

FIG. 1 illustrates a facsimile assembly of an airfoil for a turbine engine;

Turning to FIG. 1, an example of a facsimile assembly 1 is illustrated, including fixture 8, which supports a plurality of audit coupons 14, 16 and 18. The fixture 8 includes base 10 and threaded rods 19, which are threaded into complementary threaded cylindrical openings (not shown) within base 10. Threaded rods 19 extend axially through the audit coupons. In addition to base 10 and threaded rods 19, the fixture 8 further includes spacers 20 which are employed to axially space the audit coupons from each other. Alternately, the coupons can be suspended on the threaded rods at specific axial positions without spacers. However, for coating processes in which the coating build-up can be affected by rebound of material from adjacent surfaces, such as thermal spray, the use of spacers more closely replicates the airfoil surface.

The fixture 8 is reusable, and is generally fabricated from a single sacrificial airfoil. Particularly, an airfoil is obtained and sectioned so as to remove portions of the airfoil corresponding to audit coupons 14, 16, and 18. The sectioning then leaves behind base 10 and spacers 20. The base 10 is then modified to receive threaded rods 19, by tapping the base or by inserting threaded cylindrical fittings. Although the distal ends of threaded rods 19 depicted in FIG. 1 are threaded for receiving a conjugate nut, the distal ends may be replaced with screw-heads or the like for driving threaded rods into the base 10. Alternatively, the threaded rods may be permanently attached to the base by use of welding or other techniques. It is noted that the particular means of attachment of the audit coupons and spacers to the base 10 is not particularly critical, provided that means of attachment does not interfere with the coating process.

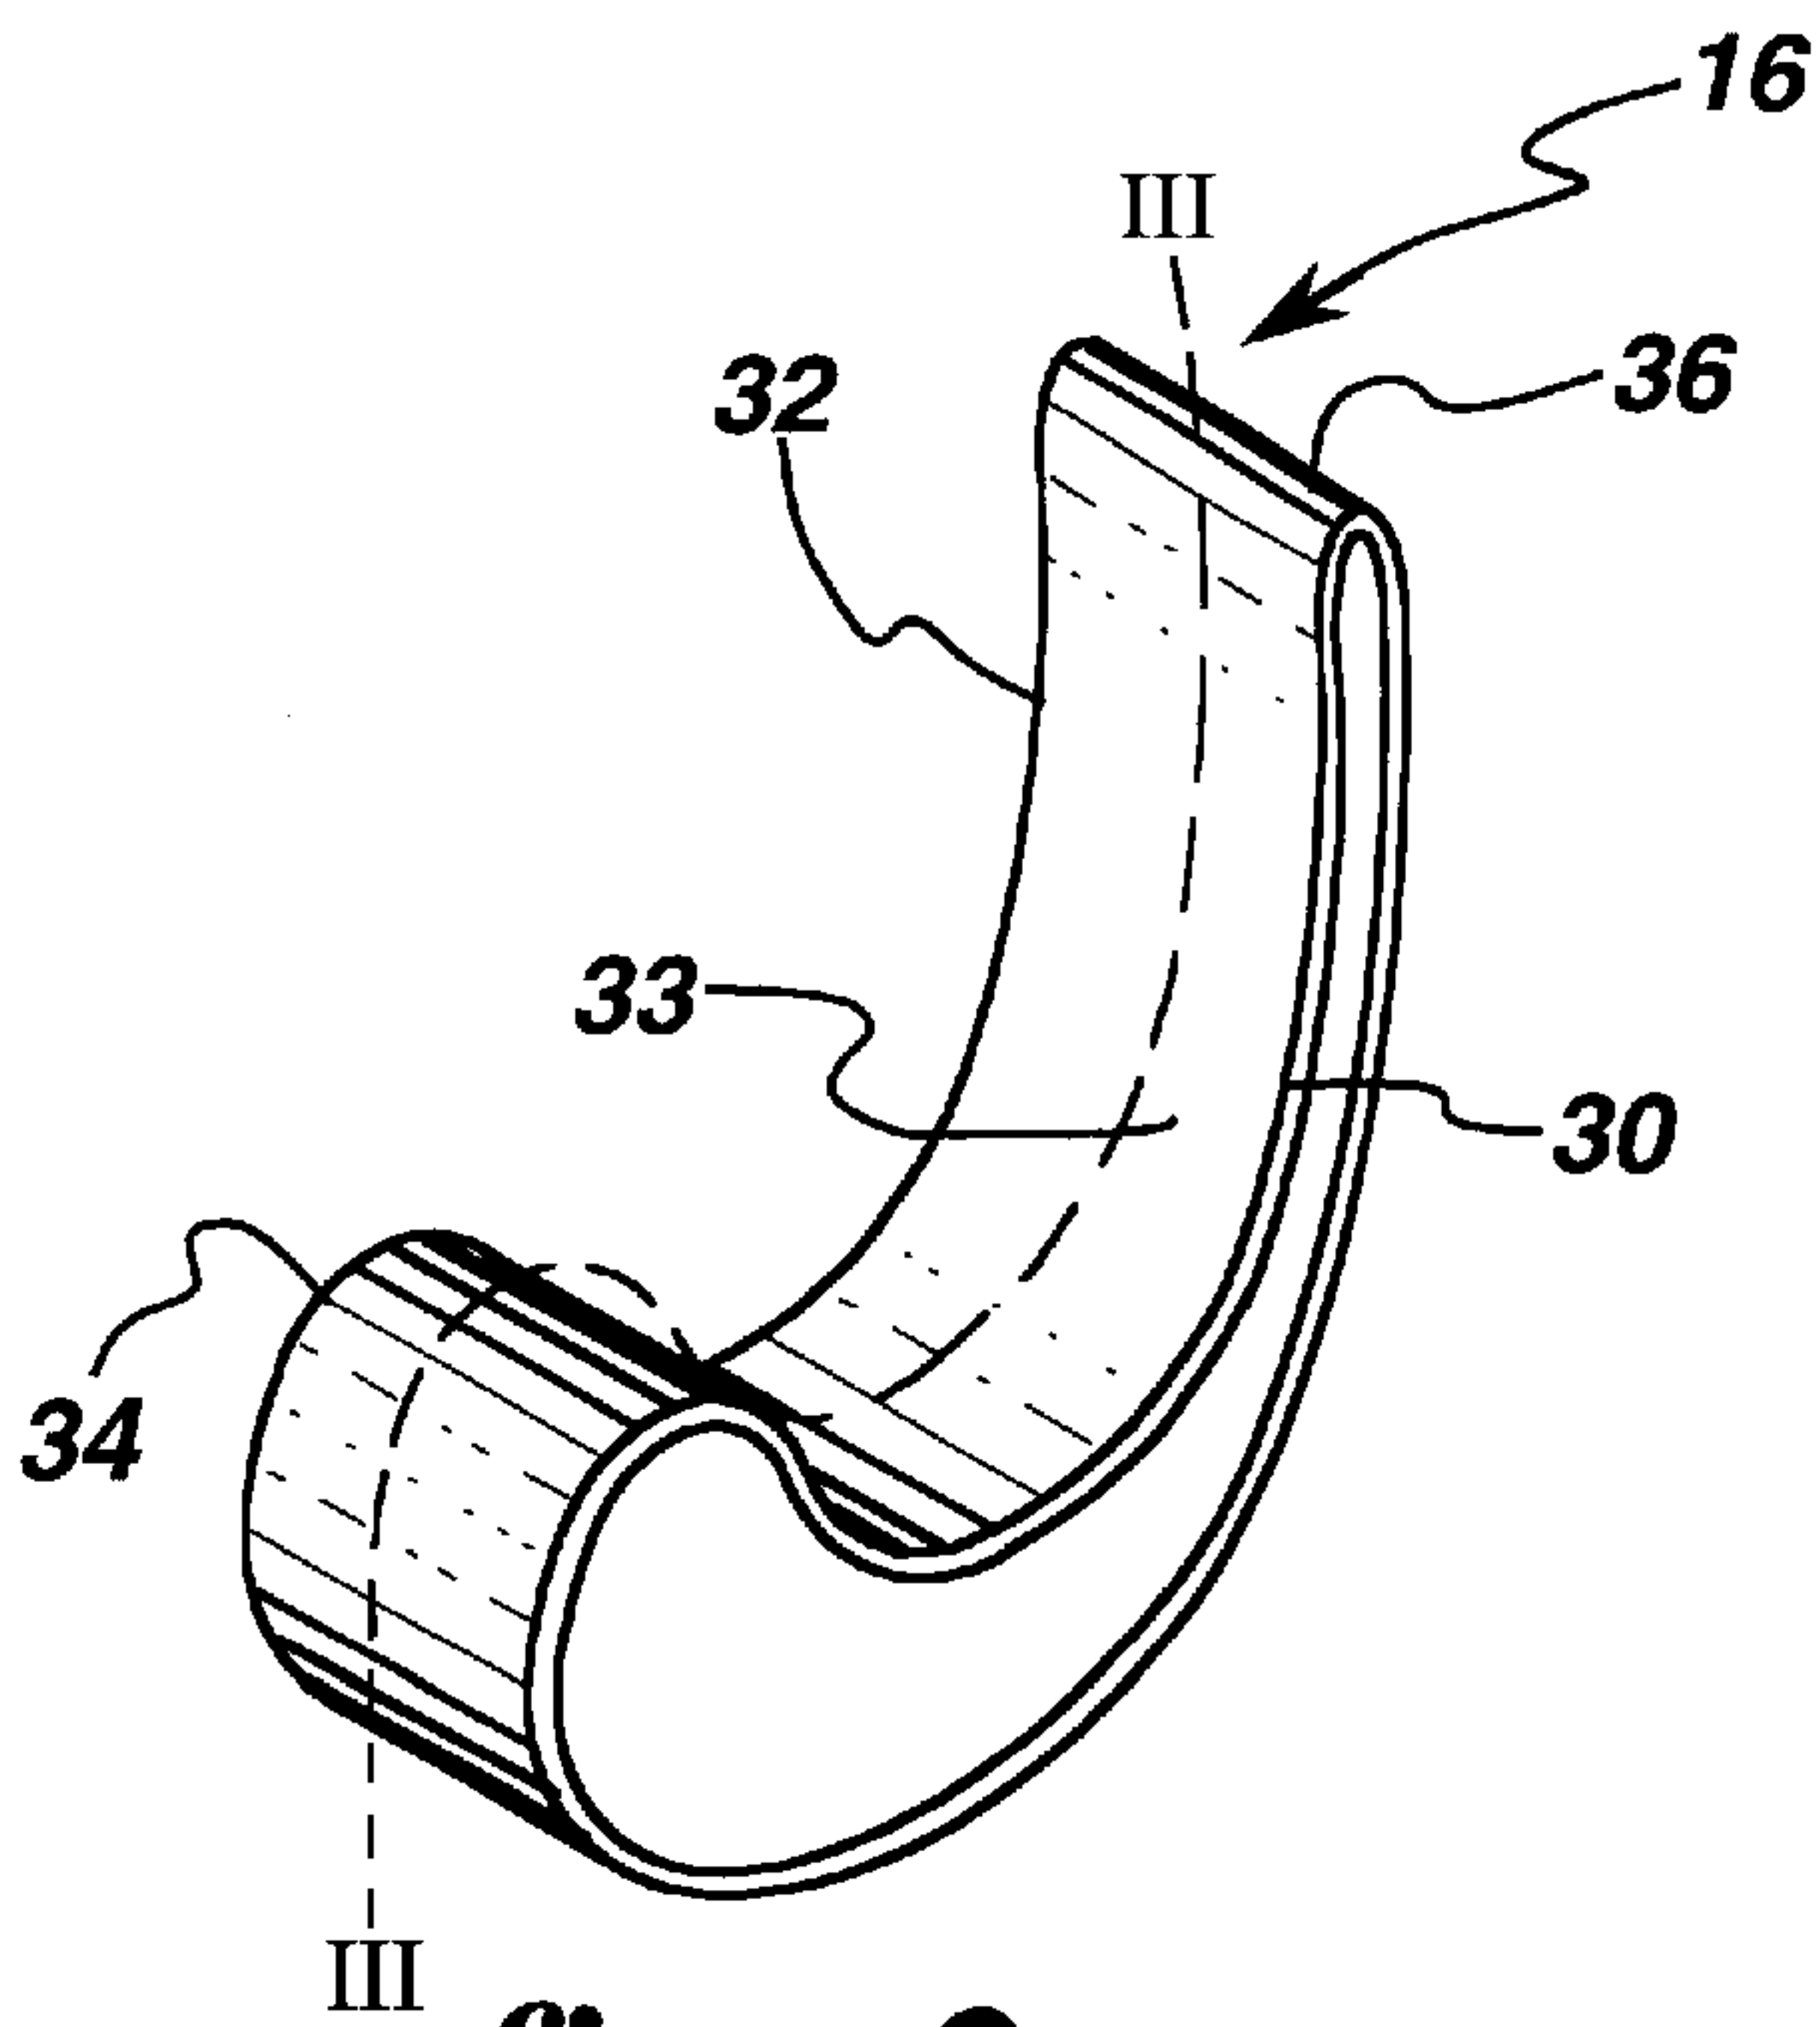
fig. 2

FIG. 2 illustrates an audit coupon of the facsimile assembly shown in FIG. 1; and

Turning to FIG. **2**, a peripheral view of audit coupon **16** of FIG. **1** is illustrated. As shown, the audit coupon **16** has a generally curved contour, including leading edge **34**, trailing edge **36**, and lateral peripheral edges **30** and **32**. The lateral peripheral edges **30** and **32** may be chamfered to assist in preventing unwanted bridging of the coating formed according to the coating process or gaps can be inserted between the coupons and the adjacent spacers.

According to the embodiment shown in the drawings, the coating is inspected along points that are interior to the lateral peripheral edges **30** and **32**. Particularly, a coating is inspected along cross-section shown by line III-III'. In order to inspect the audit coupon along this cross-section, portion **33** is removed. Removal may be carried out by various techniques, such as by machining or grinding the audit coupon **16**.

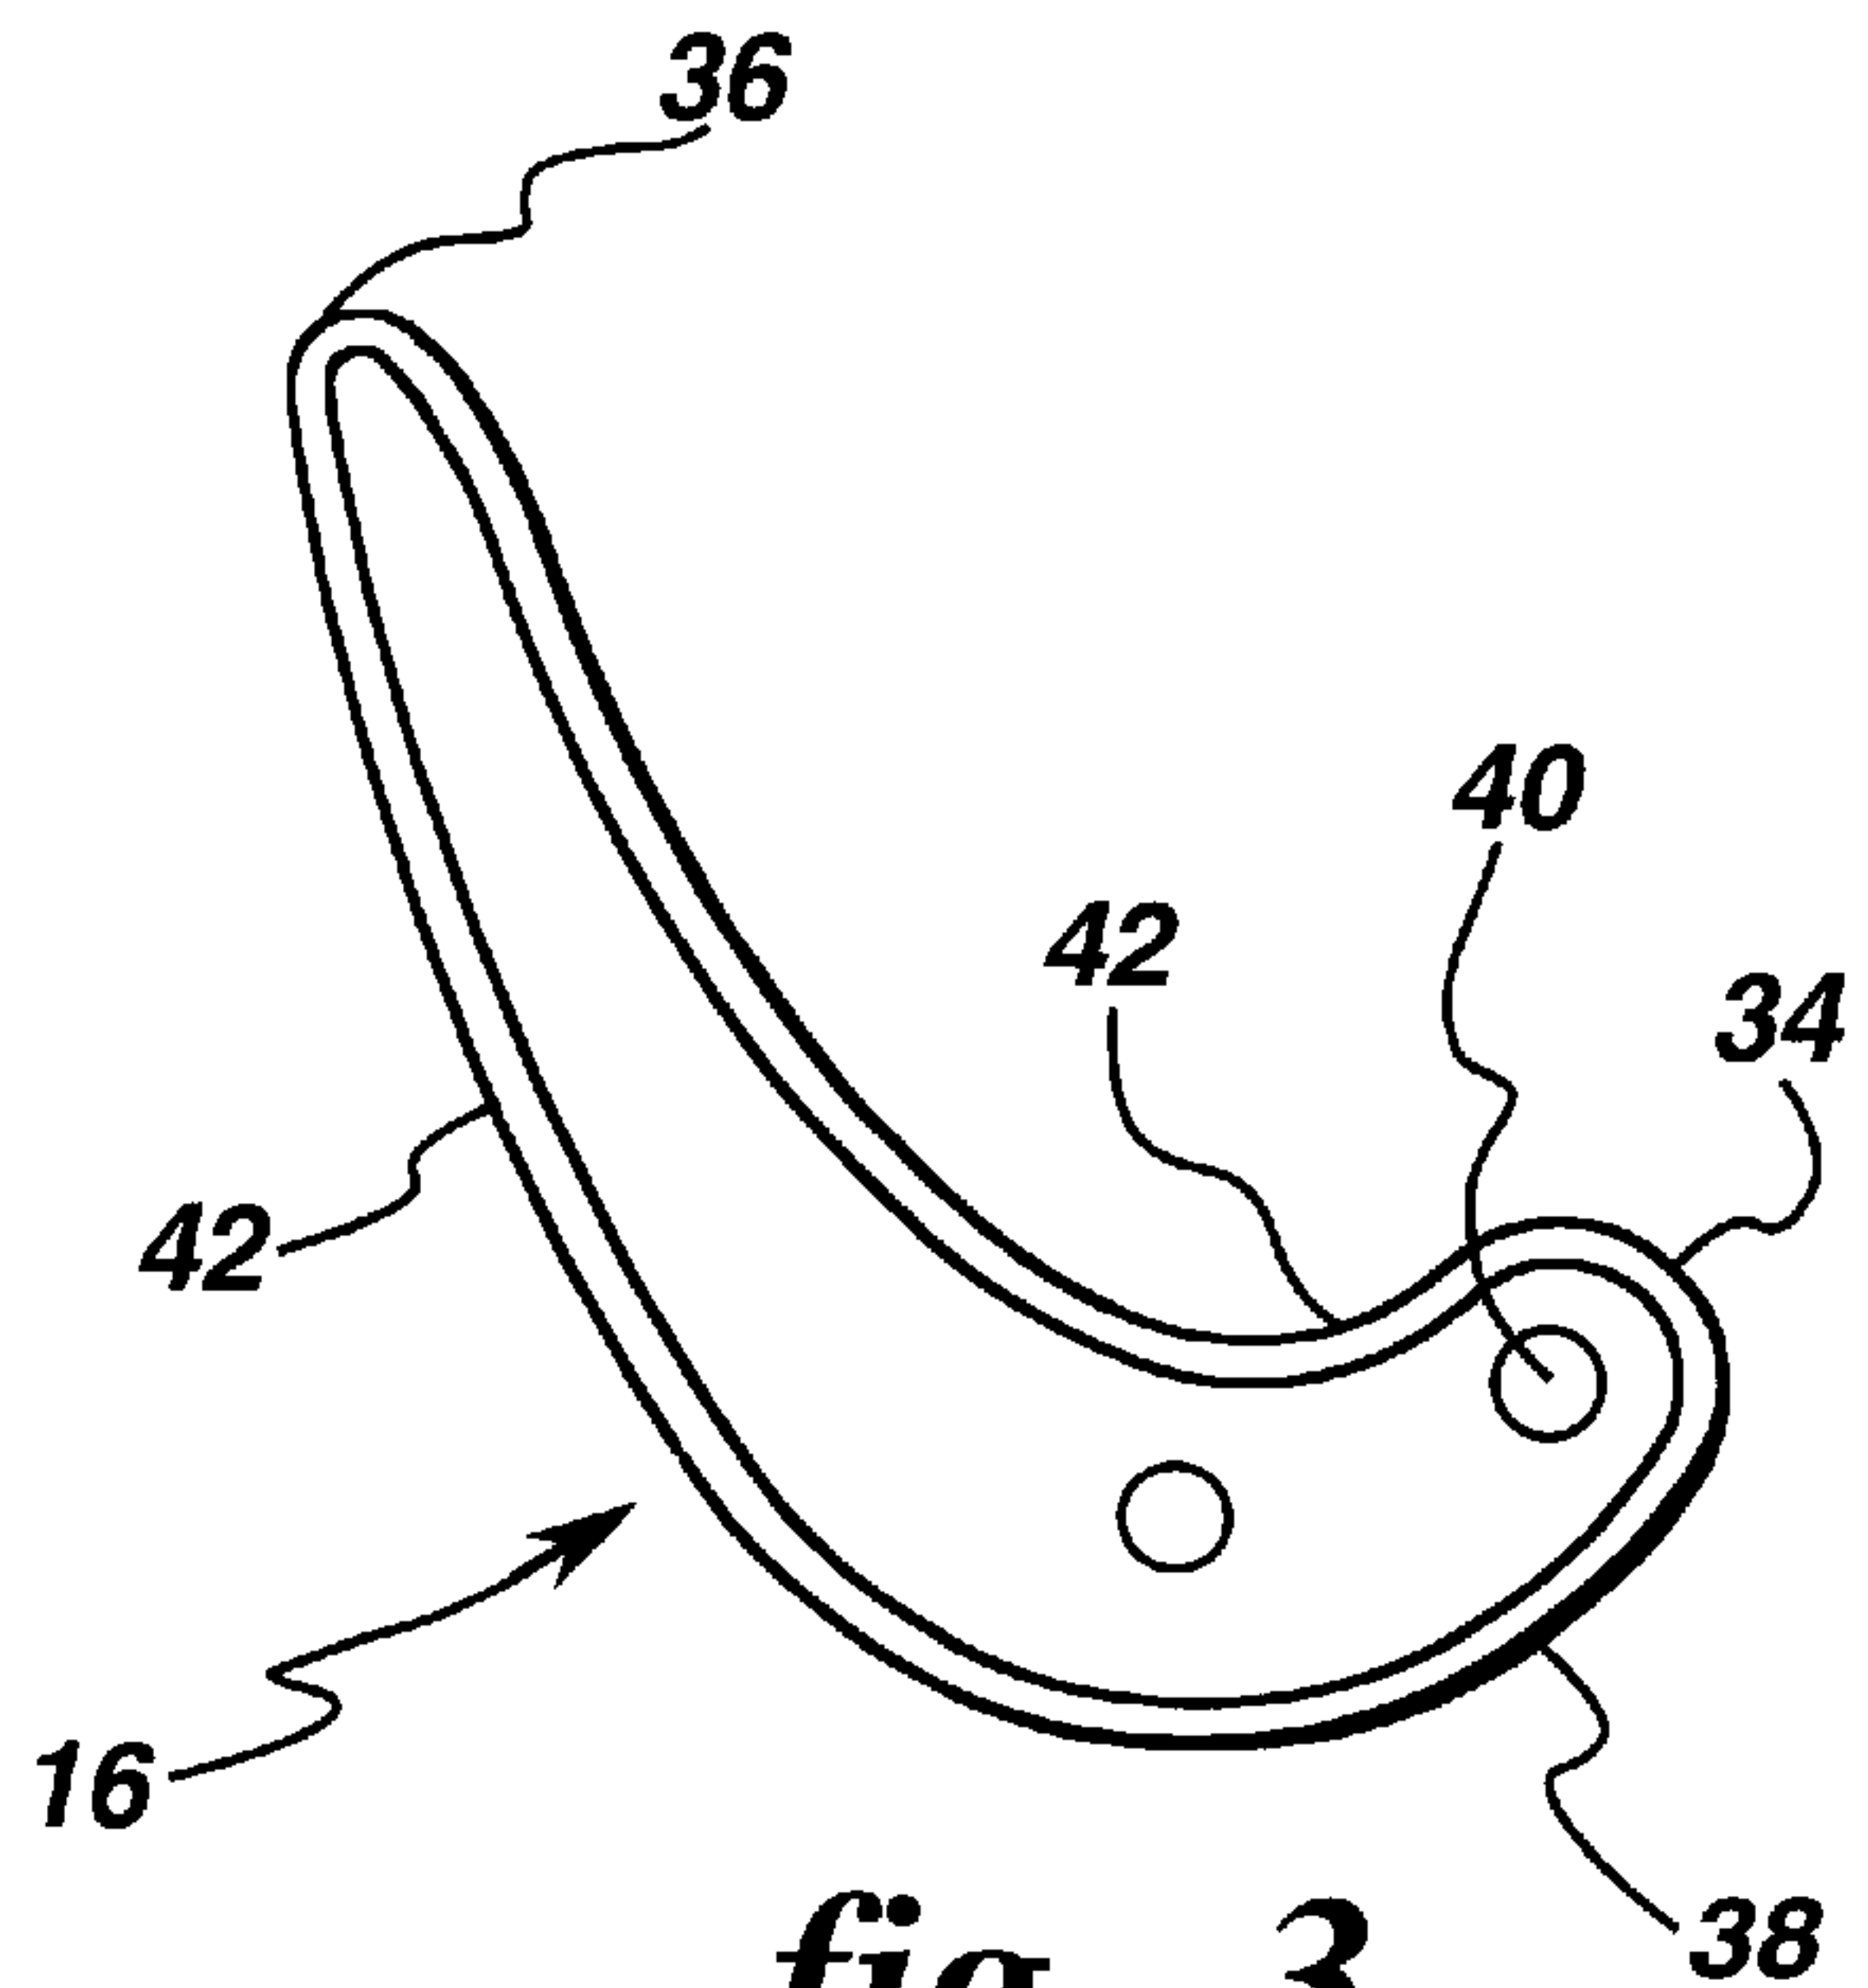
fig. 3

FIG. 3 is a cross-section along line III-III' shown in FIG. 2.

The cross section along line III-III' is depicted in FIG. **3**. As illustrated, audit coupon **16** has a coating **38**, and through holes **40**. The coating **38** is inspected at a number of interior inspection points **42**. While two inspection points **42** are

shown in FIG. **3**, any number of inspection points may be employed. The particular locations of the inspection points are chosen based upon various parameters, including local surface contours, high curvature areas (small radius of curvature regions), and other critical regions of the airfoil.
