(12) **United States Patent**
Clare et al.

(10) **Patent No.:** **US 6,352,406 B1**
(45) **Date of Patent:** **Mar. 5, 2002**

(54) **METHOD FOR ASSESSING QUALITY OF A COATING PROCESS AND ASSEMBLY THEREFOR**

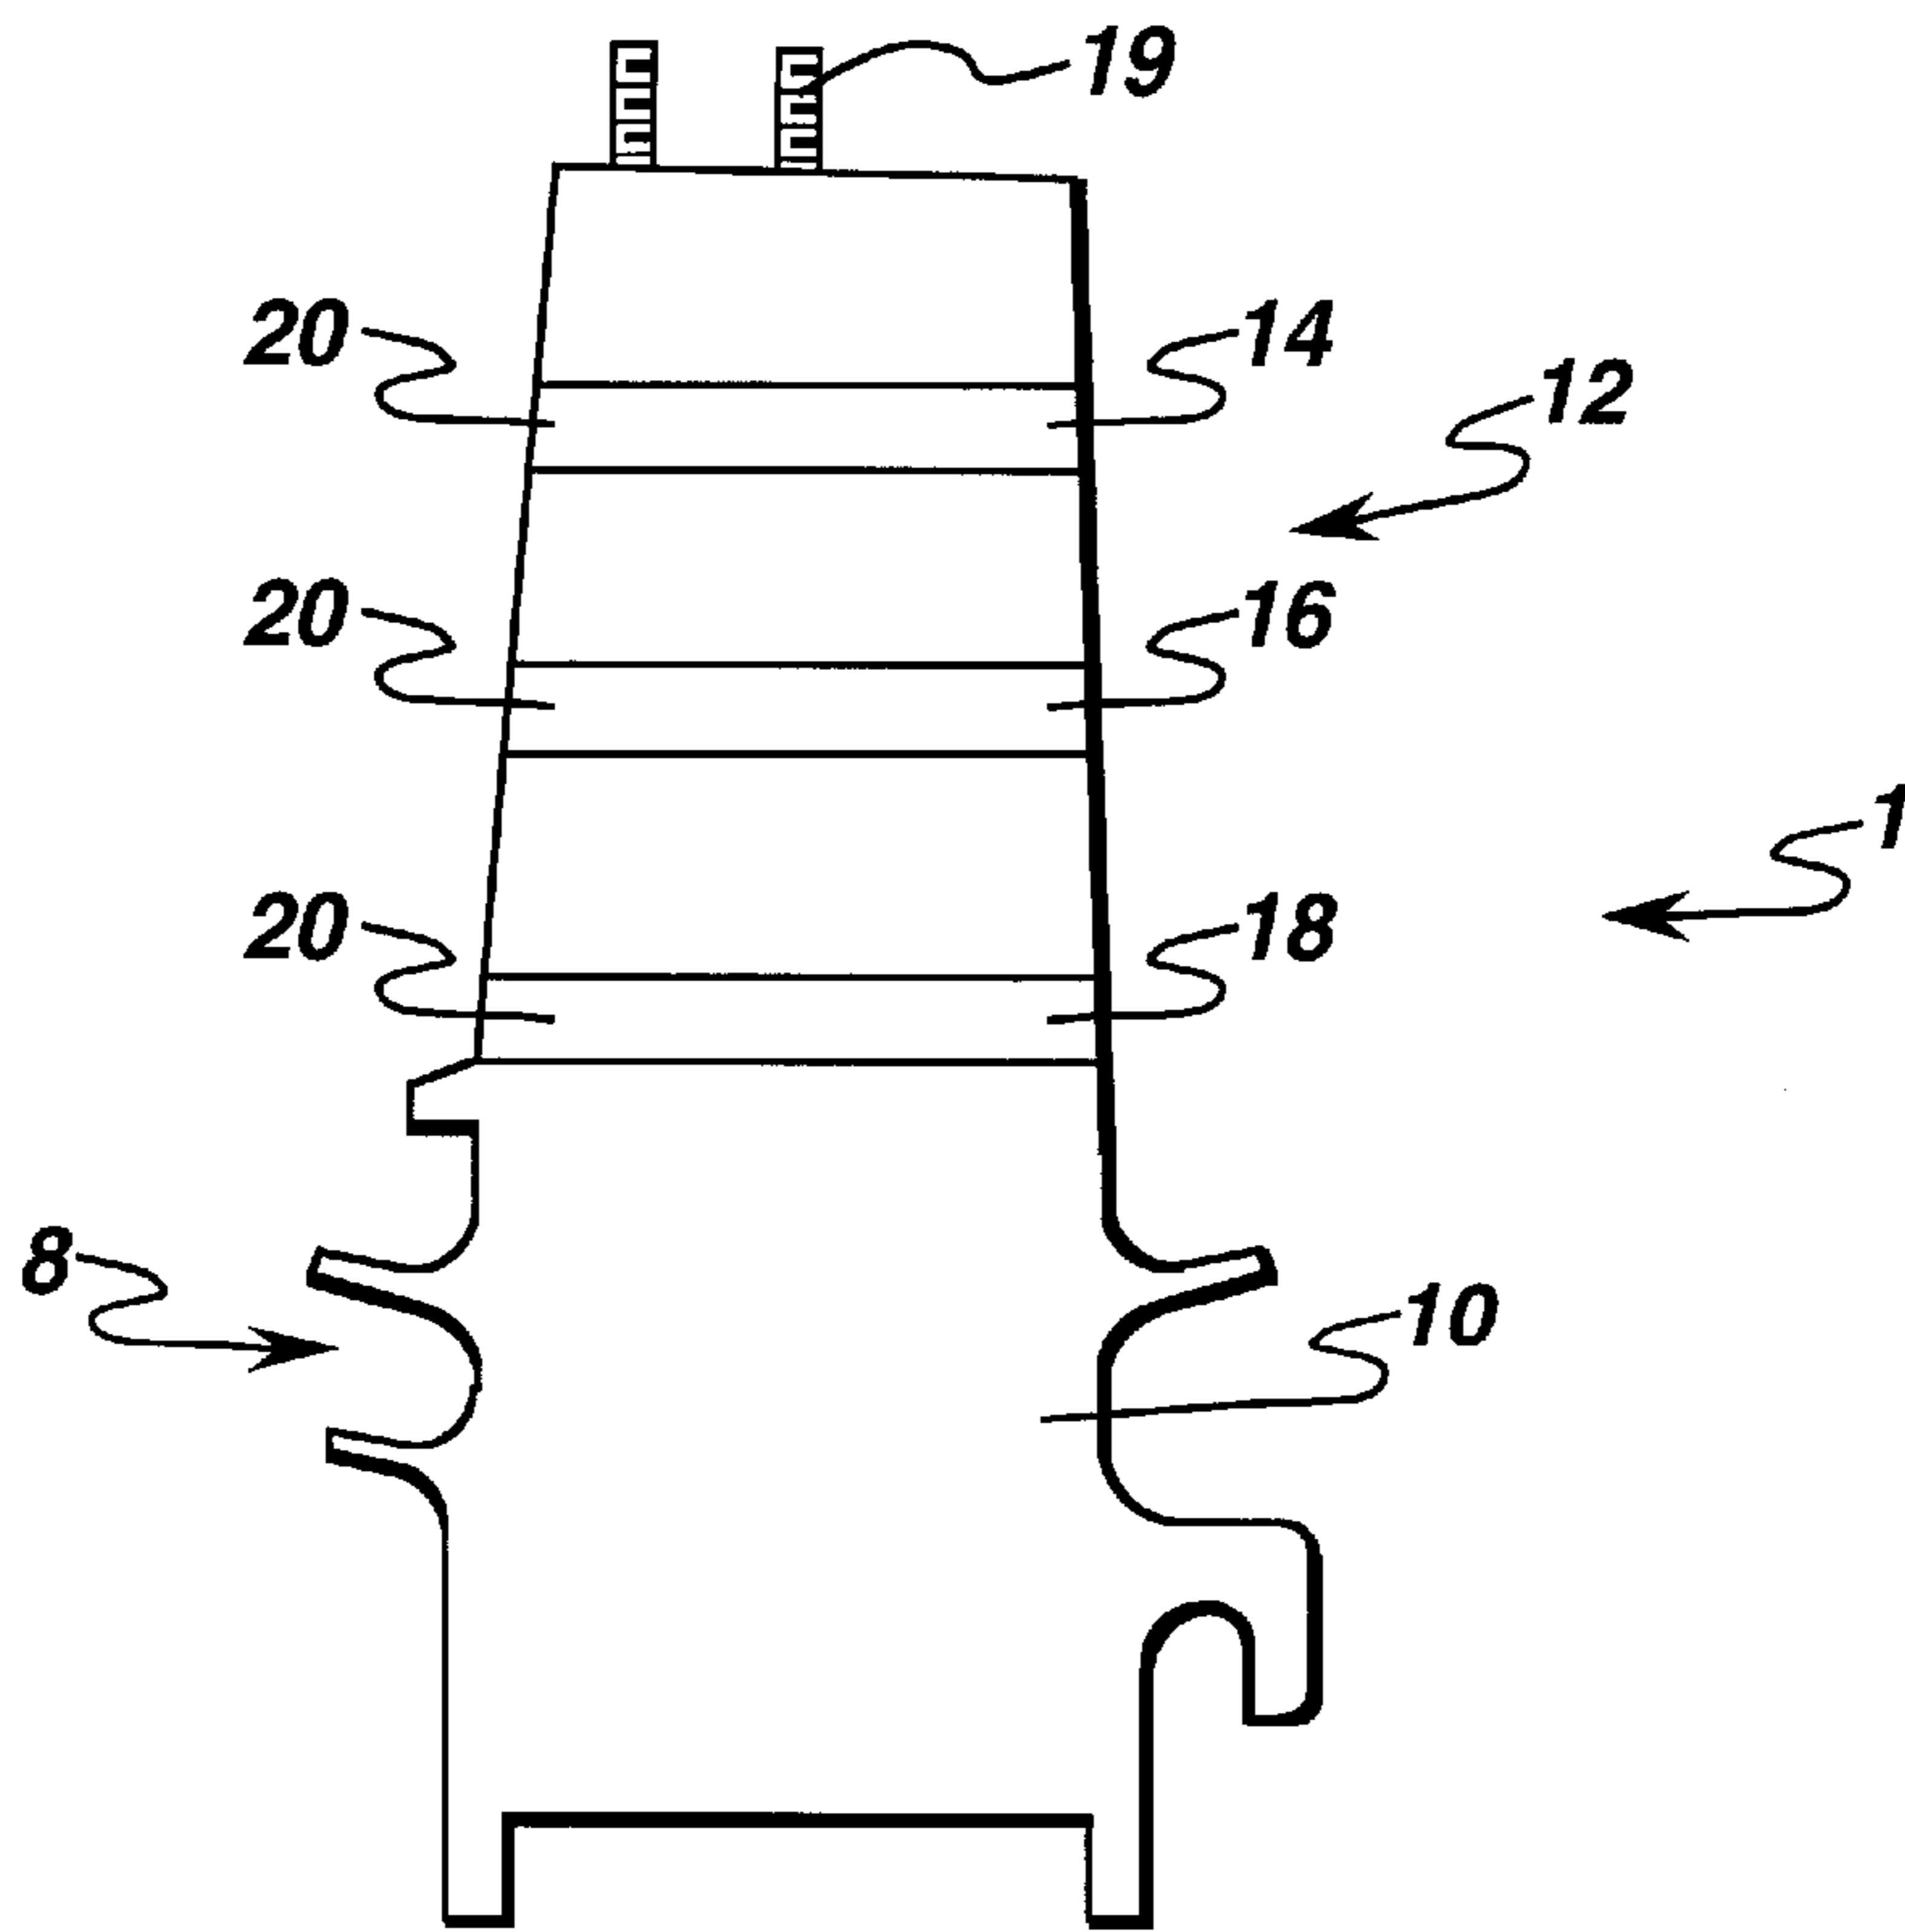
fig. 1

FIG. 1 illustrates a facsimile assembly of an airfoil for a turbine engine;

Turning to FIG. 1, an example of a facsimile assembly 1 is illustrated, including fixture 8, which supports a plurality of audit coupons 14, 16 and 18. The fixture 8 includes base 10 and threaded rods 19, which are threaded into complementary threaded cylindrical openings (not shown) within base 10. Threaded rods 19 extend axially through the audit coupons. In addition to base 10 and threaded rods 19, the fixture 8 further includes spacers 20 which are employed to axially space the audit coupons from each other. Alternately, the coupons can be suspended on the threaded rods at specific axial positions without spacers. However, for coating processes in which the coating build-up can be affected by rebound of material from adjacent surfaces, such as thermal spray, the use of spacers more closely replicates the airfoil surface.

The fixture 8 is reusable, and is generally fabricated from a single sacrificial airfoil. Particularly, an airfoil is obtained and sectioned so as to remove portions of the airfoil corresponding to audit coupons 14, 16, and 18. The sectioning then leaves behind base 10 and spacers 20. The base 10 is then modified to receive threaded rods 19, by tapping the base or by inserting threaded cylindrical fittings. Although the distal ends of threaded rods 19 depicted in FIG. 1 are threaded for receiving a conjugate nut, the distal ends may be replaced with screw-heads or the like for driving threaded rods into the base 10. Alternatively, the threaded rods may be permanently attached to the base by use of welding or other techniques. It is noted that the particular means of attachment of the audit coupons and spacers to the base 10 is not particularly critical, provided that means of attachment does not interfere with the coating process.

The audit coupons are fabricated so as to have surface contours that closely mimic the surface contours of the sections of the airfoil that they represent, particularly, the surface contours of blade portion **12**. In one embodiment, the audit coupons are fabricated by utilizing a CAD (computer-aided drawing) model of the airfoil, and manipulating the model to form three-dimensional representations of the audit coupons. The data from the computer model are then utilized to fabricate the audit coupons. Various techniques may be utilized, including machining, such as wire electro-discharge machining (EDM), as well as abrasive cutting, such as abrasive water jet cutting. During the fabrication step, the audit coupons are formed so as to have axial through holes, which align with the positions of the rods **19** of the fixture **8**.

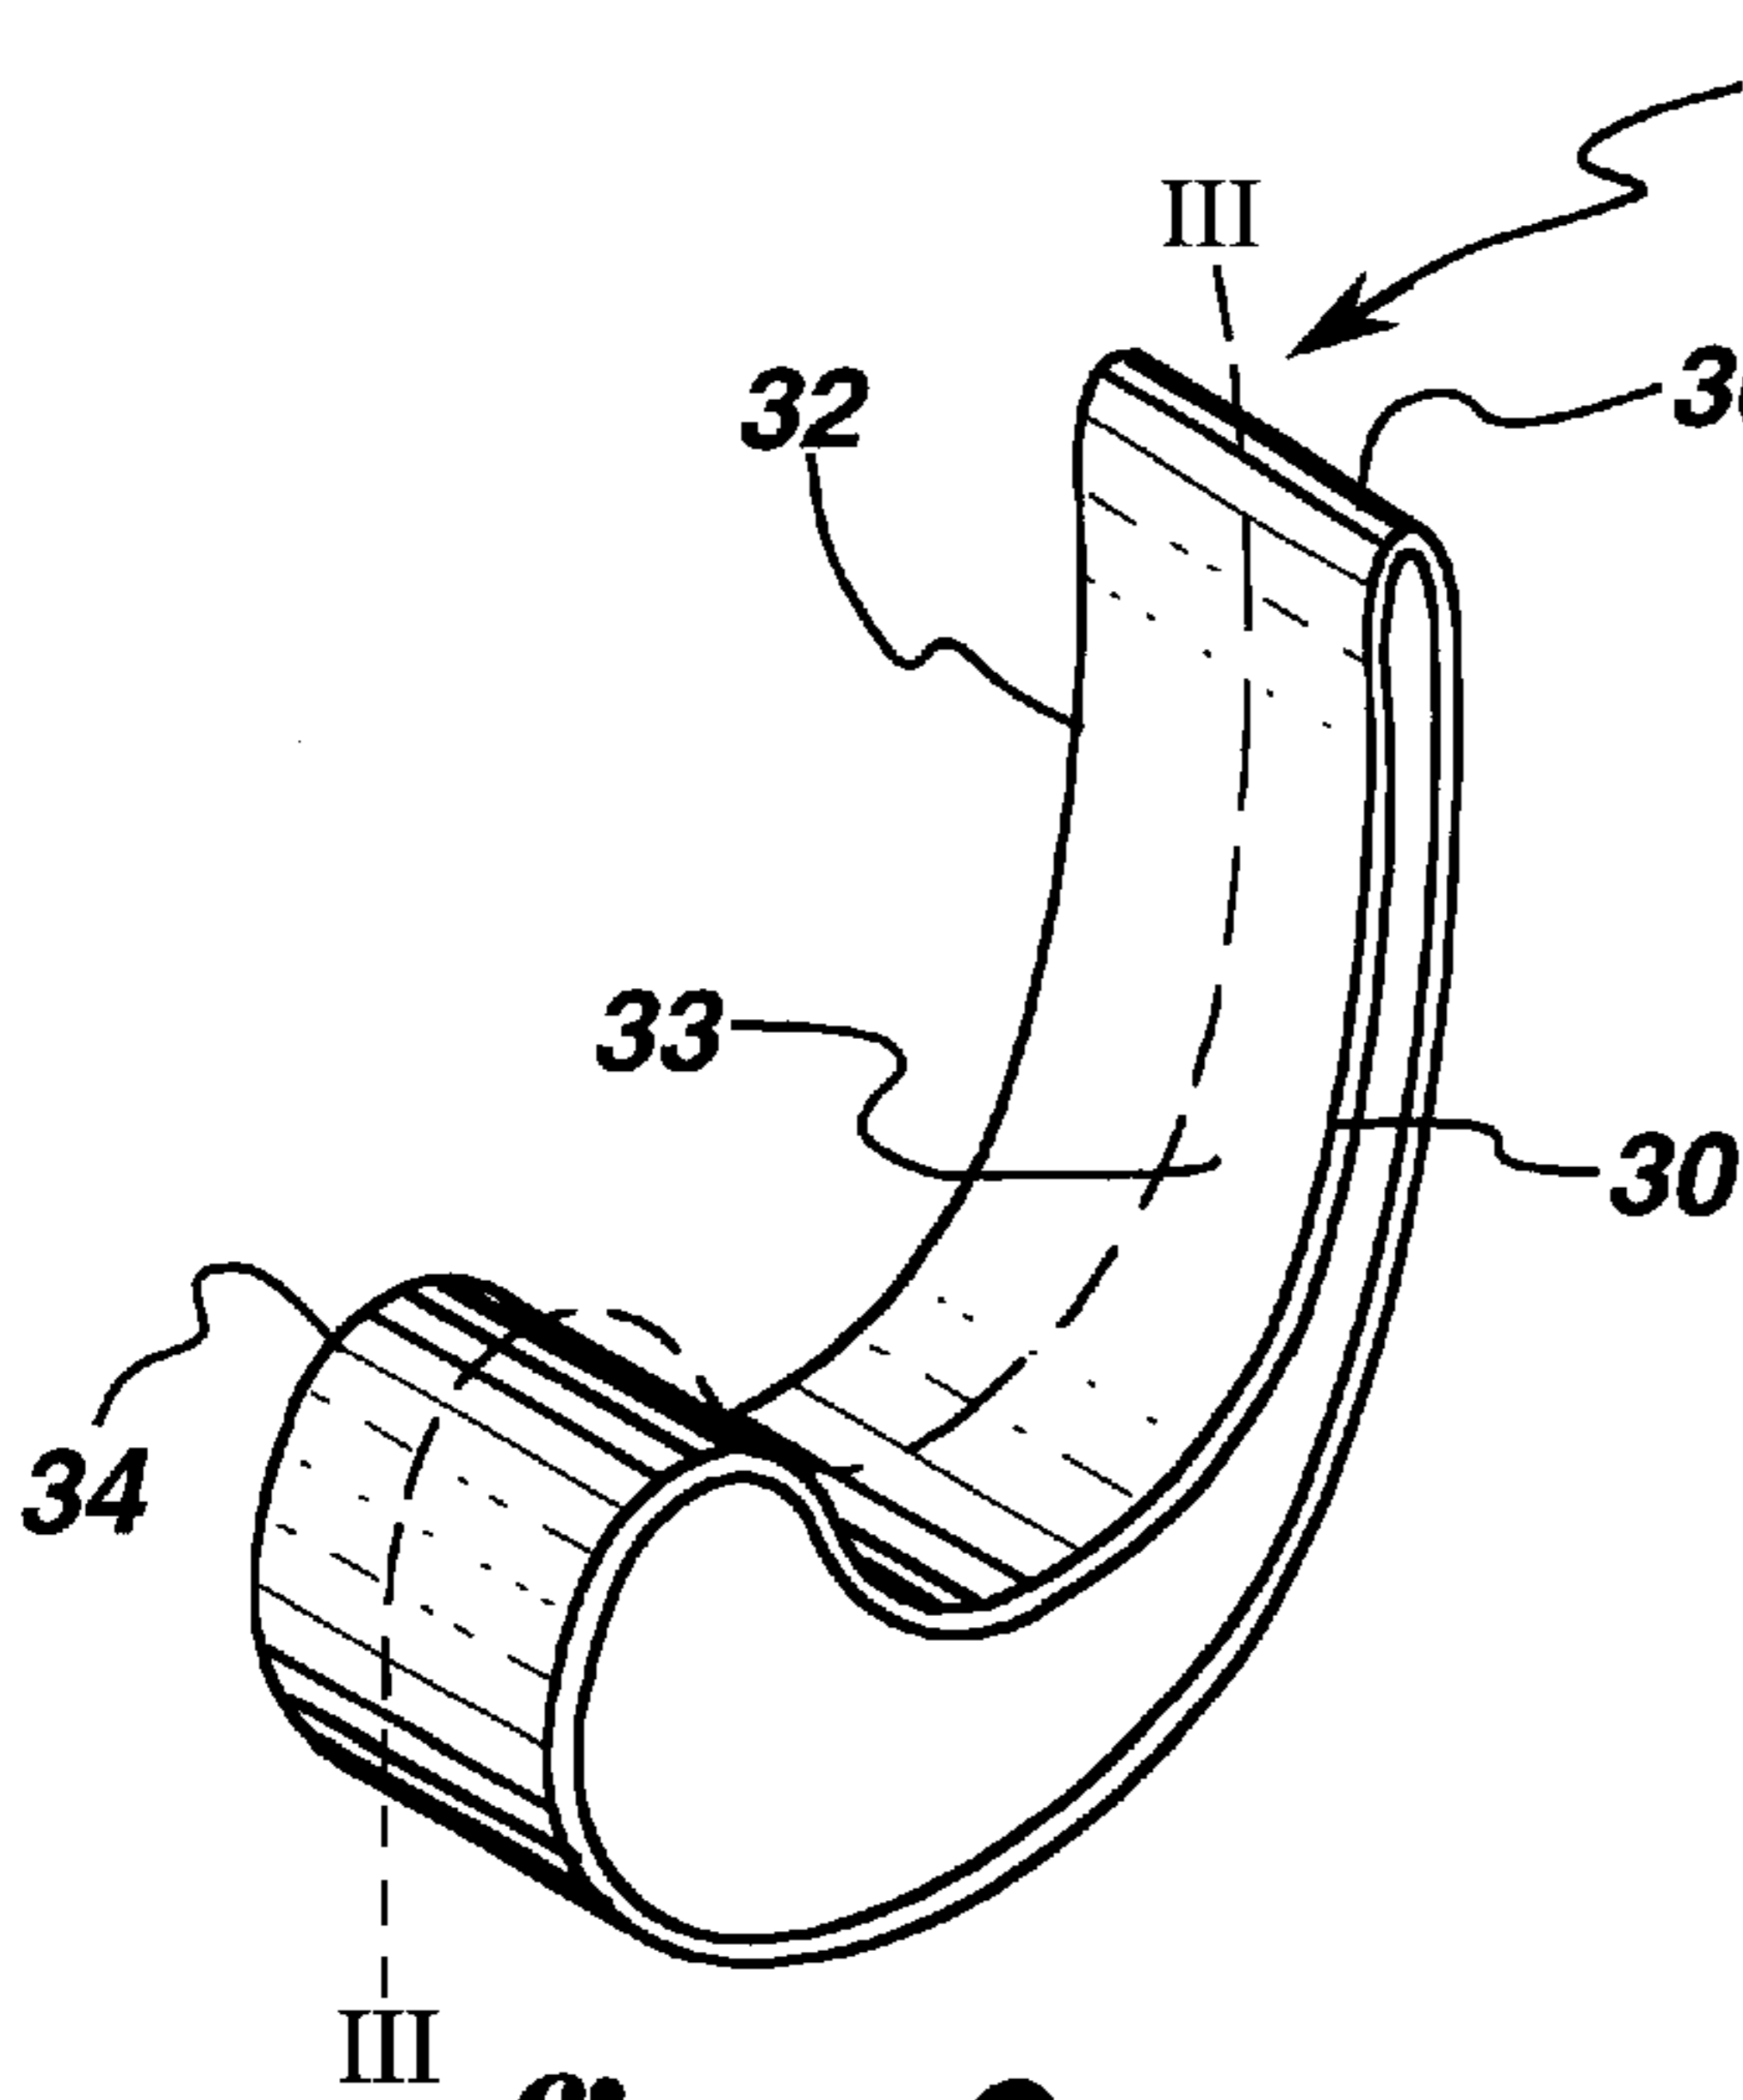
fig. 2

FIG. 2 illustrates an audit coupon of the facsimile assembly shown in FIG. 1; and

Turning to FIG. **2**, a peripheral view of audit coupon **16** of FIG. **1** is illustrated. As shown, the audit coupon **16** has a generally curved contour, including leading edge **34**, trailing edge **36**, and lateral peripheral edges **30** and **32**. The lateral peripheral edges **30** and **32** may be chamfered to assist in preventing unwanted bridging of the coating formed according to the coating process or gaps can be inserted between the coupons and the adjacent spacers.

According to the embodiment shown in the drawings, the coating is inspected along points that are interior to the lateral peripheral edges **30** and **32**. Particularly, a coating is inspected along cross-section shown by line III-III'. In order to inspect the audit coupon along this cross-section, portion **33** is removed. Removal may be carried out by various techniques, such as by machining or grinding the audit coupon **16**.

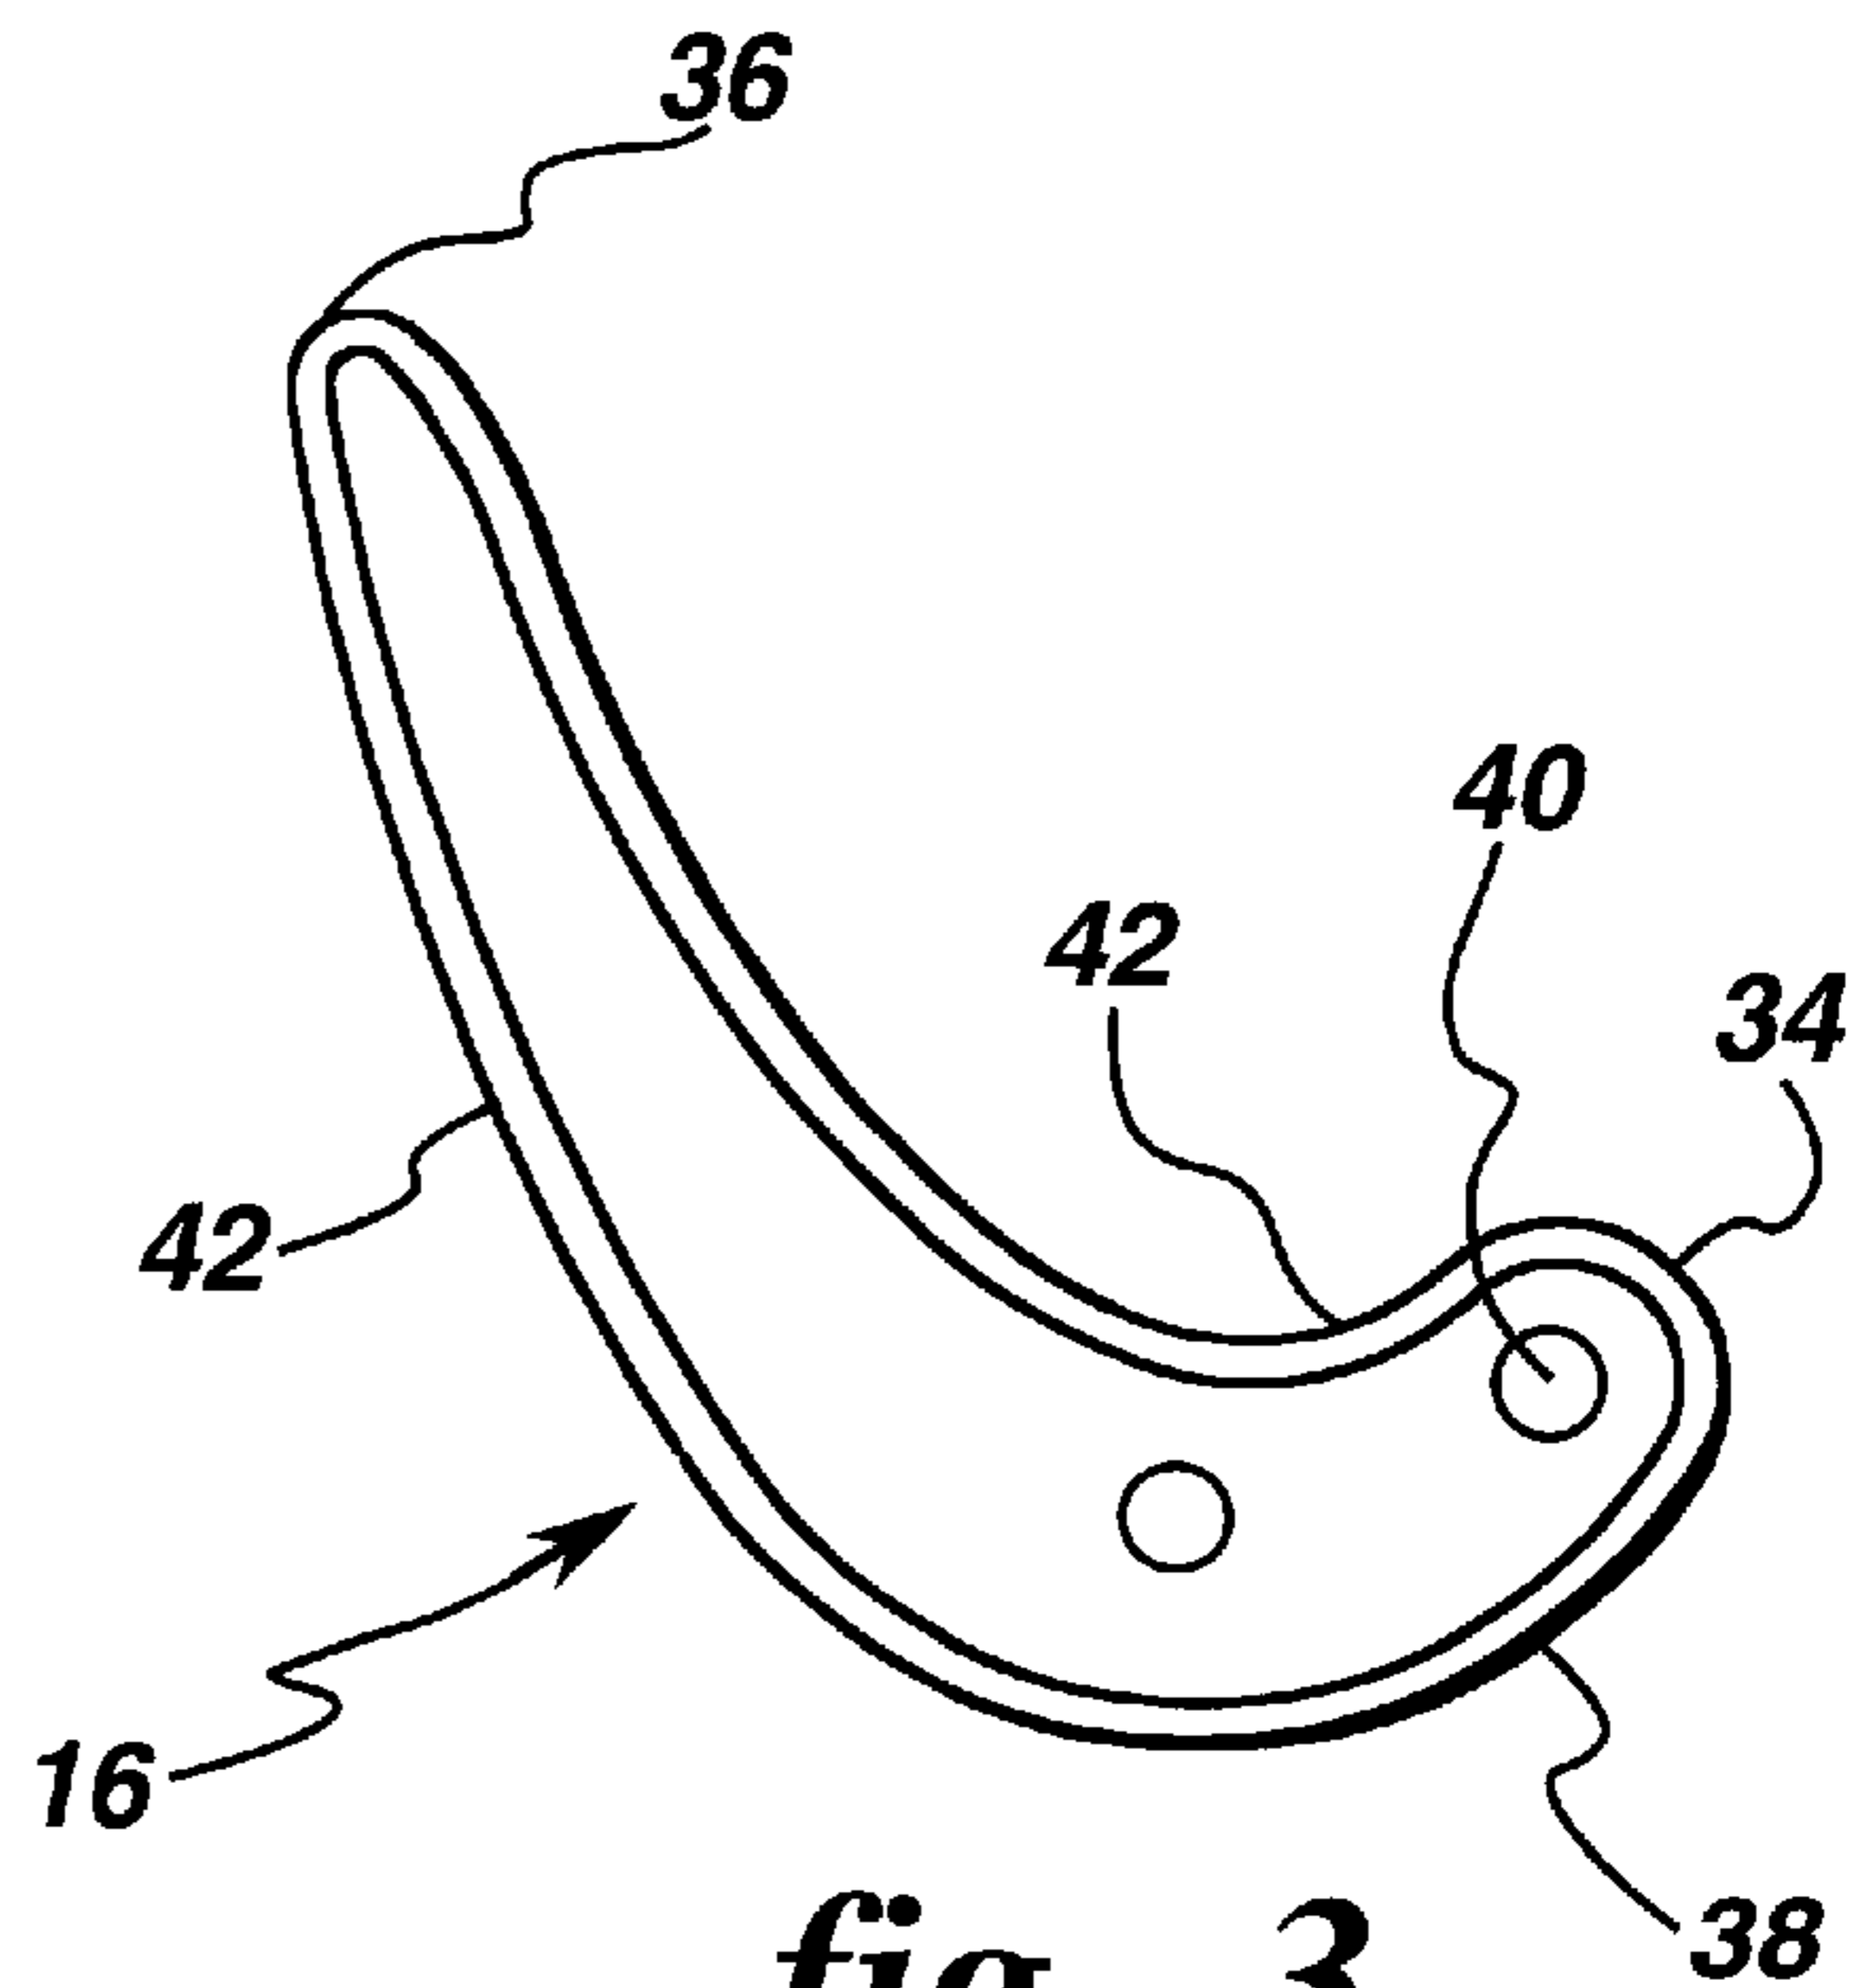
fig. 3

FIG. 3 is a cross-section along line III-III' shown in FIG. 2.

The cross section along line III-III' is depicted in FIG. **3**. As illustrated, audit coupon **16** has a coating **38**, and through holes **40**. The coating **38** is inspected at a number of interior inspection points **42**. While two inspection points **42** are

shown in FIG. **3**, any number of inspection points may be employed. The particular locations of the inspection points are chosen based upon various parameters, including local surface contours, high curvature areas (small radius of curvature regions), and other critical regions of the airfoil.
