- (54) **METHOD FOR REPAIRING A COATED ARTICLE**
- (75) Inventors: **Bhupendra Kumar Gupta**, Cincinnati;
Wayne Ray Grady, Fairfield;
Nripendra Nath Das, West Chester, all of OH (US)
- (73) Assignee: **General Electric Company**, Schenectady, NY (US)
- (*) Notice: Subject to any disclaimer, the term of this patent is extended or adjusted under 35 U.S.C. 154(b) by 0 days.

(57) **ABSTRACT**

METHOD FOR REPAIRING A COATED ARTICLE

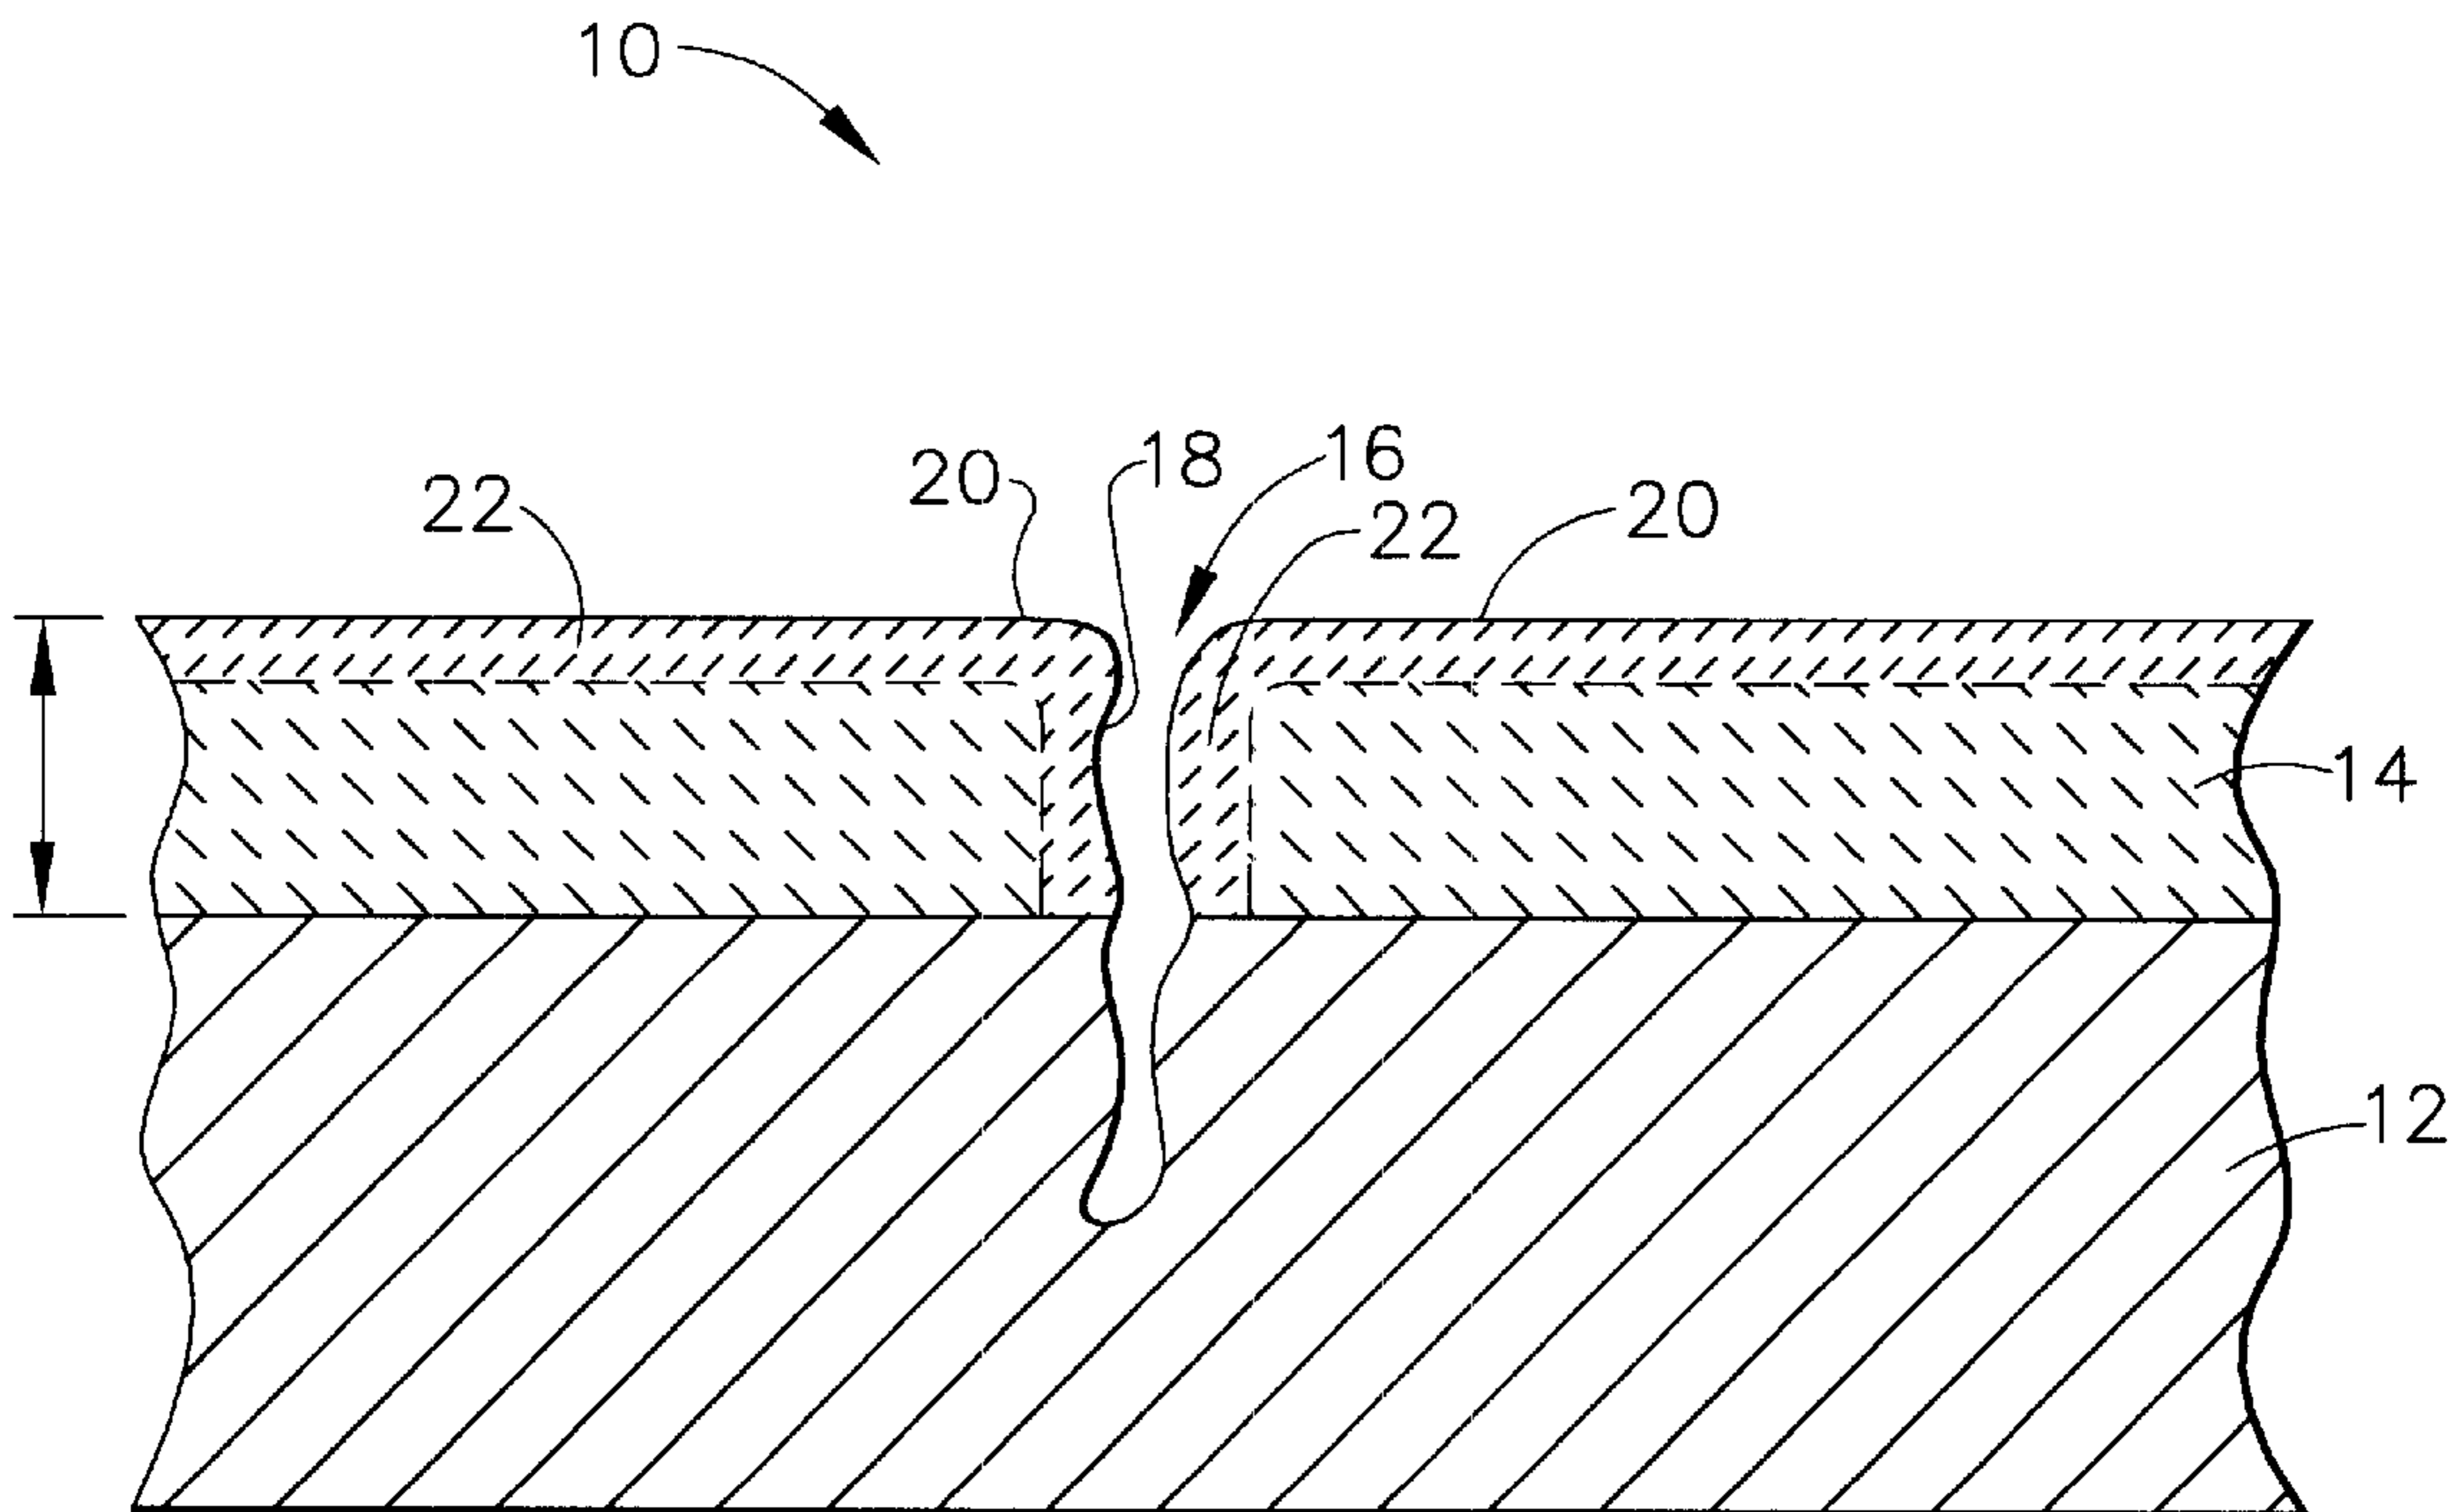
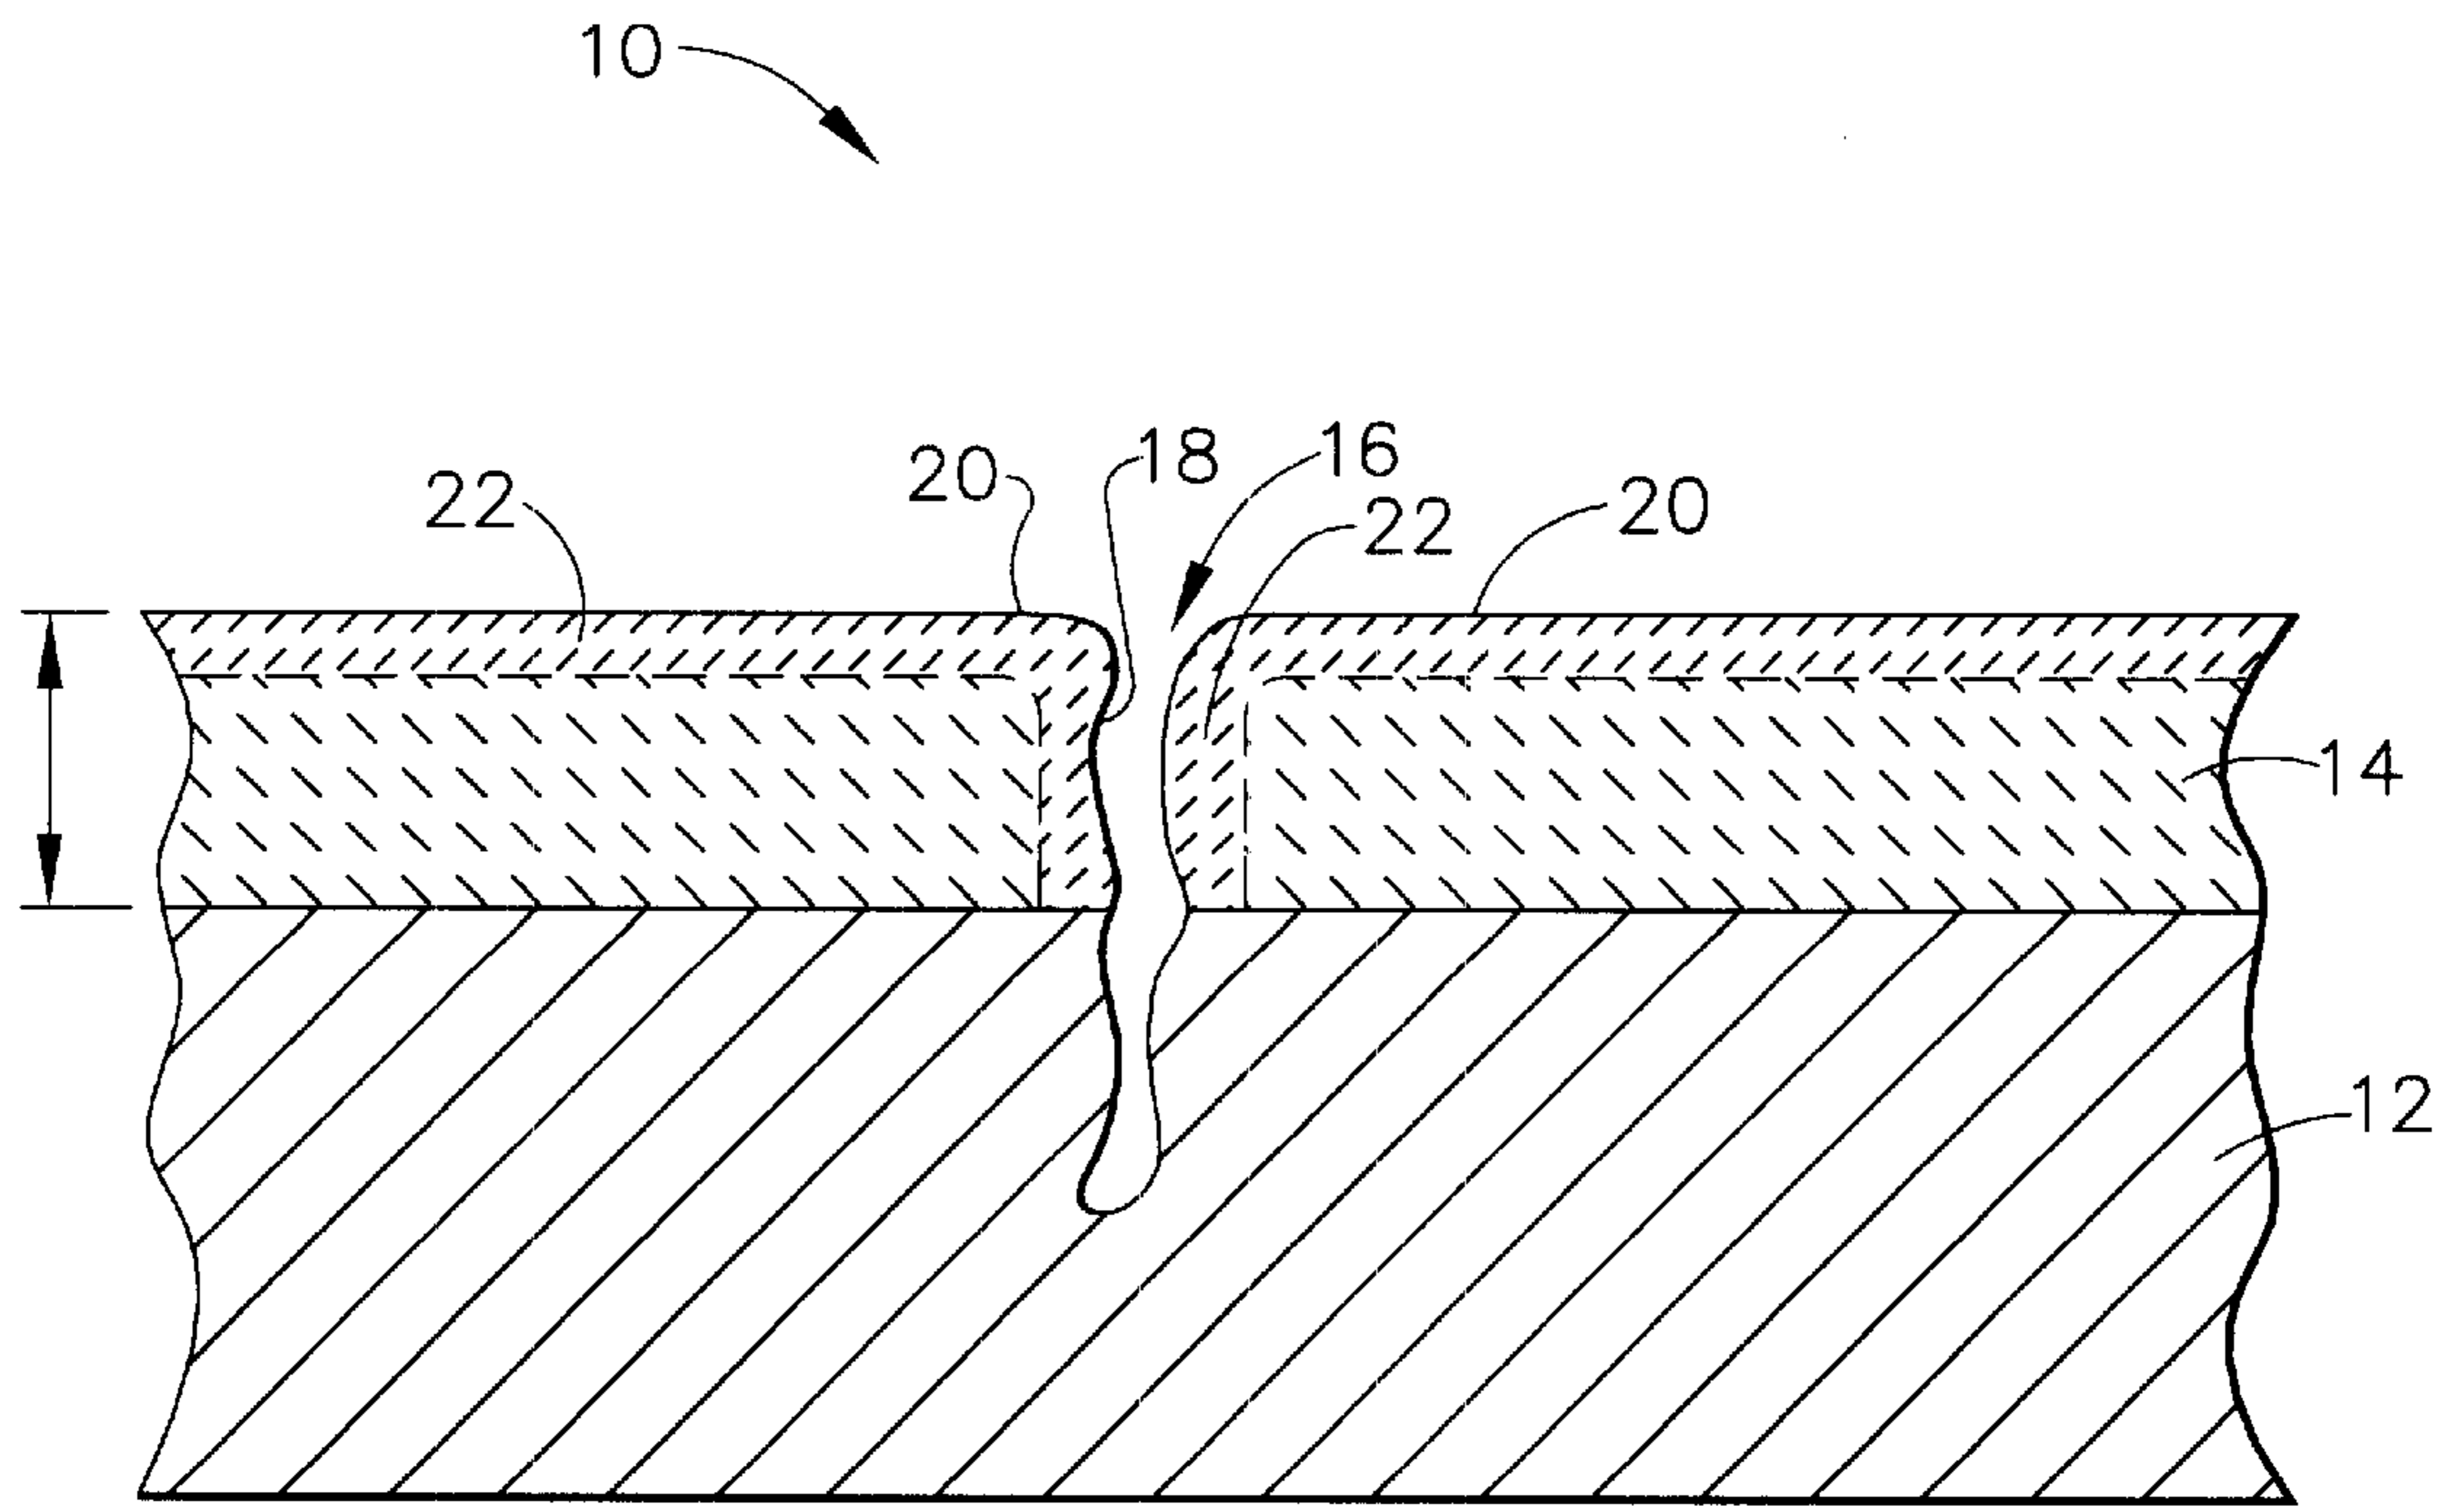
FIG. 1

The drawing is a fragmentary sectional view of a coated wall of an article including a fissure through the coating and extending into the substrate.

repair including at least one of welding, brazing and recoating. The fragmentary sectional view of the drawing shows one example of use of the present invention.

In the embodiment of the drawing, an article is shown generally at **10** in the form of a wall, for example an airfoil wall of a gas turbine engine blading member. Article **10** includes a substrate **12**, for example a Ni base superalloy, and an overlay type coating **14**, for example a commercial NiCrAlY alloy, disposed on substrate **12**. A fissure or crack shown generally at **16** has developed within coating **14** as a result of service operation and extends through coating **14** into substrate **12**. Formation of fissure **16** has exposed coating surface **18** of coating **14** within fissure **16**.

Generally as a result of high temperature exposure, surface oxides of certain elements in coating **14** will form on surface **18** of fissure **16** as well as on coating outer surface **20** of coating **14**. Practice of the method of the present invention can be used to remove such surface oxides, as described in the art. However, in addition, the present invention can deplete more than about 90 wt. % Al from the exposed coating surface **18** prior to repair, for the reasons discussed above, substantially without removal or dimensional change in the coating. A form of the present invention shown in the drawing depletes such Al from within exposed coating surface **18** within fissure **16** and from coating outer surface **20** adjacent fissure **16** to avoid formation of detrimental amounts of aluminum oxide at such surfaces during repair of fissure **16**. Such repair can include welding or brazing to close or heal fissure **16**, as well as repair of coating **14** by application of a replacement coating at least at the vicinity of fissure **16**. According to that form of the invention, a zone **22** depleted of more than 90 wt. % Al to a depth of at least about 7 mils is provided within exposed coating surface **18** within fissure **16**, and within surface **20** of coating **14** at least adjacent fissure **16**. It has been recognized that such depth of zone **22** is required to enable repair of the article without formation of detrimental aluminum oxide at surfaces **18** and **20**.
