(10) **Patent No.:** **US 6,434,823 B1**
(45) **Date of Patent:** **Aug. 20, 2002**

- (54) **METHOD FOR REPAIRING A COATED ARTICLE**
- (75) Inventors: **Bhupendra Kumar Gupta**, Cincinnati;
Wayne Ray Grady, Fairfield;
Nripendra Nath Das, West Chester, all of OH (US)
- (73) Assignee: **General Electric Company**, Schenectady, NY (US)
- (*) Notice: Subject to any disclaimer, the term of this patent is extended or adjusted under 35 U.S.C. 154(b) by 0 days.

METHOD FOR REPAIRING A COATED ARTICLE

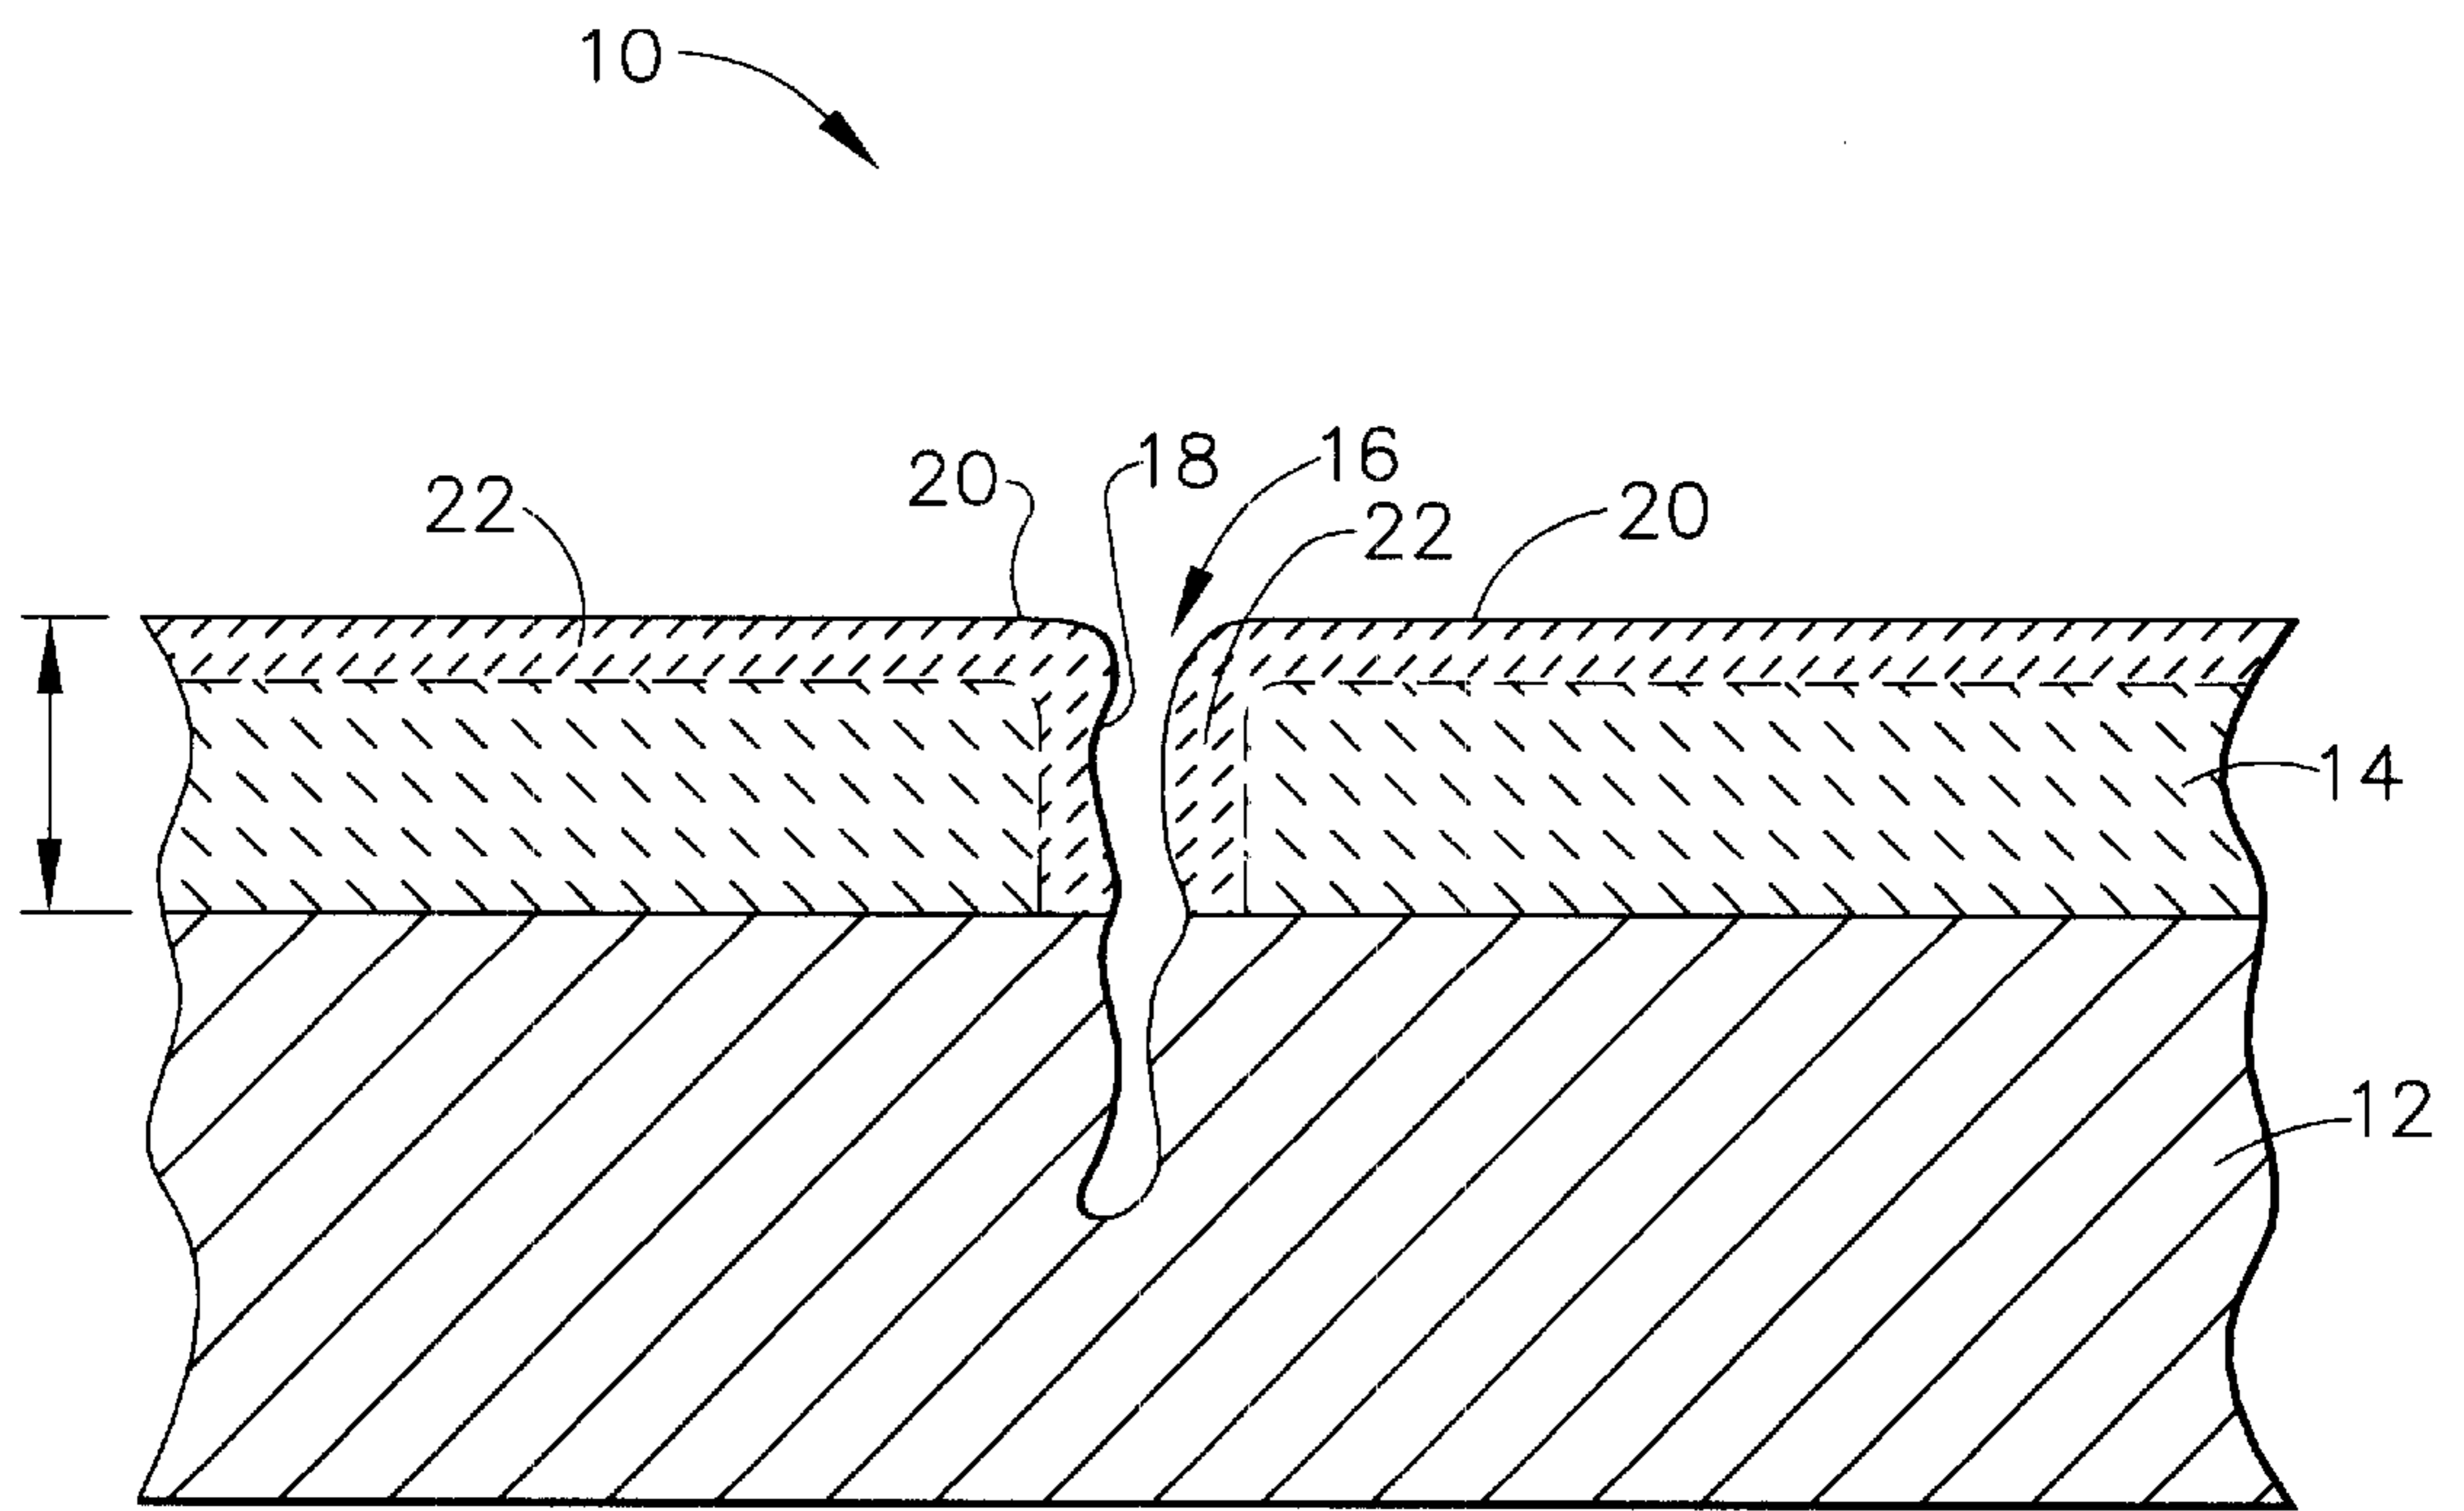
FIG. 1

The drawing is a fragmentary sectional view of a coated wall of an article including a fissure through the coating and extending into the substrate.

In the embodiment of the drawing, an article is shown generally at **10** in the form of a wall, for example an airfoil wall of a gas turbine engine blading member. Article **10** includes a substrate **12**, for example a Ni base superalloy, and an overlay type coating **14**, for example a commercial NiCrAlY alloy, disposed on substrate **12**. A fissure or crack shown generally at **16** has developed within coating **14** as a result of service operation and extends through coating **14** into substrate **12**. Formation of fissure **16** has exposed coating surface **18** of coating **14** within fissure **16**.

Generally as a result of high temperature exposure, surface oxides of certain elements in coating **14** will form on surface **18** of fissure **16** as well as on coating outer surface **20** of coating **14**. Practice of the method of the present invention can be used to remove such surface oxides, as described in the art. However, in addition, the present invention can deplete more than about 90 wt. % Al from the exposed coating surface **18** prior to repair, for the reasons discussed above, substantially without removal or dimensional change in the coating. A form of the present invention shown in the drawing depletes such Al from within exposed coating surface **18** within fissure **16** and from coating outer surface **20** adjacent fissure **16** to avoid formation of detrimental amounts of aluminum oxide at such surfaces during repair of fissure **16**. Such repair can include welding or brazing to close or heal fissure **16**, as well as repair of coating **14** by application of a replacement coating at least at the vicinity of fissure **16**. According to that form of the invention, a zone **22** depleted of more than 90 wt. % Al to a depth of at least about 7 mils is provided within exposed coating surface **18** within fissure **16**, and within surface **20** of coating **14** at least adjacent fissure **16**. It has been recognized that such depth of zone **22** is required to enable repair of the article without formation of detrimental aluminum oxide at surfaces **18** and **20**.

repair including at least one of welding, brazing and recoating. The fragmentary sectional view of the drawing shows one example of use of the present invention.
