(10) Patent No.: US 6,458,709 B2

(54) METHOD FOR FABRICATING A REPAIR FUSE BOX FOR A SEMICONDUCTOR DEVICE

(73) Assignee: Hyundai Electronics Industries Co.,

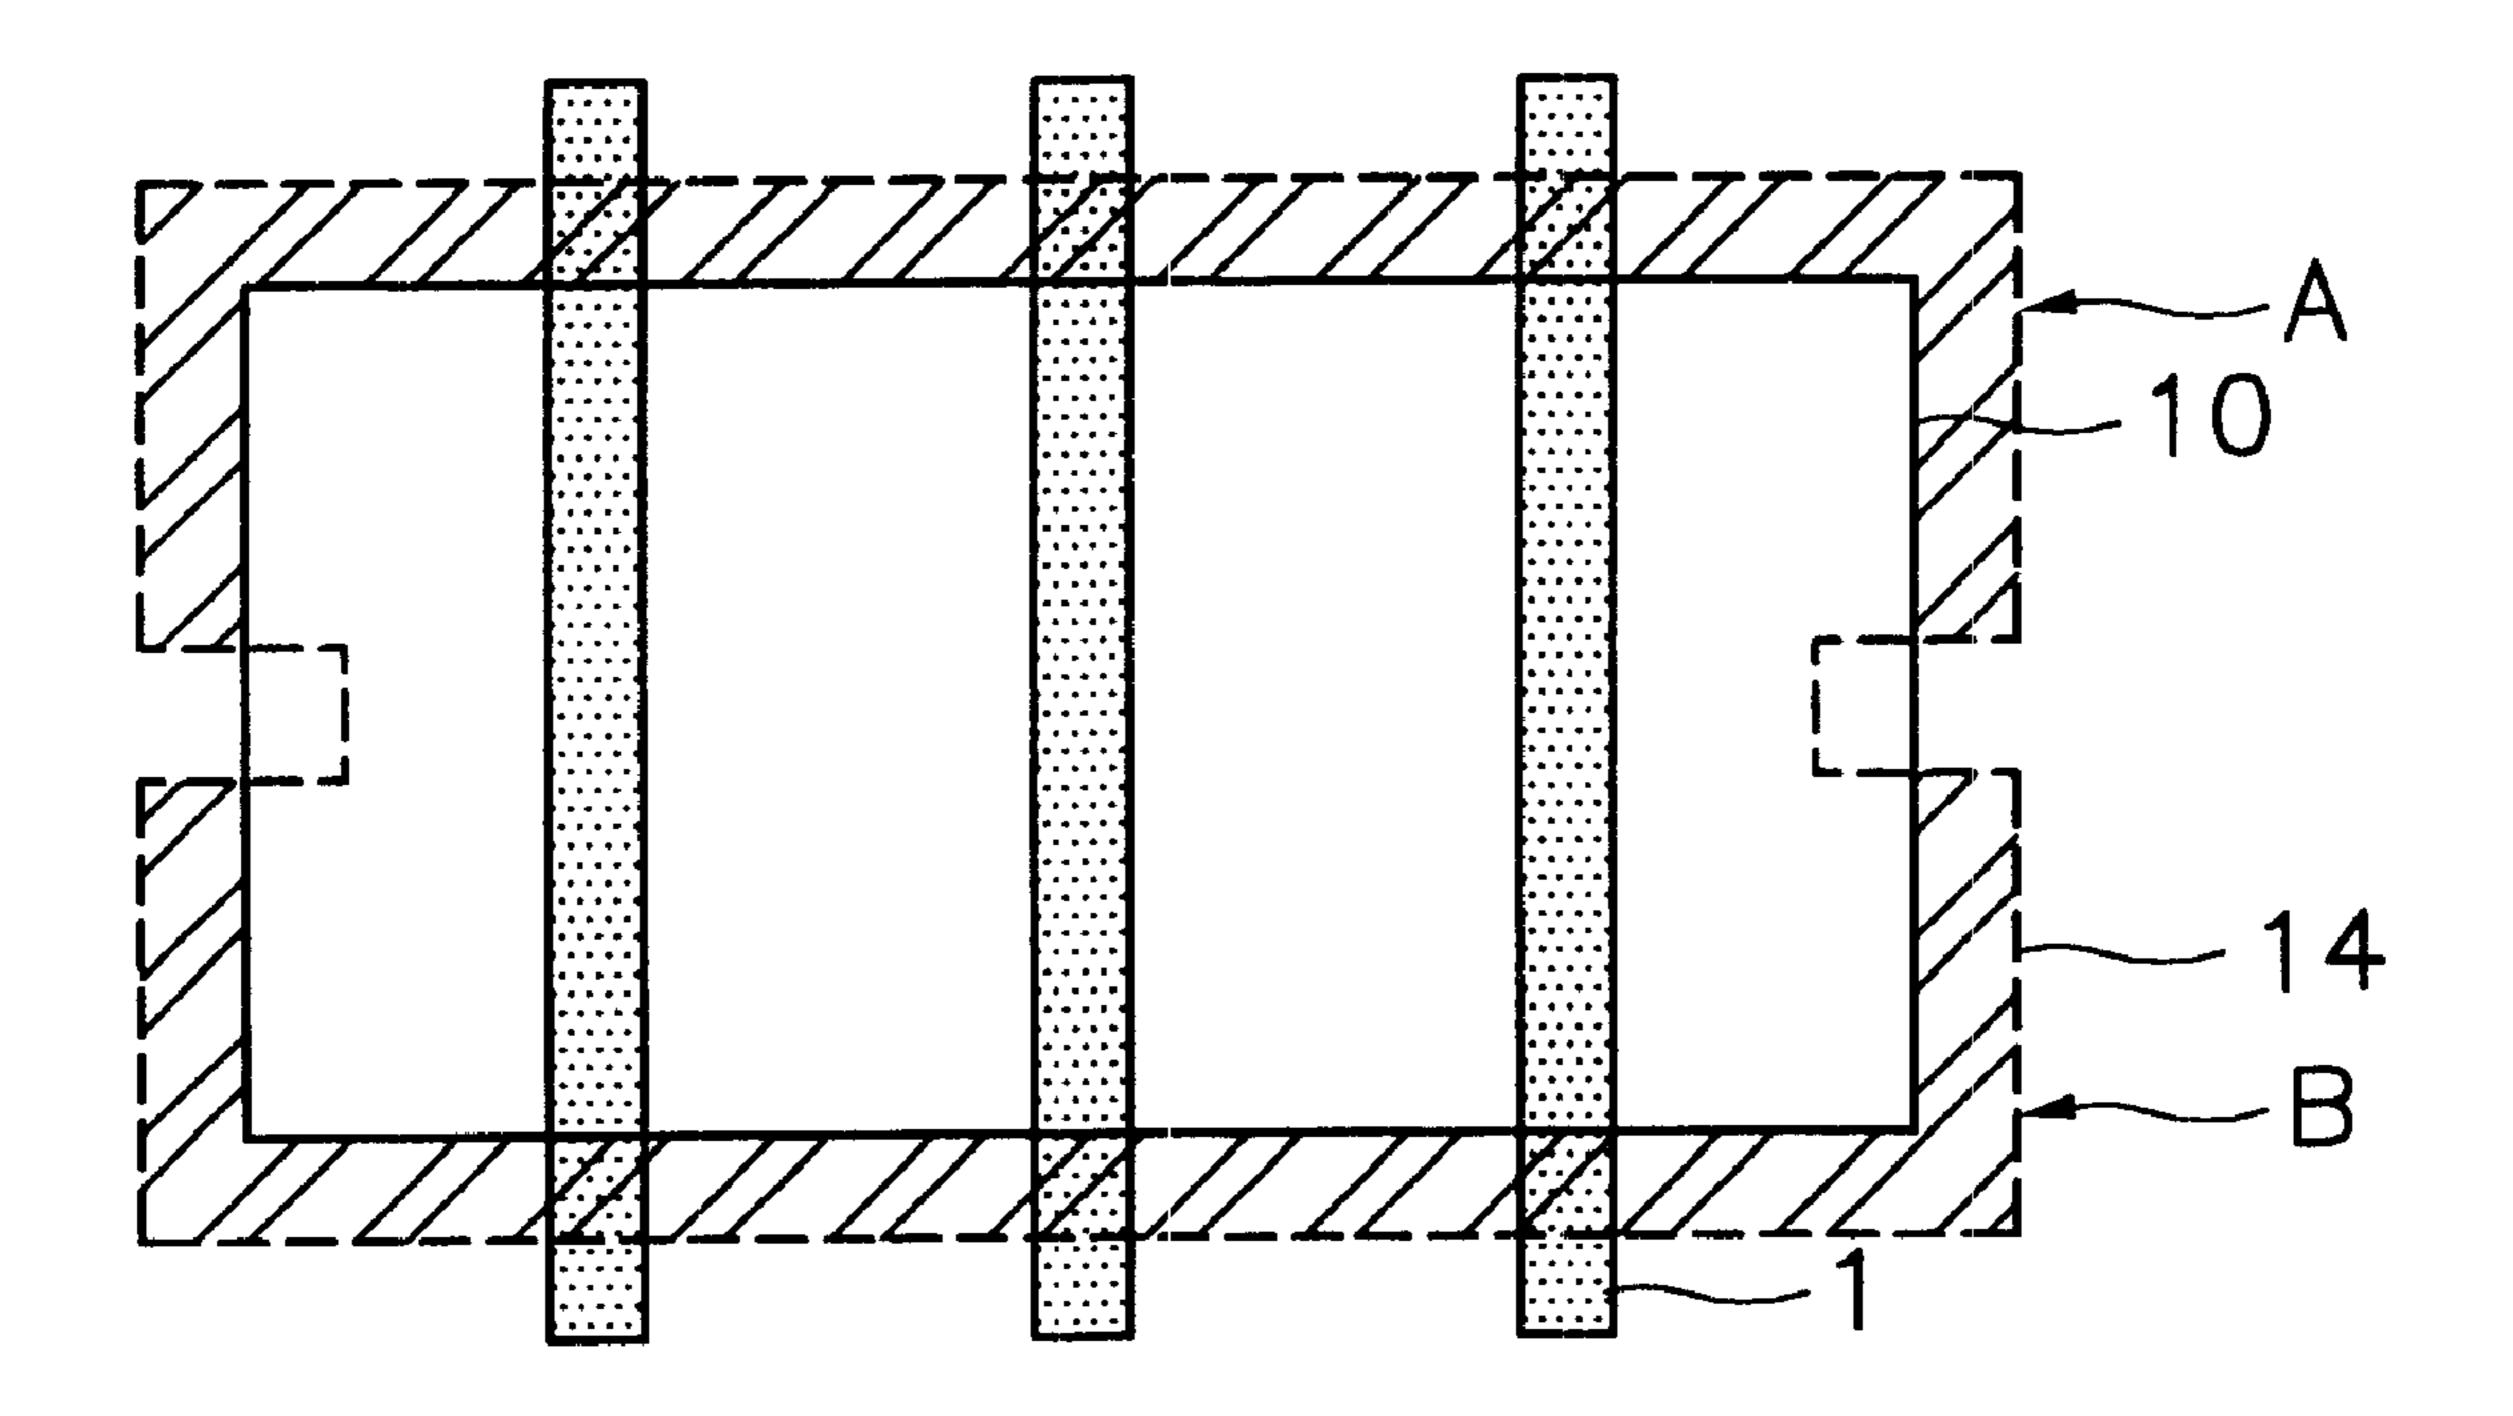
Fig. 1
Prior Art

Referring to FIG. 1, a related art repair fuse box 10 is defined in a rectangular shape. Polysilicon fuses 12 (Poly2) are arranged within the repair fuse box 10, and an etching stop polysilicon layer 14 (Poly4) is formed in a rectangular belt shape surrounding the repair fuse box 10.

FIG. 1 is a layout of a related art repair fuse box;

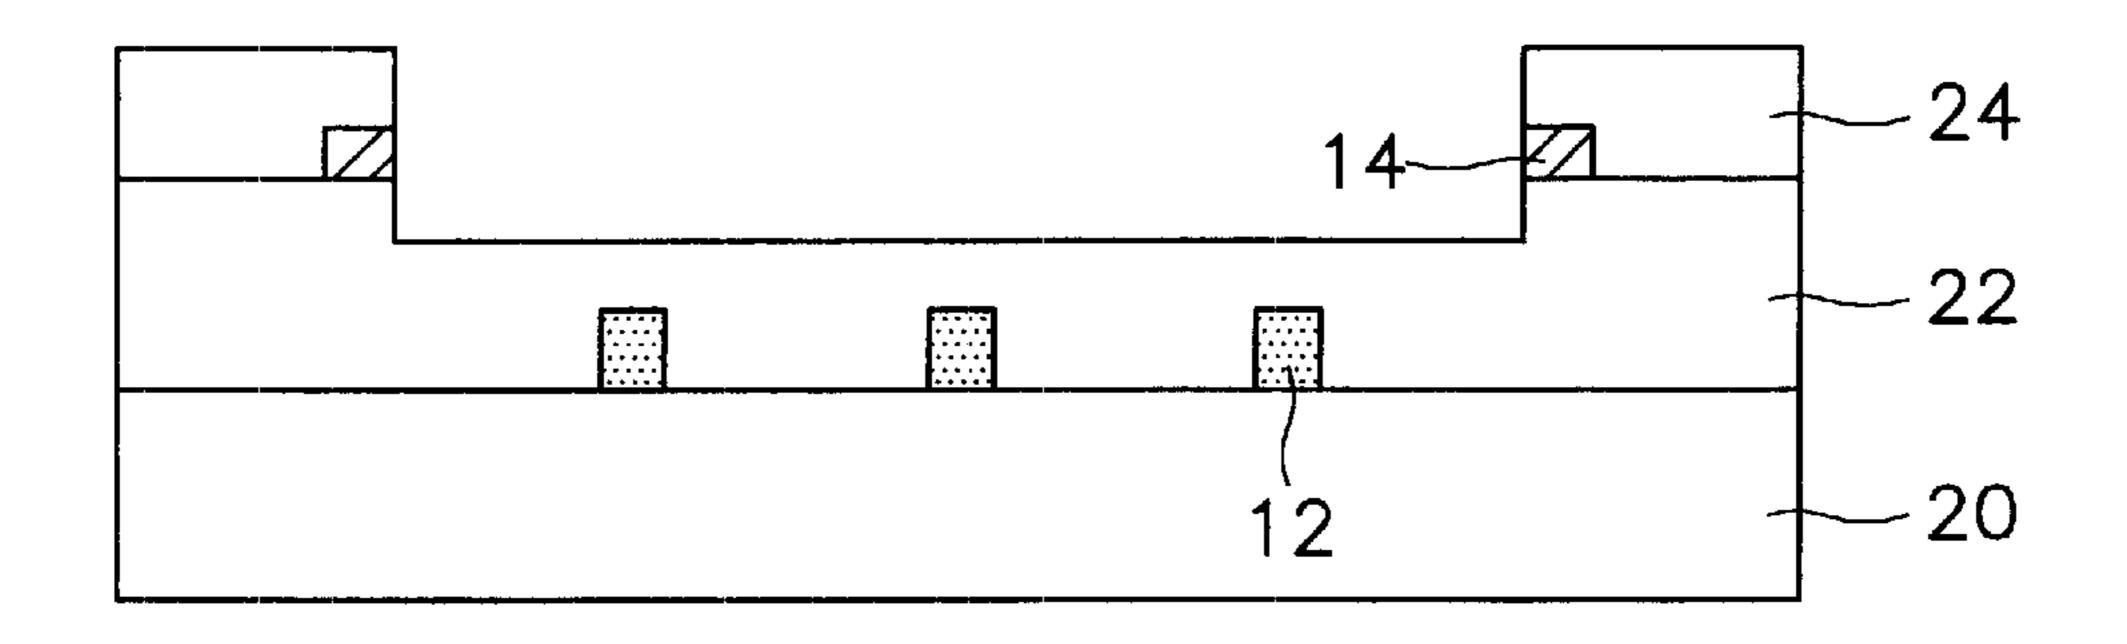
Fig. 2 Prior Art

Referring to FIG. 2, a first insulating film 20 and the fuses 30 12 are formed on a semiconductor substrate (not shown). A second insulating film 22, the etching stop polysilicon layer 14 and a third insulating film 24 are formed on upper portions of the first insulating film 20 and the fuses 12. The third insulating film 24 is formed outside the repair fuse box 35 10, and the etching stop polysilicon layer 14 is formed on insulating film 22 around the edge portions of the repair fuse box 10.

FIG. 2 is a sectional view taken along line I'-I" of FIG. 1;

A method for fabricating the repair fuse box 10 according ¹⁰ to the present invention will be described with reference to FIG. 2.

First, a first insulating film 20 is formed on a semiconductor substrate (not shown), and fuses 12 are formed on the first insulating film 20 during the process of forming Poly2 or Poly1 patterns. Then, a second insulating film 22, the etching stop polysilicon layer 14 and a third insulating film 24 are sequentially formed on the upper portion of an entire surface. The etching stop polysilicon layer 14 is formed to be larger than the intended repair fuse box 10 which will be formed later, so that the edge portions of the repair fuse box 10 are overlapped by the etching stop polysilicon layer 14.

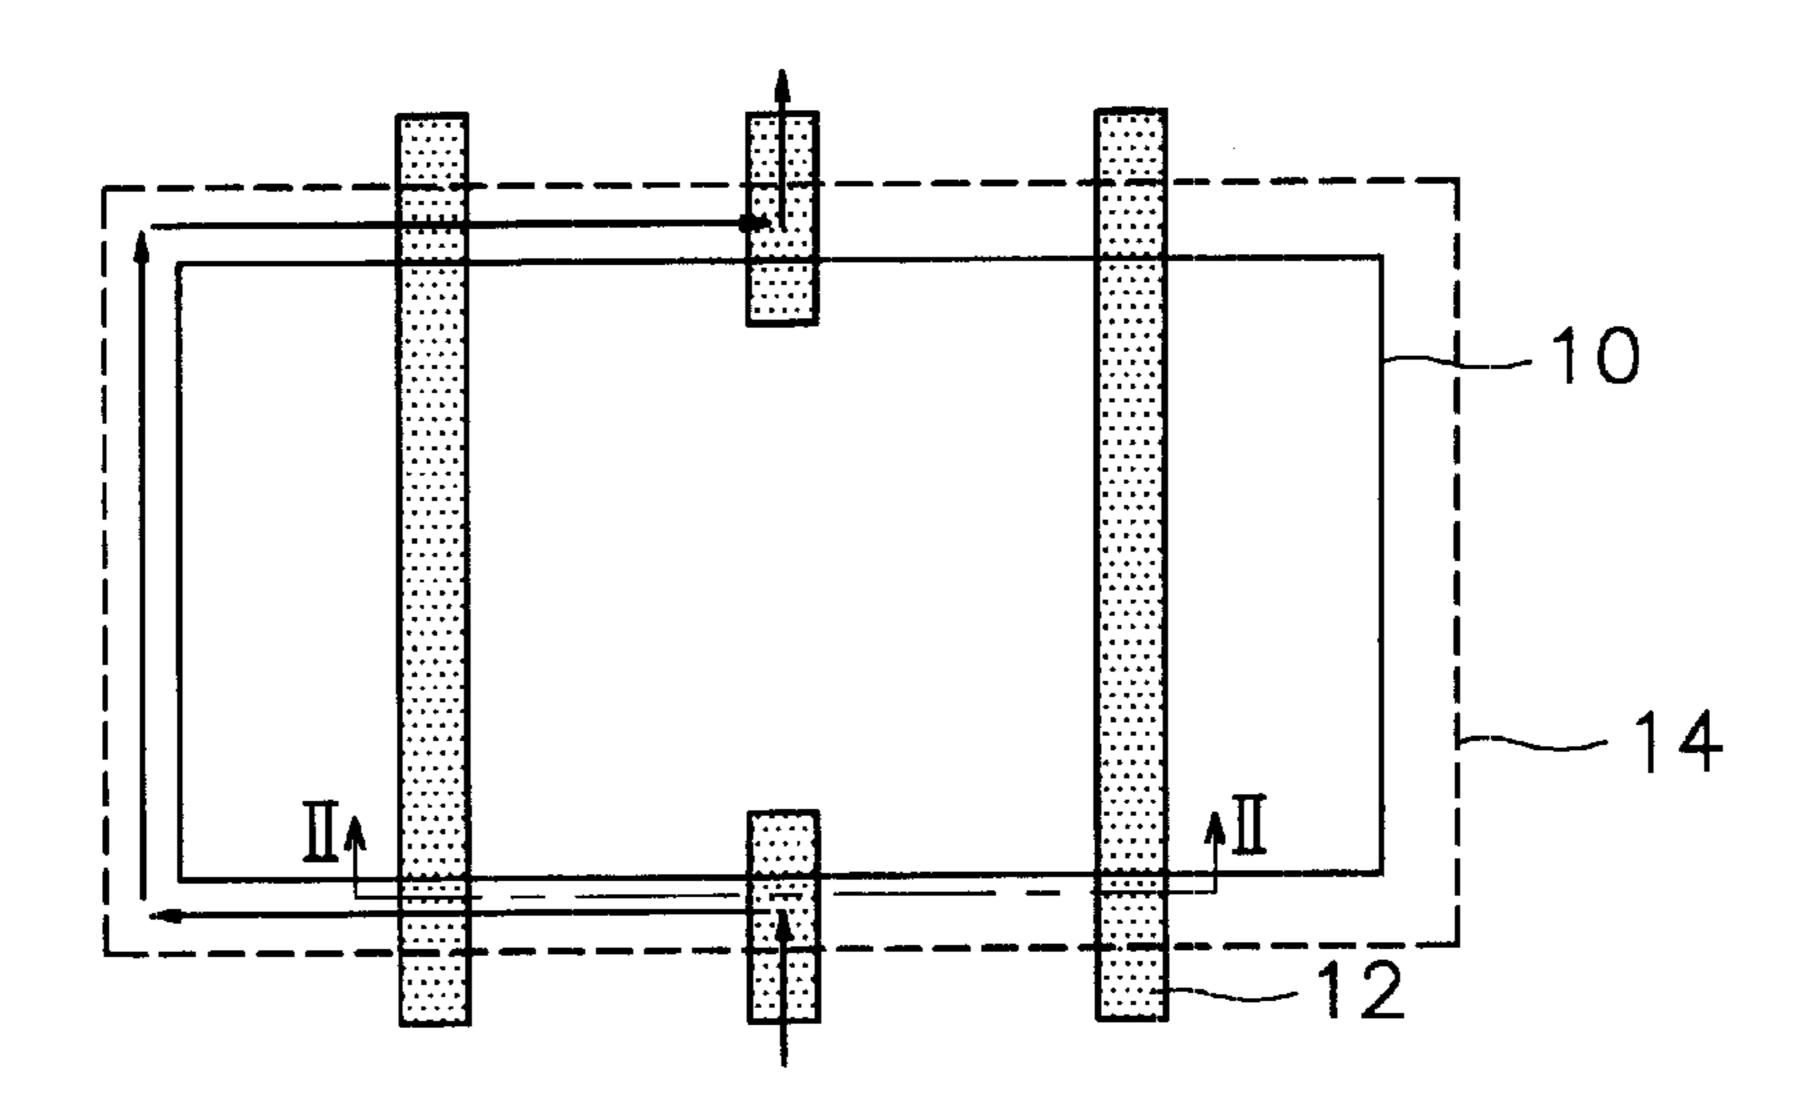
Fig. 3
Prior Art

As shown in FIGS. 3 and 4, however, a polysilicon residue 16 is fused and sticks to a sidewall of the fuse box 10 when cutting the fuses 12. In other words, if the fuses 12 are of W salicide layer, the polysilicon residue 16 of WSi_X 55 can remain within the fuse box. The remaining portion of the cut fuses 12 can become connected to the etching stop polysilicon layer 14 by this polysilicon residue 16, thereby causing poor repair performance.

FIG. 3 is a layout of a repair fuse box in case that a repair is failed;

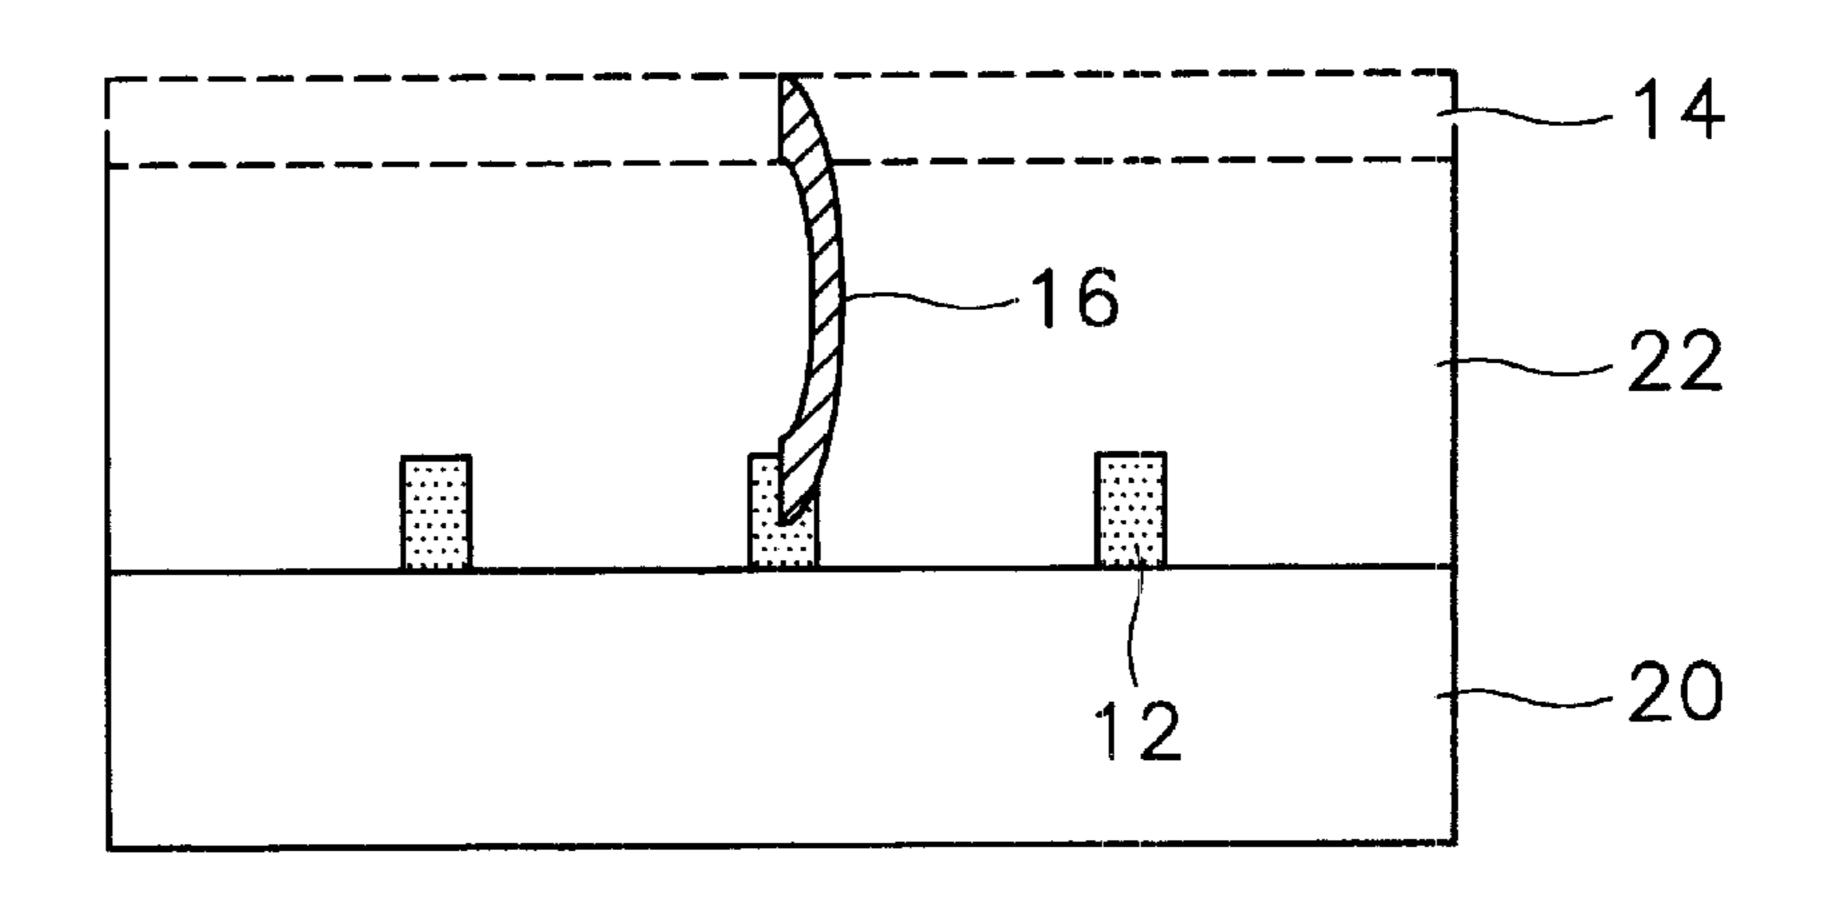
Fig.4
Prior Art

FIG. 4 is a sectional view taken along line II'-II" of FIG. 3;

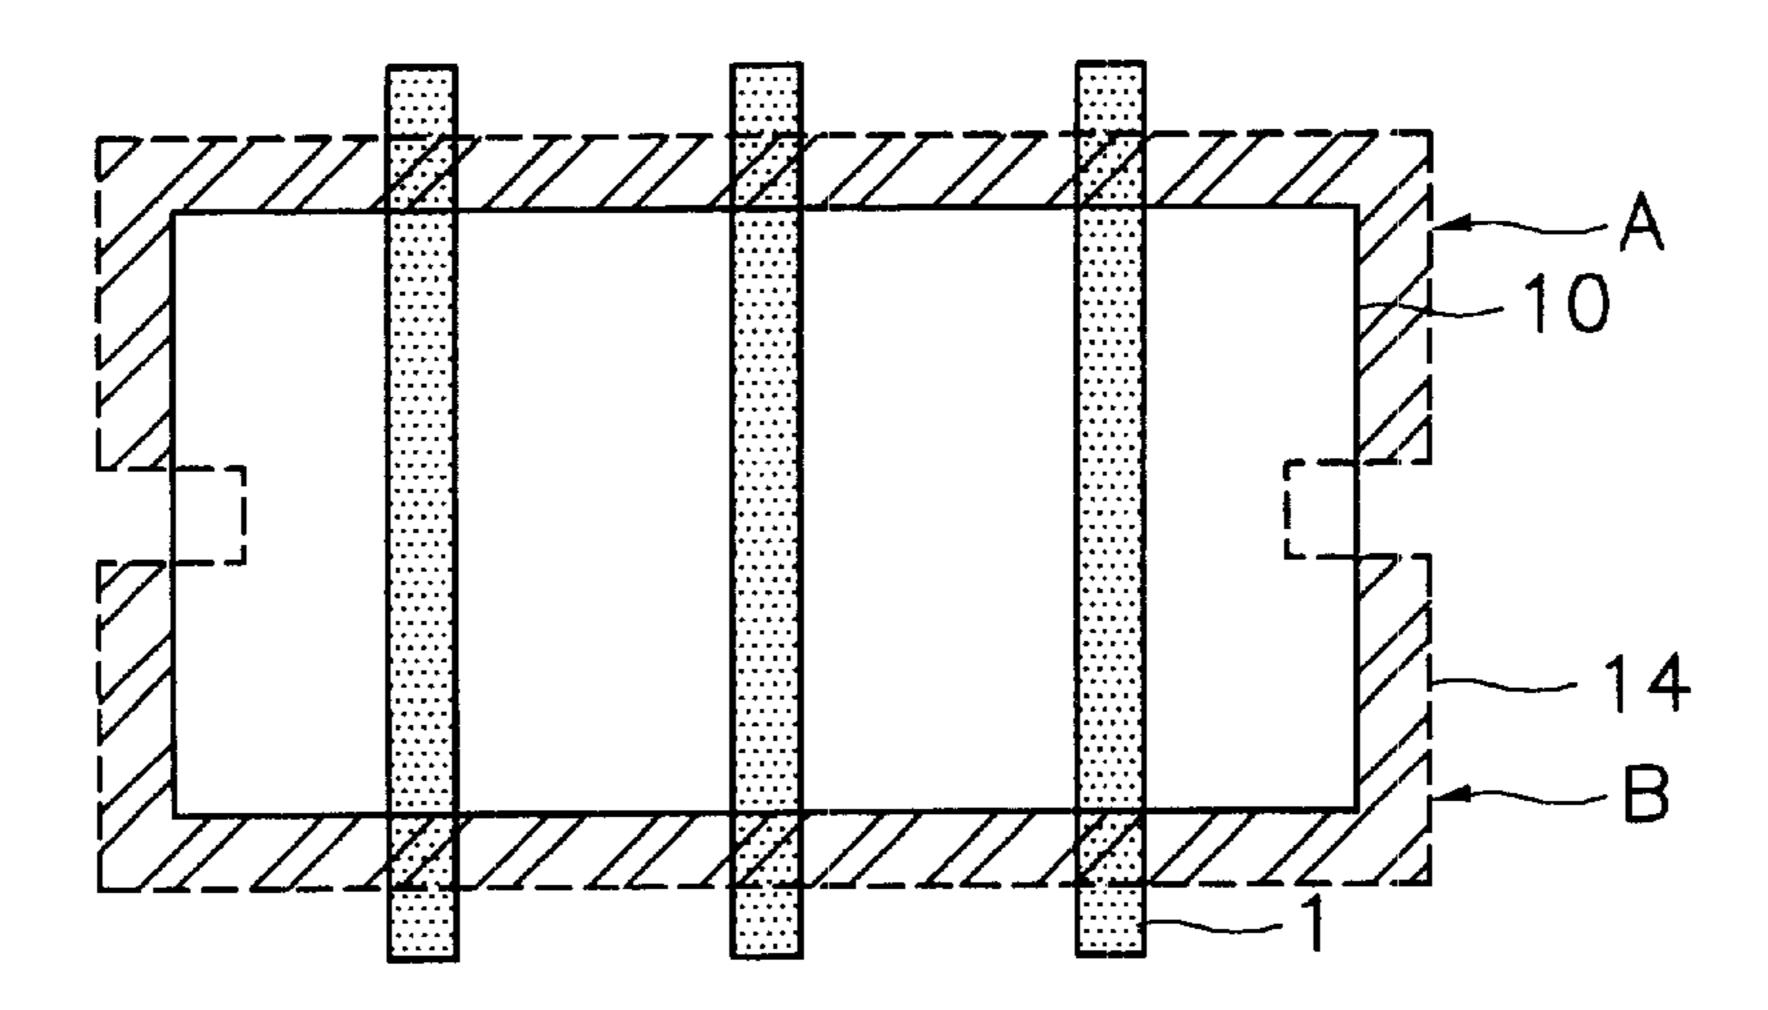
Fig.5

FIG. 5 is a layout of a repair fuse box according to one embodiment of the present invention; and

FIG. 5 illustrates a layout of a repair fuse box according to one embodiment of the present invention.

Polysilicon fuses 12 are preferably formed from a Poly2 layer in conjunction with the formation of a bitline or charge storing electrode. The fuses 12 are formed in a repair fuse box 10 that has a generally rectangular shape. At the edge portions of the repair fuse box 10, an etching stop polysilicon layer 14 formed in conjunction with the formation of the bitline or charge storing electrode. The etching stop polysilicon layer 14 is formed in a belt shape having at least two broken portions.

As shown in FIG. 5, portions A and B of the etching stop polysilicon layer 14 are formed from the same polysilicon layers. However, although the portions A and B are in contact with each other before the repair fuse box etching process, the portions A and B are defined and separated from 40 each other during the repair fuse box etching process.

As described above, if the etching stop polysilicon layer 14 is broken during the repair fuse box etching process that forms the repair fuse box 10, shorts between the fuse 12 and a portion of the etching step polysilicon wafer resulting from 45 polysilicon residue remaining from the laser repair process do not defeat the repair process.

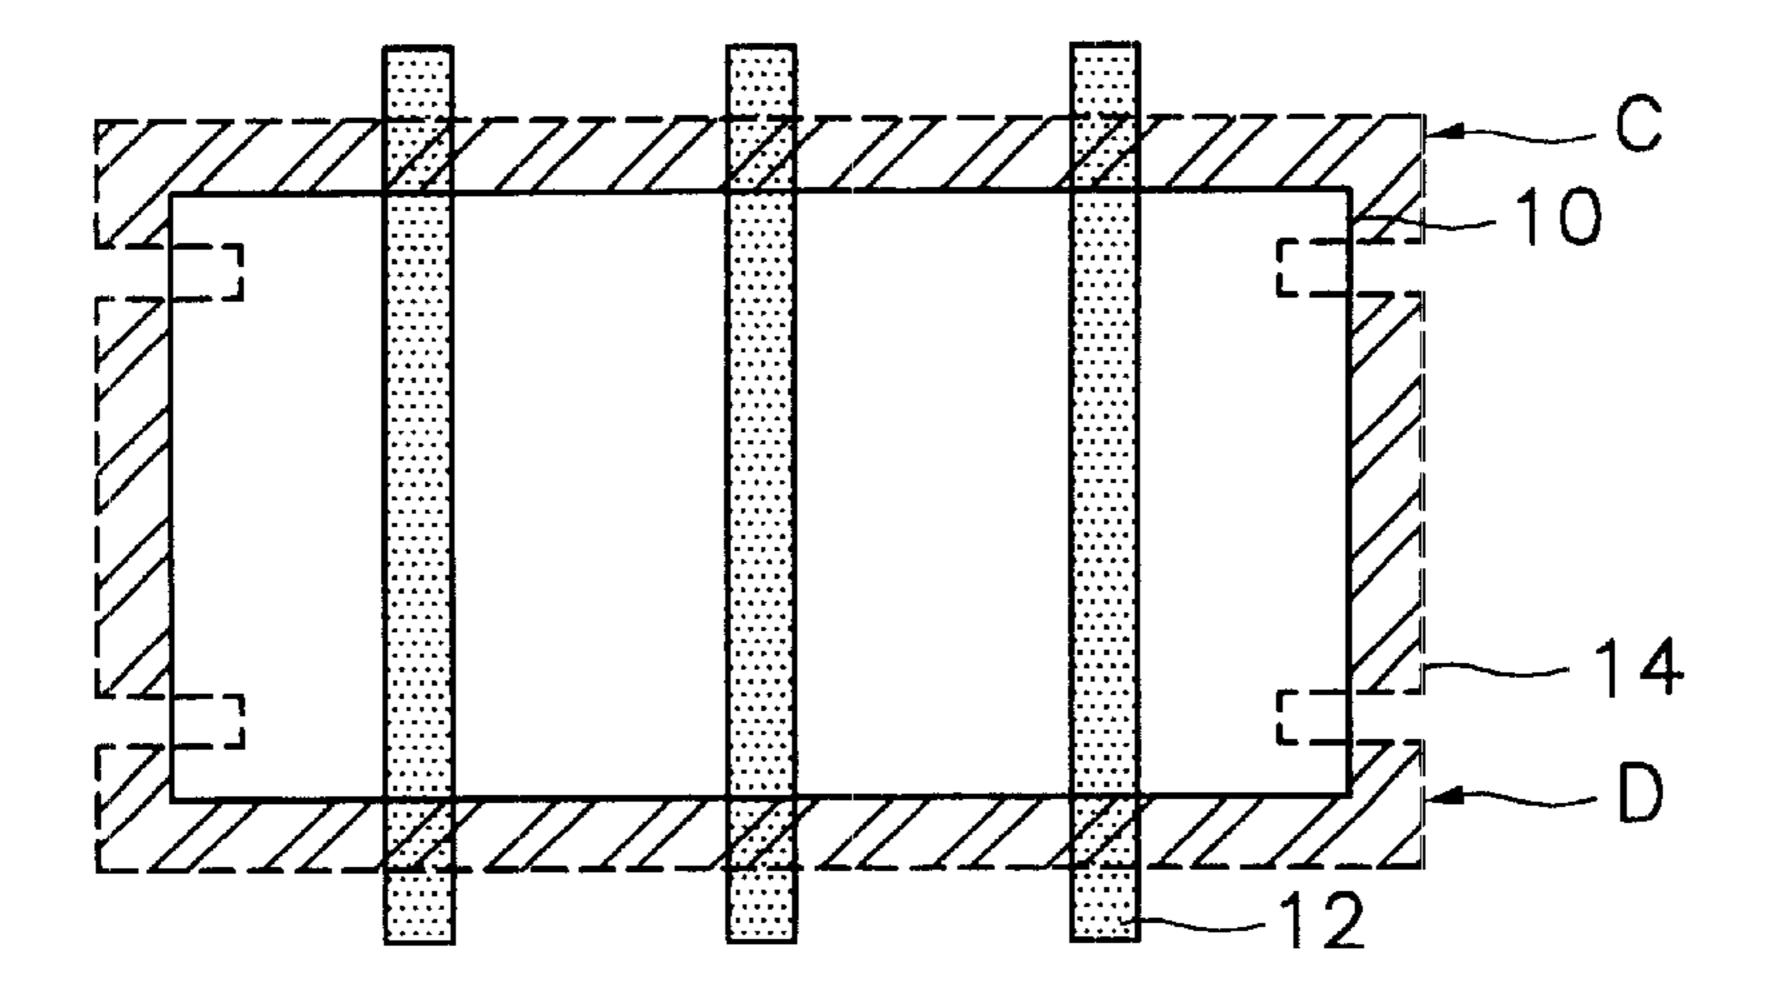
Fig.6

FIG. 6 is a layout of a repair fuse box according to another embodiment of the present invention.

FIG. 6 is a layout of a repair fuse box according to other embodiment of the present invention. Referring to FIG. 6, the etching stop polysilicon layer 14 having a belt shape is broken at both sides. In other words, portions C and D of the etching stop polysilicon layer 14 are twice broken by the repair fuse box etching process.
