(10) **Patent No.:** **US 6,601,357 B2**
(45) **Date of Patent:** **Aug. 5, 2003**

(54) **UN-REINFORCED THERMOPLASTIC COATING**

UN-REINFORCED THERMOPLASTIC COATING

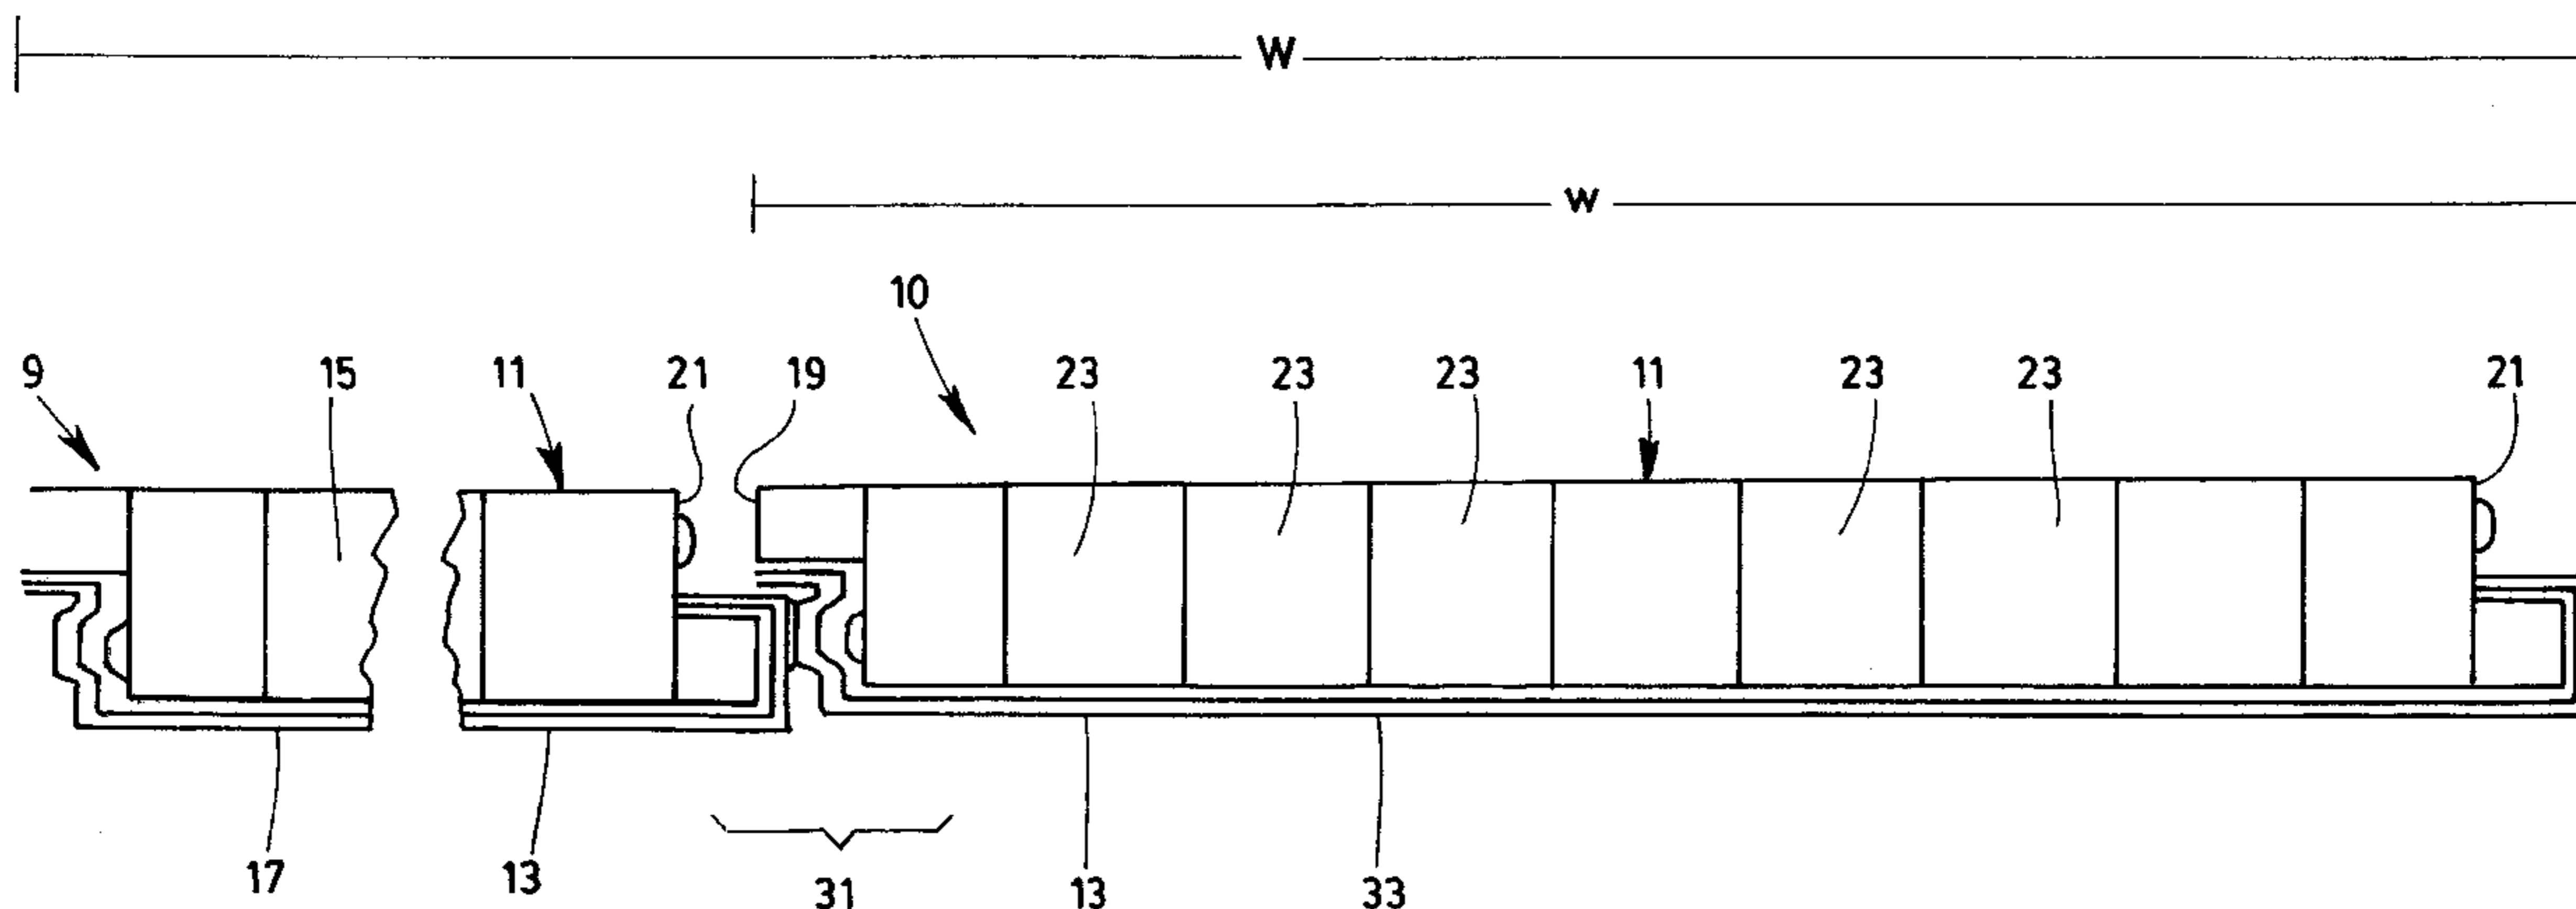
Figure 1

FIG. 1 is a photograph of average knot defect in wood floor;

FIG. 1 is a photograph of average knot defect in a wood floor. FIG. 2 is a photograph of the average split seam defect in wood floor at the glue line location. FIG. 3 is a photograph of hook joint gap defect in wood flooring. FIG. 4 is a photograph of completed wood boards with defects repaired and prepared for painting. FIG. 5 is a photograph of wood plank which has been painted according to the prior art and ready for installation. FIG. 6 is a photograph of an installed wood flooring on a truck chassis (note visible defect repairs in paint). FIG. 7 is a photograph of a truck floor undercoat

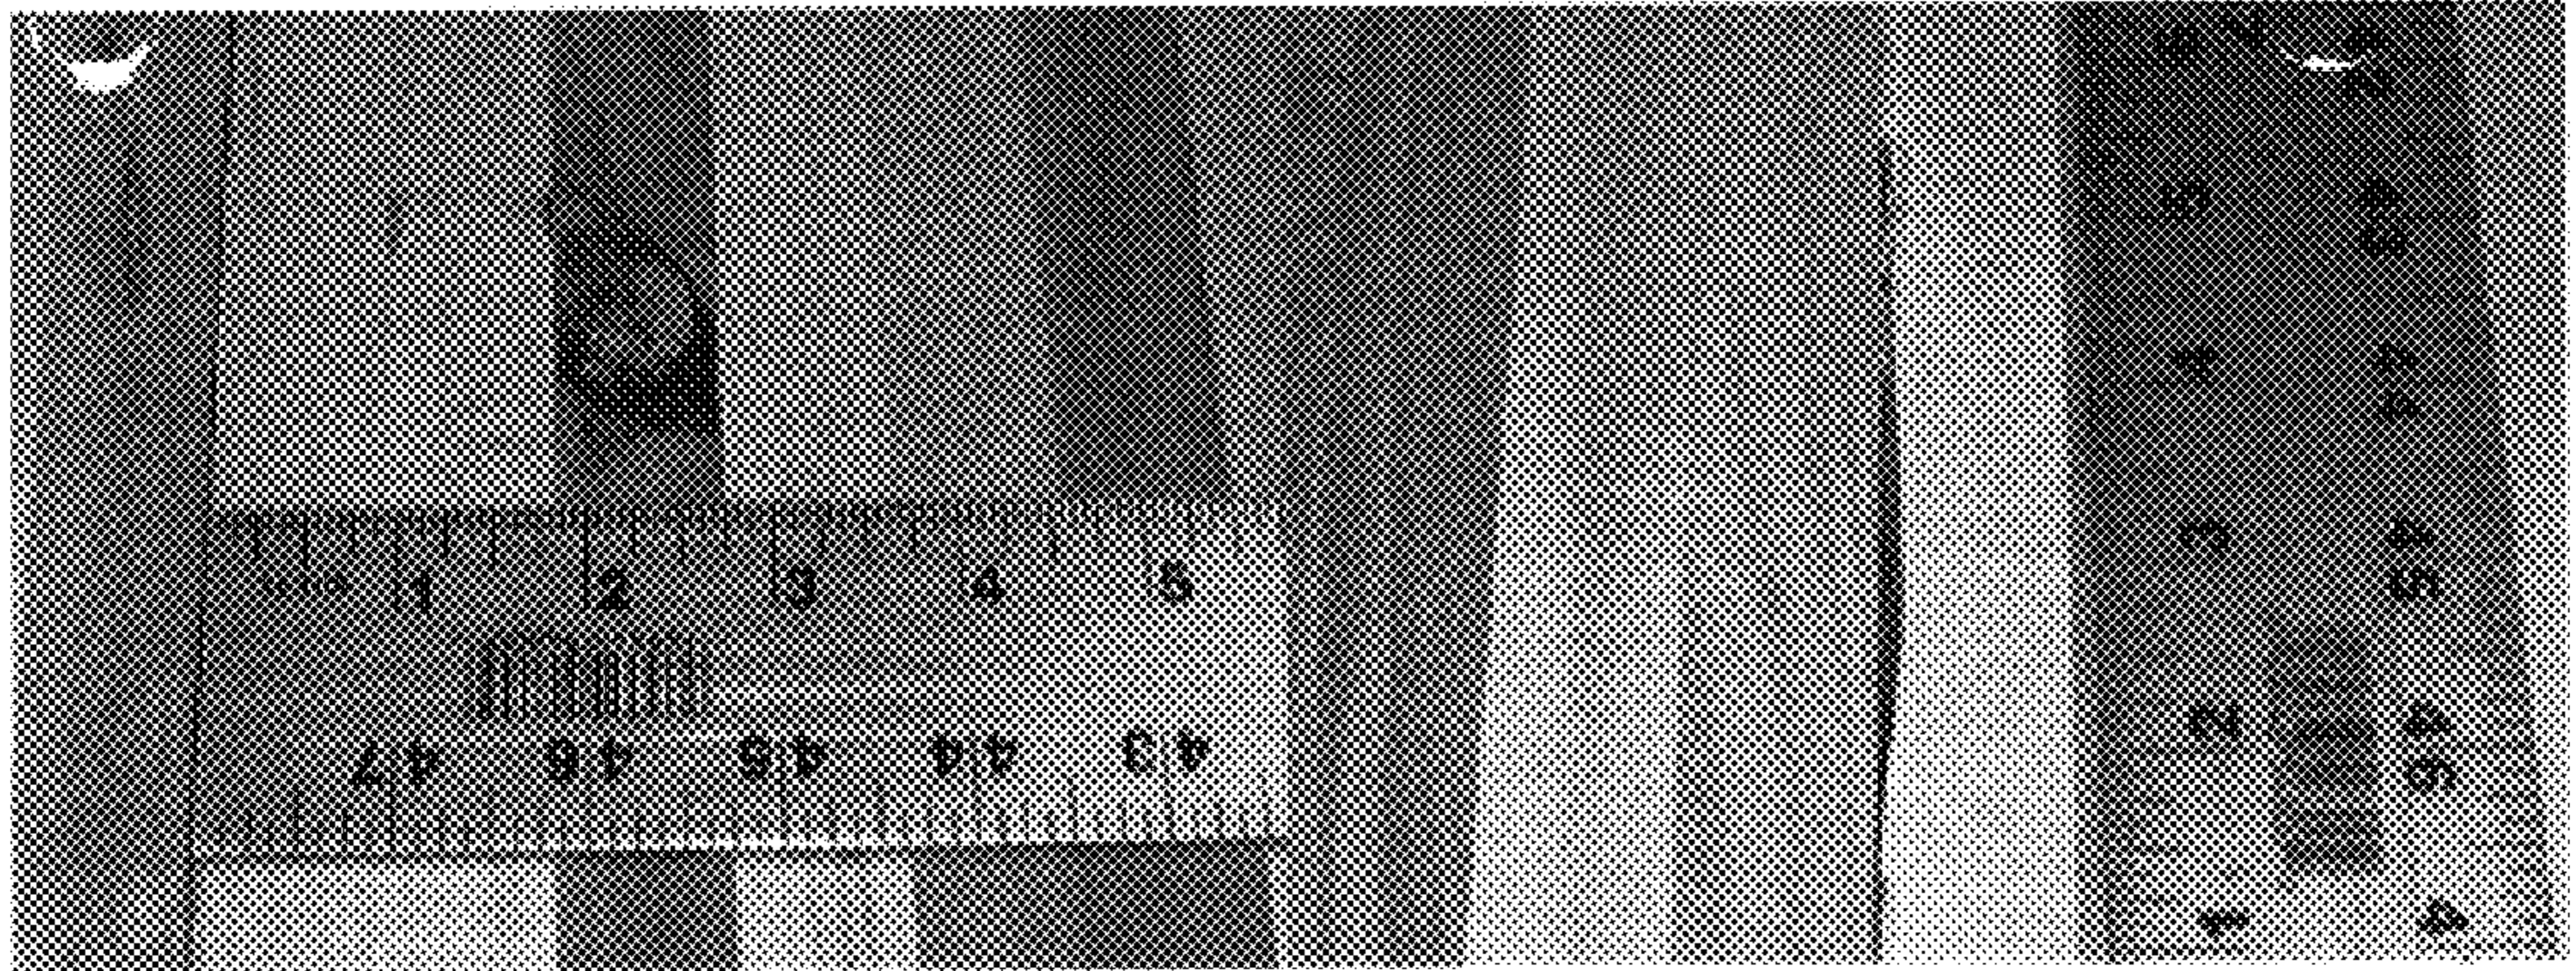
Figure 2

FIG. 2 is a photograph of average split seam defect in wood floor at the glue line location;

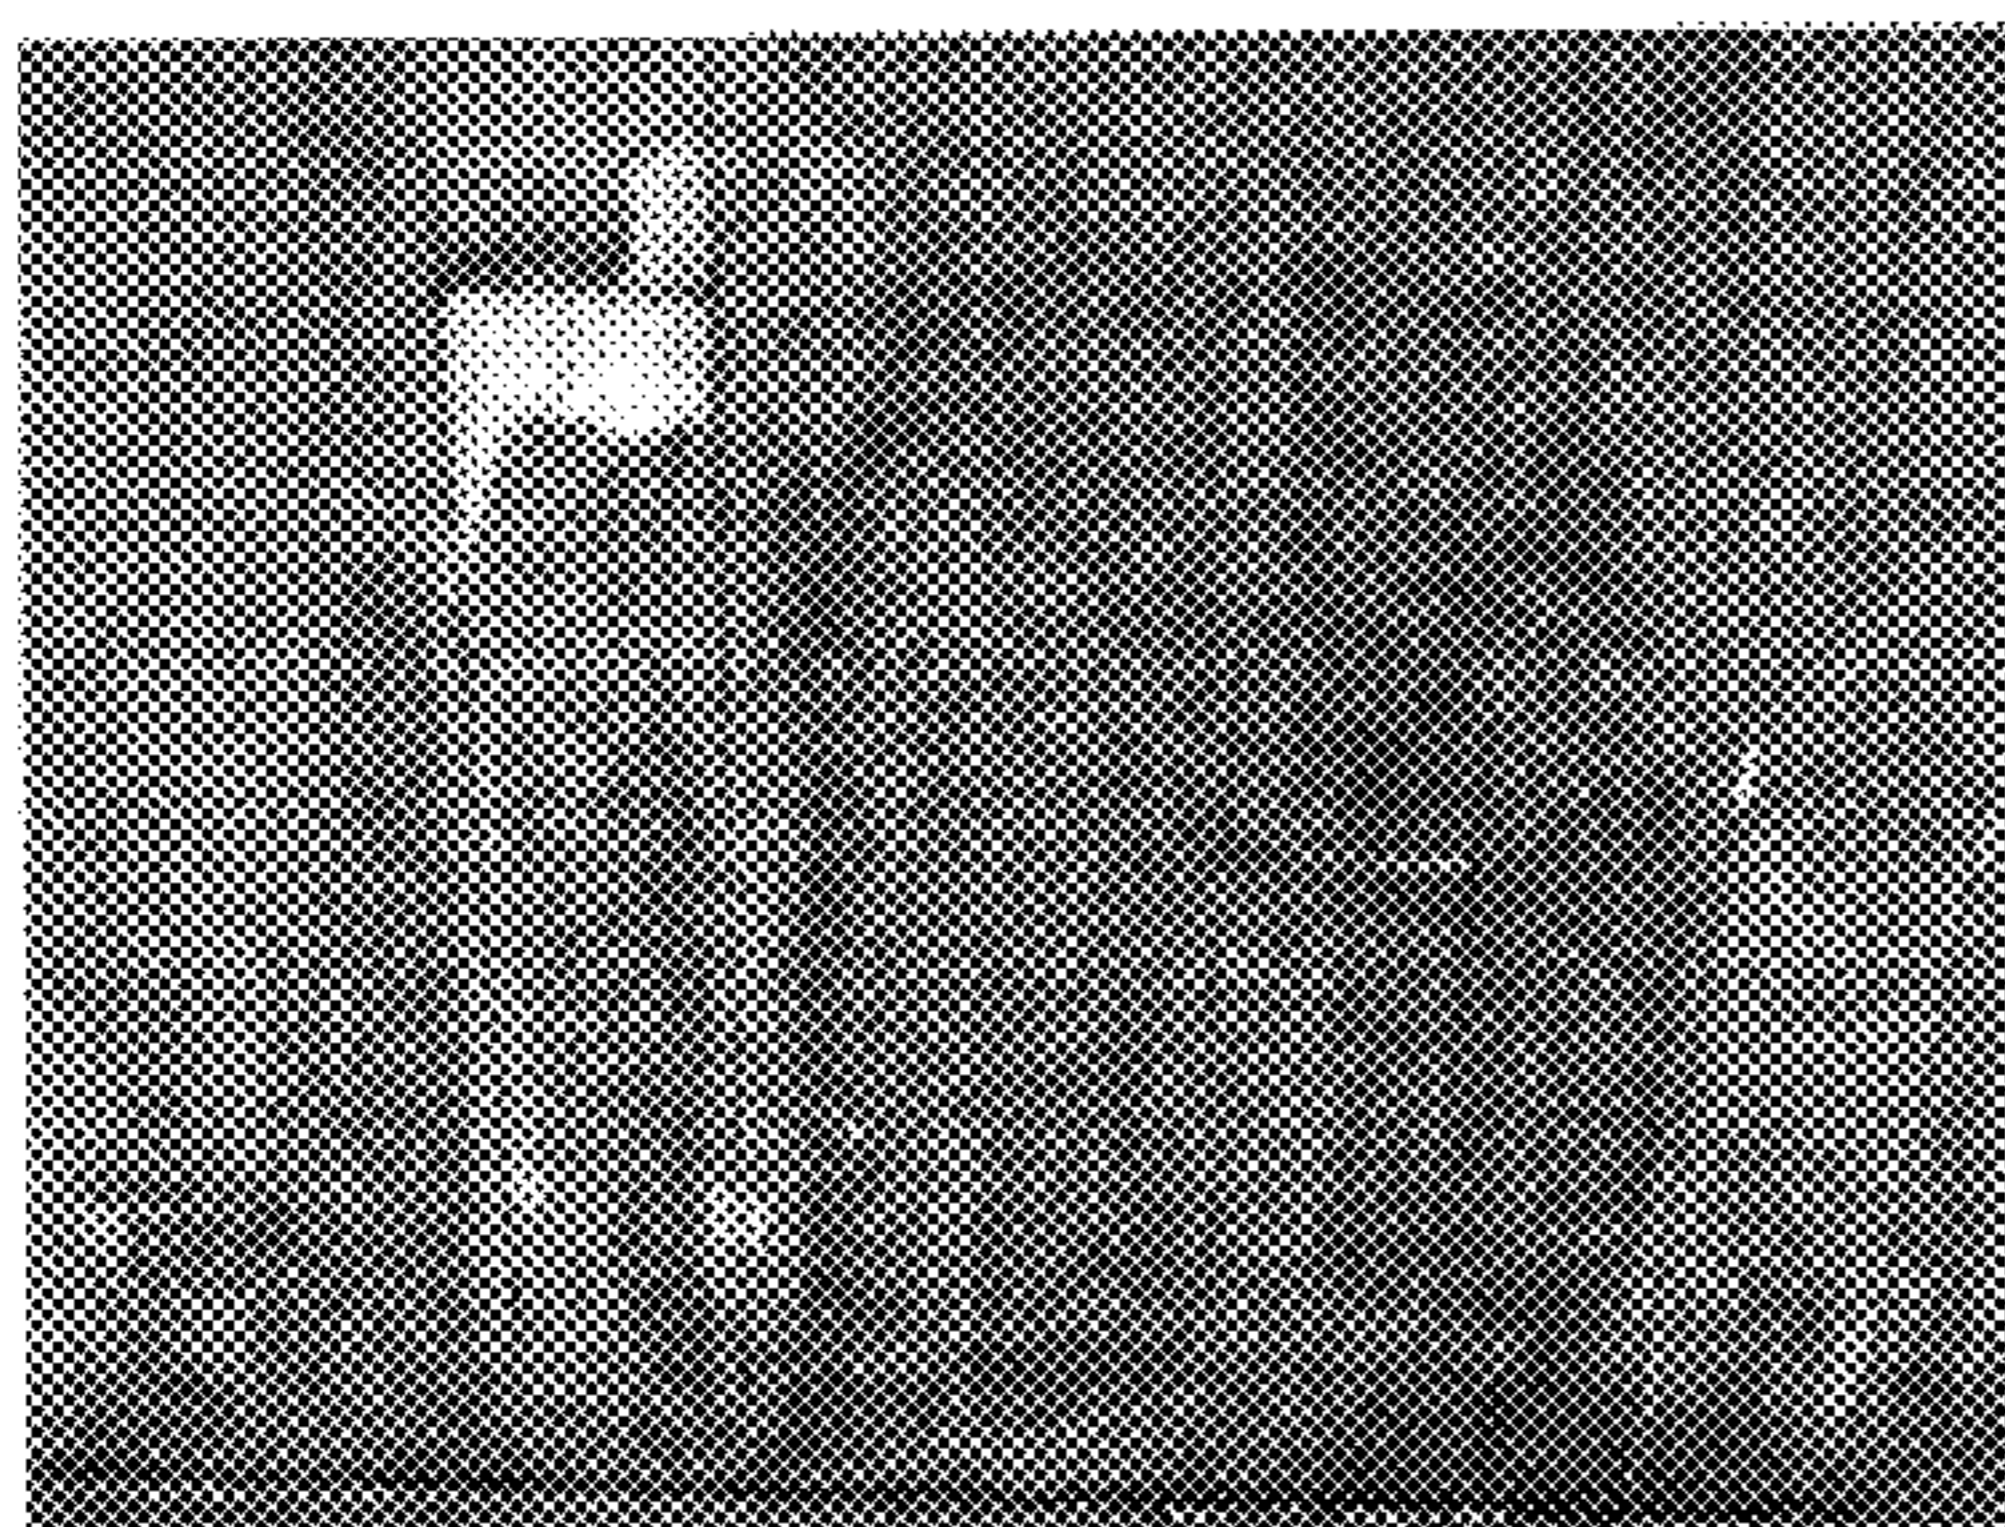
Figure 9

FIG. 9 is a photograph of hook joint defect causing breakdown of undercoat paint system;

paint peeling after 1 year of service; where FIG. 8 is a photograph of a truck floor undercoat paint showing near complete degradation after 1.5 years of service. Note the accentuated hook joint and split at glue line. FIG. 9 is a photograph of hook joint defect causing breakdown of the undercoat paint system; whereas FIG. 10 shows the accentuated hook joint swelling and subsequent board splitting and coating failure. Finally, FIG. 11 is a photograph of a floor according to the present invention installed on a truck chassis.

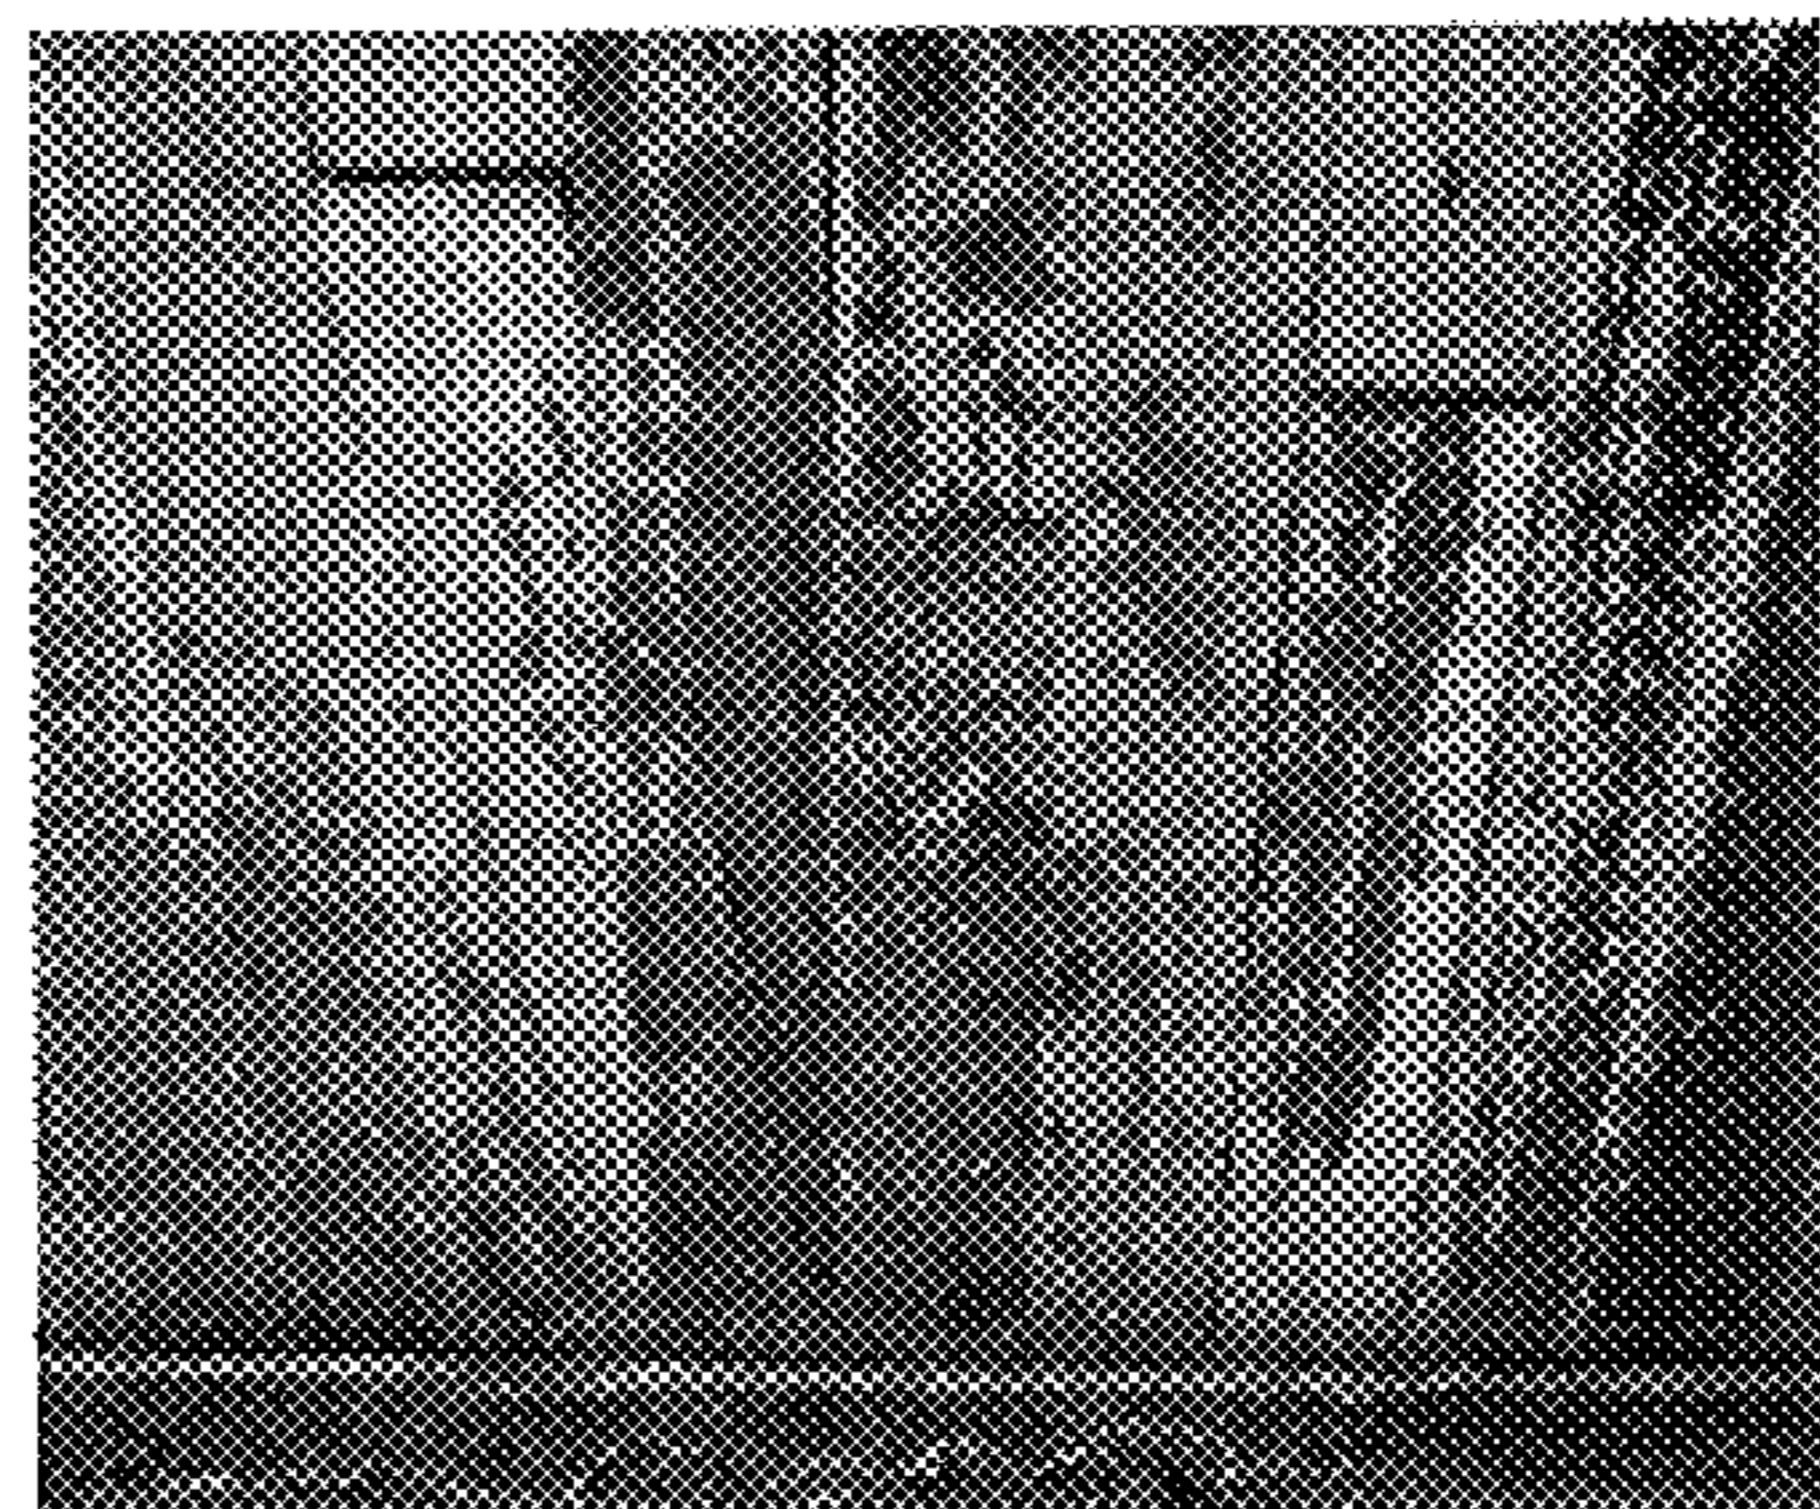
Figure 10

FIG. 10 is accentuated hook joint swelling and subsequent board splitting and coating failure;

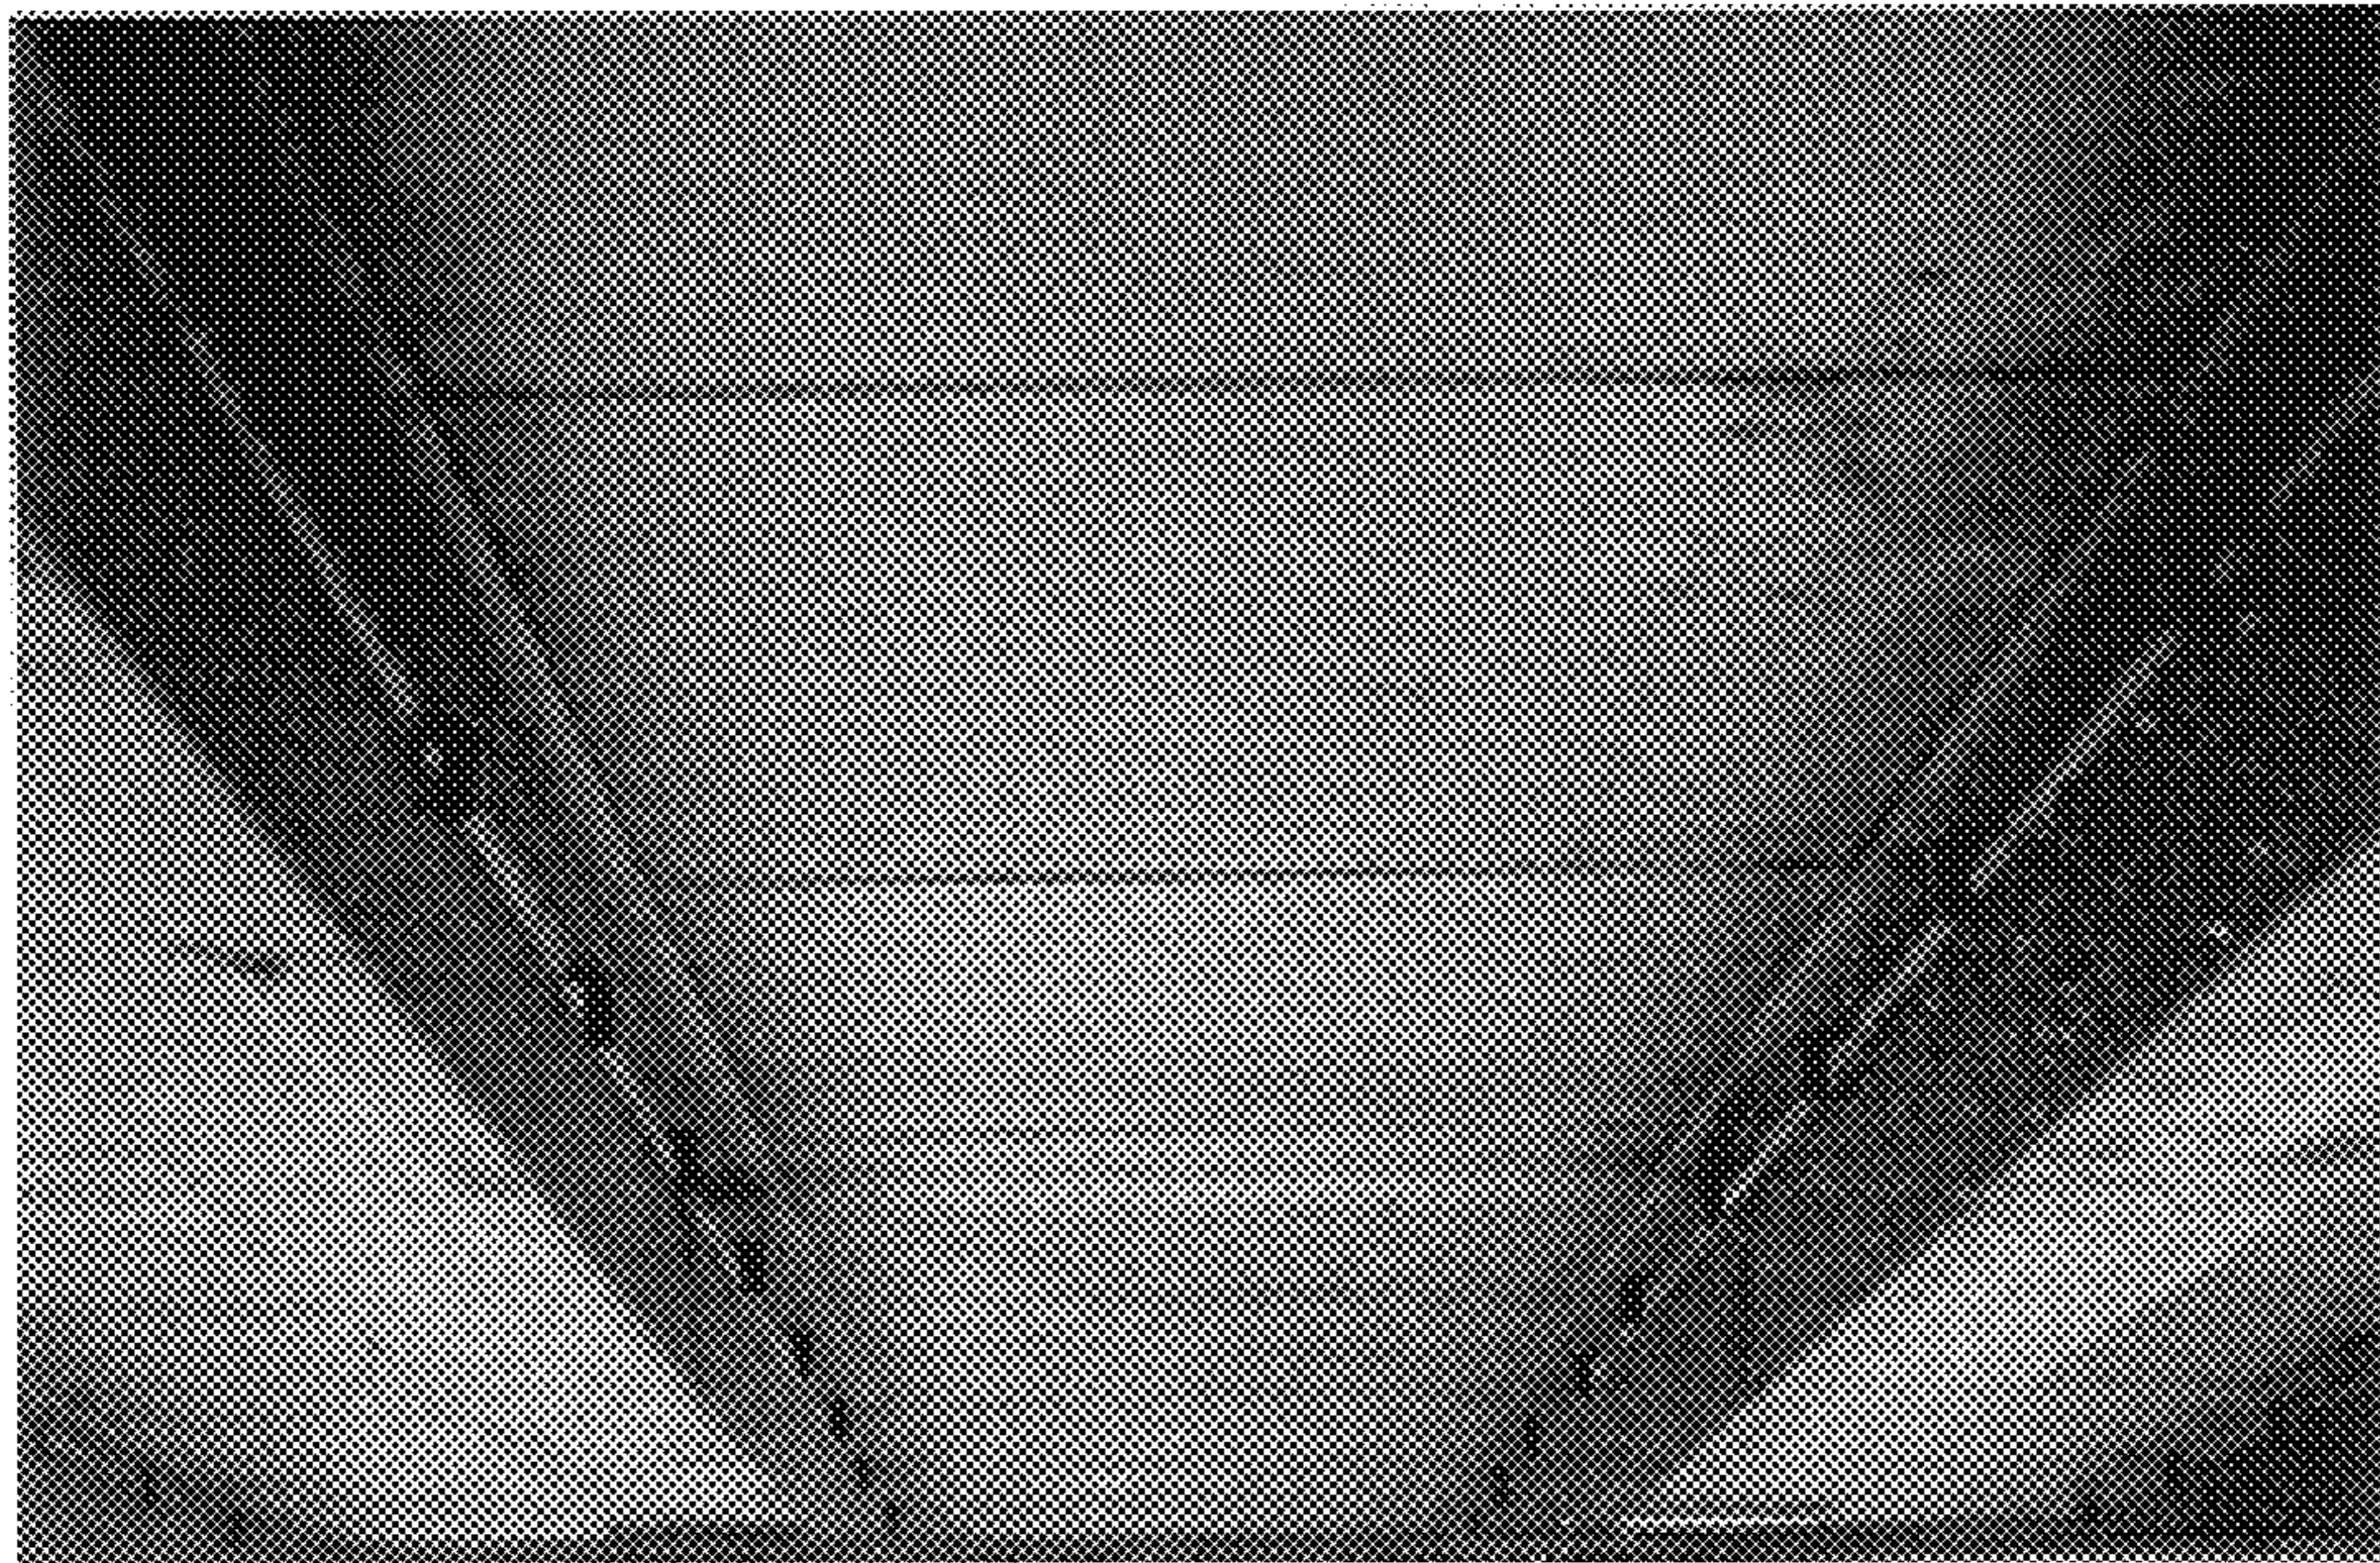
Figure 11

FIG. 11 is a photograph of installed thermoplastic undercoat system on truck chassis;

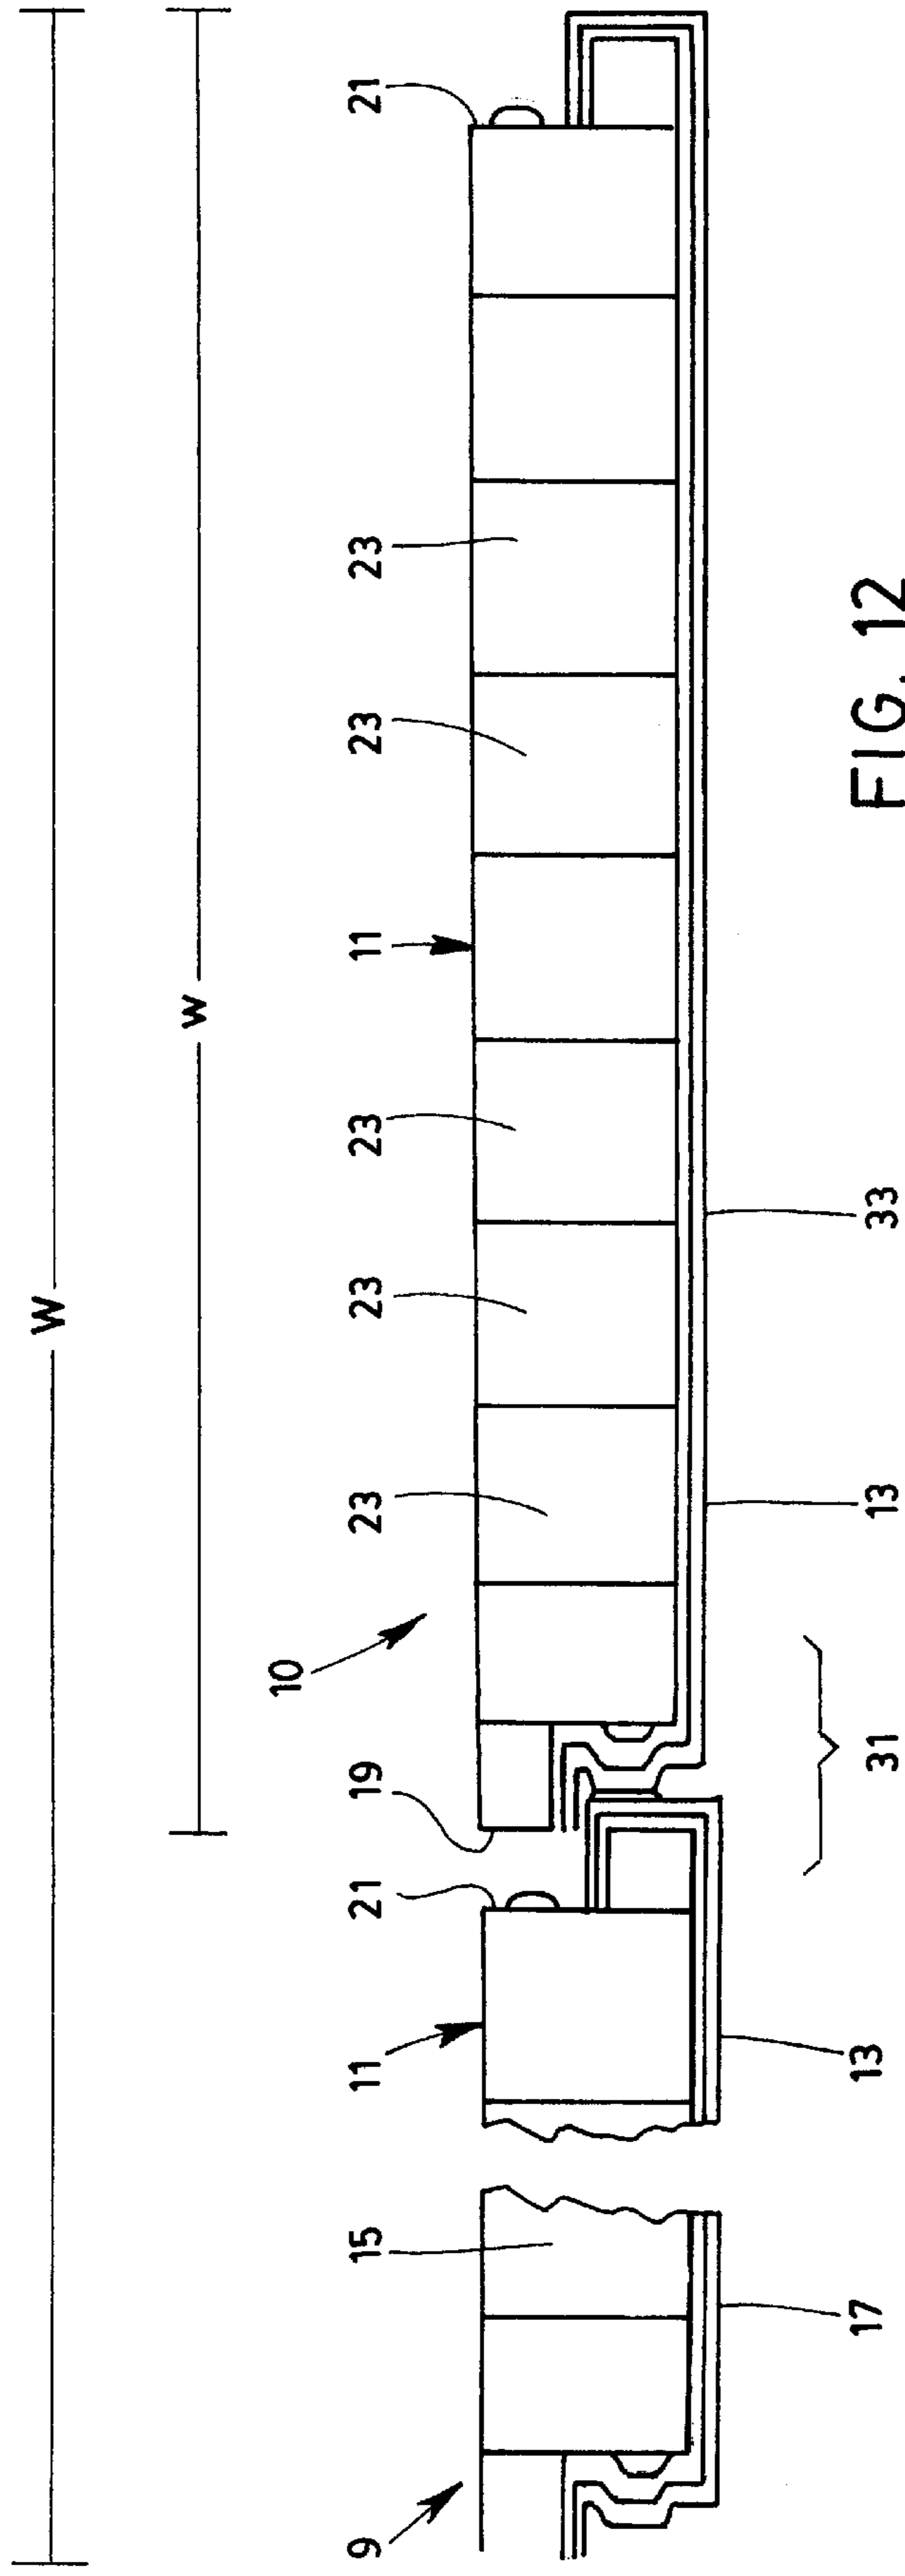
FIG. 12 is a cross-sectional area of a portion of a vehicular truck floor, showing two planks; and

Referring now to FIGS. 12 and 13, the present invention concerns a plastic coated vehicular surface flooring system having a length and a width. The plastic coated vehicular system comprises the following elements: a plurality of wood planks 11 arranged side by side to form a floor, the planks having a substantially planar polymer 13 continuously bonded to the underside thereof.

The plurality of wood planks 11 extends longitudinally up to a length substantially equal to the length of the floor, each plank 11 having a top surface 15 and a bottom surface 17, and a first 19 and second 21 side surfaces extending between the top surface 15 and the bottom 17 surface. Each plank has a width that is less than the width of the floor. Each plank 11 is formed by a plurality of boards 23 arranged side-by-side, each board being formed of a plurality of segments 25 joined end-to-end to one another by shaped coupling portions 27. In a preferred embodiment of the invention, the wood boards are a hardwood, and is most preferably selected from the group consisting of oak, maple, birch, beach and larch.

As mentioned previously, the planks 11 is arranged side-by-side such that at least one of the first 19 and second 21 side surfaces of each of the planks 11 faces one of the second 21 or first 19 side surfaces of an adjacent plank 11 to form the floor 10, a joint region 31 being formed at locations where the first side surface faces the second side surface of adjacent planks.

In a preferred embodiment, the first side surface is provided with an upper lip portion, the second side surface is provided with a lower lip portion, and the first side surface of one of the planks which faces the second side surface of an adjacent plank forms a ship lap joint in which the upper lip portion at least partially overlies the lower lip portion. Further preferably, at least one of the first side surface and the second side surface is provided with a crusher bead to prevent the upper lip portion of the first side surface from fully overlying the lower lip portion of the second side surface of an adjacent board to form a gap at the region of the ship lap joint to allow for eventual expansion of the wood. In such a case, it is preferable for the unreinforced polymer layer to also cover both surfaces of the ship lap joint and also preferably, cover the horizontal position of the joint.

Each of the plurality of planks 11 of the floor further comprises a substantially planar polymer layer 13 formed of an unreinforced polymer, the polymer being substantially continuously bonded to the bottom surface 17 of each of the plurality of planks with an adhesive layer 33 and extending unitarily substantially across the width and along the longitudinal length of each plank 11, the upper surface 15 of each of the plurality of planks being uncoated by the un-reinforced polymer layer. Preferably, the plastic polymer layer possesses a modulus of elasticity less than that of the wood.

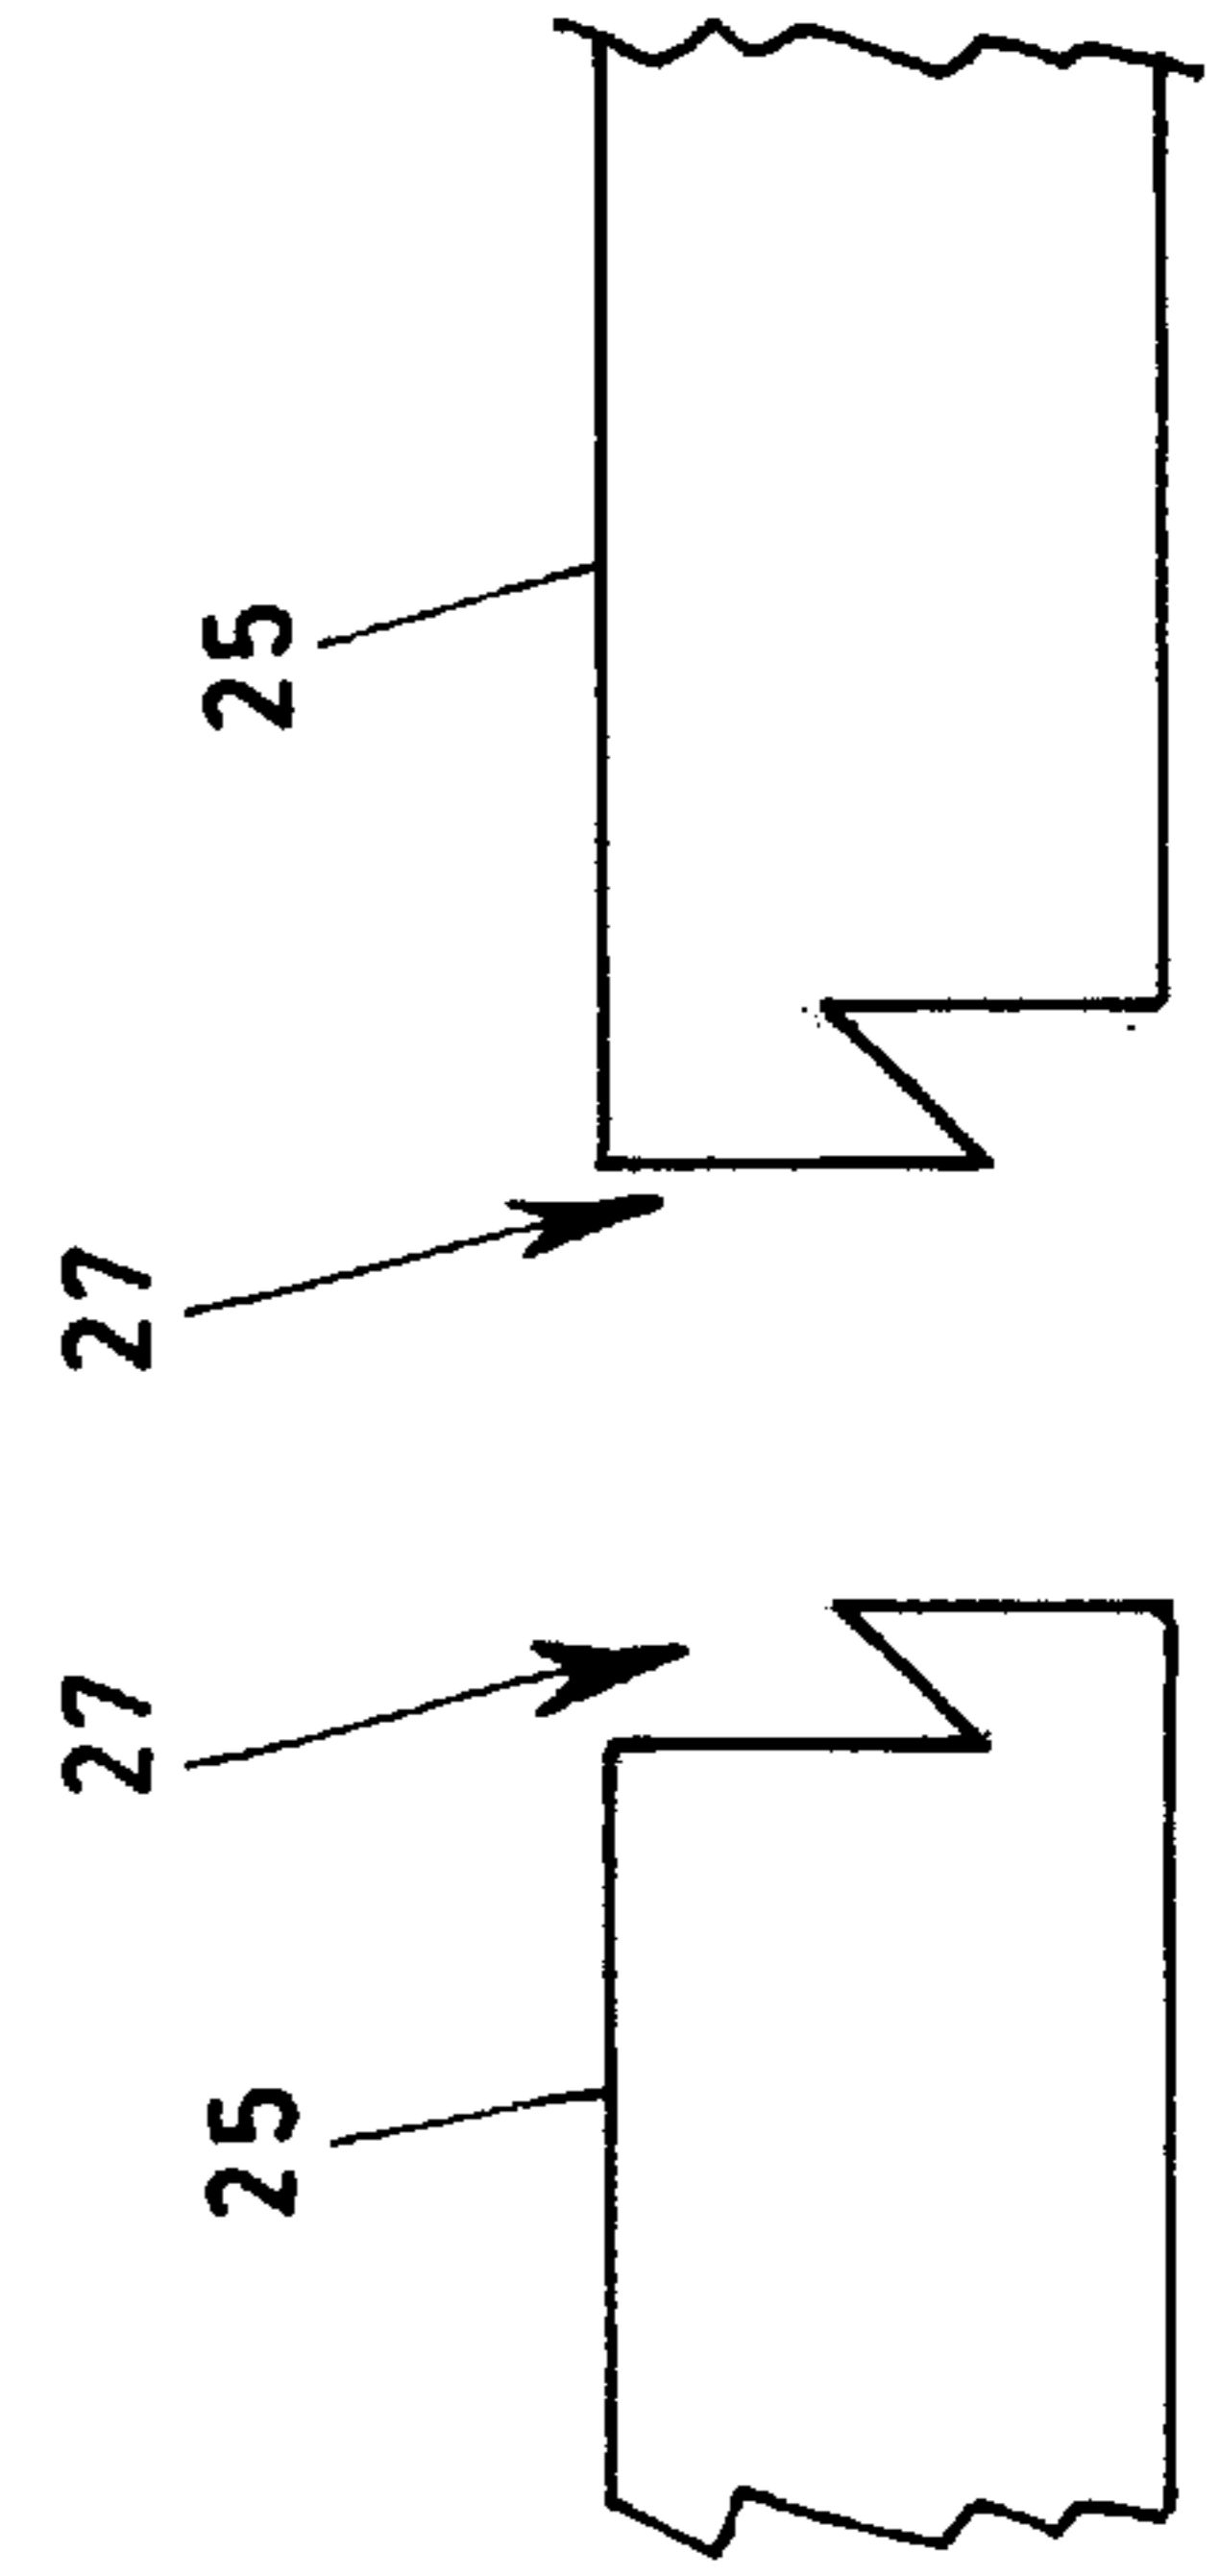
FIG. 13 is a schematic representation of the shaped coupling portions joining two pieces of wood end-to-end.
