(10) **Patent No.:** **US 6,612,006 B2**
(45) **Date of Patent:** **Sep. 2, 2003**

(54) **APPARATUS FOR EXTRACTING A FIBER FROM A FIBER-FERRULE**

(73) Assignee: **Telcordia Technologies, Inc.**, Morristown, NJ (US)

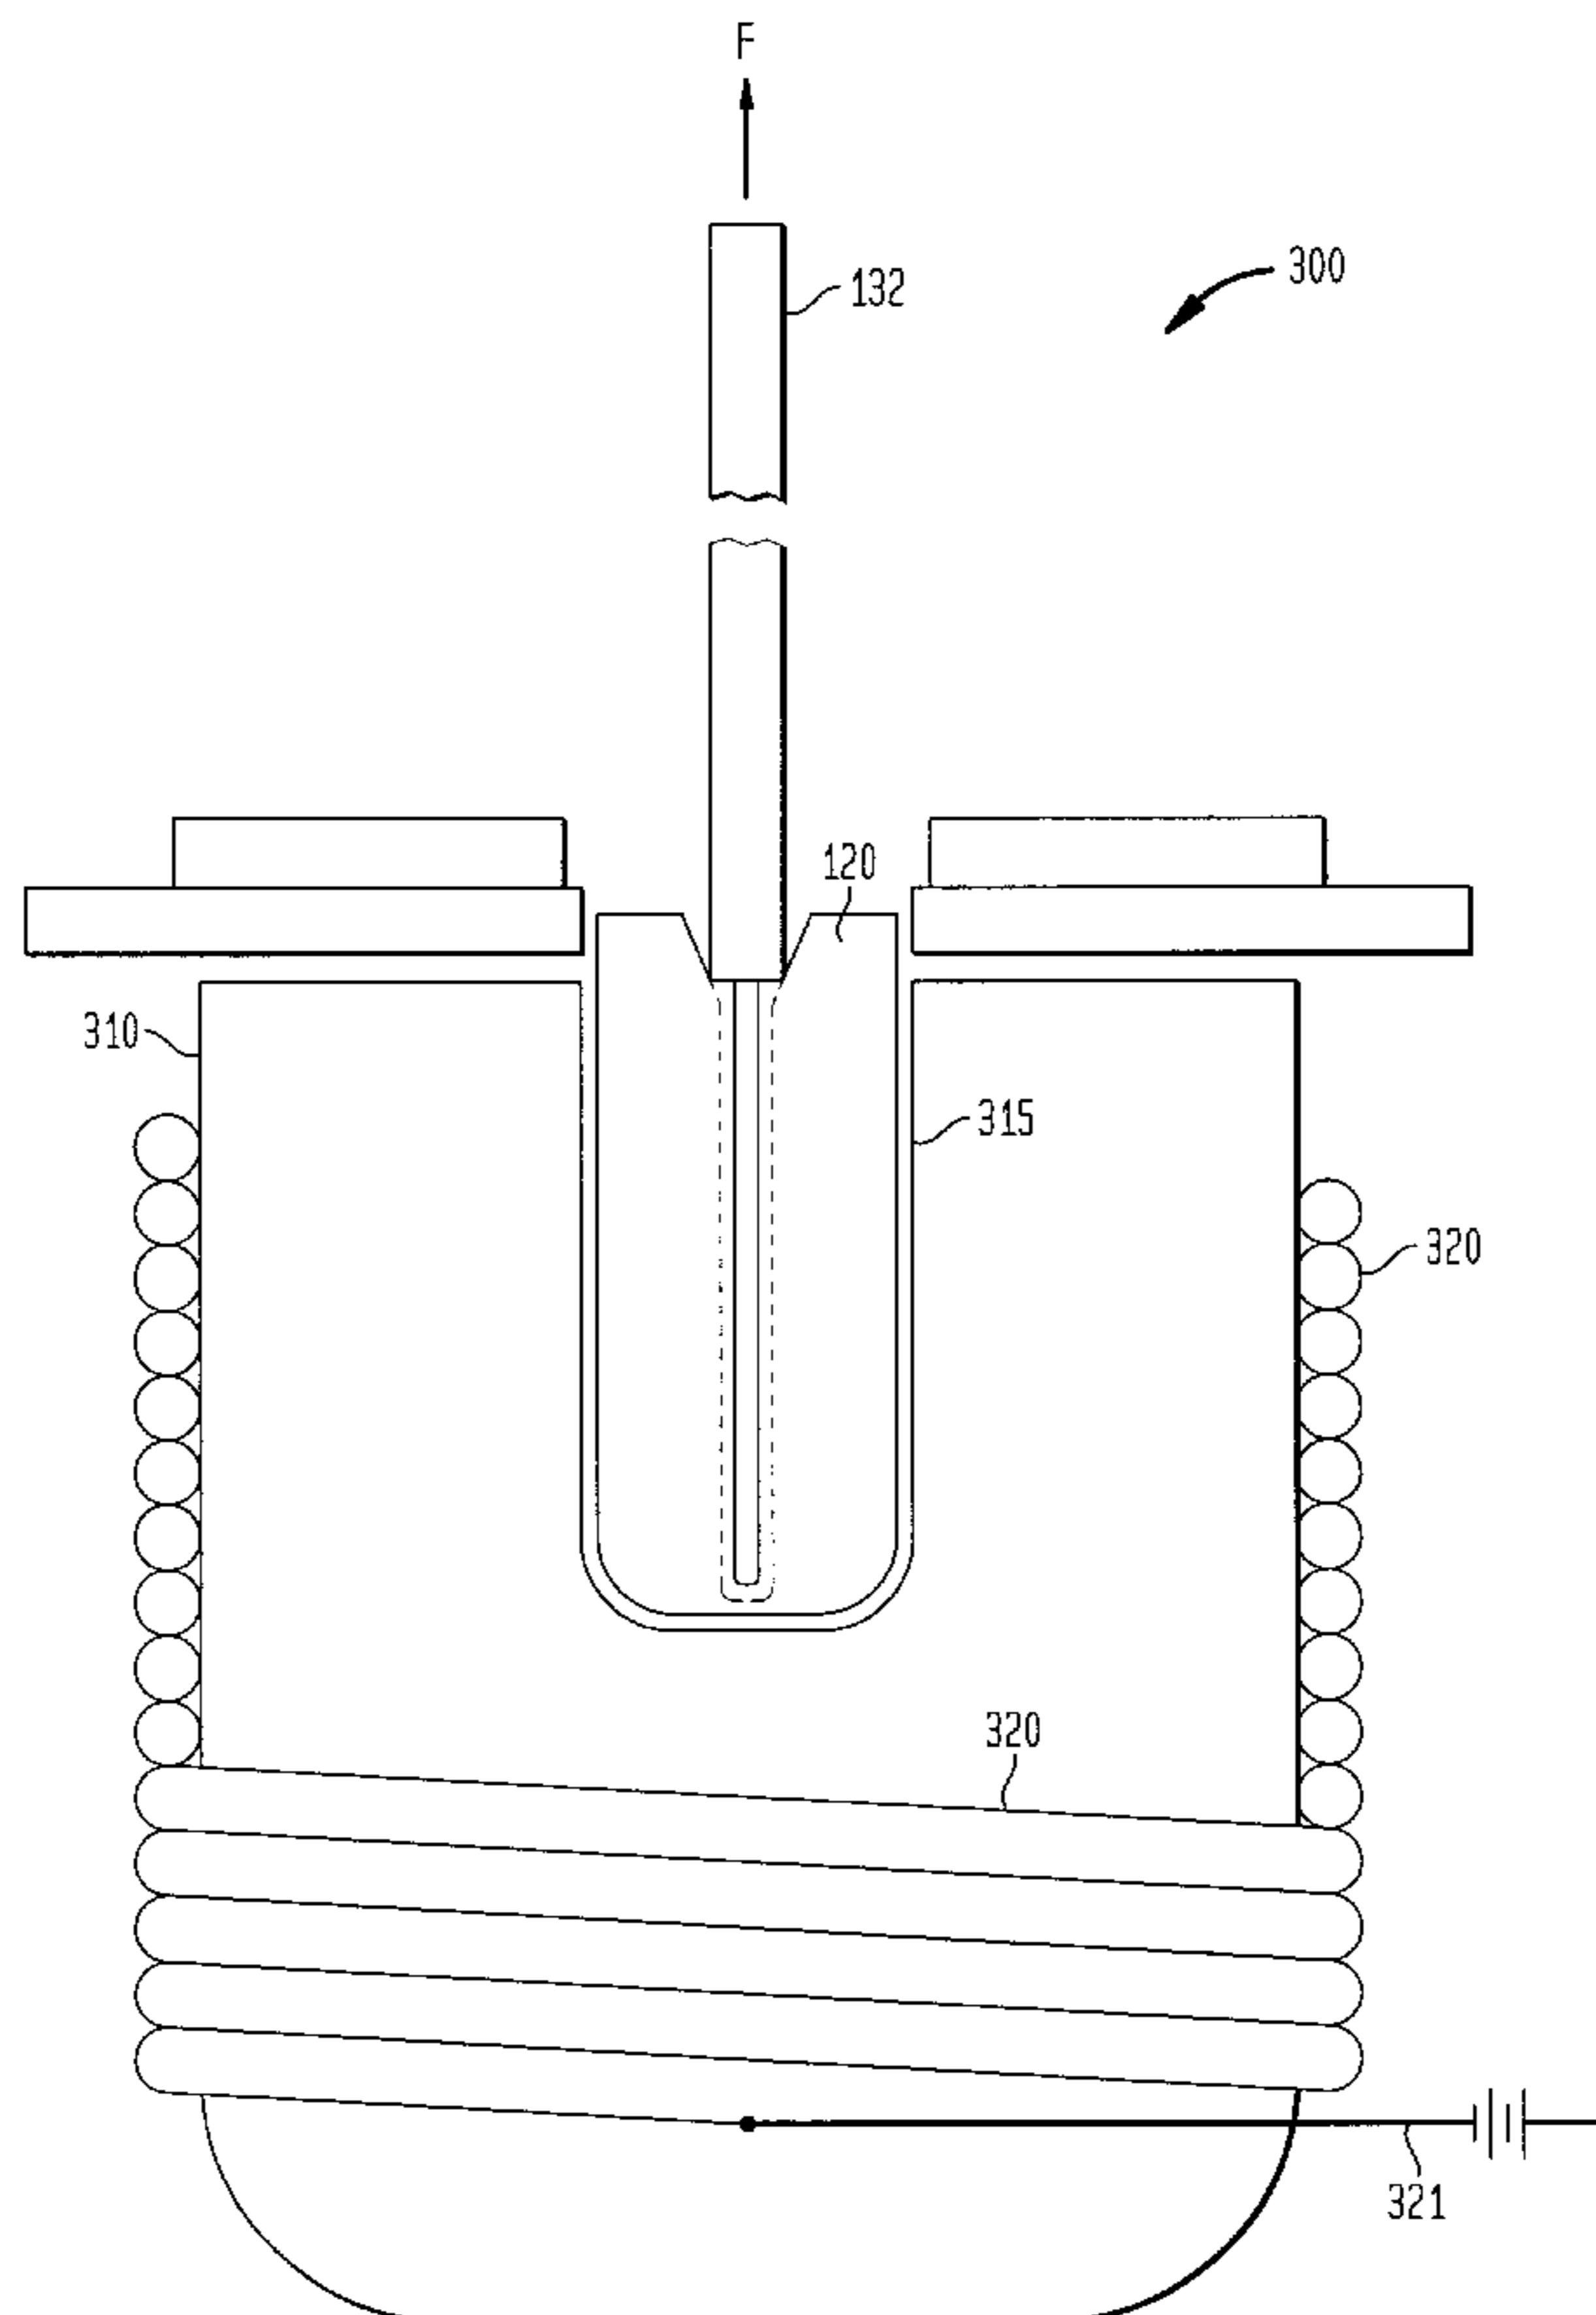
FIG. 3 depicts our inventive apparatus for extracting a fiber from a connector.

We will now turn to FIG. 3 and describe the apparatus 300 we invented and built to perform step or stage 250 described above. As FIG. 3 shows apparatus 300 has a heating block 310 into which an opening 315 is constructed. The heating block 310 can be made of copper. The opening 315 is constructed so as to receive only the ferrule 120 to minimize exposure of the fiber to the high temperature that occurs during heating. An electric coil 320 which is powered by a voltage source 321 is wound around the heating block 310. The wound heating coil provides localized heating to heating block and in turn to the adhesive in the ferrule. Fiber tension is applied to the coated portion of the fiber 132 as is illustrated by force F until the fiber is extracted. Those of ordinary skill will note that there are numerous ways in which to apply force F.

Once the degradation time and temperature of the adhesive is known, the ferrule-fiber assembly is placed in a fiber extraction unit. Our fiber extraction unit is shown in FIG. 3 and its structure is fully discussed below. The important functional features with regard to extraction are a means for providing localized heating and a fiber tension means for extracting the fiber from the ferrule. Localized heating is preferable so as to minimize exposure of the fiber to high temperatures that can run from 300° C. to 600° C. depending on the type of adhesive resin in the capillary. The fiber tension means or element maintains a tensile load of a few hundred milligrams on the fiber as the ferrule is heated until the fiber is extracted. Here, those of ordinary skill in the art will recognize that there is a trade off between the force of the load and the temperature at which heating takes place. That is, if too great a tensile load is placed on the ferrule before the time and temperature for adhesive degradation is reached, the evidence that is sought may be destroyed. In addition, if application of the tensile load and localized heating initially fails to extract the fiber, then the ferrule may then be re-immersed in the sulfuric acid (H₂SO₄) solution used in step 230. The localized heating and application of the tensile load would then be repeated. Of course, localized heating under the force of the tensile load and the immersion into the sulfuric acid may be alternately repeated until extraction is successful. Conceptually, the idea here is to heat the adhesive resin to the point where it releases the fiber and if release does not happen under a normal tensile load then re-immersion in the sulfuric acid enhances the chance that on the next pull the fiber will be extracted.
