(10) **Patent No.:** **US 6,680,099 B1**
(45) **Date of Patent:** ***Jan. 20, 2004**

(54) **ENHANCING DAMAGE TOLERANCE OF ADHESIVE BONDS**

A means and method of enhancing the damage tolerance of adhesive bonds by introducing gaps in the adhesive to divide the adhesive layer into discrete regions. The gaps are created by placing strips of barrier material between the two adherends before the adhesive is put in place and cured. If the two adherends begin to debond along the interface between one of the adherends and the adhesive, the gap arrests the debonding process.

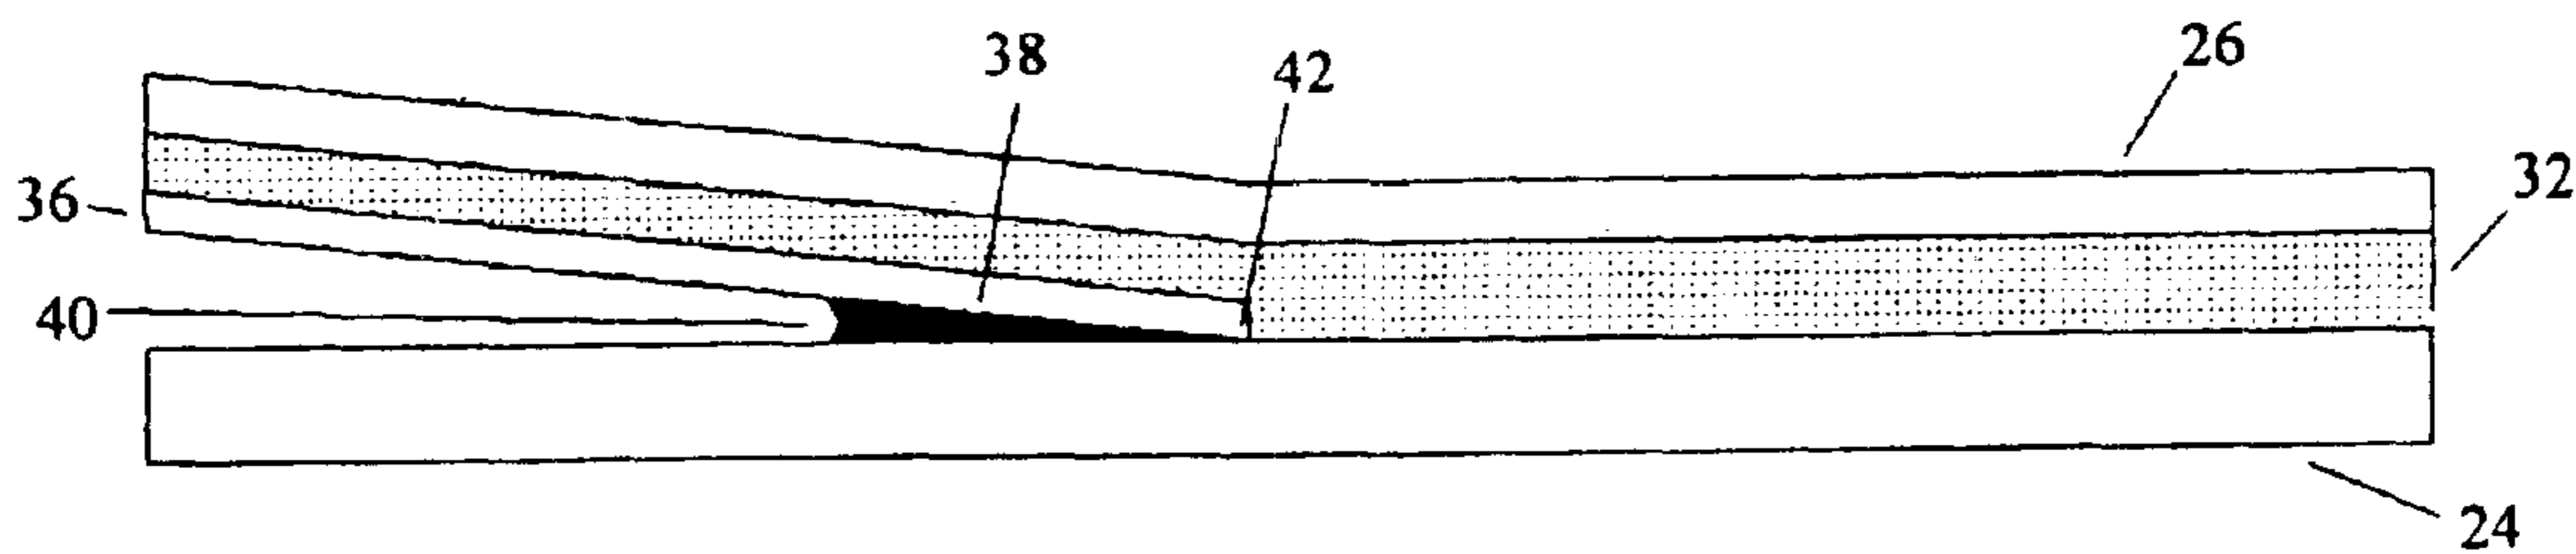
FIGURE 1

FIG. 1 shows an overall view of the experimental apparatus of the present invention.

FIG. 1 shows the overall layout of the experimental apparatus 10 used on the tests simulating a crack in an aluminum aircraft skin. Aluminum sheet 12 simulates the skin of the aircraft with crack 14 in it that is covered with patch 16. Patch 16 is a unidirectional graphite/epoxy patch, with the direction of the fibers 17 parallel to the direction of the applied load 18 and perpendicular to crack 14. Most skin patches on military planes are thought to be boron/epoxy, but graphite/epoxy was used in the tests primarily because it is less opaque to X-ray inspection used in the debond growth tests. The adhesive used to bond patch 16 to sheet 12 is "Cytec® FM-73M®", a proprietary modified epoxy film made by Cytec Engineered Materials of Havre de Grace, Maryland; this is recommended by the manufacturer for use with boron/epoxy patches, hence was used for the tests. Priming, bonding, and curing procedures in accordance with the manufacturer's instructions were used in preparing all of the specimens.

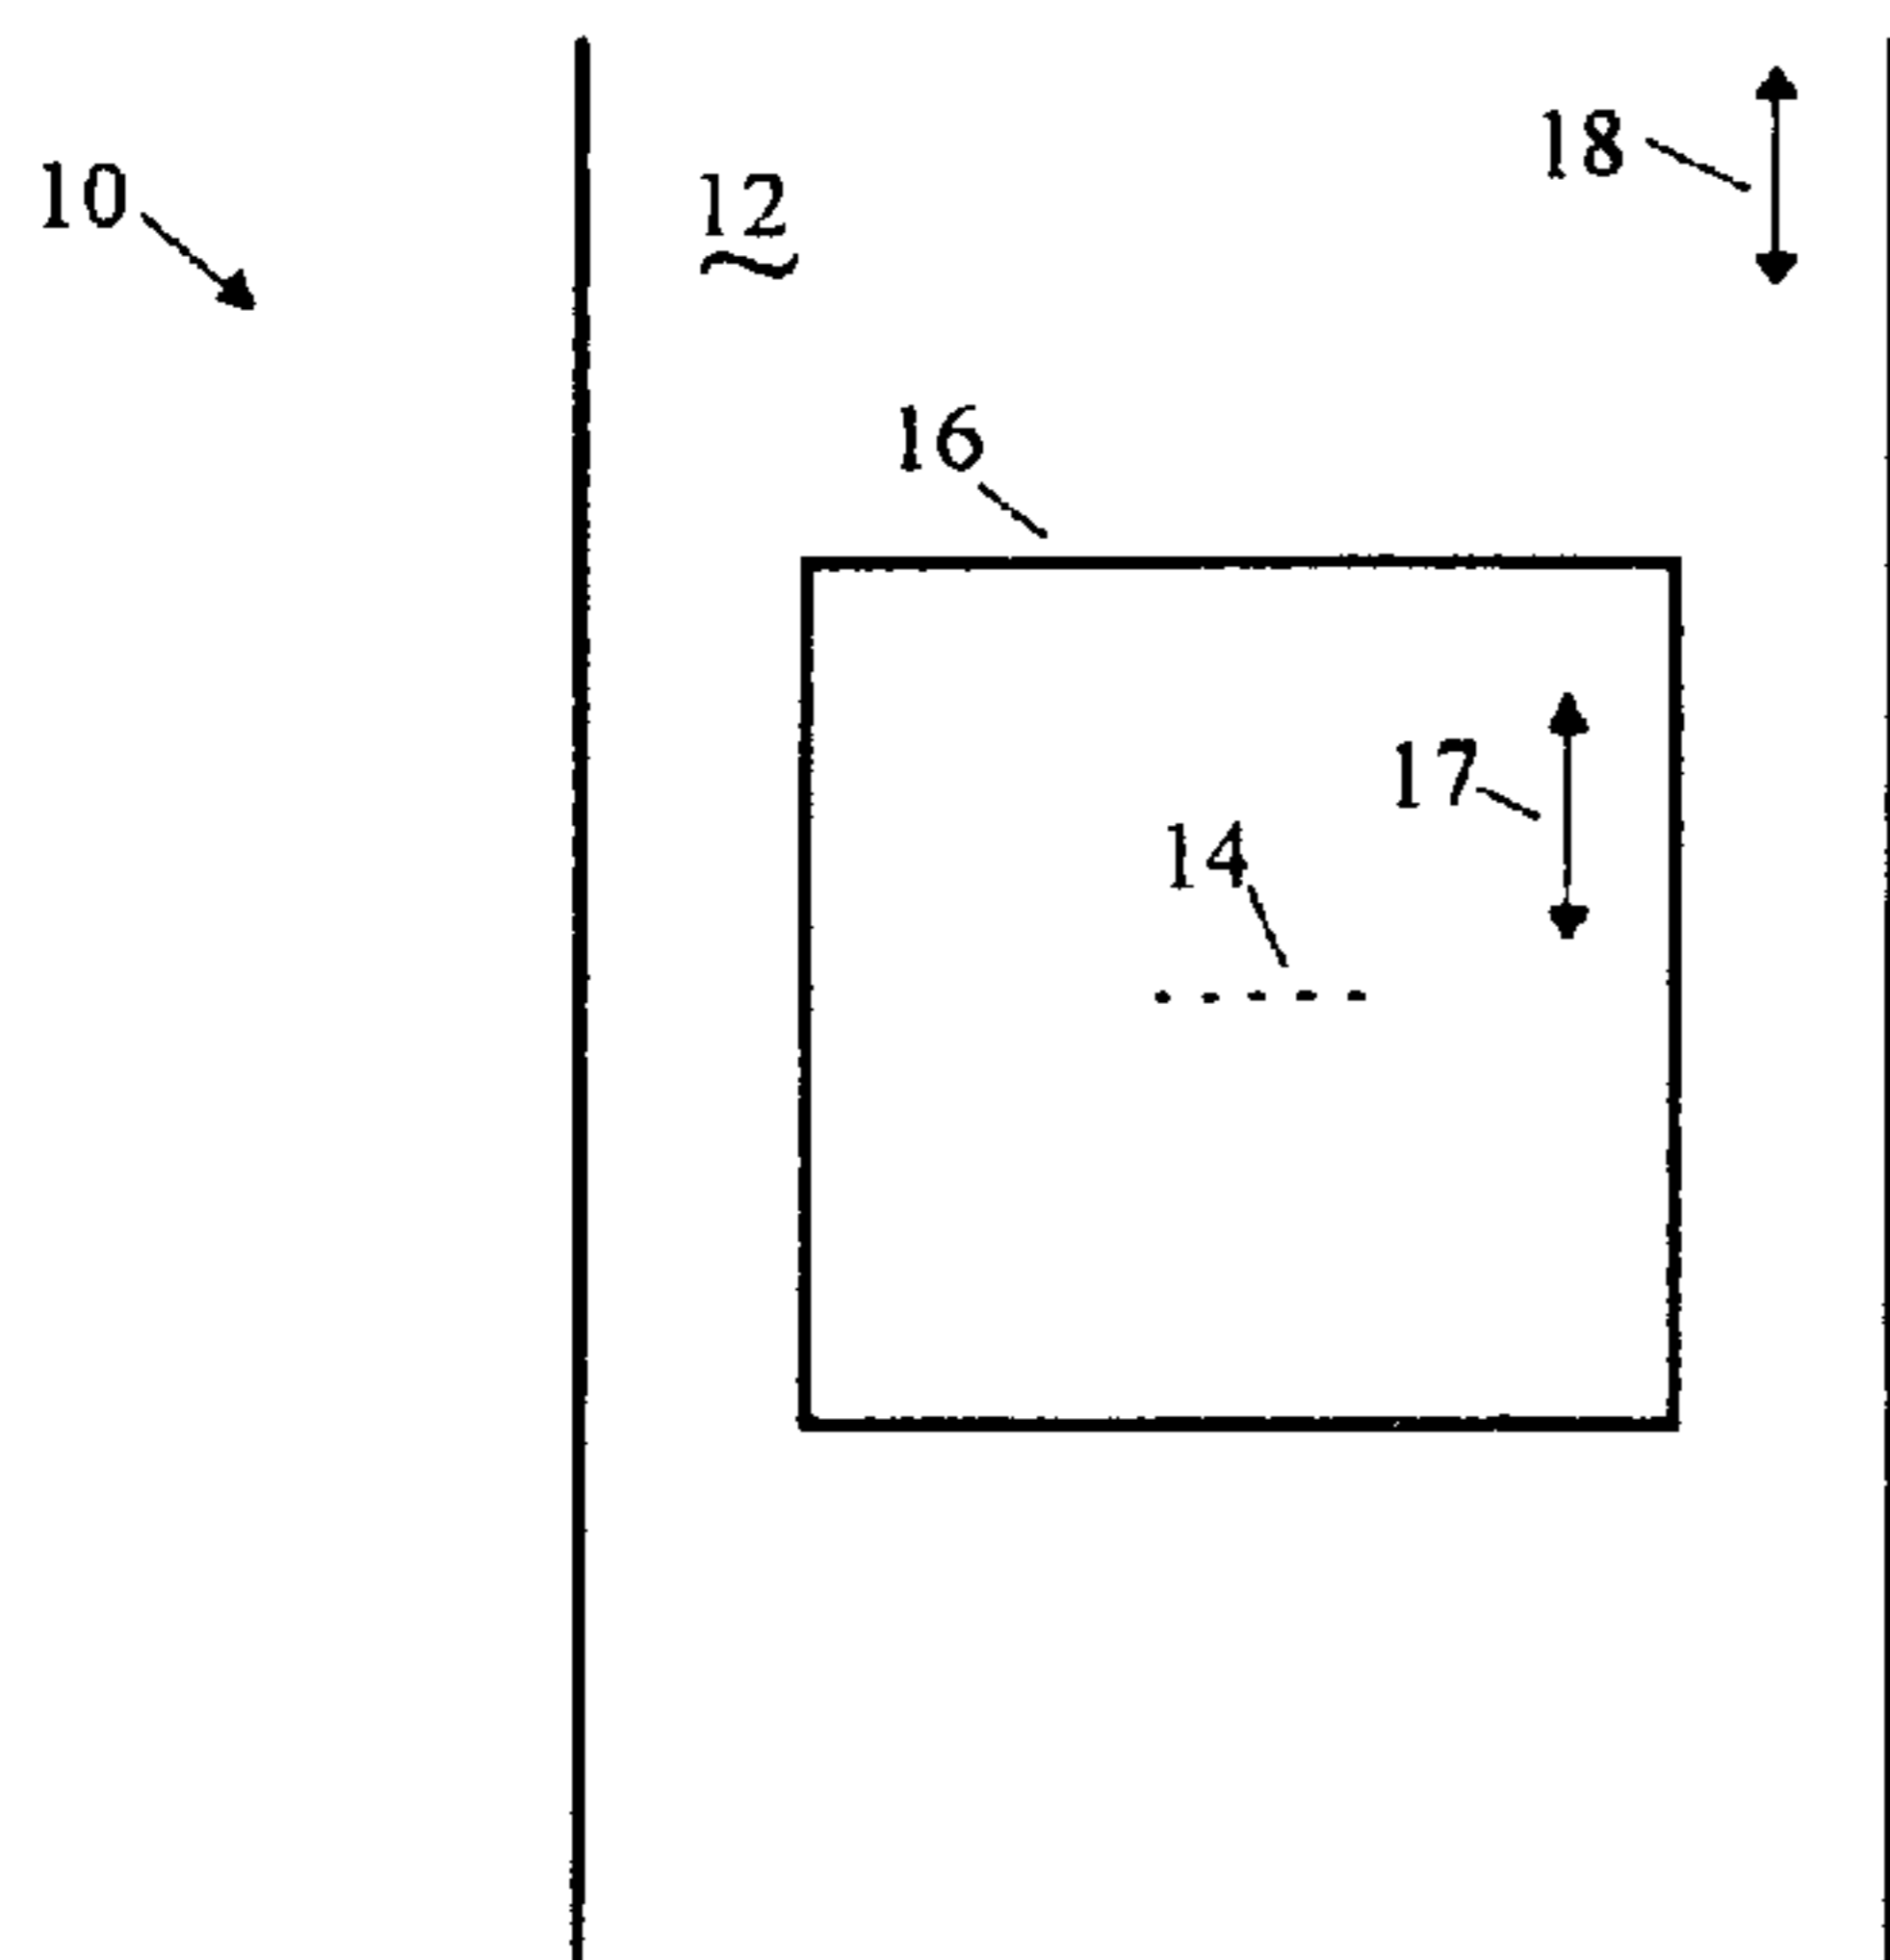
FIGURE 2

FIGS. 2 and 3 show the difference between internal and external debonds and the test specimens used for tests on cracked aluminum.

FIGS. 2 and 3 show specimens with an internal debond 18 (FIG. 2) and an external debond 20 (FIG. 3). The debonded areas of the patches are shown in cross hatching. That is, in an internal debond crack 14 is covered by a part of patch 16 that has become debonded from the skin; in an external debond the part of patch 16 that is over crack 14 is bonded to the skin, but the edges of patch 16 have become debonded. In both cases the graphite fibers are as in FIG. 1—parallel to the direction of the applied force and perpendicular to the crack.

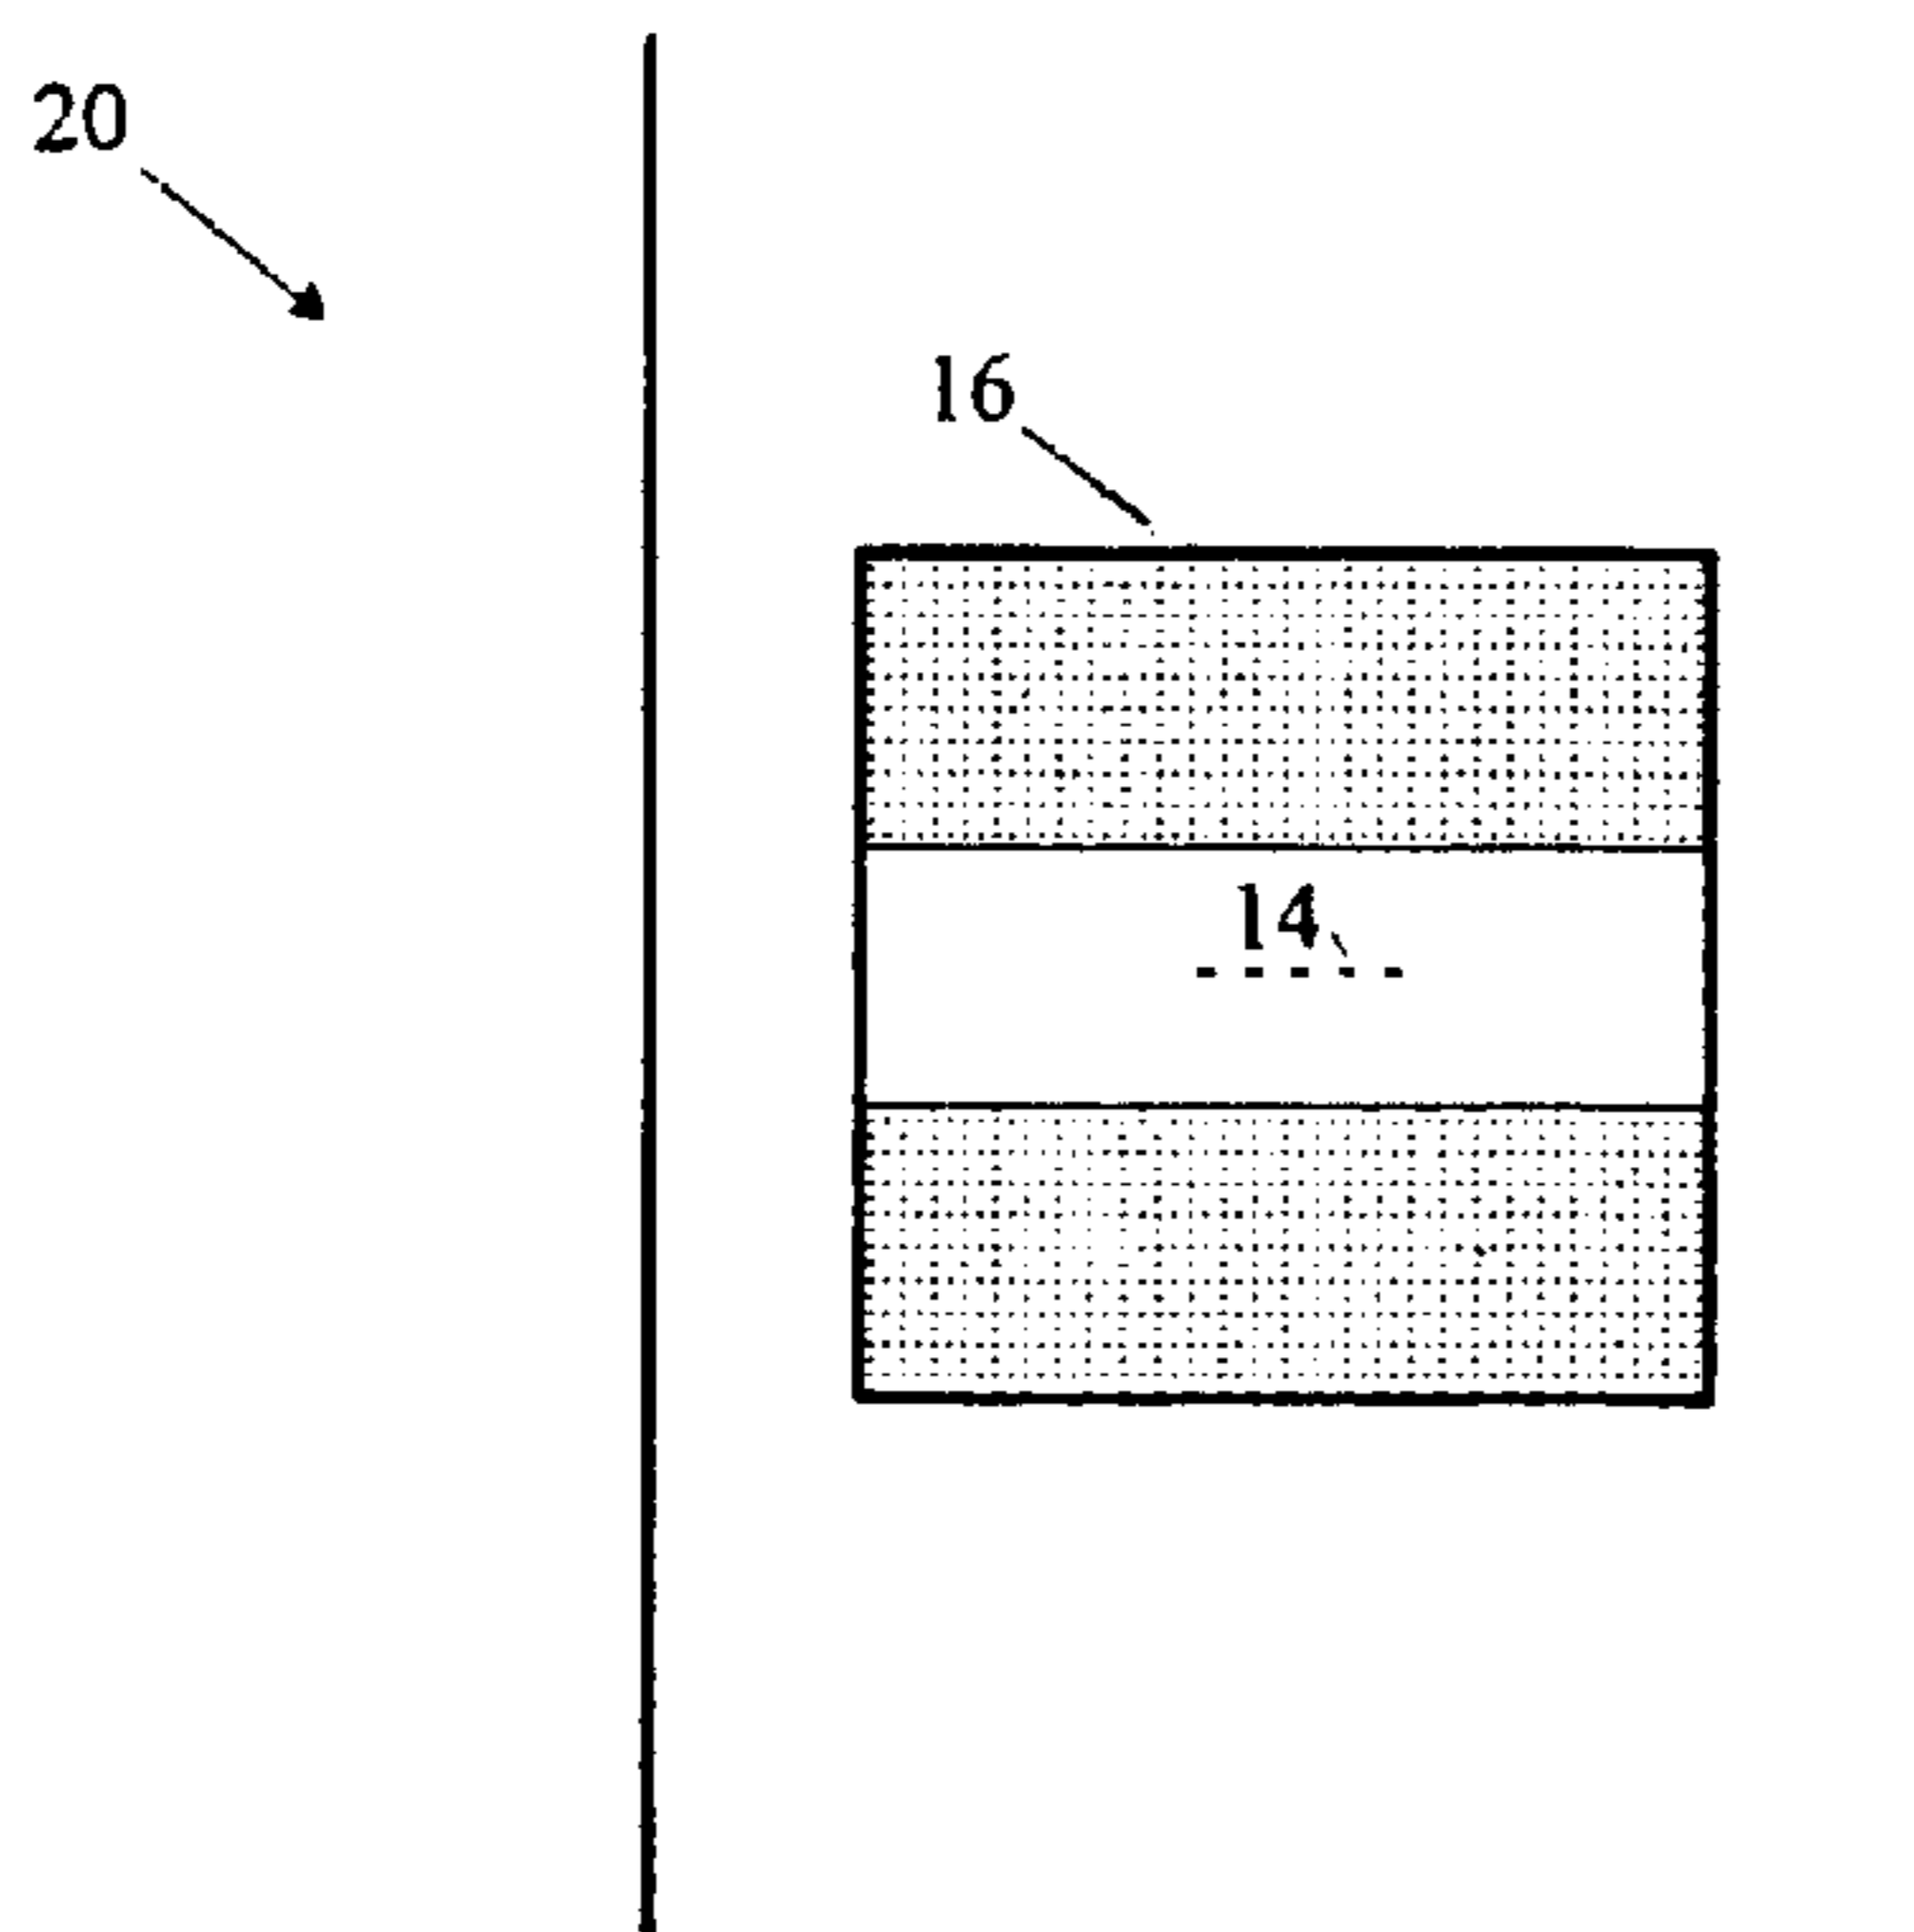
FIGURE 4

FIG. 4 shows the overall results of the tests on the aluminum specimens.

FIG. 4 shows the results of testing these patched specimens, as well as two control (unpatched) specimens. The control specimens were tested until they failed, at fewer than 6600 cycles. The patched specimens were tested to

40,000 cycles in tension at a stress of 16,000 pounds per square inch with only minimal crack lengthening of about 22% (since the patches were on only one side of the specimen, the crack length was visible on the other side). As can be seen, the location of the debond made essentially no difference in the performance of the patch; that is, a patch with an internal debond performed as well as a patch with an external debond, within the limits of the experimental scatter of the data.

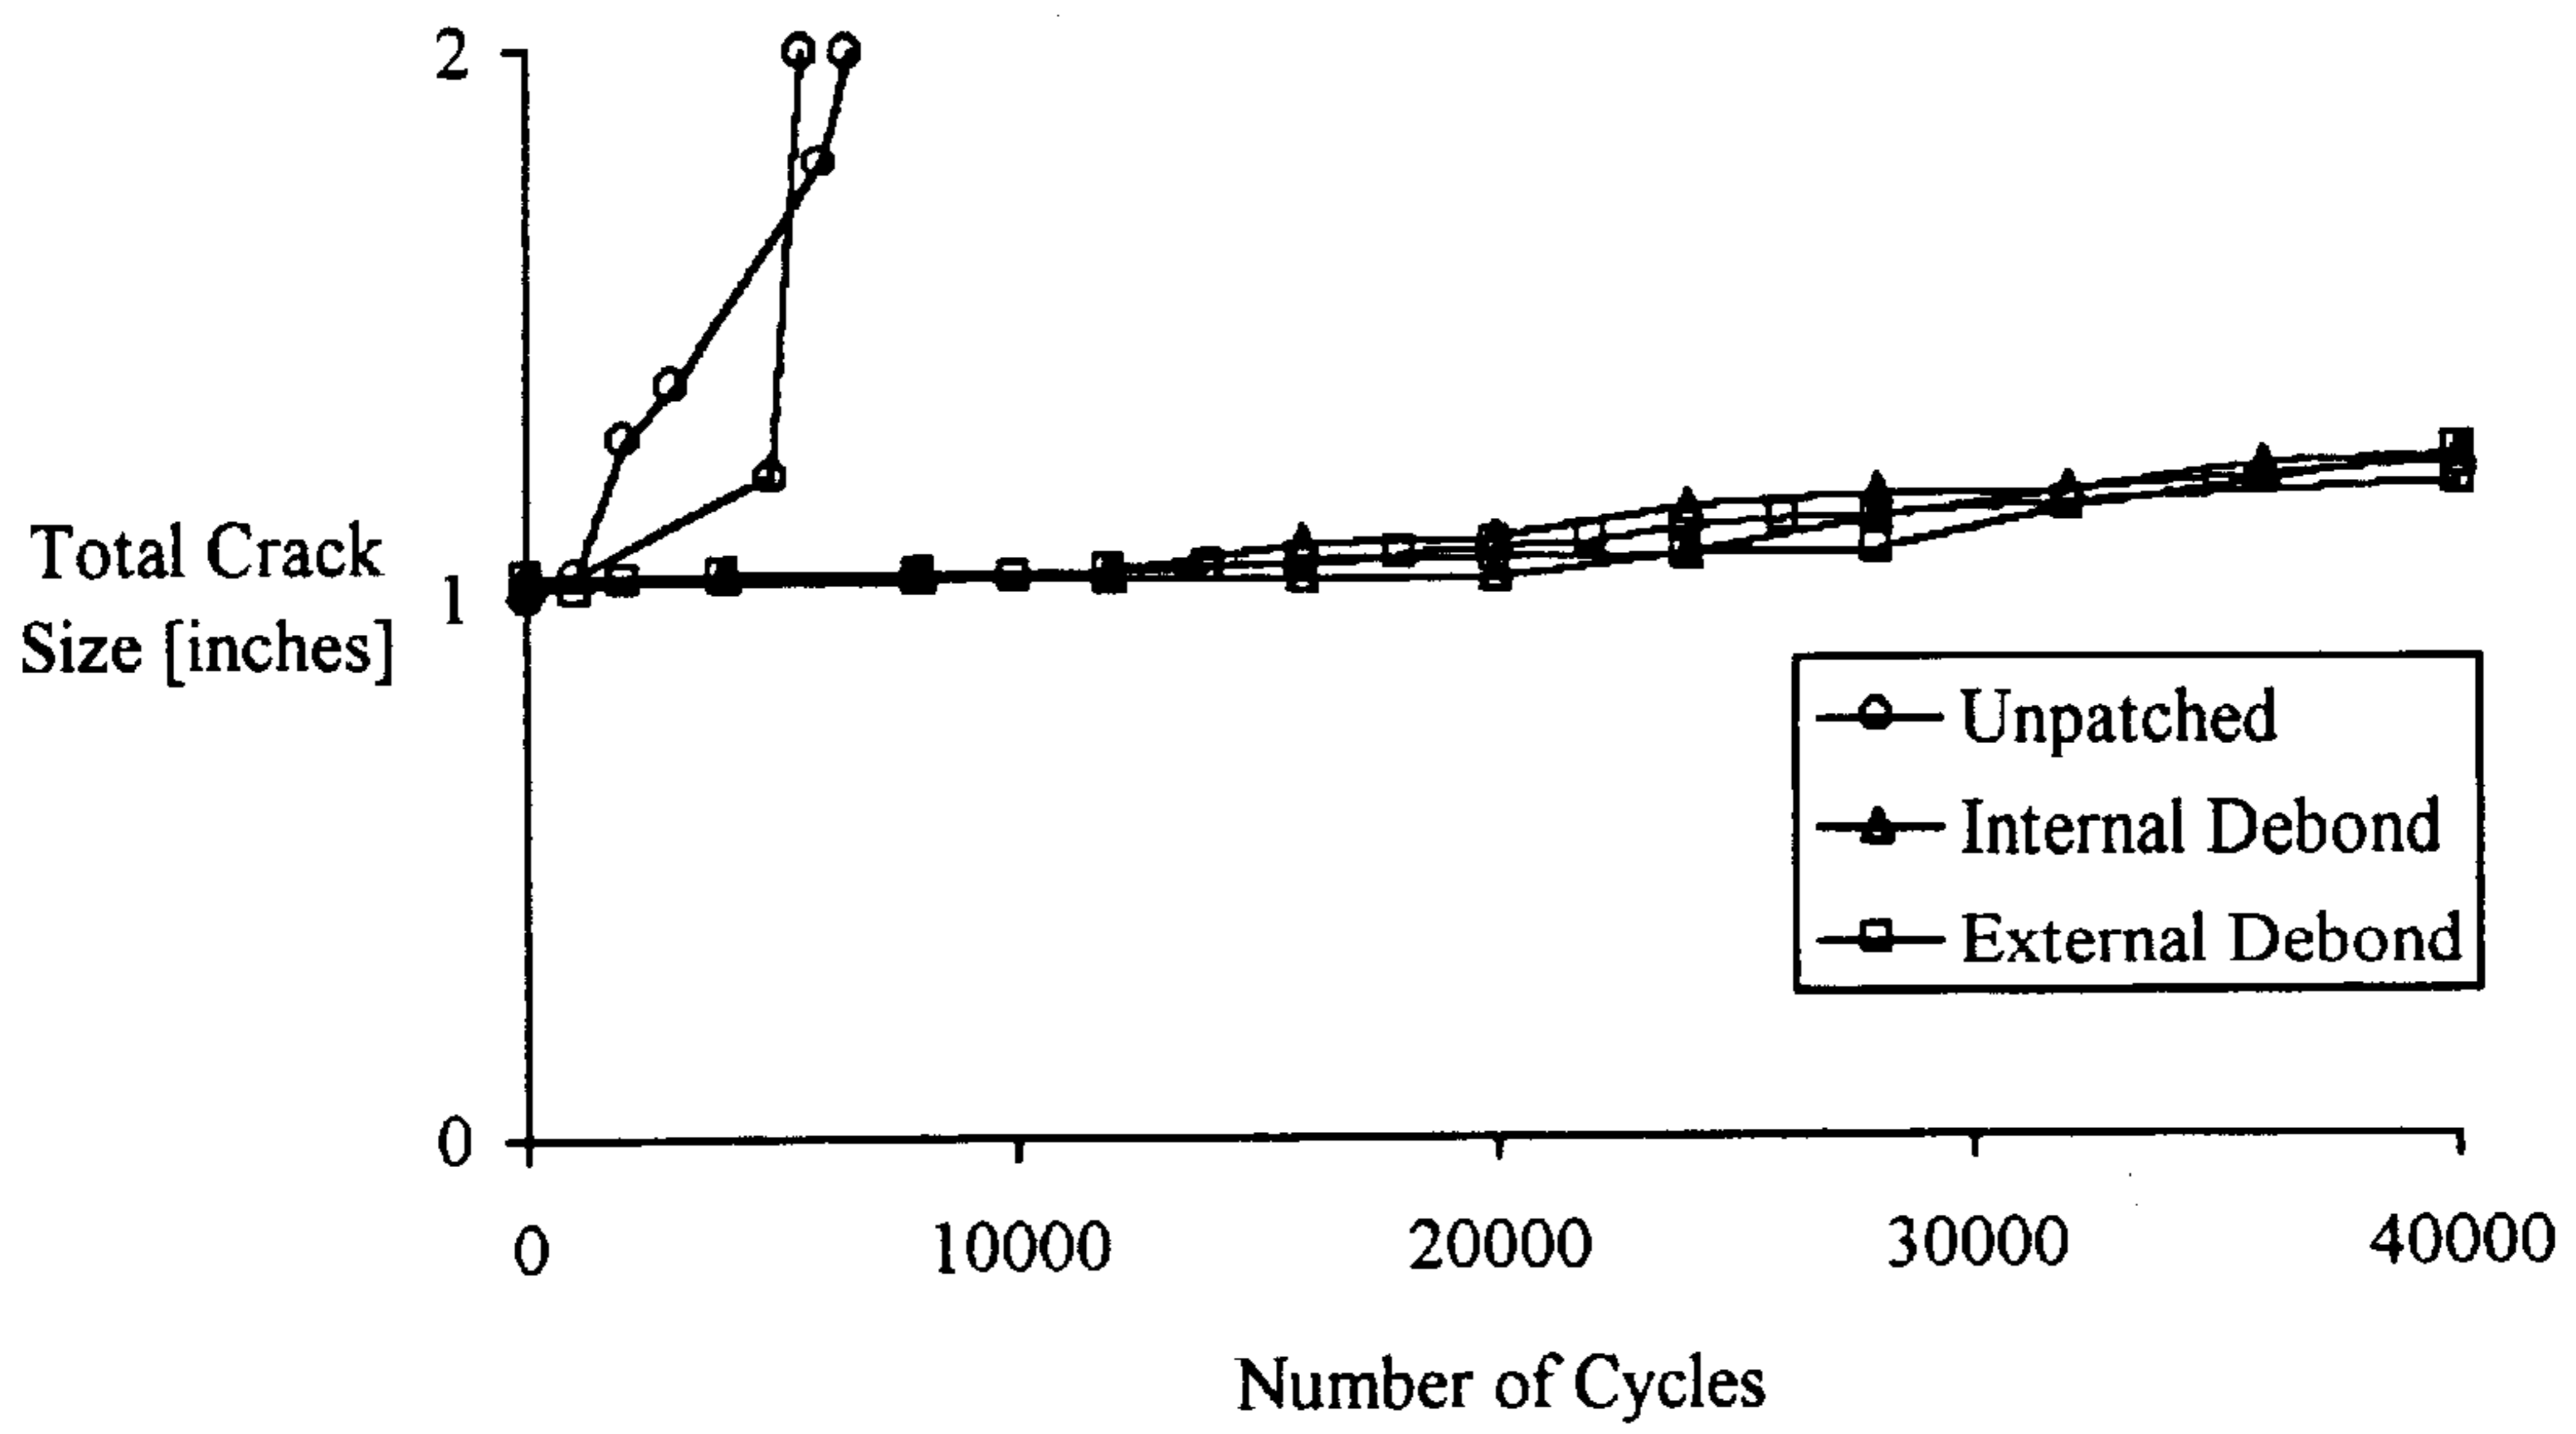
FIGURE 5

FIG. 5 shows a front view of the specimens used in the fiberglass/epoxy tests.

FIG. 5 shows a front view of specimens 22 used to study the growth of debonds; FIG. 6 shows specimens 22 in side view. The specimens, designed to be simplified models of a patched crack, are fiberglass/epoxy sheets 24 butted against each other with a graphite/epoxy patch 26 on each side of the joint. Space 28 between the two sheets simulates a crack with its tips far to either side of the sheets, i.e. simulates the central region of the crack. Fiberglass/epoxy sheets were used instead of aluminum to avoid the complicating effects of gradient stress fields or thermal mismatch stresses present in a sheet of cracked aluminum as well as enhance the contrast of the X-rays used to measure the debond growth.

Specimens 22 were two inches wide and 11.5 inches long between the loading tabs; patches 26 were four inches long and centered over the joint. The thickness of the specimens was chosen to simulate the stiffness of the 0.036 inch aluminum usually used in transport aircraft skin. Although patches are normally applied to only one side of an airplane skin, the necessity of representing a curved pressurized structure with a flat test specimen required the use of two patches, one on each face of the specimen, to eliminate the effects of the inappropriately high bending moments that would arise by using a single patch on the relatively thick fiberglass/epoxy sheet. These bending moments are not significant on a curved fuselage surface. The patches were constructed of unidirectional graphite/epoxy. In service, patches normally have approximately the same stiffness as the base sheet. Thus, on these specimens, each patch had approximately half the stiffness of the base sheet.

Two types of barriers were used to create gaps 30: a non-stick substance with a 0.011 inch diameter circular cross section, and strips of soft rubber sheet approximately 0.050 inch wide by 0.010 inch thick. The barriers were spaced 0.8 inch from center to center symmetrically about the crack. Double layers of 0.030 lb/ft² Cytac FM-73M adhesive 32 (see FIG. 8) were used on these specimens. The nominal precured thickness of the adhesive layers is 0.005 inch, but it usually reduces to 0.003 inch after the flow stage of the cure. Thus both barriers were slightly thicker than the nominal adhesive layer, but there was enough flow near the barriers during curing to assure a continuous adhesive layer between the specimens and the patches. Attempts were made to use an air gap, but as expected the adhesive appeared to flow enough during curing to essentially eliminate the gap.

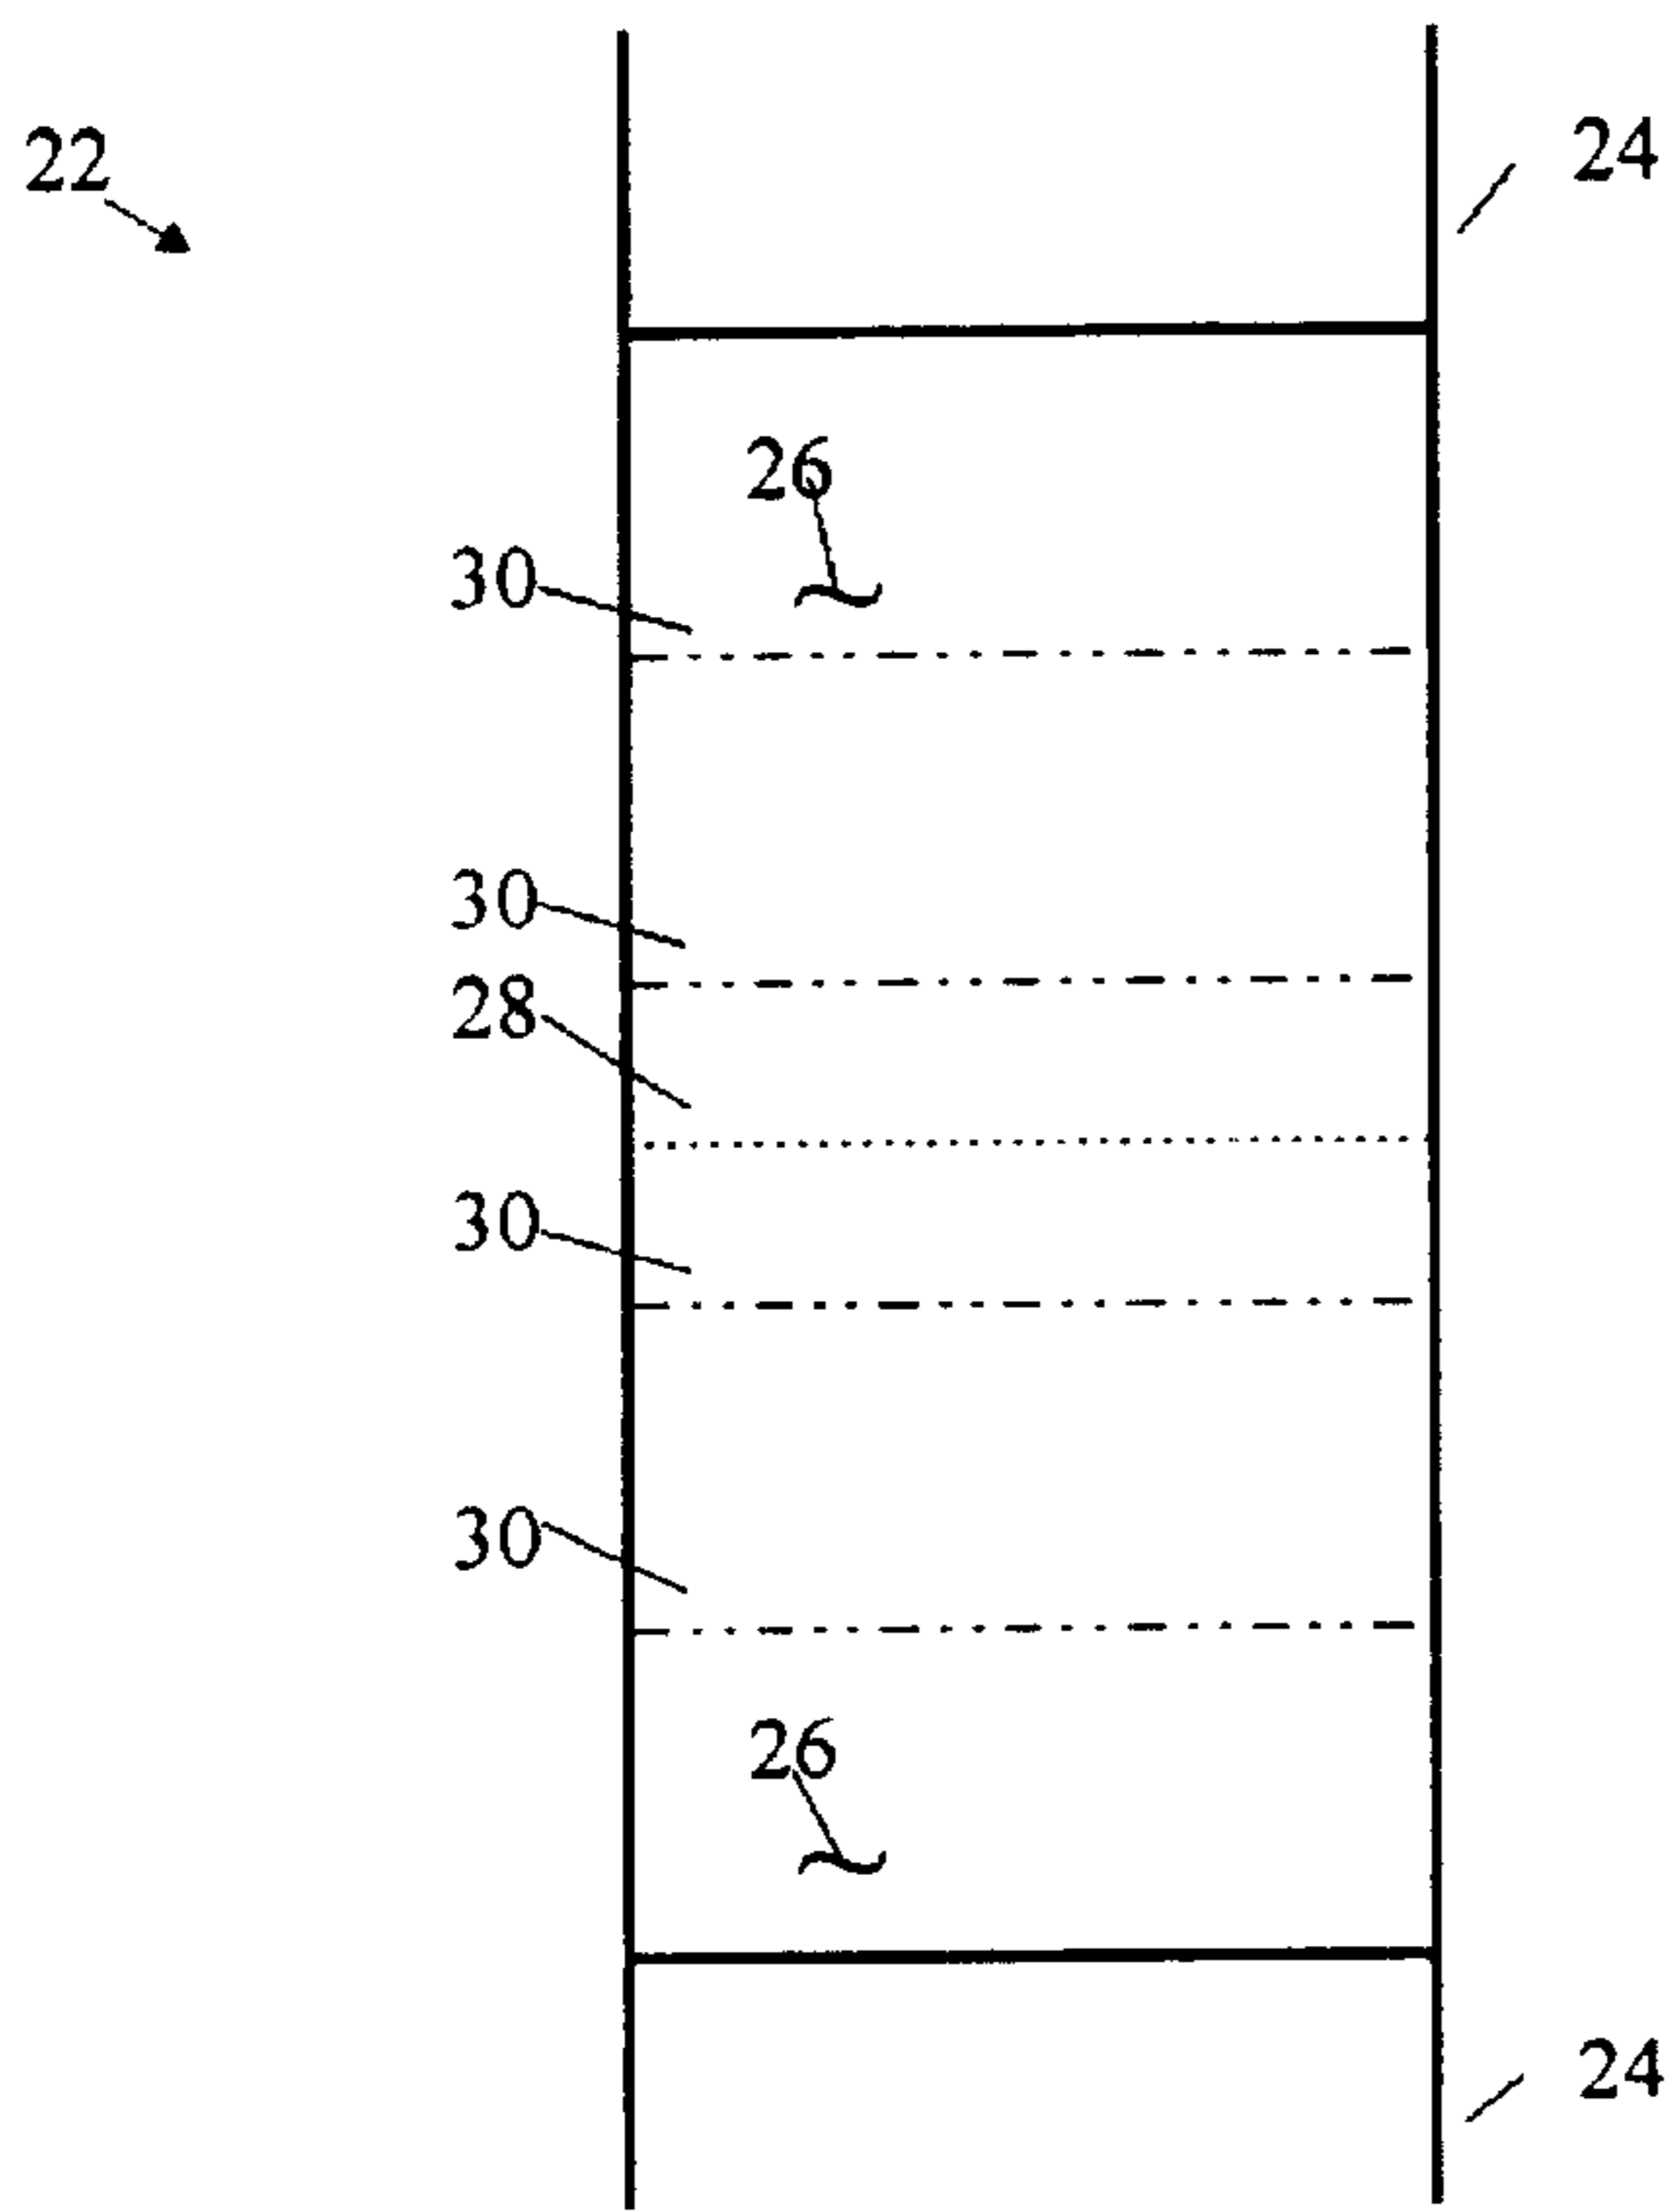
FIGURE 6

FIG. 6 shows a side view of the specimens used in the fiberglass/epoxy tests.

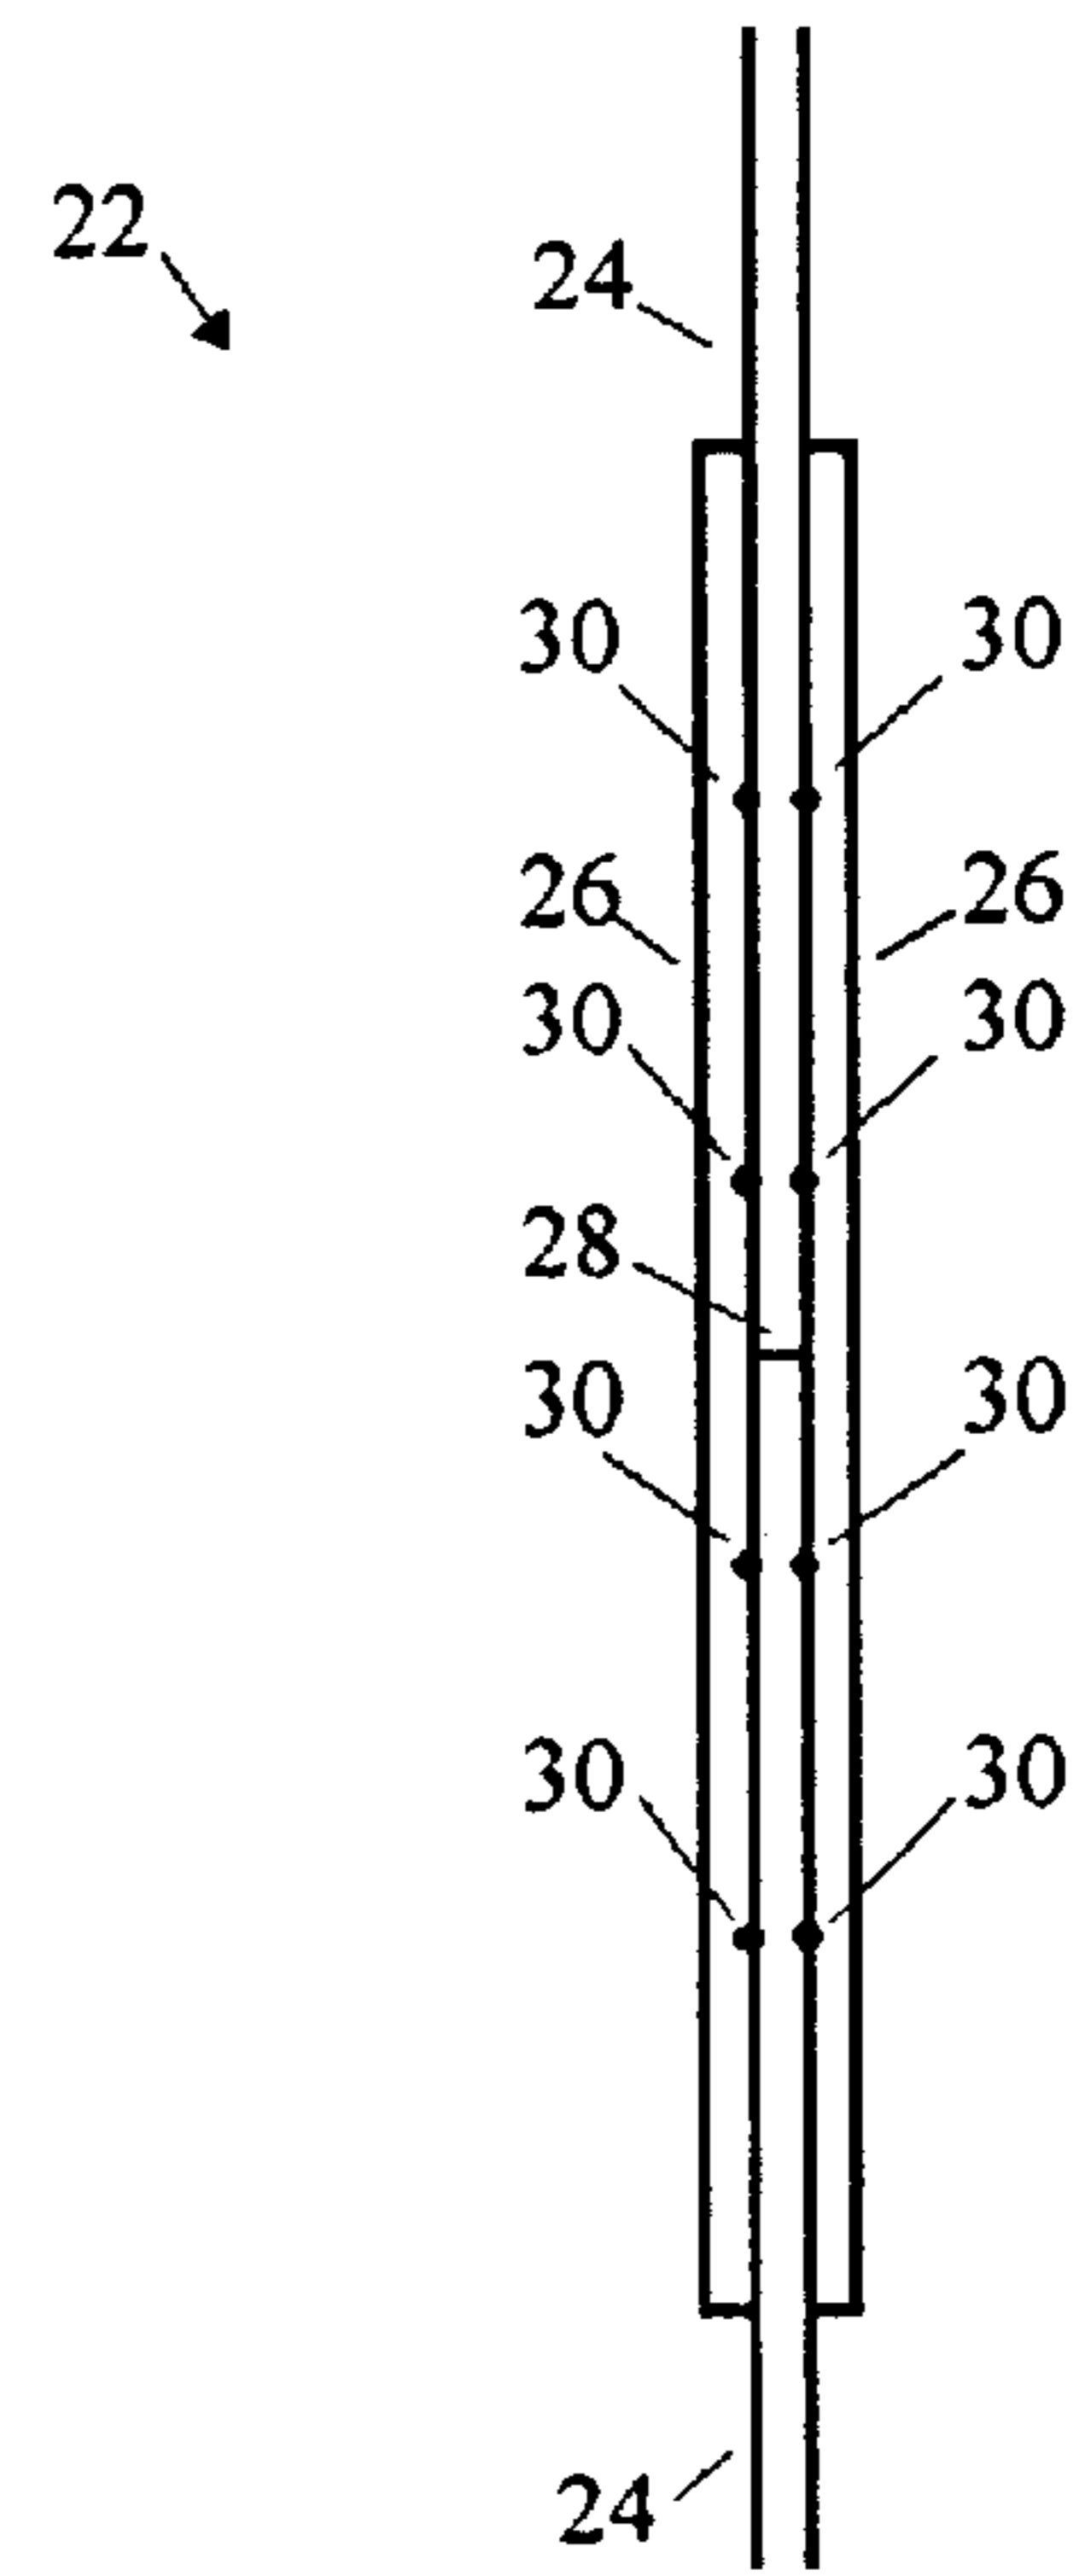
FIGURE 7

FIG. 7 shows the locations of the inserts used in the debond initiation tests.

Four specimens with each type of barrier were tested. Two specimens in each set of four were tested to evaluate the potential for the barriers themselves to initiate debonds, the other two were tested to assess the ability of the barriers to arrest debond growth. In these latter two specimens, non-stick inserts were used to create debonds in several areas. The arrangement of these areas is shown in front view in FIG. 7 and in side view in FIG. 8. Cross-hatched inserts 34 were placed on one side of the specimen, and non cross-hatched inserts 36 were placed on the other side of the specimen. Two crucial differences between inserts 34 and 36 on the one hand and the barriers on the other hand are that (1) the barriers are smooth on the microscale whereas the inserts are not, and (2) the inserts prevent bonding between
