(10) **Patent No.:** **US 6,680,099 B1**
(45) **Date of Patent:** ***Jan. 20, 2004**

(54) **ENHANCING DAMAGE TOLERANCE OF ADHESIVE BONDS**

A means and method of enhancing the damage tolerance of adhesive bonds by introducing gaps in the adhesive to divide the adhesive layer into discrete regions. The gaps are created by placing strips of barrier material between the two adherends before the adhesive is put in place and cured. If the two adherends begin to debond along the interface between one of the adherends and the adhesive, the gap arrests the debonding process.

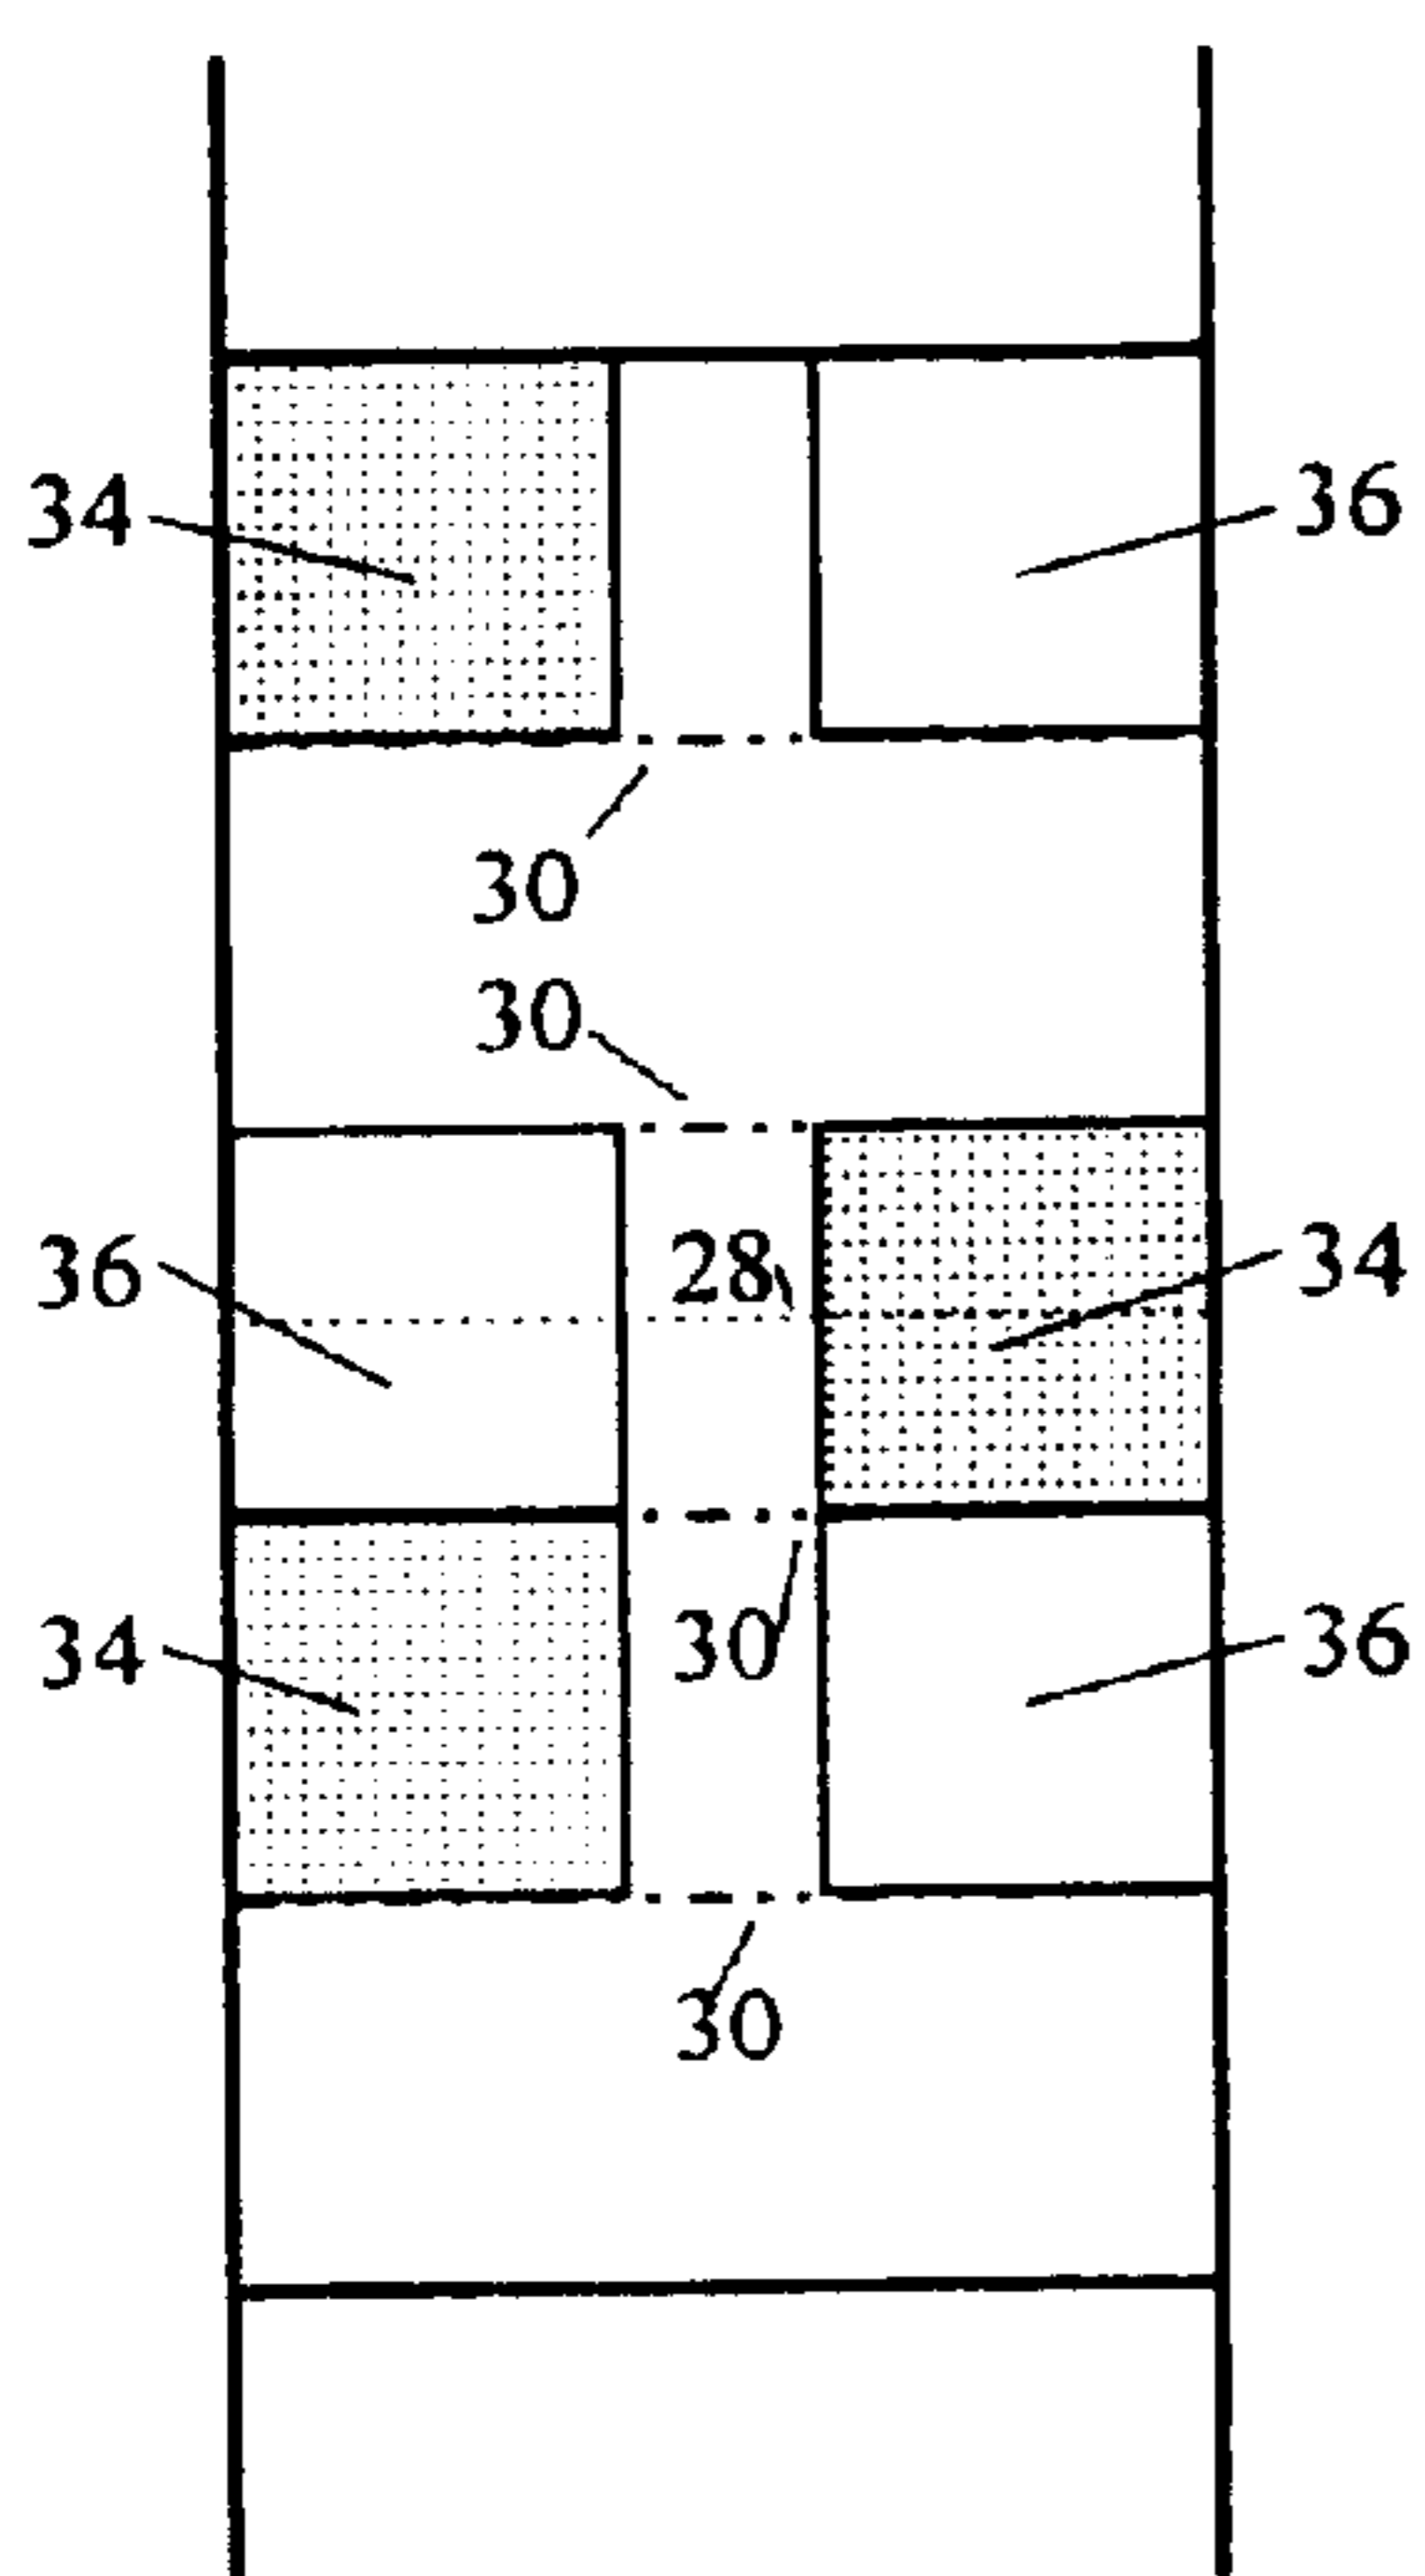
FIGURE 8

FIG. 8 shows a cross-section of the specimens used in the debond initiation tests.

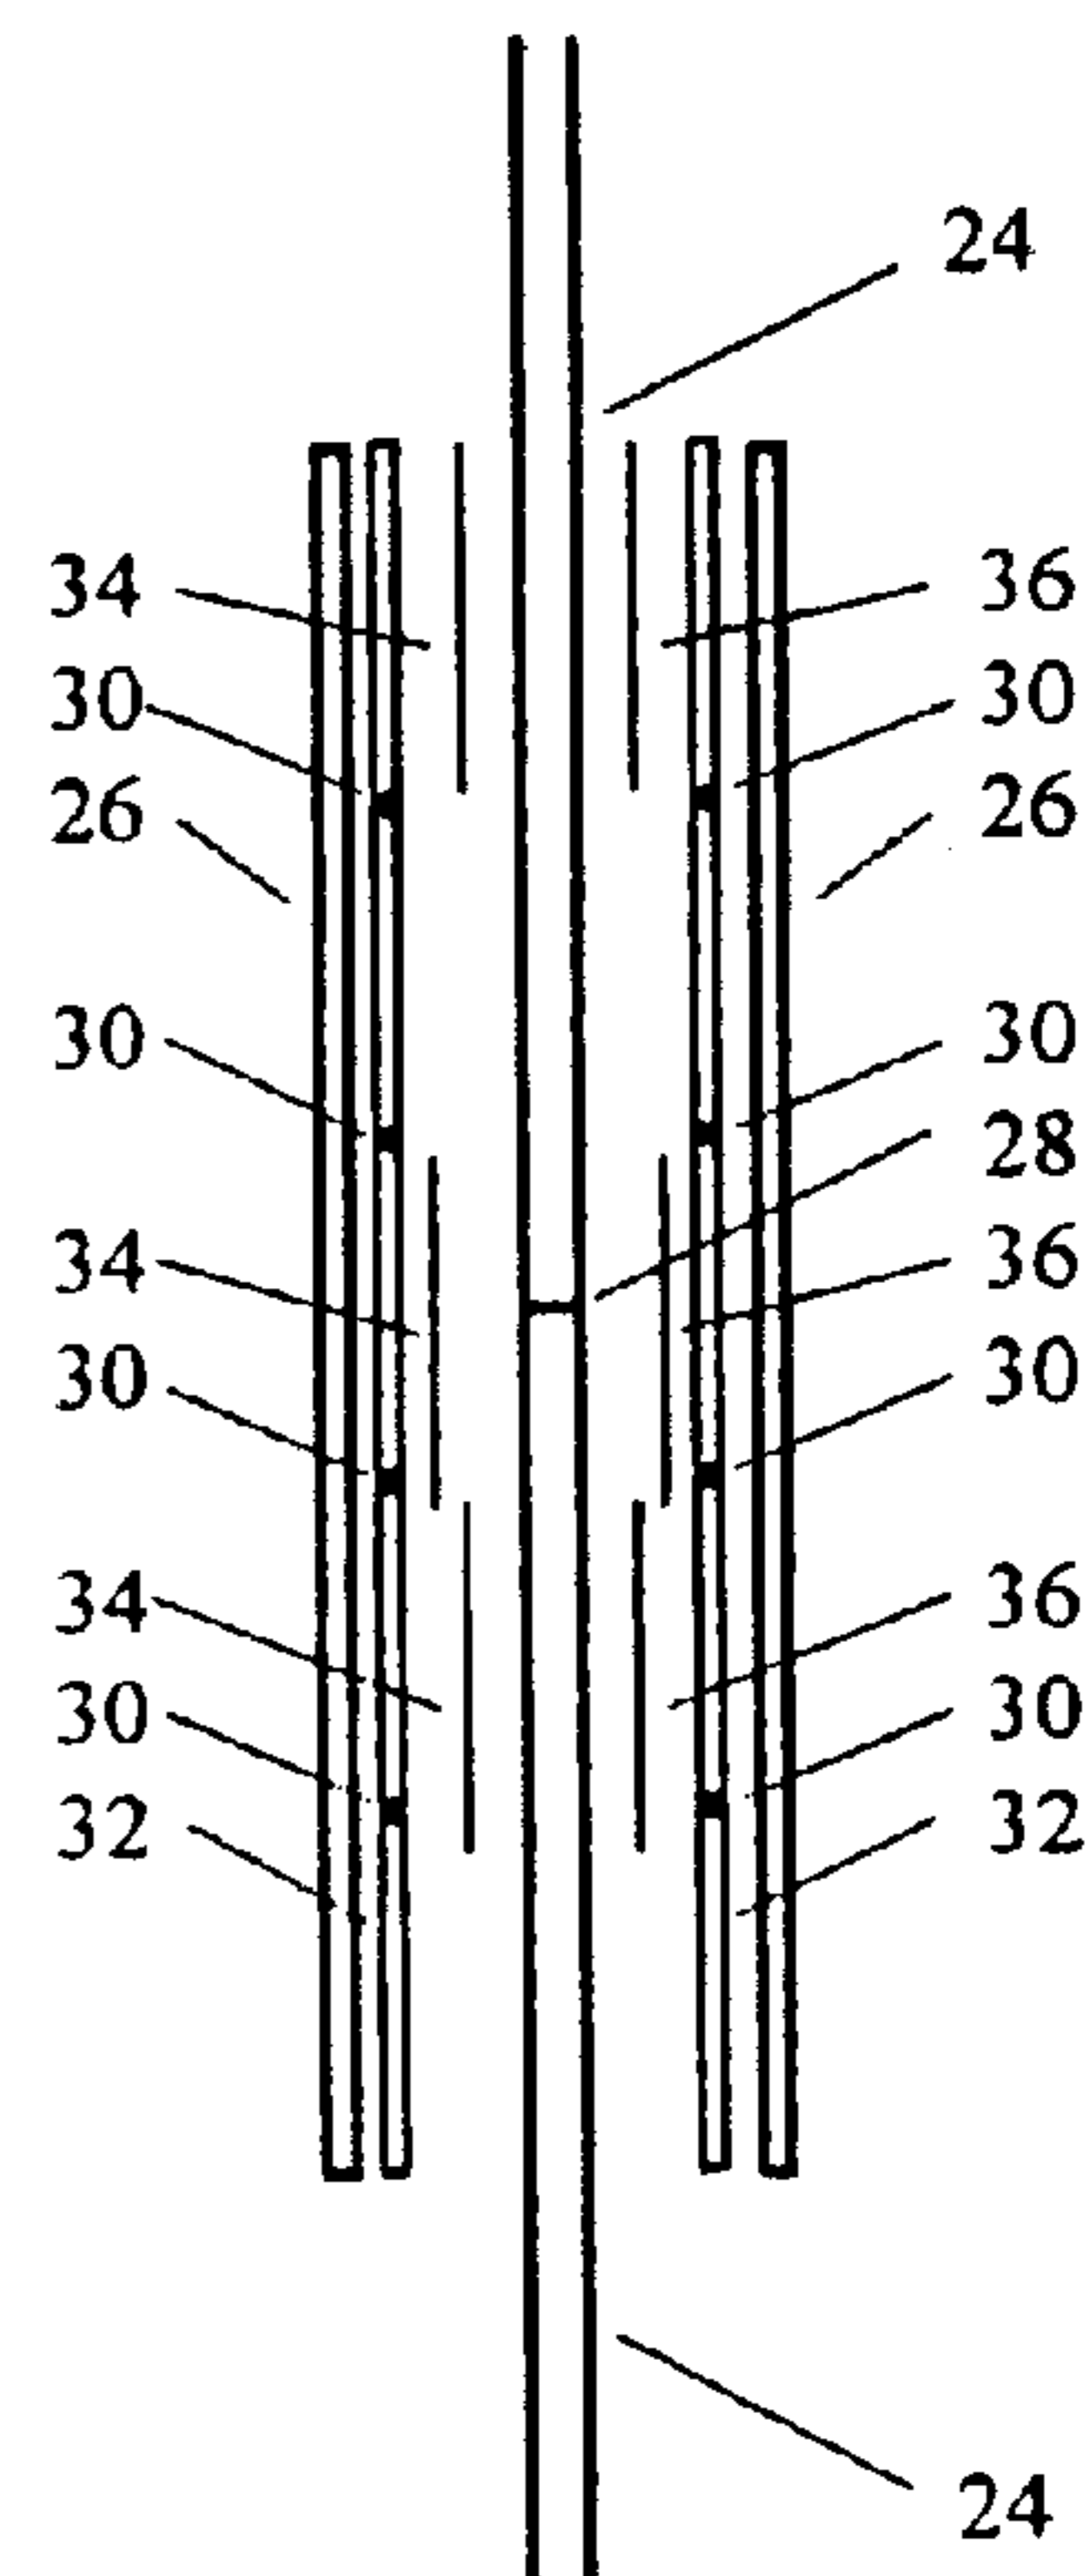
FIGURE 9

FIG. 9 shows an X-ray of a debond test specimen.

FIG. 9 is a representative radiograph of one of the specimens shown in FIG. 7 showing the debonding associated with non-stick insert 36 at the corner of patch 26 after 40,000 cycles. The unpatched region of fiberglass/epoxy sheet 24 is at the top (the upper edge of patch 26 coincides with the upper edge of insert 36). The approximately square region is insert 36, which is not bonded to fiberglass/epoxy sheet 24. Irregular area 38 indicates the thickest layer of dye penetrant in the volume under insert 36. The dye penetrant has a sharply defined inner boundary 40 which is its meniscus. Outer boundary 42 of the dye penetrant is far less distinct because it is the leading edge of the debond and the dye penetrant layer is approaching zero thickness at this point. However, outer boundary 42 appears to correspond to the outer dimensions of insert 36, indicating that the inserts probably did not initiate debonding.

None of these specimens showed any evidence of debonds initiating from the barriers, but debonds were evident under the inserts. Unfortunately, the debond opening displacement approaches zero at the debond front, so there was insufficient contrast to conclusively determine the location of the debond front. Thus, although there was no evidence that any debond penetrated past an adhesive layer barrier or an insert, the resolution was insufficient to definitively state that the debonds grew to the barriers and stopped or that debonding was not initiated by the inserts.

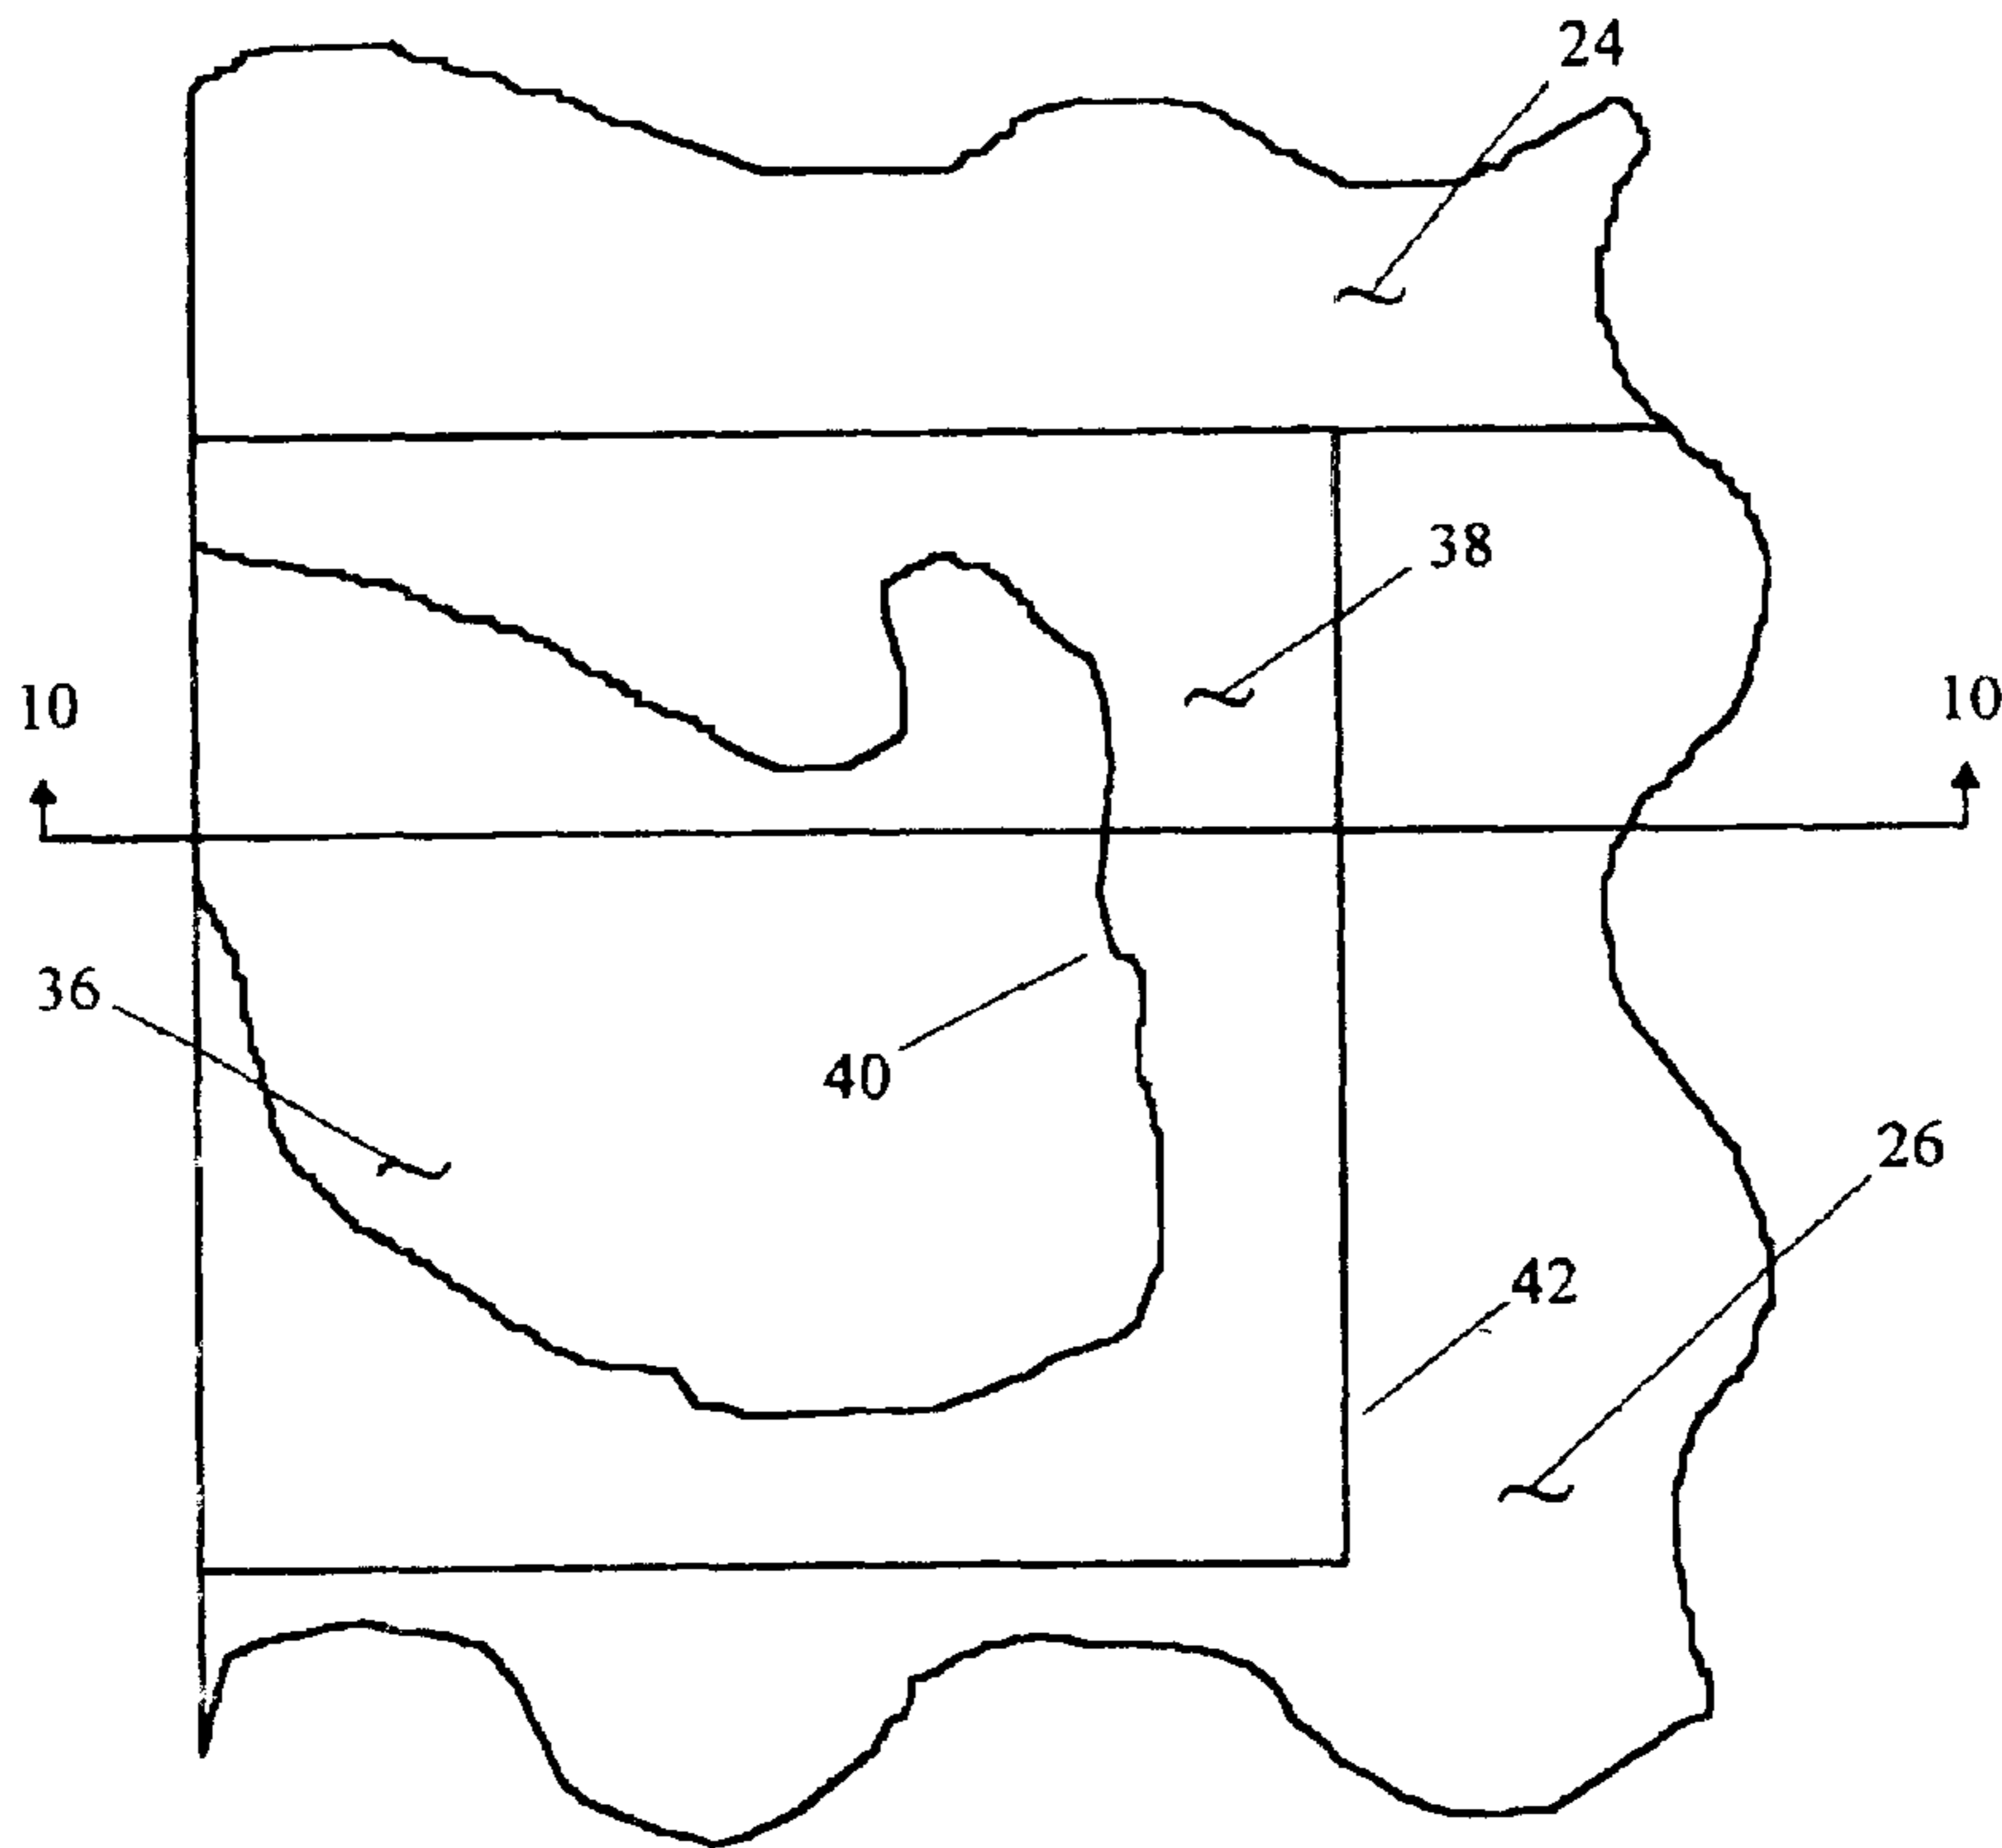
FIGURE 10

FIG. 10 shows a cross-section taken along line 10—10 in FIG. 9.

FIG. 10 is taken along line 10—10 in FIG. 9 and shows a cross-section through the specimen; the vertical scale has been exaggerated somewhat for clarity. Outer boundary 42 of the dye penetrant has been shown as extending to the edge of insert 36. This is not an exact representation, since the dye layer approaches zero thickness at this point and its location cannot be determined with precision. However, as stated above it appears to coincide with the edges of insert 36 and the debond appeared to not progress beyond insert 36.

There is a buildup of dye at the top edge of the insert, implying that the patch overlaid the top edge of the insert even though the top edge of the patch coincided with the top edge of the insert. This is caused by the fact that during the cure cycle the adhesive initially becomes thin and watery; it travelled along the top edge of the patch by capillary action, then hardened to form a dye-retaining seal. The same holds true for the buildup of dye at the lower part of the left side of the insert.
