(10) **Patent No.: US 6,680,099 B1**
(45) **Date of Patent: *Jan. 20, 2004**

(54) **ENHANCING DAMAGE TOLERANCE OF ADHESIVE BONDS**

A means and method of enhancing the damage tolerance of adhesive bonds by introducing gaps in the adhesive to divide the adhesive layer into discrete regions. The gaps are created by placing strips of barrier material between the two adherends before the adhesive is put in place and cured. If the two adherends begin to debond along the interface between one of the adherends and the adhesive, the gap arrests the debonding process.

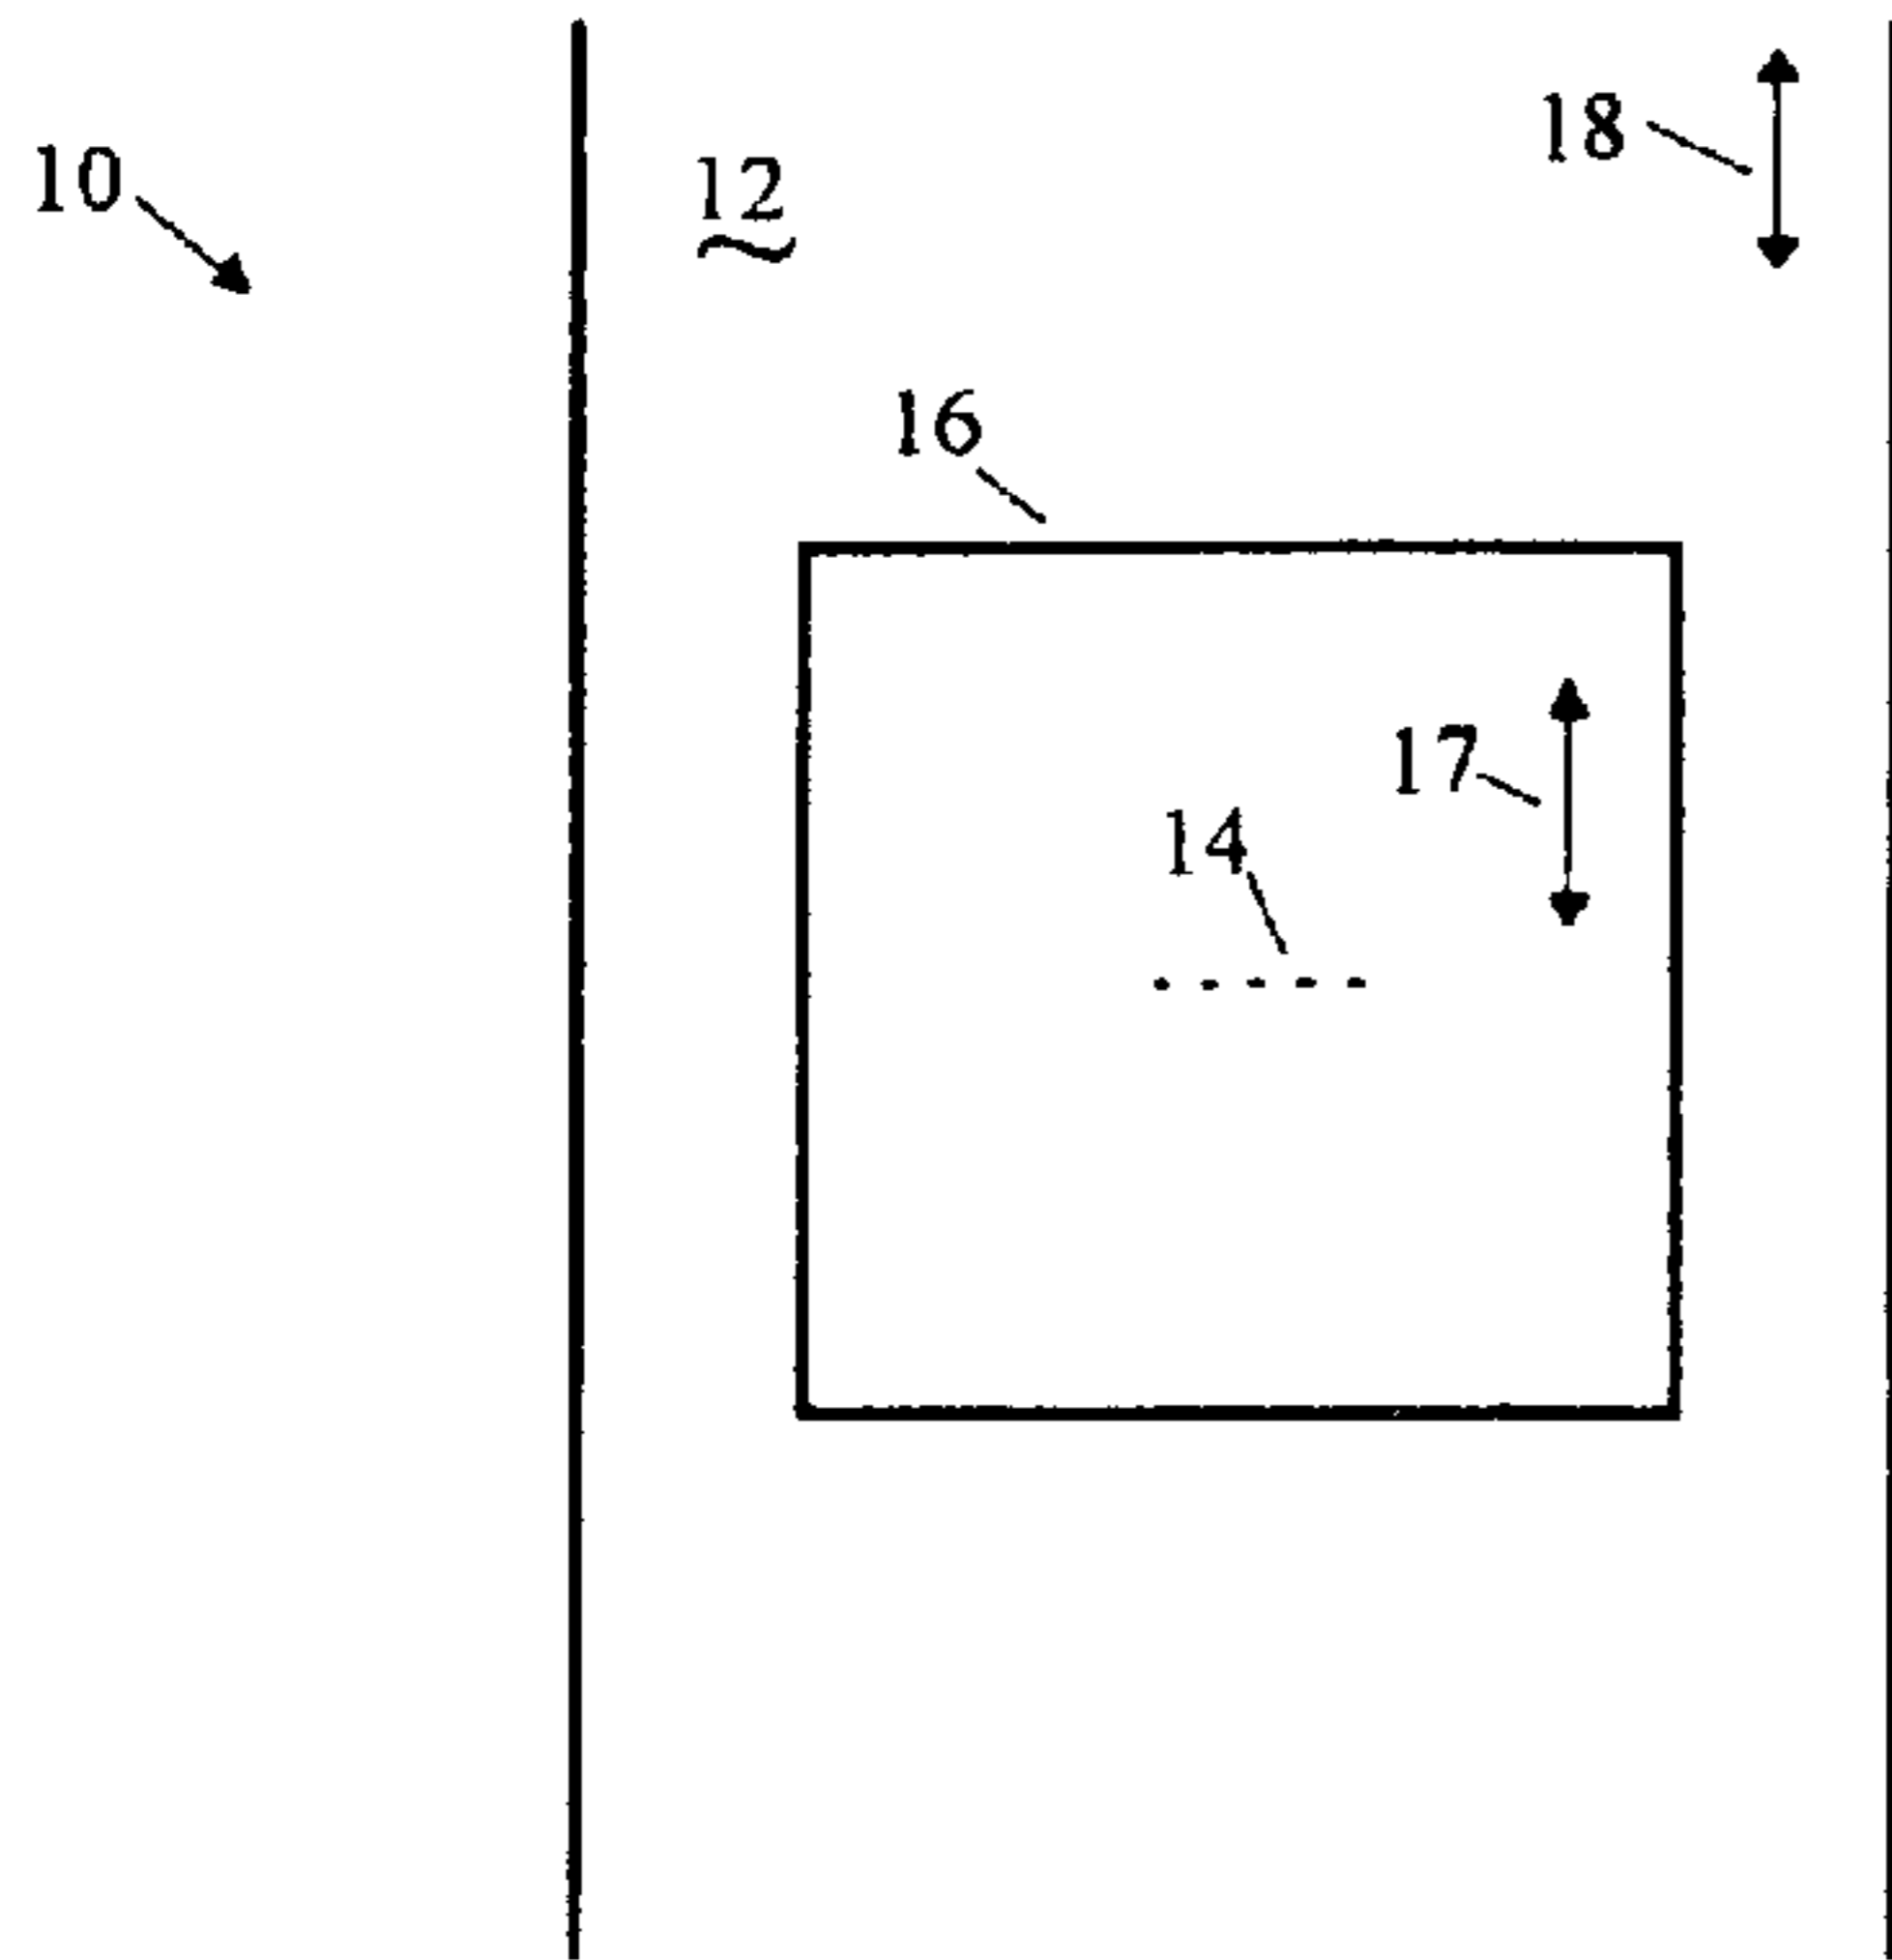
FIGURE 1

FIG. 1 shows an overall view of the experimental apparatus of the present invention.

FIG. 1 shows the overall layout of the experimental apparatus 10 used on the tests simulating a crack in an aluminum aircraft skin. Aluminum sheet 12 simulates the skin of the aircraft with crack 14 in it that is covered with patch 16. Patch 16 is a unidirectional graphite/epoxy patch, with the direction of the fibers 17 parallel to the direction of the applied load 18 and perpendicular to crack 14. Most skin patches on military planes are thought to be boron/epoxy, but graphite/epoxy was used in the tests primarily because it is less opaque to X-ray inspection used in the debond growth tests. The adhesive used to bond patch 16 to sheet 12 is "Cytec® FM-73M®", a proprietary modified epoxy film made by Cytec Engineered Materials of Havre de Grace, Maryland; this is recommended by the manufacturer for use with boron/epoxy patches, hence was used for the tests. Priming, bonding, and curing procedures in accordance with the manufacturer's instructions were used in preparing all of the specimens.

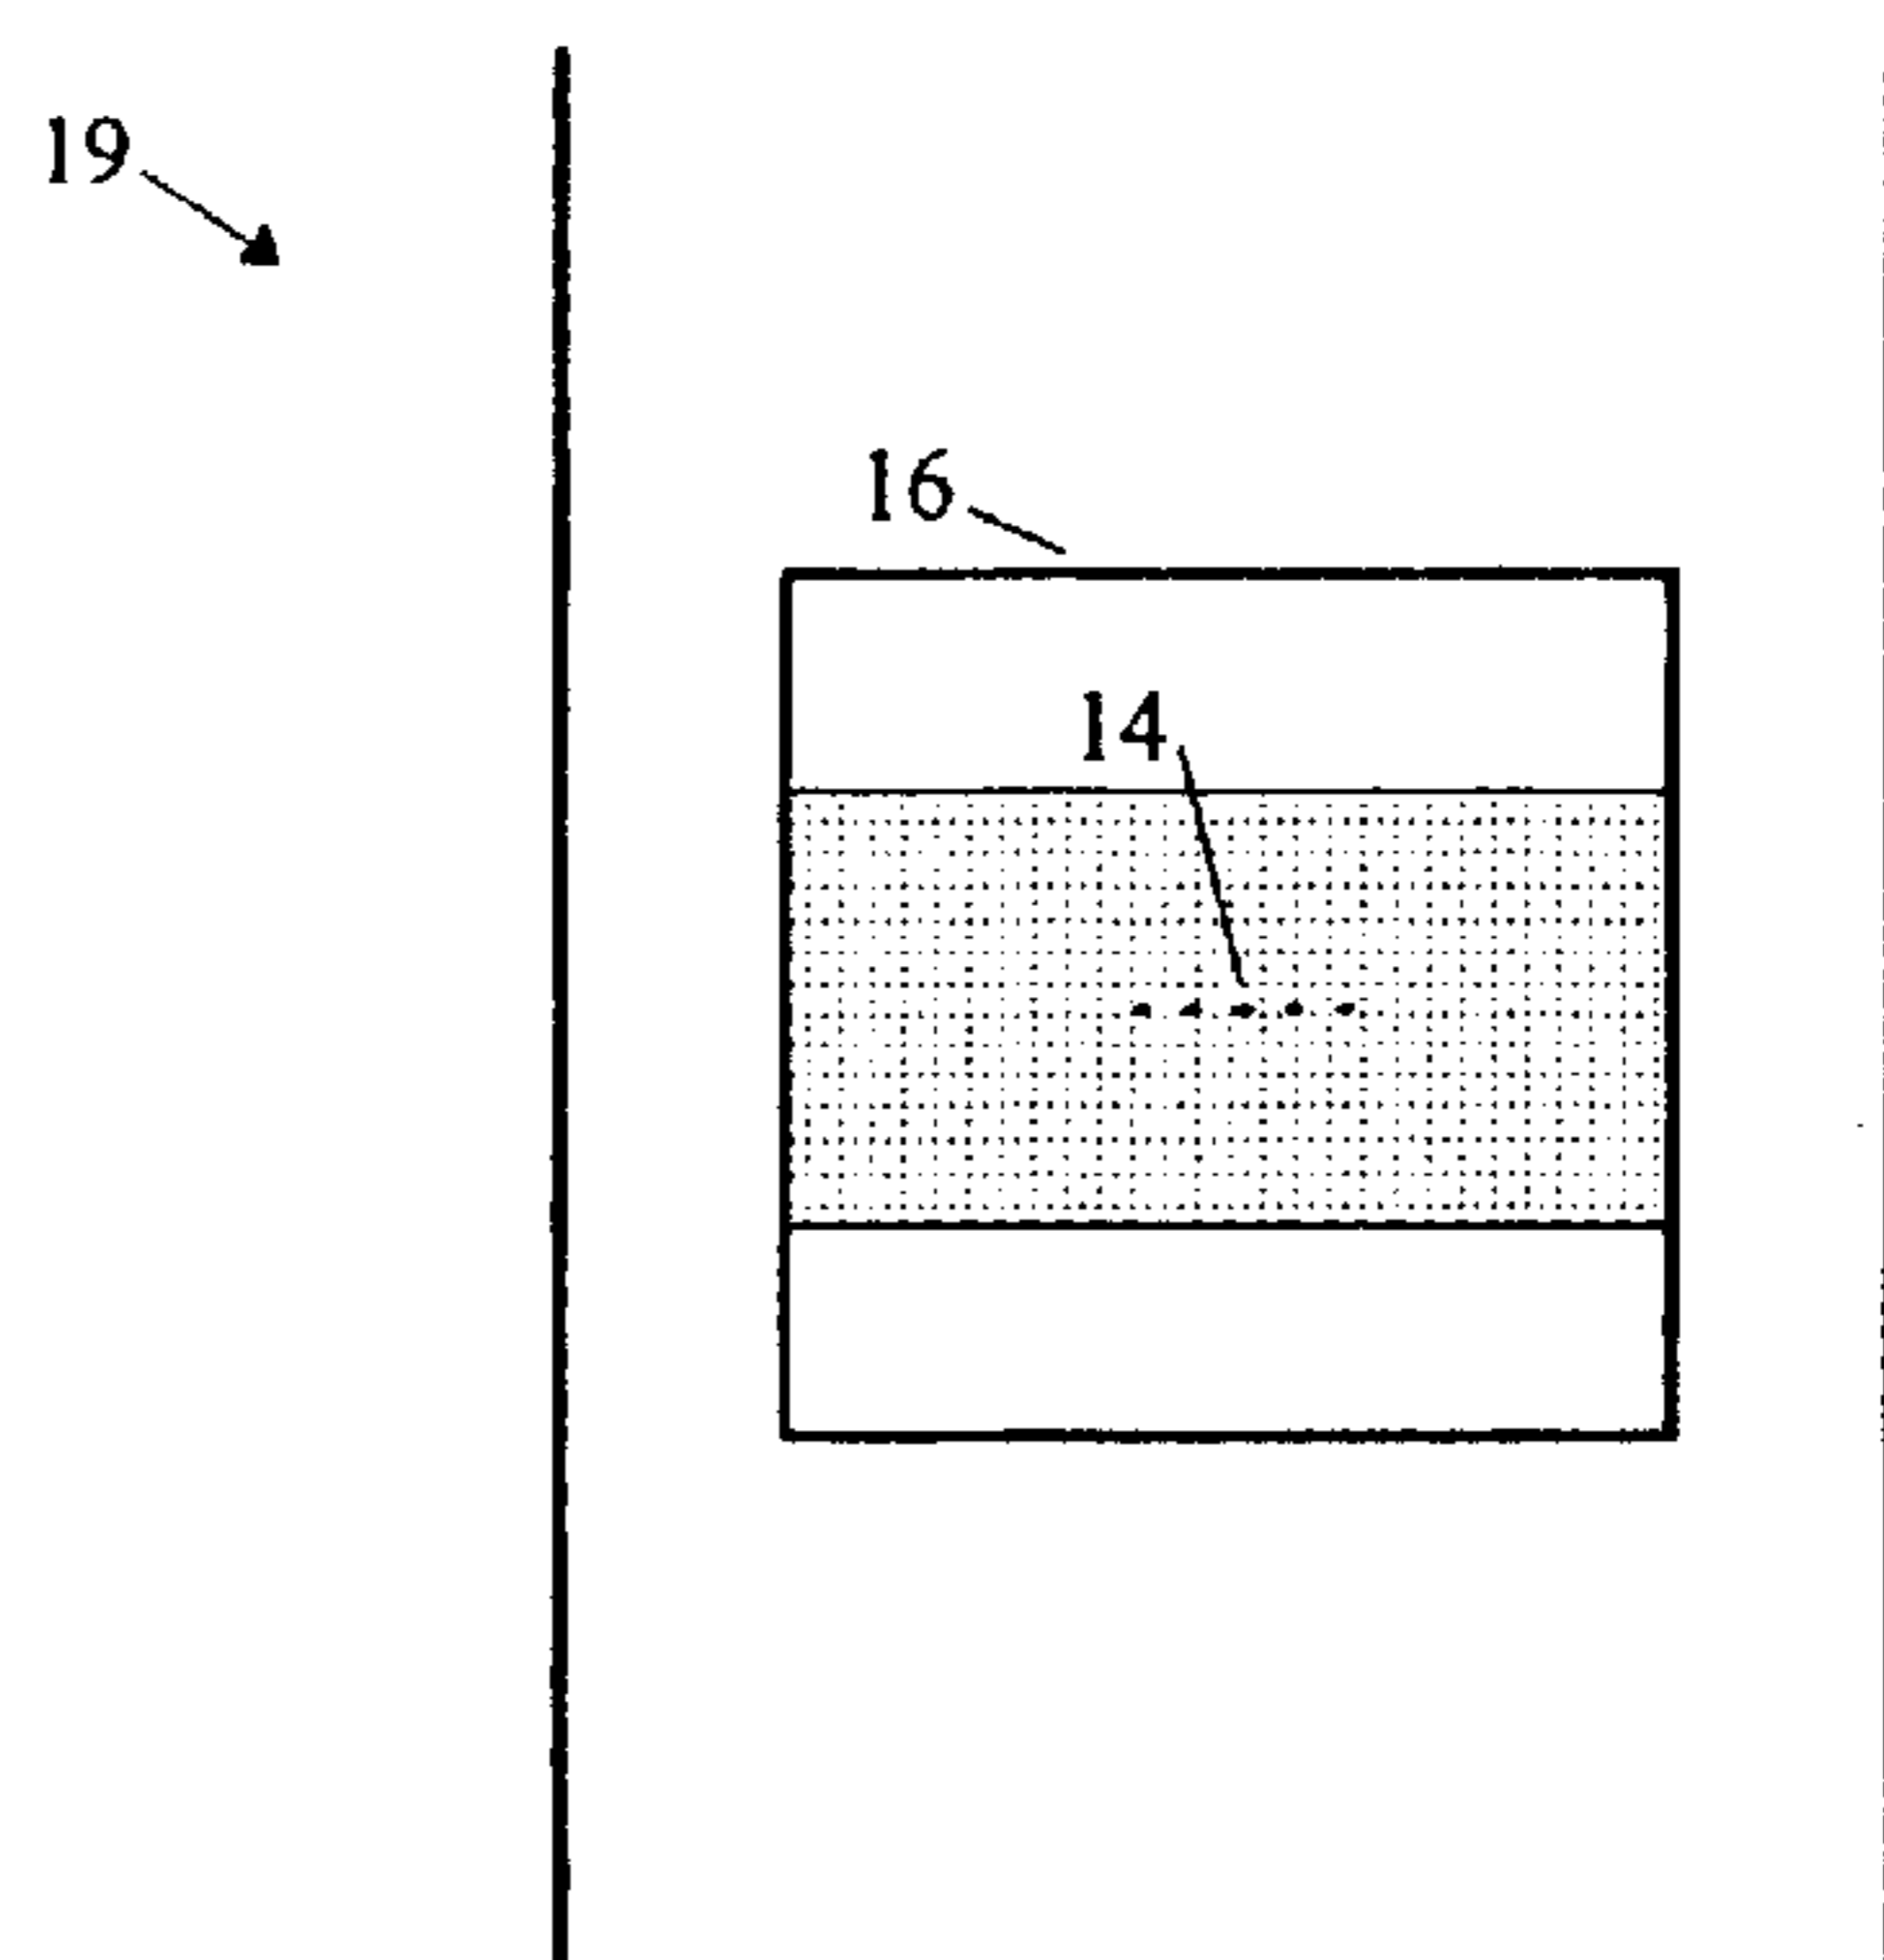
FIGURE 2

FIGS. 2 and 3 show the difference between internal and external debonds and the test specimens used for tests on cracked aluminum.

FIGS. 2 and 3 show specimens with an internal debond 18 (FIG. 2) and an external debond 20 (FIG. 3). The debonded areas of the patches are shown in cross hatching. That is, in an internal debond crack 14 is covered by a part of patch 16 that has become debonded from the skin; in an external debond the part of patch 16 that is over crack 14 is bonded to the skin, but the edges of patch 16 have become debonded. In both cases the graphite fibers are as in FIG. 1—parallel to the direction of the applied force and perpendicular to the crack.

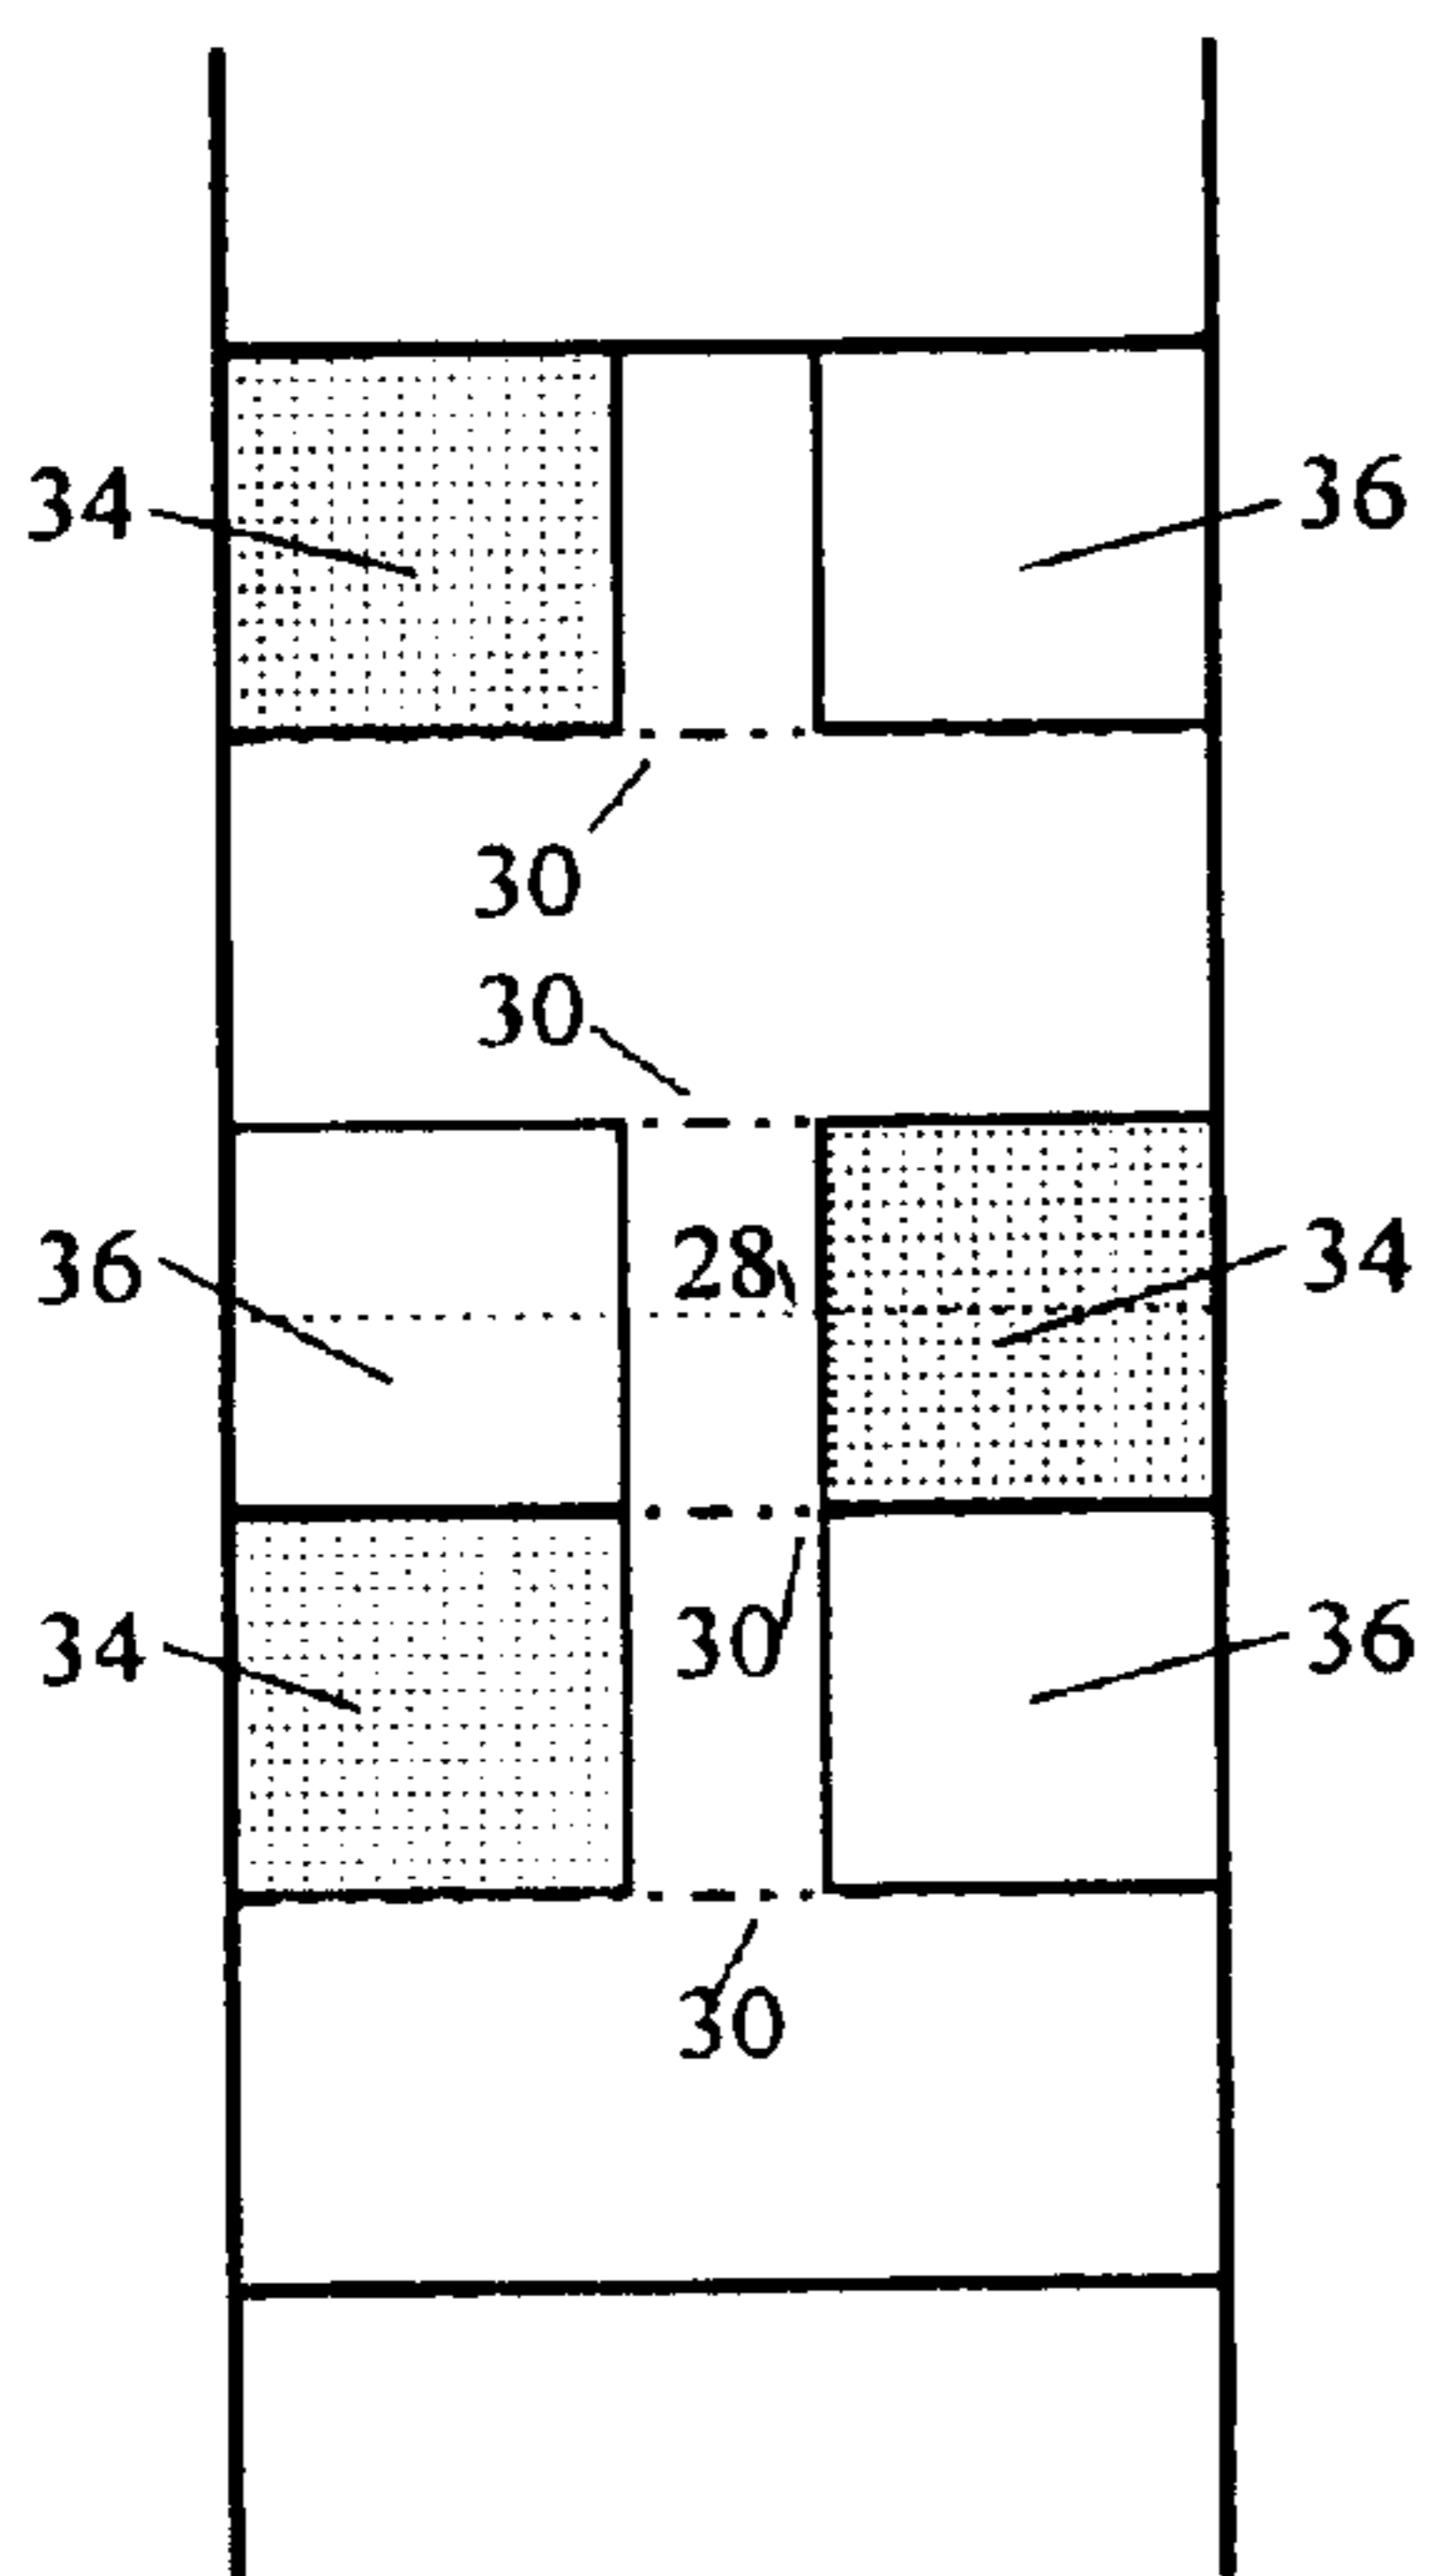
FIGURE 7

FIG. 7 shows the locations of the inserts used in the debond initiation tests.

Four specimens with each type of barrier were tested. Two specimens in each set of four were tested to evaluate the potential for the barriers themselves to initiate debonds, the other two were tested to assess the ability of the barriers to arrest debond growth. In these latter two specimens, non-stick inserts were used to create debonds in several areas. The arrangement of these areas is shown in front view in FIG. 7 and in side view in FIG. 8. Cross-hatched inserts 34 were placed on one side of the specimen, and non cross-hatched inserts 36 were placed on the other side of the specimen. Two crucial differences between inserts 34 and 36 on the one hand and the barriers on the other hand are that (1) the barriers are smooth on the microscale whereas the inserts are not, and (2) the inserts prevent bonding between

FIG. 9 is a representative radiograph of one of the specimens shown in FIG. 7 showing the debonding associated with non-stick insert 36 at the corner of patch 26 after 40,000 cycles. The unpatched region of fiberglass/epoxy sheet 24 is at the top (the upper edge of patch 26 coincides with the upper edge of insert 36). The approximately square region is insert 36, which is not bonded to fiberglass/epoxy sheet 24. Irregular area 38 indicates the thickest layer of dye penetrant in the volume under insert 36. The dye penetrant has a sharply defined inner boundary 40 which is its meniscus. Outer boundary 42 of the dye penetrant is far less distinct because it is the leading edge of the debond and the dye penetrant layer is approaching zero thickness at this point. However, outer boundary 42 appears to correspond to the outer dimensions of insert 36, indicating that the inserts probably did not initiate debonding.

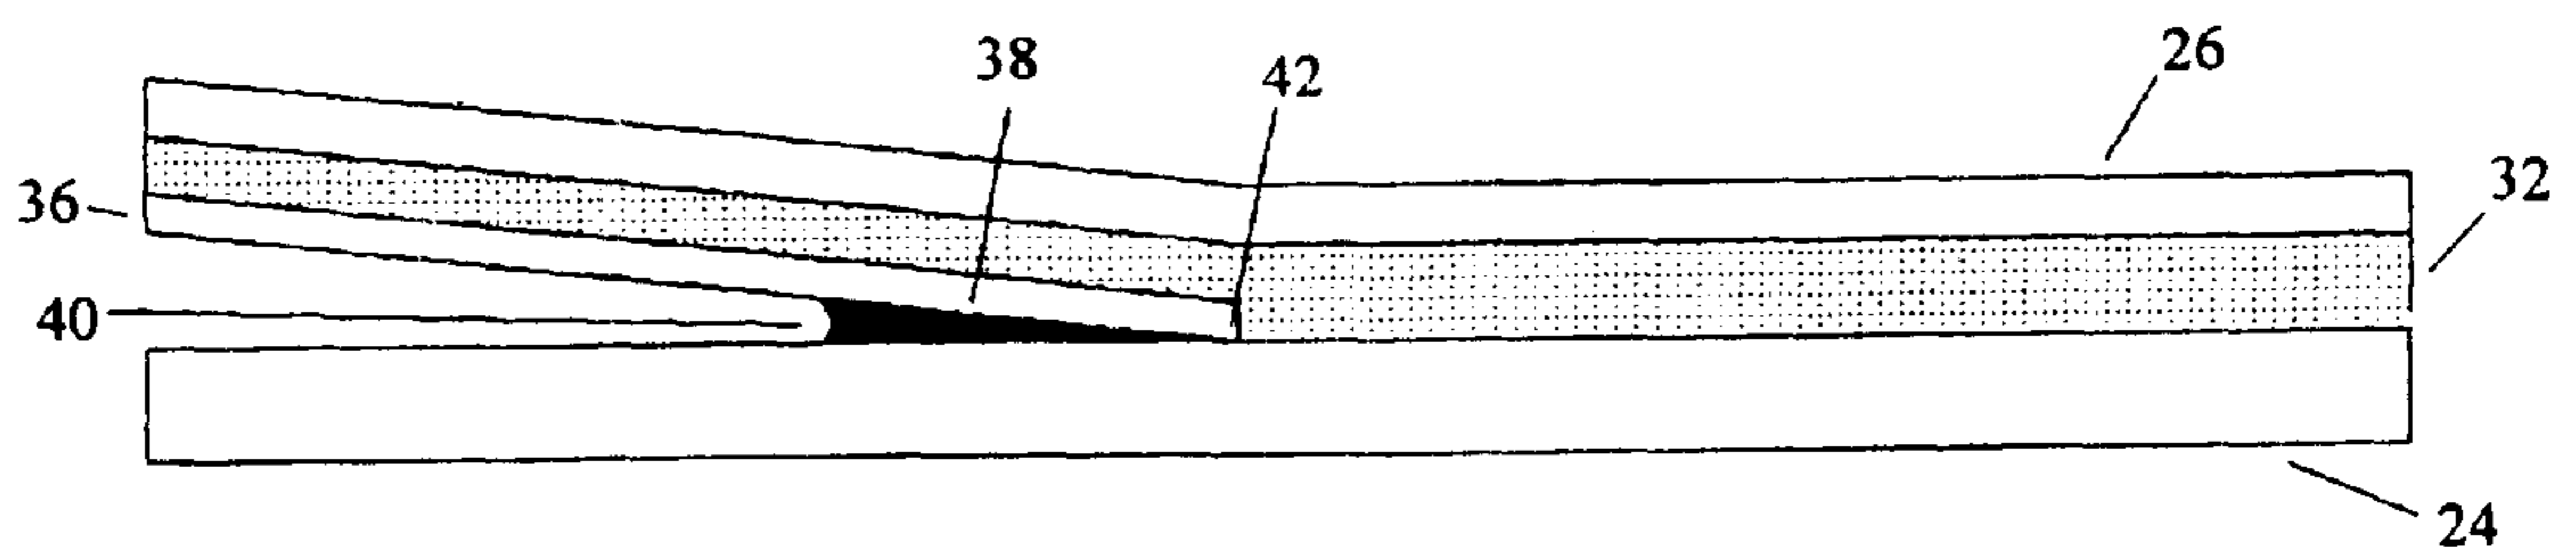
FIGURE 10

FIG. 10 shows a cross-section taken along line 10—10 in FIG. 9.

FIG. 10 is taken along line 10—10 in FIG. 9 and shows a cross-section through the specimen; the vertical scale has been exaggerated somewhat for clarity. Outer boundary 42 of the dye penetrant has been shown as extending to the edge of insert 36. This is not an exact representation, since the dye layer approaches zero thickness at this point and its location cannot be determined with precision. However, as stated above it appears to coincide with the edges of insert 36 and the debond appeared to not progress beyond insert 36.

There is a buildup of dye at the top edge of the insert, implying that the patch overlaid the top edge of the insert even though the top edge of the patch coincided with the top edge of the insert. This is caused by the fact that during the cure cycle the adhesive initially becomes thin and watery; it travelled along the top edge of the patch by capillary action, then hardened to form a dye-retaining seal. The same holds true for the buildup of dye at the lower part of the left side of the insert.
