(10) **Patent No.:** **US 6,719,853 B2**
(45) **Date of Patent:** **Apr. 13, 2004**

(54) **METHOD FOR RESTORING THE MICROSTRUCTURE OF A TEXTURED ARTICLE AND FOR REFURBISHING A GAS TURBINE BLADE OR VANE**

(73) Assignee: **Siemens Aktiengesellschaft**, Munich (DE)

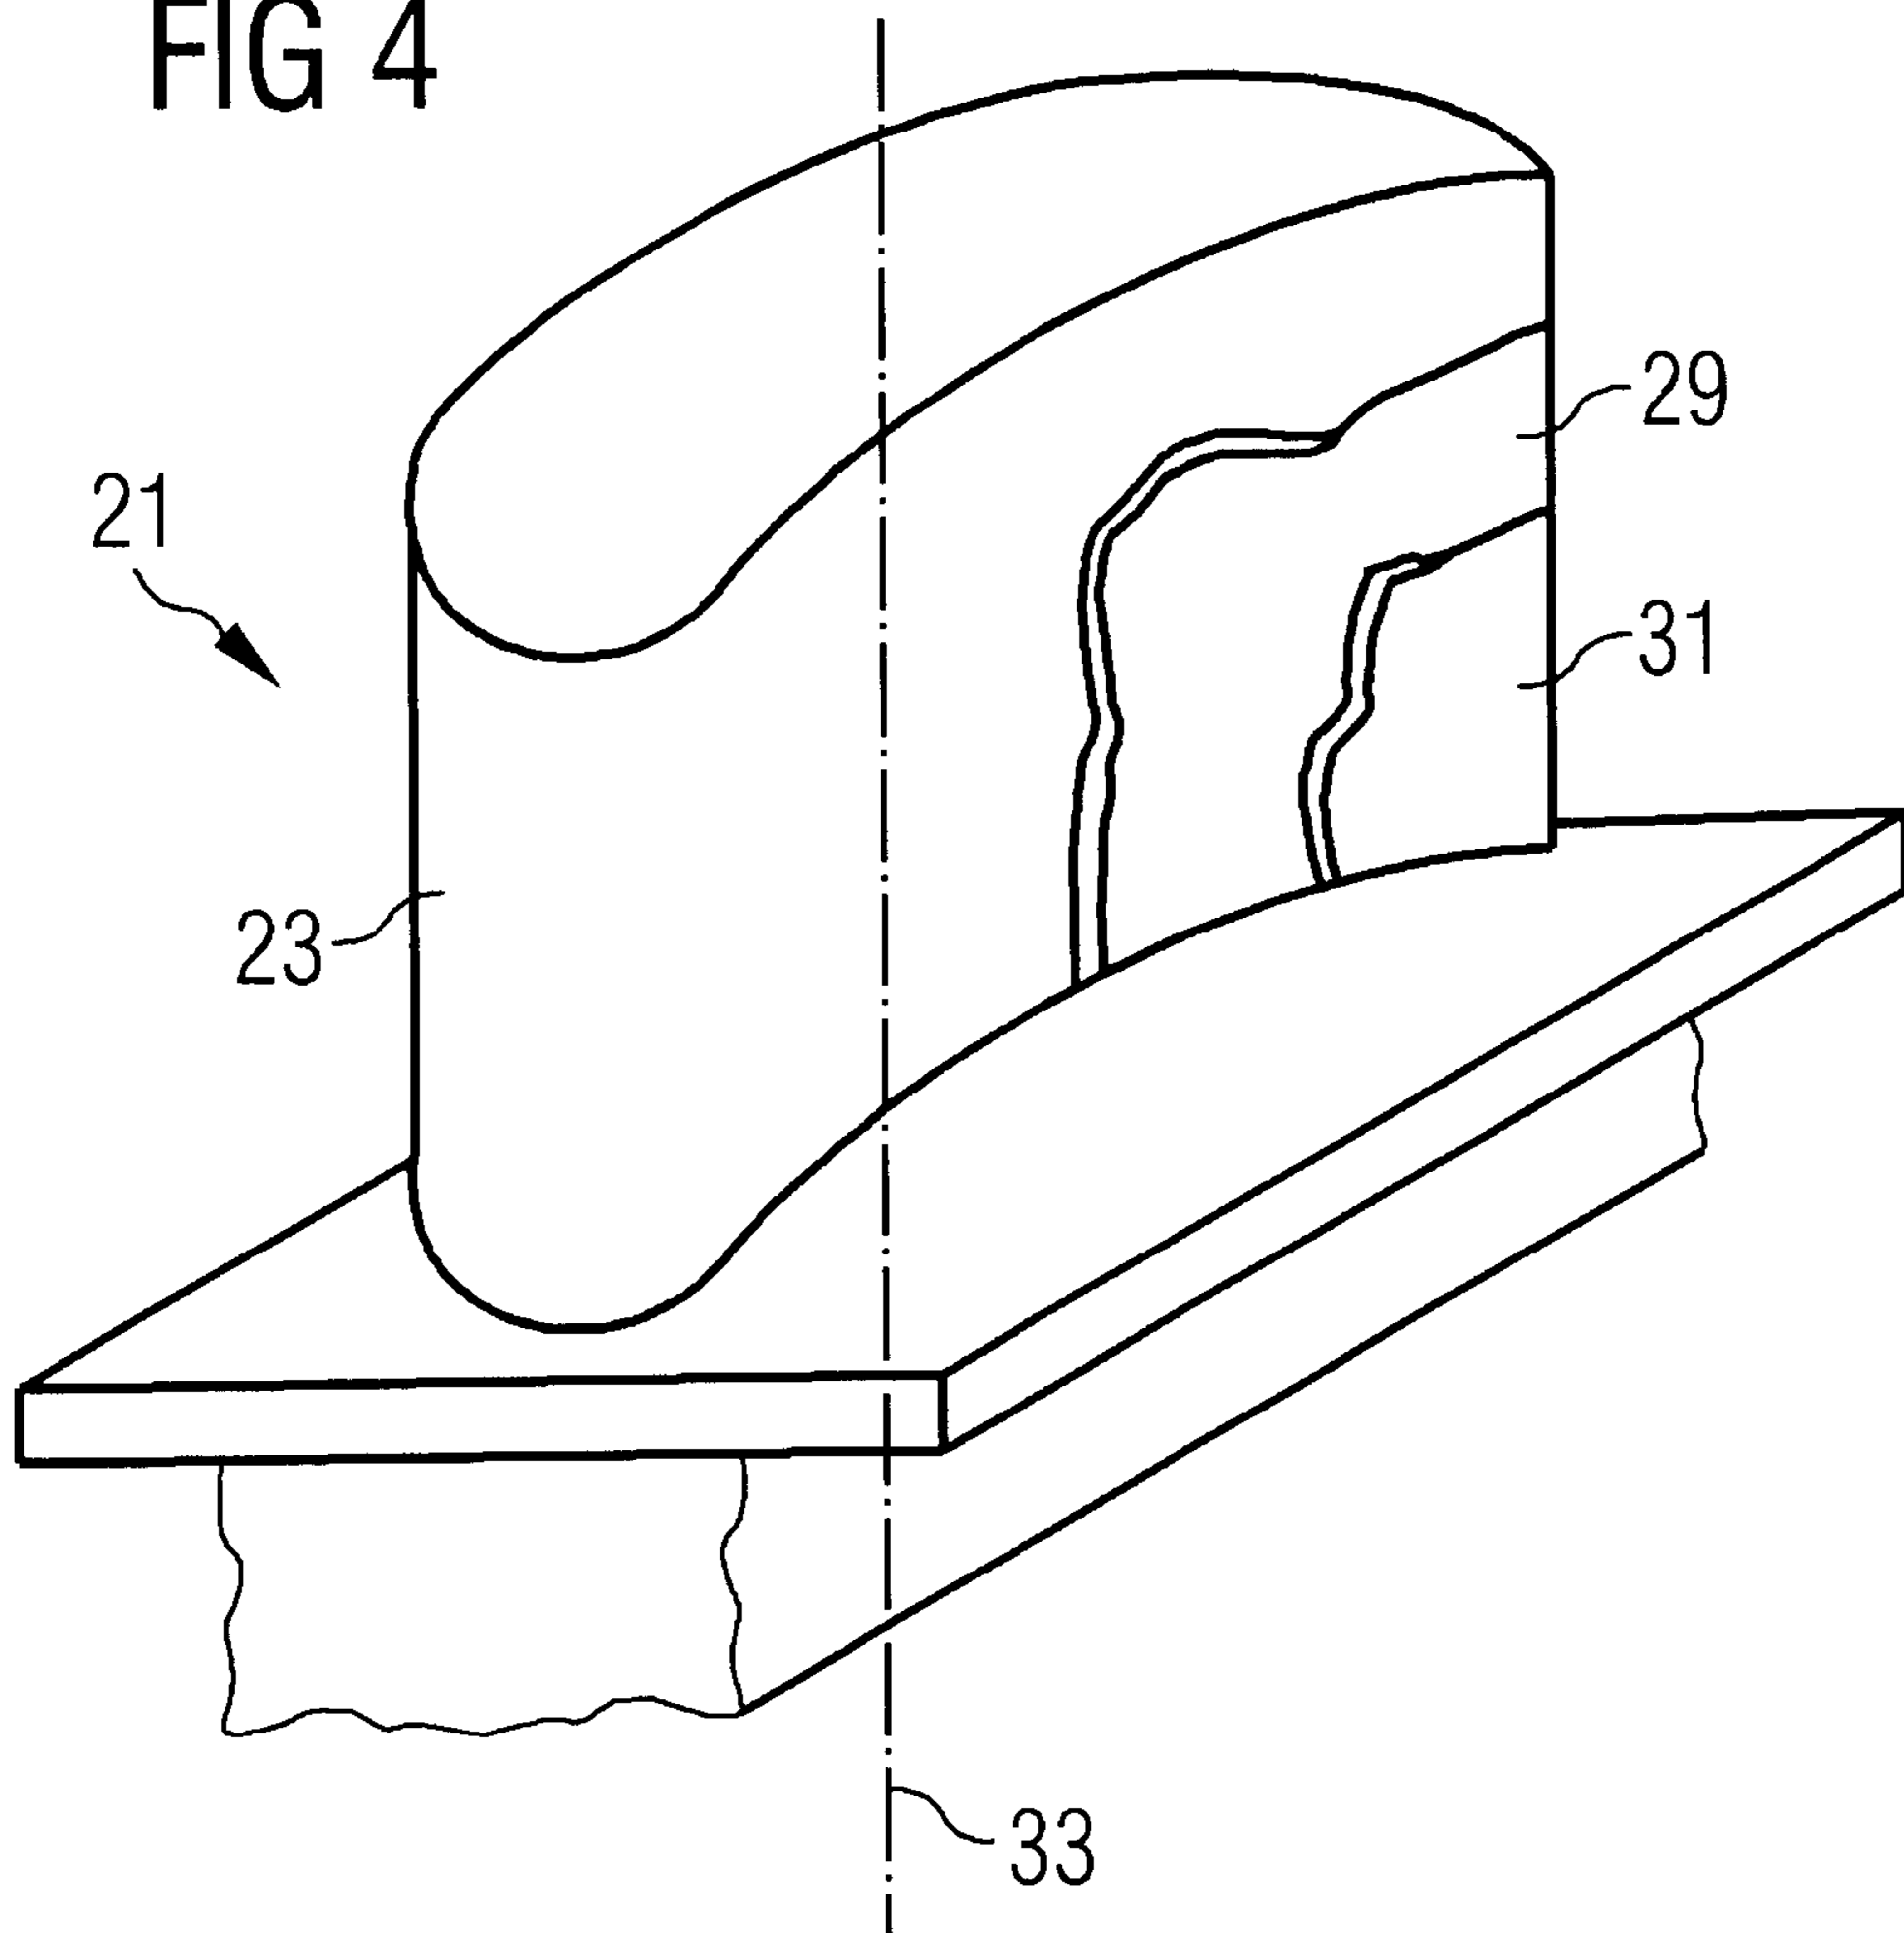
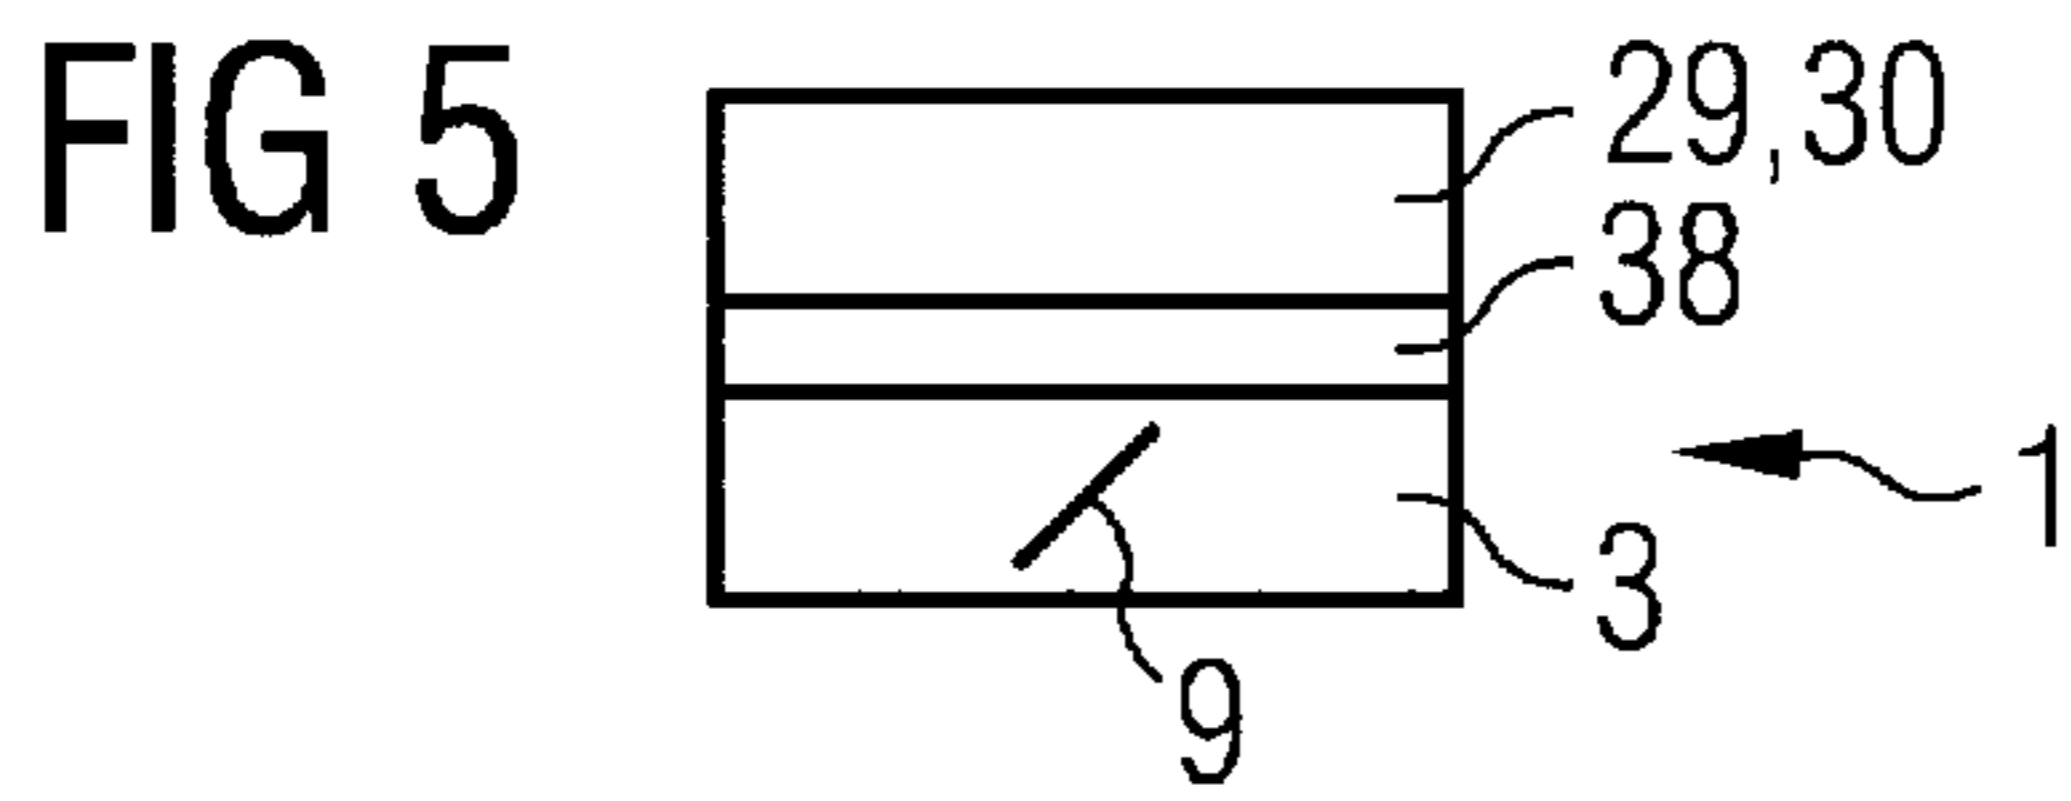
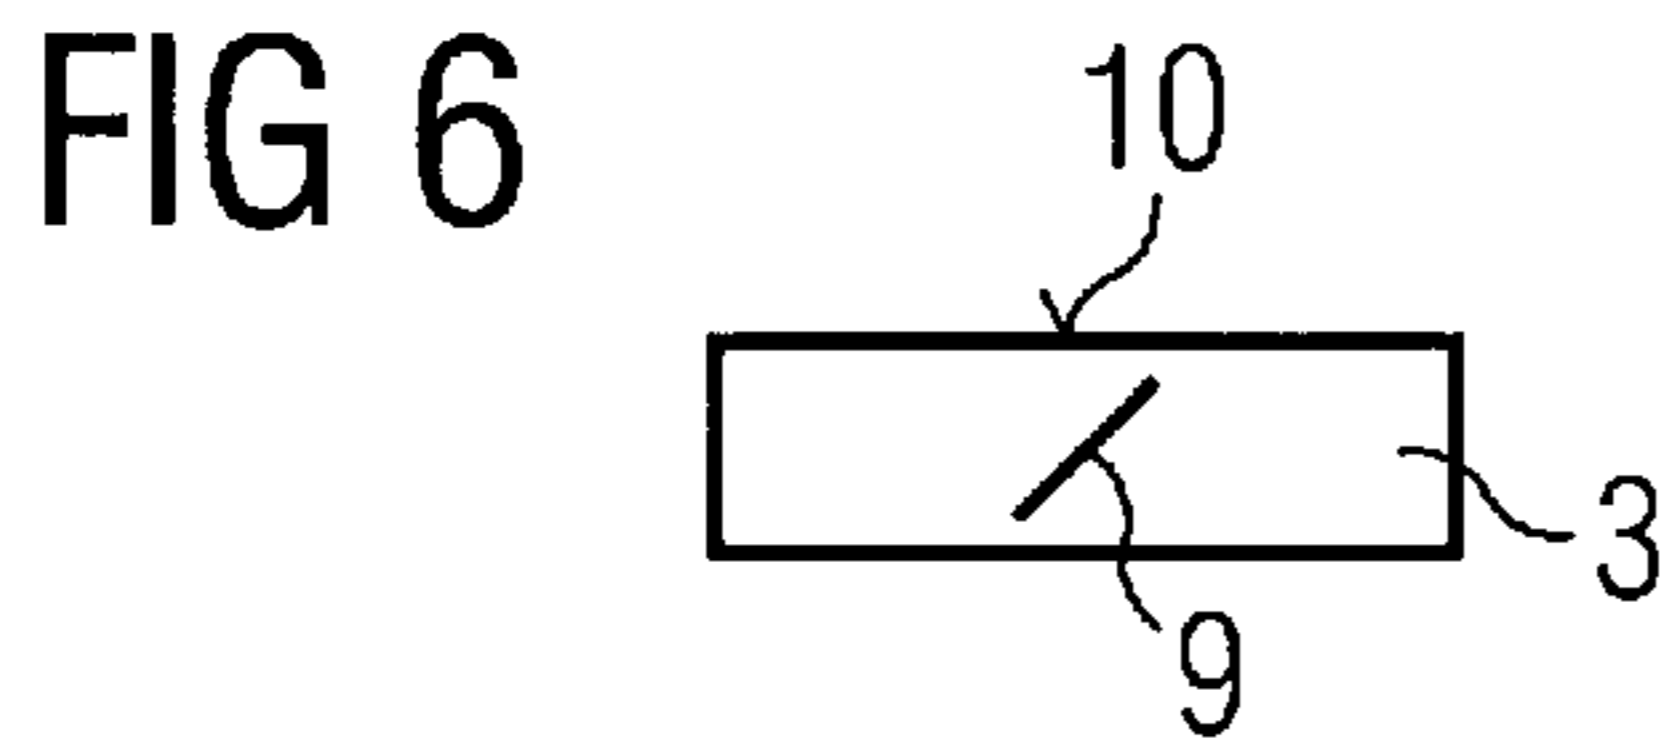
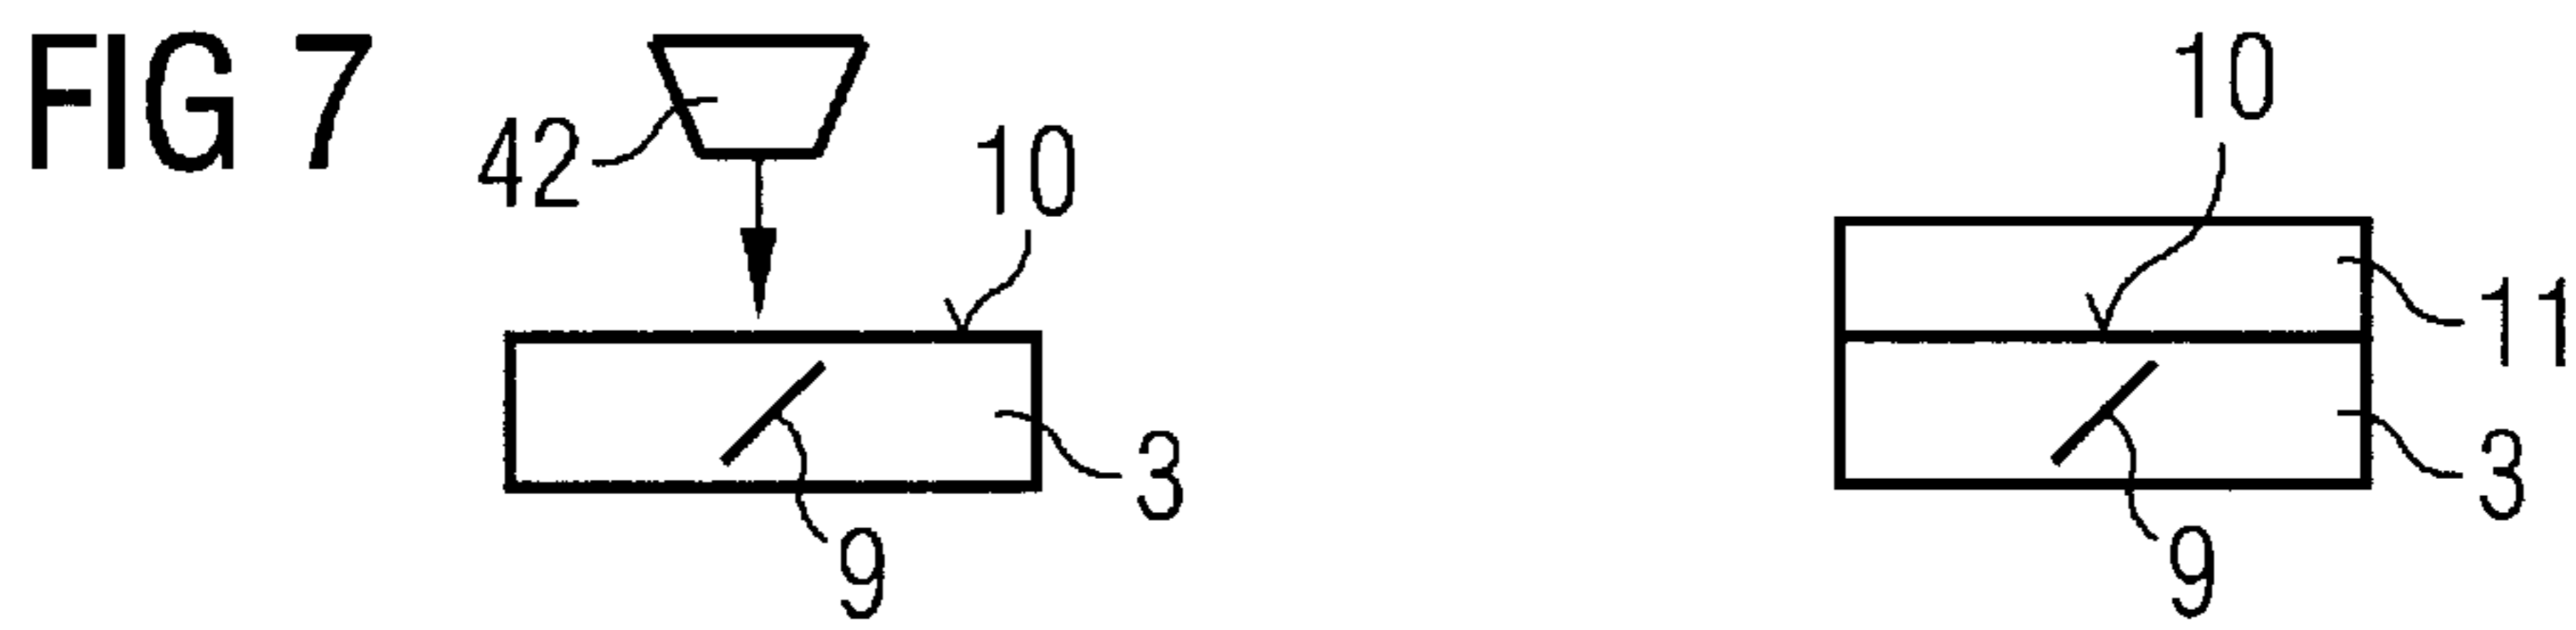
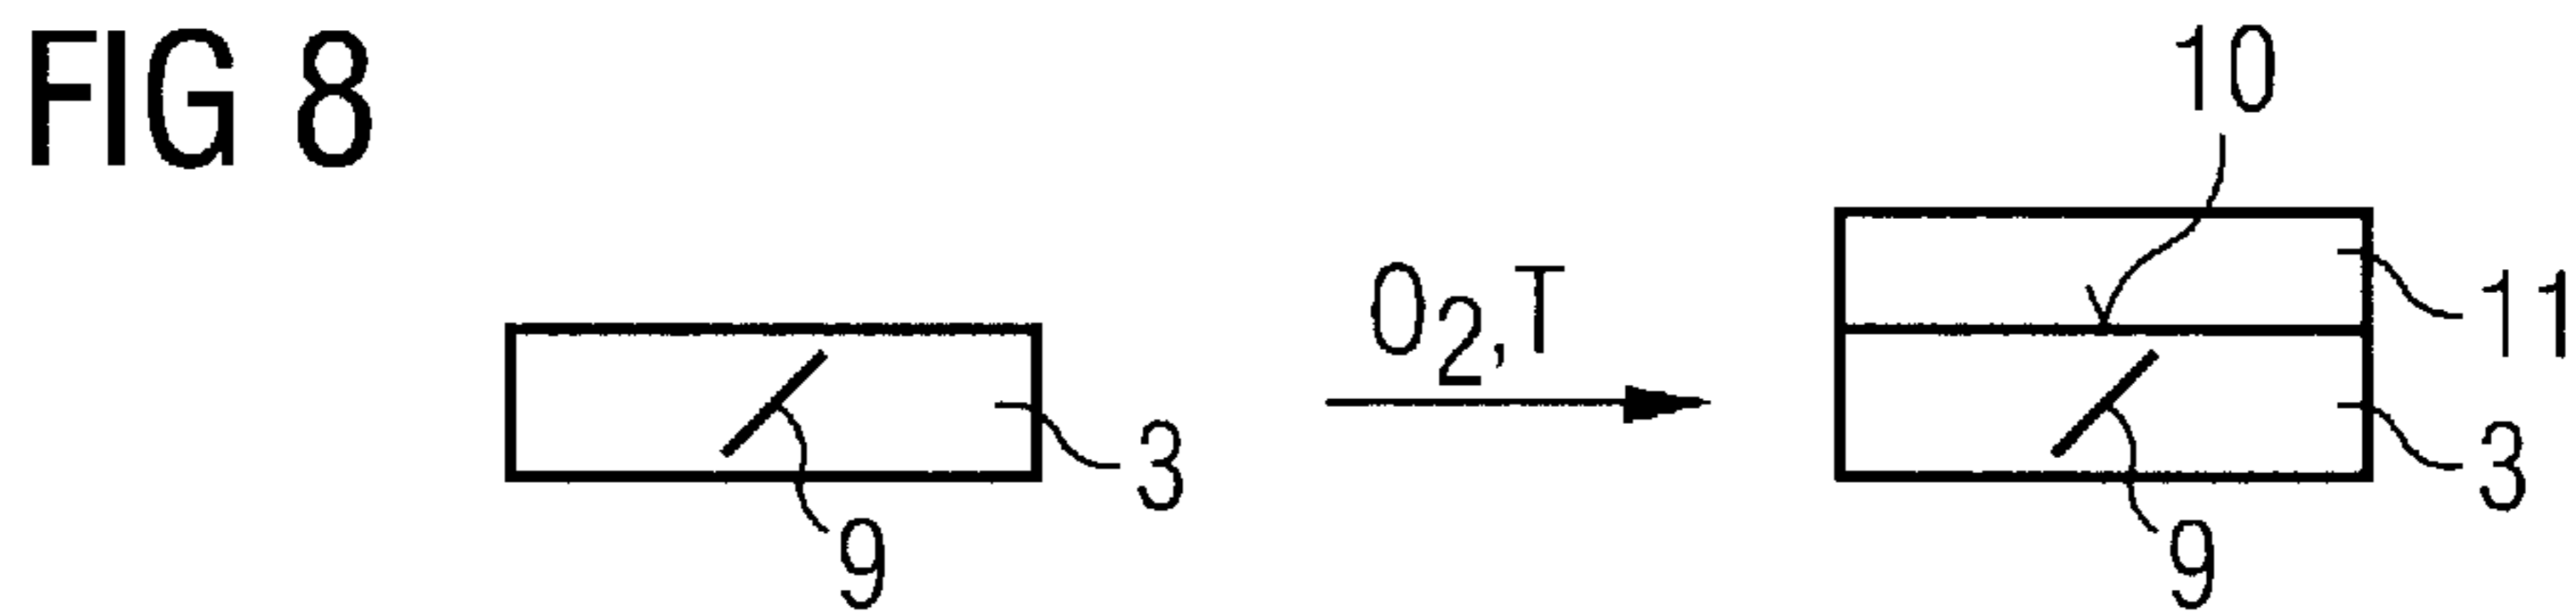
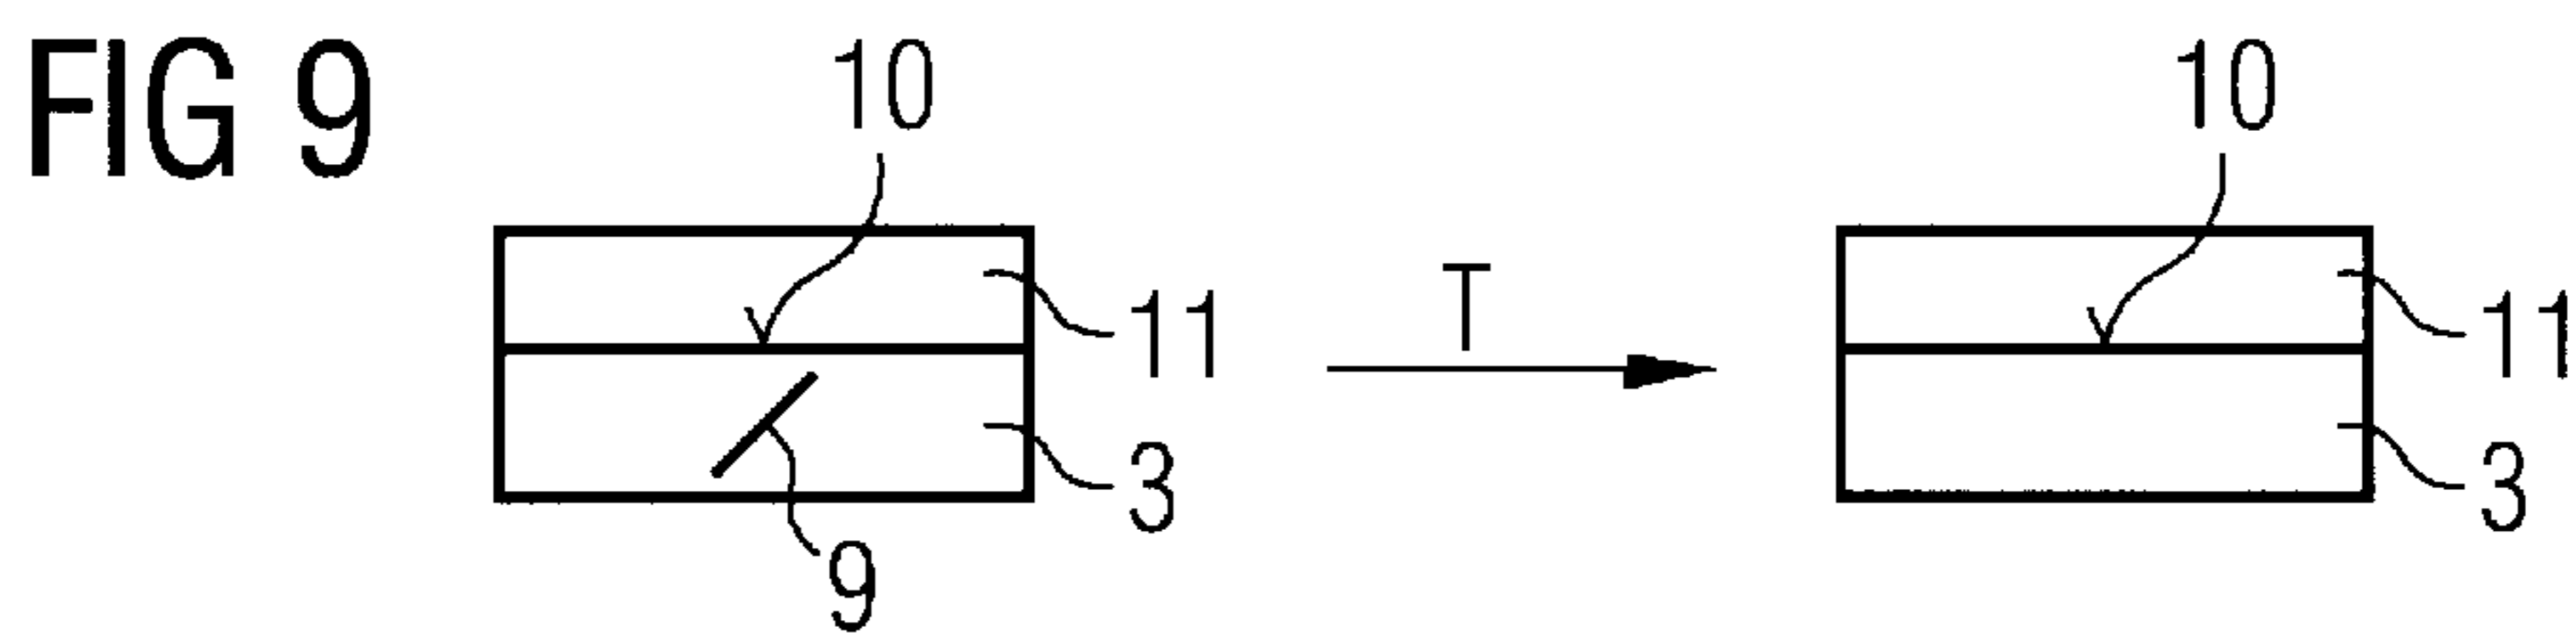
FIGS. 5 to 11 show schematically the steps of restoring the microstructure of a textured article and/or the refurbishing of a textured article. FIG. 5 shows the article **1** with the body **3** having a dislocation accumulation **9**. On the body **3** there is e.g. a layer **38** with corrosion products on which the protective layer **29** and thermal barrier coating **30** is laying.

In a first step of the method of the invention, the protective layer **29**, the thermal barrier coating **30** and the corrosion products in the layer **38** are removed (FIG. 6). Secondly, on the surface **10** of the body **3** the surface coating **11** is applied by a coating apparatus **42**. (FIG. 7) Different kinds of coating apparatus or processes can be used. The surface coating **11** can also be applied by oxidising the body **3** at higher temperatures HT (FIG. 8) in an atmosphere with oxygen O_2 . The article with the surface coating **11** according to FIGS. 7, 8 is now applied to a solution heat treatment as indicated in FIG. 9. The thermal stable surface coating **11** is maintained during the solution heat treatment.

FIG. 10 shows the article **1** with his body **3** after the solution heat treatment and removal of the surface coating **11**. No grain boundary inside the single crystal or no additional grain boundary inside the directionally solidified article **1**, especially in the surface rim is present. A new protective layer **29** and a new thermal barrier coating **30** can now be applied again on the body **3** of the article **1** (FIG. 11).

FIGS. 5 to 11 shows several steps of the method of the present invention.
