(12) **United States Patent**
Preece

(10) **Patent No.:** **US 6,825,487 B2**
(45) **Date of Patent:** **Nov. 30, 2004**

(54) **METHOD FOR ISOLATION OF WAFER SUPPORT-RELATED CRYSTAL DEFECTS**

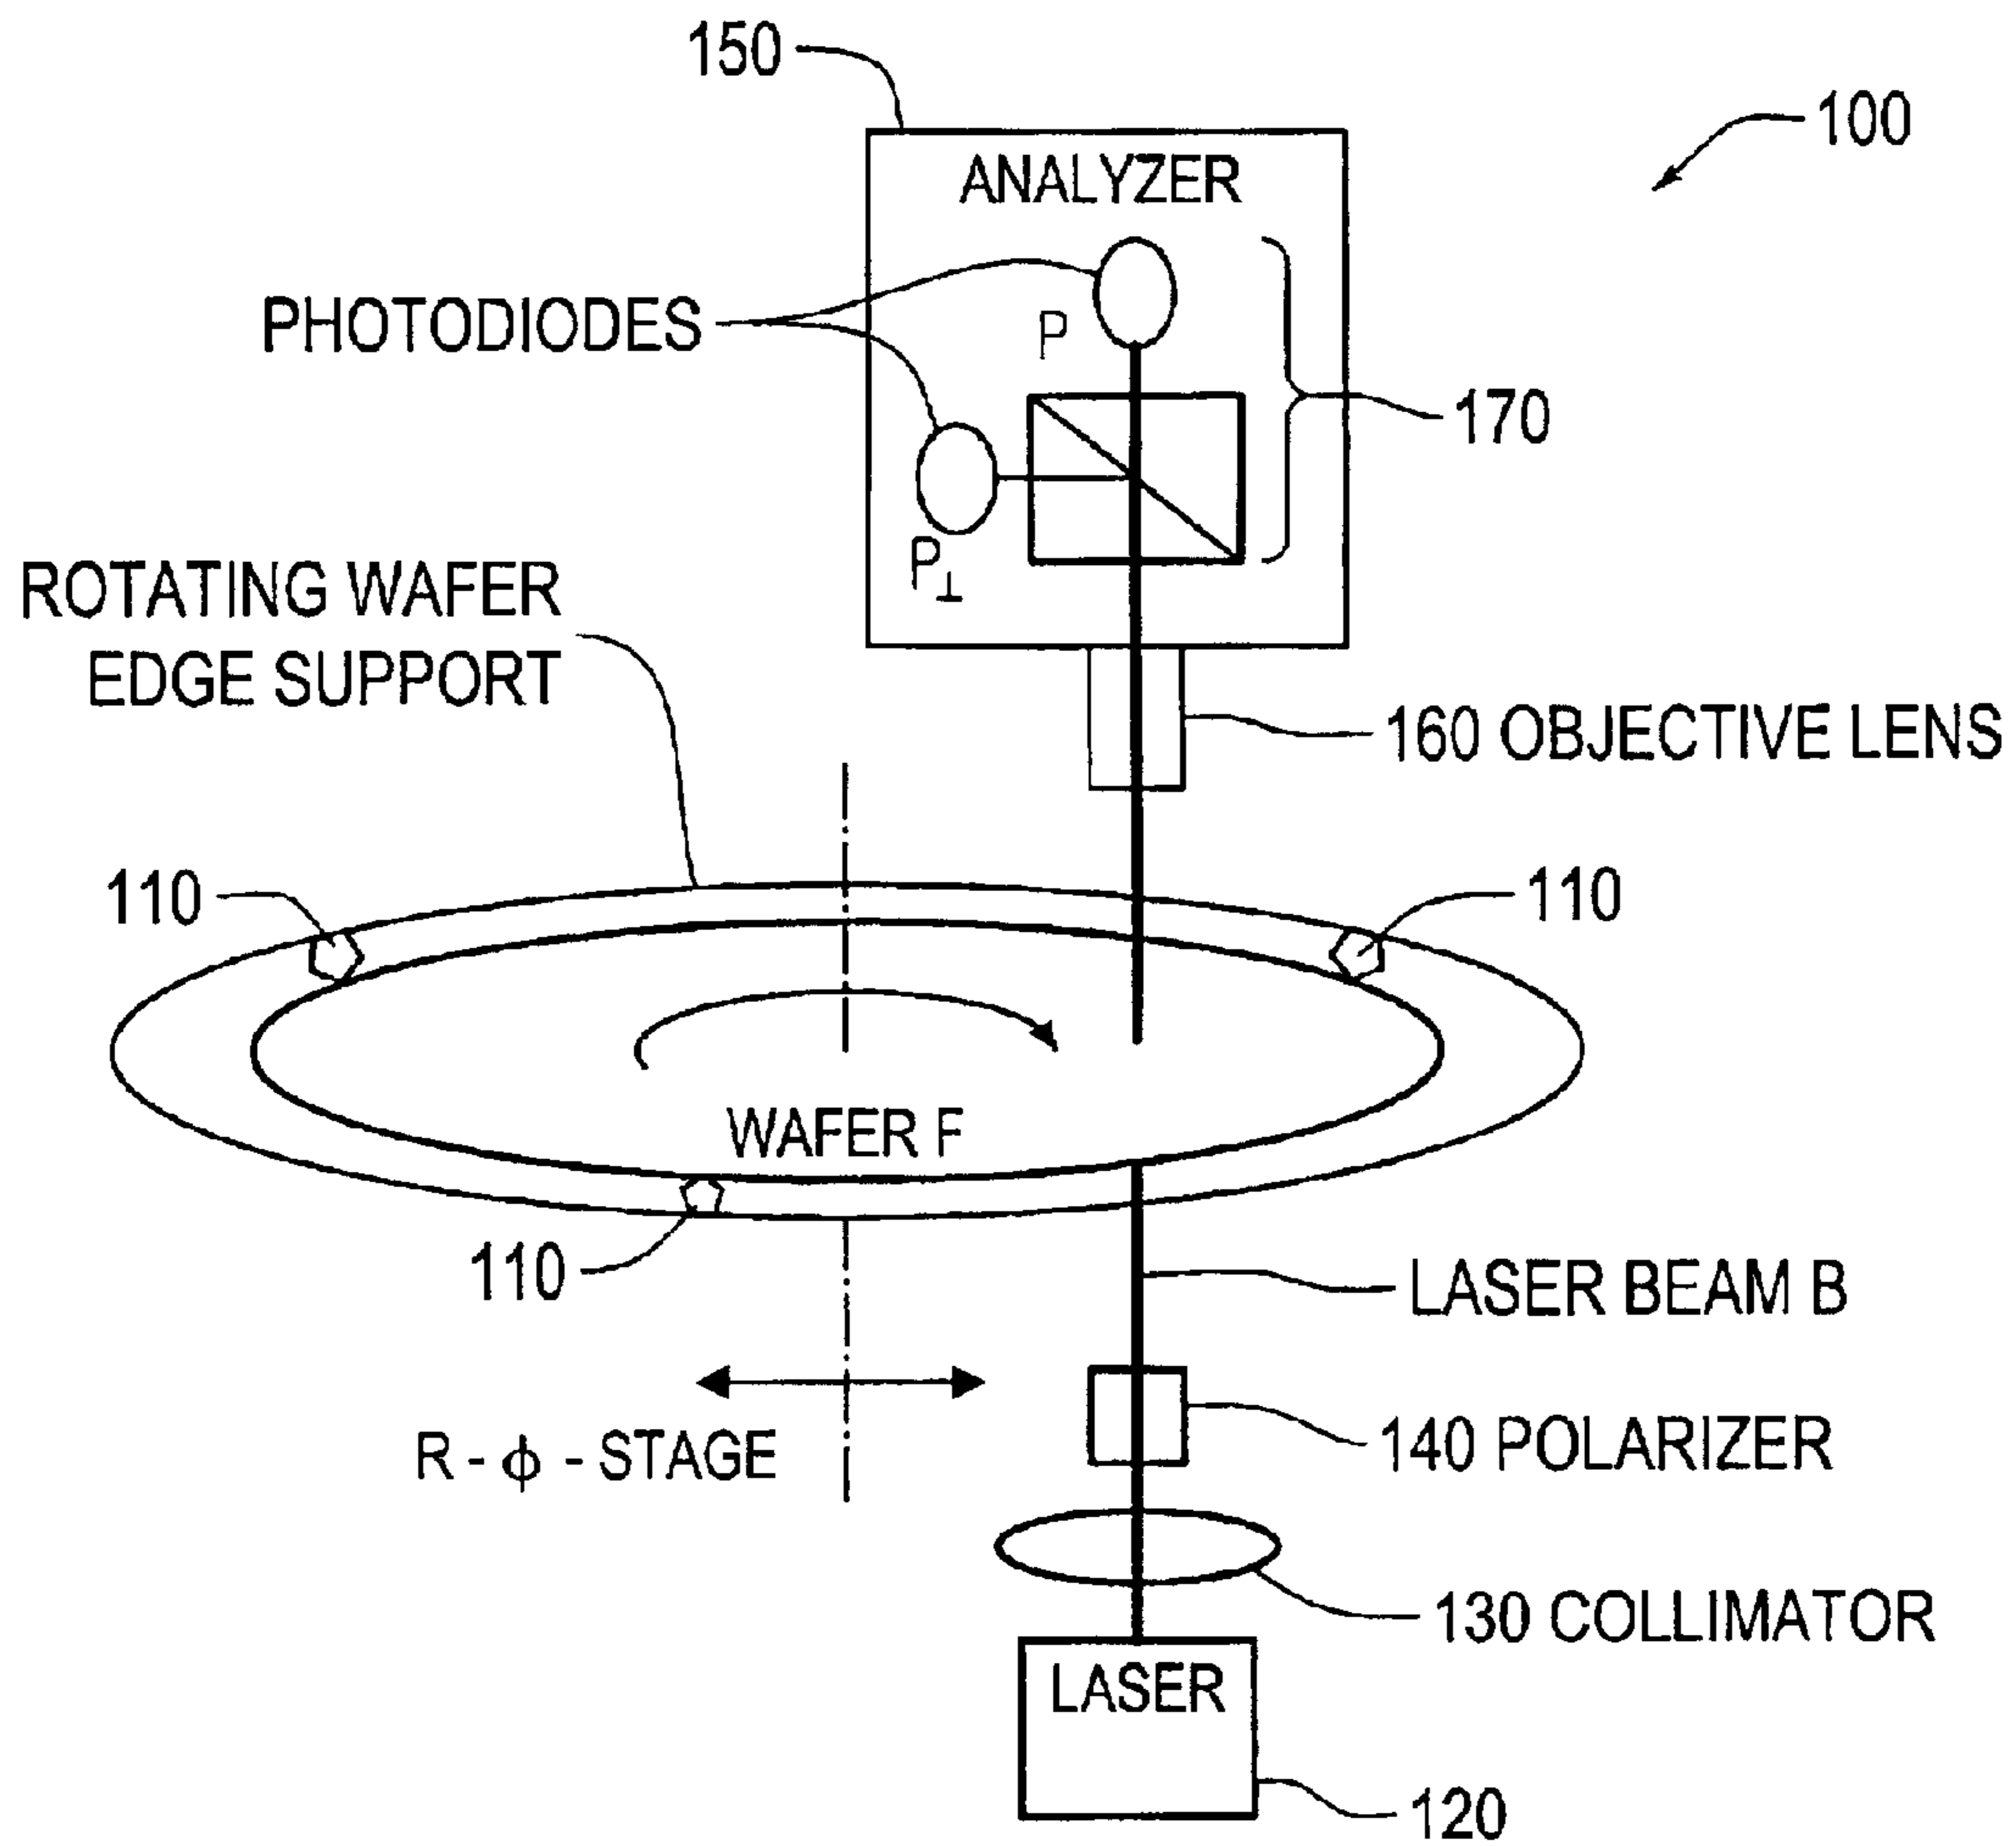
FIG. 1 shows an exemplary Scanning Infrared Depolarization tool used to perform a crystal defect characterization and isolation according to the invention;

FIG. 1 shows an exemplary Scanning Infrared Depolarization (SIRD) imager process and measurement principle used to perform aspects of the inventive methods of defect characterization. A suitable SIRD depolarization imager **100** is available from Tepla AG of Kahla, Germany or Tepla, Inc. of Carrollton, Tex. This imager is a non-contact, nondestructive analytical tool that can be used to characterize mechanical stress fields in semiconductor wafers by scanning infrared depolarization measurement. Stress fields present in the semiconductor material cause birefringence due to the photoelastic effect of the semiconductor material. The SIRD visualizes this stress by measuring and recording the depolarization of incident polarized infrared laser light transmitted through the wafer.

In particular, SIRD tool **100** includes a rotating wafer edge support **110**, typically supporting three spaced edges of a semiconductor wafer **F**, driven by a suitable driving stage about an axis ($R-\phi$). A laser source **120** emits a laser beam **B** through a collimator **130** and polarizer **140** through wafer **F**, to an analyzer section **150**, which includes an objective lens **160** leading to a detector unit **170**, which includes a polarizing beam splitter and two detectors, such as photodiodes, and an unshown processor, such as a computer, PC, or RISC processor.

In use, a wafer **F** for inspection is placed on the driving stage and placed into rotation about axis $R-\phi$. The fixed laser beam **B** is scanned from the edge to the center of the wafer to complete an entire scan of the wafer area. This generates a SIRD map that can then be analyzed to characterize crystal defects through non-destructive evaluation.

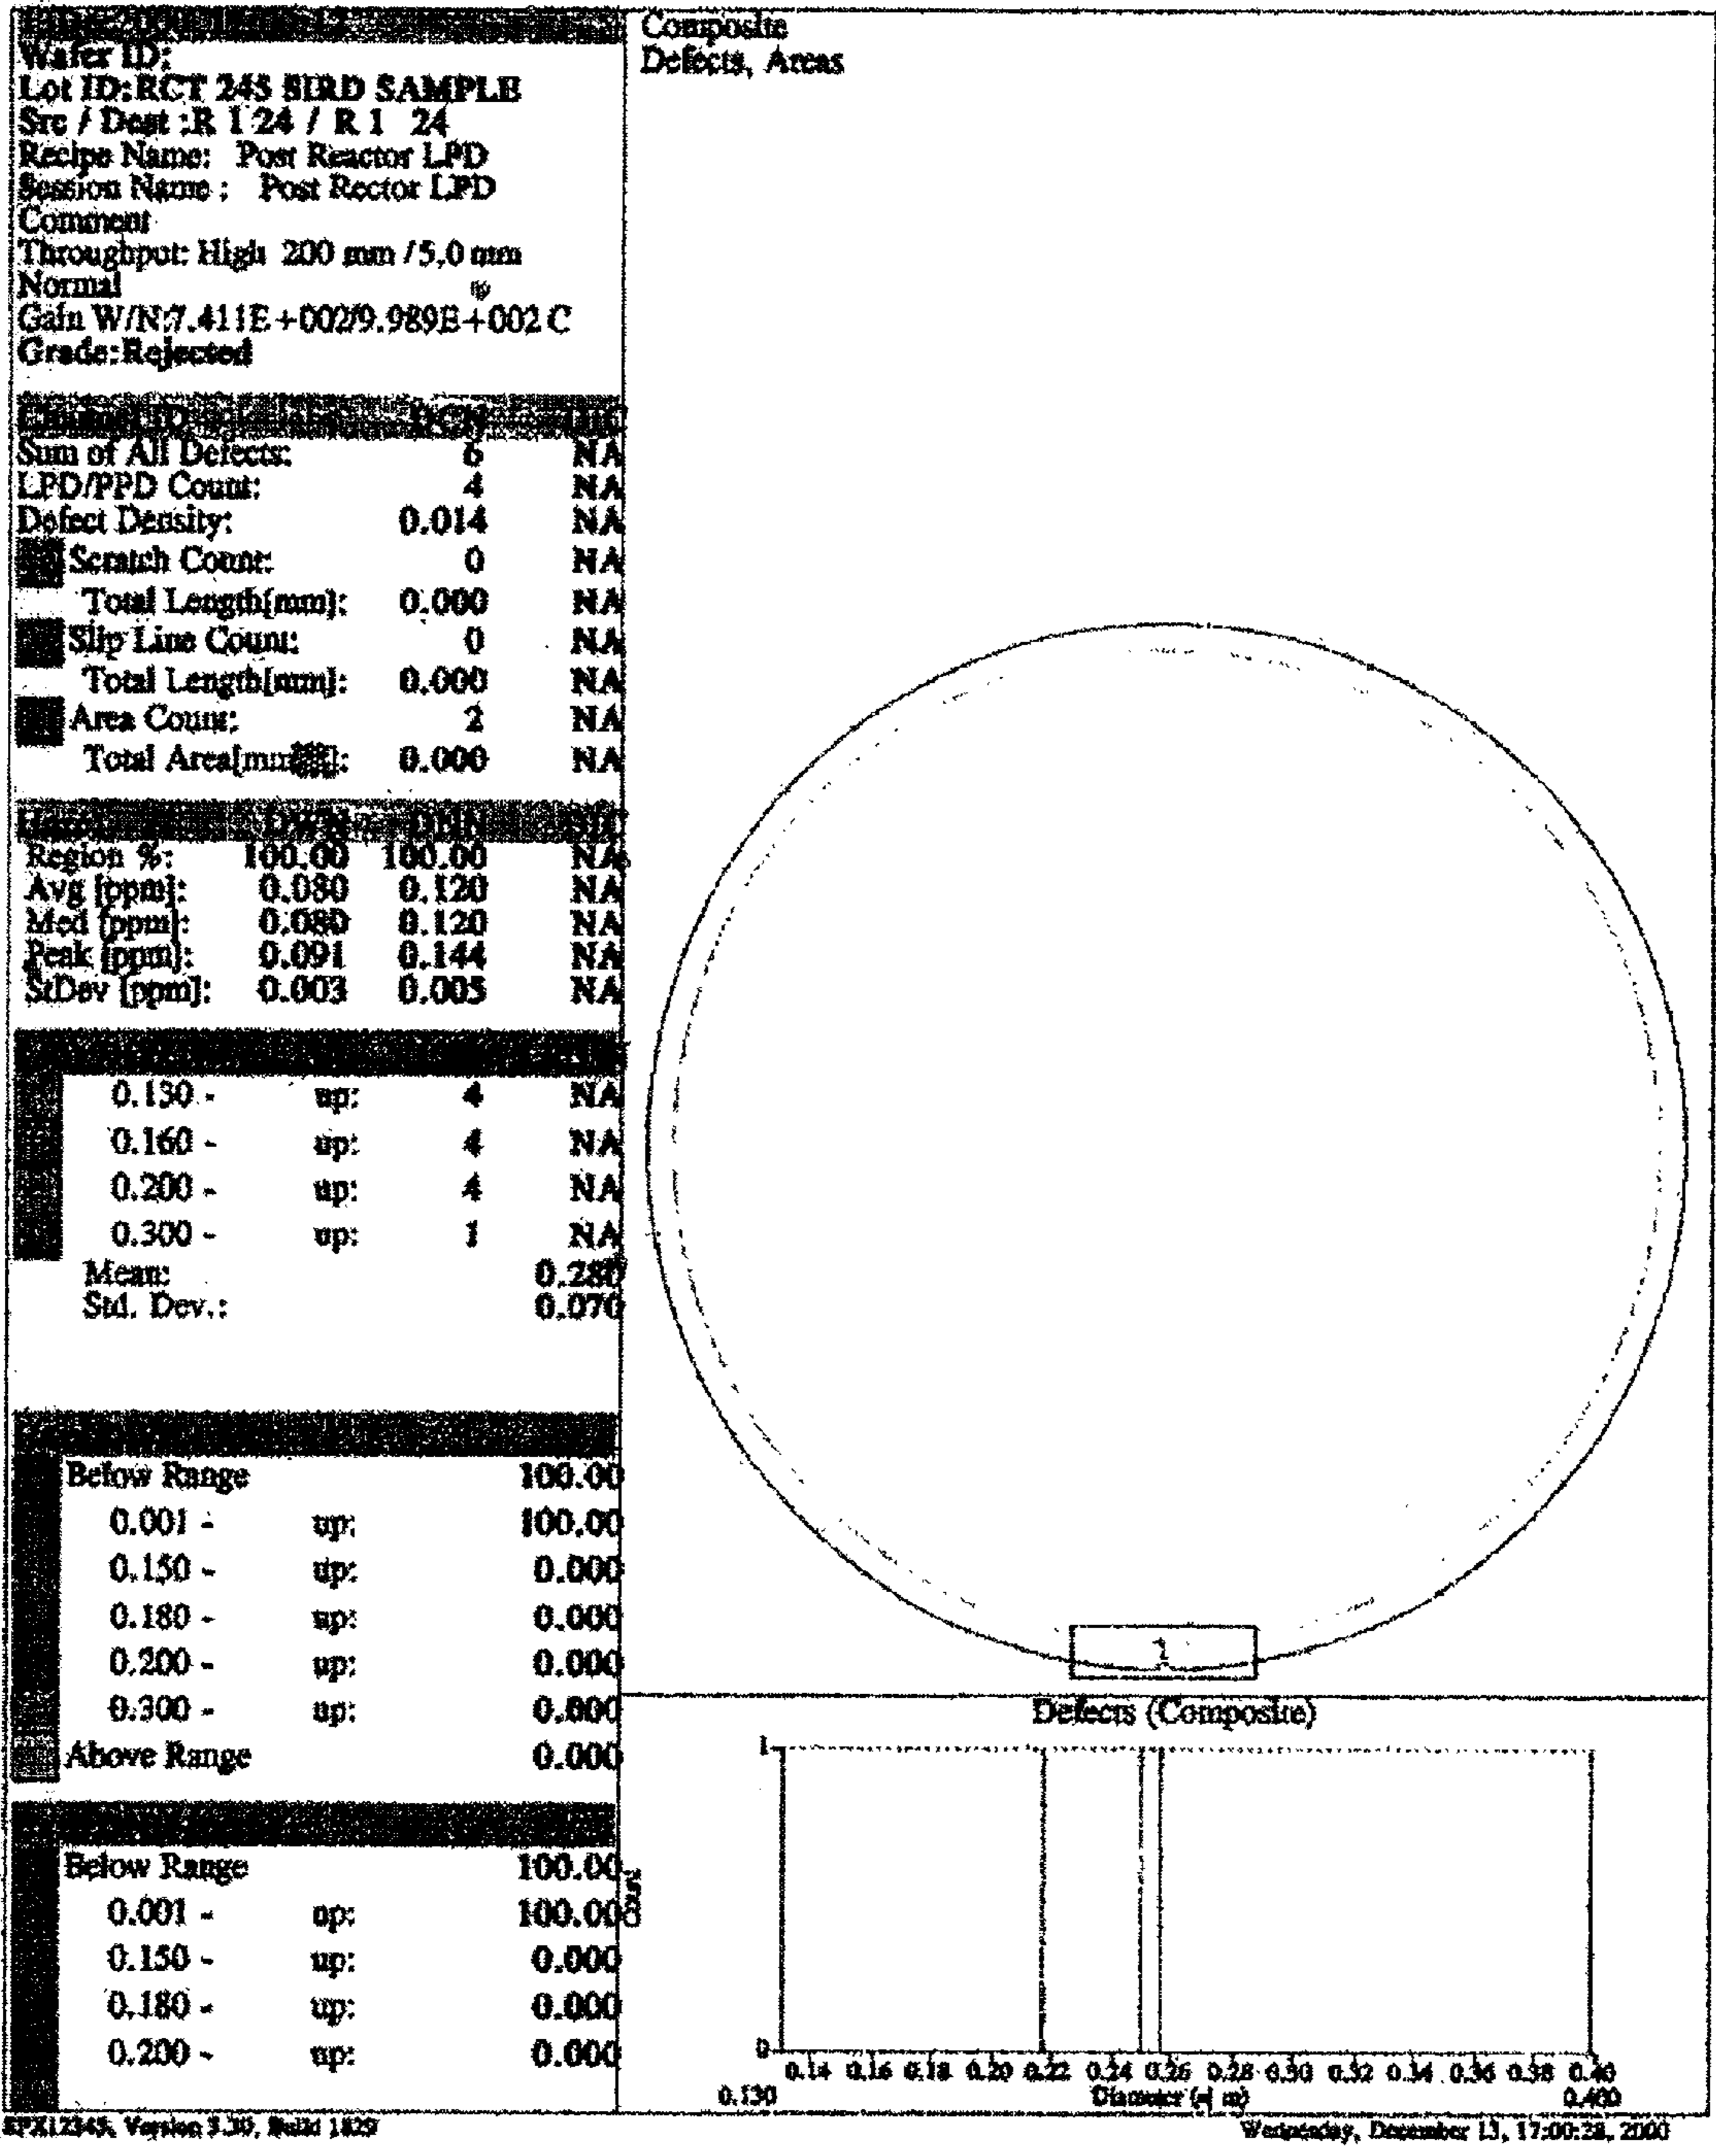
FIG. 2 is a surface scan display showing the front side of a SIRD scanned wafer after Epi deposition (post SP-1);

The post reactor SP-1 measurement found the following information: 4 localized light scattering defects of $\geq 0.13 \mu\text{m}$, 0 scratches, 0 slip, and 2 area counts (0.000 mm^2). See FIG. 2, which is an output from a KLA-Tencor surface scan tool SP-1. The microscope slip inspection found no front side slip. The back side H light inspection found the typical susceptor ring visible and several particles (count <5). See FIG. 3, which also is an output from a KLA-Tencor surface scan tool SP-1. Also see FIG. 4 showing possible defects. Several high spots of heights of about 20–50 μm were identified on the susceptor that correspond to defect locations on the wafer uncovered during the subsequent SIRD. A small pinhole of about 0.5 mm diameter was located approximately 2 mm away from the high spot corresponding to defect 3. See FIGS. 6C–D.

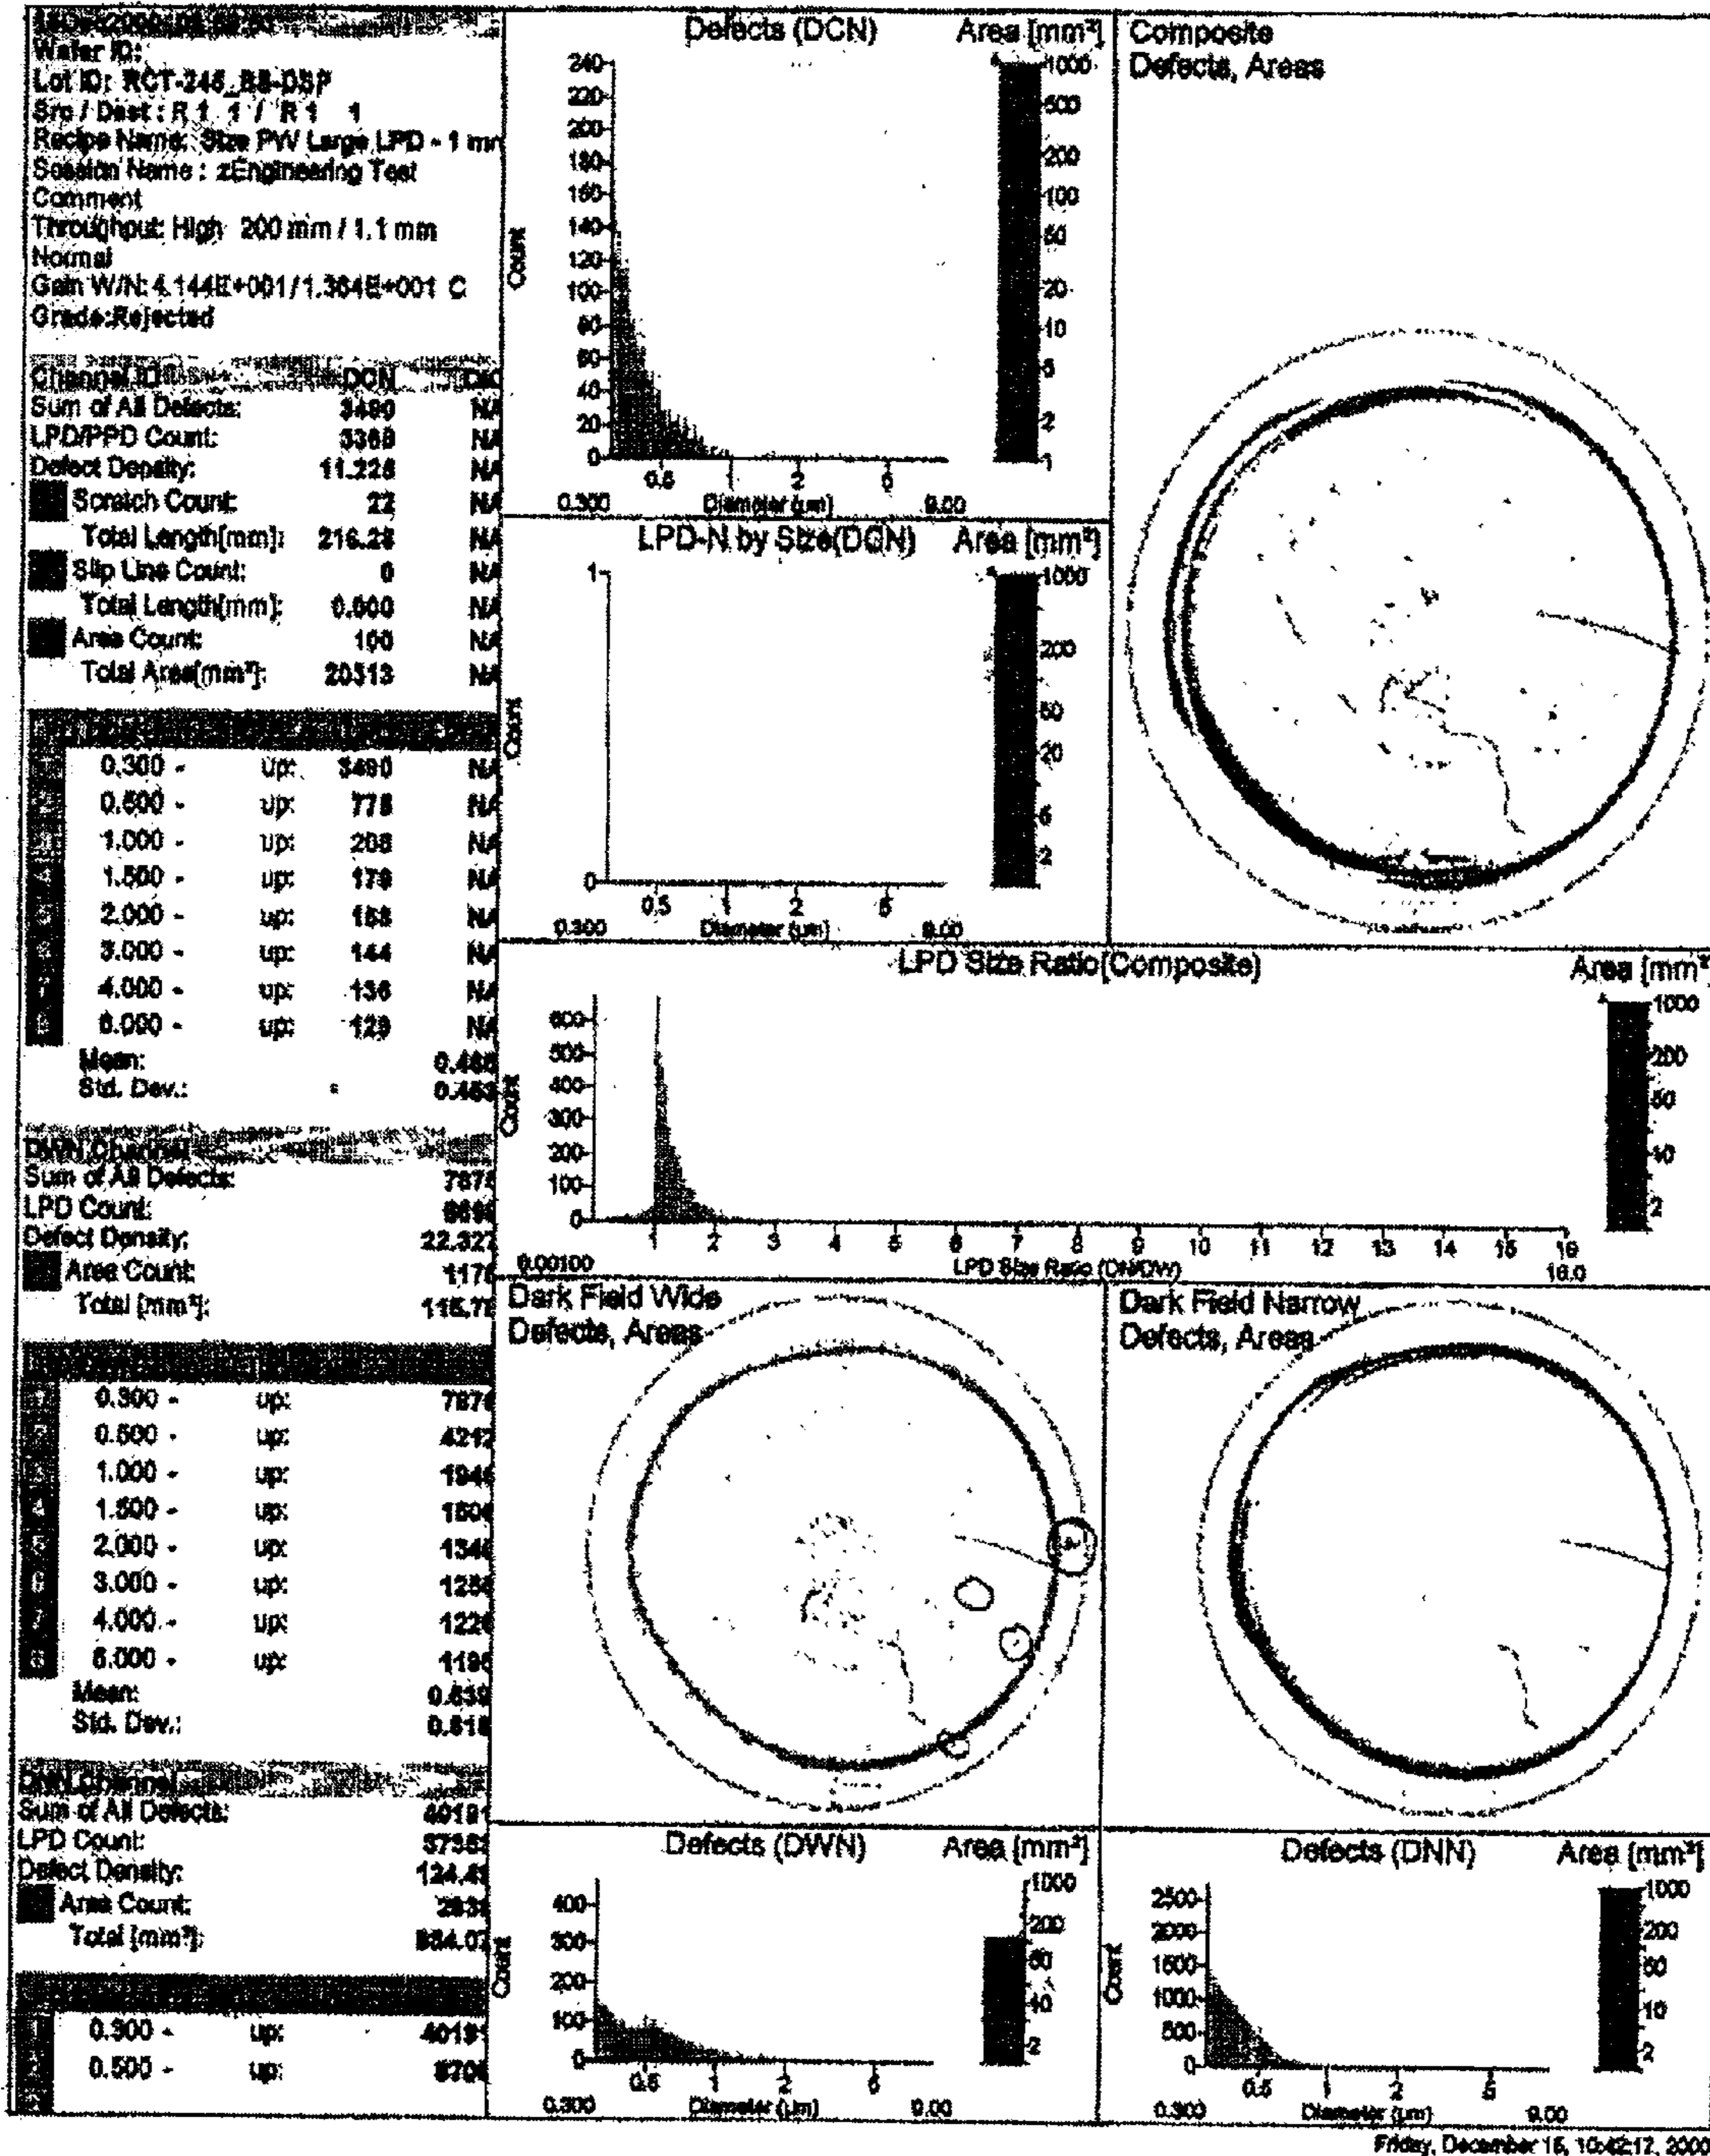
FIG. 3 shows a surface scan display showing the back side of the wafer of FIG. 2;

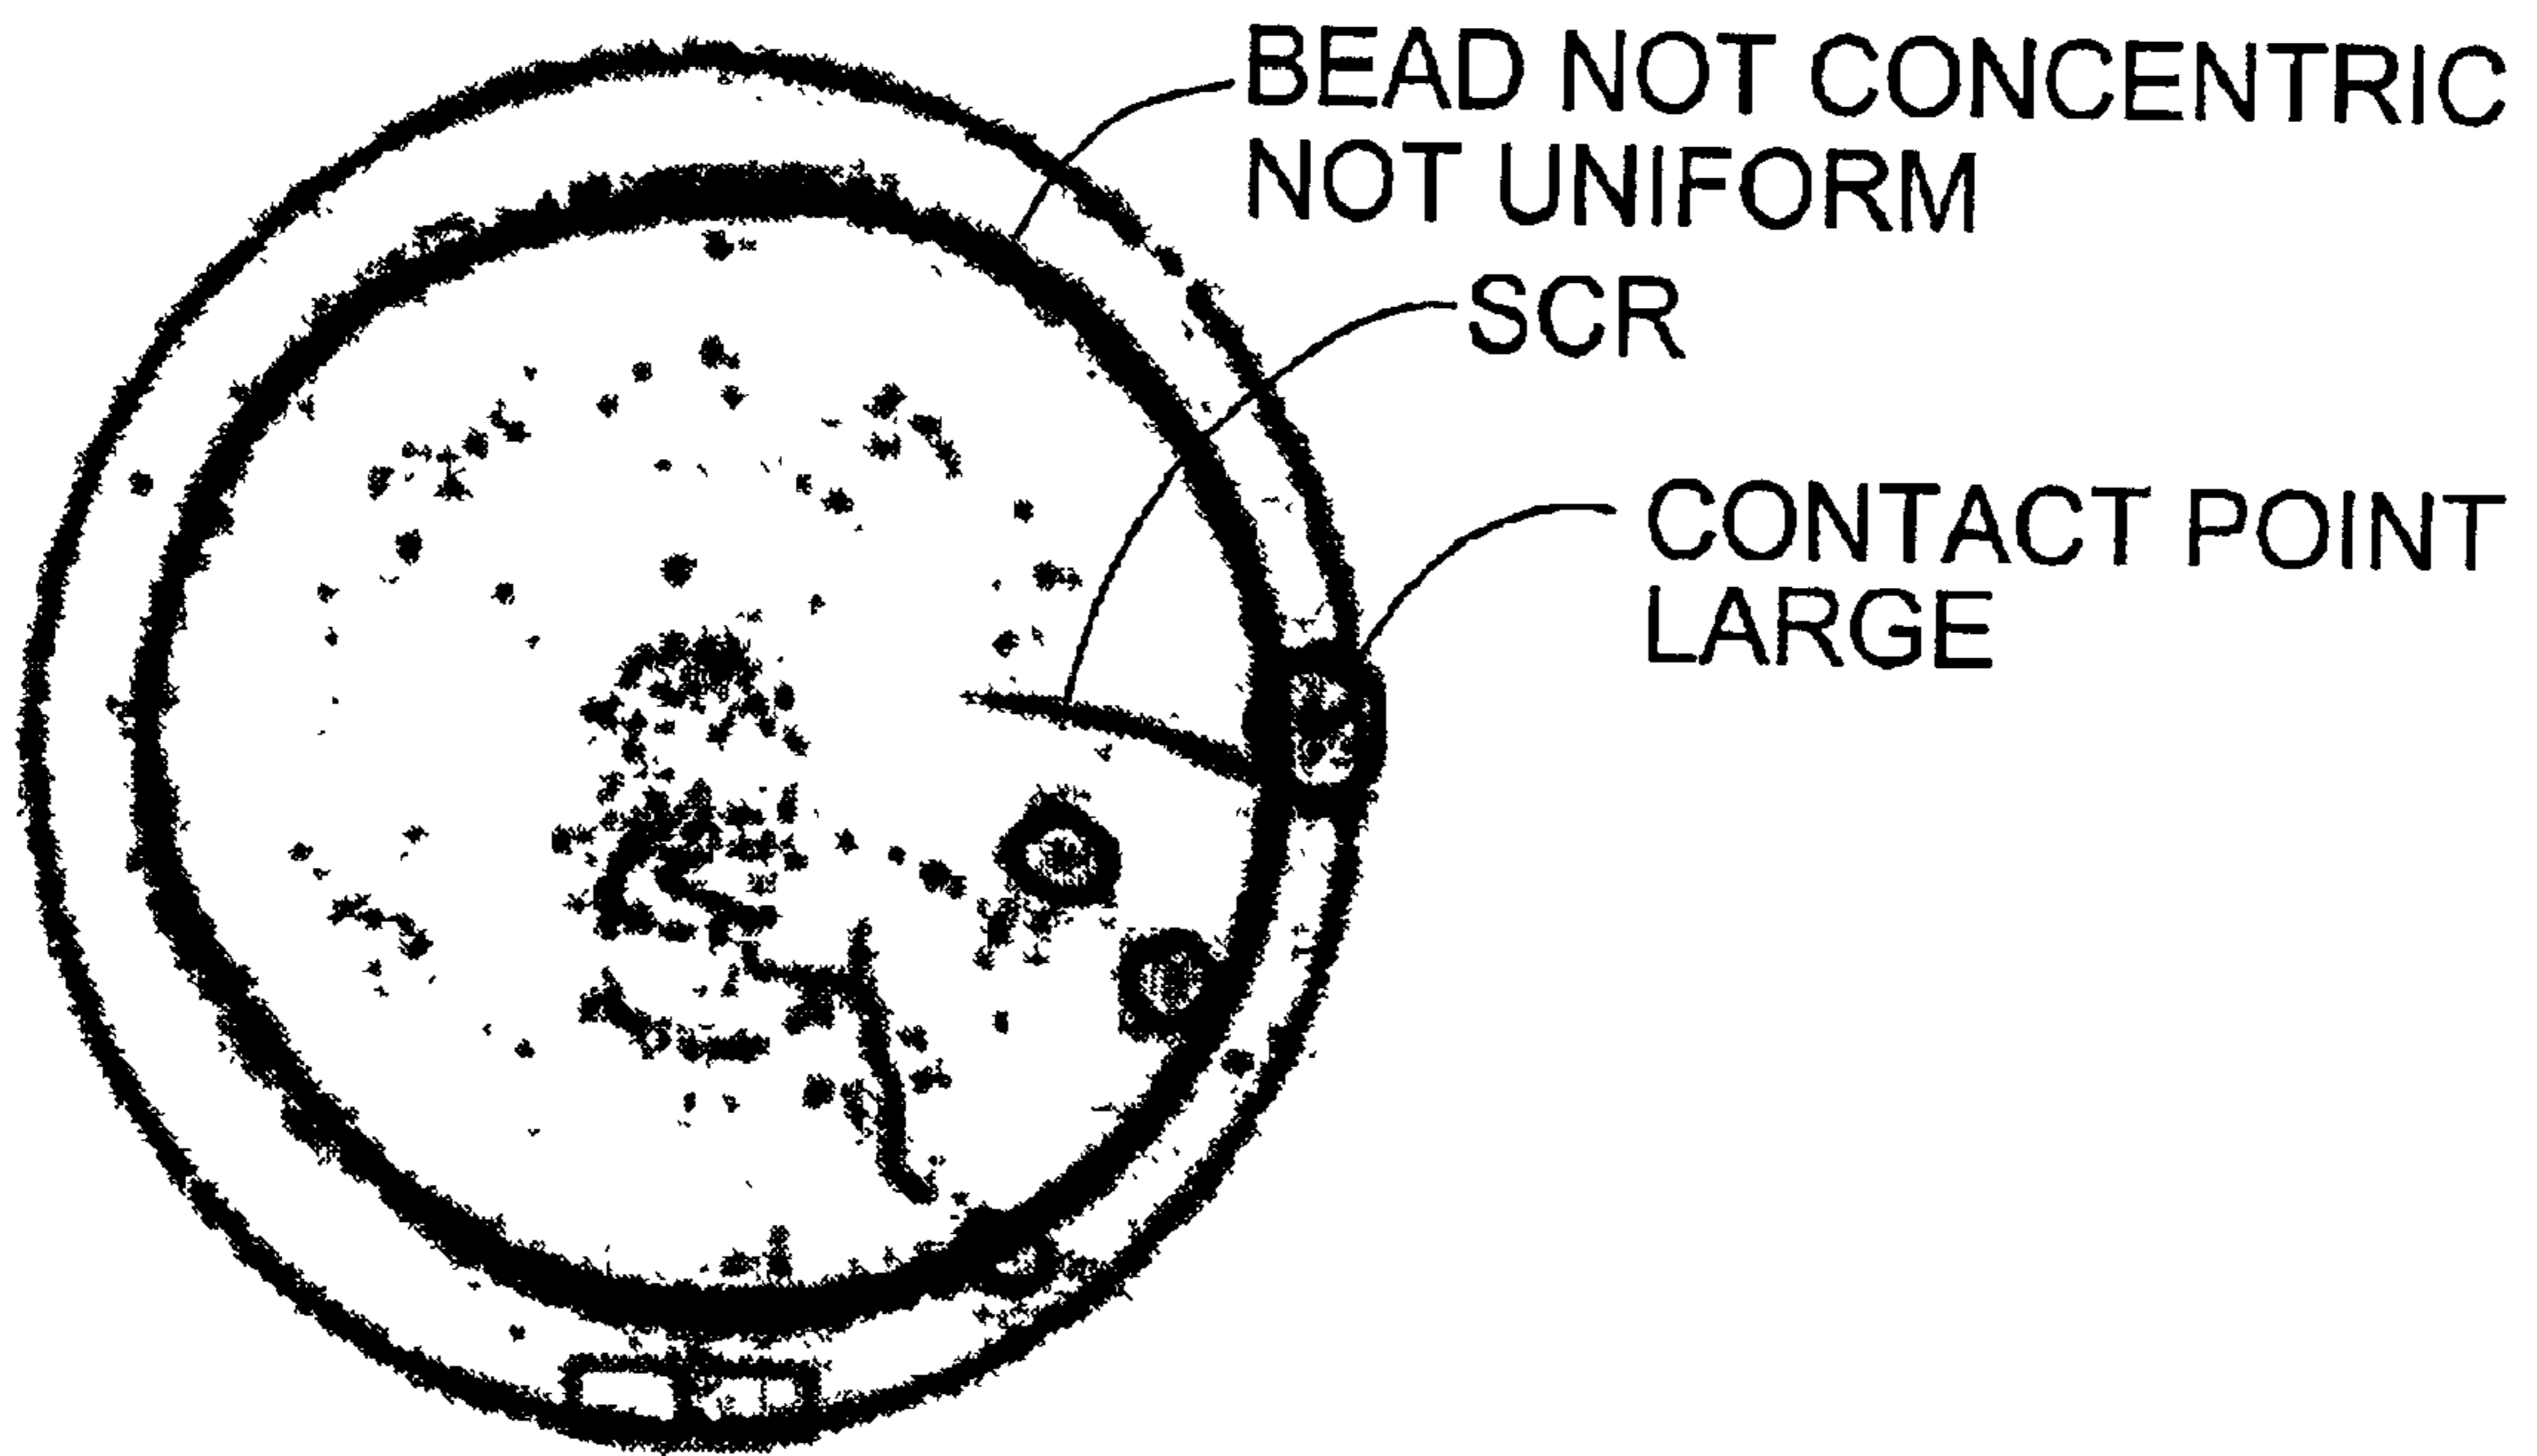
FIG. 4 shows an enlarged view of the composite area defects with circled areas indicating defects that look like LPD;

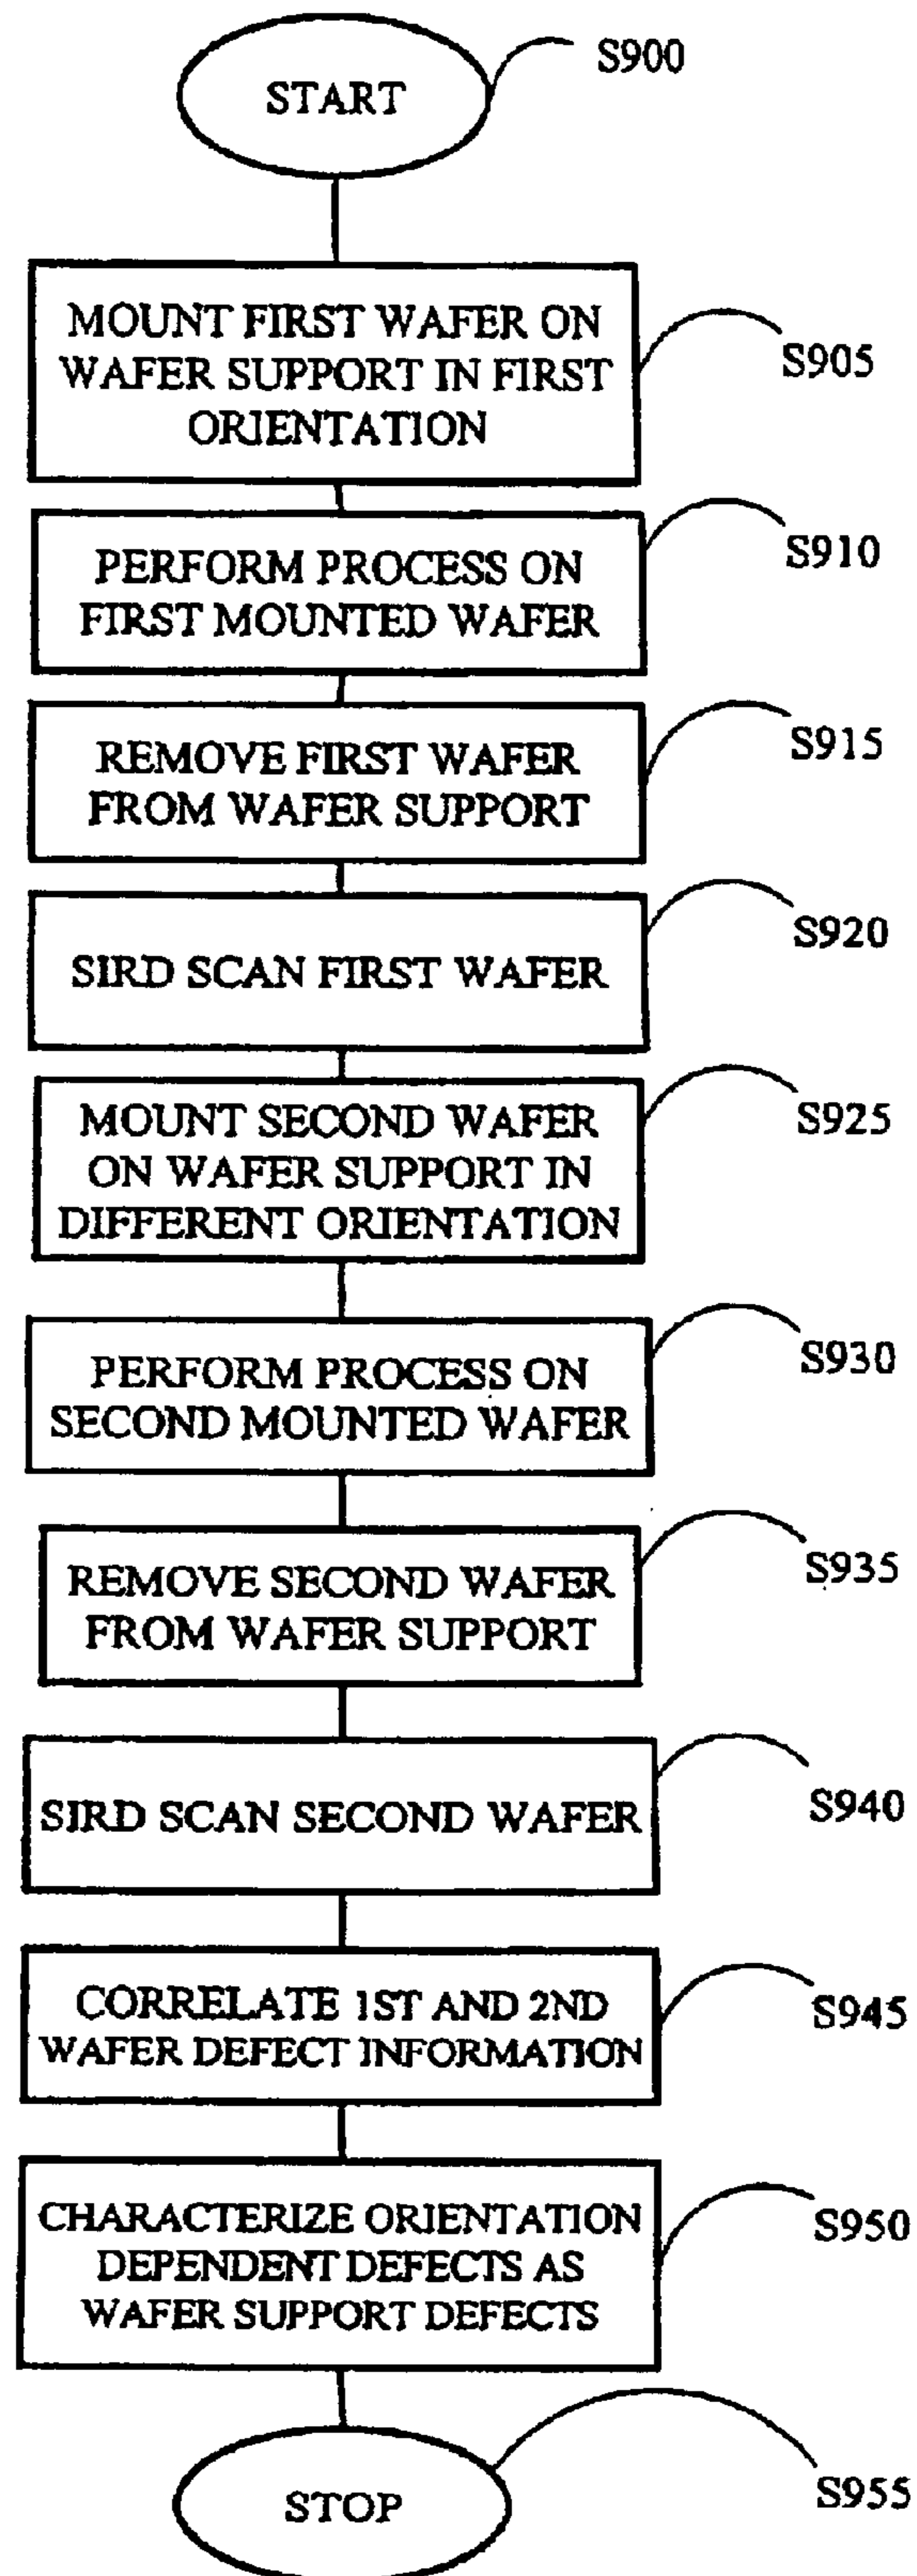
FIG. 10 shows a flow chart for SIRD measurement and isolation of wafer support-related defects according to an exemplary embodiment of the invention; and

One exemplary process of isolating wafer support-related defects will be described with reference to FIG. 10. The process starts at step S900 and proceeds to step S905 where a first semiconductor wafer is mounted on a wafer support, preferably a susceptor, in a first orientation relative to the wafer support. Then, at step S910 a first wafer process is performed on the mounted wafer. For example, an epitaxial growth layer may be formed. Then, after the process is completed, the first wafer in step S915 is removed from the wafer support. At step S920, the first wafer is scanned by a SIRD tool to obtain first wafer defect information.

At step S925, a second wafer is mounted on the same wafer support, preferably a susceptor, in a second, different orientation from that used for the first wafer. Then, at step S930, a first wafer process is performed on the mounted wafer. Preferably, the process is the same as that performed on the first wafer. Again, this may be epitaxial growth. Then, after the wafer process is completed, the second wafer in step S935 is removed from the wafer support. As step S940 the second wafer is scanned by the SIRD tool to obtain second wafer defect information.

At step S945, the first and second wafer defect information is correlated to characterize and isolate semiconductor wafer defects. This can be by first orienting the data according to the wafer notch/flat (i.e., so that defect locations are commonly measured relative to the wafer notch/flat). Then, it can also be by orienting the data according to mounting positions (i.e., so that defect locations are commonly measured relative to the orientation of the wafer support). Then, at step S950, this correlated data is used to characterize wafer defects as either being wafer support related or not. Defects commonly oriented relative to the wafer notch for same-side defects are characterized as being attributable to pre-processing defects occurring prior to the process performed on the wafer support. Similarly, when the orientation difference is one wafer being mounted lasermark side up and the other lasermark side down, if the wafer defects are mirror-image of each other, this also signifies a pre-existing defect not induced by the wafer support. However, all defects whose location varied relative to the wafer notch, but were in the same location relative to the mounting position on the susceptor, are characterized as wafer support-related defects. Regardless of the type or cause of defect, the defect depth can be determined by looking at ΔD_{max} , which varies with measured stress. The process stops at step S955.

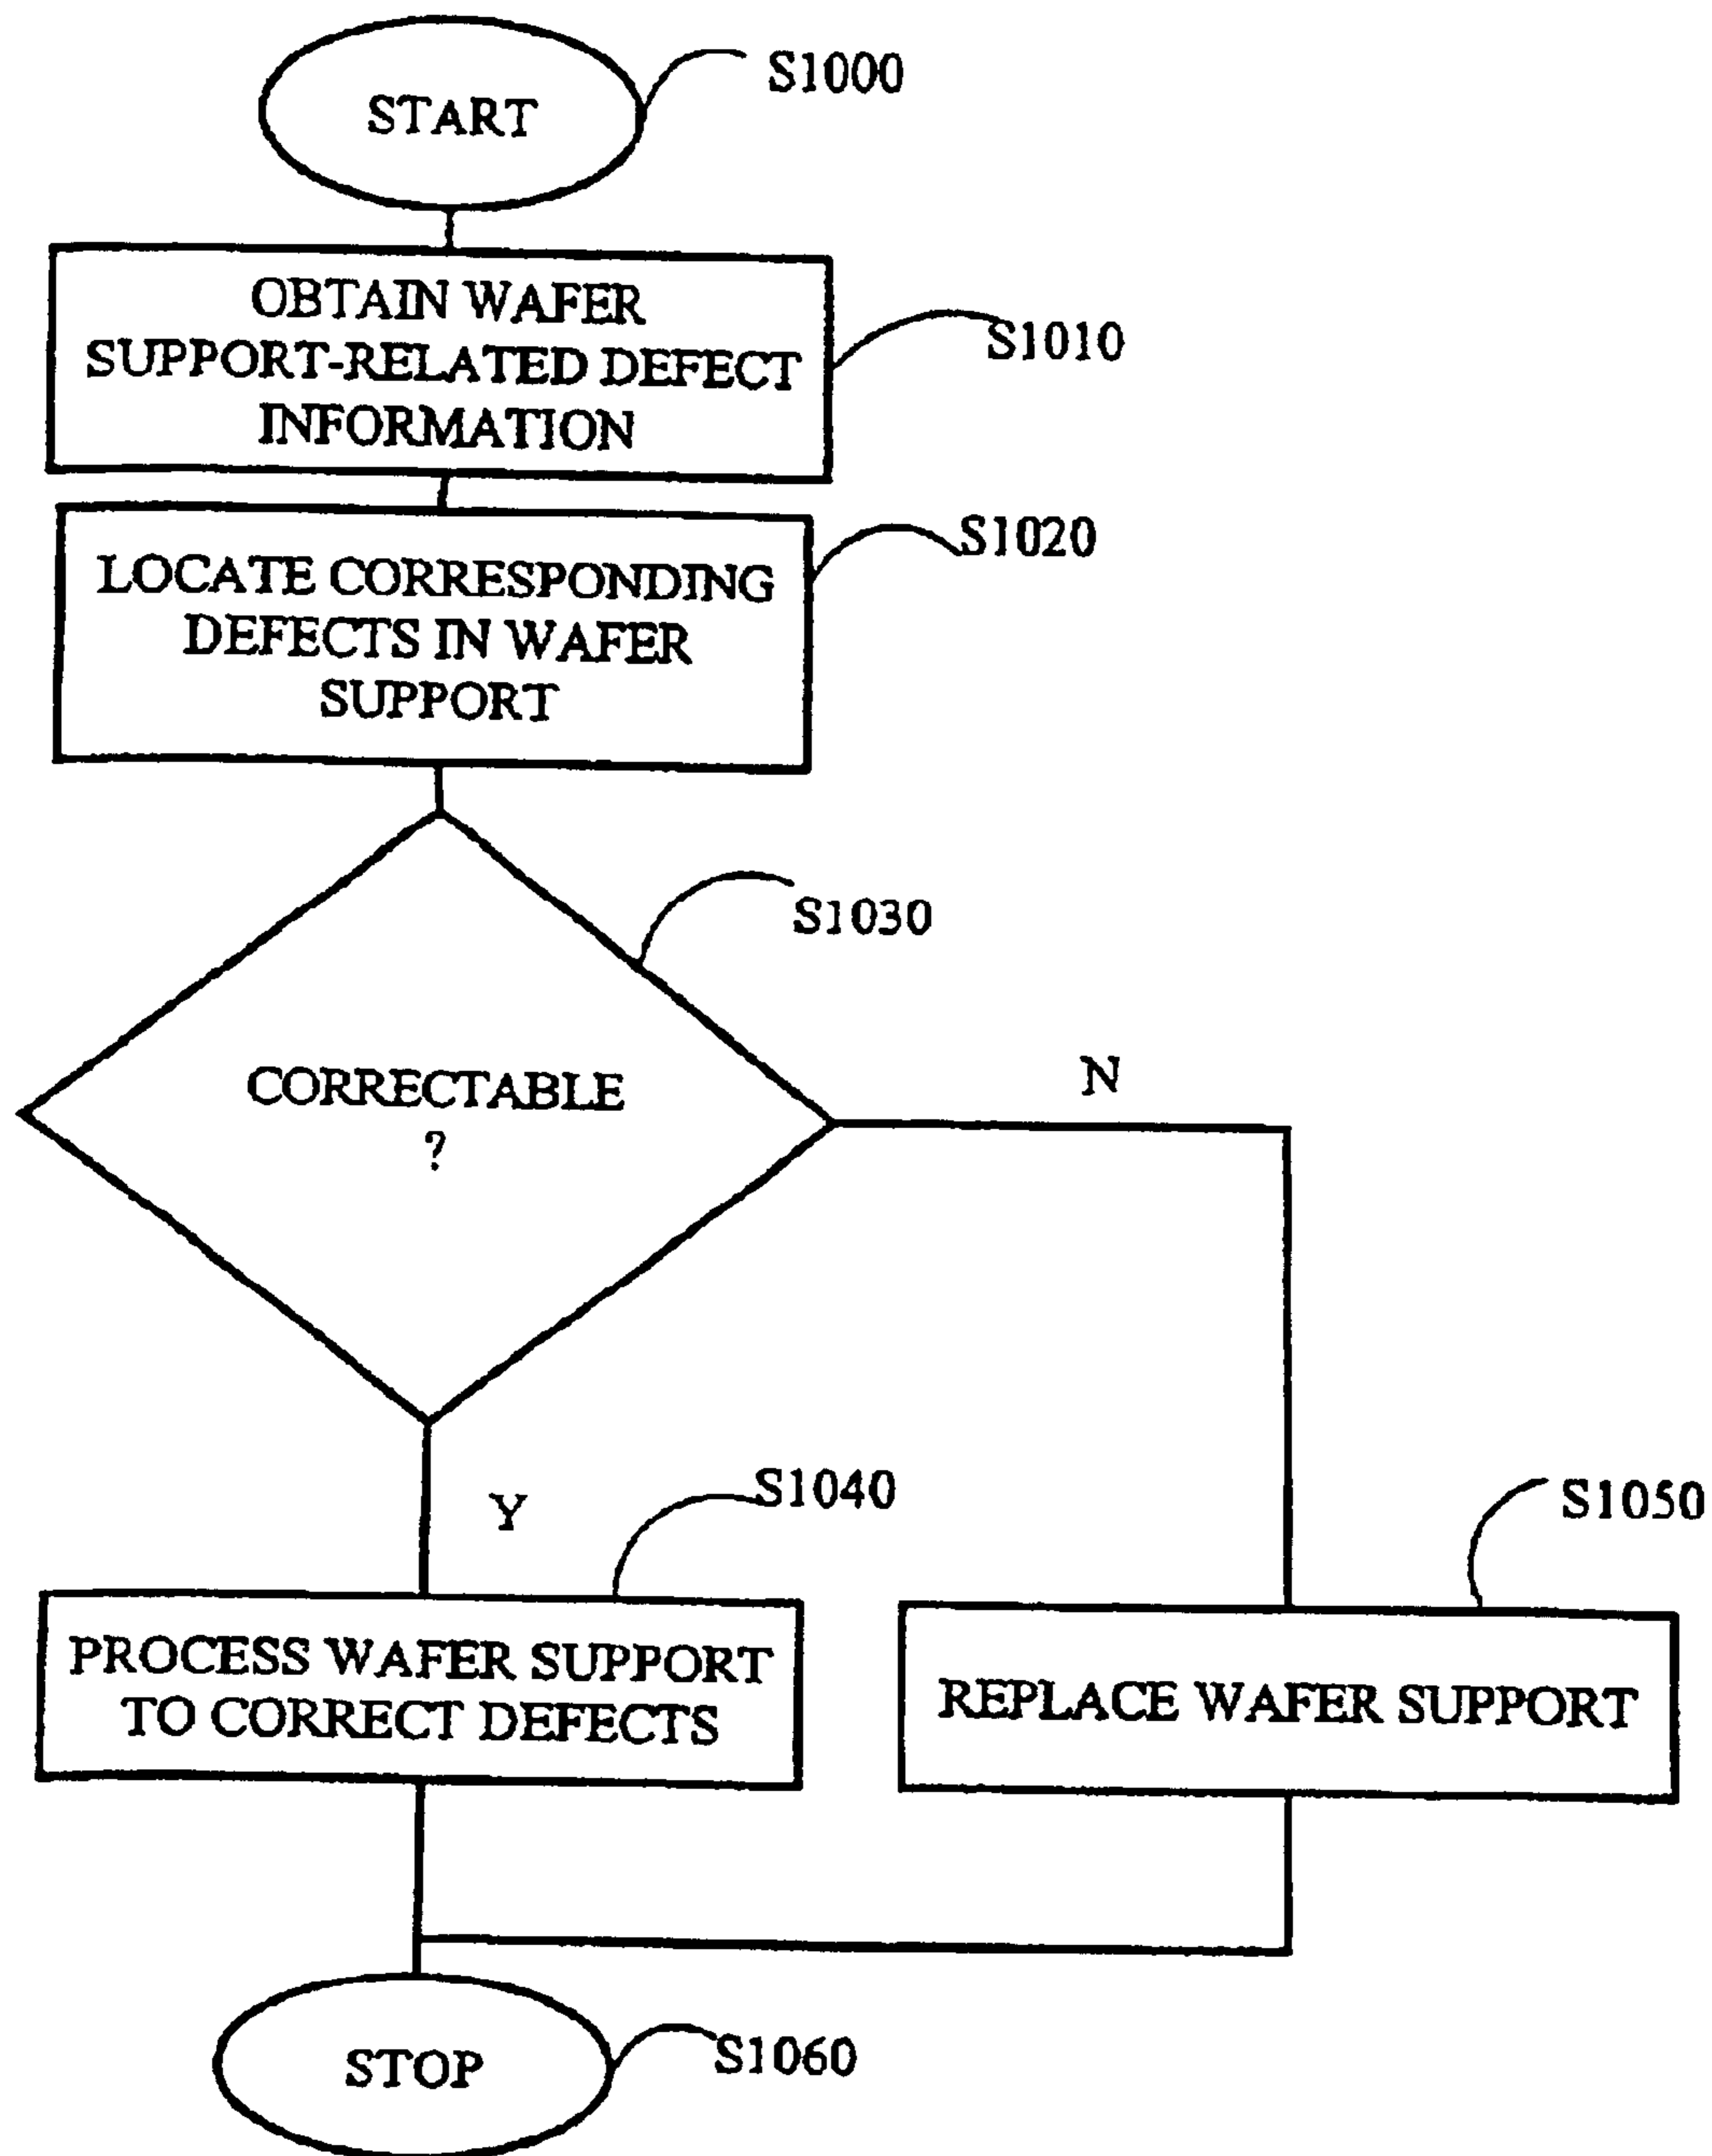
FIG. 11 shows a flow chart for wafer support correction using the information obtained from the process of FIG. 10.

FIG. 11 shows a flow chart outlining a basic process for correction of isolated and characterized wafer support-related defects. The process starts at step S1000. At step S1010 wafer support-related defect information is obtained. This may be achieved by the process of FIG. 10. Then, at step S1020 locations on the wafer support corresponding to the wafer support-related defects are obtained. At step

S1030, it is determined whether the wafer support defects are correctable. This may be obtained by visual inspection, microscopic inspection or other inspection techniques. If the defects are correctable, the process advances to step S1040 where the wafer support is processed to correct the noted defects. If, however, step S1030 determines that the errors are not correctable, flow advances to step S1050 where the wafer support is replaced. The process stops at step S1060.
