(10) **Patent No.:** **US 6,862,944 B2**  
(45) **Date of Patent:** **Mar. 8, 2005**

(54) **NON-DESTRUCTIVE BUTT WELD INSPECTION METHOD**

(73) Assignee: **Edison Welding Institute, Inc.**,  
Columbus, OH (US)

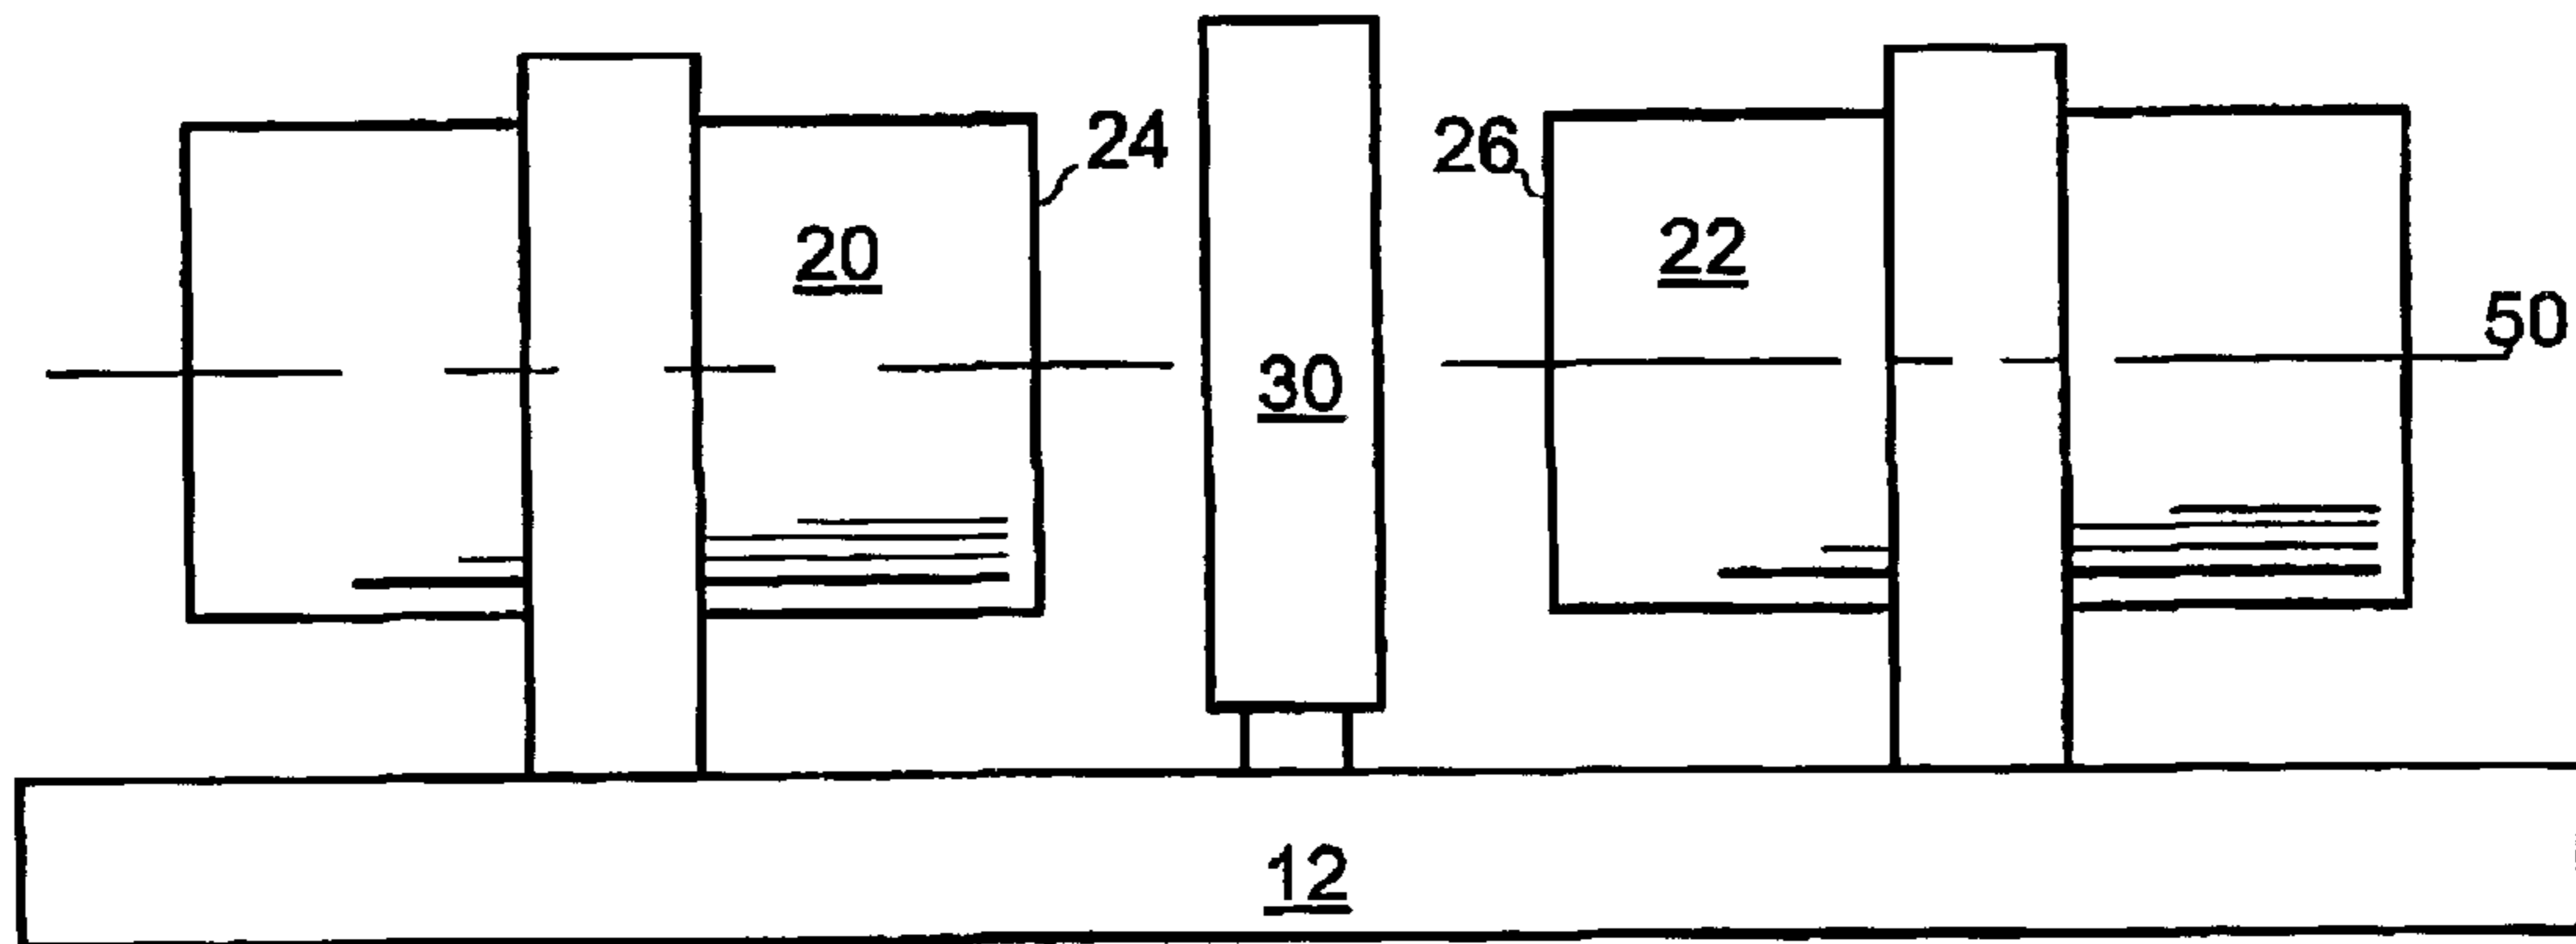
Fig. 1

FIG. 1 is a plan view of two pipe sections placed in a axial aligning clamping device with a hot plate between the ends of the pipe sections.

In forming a typical butt weld as shown initially in FIGS. 1-2, sections 20, 22 of a thermo-plastic material such as poly-ethylene pipe are placed in a clamping device 12 and aligned with each other as noted by the common longitudinal center axis 50. The ends 24, 26 are planed until the ends are smooth and parallel. The ends 24, 26 are then brought in contact with a heated hot plate 30 (FIG. 2) until a uniform bead 32, 34 becomes visible around the perimeter of both ends 24, 26. The ends 24, 26 are retracted from the hot plate 30 which is removed. As seen in FIG. 3, the ends 24, 26 are quickly brought together with pressure to form a weld at the interface of the ends 24, 26 of each section 20, 22, respectively. Some of the molten thermoplastic material oozes from the interface of the ends 24, 26 of the two sections 20, 22 to form a weld bead 42. FIG. 4 is a right end view of FIG. 3 showing the weld bead 42. FIG. 5 is a cross section that illustrates the small weld bead 46 that is formed on the interior surface of the joined pipes 20, 22 as well as the weld zone region 44 in which the molten plastic from each section 20, 22 are thoroughly intermixed and fused to each other.

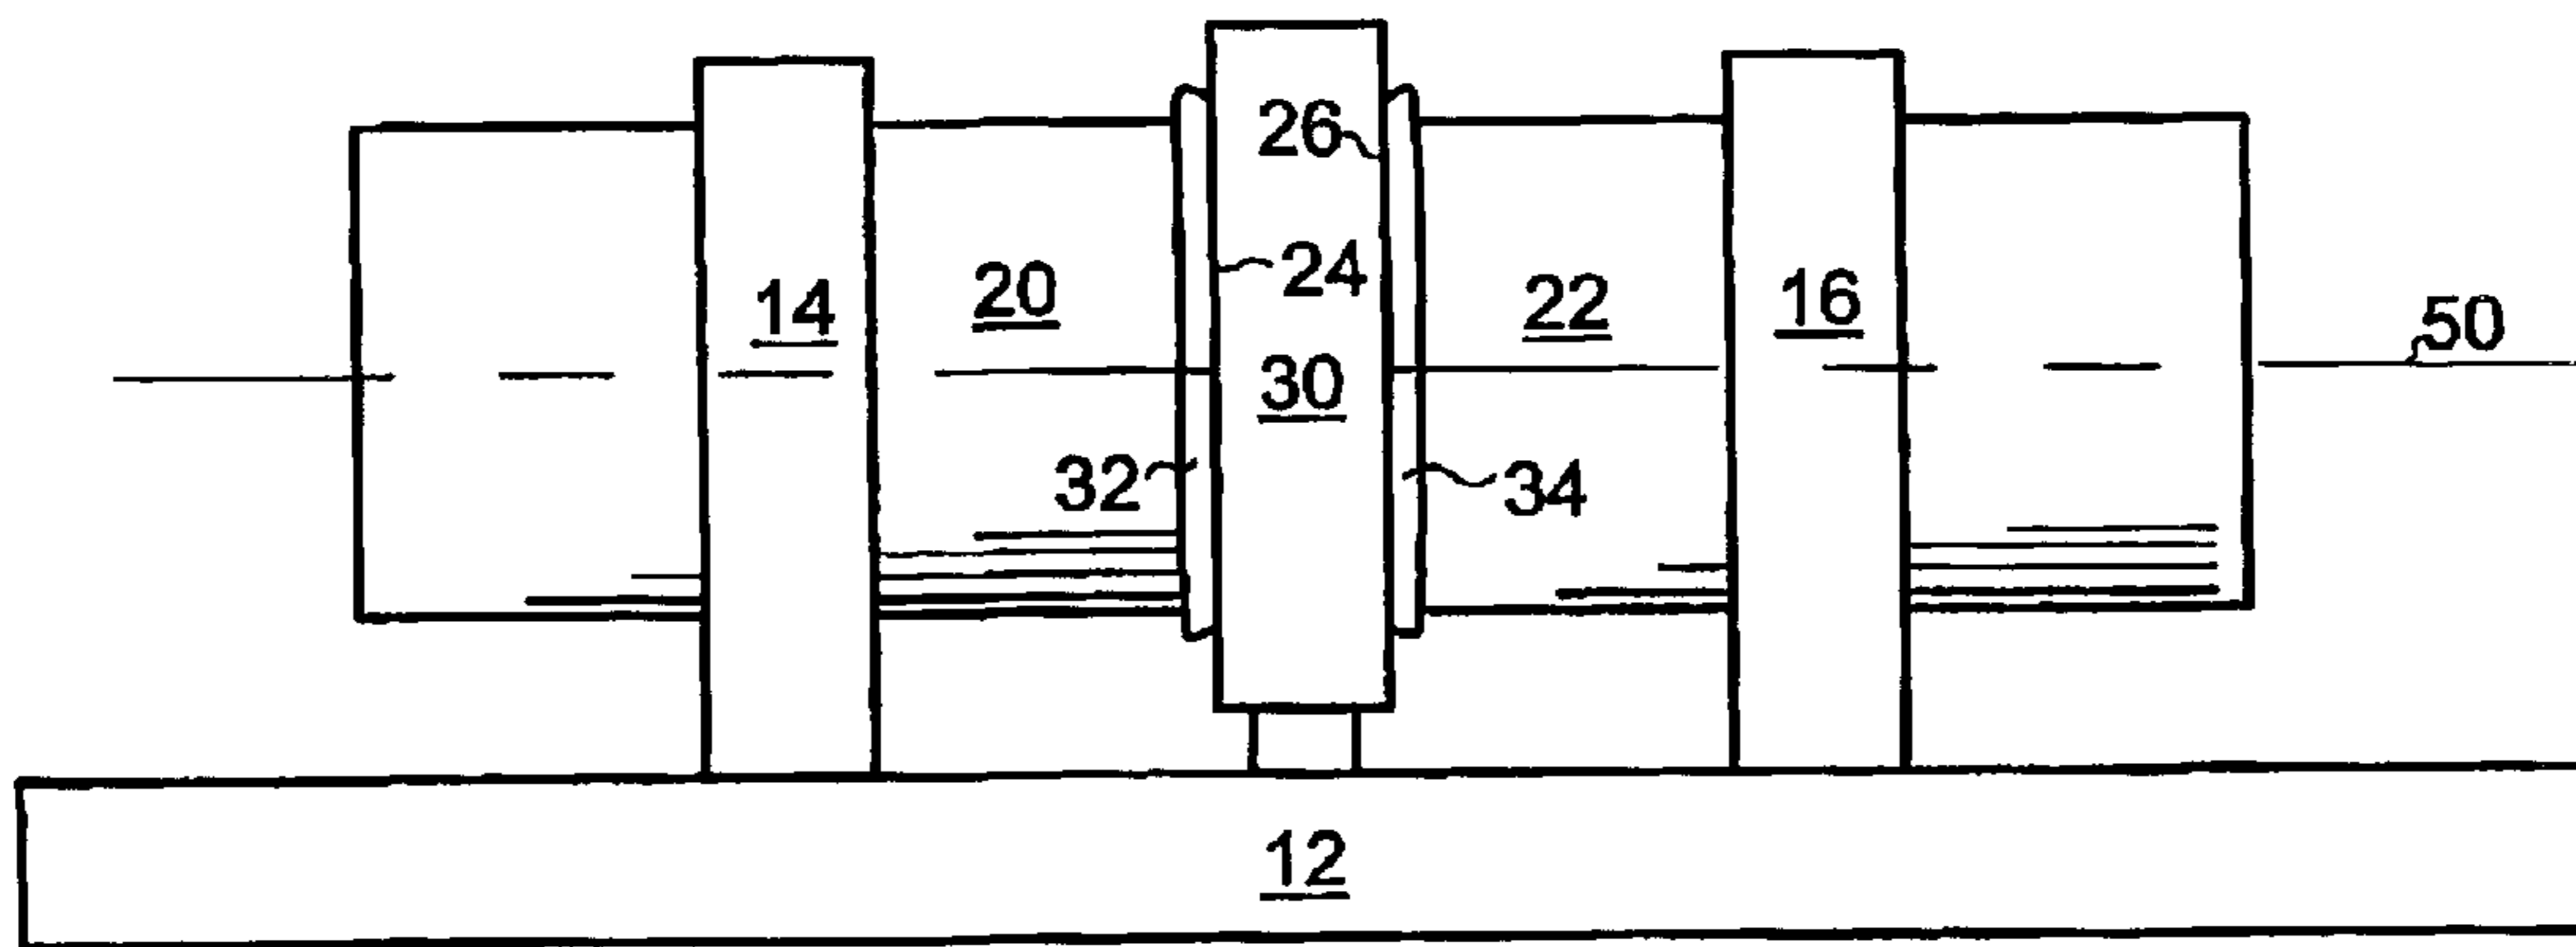
Fig. 2

FIG. 2 is a plan view of the two pipe sections shown in FIG. 1 in which the ends of the pipe sections have been brought in contact with the hot plate and heated sufficiently to melt the end of the pipe sections.

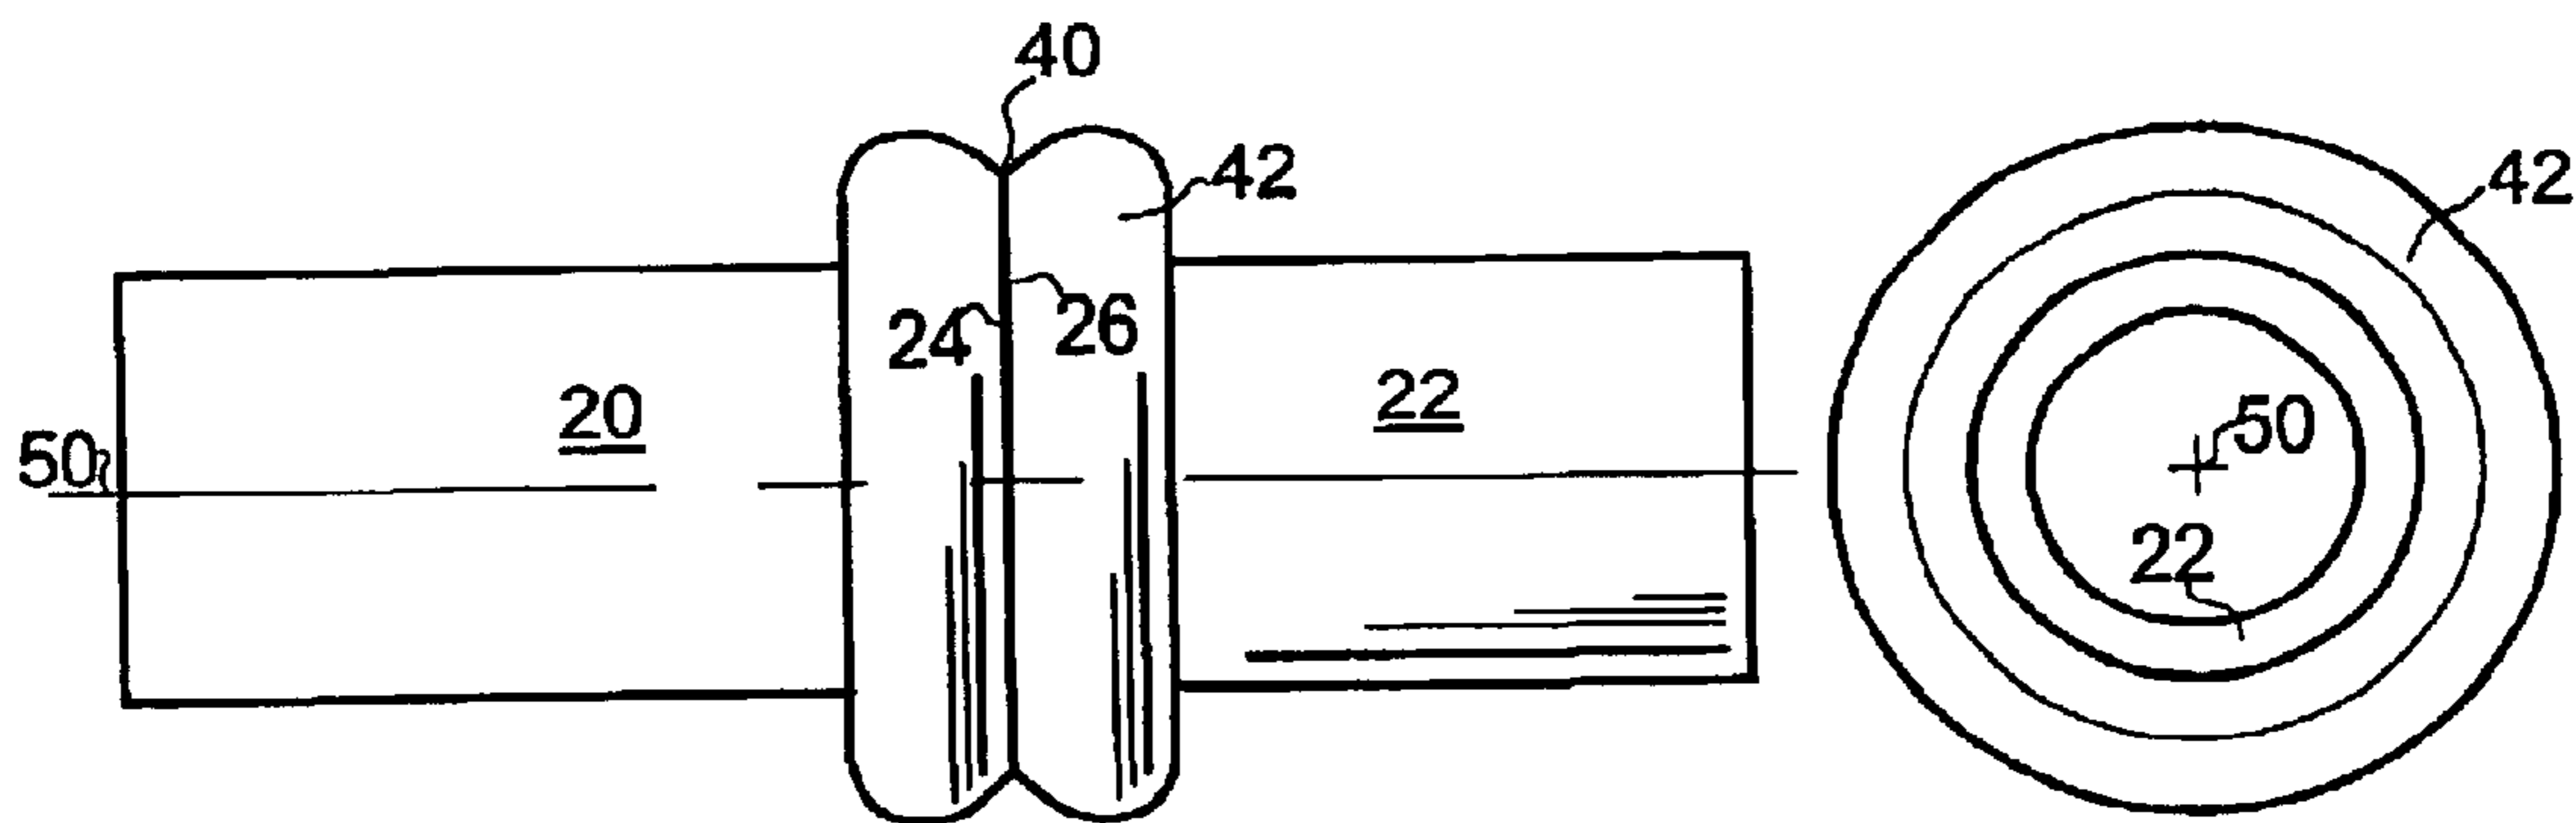
Fig. 3

FIG. 3 is a plan view of the resulting butt weld of the two pipe sections shown in FIG. 2 after the hot plate has been removed and the ends brought in contact with each other under pressure.

As shown especially in FIGS. 3 and 6, to practice the method of the current invention, the exterior weld bead 42 is removed, typically by cutting with a suitable cutting tool. At this point, the exterior surface of the joint is perfectly smooth and it is impossible to differentiate a good joint from a defective joint. After the exterior weld bead 42 has been completely removed, the weld zone region 44 is heated with a convenient heating device to a temperature sufficient to render visible the bonding between the sections 20, 22 of plastic material. After this secondary heating, the weld zone region 44 is visibly inspected and any weld exhibiting a

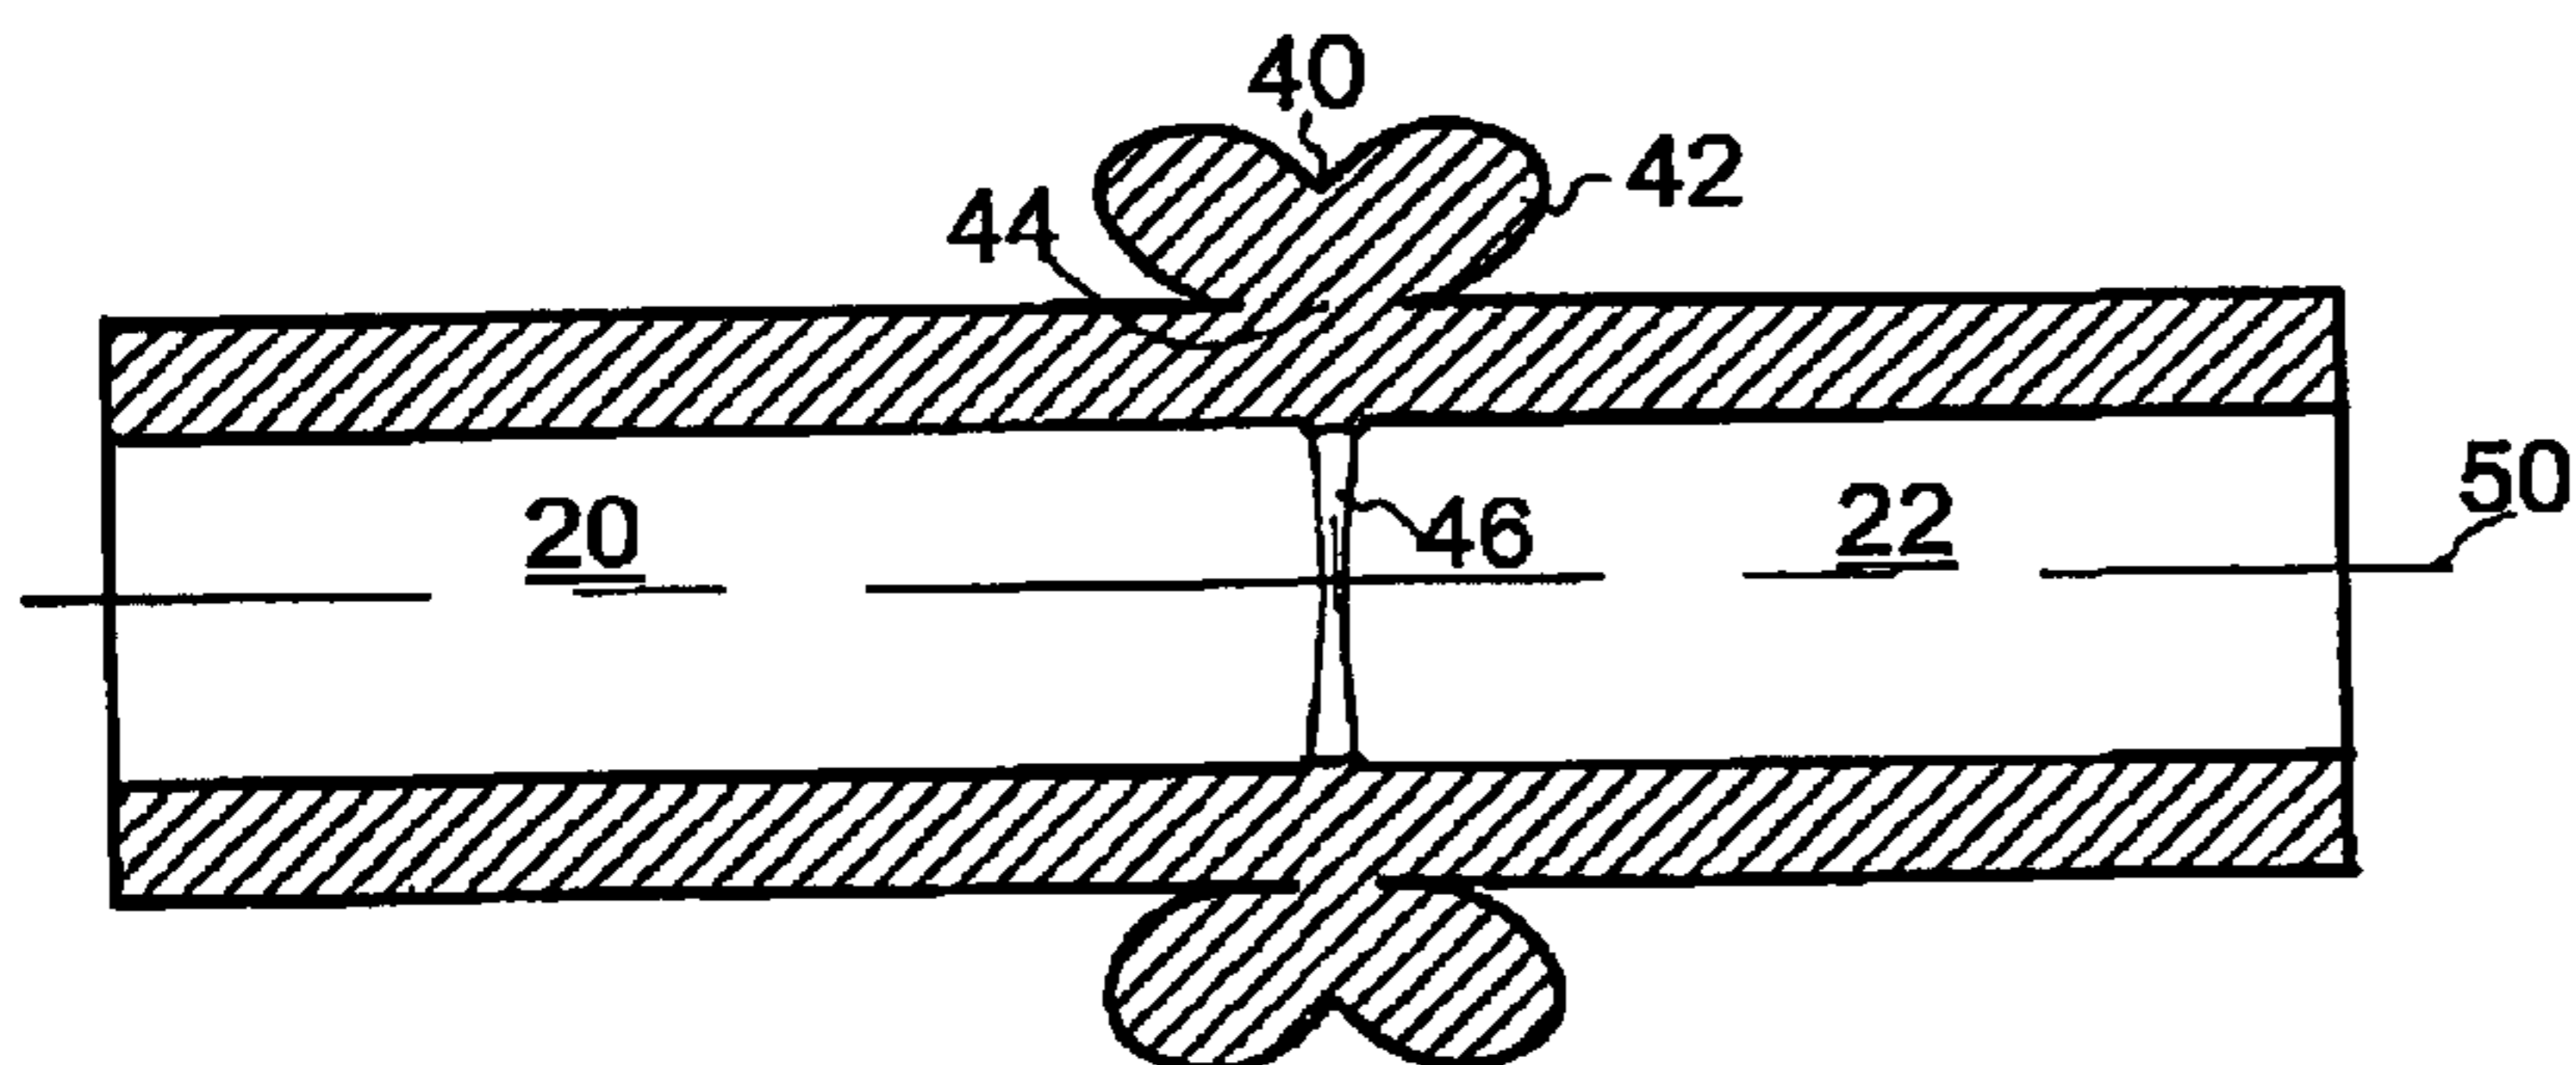
Fig. 5

FIG. 5 is a cross-sectional view through the longitudinal axis of the butt weld joint of FIG. 3 illustrating the uniform intermixing of the ends of the two pipe sections in the weld zone region throughout the thickness of the pipe when the joint is formed under optimal conditions.

bond line 40 is rejected. FIG. 6 illustrates a heated weld zone region 44 in which the butt-joint between the two sections 20, 22 was made under optimal conditions. It is to be noted that no bond line 40 between the two sections 20, 22 is visible nor are any surface distortions present. As seen in the cross section view of FIG. 5, the plastic from each section 20, 22 has fused and intermingled to produce a smooth continuous region throughout the weld region that is at least as thick as the thickness of the pipe.

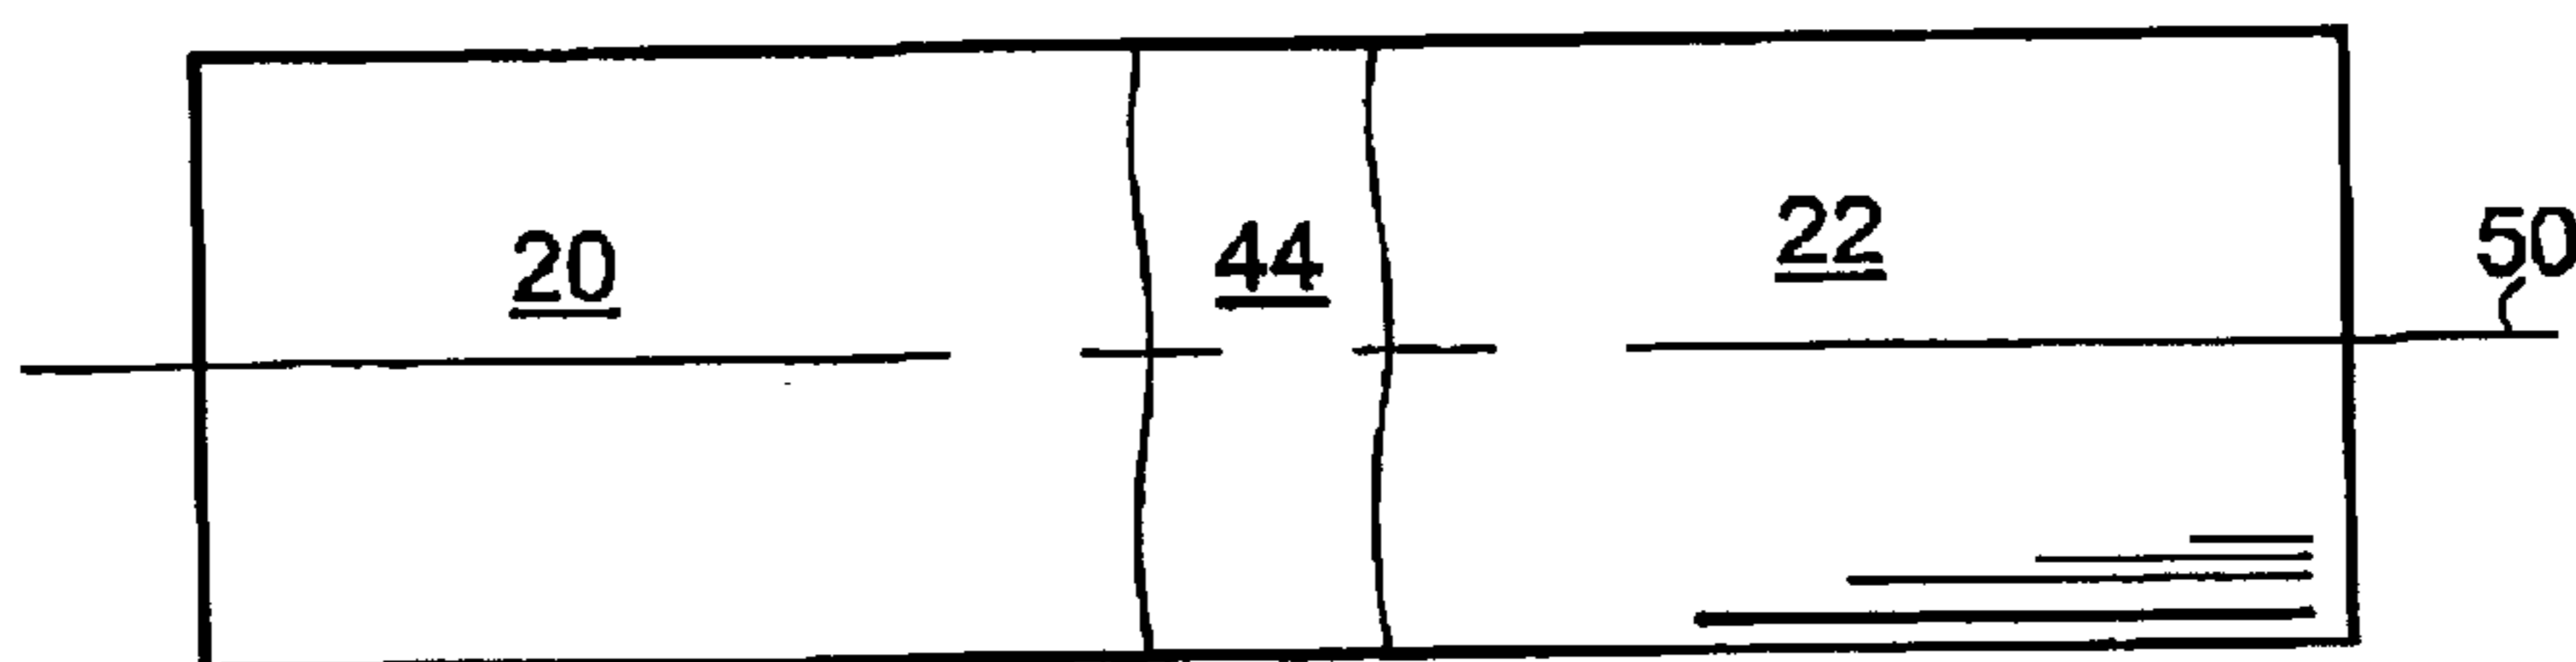
Fig. 6

FIG. 6 is a plan view of the butt weld joint of FIG. 3 from which the weld bead has been removed and the weld zone

region heated. Lack of the observation of a bond line in the weld zone region demonstrates the formation of a satisfactory weld (butt joint).

The secondary heating step causes a relaxation of the material in the surface layer of the weld zone region 44 that eliminates the residual stress that develops when the melted polymer cools under pressure during the primary welding cycle. As a result of this material relaxation, the outline of the weld zone 44 becomes visible. As seen in FIG. 6, for a joint formed under optimal conditions, the material relaxation in the bond zone 44 produced by the secondary heating is merely a slight difference in texture over the entire bond zone 44 with no evidence of the initial interface (bond line) between the ends 24, 26 of sections 20, 22 apparent.

The weld zone **44** was then made visible by carrying out a secondary heating of the butt joint weld region **44**. This heating can be done with any convenient heat source such as a radiant, convection or contact heat source. In the present instance, the weld zone **44** was visualized by directing the flow of hot air from a hot air gun on the sanded surface, keeping the nozzle approximately  $\frac{3}{8}$  inch (1 cm) from the surface. The surface was heated until the outline of the weld zone **44** became visible. The temperature setting for the hot air gun (Leister CH 6056 Hot Air Blower type Ghibli) was 480° F.–500° F. (249° C.–260° C.). FIG. 6 shows the exterior weld zone **44** of a joint made under optimal conditions after the secondary heating. The absence of the bond line or surface distortion shows good fusion between two sections **20, 22**.

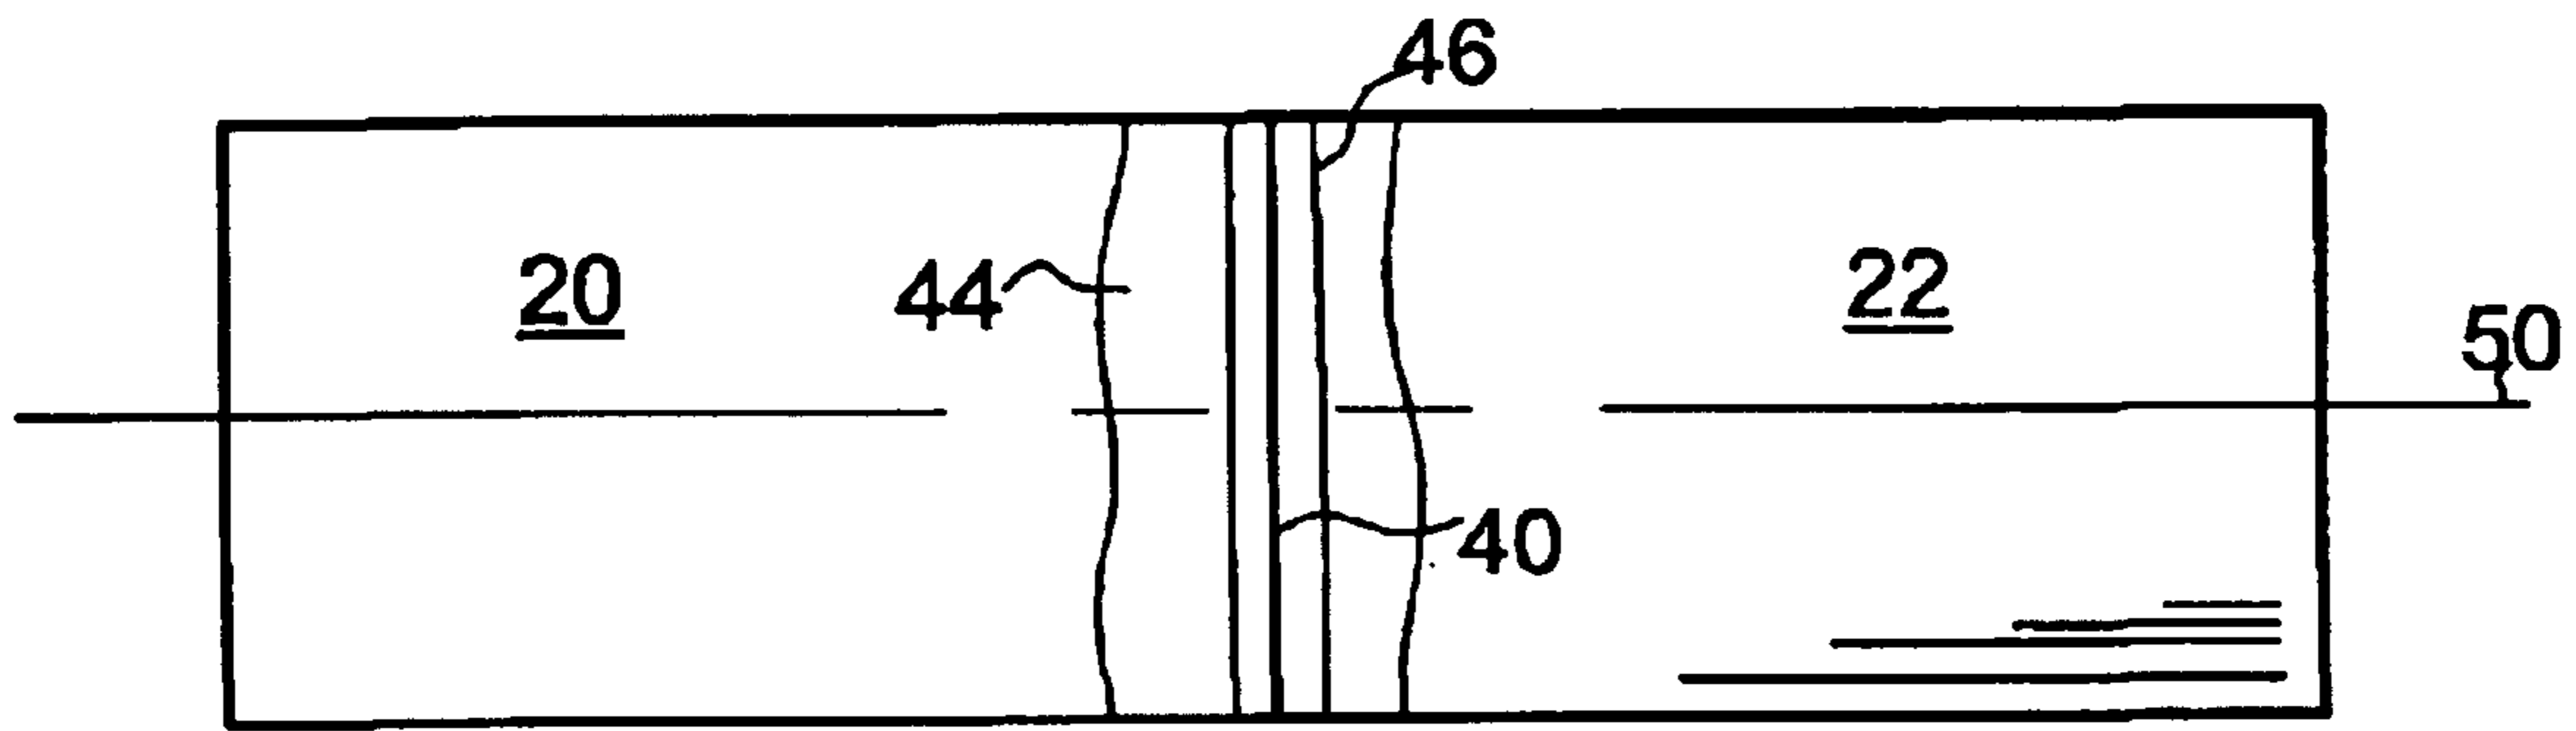
Fig. 7

FIG. 7 is a plan view of a butt weld joint weld made with insufficient interfacial pressure in the initial joining step. The observation of the bond line and other deformities after the secondary heating step clearly shows the formation of a defective joint.

FIG. 7 illustrates the presence of a bond line 40 between the two sections 20, 22 along with ridges 46 in the weld zone region 44 when the two sections 20, 22 are joined with insufficient interfacial pressure. FIG. 8 shows the presence of bond line 40 when the two sections 20, 22 are joined after heating the ends of the two sections 20, 22 to too high a temperature prior to the joining operation. In addition to the appearance of the defect indicating bond line 40, ridges 46 and valleys 48 may also develop on either side of the bond line 40 during the heating step. However, the observation of a bond line 40 is clear evidence of a defect weld. Butt weld failures are caused by weakened or incomplete fusion of the mating surfaces 24, 26 which give rise to the bond line 40. This can arise for a variety of reasons including insufficient pressure at portions or the entire interface of the joint, solidification of the material in the contact zone due to weather conditions, an over extended open time, contamination, and other factors. Regardless of the cause of the weak bond. Its presence can be readily identified by the appearance of the bond line 40 when the weld zone region 44 is rendered visible by a secondary heating step once the bond has been formed and allowed to cool.

The weld illustrated in FIG. 7 was prepared according to the method described above for Example I except that the

interfacial pressure applied to the two pieces of pipe during the welding process was reduced by approximately 50%. The incompleteness of the weld is evident by the appearance of a bond line **40** between the two pipe segments **20, 22** along with slight ridges **46** on each side of the bond line **40**.

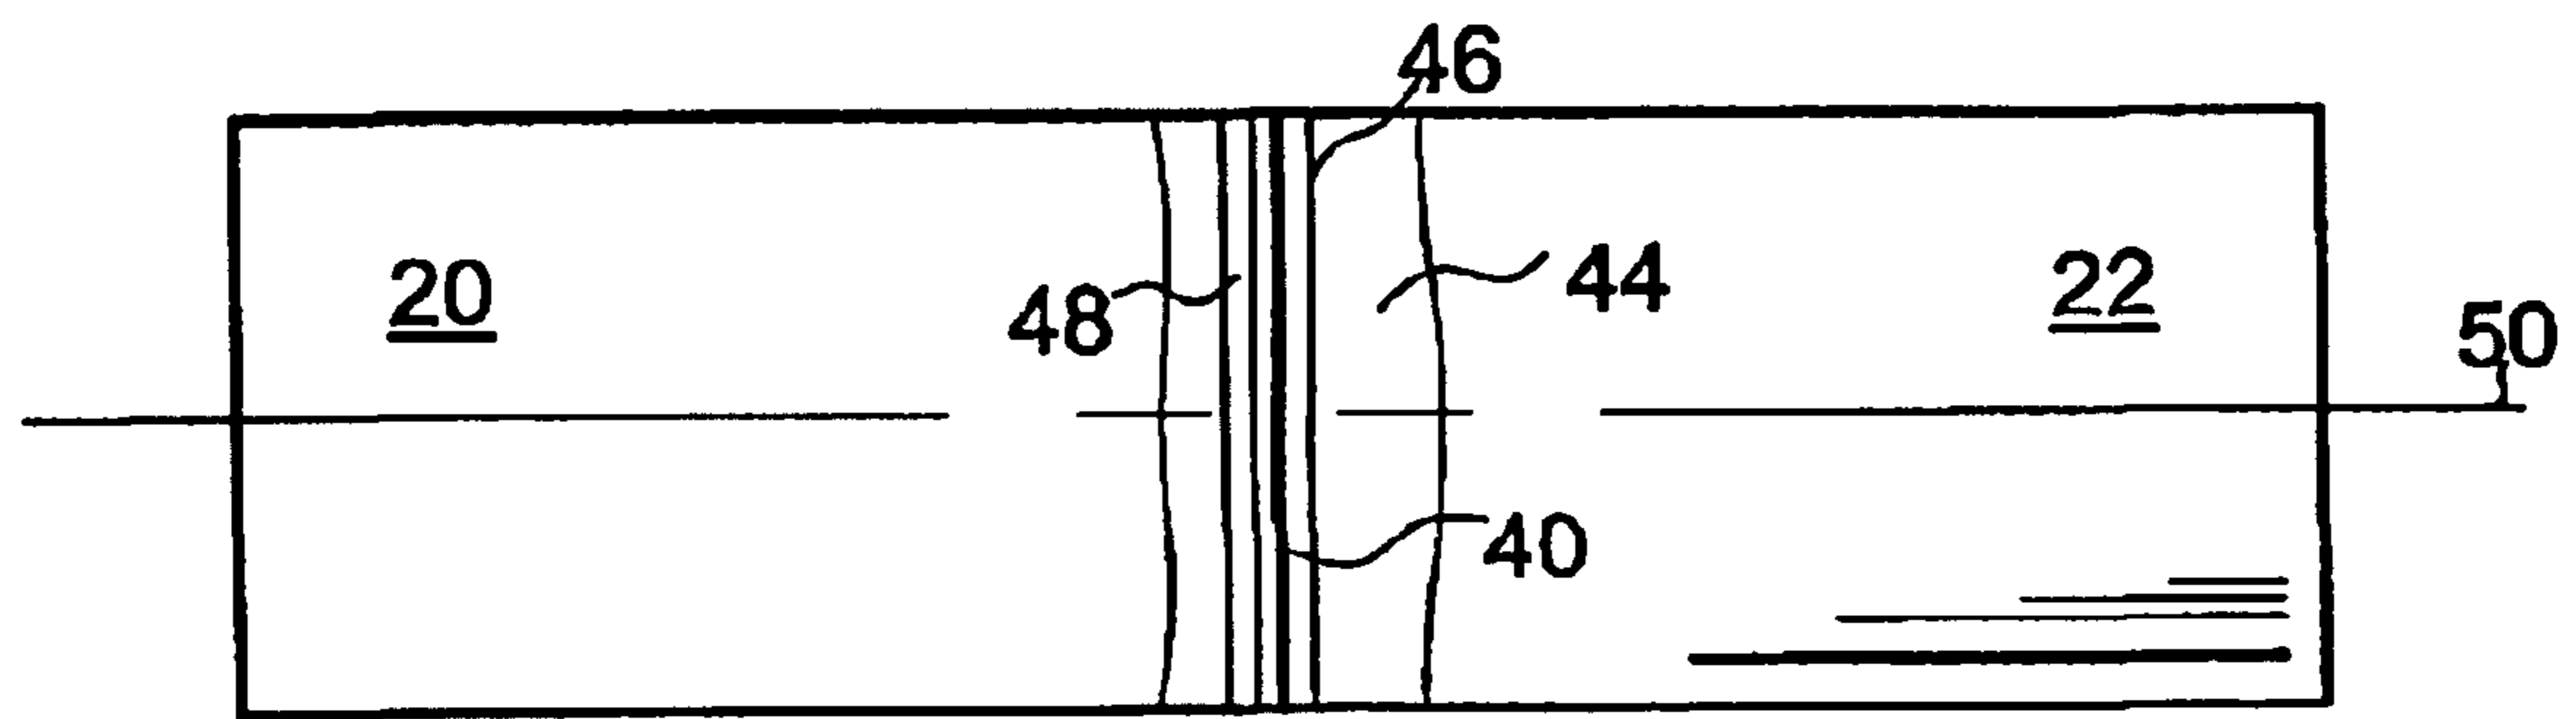
Fig. 8

FIG. 8 is a plan view of the weld zone region after secondary heating. Illustrating the appearance of a bond line when the ends of the pieces are overheated prior to the initial joining step. The observation of the bond line after the secondary heating step clearly shows the formation of a defective joint.

The weld illustrated in FIG. 8 was prepared according to the method described above for Example I except that the ends of the pipe were overheated during the initial welding process, that is, to a temperature of about 2800° C. As a result, the incompleteness of the weld is clearly evident by the appearance of the bond line **40** between the two pipe segments **20, 22** as well as ridges **46** and valleys (indentations) **48** on either side of the bond line **40**.
