(10) Patent No.: US 6,950,359 B2

(54) MEMORY BIT LINE LEAKAGE REPAIR

(73) Assignee: Qualcomm Inc., San Diego, CA (US)

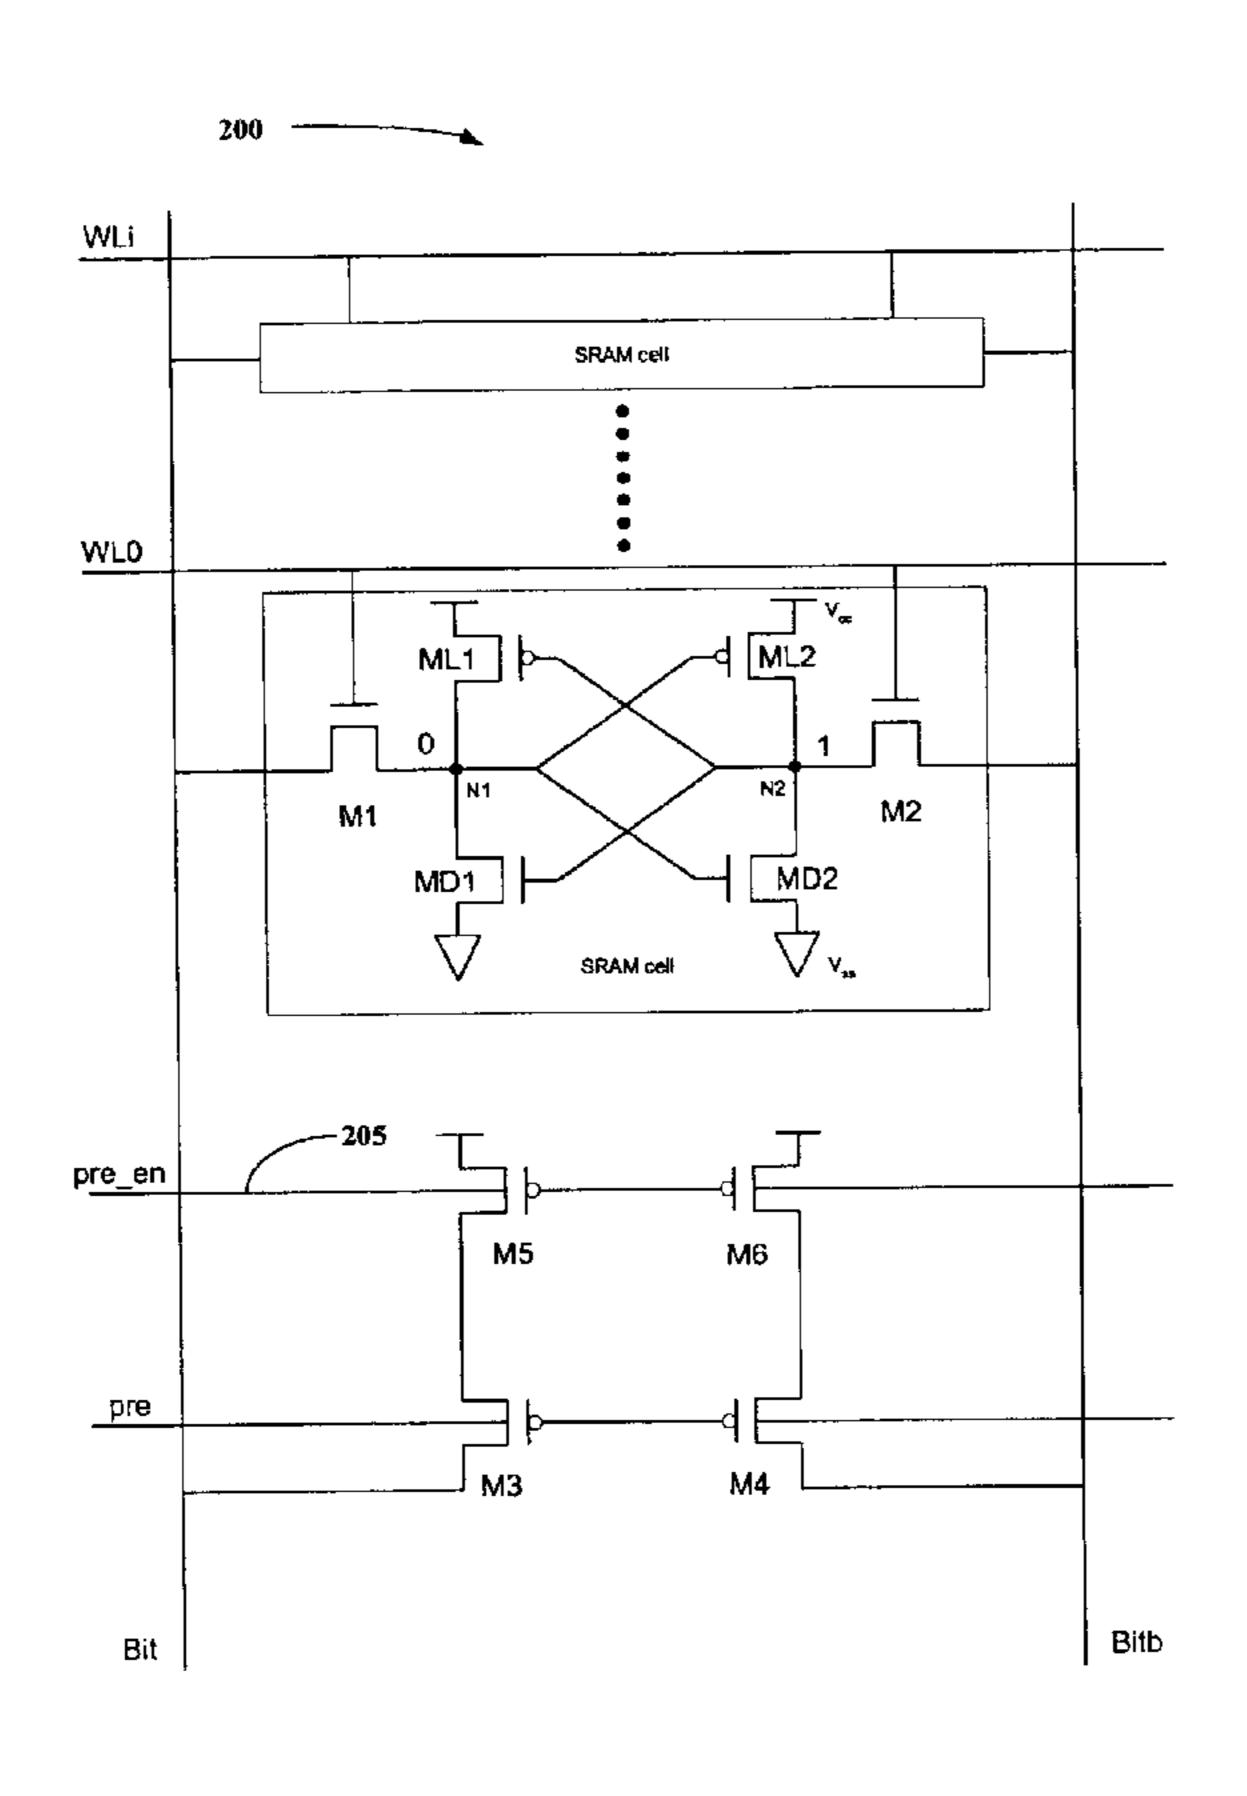
Figure 1

FIG. 1 illustrates a leakage path in a conventional SRAM precharge circuit.

FIG. 1 is a circuit diagram a conventional SRAM precharge circuit 100. The circuit consists of a plurality of Static Random Access Memory (SRAM) memory cells 105 and precharge transistors M3 and M4. Each of the memory cells 105 is connected to a word line (WLi, WL0), a first bit line 115, and a second bit line 120. A detailed diagram is provided of one of the SRAM cells 110. The CMOS SRAM cell is formed of a pair of driver transistors MD1 and MD2, a pair of transfer transistors M1 and M2, and a pair of load transistors ML1 and ML2. Here, the pair of driver transistors TD1 and TD2, and the pair of transfer transistors M1 and M2 are NMOS transistors. The pair of load transistors ML1 and ML2 are typically PMOS transistors.

FIG. 2 is a circuit diagram, in accordance with an embodiment of the invention, of a modified SRAM precharge circuit 200 configured to remove the leakage path from a circuit, such as that in FIG. 1. In the modified circuit 200, two precharge enable transistors M5 and M6 and a precharge enable signal 205 are added. The source of the precharge enable transistor M5 is connected to the power line and the drain of the precharge enable transistor M5 is connected to the precharge enable transistor M6 is connected to the power line and the drain of the precharge enable transistor M6 is connected to the power line and the drain of the precharge enable transistor M6 is connected to the source of the precharge transistor M4.

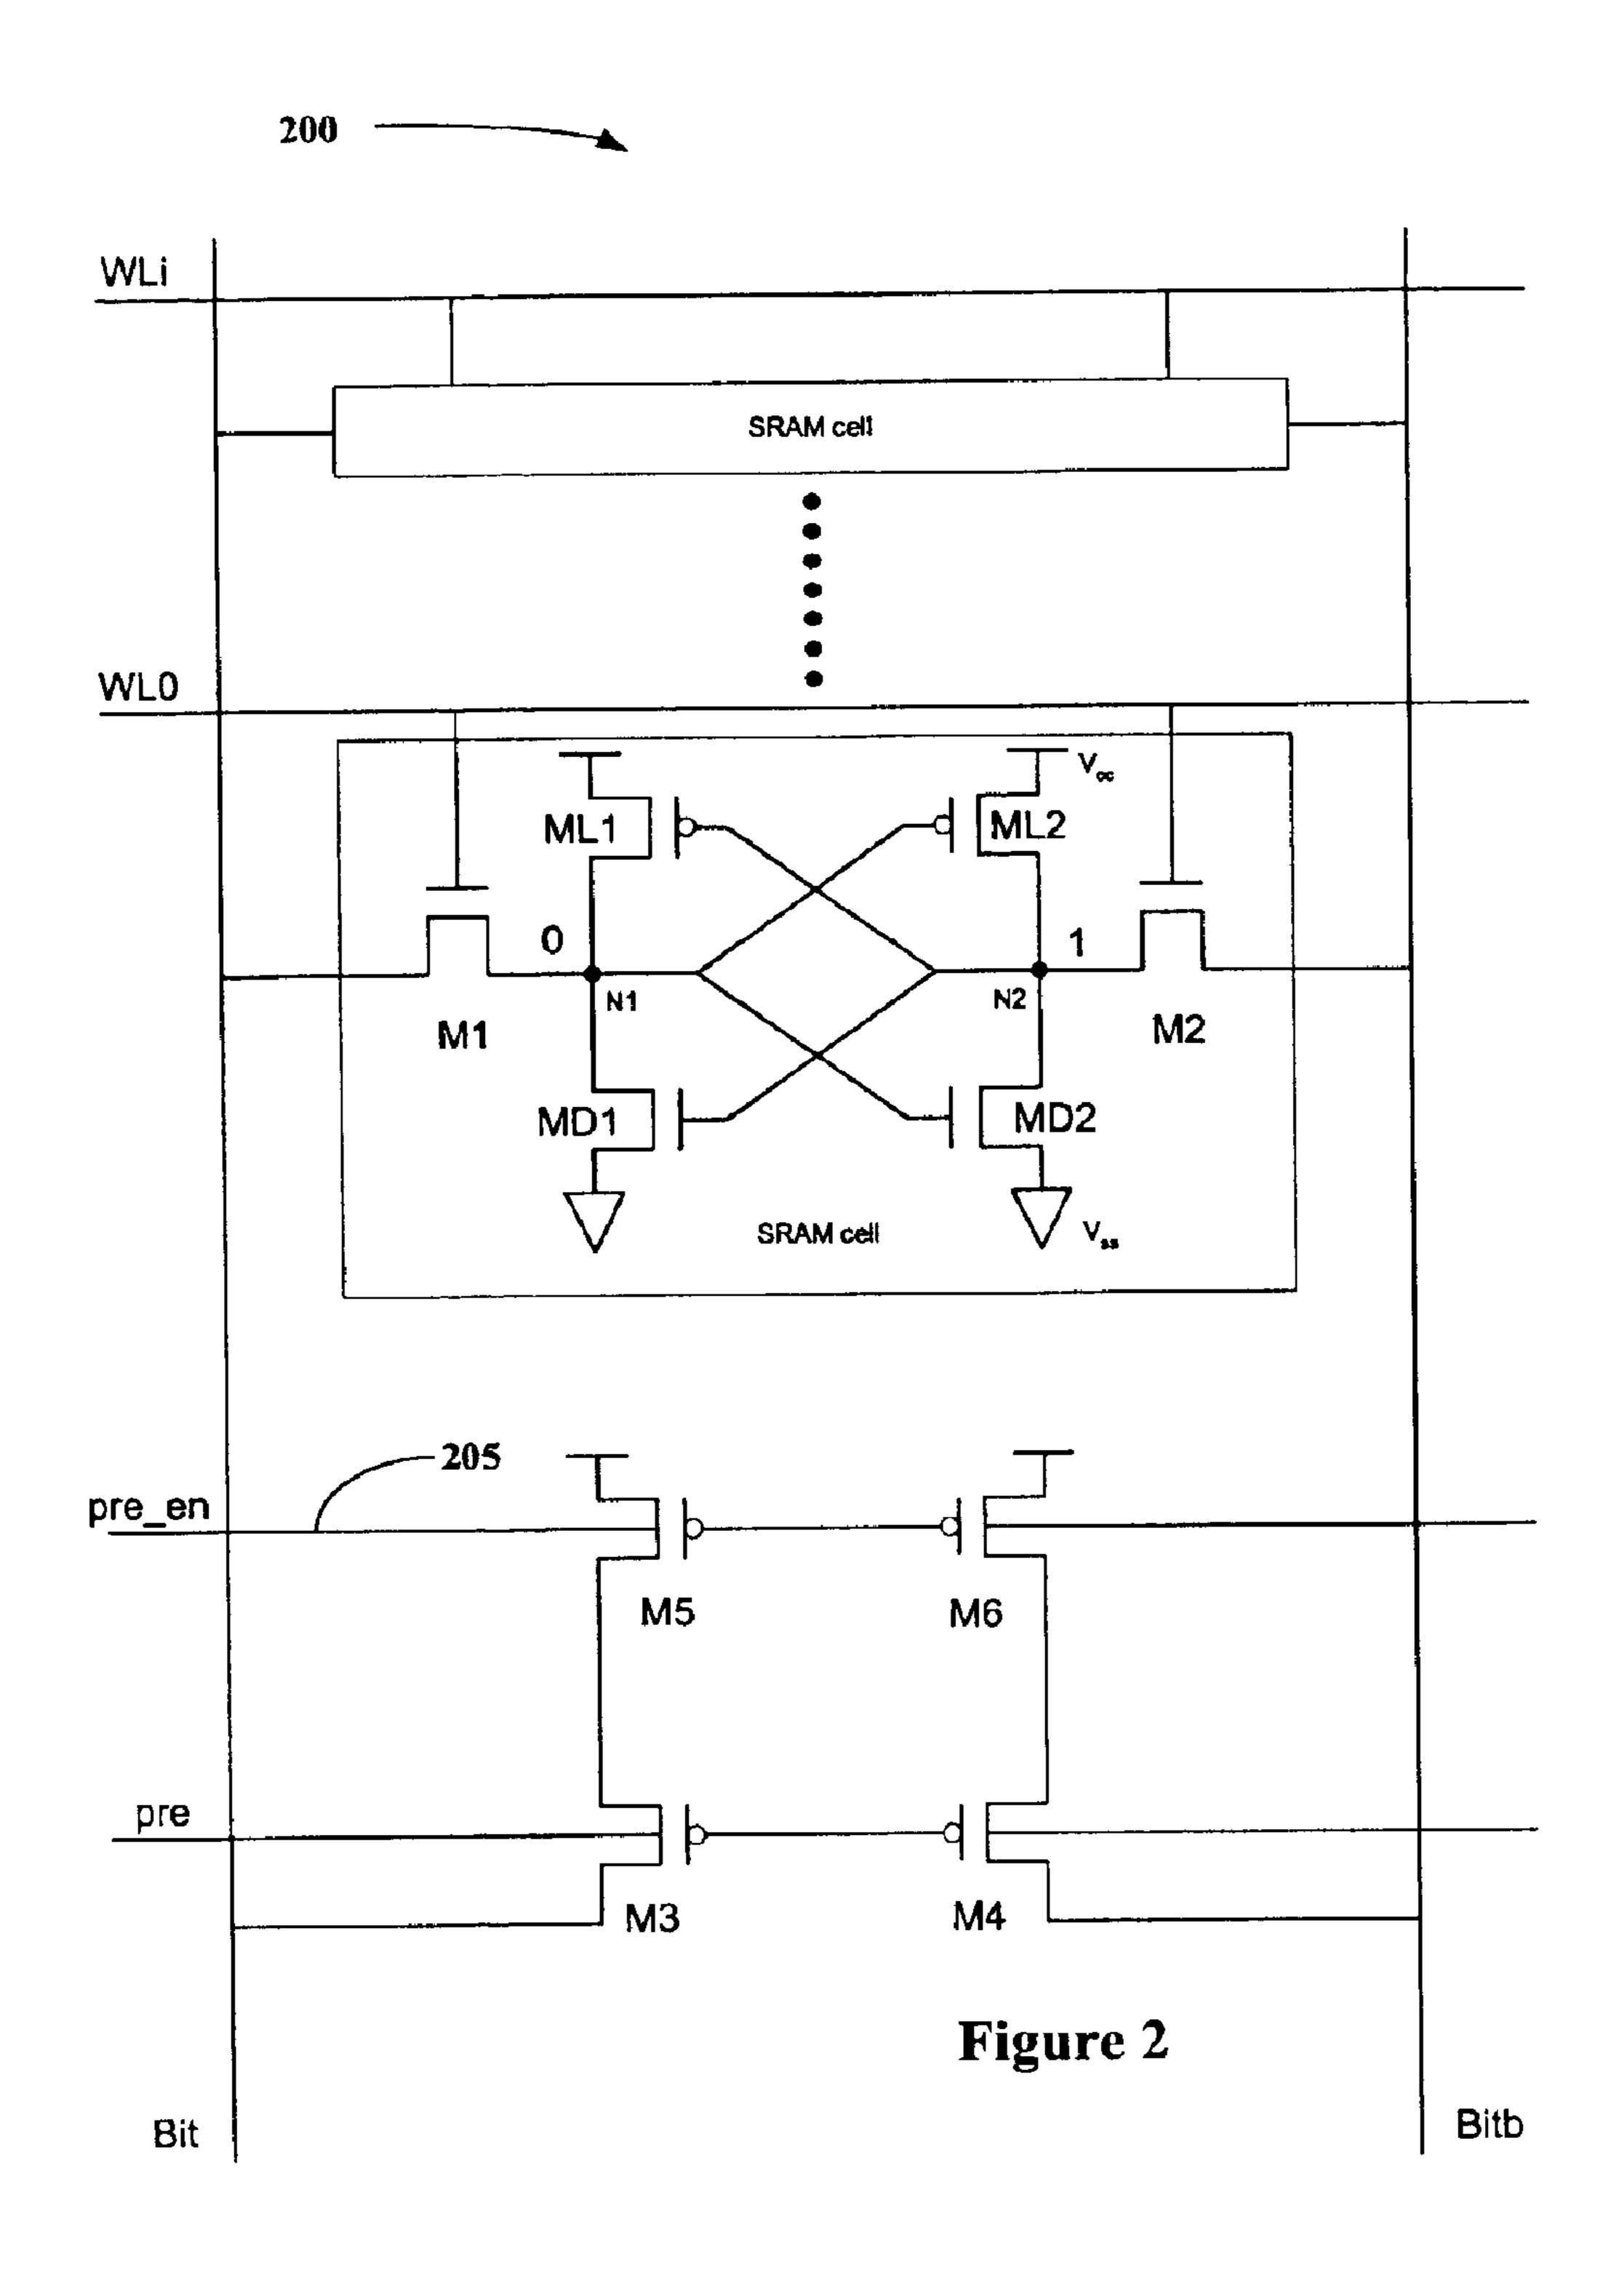
FIG. 2 is a circuit diagram of a SRAM precharge circuit configured to remove the leakage path from the circuit in accordance with an embodiment of the invention.

The precharge enable signal **205** is associated with the fuse control logic and each column has a distinct precharge signal. If there is no column replacement, the precharge enable signal 205 remains low through the fuse logic, thus ensuring that the precharge enable transistors M5 and M6 are always on. In this circumstance, the precharge enable 25 transistors M5 and M6 simply pass any signals, so the column works as if the precharge enable transistors M5 and M6 were not there. However, if a column is replaced because of a defect, the precharge enable signal 205 is set high through the fuse logic. In this situation, high precharge 30 enable signal 205 turns off the precharge enable transistors M5 and M6, effectively opening the circuit between the precharge transistor M3 and the transfer transistor M1. By turning off the precharge enable transistors M5 and M6, the leakage path is interrupted, and therefore the IDDQ failure 35 is removed from the circuit.

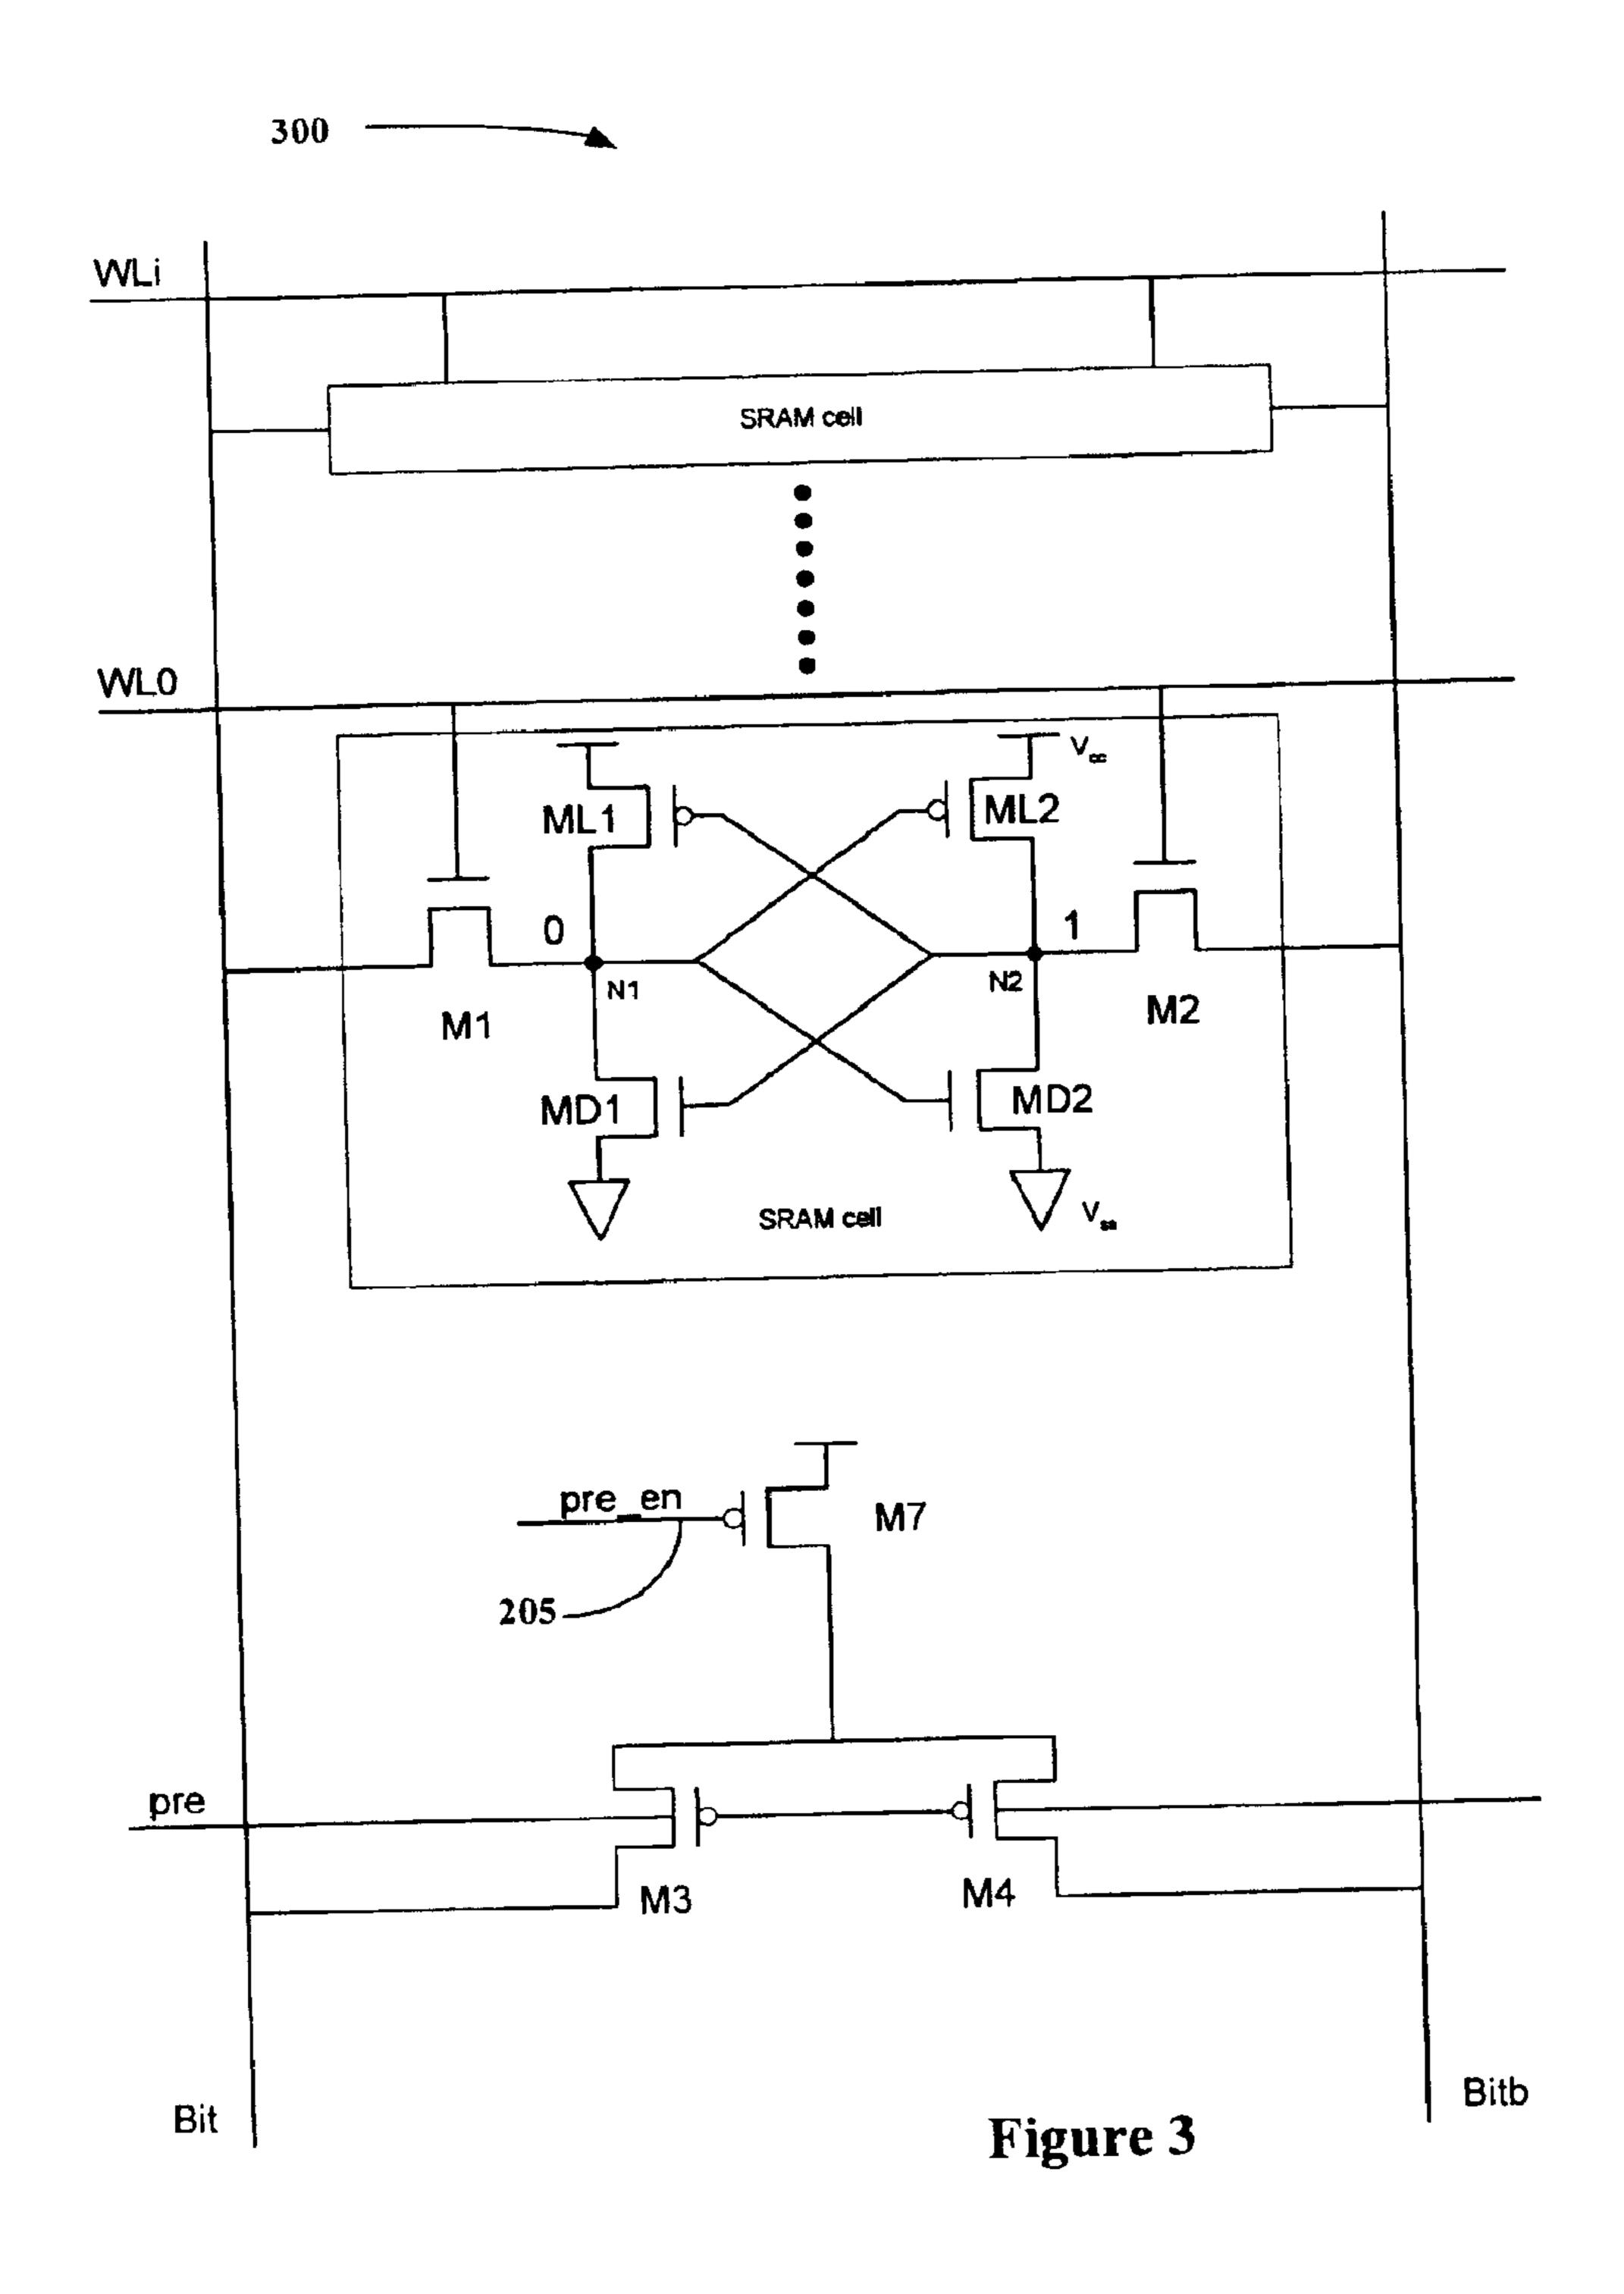
FIG. 3 is an alternative design of a SRAM precharge circuit configured to remove the leakage path from the circuit.

FIG. 3 is a modified SRAM precharge circuit 300 configured to remove the leakage path from the circuit, in accordance with an alternate embodiment. In the modified 40 circuit 300, a single precharge enable transistor M7 and the precharge enable signal 205 are added. The source of the precharge enable transistor M7 is connected to the power line and the drain of the precharge enable transistor M7 is connected to the source of the precharge transistors M3 and 45 M4. If there is no column replacement, the precharge enable signal 205 remains low through the fuse logic, thus ensuring that the precharge enable transistor M7 remains on so any signals are passed. If a column is replaced because of a defect, the precharge enable signal 205 is set high through 50 the fuse logic. In this situation, the high precharge enable signal 205 turns off the precharge enable transistor M7, effectively interrupting the leakage path and removing the IDDQ failure from the circuit. By using only one precharge enable transistor M7, more precharge balance is achieved. 55

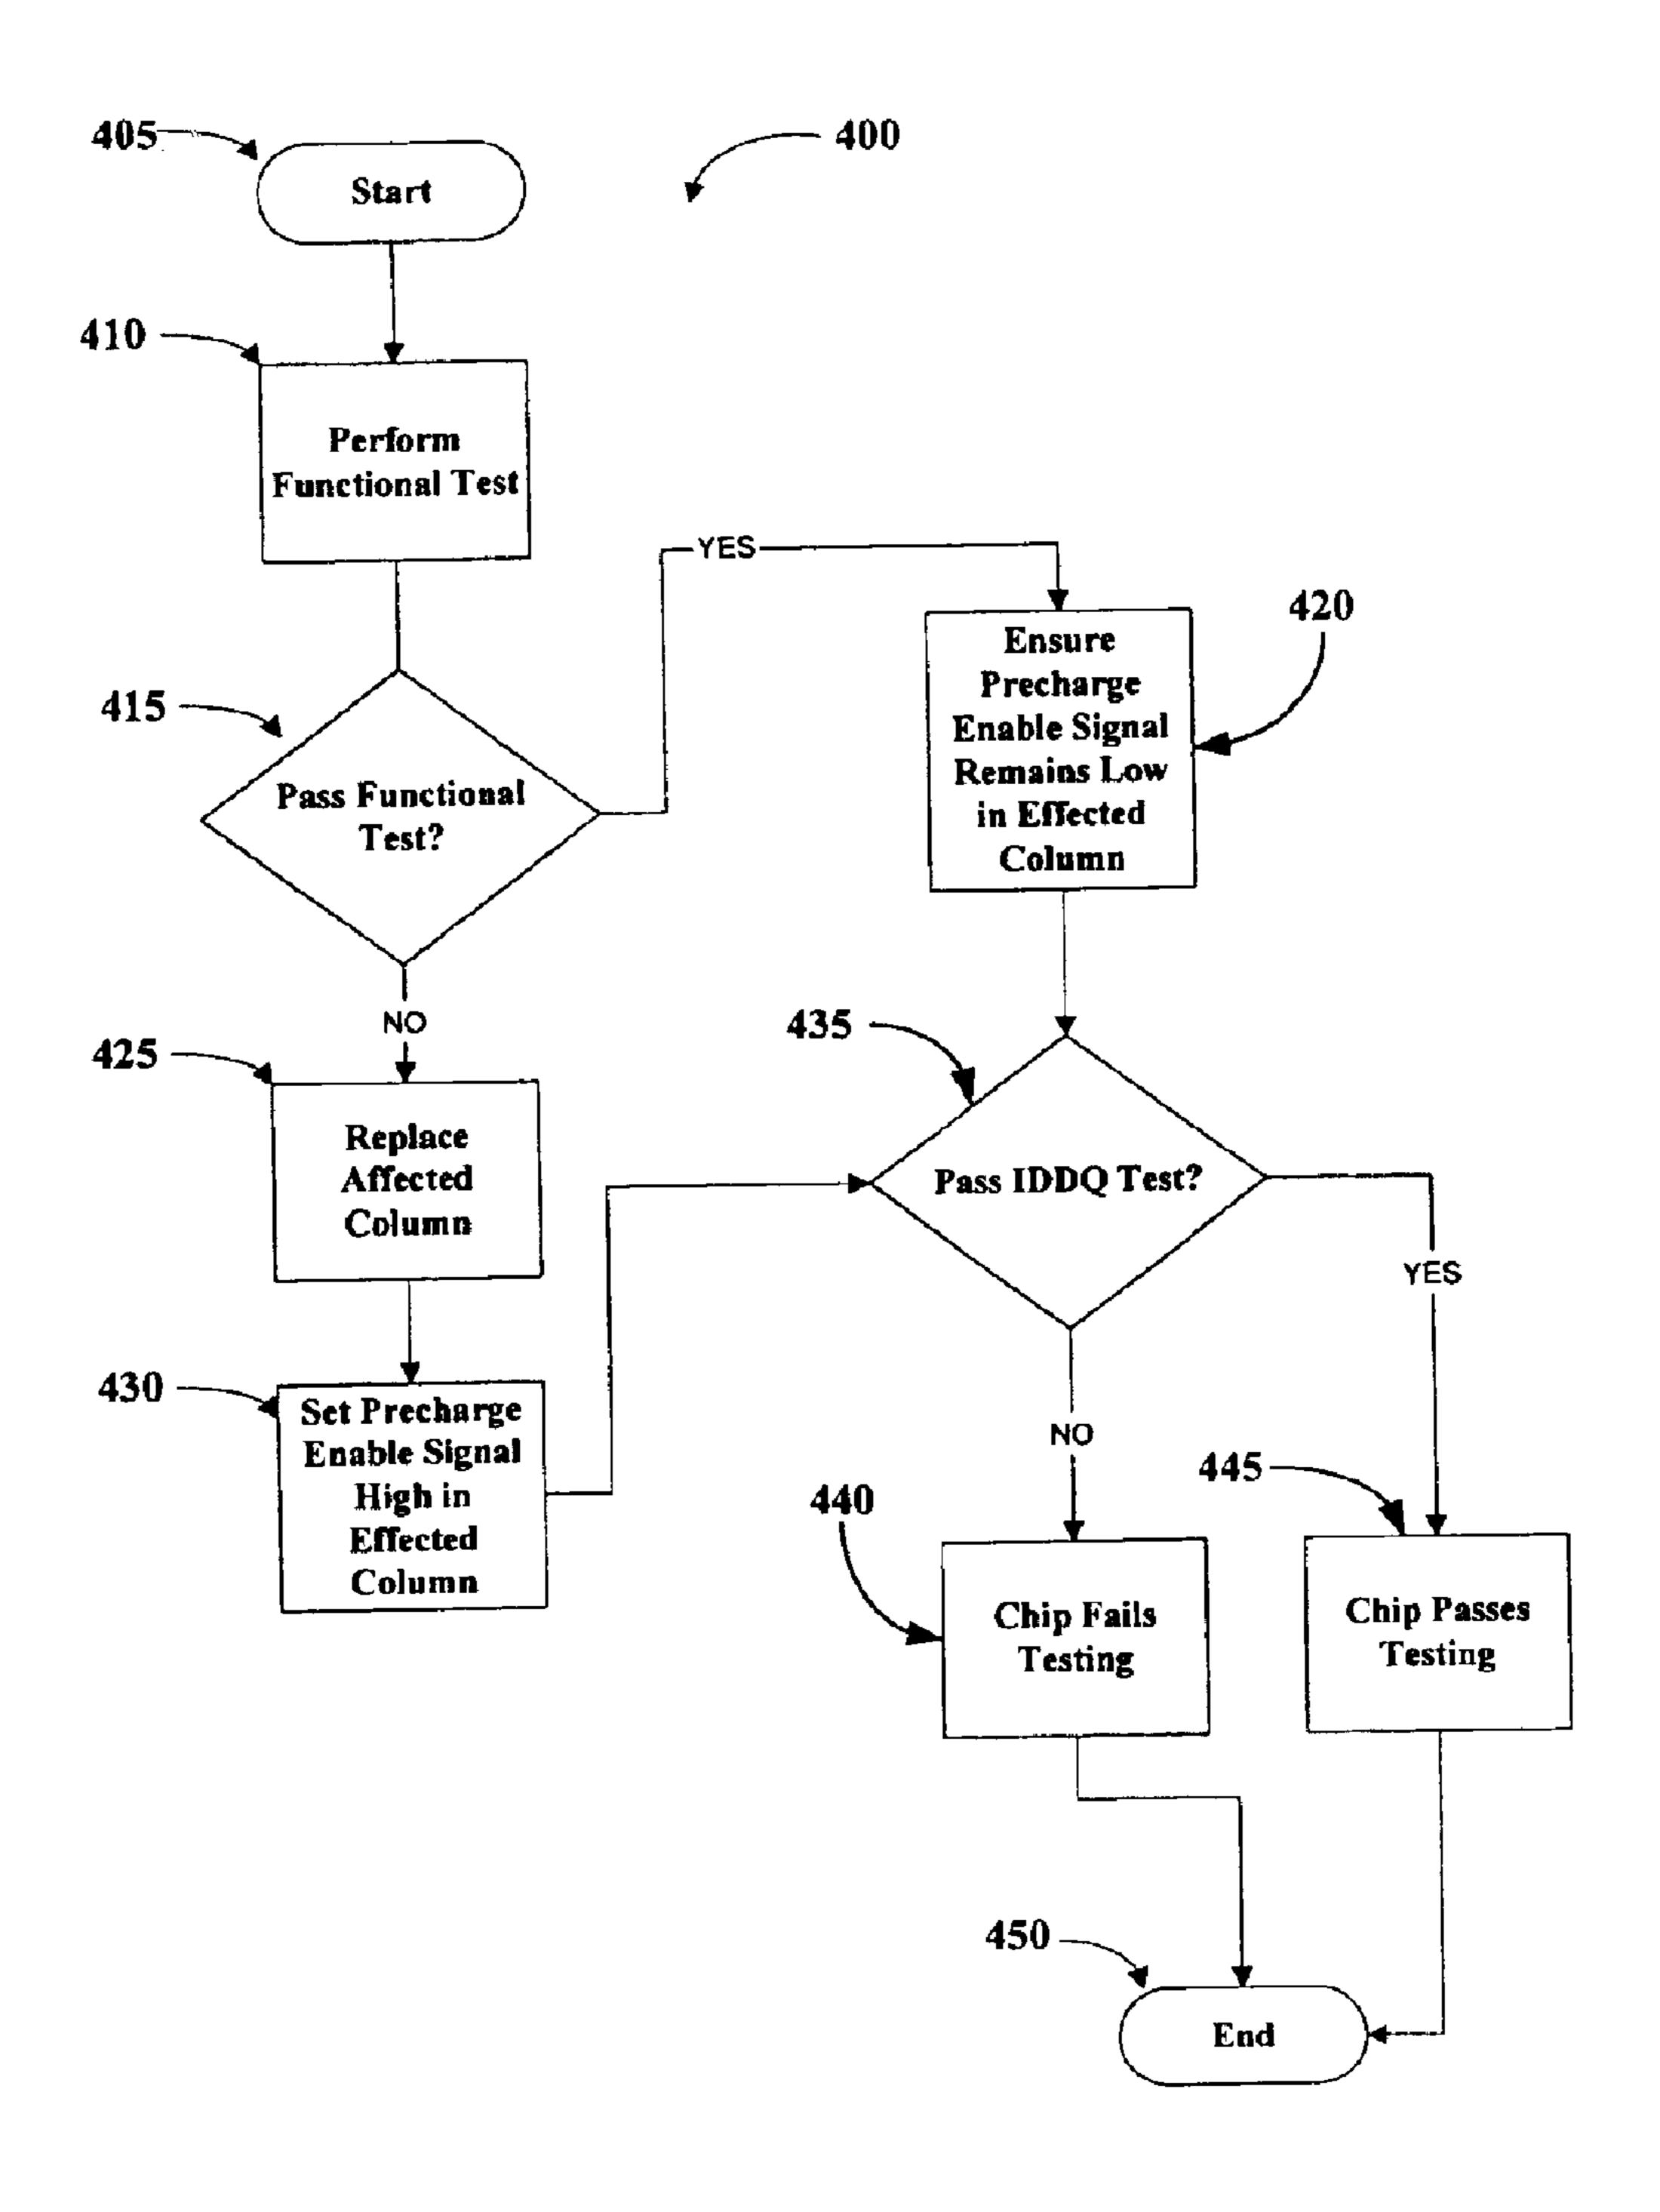
Figure 4

FIG. 4 illustrates a process for detecting and repairing errors on memory wafers in accordance with one embodiment of the invention.

FIG. 4 illustrates a process 400 for detecting and repairing errors, employing the principles of the various embodiments disclosed herein, on memory wafers. The process 400 begins in START block 405. Proceeding to block 410, a functional test is performed on a memory chip on the wafer to determine if any errors are present in the memory column.

Proceeding to block 415, the process 400 determines if the circuit passed the functional test. The functional test determines if the memory column is operating properly. The functional test may not specifically identify any particular 65 cause of a failure. If the circuit passes functional testing, the process 400 proceeds along the YES branch to block 420. In

block 420, the process 400 ensures the precharge enable signal remains low. By having the precharge enable signal low, the precharge enable transistors M5, M6, or M7 (FIGS. 2–3) remain on, effectively passing any signals to the precharge transistors M3 and M4. This allows the circuit to operate normally. The process 400 then proceeds to block 435 for IDDQ testing, which will be discussed below.

Returning to block 415, if the circuit fails functional testing, the process 400 proceeds along the NO branch to block 425. In block 425, the process 400 replaces the effected column with a redundant column. By replacing the effected column, the functionality of the column can be maintained in the circuit. The circuit may be designed with a plurality of redundant columns to allow for replacement of any columns failing the functional test.

Proceeding to block 430, the process 400 sets the precharge enable signal to a high state. By having the precharge enable signal high, the precharge enable transistors M5, M6, or M7 turn off, effectively removing the precharge transistors M3 and M4 from the circuit. By removing the precharge transistors M3 and M4, the path for any potential leakage current to flow is removed, and therefore any leakage current in the memory column is repaired. Thus, the column functionality may be replaced with a redundant column, and the defect in the column removed from the circuit using the precharge enable signal and the precharge enable transistors M5, M6, or M7.

Proceeding to block 435, IDDQ testing is performed on the memory chip on the wafer. IDDQ testing measures the quiescent supply current of the device under test. A CMOS circuit does not draw any significant current when in a stable situation. In a quiescent state only the leakage current flows, which may typically be neglected. IDDQ testing measures whether a significant current flows in the device under test. If a precharge transistor (such as precharge transistor M3, FIG. 2) is defective, current may flow through the precharge transistor at all times. This current, known as the leakage current, is detected during the IDDQ test. If the circuit is operating properly and all the malfunctioning memory columns were replaced and removed from the circuit with the precharge enable transistors, no leakage current will be present and the process 400 proceeds along the YES branch to block 445. In block 445, the memory chip on the wafer is determined to be operating properly with any defects repaired. The process 400 then terminates at END block 450.

Returning to block 435, if the memory chip on the wafer fails IDDQ testing, the process 400 proceeds along the NO branch to block 440. In block 440, the memory chip on the wafer fails the testing procedure and is determined to be defective. This memory chip may then be discarded before any expensive packaging is performed. After identifying any defective memory chips on the wafer, the process 400 terminates in END block 450.
