(10) **Patent No.:** **US 7,027,089 B2**
(45) **Date of Patent:** **Apr. 11, 2006**

(54) **IMAGE SENSOR WITH DEFECTIVE PIXEL ADDRESS STORAGE**

(73) Assignee: **Hynix Semiconductor, Inc.**,
Kyoungki-Do (KR)

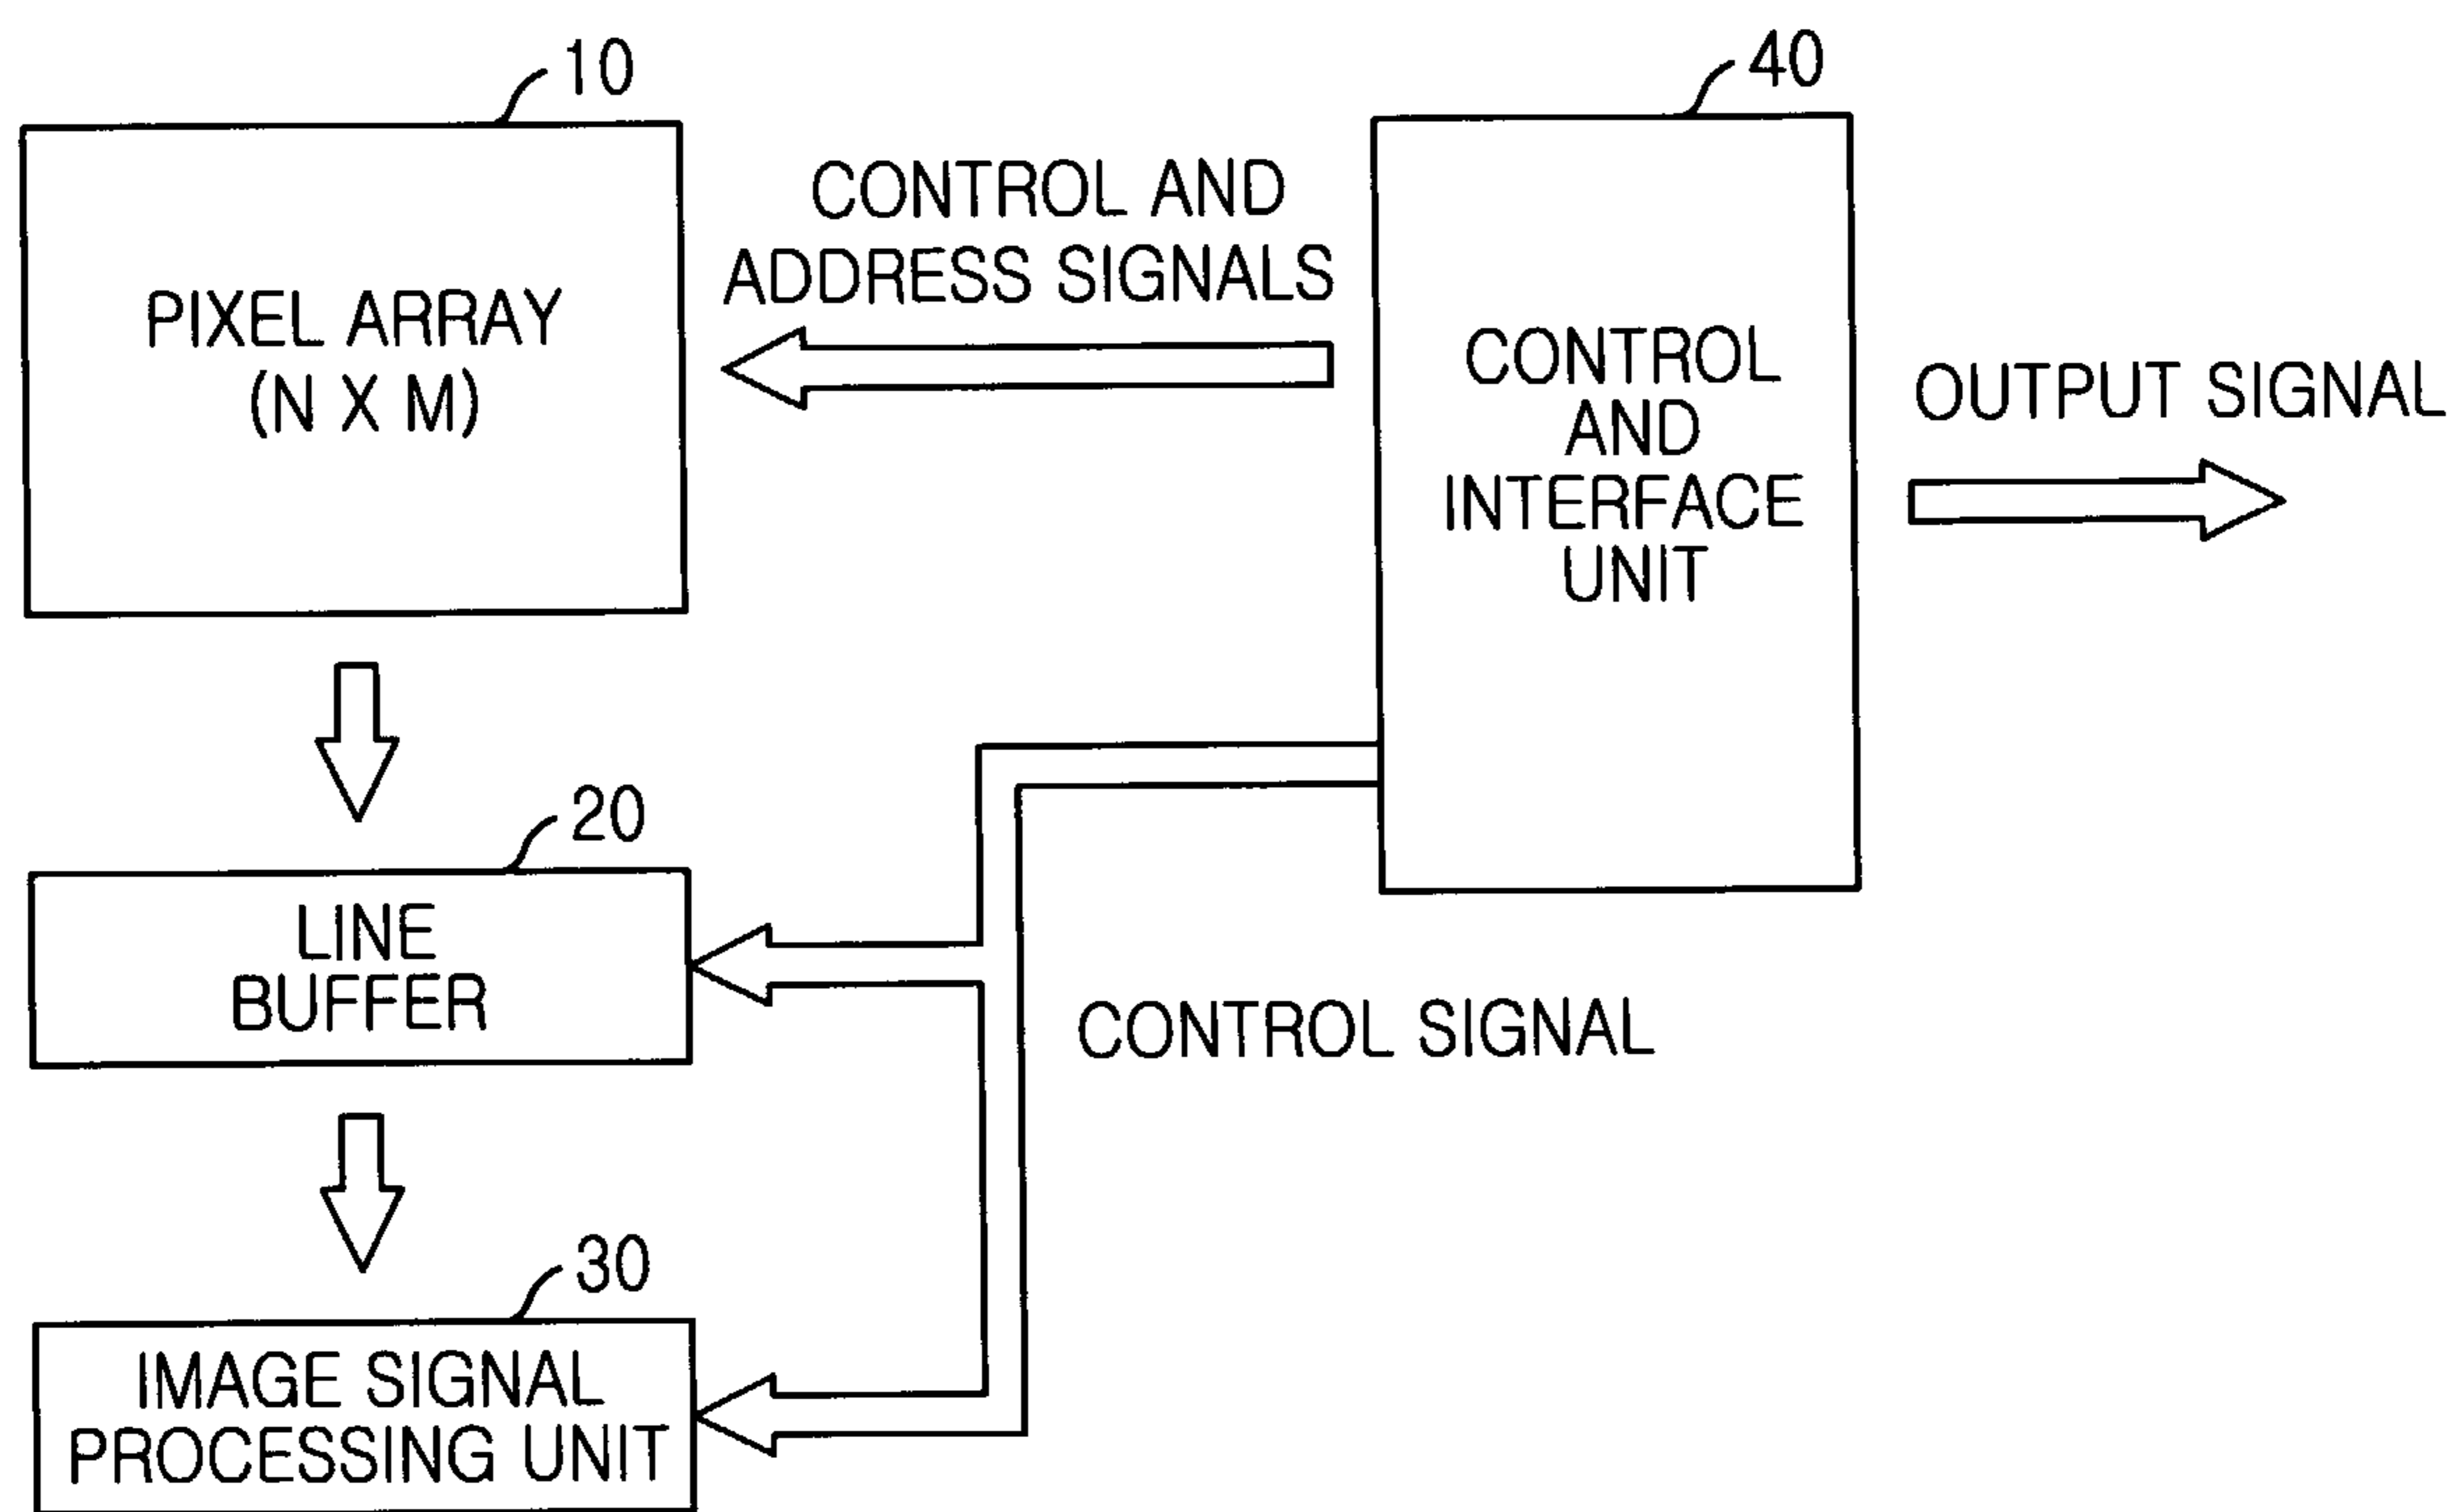
FIG. 2 is a block diagram of an example image sensor constructed in accordance with the teachings of the present invention.

FIG. 2 is a block diagram of an example image sensor capable of storing addresses of defective pixels by using the fuse blowing technology. Referring to FIG. 2, the image sensor includes a pixel array **100**, a line buffer **200**, an image signal processing unit **300**, a defective pixel address storing unit **500**, a control and interface unit **400** and a defective pixel compensation unit **600**.

The line buffer **200** stores data transmitted from the pixel array **100**. The image signal processing unit **300** performs signal processing to improve the performance of the image sensor in response to outputs of the line buffer **200**. The defective pixel address storing unit **500** stores addresses of defective pixels by using the fuse blowing technology. These defective pixels are detected via a wafer level test. The control and interface unit **400** receives the address information of the defective pixels from the defective pixel address storing unit **500** and controls the overall operation of the image sensor. Also, the control and interface unit **400** manages an interface with an external system. The defective pixel compensation unit **600** receives the address information of the defective pixels from the defective pixel address storing unit **500**, control signals from the control and interface unit **400** and pixel data from the line buffer **200**. Thereby, the defective pixel compensation unit **600** compensates the data associated with the defective pixels by replacing the defective pixel data with normal pixel data from pixels around the defective pixels and outputs the replaced pixel data to the image signal processing unit **300**.

The defective pixel address storing unit **500** employing the fuse blowing technology can be variously configured. The example illustrated in FIG. 2 shows the defective pixel address storing unit **500** employing a data processing scheme performed based on row addresses.

In FIG. 2, the defective pixel address storing unit **500** includes a row address selection block **510**, a column address storage block **520** and a selection bit block **530**. The row address selection block **510** stores information for

whether or not defect pixels exist for each row of the pixel array **100** by switching a fuse on/off therein and outputs a row address selection signal RASS to the control and interface unit **400**. The column address storage block **520** stores information for column addresses of the defective pixels and outputs a column address signal CAS to the defective pixel compensation unit **600**. The selection bit block **530** stores information for correctly matching information stored in the row address selection block **510** and the column address storage block **520** and outputs a matching signal to the control and interface unit **400**.

The defective pixel address storing unit 500 can be differently implemented. Using the row address selection block 510, the column address storage block 520 and the selection bit block 530 as shown in FIG. 2 is a case wherein the data processing of the image sensor is carried out based on the row addresses under the control of the control and interface unit 400. If the data processing is carried out based on the column addresses, the defective pixel address storing unit 500 is constructed by a column address selection block 510a, a row address storage block 520a and the selection bit block 530a as shown in FIG. 12.

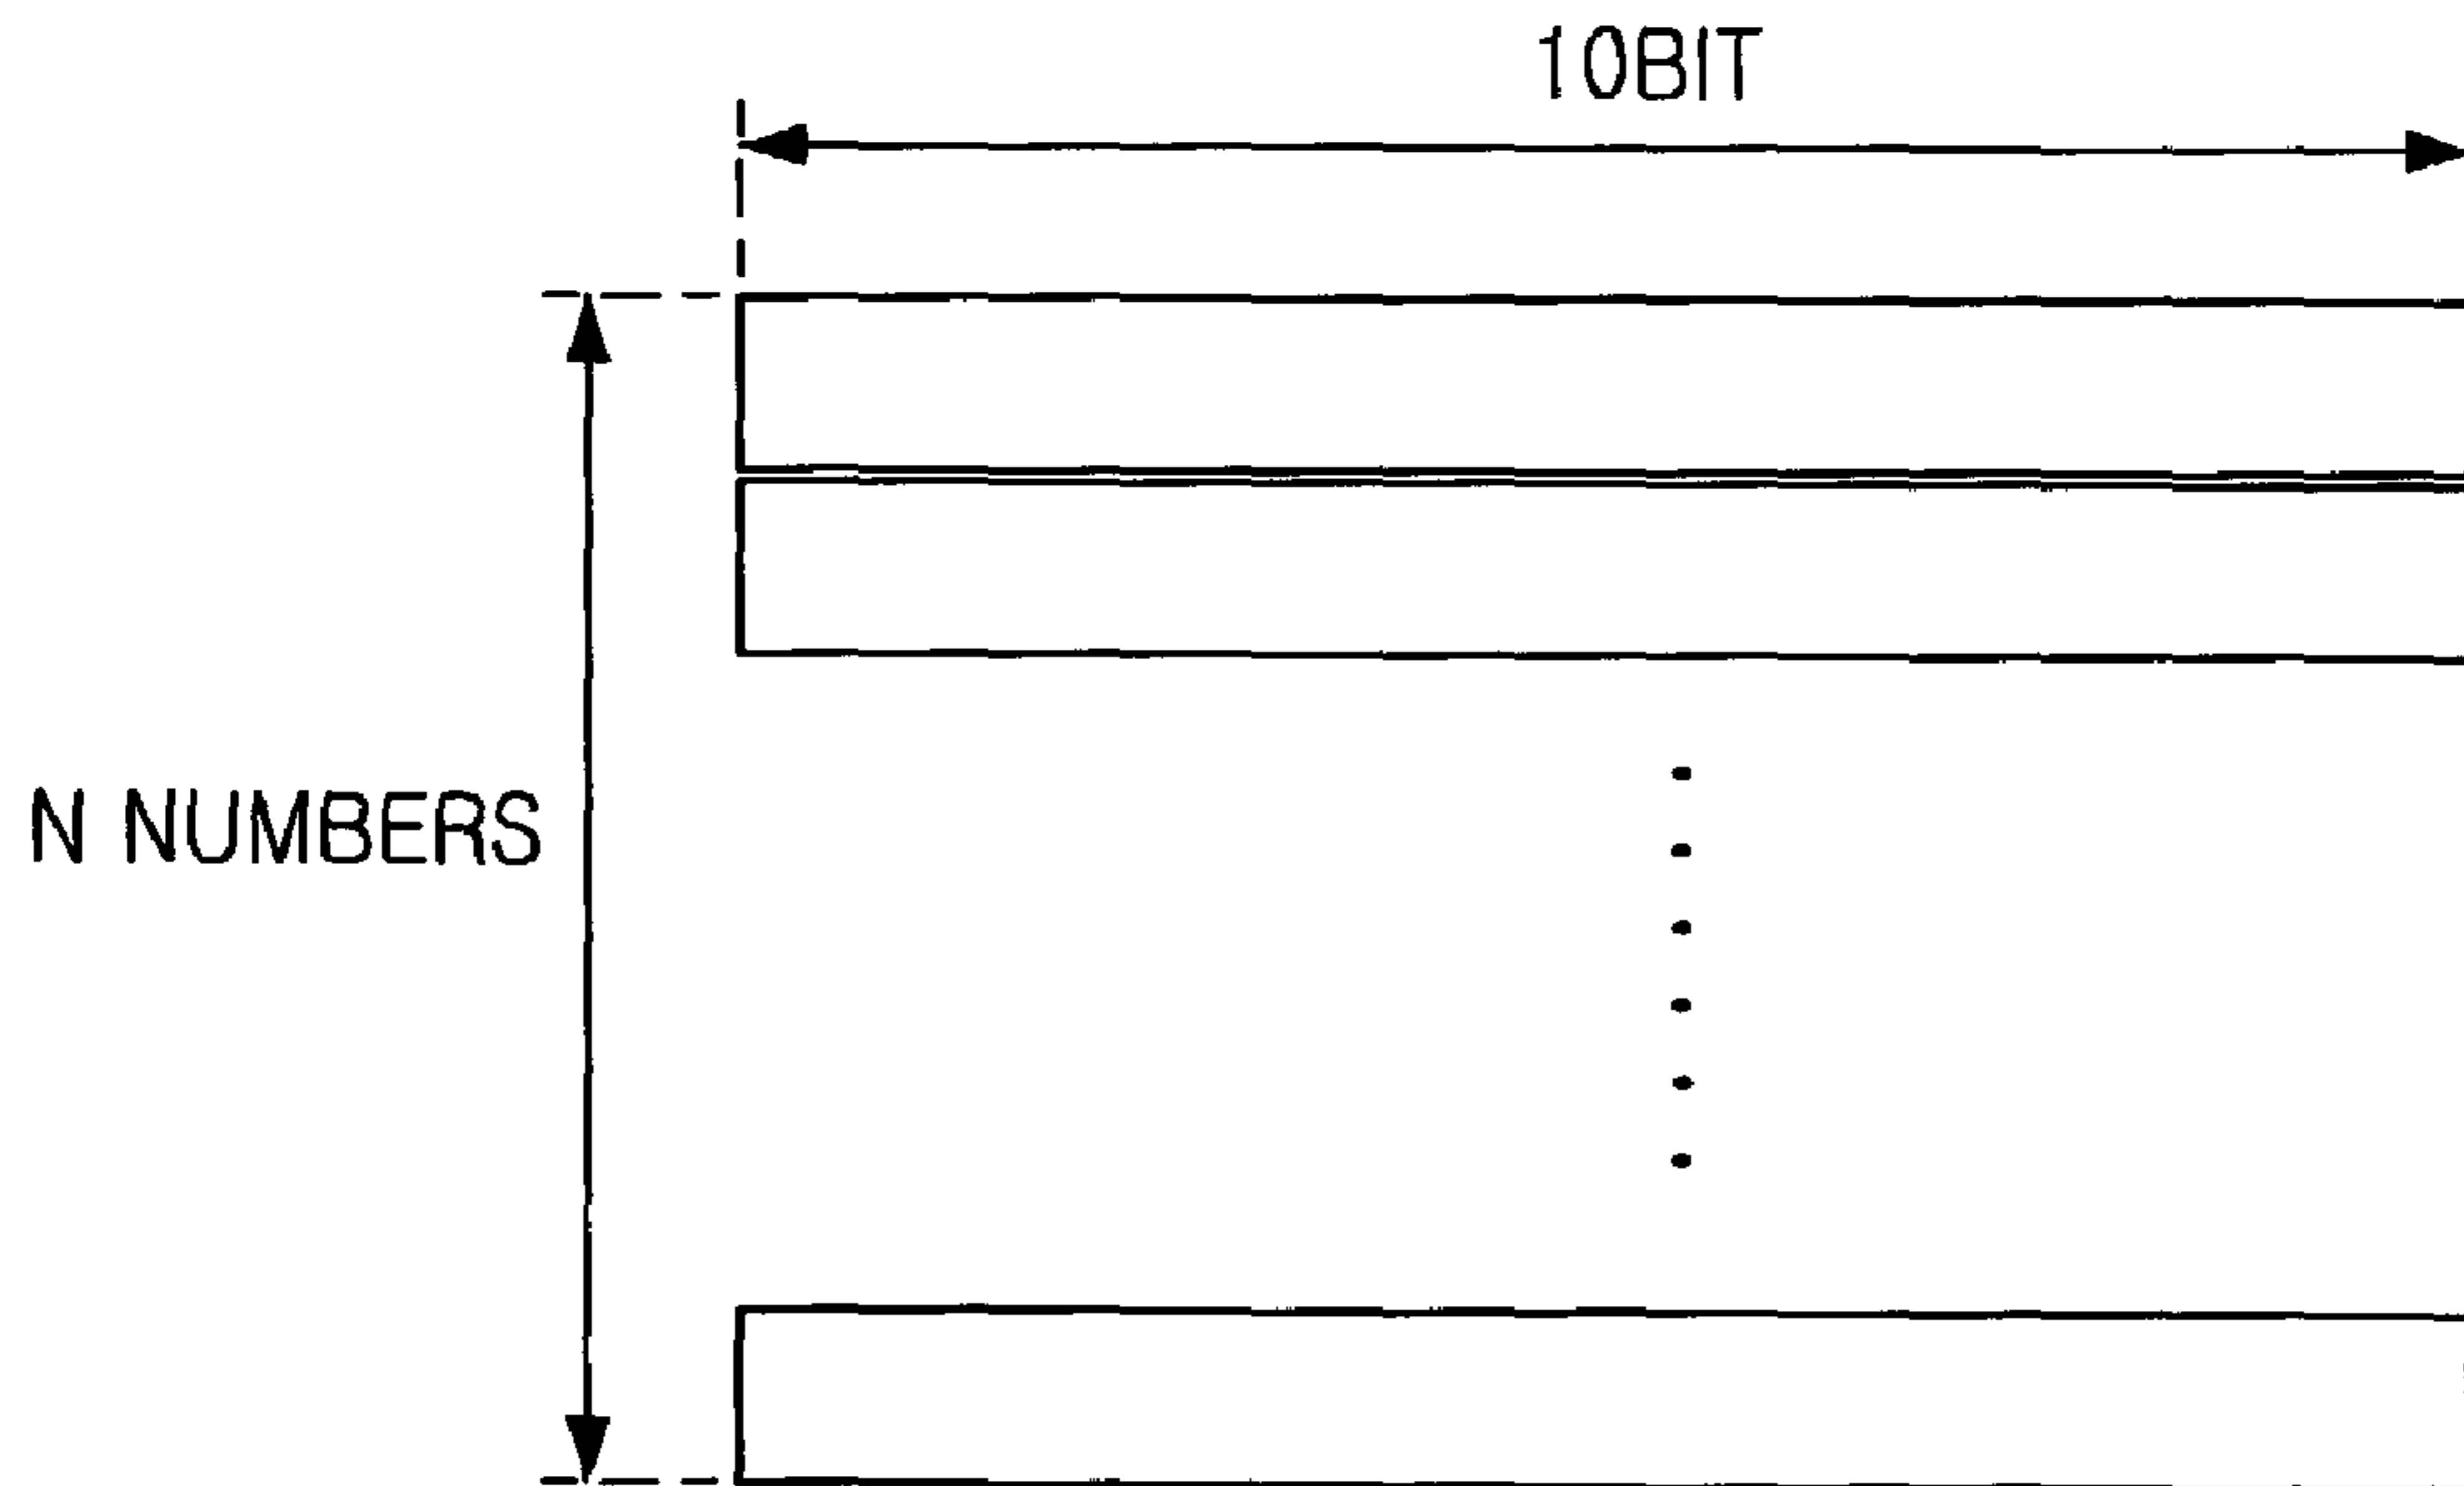
FIG. 5 is a block diagram of an example selection bit block 530 for the example of FIG. 2.

FIG. 5 is a block diagram of an example selection bit block **530**. One selection bit is required for each column address corresponding to the defective pixel. Accordingly, in order to compensate N defective pixels, N selection bits are required. The selection bit block **530** is required to correctly match the row of the pixel array selected by the row address selection block **510** with the column of the pixel array selected by the column address storage block **520** for the defective pixel. That is to say, if the defective pixels are present at (row, column) positions of (10, 100) and (20, 200) in the pixel array, respectively, fuses are off at the 10th row and the 20th row of the row address selection block **510** and the row address selection signals are generated. And, the column addresses of the defective pixels are stored in the 100th column and the 200th column of the column address storage block **520**. If the selection bit block **530** is absent, there may occur an error that the pixels at positions of (10, 200) and (20, 100) are recognized as defective pixels. Namely, the selection bit block **530** is used to avoid the above transposition error.

When a defective pixel is detected at a certain row by the row address selection block **510**, if the detected pixel is the first defective pixel at the certain row, the selection bit is set to “0” and if otherwise, set to “1.” Of course, the logic value of the selection bit can also be inversely defined according to the circuit configuration.
