(10) **Patent No.:** **US 7,090,393 B2**
(45) **Date of Patent:** **Aug. 15, 2006**

(54) **USING THERMAL IMAGING TO PREVENT LOSS OF STEAM TURBINE EFFICIENCY BY DETECTING AND CORRECTING INADEQUATE INSULATION AT TURBINE STARTUP**

(73) Assignee: **General Electric Company**, Schenectady, NY (US)

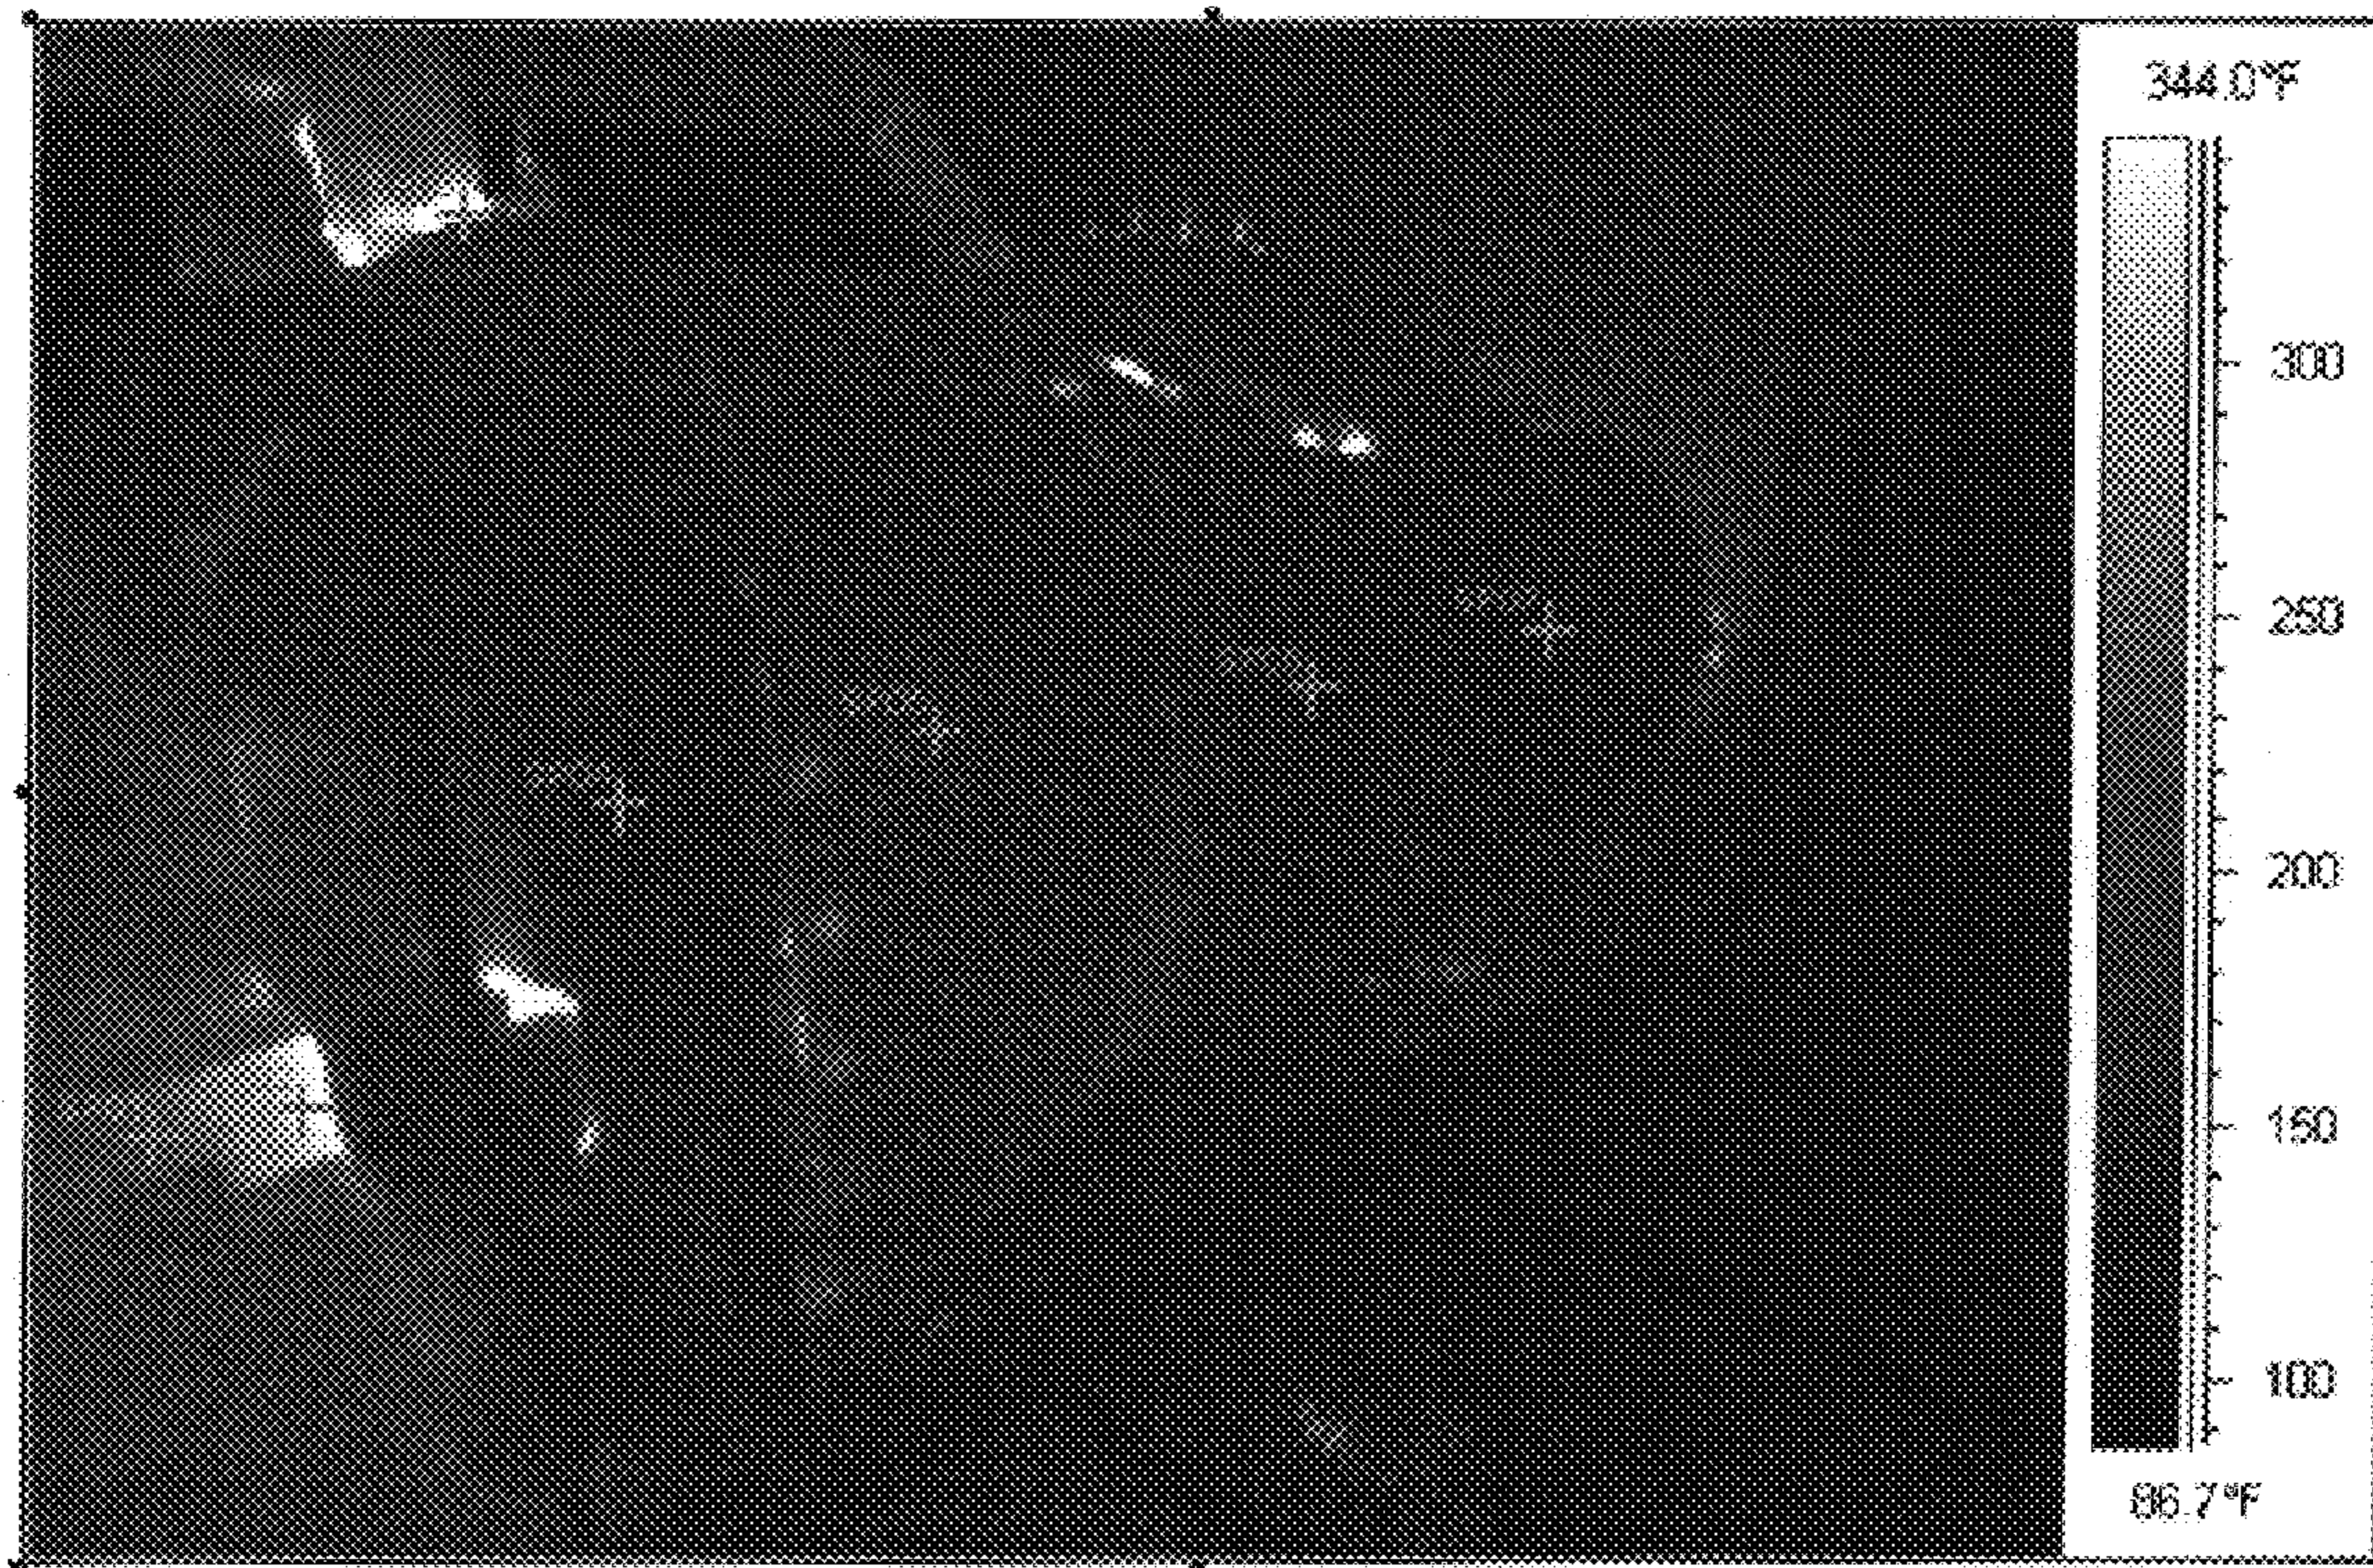
Figure 1

FIG. 1 is an example of an infrared image of a steam turbine taken during start-up by digital thermal imaging equipment.

Vibration data is frequently acquired during steam turbine startup. FIG. 1 shows an example of an infrared image taken of a steam turbine with new insulation, by digital thermal imaging equipment, and which can then be used in conjunction with acquired vibration data. As shown, in FIG. 1, location SP02 reflects a temperature more than 200° F. hotter than location SP04.

The exterior temperatures can then be correlated with the turbine vibration data to determine which insulation temperature patterns reflect insulation poor enough to cause packing seal teeth to rub and the turbine to vibrate during operation or shut-down due to uneven or rapid temperature changes in the steam turbine shells. From the thermal images and vibration data, control limits can be developed for insulation surface temperature particular to a specific steam turbine or class of steam turbines.
