(10) **Patent No.:** **US 7,090,393 B2**
(45) **Date of Patent:** **Aug. 15, 2006**

(54) **USING THERMAL IMAGING TO PREVENT LOSS OF STEAM TURBINE EFFICIENCY BY DETECTING AND CORRECTING INADEQUATE INSULATION AT TURBINE STARTUP**

(73) Assignee: **General Electric Company**, Schenectady, NY (US)

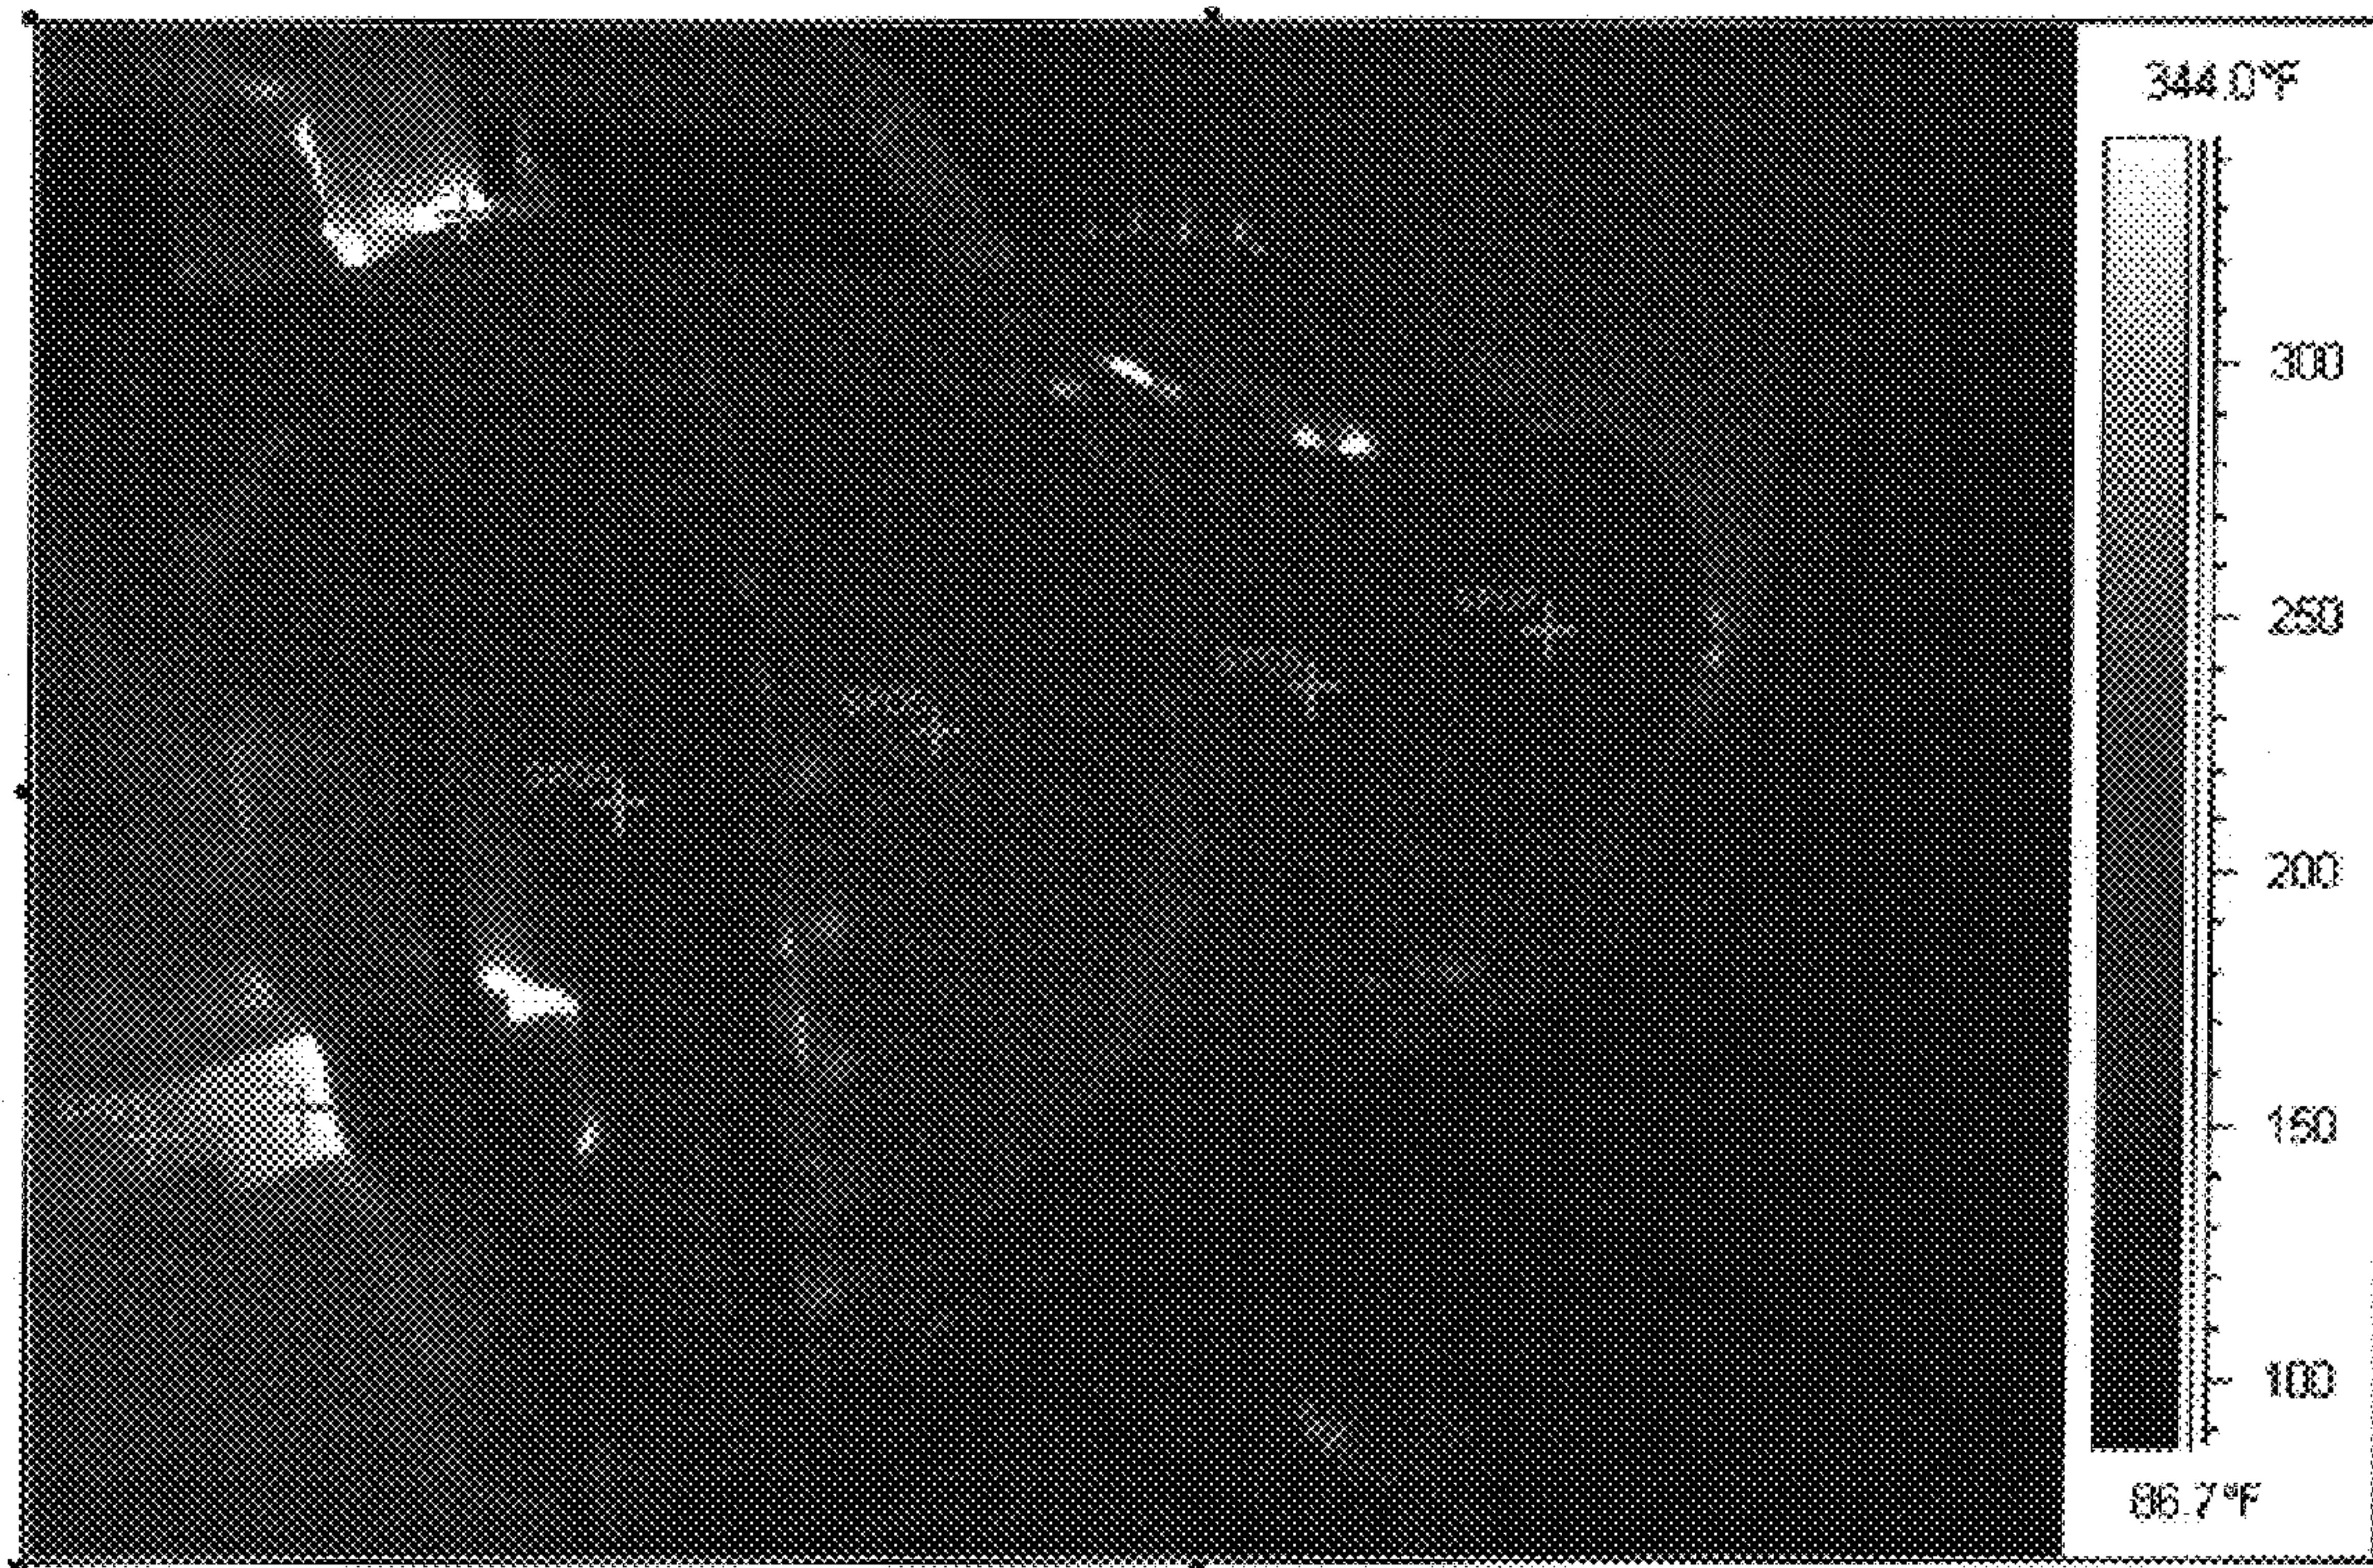
Figure 1

FIG. 1 is an example of an infrared image of a steam turbine taken during start-up by digital thermal imaging equipment.

Vibration data is frequently acquired during steam turbine startup. FIG. 1 shows an example of an infrared image taken of a steam turbine with new insulation, by digital thermal imaging equipment, and which can then be used in conjunction with acquired vibration data. As shown, in FIG. 1, location SP02 reflects a temperature more than 200° F. hotter than location SP04.

The exterior temperatures can then be correlated with the turbine vibration data to determine which insulation temperature patterns reflect insulation poor enough to cause packing seal teeth to rub and the turbine to vibrate during operation or shut-down due to uneven or rapid temperature changes in the steam turbine shells. From the thermal images and vibration data, control limits can be developed for insulation surface temperature particular to a specific steam turbine or class of steam turbines.

These procedures for using digital thermal (infrared) cameras can be developed and provided for those starting turbines that are new or have undergone maintenance. Preferably, when a turbine is started up and reaches full temperature, the thermal images are taken and evaluated against the control limits. If temperatures indicate inadequate insulation, more insulation can be added before turbine shutdown to avoid potential damage to packing seals.
