US007145148B2

(10) Patent No.: US 7,145,148 B2

(54) SYSTEMS AND METHODS FOR NON-DESTRUCTIVELY DETECTING MATERIAL ABNORMALITIES BENEATH A COATED SURFACE

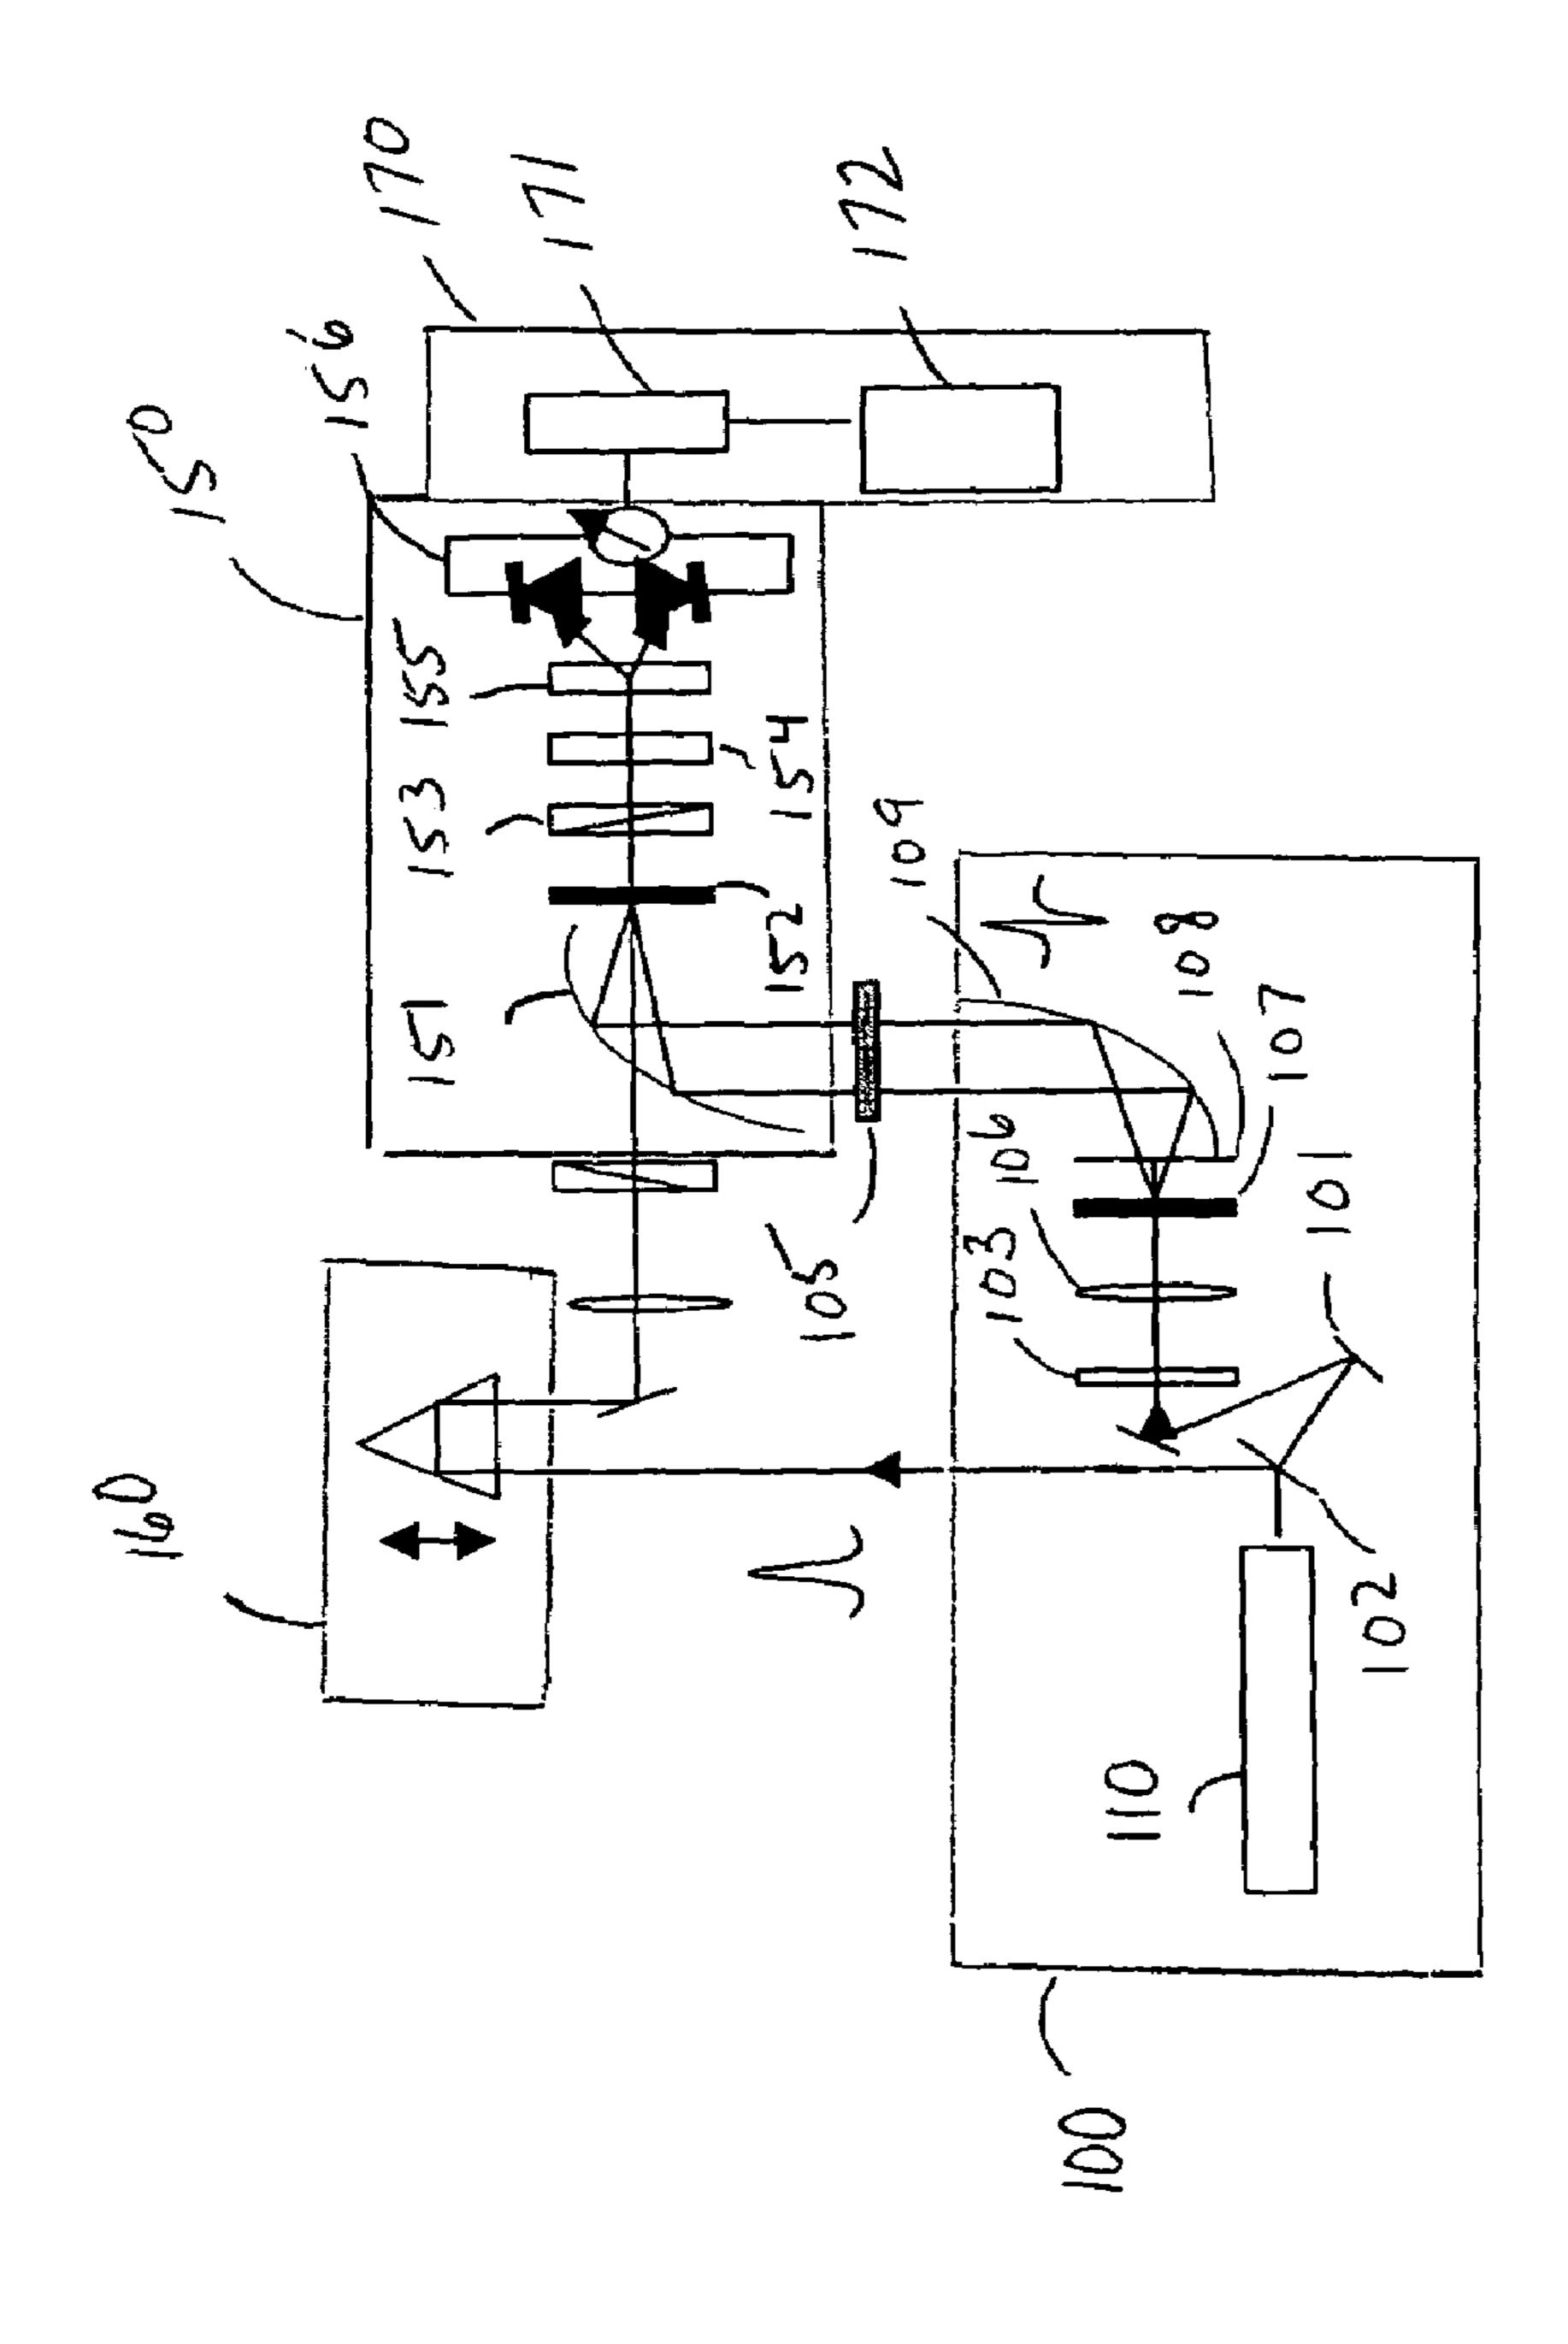
H. C.

FIG. 1 is a diagram illustrating a system for measuring an optical transmission of a paint according to an embodiment of the present invention;

FIG. 1 is a diagram illustrating a system for measuring an optical transmission of a paint according to an embodiment of the present invention. Referring to FIG. 1, the system includes a THz illumination unit 100, a detection unit 150, 30 a time delay 160, and a processing unit 170. The THz illumination unit 100 creates and directs THz light (radiation) to a sample 105, which is a substrate that is at least partially coated with the paint being tested. The THz light detection unit 150. Additionally, the THz illumination 100 transmits the THz light to the time delay 160, which then transmits the delayed THz light to the detection unit 150. The detection unit 150 detects received THz light and transmits detected signal information to the processing unit 40 170, which processes the signal information in order to determine the optical transmission of the paint.

The THz illumination unit 100 includes a fast laser light source 110 such as fs, ps or ns lasers (solid state, semiconductor, Cr⁴⁺:YAG, fiber) and beam focusing elements. For 45 example, in FIG. 1, the beam focusing elements include mirrors 101 and 102, a chopper 103, a lens 106, an optical rectifier 107, a silicon filter 108, and a parabolic mirror 109. The beam focusing elements focus (or direct) the THz light to the sample.

The time delay unit **160** includes mirrors and controlled translation stages and is used to delay the laser pulse.

The detection unit 150, like THz illumination unit 100, also includes beam focusing elements and includes a balanced detector **156**. The beam focusing elements focus/ direct the THz light that has passed through the sample 105 to the balanced detector **156**. For example the beam focusing elements may include a parabolic mirror 151, a nonlinear semiconductor crystal 152, such as ZnTe, GaSe, GaAs or other alloy semiconductors, a polarizer **153**, a quarter wave 60 plate 154, and a Wollaston prism 155. The balanced photo detector 156, which preferably consists of two photodiodes, detects the received signals and produces detected signal information, which is transmitted to the processing unit 170.

The processing unit 170 may include a lock-in amplifier 65 171 for processing the detected signal information received from the detection unit, and a computer 172 for digitizing

and storing the processed signals for further computation and/or analysis. From the processed signals, it is possible to determine the transmittance of the paint at different frequencies.

Hereinbelow, a description will be given of an operation for determining the transmittance of a paint sample using the system illustrated in FIG. 1.

Preferably, the THz light source 110 is a mode-locked Ti:sapphire amplifier system that provides 200-fs pulses at a wavelength of 800 nm with a repetition rate of 250 kHz. Additionally, it is preferable that the THz light is produced by optical rectification in a nonlinear medium. The optical rectification is performed by the optical rectifier 107, which can be embodied as a ZnTe crystal via second order nonlinearity coefficient $\chi^{(2)}$.

The electric field of the THz pulses after passing through the sample is detected in the crystal 153, which can be embodied as a second ZnTe crystal, via electro-optic sampling.

As illustrated in FIG. 1, the sample 105 is positioned between the THz illumination unit 100 and the detection unit 150. In actual lab experimentation, the system was enclosed in dry nitrogen purged boxes to diminish the THz absorption due to ambient humidity. Pulses of different optical duration from ps to fs in the far infrared region can be produced and detected using $\chi^{(2)}$ material.

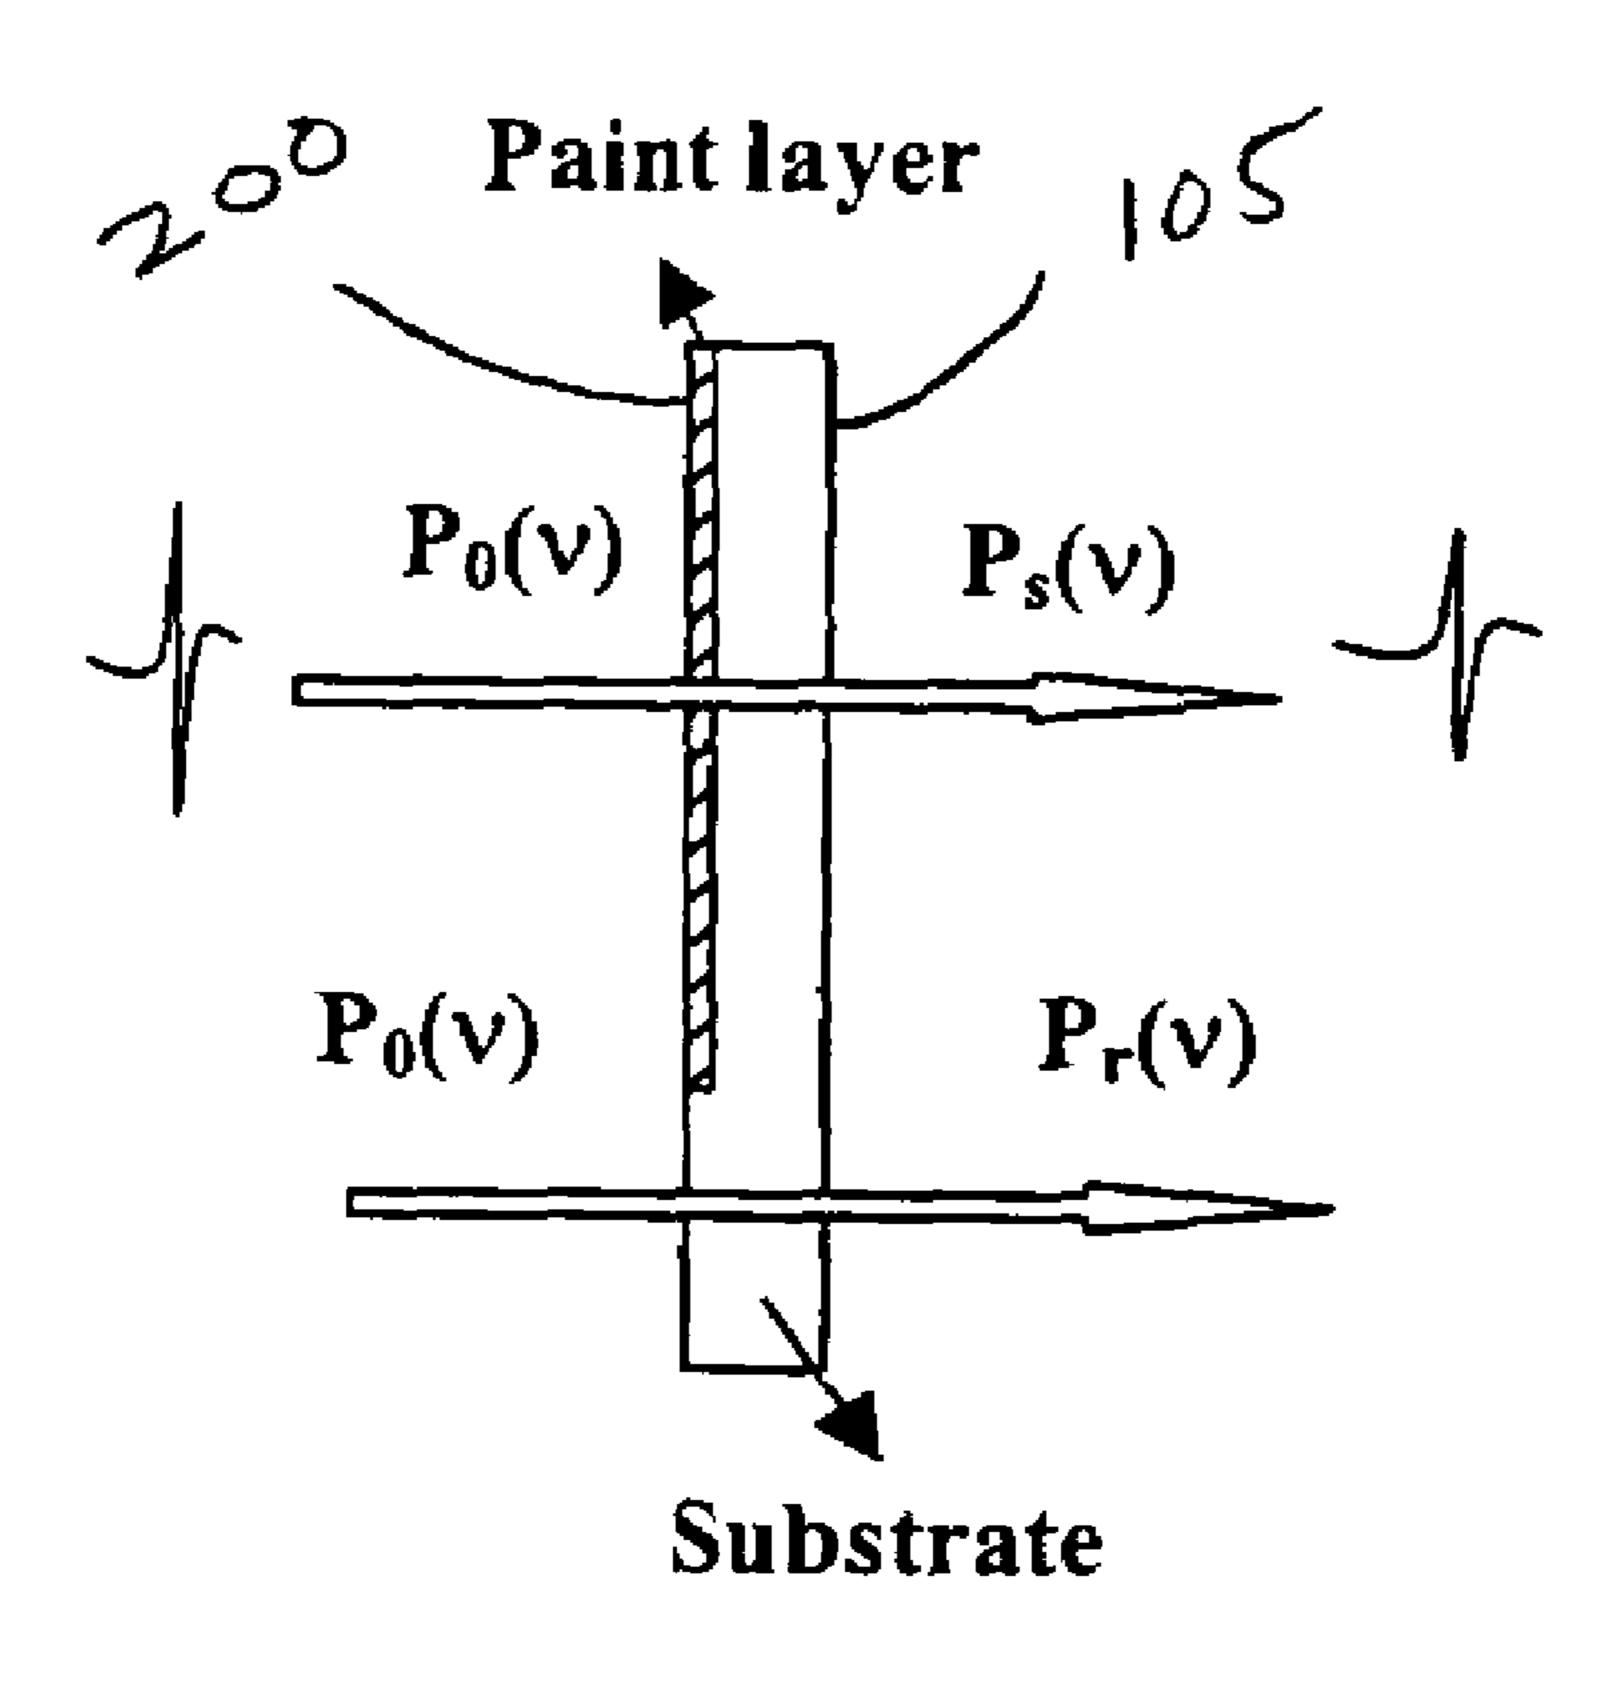
FIG. 2 is a cross-sectional view of a sample deposited on a polyethylene substrate to measure an optical transmission of a paint system according to the first embodiment of the present invention;

FIG. 2 is a cross-sectional view of a sample deposited on a polyethylene substrate to measure an optical transmission of a paint according to the first embodiment of the present invention. The sample 105 includes a paint layer 200 deposited on the polyethylene substrate to measure the optical transmission of the paint against frequency (wavelength). Assuming the non-absorbing substrate has a refractive index of $n_s=1.52\pm0.01$ at 300 K, the transmittance of the paint at passes through the sample 105 and is detected by the 35 different frequencies T(v) can be calculated from Equation

$$T(v) = \frac{4n_p^2(1 + n_s)^2}{(1 + n_p)^2(n_p + n_s)^2} \cdot \frac{P_s(v)}{P_r(v)}$$
(1)

In Equation (1), $P_s(v)$ and $P_r(v)$ are the transmitted powers of the THz light through the paint layer 200 and a reference, i.e., the non-covered portion of the substrate, respectively. n_n is the group refractive index of paint. Preferably, the thickness of the polyethylene substrate is approximately 4.0 mm to avoid interference peaks in the THz profile in the studied time zone arising from multiple reflections from the two 50 surfaces of the polyethylene substrate.

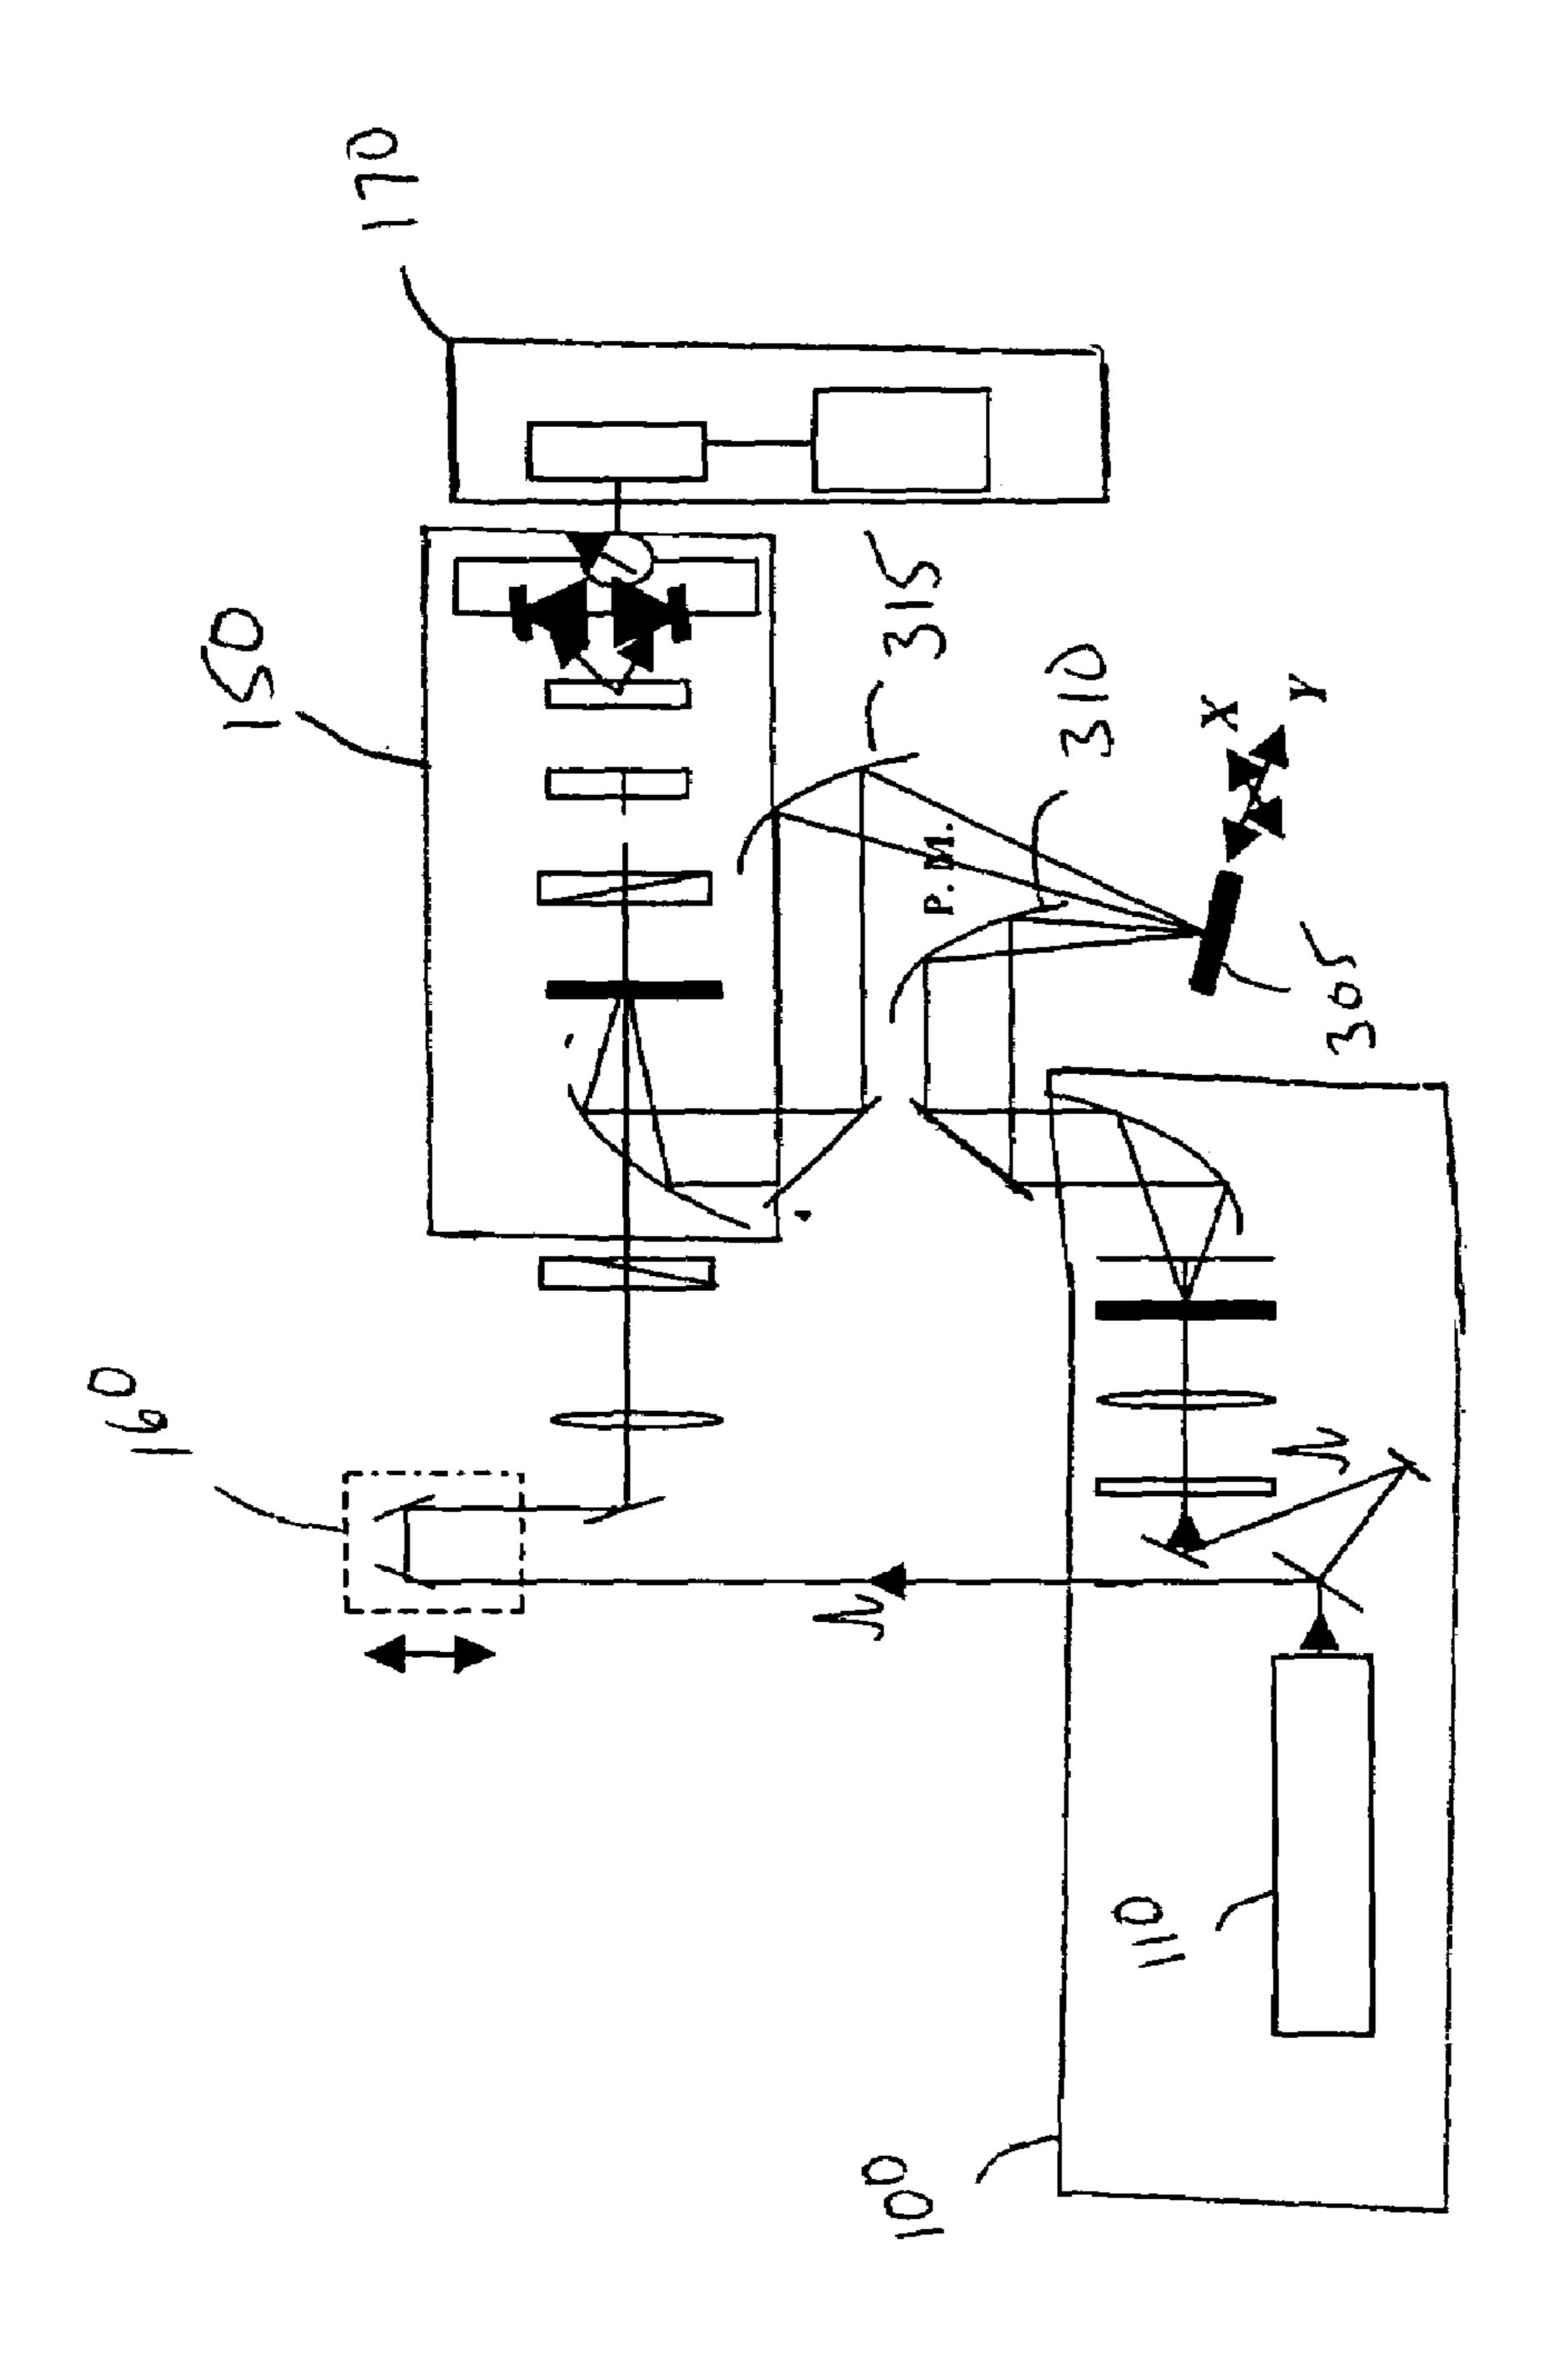
FIG. 3 is a diagram illustrating a detection system according to a second preferred embodiment of the present invention;

FIG. 3 is a diagram illustrating a detection system according to a second preferred embodiment of the present invention. More specifically, FIG. 3 illustrates a setup for detecting and imaging material abnormalities such as corrosion and/or cracks beneath the thick paint layer or zinc rich primer (up to 200 µm thick) using a THz scanning reflection imaging technique by scanning the beam on a moveable sample. As described above, the previously used NIR and MIR radiations do not pass through this type of paint.

Referring to FIG. 3, the detection system includes a THz illumination unit 100, a detection unit 150, a time delay 160, and a processing unit 170. Additionally, because these structures are substantially identical to those described in FIG. 1, a detailed description thereof will not be given again.

In FIG. 3, however, because the sample 305 is not placed between the THz illumination unit 100 and the detection unit 150, as in FIG. 1, the THz illumination unit 100 and the detection unit 150 illustrated in FIG. 3 also included parabolic mirrors 310 and 315, respectively. Parabolic mirror 5 310 is used to focus the THz light onto a specific point of the sample 305, and the parabolic mirror 315 is used capture and direct the reflected THz light from the sample into the detection unit 150. Accordingly, back reflection geometry is used to image the subsurface structure of the corroded 10 samples coated with paint or primer by scanning the beams.

Additionally, in FIG. 3, the lock-in amplifier 171 processes signals received from the detection unit 150, and the computer 172 digitizes and stores the processed signals to produce a 2-D image of the scanned area. The 2-D image of 15 the scanned area can then be stored in a memory of the computer and/or displayed on a display, such as monitor.

In order to increase the imaging area of the system illustrated in FIG. 3, the system may also includes an X-Y scanning system, which may comprise sliding stages, to 20 move the THz illumination unit 100 and the detection unit 150 relative to the sample 305.

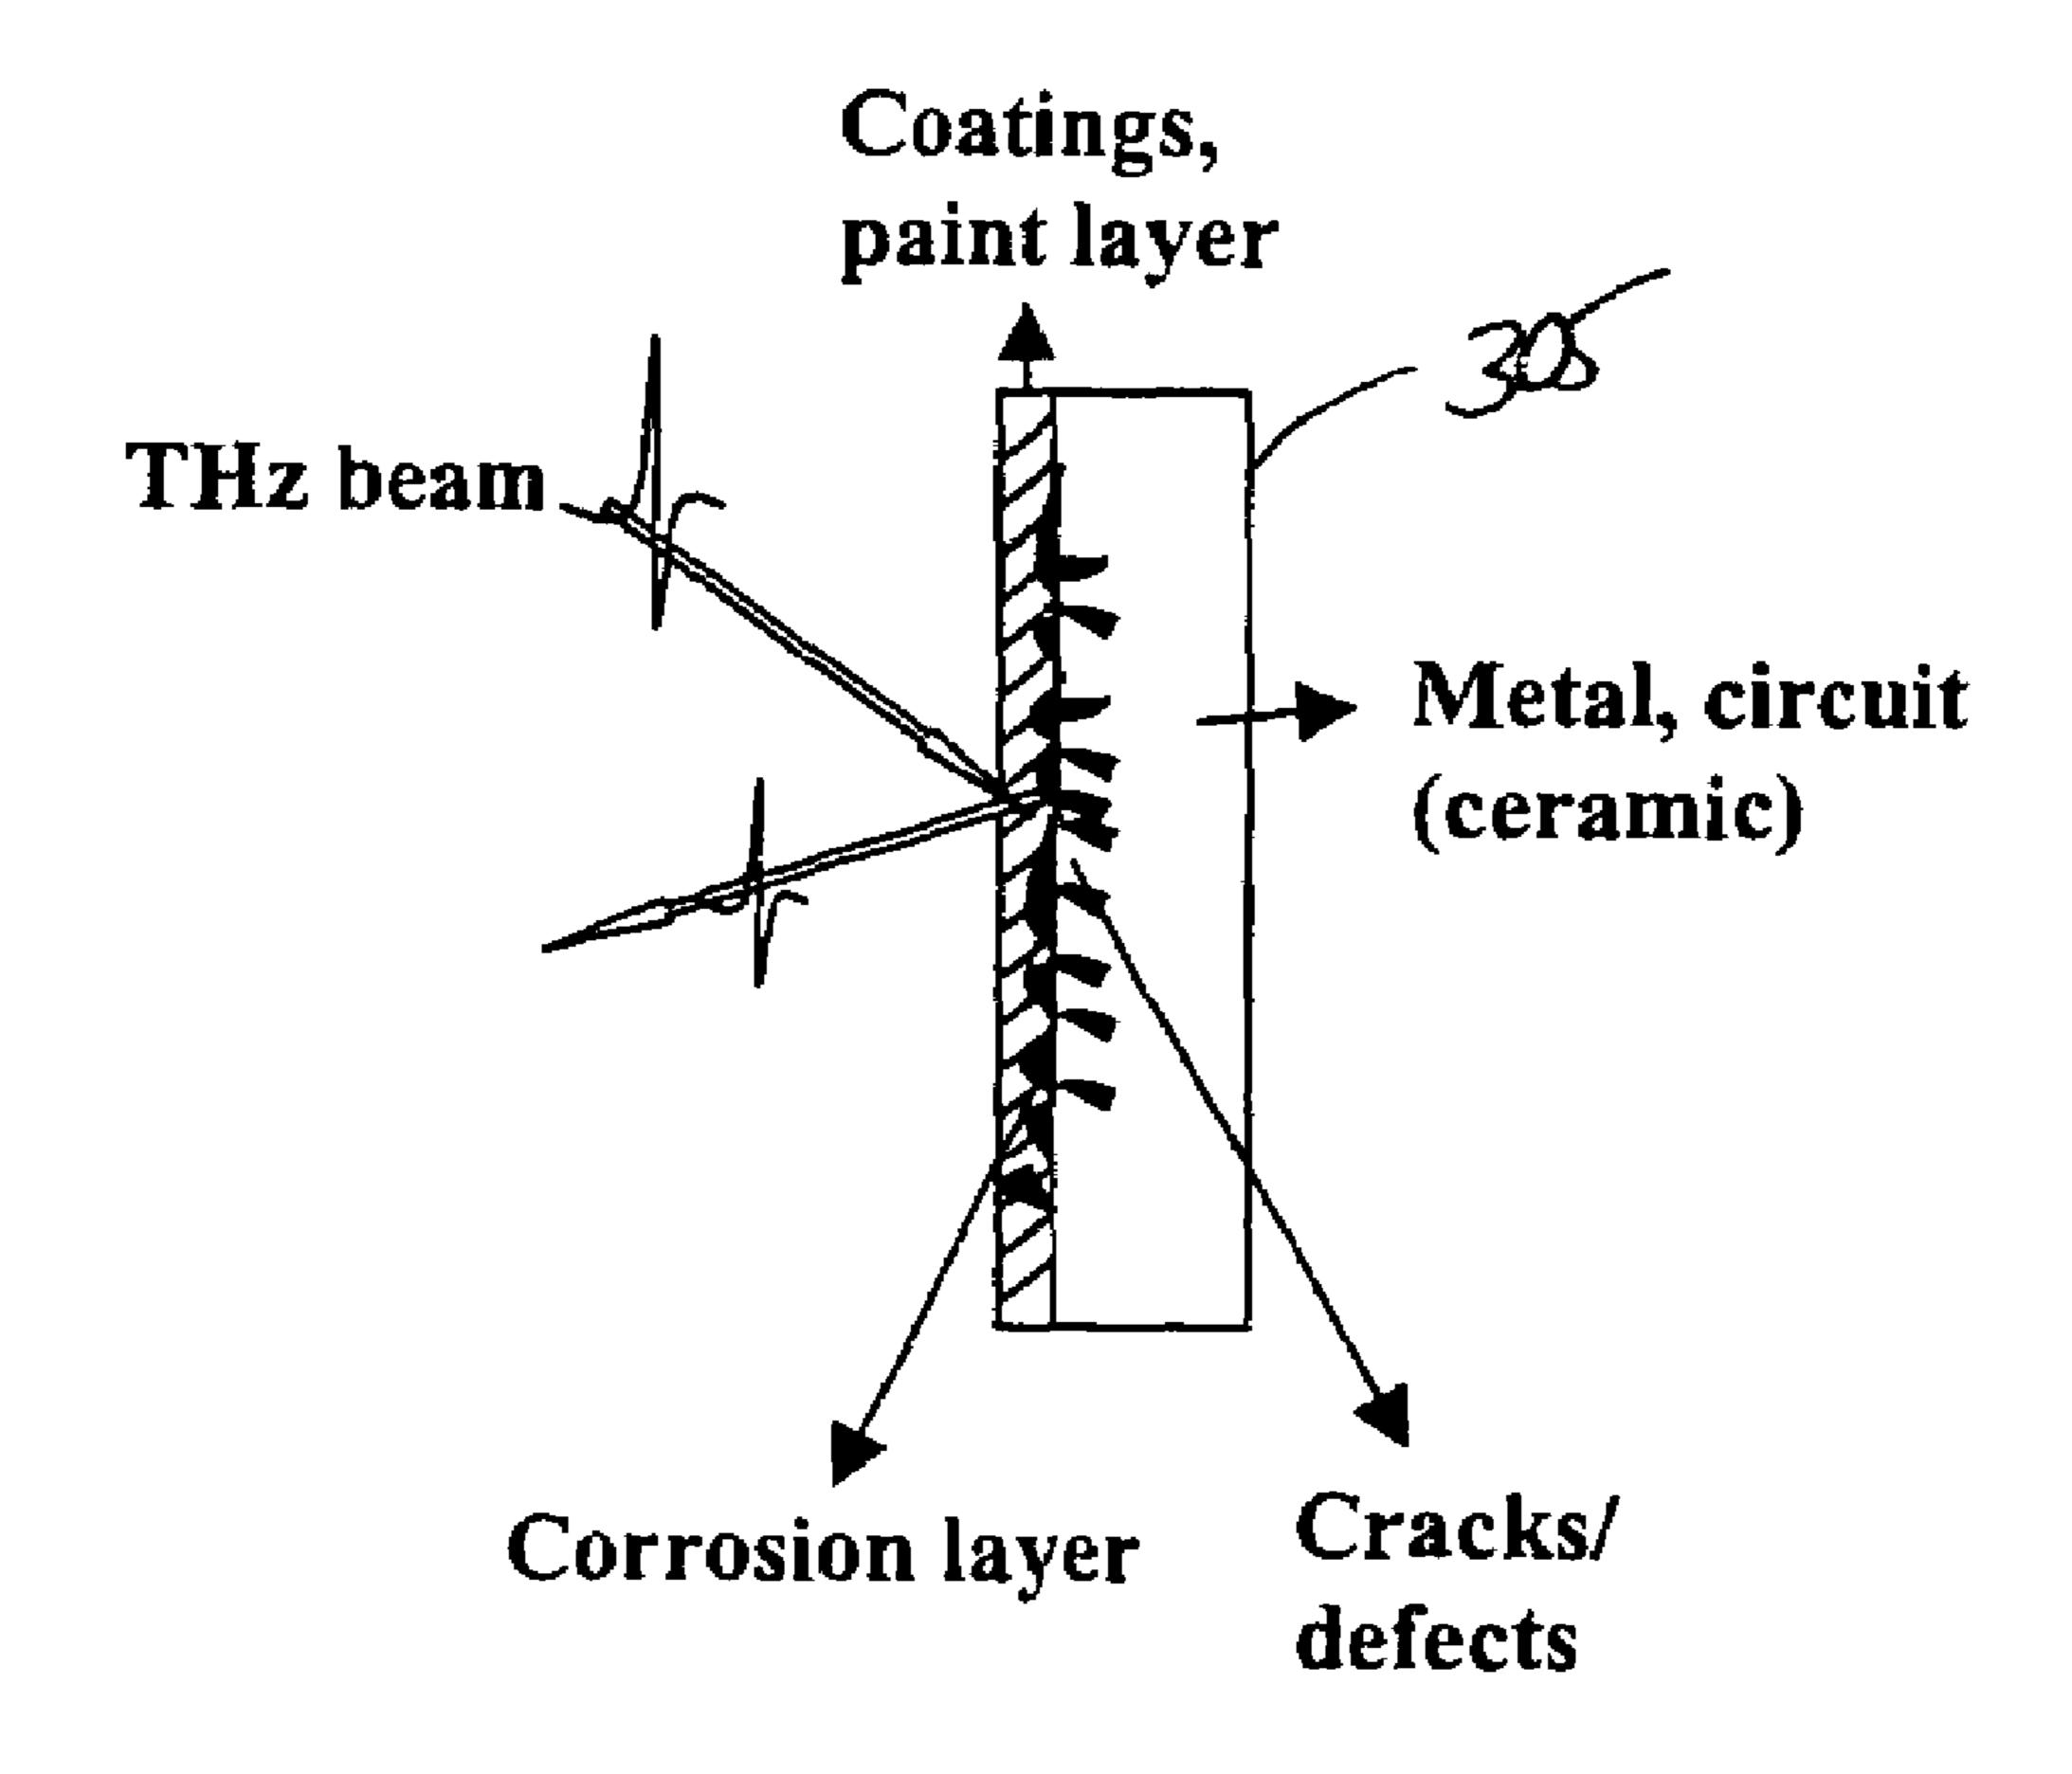
FIG. 4 is a cross-sectional view of a sample deposited on a polyethylene substrate to measure an optical transmission of a paint system according to the second embodiment of the present invention;

FIG. 4 is a cross-sectional view of a sample deposited on a polyethylene substrate to measure an optical transmission of a paint system according to the second embodiment of the present invention. Referring to FIG. 4, the THz light focused to a diffraction-limited spot on the sample 305, and the reflected THz waveforms are acquired and processed in real time at each point of the sample. Preferably, the sample is scanned in x and y directions at a rate of approximately 30 10–20 pixels/s to form an image in the computer 172. By analyzing the temporal waveform reflected from the sample 305 at every pixel of the object in real time, information on the surface of the sample 305 can be inferred in many cases. Information under coatings of circuit boards, computer 35 chips, bridges, boats, etc., about defects can be obtained using THz-TDS.

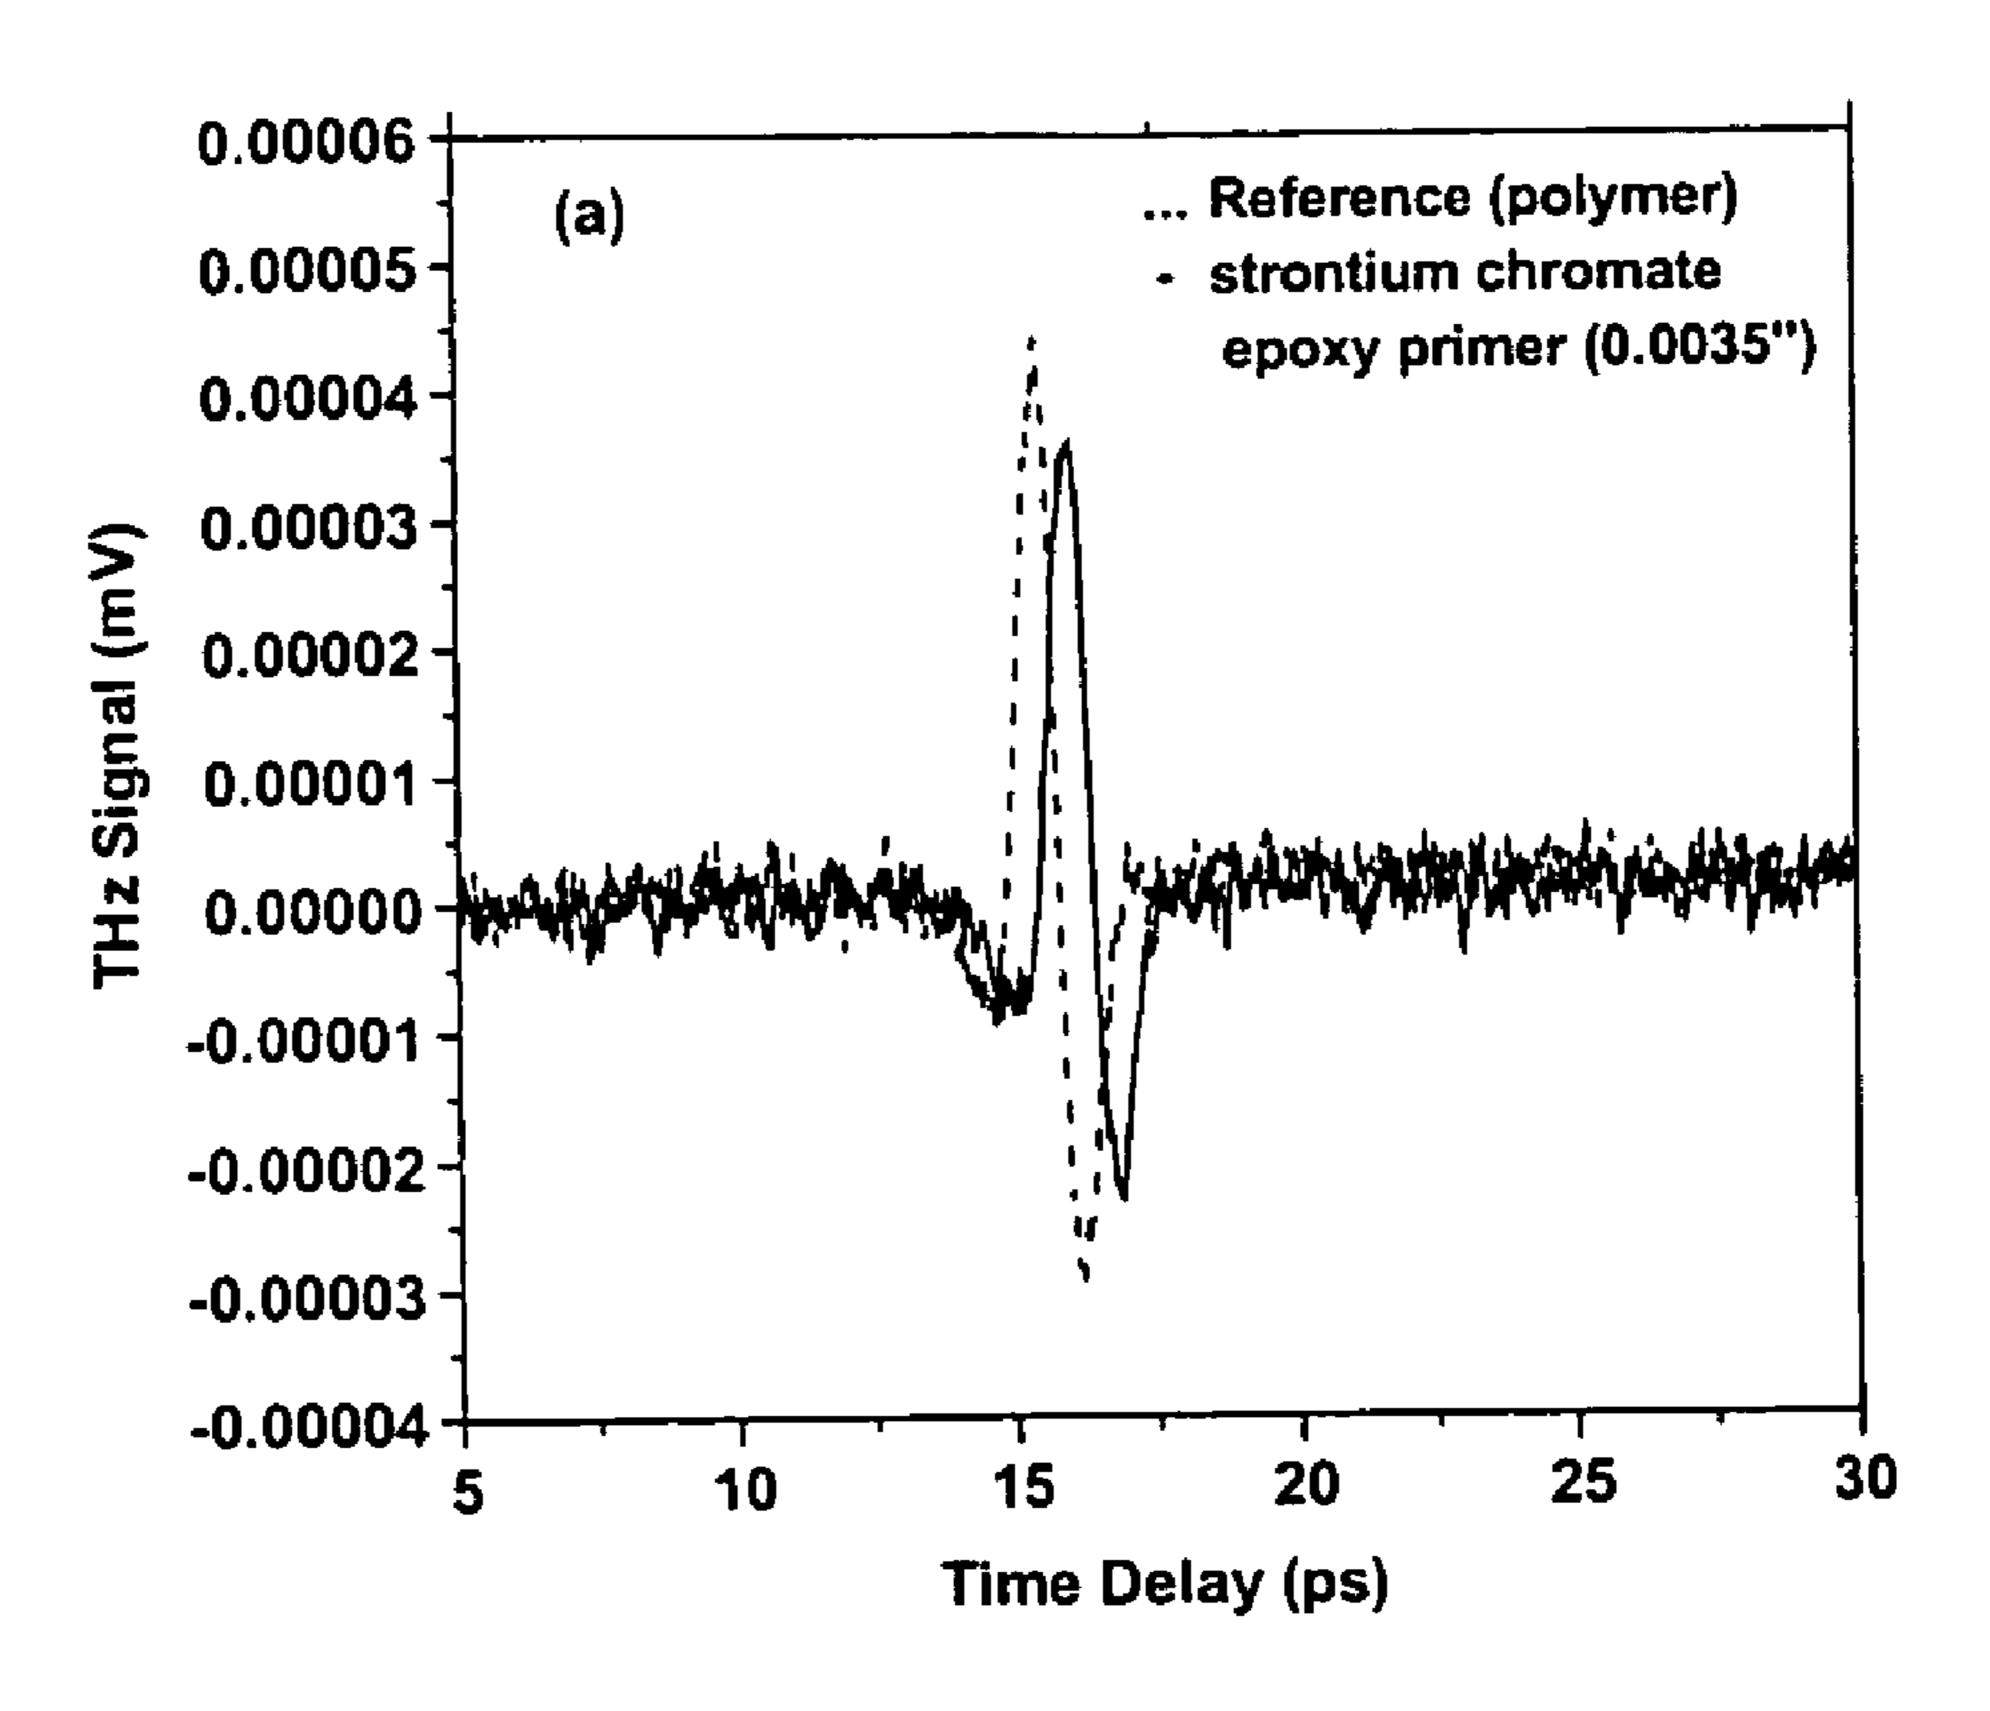
FIG. **5** is a graph illustrating THz temporal profiles of strontium chromate epoxy primer (Mil-P-23377) after passing through a pure polymer polyethylene substrate as reference;

- FIG. 5 is a graph illustrating the THz temporal profiles of strontium chromate epoxy primer (Mil-P-23377) after passing through a pure polymer polyethylene substrate as reference.
- FIG. 6 is a graph illustrating the THz transmitted profiles through primer layer. The transmission through the paint is more than 40%.
- FIG. 7 is a graph illustrating the THz temporal profiles of inorganic zinc rich primer (Dimetcote D9 HS) after passing 50 through a pure polymer polyethylene substrate as reference. The thickness of the primers are 0.0027", 0.005" and 0.008", respectively.
- FIG. 8 is a graph illustrating the THz transmitted profiles through primer films with different thickness in the fre- 55 quency range 0.2 to 2.0 THz. At 0.7 THz, the transmission is more than 20%.

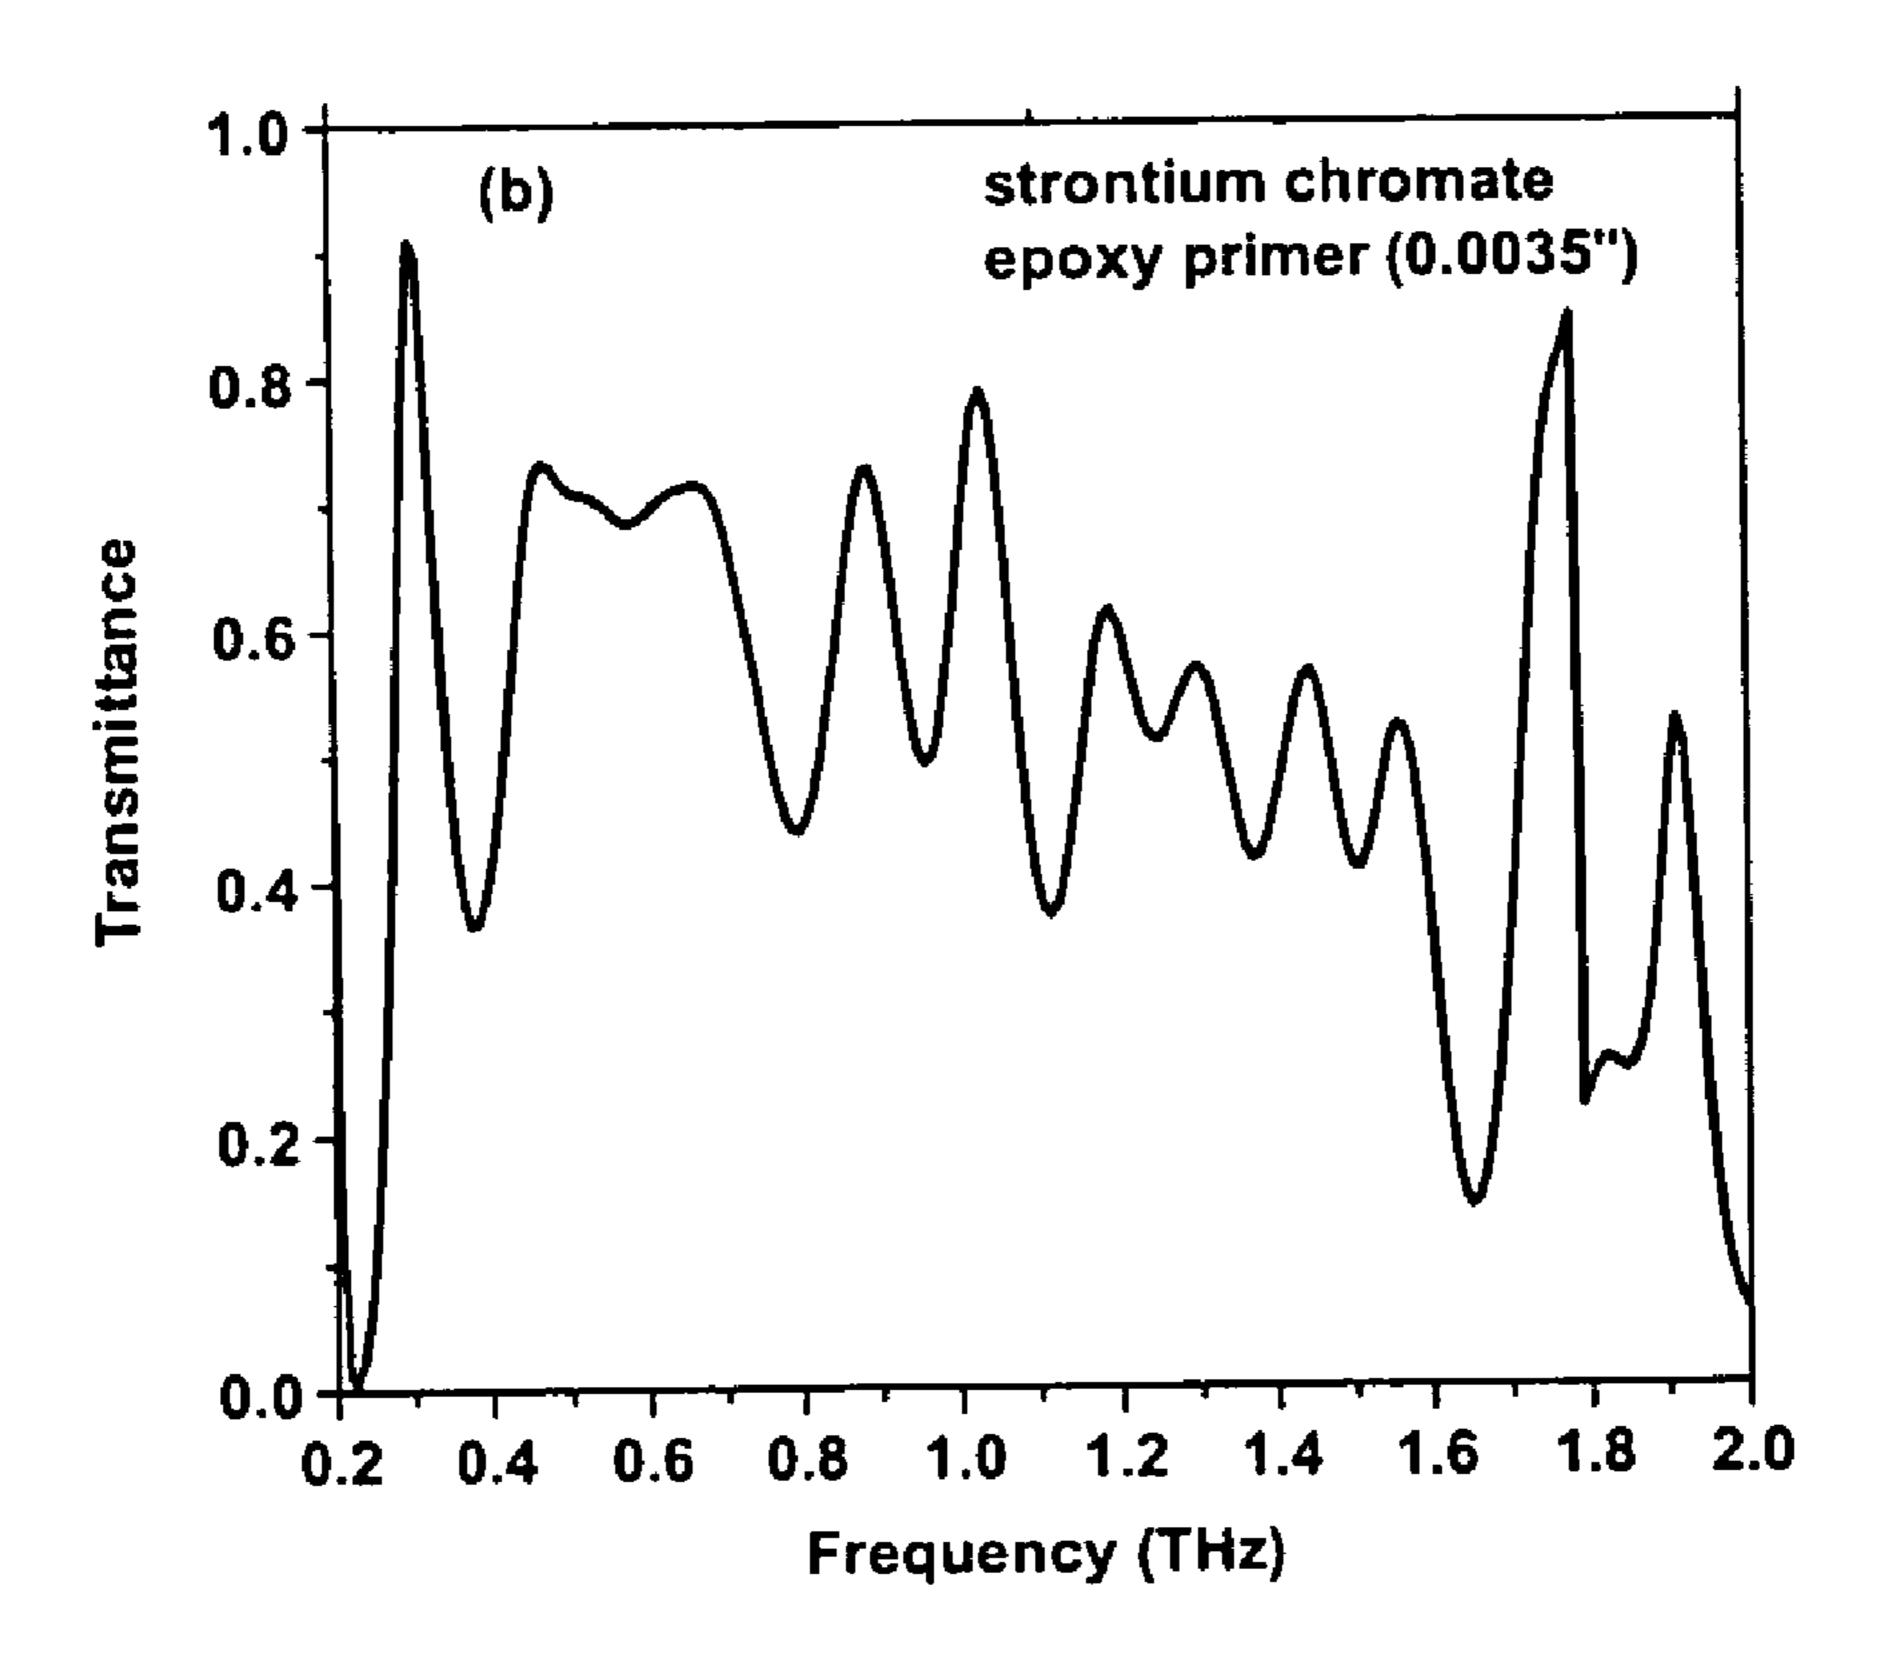
FIG. 6 is a graph illustrating THz transmitted profiles through a primer;
