US007145148B2

(10) Patent No.: US 7,145,148 B2

(54) SYSTEMS AND METHODS FOR NON-DESTRUCTIVELY DETECTING MATERIAL ABNORMALITIES BENEATH A COATED SURFACE

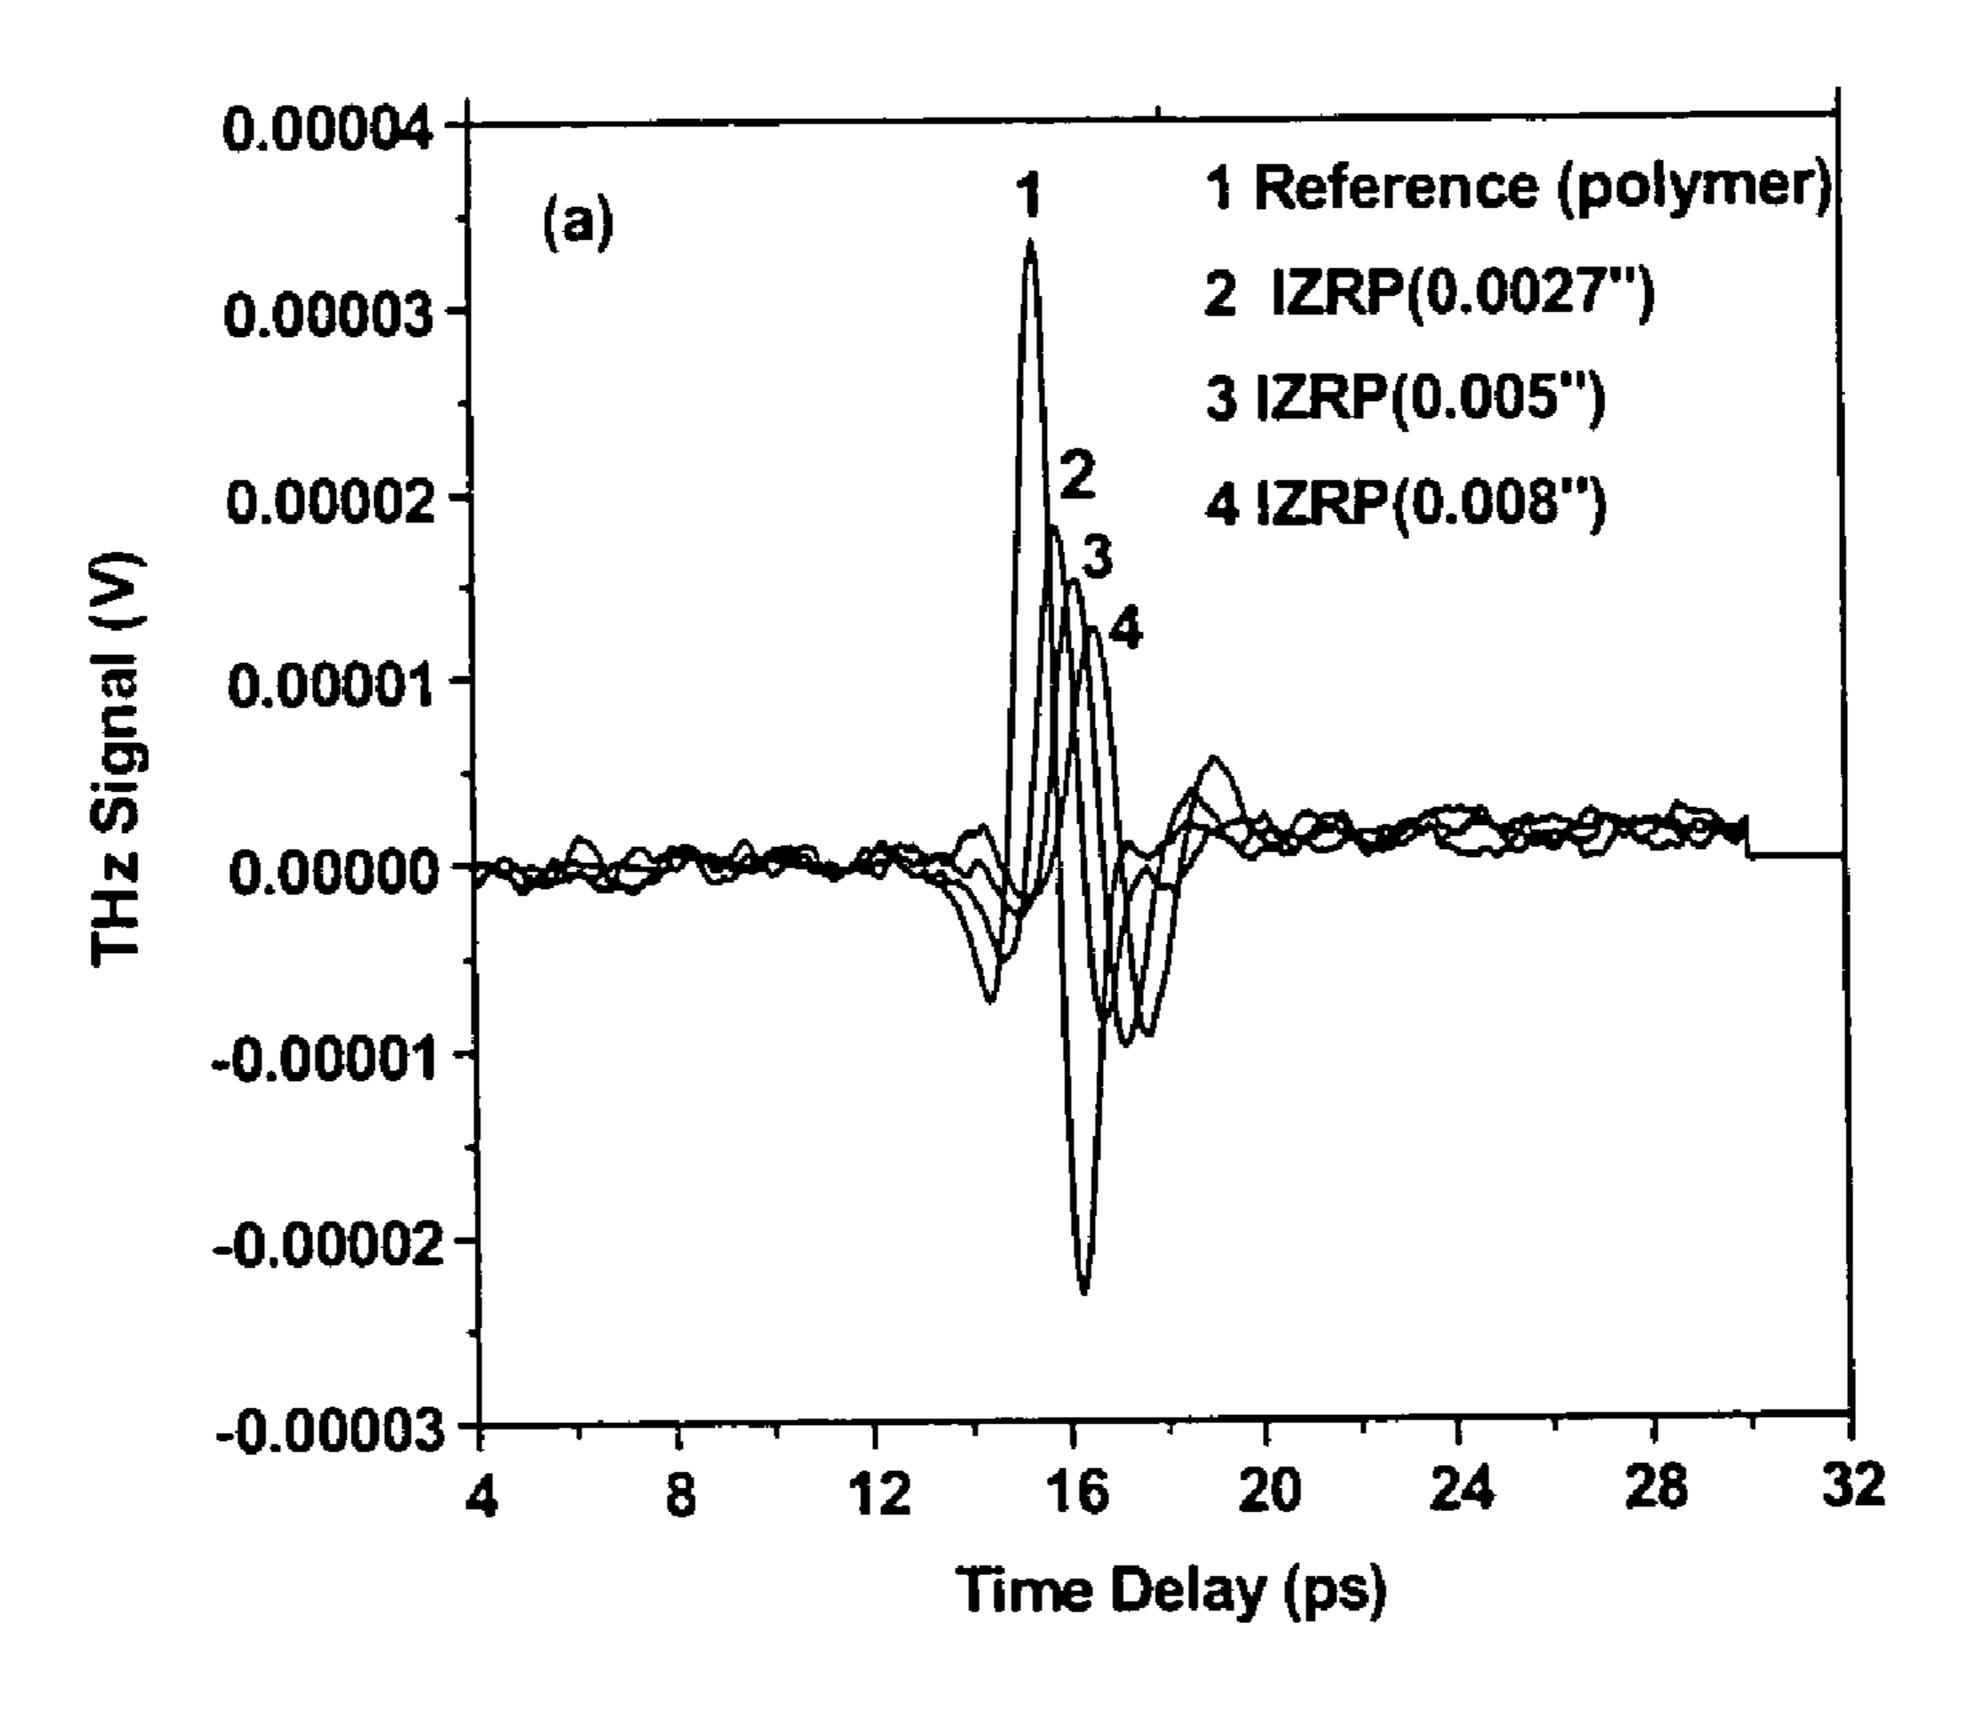
FIG. 7 is a graph illustrating THz temporal profiles of inorganic zinc rich primer (Dimetcote D9 HS) after passing through a pure polymer polyethylene substrate as reference;

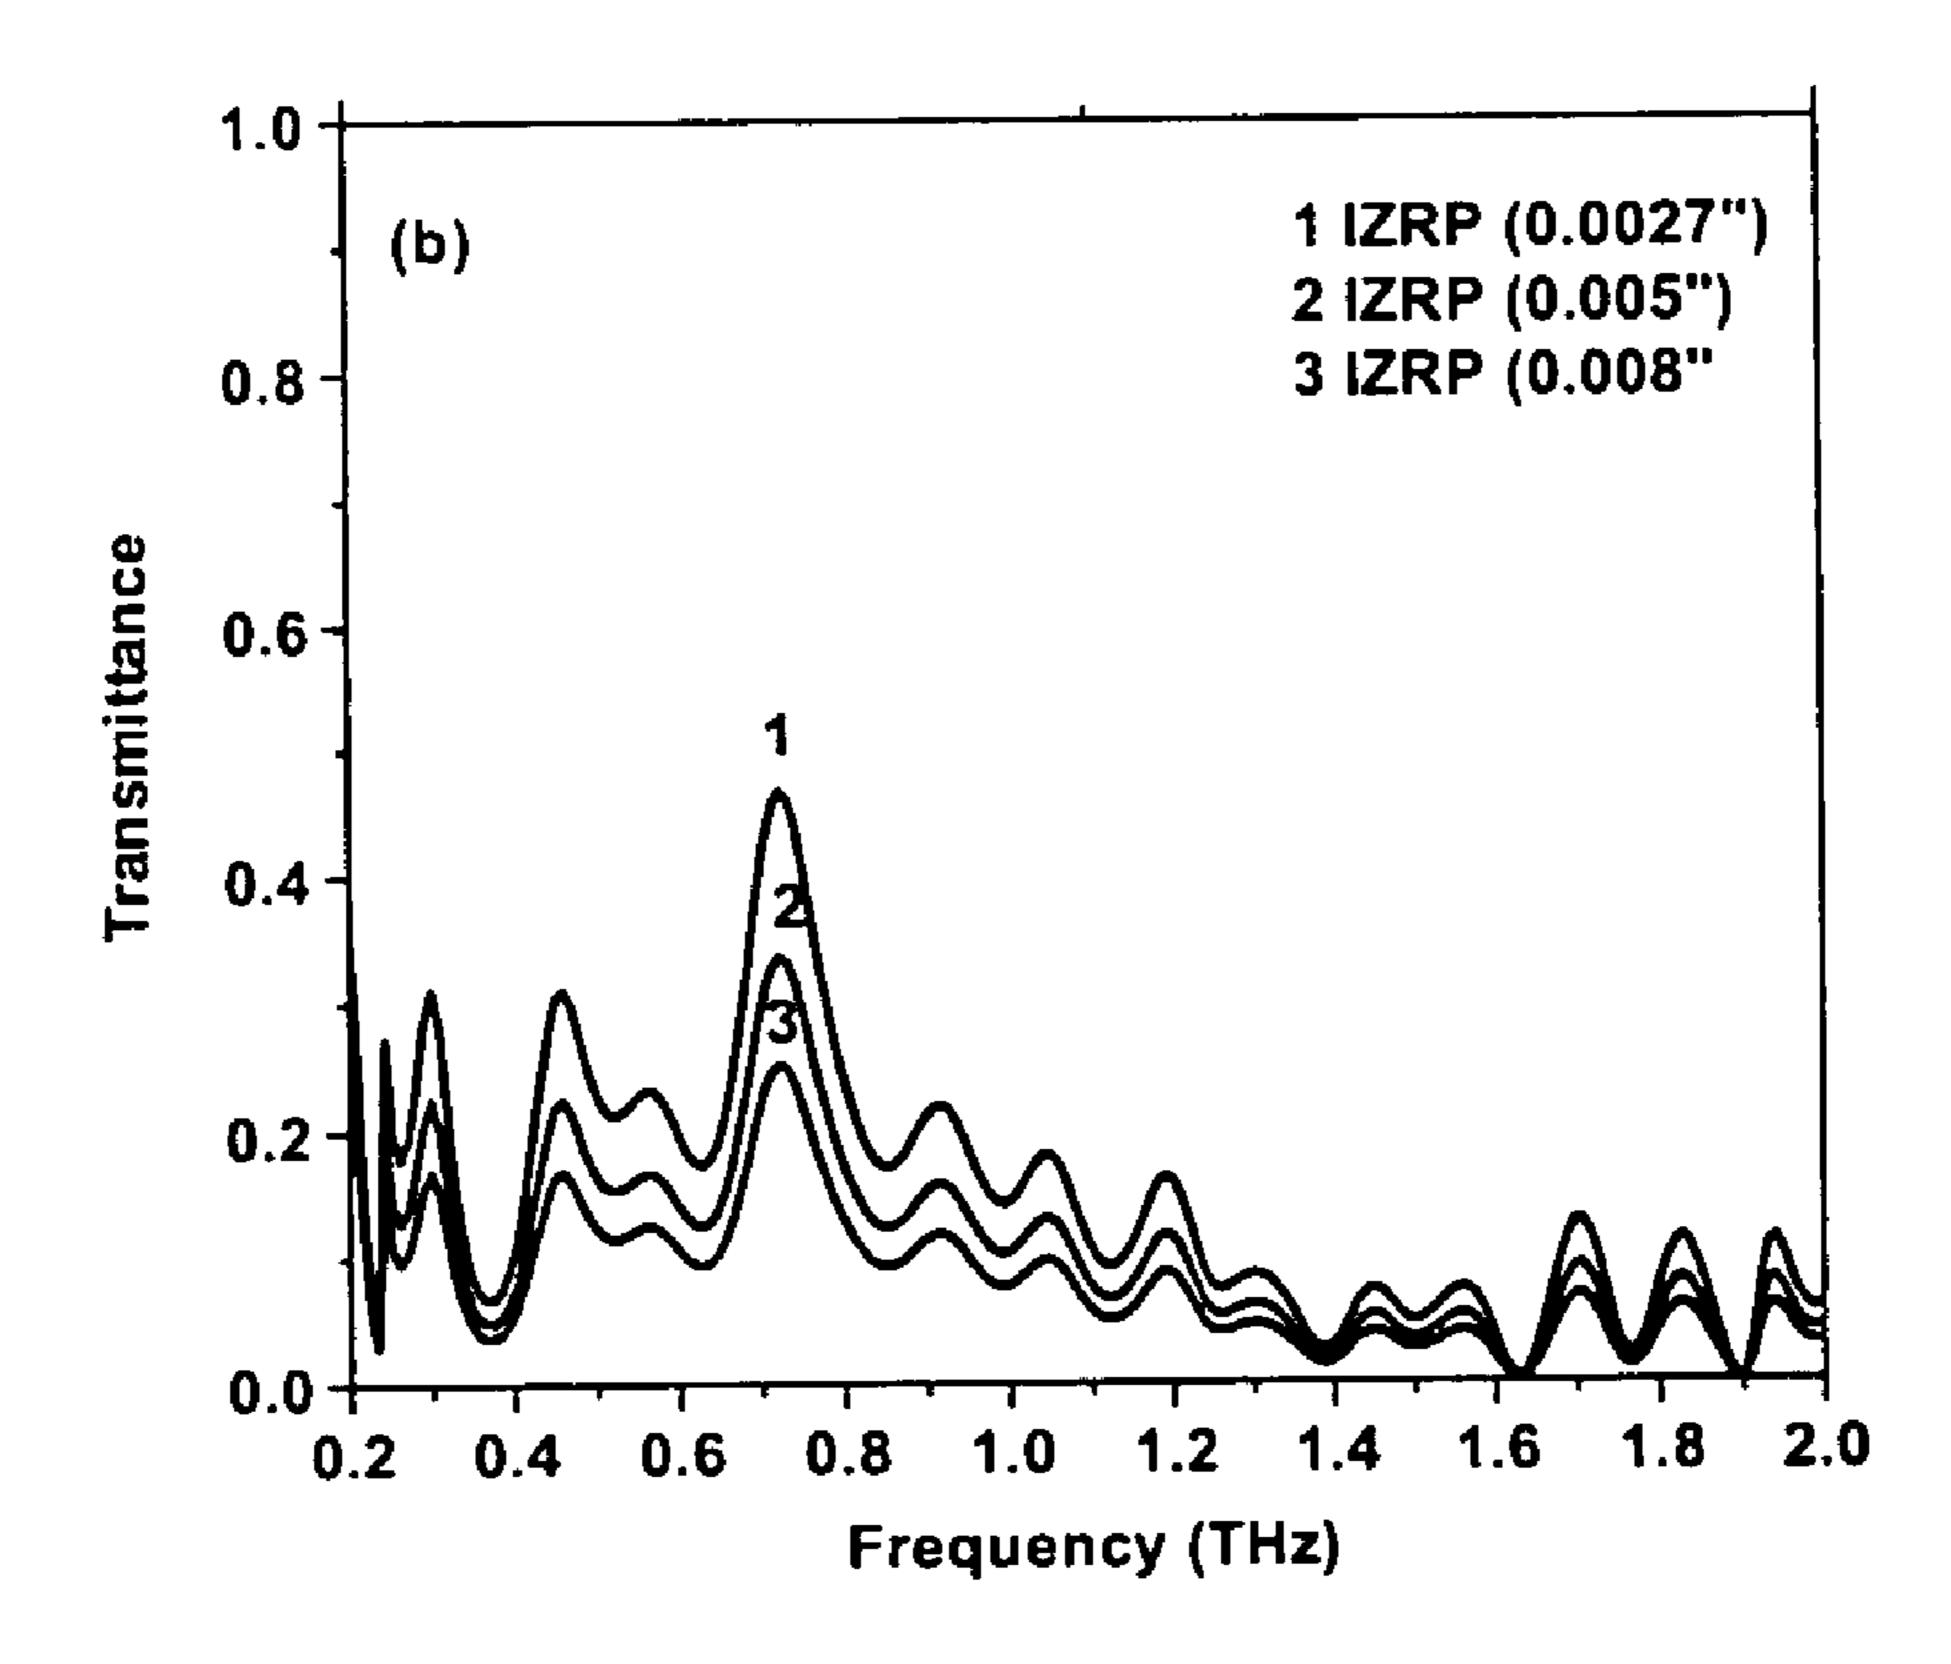
FIG. 8 is a graph illustrating THz transmitted profiles through primer films with different thickness in the frequency range 0.2 to 2.0 THz;

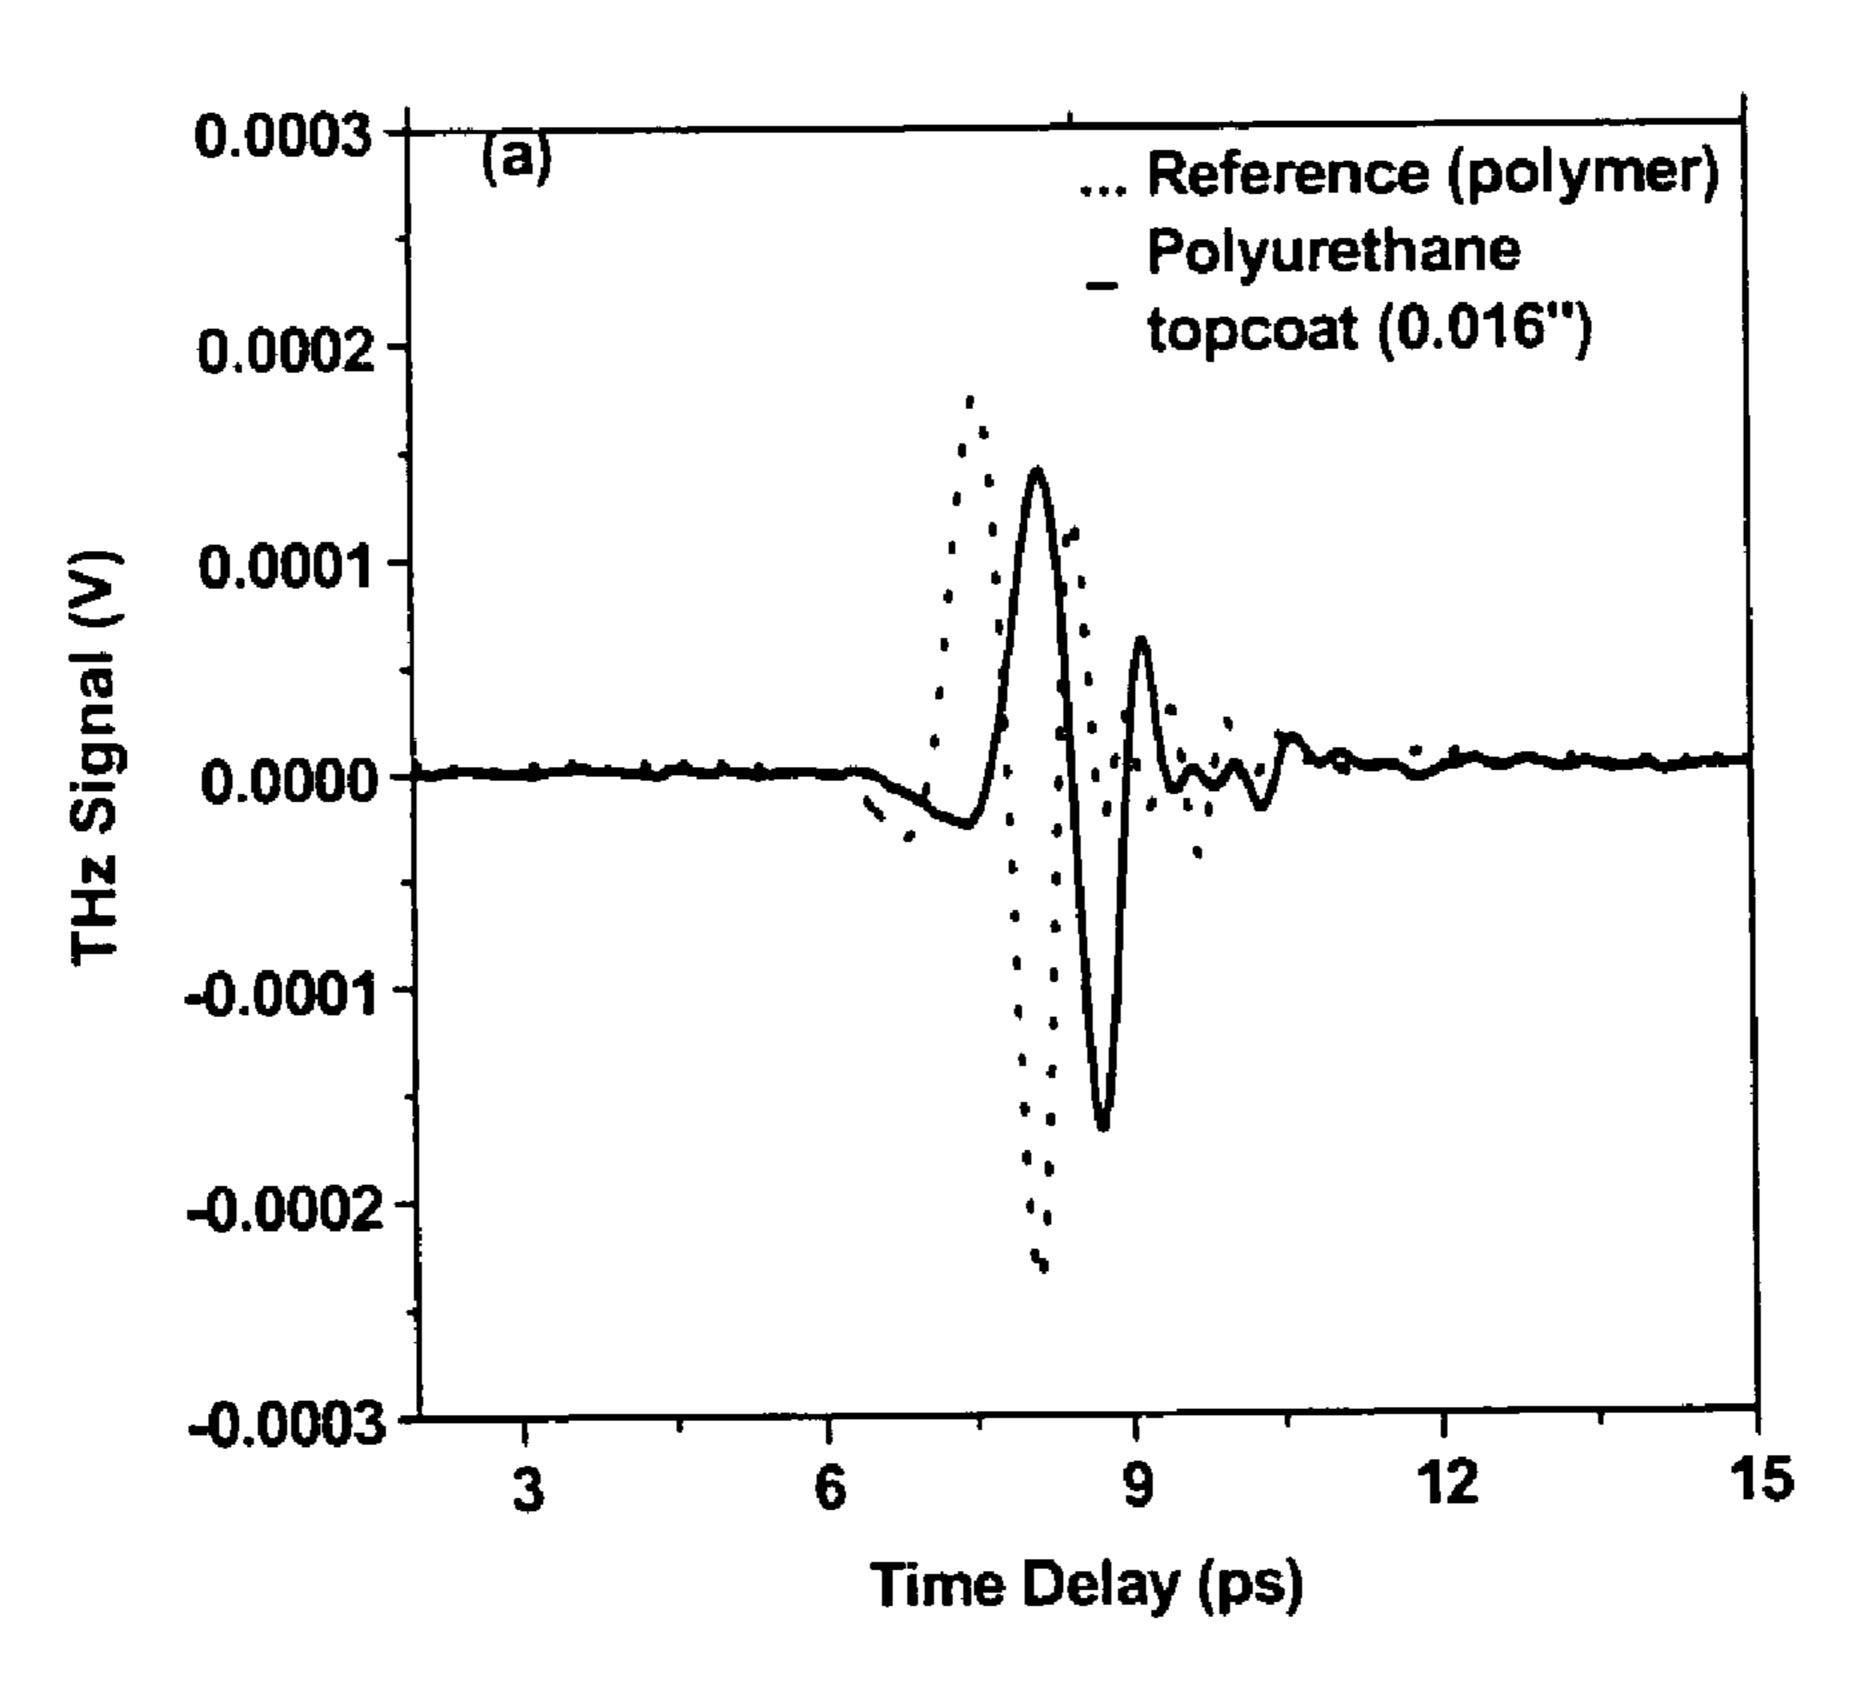
FIG. 9 is a graph illustrating THz temporal profiles for polymer polyurethane topcoat (Mil-PRF-85285, type I color 35237 blue) (0.016") (#31);

FIG. 9 is a graph illustrating the THz temporal profiles for polymer polyurethane topcoat (Mil-PRF-85285, type I color 35237 blue) (0.016") (#31).

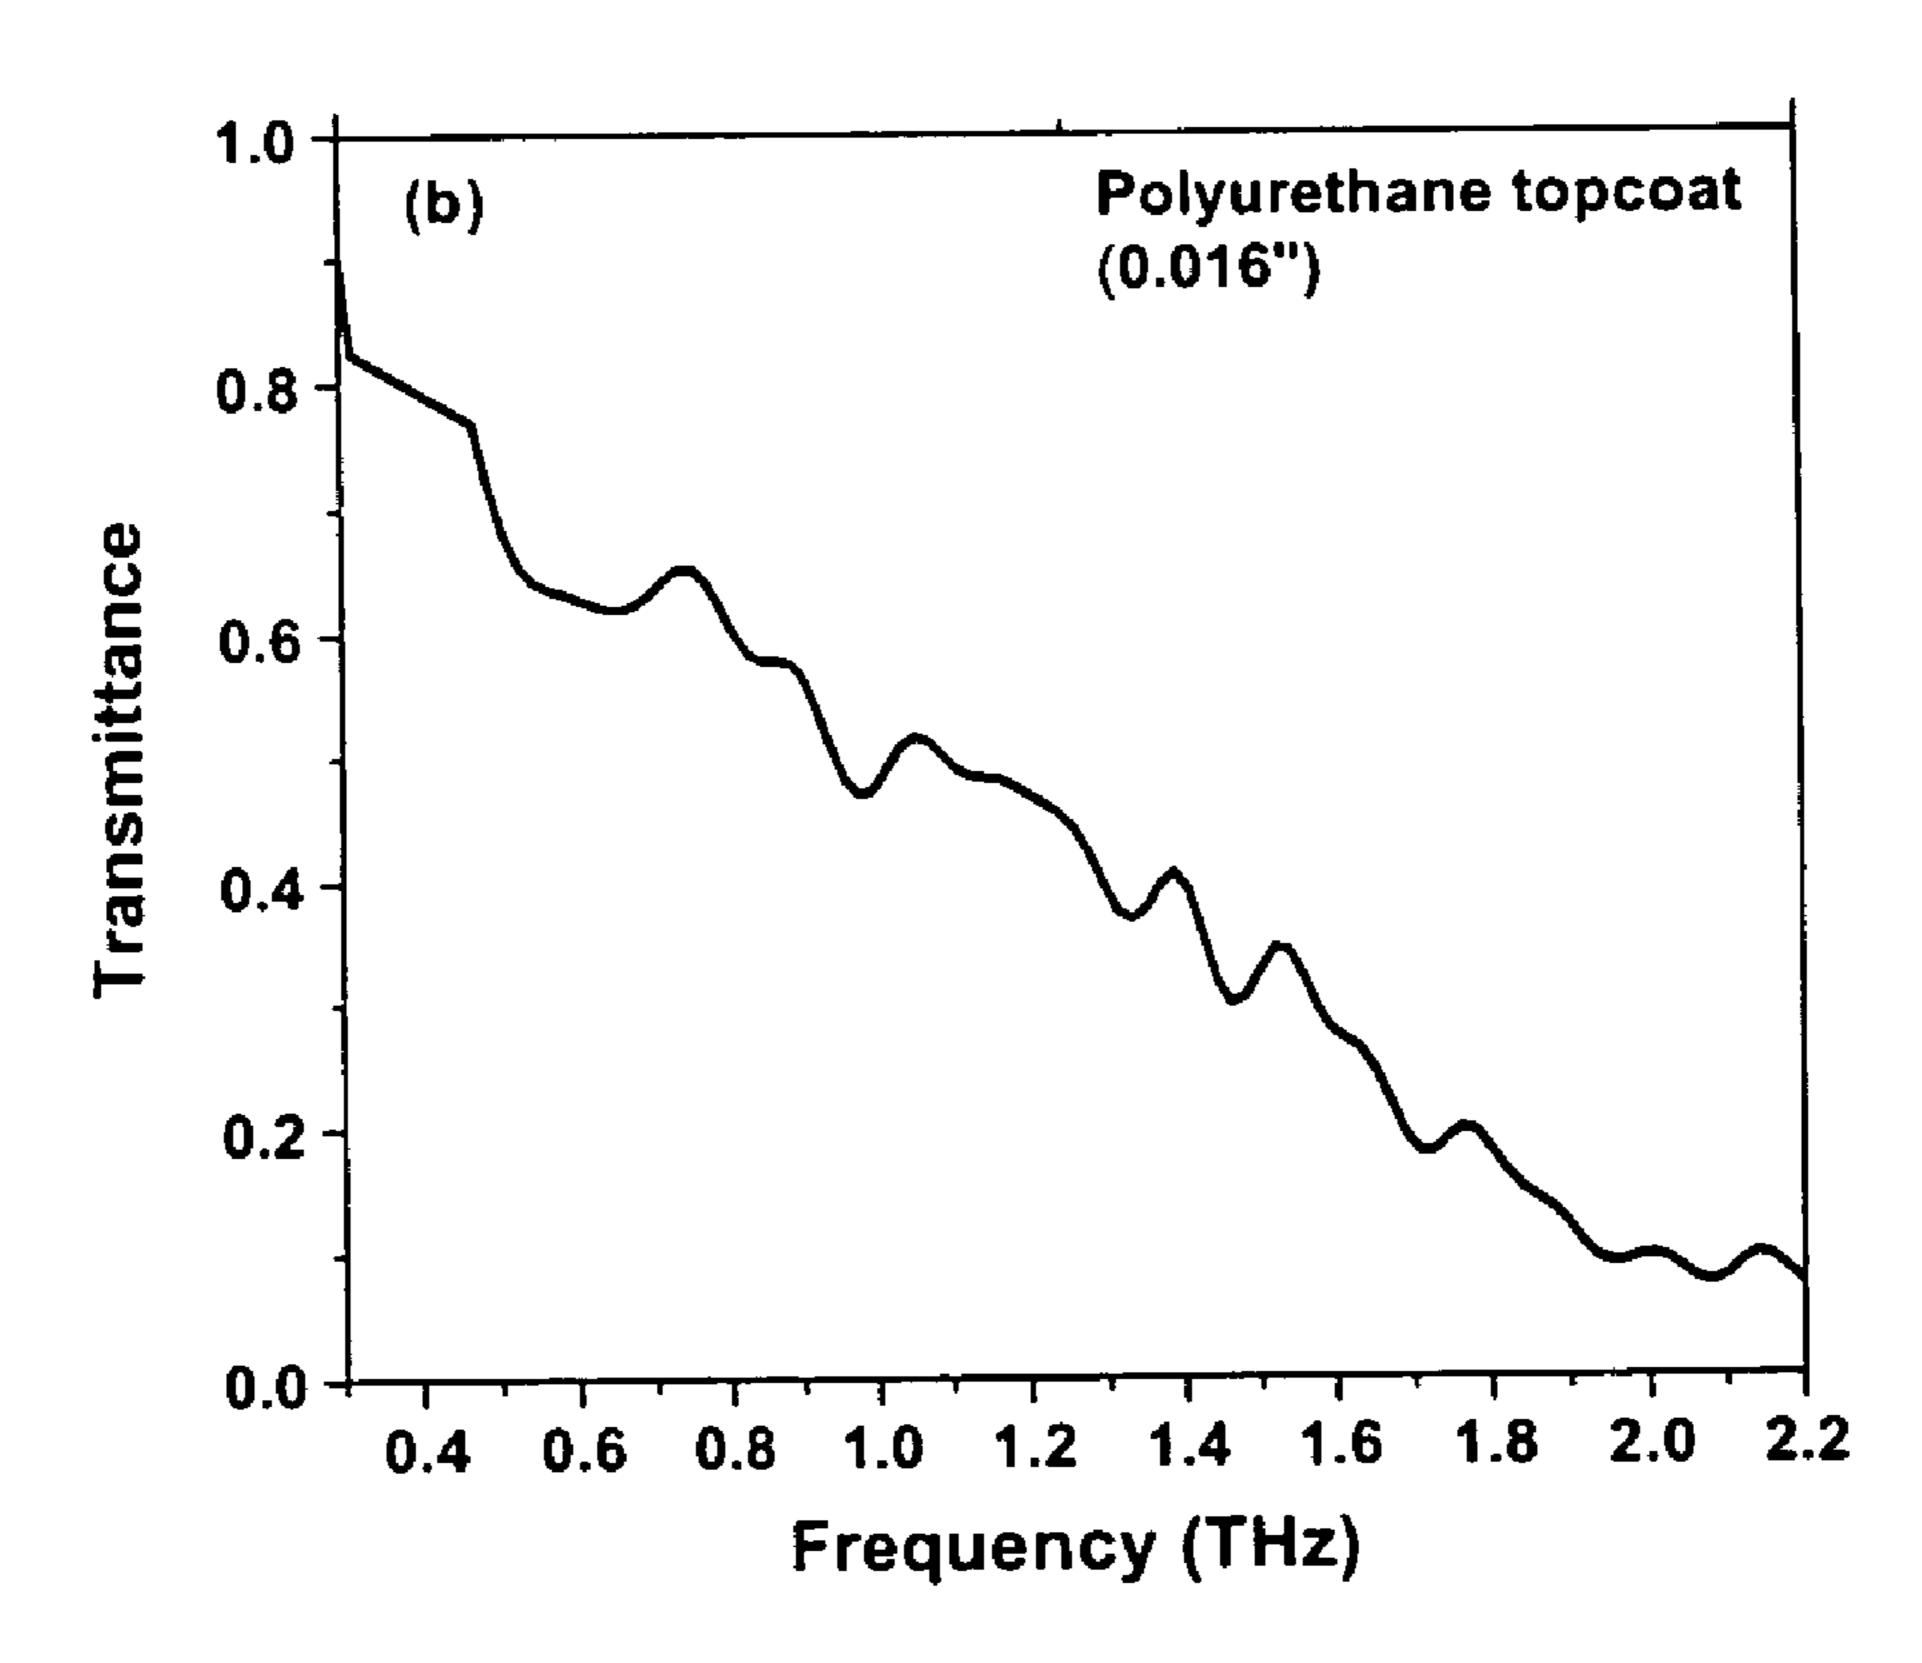
FIG. 10 is a graph illustrating a transmittance curve of a polyurethane topcoat (Mil-PRF-85285, type I color 35237 blue) in the frequency range 0.2–2.3 THz.

FIG. 10 is a graph illustrating the transmittance curve of polyurethane topcoat (Mil-PRF-85285, type I color 35237 blue) in the frequency range 0.2–2.3 THz. The transmission through the coating is from 20% to 80%.
