**THIN FILM TRANSISTOR ARRAY  
SUBSTRATE AND REPAIRING METHOD OF  
THE SAME**

The present invention generally relates to a thin film transistor (TFT) array substrate and the repairing method thereof. More particularly, the present invention relates to a TFT array substrate and the repairing method thereof having high yield of repairing.

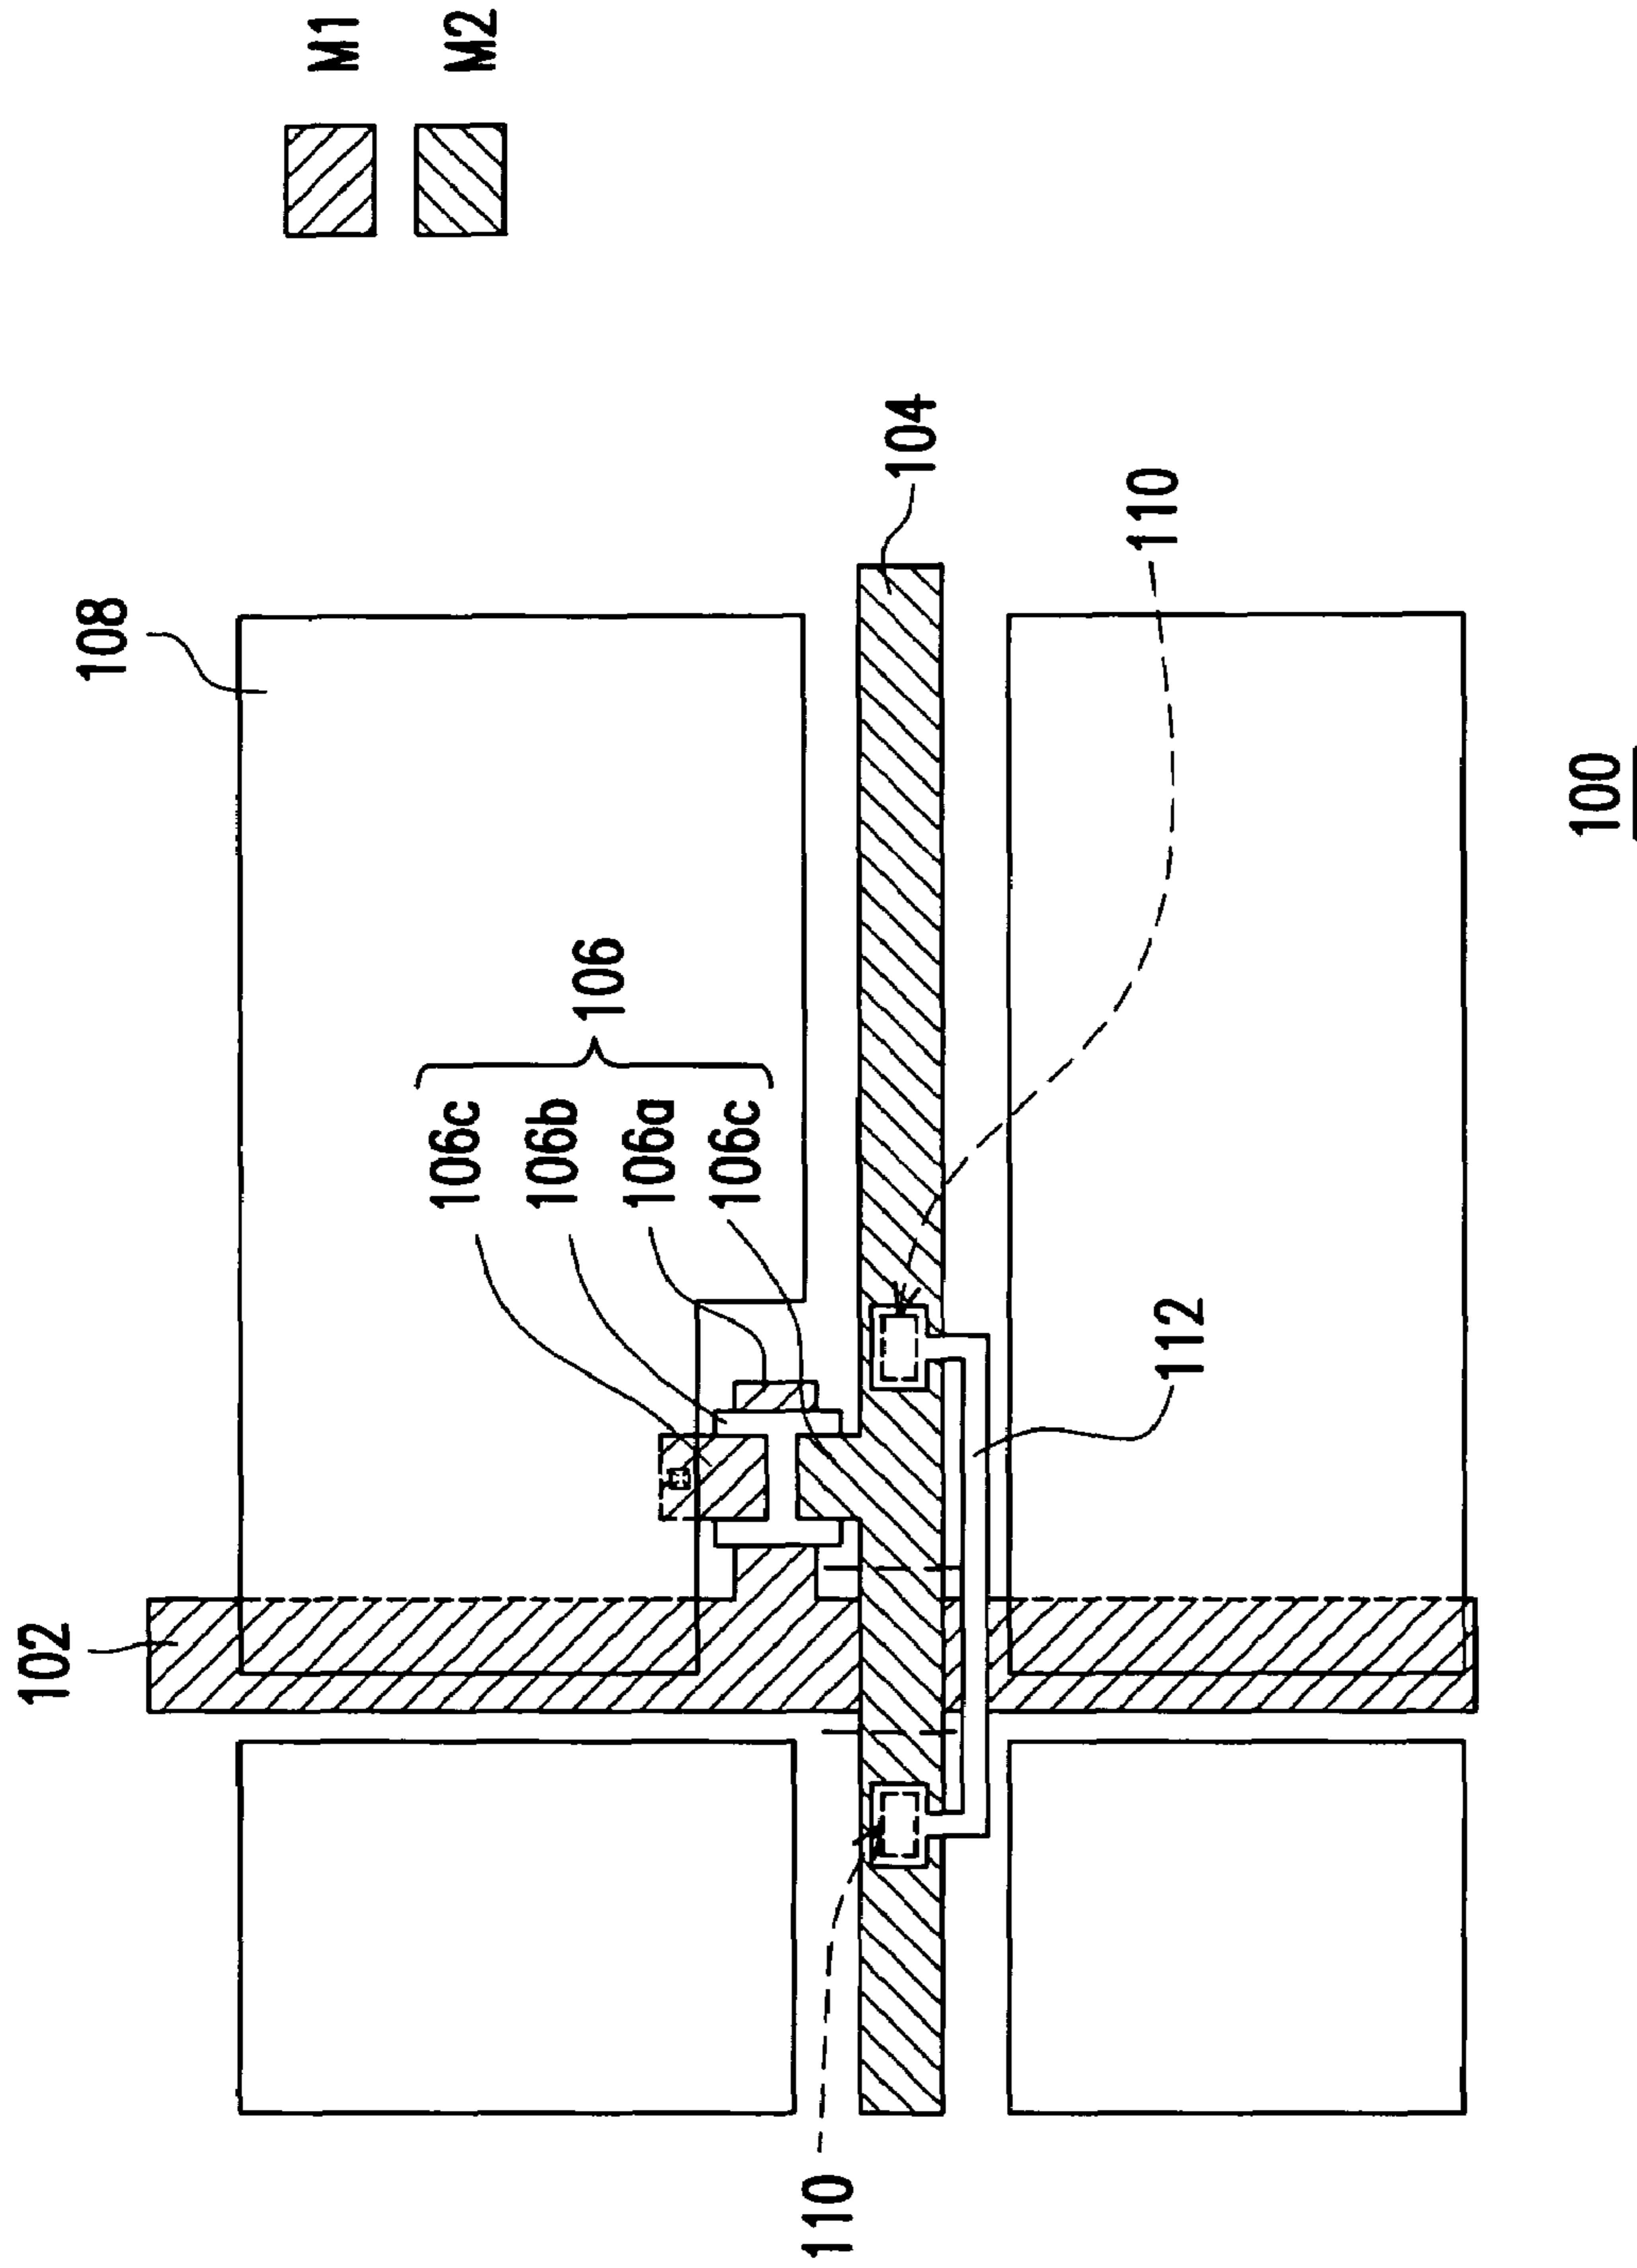
FIG. 1 (PRIOR ART)

FIG. 1 is a drawing schematically illustrating the conventional laser chemical vapor deposition (CVD) repairing method. Referring to FIG. 1, a conventional pixel structure **100** includes at least a scan line **102**, a signal line **104**, a thin film transistor (TFT) **106** and a pixel electrode **108**. The thin film transistor (TFT) **106** includes a gate **106a**, a channel layer **106b** and a source/drain **106c**, in which the gate **106** is electrically connected to the scan line **102**, and the source/drain **106c** are electrically connected to the signal line **104** and pixel electrode **108** respectively.

Since the scan line **102** is a portion of the first metal layer M1, and the signal line **104** is a portion of the second metal layer M2, the scan line **102** and the signal line **104** are electrically insulated from each other by a first dielectric layer (or called gate isolation layer). Moreover, a second dielectric layer (or a protection layer) may be formed to cover the signal line **104**. However, the intersection of the scan line **102** and the signal line **104** may be shorted

abnormally due to the faulty the dielectric layer, for example, due to contamination by impurity or particles. Thereafter, repairing of the abnormally shorted intersection is required. A conventional repairing method is to cut both ends of the signal line **104** of the shorted intersection shown by the dotted line in FIG. 1. Then, two repairing openings **110** are formed by irradiating laser on the second dielectric layer. Thereafter, a repair line **112** is formed to reconnect the cut signal line **104** via the opening **110** by performing a laser chemical vapor deposition (CVD) process. Therefore, the abnormally shorted intersection is repaired by a conventional method.

FIG. 1 is a drawing schematically illustrating a conventional laser chemical vapor deposition (CVD) repairing method.

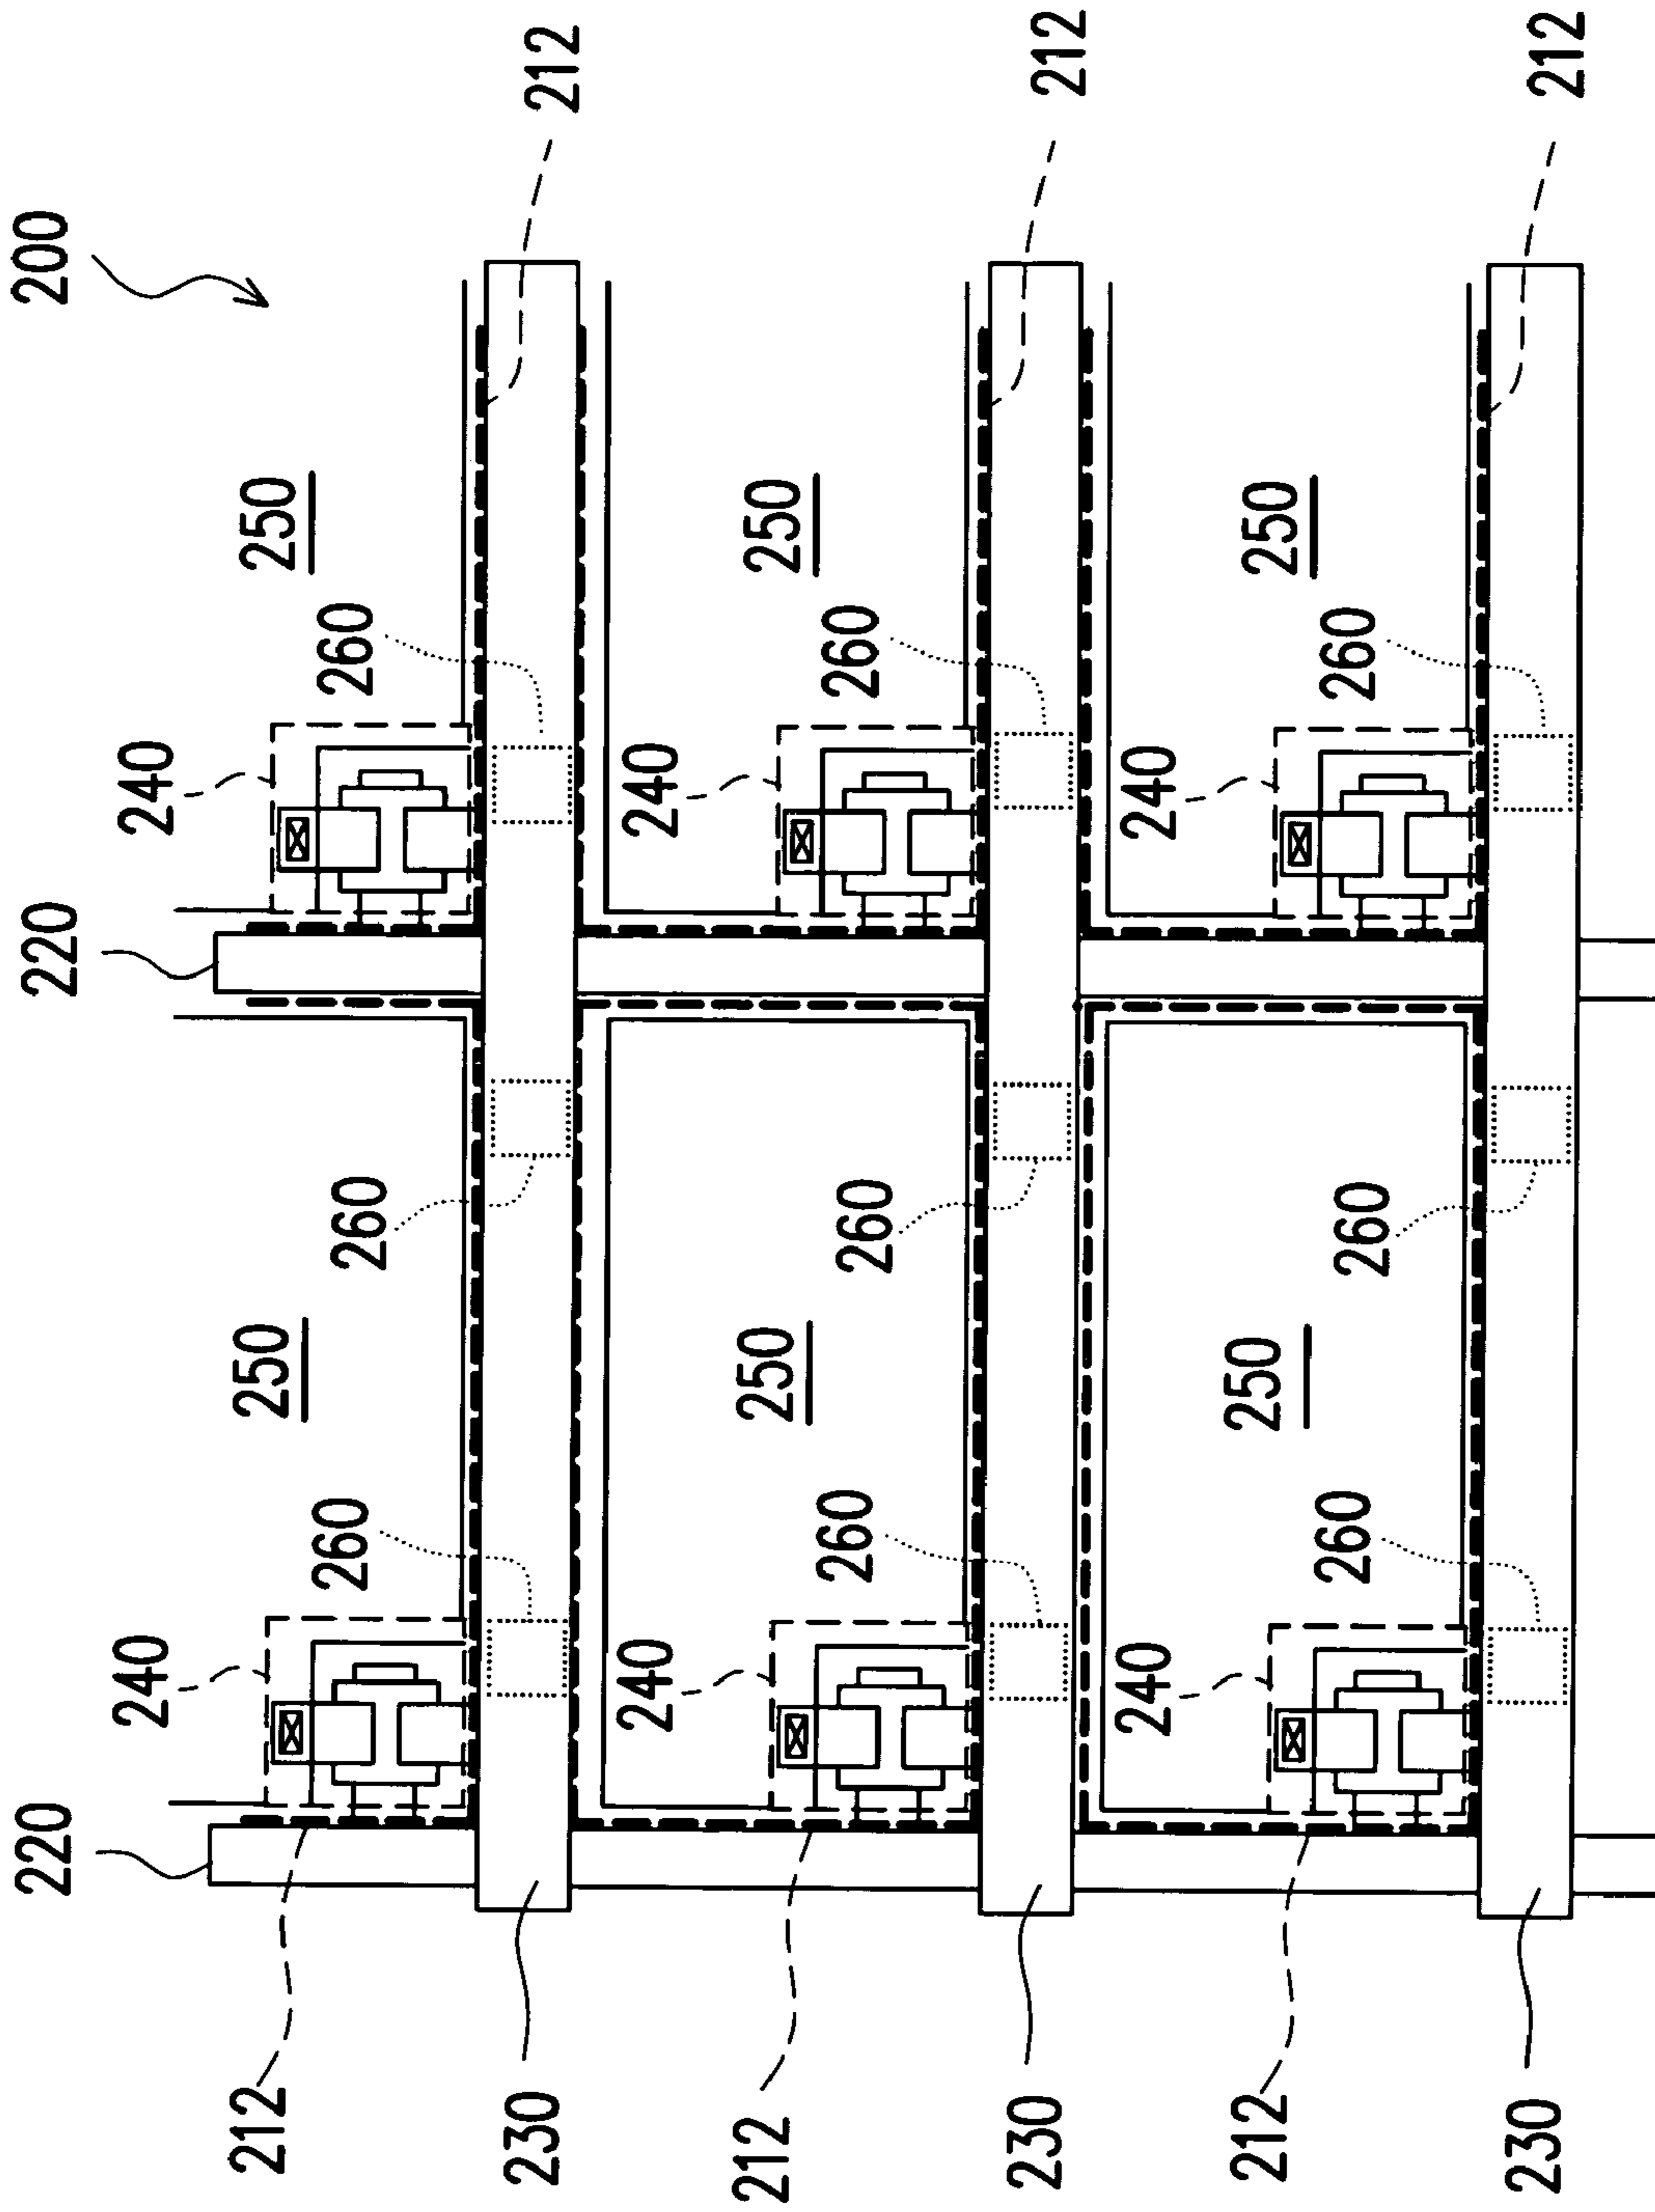
FIG. 3 is a drawing schematically illustrating a thin film transistor array substrate according to one embodiment of the present invention.

FIG. 3 is a drawing schematically illustrating a thin film transistor array substrate according to one embodiment of the present invention. Referring to FIG. 3, the thin film transistor (TFT) array substrate **200** comprises, for example but not limited to, a substrate **210** (shown in FIG. 5), a plurality of scan lines **220**, a plurality of data lines **230**, a plurality of thin film transistors **240**, a plurality of pixel electrodes **250**, and a plurality pairs of repair pads **260**. The scan lines **220** and data lines **230** are formed over the substrate **210** to define a plurality of pixel regions **212** over the substrate **210**. The thin film transistors **240** are disposed in each pixel region **212** respectively and driven by the corresponding scan line **220** and data line **230**. The pixel electrodes **250** are also disposed in each pixel region **212** respectively and electrically connected to the corresponding thin film transistor **240**. The repair pads of each pair of repair pads **260** are disposed at of the intersection of each scan line **220** and data line **230**. Each pair of repair pads **260** is disposed under the corresponding data line **230**. Furthermore, the repair pads **260** are formed together with the gate

of the thin film transistor **240**, thus the material of the repair pads **260** is, for example but not limited to, the same as that of the scan line.

In one embodiment of the invention, the substrate **210** comprises, for example but not limited to, glass, quartz, plastic, or other transparent insulation substrate. The scan line **220** and the data line **230** are comprised of, for example but not limited to, aluminum (Al), chromium (Cr), titanium (Ti), tungsten (W), tantalum (Ta), molybdenum (Mo), or a multilayer structure or alloys thereof. The thin film transistor **240** includes, for example but not limited to, a bottom gate amorphous silicon (a-Si) TFT, a bottom gate polysilicon TFT or a bottom gate low temperature polysilicon TFT (LTPS-TFT). The thin film transistor **240** includes, for example but not limited to, a top gate a-Si TFT, a top gate polysilicon TFT or a top gate LTPS-TFT. A thin film transistor **240** including the bottom gate a-Si TFT will be described in detail in reference with FIG. 3 according to one embodiment of the invention.

Referring to FIG. 3, the pixel electrode **250** comprises, for example but not limited to, indium tin oxide (ITO), indium zinc oxide (IZO) or other conductive transparent materials, or other conductive material with light reflecting property such as metal. In other words, when the pixel electrode **250** is comprised of transparent material, a transparent liquid crystal panel may be constructed by combining the TFT array substrate **200** with the other opposite aligned substrate. On the other hand, when pixel electrode **250** is comprised of metal or other light reflecting material, a reflective liquid crystal panel may be constructed when the TFT array substrate **200** is combined the other opposite aligned substrate. Moreover, when one portion of the pixel electrode **250** is comprised of transparent material and the other portion thereof is comprised of metal or other light reflecting material, a semi-transparent semi-reflective liquid crystal panel may be formed after the TFT array substrate **200** and the other opposite aligned substrate are combined.

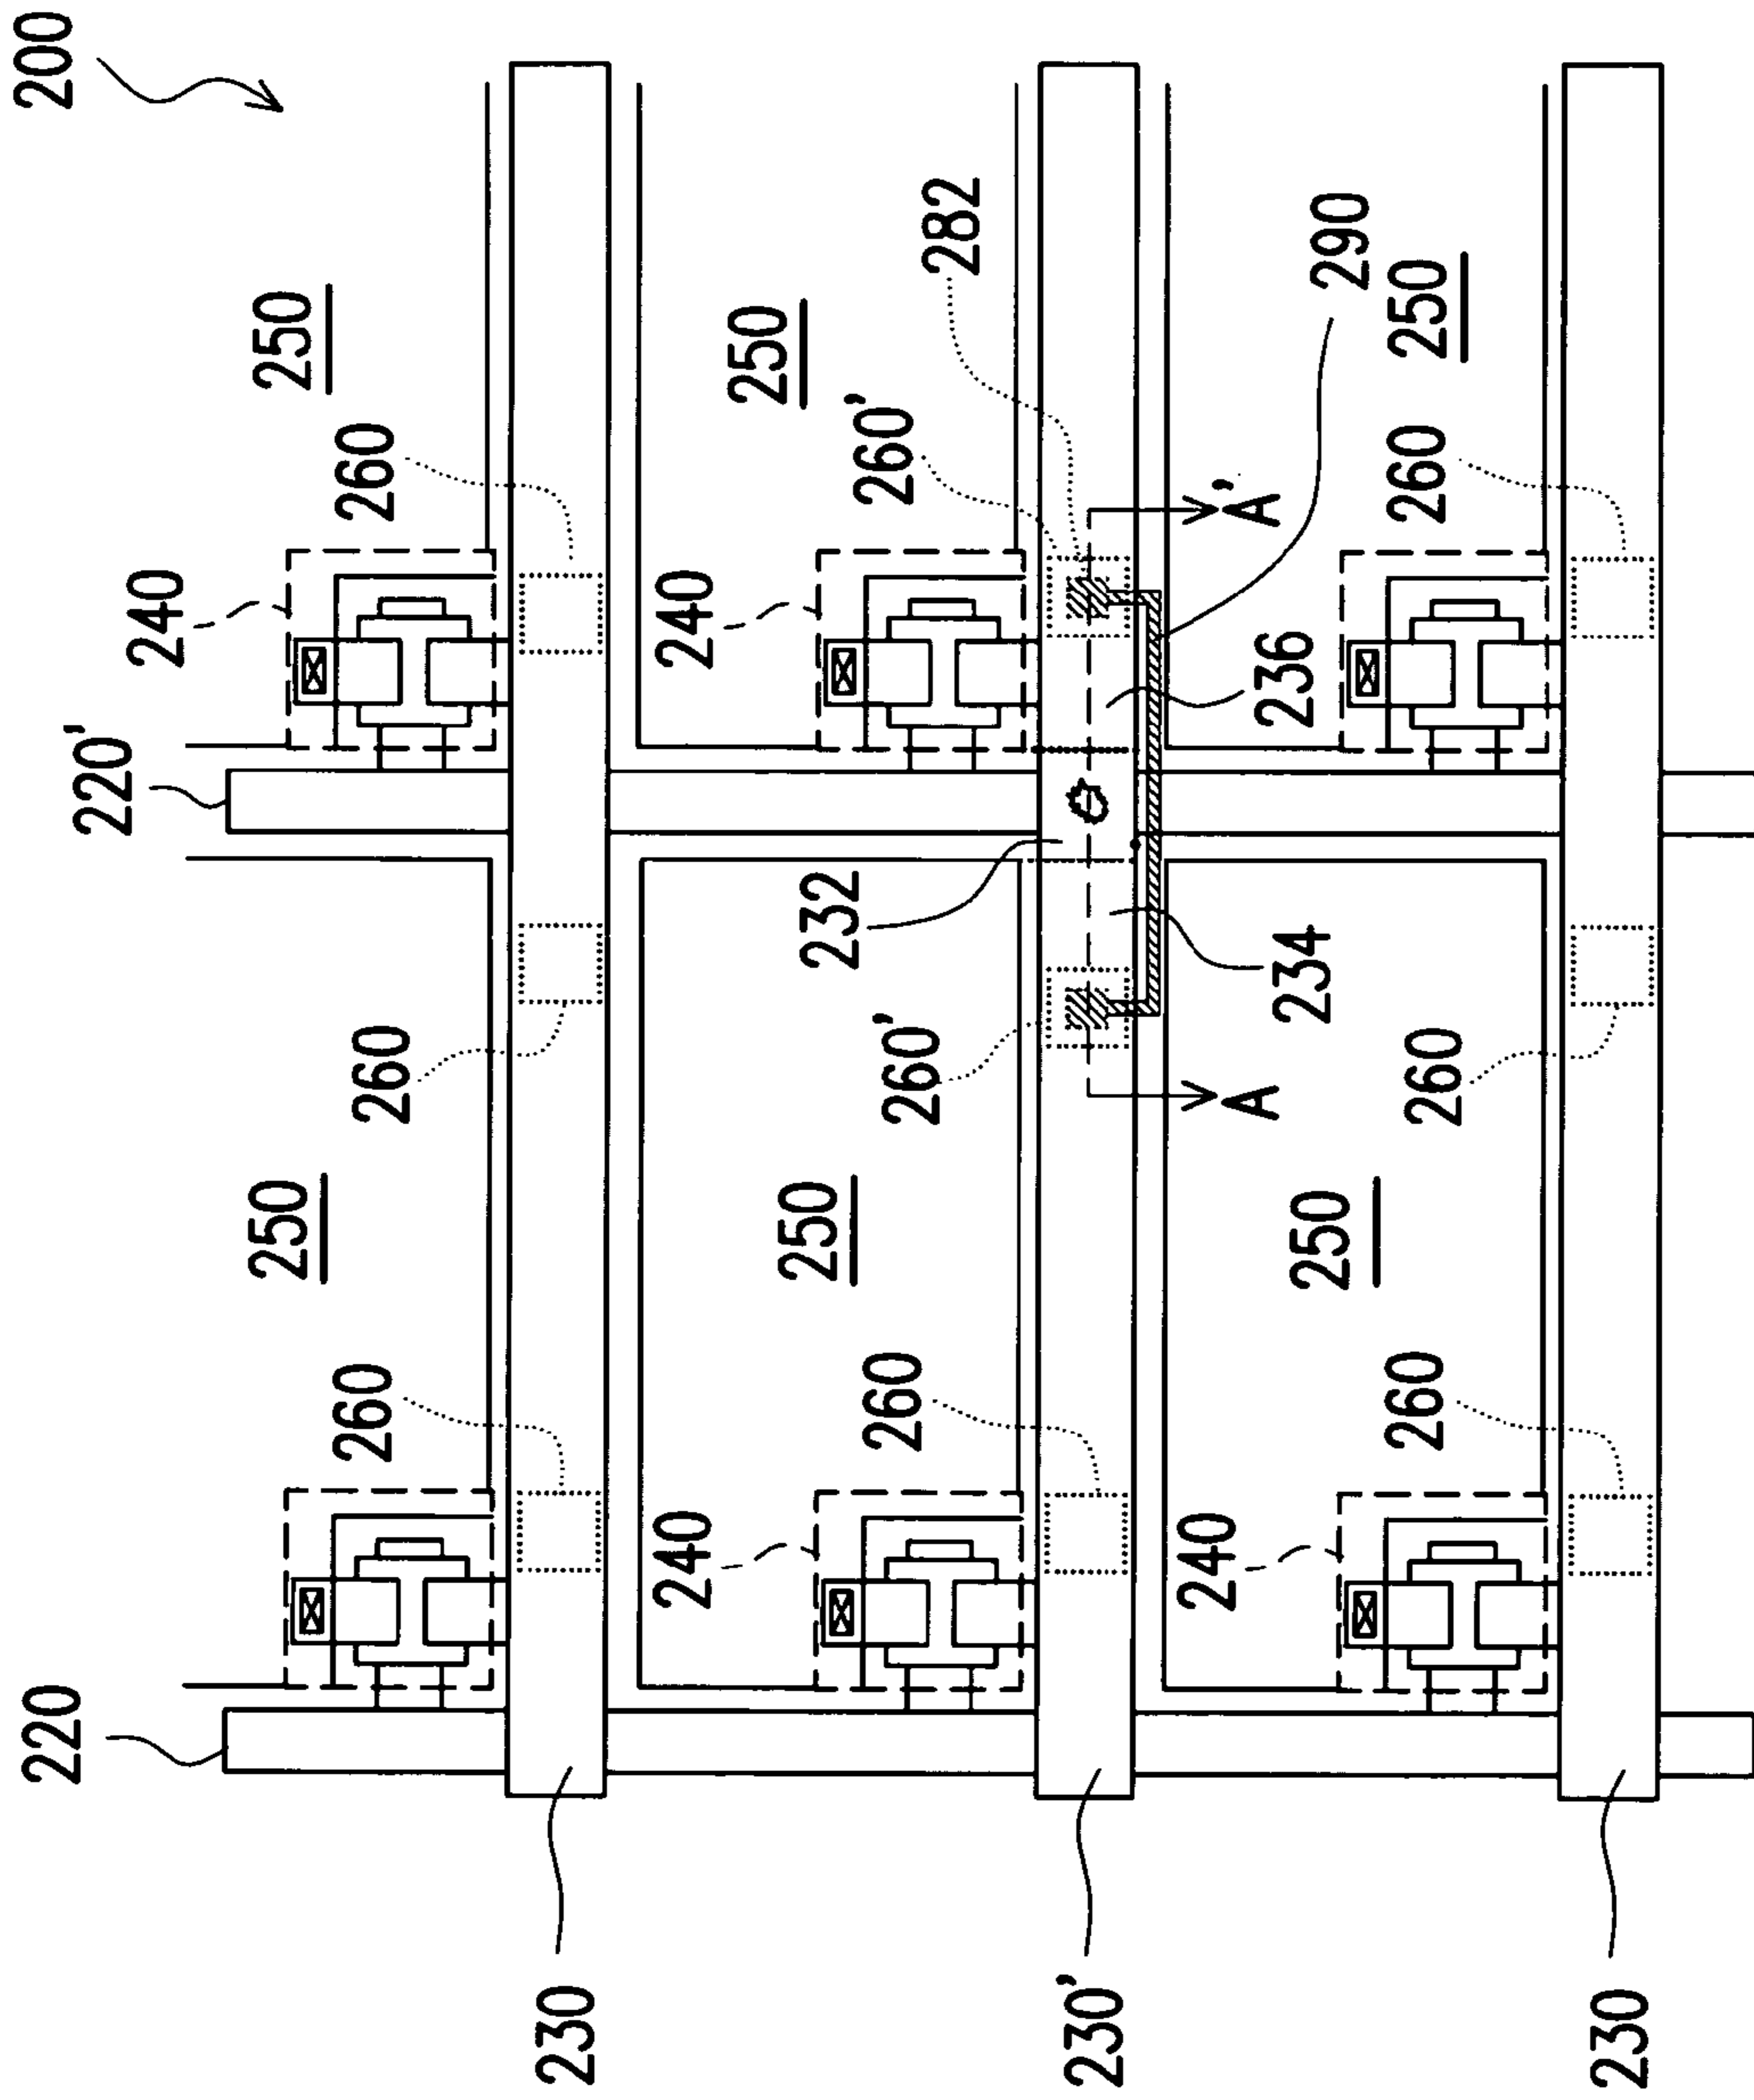
FIG. 4 is a drawing schematically illustrating the TFT array substrate of FIG. 3 after being repaired by a laser repairing method.

Referring to FIG. 4, when a defective scan line **220'** and a defective data line **230'** are abnormally conductive at the intersection of both, the data signal can not be written into the pixel controlled by the defective scan line **220'** and the defective data line **230'**. Therefore, the pixel needs to be repaired. In one embodiment of the present invention, the defective data line **230'** is cut to form a defective line **232** and two normal lines **234**, **236** at both sides of the defective scan lines **220'**. The defective line **232** is above the defective scan line **220'**, and the normal lines **234** and **236** are at both sides of the defective scan line **220'** respectively. In addition, the defective data line **230'** is cut by using, for example but not limited to, a laser cutting method.

Thereafter, referring to FIG. 4 and FIG. 5, after the defective data line **230'** is cut to form the defective line **232** and the normal lines **234** and **236**, a pair of quasi-welding repair pads **260'** corresponding to the defective data line **230** are welded to the normal line **234** and **236** respectively. It is noted that, the quasi-welding repair pads **260'** and the normal lines **234** and **236** are welded by using, for example but not limited to, a laser beam. The protection layer **280** above the normal lines **234** and **236** are irradiated by the laser beam to form an opening **282**. Thereafter, the normal lines **234** and **236**, the inter-gate dielectric layer **270** and the quasi-welding repair pad **260'** are irradiated by the laser beam, and then the

Then, a repair line **290** crossing over the defective scan line **220'** is formed after the laser beam welding process to reconnect the normal lines **234** and **236** that correspond to the quasi-welding repair pad **260'**. In one embodiment, the repair line **290** is formed by performing, for example but not limited to, a laser chemical vapor deposition (CVD) process.

Thereafter, the normal lines **234** and **236** of the defective data line **230'** are welded to a portion of the quasi-welding repair pad **260'** after the TFT array substrate **200** is repaired and electrically connected to each other by the repair line **290**. Therefore, the defective line **232** of the defective data line **230'** that is conducted to the defective scan line **220'** will not adversely influence the driving of the pixel.

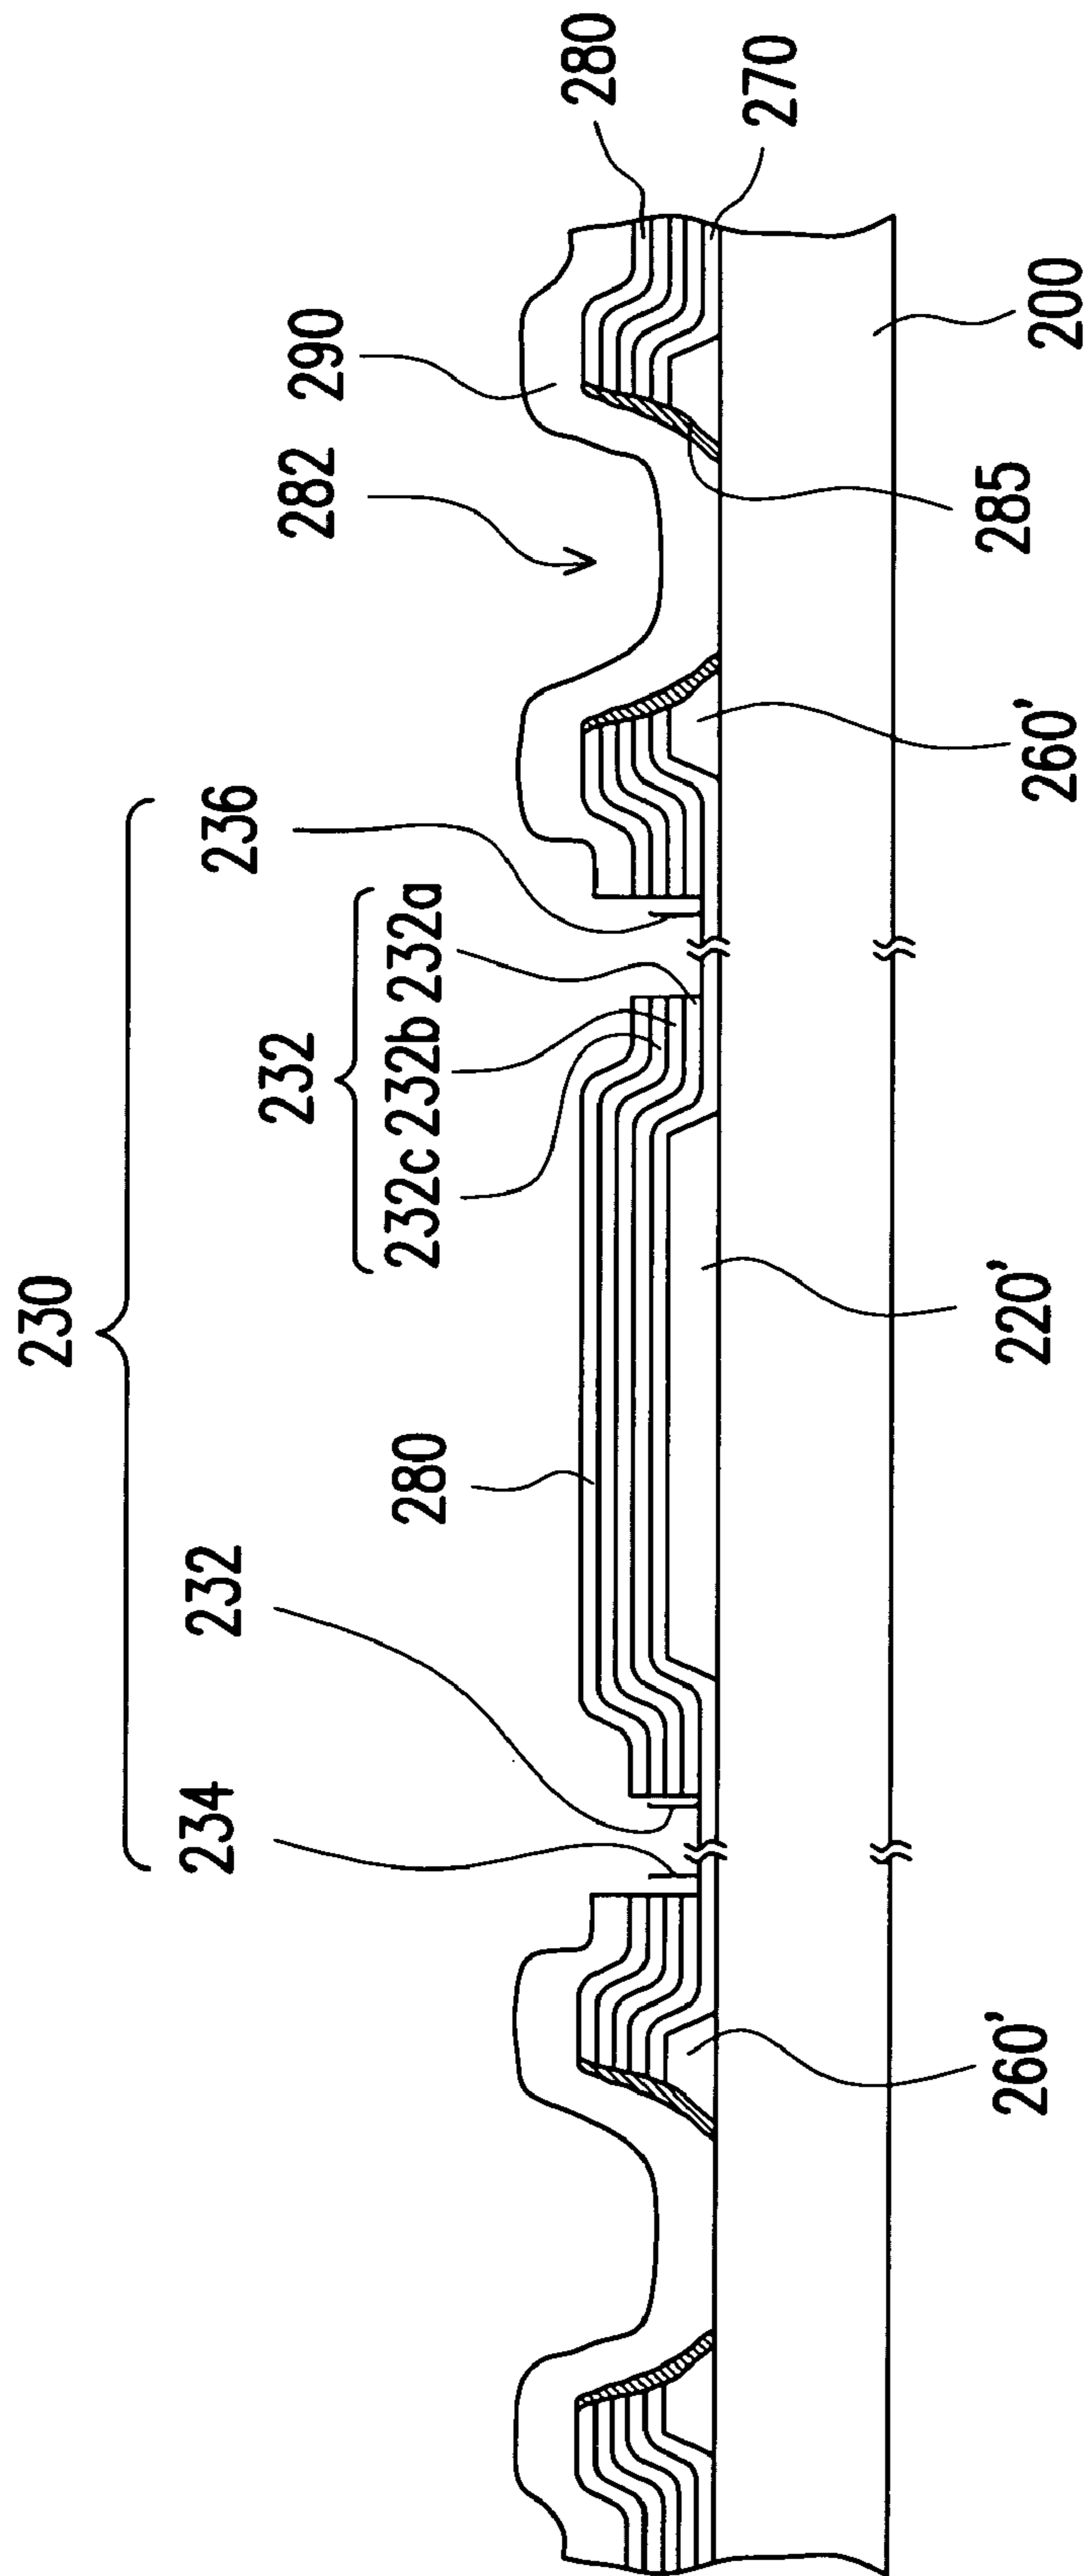
FIG. 5 is a cross-sectional view schematically illustrating the TFT array substrate of FIG. 4 taken along line A-A'.

inter-gate dielectric layer **270** will be burned through to weld the normal lines **234** and **236** with corresponding quasi-welding repair pads **260'** respectively. The normal lines **234** and **236** are electrically connected to the corresponding quasi-welding repair pads **260'** respectively by welding metal **285**. In the embodiment, the welding metal **285** is generated during the laser beam welding process, and gets deposited on, for example but not limited to, at least a portion of the sidewall of the opening **282**.

Thereafter, referring to FIG. 5, in one embodiment, the data line **230** comprised of, for example but not limited to, a multilayer metal structure such as a first metal layer **232**, a second metal layer **234** and third metal layer **236**. In addition, the melting point of the first metal layer **232** is higher than that of the second metal layer **234**. The first metal layer **232** and the third metal layer **236** is comprised of, for example but not limited to, a molybdenum metal having a high melting point. The second metal layer **234** is comprised of, for example but not limited to, aluminum metal having a low melting point lower. For example, when the data line **230** is a multilayer metal structure comprised of molybdenum, aluminum and molybdenum, if a conventional design and repairing method is applied, the repairing process will fail. However, in the embodiment of the invention, the normal lines **234** and **236** are welded to the quasi-welding repair pads **260'** and electrically connected to each other by repair line **290**. Therefore, the forming and breaking of the bending profile A near the repair line **112** as shown in FIG. 2 will not occur in the present invention. Thus, the repairing yield can be effectively increased.
