**THIN FILM TRANSISTOR ARRAY  
SUBSTRATE AND REPAIRING METHOD OF  
THE SAME**

The present invention generally relates to a thin film transistor (TFT) array substrate and the repairing method thereof. More particularly, the present invention relates to a TFT array substrate and the repairing method thereof having high yield of repairing.

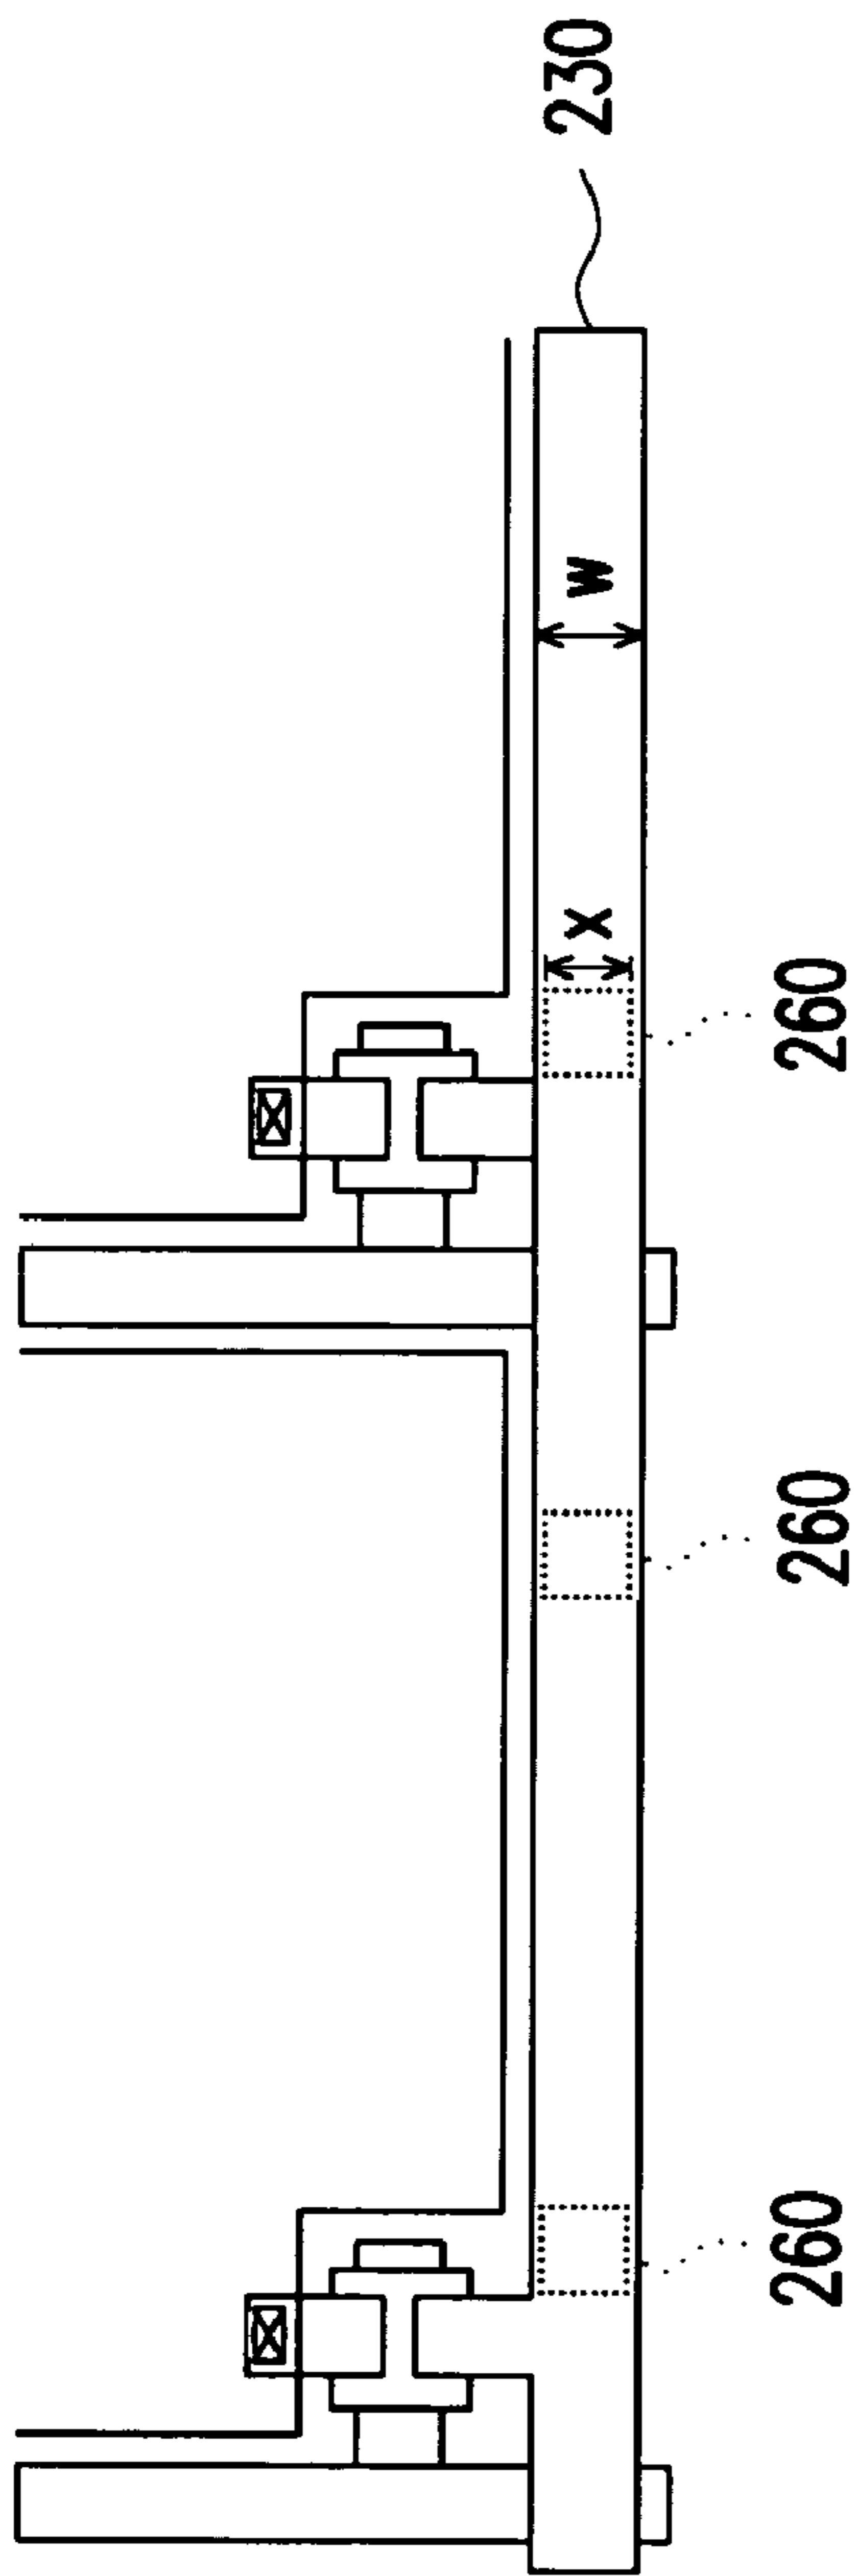
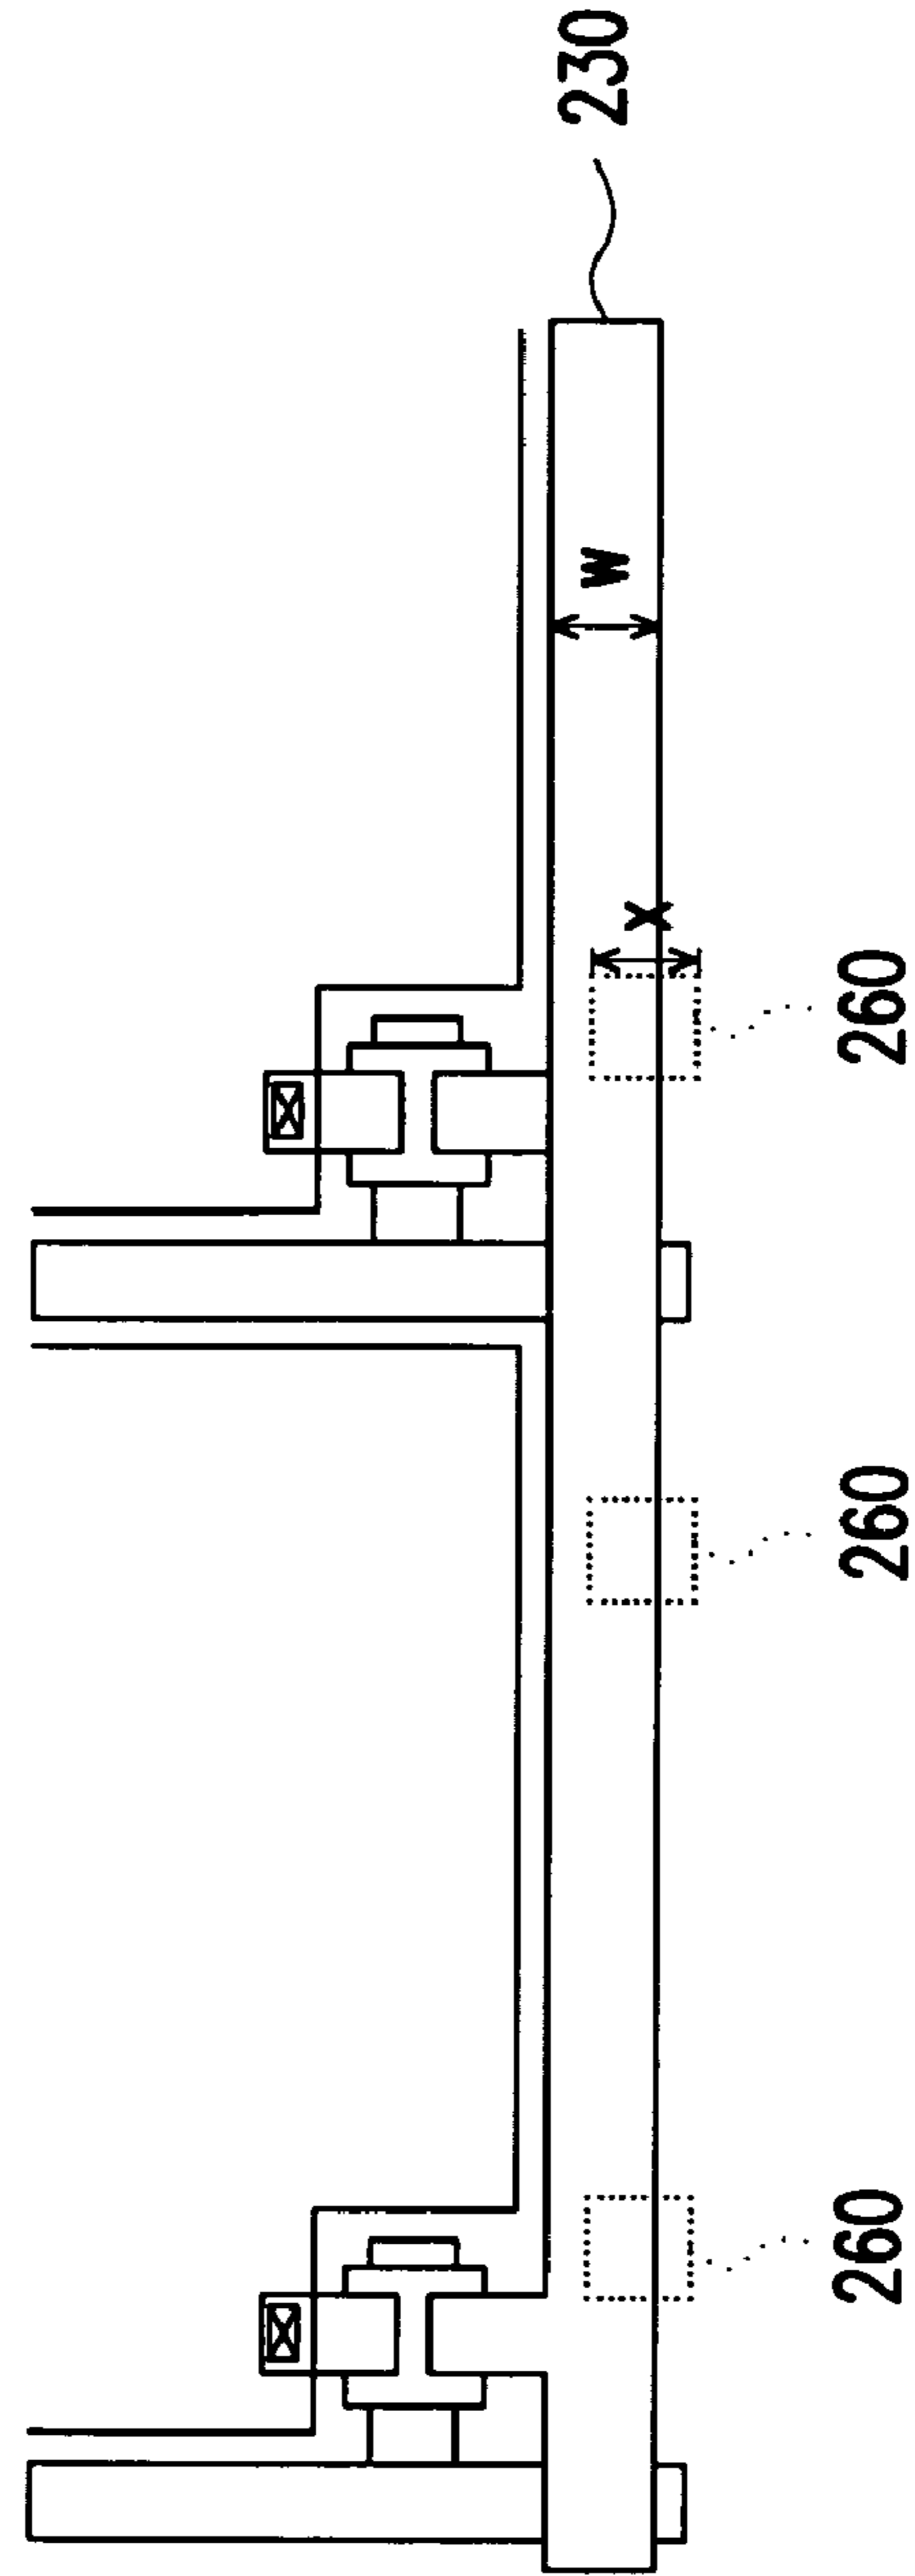
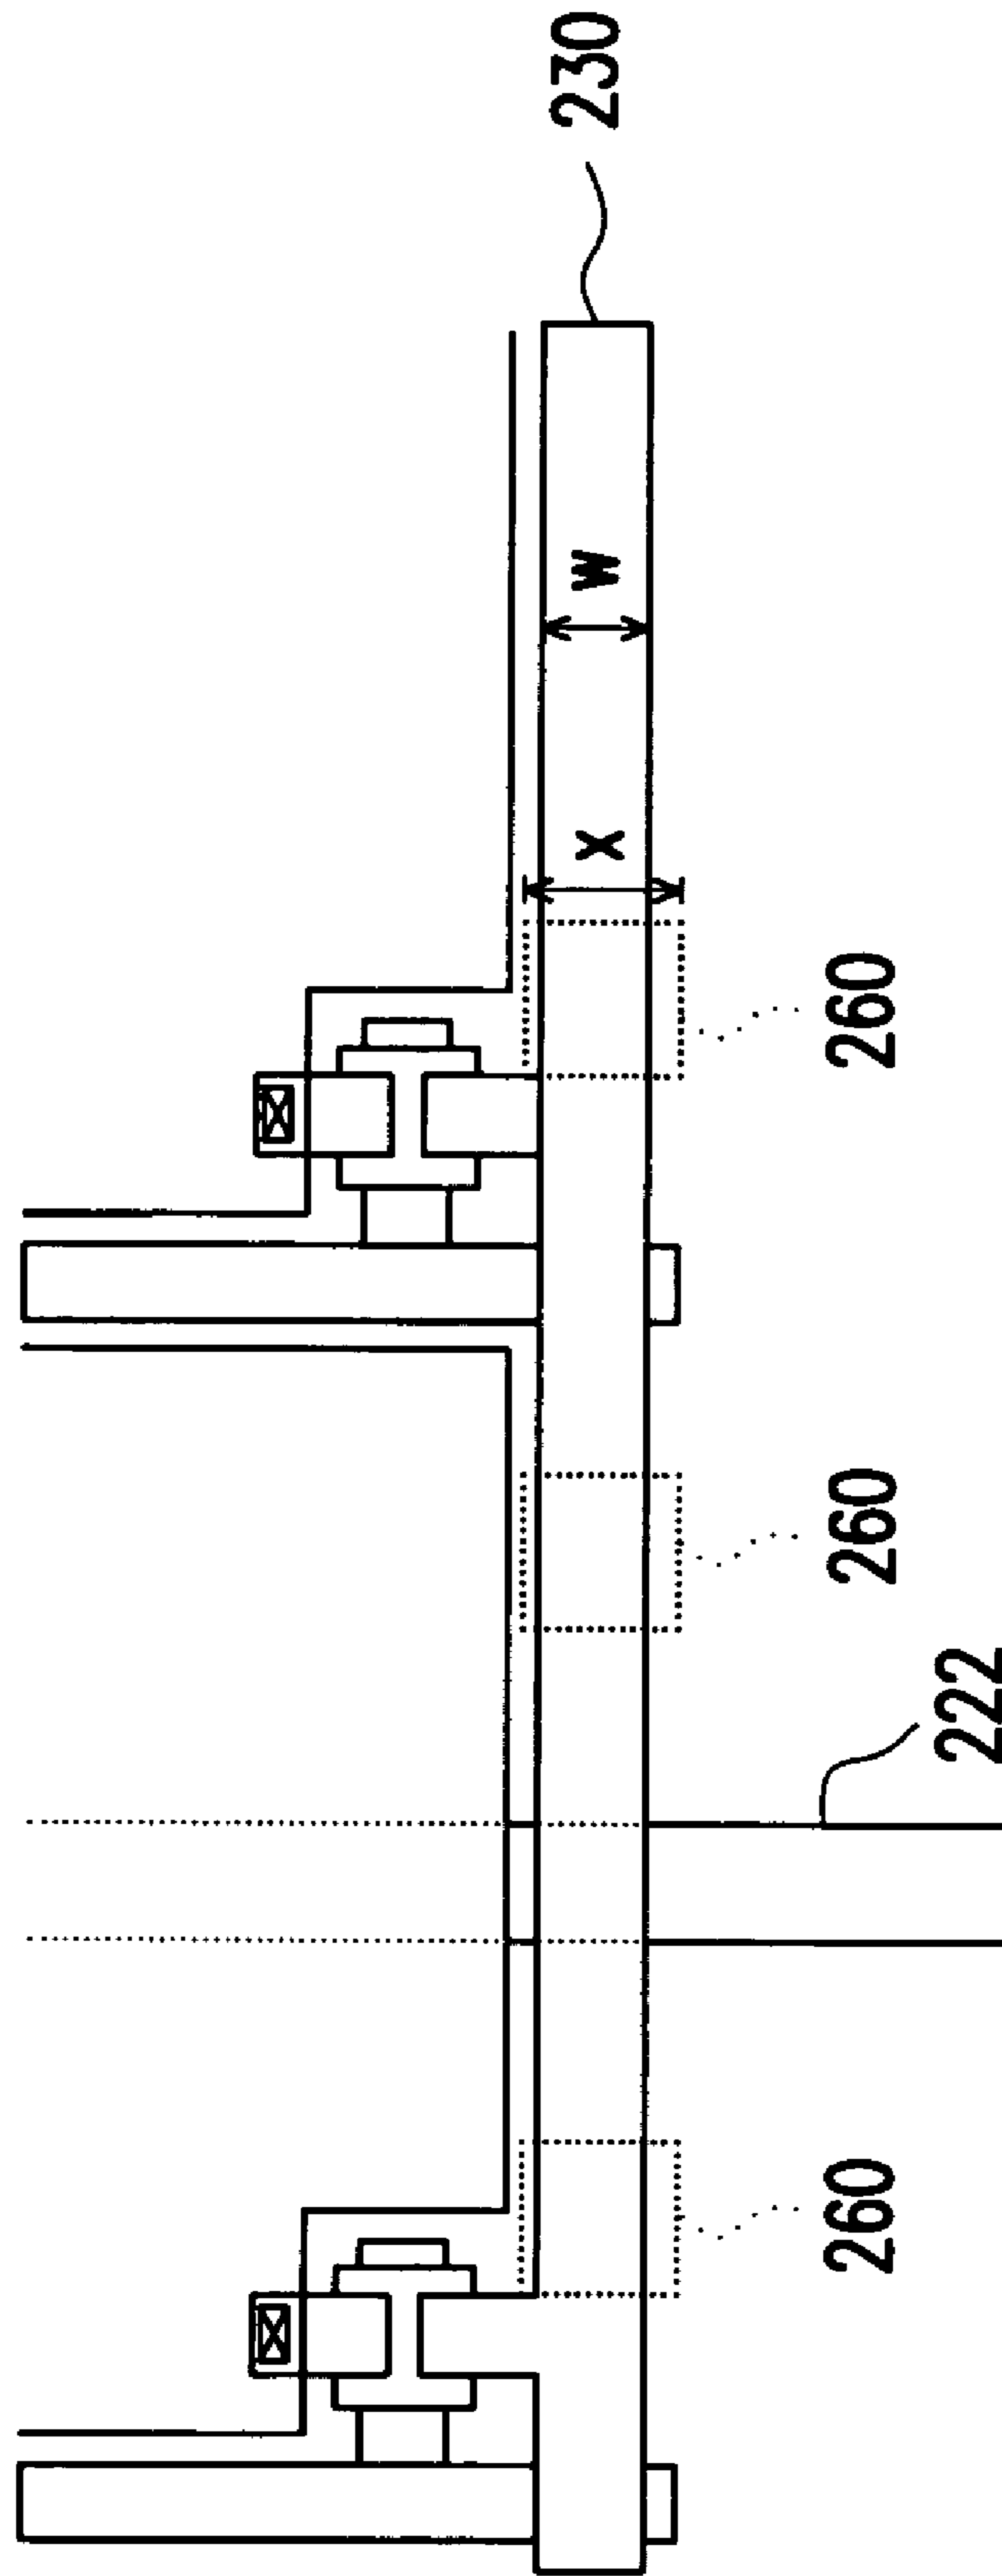
FIG. 6A, FIG. 6B and FIG. 6C are views schematically illustrating the distribution of repair pads and data lines with different sizes according to one embodiment of the present invention.

FIG. 6A, FIG. 6B and FIG. 6C are views schematically illustrating the distribution of repair pads and data lines with different sizes according to one embodiment of the present invention. Referring to FIG. 6A to FIG. 6C, the size X of the repair pad **260** is, for example but not limited to, less than the width W of the data line **230** (as shown in FIG. 6A), equal to the width W of the data line **230** (as shown in FIG. 6B), or larger than the width W of the data line **230** (as shown in FIG. 6C). Furthermore, the repair pad **260**, for example but not limited to, need not be totally disposed under the data line **230** (as shown in FIG. 6A), or a portion of the repair pad **260** is disposed under the data line **230** (as shown in FIG. 6B and FIG. 6C). It is noted that, those skilled in the art may change the shape, distribution, position, size and so on, of the repair pads **260**, which is still within the scope and spirit of the present invention.

Referring to FIG. 6C, it is noted that in one embodiment of the invention, the repair pads (or the quasi-welding repair pads) **260** are set in pairs and located on two sides of an intersection of the scan line and the data line **230** respectively.

In addition, referring to FIG. 6C, it is noted that in one embodiment of the invention, the repair pads (or the quasi-welding repair pads) **260** are set in pairs and can also be

located on two sides of an intersection of a common line **222** and the data line **230** respectively. The characteristic and function of the repair pad of the present embodiment is similar to the other embodiments described above and will not be described in detail.
