(10) **Patent No.:** **US 7,165,442 B2**
(45) **Date of Patent:** **Jan. 23, 2007**

(54) **METHOD OF DETECTING A WATER LEAK
IN A LOCOMOTIVE**

(73) Assignee: **General Electric Company**,
Schenectady, NY (US)

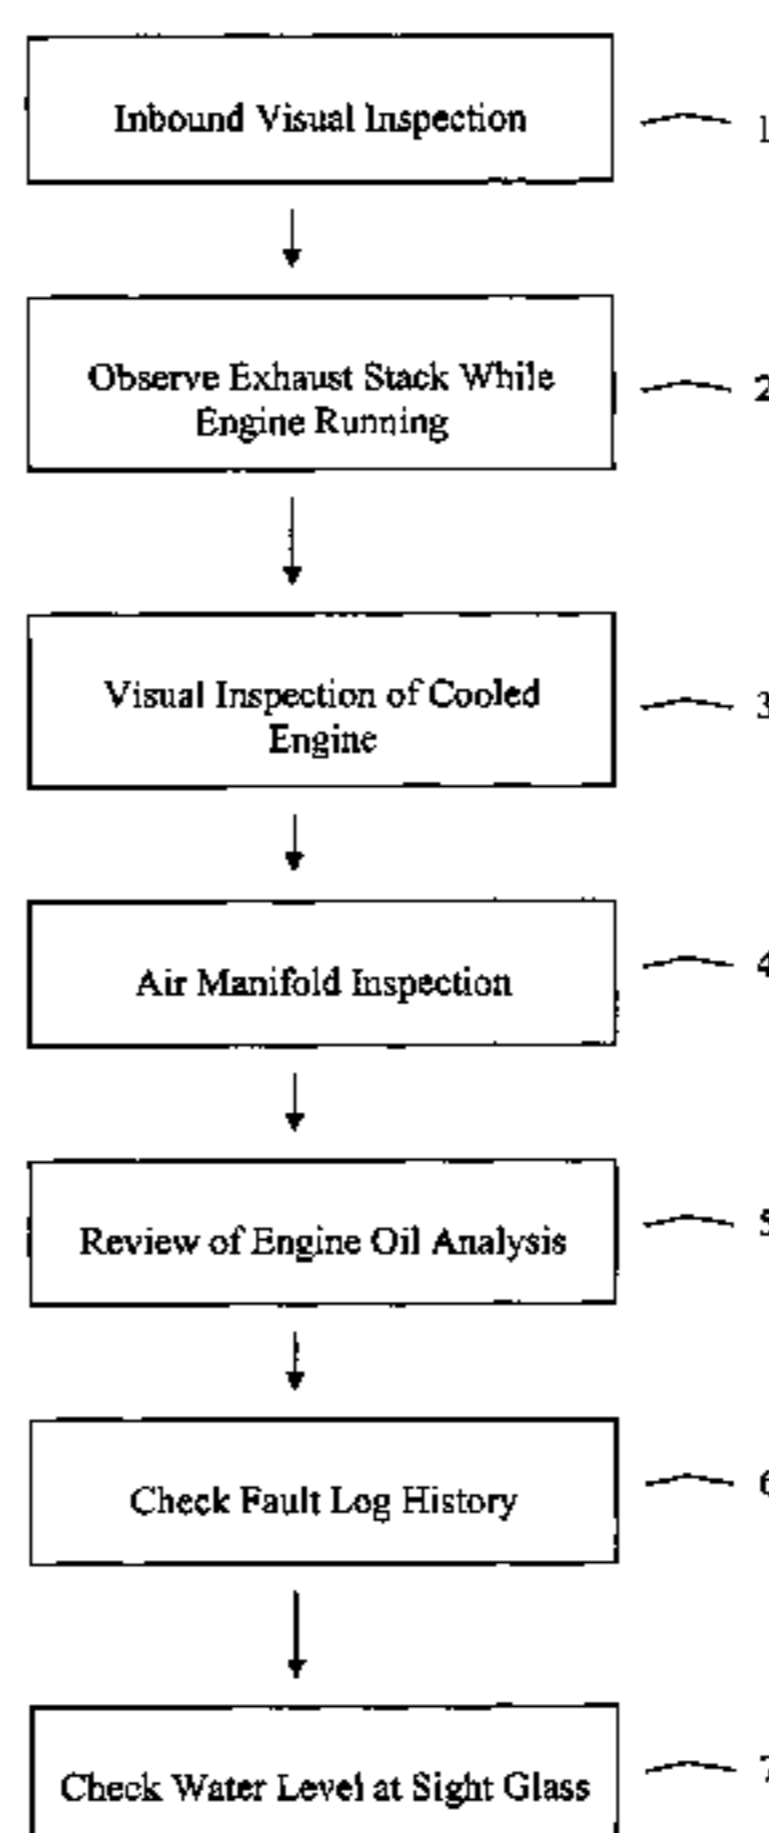
FIG. 1 is a schematic illustration of a method for detecting a water leak in a locomotive.

In order to reduce the time and cost of removing and inspecting non-failed power assemblies, the present inventors have developed an improved method of detecting a water leak in a locomotive, as illustrated in FIG. 1 and described more fully below. The method is discussed with reference to a typical modern locomotive driven by a sixteen cylinder turbo-charged diesel engine, however, one skilled in the art will appreciate that other embodiments of the present invention may be applied to other styles of locomotives and to other machines.

FIG. 1 illustrates steps in an improved leak detection method. Step 1 is an inbound visual inspection for water leaks that may be accomplished while the locomotive engine is heated and operating as it is tested prior to moving into a service facility. This visual inspection should identify the location of leaks that are external to the engine. Areas of interest may include piping, valves, engine water outlet header, water disconnects, sight glass sample valve and water fill valve, automatic drain valve, and the intercooler weep holes.

Step 2 is to observe the exhaust stack with the engine running for signs of white smoke or steam, which would be an indication of water entering the exhaust manifold.

Step 3 is a shop visual inspection similar to the inbound visual inspection of step 1 but performed after the engine has been stopped and cooled. Puddles of treated water or a build up of dried water treatment chemicals (typically green or pink) may be observed.

Step 4 is the inspection of the insides of the air manifolds for dried water treatment chemicals or puddles of treated water. Such inspection may require the removal of the air intake manifold end caps at the number 8 cylinder locations on both the left and right banks of a typical V-16 turbo-charged diesel locomotive engine.

Step 5 is to review a recent engine oil analysis for any indication of water in the engine oil. A new oil analysis may be conducted, or the most recent oil analysis data may be used if it is not too old (older than 20 days, for example). A predetermined quantifiable condemning limit may be established to declare the existence of water in the oil.

Step 6 involves checking the fault log history for the locomotive for any fault that would indicate a low water level, such as a low water level shutdown. The log should be reviewed back to the previous water leak inspection time-frame. Any low water fault that was previously diagnosed and corrected may be ignored provided that no further low water level indications occurred. Simply adding water to the system to raise the water level above an acceptable limit does not constitute a diagnosis and repair.

Step 7 is to check the water level at the sight glass. Locomotive water systems are sealed systems and should have essentially no water loss if operating perfectly. If the

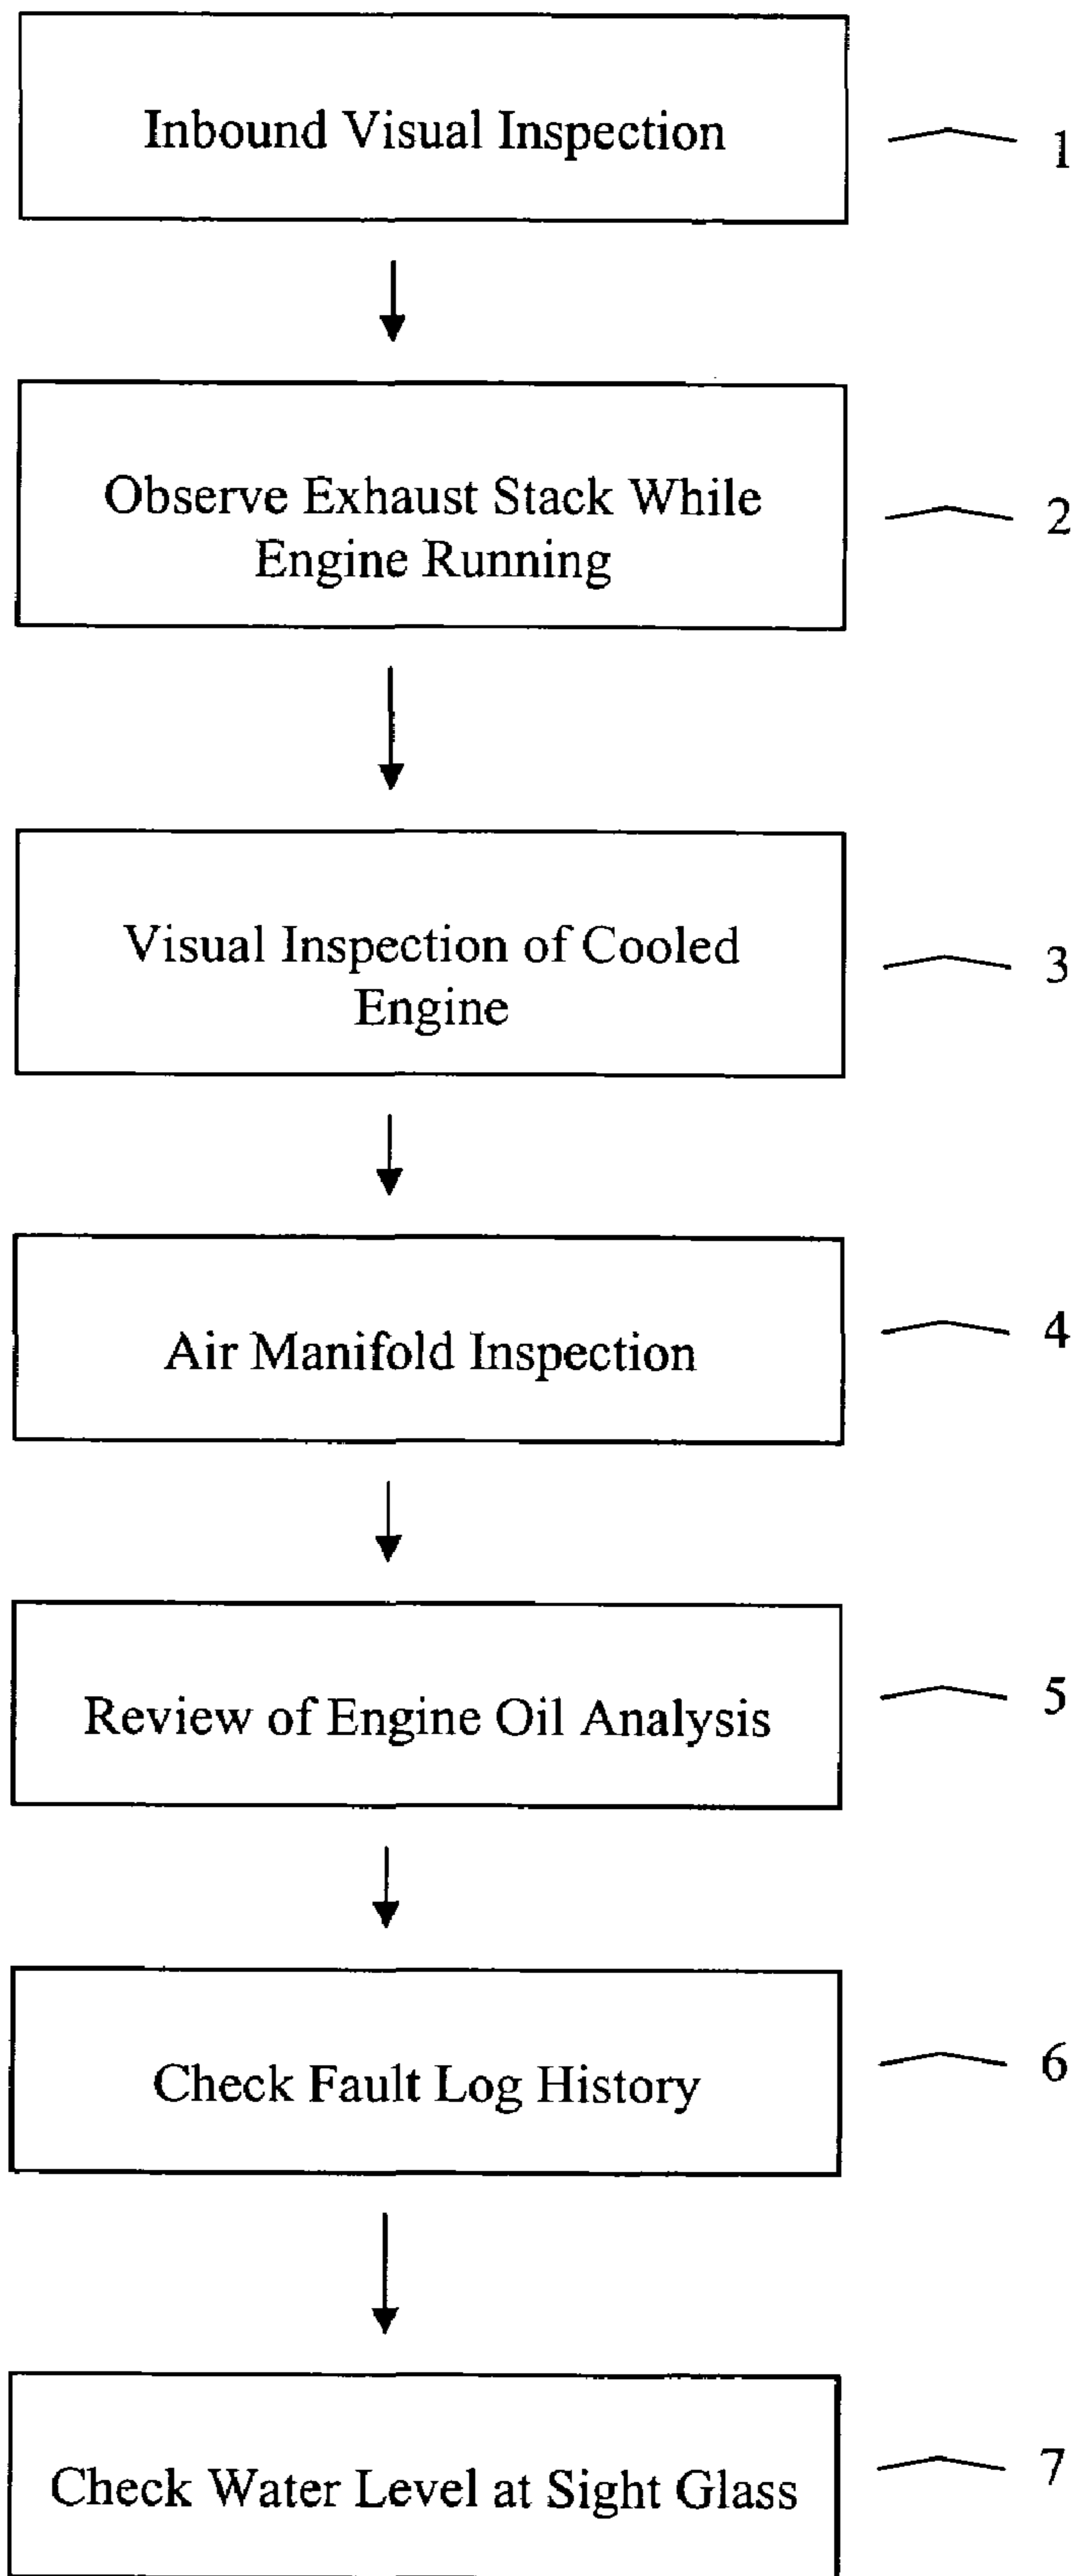
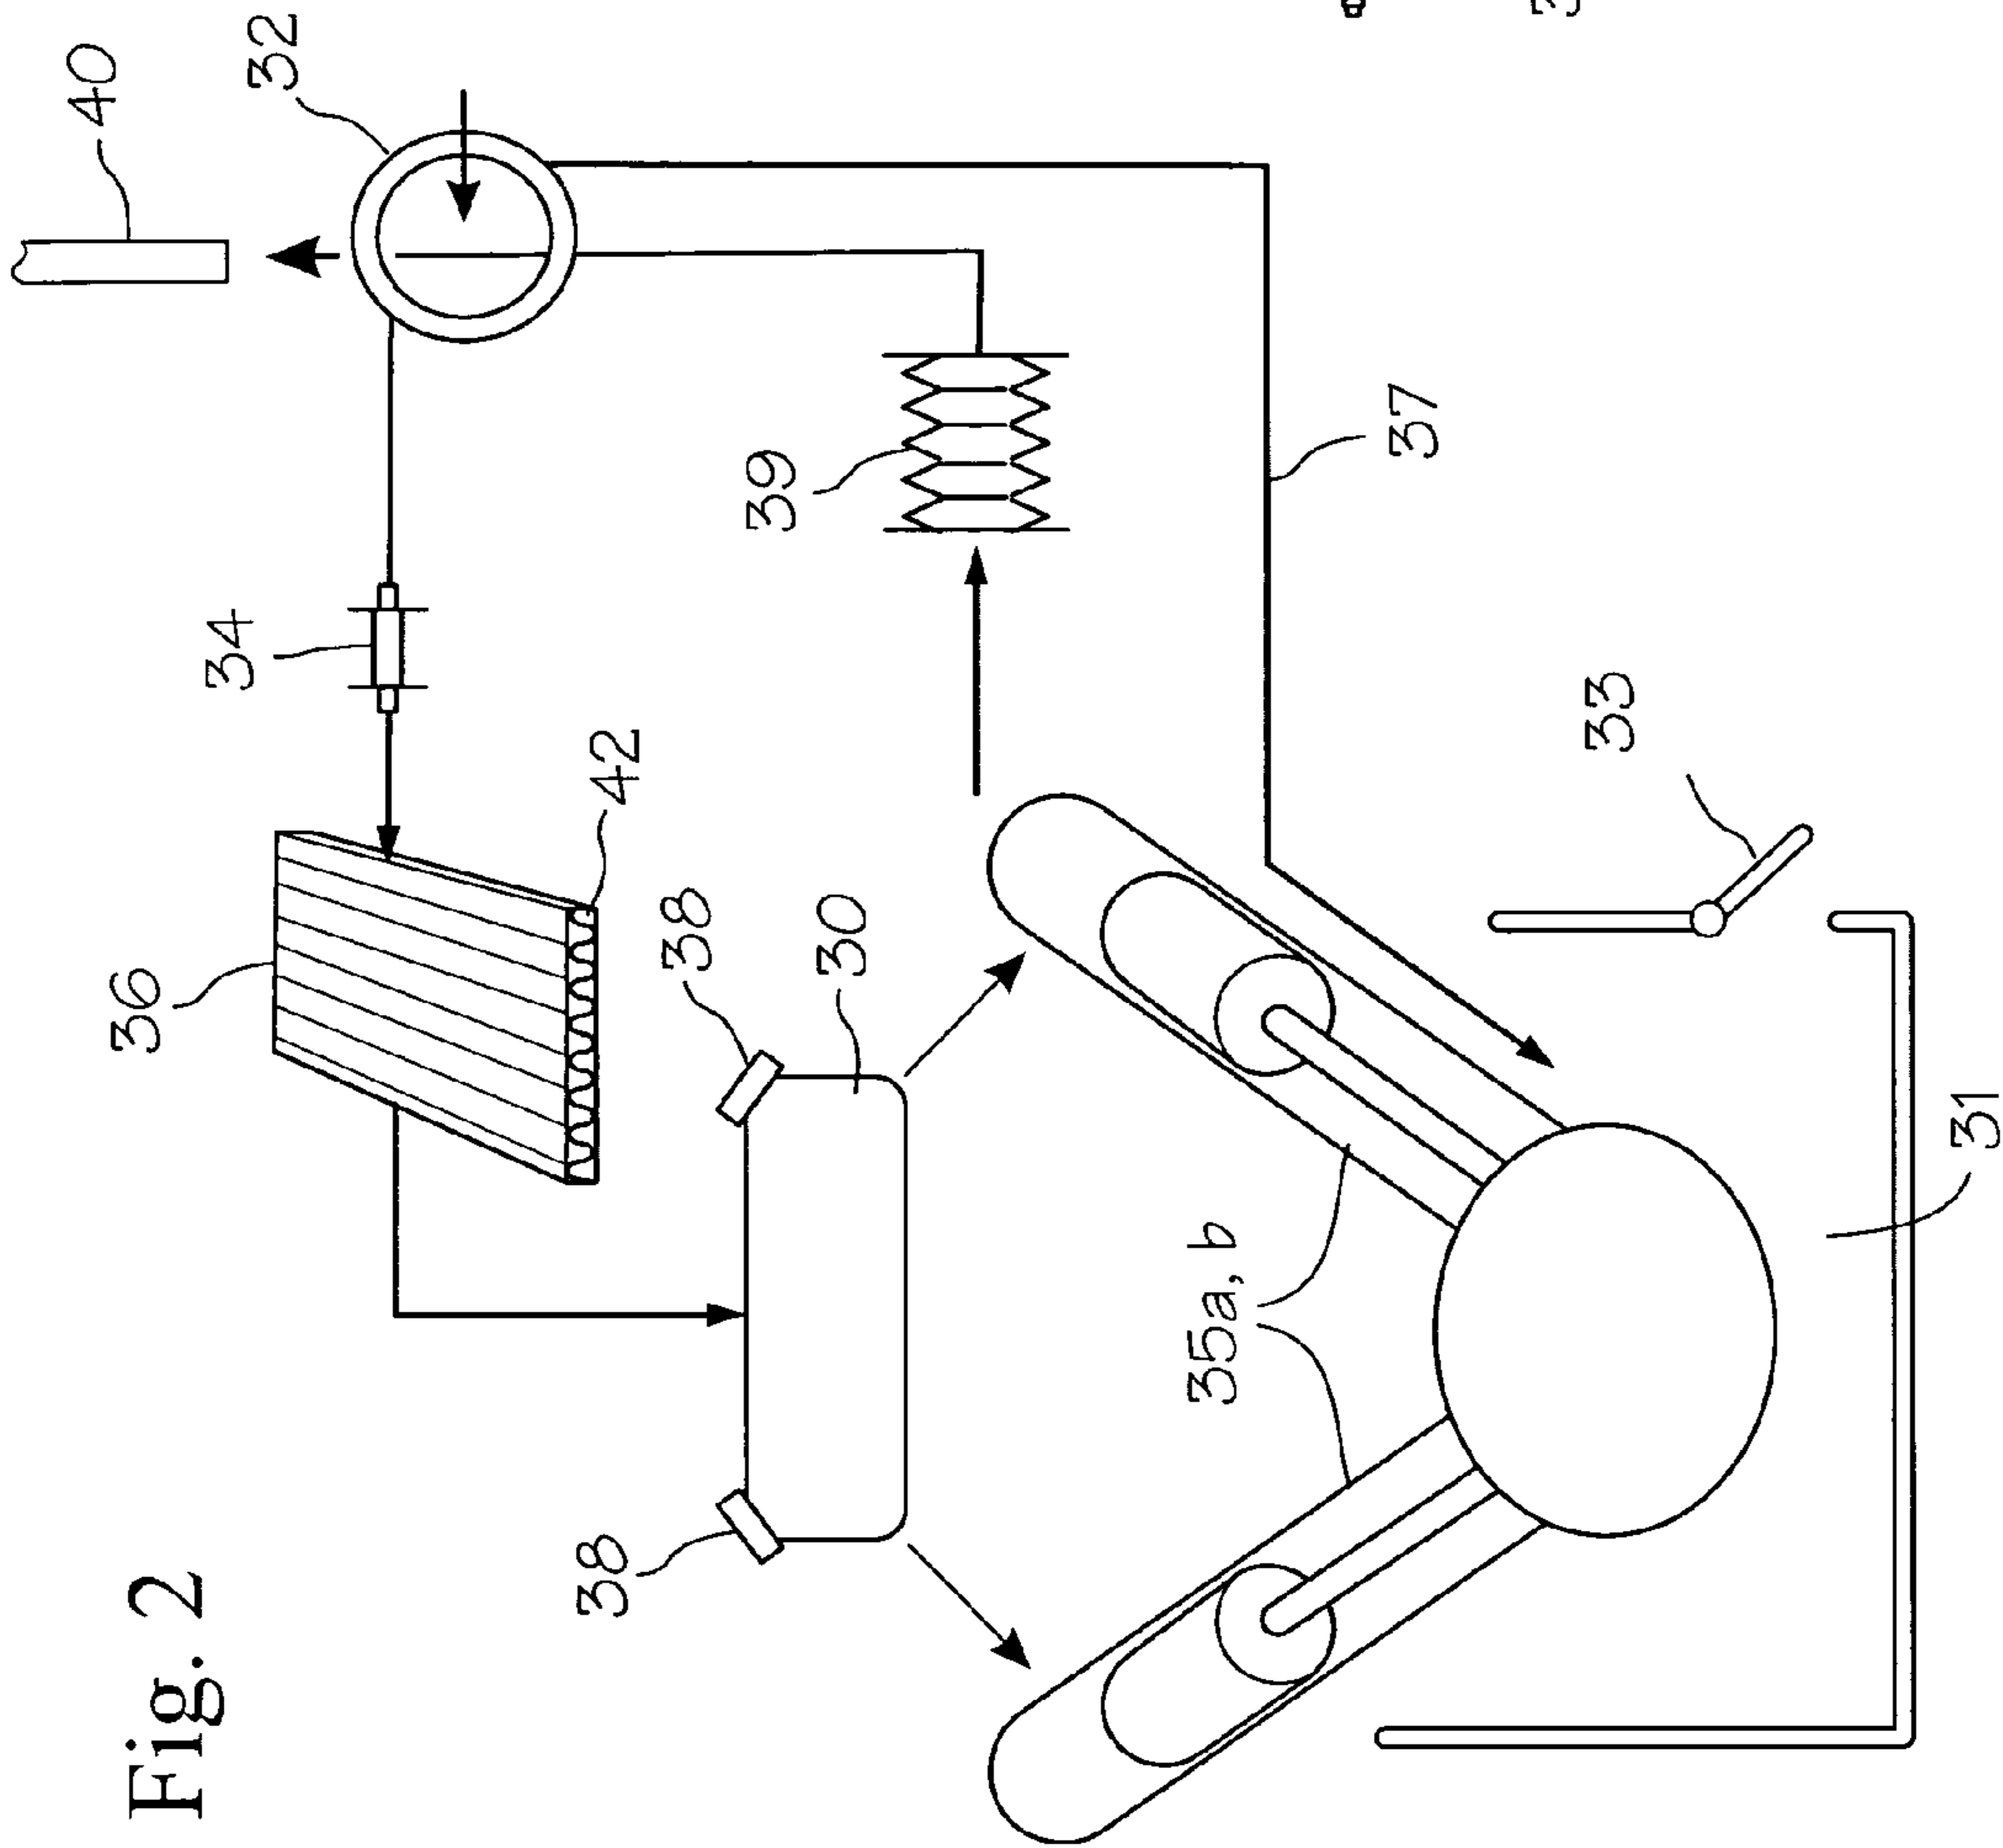
FIG. 2 is a schematic illustration of a typical V-16 turbo-charged diesel locomotive engine and a portion of the cooling system.

If leaks or indications were found during inspection steps **2**, **4**, **5** or **6**, further water leak diagnosis steps are required, as described below, to identify the exact location of the leak within the engine components. These diagnostic steps serve to isolate the possible water leak locations from one another, as illustrated in FIG. **2**, in order to eliminate the uncertainty created by transient water.

FIG. **2** represents a schematic to assist in describing one embodiment of the subject water leak detection system. One skilled in the art will appreciate that many of the engine components are represented symbolically and should not be construed to represent the actual spatial arrangement and proximity of such components in situ. If water indications were present in the air manifold **30** during inspection step **4**, the air manifold **30** should be isolated from the turbocharger **32** to prevent water from a leaking turbocharger **32** from entering the intake air manifold **30**. This may involve removing or at least partially disassembling a steel sleeve **34** existing in the intake air passageway between the turbocharger **32** and the intercooler **36** between the numbers **1** and **2** cylinders (**35a** and **35b**) on both sides of a V-16 diesel locomotive engine. The air intake manifold end caps **38** should be removed at this time if they had not been removed previously.

If water was found in the oil analysis of inspection step **5**, access should be provided to the inside of the crankcase **31** to facilitate visual inspection of the cylinders and turbocharger drain line **37**. This may be accomplished by removing crankcase doors **33** provided on the engine.

If the exhaust stack **40** showed indications of water vapor during inspection step **2**, the exhaust manifold should be isolated from the turbocharger **32** to eliminate the possibility of transient water there between, such as by dislodging the exhaust bellows **39** located behind the turbocharger **32**.

Once the above steps are taken to isolate the potentially leaking components, the cooling system is pressurized to a test pressure, for example 10–12 psi, and the various components are inspected for signs of leakage. A leak in the turbocharger **32** should be evidenced by water leaking into the crankcase **31** through the turbocharger oil drain line **37** or a leak indication from the turbocharger side of the exhaust manifold where the exhaust bellows **39** were dislodged. A water leak from any of the cylinders should be evidenced by water dripping into the crankcase **31** or water accumulating in the air manifold **30** from the leaking cylinder. A water leak from the intercooler **36** should be evidenced by water leaking from the weep hole **42** located at the bottom of the intercooler **36**. An internal inspection of the intercooler **36** can be performed by using a mirror and a flashlight. None of these potential leaks can generate transient water that would be misinterpreted as coming from a different component because each component is mechanically isolated from the others, thereby providing a high level of assurance that the source of the leak is correctly identified.

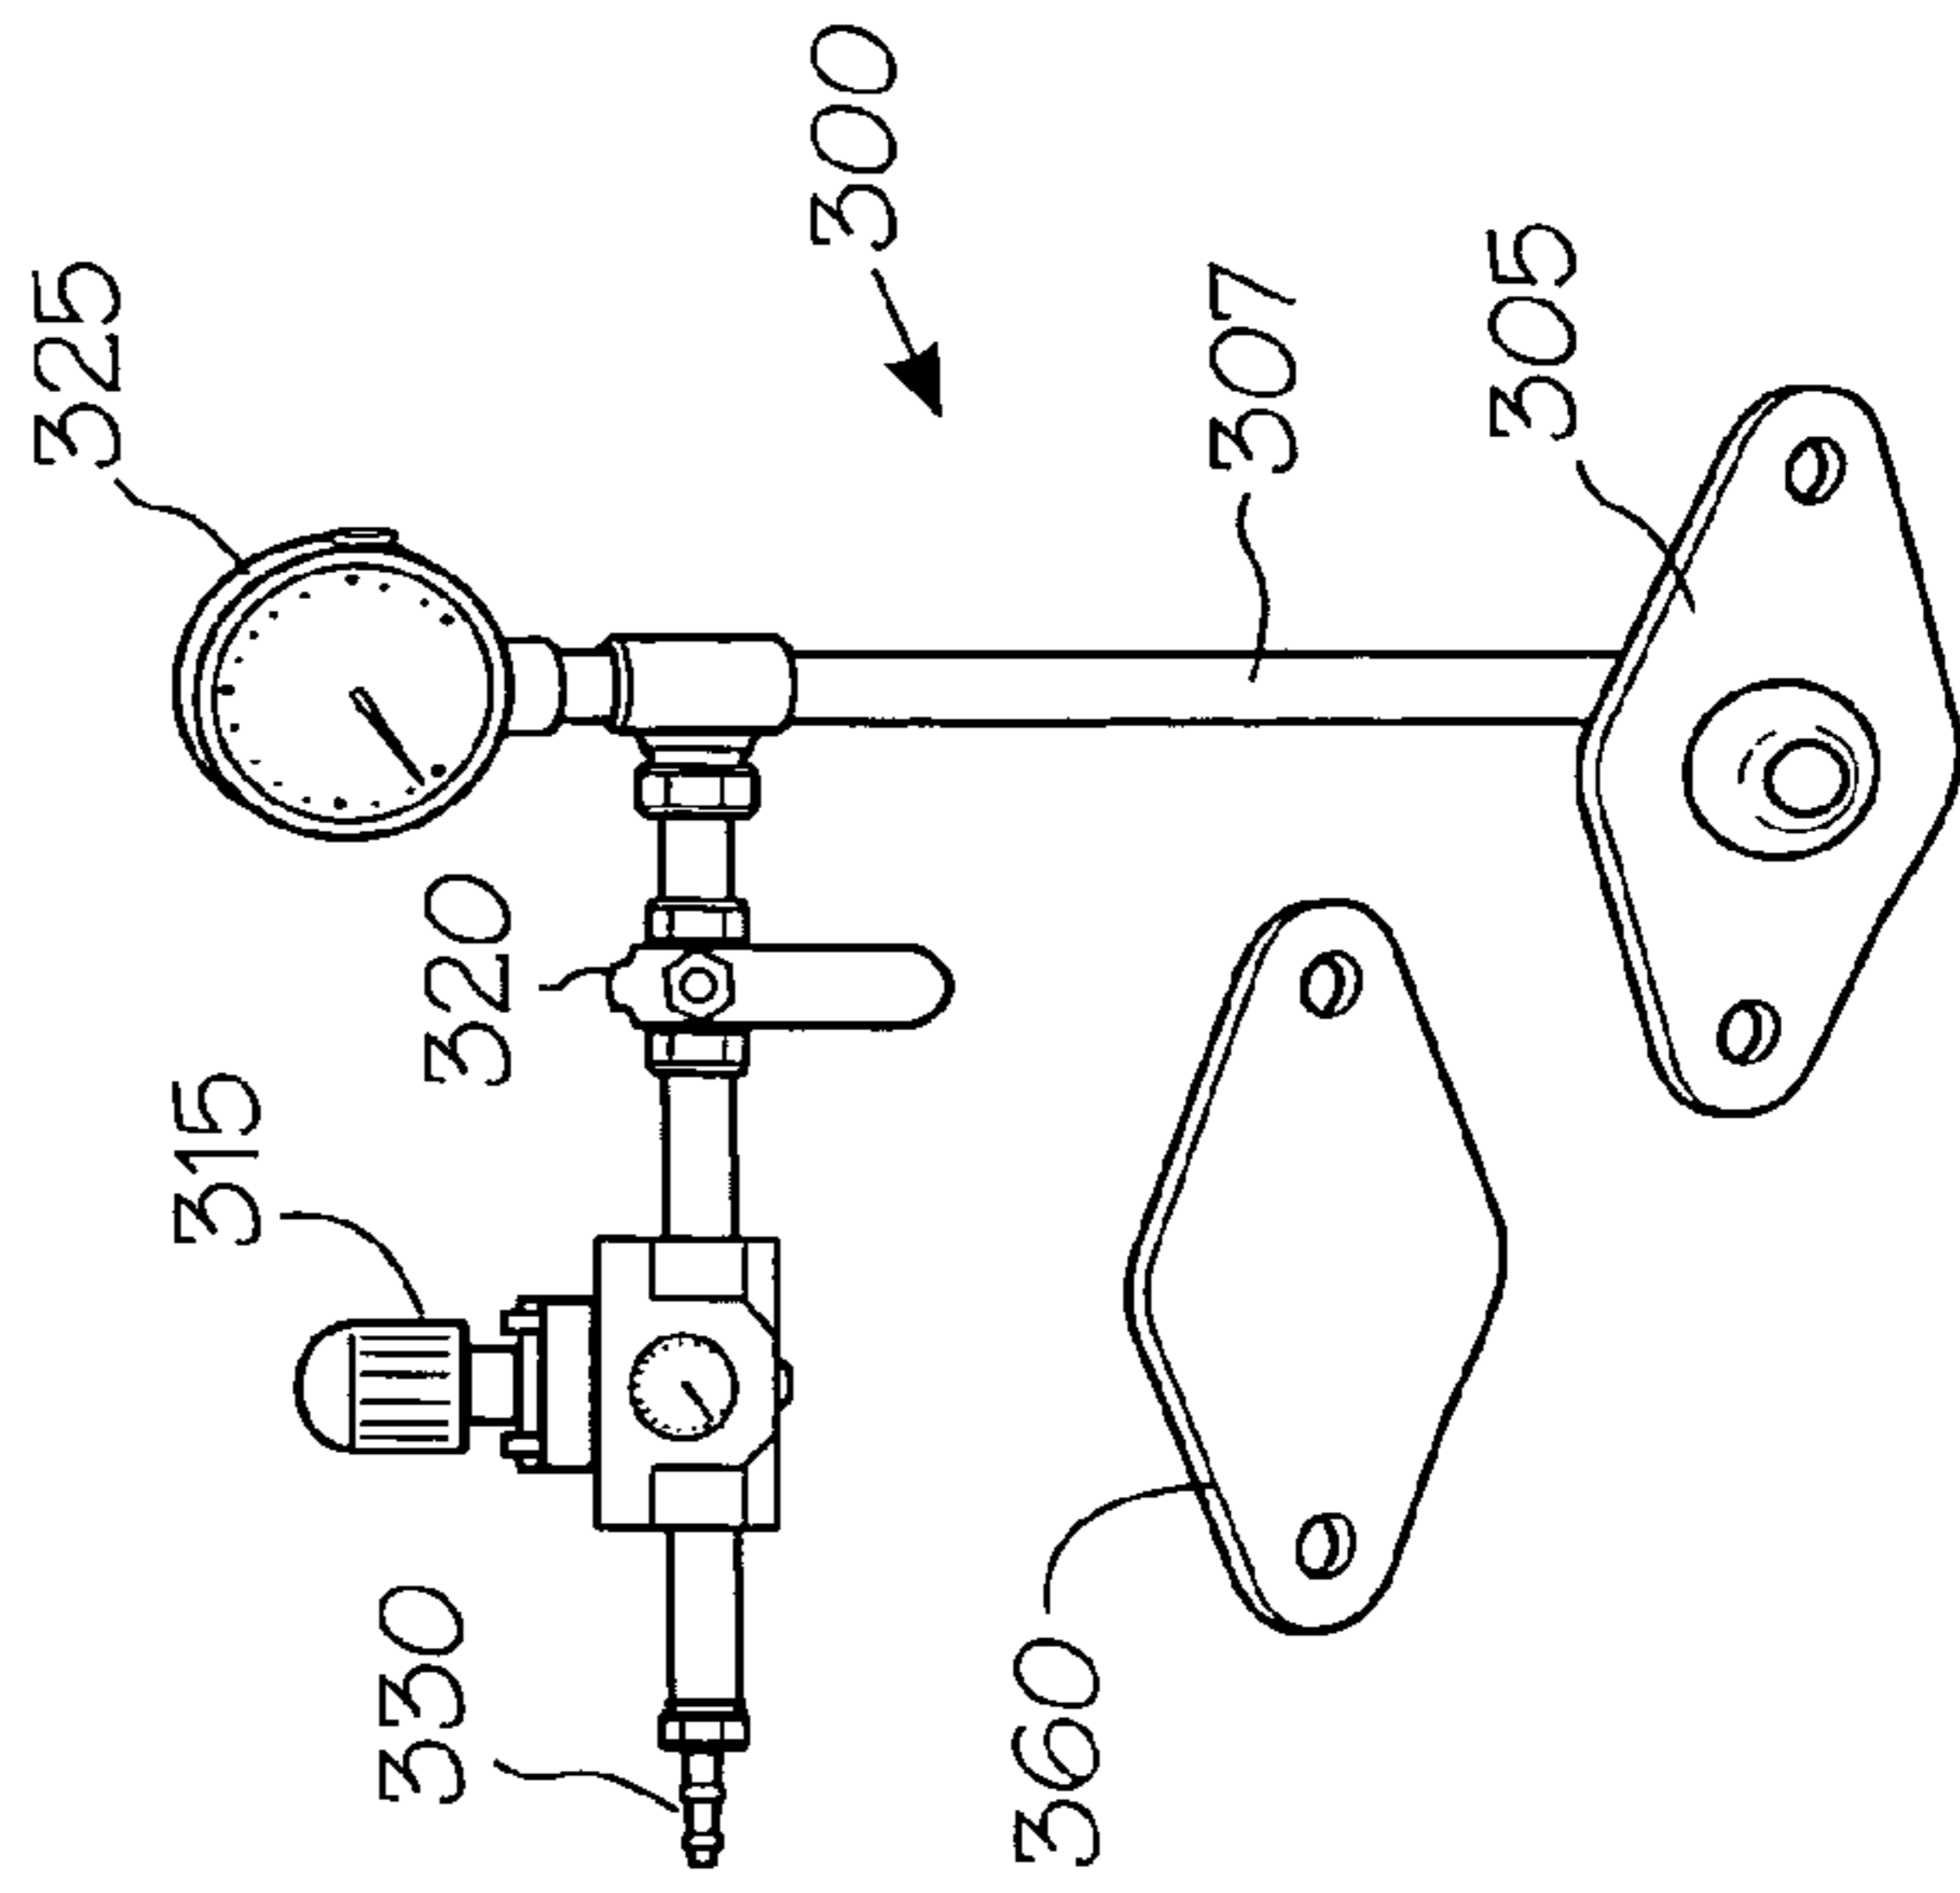
Fig. 3

FIG. 3 is a perspective view of a cylinder leak air testing apparatus.

If one or more cylinders indicate signs of a water leak, a further cylinder-specific air leak test may be performed prior to removal of that cylinder power assembly. The air leak test may be performed by using the testing apparatus illustrated in FIG. **3** or other appropriate fixture. With the water drained from the system, a water inlet blanking flange **360** is installed onto the cylinder assembly water inlet port, and the water outlet test fixture **300** is installed onto the water outlet port. In certain embodiments it may be more convenient to reverse the locations of these two parts. The test fixture **310** includes a blanking flange **305** containing a pipe connection and adapted for installation onto the water port. The pipe **307** connected to the flange provides a fluid communication between a source of compressed air, regulated through a pressure regulator **315**, and the water jacket of the cylinder being tested. An isolation valve **320** allows the water jacket to be pressurized by the compressed air and then isolated. A pressure gauge **325** is connected to the pipe between the isolation valve **320** and the flange **305** for providing an indication of the pressure inside the cylinder water jacket being tested. The testing apparatus is thus a single device that creates a sealed volume within the water jacket of the specific power assembly to be tested, provides a connection **330** to a supply of compressed air, and provides a pressure indication. Compressed air is slowly introduced into the water jacket via the test fixture **300** to establish a predetermined test pressure, for example 60 psi as indicated on the pressure gauge. The isolation valve **320** on the test fixture **300** is then closed to hold the pressure steady. If the pressure leaks at greater than a predetermined rate, for example if the pressure declines by 2 psi or greater in 5 minutes, the cylinder water leak is confirmed. An individual power assembly may be removed due to a water leak for inspection and repair only if it fails this supplemental air leak test, thereby minimizing the number of non-leaking power assemblies that will be removed.
