(54) **METHOD OF REPAIRING A NI-BASE ALLOY PART**

(73) Assignee: **Mitsubishi Heavy Industries, Ltd.**, Tokyo (JP)

METHOD OF REPAIRING A NI-BASE ALLOY PART

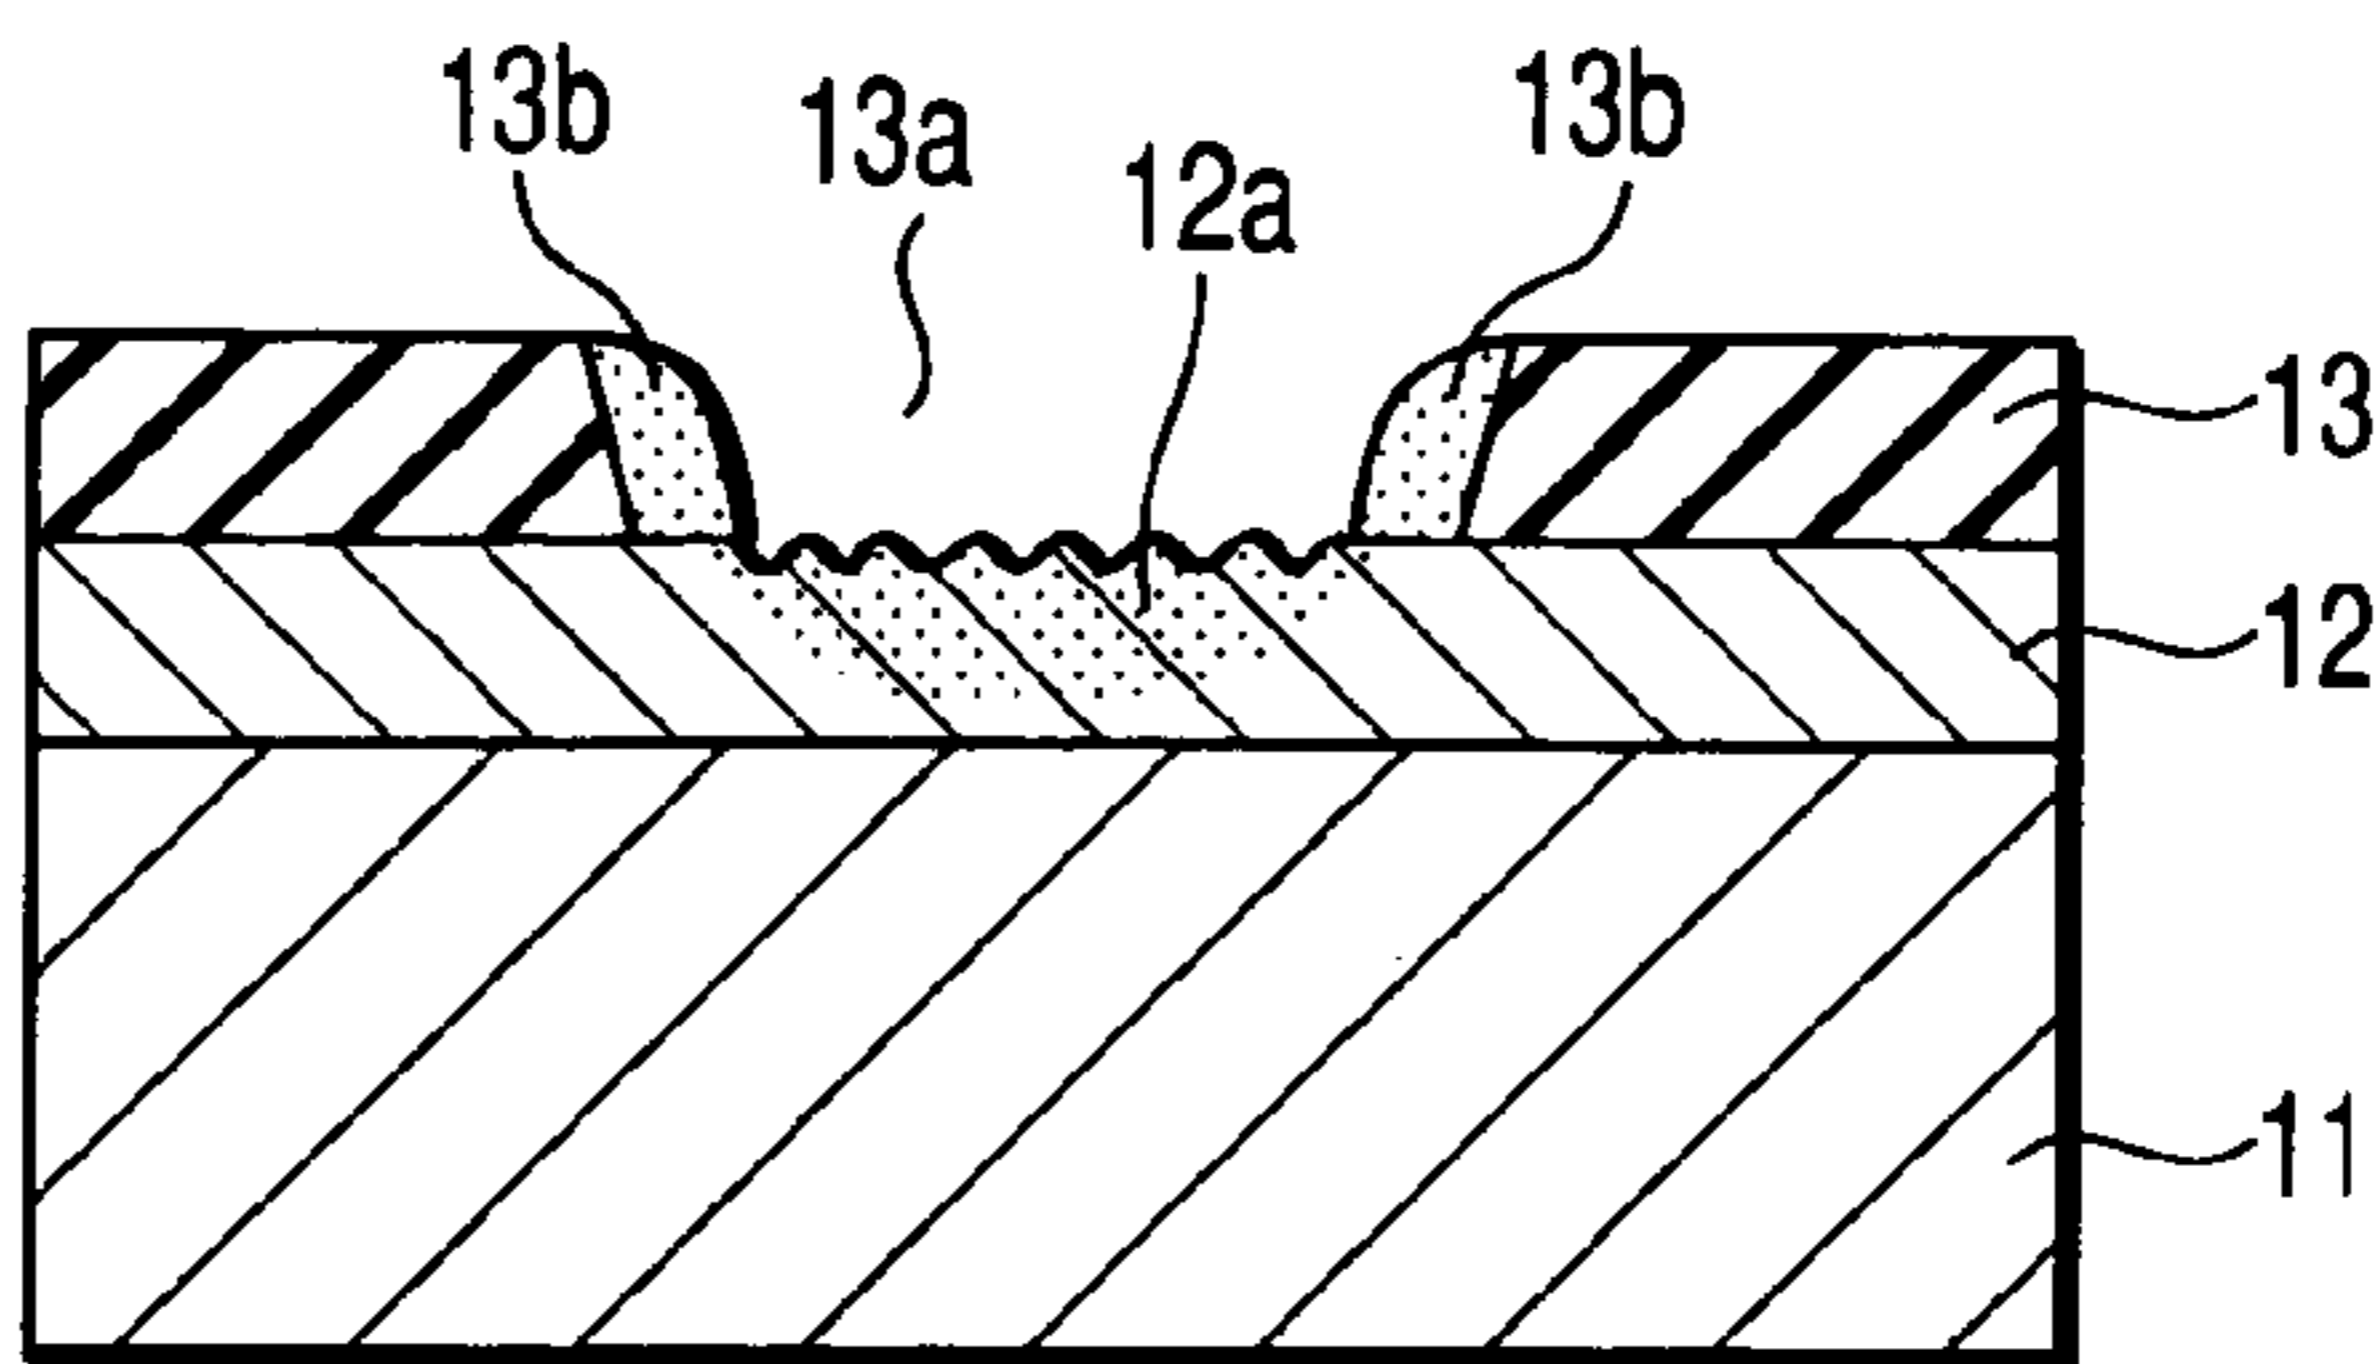
FIG. 1A

Referring to FIGS. 1A to 1D, explanation will be made. As shown in FIG. 1A, an undercoat layer **12** composed of a Co-based material (e.g., Co-32% Ni-21% Cr-8% Al-0.5% Y), which has a denatured portion **12a** on its surface, is formed on a base material **11**. Also as shown in FIG. 1A, a topcoat layer **13**, which has a peeled-off portion (where the topcoat layer has been removed) **13a** and a damaged portion **13b** surrounding the peeled-off portion **13a**, is formed on the undercoat layer **12**. The topcoat layer **13** is composed of $ZrO_2.8Y_2O_3$. From the structure in this state, the undercoat layer **12** present on the bottom of the peeled-off portion **13a** and the damaged portion **13b** of the topcoat layer **13** are selectively removed by grind-polishing to form an opening portion **14** (where the coat layers have been removed) in the undercoat layer **12** and the topcoat layer **13** (see FIG. 1B). Note that reference numeral **12'** of FIG. 1B indicates the portion where the undercoat layer **12** has been removed, and reference numeral **13'** indicates the portion where the topcoat layer **13** has been removed.

FIGS. 1A to 1D illustrate a method of repairing a Ni-based alloy part according to Embodiment 1 of the present invention, in accordance with order of repairing steps;

In Embodiment 1, the undercoat layer **12** present on the bottom of the peeled-off portion **13a** of the topcoat layer **13** and the damaged layer **13b** are selectively removed to form the opening portion **14** in the undercoat layer **12** and the topcoat layer **13**. Thereafter, plasma spraying is applied to the opening portion **14** right above it by means of the plasma spray gun **16** in the atmosphere at a thermal particle speed of 500 m/s and a base-material temperature of 150° C. or less. In this manner, the removed portion **12'** of the undercoat layer **12** and the removed portion **13'** of the topcoat layer **13** are sequentially repaired. Accordingly, since further coating of the entire rotor blade is not required as is in the art, the cost can be reduced.

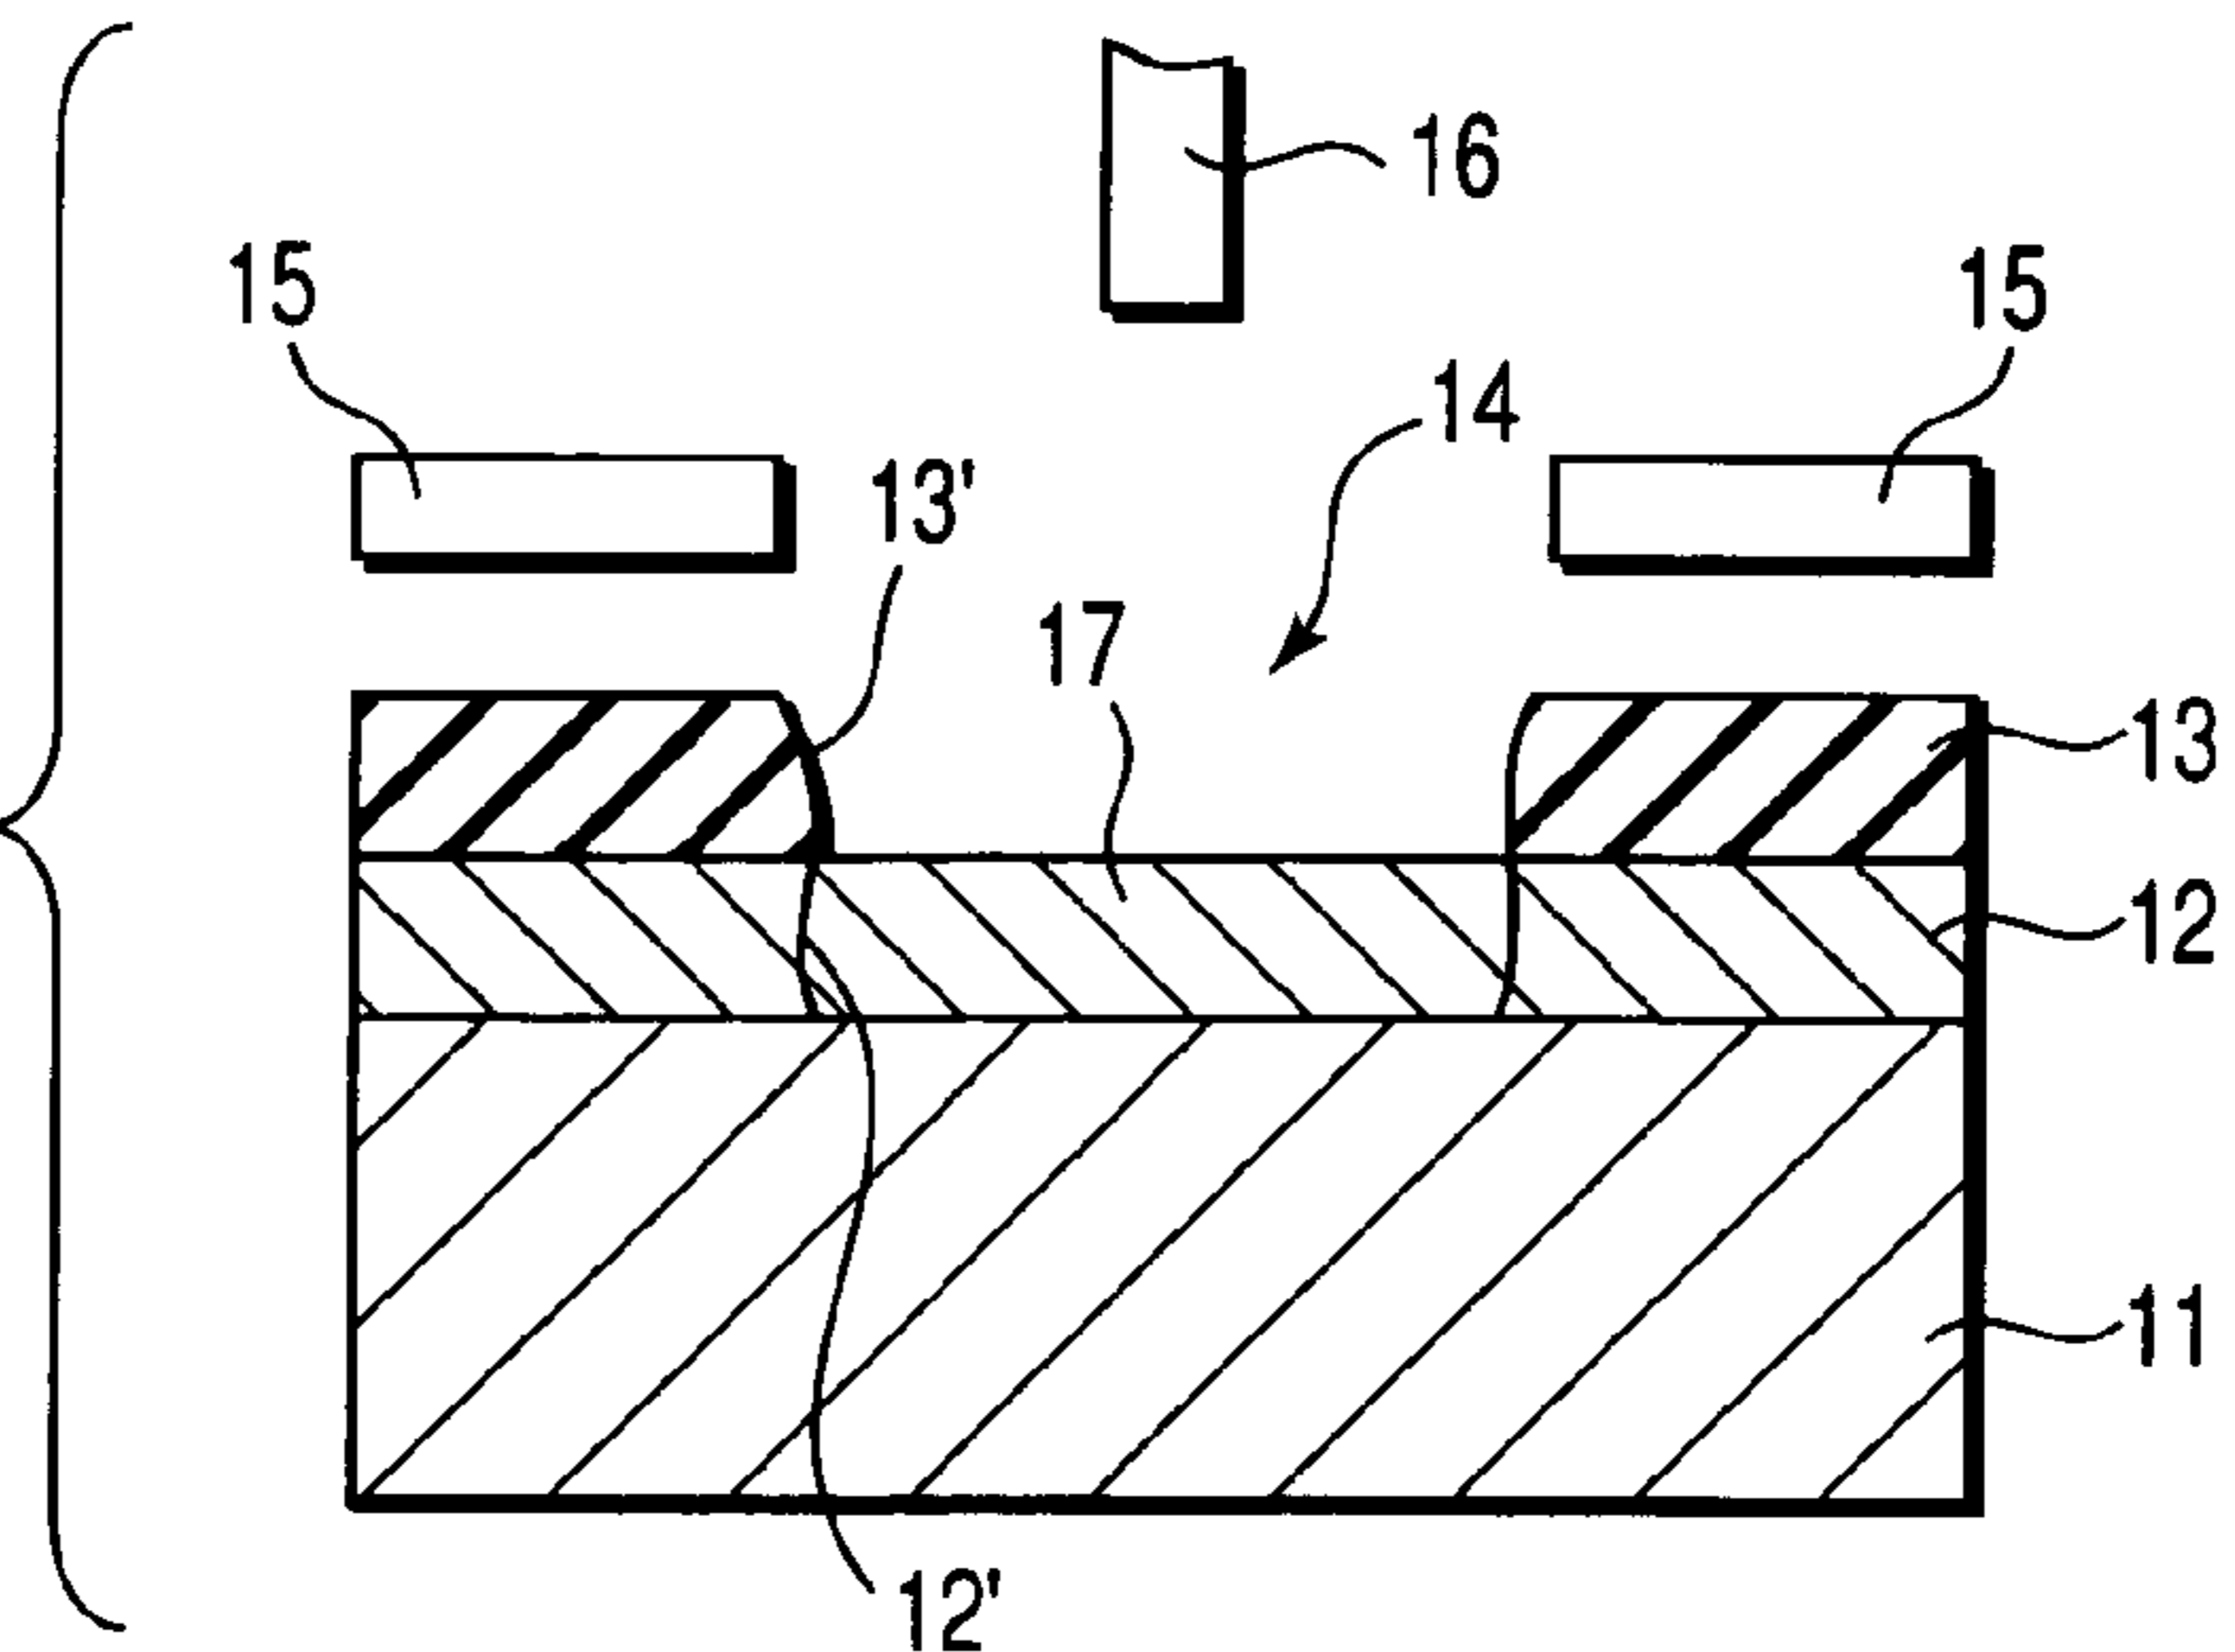
FIG. 1C

Next, a masking material **15** having an opening corresponding to the opening portion **14** is arranged right upon the topcoat layer **13** and a plasma spray gun **16** is arranged right above the opening portion **14**. Subsequently, plasma spray is applied to the opening **14** in the atmosphere at a spray particle speed of 500 m/s and a base-material temperature of 150° C. to form a Co-based alloy layer, e.g., CoNiCrAlY layer **17** in the removed portion **12'** where the undercoat layer **12** has been removed. In this way, the repair of the undercoat layer **12** is completed (see FIG. 1C). Furthermore, plasma spraying is applied to the opening portion **14** by means of the plasma spray gun **16** to form a topcoat layer **18** composed of $ZrO_2-Yb_2O_3$ in the removed portion **13'** where the topcoat layer **13** has been removed. In this way, the repair of the topcoat layer **13** is completed (see FIG. 1D).

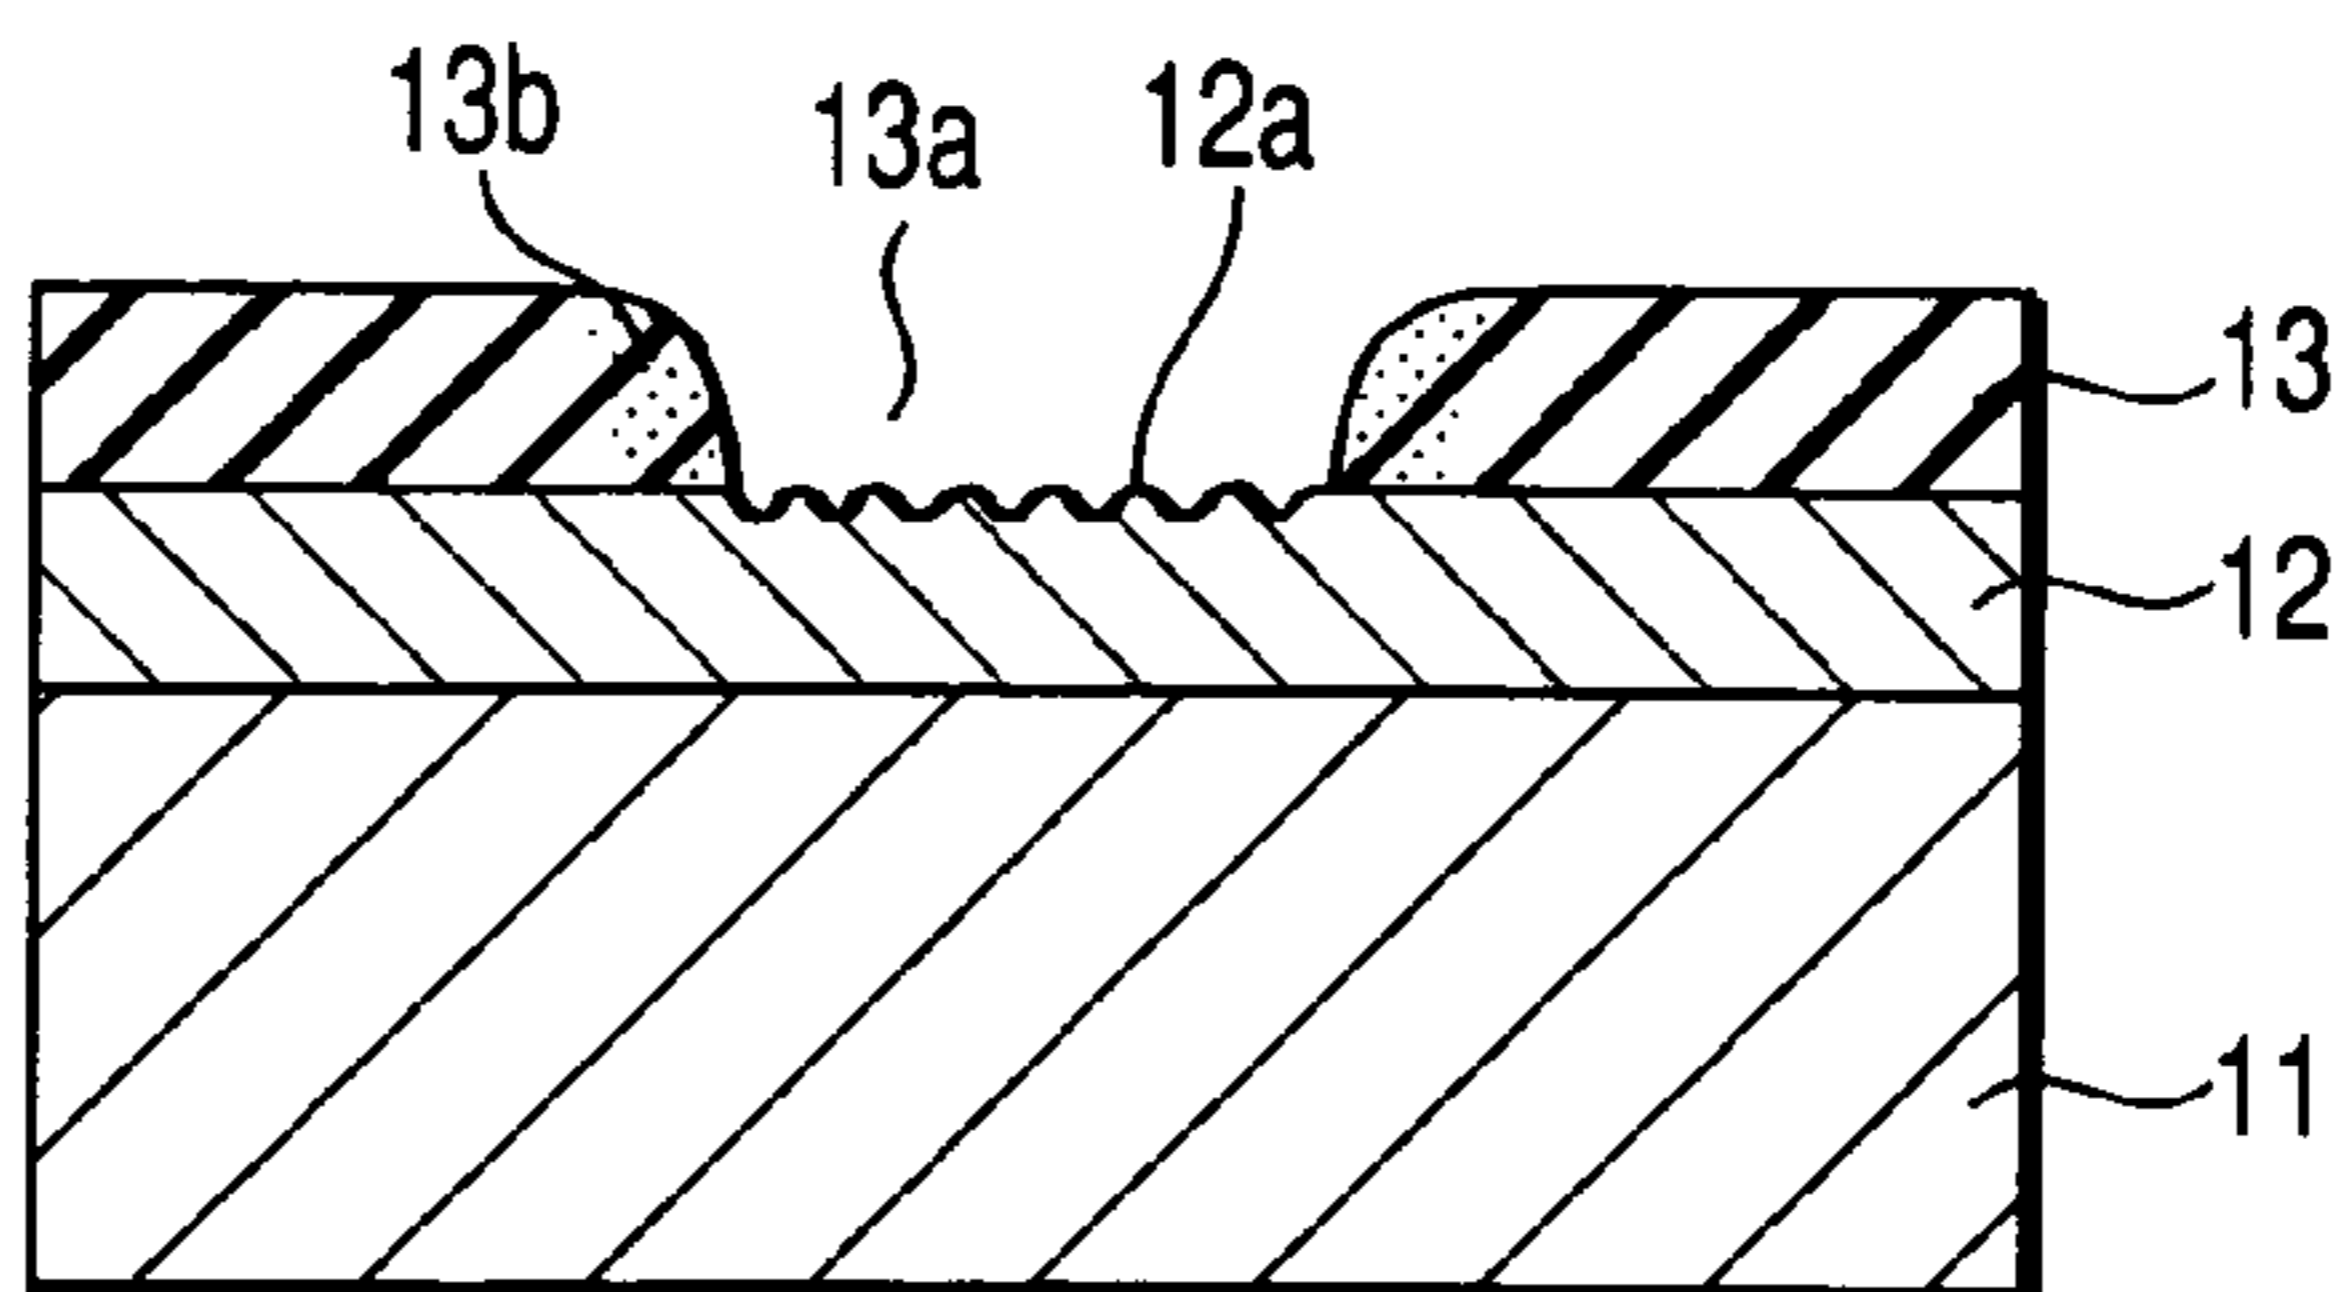
FIG. 2A

As shown in FIG. 2A, an undercoat layer 12 having a denatured portion 12a is formed on a base material 11. The undercoat layer 12 used herein is composed of a Ni-based material, for example, NiCoCrAlY. Furthermore, as shown in FIG. 2A, a topcoat layer 13, which has a peeled-off portion (removed portion) 13a and a damaged portion 13b surrounding the removed portion 13a, is formed on the undercoat layer 12. The topcoat layer 13 is composed of $ZrO_2 \cdot 8Y_2O_3$.

FIGS. 2A to 2D illustrate a method of repairing a Ni-based alloy part according to Embodiment 2 of the present invention, in accordance with order of repairing steps;

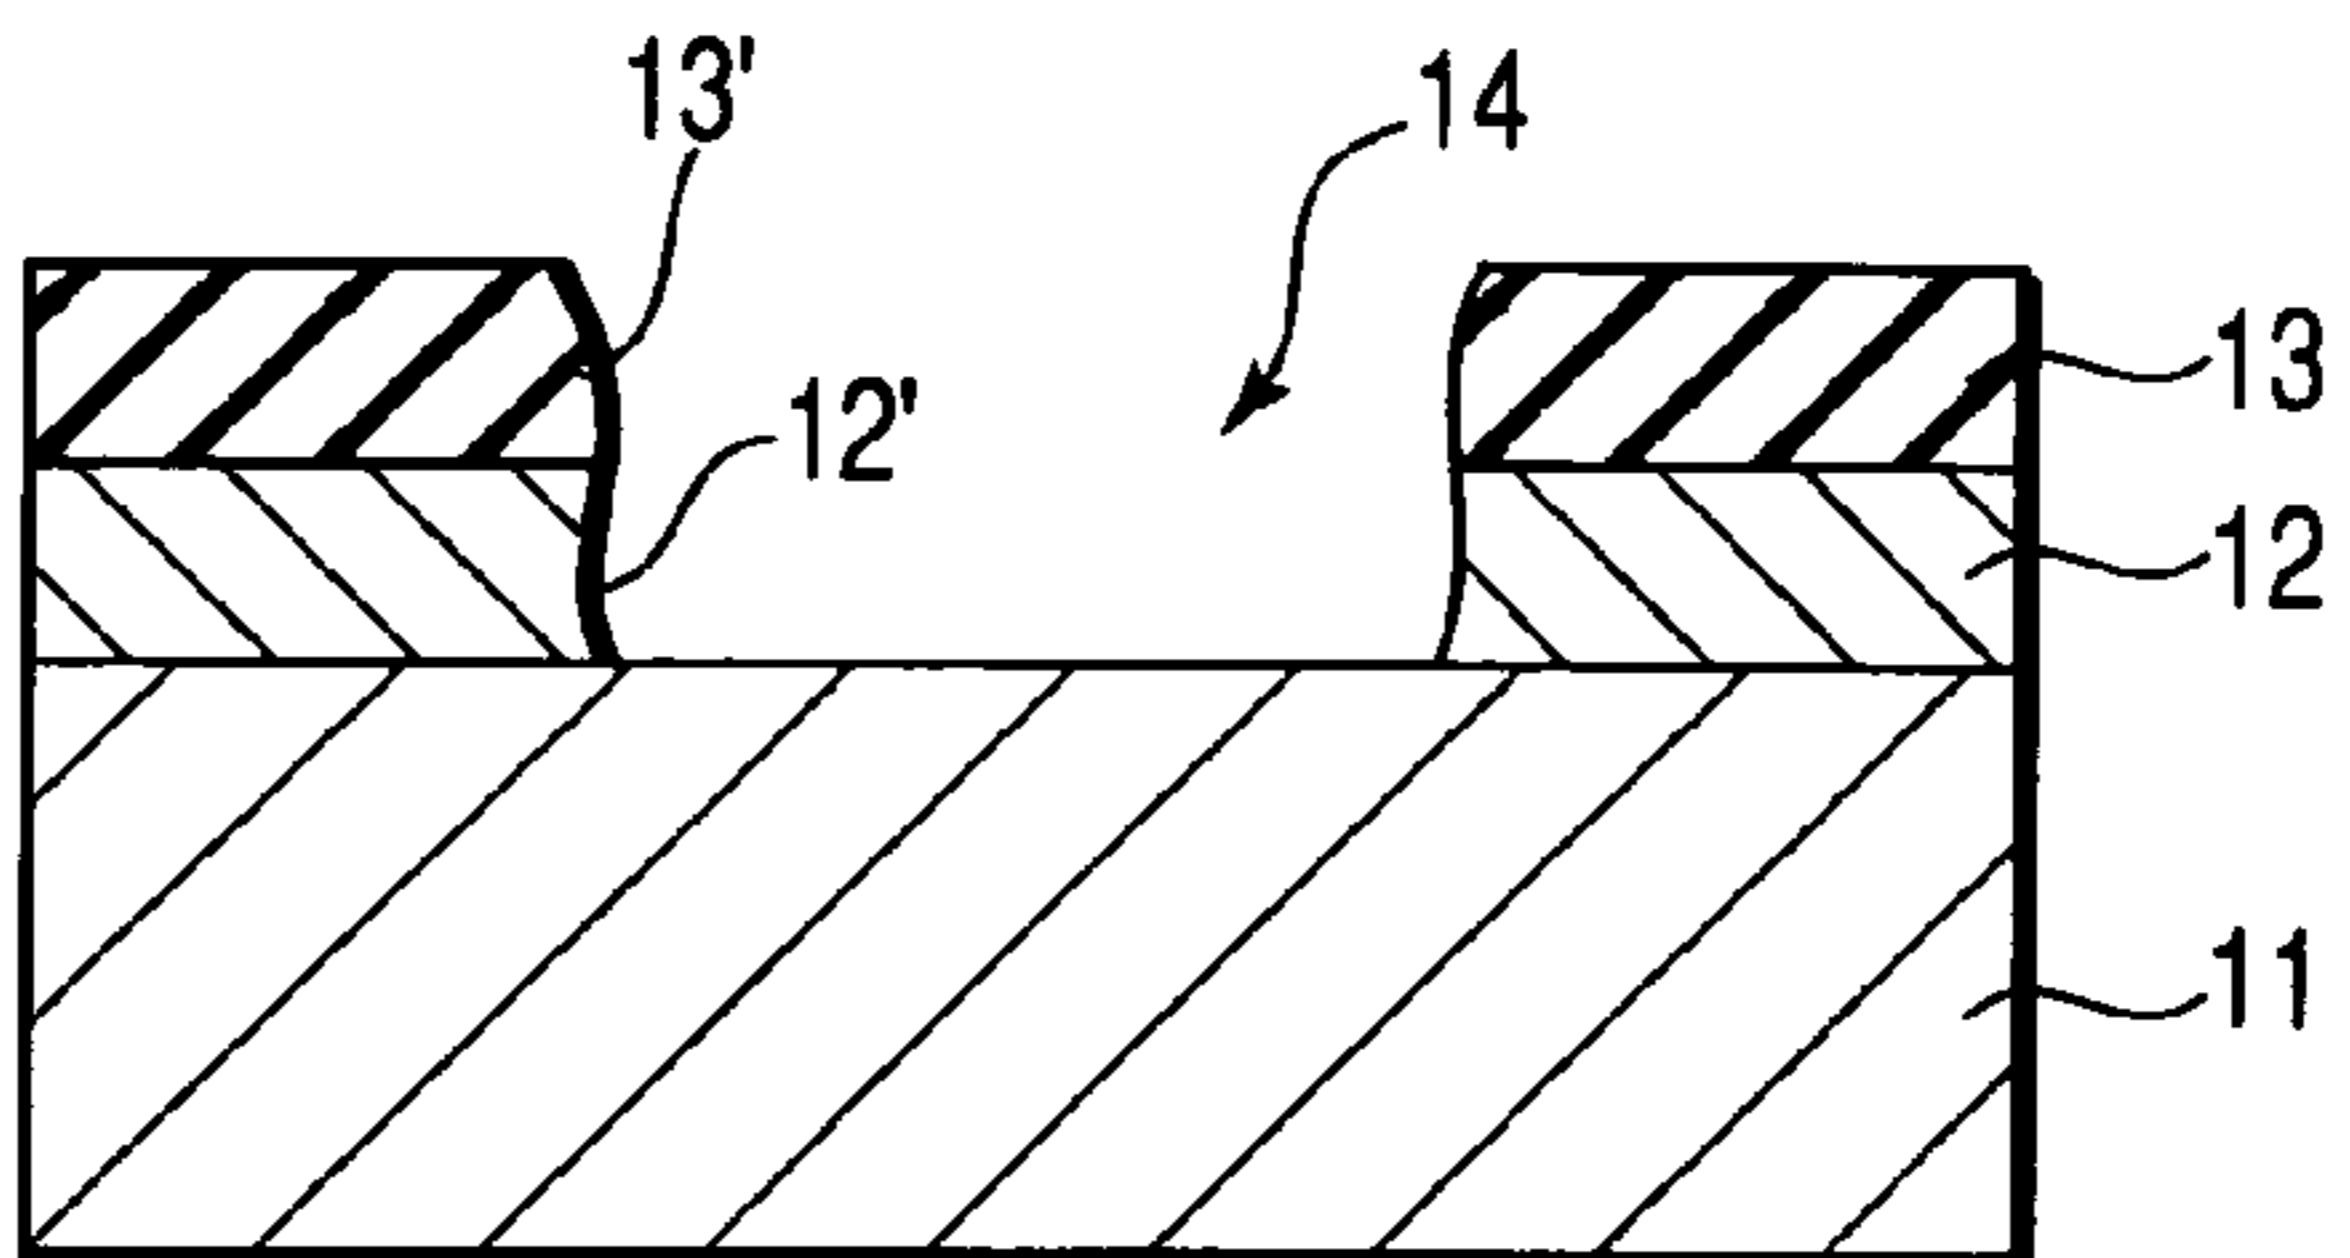
FIG. 2B

From the structure in this state, the undercoat layer 12 present on the bottom of the peeled-off portion 13a and the damaged portion 13b of the topcoat layer 13 are selectively removed by grind-polishing, thereby forming an opening portion 14 in the undercoat layer 12 and the topcoat layer 13 (see FIG. 2B).

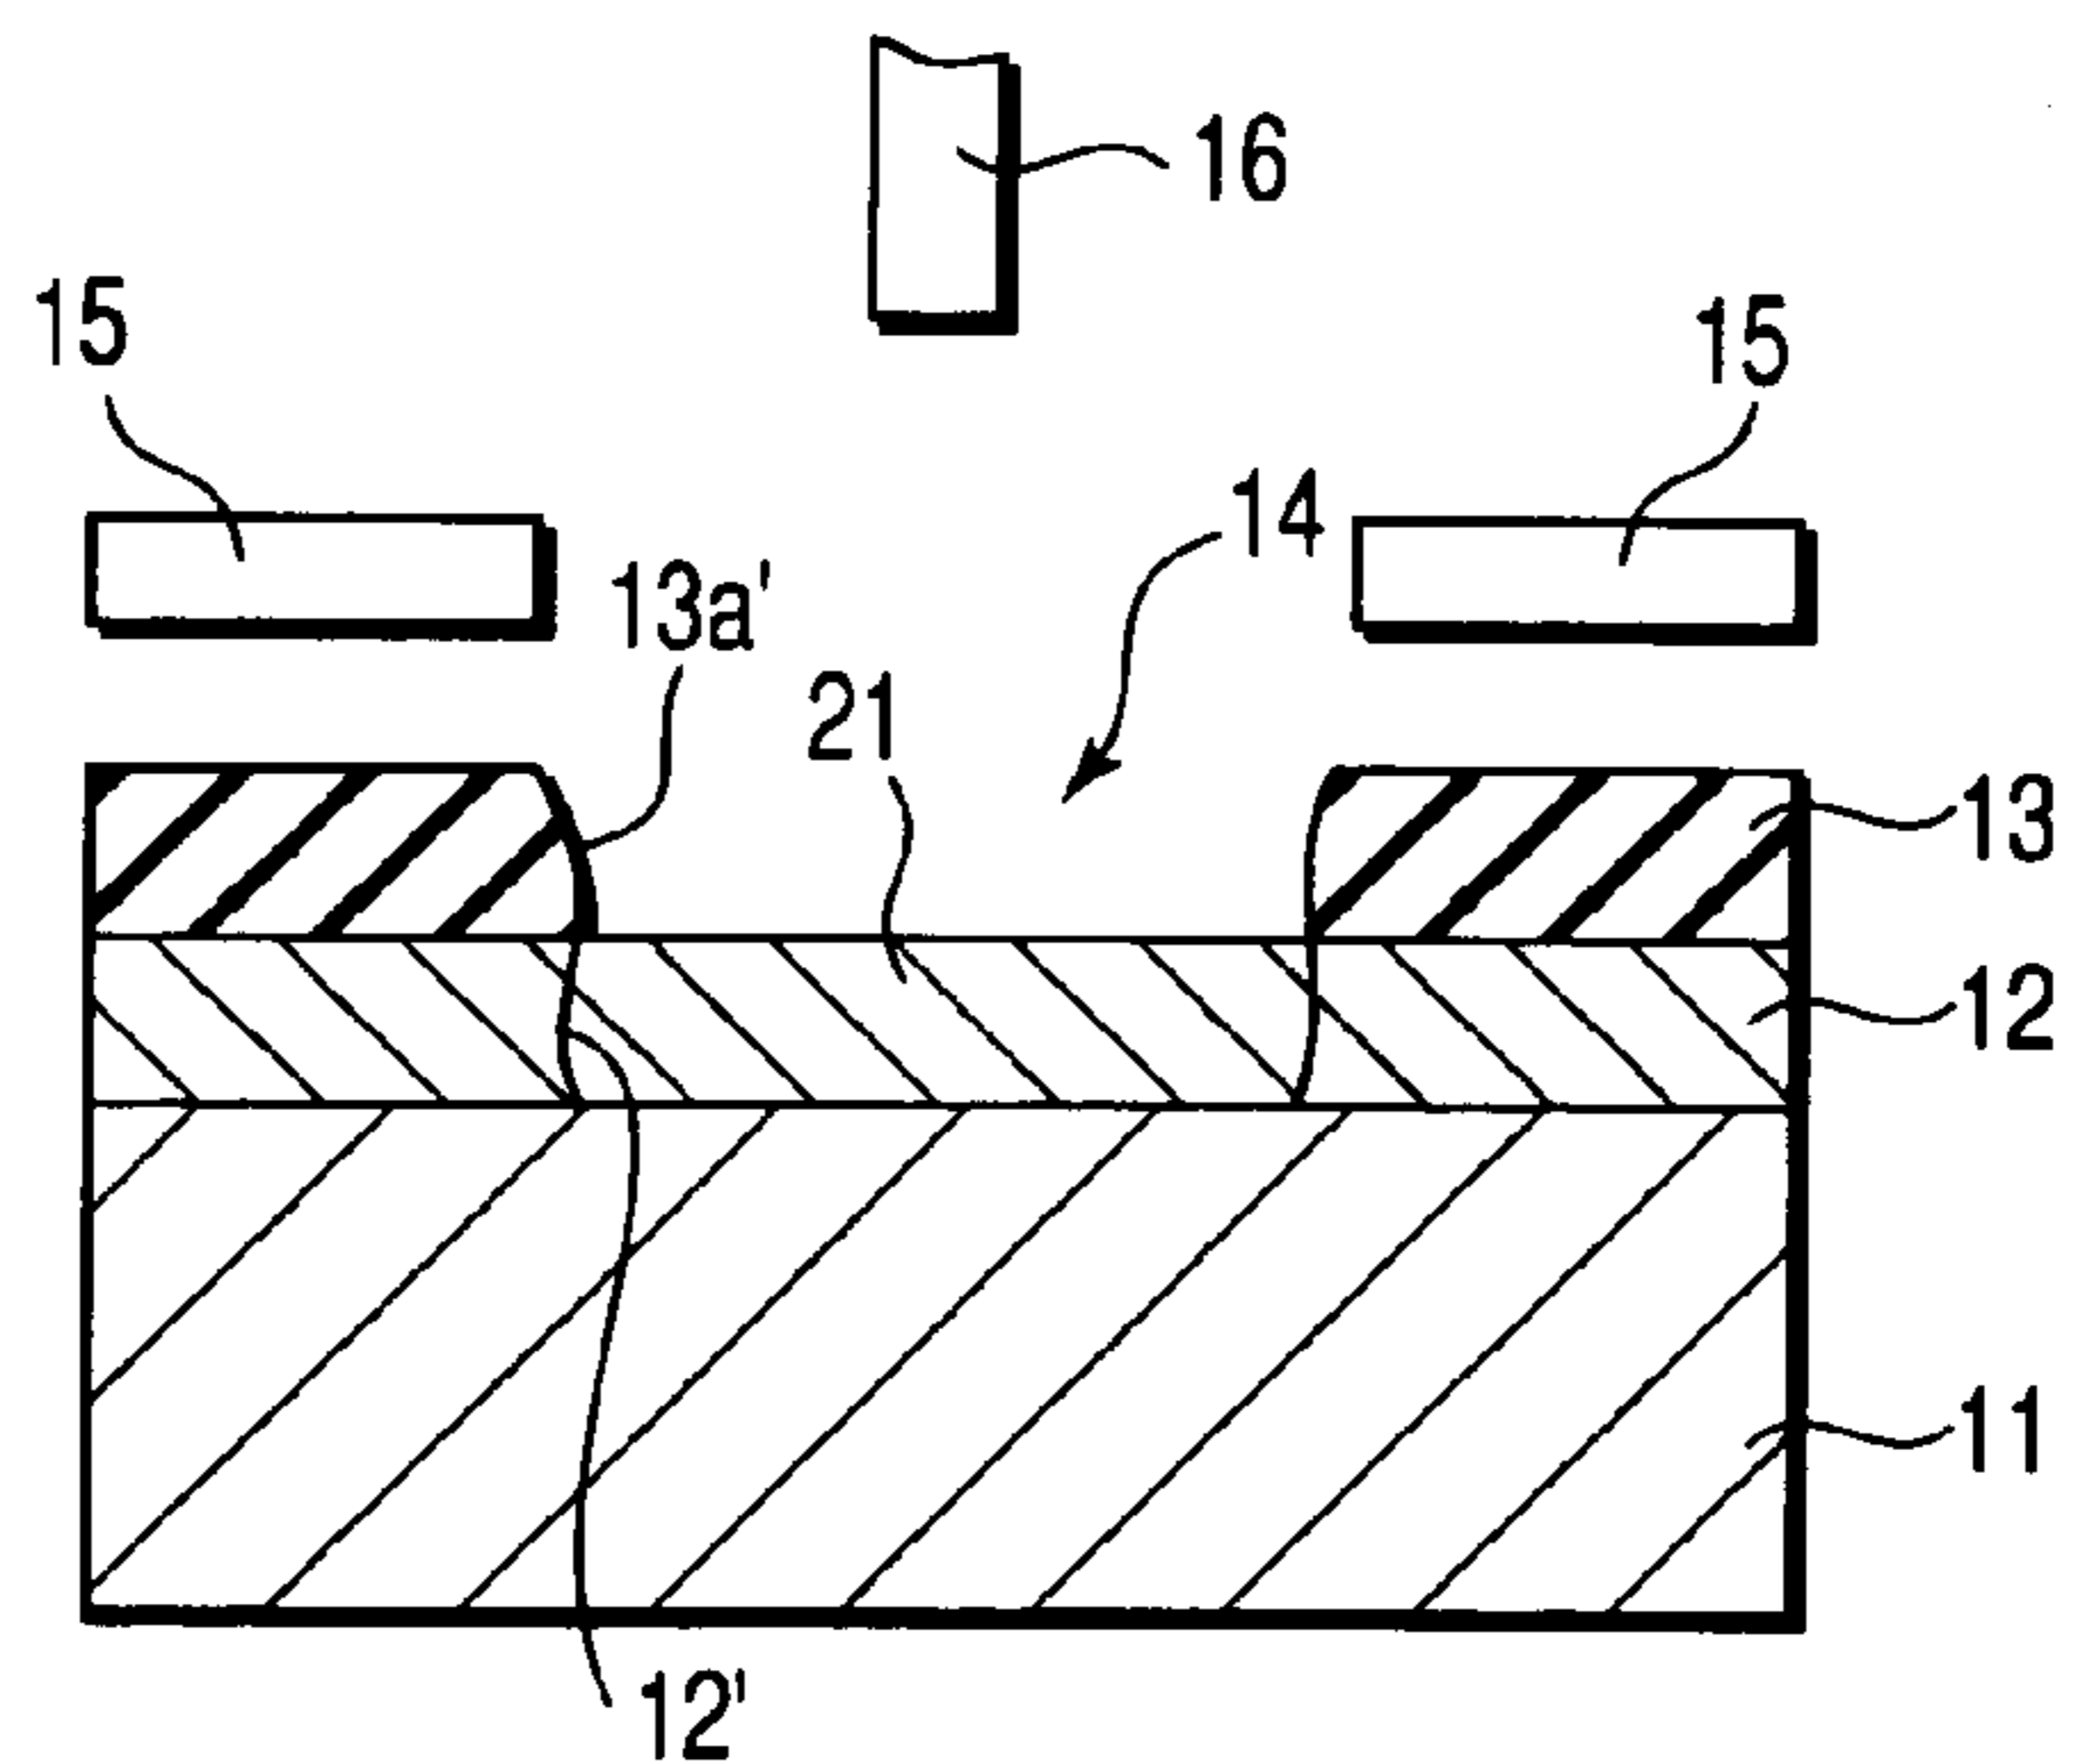
FIG. 2C

Next, a masking material 15 having an opening corresponding to the opening portion 14 is arranged right upon the topcoat layer 13 and a plasma spray gun 16 is arranged right above the opening portion 14. Subsequently, plasma spraying is applied to the opening 14 at reduced pressure, a spray particle speed of 200 m/s, and a base-material temperature of 150° C. to form a Ni-based alloy layer, an NiCoCrAlY layer 21, in the removed portion 12' where the undercoat layer 12 has been removed. In this way, the repair of the undercoat layer 12 is completed (see FIG. 2C). Furthermore, spraying is applied to the opening portion 14 by means of a plasma spray gun 16 to form a topcoat layer 22 composed of $ZrO_2 \cdot Yb_2O_3$ in the removed portion 13' where the topcoat layer has been removed. In this way, the repair of the topcoat layer 13 is completed (see FIG. 2D).

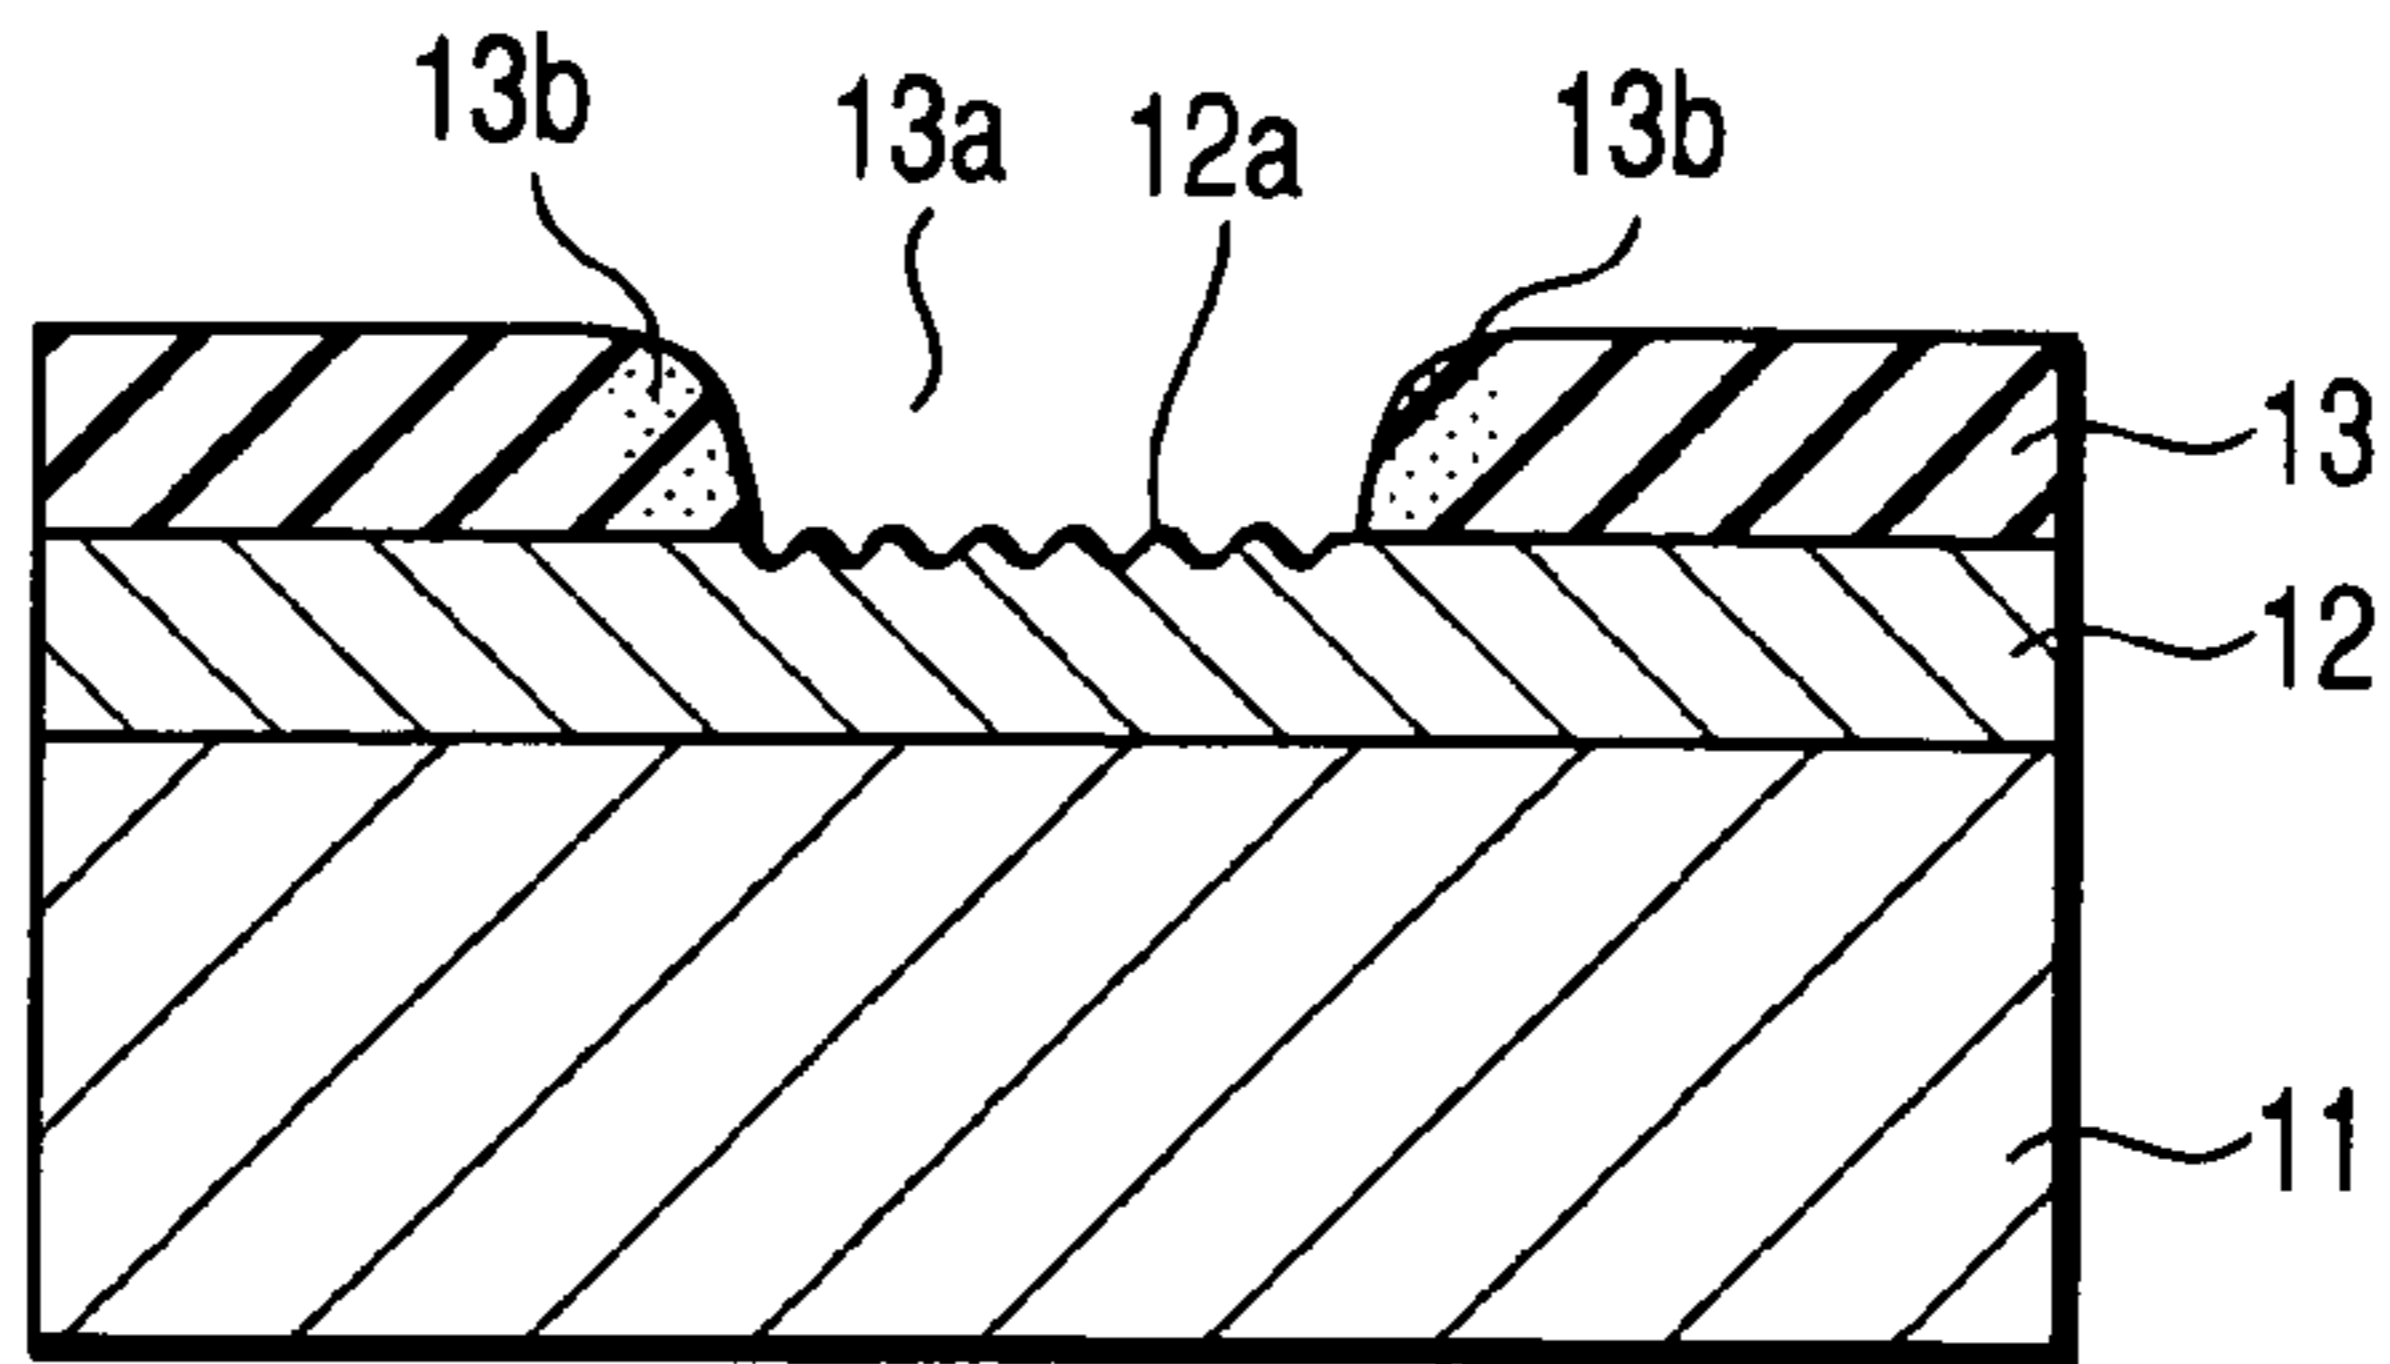
FIG. 3A

Similarly to Embodiment 1, as shown in FIG. 3A, an undercoat layer 12, which has a denatured portion 12a, is formed on a base material 11 and a topcoat layer 13, which has a peeled-off portion (removed portion) 13a and a damaged portion 13b surrounding the removed portion 13a, is formed on the undercoat layer 12. The topcoat layer 13 is composed of $ZrO_2 \cdot 8Y_2O_3$. From the structure in this state, the undercoat layer 12 corresponding to the peeled-off portion 13a and the damaged portion 13b of the undercoat

FIGS. 3A to 3D illustrate a method of repairing a Ni-based alloy part according to Embodiment 3 of the present invention, in accordance with order of repairing steps;
