(54) **METHOD OF REPAIRING A NI-BASE ALLOY PART**

(73) Assignee: **Mitsubishi Heavy Industries, Ltd.**, Tokyo (JP)

METHOD OF REPAIRING A NI-BASE ALLOY PART

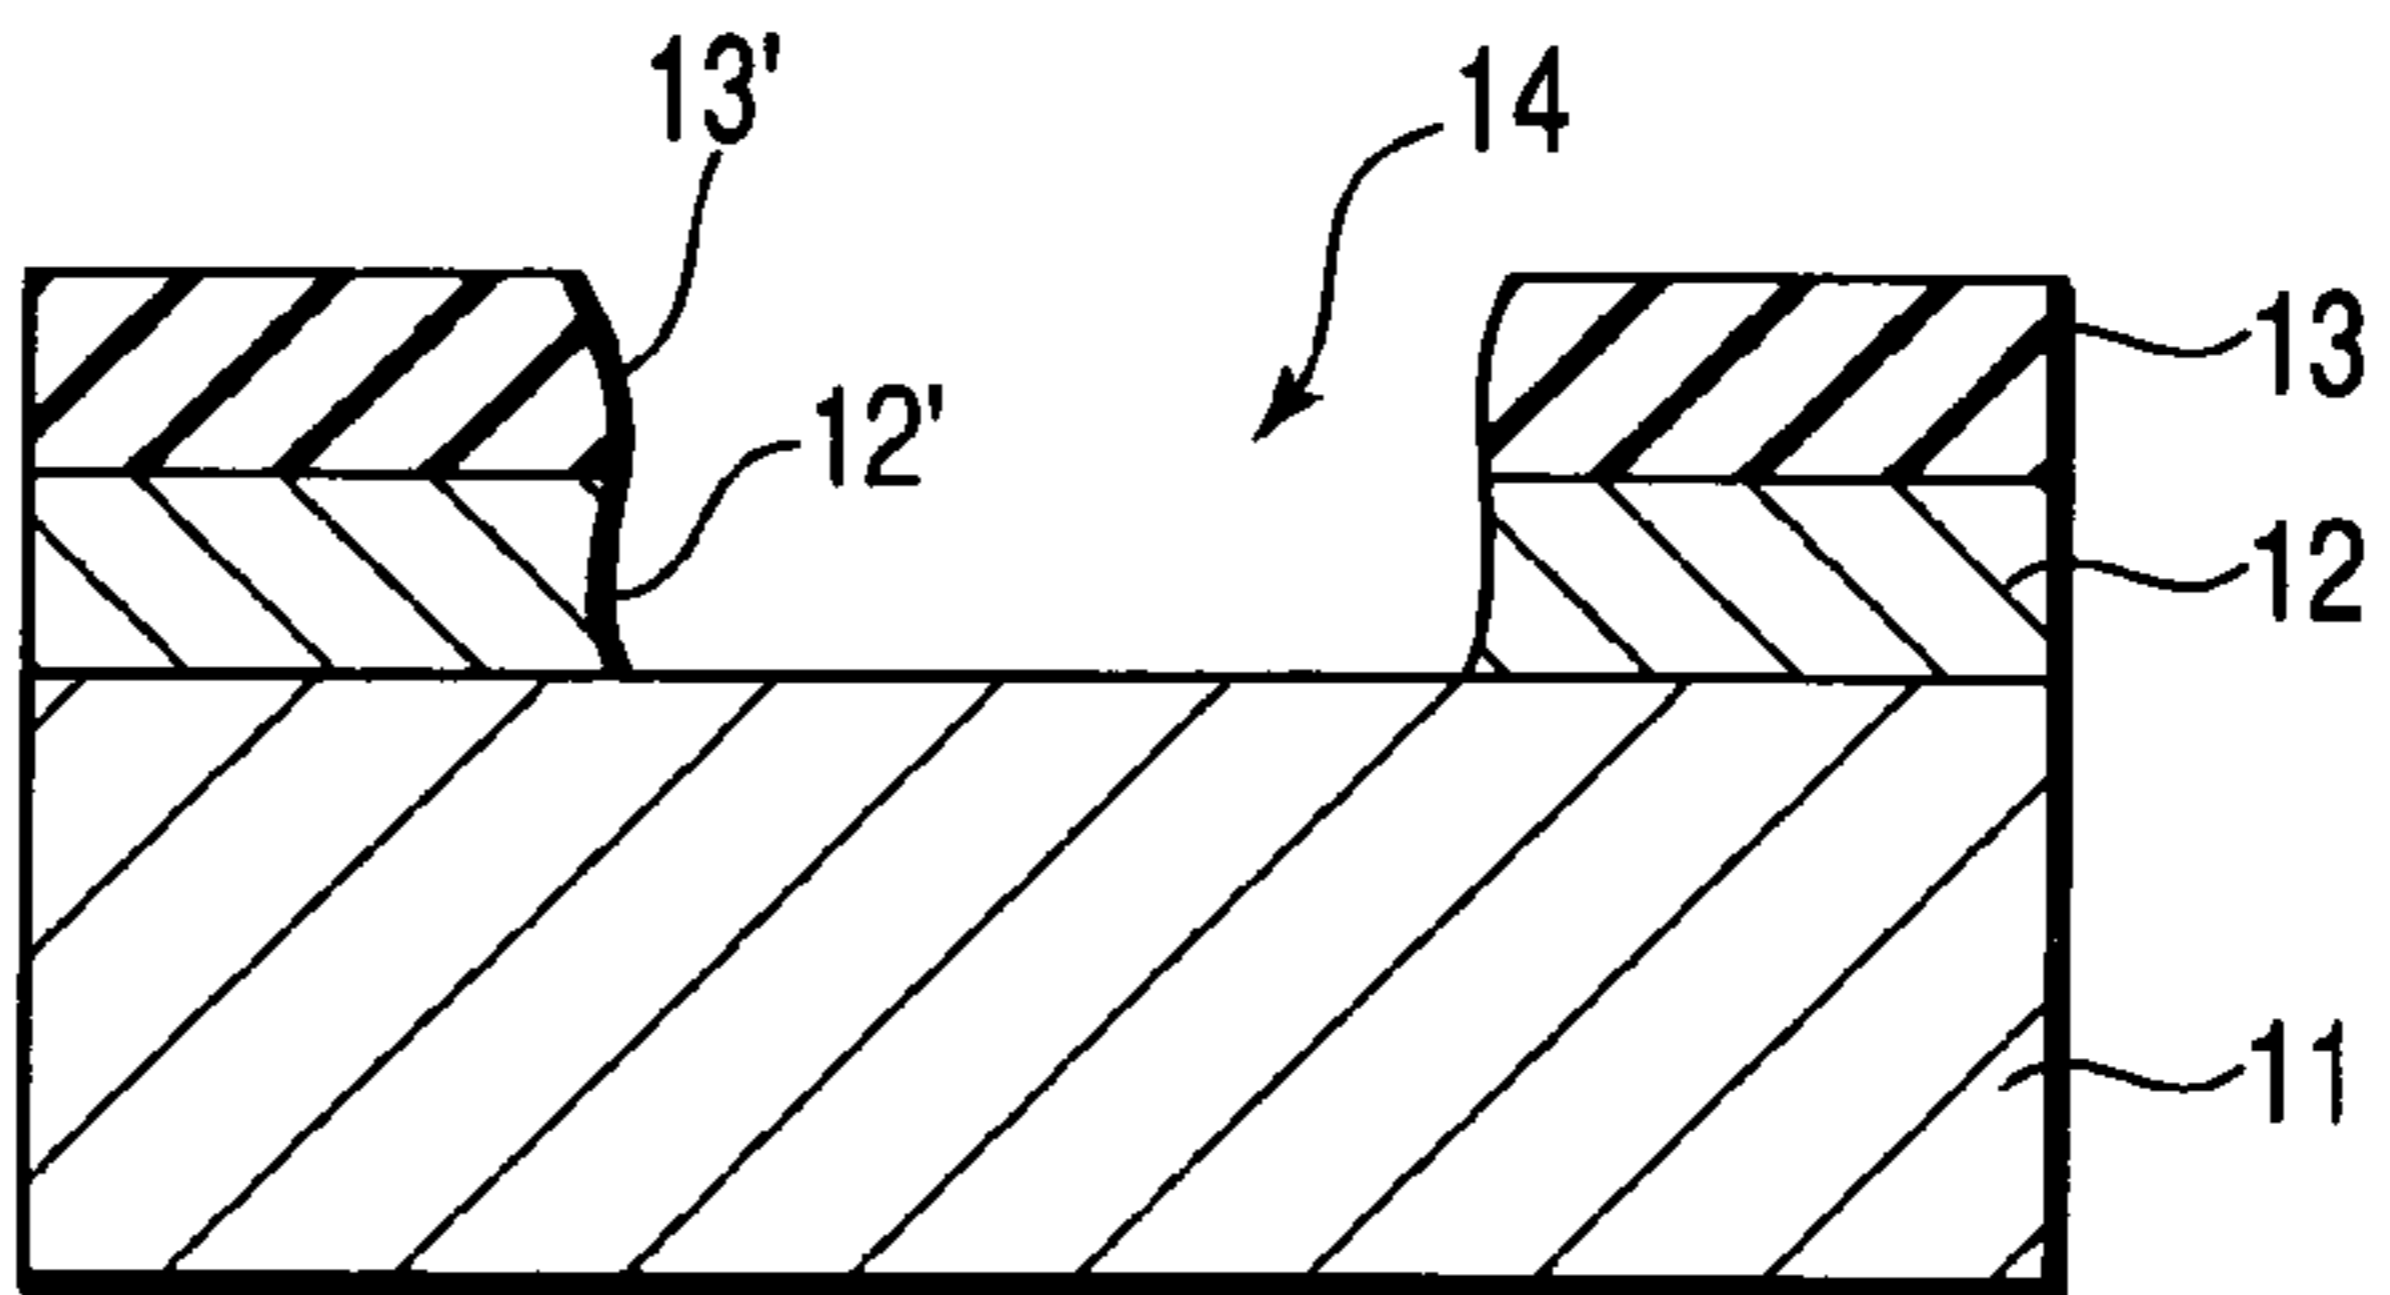
FIG. 3B

layer 12 are selectively removed by grind-polishing to thereby form an opening portion 14 in the undercoat layer 12 and the topcoat layer 13 (see FIG. 3B).

FIGS. 3A to 3D illustrate a method of repairing a Ni-based alloy part according to Embodiment 3 of the present invention, in accordance with order of repairing steps;

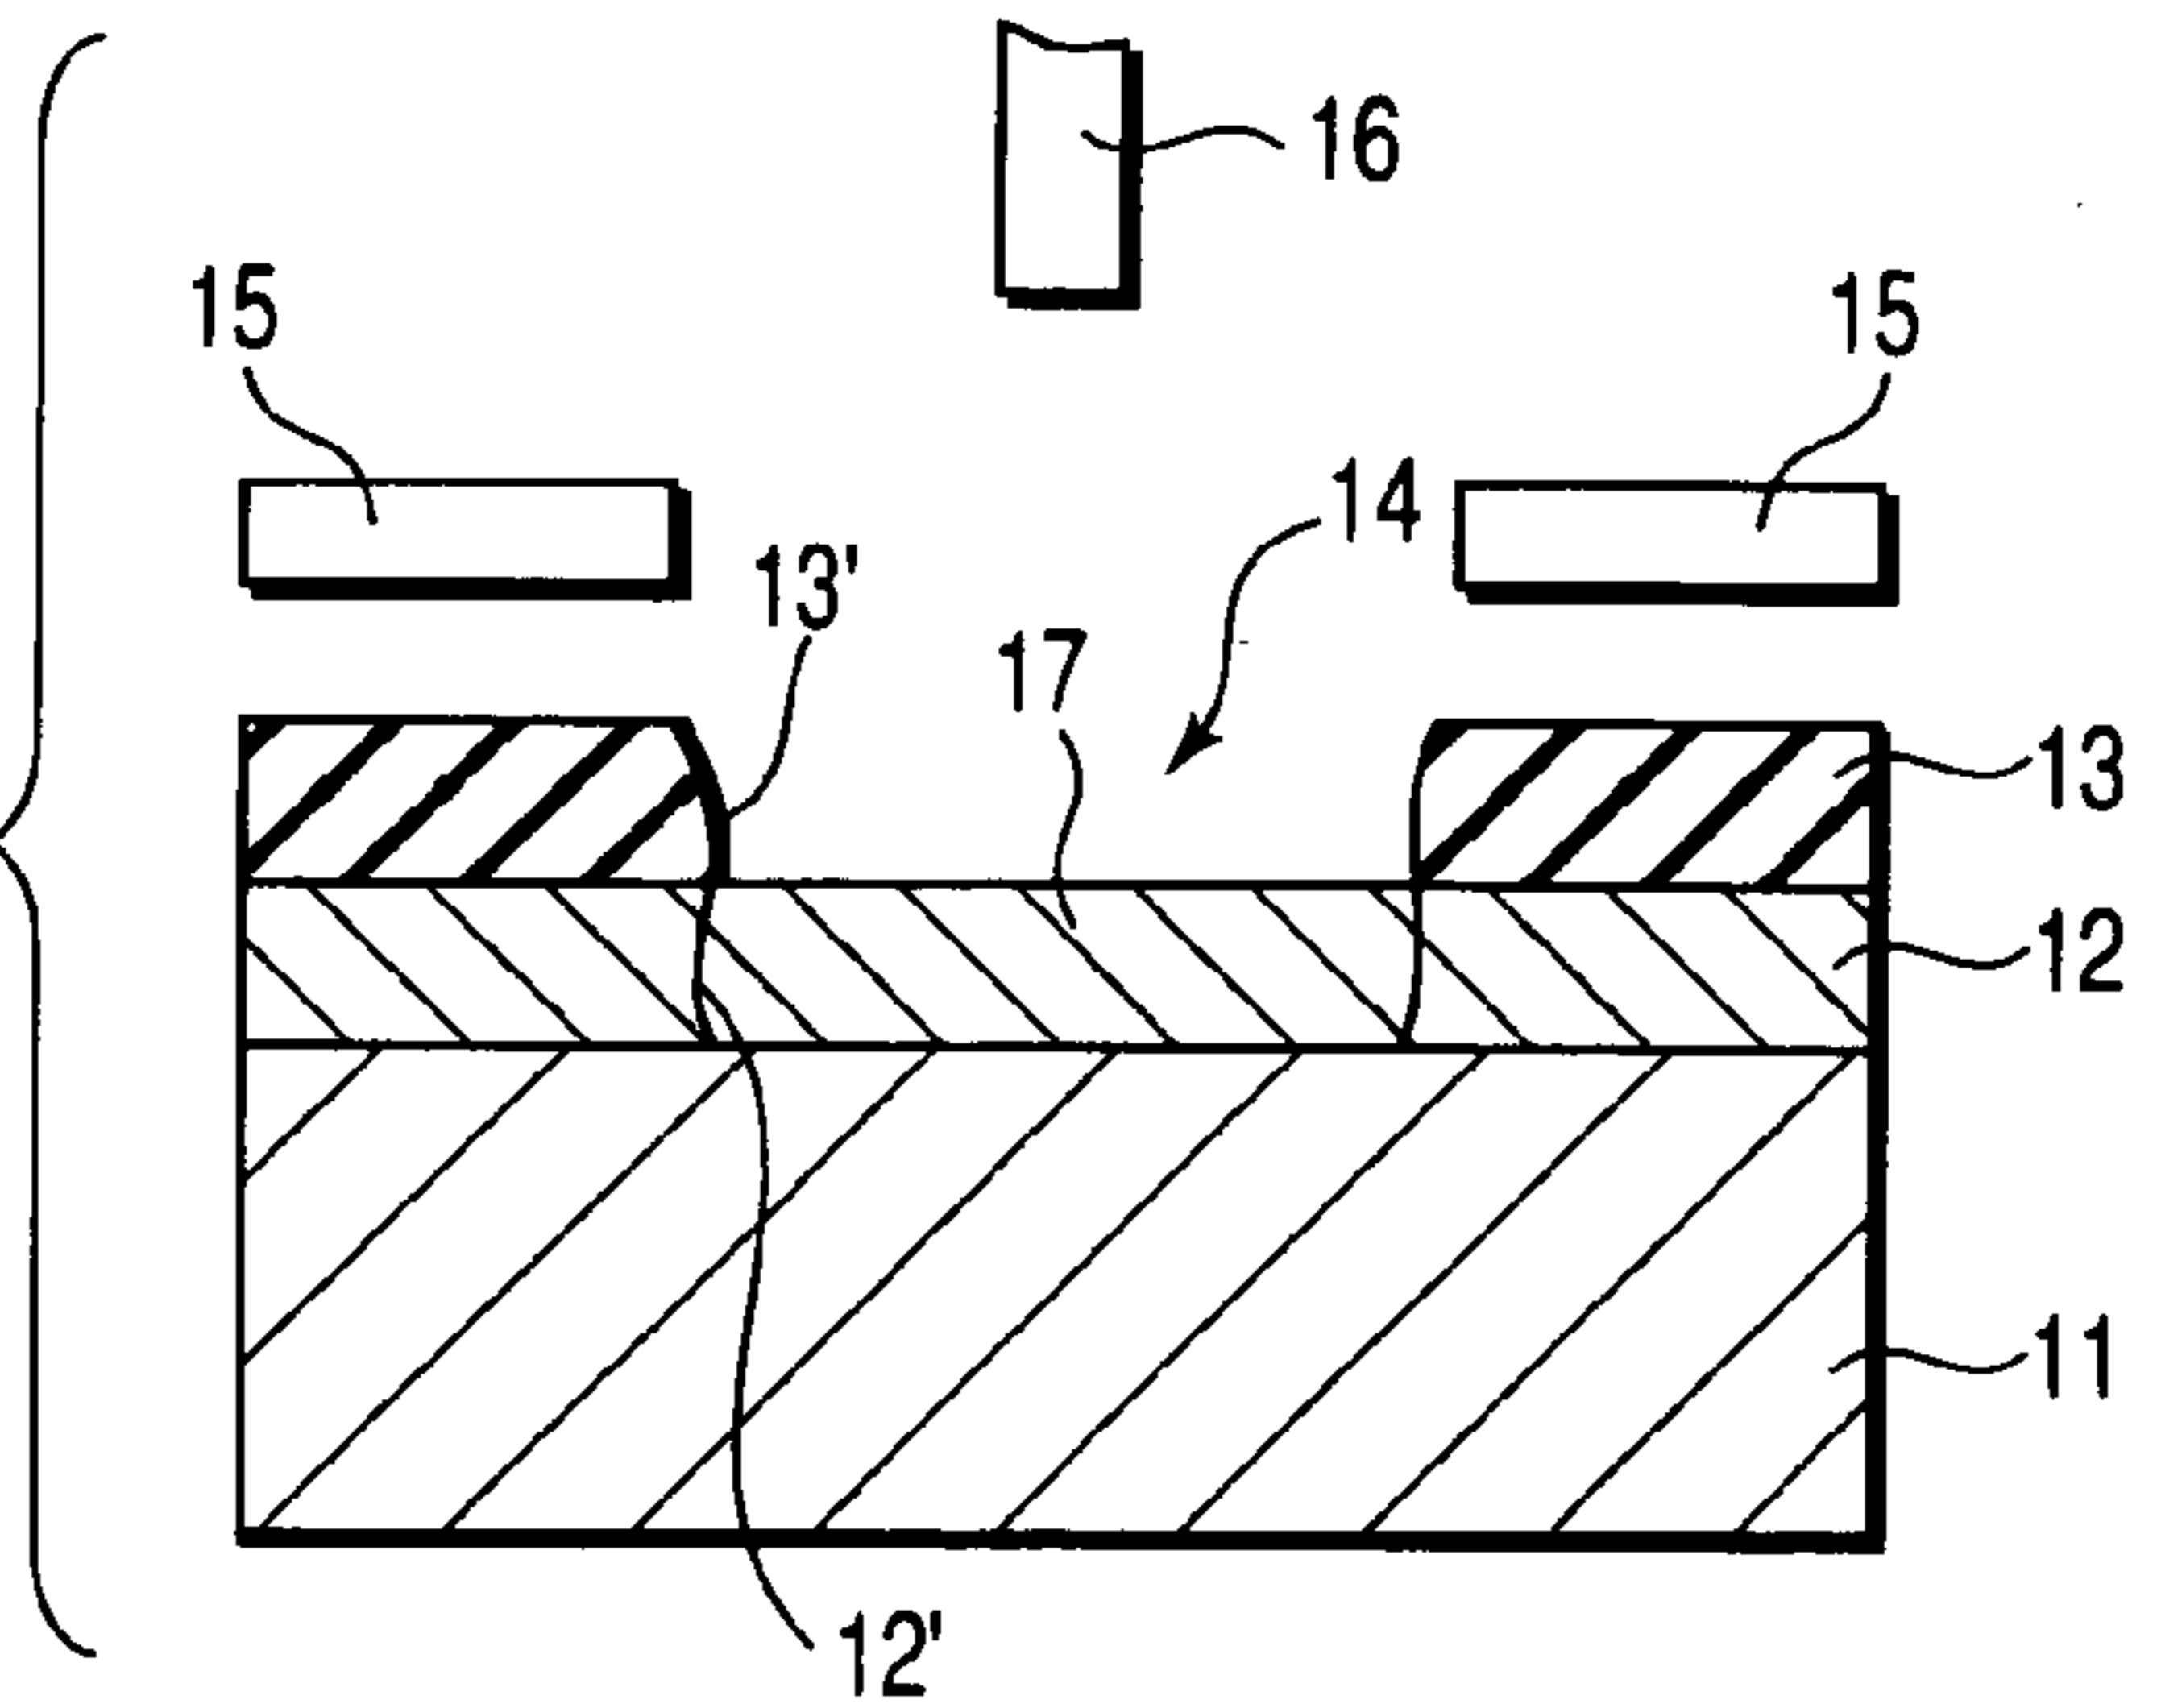
FIG. 3C

Next, a masking material 15 having an opening corresponding to the opening portion 14 is arranged right upon the topcoat layer 13 and a plasma spray gun 16 is arranged right above the opening portion 14. Subsequently, plasma spraying is applied to the opening 14 in the atmosphere at a spray particle speed of 500 m/s and a base-material temperature of 150° C. to form a Co-based alloy layer, a CoNiCrAlY layer 17, in the removed portion 12' of the undercoat layer 12. In this way, the repair of the undercoat layer 12 is completed (see FIG. 3C). Furthermore, after the masking material 15 and the plasma spray gun 16 are removed, a topcoat layer 23 composed of $ZrO_2 \cdot Yb_2O_3$ in the removed portion 13' where the topcoat layer has been removed, was formed by the EB-PVD method. In this way, the repair of the topcoat layer 23 is completed (see FIG. 3D).

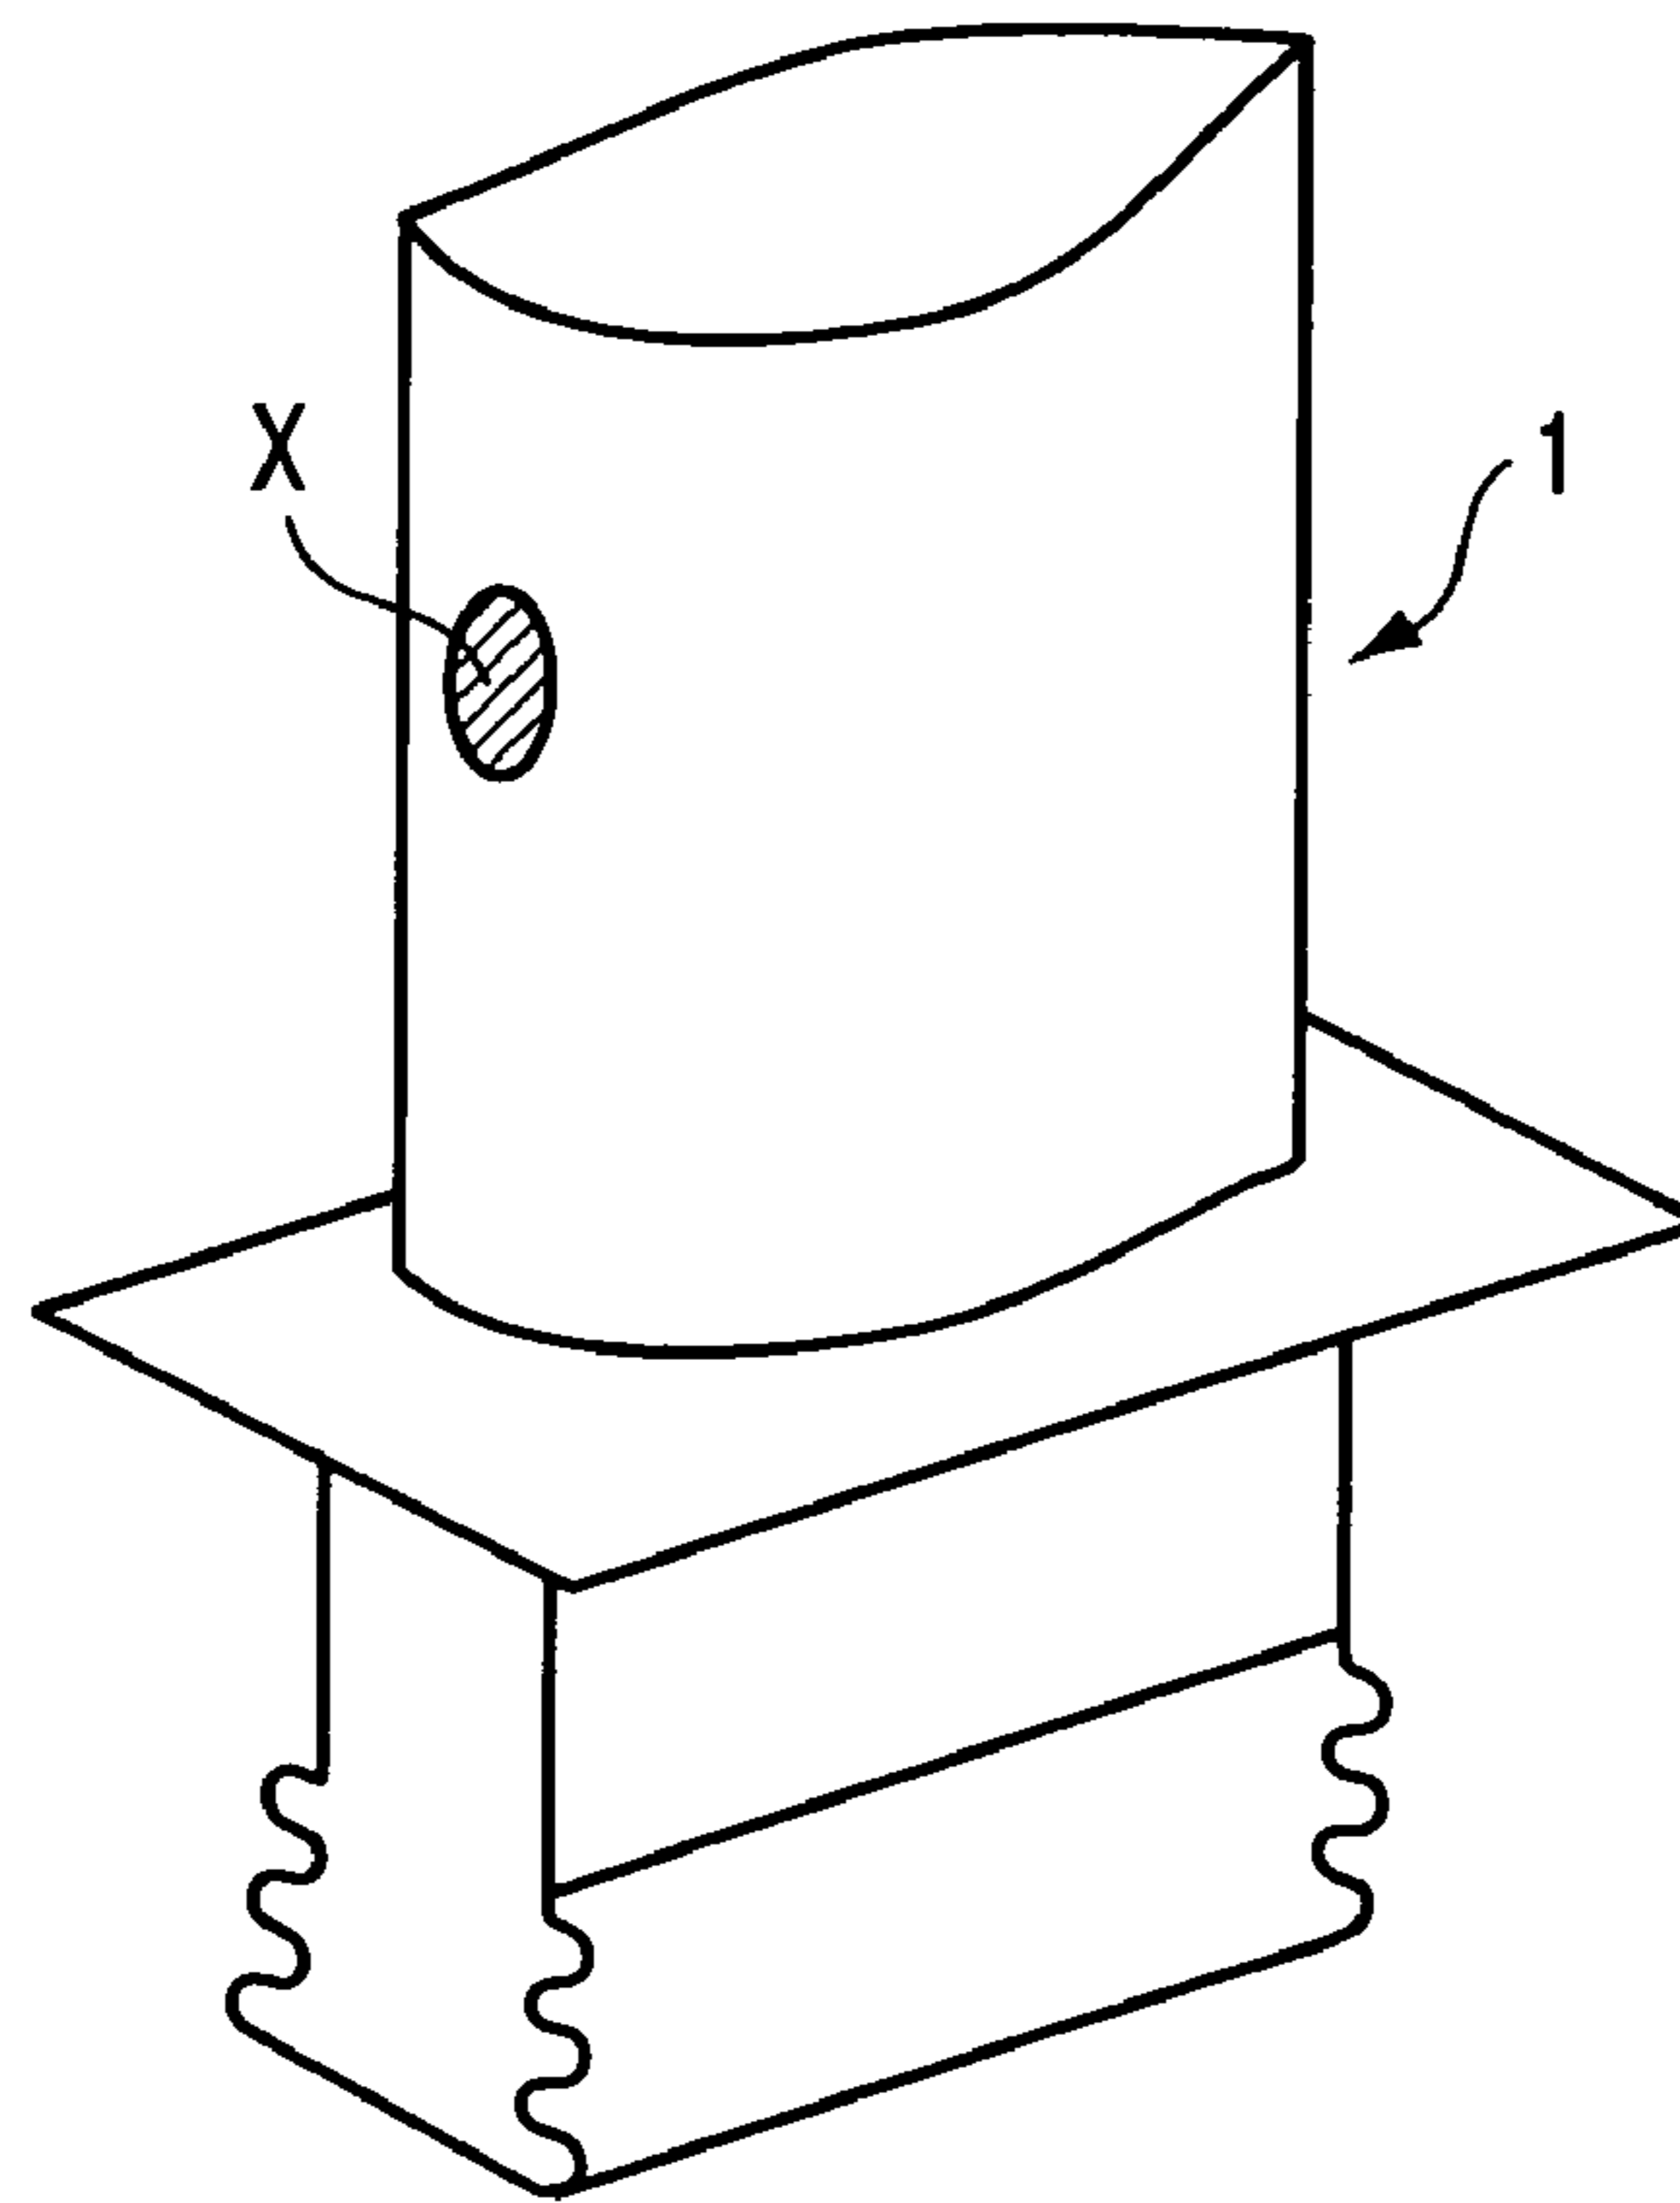
FIG. 4 is a schematic view of a rotor blade 1 of a gas turbine and FIG. 5 is an enlarged sectional view of the damaged portion X shown in FIG. 4. As shown in FIG. 5, an undercoat layer 3 and a topcoat layer 4 formed of, for example, a ZrO₂-based ceramic, are sequentially formed on a base material 2. Part of the topcoat layer 4 is peeled off. The peeled-off portion is called a thermal barrier coating (TBC) peeled-off portion 5. It should be noted that reference numeral 6 in FIG. 5 indicates a denatured portion of the surface of the undercoat layer 4 formed at a position corresponding to the peeled-off portion 5, and reference numeral 7 indicates a damaged portion formed on the topcoat layer 4 around the peeled-off portion 5.

FIG. 4 illustrates a rotor blade of a gas turbine having a damaged portion; and
