(10) Patent No.: US 7,185,955 B2

(54) VISUAL INDICATOR FOR PRESSURIZED HUB

A tactile and visual indicator is mounted on the hub cap of an axle of a vehicle. The indicator has a deformable face that protrudes away from the hub cap in response to the presence of pressurized air in the space containing the wheel bearings. The position of the deformable face indicates the presence or absence of hub integrity and indication of grease about the wheel bearings.

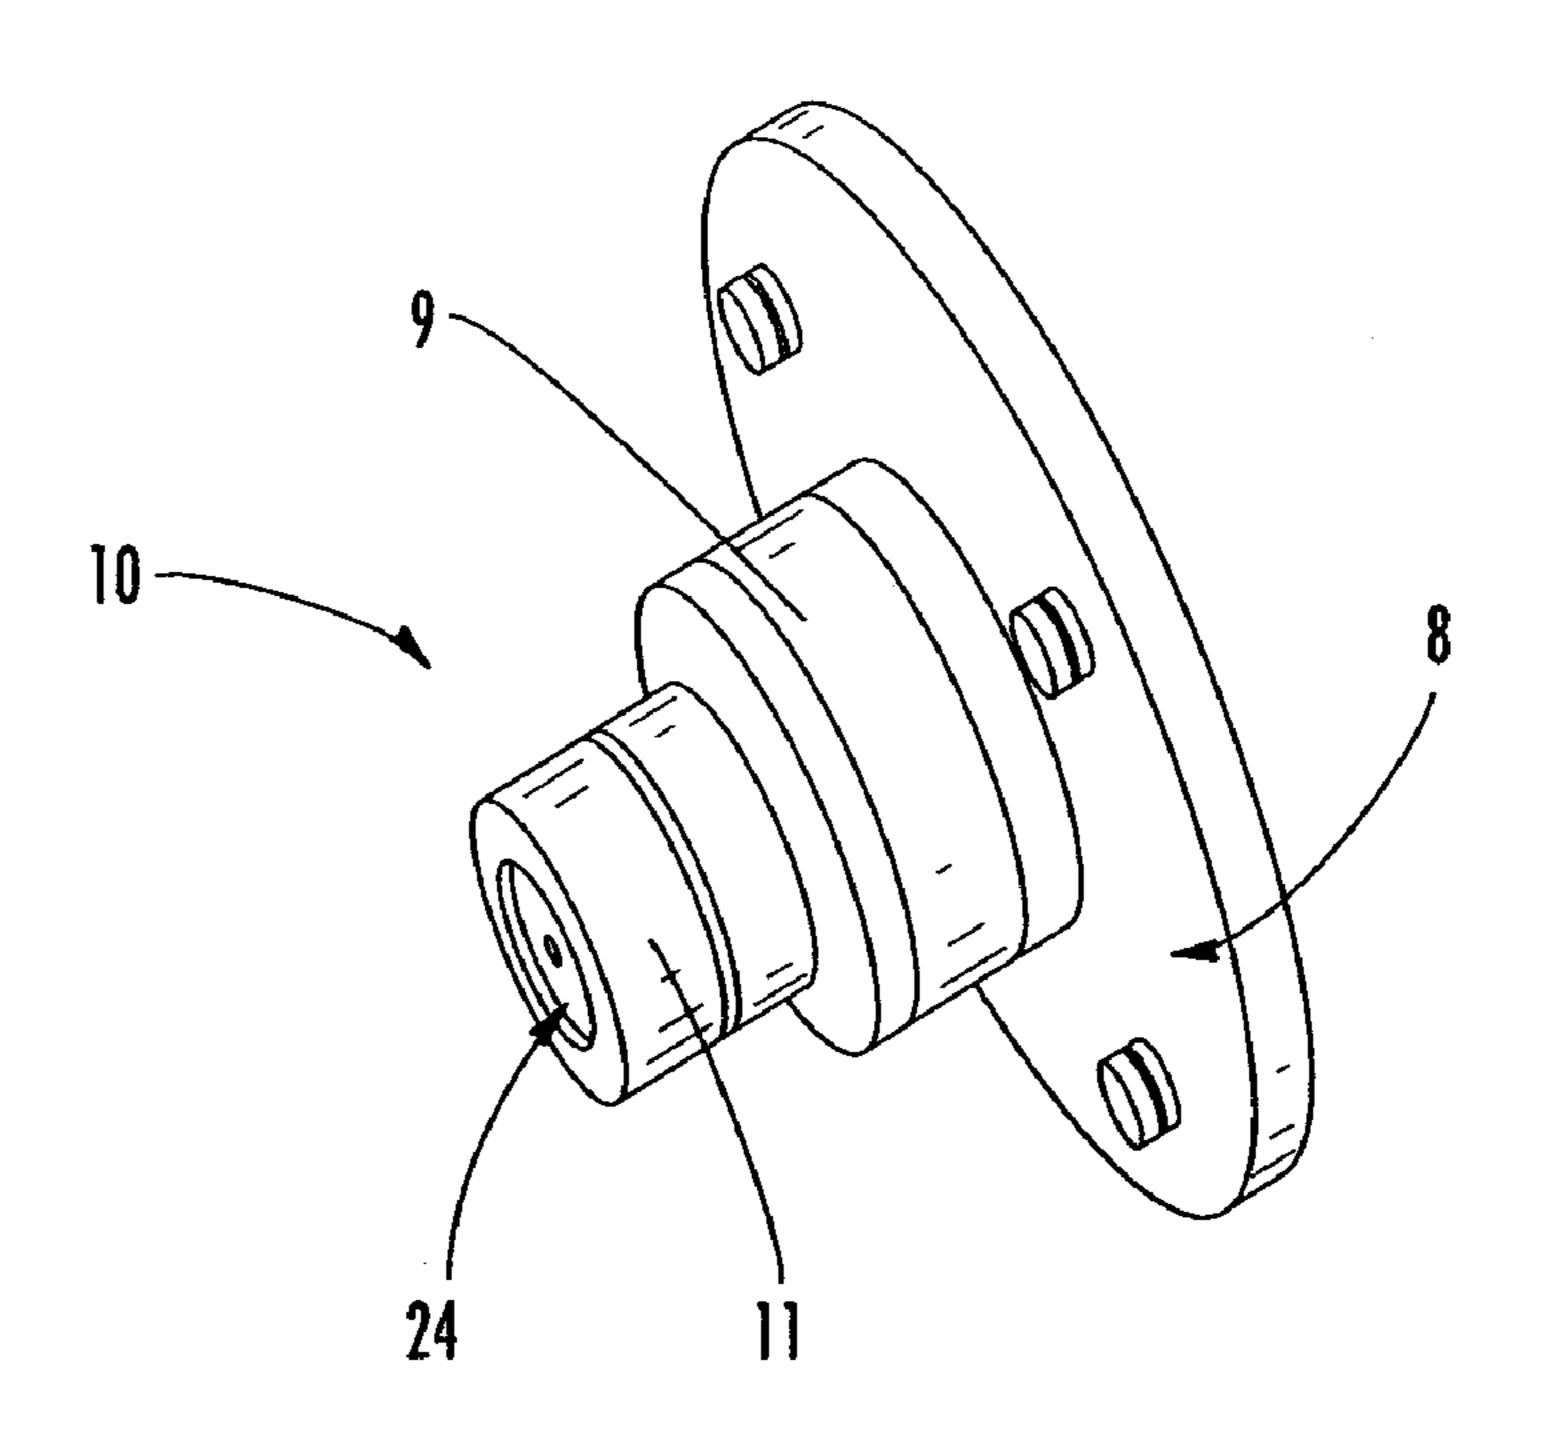
- FIG. 1 is a perspective view of a hub cap according to a 60 preferred embodiment of the invention as installed on a trailer wheel hub;
- FIG. 2 is a side view of the hub cap of FIG. 1 with deformed valve;
 - FIG. 3 is a cross-sectional view of the hub cap of FIG. 2; 65
- FIG. 4 is a cross-sectional view of the hub cap of FIG. 1 installed on a wheel hub and axle assembly; and

A hub cap 10 according to a preferred embodiment of the invention is shown in FIGS. 1–3. FIG. 1 illustrates the hub cap 10 as installed to the wheel hub 9 of a boat trailer wheel. FIG. 4 is a cross-sectional view of the hub cap 10 as assembled with a hub 9 of an axle and wheel unit 8 for a trailer. The hub 9 is rotatably supported on bearing assemblies 3 and 4 and mounted on an axle 6. A seal 7 adjacent the inner bearing 3 seals the end of the chamber within the hub

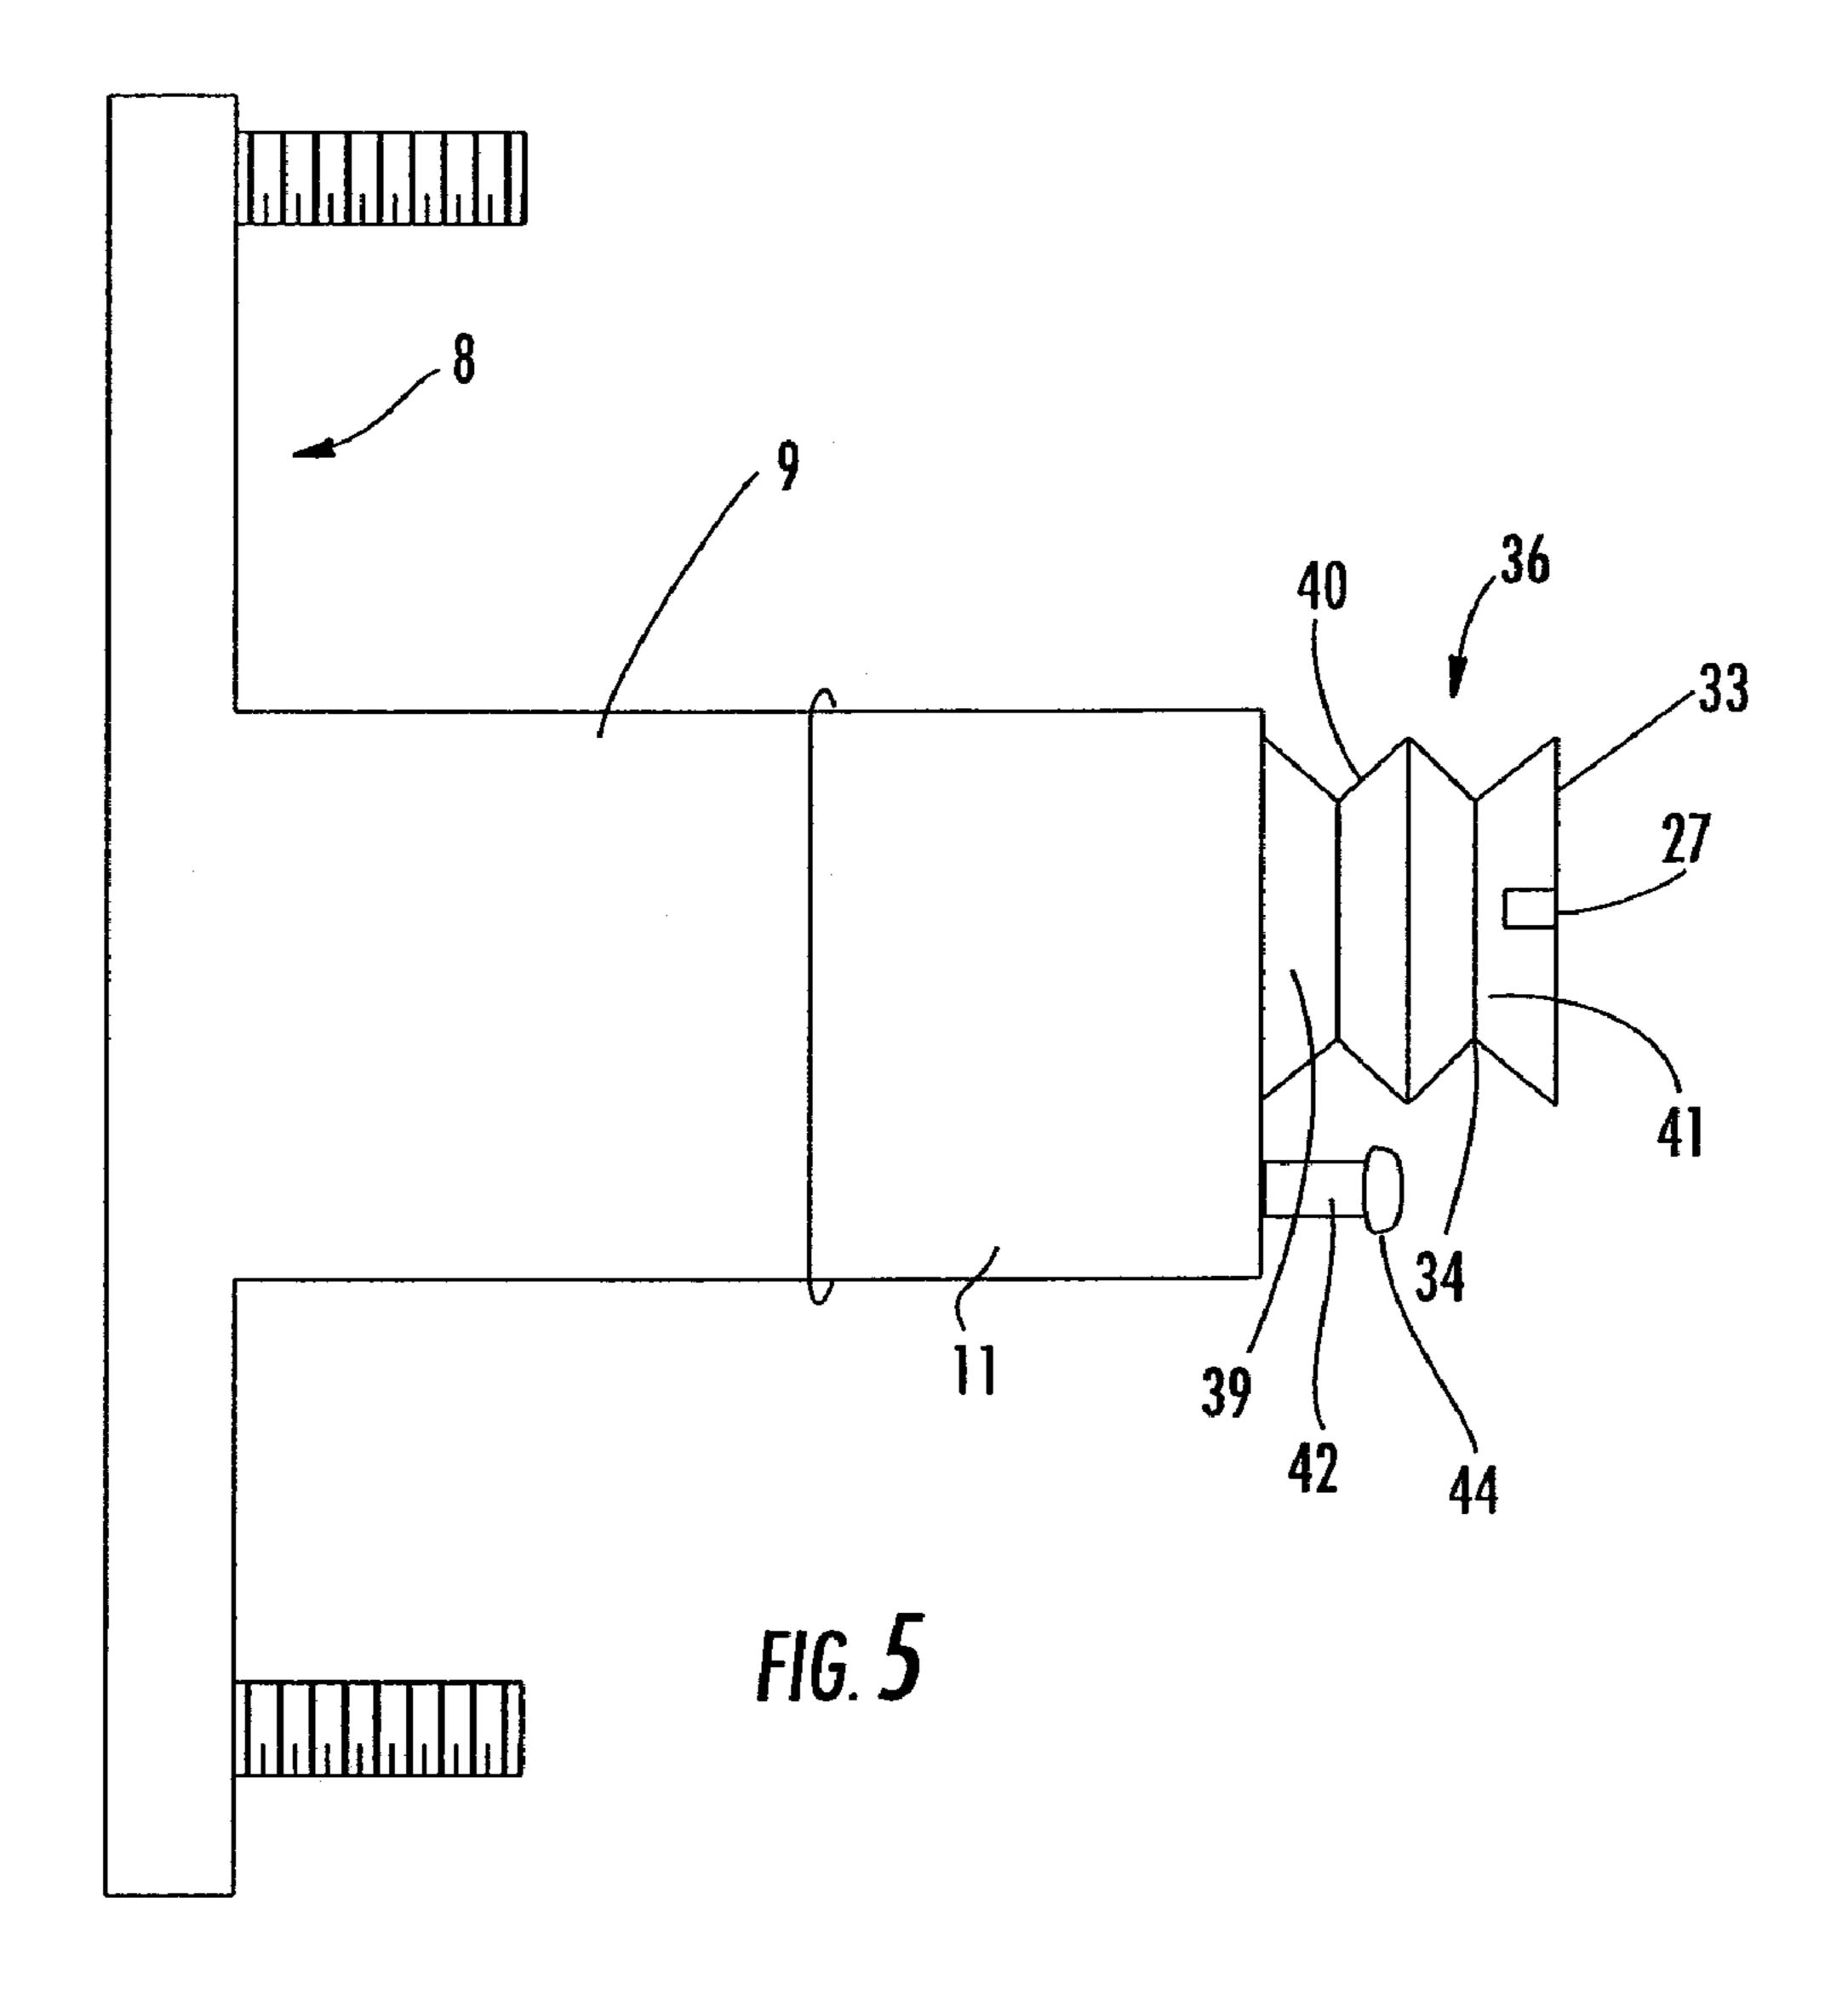
FIG. 5 is a side view of the hub cap of FIG. 4 with the valve deformed; and

As shown in FIGS. 4–6, the air valve 24 may also be formed as a bellows 36. The bellows may be tubular with circumferential rings 34 spaced along the length of the structure defining interconnected air chambers 39, 40 and 41, FIG. 5. The rings 34 restrict the expansion of the bellows and provide shape to the expanded bellows. The bellows 36 may be designed to expand in a certain sequence relative to the air pressure present in the wheel hub. For example, 5 psi (pounds per square inch) air pressure would inflate one chamber 41 and 10 psi would expand another chamber 40. In this manner, the air valve would operate as a visual or 15 tactile gauge to indicate a trend and show any remaining air pressure.

As shown in FIG. 5, the closed end of the hub cap housing 11 can optionally include a through bore for receiving the conduit or clindrical metal tube 42, which is fixedly secured therein to provide an air flow coupling between a source of pressurized air and the wheel hub 9. In this alternative embodiment, the conduit 42 is fitted with a conventional inflation valve 43 of any operable construction as would commonly be utilized to inflate automobile tires and the like. As is the conventional construction, a spring-loaded axially disposed post is contained in the valve 43 which is depressed by attachment of an inflation device. The inflation valve 43 is receptive to air from an air compressor, a hand pump, or insertion. When such a valve is employed, the bellows continues to operate as a visual indicator of the hub integrity. The preferred embodiment of the bellows requires a positive air pressure for expansion to indicate a pressurized condi-

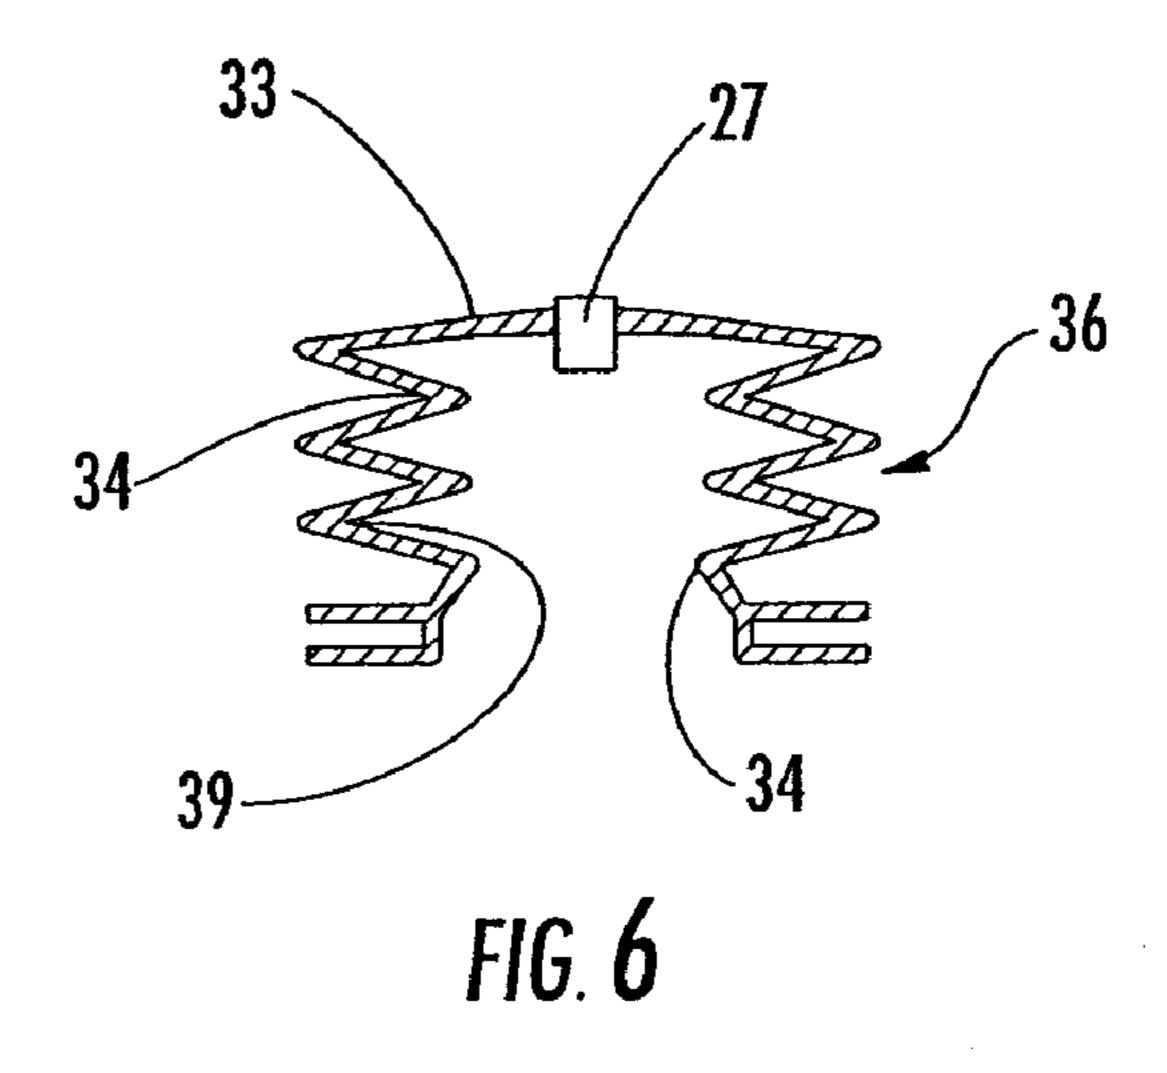
FIG. 6 is a cross section of the valve of FIG. 4 and FIG. 5.
