(12) **United States Patent**
Ducotey, Jr. et al.

(10) **Patent No.:** **US 7,204,019 B2**
(45) **Date of Patent:** **Apr. 17, 2007**

(54) **METHOD FOR REPAIRING AN APERTURED GAS TURBINE COMPONENT**

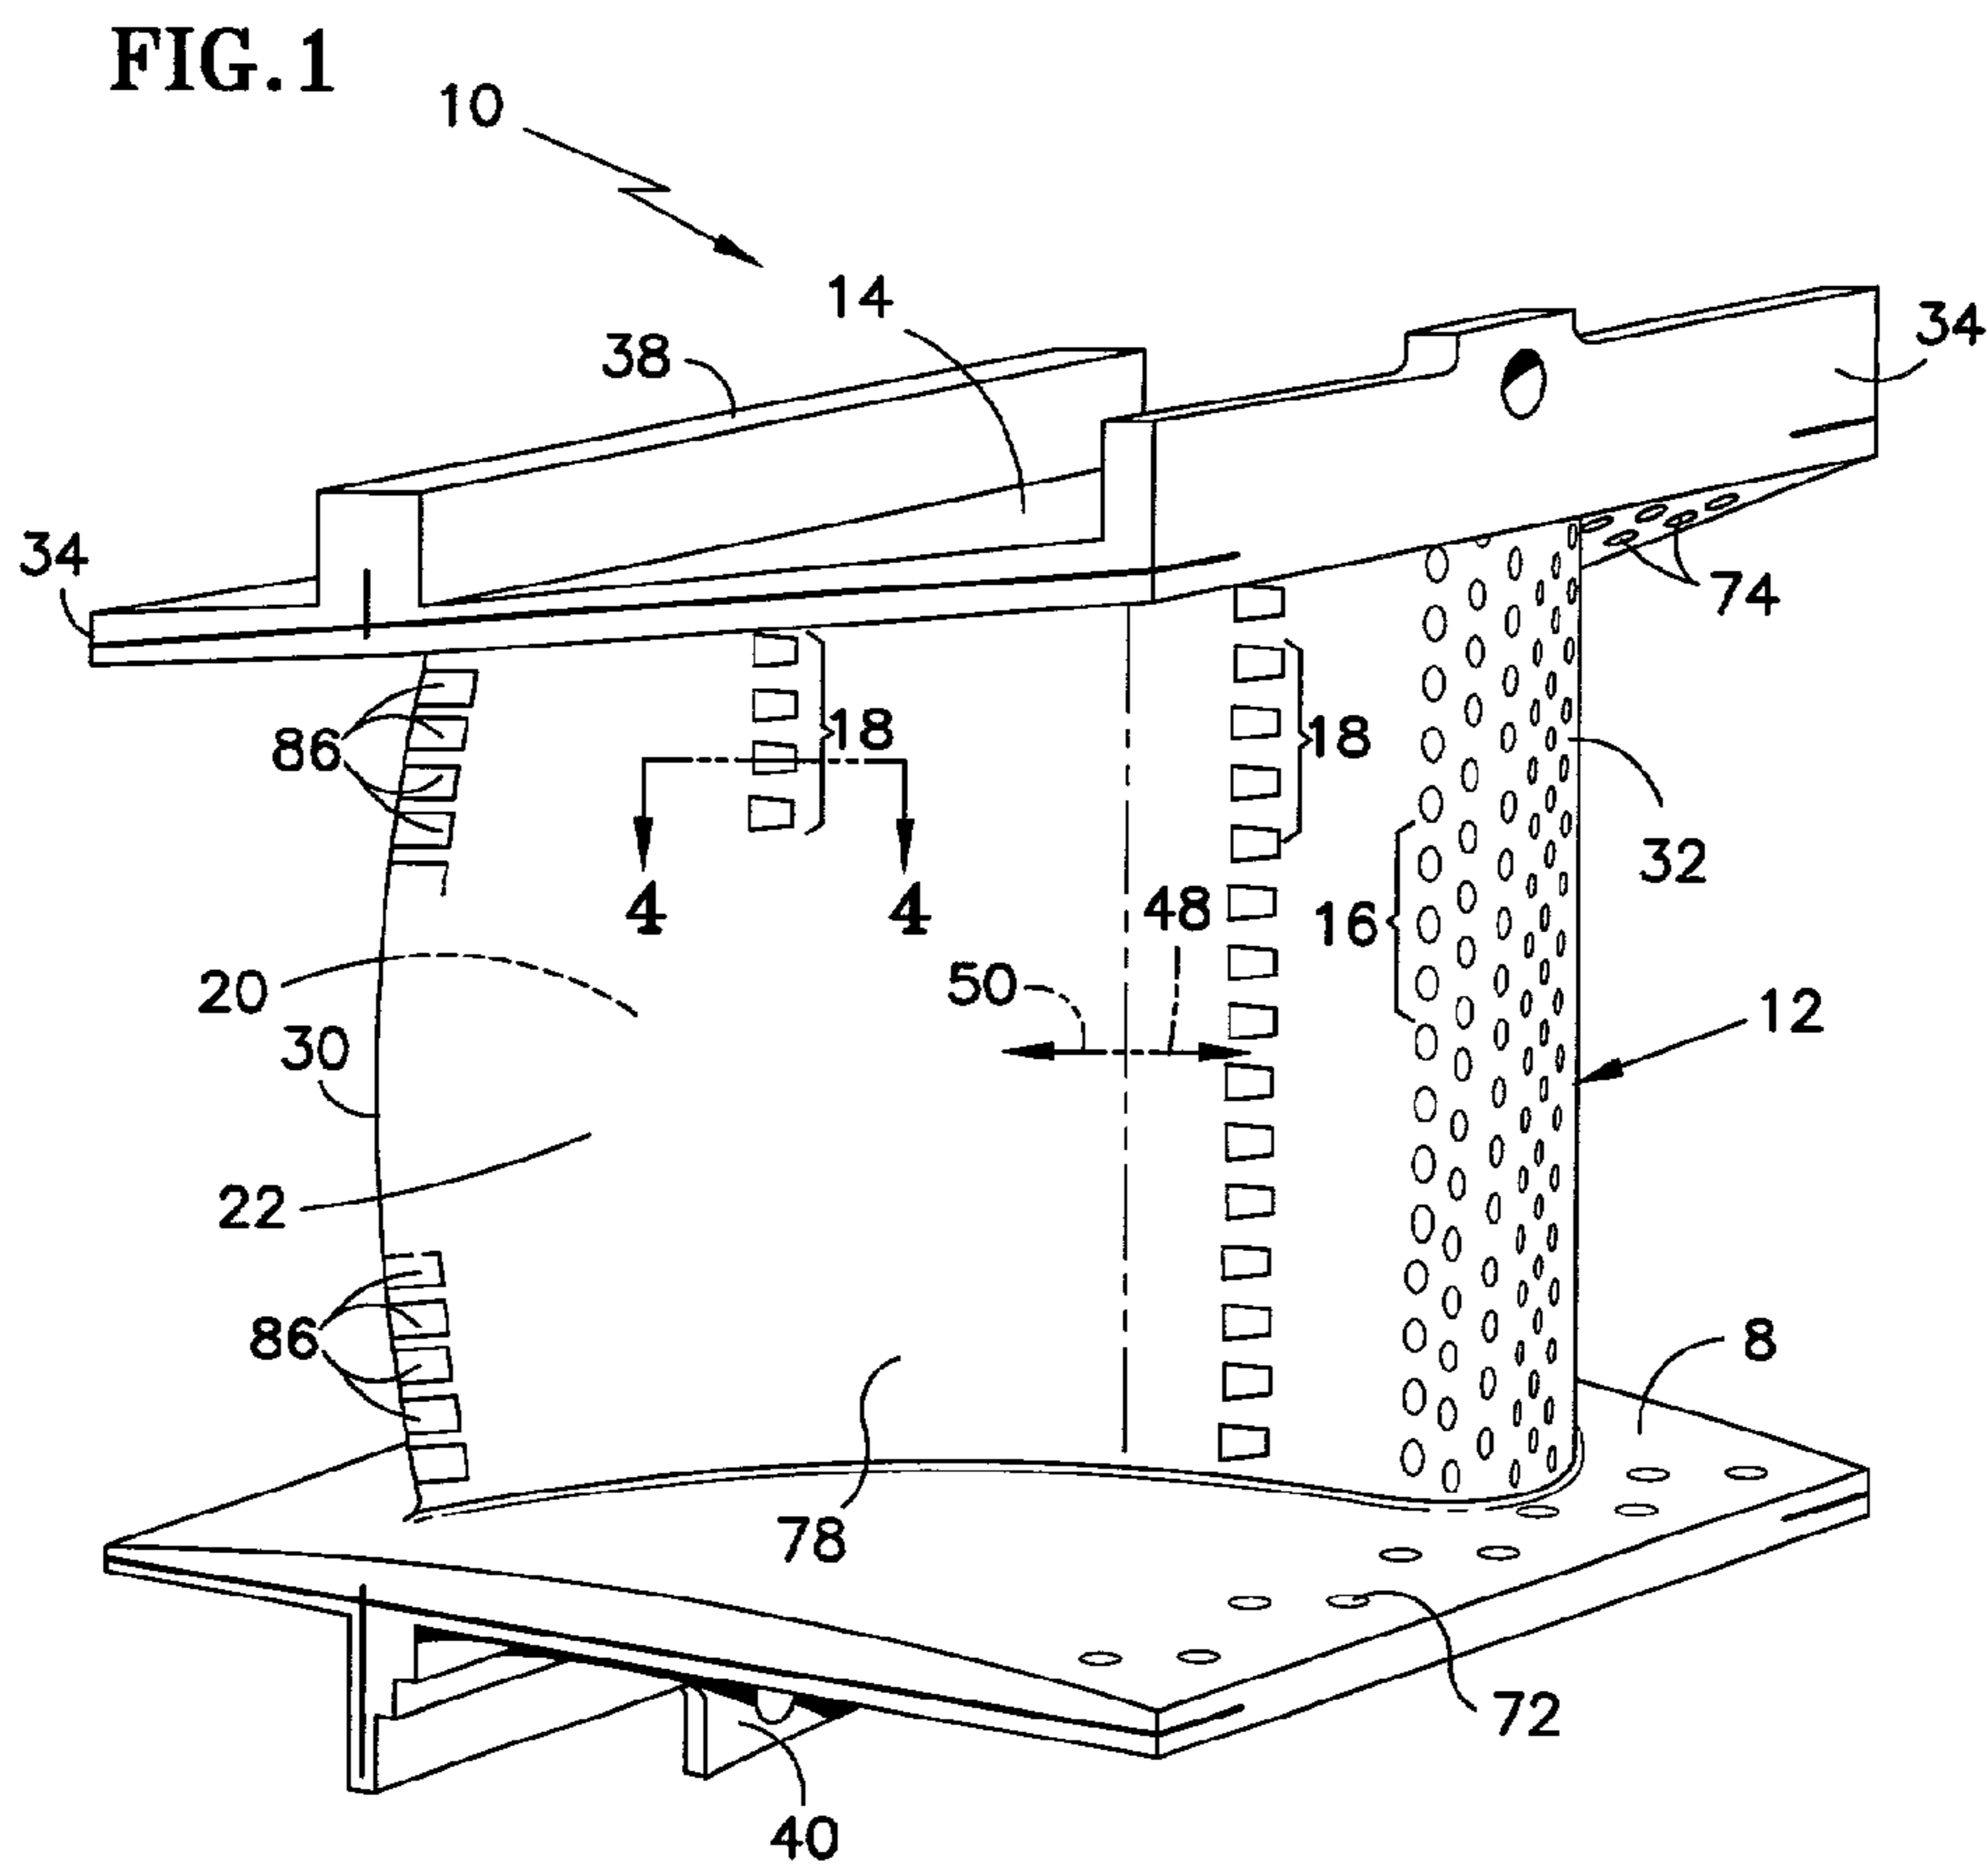
FIG. 1 is a perspective view of a typical gas turbine engine high pressure turbine vane;

Referring to FIG. 1, a high pressure turbine vane (article) 10 is shown. Referring also to FIGS. 2 and 3, a top view and a bottom view are respectively shown for the vane 10 of FIG. 1. The vane 10 comprises an airfoil section (airfoil) 12 having at least one internal cavity 24 (FIG. 2), the internal cavity 24 having an internal surface 26 (FIG. 2). The airfoil section 12 has a convex surface 20 and a concave surface 22. The convex and concave surfaces 20, 22, respectively, are bounded by a trailing edge 30 and a leading edge 32 and together form an exterior surface 78 of the airfoil. The exterior surface 78 is exposed to the hot gas path. The trailing edge 30 of the airfoil 12 includes cooling slots 86. Also, the airfoil section 12 is bounded by an inner diameter platform (platform) 8 and an outer diameter platform (platform) 14. The inner and outer diameter platforms 8, 14 create the gas path annulus and include cooling holes 72, 74, respectively. The outer diameter platform 14 includes opposing flanges 34, at least one cover 36 (FIG. 2), preferably two, and a rail 38. The inner diameter platform 8 includes a rail 40 and a cover 42 (FIG. 3), preferably two.

Although FIG. 1 shows the plurality of cooling holes 16, 18 located on the concave surface 22, it is readily understood by those skilled in the art that the plurality of cooling holes 16, 18 are formed on both the convex and concave surfaces 20, 22, respectively.

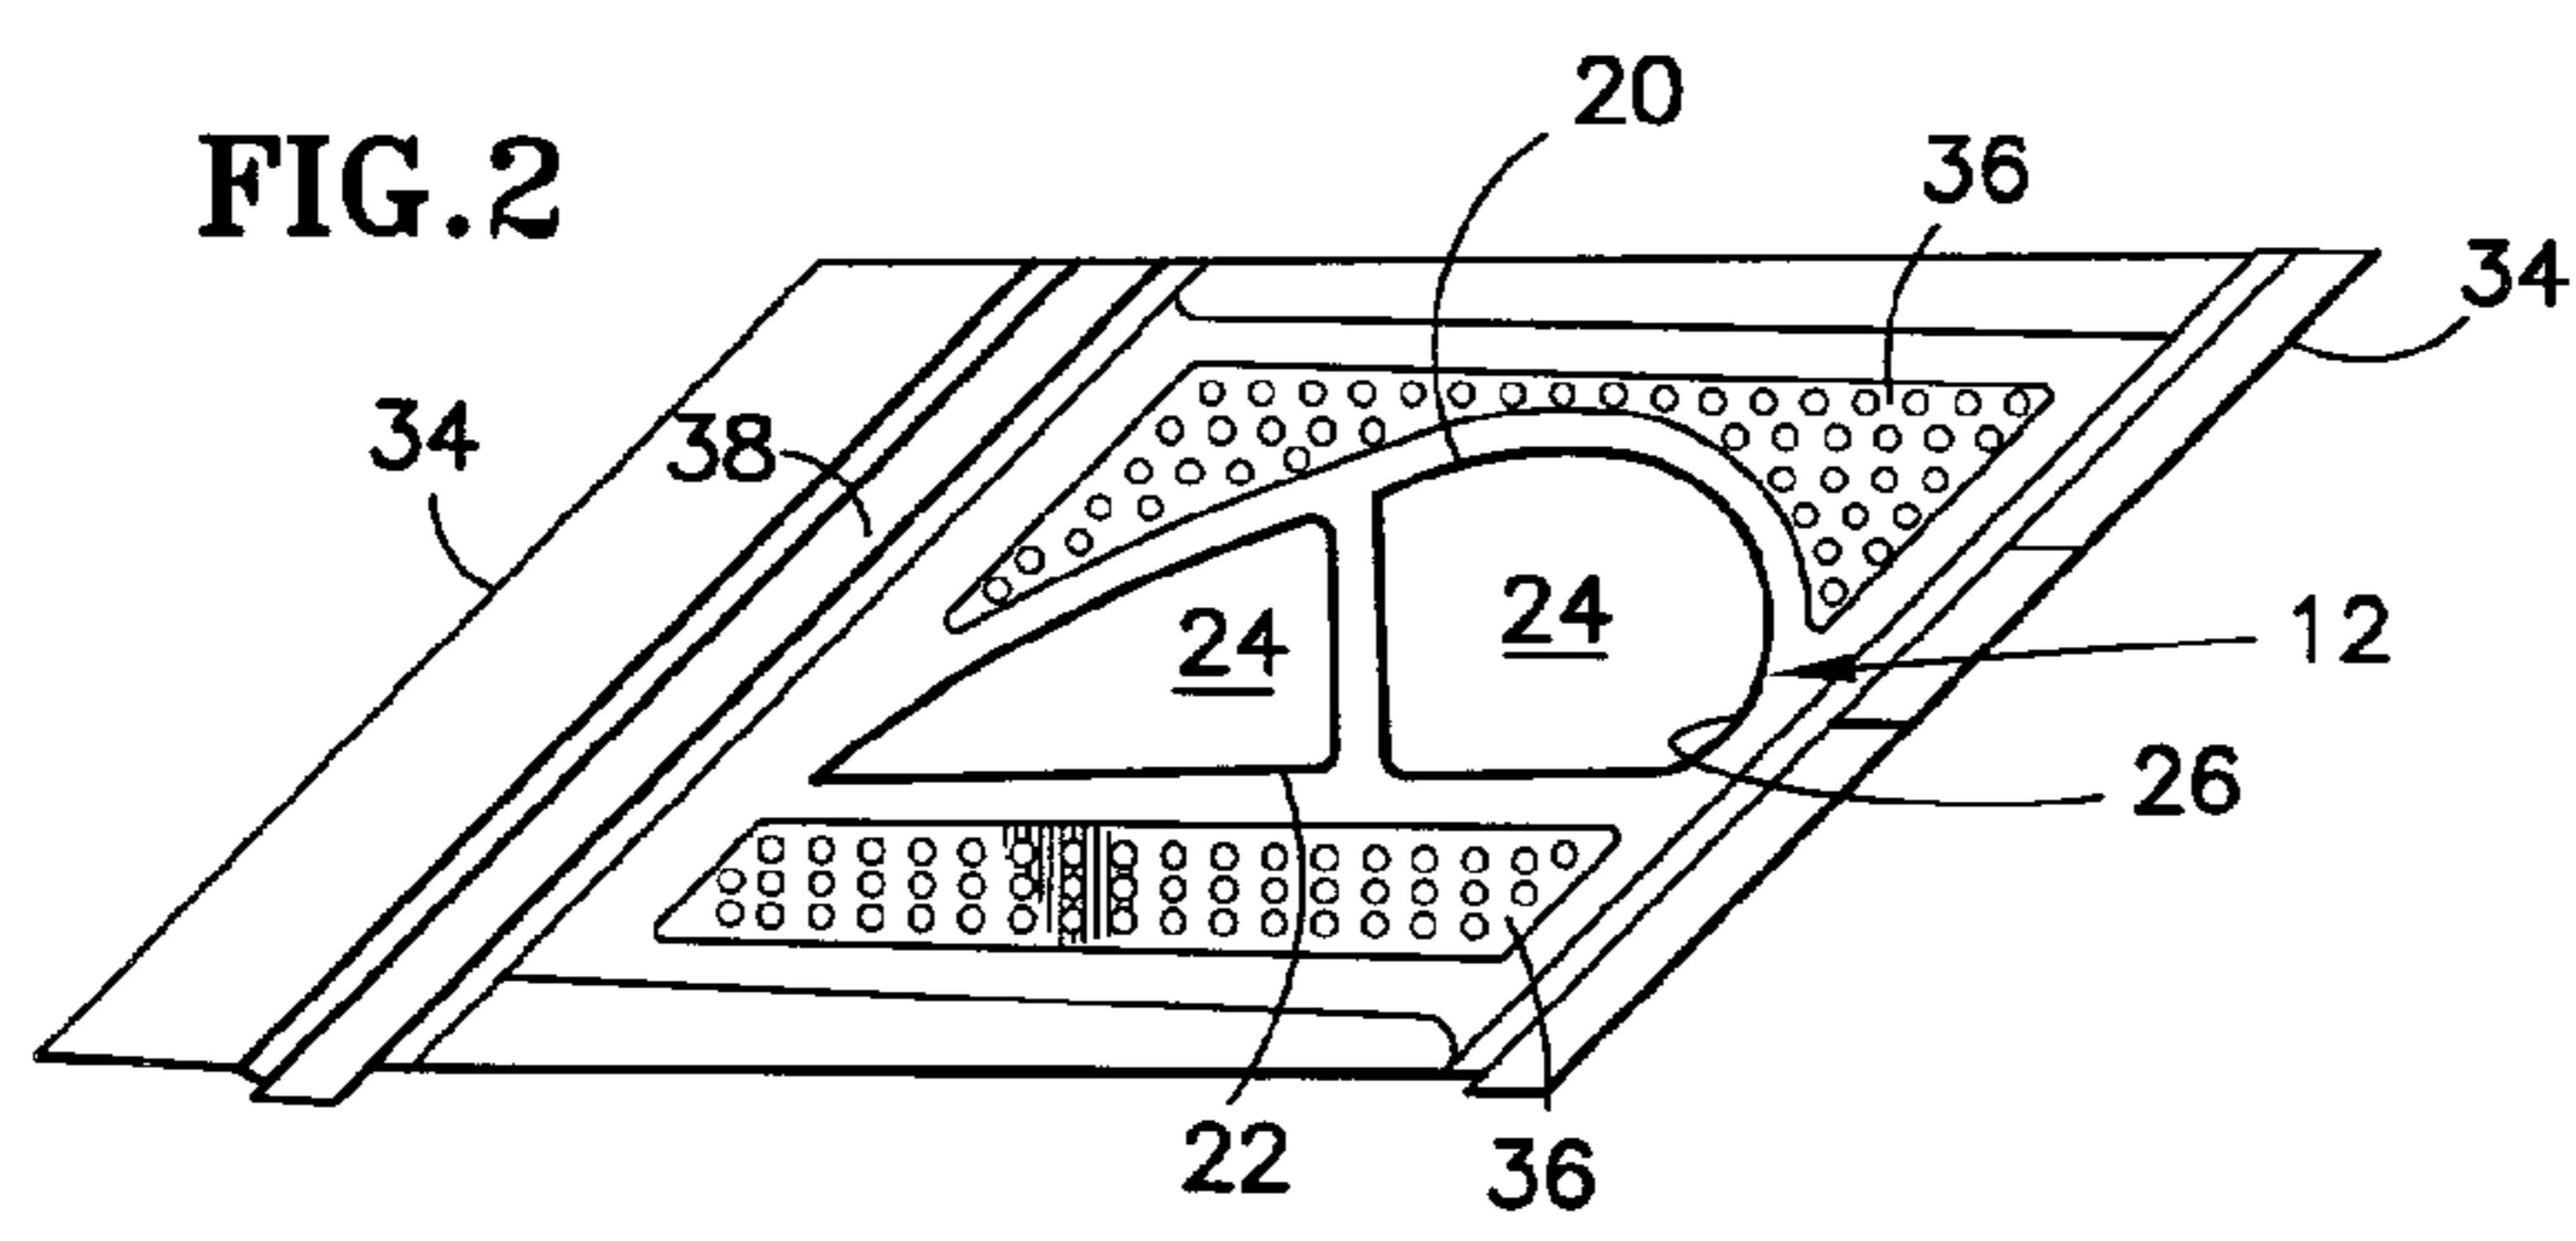
FIG. 2 is a top view of the vane of FIG. 1;

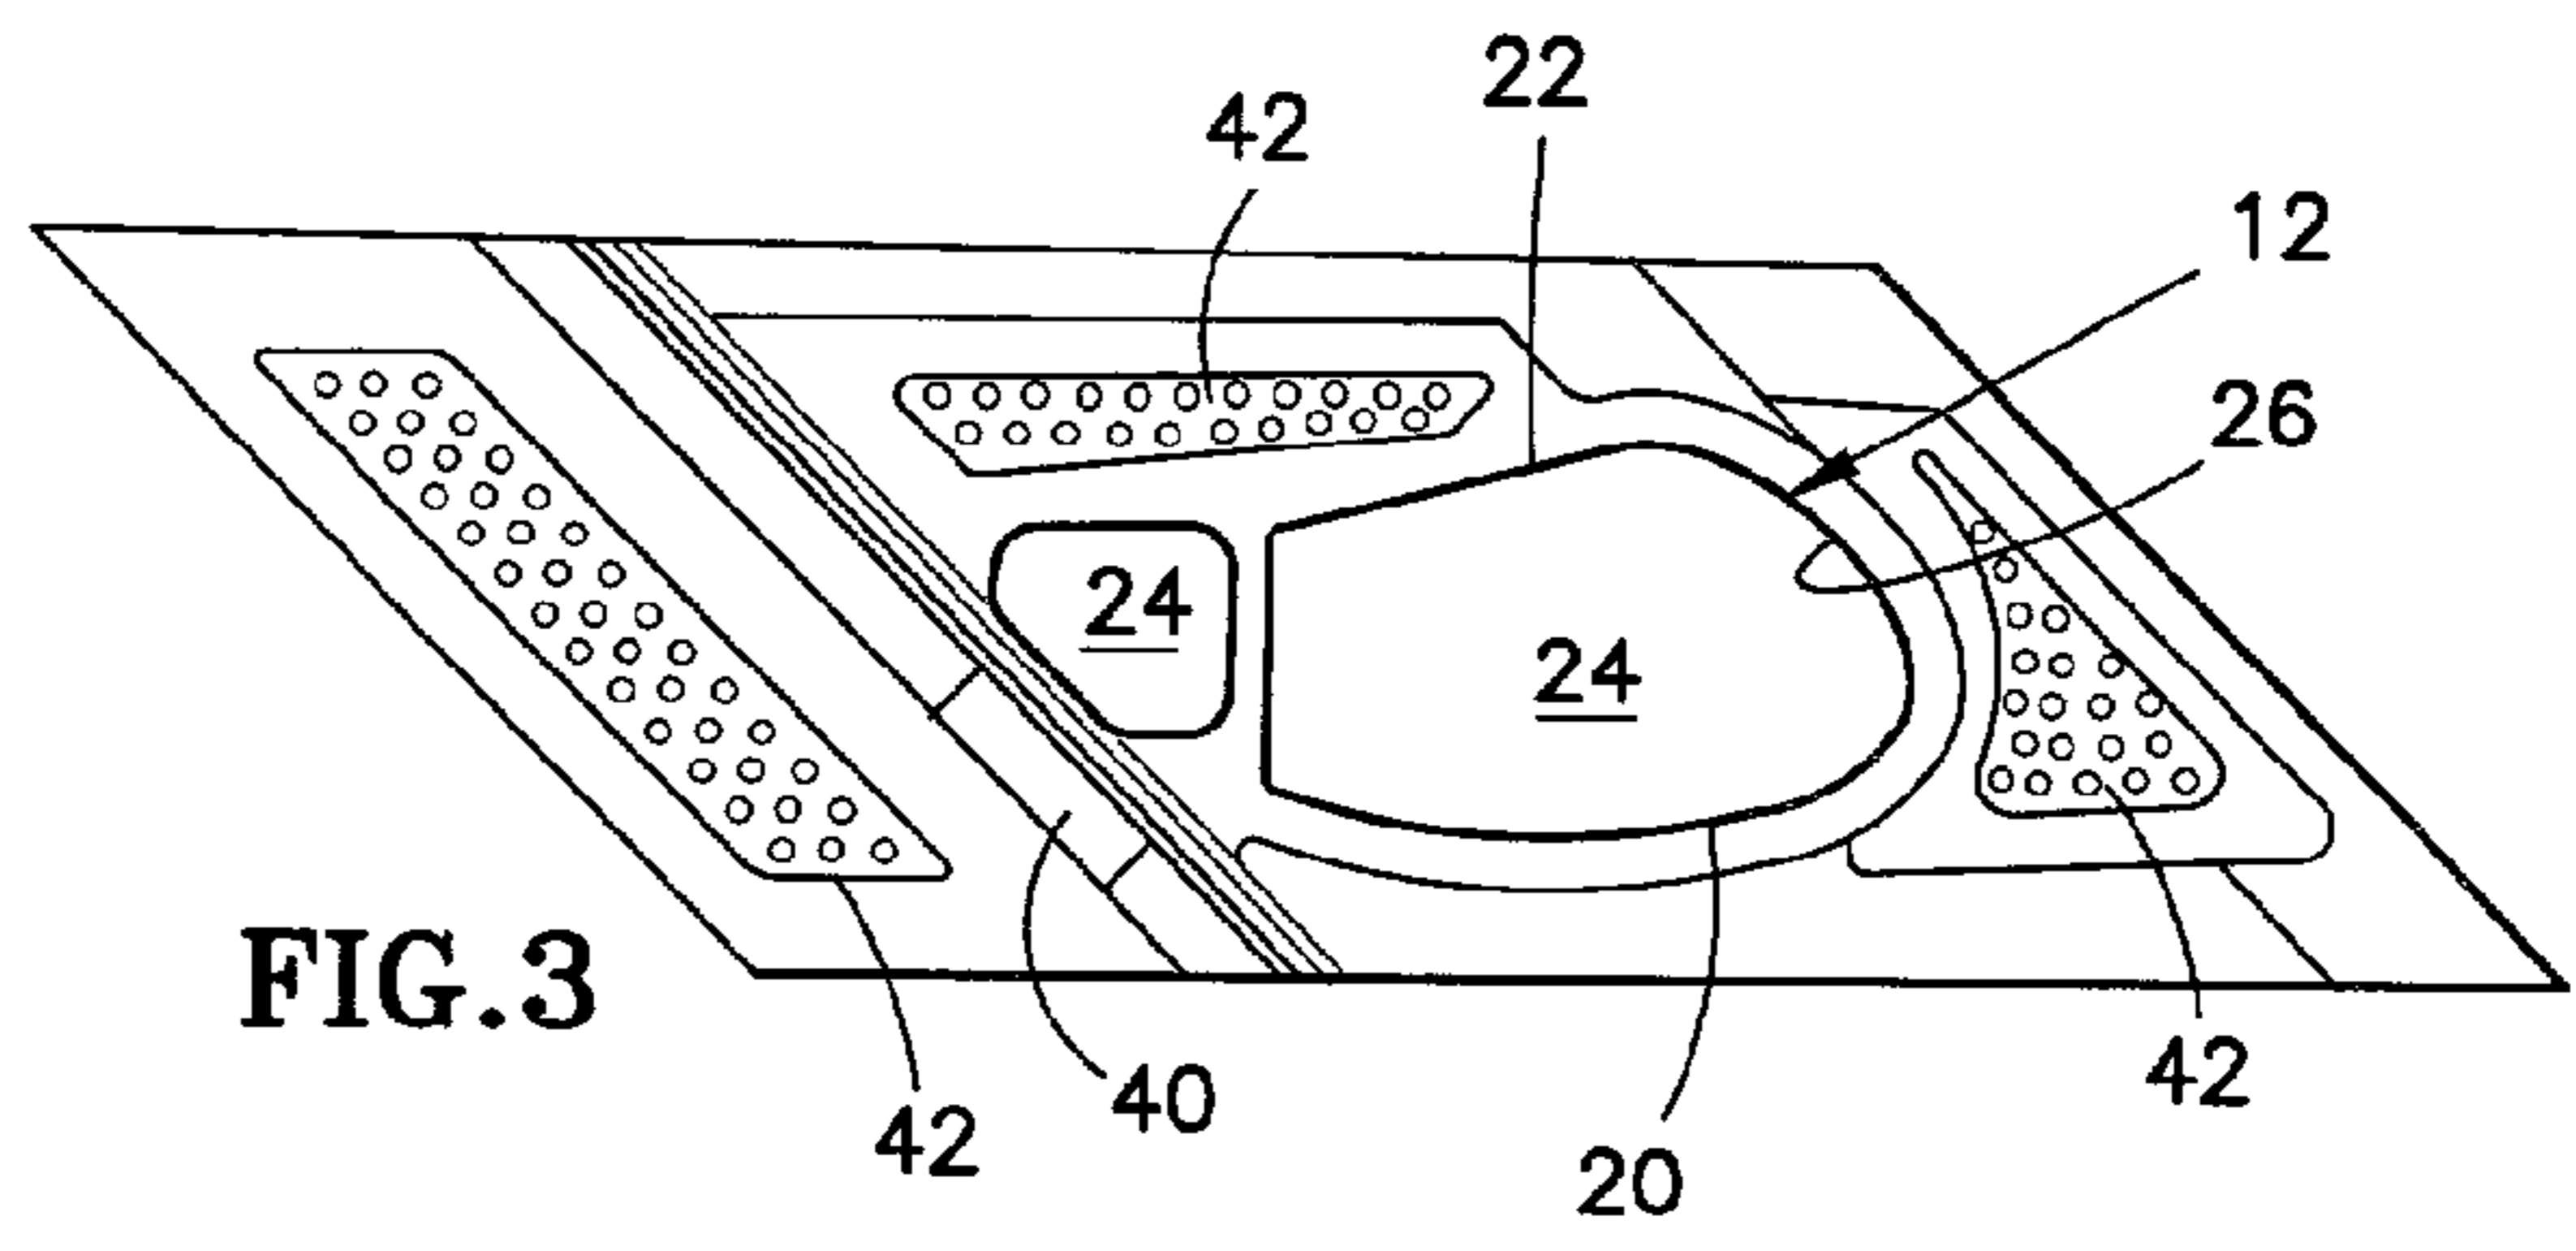
FIG. 3 is a bottom view of the vane of FIG. 1;

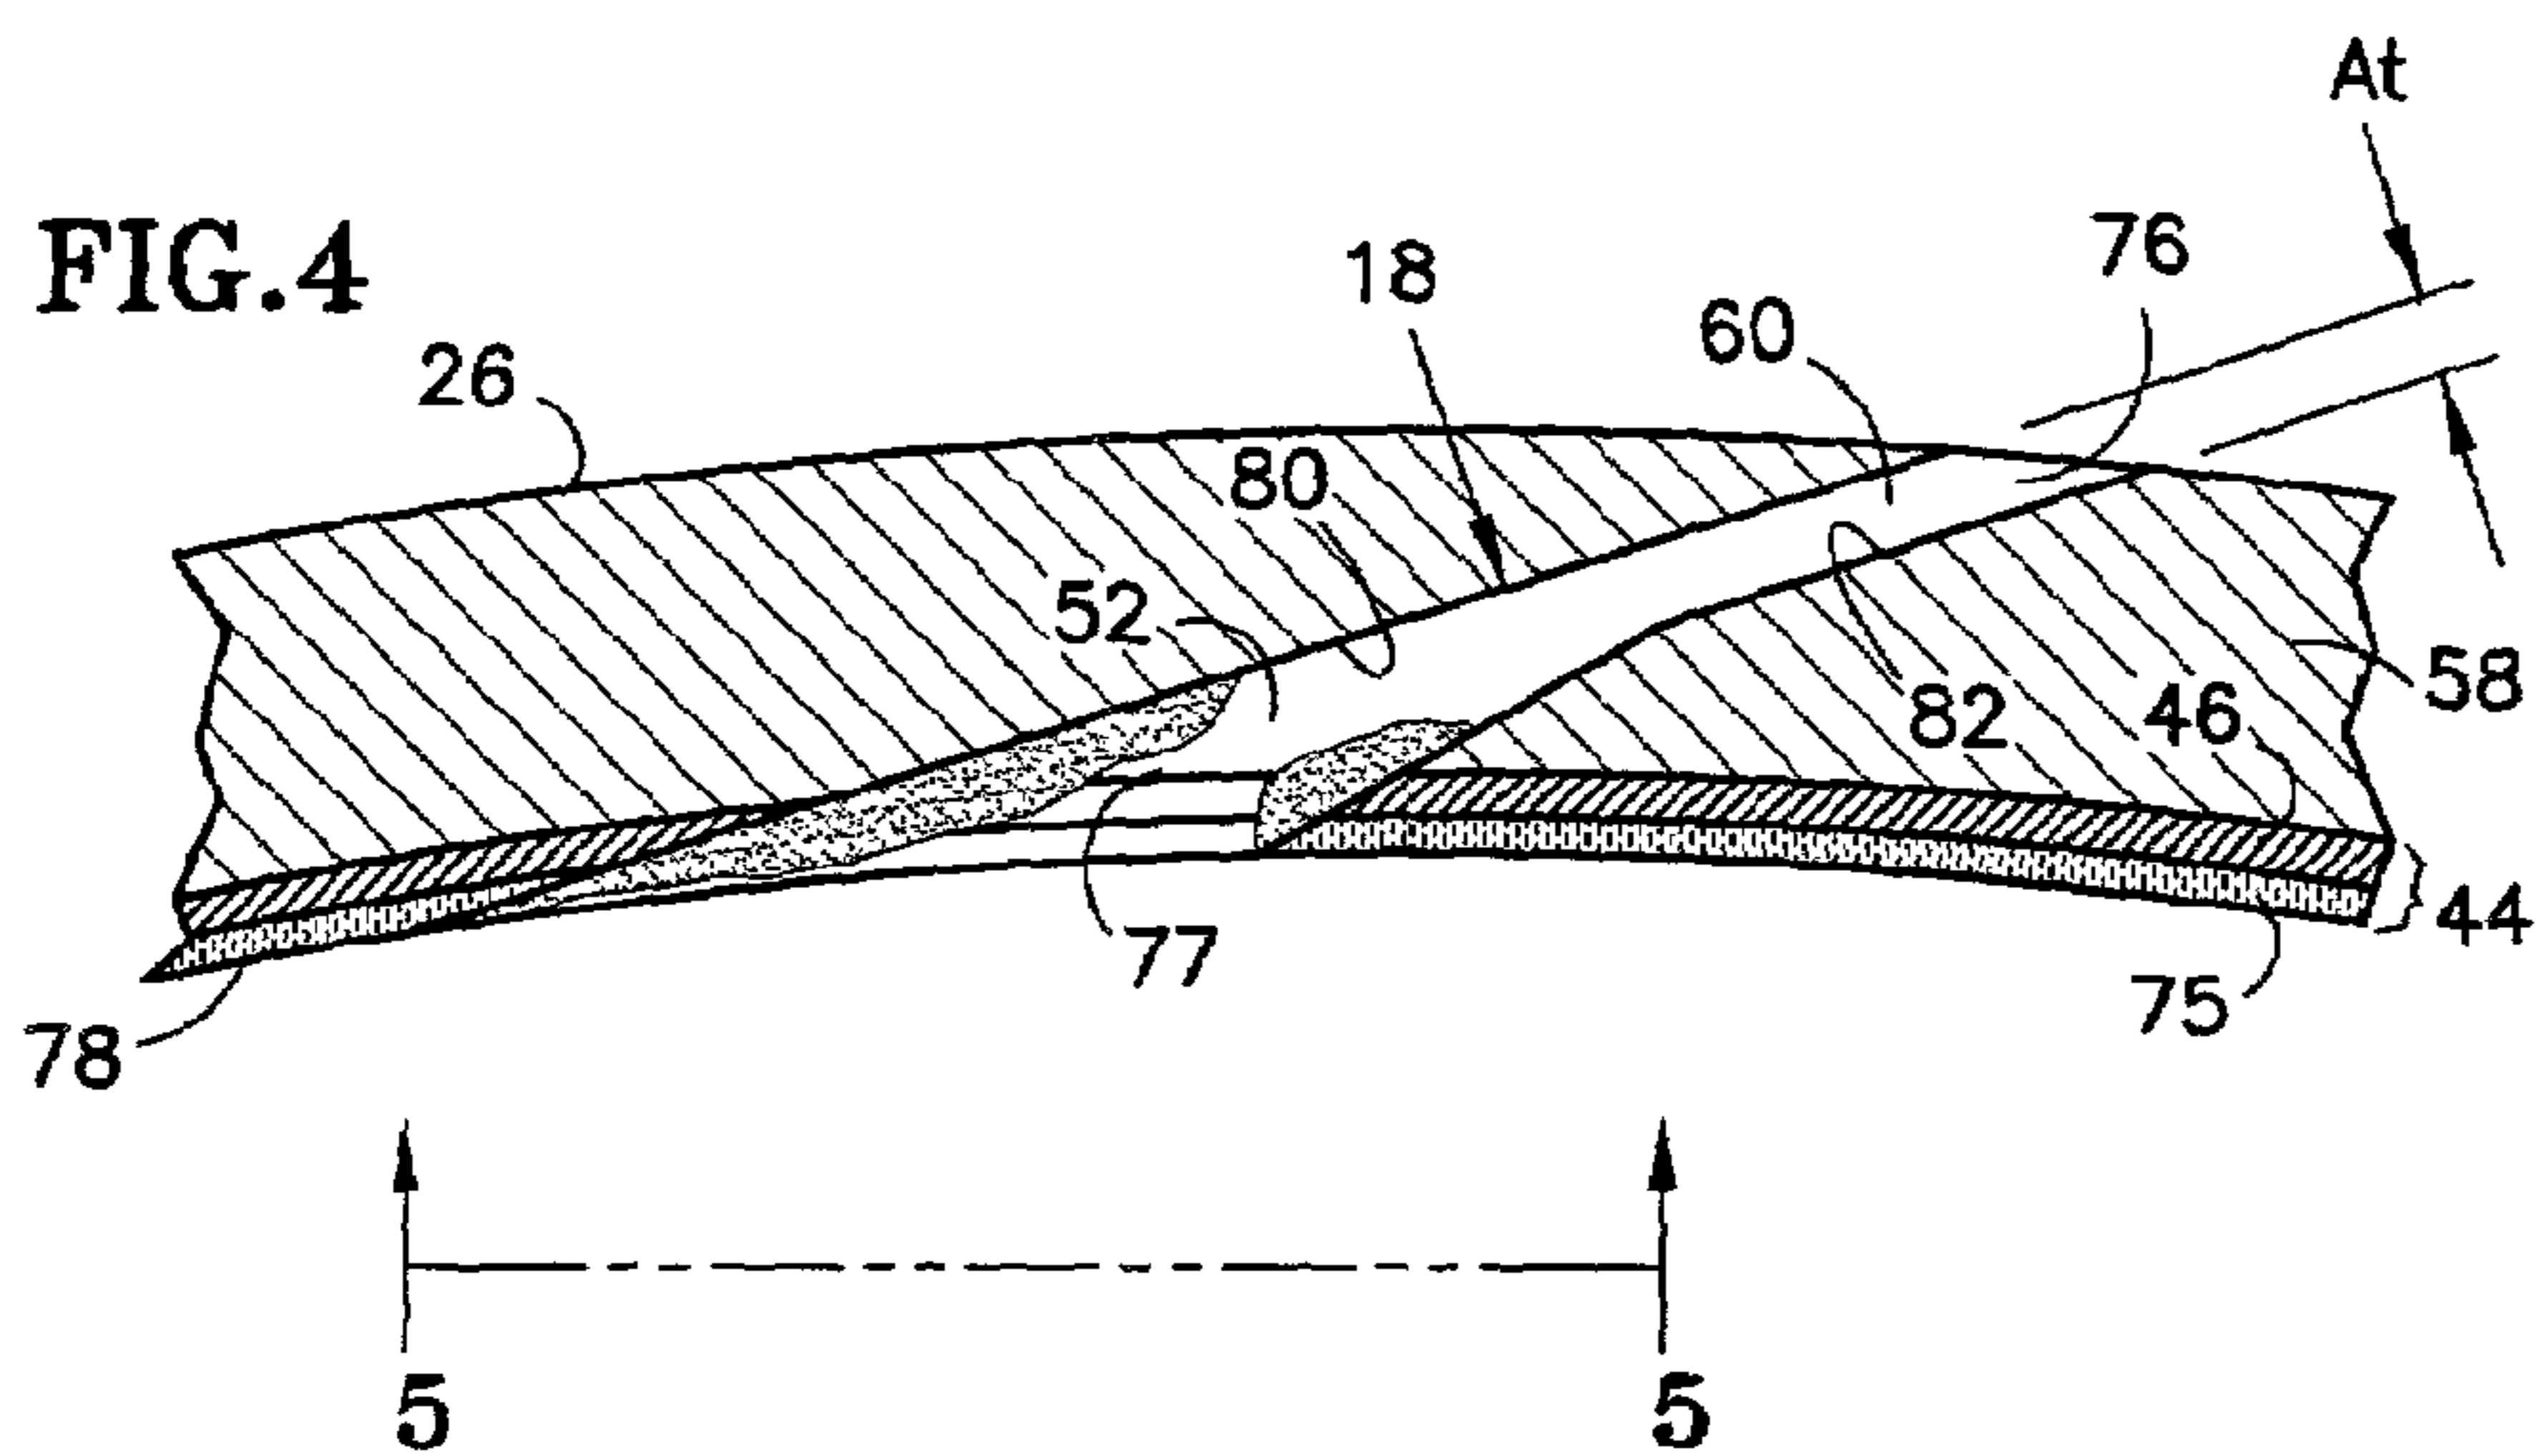
FIG.5

FIG. 5 is a view taken essentially in the direction 5—5 of FIG. 4 showing the diffusion hole prior to the repair of the present invention;

Referring to FIG. 4, a cross-sectional view of the wall thickness of the airfoil 12, and in particular the diffusion hole 18, is shown taken along the line 4—4 of FIG. 1. FIG. 5 shows a view taken essentially in the direction 5—5 of FIG. 4 showing the diffusion hole 18 prior to the repair of the present invention.

Referring now to FIGS. **1**, **4** and **5**, diffusion holes **18** located in region **50** may require reworking. The application of the nonoriginal metallic bond coat **46** to the entire surface **78** of the vane **10** may result in a quantity of excess bond coating accumulating in the diffusion passage **52** of the diffusion holes **18** thus reducing the area through which the cooling air passes. Since this "coatdown" phenomena, as shown in FIGS. **4** and **5**, affects most, if not all of the diffusion holes **18** in region **50**, the effectiveness of the cooling medium is diminished and the vane's durability is compromised. The coatdown phenomenon is normally not a problem during the manufacture of original equipment vanes since the protective coatings, and in particular, the metallic bond coat, are usually applied prior to installation of the cooling holes.

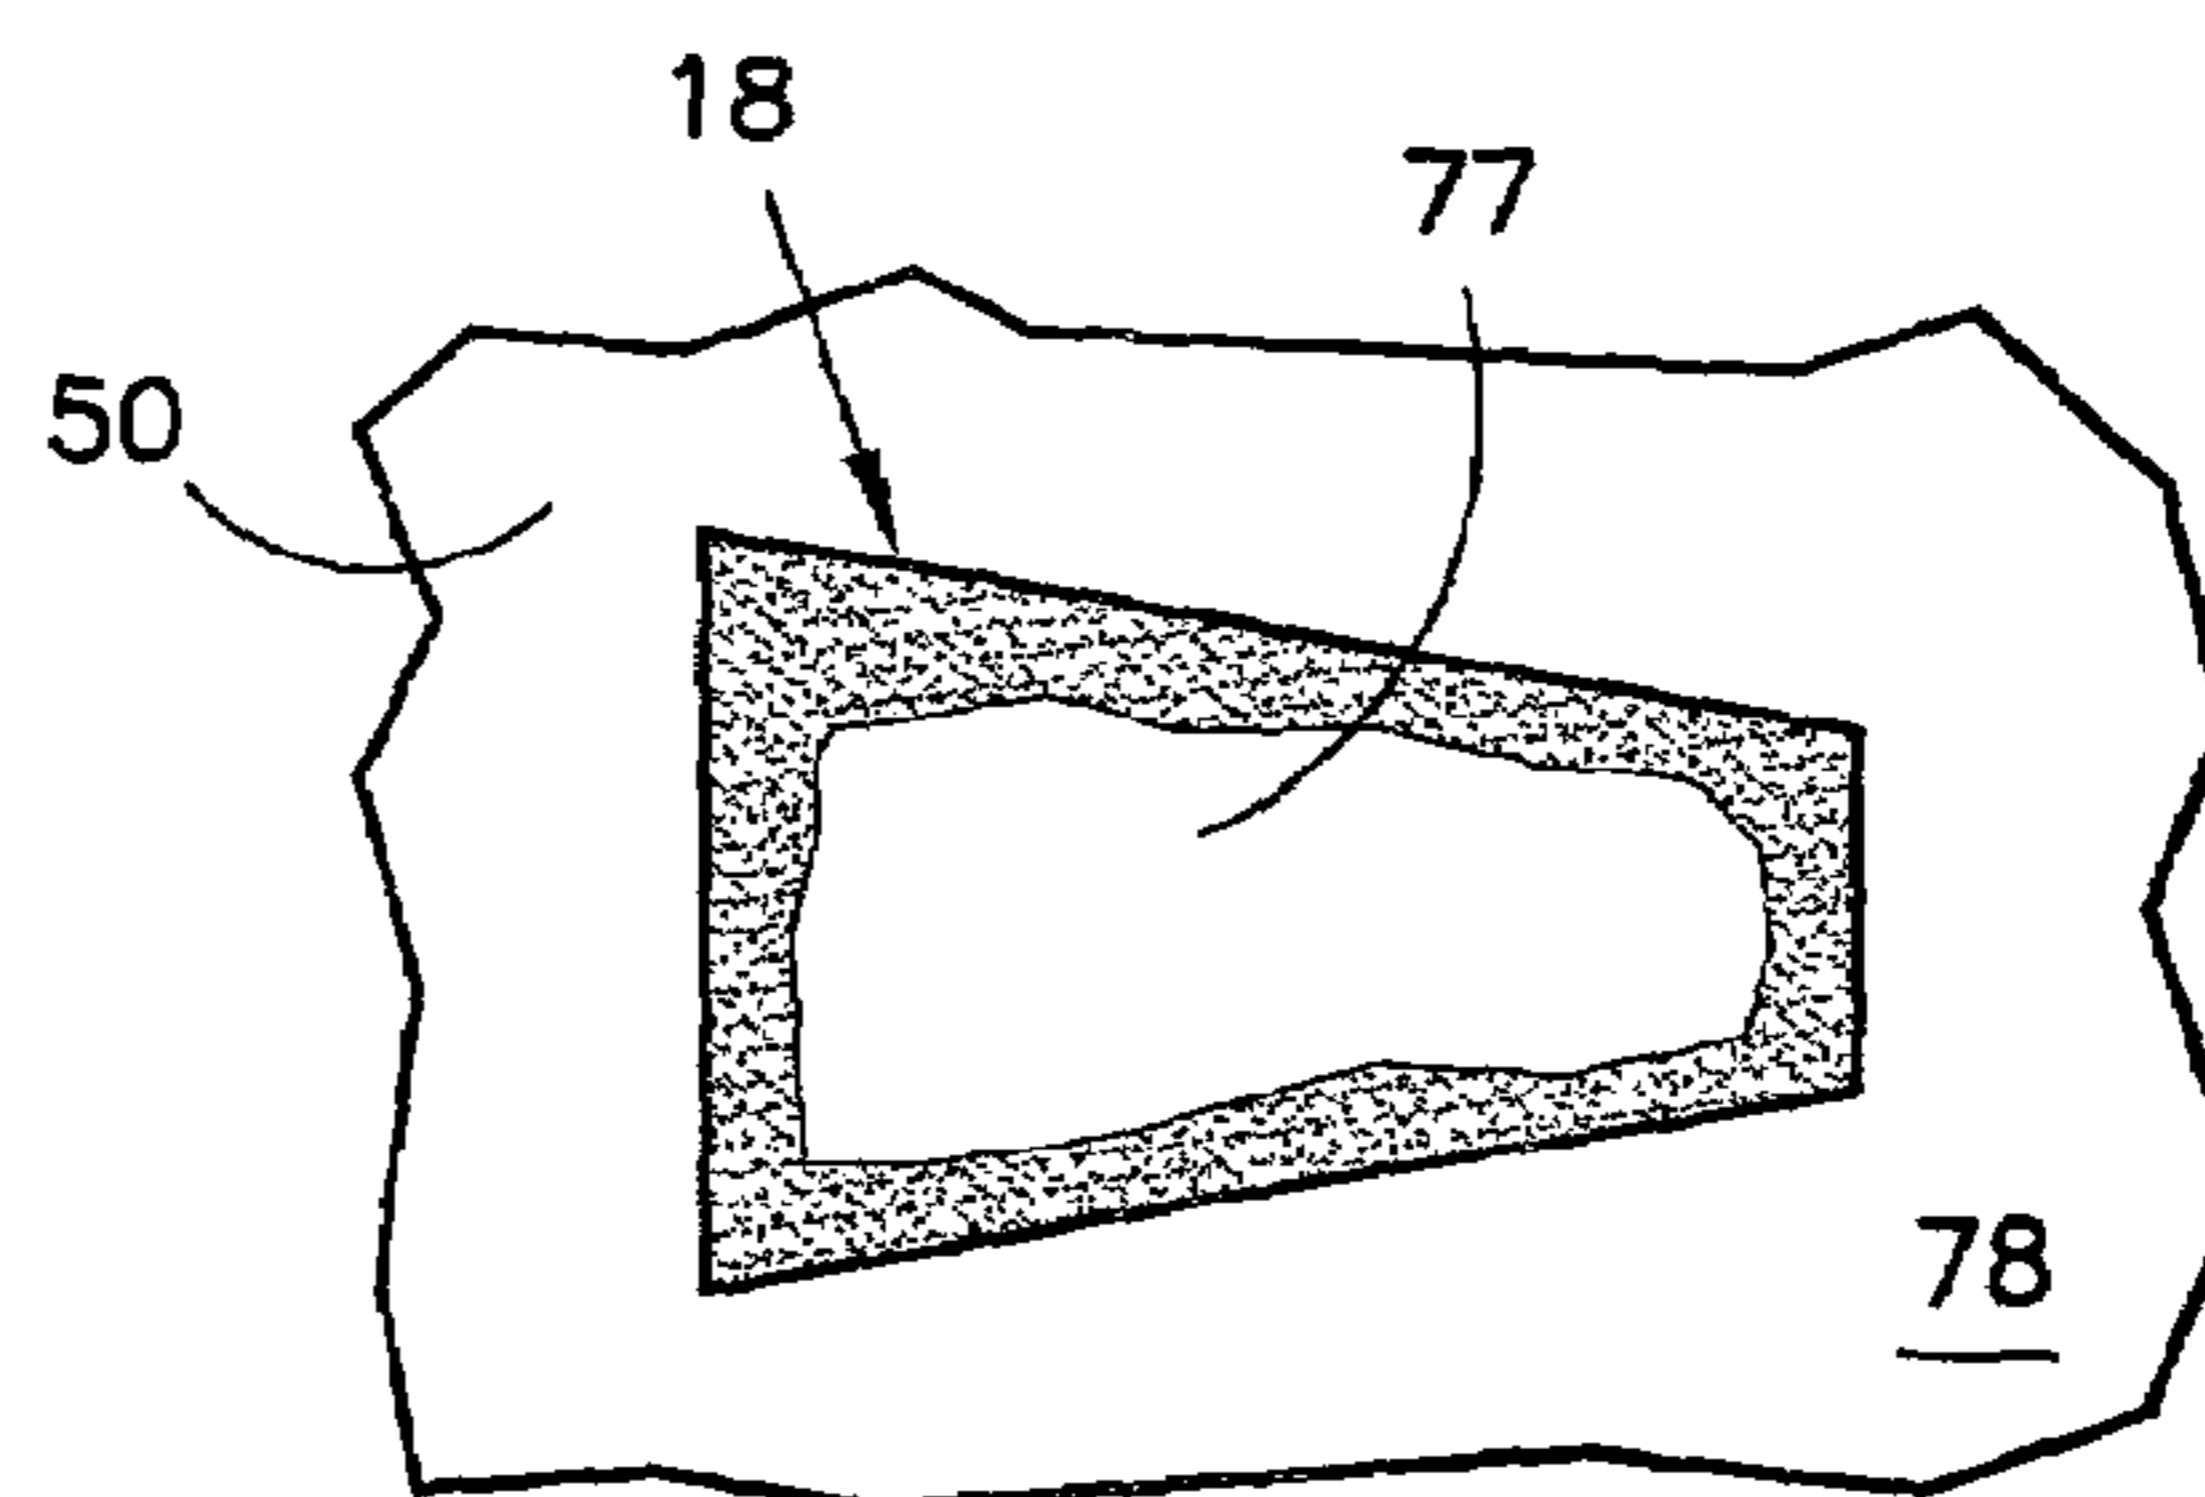
FIG.6

FIG. 6 is a side view of an electrode suitable for use with the repair method of the present invention; and

Referring to FIGS. **5**, **6** and **7**, electrodes **56**, **62** suitable for insertion into an electric discharge machining device are shown. Referring to FIGS. **1**, **4** and **6**, the remanufacture and repair of the diffusion holes **18** in local regions **48**, **50** of vane **10** using electrodes **56**, **62**, respectively, will now be described.

The electrode **56** includes a metering portion **66** and a diffuser portion **68**. The electrode **62** includes a diffuser portion **70**. It is noted that the geometry of the individual electrodes **56**, **62**, specifically the respective portions **66**, **68**, **70**, are preselected to correspond to the required shape of the corresponding diffusion hole **18** to which it is used. In particular, the electrode **56** is chosen to restore the inner diffuser portion **80** and inner metering portion **82** of the respective diffusion hole **18** being repaired in region **48**. Similarly, the electrode **62** is chosen to restore the inner diffuser portion **80** of the respective diffusion hole **18** being repaired in region **50**. This ensures that after the repair is

In local region **48**, the diffusion hole **18** is now remanufactured using the electrode **56**. Since the repair material filled the diffusion hole **18**, both the metering portion **66** and diffuser portion **68** of the electrode **56** are required to effect the remanufacture. The diffuser portion **68** of the electrode **56** corresponds in shape to the diffuser passage **52**, and more specifically, the inner diffuser portion **80**, of the diffusion hole **18**. While, the metering portion **66** of the electrode **56** corresponds to the metering passage **60**, and more specifically, the inner metering portion **82** of the diffusion hole **18**.

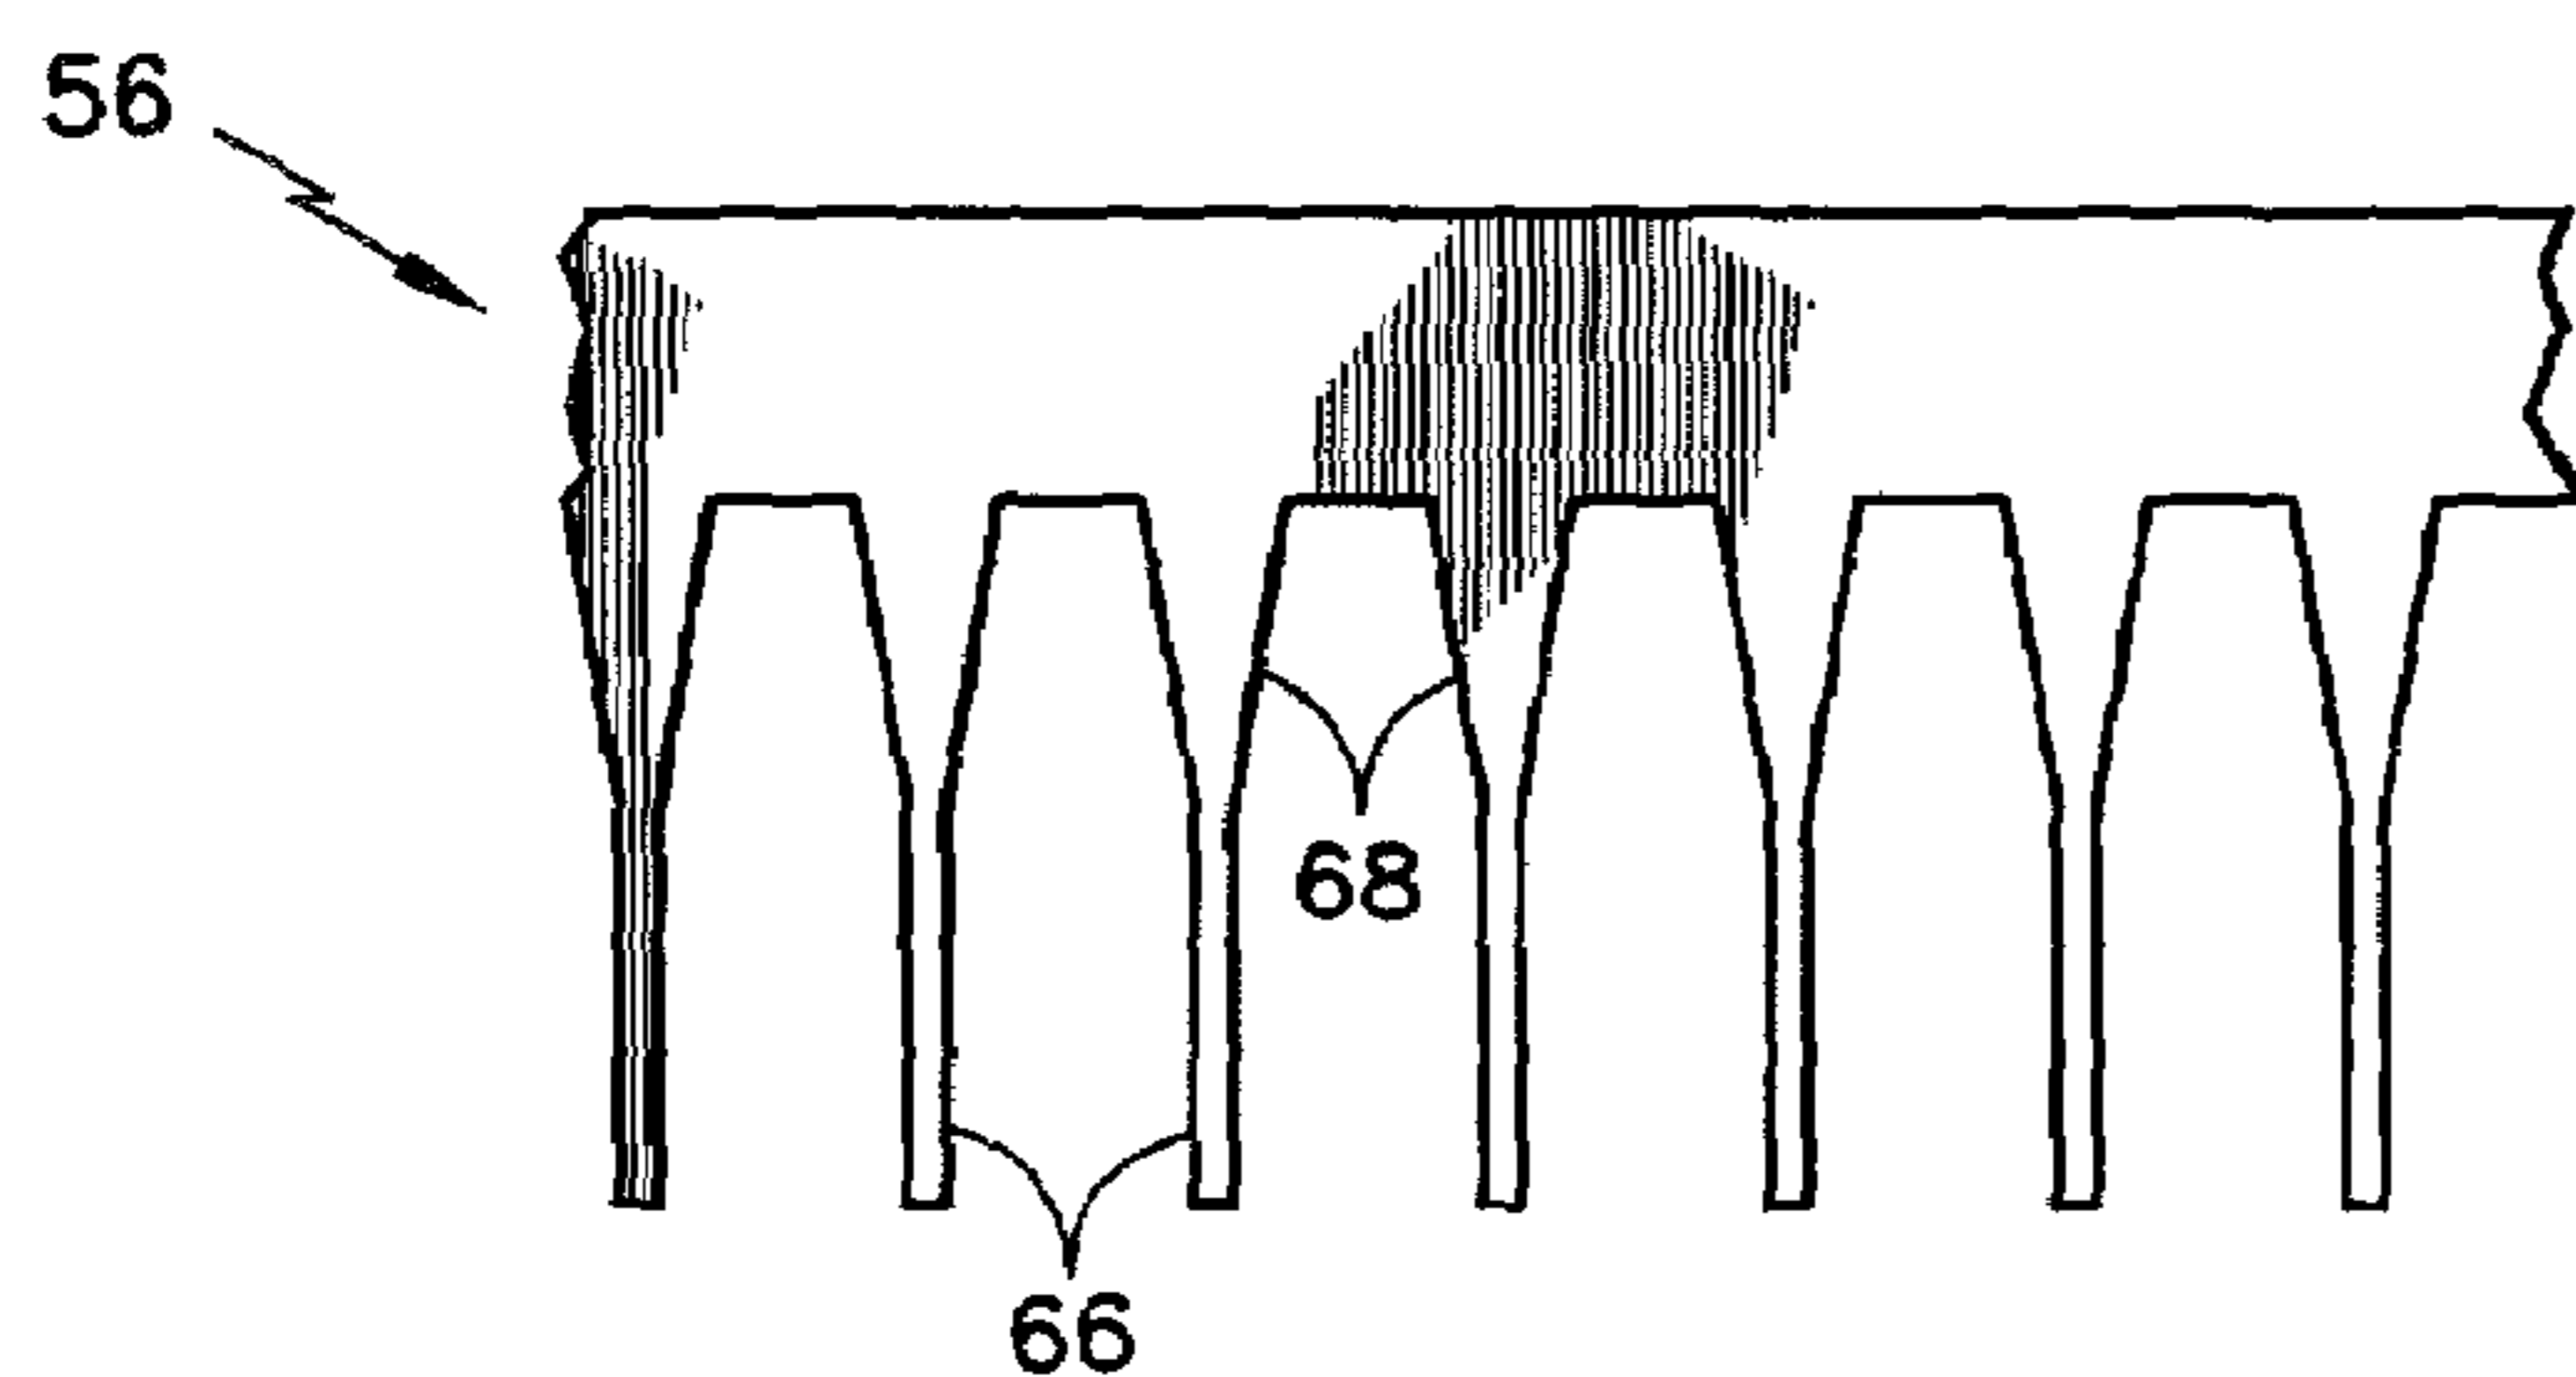
FIG.7

FIG. 7 is a side view of an electrode suitable for use with the repair method of the present invention.

However, in local region **50**, the diffusion holes **18** may be partially or fully clogged, as described earlier, and therefore will need to be reworked to restore the cooling effectiveness of the diffusion hole **18** as well as vane durability. This is accomplished by using the electrode **62** to remove the excessive bond coat material. The electrode **62** may be easily formed by removing a metering portion from an electrode that has a diffuser portion corresponding in shape to the diffuser passage **52**, and more specifically, the inner diffuser portion **80**, of the diffusion hole **18**. This can be accomplished by using a cutting means, for example scissors, to remove the metering portion.
