(10) **Patent No.:** **US 7,210,366 B2**
(45) **Date of Patent:** **May 1, 2007**

(54) **FULL SUPPORT MAINSHAFT AND FIFTH GEAR DESIGN**

The present invention relates to the field of automotive transmissions, and more particularly, to a full support mainshaft and fifth gear design for the New Venture/MTM NV4500 transmissions.

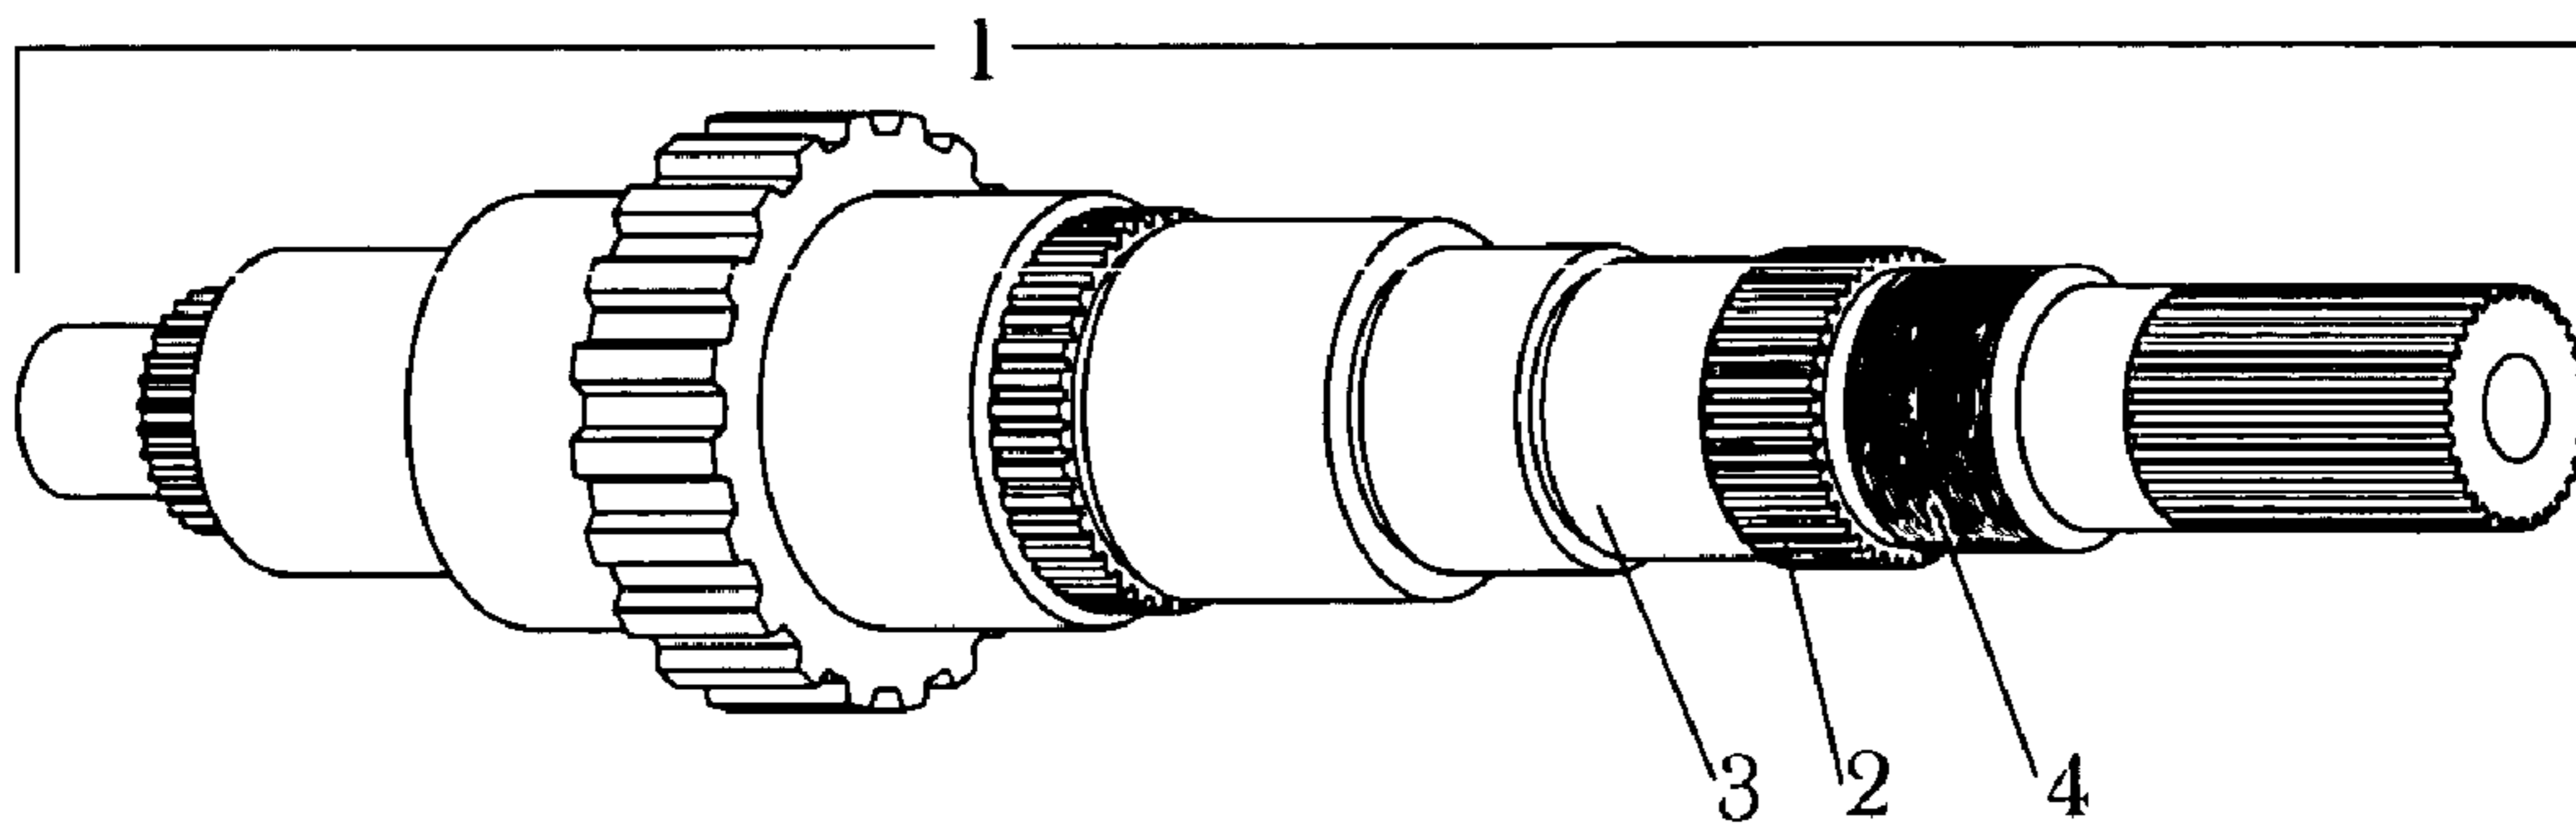
FIG. 1 is a perspective view of a new factory mainshaft without the gear.

FIGS. 1–14 illustrate the prior art. FIG. 1 is a perspective view of a new factory mainshaft 1 without the gear. This figure shows the splines 2, smooth support area 3, and threaded area 4 of the mainshaft. The gear fits over the splines 2 and the smooth support area 3.

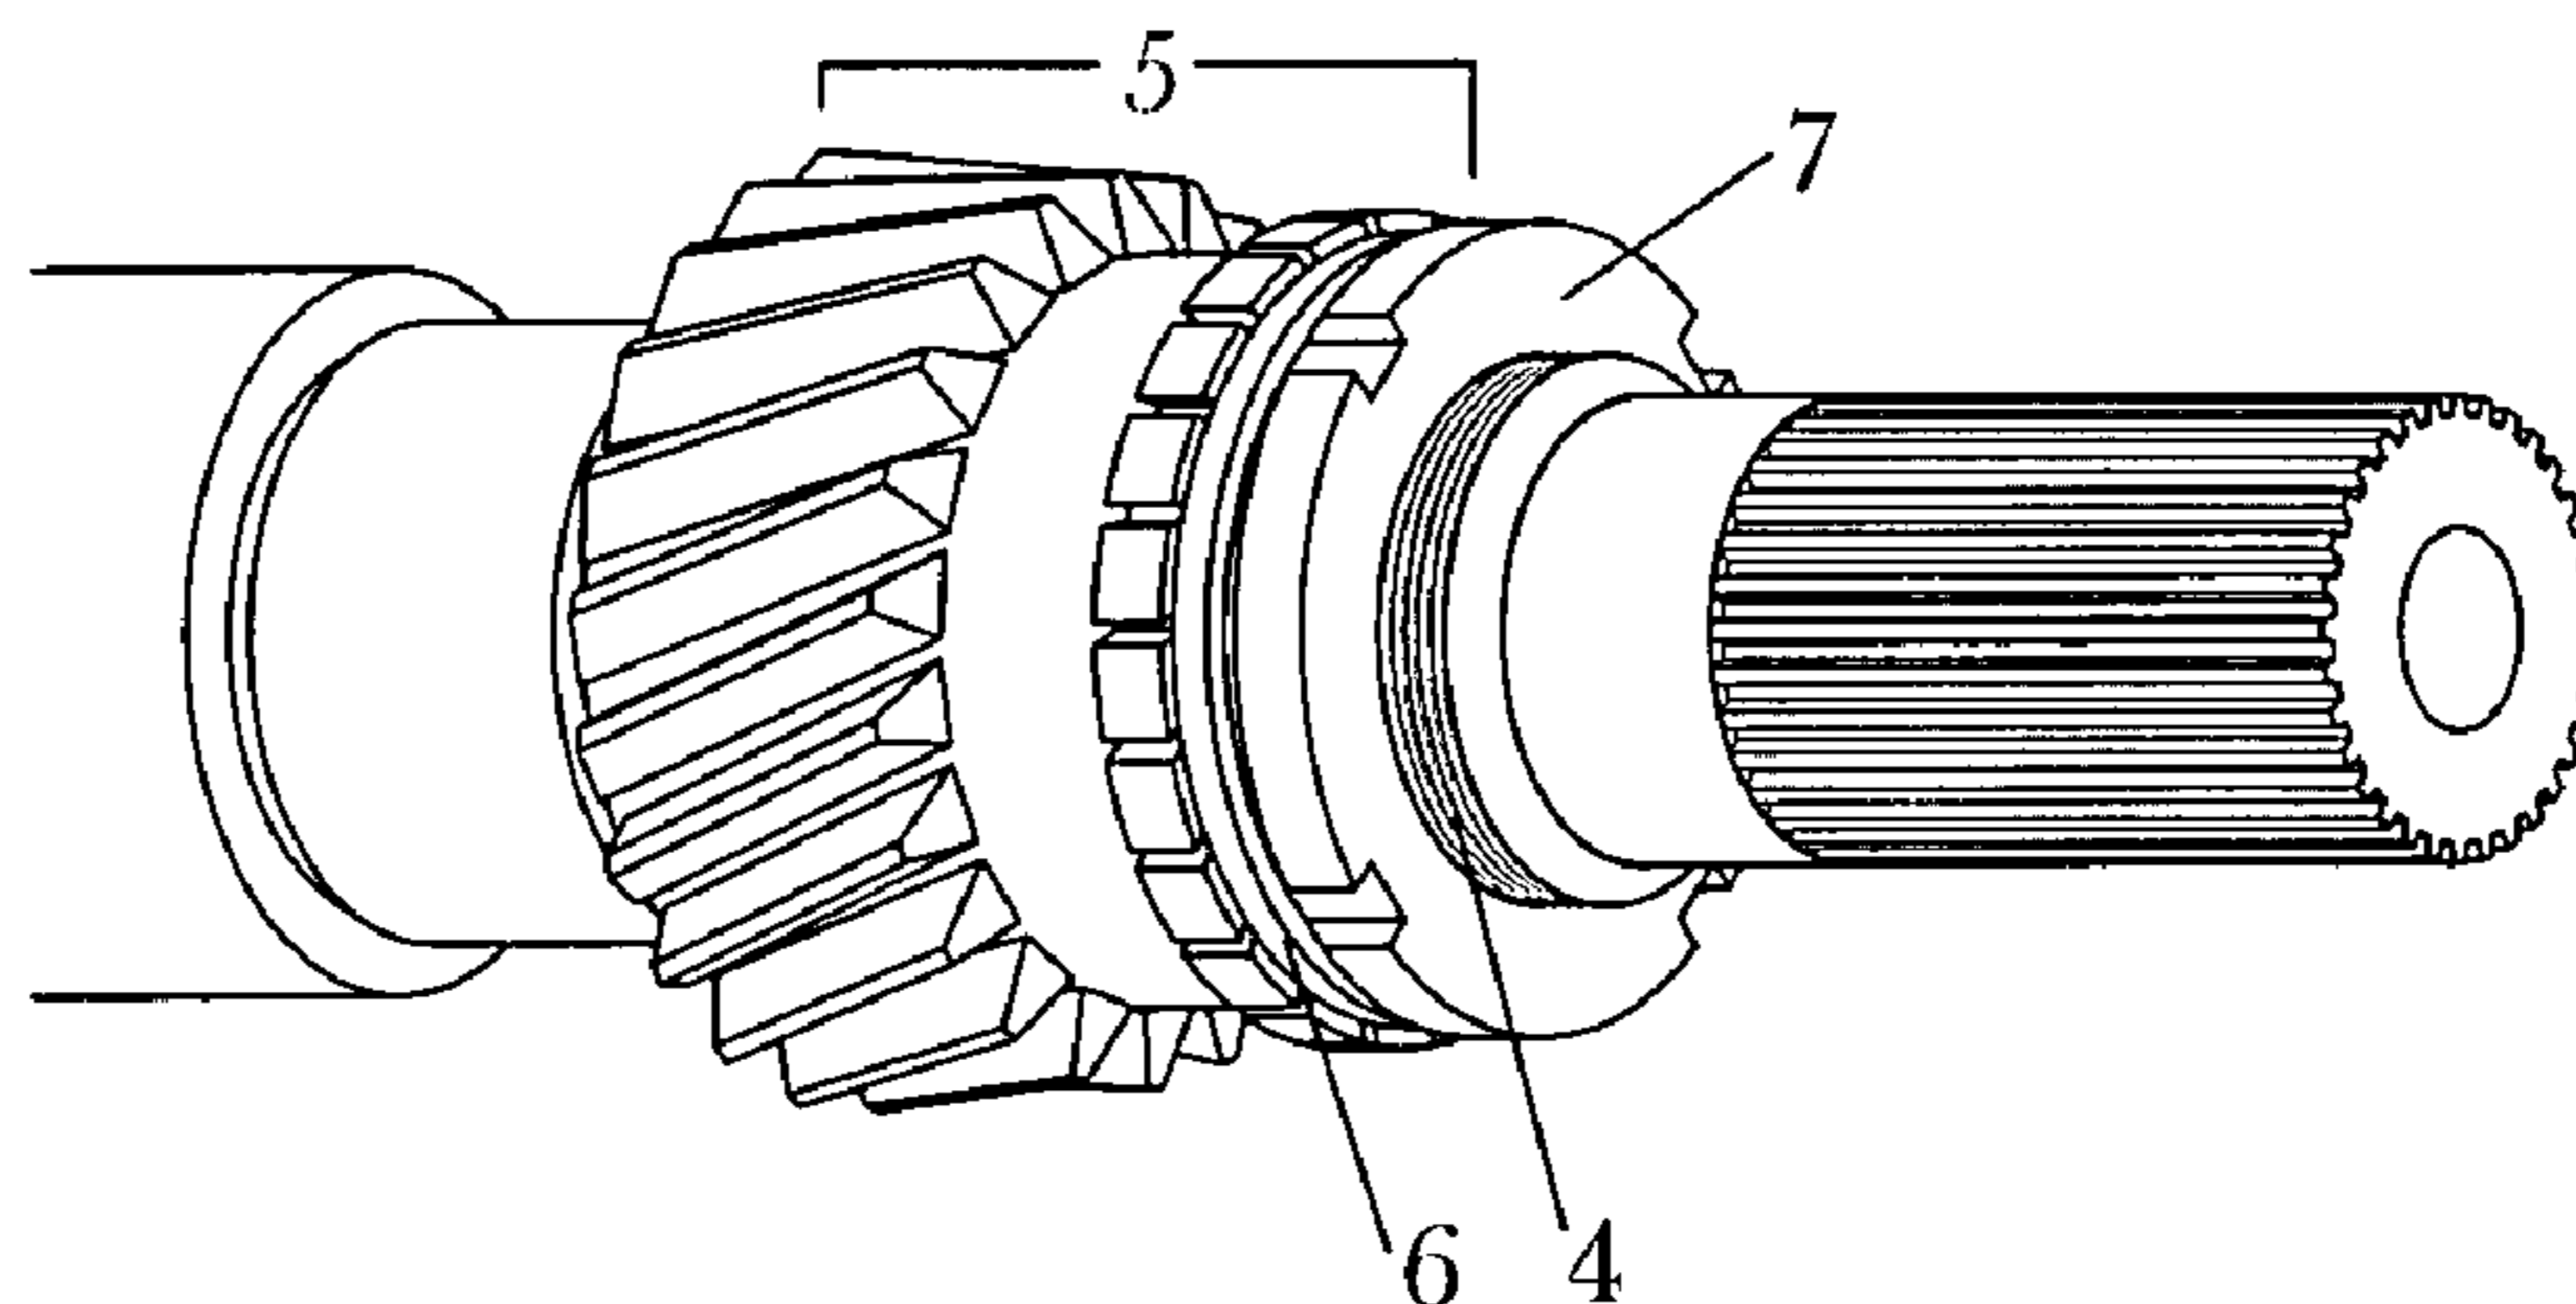
FIG. 2 is a partial perspective view of a factory mainshaft with the factory gear, spring washer and flat nut.

FIG. 2 is a partial perspective view of a factory mainshaft 1 with the factory gear 5, spring washer 6 and flat nut 7. The washer 6 and nut 7 fit over the threaded area 4 of the shaft. In an early attempt to solve the problem of the gear working itself off of the shaft, the spring washer 6 was added between the gear 5 and the nut 7. The addition of the washer, however, did not solve the problem.

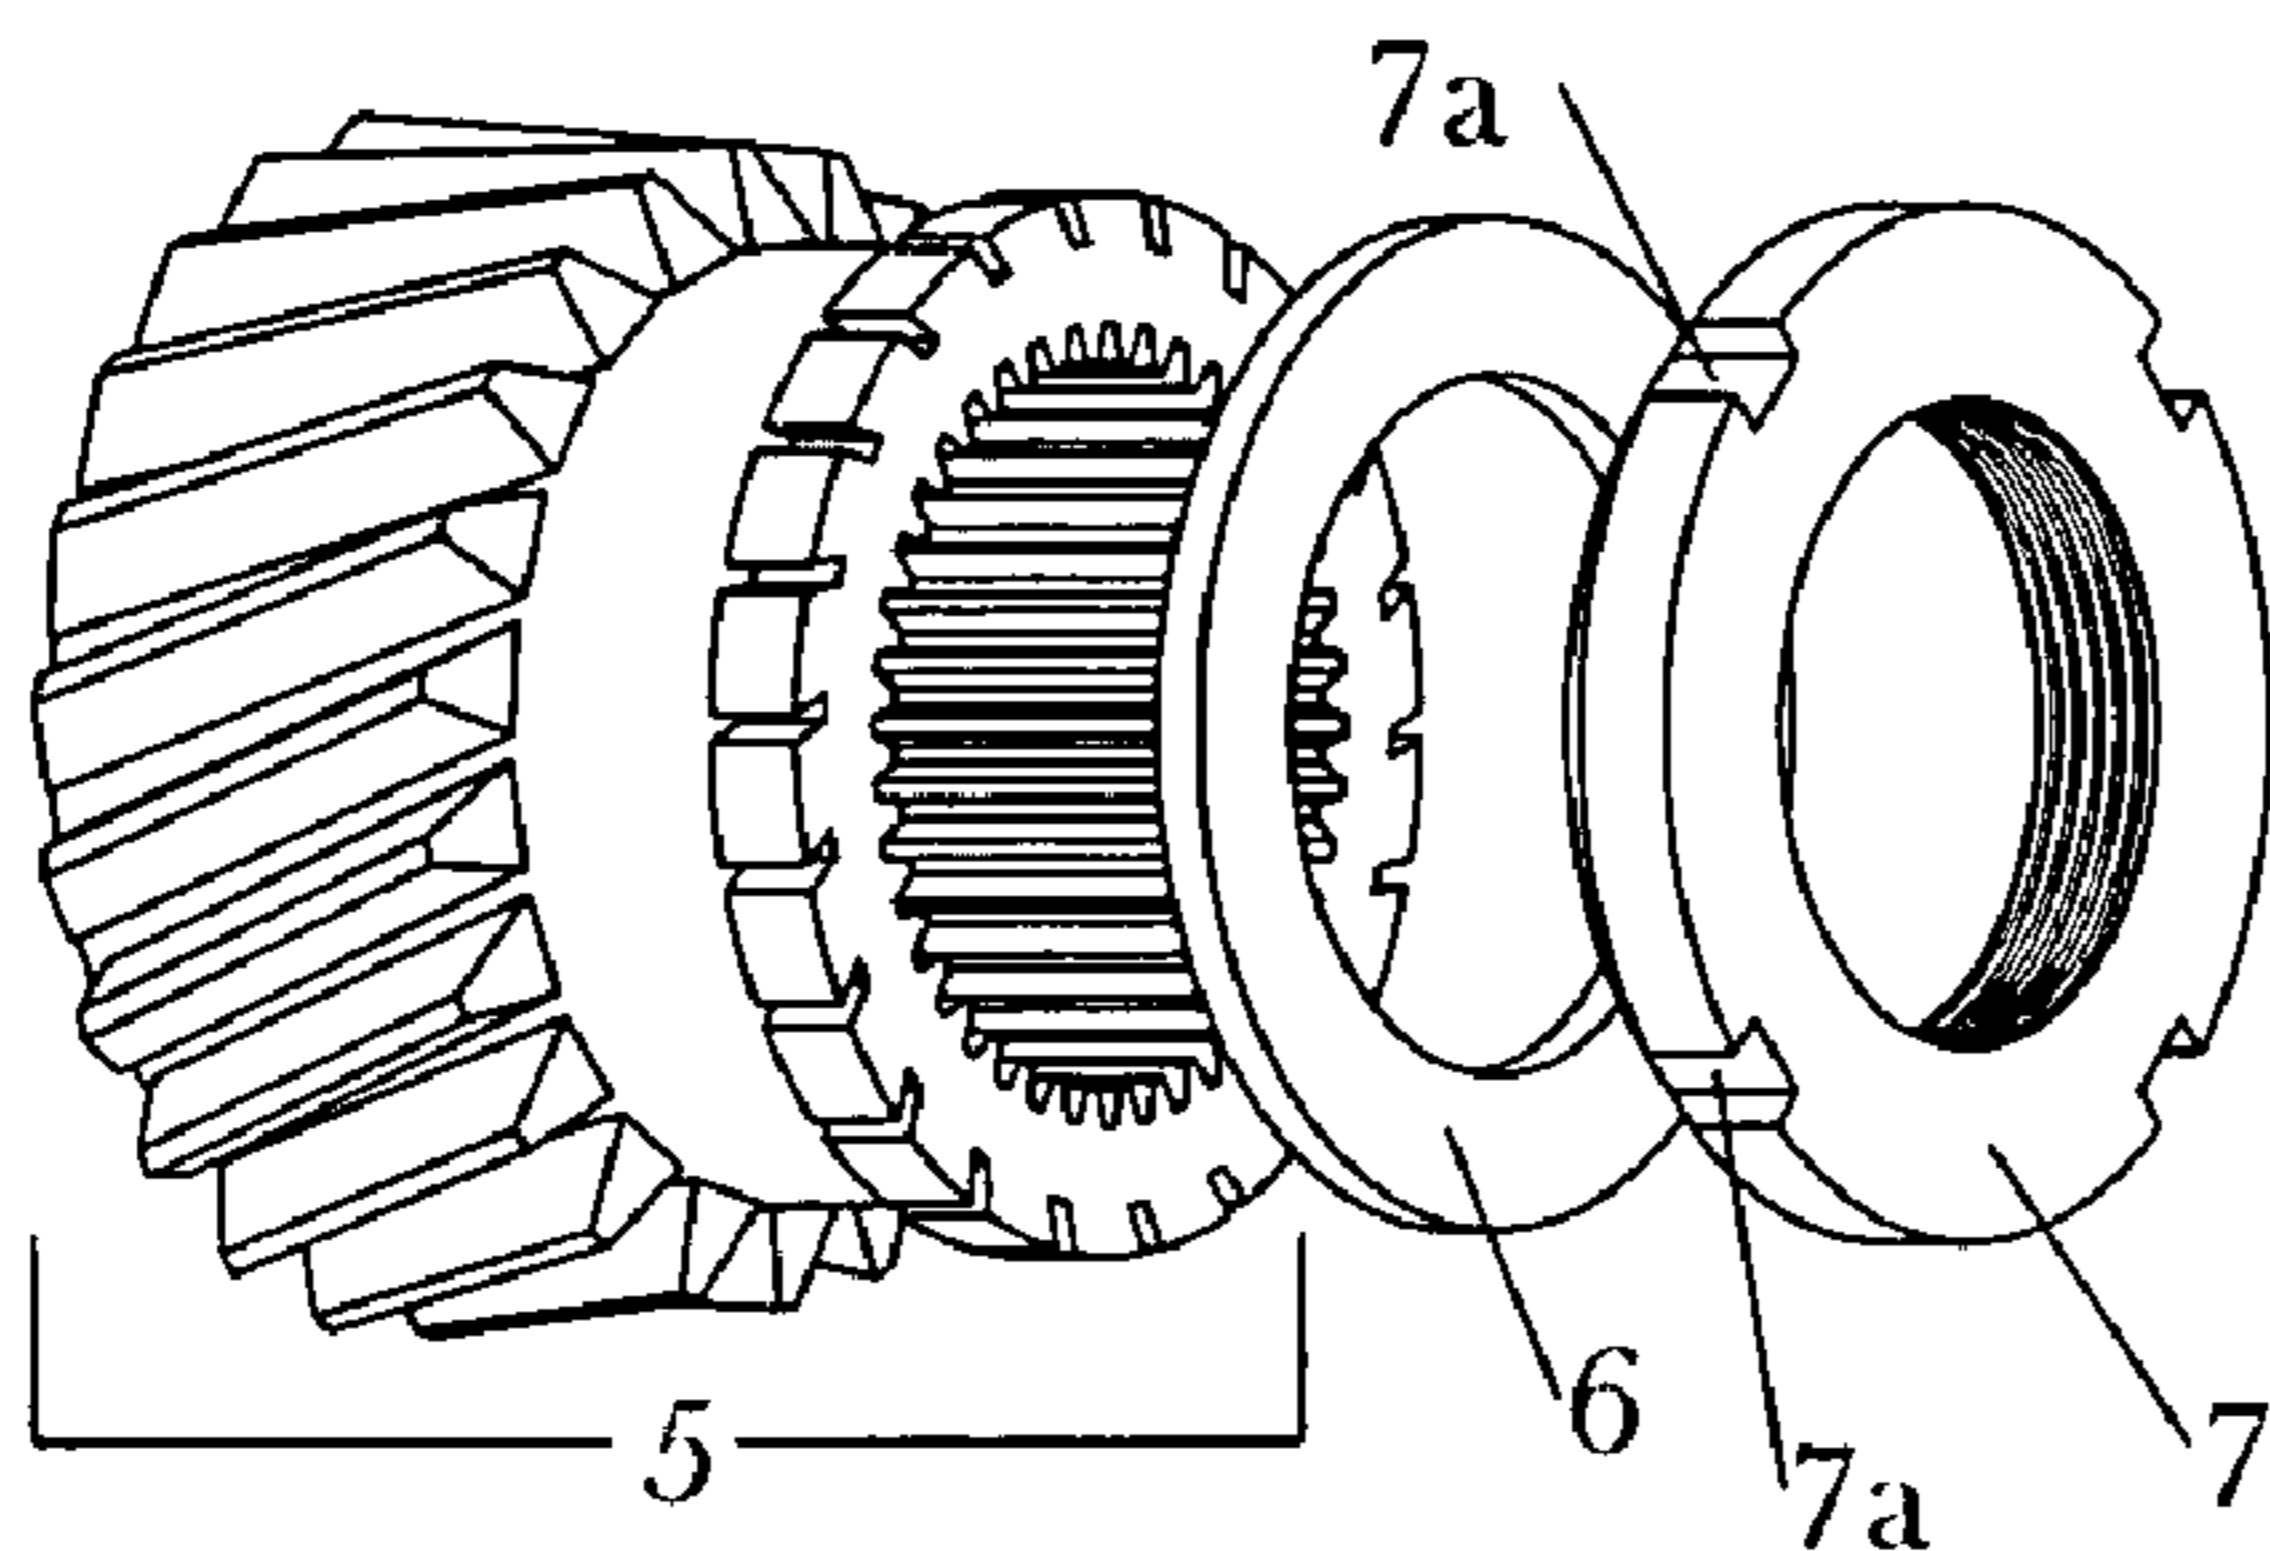
FIG. 3 is an exploded perspective view of the factory gear, spring washer and flat nut of FIG. 2.

FIG. 3 is an exploded perspective view of the factory gear 5, spring washer 6 and flat nut 7 of FIG. 2. The nut 7 comprises notches 7a that allow the nut to be turned with a

wrench. In the prior art, the nut typically has a beveled edge (not shown) facing the spring washer. The beveled edge has no functional purpose.

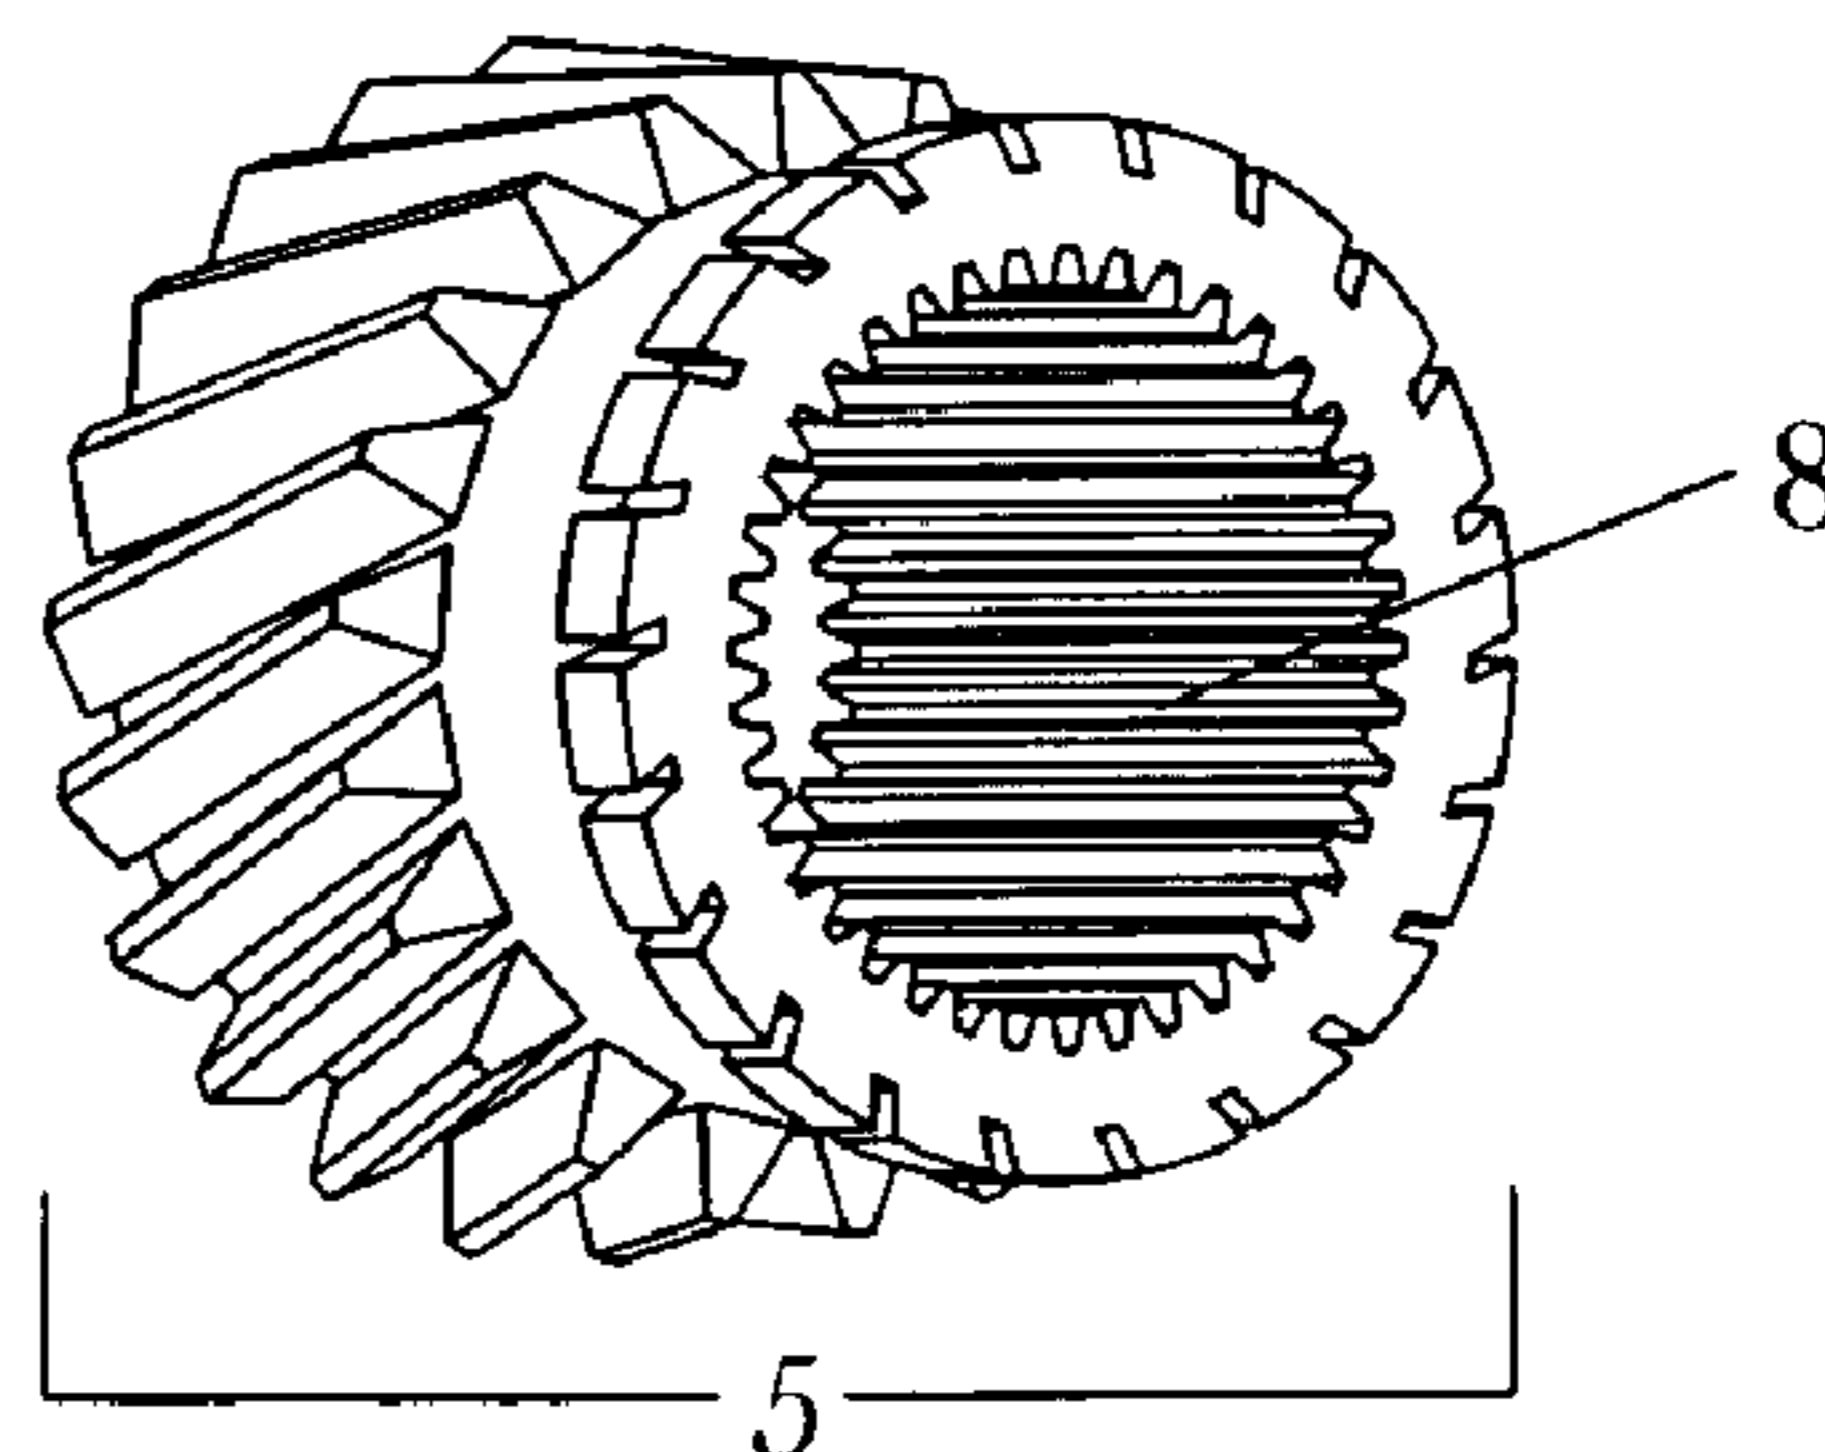
FIG. 4 is a perspective view of the factory gear showing the full inner splines.

FIG. 4 is a perspective view of the factory gear 5 showing the full inner splines 8. As shown in this figure, the splines are triangular in shape with blunt (as opposed to pointed) tips.

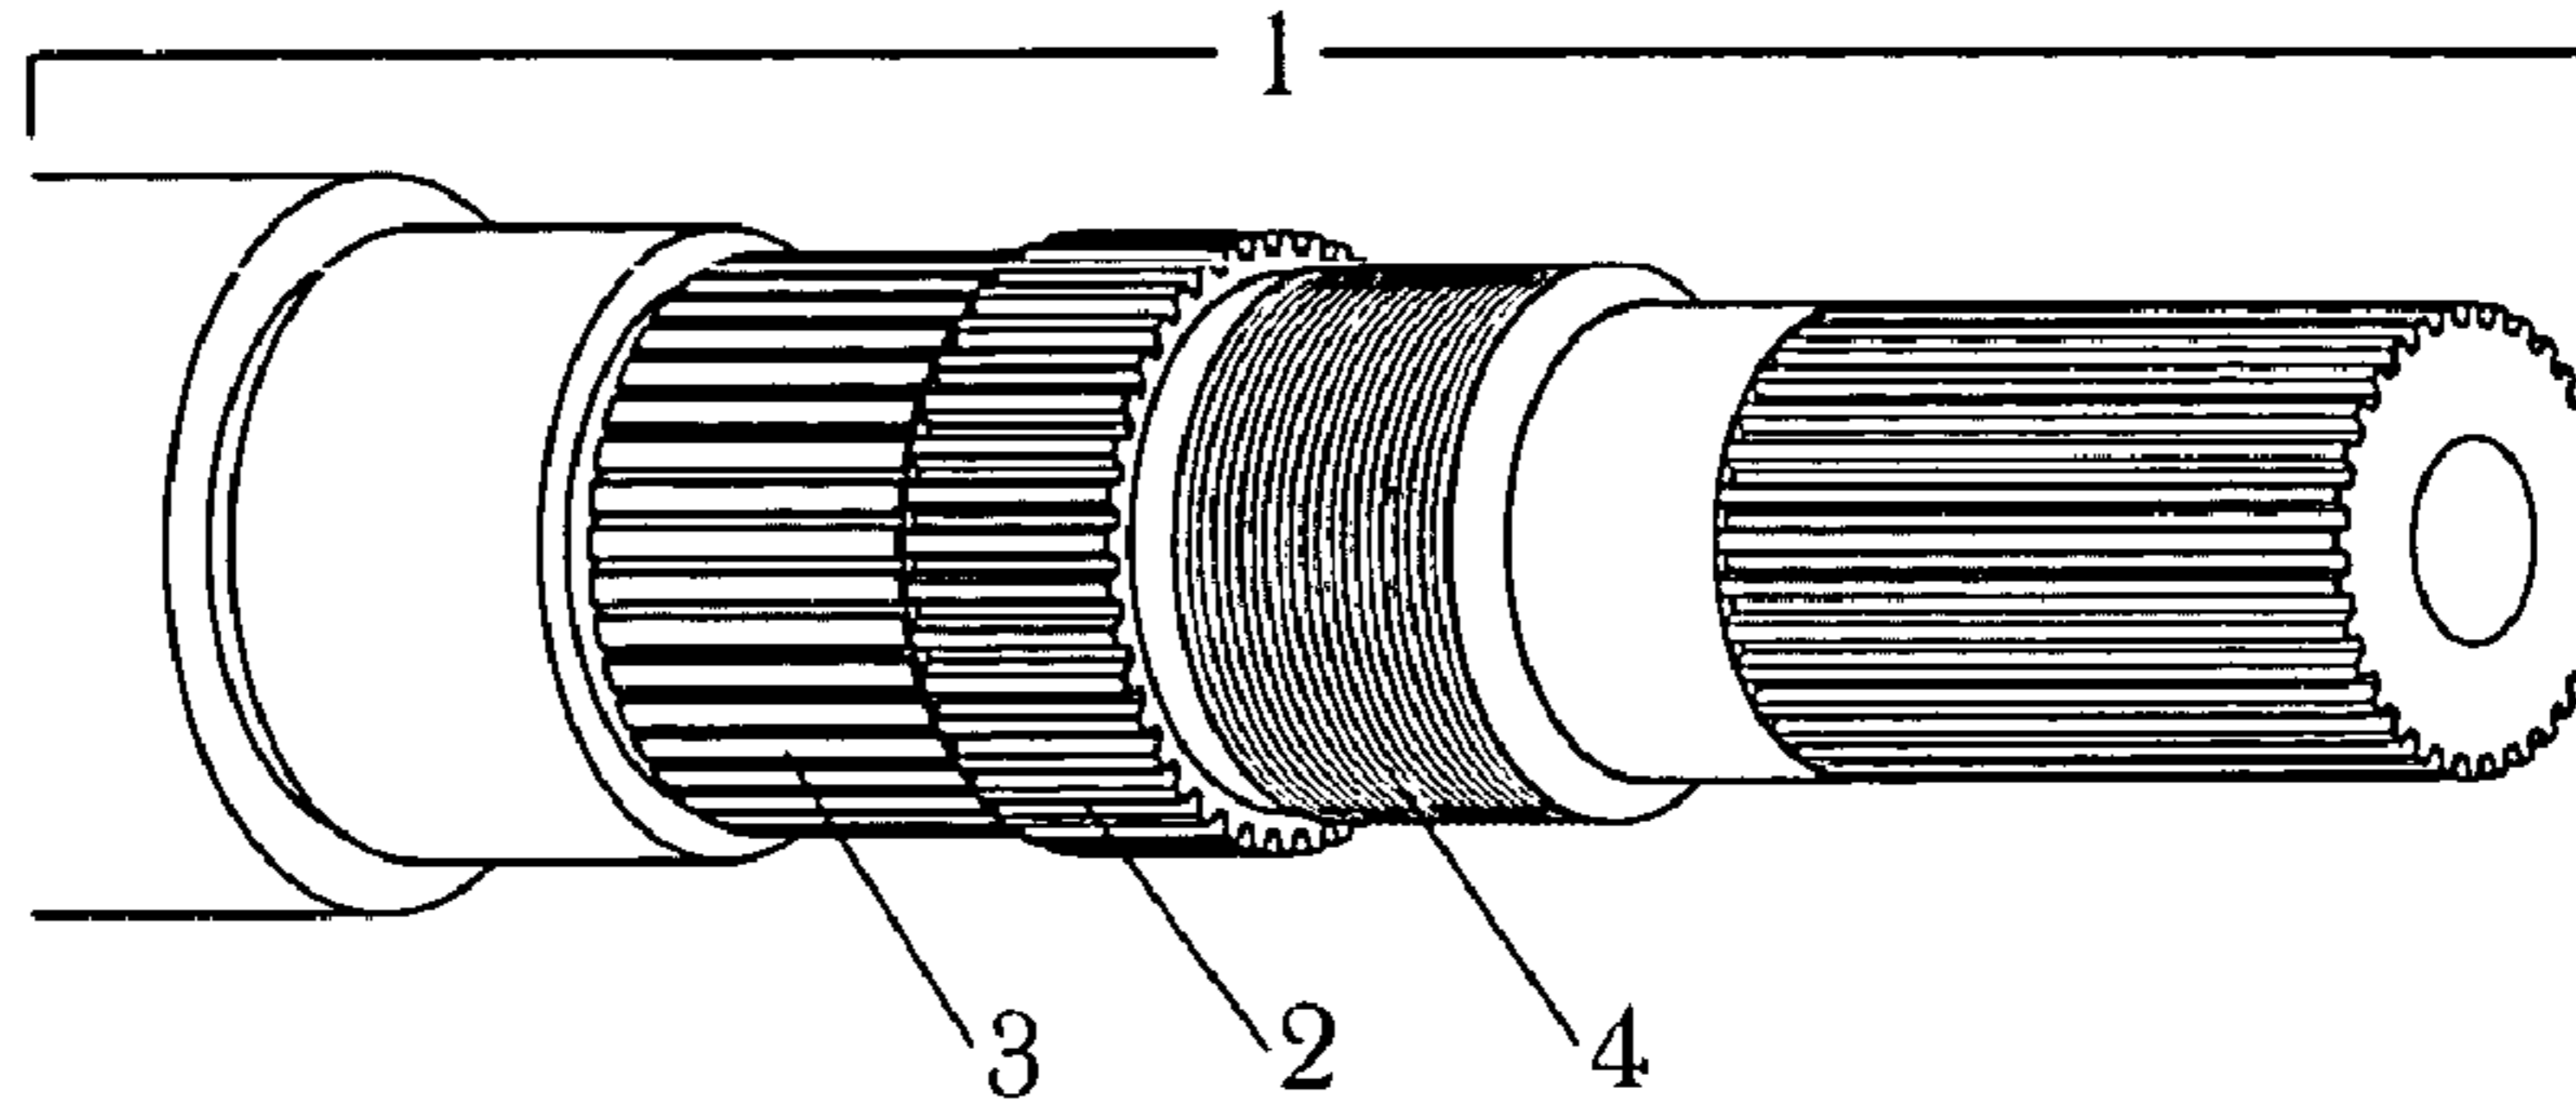
FIG. 5 is a partial perspective view of a used factory mainshaft showing the area where the gear wears into the shaft.

FIG. 5 is a partial perspective view of a used factory mainshaft 1 showing the area where the gear 5 (not shown) wears into the shaft. As shown in this figure, the smooth support area 3 is no longer smooth but actually has subtle indentations that have been worn into it by the gear splines 8 (see FIG. 4). These indentations cause the gear to work loose. Once the gear is loose, it works the nut and washer loose, which leads to fifth gear failure. Note that the diameter of the support surface 3 on the factory mainshaft 1 is smaller in diameter than the splined area 2. That difference in diameter is a key factor in the problem addressed by the present invention.

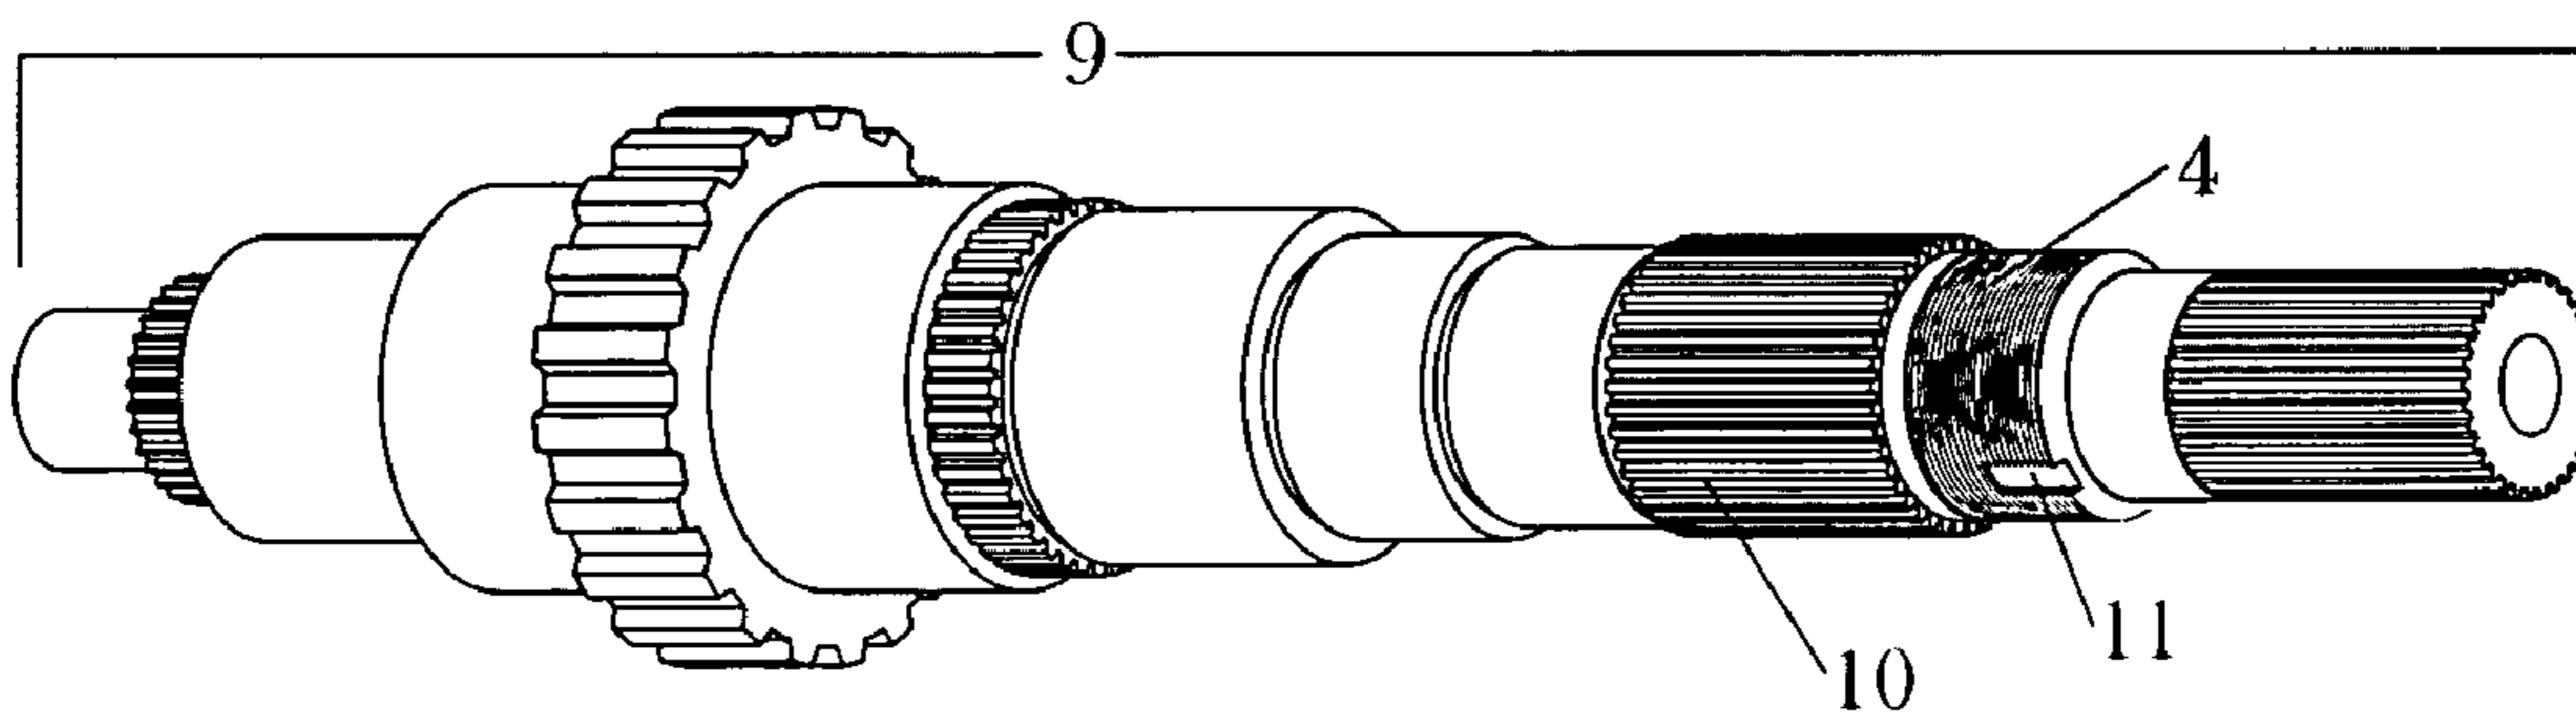
FIG. 6 is a perspective view of a press fit aftermarket mainshaft without the gear.

FIG. 6 is a perspective view of the first aftermarket mainshaft variation without the gear. This variation is a press fit aftermarket shaft 9. As shown in this figure, there is no smooth support surface 3 (see FIGS. 1 and 5). Instead, the splined area 10 has been extended so that the entire area below the gear is splined. The shaft still contains a threaded area 4, which further comprises a keyslot 11. The purpose of the keyslot 11 is illustrated in FIGS. 7 and 8.

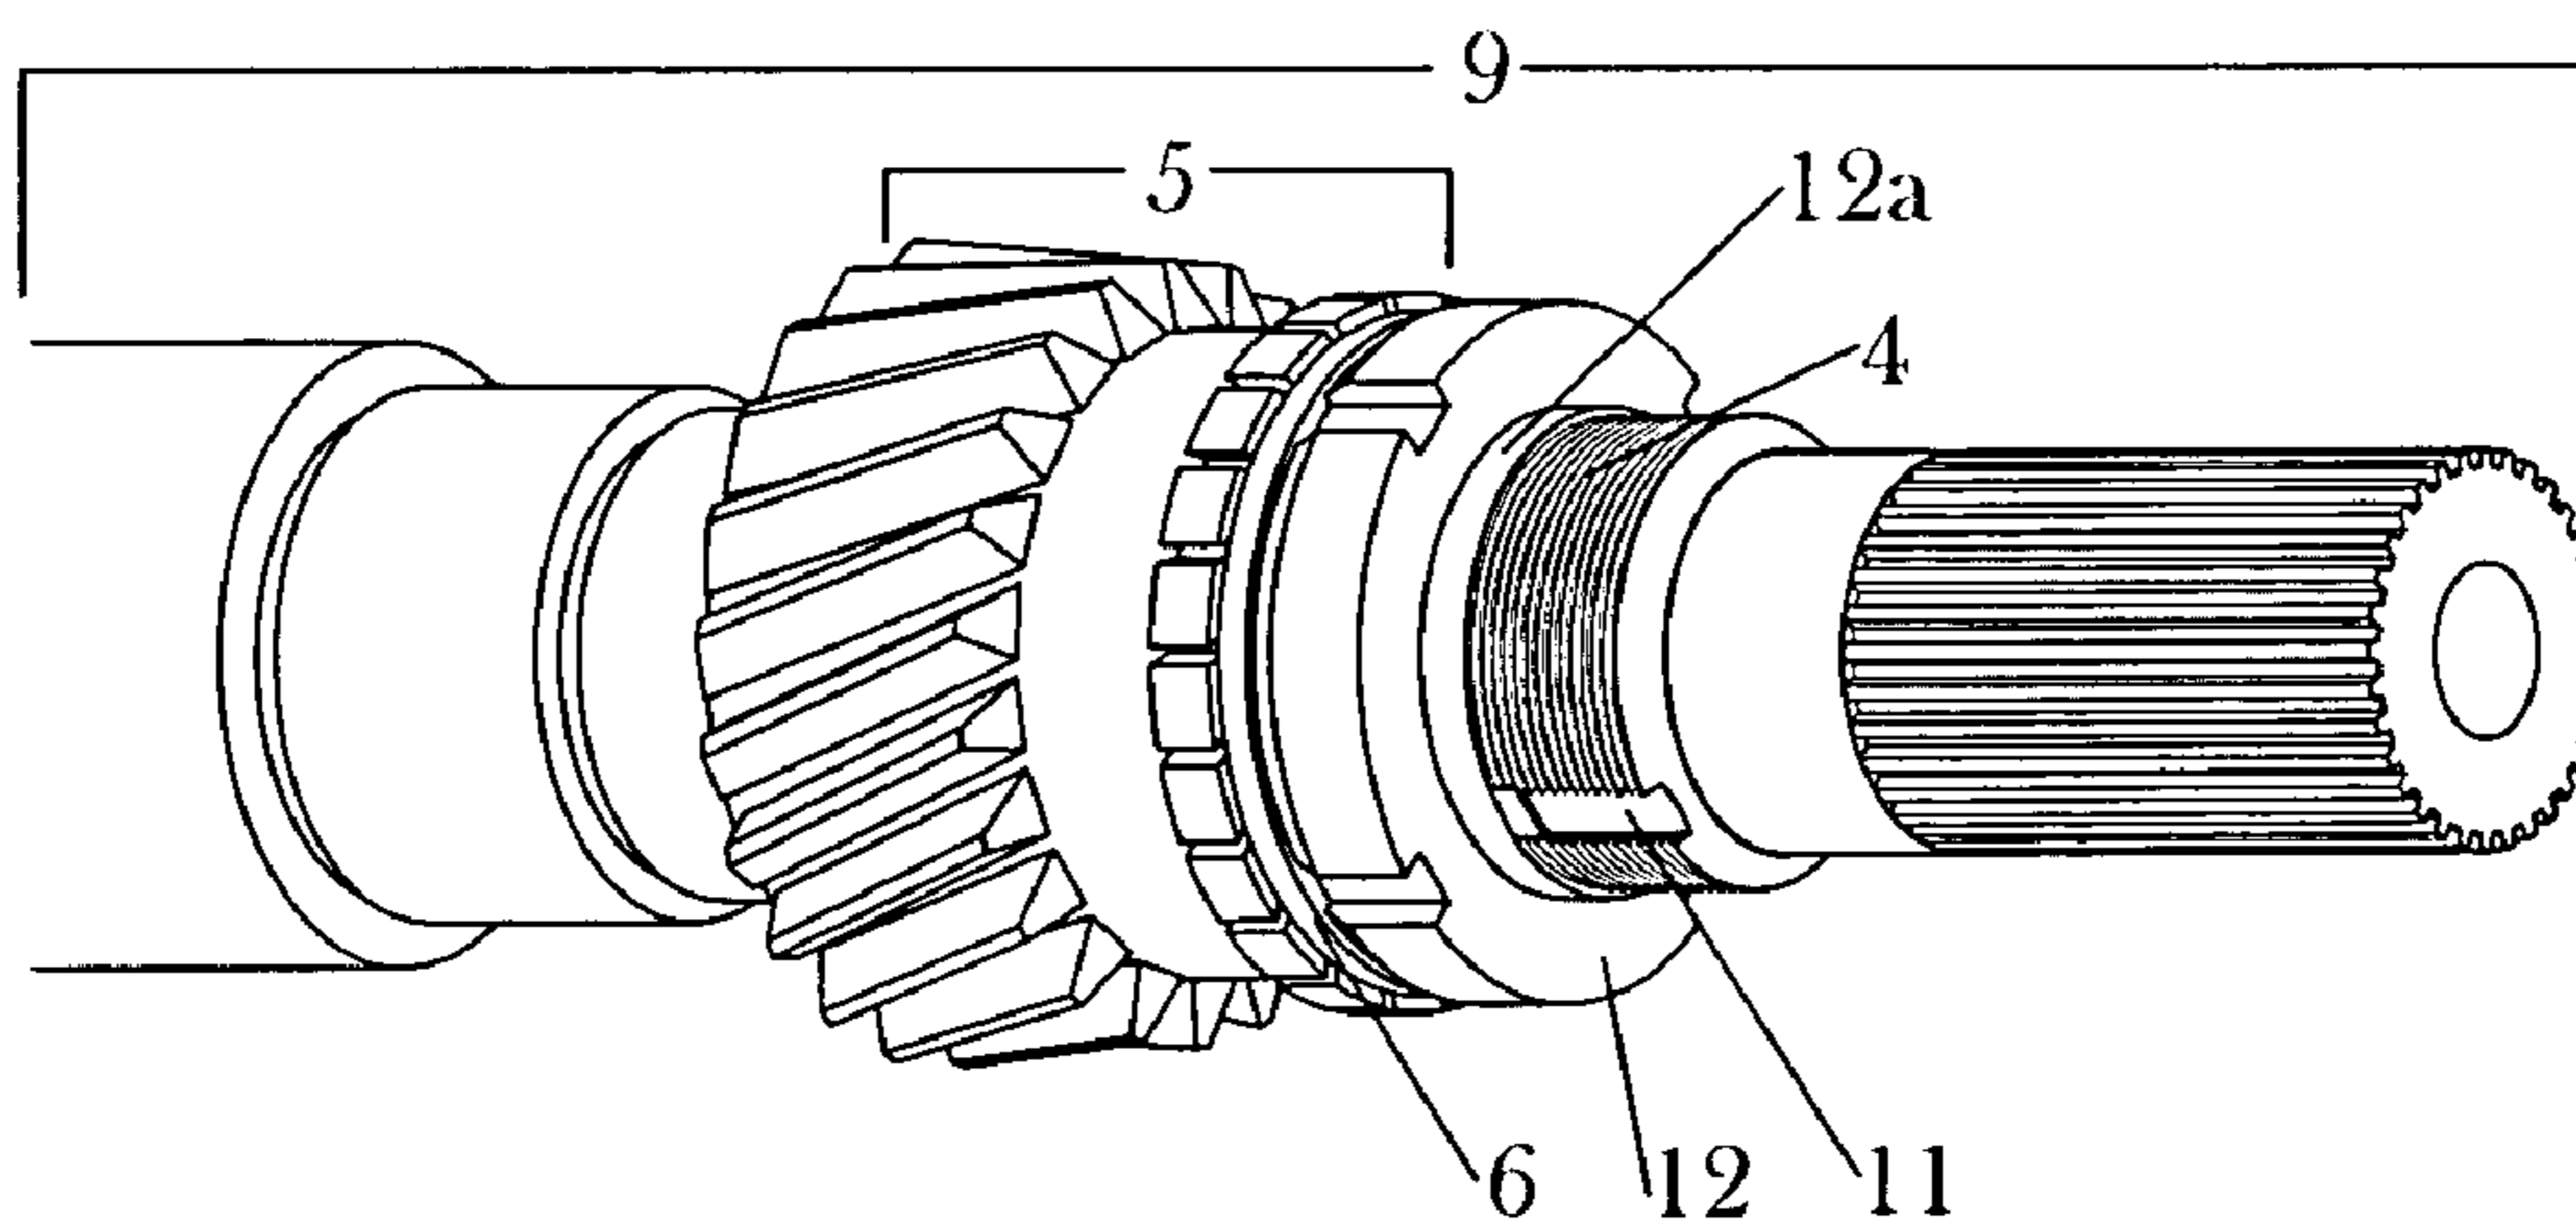
FIG. 7 is a partial perspective view of a press fit aftermarket mainshaft with the factory gear, spring washer and lipped nut.

FIG. 7 is a partial perspective view of the aftermarket mainshaft 9 shown in FIG. 6 with the factory gear 5, spring washer 6 and lipped nut 12. The washer 6 and nut 12 fit over the threaded area 4 of the shaft. The lipped nut 12 represents another attempt to solve the problem of the gear working loose. With this type of nut, part of the lip 12a is bent and pressed down into the keyslot 11. The thought was that the lip 12a in the keyslot 11 would prevent the nut 12 from coming loose, even if the gear 5 came loose. This nut design did not work either. FIG. 8 is an exploded perspective view of the factory gear 5, spring washer 6, and lipped nut 12.
