(10) **Patent No.:** **US 7,210,366 B2**
(45) **Date of Patent:** **May 1, 2007**

(54) **FULL SUPPORT MAINSHAFT AND FIFTH GEAR DESIGN**

The present invention relates to the field of automotive transmissions, and more particularly, to a full support mainshaft and fifth gear design for the New Venture/MTM NV4500 transmissions.

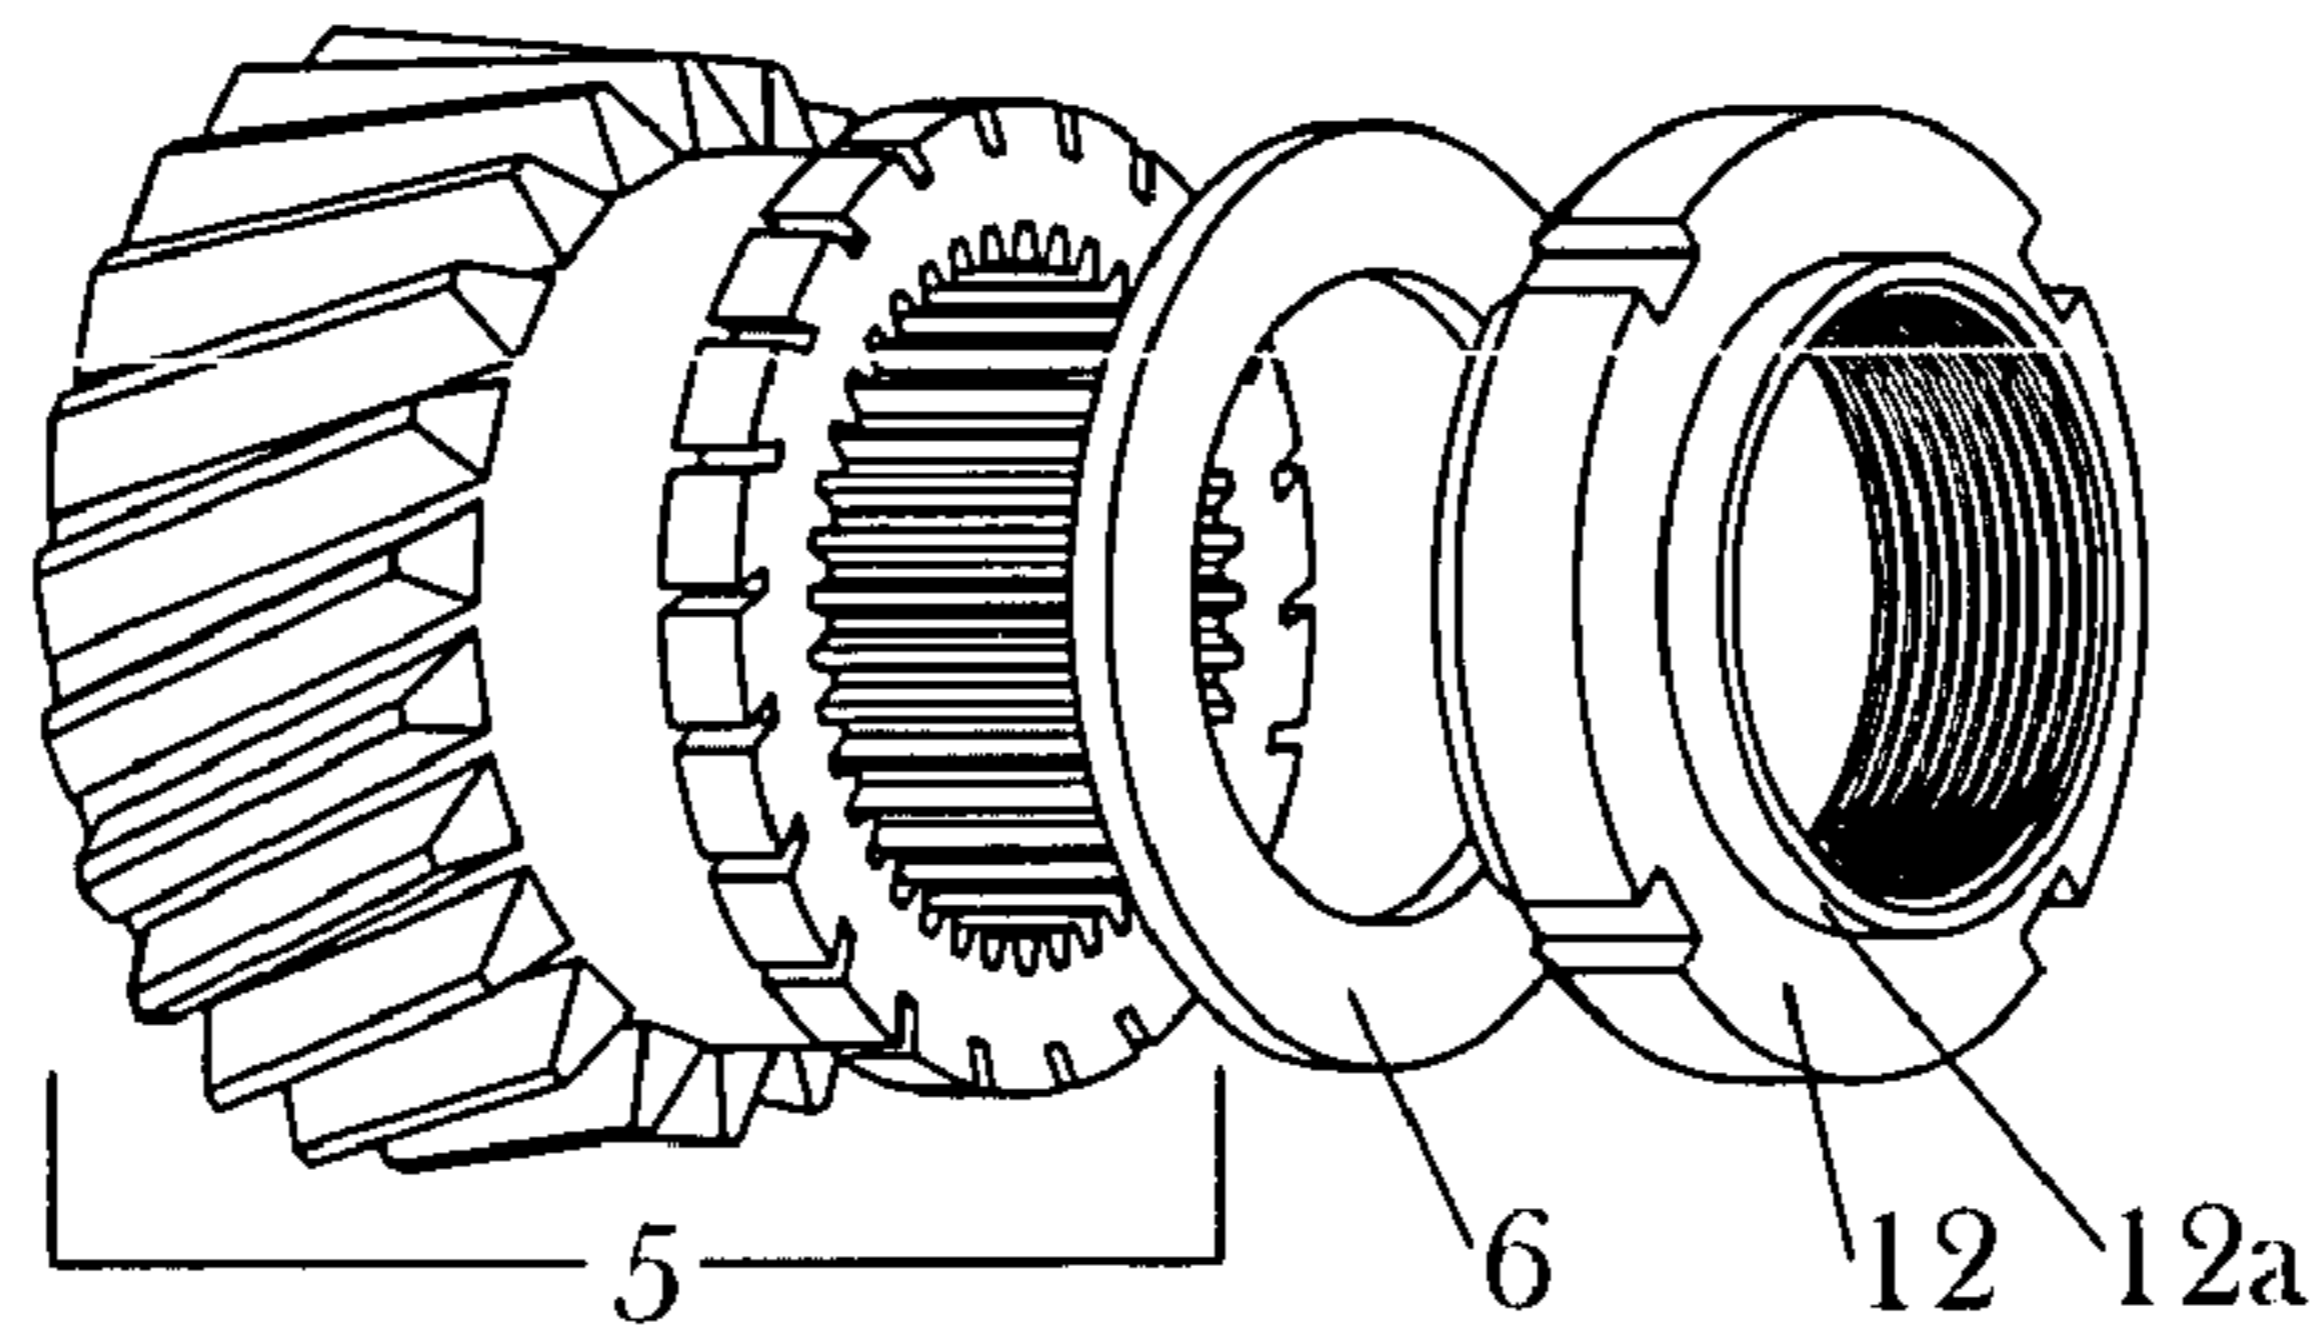
FIG. 8 is an exploded perspective view of the factory gear, spring washer, and lipped nut.

FIG. 7 is a partial perspective view of the aftermarket mainshaft 9 shown in FIG. 6 with the factory gear 5, spring washer 6 and lipped nut 12. The washer 6 and nut 12 fit over the threaded area 4 of the shaft. The lipped nut 12 represents another attempt to solve the problem of the gear working loose. With this type of nut, part of the lip 12a is bent and pressed down into the keyslot 11. The thought was that the lip 12a in the keyslot 11 would prevent the nut 12 from coming loose, even if the gear 5 came loose. This nut design did not work either. FIG. 8 is an exploded perspective view of the factory gear 5, spring washer 6, and lipped nut 12.

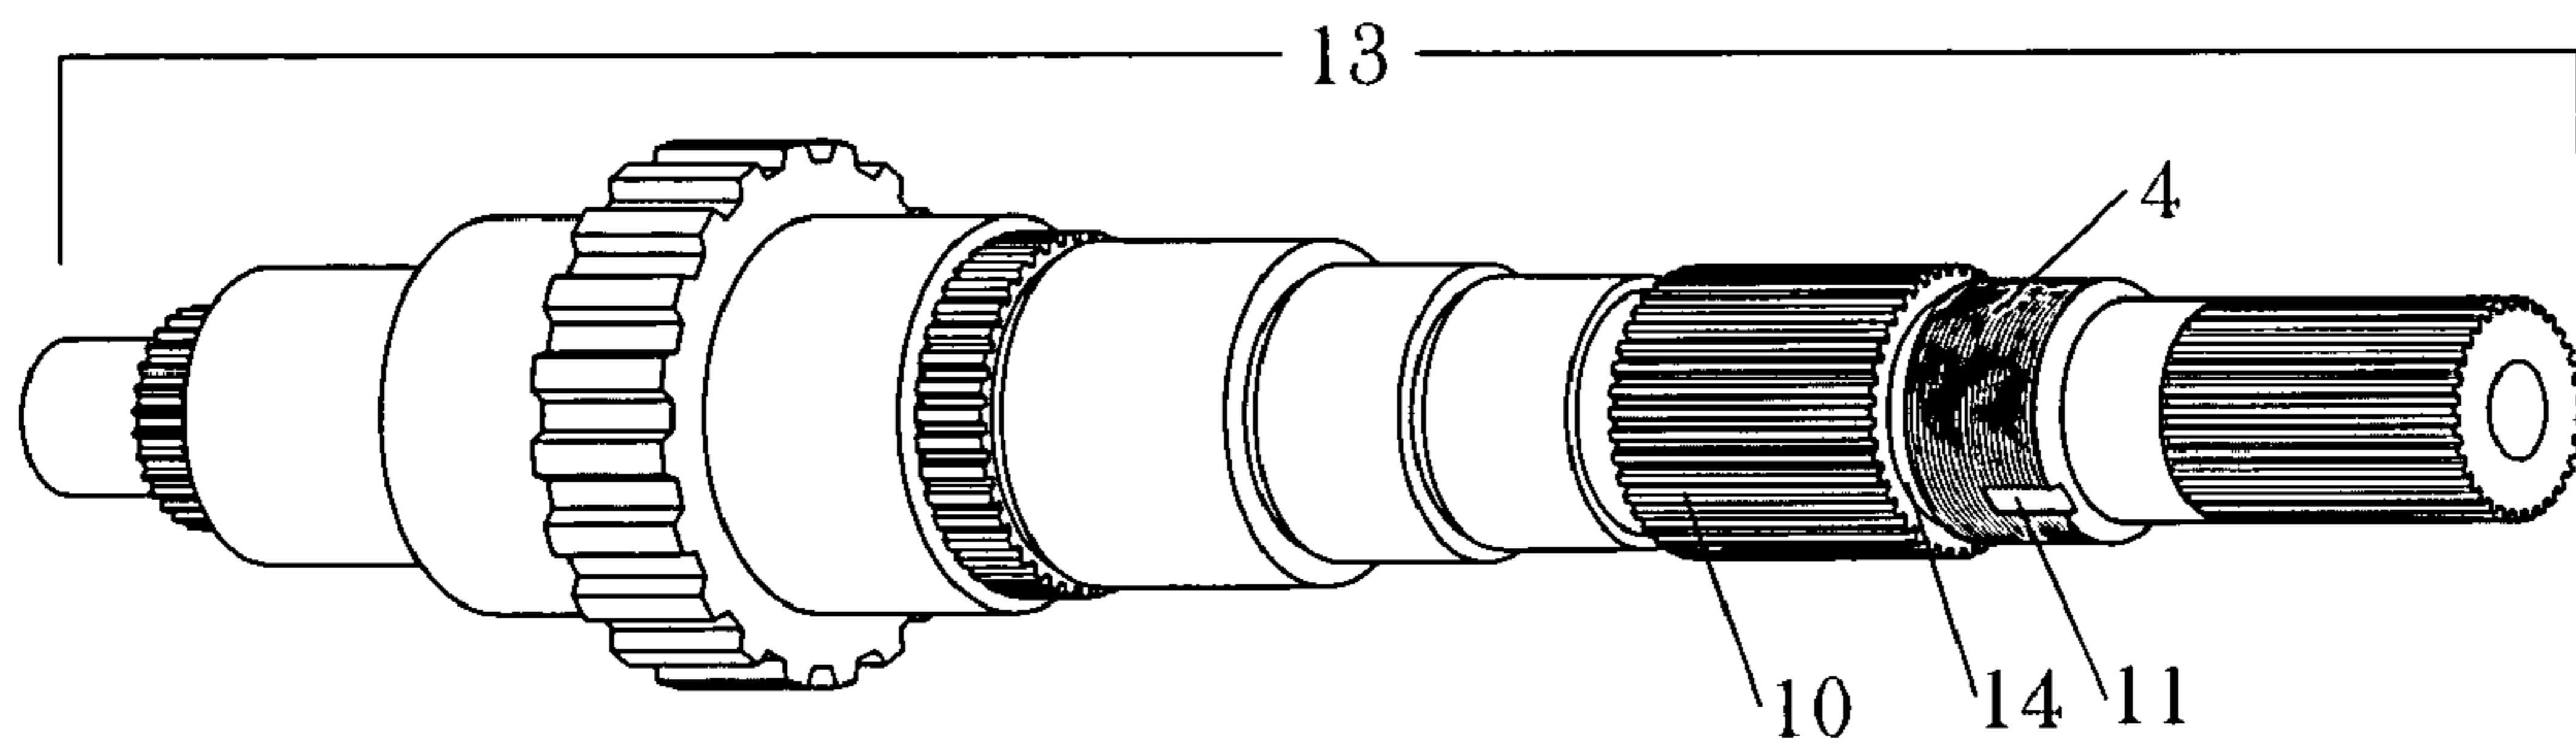
FIG. 9 is a perspective view of a slip fit aftermarket mainshaft without the gear showing the groove for the split washer.

FIG. 9 is a perspective view of the second aftermarket mainshaft variation without the gear. This variation is a slip fit aftermarket mainshaft 13 showing a groove 14 for a split washer (shown in FIG. 10). The groove is located between the splined area 10 and the threaded area 4. As with the press fit aftermarket shaft, the splined area 10 is extended so that the entire area below the gear is splined, and the threaded area 4 includes a keyslot 11.

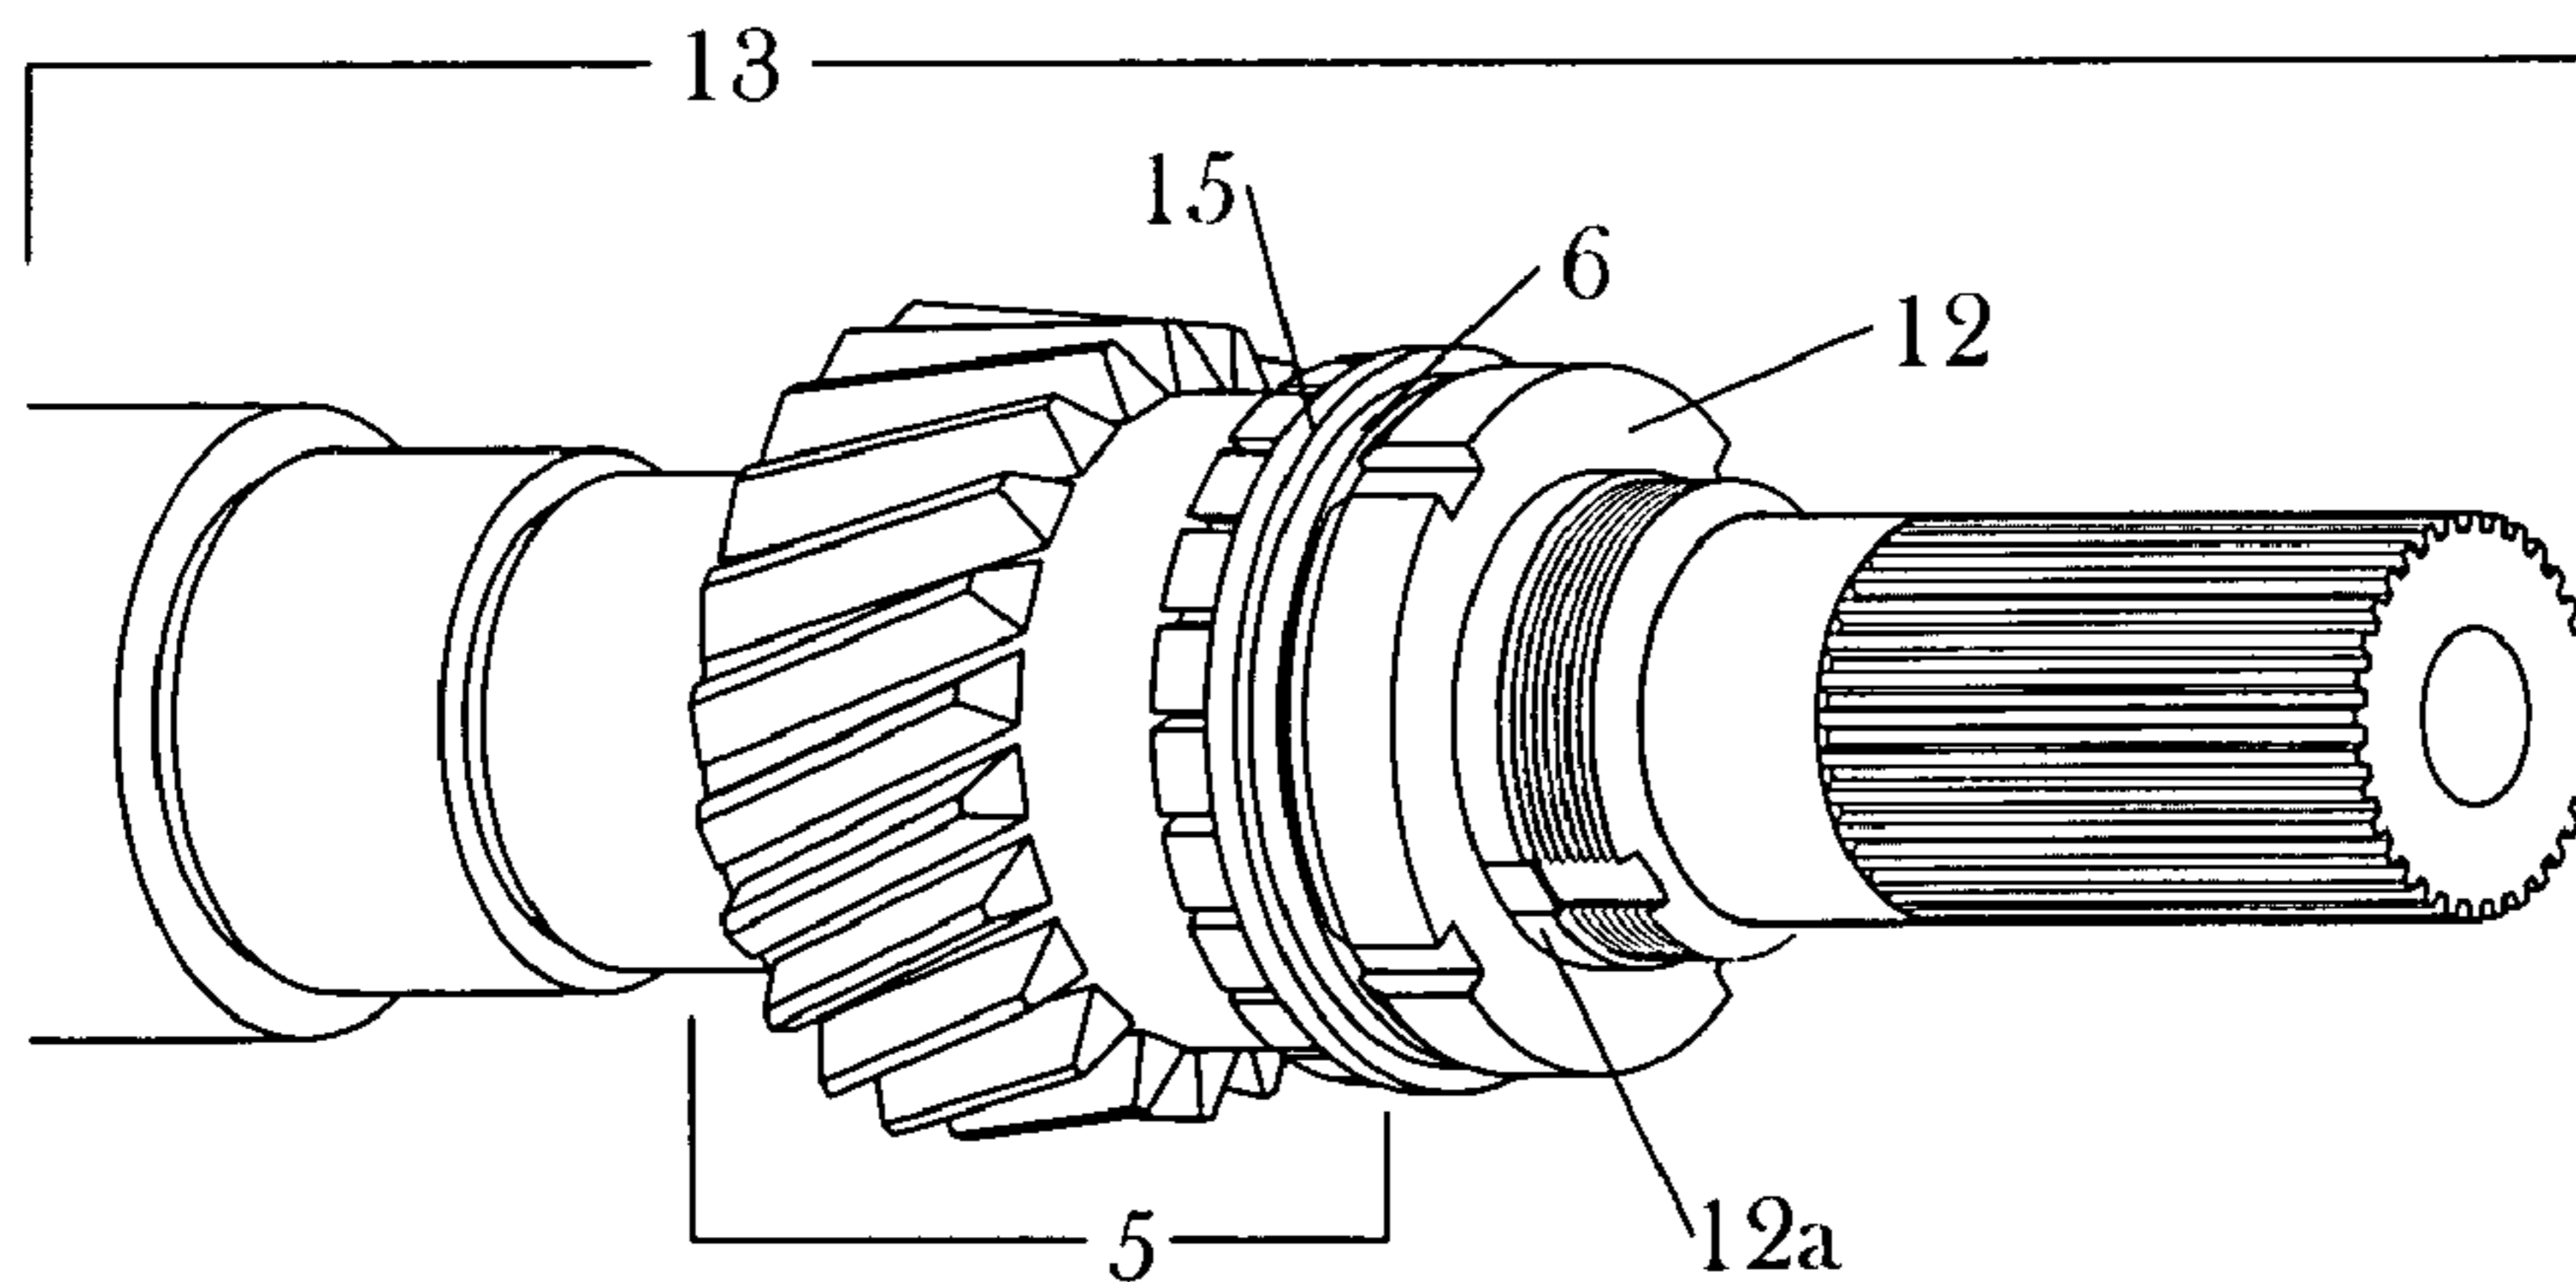
FIG. 10 is a partial perspective view of the slip fit aftermarket mainshaft with the gear, split washer and retaining ring, spring washer, and lipped nut.

FIG. 10 is a partial perspective view of the slip fit aftermarket mainshaft 13 shown in FIG. 9 with the gear 5, split washer (not shown) and retaining ring 15, spring washer 6, and lipped nut 12. The split washer and retaining ring fit within the groove 14 shown in FIG. 9. The spring washer 6 and nut 12 fit over the threaded area 4 of the shaft. As in FIG. 7, the lip 12a of the nut is pressed down into the keyslot. Because the configuration shown in FIG. 7 was not effective in keeping the gear on the shaft, the split washer (not shown) and retaining ring 15 were added. FIG. 11 is an exploded perspective view of the gear 5, split washer 16 and retaining ring 15, spring washer 6, and lipped nut 12.

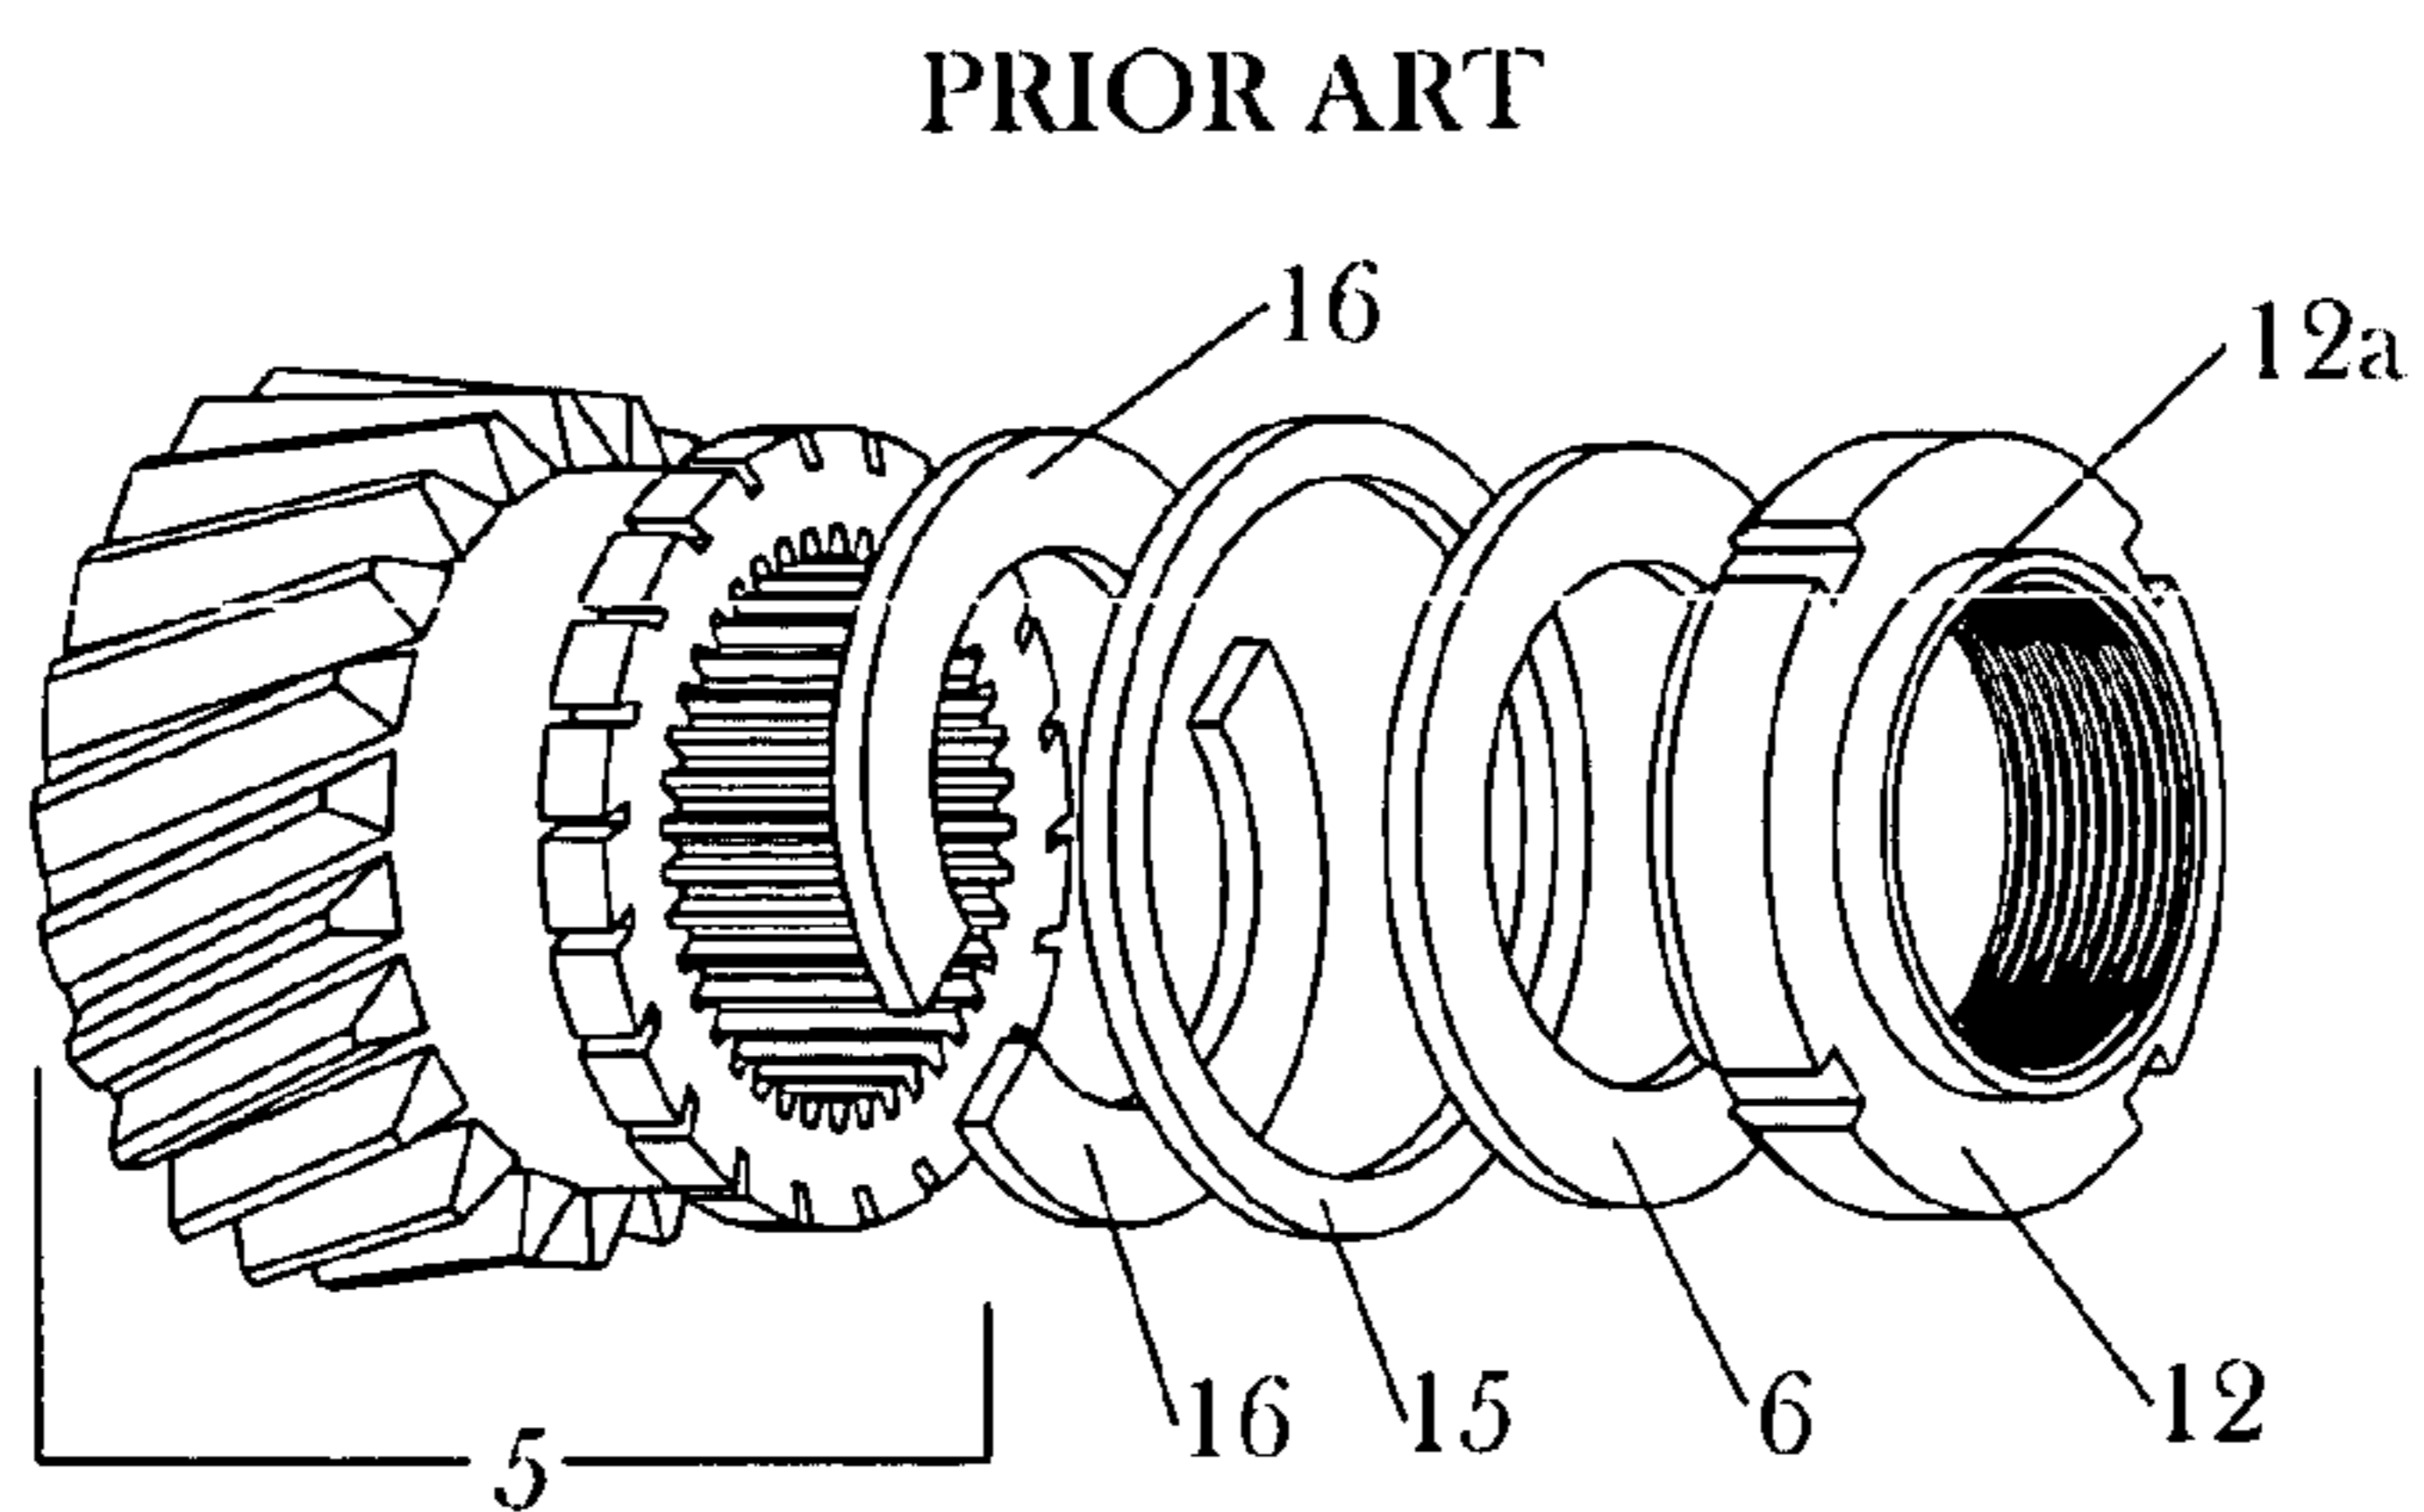
FIG. 11 is an exploded perspective view of the gear, split washer and retaining ring, spring washer, and lipped nut.

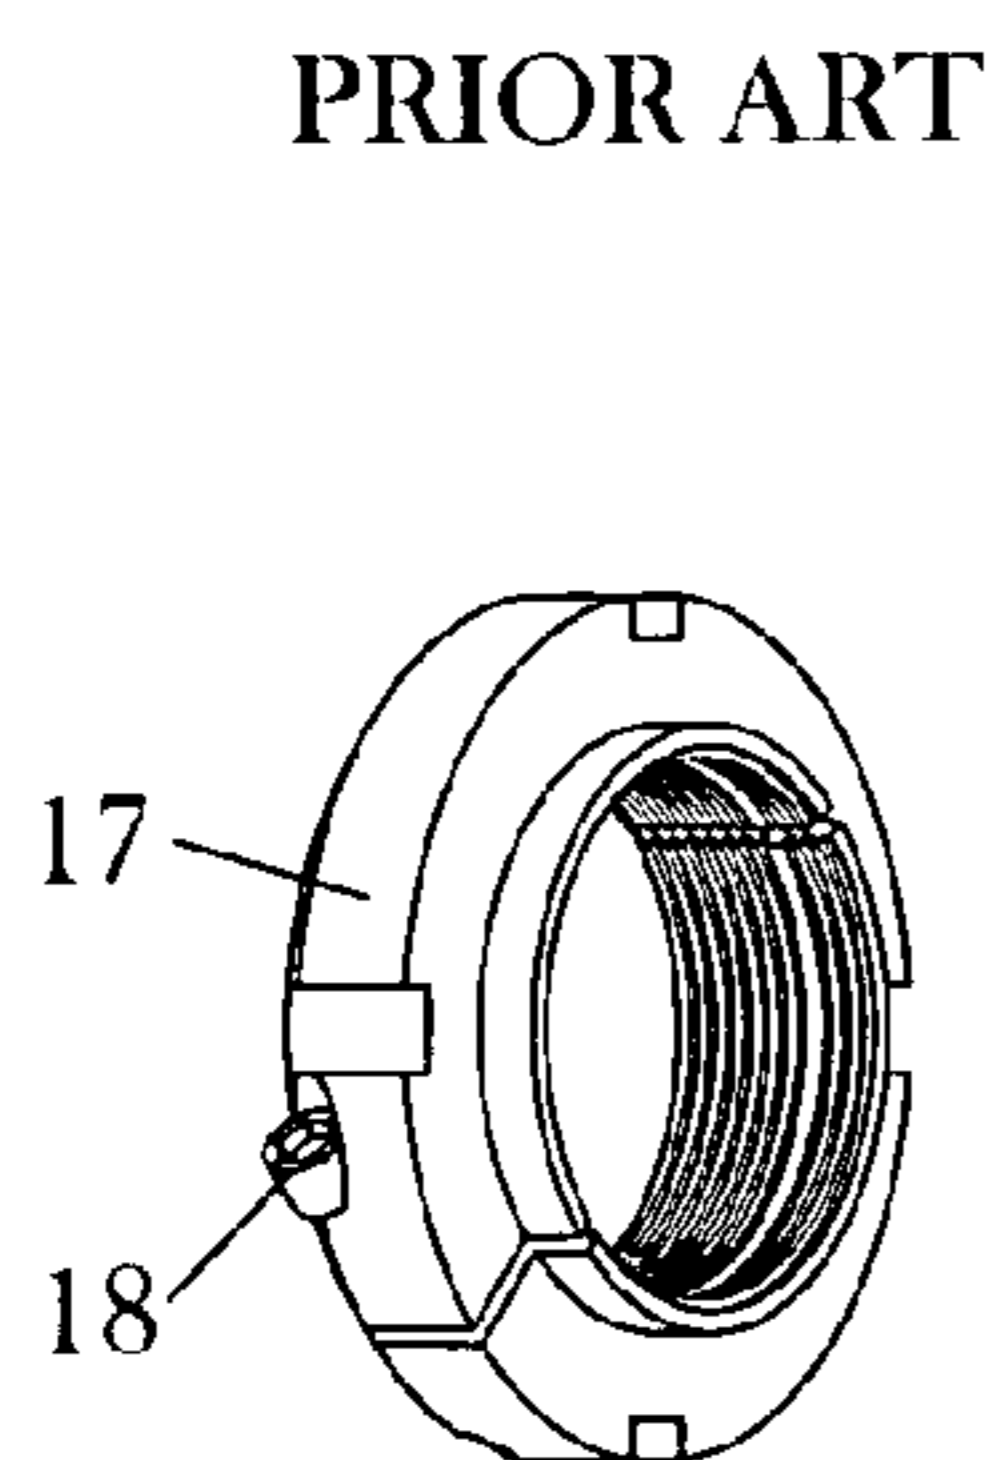
FIG. 12 is a perspective view of a clamp-style nut.

None of the designs described above was successful in preventing fifth gear failure, and alternate nut designs were developed with the hope that they would serve to keep the gear on the shaft. FIG. 12 is a perspective view of a clamp-style nut 17. This nut has horizontal screws or clamps 18 that were intended to hold the nut more tightly on the threaded area 4 of the mainshaft. FIG. 13 is a perspective view of a nut with set screws 13. This nut comprises vertical screws 20 that are screwed down against the threads of the

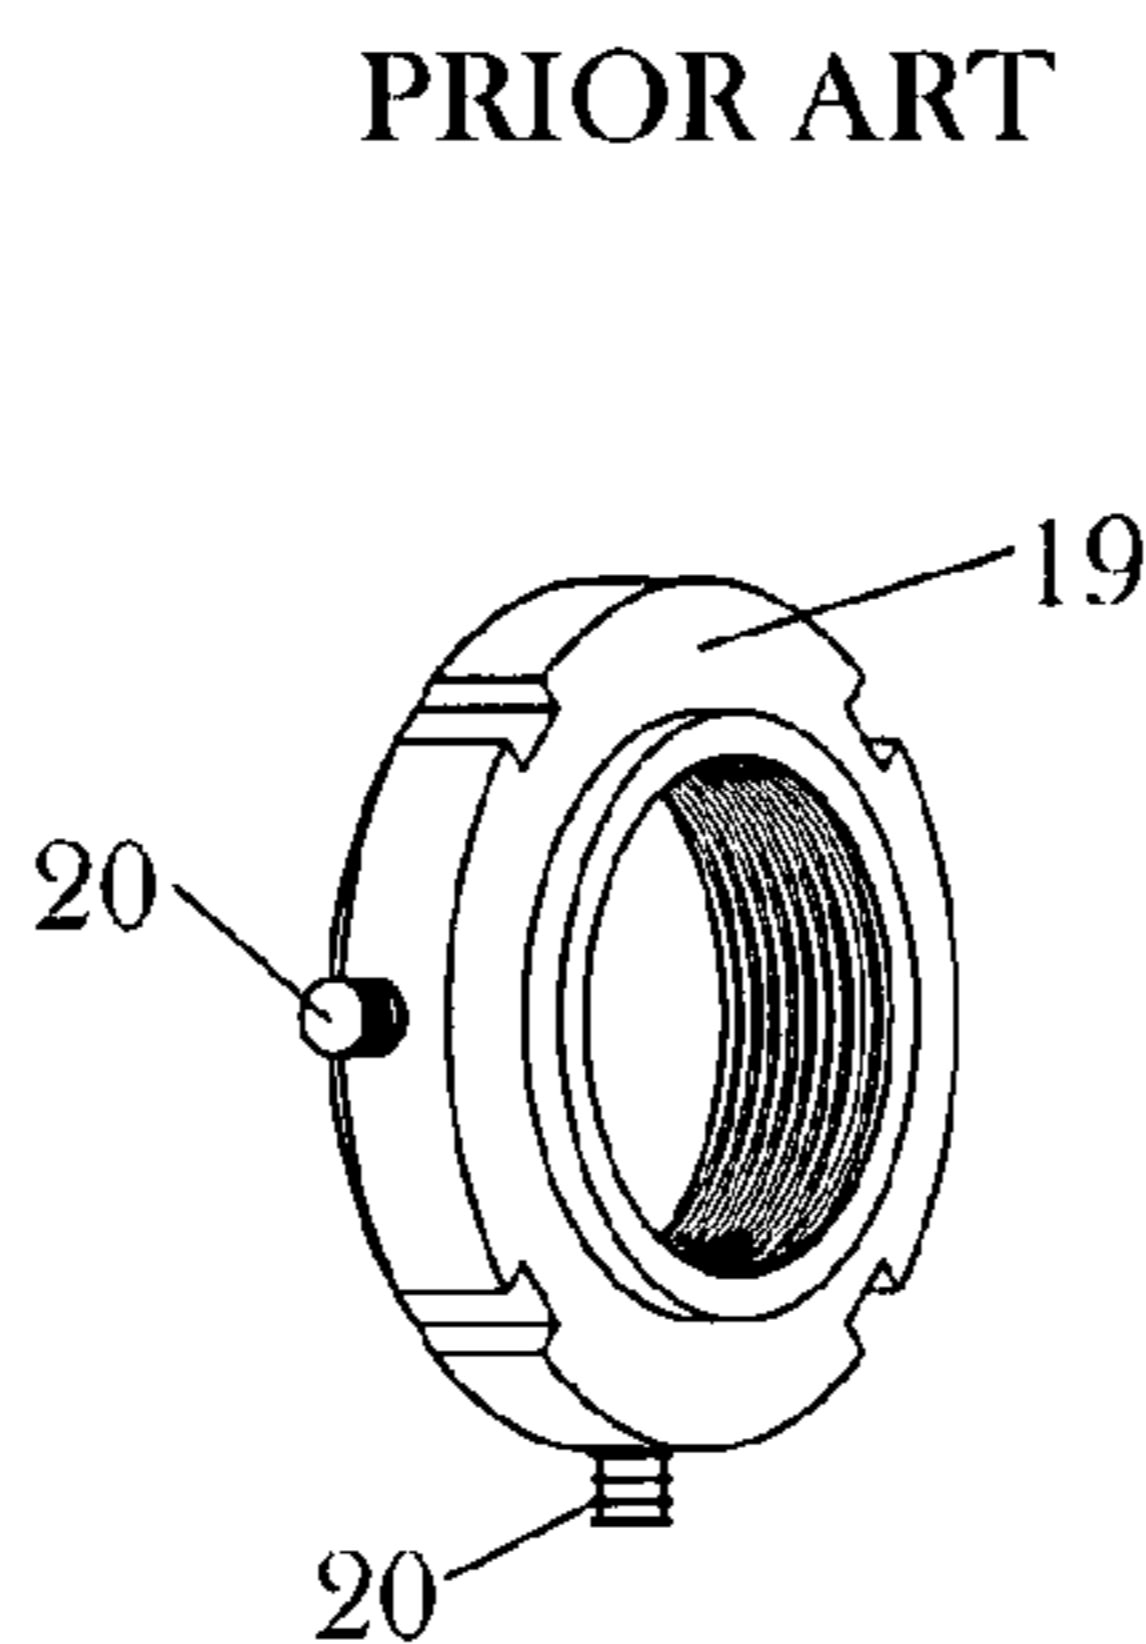
FIG. 13 is a perspective view of a nut with set screws.

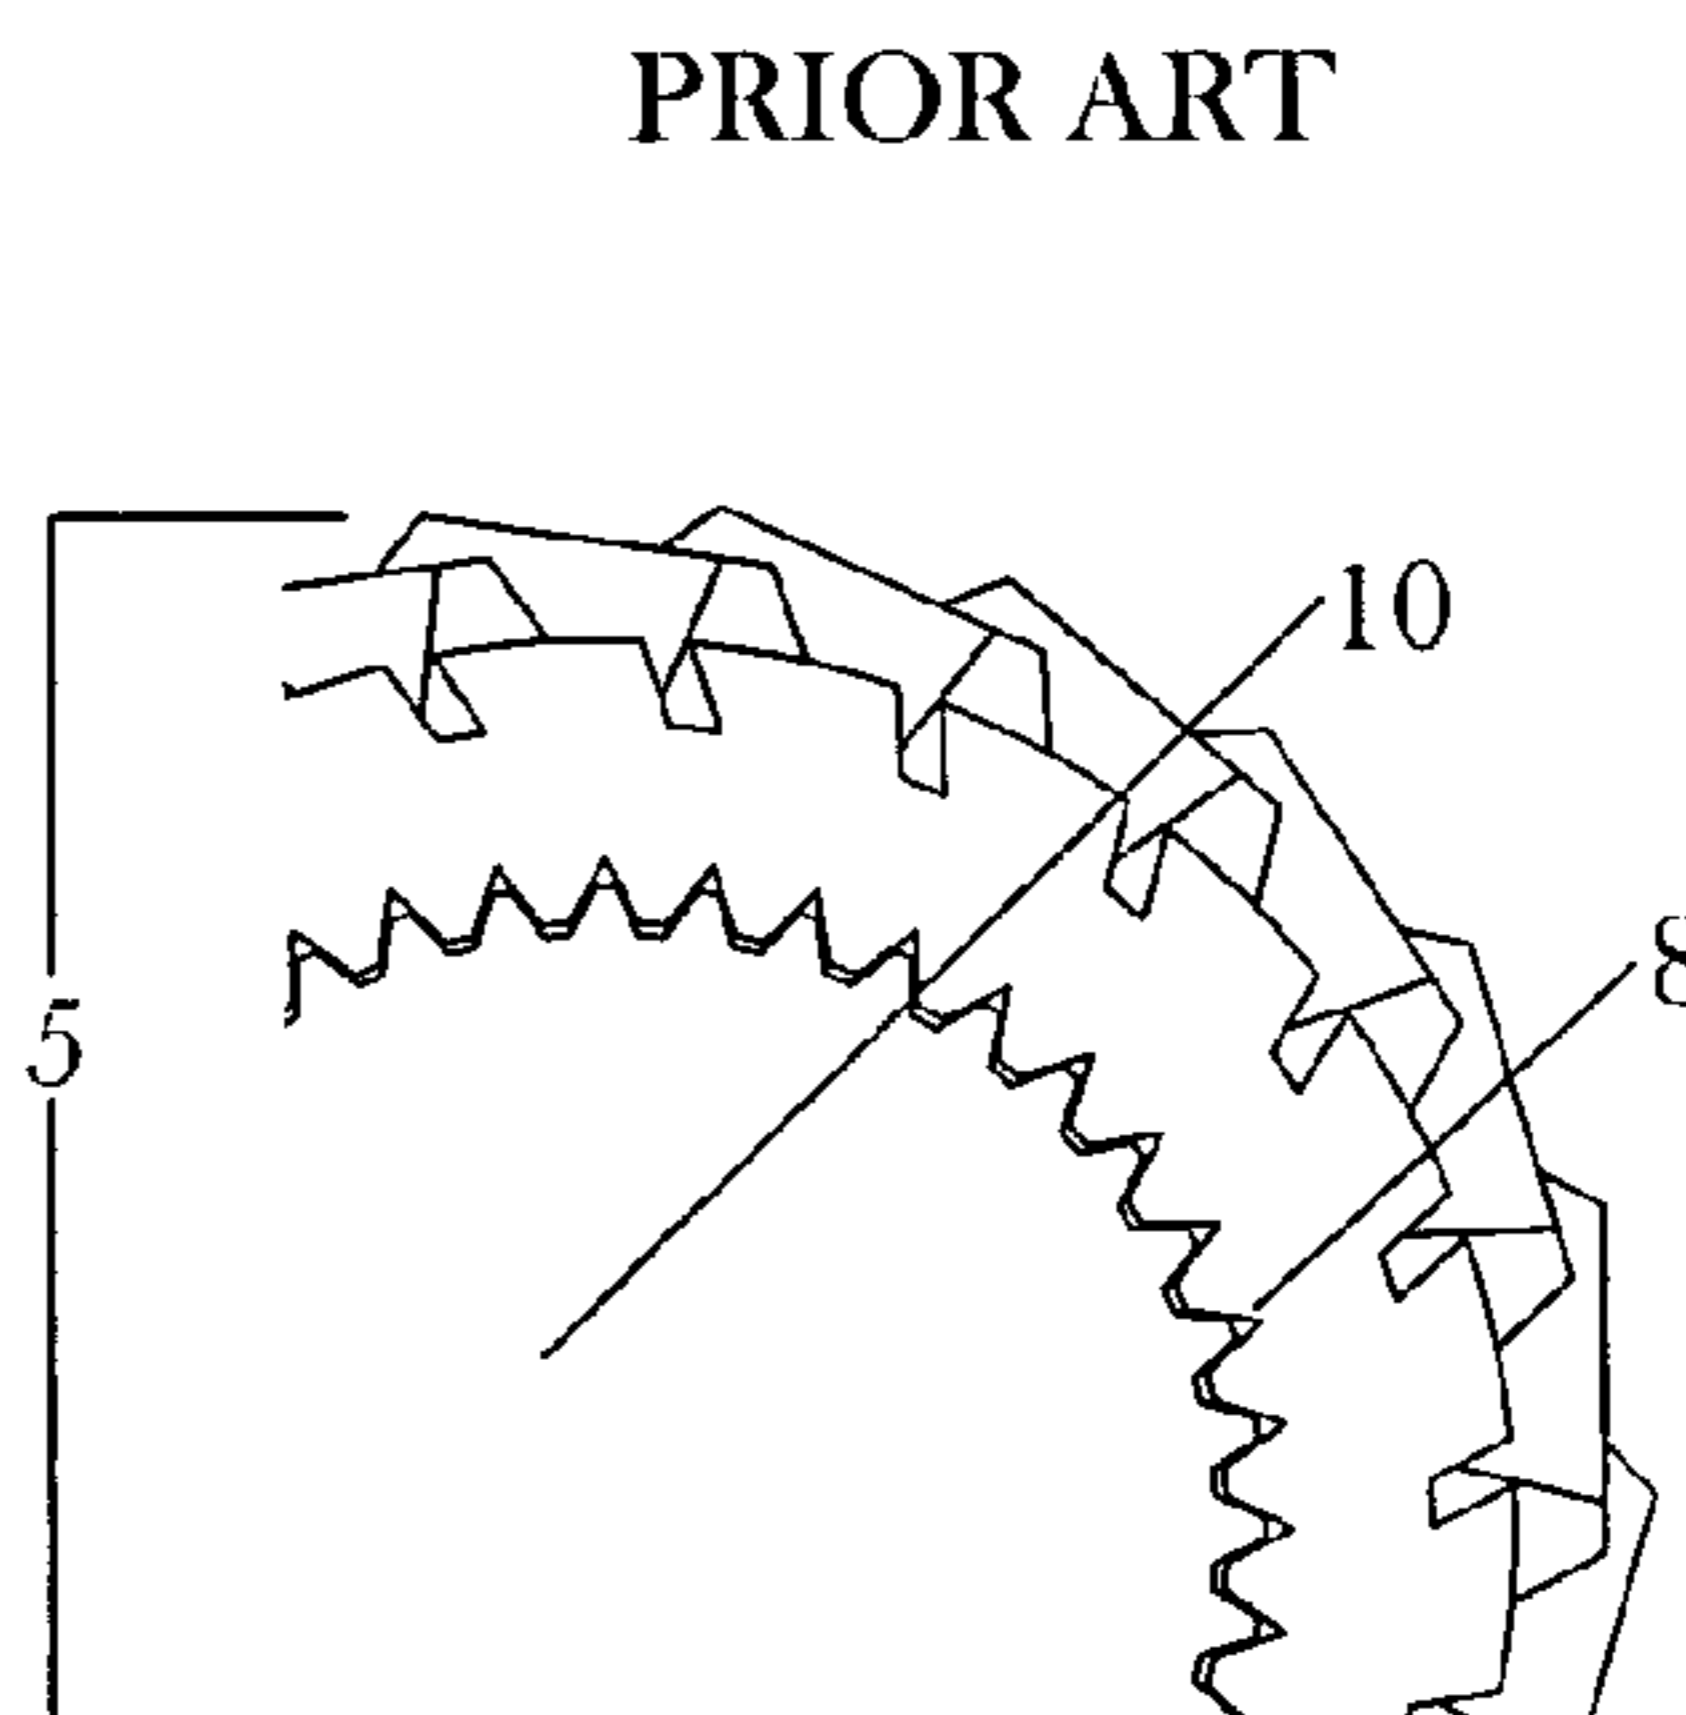
FIG. 14 is a partial section view of the gear on an aftermarket mainshaft showing the non-alignment of the splines on the inside of the gear with the splines on the outside of the mainshaft.

With both the factory shaft and the aftermarket shaft, the gear is not fully supported by the area underneath it on the shaft. With the factory shaft, the smooth support area is smaller in diameter than the splined area so that only the tips of the inner gear splines are in contact with the smooth support area. With the aftermarket shaft, although the area beneath the gear is fully splined, the inner splines of the gear are not fully congruent with the splines on the shaft. This point is illustrated in FIG. 14, which is a partial section view of the gear 5 on an aftermarket mainshaft. The splined area of the mainshaft 10 is shown in relation to the inner gear splines 8. As shown in this figure, there are gaps between the inner gear splines 8 and the splines 10 on the mainshaft. These gaps lead to instability of the gear on the shaft and, ultimately, the loosening of the gear on the shaft.

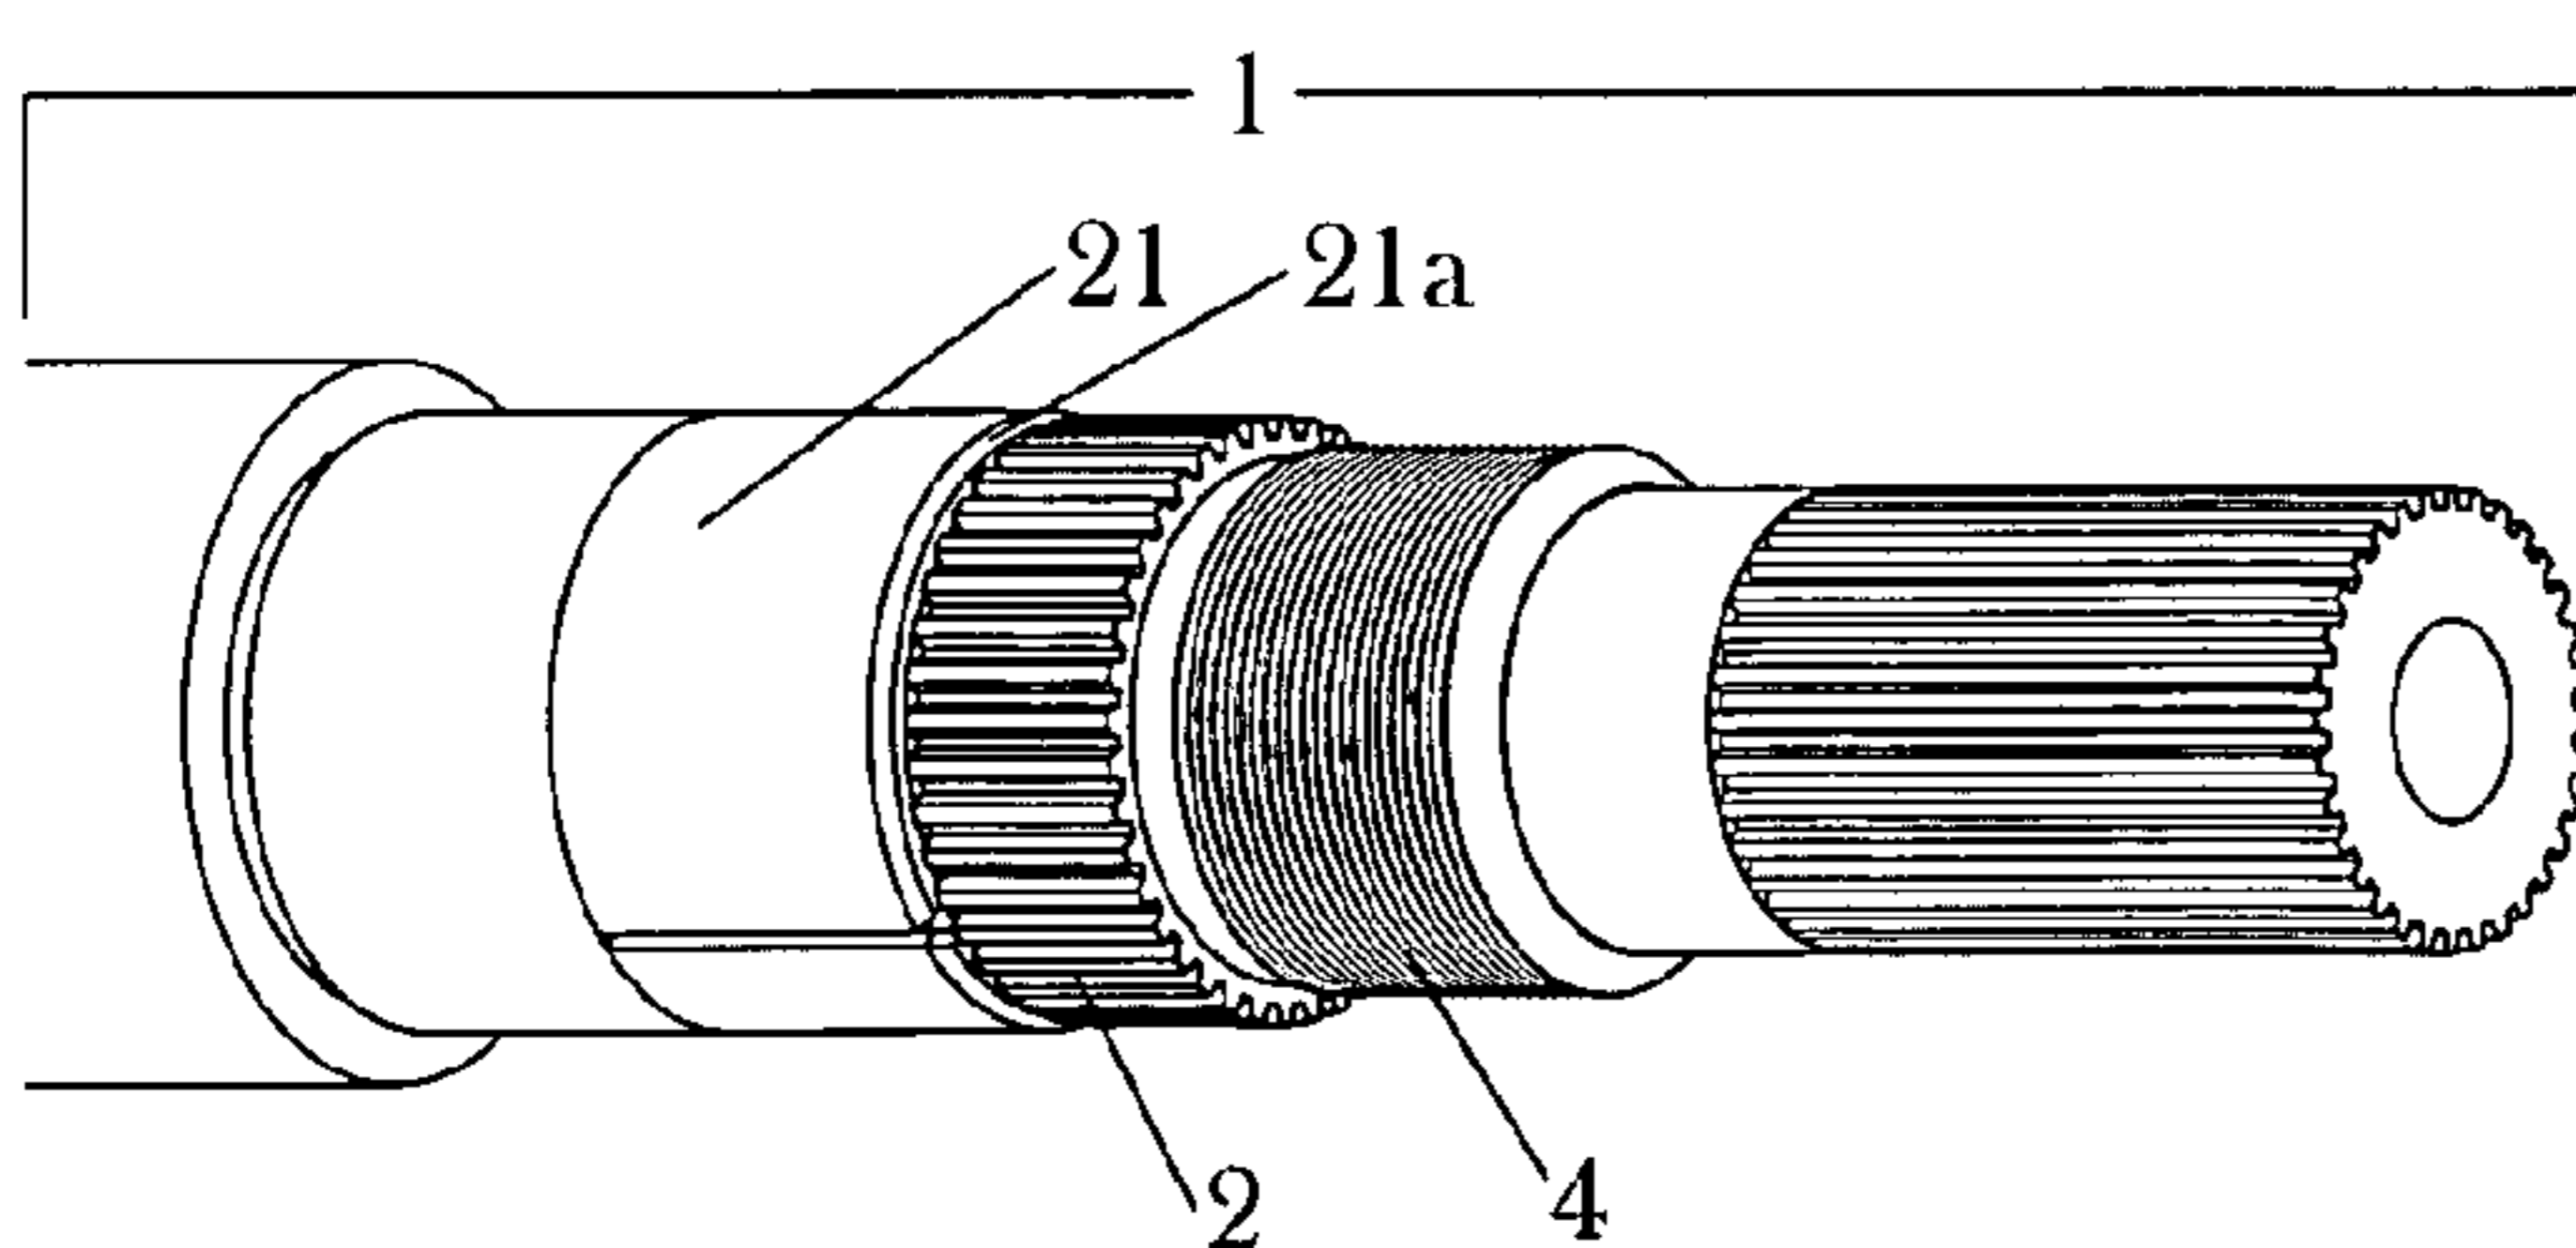
FIG. 15 is a partial perspective view of a first embodiment of the mainshaft of the present invention, in which a sleeve is added to a factory mainshaft.

FIGS. 15–22 depict the mainshaft and fifth gear design of the present invention. The first embodiment is a retrofit of a factory mainshaft. In this embodiment, shown in FIG. 15, a sleeve 21 is installed over the smooth support surface 3 (see FIG. 1) of a factory mainshaft 1. The sleeve is preferably made of steel, although it can be made of any other metal or

material that provides the requisite durability. The sleeve has a tapered edge 21a to facilitate installation of the gear over the sleeve 21. The outside diameter of the sleeve is slightly greater than the outside diameter of the splines 2. In the preferred embodiment, the outside diameter of the sleeve is 0.01 to 0.30 inches greater than the outside diameter of the splines on the mainshaft. The outside diameter of the rear end of the sleeve (i.e., the end with the sleeve adjacent to the splined area 2 but before the tapered edge 21a) is preferably 0.001 to 0.003 inches less than the outside diameter of the front end of the sleeve. The purpose of this slight difference in diameter is to allow the gear splines (shown in FIG. 16) to engage with the shaft splines 2 before the press fit begins. The threaded area 4 is the same as on a standard factory mainshaft.
