(10) **Patent No.:** **US 7,210,366 B2**
(45) **Date of Patent:** **May 1, 2007**

(54) **FULL SUPPORT MAINSHAFT AND FIFTH GEAR DESIGN**

The present invention relates to the field of automotive transmissions, and more particularly, to a full support mainshaft and fifth gear design for the New Venture/MTM NV4500 transmissions.

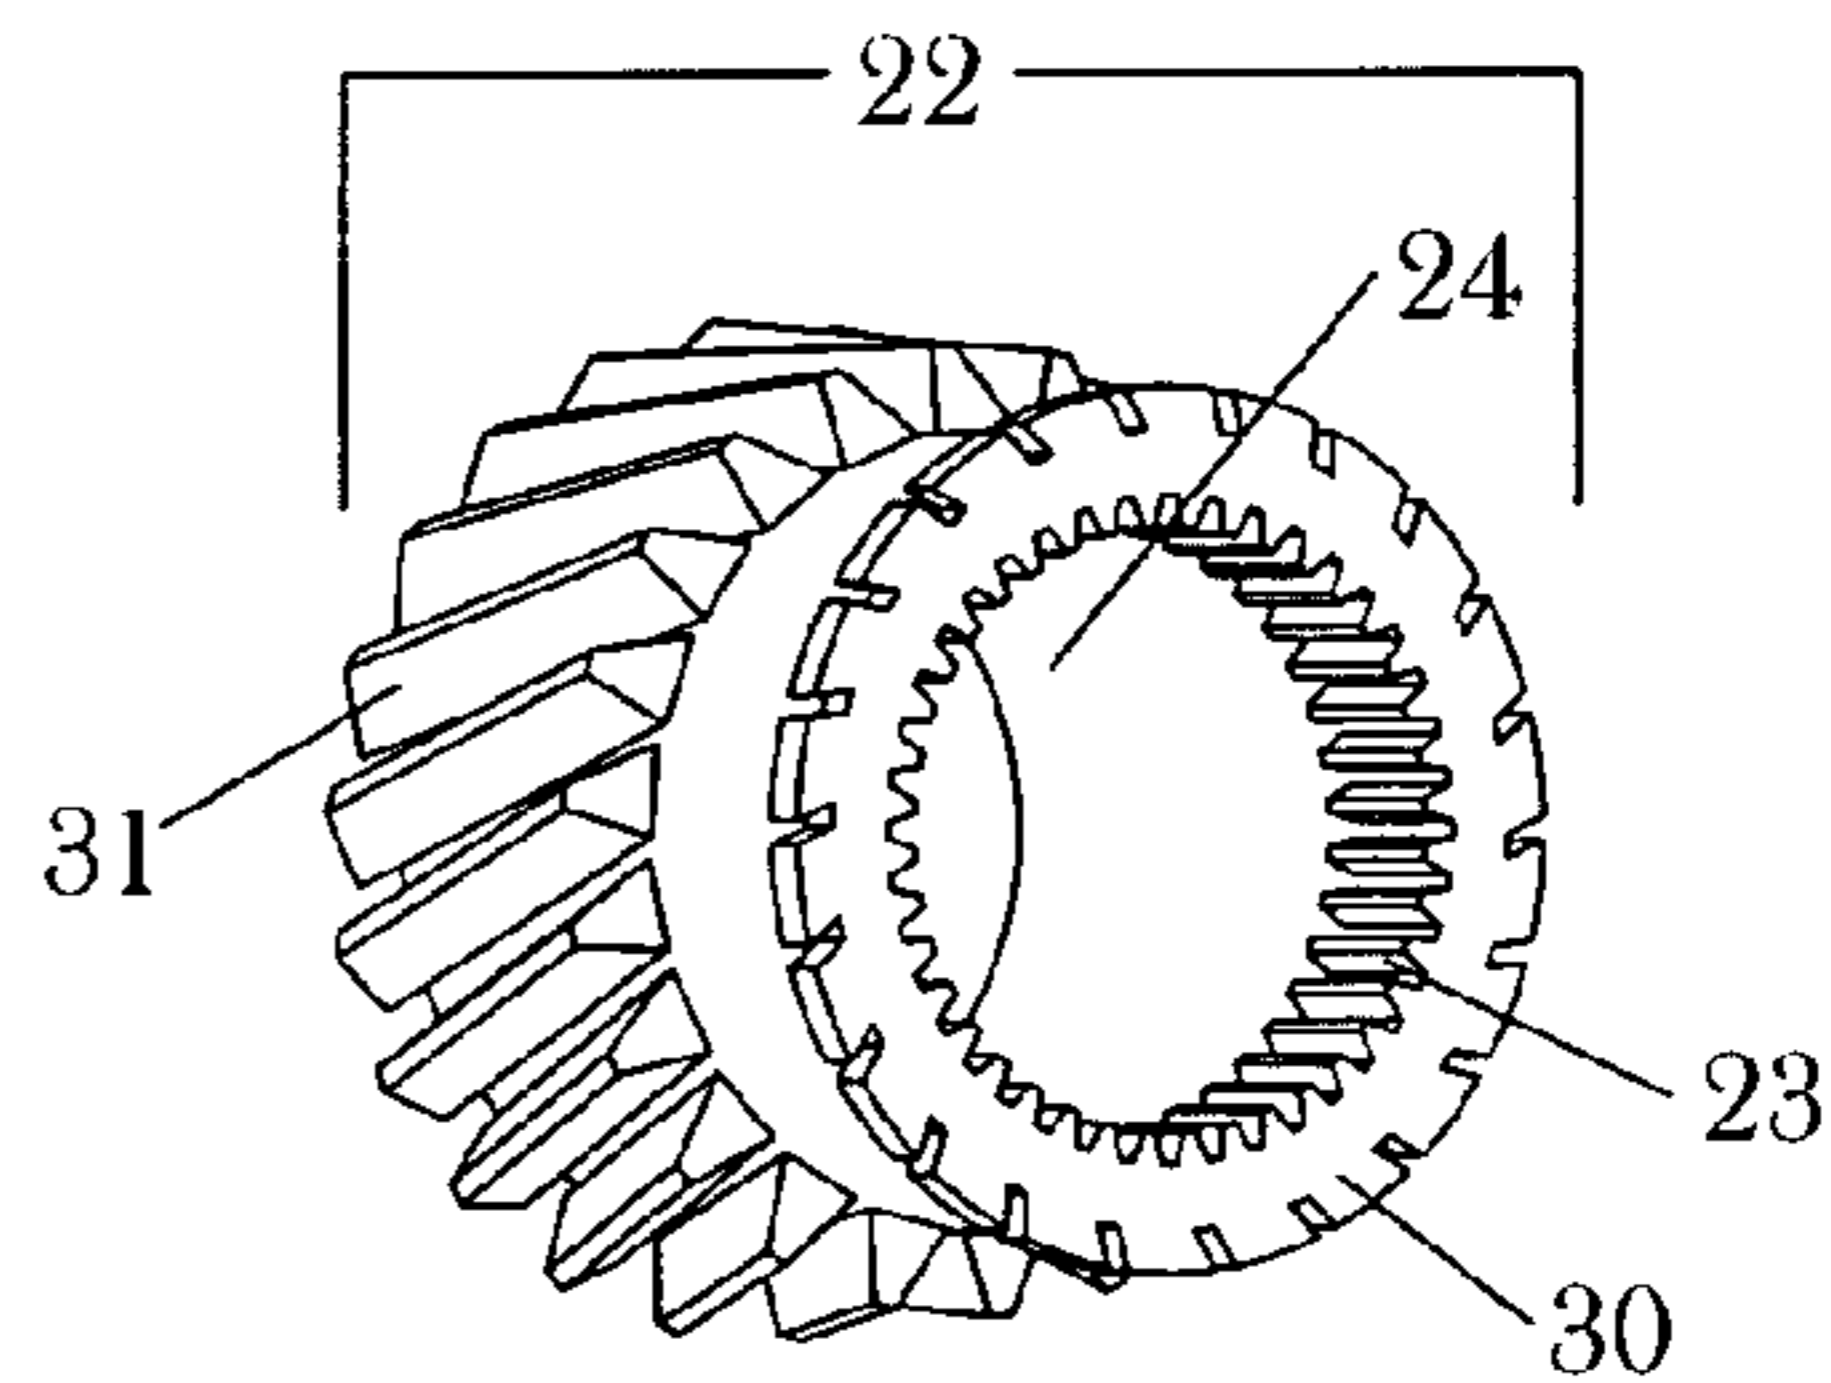
FIG. 16 is a perspective view of a first embodiment of the gear of the present invention, in which approximately half of the inner splines of the gear are removed.

FIG. 16 shows a first embodiment of the fifth gear design of the present invention. In this embodiment, the inside of the gear 22 comprises a splined area 23 and a smooth bore area 24. The smooth bore area corresponds to the sleeve 21 of FIG. 15, and the splined area 23 corresponds to the splines 2 of FIG. 15. The inside diameter of the gear is preferably 0.001 to 0.003 smaller than the outside diameter of the sleeve 21 to provide a press fit. In addition, the rear face 30 of the gear is preferably machined down (made thinner) to accommodate the nut configuration shown in FIG. 17.

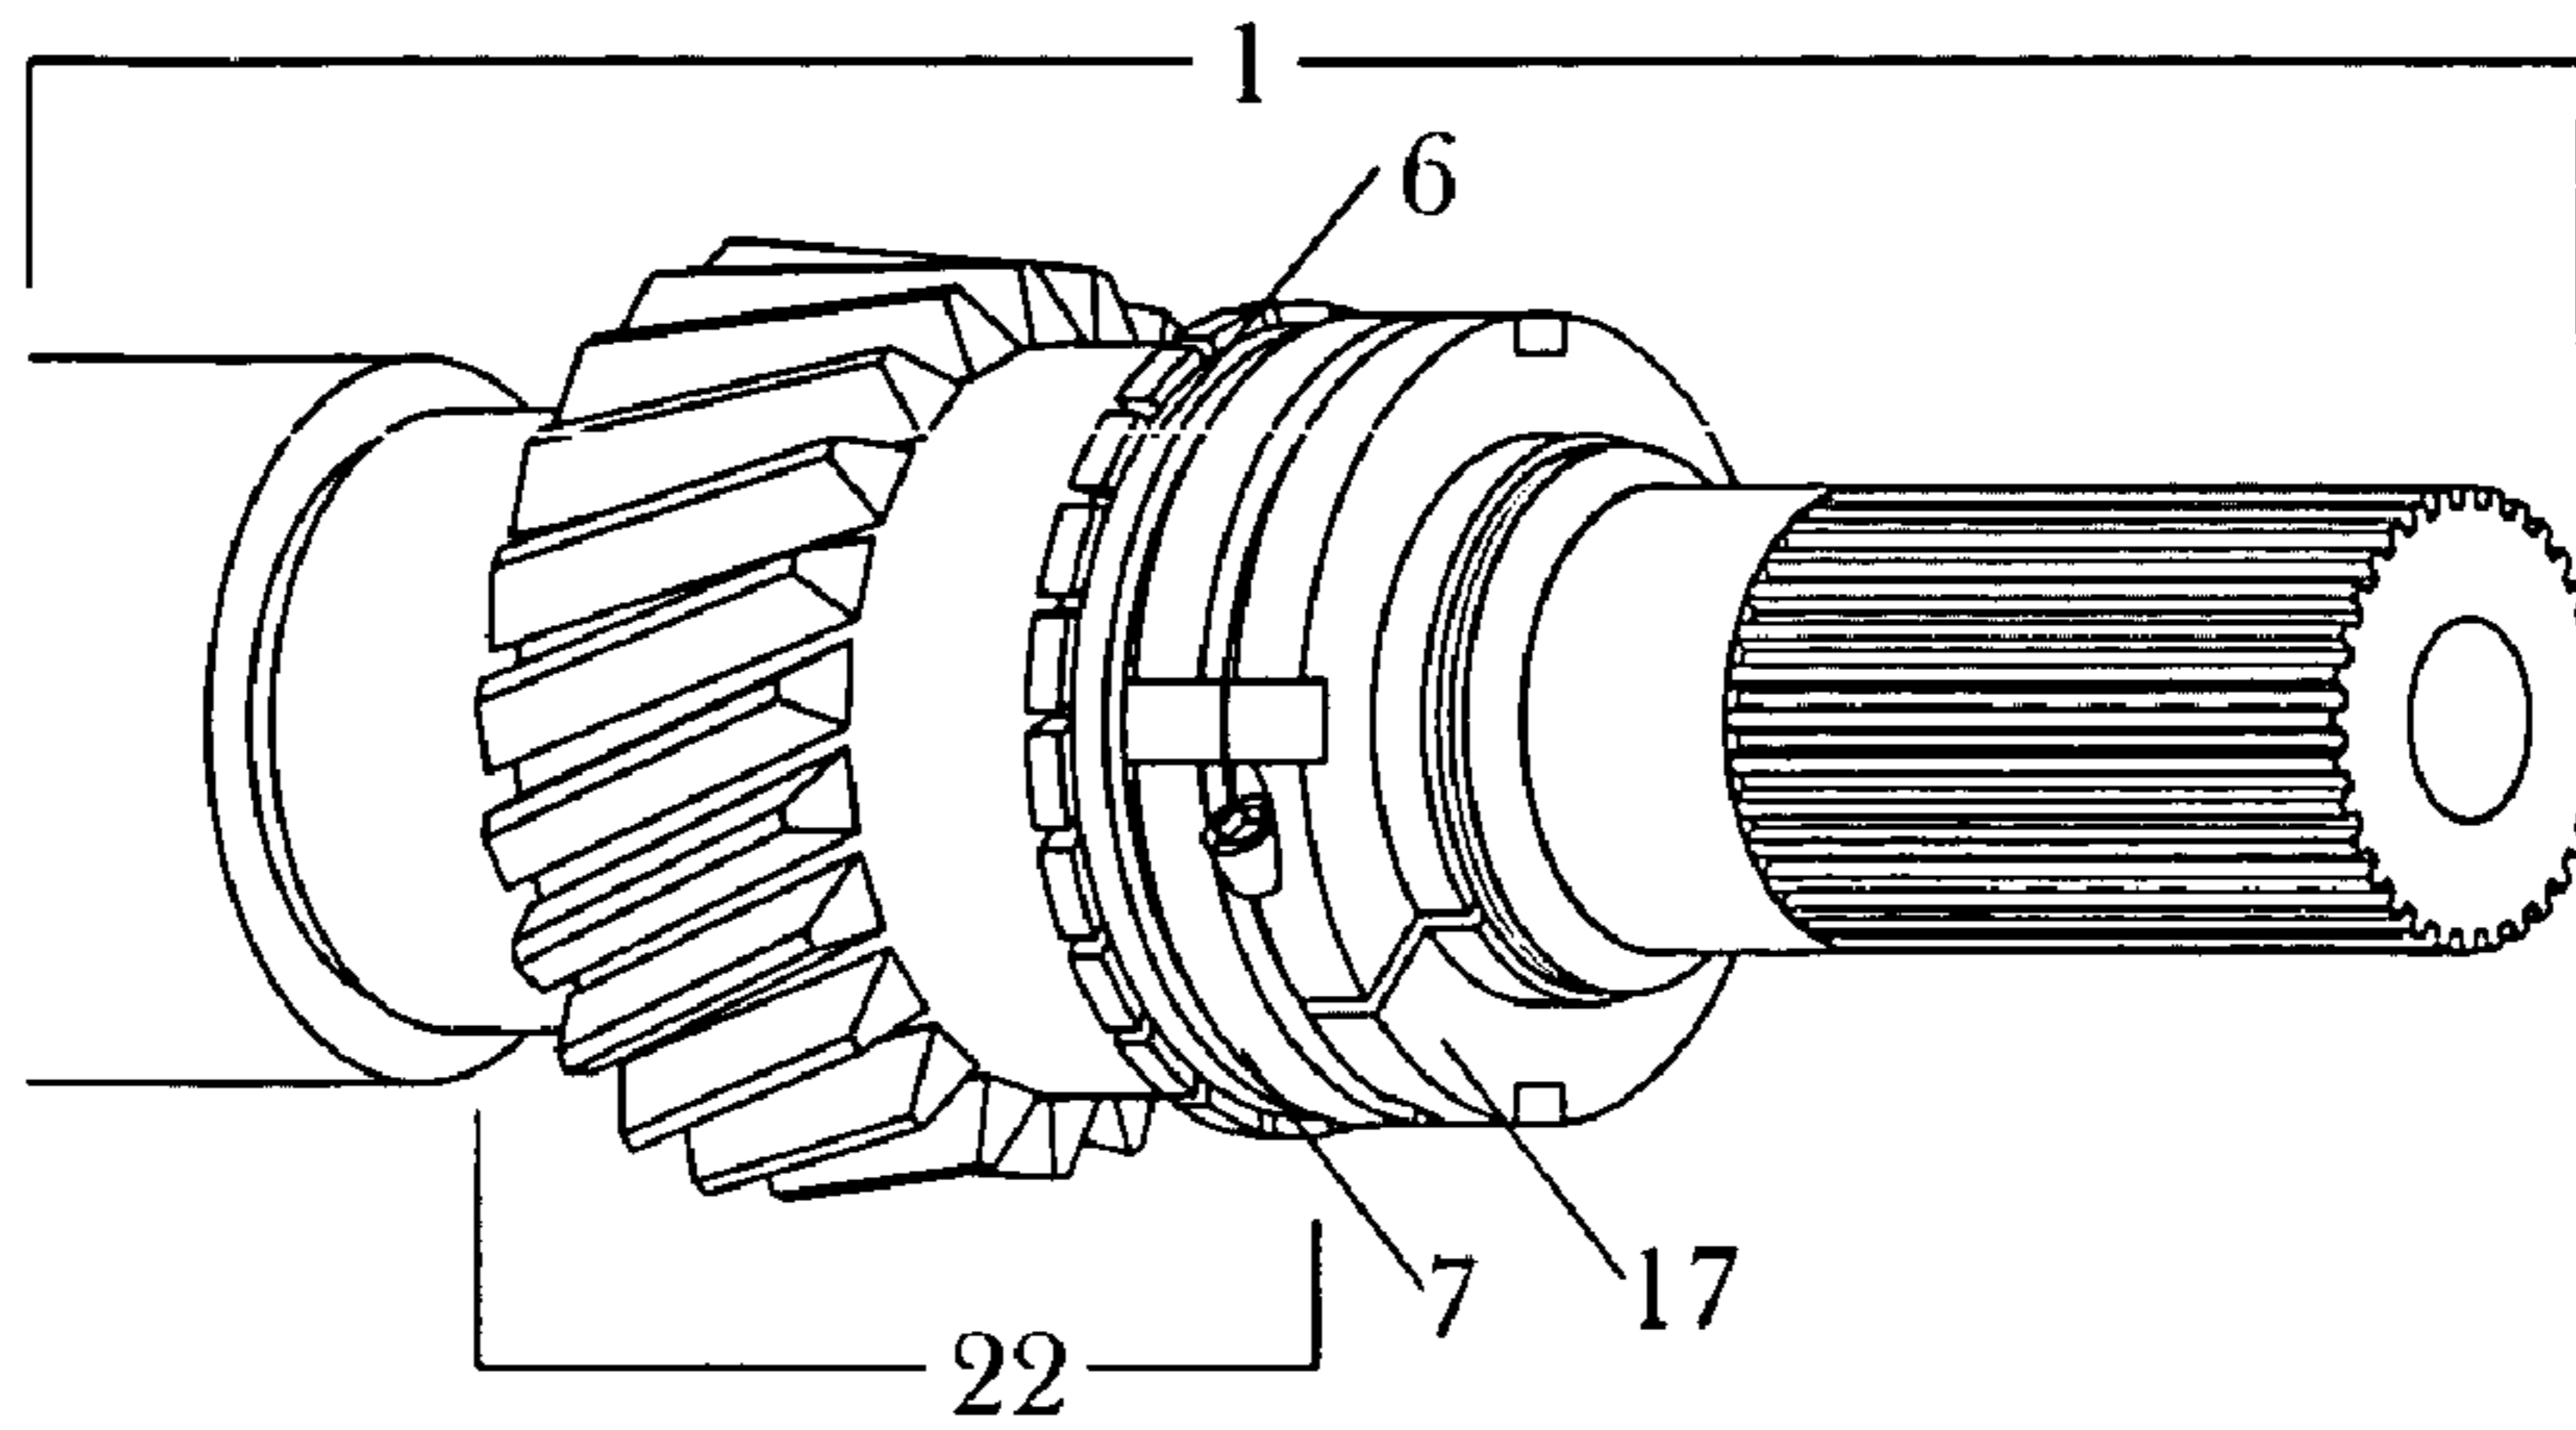
FIG. 17 is a partial perspective view of the mainshaft of FIG. 15 with the gear, spring washer, flat nut, and clamp-style nut.

FIG. 17 is a partial perspective view of the mainshaft of FIG. 15 with the gear 22, spring washer 6, flat nut 7 and clamp-style nut 17. The gear is now fully supported because the sleeve 21 adds diameter to the smooth support surface 3, and the inside of the gear is smooth (rather than splined) over the sleeve. There is still some spline-to-spline contact between the gear and the mainshaft, but it is not the main or sole basis for contact between the gear and the mainshaft, as in the factory and aftermarket designs, respectively. In contrast to the configuration shown in FIG. 2, a clamp-style nut 17 is added after the flat nut 7 to provide additional stability. The clamp-style nut 17 is preferably thinner than the flat nut 7. FIG. 18 is an exploded perspective view of the gear of FIG. 16, spring washer, flat nut and clamp-style nut.

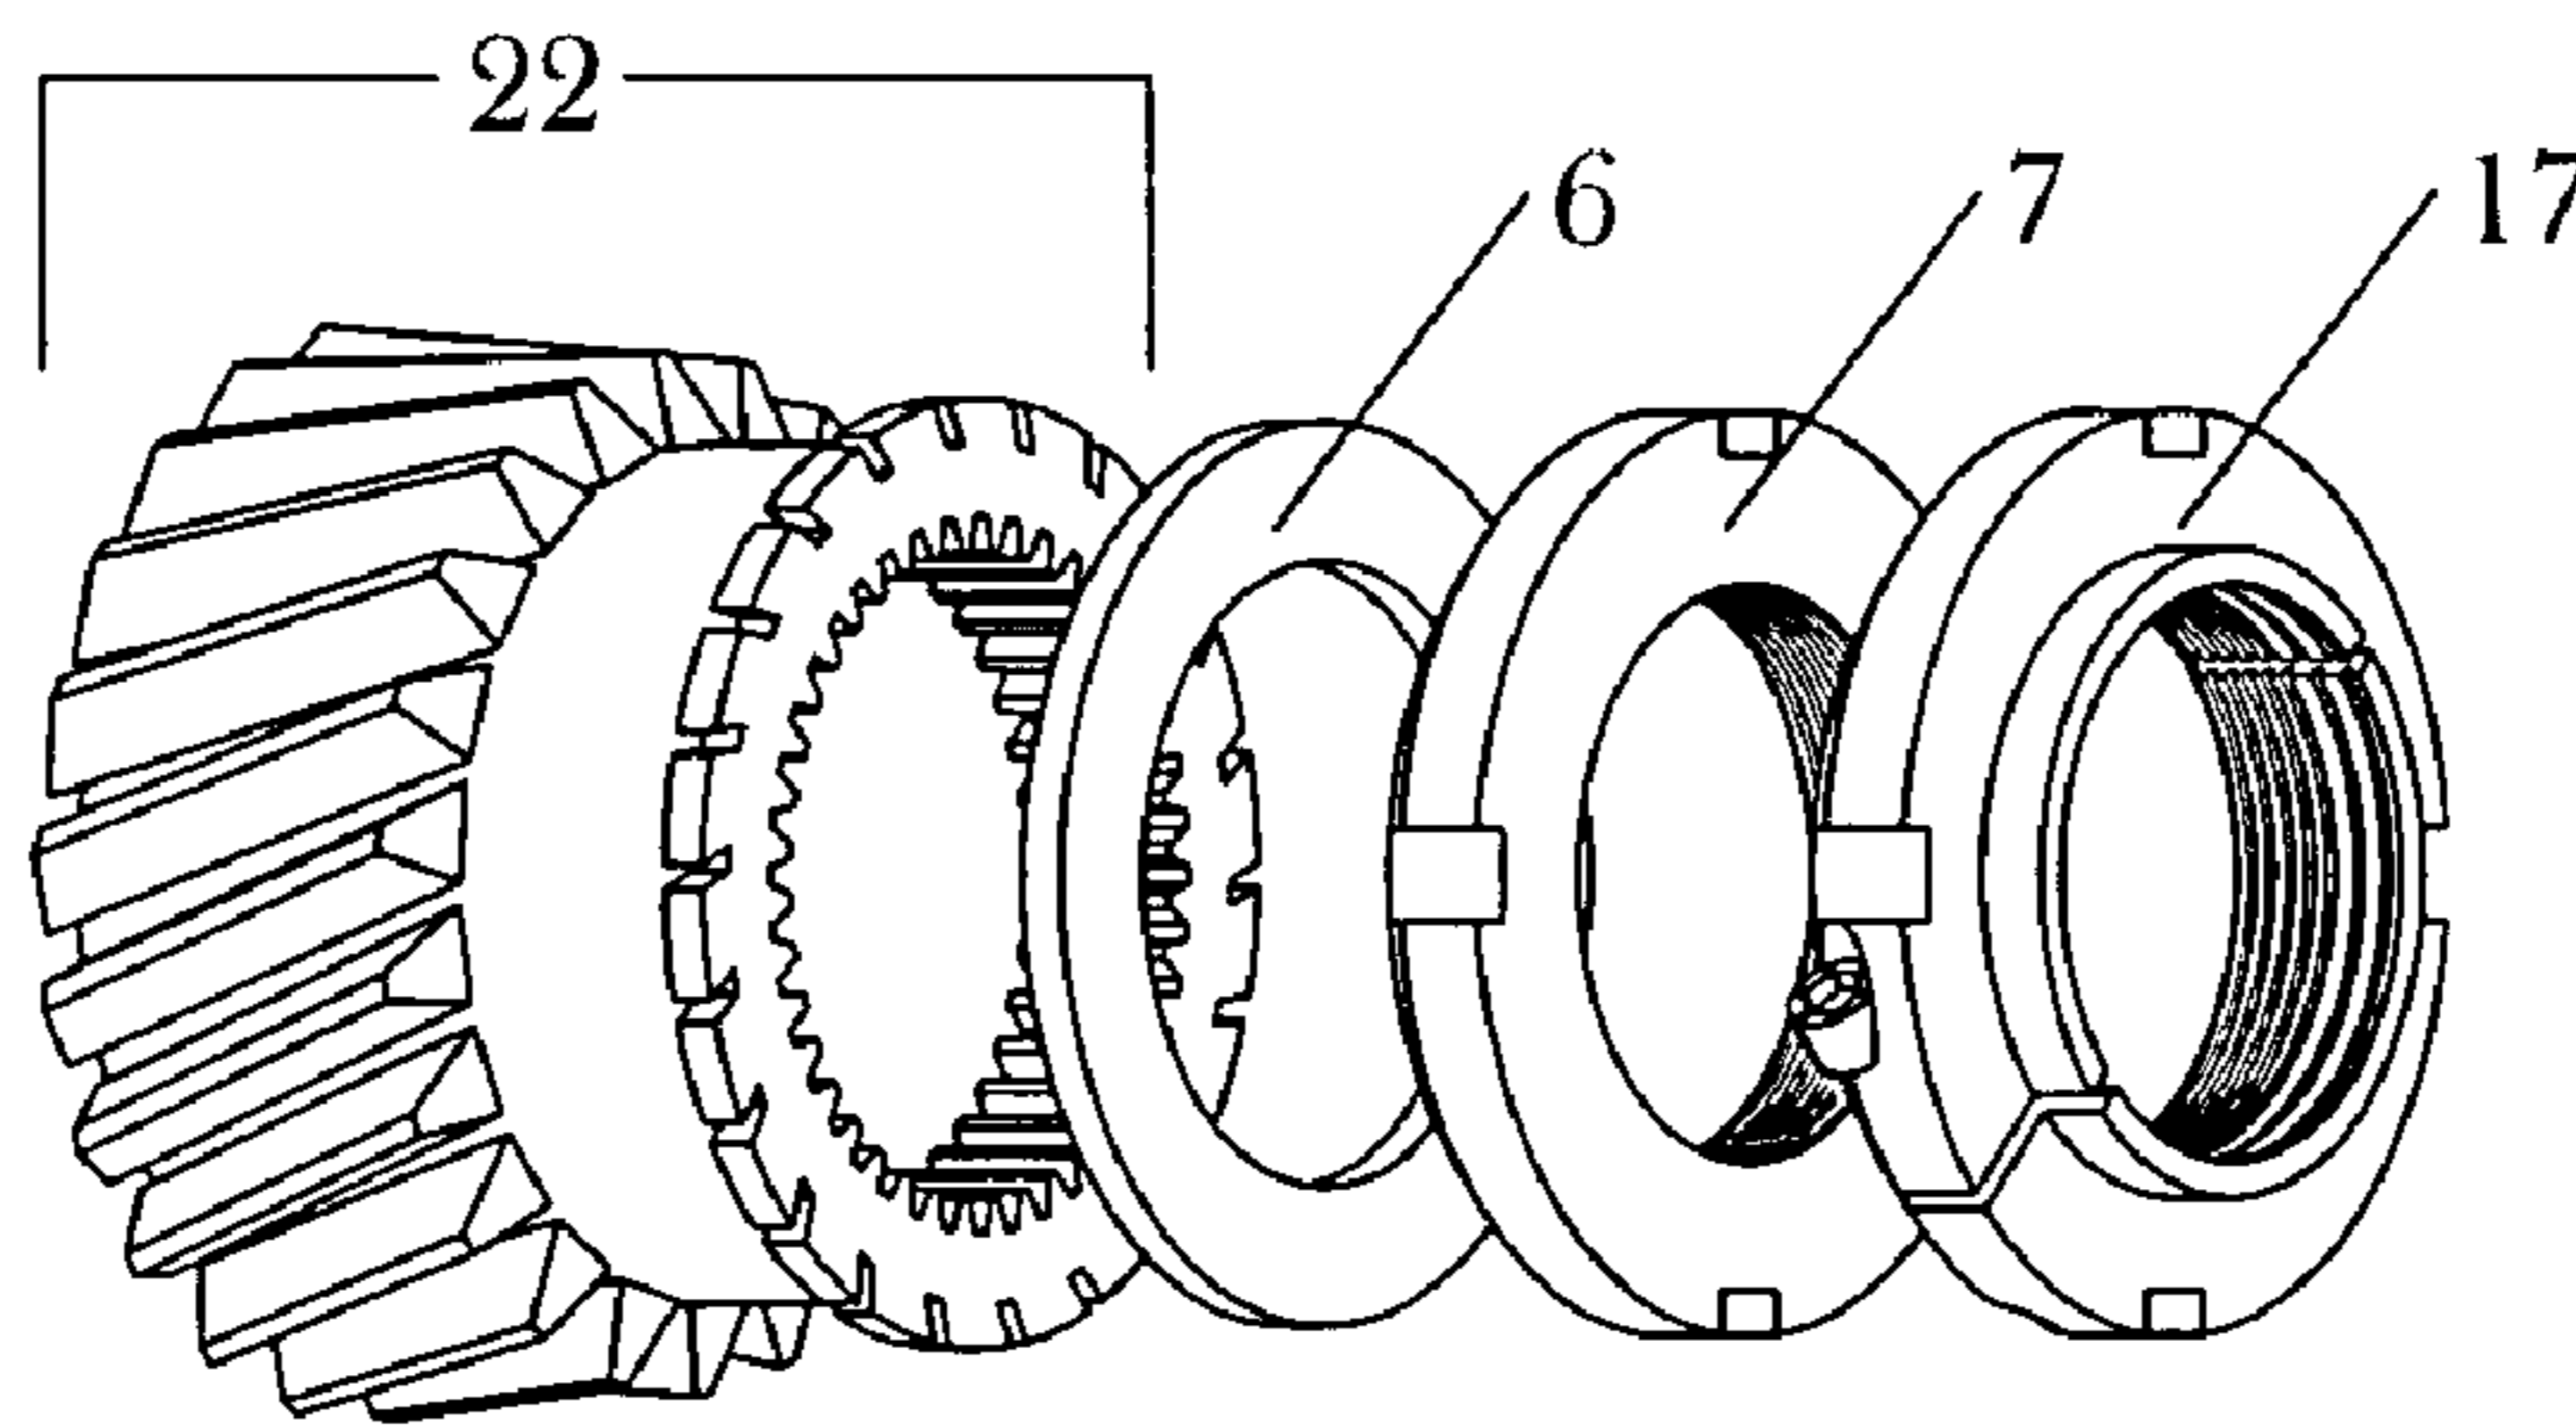
FIG. 18 is an exploded perspective view of the gear of FIG. 16, spring washer, flat nut, and clamp-style nut.

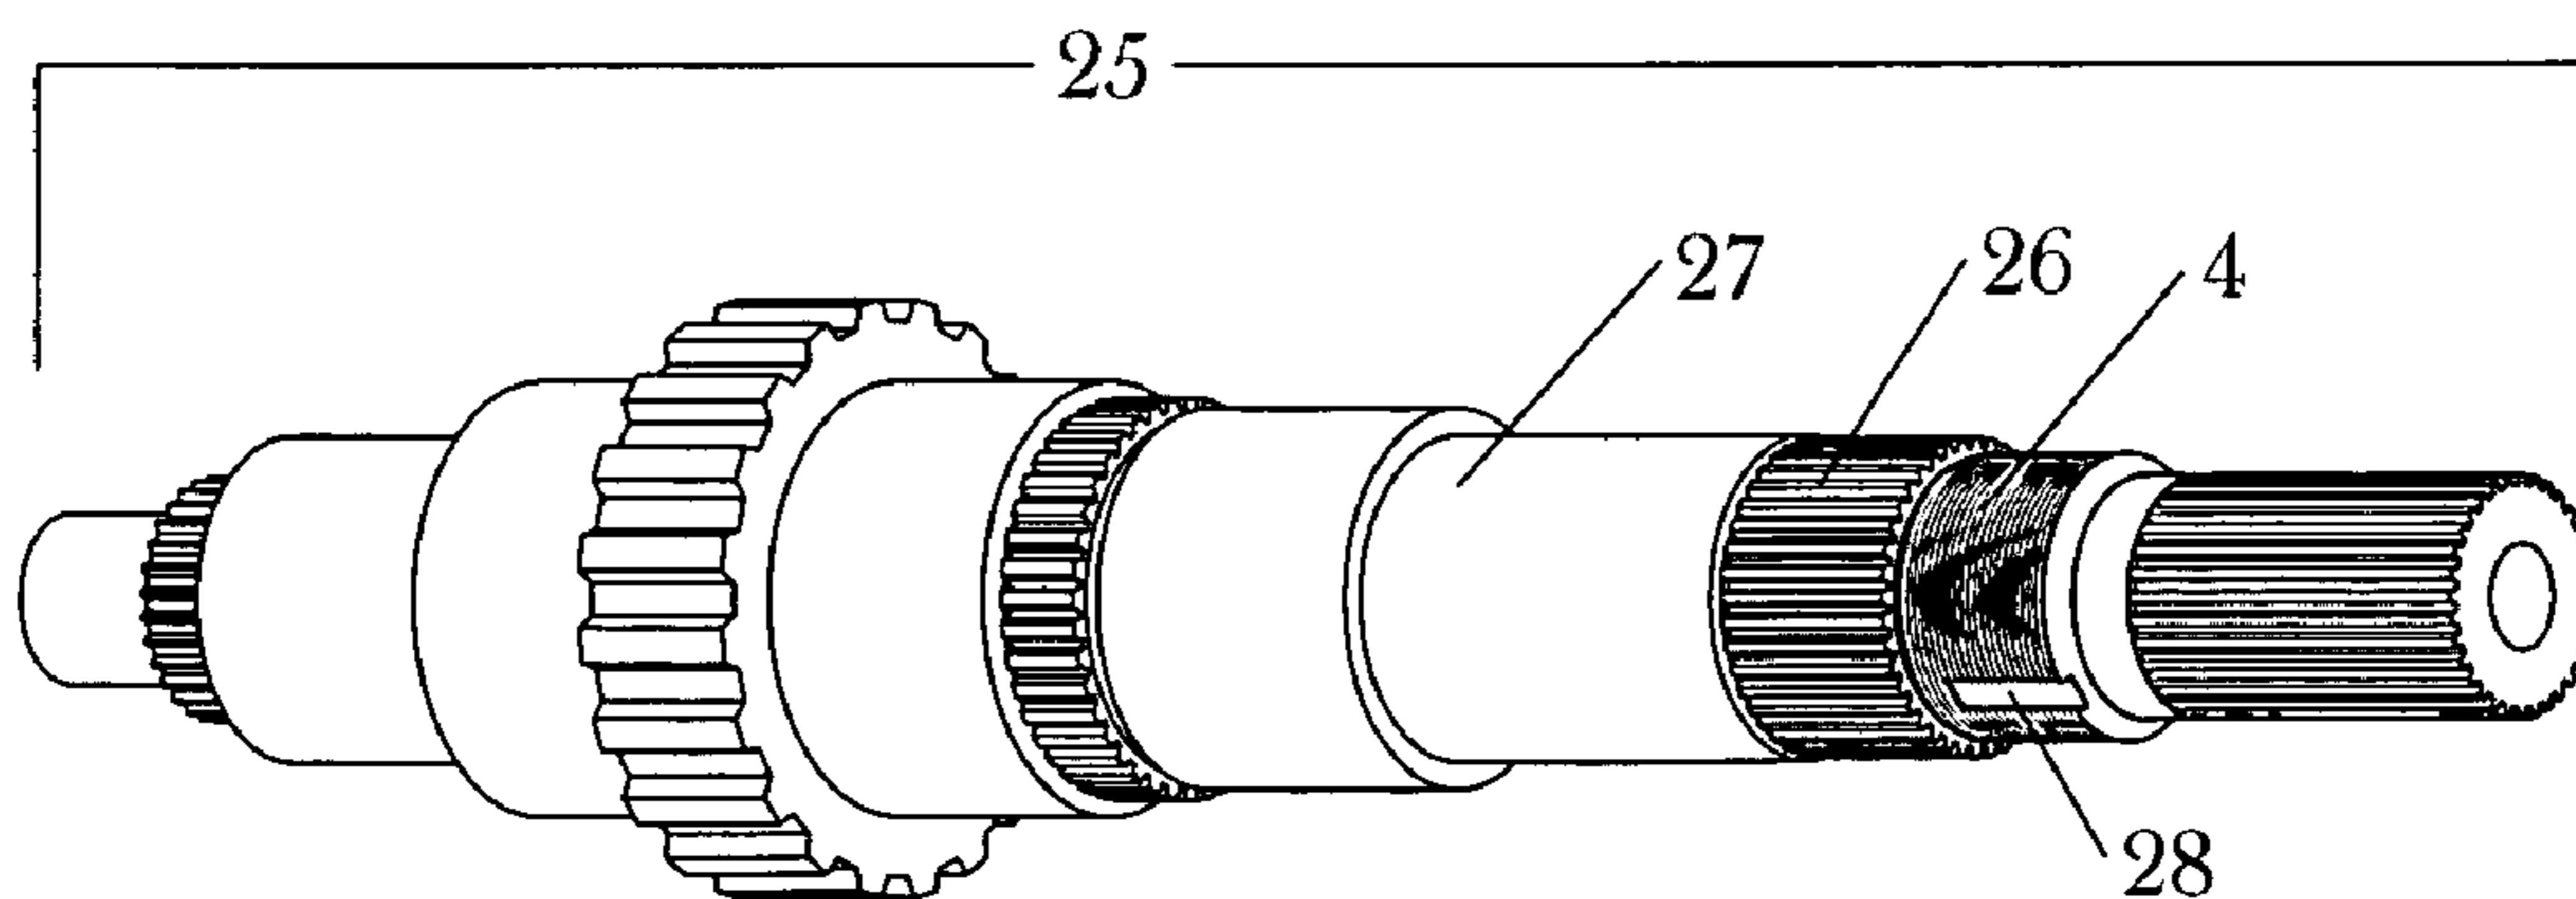
FIG. 19 is a perspective view of a second embodiment of the mainshaft of the present invention, in which the mainshaft comprises a support shoulder.

The second embodiment of the present invention is an entirely new mainshaft (not a retrofit). In this embodiment, shown in FIG. 19, the mainshaft comprises a lengthened splined area 26 and a support shoulder 27. In the preferred embodiment, the splined area 26 is approximately 0.5 inches longer than the splined area on a factory mainshaft (see FIG. 1). The threaded area 4 comprises a keyslot 28 that is longer than the keyslot 11 shown in FIGS. 6 and 9. Like the sleeve of the previous embodiment, the diameter of the support shoulder 27 is slightly greater than the diameter of the splined area 26. This increased diameter provides for a tighter fit between the gear and the mainshaft. In the preferred embodiment, the outside diameter of the support shoulder is 0.01 to 0.30 inches greater than the outside diameter of the splines on the mainshaft. The support shoulder 27 does not have a tapered edge (as does the sleeve shown in FIG. 15) because the lengthened splines 26 make it easier to install the gear on the support shoulder 27.

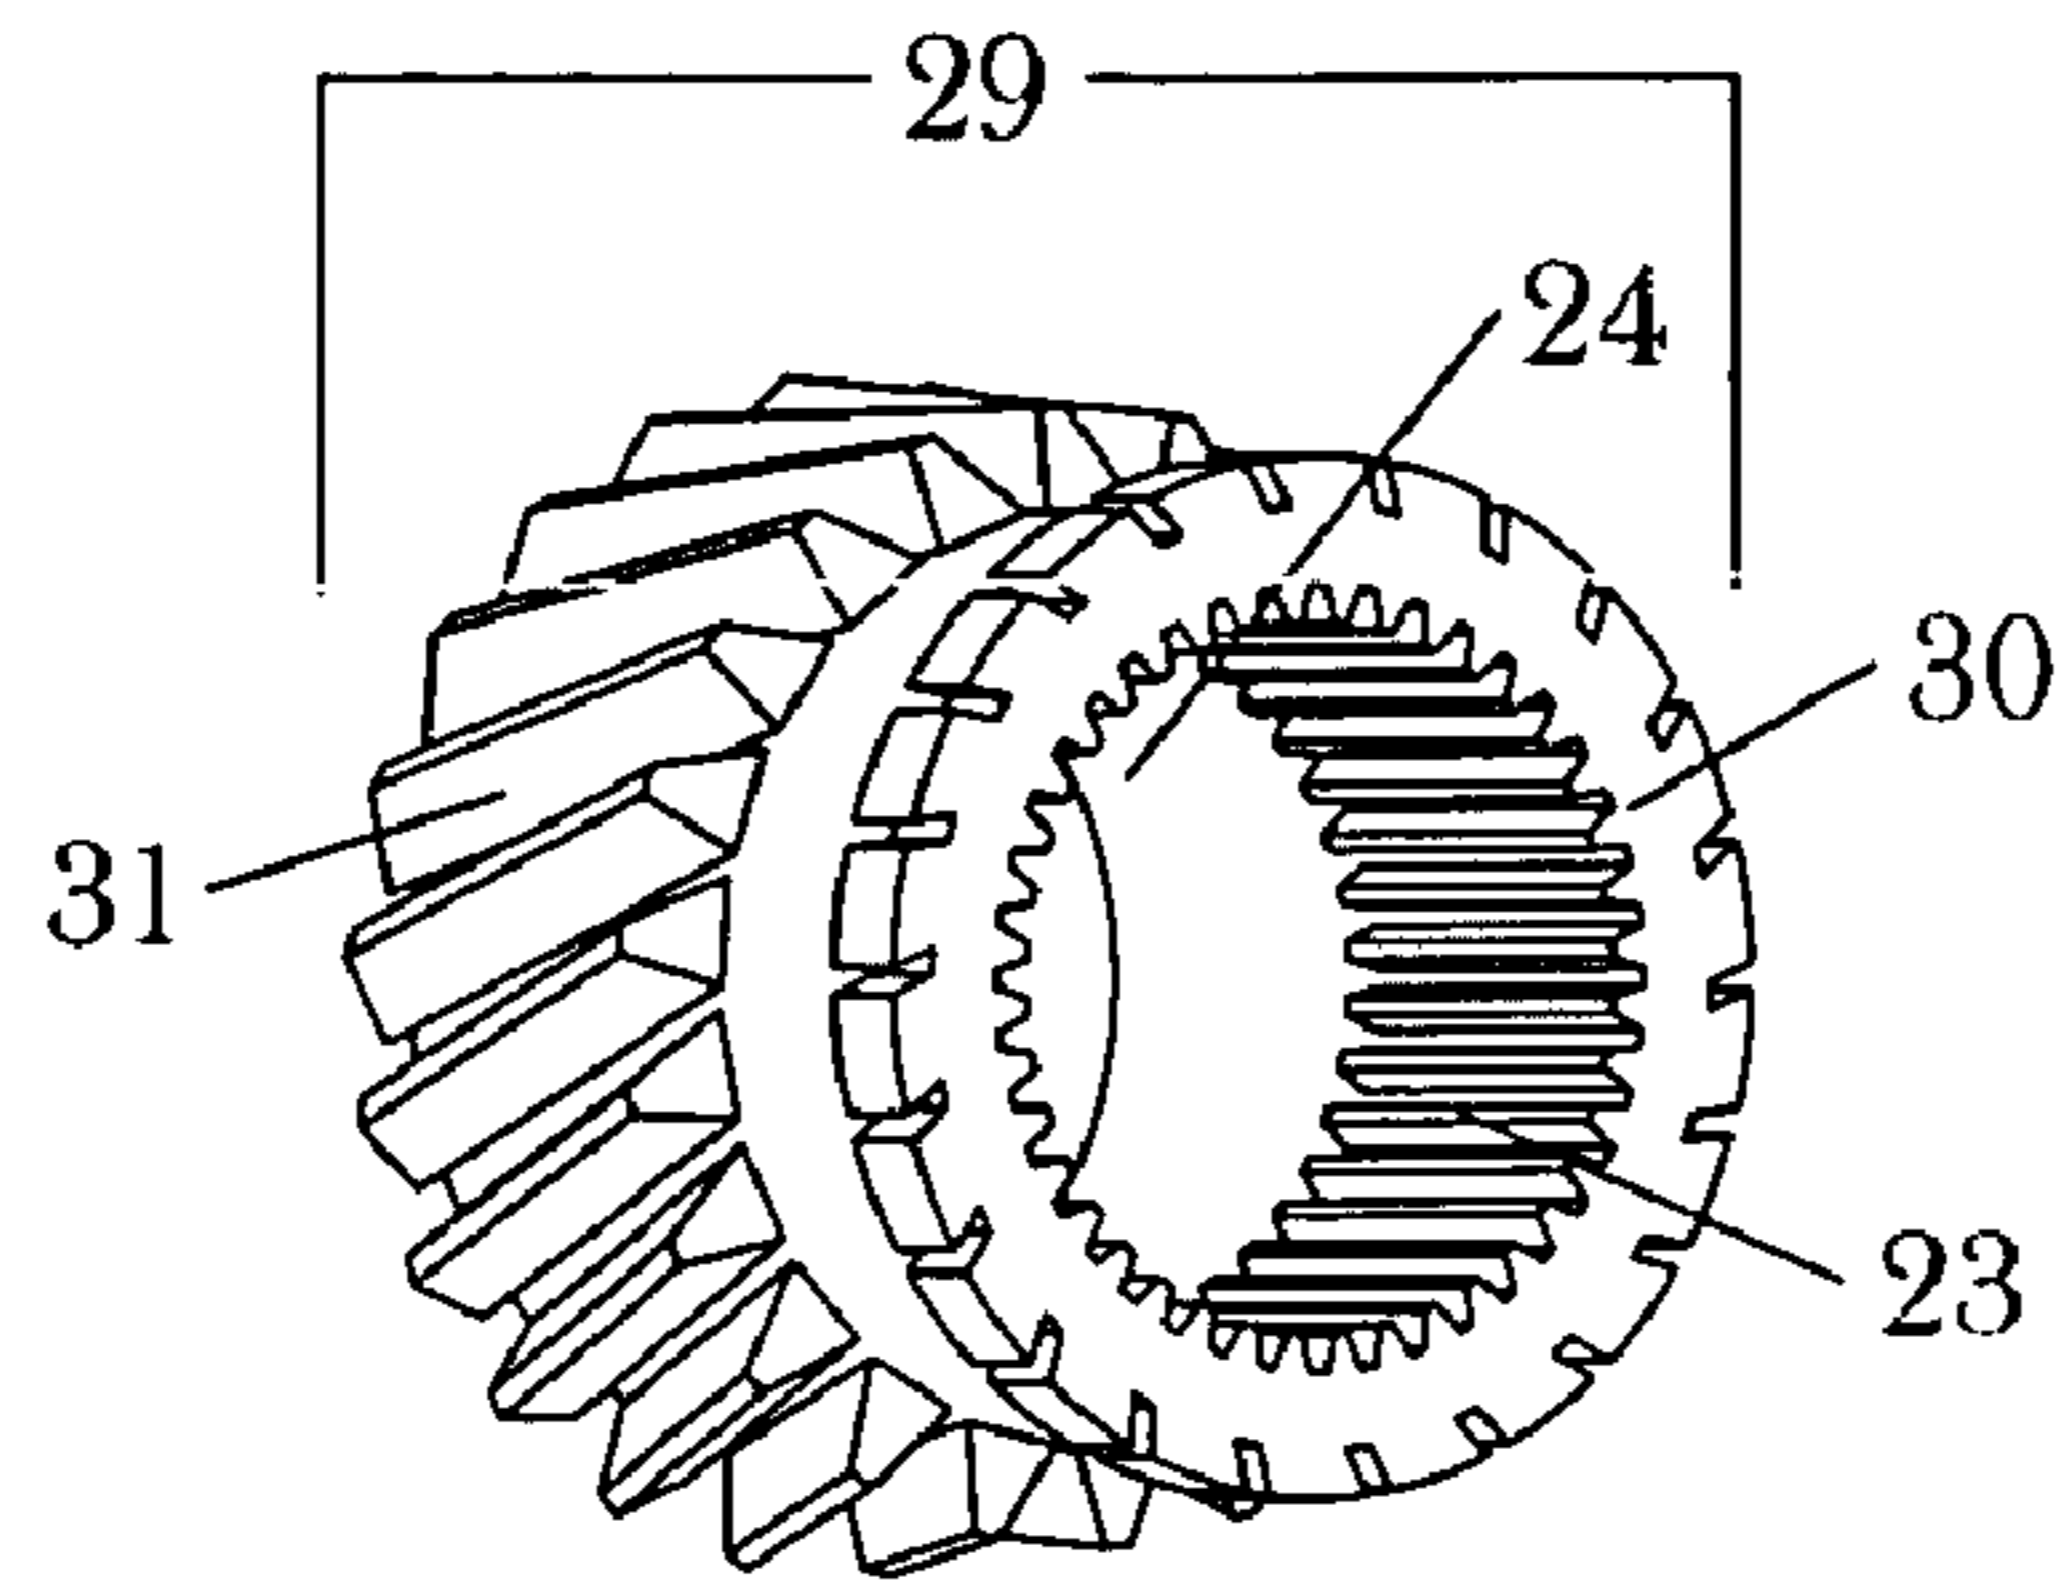
FIG. 20 is a perspective view of a second embodiment of the gear of the present invention, in which approximately half of the inner splines of the gear are removed and the end of the gear opposite the gear teeth is reduced in width.

FIG. 20 shows a second embodiment of the fifth gear design of the present invention. In this embodiment, the inside of the gear 29 comprises a splined area 23 and a smooth bore area 24. The splined area 23 corresponds to the splines 26 on the mainshaft, and the smooth bore area 24 partially covers the support shoulder 27 when the gear is installed on the mainshaft. The splined area 23 is longer in this embodiment than in the retrofit design (shown in FIG. 16) because the splines on the new mainshaft 25 are longer than the splines on the factory shaft 1. The rear face 30 of

the gear may be machined down (as shown in FIG. 16) to allow for the nut configuration shown in FIG. 21, but in most cases this will not be necessary due to the longer threaded area on the shaft. The inside diameter of the gear is preferably 0.001 to 0.003 smaller than the outside diameter of the support shoulder 27 to provide a press fit.

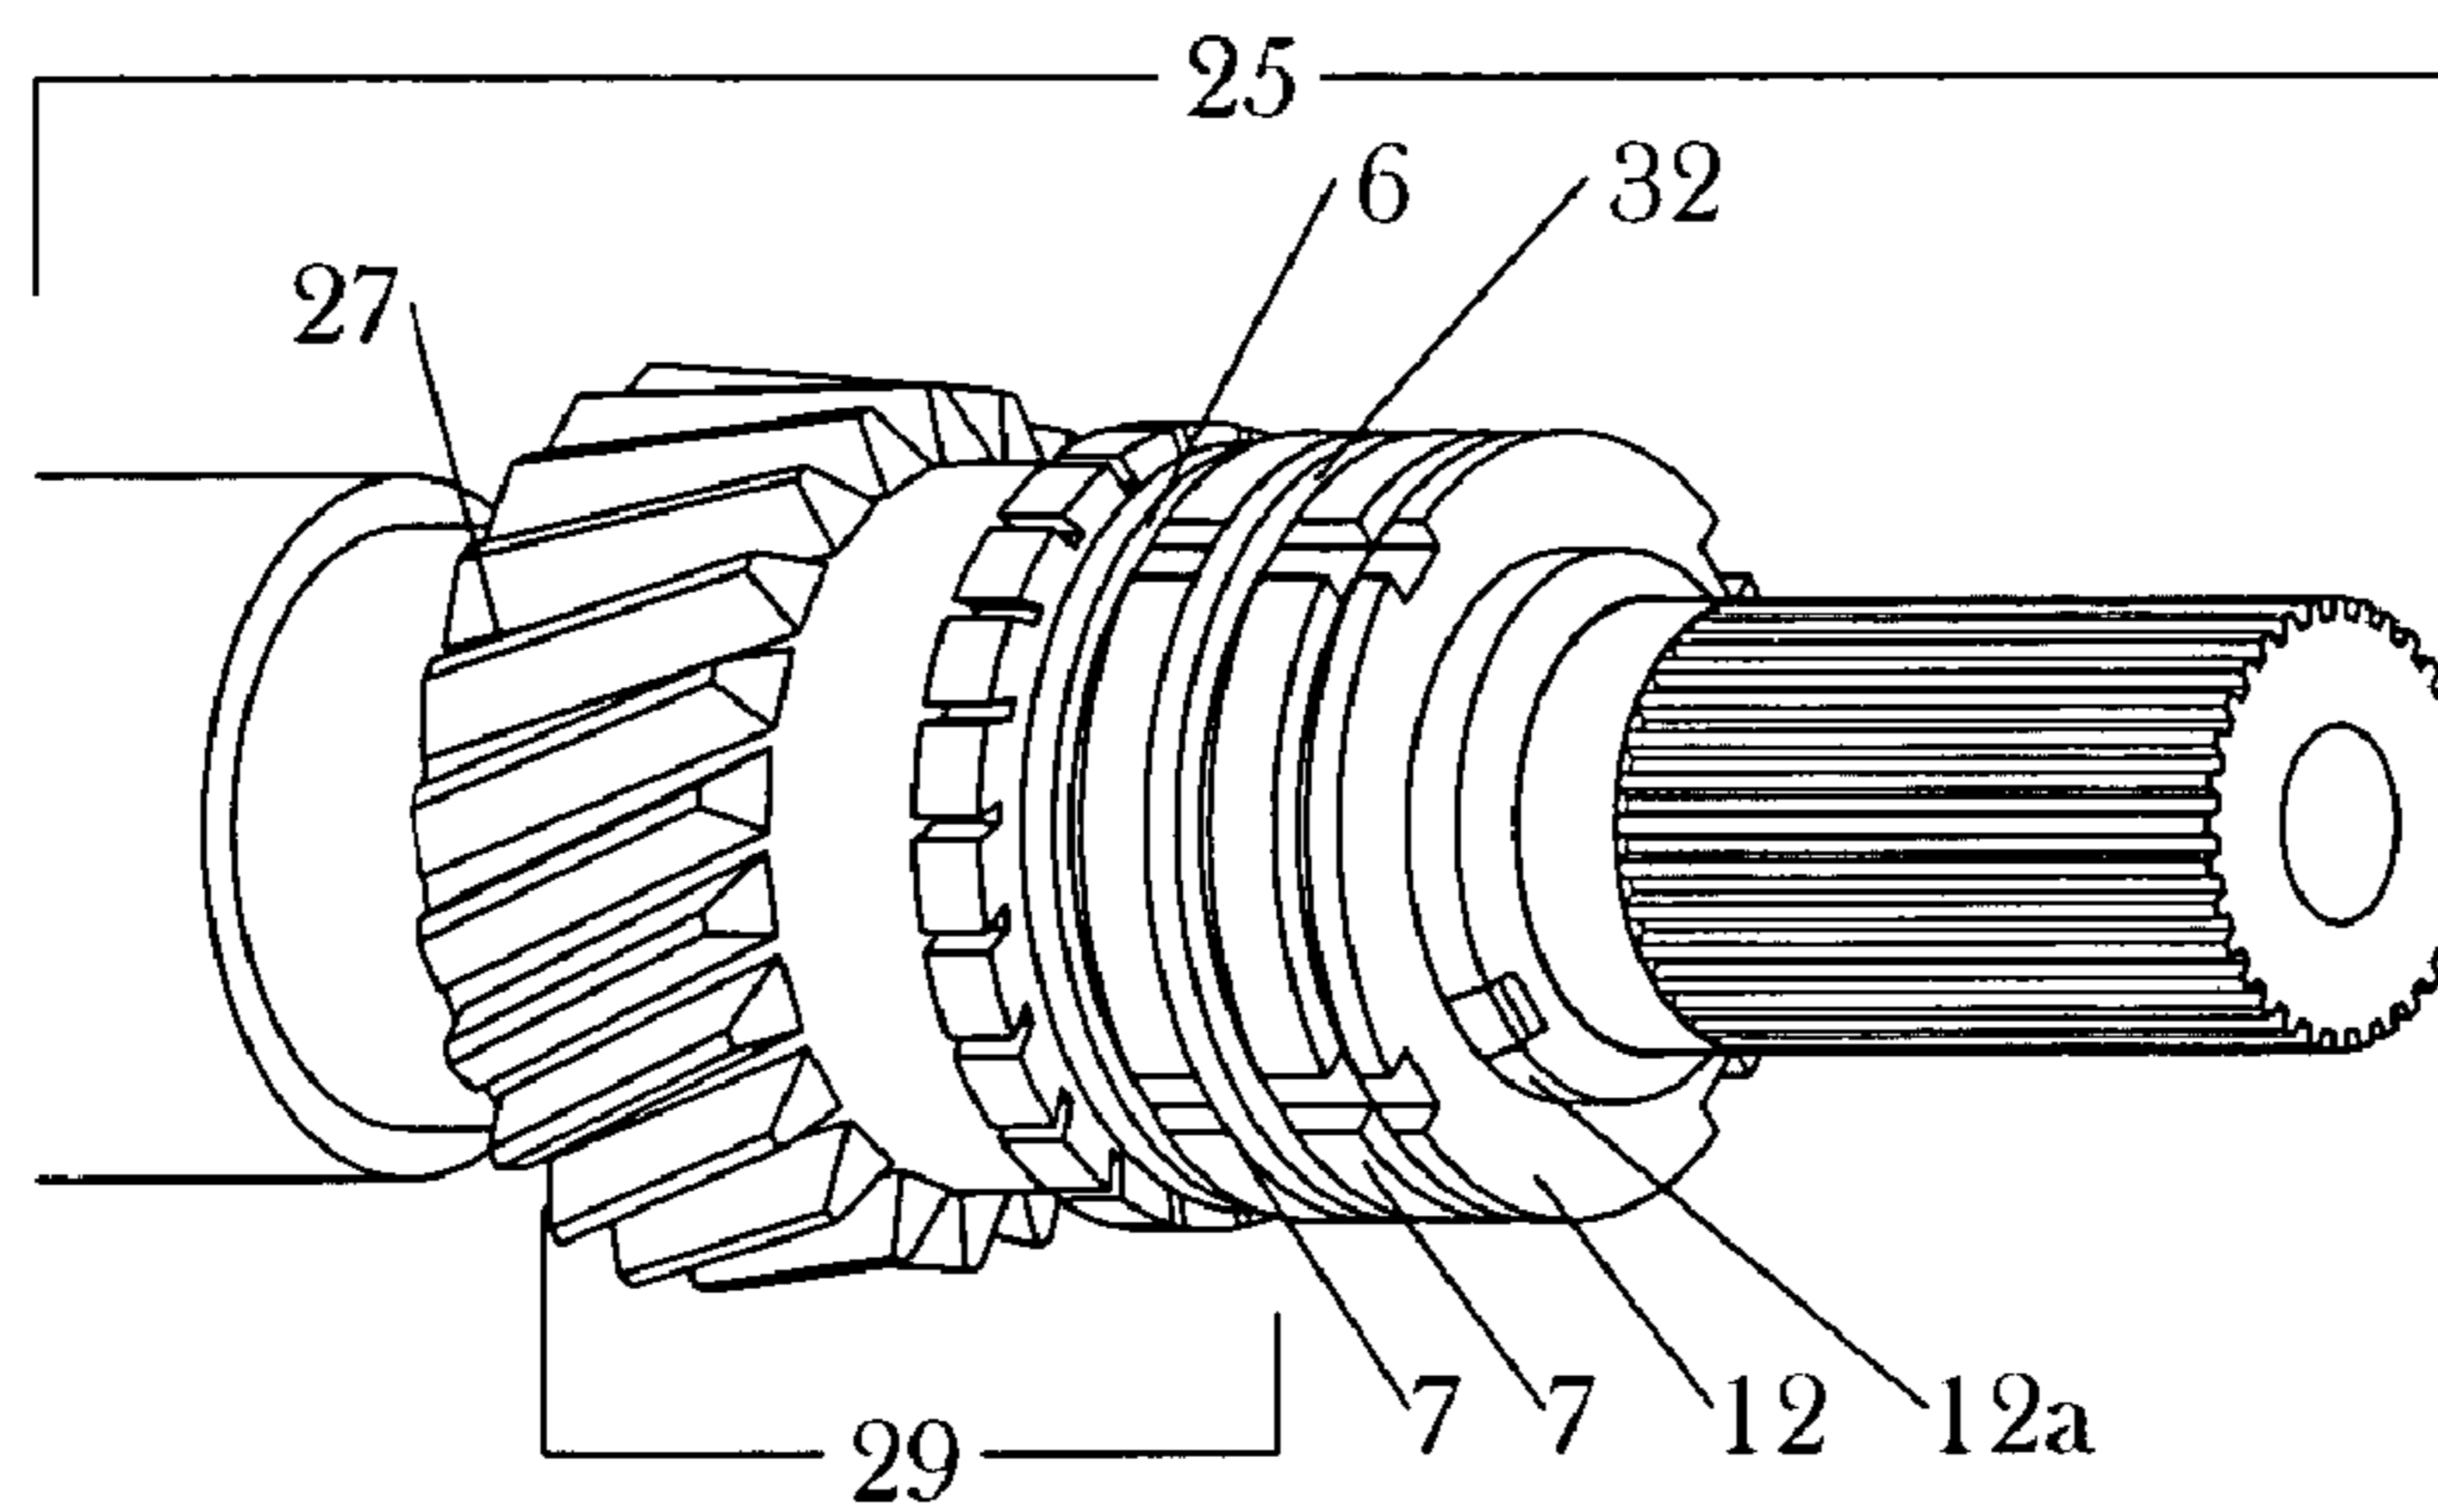
FIG. 21 is a partial perspective view of a second embodiment of the mainshaft of the present invention with the gear, spring washer, single flat nut, tanged lock washer, and double flat nuts.

FIG. 21 is a partial perspective view of the mainshaft of FIG. 19 with the gear installed on it. This embodiment includes a unique nut and washer configuration, namely, a spring washer 6, single flat nut 7, tanged lock washer 32, flat nut 7 and lipped nut 12. The tanged lock washer 32 has a tang that fits into the keyslot 28 shown in FIG. 19. The lip 12a of the lipped nut 12 also fits into the keyslot 28. The spring washer 6, flat nut 7, tanged lock washer 32, flat nut 7 and lipped nut 12 all fit within the threaded area 4 of the shaft. For that reason, the width of the gear 29 may be decreased as described in connection with FIG. 20, and the lipped nut 12 is preferably thinner than the flat nut 7. FIG. 22 is an exploded perspective view of the mainshaft of FIG. 19 with the gear 29, spring washer 6, first flat nut 7, tanged lock washer 32, second flat nut 7 and lipped nut 12.
