(10) **Patent No.:** **US 7,210,366 B2**
(45) **Date of Patent:** **May 1, 2007**

(54) **FULL SUPPORT MAINSHAFT AND FIFTH GEAR DESIGN**

The present invention relates to the field of automotive transmissions, and more particularly, to a full support mainshaft and fifth gear design for the New Venture/MTM NV4500 transmissions.

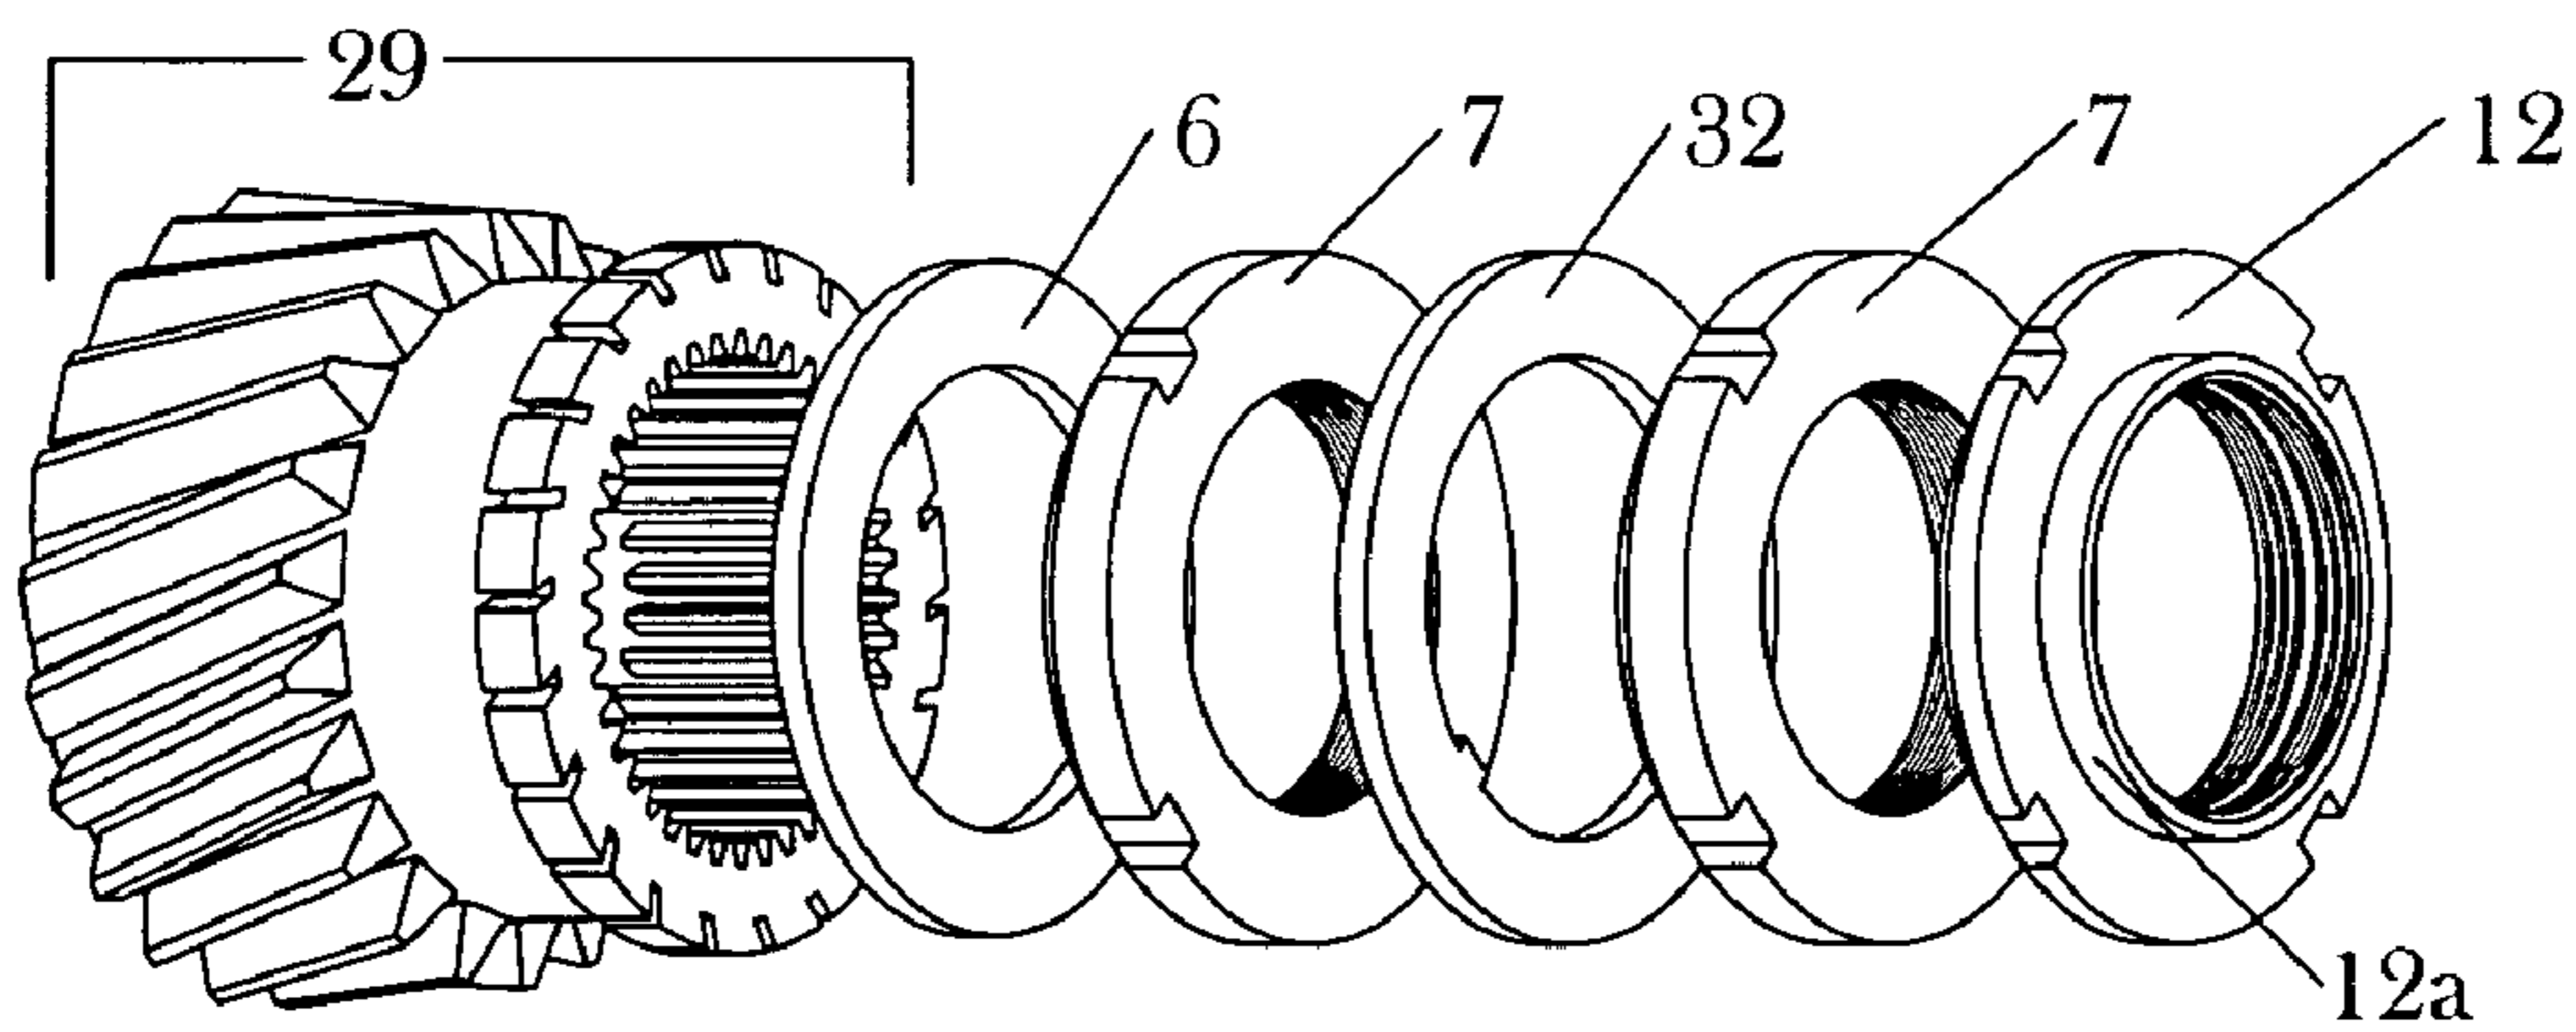
FIG. 22 is an exploded perspective view of the mainshaft of FIG. 19 with the gear, spring washer, single flat nut, tanged lock washer, and double flat nuts.

FIG. 21 is a partial perspective view of the mainshaft of FIG. 19 with the gear installed on it. This embodiment includes a unique nut and washer configuration, namely, a spring washer 6, single flat nut 7, tanged lock washer 32, flat nut 7 and lipped nut 12. The tanged lock washer 32 has a tang that fits into the keyslot 28 shown in FIG. 19. The lip 12a of the lipped nut 12 also fits into the keyslot 28. The spring washer 6, flat nut 7, tanged lock washer 32, flat nut 7 and lipped nut 12 all fit within the threaded area 4 of the shaft. For that reason, the width of the gear 29 may be decreased as described in connection with FIG. 20, and the lipped nut 12 is preferably thinner than the flat nut 7. FIG. 22 is an exploded perspective view of the mainshaft of FIG. 19 with the gear 29, spring washer 6, first flat nut 7, tanged lock washer 32, second flat nut 7 and lipped nut 12.
