# (10) Patent No.: US 7,219,424 B2

### (54) METHOD FOR TEMPORARY REPAIR OF THE OVERBRAID FOR METAL OVERBRAIDED WIRING HARNESSES

(73) Assignee: Honeywell International, Inc.,

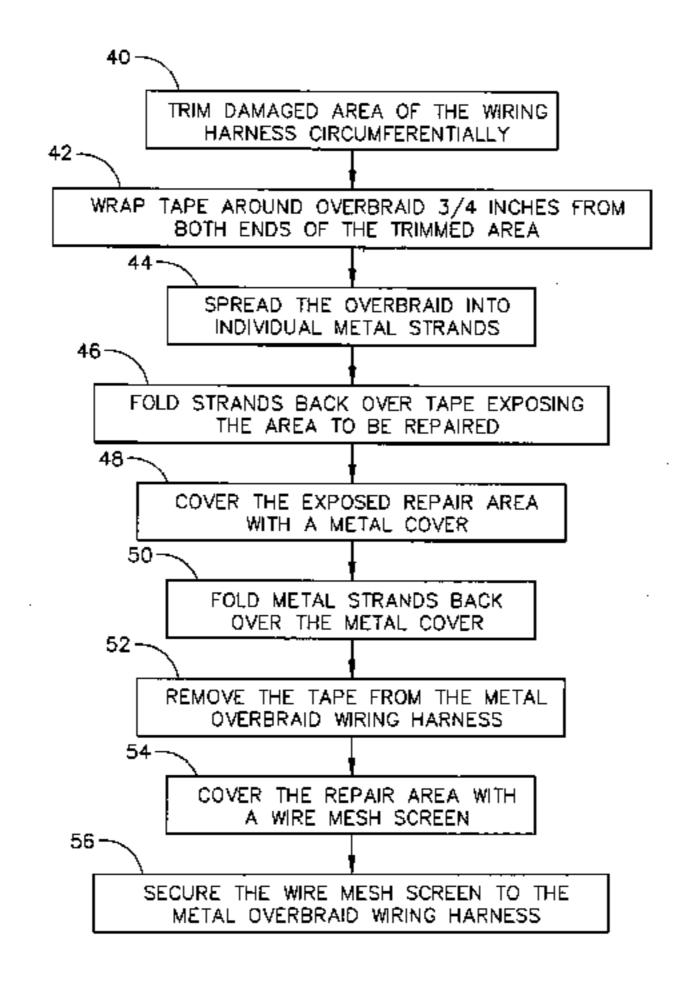
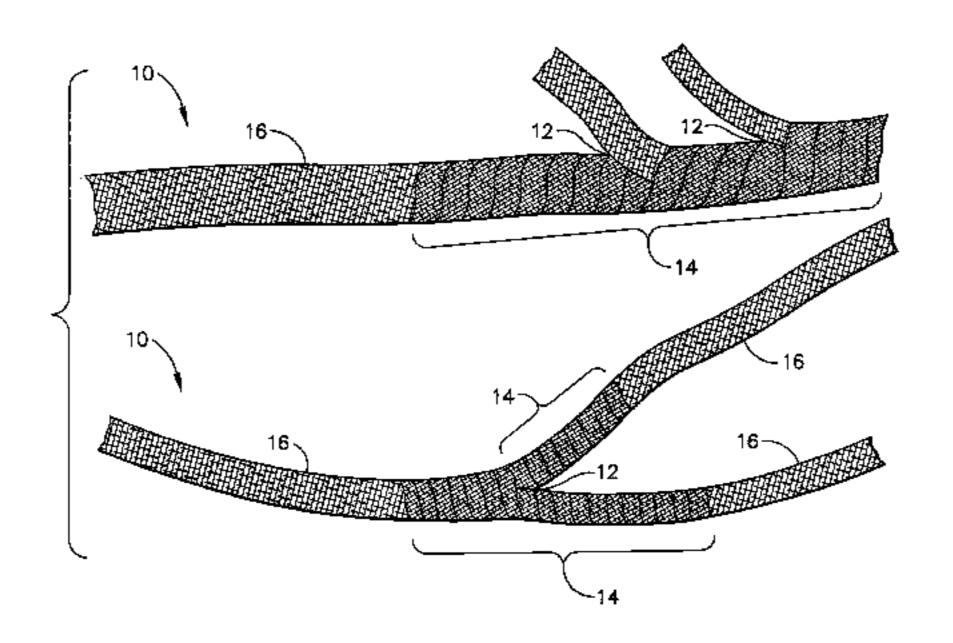
FIG. 1

The present invention provides a method for repairing the metal overbraid of a metal overbraid wiring harness. An exemplary method of the present invention may comprise the steps shown in the flow diagram of FIG. 1. The first step 40 comprises circumferentially trimming the metal overbraid around the damaged area. In the second step 42 tape may be wrapped around the metal overbraid at a distance of from about 0.5 inches to about 1.0 inches, for example, from both edges of the repair area. In step three 44 of the present invention, the metal overbraid may be spread apart from the 50 trim area to the tape producing individual metal strands. The metal strands may then be folded back over the tape, leaving a clear repair area in the fourth step 46. In step five 48, a metal cover may then be placed over the repair area, completely covering the exposed inner harness bundle. In 55 the next step, step six 50 the strands may then be folded back over the repair area, trimming the ends if necessary. Step seven 52 comprises removing the tape followed by step eight 54 where a wire mesh screen may be placed over the repair area. Finally, in step nine 56, the repair may be 60 completed by securing the wire screen mesh to the metal overbraid wiring harness. The repaired part of the harness should have about the same conductivity and flexibility as the undamaged metal overbraid.

In the next step of the repair method the metal overbraid 16 on either side of the repair area 18 may be moved away 60 from the trimmed repair area 18. As illustrated in FIG. 6, step three 44 of FIG. 1, in which the metal overbraid 16 may be to spread from the ends 22 of the trimmed repair area 18 to the tape 24 may be used to aid in moving the metal overbraid 16 from repair area 18. Spreading of the metal 65 overbraid 16 may produce individual metal strands 28 that make up the braid. Spreading of the metal overbraid 16 may

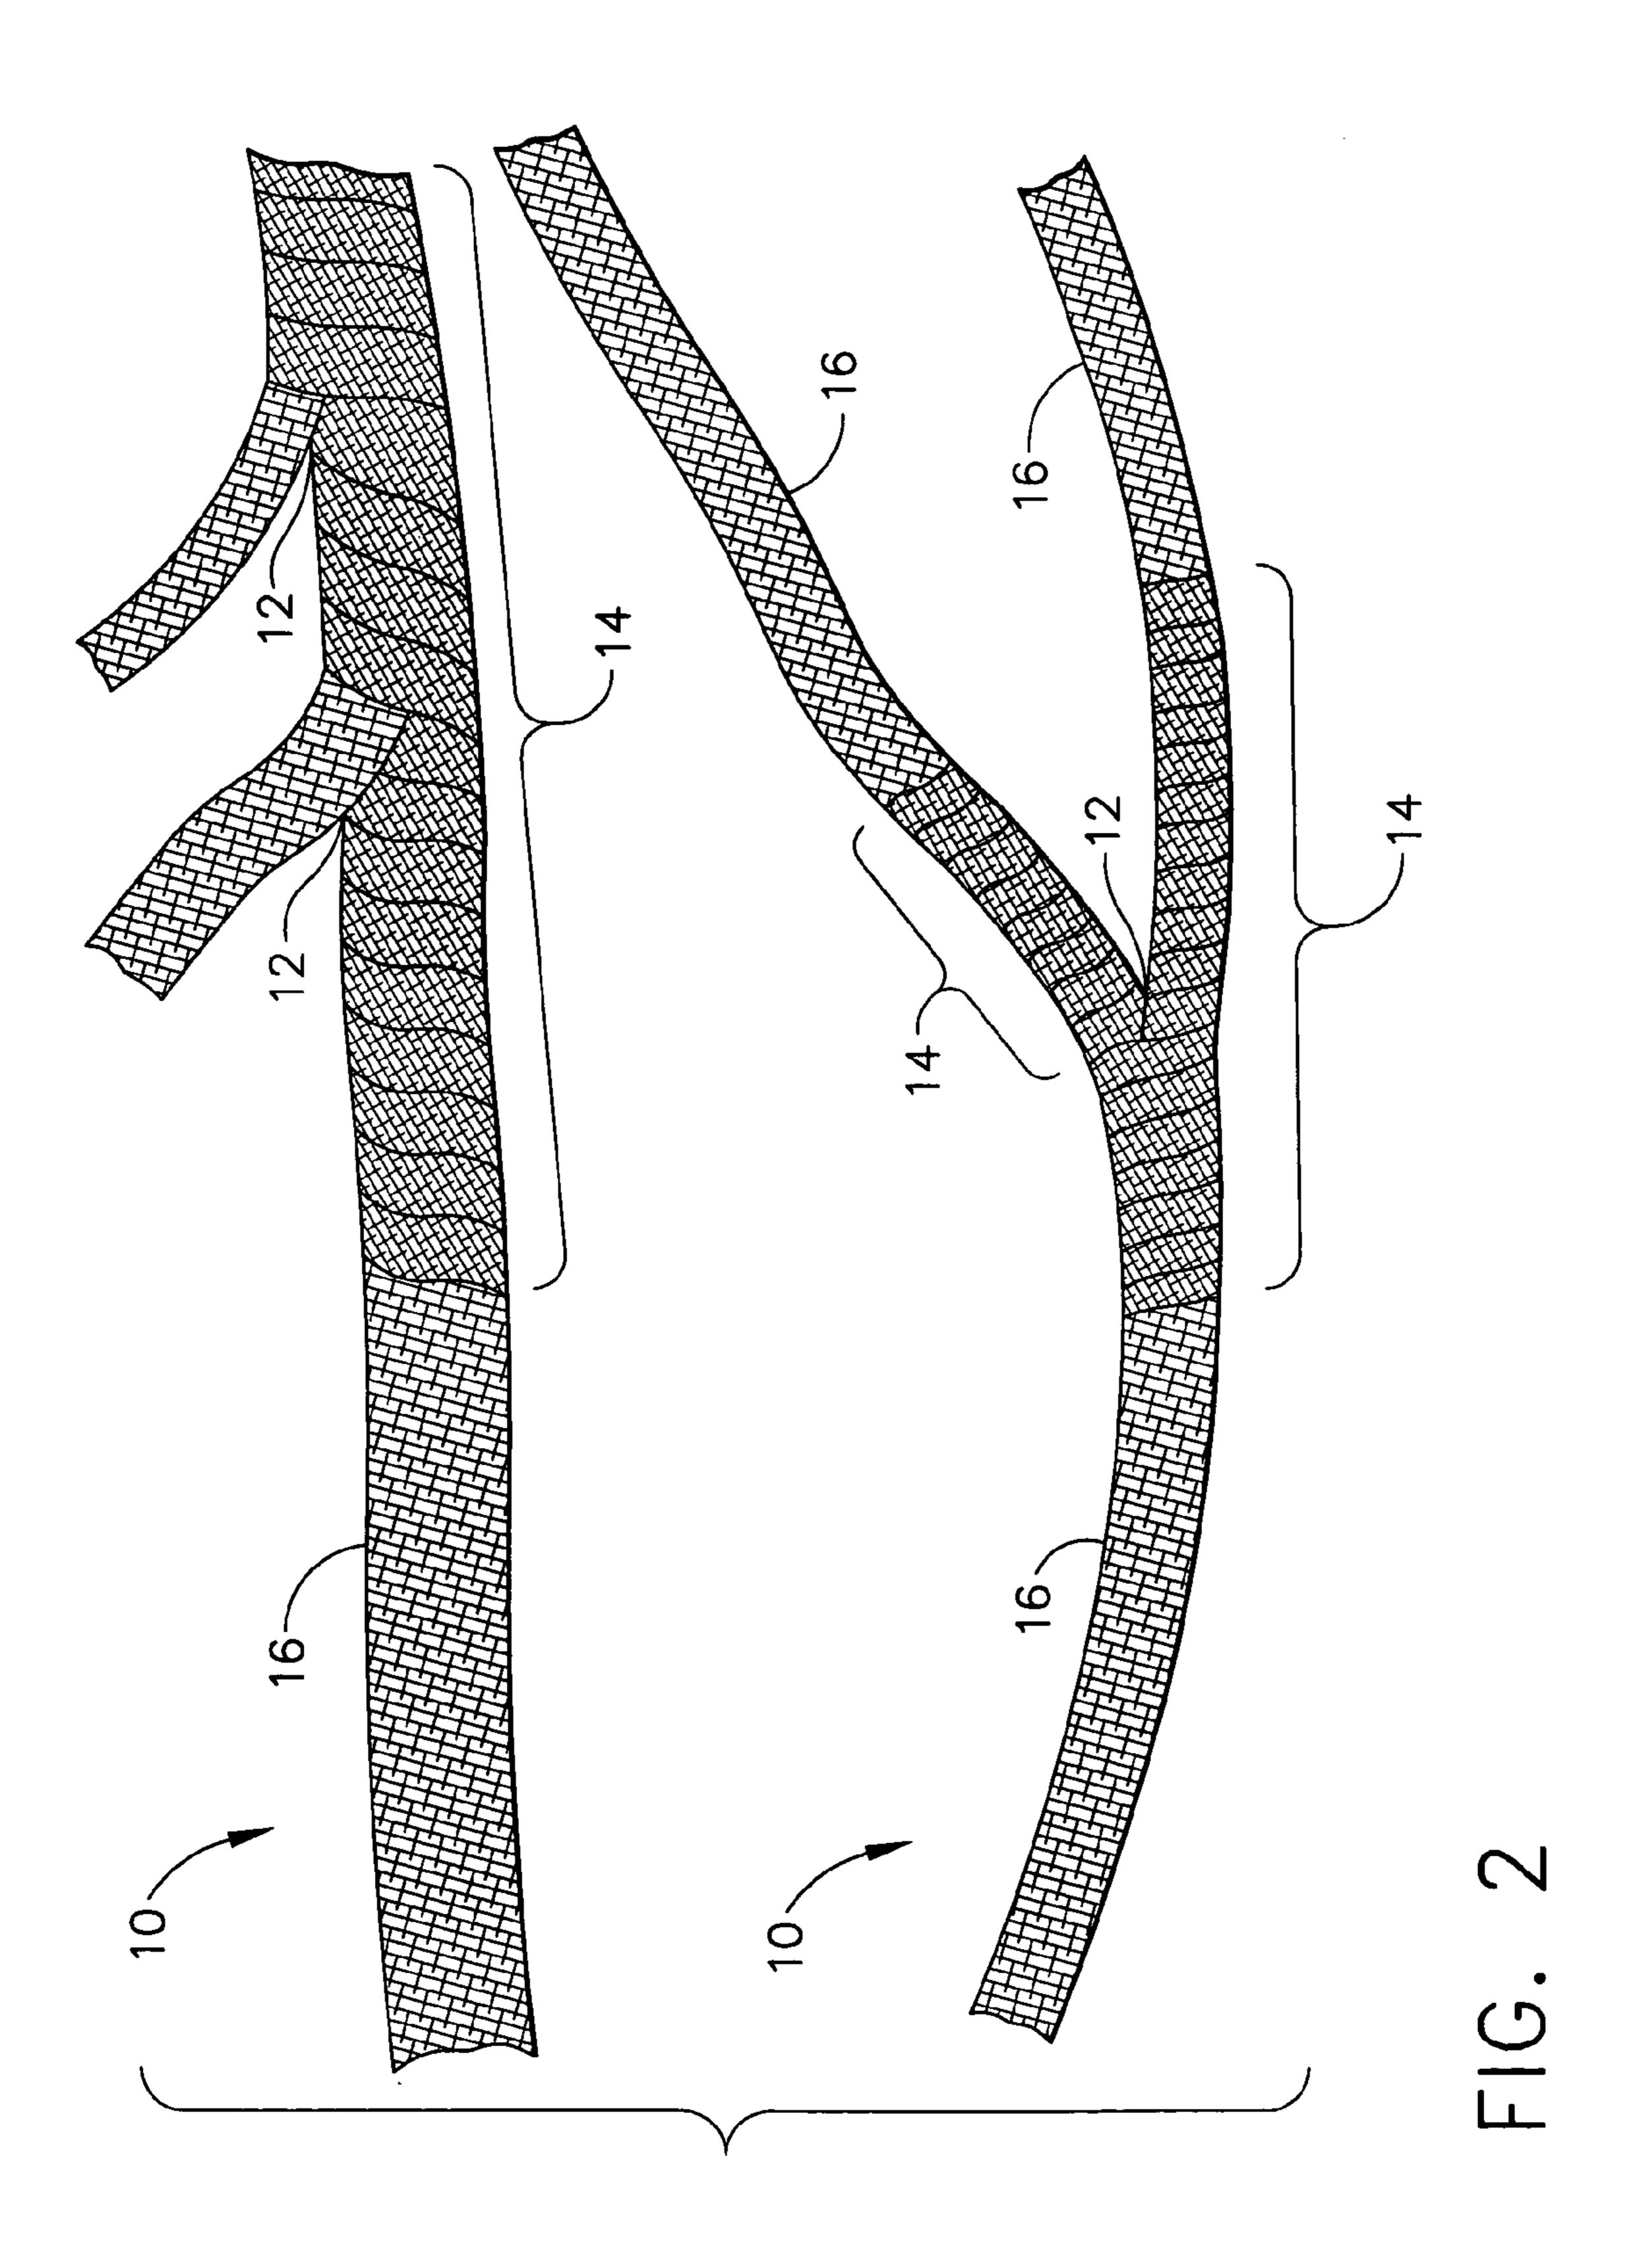
- metal overbraid of a metal overbraid wiring harness;
  - FIG. 2 illustrates a metal overbraid wiring harness;
- FIG. 3 illustrates damage to the metal overbraid of a metal overbraid wiring harness.

As shown in FIG. 2, a metal overbraid wiring harness 10 may have a plurality of harness junctions 12. The metal overbraid on either side of the harness junction 12 may comprise a double braid overlap 14, where the double braid

overlap 14 is from about 0.5 inches to about 1.5 inches from the harness junction 12. Any damage to the double braid overlap 14 of the harness may require that the harness be removed and rebraided. If the damage, however, is in the single overlap region of the metal overbraid 16, the present 5 method may be used to repair the damage. Therefore, by way of non-limiting example, the damage should be at least about 0.5 inches from the double braid overlap 14 in order to use the repair method of the present invention. It will be appreciated that the distance of the damage from the harness 10 junction 12 and/or double braid overlap 14 may depend on the individual harness to be repaired. The present method may be applicable when the damage is in the single overbraid portion of the metal overbraid wiring harness 10 and there may be sufficient distance from the double braid 15 overlap 14 to make the repair.

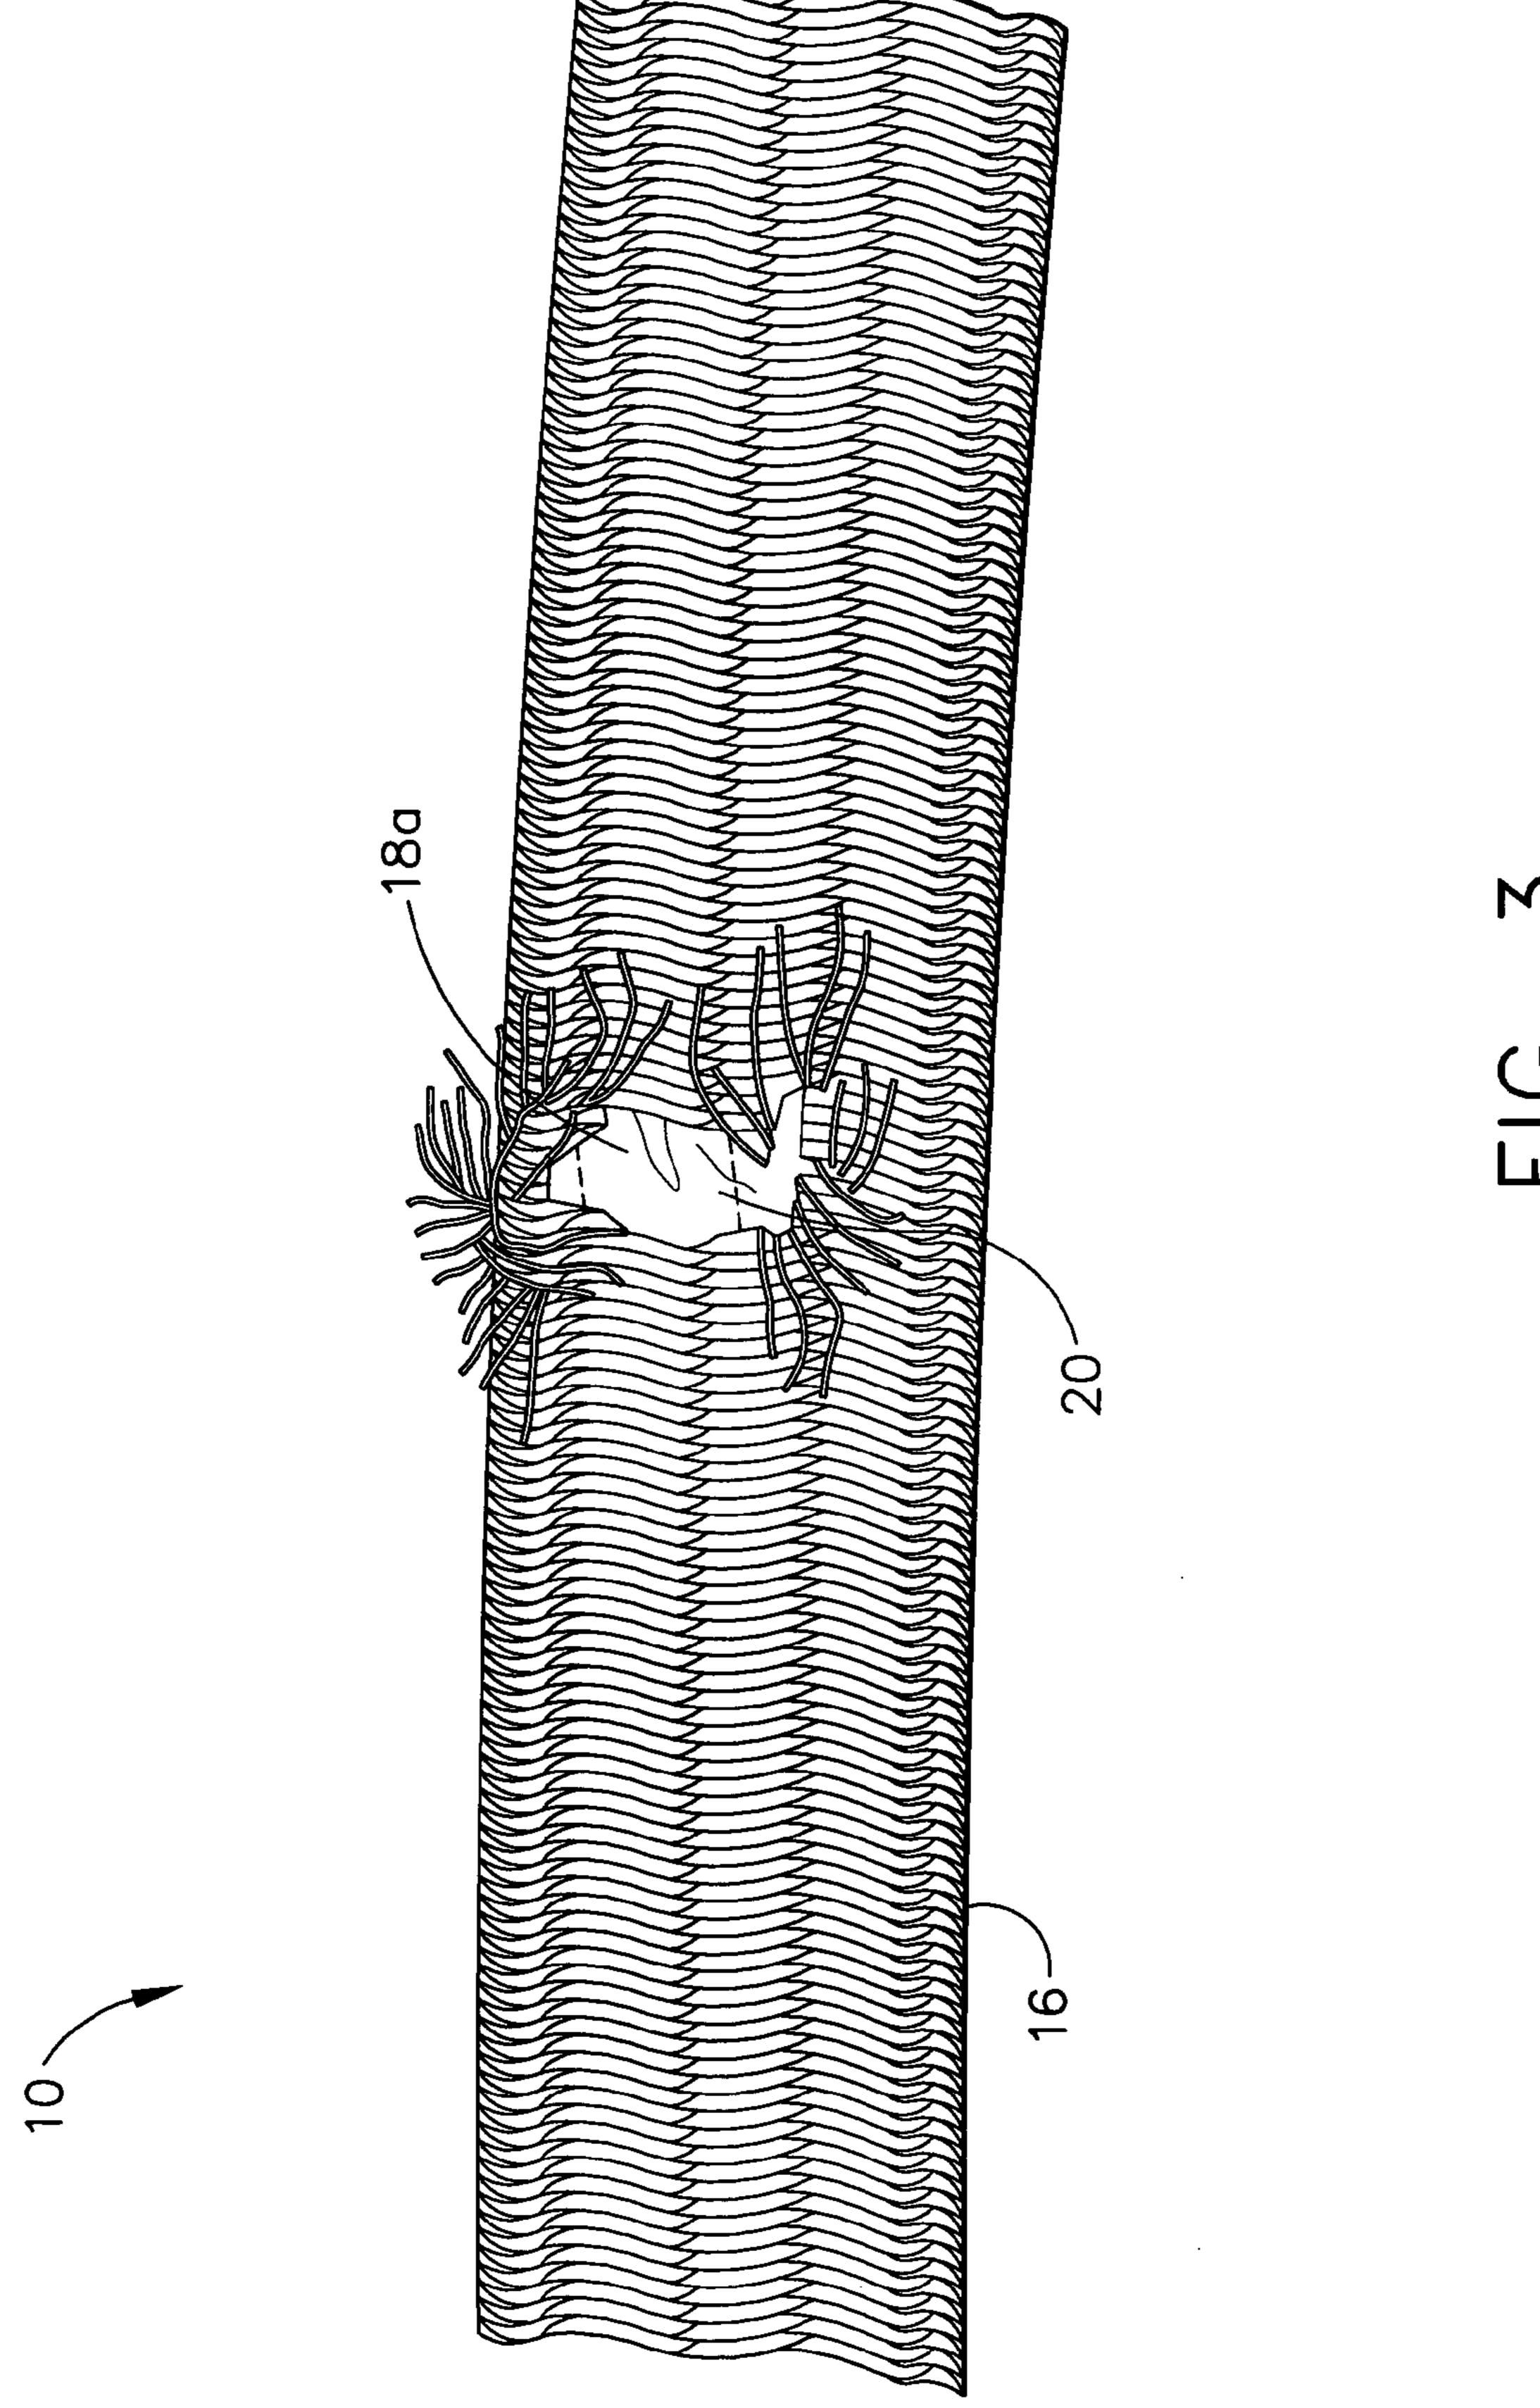
The damage to the metal overbraid may be any damage that threatens the integrity of the wiring harness. The damage may be a hole in the metal overbraid or a frayed area of the overbraid, with the potential for forming a hole in the 20 overbraid. As shown in FIG. 3, damage to the wiring harness 10 may be a hole 18a in the metal overbraid 16 exposing the inner harness bundle 20.

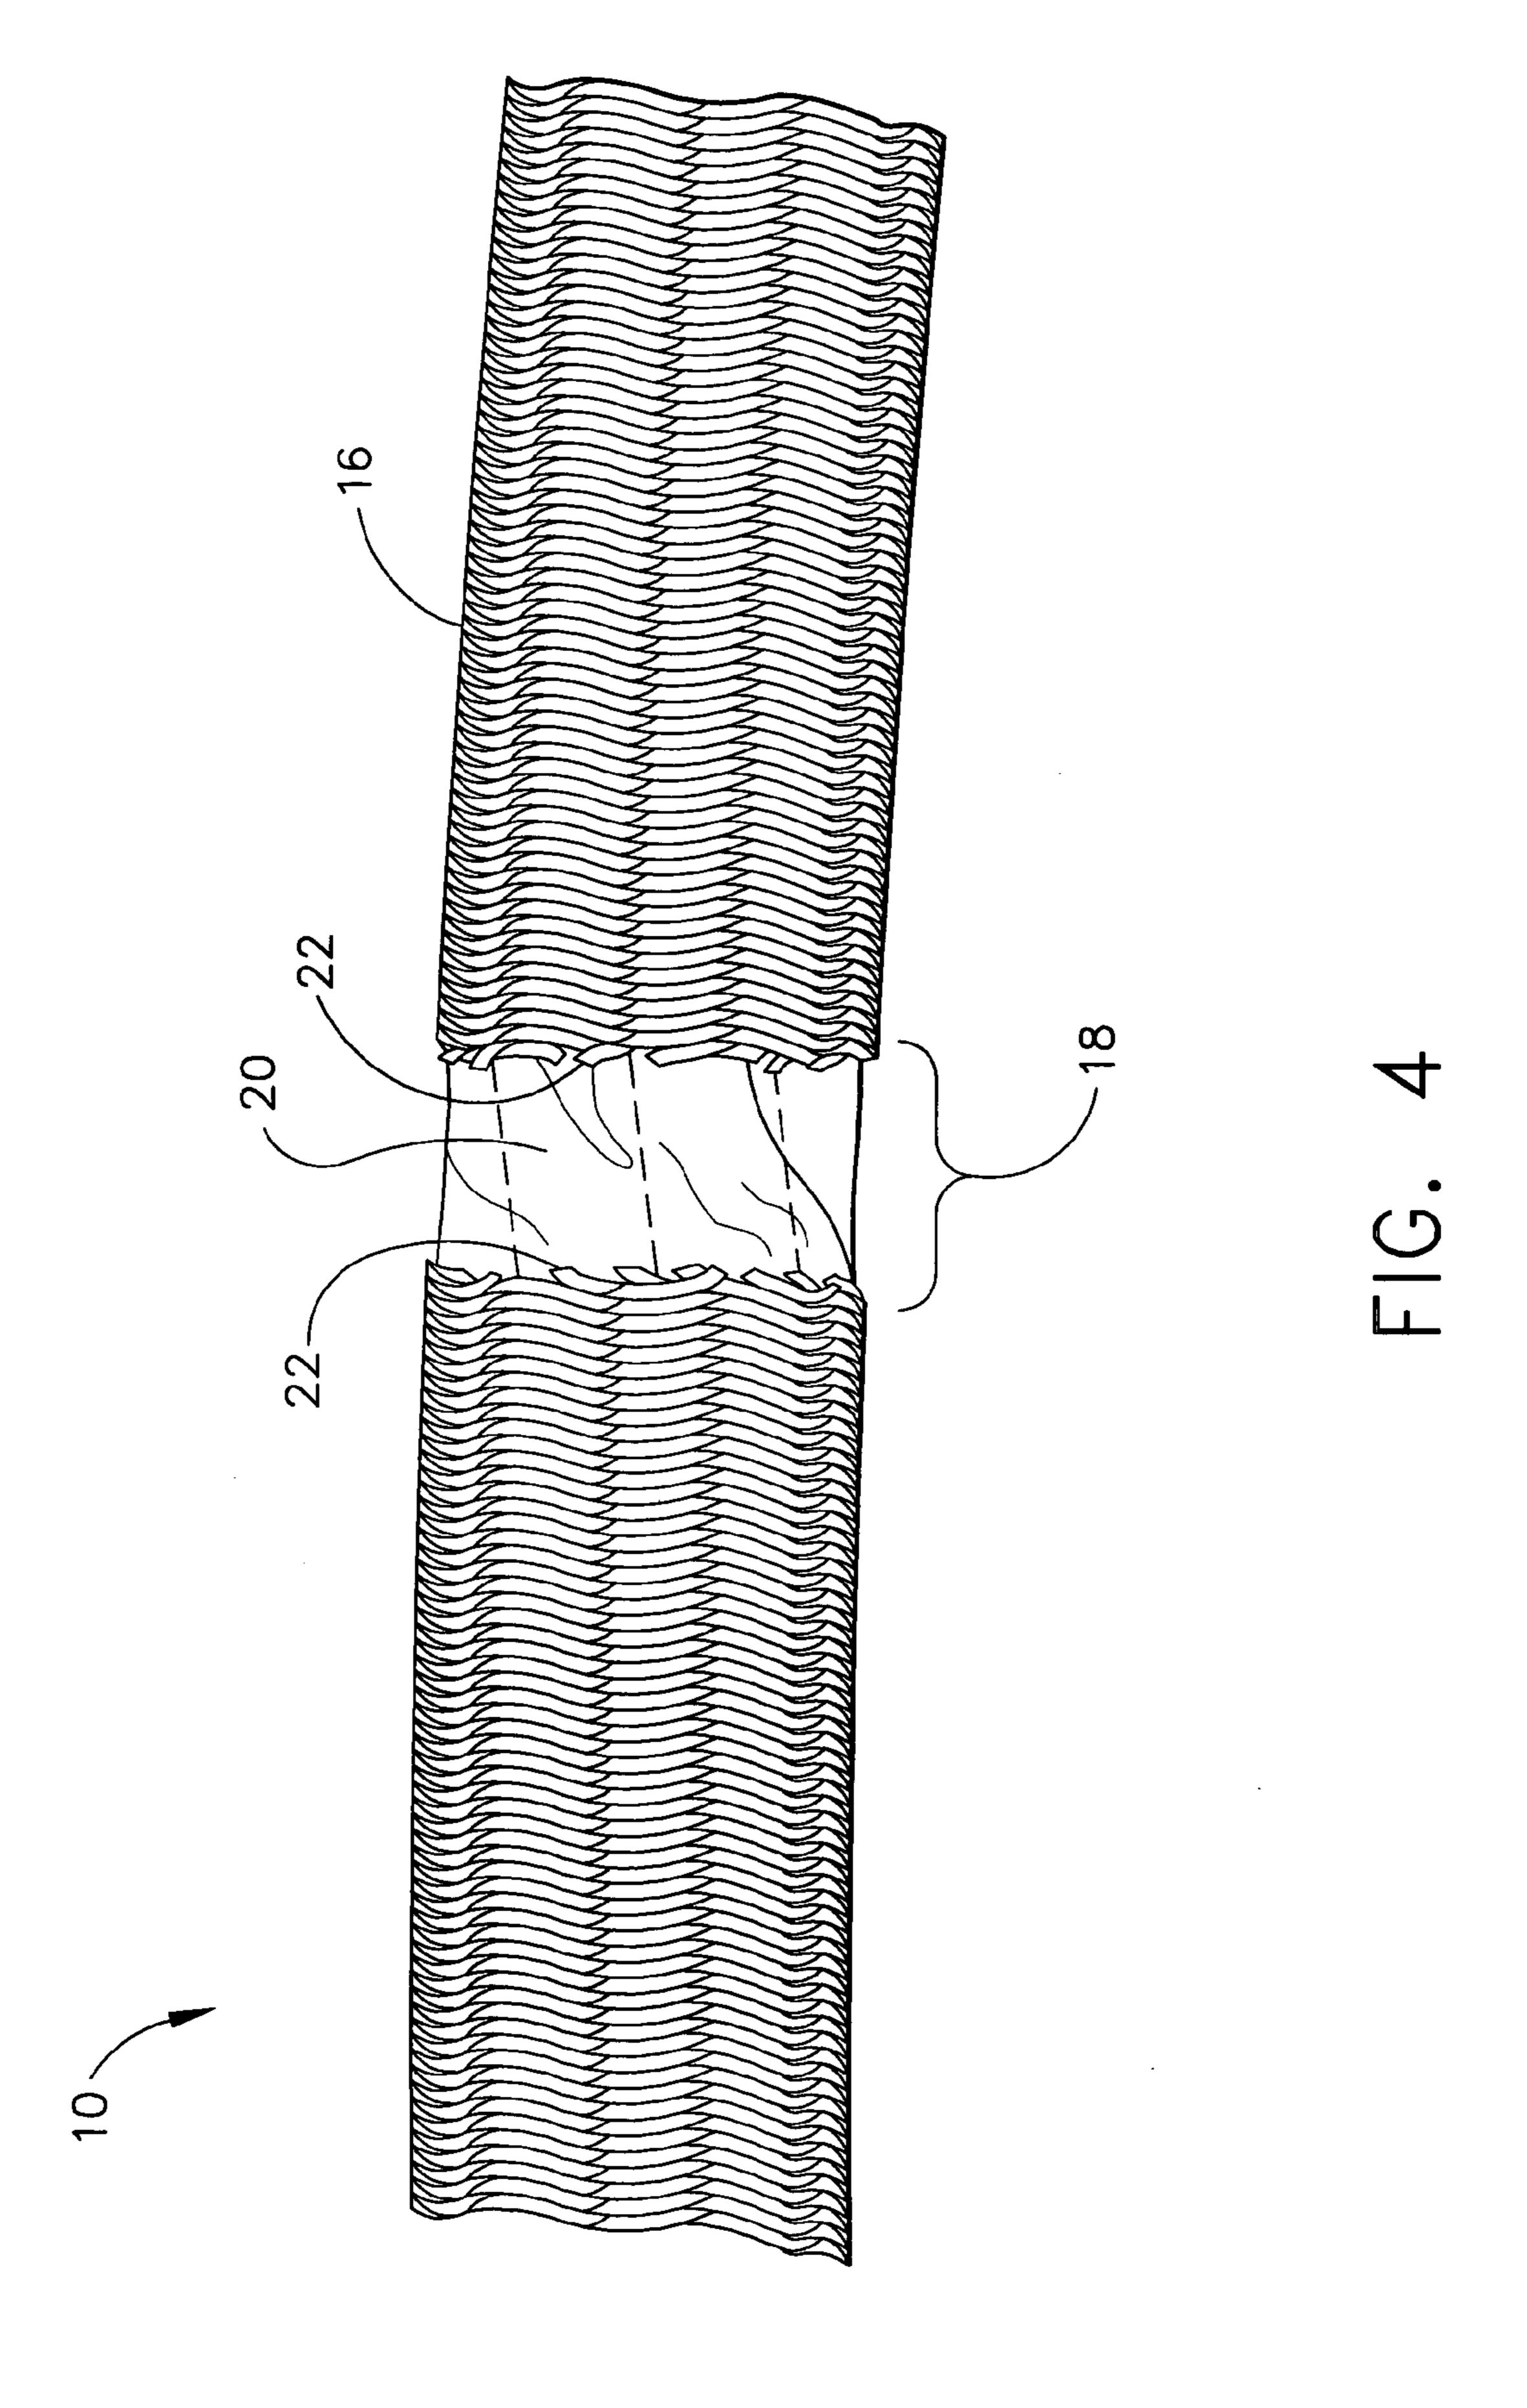
- FIG. 4 illustrates a metal overbraid wiring harness where 40 the damaged area of the overbraid has been trimmed;
- FIG. 5 illustrates a metal overbraid wiring harness where tape has been applied to the metal overbraid on both ends of a trimmed repair area;

FIGS. 4–11 help to illustrate the method of the present invention. The damaged area of the metal overbraid should 25 be free of oils, grease and/or fuel. In the first step 40, the damaged area of the metal overbraid 16 may be trimmed circumferentially, producing a repair area 18 with an exposed inner harness bundle 20 (FIG. 4). A minimal amount of the overbraid **16** may be trimmed. In one embodiment of the present invention, the repair area 18 of the metal overbraid 16 may be up to about 2 inches. In a further embodiment, the repair area 18 may be from about 0.5 inches to about 2.0 inches. Care should be taken not to damage the inner harness bundle 20. Any tool, such as but 35 not limited to, wire cutters may be used to trim the metal overbraid 16. After the damaged area has been trimmed, tape 24 may be wrapped around the metal overbraid 16 in the second step 42 of the present method. The tape 24 may be wrapped at a distance from both ends 22 of the repair area 40 18 sufficient to allow the placement of a metal cover 30 (see FIG. 8) in the repair area 18, typically from about 0.5 inches to about 1.0 inches from both ends 22 of the repair area (FIG. 5). In one embodiment, the tape 24 is wrapped about 0.75 inches from both ends 22 of the repair area 18. Any tape that 45 is removable and will prevent the overbraid from fraying may be used, such as, but not limited to, masking tape. It will be appreciated that the method of the present invention may be practiced without using the tape 24. The tape 24 is used as a guide to help in the repair of the metal overbraid 16 and 50 helps to facilitate the method. Wrapping tape 24 around the metal overbraid 16 may prevent an excessive amount of unraveling of the metal overbraid 16. Therefore, any device, such as a metal or plastic band, that works the same as the tape, may be used. Alternatively, if the tape is not applied, 55 extra care should be taken so that the overbraid does not unravel more than from about 0.5 inches to about 1.0 inches from the ends 22 of the repair area 18.

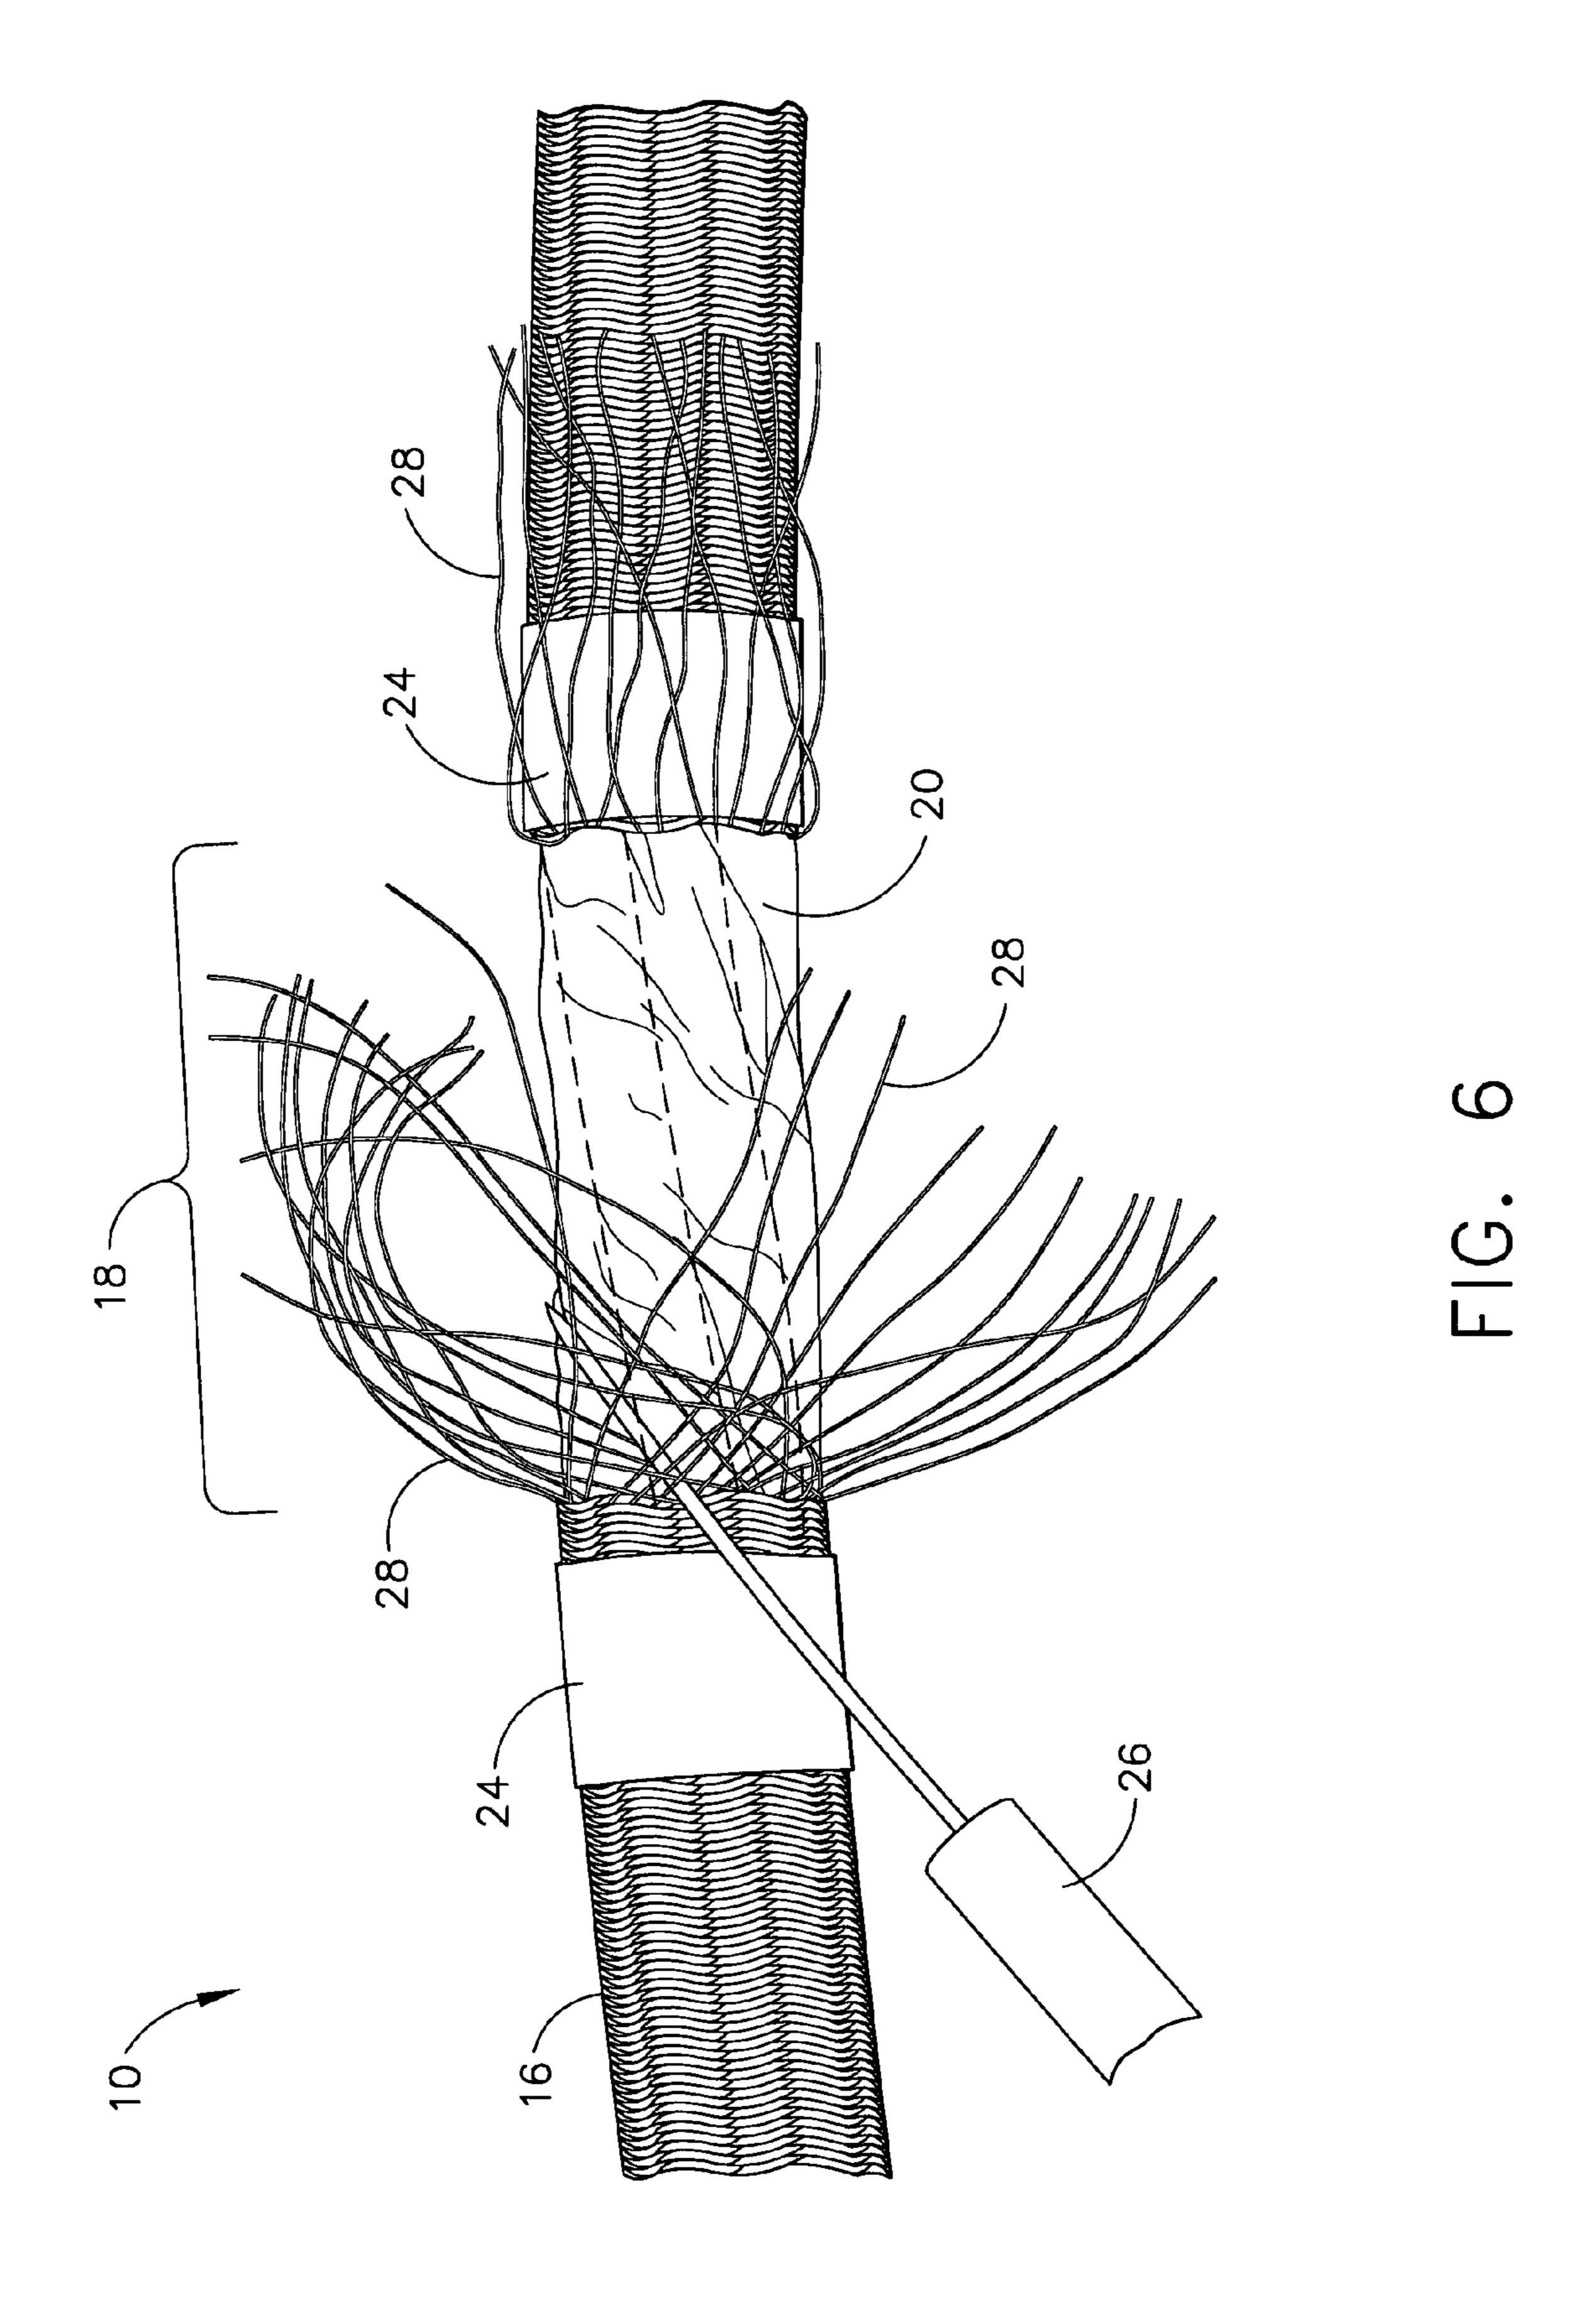
- FIG. 6 illustrates a metal overbraid wiring harness where the metal overbraid has been spread to form individual metal strands;
- FIG. 7 illustrates a metal overbraid wiring harness where a repair area is exposed by folding back the metal strands of a spread metal overbraid;

be done using a teasing needle 26 or an orange stick (not shown). It will be appreciated that any tool with a pointed end may be used to spread the metal overbraid 16. If no tape is present, then the overbraid may be spread from about 0.5 inches to about 1.0 inches from the ends 22 of the repair area 18 or an amount sufficient to produce a repair area that may be readily repaired. Once spread, the next step, step four 46, may be folding the individual metal strands 28 back over the tape 24 and away from the repair area 18, exposing the inner harness bundle 20 as shown in FIG. 7.

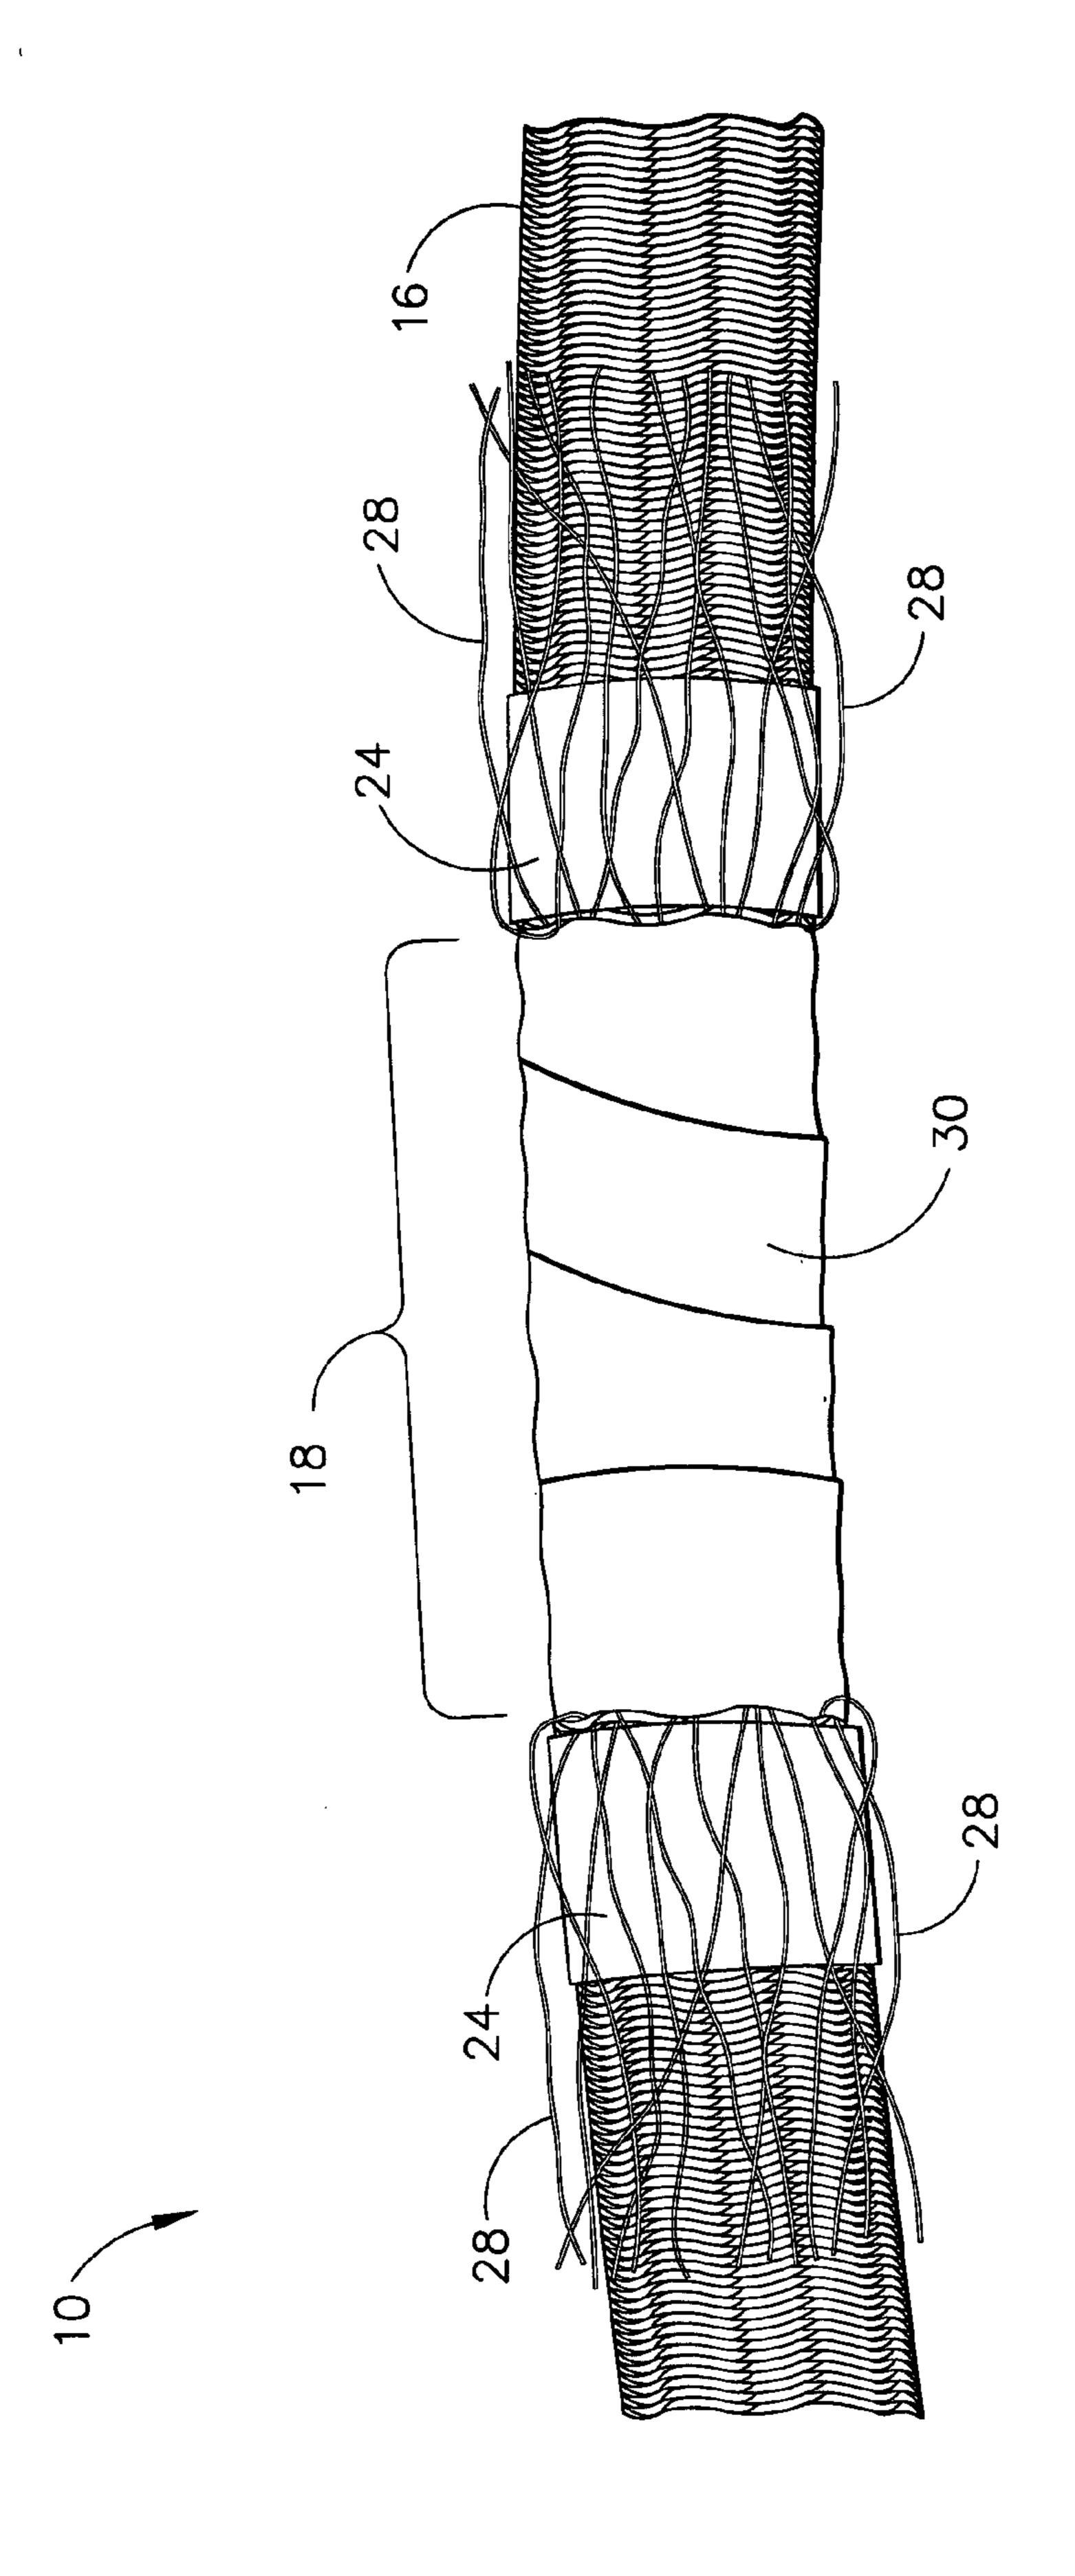
- FIG. 8 illustrates a metal overbraid wiring harness where the repair area is covered by metal tape;
- FIG. 9 illustrates a metal overbraid wiring harness where the metal strands are folded back over the metal tape;

In the next step, step five 48, an electrically conductive material may then be placed over the repair area. By way of non-limiting example, a metal cover 30 may then be applied to the repair area 18. The metal cover 30 may cover the repair area 18 completely, with no metal strands 28 caught under the metal cover 30 (FIG. 8). The electrically conductive material, including metal cover 30, is any material that has conductivity substantially similar to that of the metal overbraid 16. By substantially similar, it is meant that the conductivity of the electrically conductive material should vary by no more than about 5% from the overbraid material. Non-limiting examples of electrically conductive materials are metal foil tape and tin foil. The metal cover 30 provides protection for the inner harness bundle 20 and conductivity.
