# (10) Patent No.: US 7,219,424 B2

### (54) METHOD FOR TEMPORARY REPAIR OF THE OVERBRAID FOR METAL OVERBRAIDED WIRING HARNESSES

(73) Assignee: Honeywell International, Inc.,

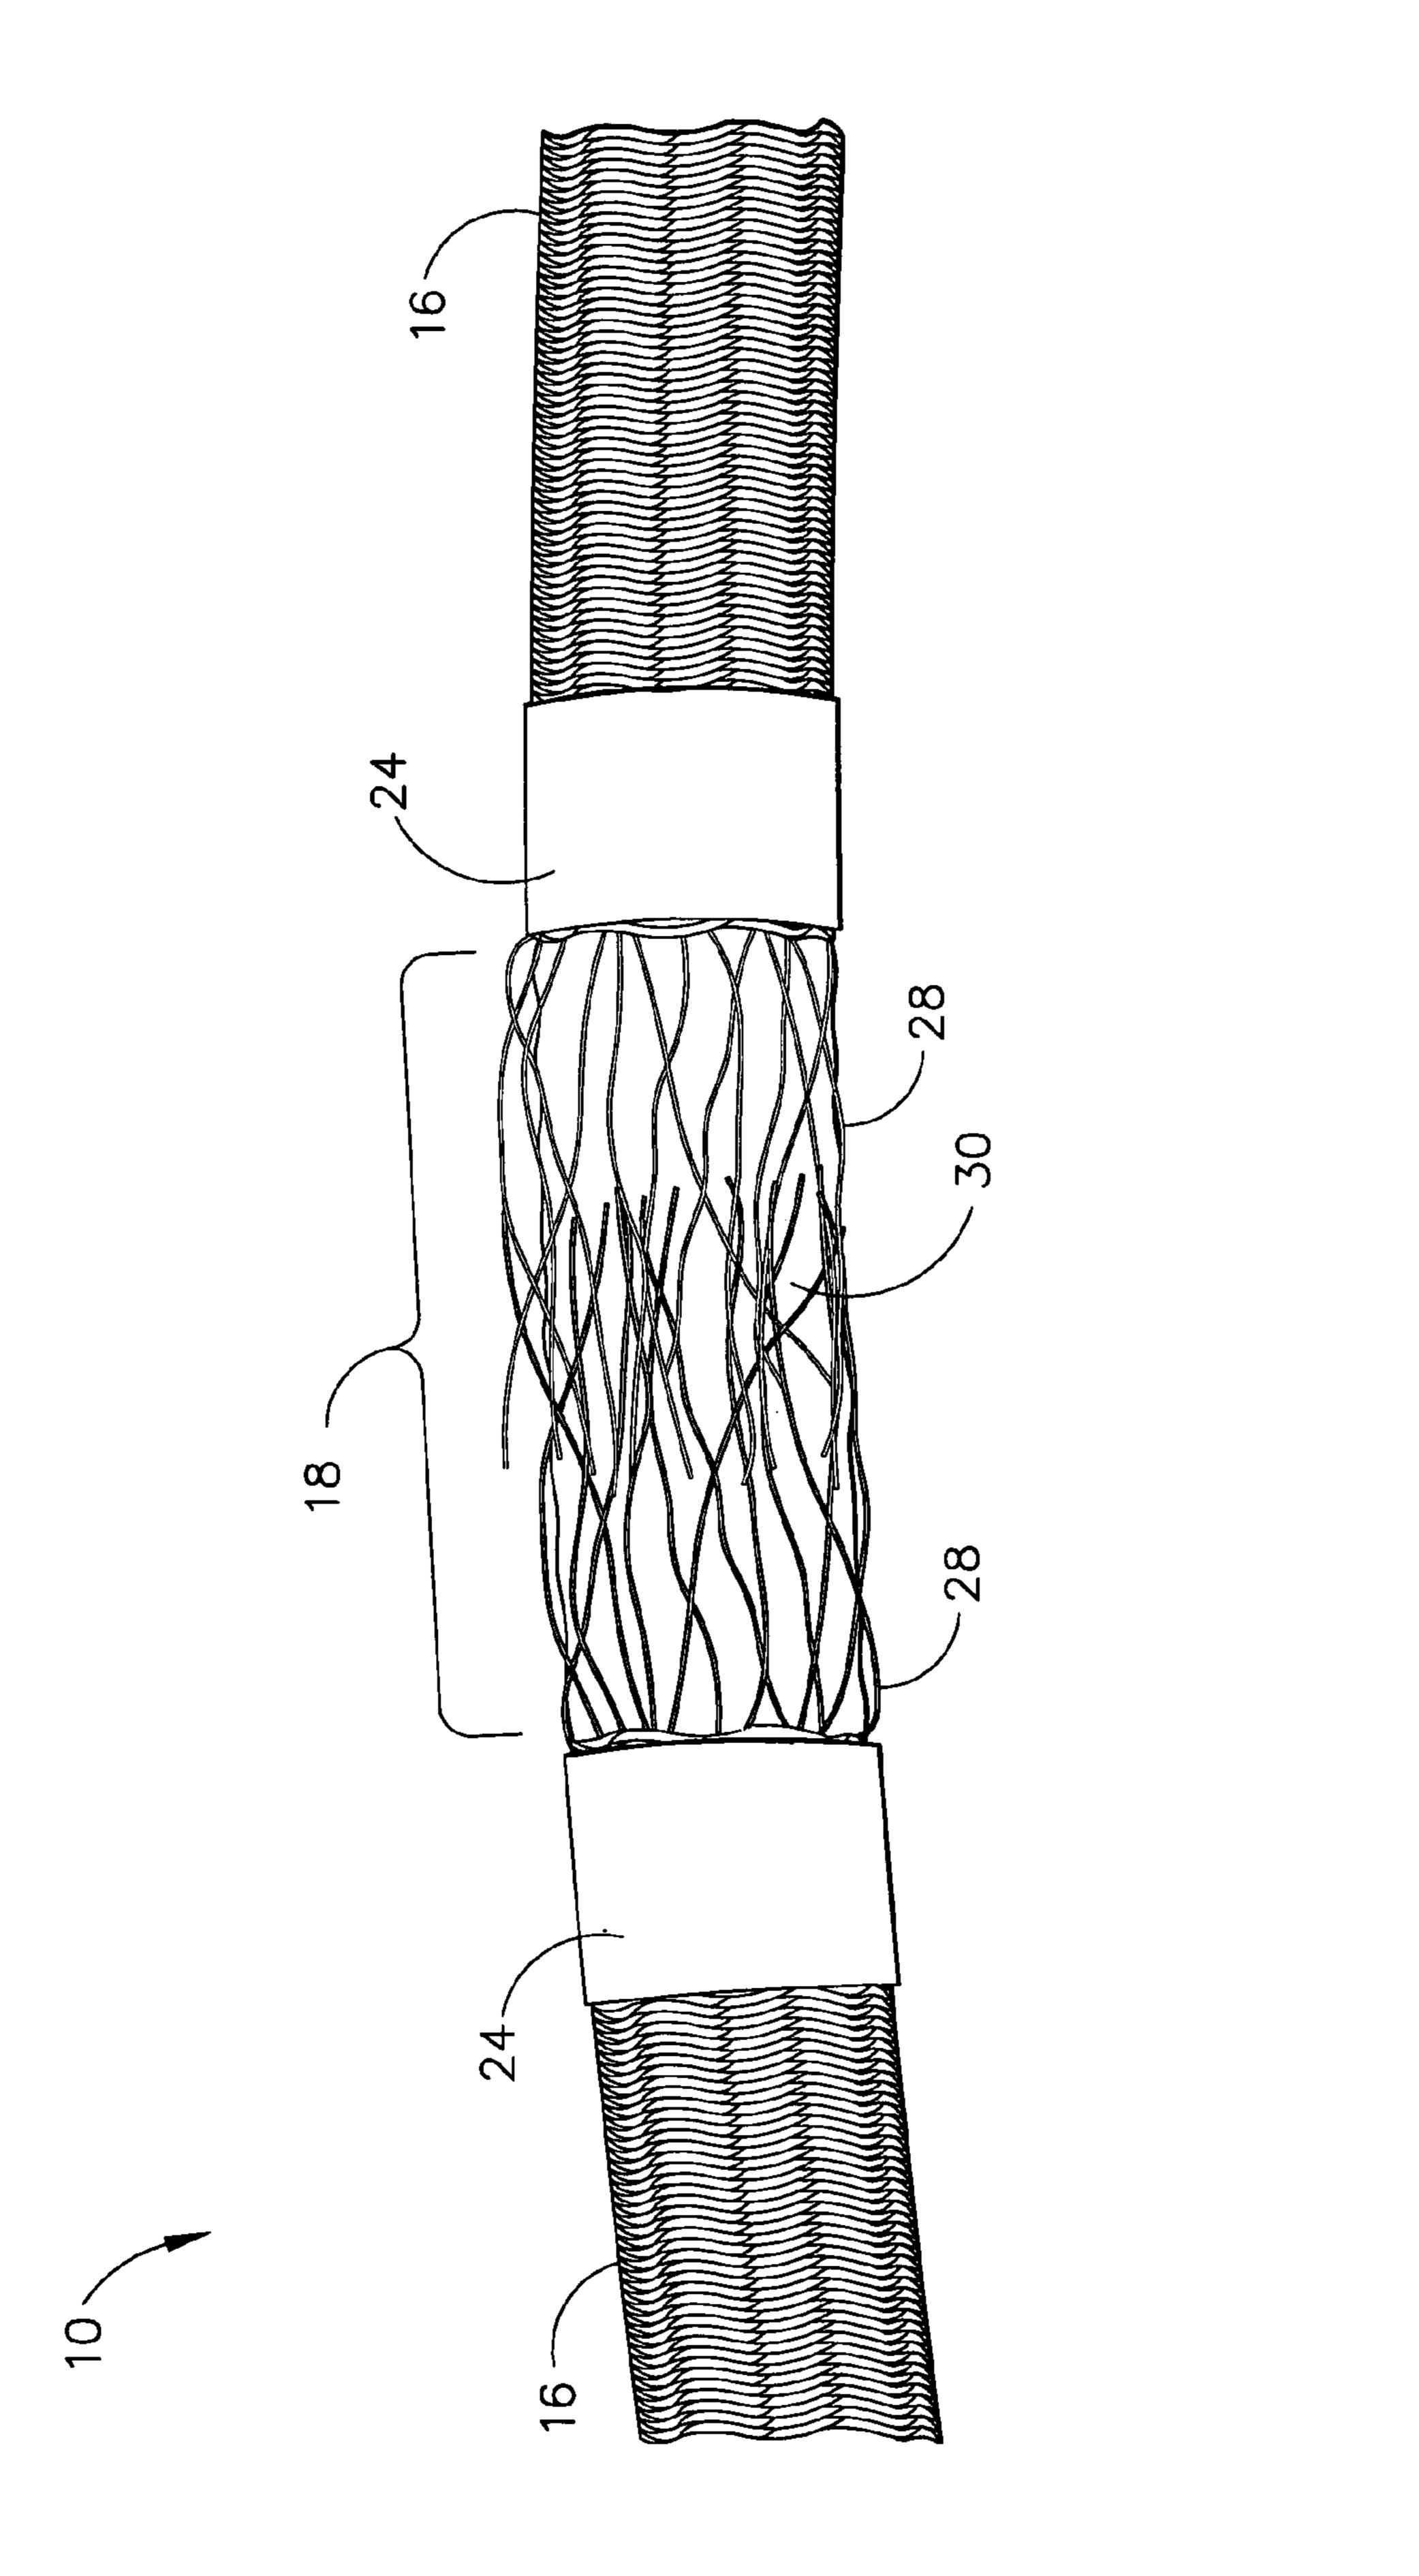
- FIG. 8 illustrates a metal overbraid wiring harness where the repair area is covered by metal tape;
- FIG. 9 illustrates a metal overbraid wiring harness where the metal strands are folded back over the metal tape;

After covering the repair area 18 with an electrically conductive material, the next step may be moving the metal overbraid back over the repair area 18. If the metal overbraid 16 has been spread into individual metal strands 28, the metal strands 28 may be folded back over the repair area 18 as in step six 50 and as illustrated in FIG. 9. If the strands are too long, they may be trimmed near the center. After the metal strands 28 are folded back over, the tape 24 (or any equivalent) may be carefully removed.

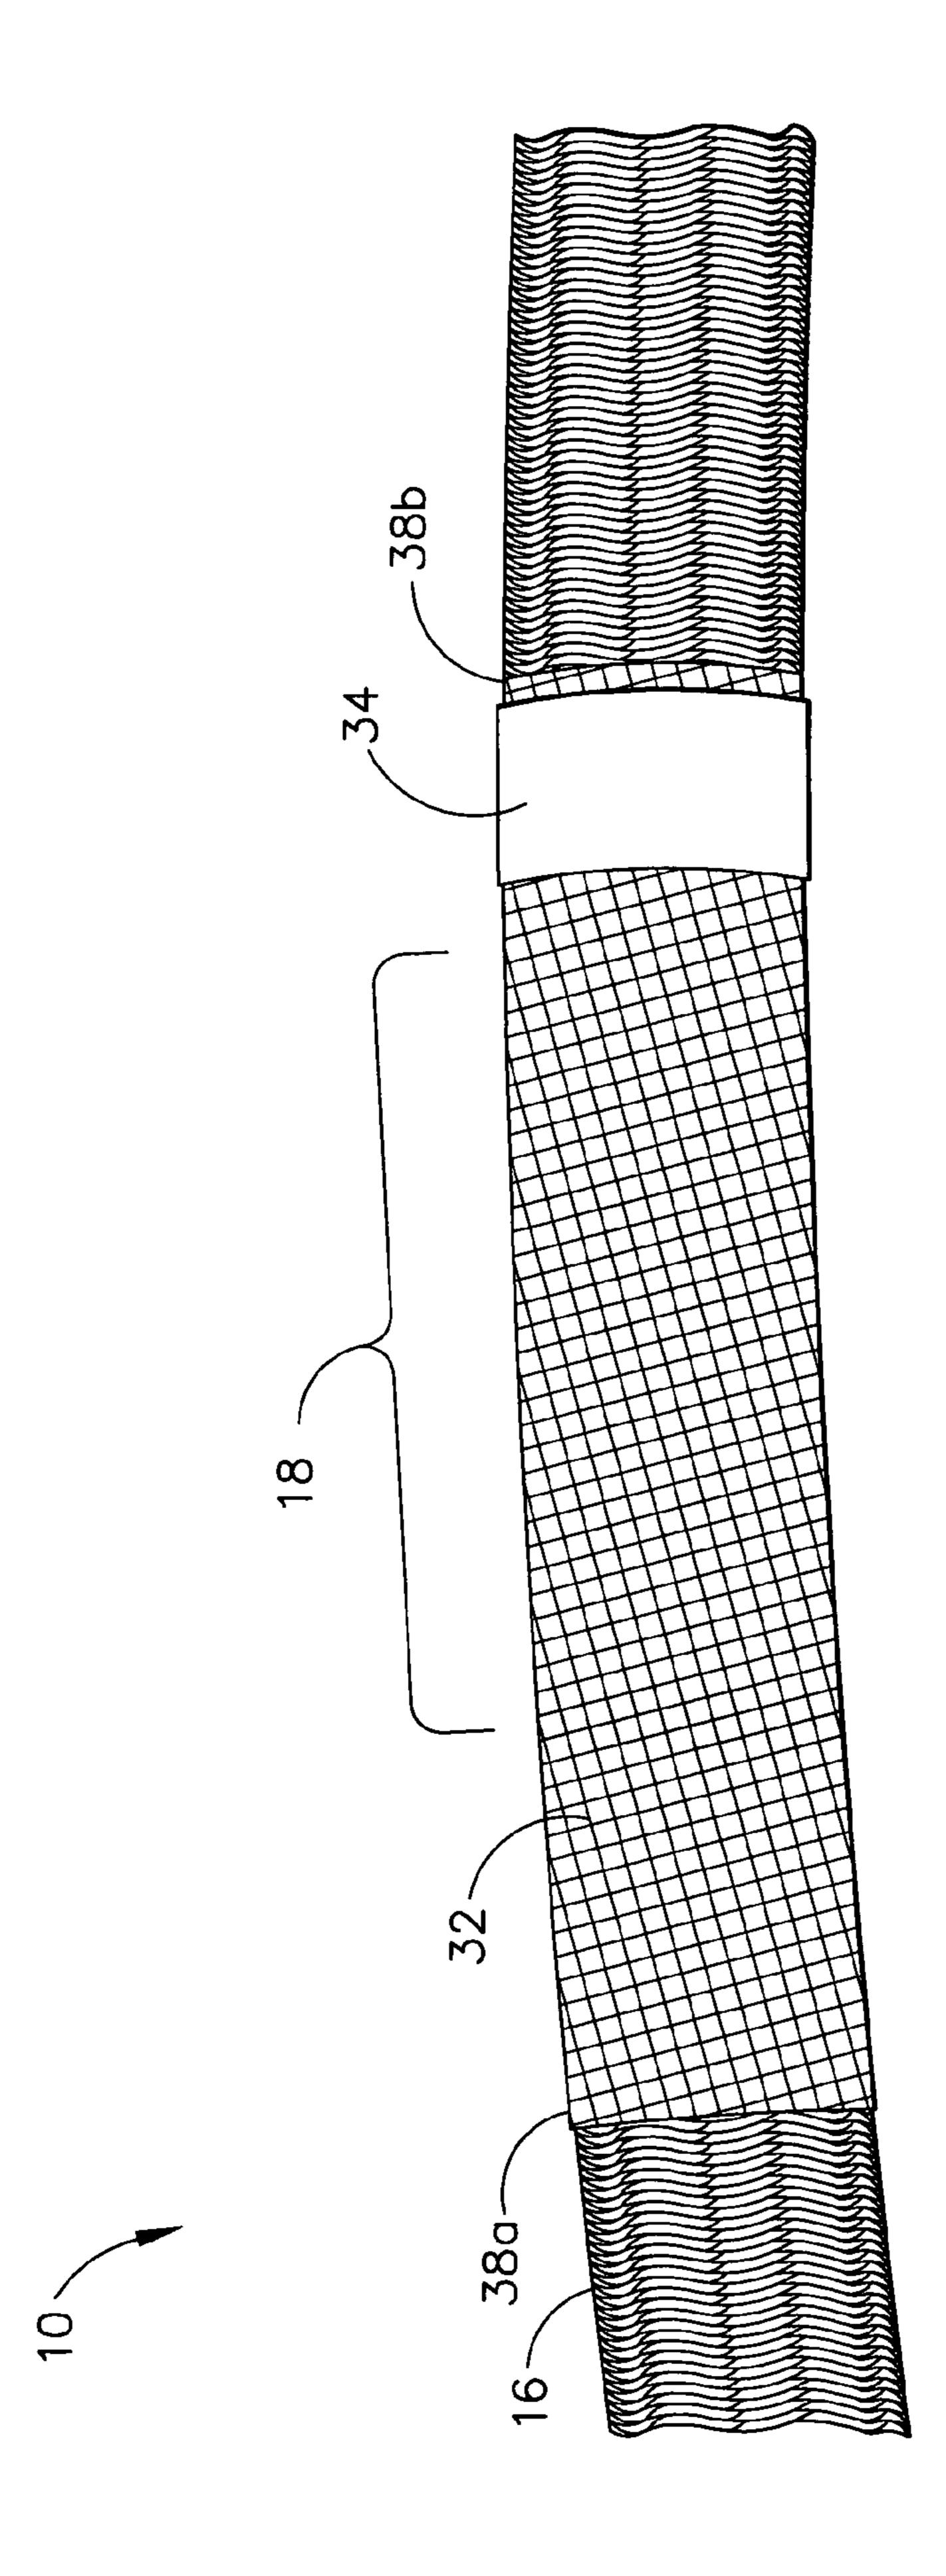
- FIG. 10 illustrates a metal overbraid wiring harness where a wire mesh screen is placed over the repair area; and
- FIG. 11 illustrates a metal overbraid wiring harness where the wire screen mesh is secured to the metal overbraid.

In the next step **54** the repair area **14** may be covered with wire screen mesh 32 which is secured to the metal overbraid wiring harness 10 (FIG. 10). The wire screen mesh 32 may be chosen so that once applied, it has the same visual density as the metal overbraid 16. Also, once applied, it may provide the same flexibility as the original overbraid. Moreover, the wire screen mesh 32 should have substantially similar conductivity as the metal overbraid 16. By substantially similar, it is meant that the wire screen mesh 32 should vary by no more than about 5% from the overbraid material. The wire screen mesh 32 may need to be temporarily secured to the metal overbraid wiring harness. The wire screen mesh 32 may be temporarily secured by overlapping the wire screen mesh 32 on itself to capture an end and/or by tape or other physical means. For example, fiberglass tape 34 may be used.

By way of non-limiting example, a 1 inch wide wire screen mesh 32 may be used. Starting at one end 38a of the repair area 18, the wire screen mesh 32 may be overlapped tightly on itself to capture the end. The mesh 32 may be tightly and firmly stretched while being wrapped around to completely cover the repair area 18. As the mesh 32 is wrapped around, it should overlap at least 50% of its width. It may be secured on the finishing end 38b with a wrap of fiberglass tape 34 (FIG. 10).

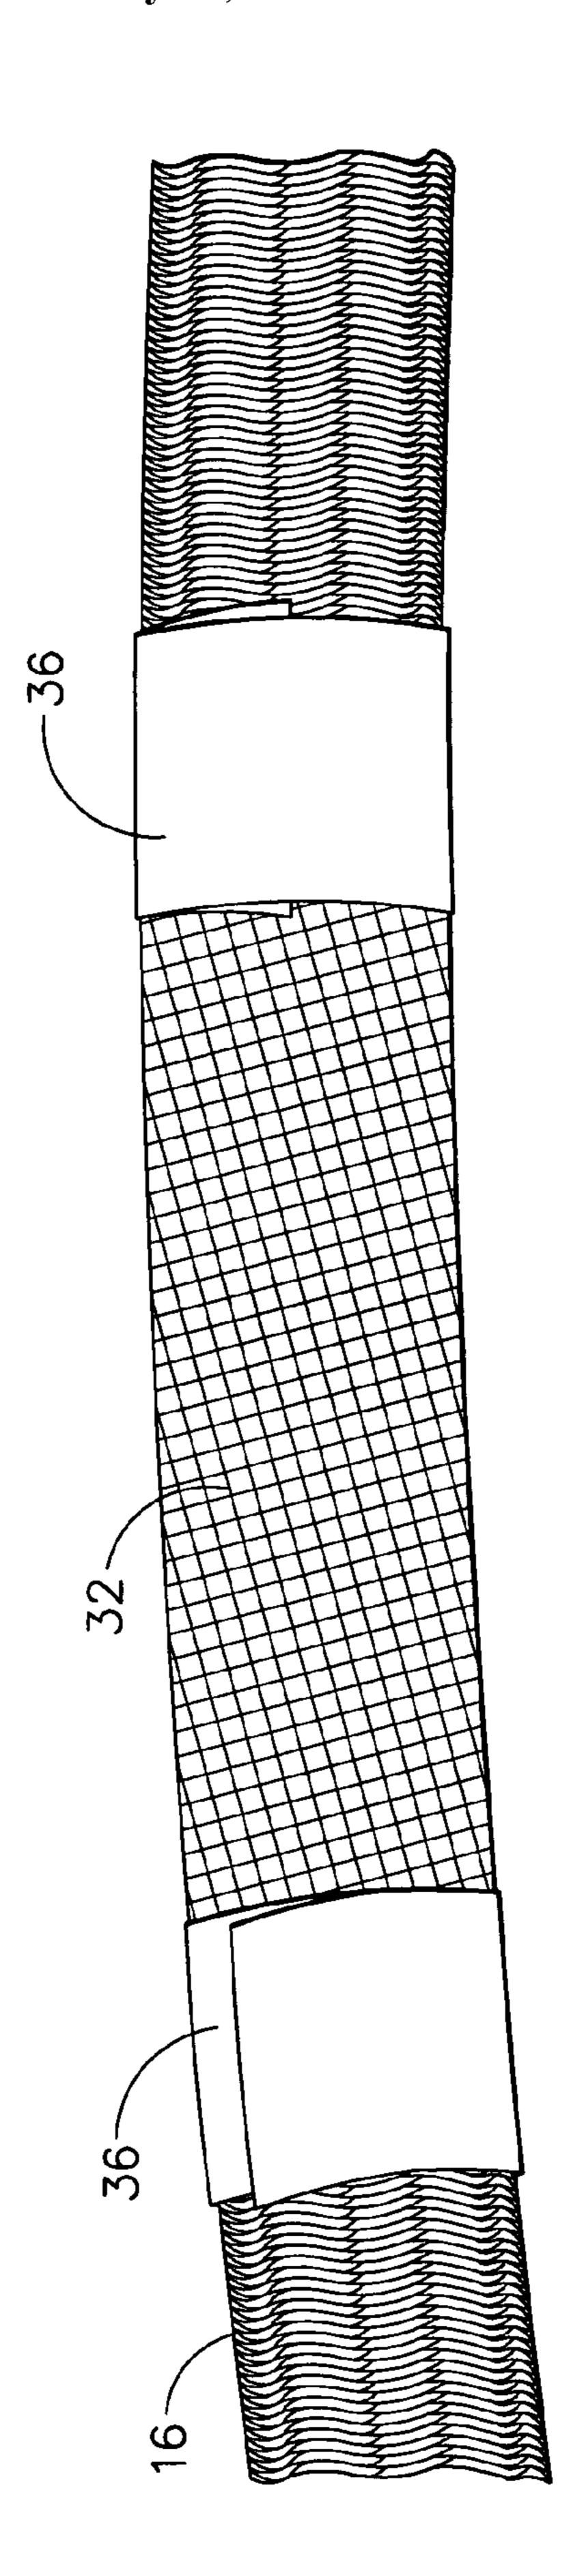
In the final step 56 the mesh 32 may be secured to the wiring harness 10. Although heat shrink tape 36 is used illustratively in FIG. 11, any means may be used as long as a strong seal is formed so that the mesh remains secure under operating conditions for the wiring harness 10 and the conductivity of the wiring harness 10 is not affected. As

illustrated in FIG. 11, heat shrink tape 36 may be centered over each end 38a,b of the wire screen mesh 32 and heated to form a seal. It may be desirable to have a heat shrink tape 36 with a high temperature range rating. The heat shrink tape 36 may have a temperature range rating of, by way of non-limiting example, from about 250° F. to about 500° F. Heat shrink tape 36 with a high temperature rating may be made of polytetrafluoroethylene, commonly known as Teflon®. A non-limiting example of a suitable heat shrink tape is Raychem TMS-WM shrink tape.
