(10) **Patent No.:** **US 7,401,570 B2**  
(45) **Date of Patent:** **Jul. 22, 2008**

(54) **AIRCRAFT EXTREMITY MARKER**

A marker for the wingtip or other extremity of an aircraft. The marker includes a fabric pouch having a flap containing hook and loop fasteners, to hold the pouch on the aircraft extremity. A fabric tube extends outwardly and substantially horizontally from the pouch and supports a marker flag at its tip. The fabric tube contains a breakable support rod, so that if the aircraft wingtip collides with an object, the support rod will break and the flag will droop, providing a visible indication that a collision has occurred. The broken rod can then be replaced.

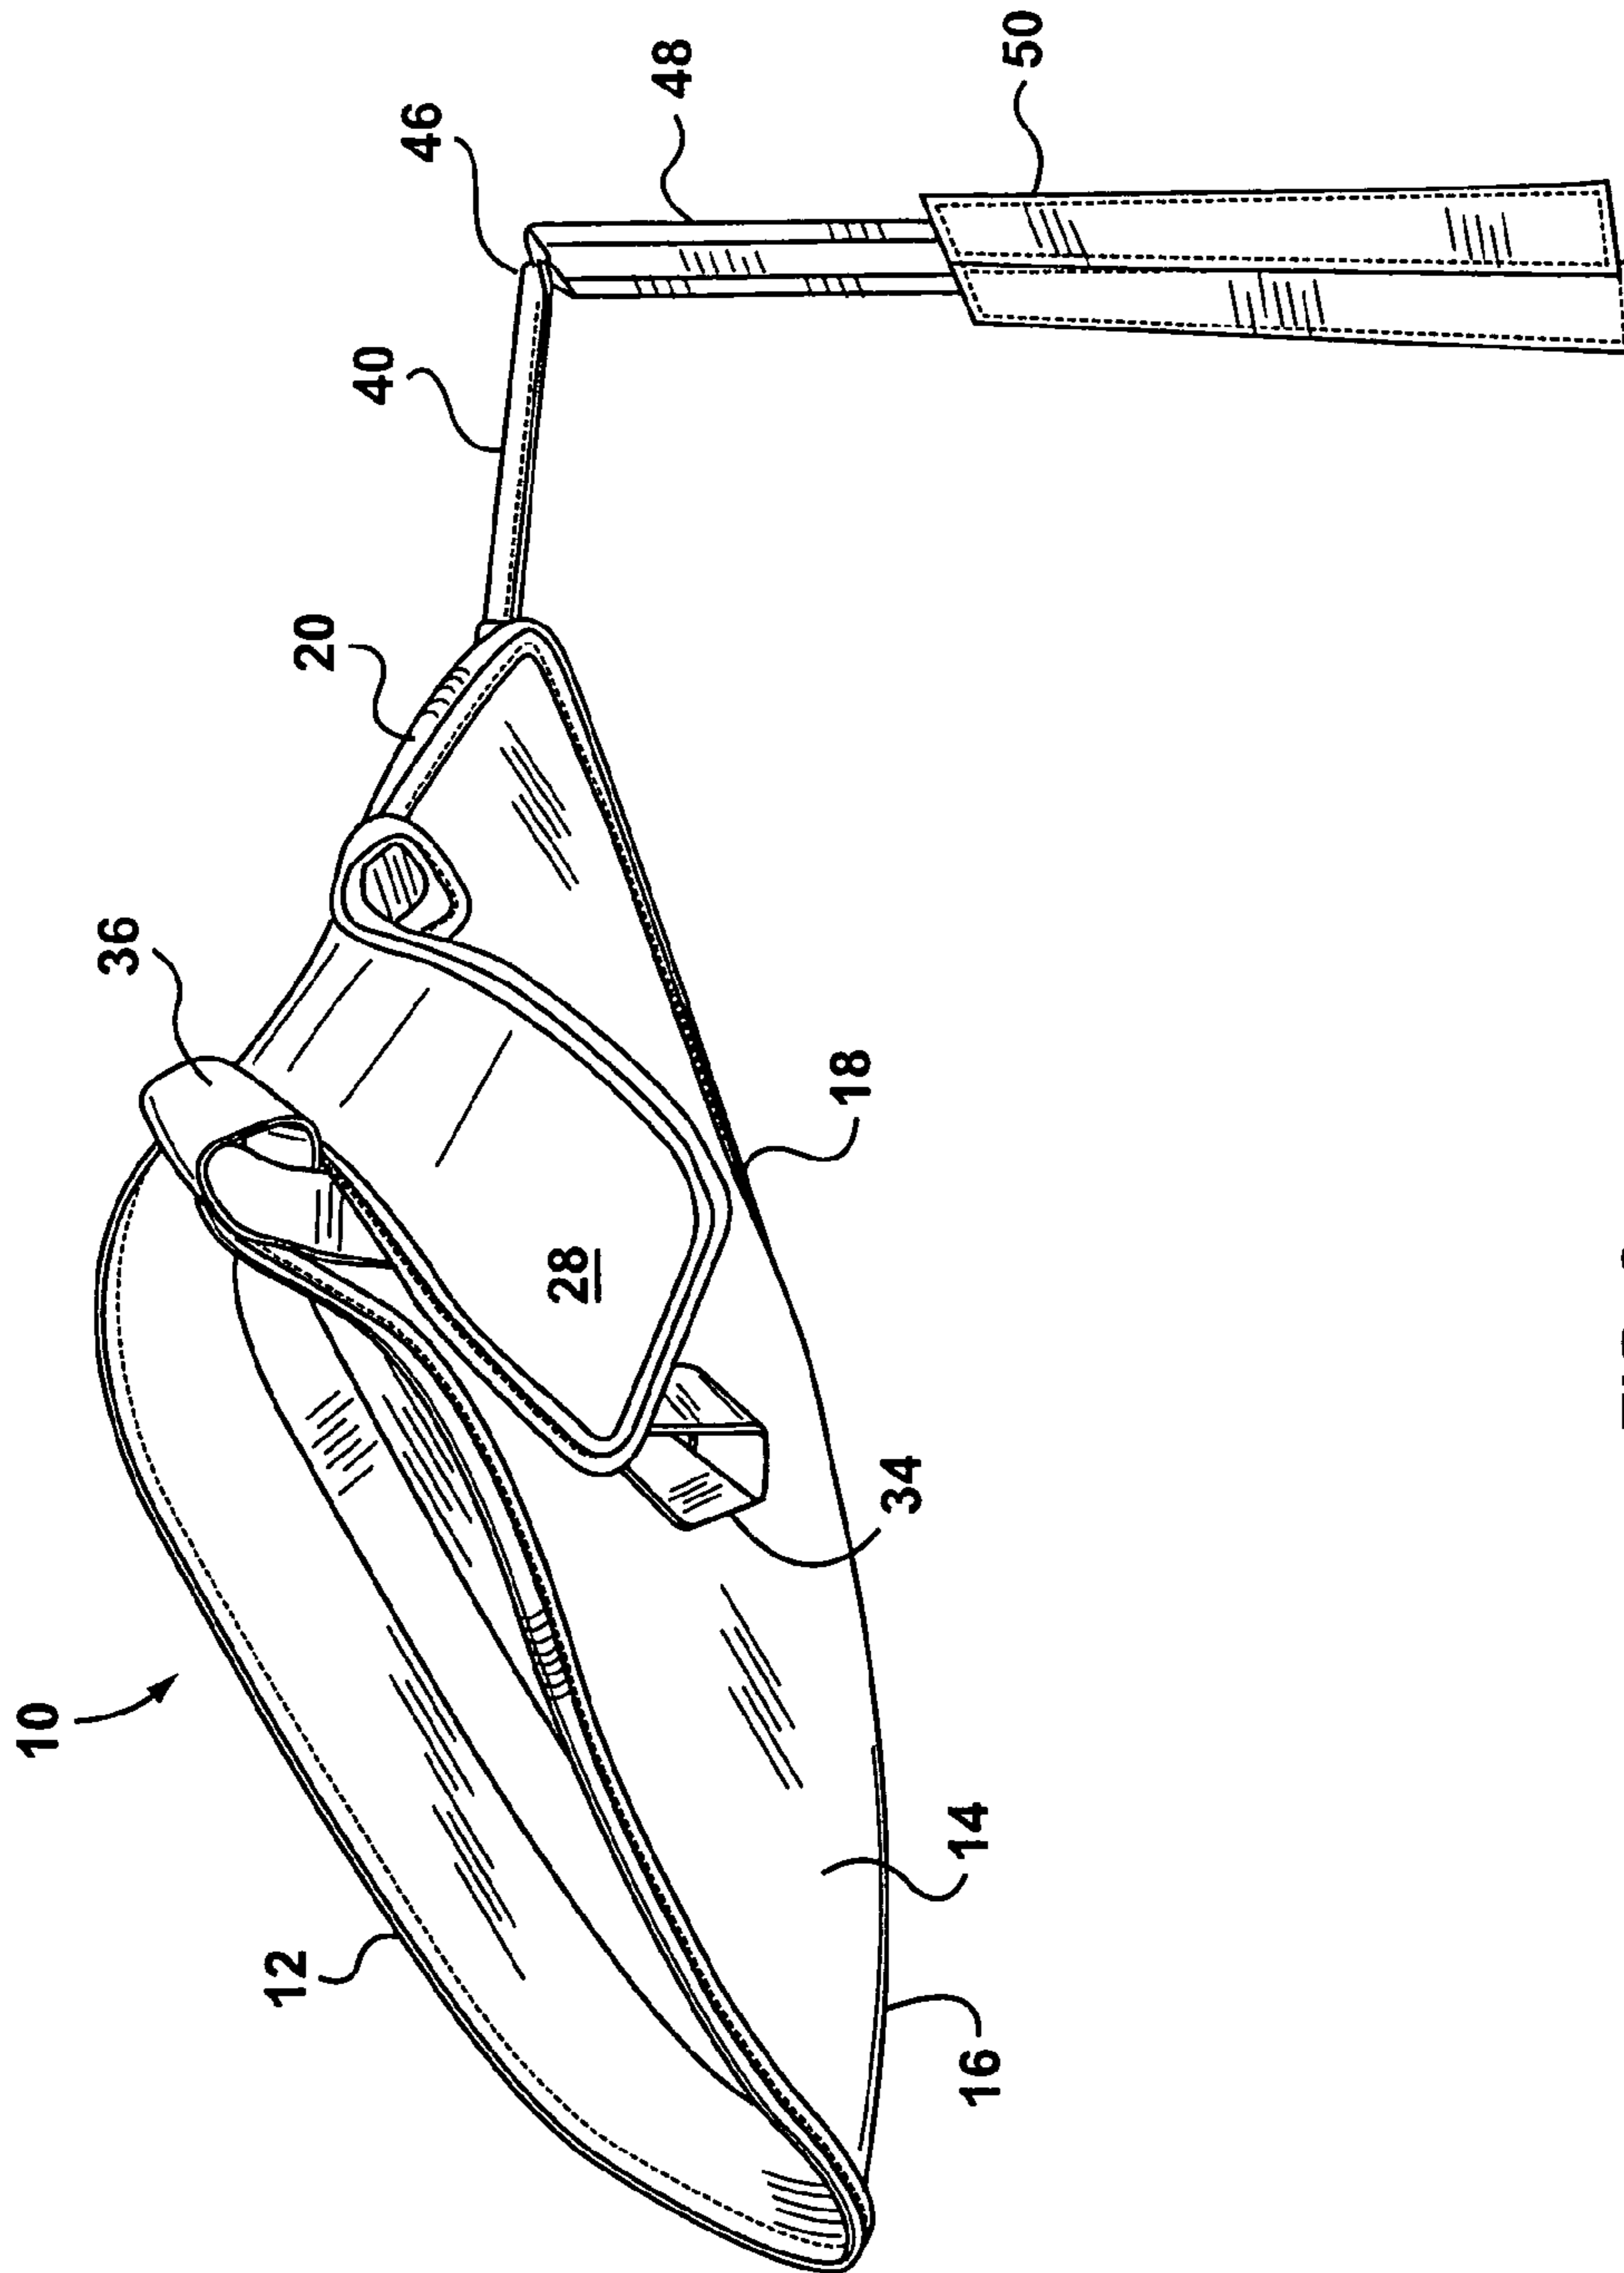
**FIG. 3**

FIG. 3 is a view similar to FIG. 2 but with the fastening flap of the marker in closed position;

Reference is first made to FIGS. 1 to 6, which show a preferred embodiment of the invention. As shown, there is provided a wingtip marker 10, typically formed from a woven solution dyed, acrylic fiber or ballistic nylon with a polyurethane coating. (Other suitable materials may also be used.) The marker 10 includes an upper layer 12 and a lower layer 14 sewn together along three edges 16, 18, 20 to form a type of pouch or open-ended envelope adapted to slide onto the wingtip 24 of an aircraft 26. The marker 10 includes a flap 28 extending from one edge thereof, as best shown in FIG. 2. The inside or lower surface of the flap 28 is covered with a patch 30 of a hook and loop fastener (such as that sold under the trade-mark VELCRO) attached thereto (by sewing or by adhesive or both). After the marker 10 is pulled tightly onto an aircraft wingtip, the flap 28 is folded over a complementary hook and loop fastener patch 32 fastened to the lower surface of the lower layer 14. The patch 30 is then pressed against the patch 32 to retain the marker 10 on the aircraft wingtip.

To facilitate the process of placing the marker 10 on the wingtip 24, a first tab 34 is connected to the outer end of the flap 28, and a second tab 36 is connected to the outside edge of the lower layer 14, adjacent the patch 32. The tabs 34, 36 are typically simply fabric loops sewn to the flap 28 and to the lower layer 14. The loops 34, 36 can be grasped by a user to help the user to install the marker 10 tightly onto the aircraft wingtip 24.

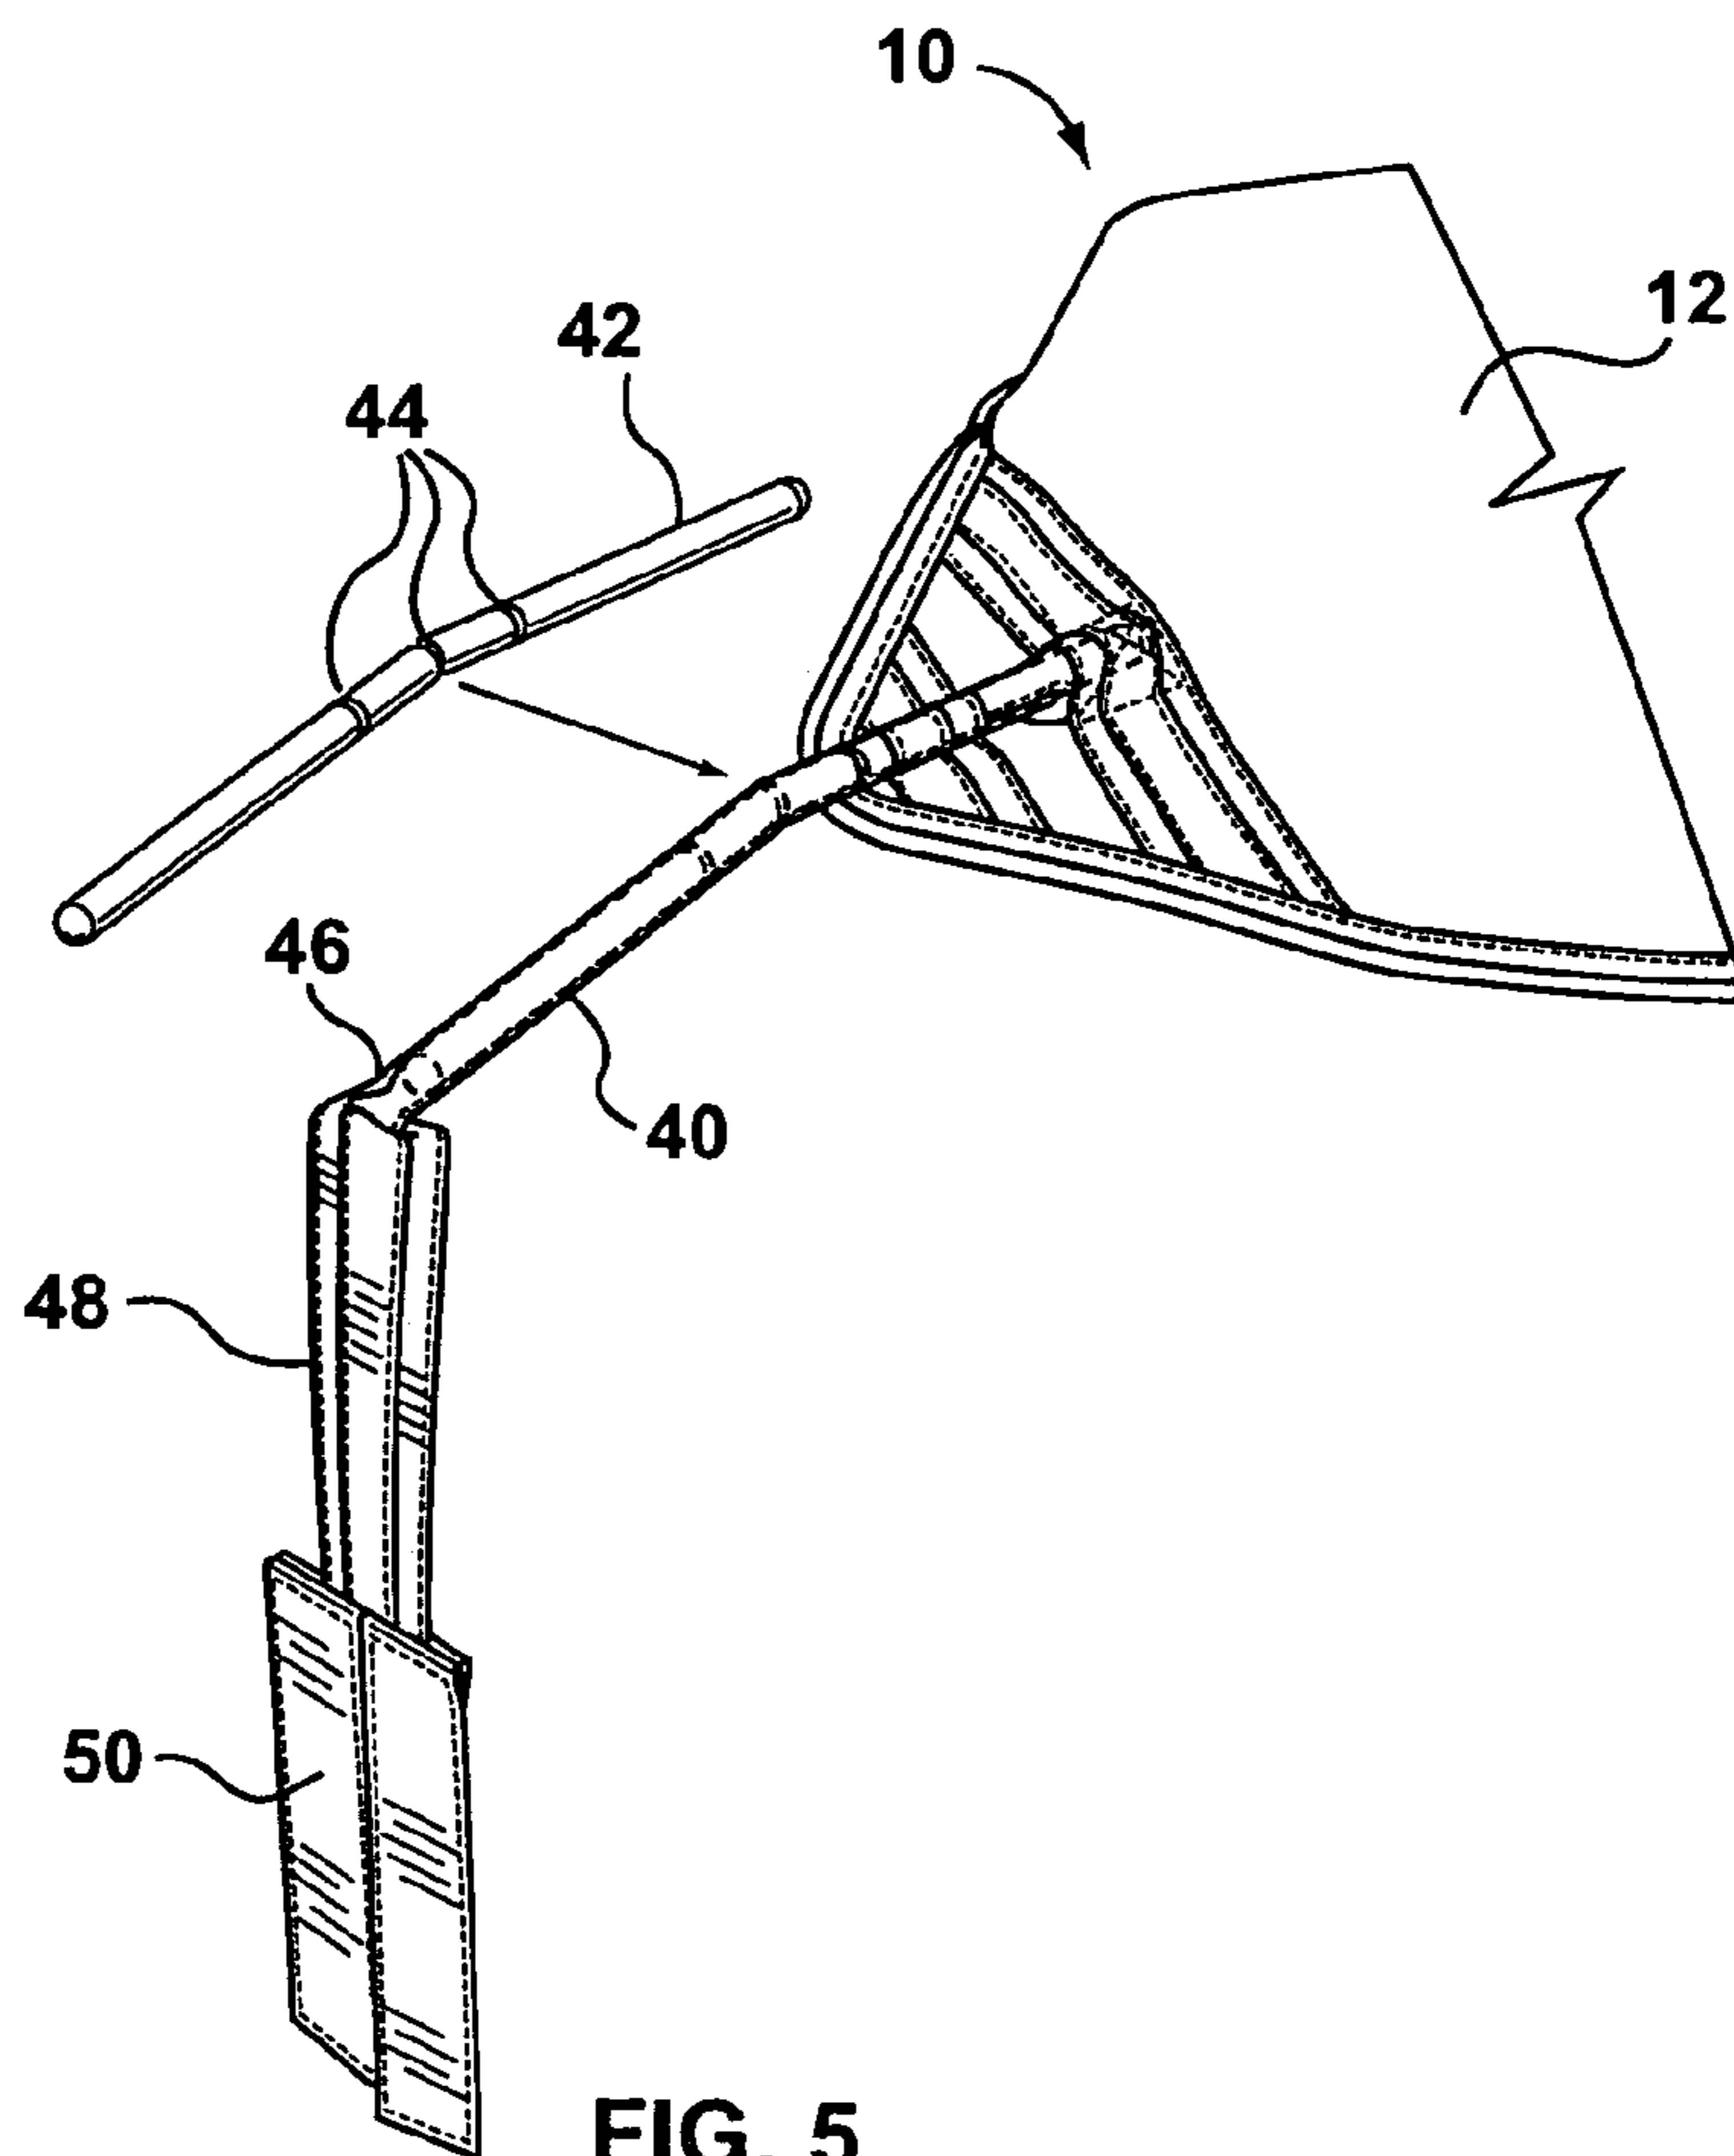
**FIG. 5**

FIG. 5 is a perspective view similar to that of FIG. 4 but showing the collision marking part broken;

As best shown in FIGS. **4** and **5**, the fabric tube **40** is secured to the upper surface of the upper layer **12** by several fabric strips **52** extending across the fabric tube **40** at right angles thereto. The strips **52** are sewn to the upper layer **12** and to the fabric tube **40** to ensure that the fabric tube **40** will not droop downwardly under normal circumstances. Instead, fabric tube **40** will normally extend horizontally outwardly, or at least will have a substantial horizontal component, as best shown in FIG. **4**.

If, while the aircraft on which the marker **10** is located is being moved, its wingtip **24** collides with another object, or if another aircraft is moved past the marked aircraft and collides with the marked wingtip, then the support rod **42** will fracture at one of the weakened locations **44**. The fabric tube **40** will then droop downwardly, as shown in FIG. **5**. This provides an immediately visible and lasting indication that a collision has occurred and that there may be damage to the aircraft which needs to be repaired.

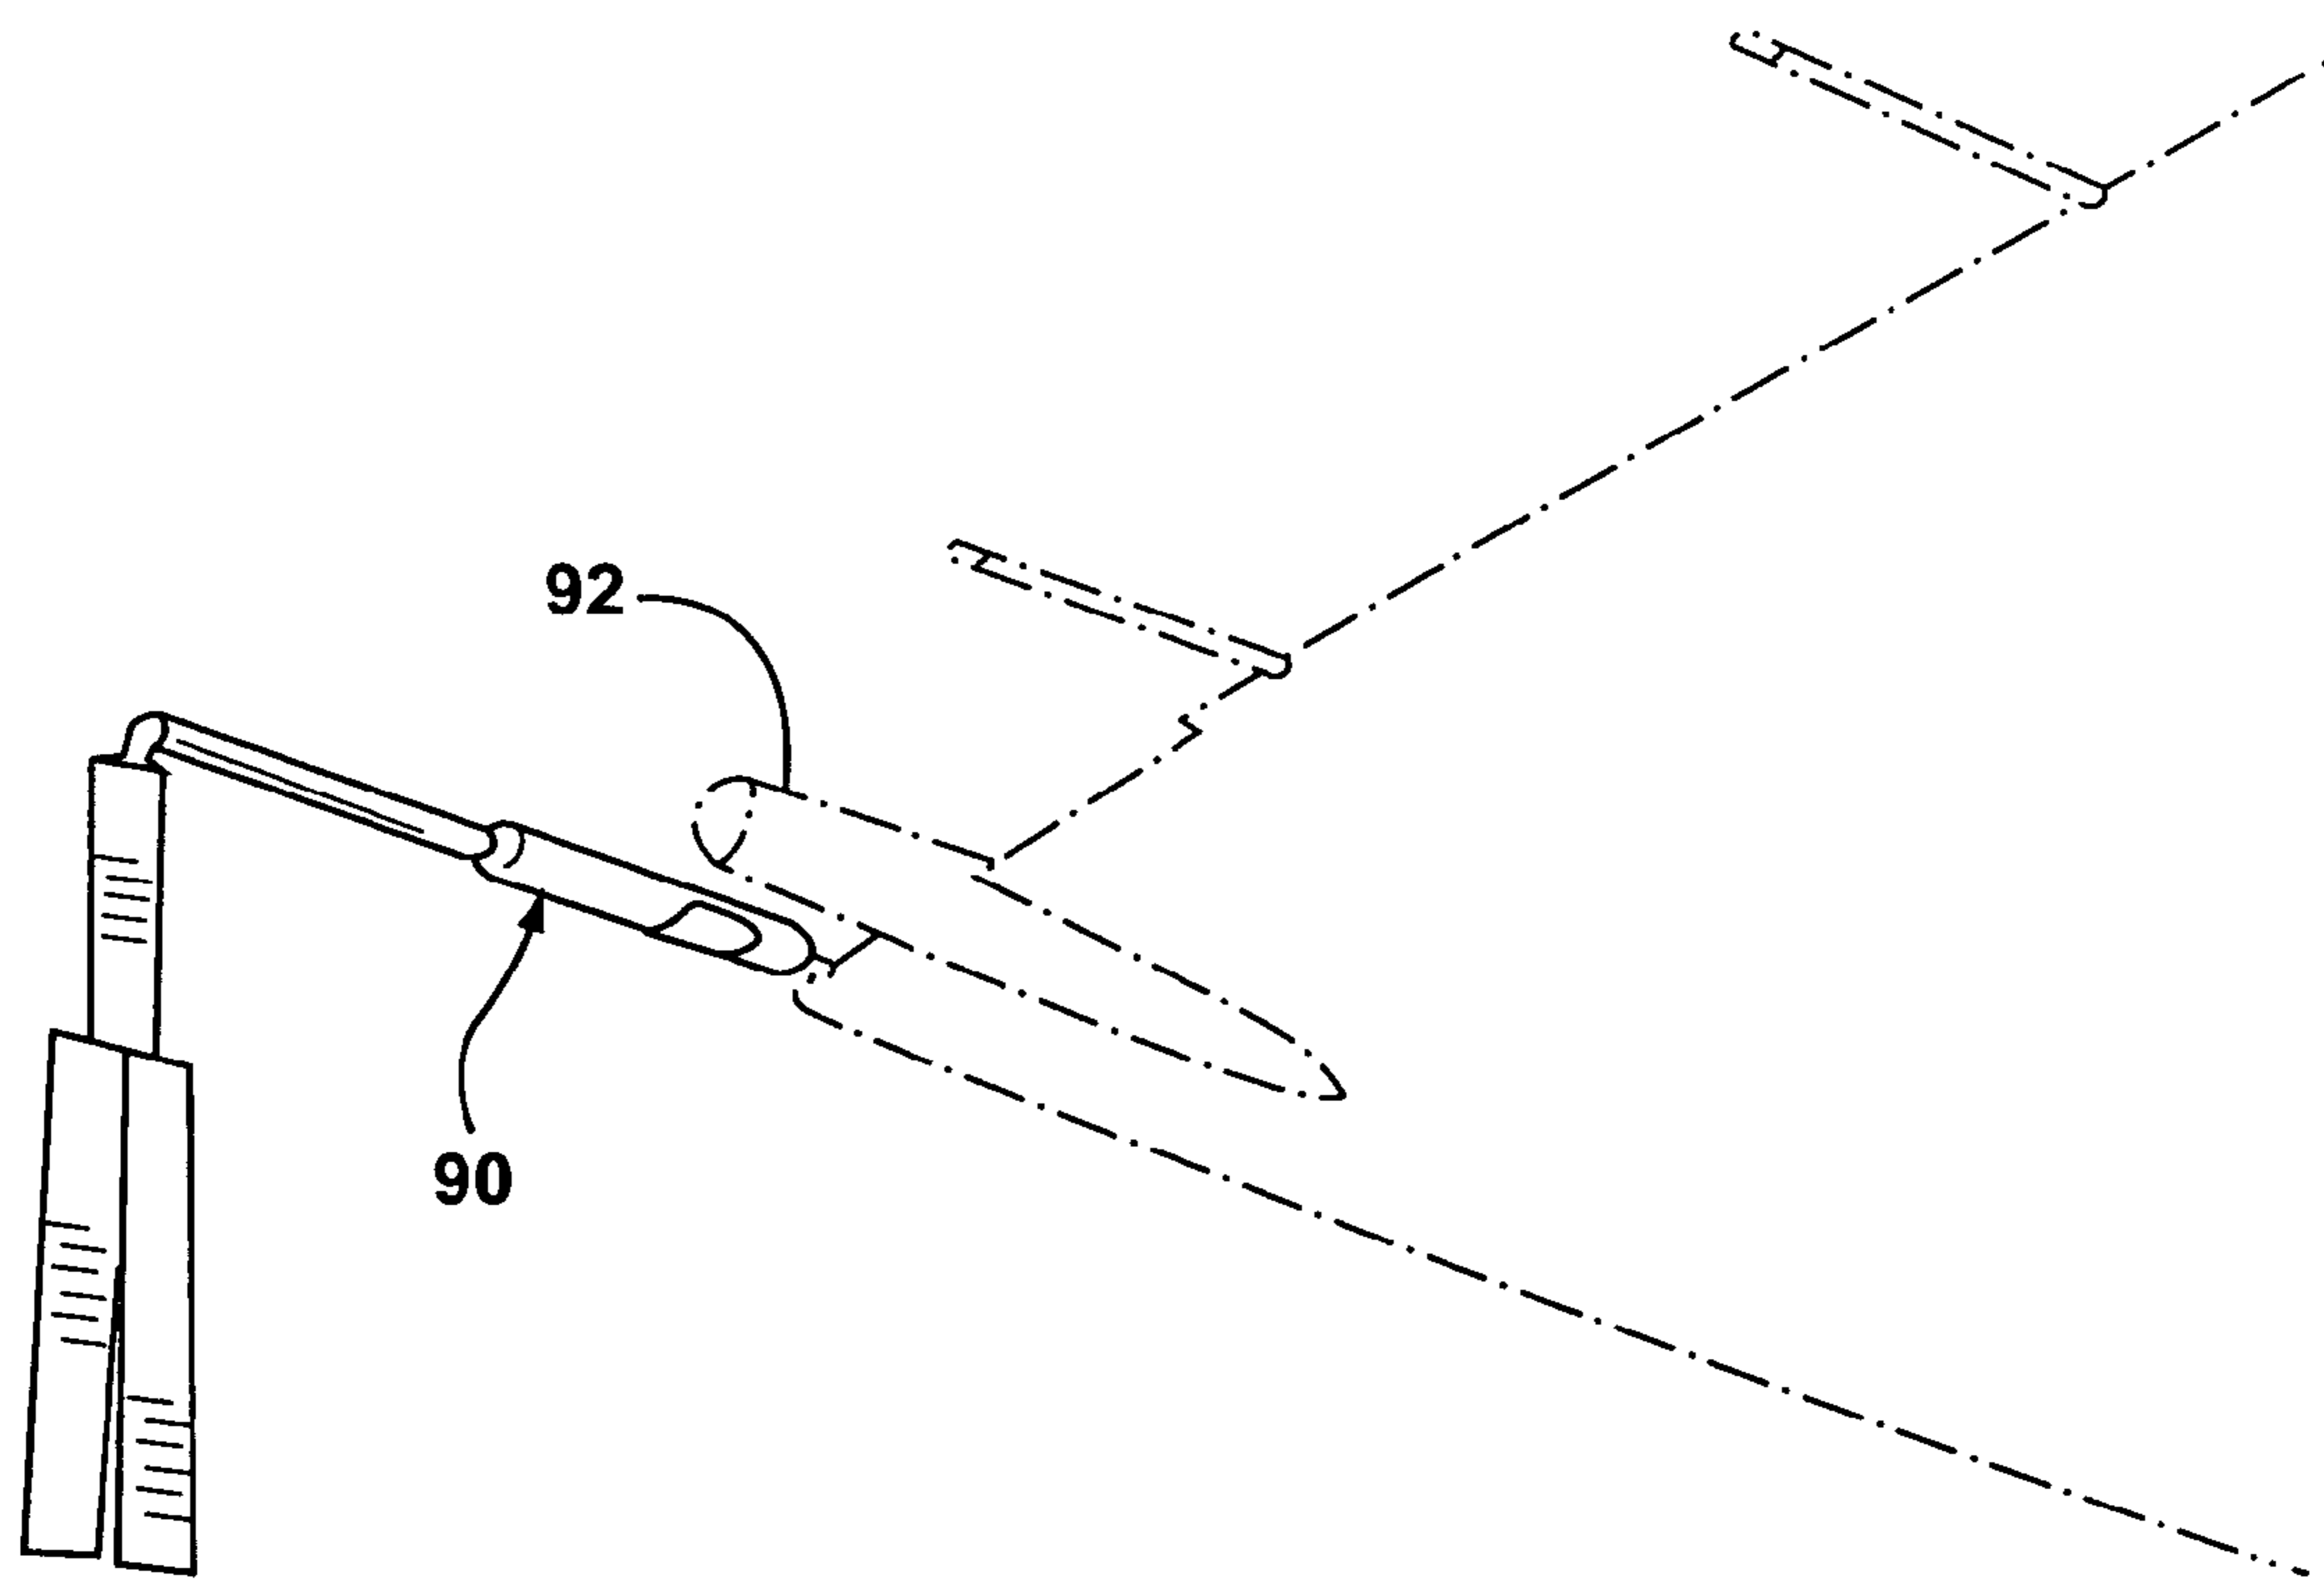
**FIG. 8**

FIG. 8 is a diagrammatic view showing a device according to the invention applied to an aircraft static wick;

FIGS. **8** to **10** show a marker **90** wrapped around a static wick **92** (also sometimes called a static discharger) on the rear edge of an aircraft wing near the wingtip. The marker **90** includes a fabric tube **94**, like tube **40** and containing a support rod having a weakened portion (not shown) like rod **42**, and having a hole (not shown) for insertion and removal of the support rods. The tube **94** is preferably of a high friction material. Two inner flaps **96**, **98**, joined by a fabric bridge **100**, are sewn to the tube **94** near one end thereof and can be wrapped around the static wick and held tightly thereon by an outer flap **101** sewn to the inner flaps **96**, **98**. The outer flap **101** has two cooperating patches **102**, **104** of hook and loop fasteners which can be pressed together as shown in FIG. **10** to hold the tube **94** on the static wick **92**.

A fabric strip **106** is connected to the end of tube **94** and supports a flag **108**, like flag **50**, to mark the static wick. As before, if a collision occurs which breaks the support rod in the fabric tube **94**, then the fabric tube **94** will again droop to provide a visible indication that a collision has occurred.

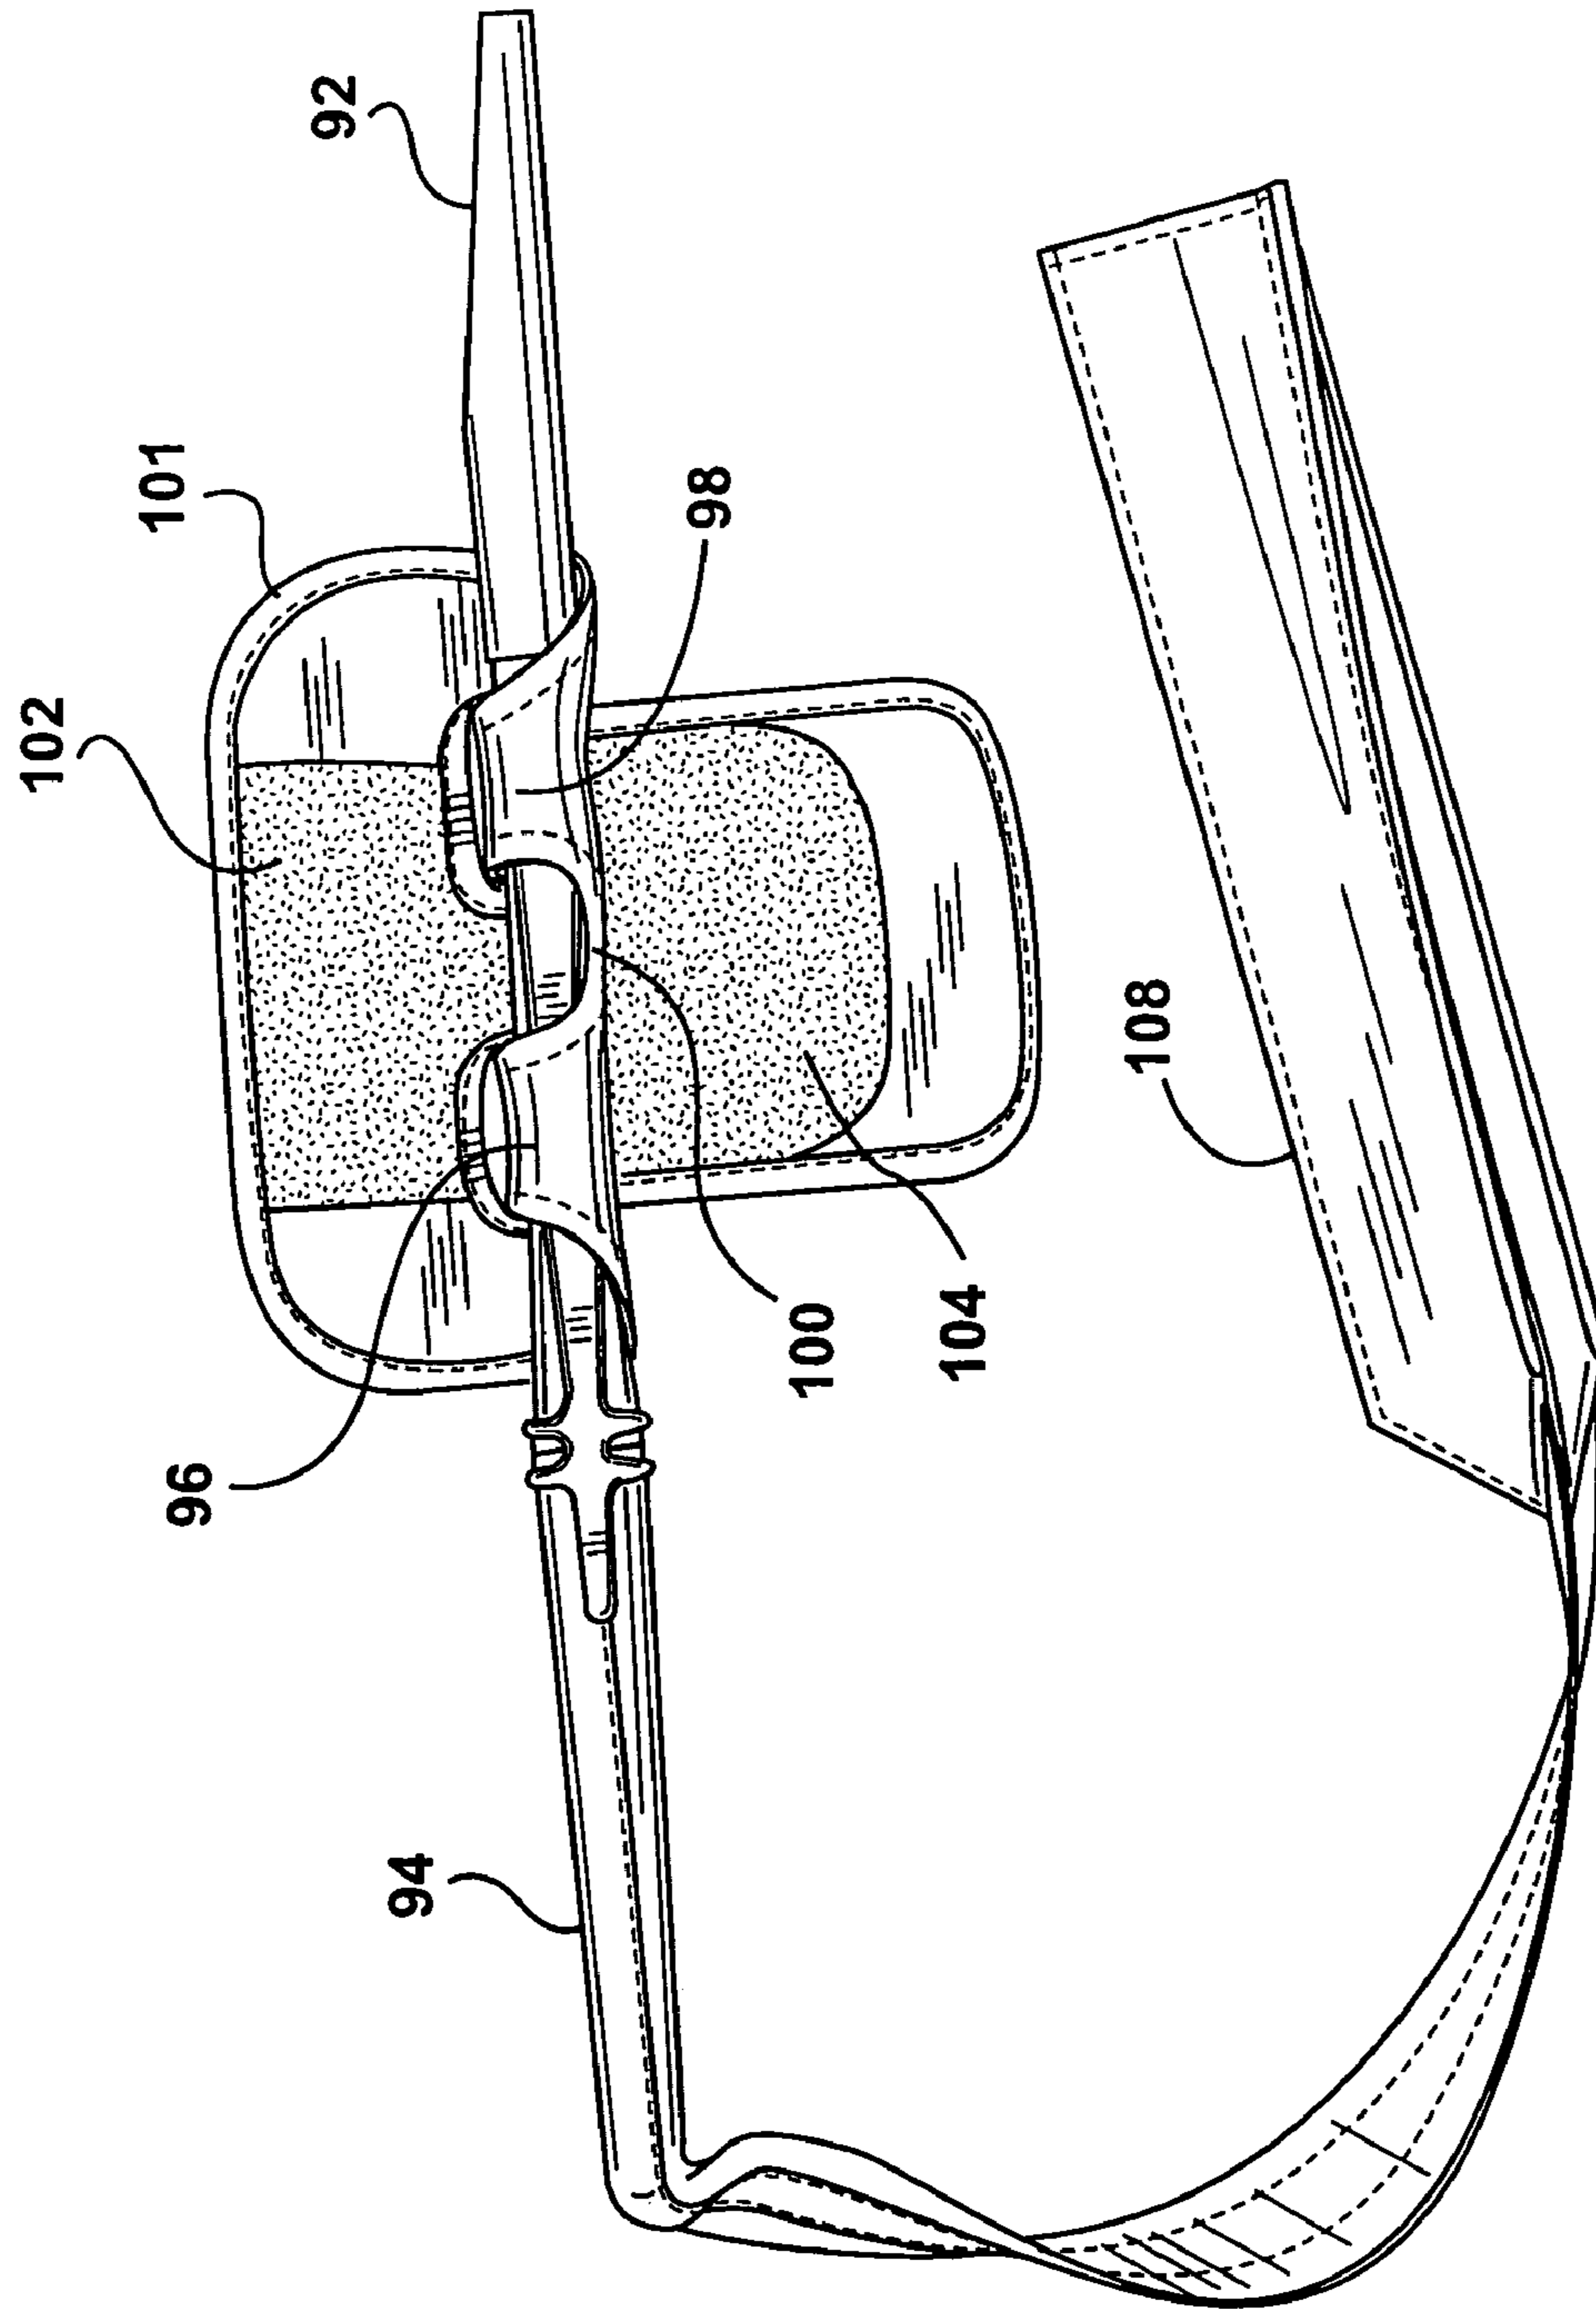
**FIG. 9**

FIG. 9 is a perspective view of the embodiment of FIG. 8, in open condition; and

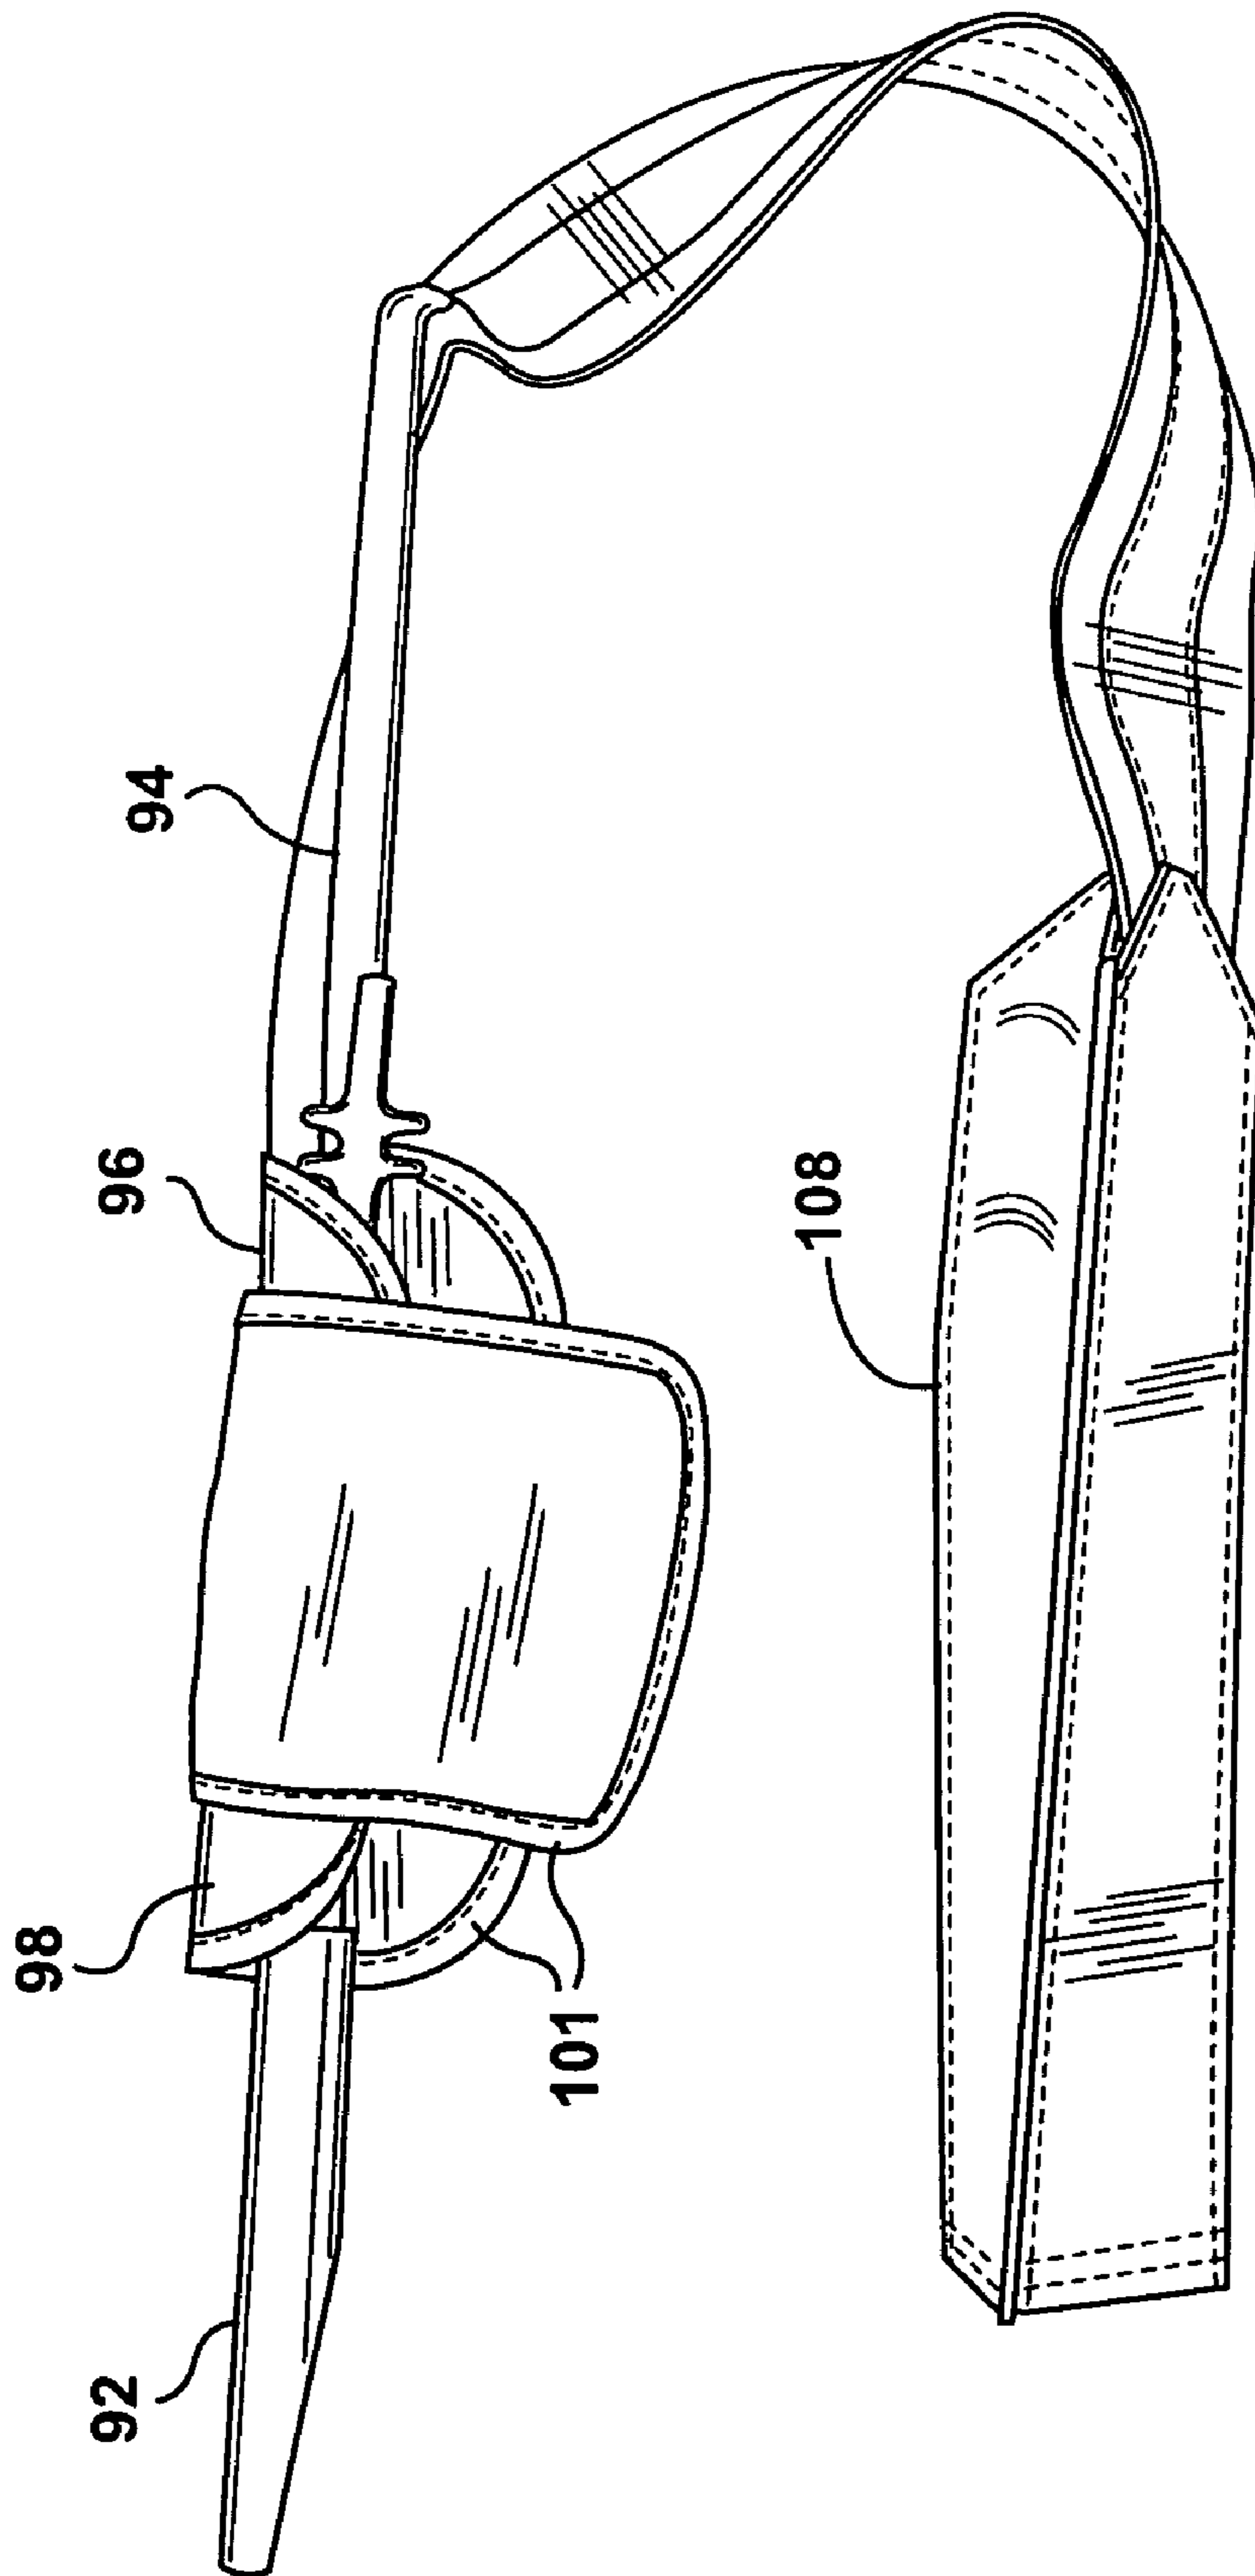
**FIG. 10**

FIG. 10 is a perspective view of the embodiment of FIG. 8, in closed condition.
