(10) **Patent No.:** **US 7,401,570 B2**  
(45) **Date of Patent:** **Jul. 22, 2008**

(54) **AIRCRAFT EXTREMITY MARKER**

A marker for the wingtip or other extremity of an aircraft. The marker includes a fabric pouch having a flap containing hook and loop fasteners, to hold the pouch on the aircraft extremity. A fabric tube extends outwardly and substantially horizontally from the pouch and supports a marker flag at its tip. The fabric tube contains a breakable support rod, so that if the aircraft wingtip collides with an object, the support rod will break and the flag will droop, providing a visible indication that a collision has occurred. The broken rod can then be replaced.

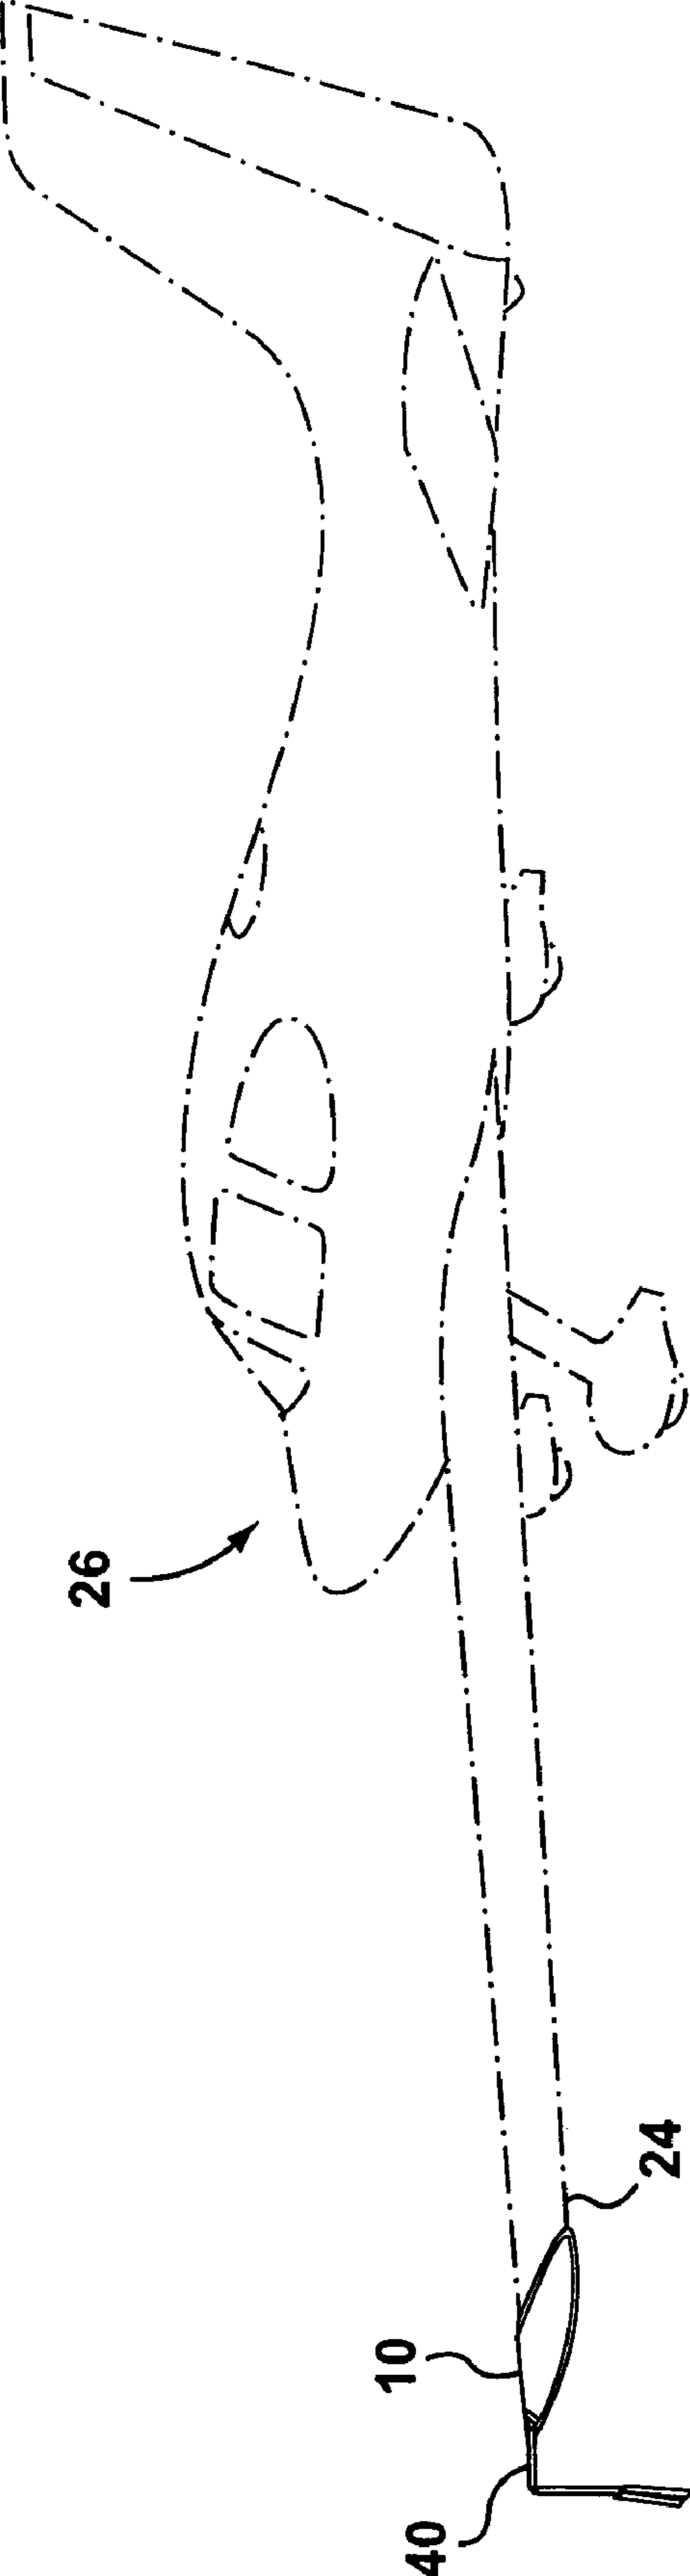
**FIG. 1**

FIG. 1 is a diagrammatic view of an aircraft having on its wingtip a marker according to the invention;

Reference is first made to FIGS. 1 to 6, which show a preferred embodiment of the invention. As shown, there is provided a wingtip marker 10, typically formed from a woven solution dyed, acrylic fiber or ballistic nylon with a polyurethane coating. (Other suitable materials may also be used.) The marker 10 includes an upper layer 12 and a lower layer 14 sewn together along three edges 16, 18, 20 to form a type of pouch or open-ended envelope adapted to slide onto the wingtip 24 of an aircraft 26. The marker 10 includes a flap 28 extending from one edge thereof, as best shown in FIG. 2. The inside or lower surface of the flap 28 is covered with a patch 30 of a hook and loop fastener (such as that sold under the trade-mark VELCRO) attached thereto (by sewing or by adhesive or both). After the marker 10 is pulled tightly onto an aircraft wingtip, the flap 28 is folded over a complementary hook and loop fastener patch 32 fastened to the lower surface of the lower layer 14. The patch 30 is then pressed against the patch 32 to retain the marker 10 on the aircraft wingtip.

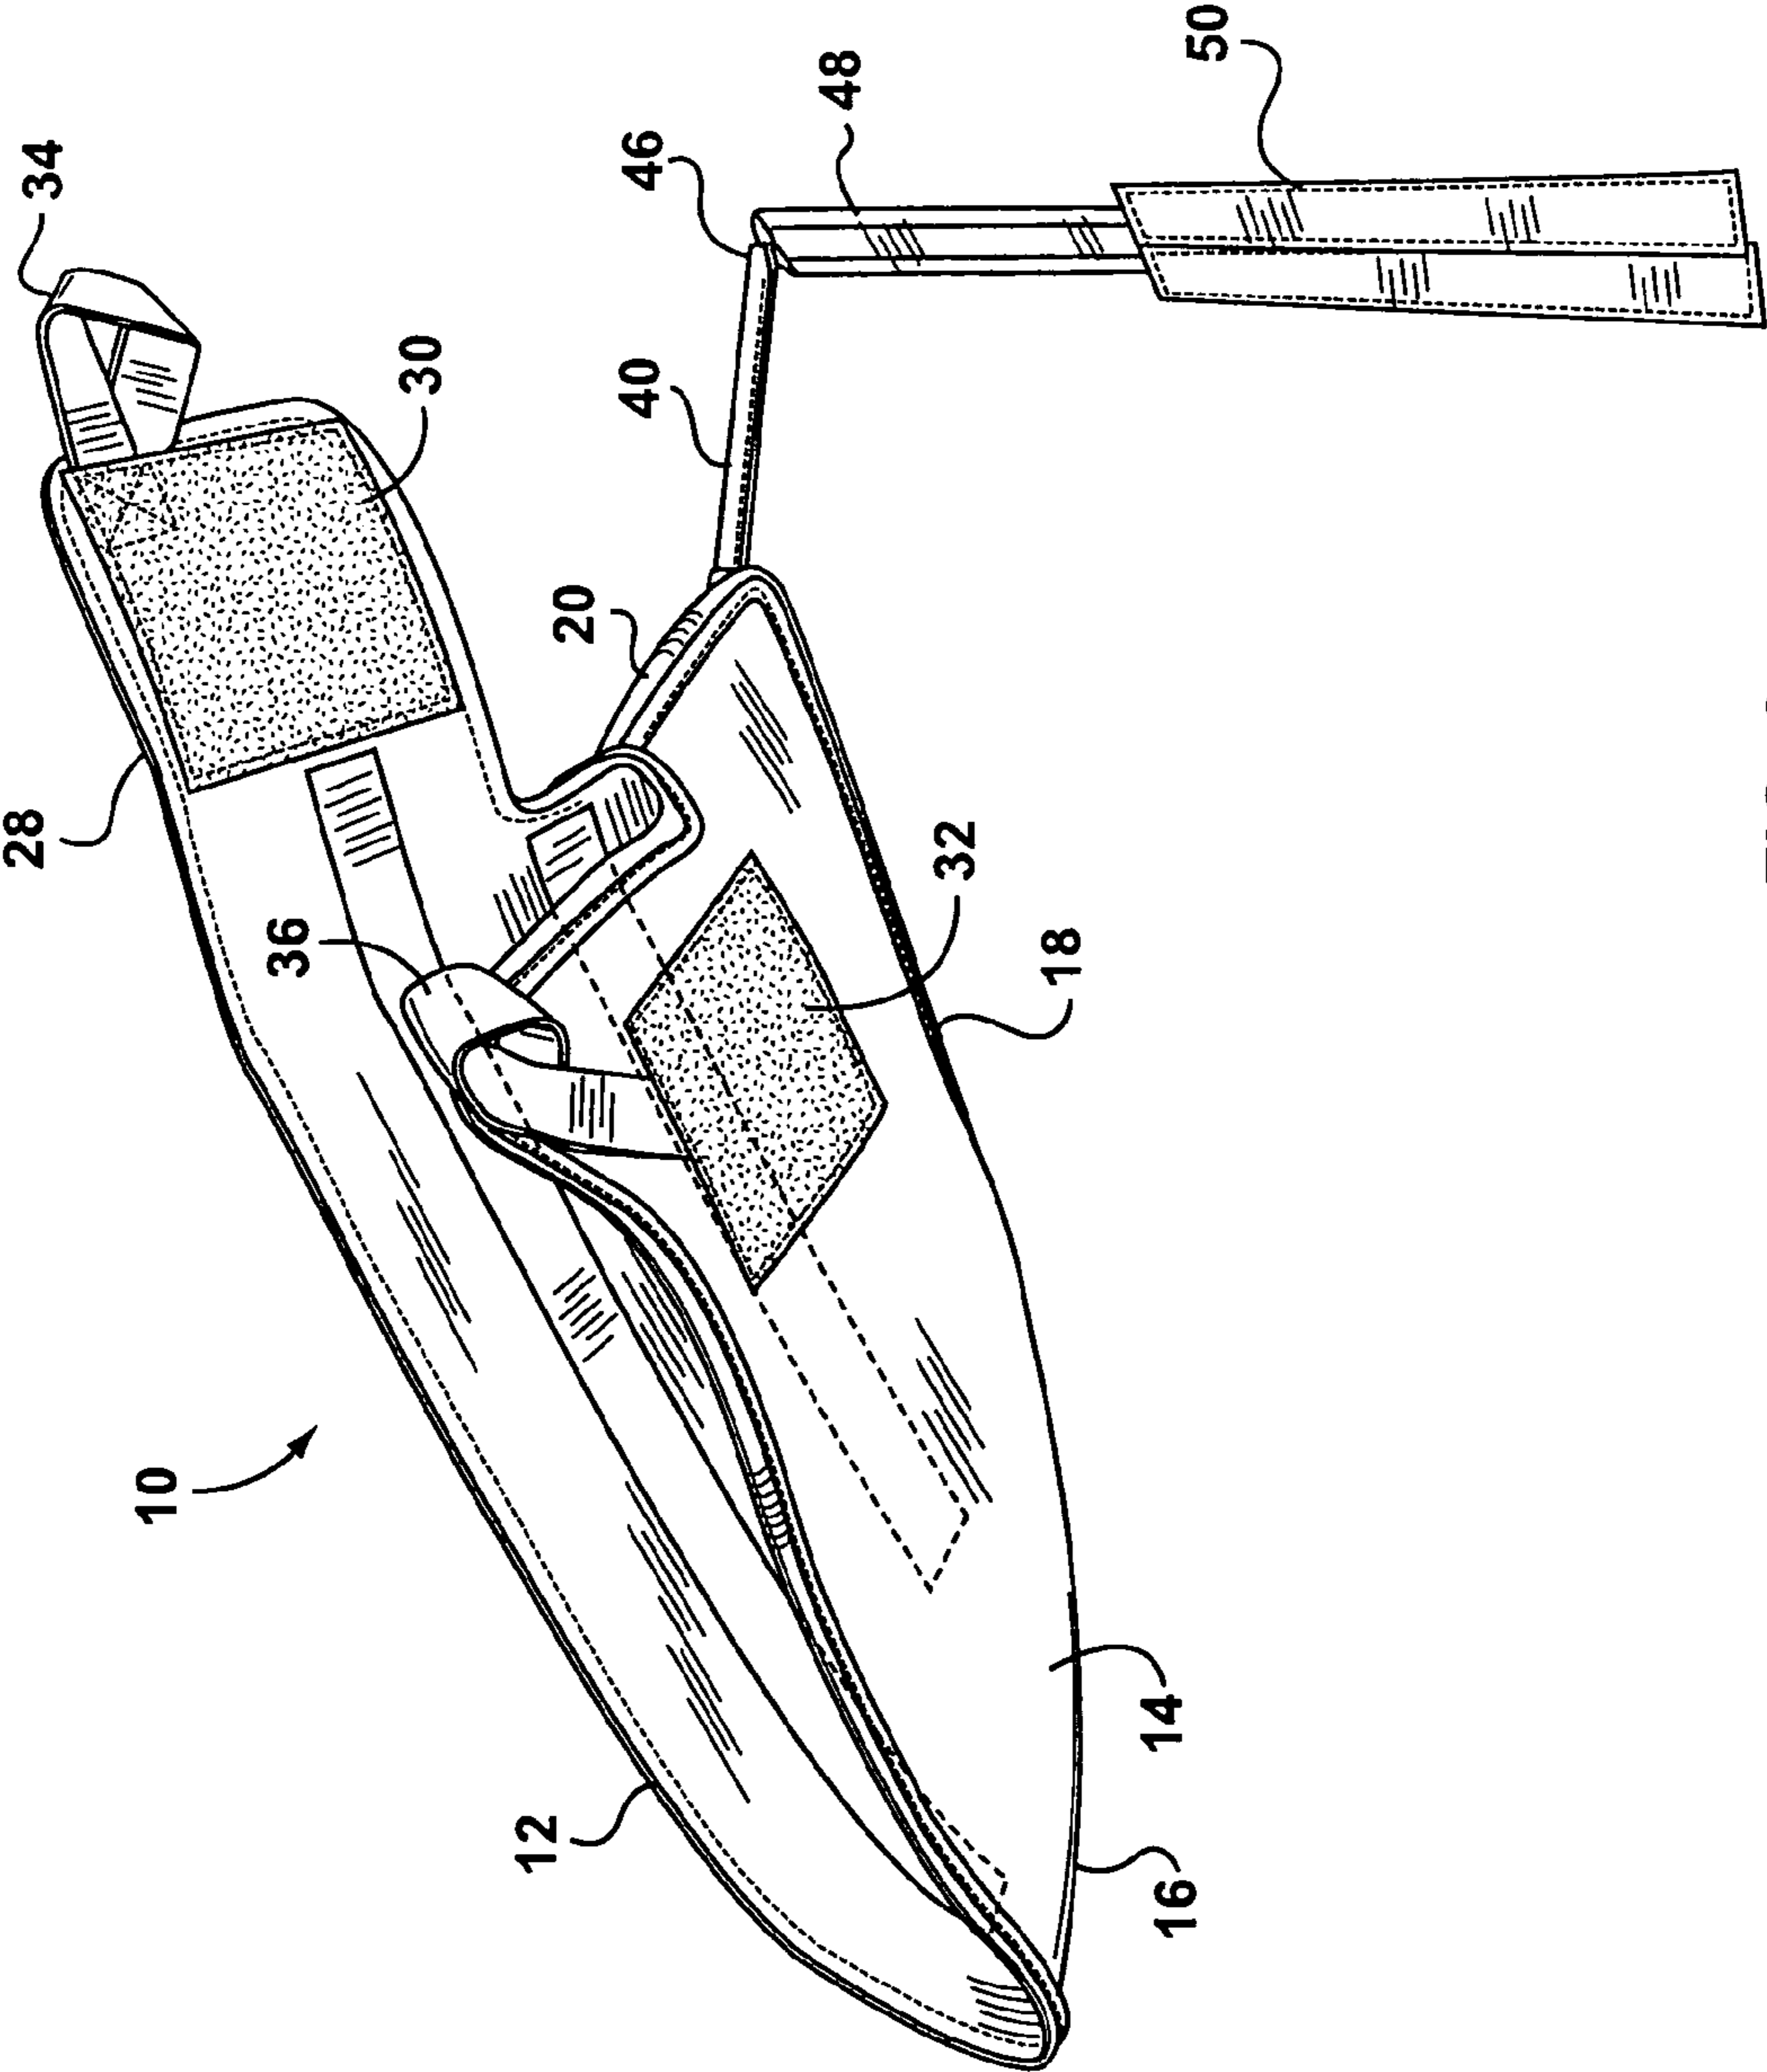
FIG. 2 is a perspective view of a wing marker according to the invention, as seen from below, and with a fastening flap in an open position;

To facilitate the process of placing the marker 10 on the wingtip 24, a first tab 34 is connected to the outer end of the flap 28, and a second tab 36 is connected to the outside edge of the lower layer 14, adjacent the patch 32. The tabs 34, 36 are typically simply fabric loops sewn to the flap 28 and to the lower layer 14. The loops 34, 36 can be grasped by a user to help the user to install the marker 10 tightly onto the aircraft wingtip 24.

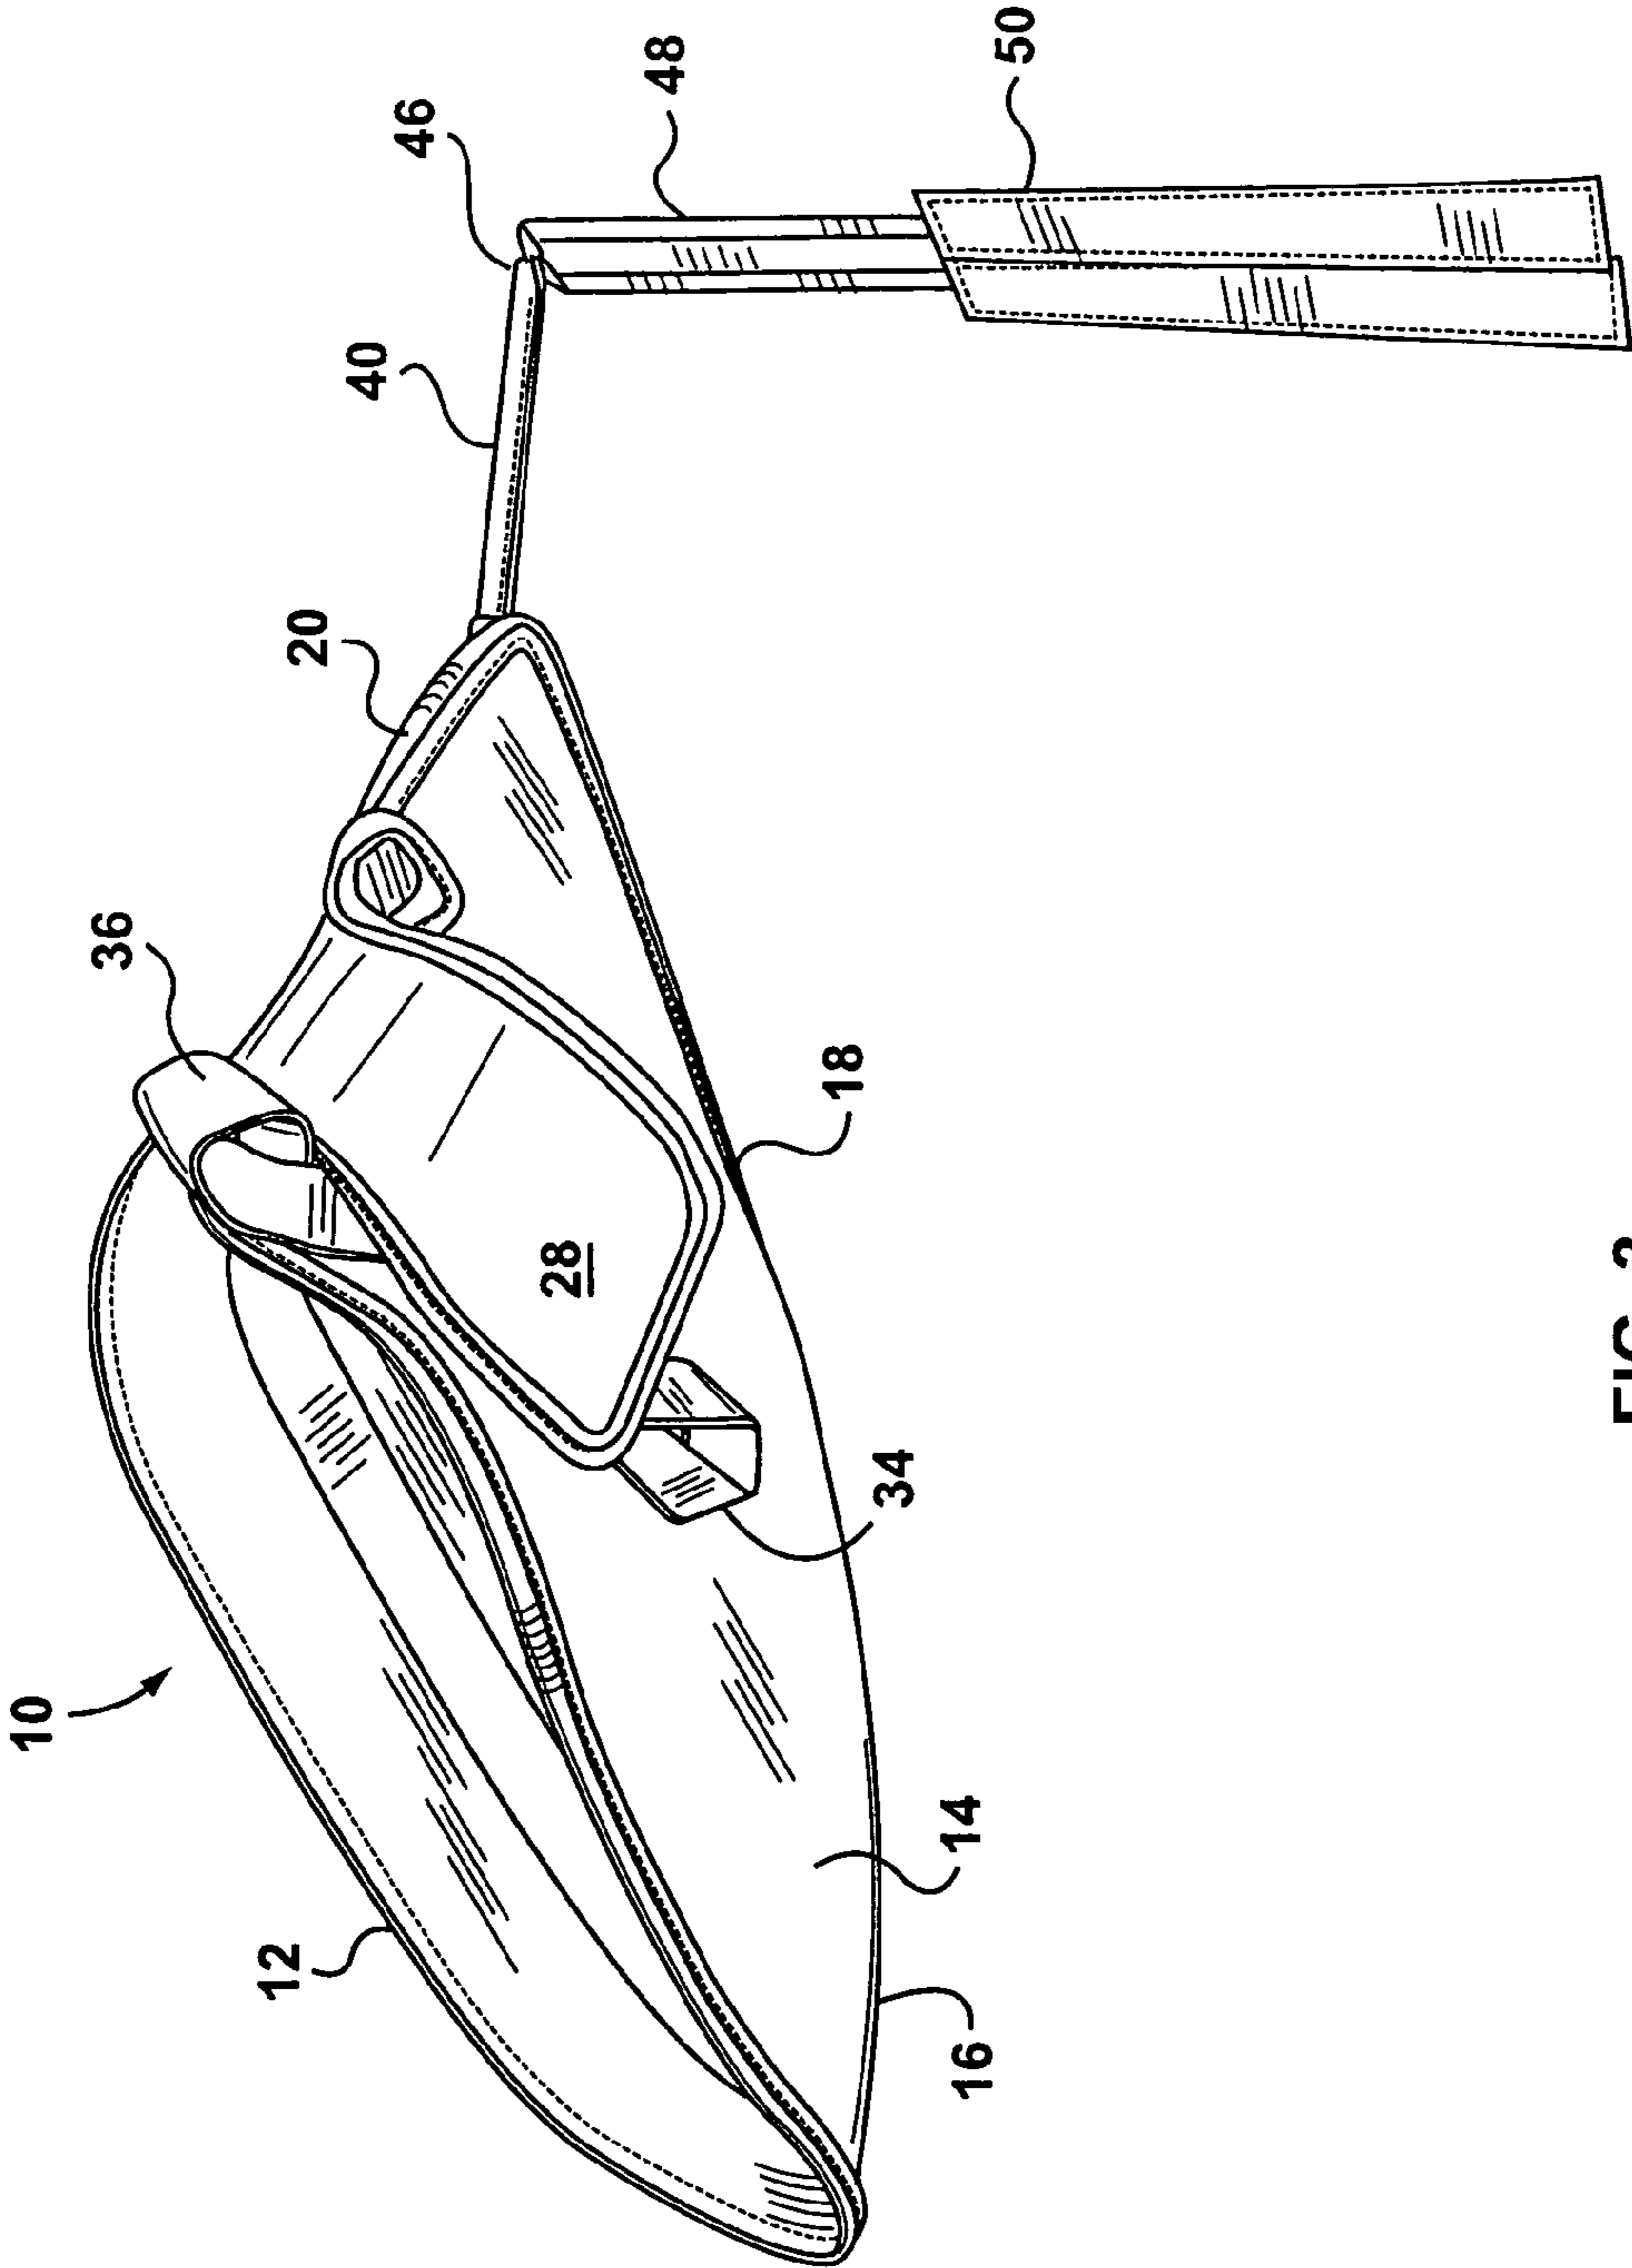
**FIG. 3**

FIG. 3 is a view similar to FIG. 2 but with the fastening flap of the marker in closed position;

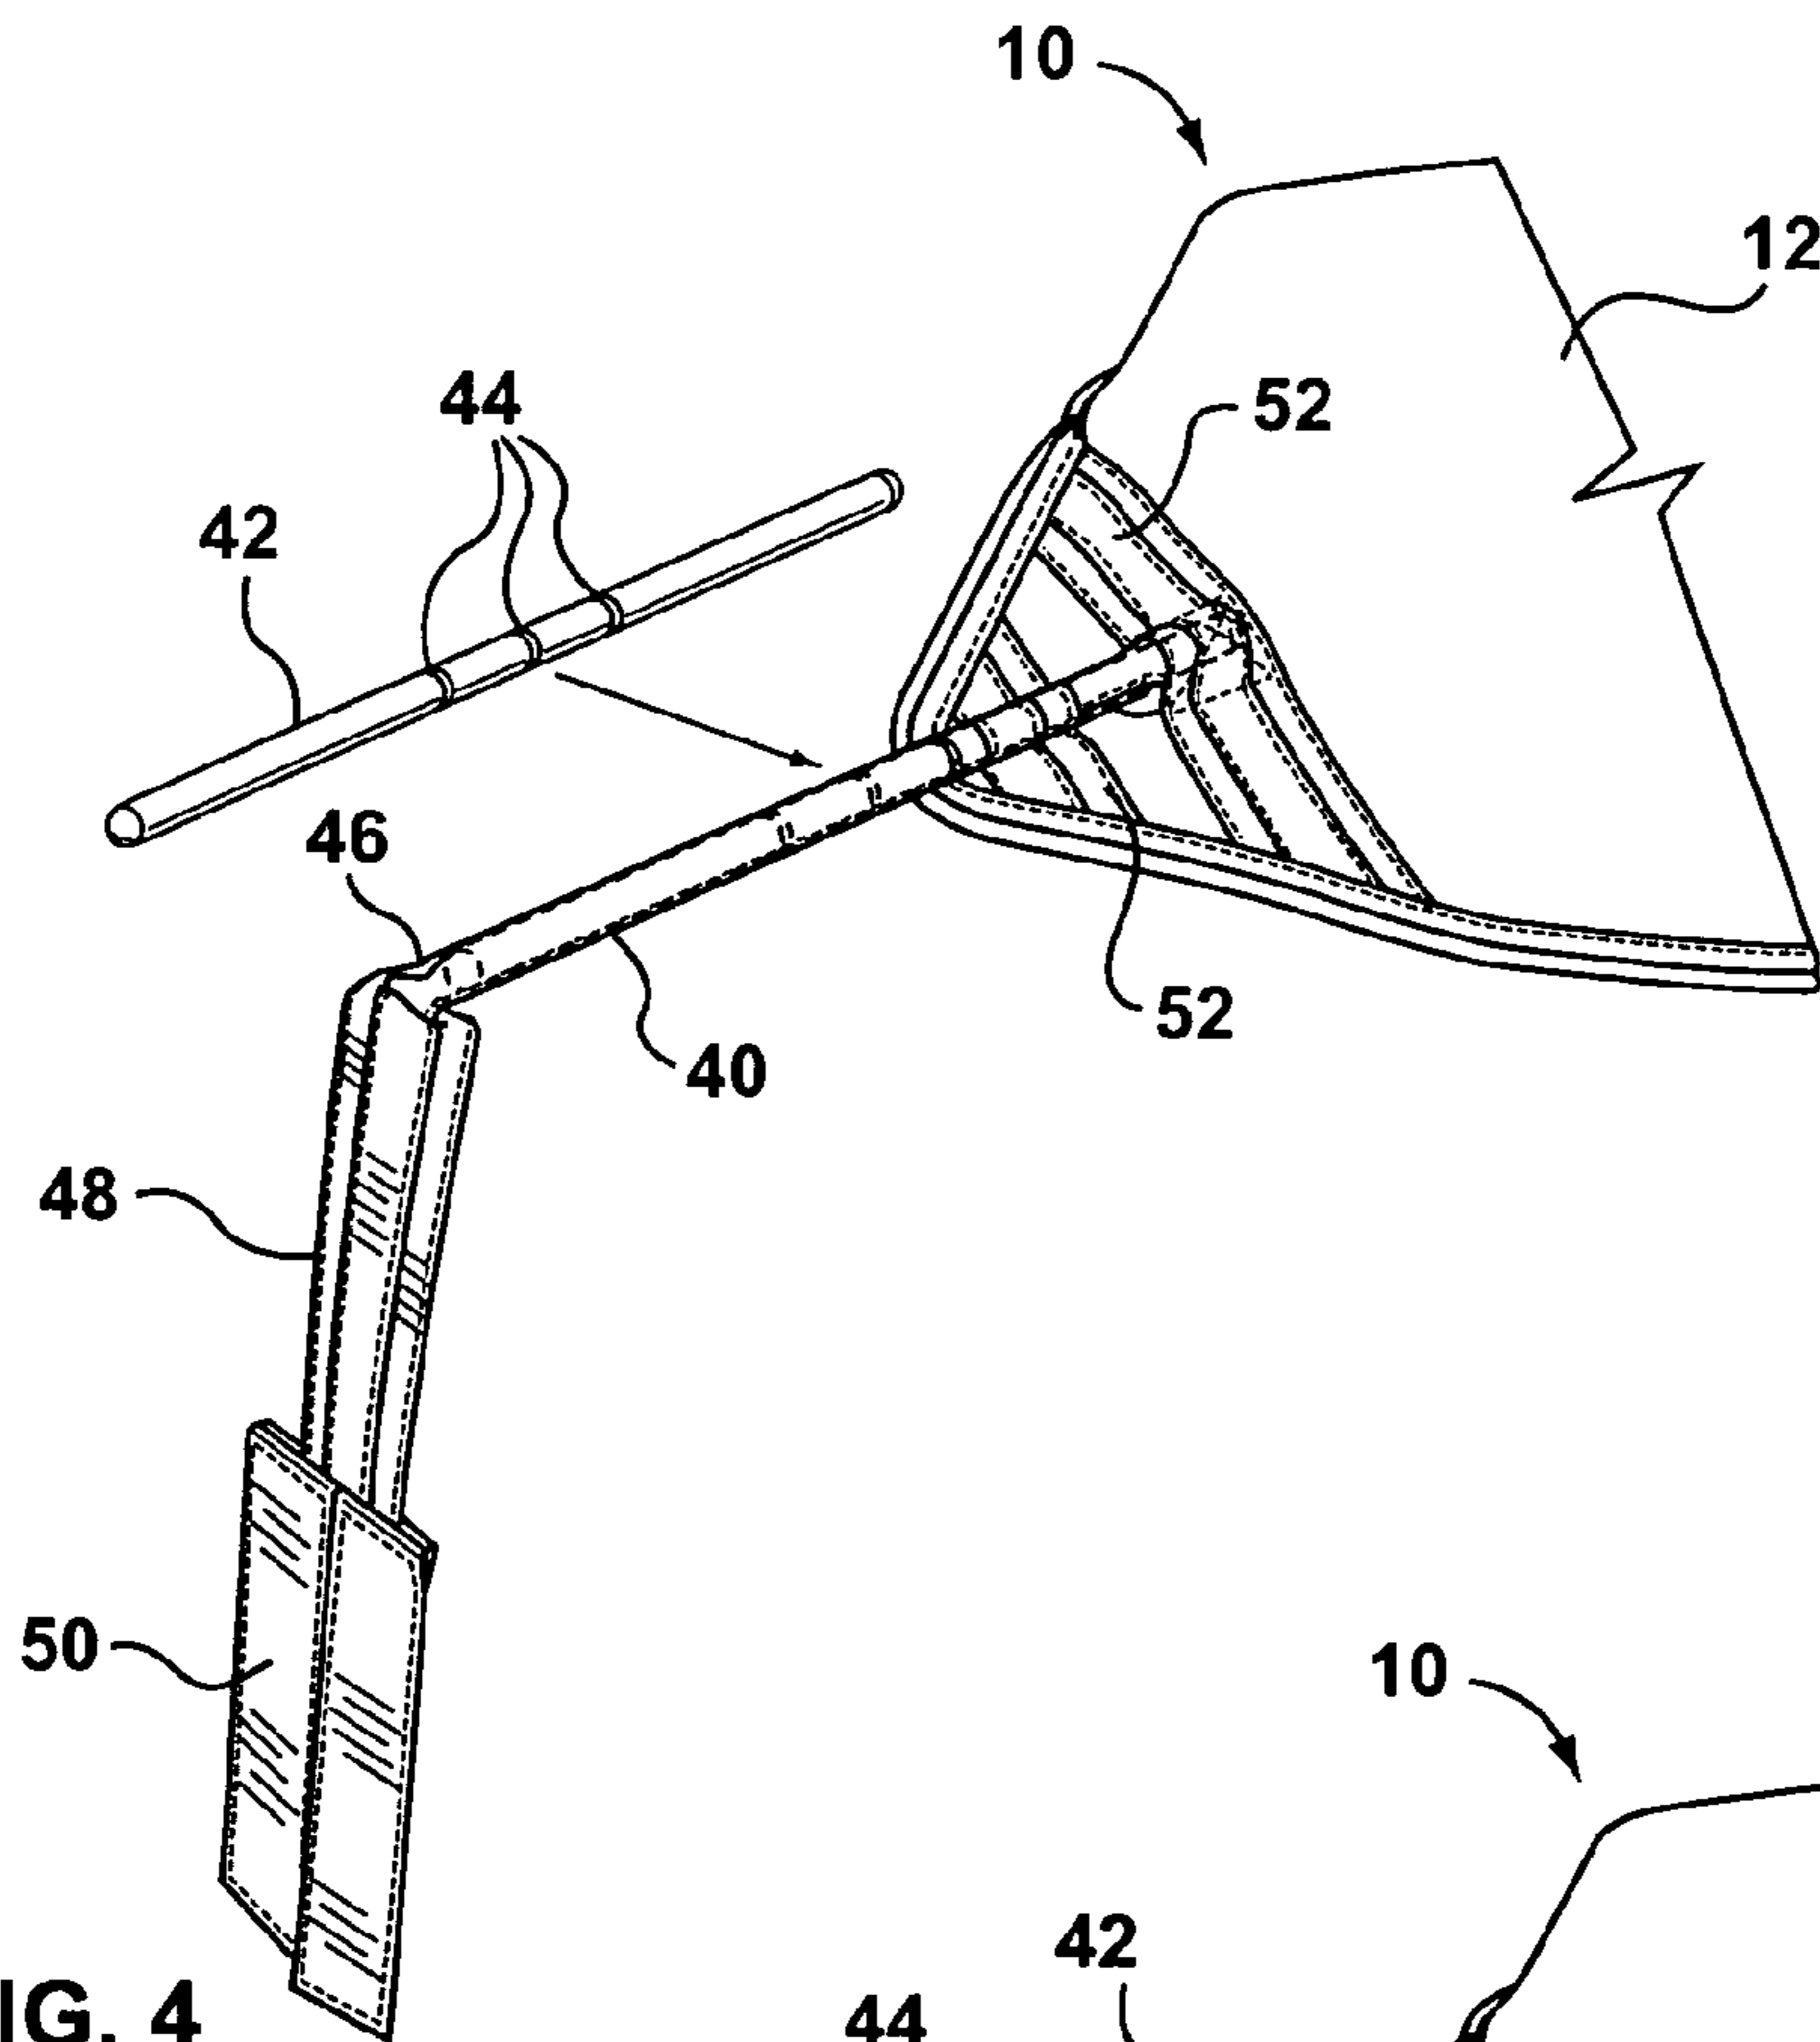
**FIG. 4**

FIG. 4 is a perspective view of the marker of FIGS. 1 to 3 and showing details of a collision marking part;

As shown in the drawings, a fabric tube **40** is securely fastened to the upper layer **12** of the marker **10** and projects outwardly from an edge of the marker **10**. Preferably, the fabric tube **40** projects horizontally from a rear corner of the marker **10**. Located within the tube **40** is a support rod **42**, preferably made of a plastic material. The function of the support rod **42** is to provide mechanical support so that the tube **40** will extend outwardly horizontally, or with a substantial horizontal component, and will not droop. However, the support rod **42** includes several encircling grooves **44** near its center, which weaken it so that if it is impacted by another object, it will relatively easily break.

As best shown in FIGS. **4** and **5**, the fabric tube **40** is secured to the upper surface of the upper layer **12** by several fabric strips **52** extending across the fabric tube **40** at right angles thereto. The strips **52** are sewn to the upper layer **12** and to the fabric tube **40** to ensure that the fabric tube **40** will not droop downwardly under normal circumstances. Instead, fabric tube **40** will normally extend horizontally outwardly, or at least will have a substantial horizontal component, as best shown in FIG. **4**.

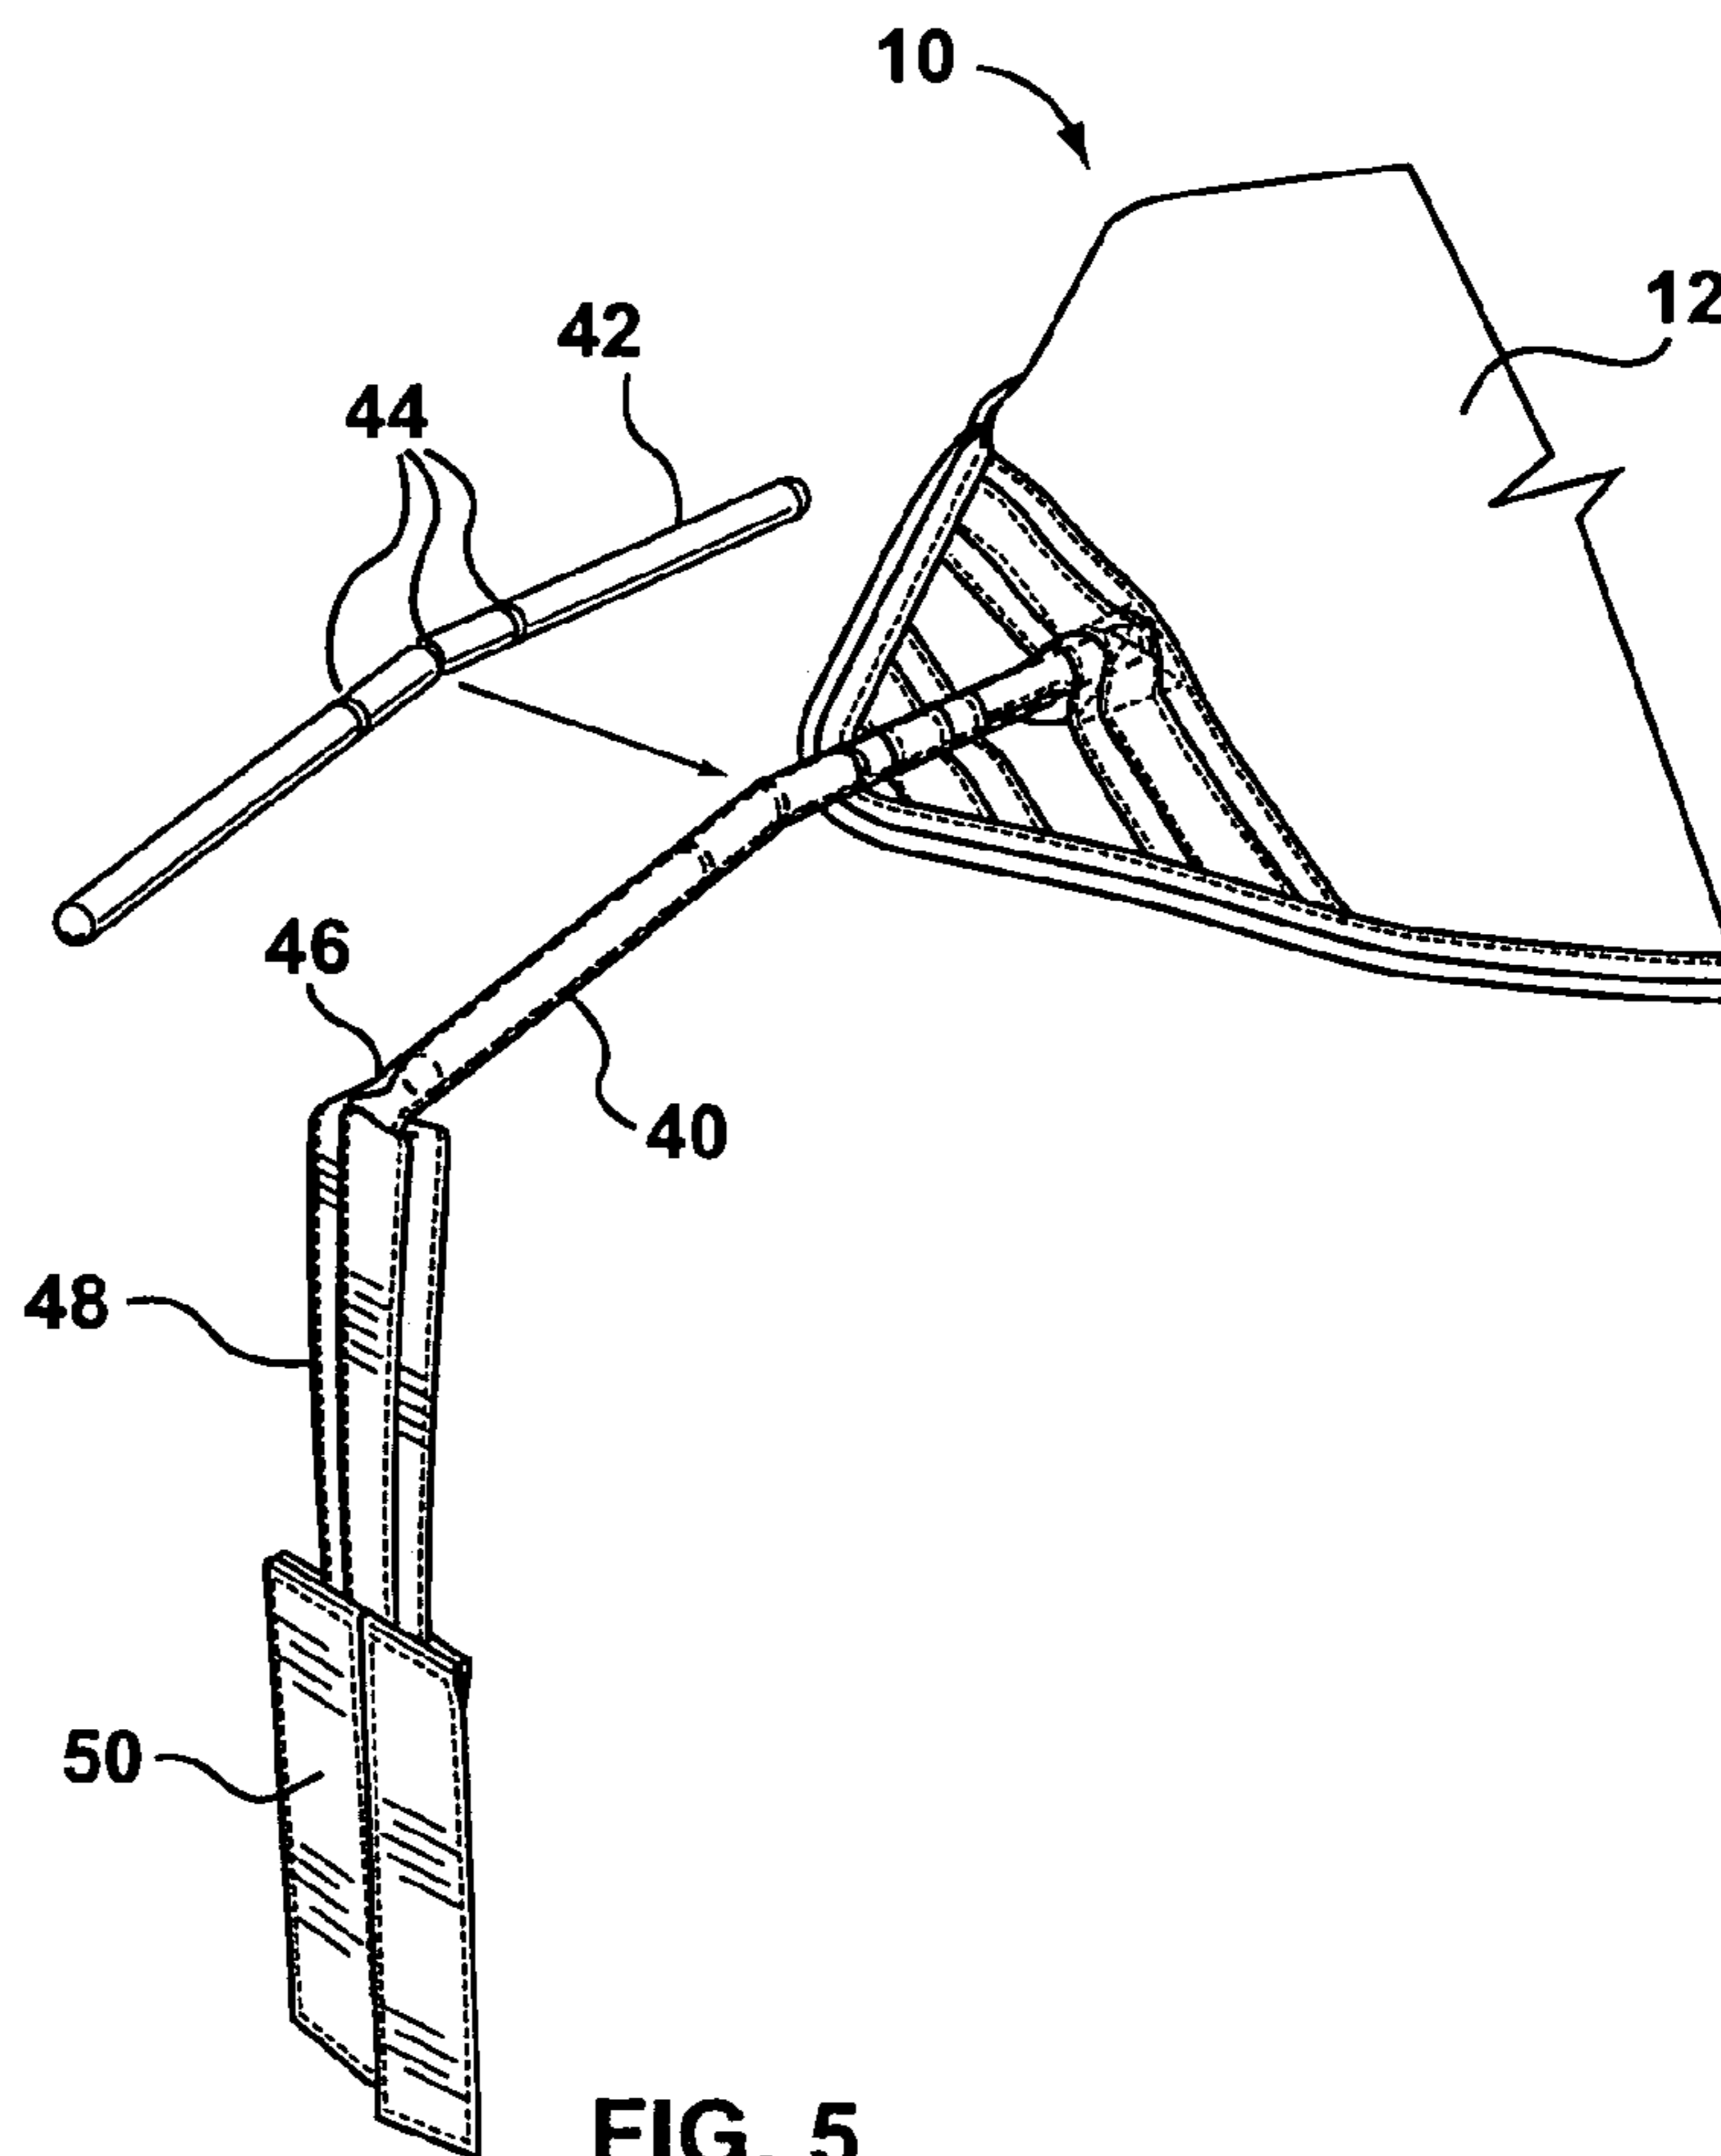
**FIG. 5**

FIG. 5 is a perspective view similar to that of FIG. 4 but showing the collision marking part broken;

If, while the aircraft on which the marker **10** is located is being moved, its wingtip **24** collides with another object, or if another aircraft is moved past the marked aircraft and collides with the marked wingtip, then the support rod **42** will fracture at one of the weakened locations **44**. The fabric tube **40** will then droop downwardly, as shown in FIG. **5**. This provides an immediately visible and lasting indication that a collision has occurred and that there may be damage to the aircraft which needs to be repaired.

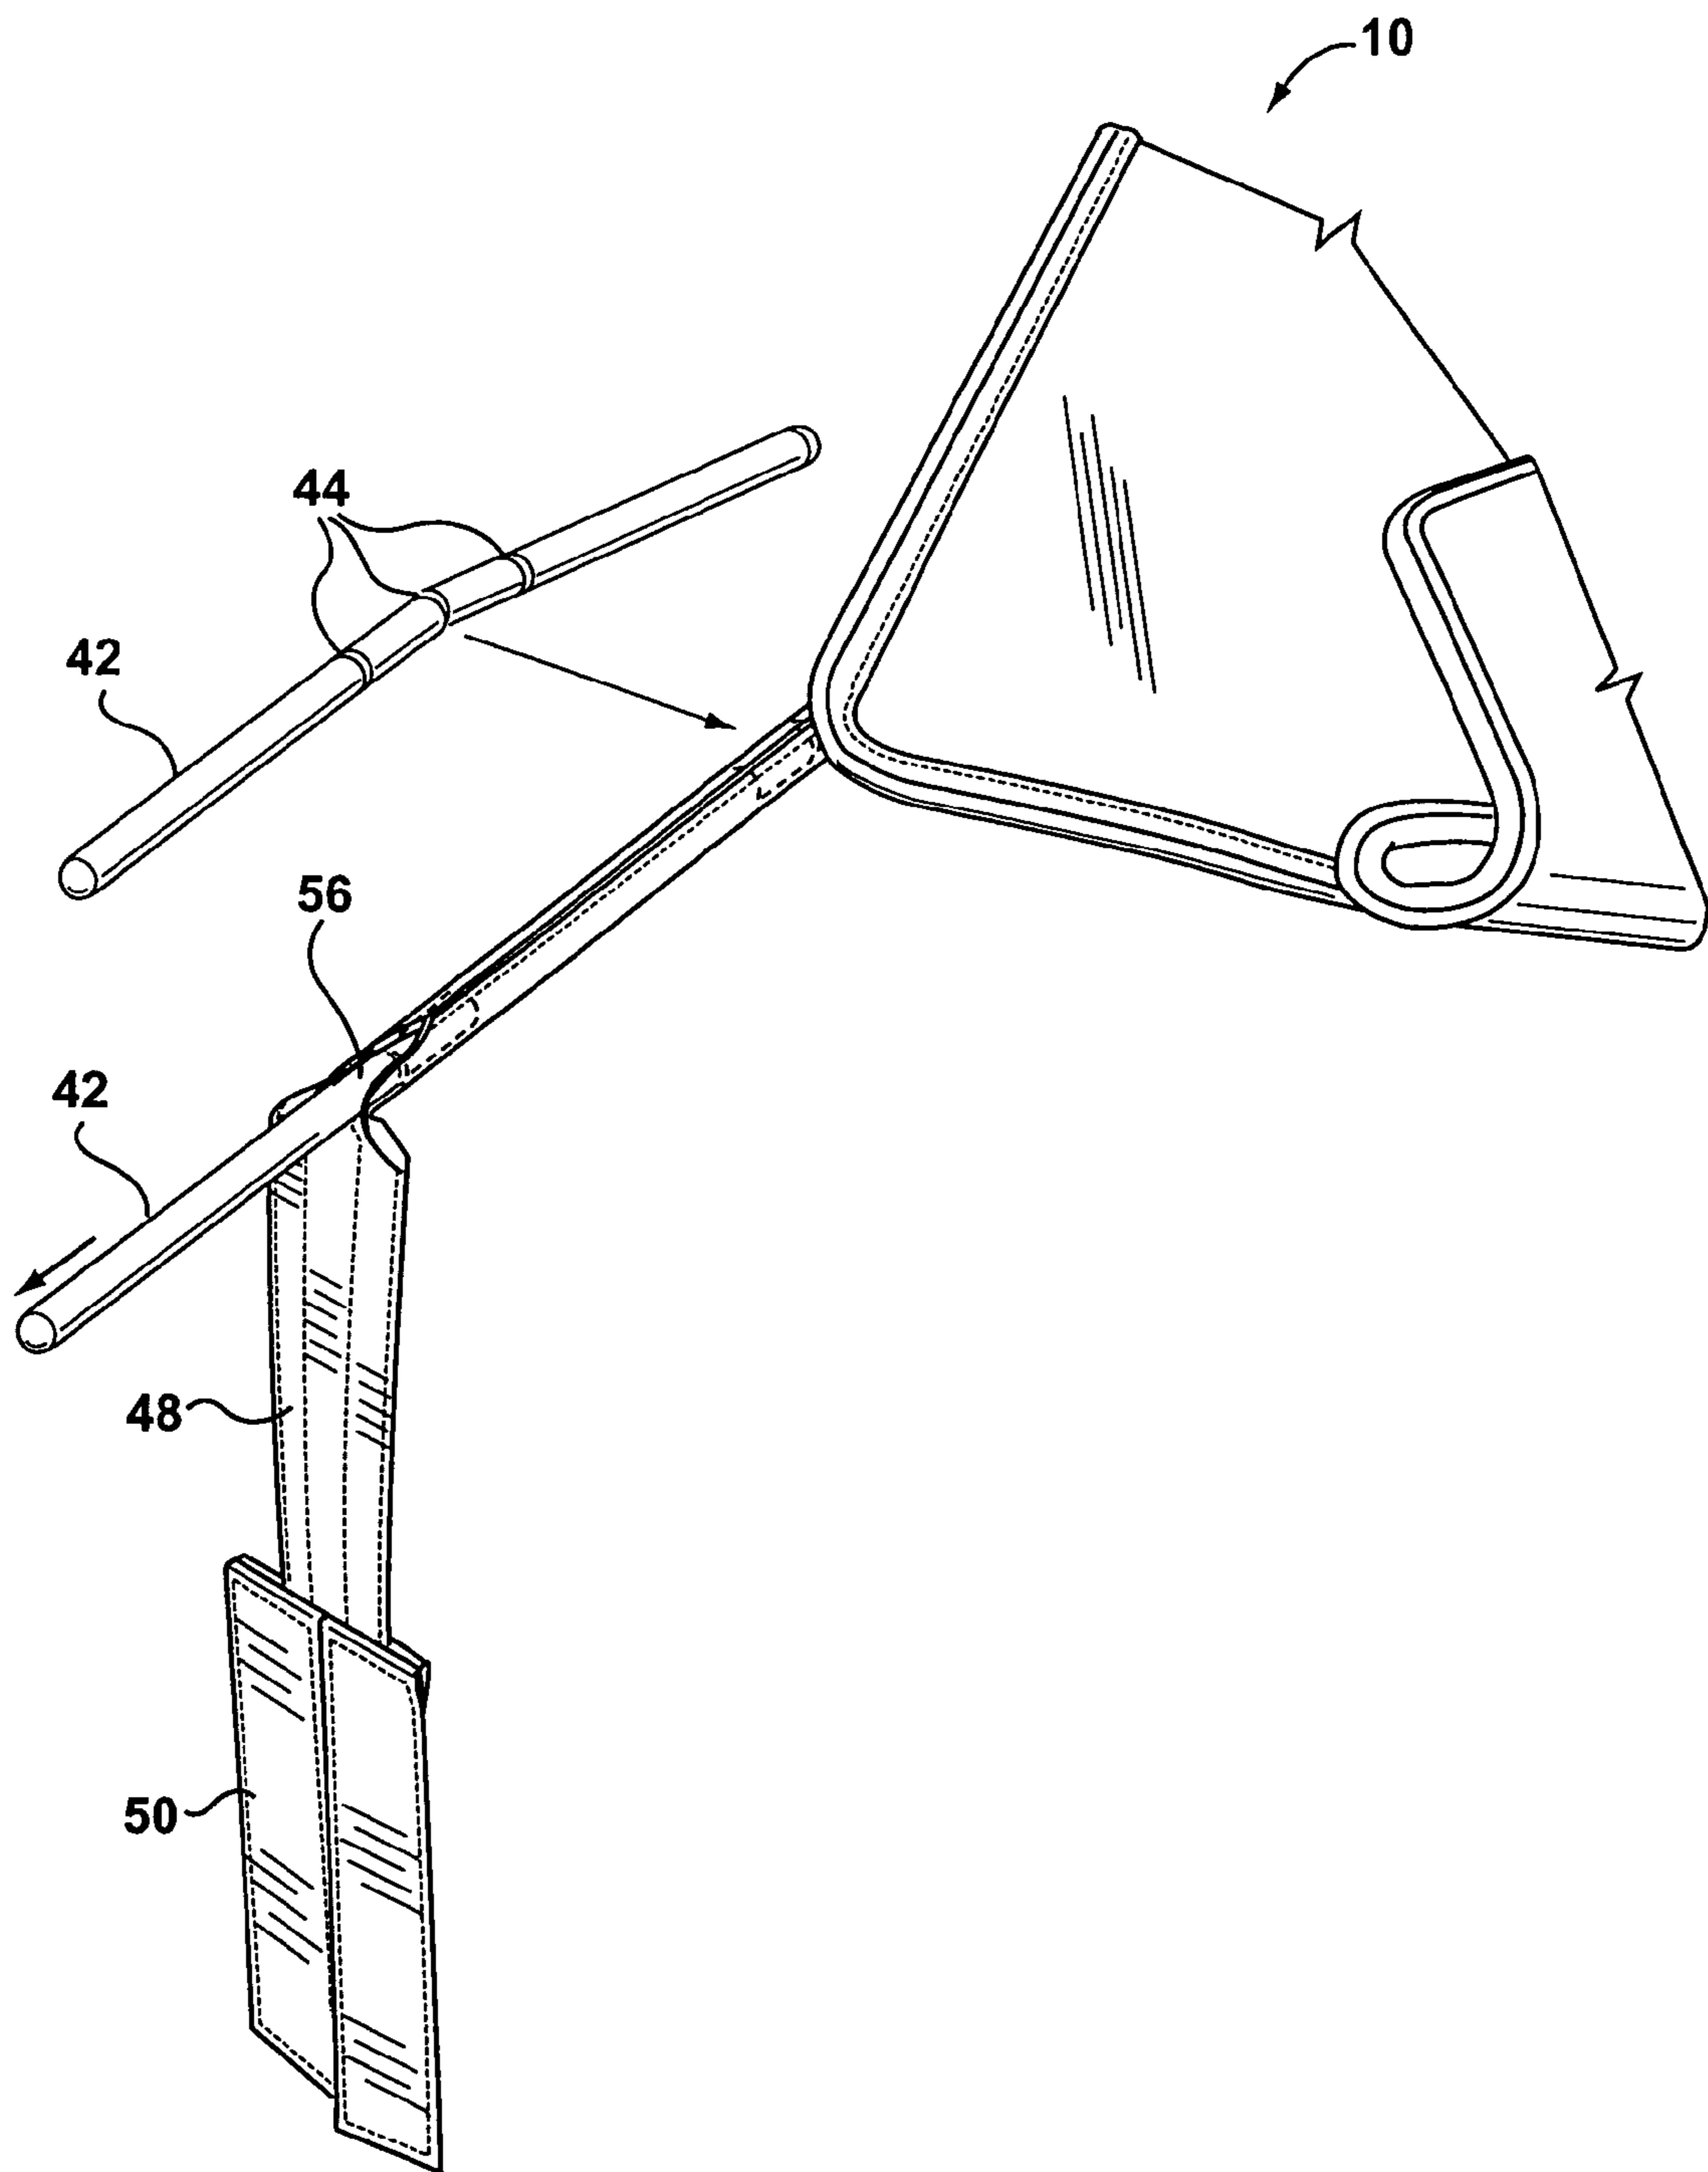
**FIG. 6**

FIG. 6 is a perspective view similar to that of FIG. 5 but showing a portion of the collision marking part being removed;

If the support rod **42** is broken, then it can be removed from the fabric tube **40** through a small hole **56** (FIG. **6**) in the fabric tube **40**. The hole **56** is preferably dimensioned so that the support rod **42** must be pushed through the hole with some force, so that in normal use, the support rod **42** will not fall out of the fabric tube **40**. A new and unbroken support rod **42** can then be inserted in the fabric tube **40** to replace the broken rod.
